# **CHAPTER 9 Rigid Blocks**

GEER/EERI/ATC Cephalonia, Greece 2014 Report Version 1

## 9.1 Overview and Key Observations

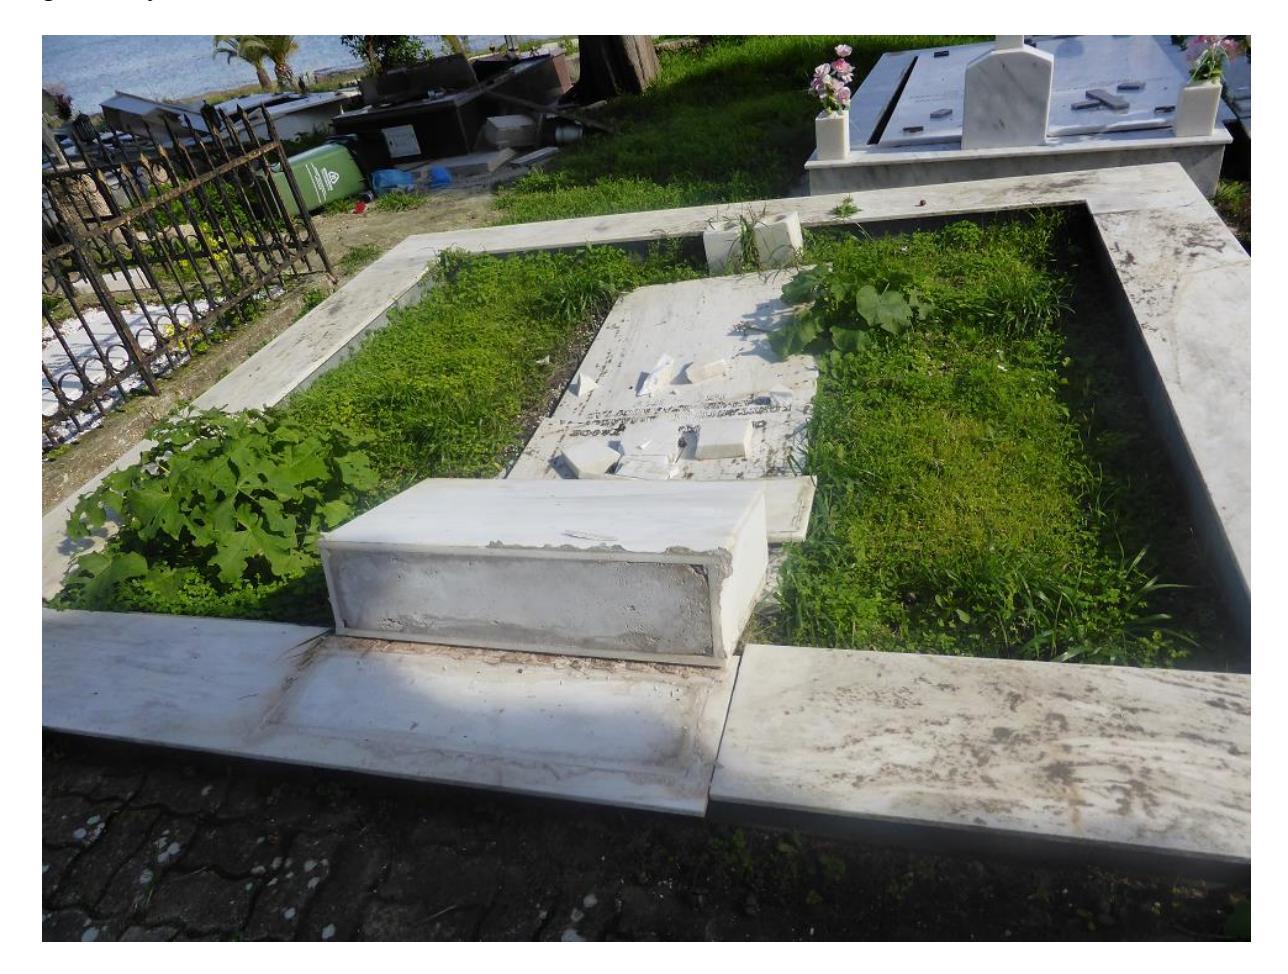
**Figure 9.1.2.** Overturning of the headstone in Lixouri cemetery taken on 2/9/14 by NTUA team (GPS coordinates: 38.192586, 20.438769).

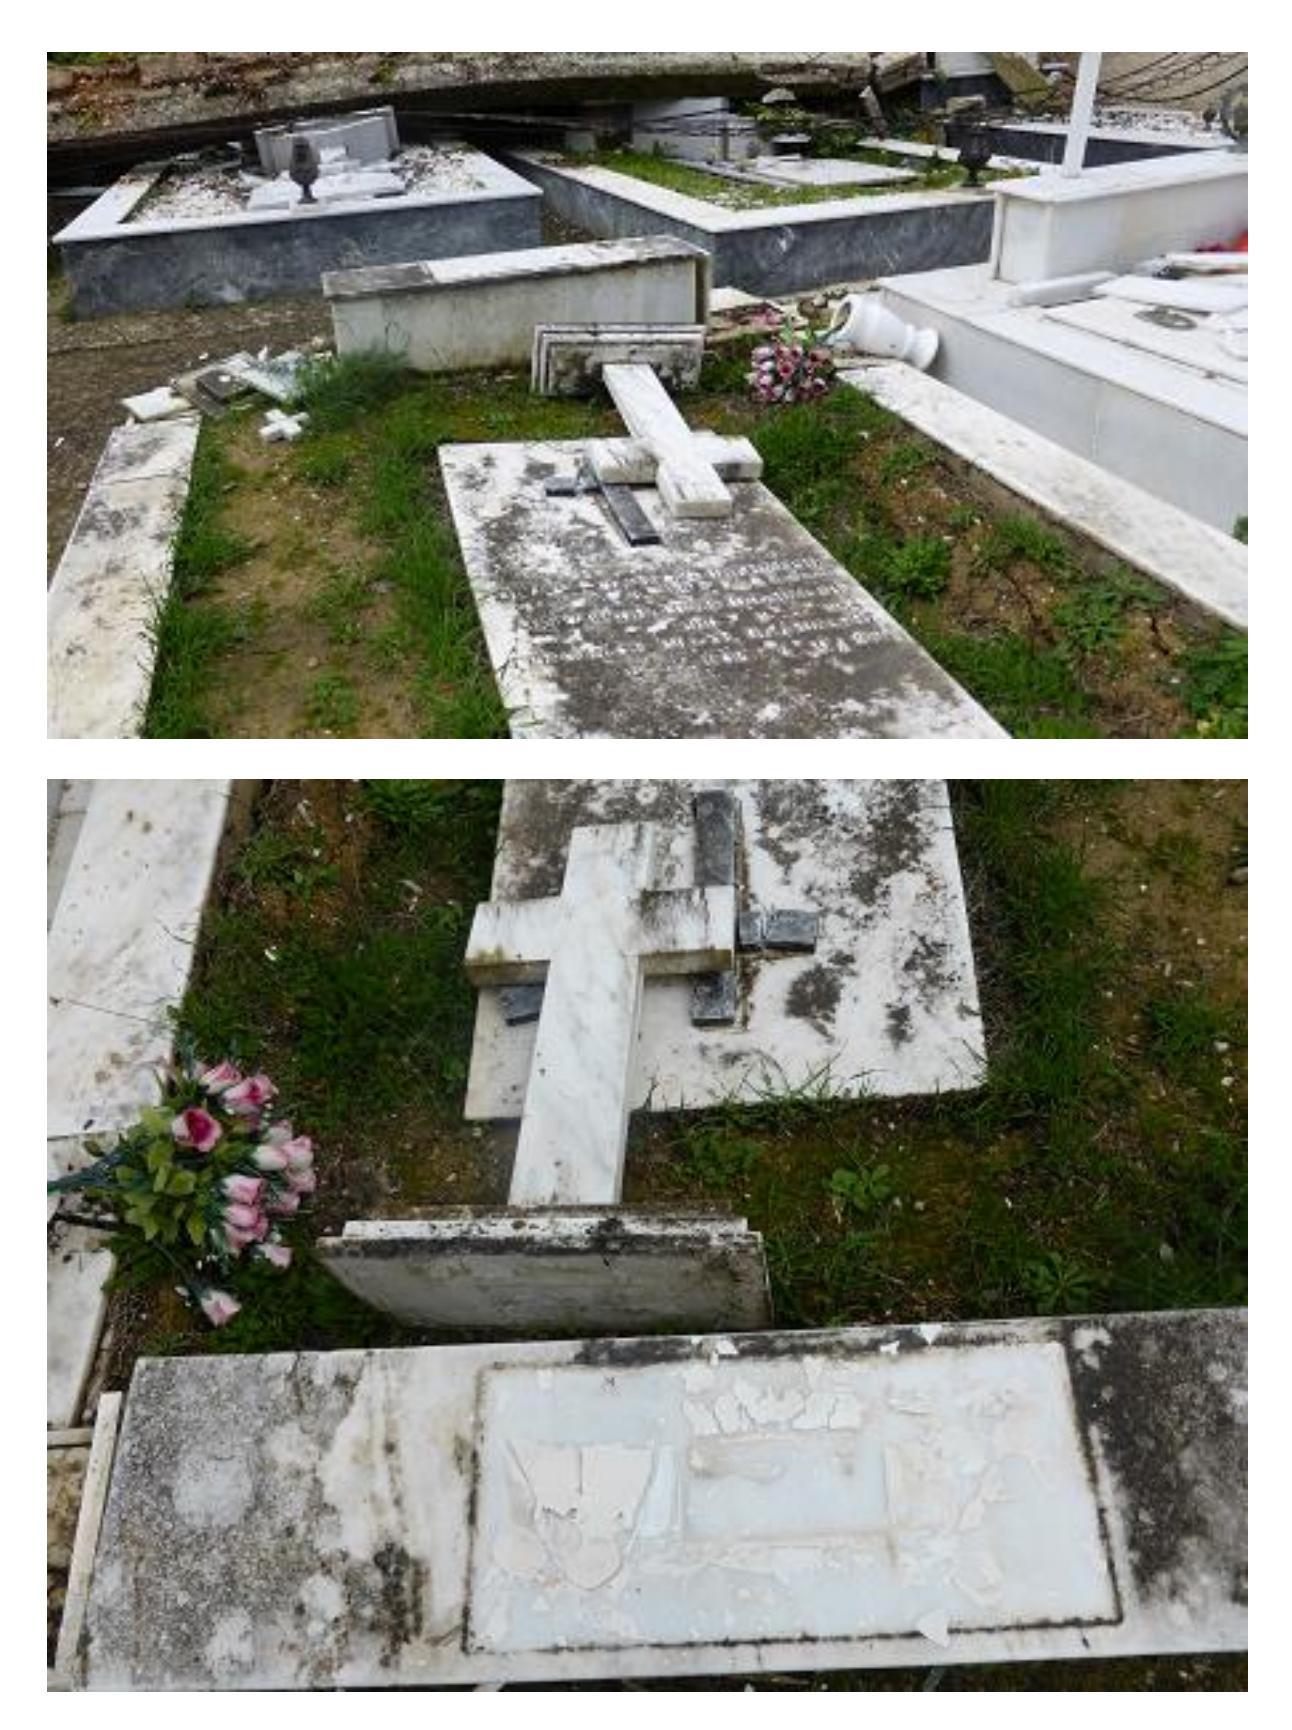
**Figure 9.1.3.** Toppling of marble head-cross in Lixouri cemetery taken on 2/9/14 by NTUA team (GPS coordinates: 38.255833, 20.42111).

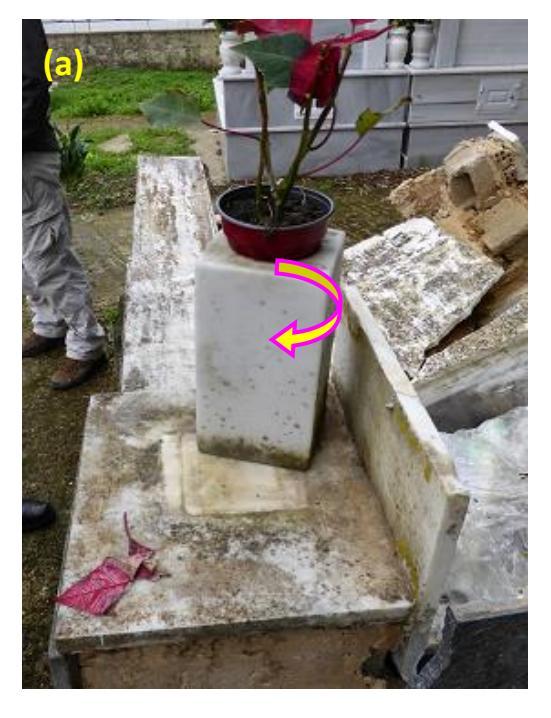
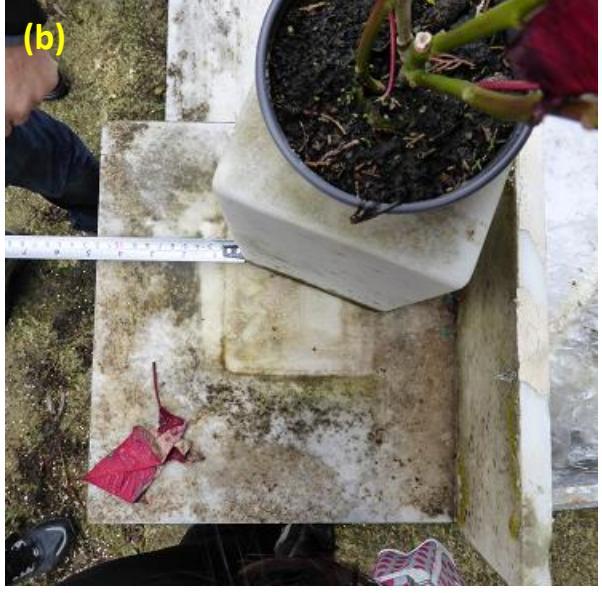
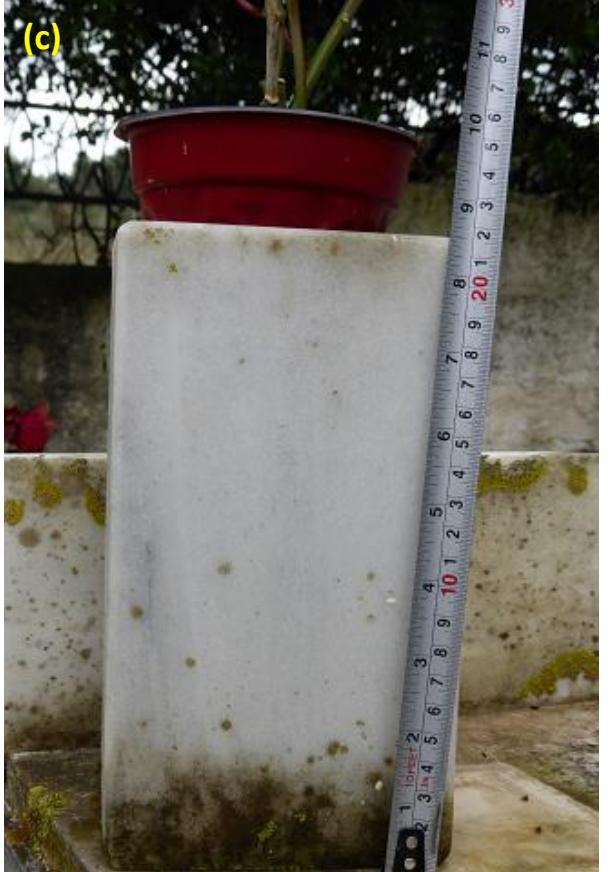
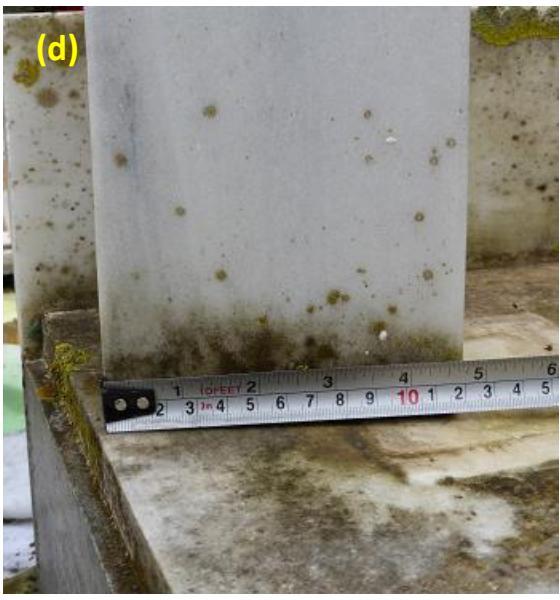
**Figure 9.1.4.** Displacement and rotation of a marble vase, responding as a rigid body at Livadi cemetery taken on 2/8/14 by NTUA team (GPS coordinates: 38.255555, 20.421111).

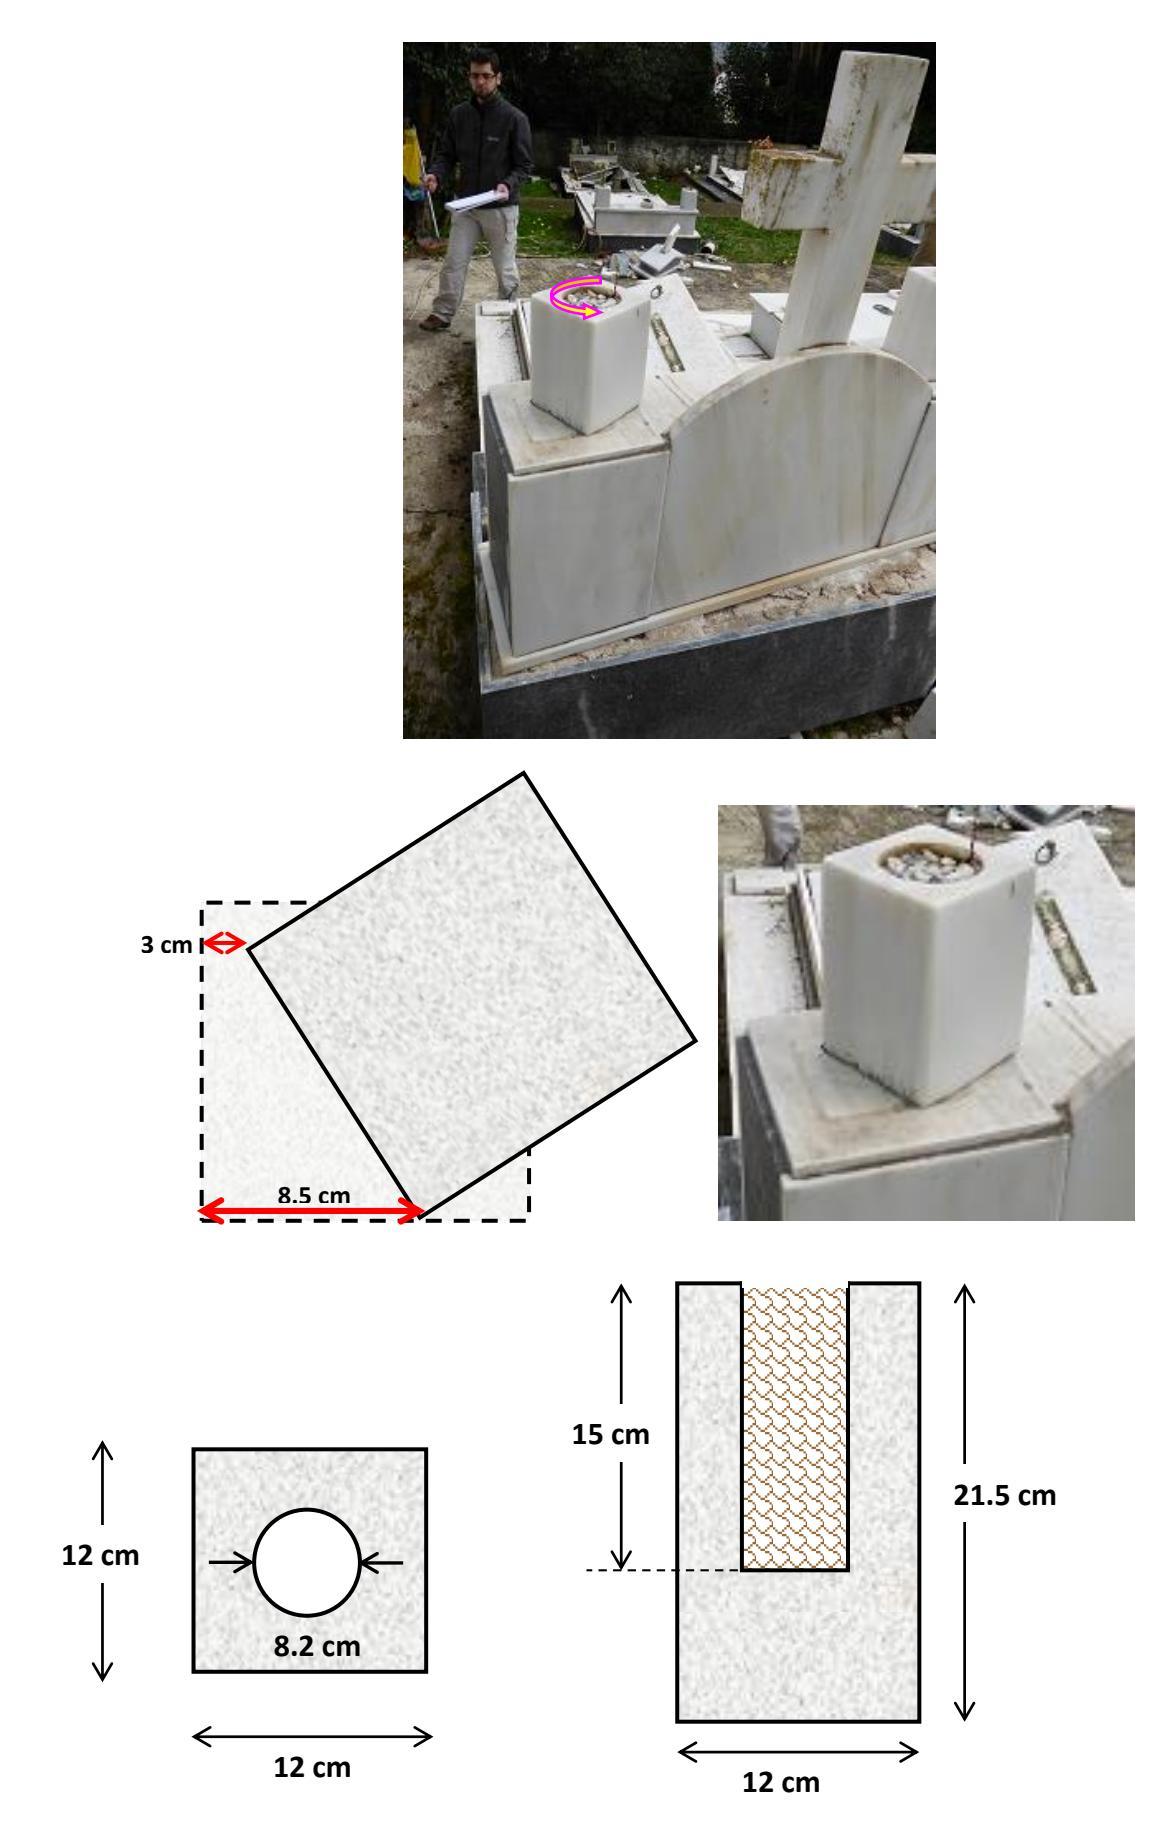
**Figure 9.1.5.** (a) A case of "double-rotation" in the Livadi cemetery: first rotates the massive headstone structure and then the marble vase. (b) Sketch of the dimensions and displacements of the slender marble artifact (GPS coordinates: 38.255833, 20.421111; NTUA team, 2/8/14).

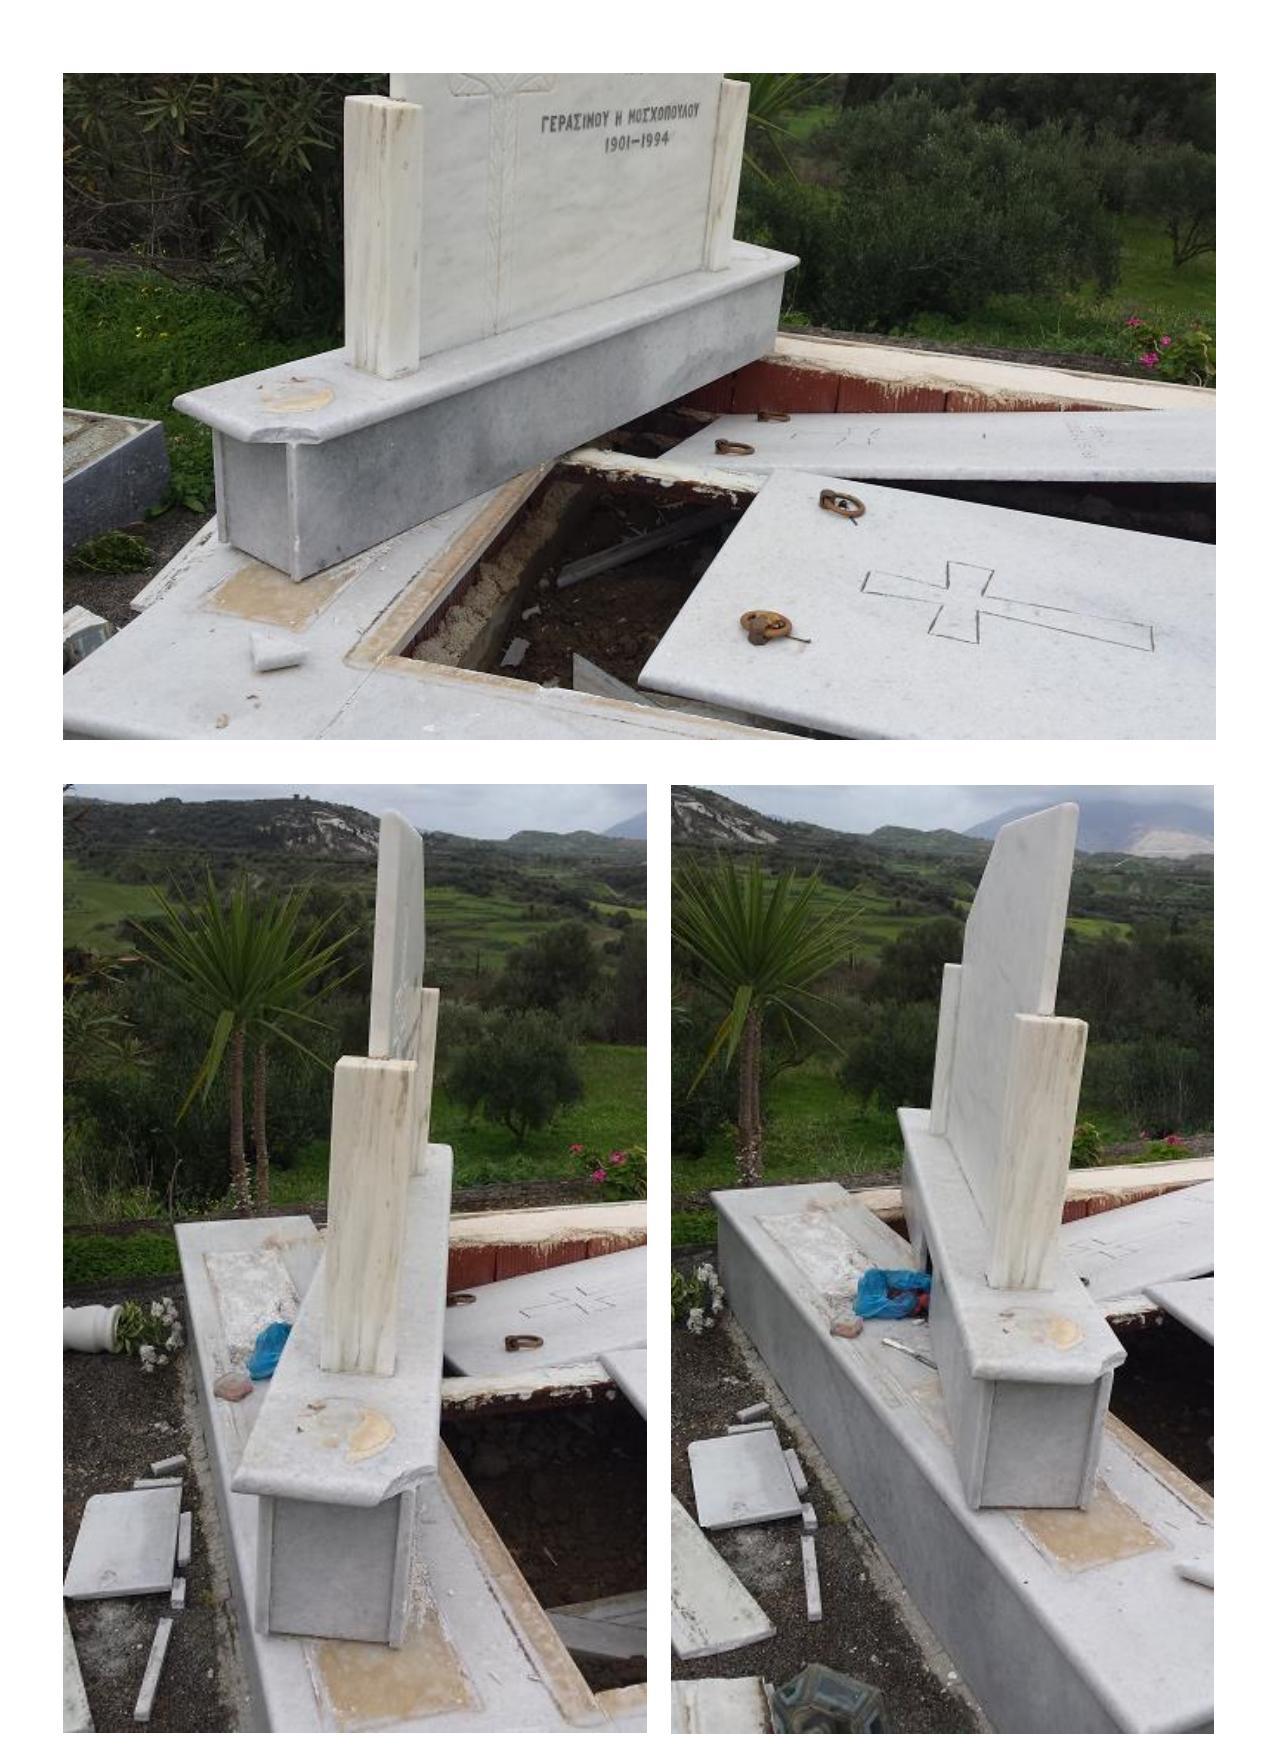
**Figure 9.1.6.** Rotation of a massive headstone in Chavriata (GPS coordinates: 38.183219, 20.389813). Photo taken by NTUA on 2/10/14.

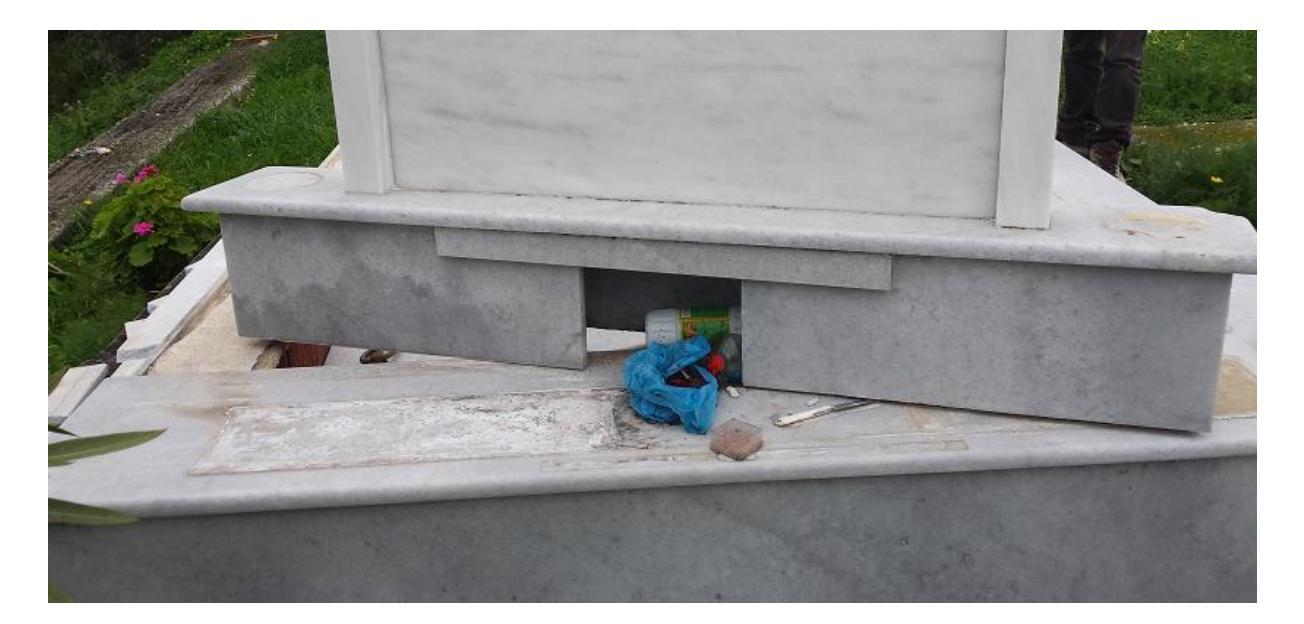
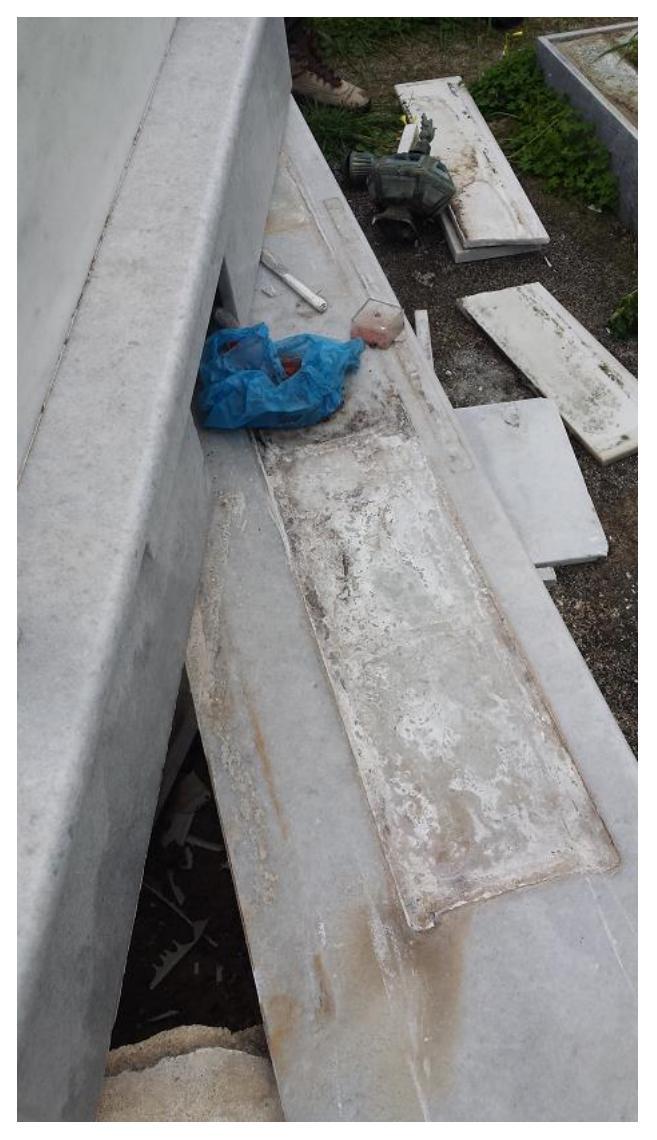
Figure 9.1.7. Detailed views of the previous photo taken on 2/10/14 by NTUA team (GPS coordinates: 38.183219, 20.389813).

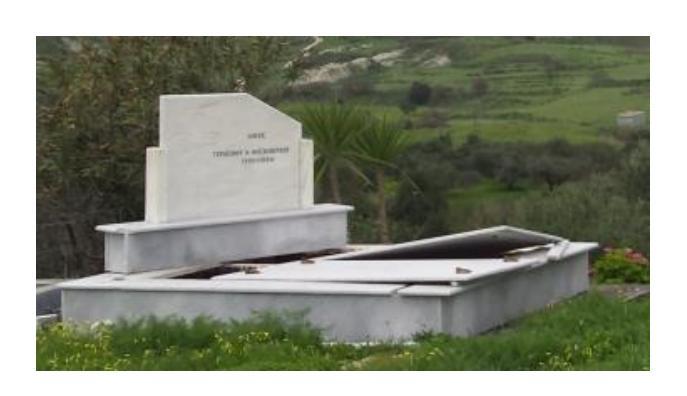
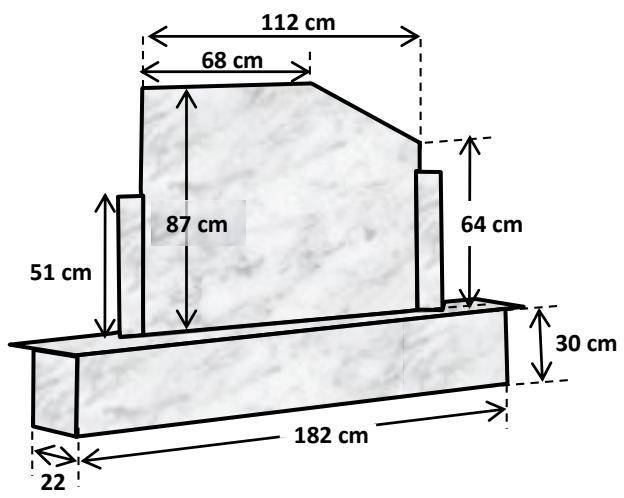
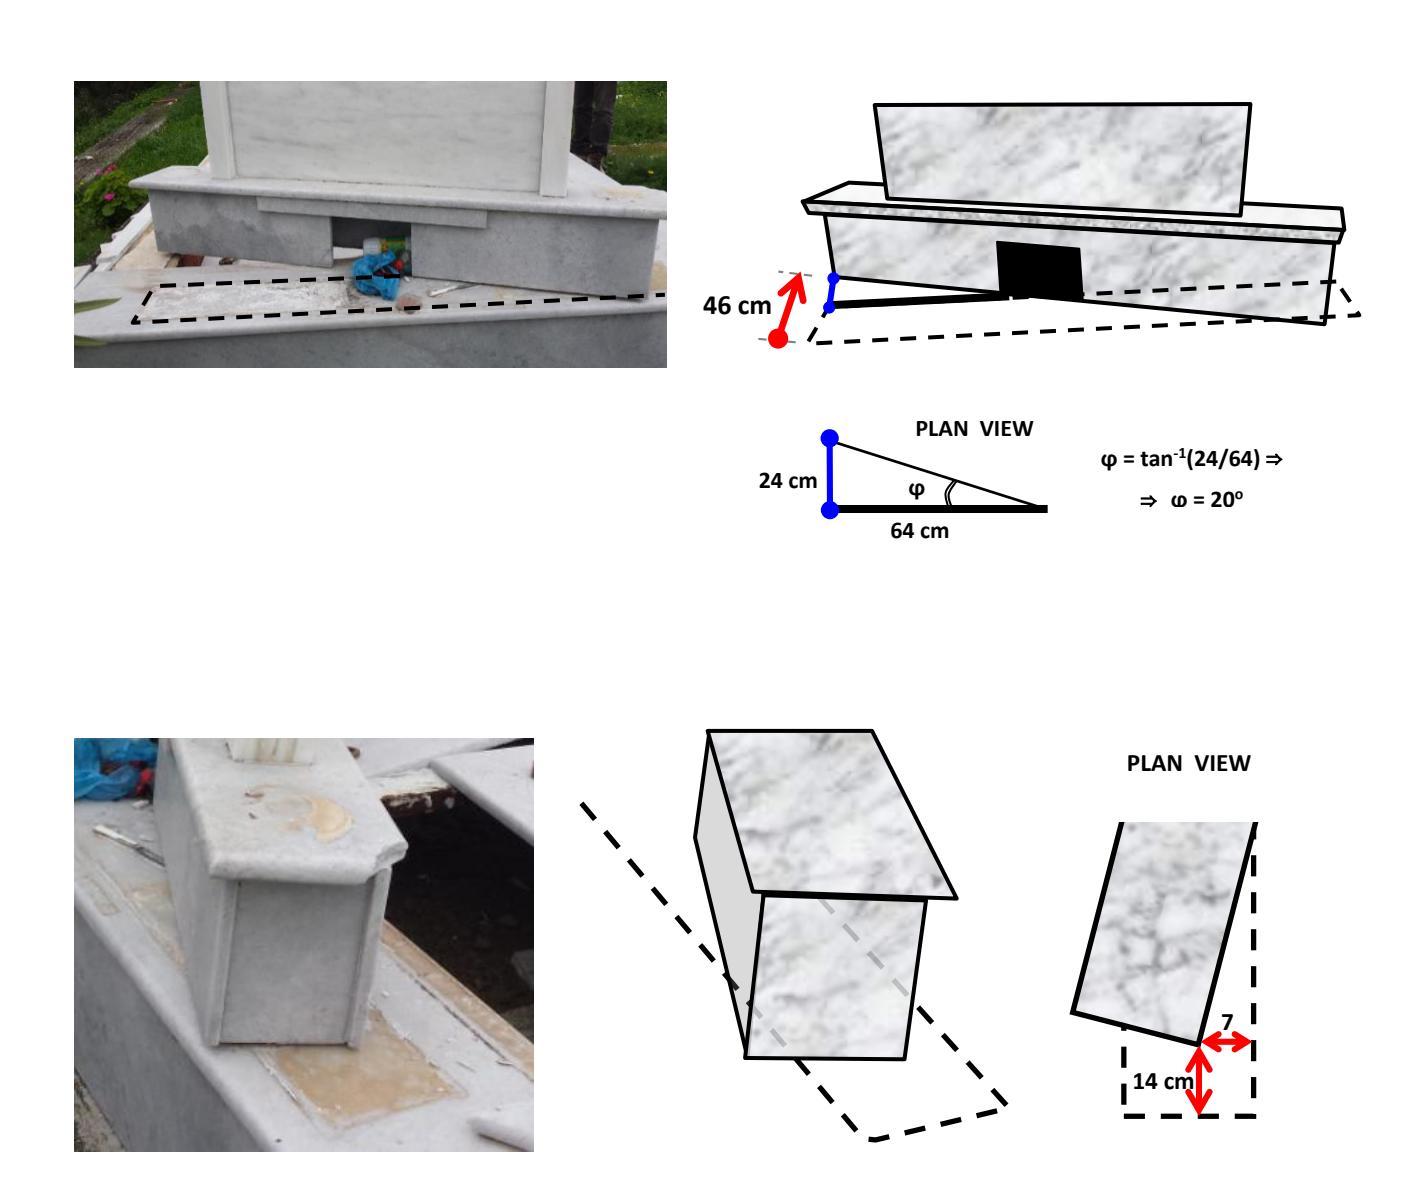
Figure 9.1.8. Sketch of the dimensions and displacement of rotated headstone.

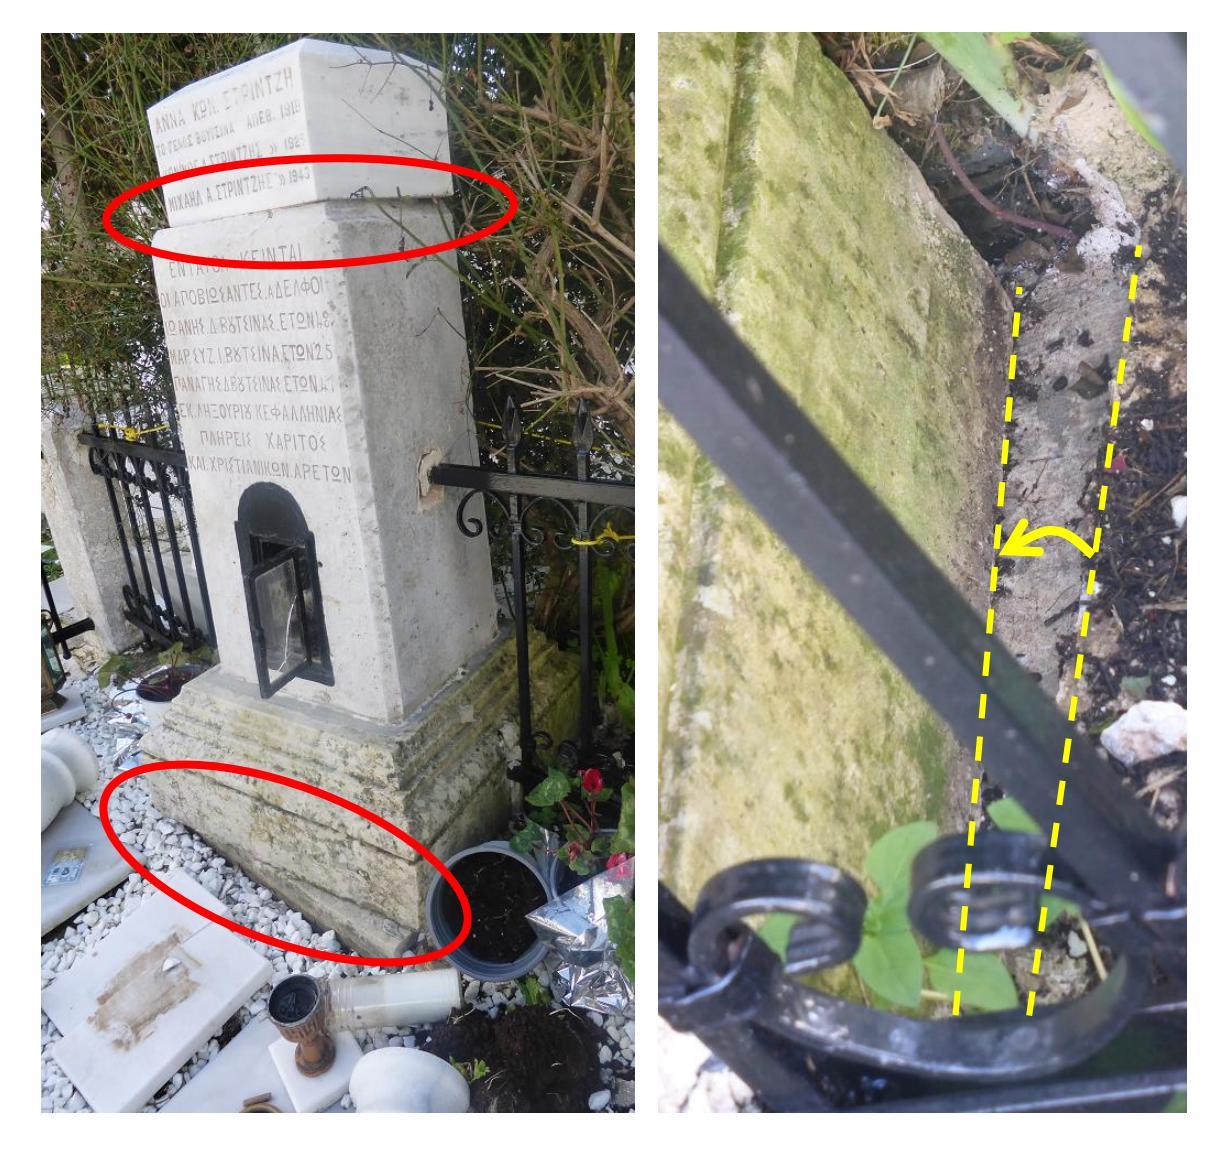
**Figure 9.1.9.** Double rotation of the headstone and its base in opposite directions. The photo on the left is a plan view of the rotation at the base. Lixouri cemetery, dated 2/9/14 (GPS coordinates: 38.192561, 20.438797).

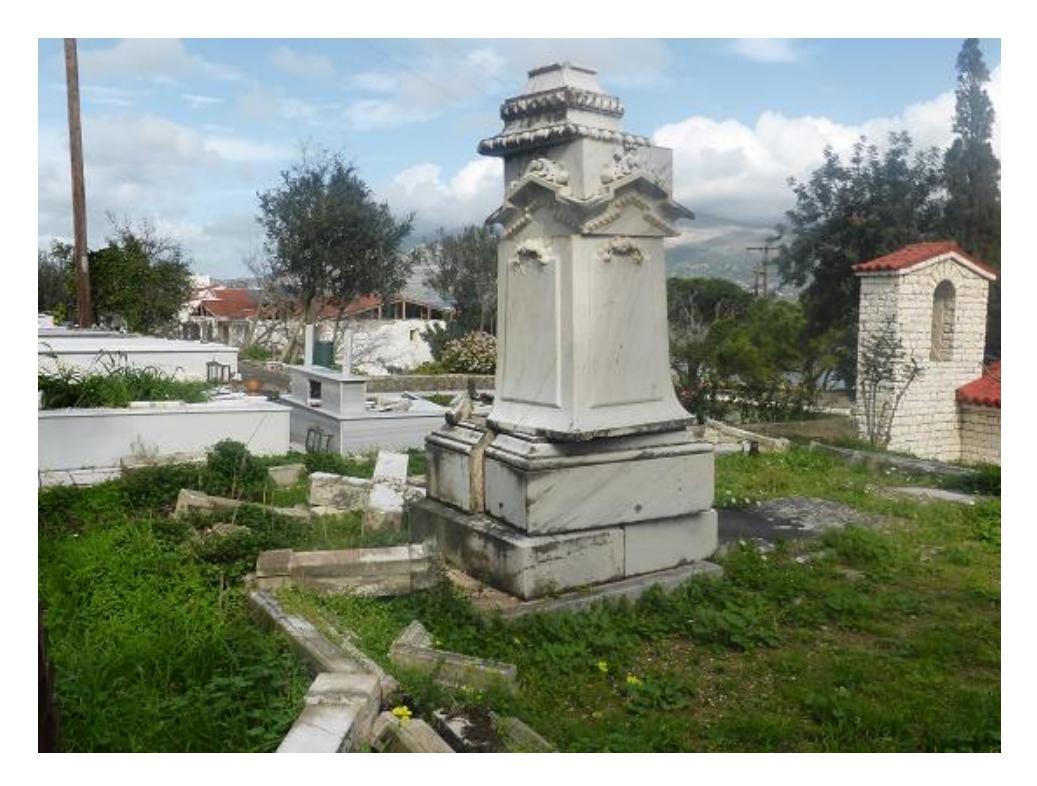
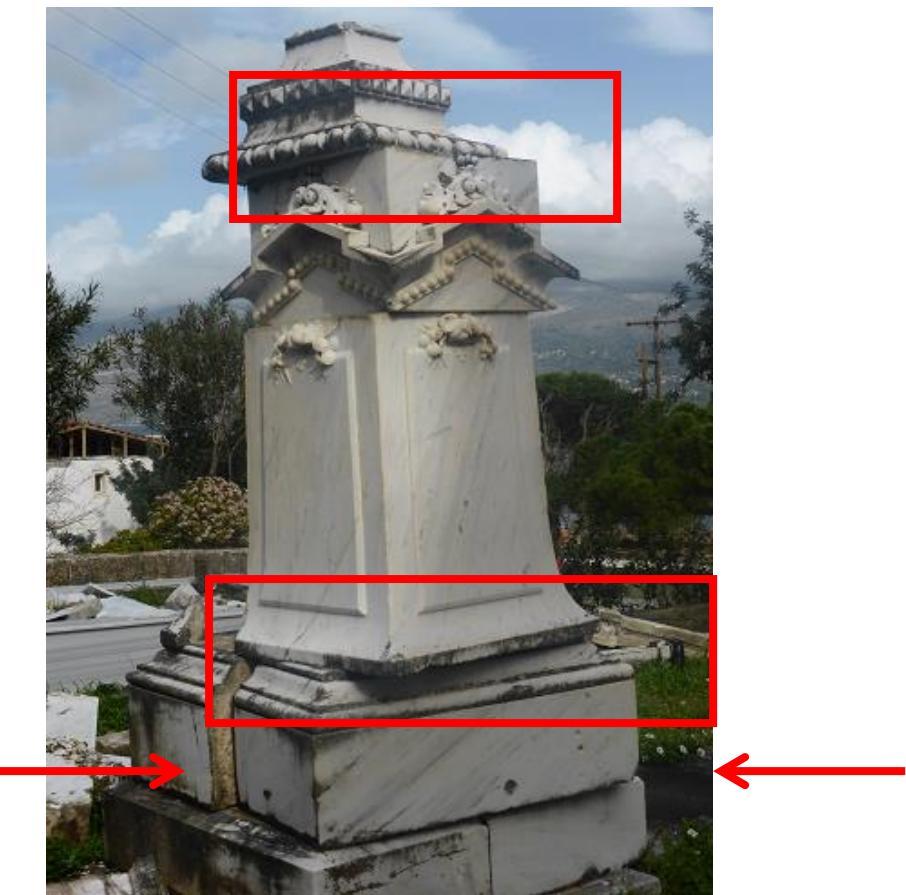
**Figure 9.1.10.** Detailed views of the rotational movement located at three different interfaces (shown with red rectangles and arrows). Rotations occurred in opposite directions. Lixouri photo taken on 2/9/14 by NTUA team (GPS coordinates: 38.192780, 20.438486).

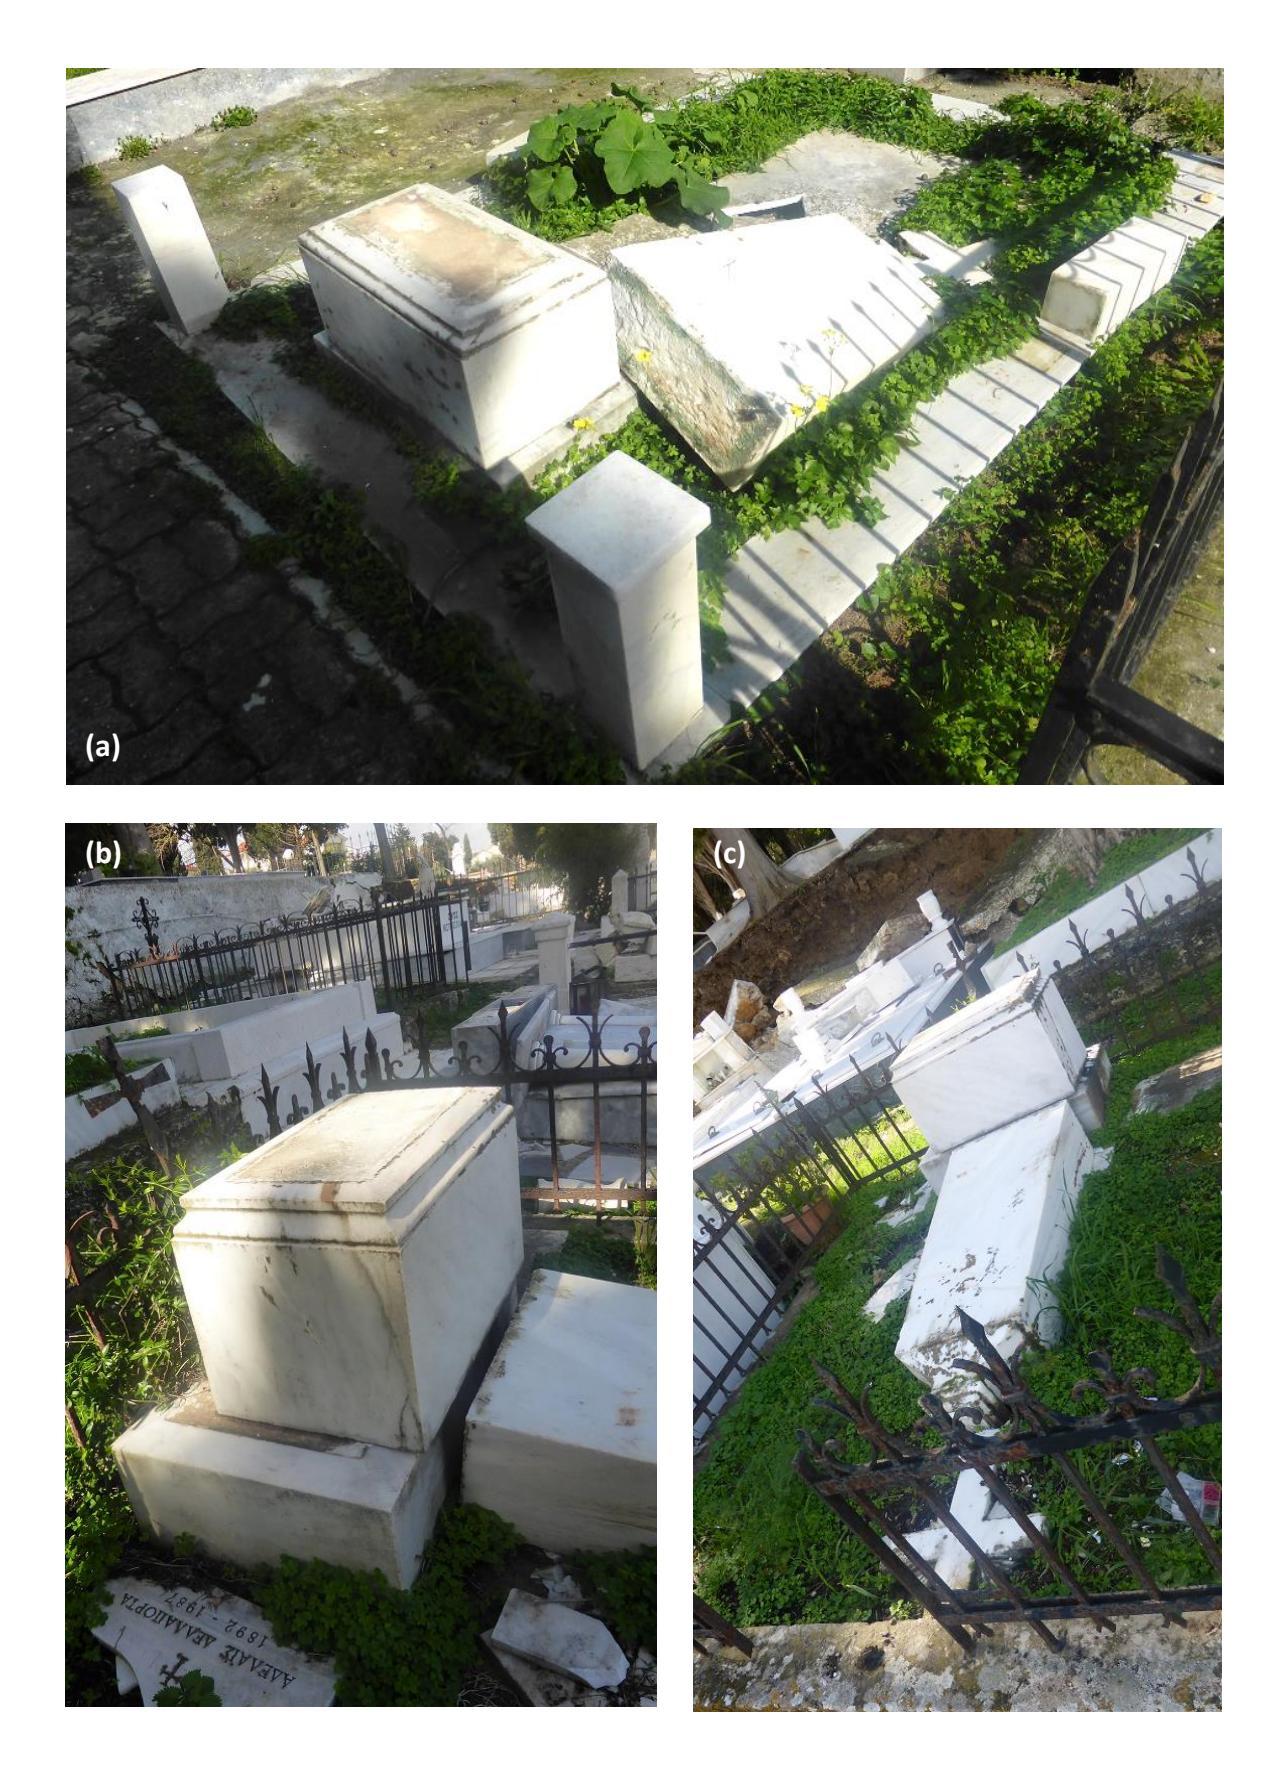
**Figure 9.1.11.** Detailed views of the rotated lower marble pedestal and toppling of the slender cross headstone. Lixouri cemetery, photo taken on 2/9/14 by NTUA team (GPS coordinates: 38.192436, 20.438666).

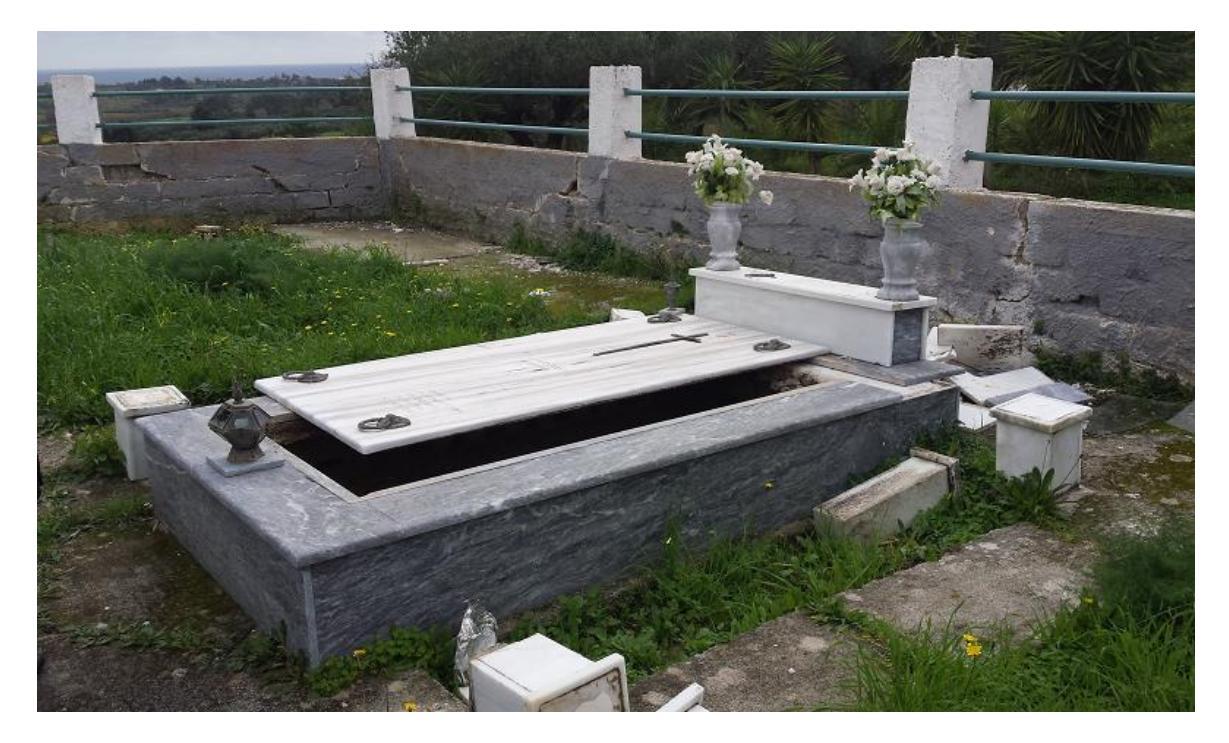
**Figure 9.1.12.** Toppled headstone (top) and horizontal slippage of tomb panel (bottom). Chavriata cemetery photo taken on 2/11/14 by NTUA team (GPS coordinates: 38.183013, 20.389619).

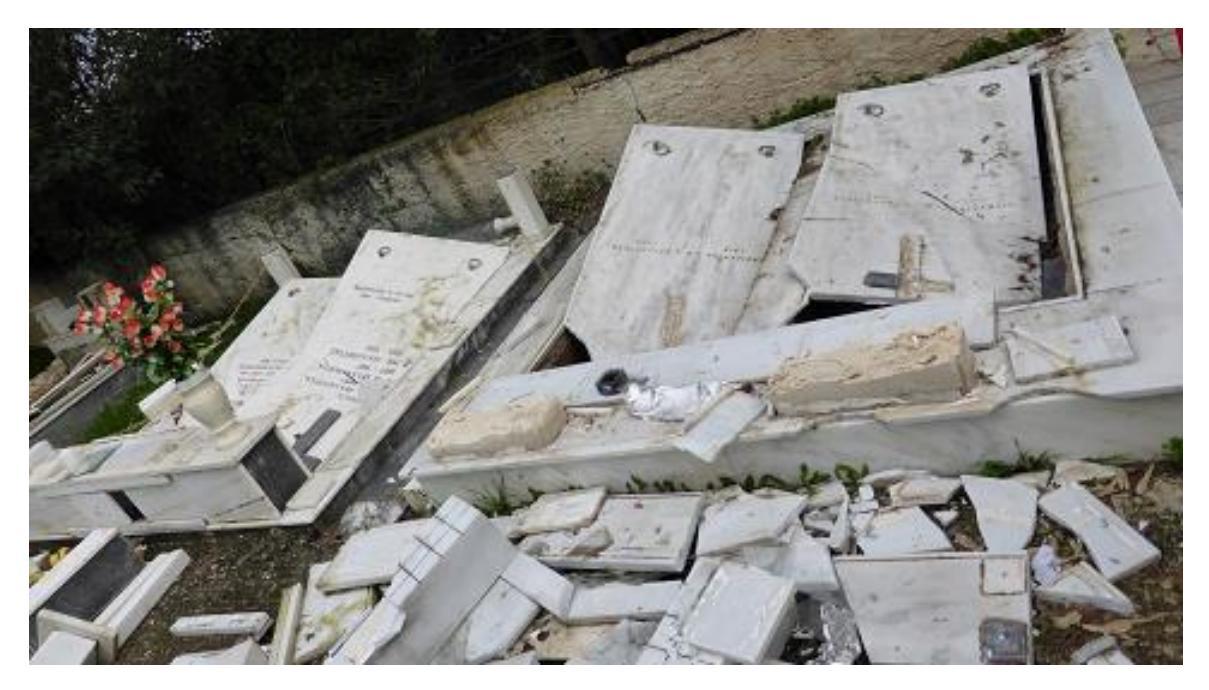
**Figure 9.1.13.** Rotation of several grave ledgers at the same direction in Livadi (GPS coordinates: 38.255833, 20.421111). Photo taken on 2/8/14 by NTUA team.

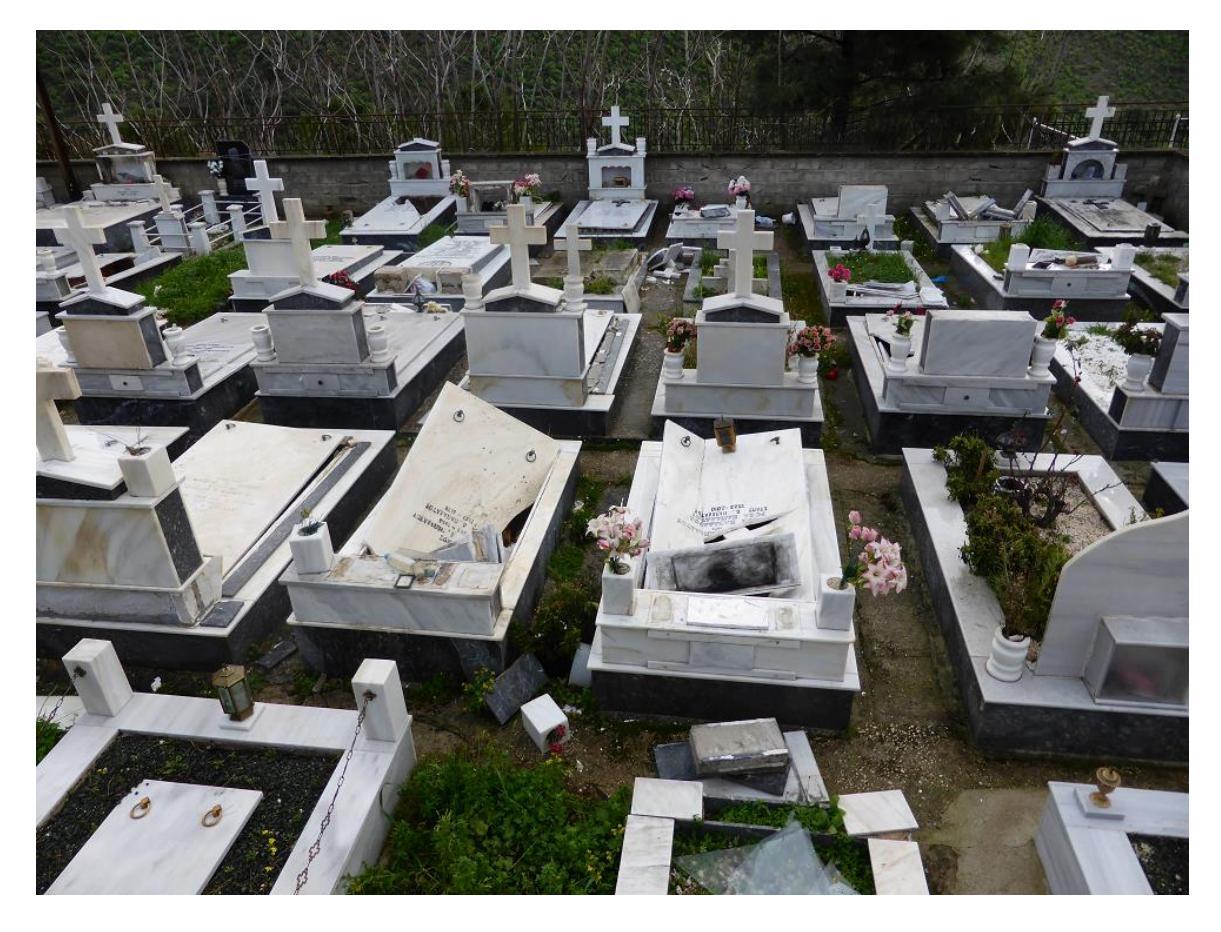
**Figure 9.1.14.** Cracked marble panels, toppled artifacts and overturning headstones in Kourouklata (GPS coordinates: 38.242500, 20.474166]. Photo taken on 2/8/14 by NTUA team.

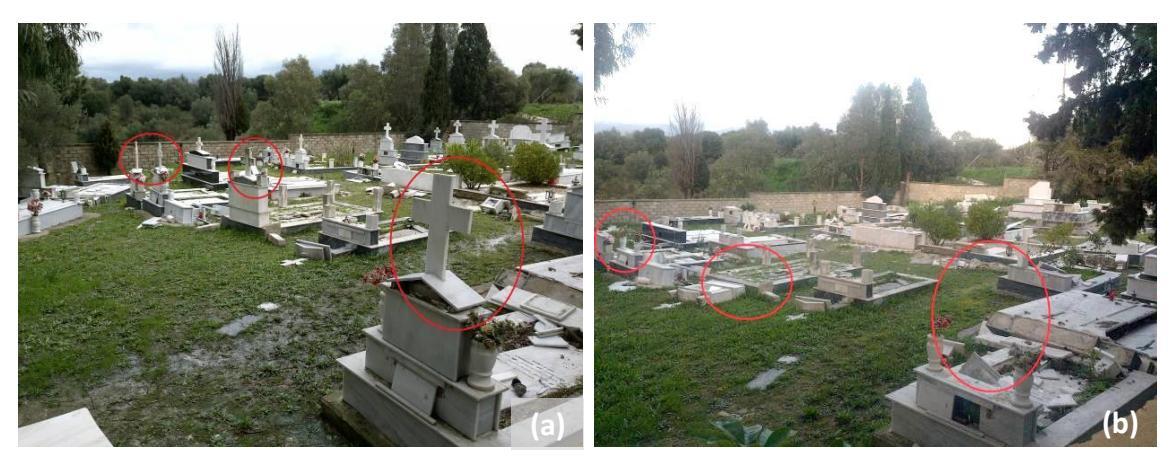
The Vouni village cemetery is the only one where observations were made after both the  $1^{st}$  and  $2^{nd}$  events. After the  $1^{st}$  event, the Vouni village cemetery experienced severe damage (Fig. 9.2.2a). Following the  $2^{nd}$  event, objects that were still standing after the first event, eventually toppled, as shown on Fig. 9.2.2b.

**Figure 9.2.2.** Vouni village cemetery [GPS: 38.178456, 20.404778] toppled objects following the: (a)  $1^{st}$  event (on 1/28/14) and (b)  $2^{nd}$  event (taken on 2/20/14). Photos by ITSAK and DUTH teams.

However, the investigators could not verify these statements in most of the cemeteries based on our observations solely without analytical studies. In fact, Fig. 9.2.2 contradicts this assertion, since minimal damage was caused by the 1<sup>st</sup> event, while most of the damage seems to have been inflicted by the 2<sup>nd</sup> event.
