# **CHAPTER 9 Rigid Blocks**

GEER/EERI/ATC Cephalonia, Greece 2014 Report Version 1

## 9.1 Overview and Key Observations

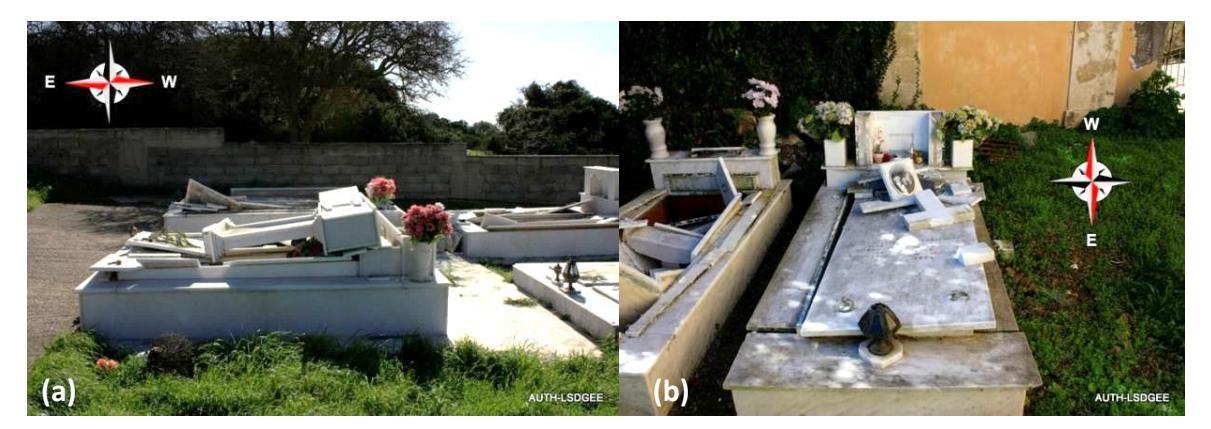
**Figure 9.2.3.** Objects toppled mainly towards the East: (a) Atheras [38.311280, 20.418498] and (b) Kontogennada East [GPS: 38.250936, 20.396137]. Photos by AUTH team on 2/11/14.

Notably, in most cemeteries inspected, the rigid objects (crosses, vases, markings) placed on the tombs generally oriented in the EW direction, persistently toppled towards the East (Fig. 9.2.3). In very few cases, crosses toppled towards the West (Fig. 9.2.4). This observation may suggest strong near-field effects, with a single or multiple pulses being responsible for the almost uniform direction of toppling. Analyses based on recorded ground motions is needed to confirm near-field effect assumption. However, analytical investigations in the literature reveal sensitivity of the direction of toppling to details of the rocking block geometry, restitution coefficient, and excitation waveform (assuming horizontal rocking plane), which make the possibility of unilateral topping hard to justify. No systematic effort has been conducted to establish if the rocking plane was indeed horizontal, or soil settlements caused an inclination in the direction of the grave (i.e., in East). Likewise, no variability of damage related to the grave construction method was established, since by inspection no major construction variations were identified among the total of ten funeral homes of the island by inspection.

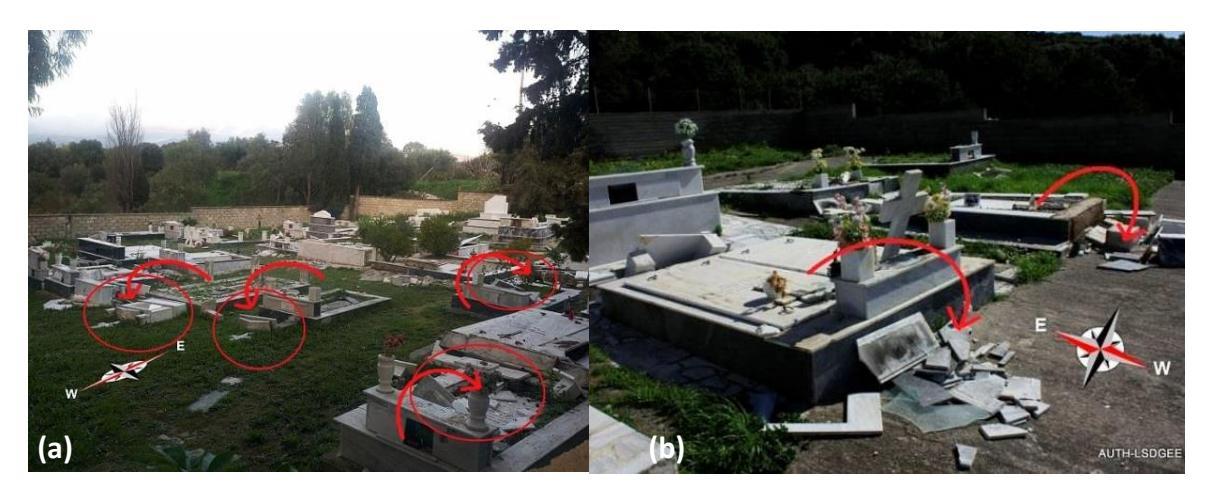
**Figure 9. 2.4.** Cases of tomb objects toppling to the West: (a) Vouni [GPS: 38.178455, 20.404778] and (b) Atheras [GPS: 38.311280,2 0.418498]. Photo by DUTH and AUTH teams on 2/11/14.

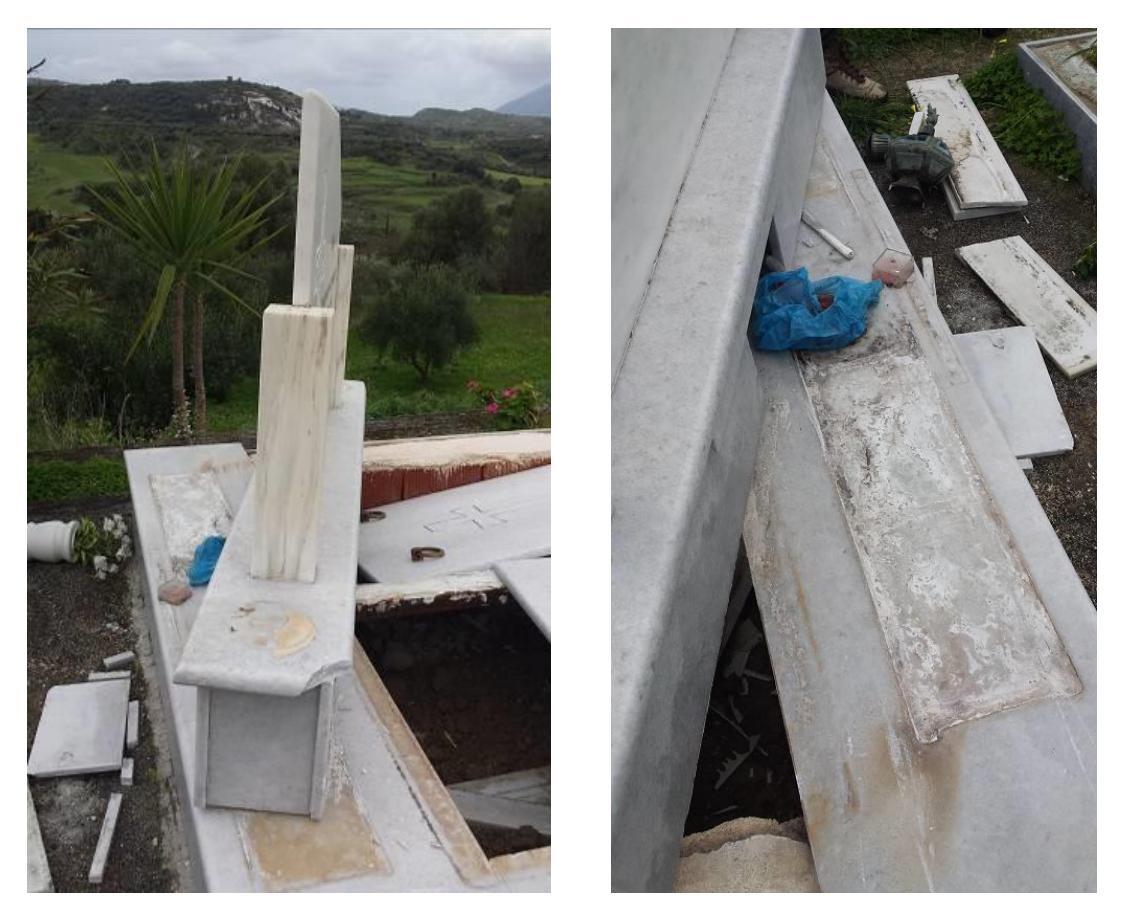
The principal cause of tomb damage was object toppling on the grave marble slab, resulting in rupturing the latter. Other types of damage observed in tombs were slippage, vertical separation, and/or rotation of blocks and tombstones, without toppling. Marble blocks are displaced and rotated as seen in Fig. 9.2.5 at the cemetery of Chavriata [GPS: 38.183026, 20.389692]. Similar response was observed at the southern cemetery of Kourouklata, behind the church shown in Fig. 9.2.6 [GPS: 38.242544, 20.474056].

**Figure 9.2.5.** Rotation of a massive headstone, responding as a rigid body without toppling, at the Chavriata cemetery [GPS: 38.183219, 20.389813]. Photo by NTUA team on 2/10/14.

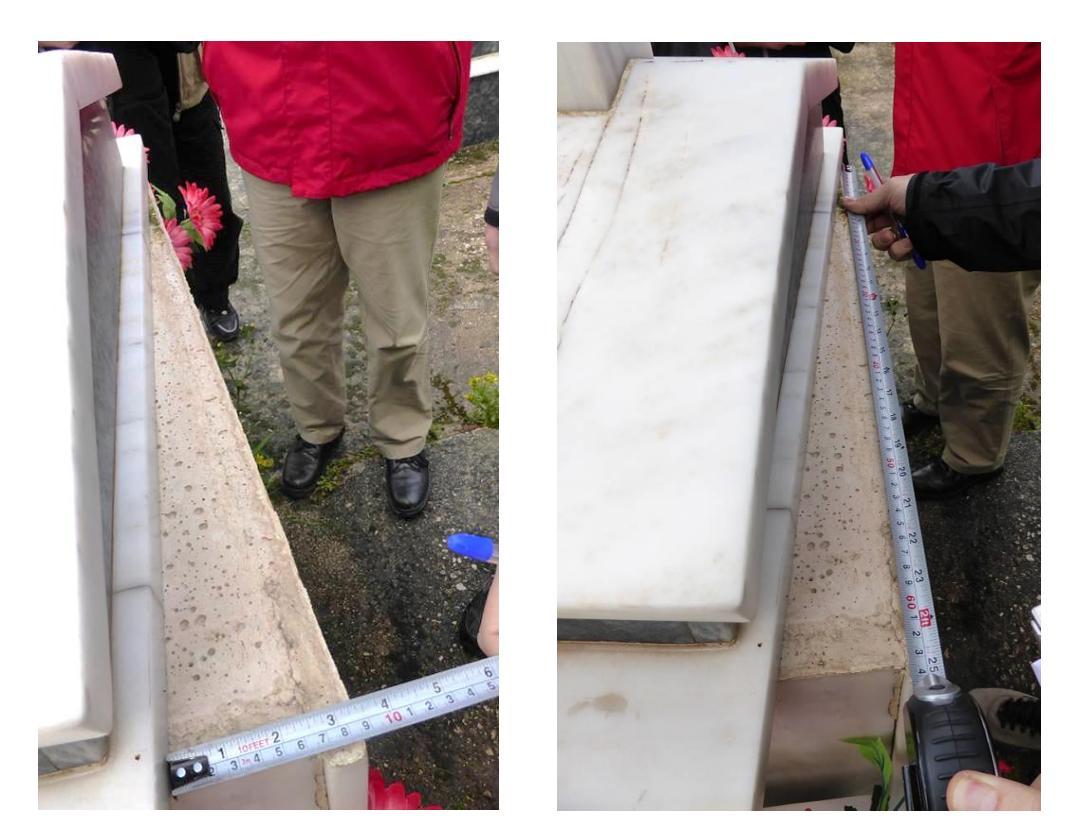
**Figure 9.2.6.** Headstone rotation without toppling at the south cemetery of Kourouklata [GPS: 38.242361, 20.474188]. Photos by NTUA team on 2/8/14.

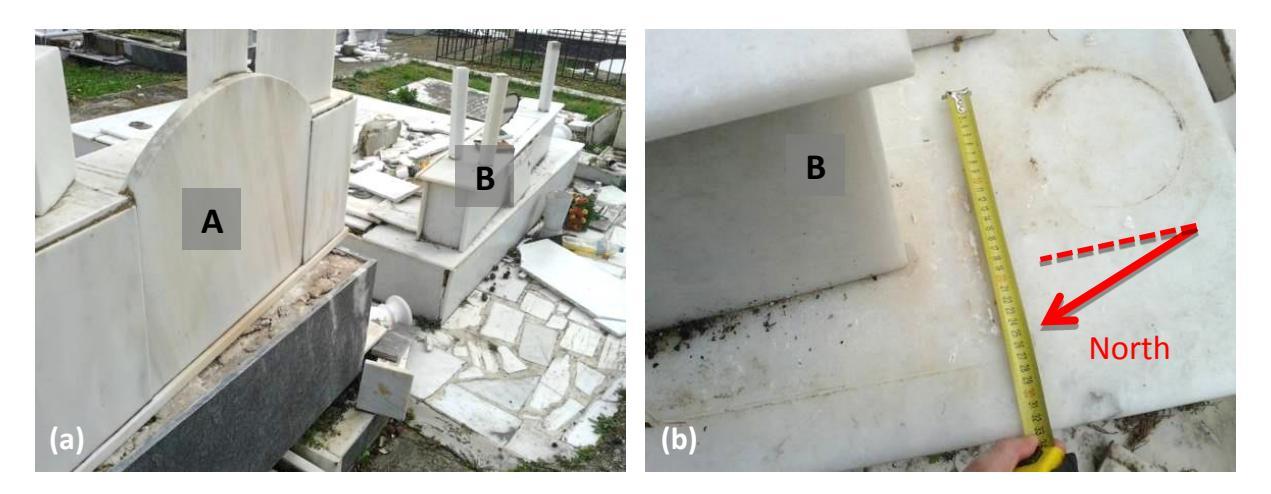
Another interesting case of marble block dislocation was observed in the Livadi cemetery [GPS: 38.255689, 20.421035]. Notice the practically identical type of sliding and rotation of two neighboring low rise marble block constructions (A and B) on Fig. 9.2.7(a). The detail in Fig. 9.2.7(b) is related to marble block construction B, which reads a displacement of 8.7 cm to the North, 8.1 cm to the East, and a counter-clockwise rotation of approximately 3.5°. If these displacements were due to a single shaking, they could qualitatively indicate that ground motions at the Livadi cemetery had comparable intensities in both the NS and EW directions. Since reconnaissance was performed by the UTH team only after the 2<sup>nd</sup> event, this hypothesis cannot be confirmed. The observed damage could likely involve asymmetric friction under the blocks or even a torsional excitation component, and possible variations in cohesive/frictional resistance under the blocks, especially block A.

**Figure 9.2.7.** Livadi cemetery [GPS: 38.255689, 20.421035] after the 2<sup>nd</sup> event: (a) Displacement and rotation of two neighboring low rise marble block constructions (A and B) and (b) Detail of displacement and rotation of marble block construction B. Photos taken by UTH team on 2/8/14.

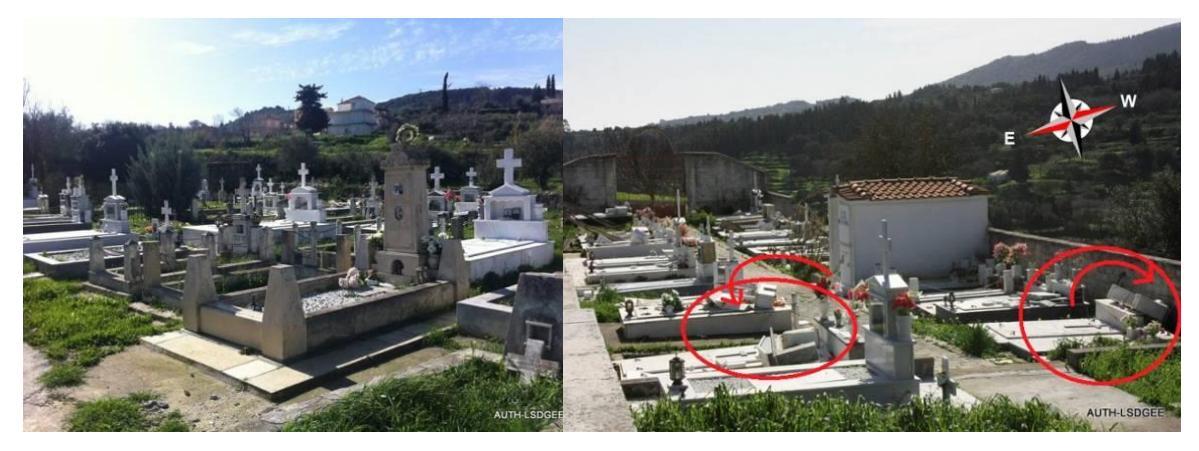
It is unclear whether the distance from source (fault trace and dip angle not precisely determined by seismologists yet) in the meioseismal area was as important as soil and topographic conditions. In the village of Skineas [GPS: 38.240479, 20.395151], 7% of tomb objects toppled, while the rest are still standing (Fig. 9.2.8a). In contrast, just 1 km away, at the village of Vlihata [GPS: 38.238268, 20.403932], more than 70% of objects

**Figure 9.2.8.** In (a) Skineas [GPS: 38.240479, 20.395151] a mere 7% of objects toppled; in 0.8 km east at (b) Vlichata [GPS: 38.238268, 20.403932] 71% of objects toppled. AUTH photos, 2/11/14.

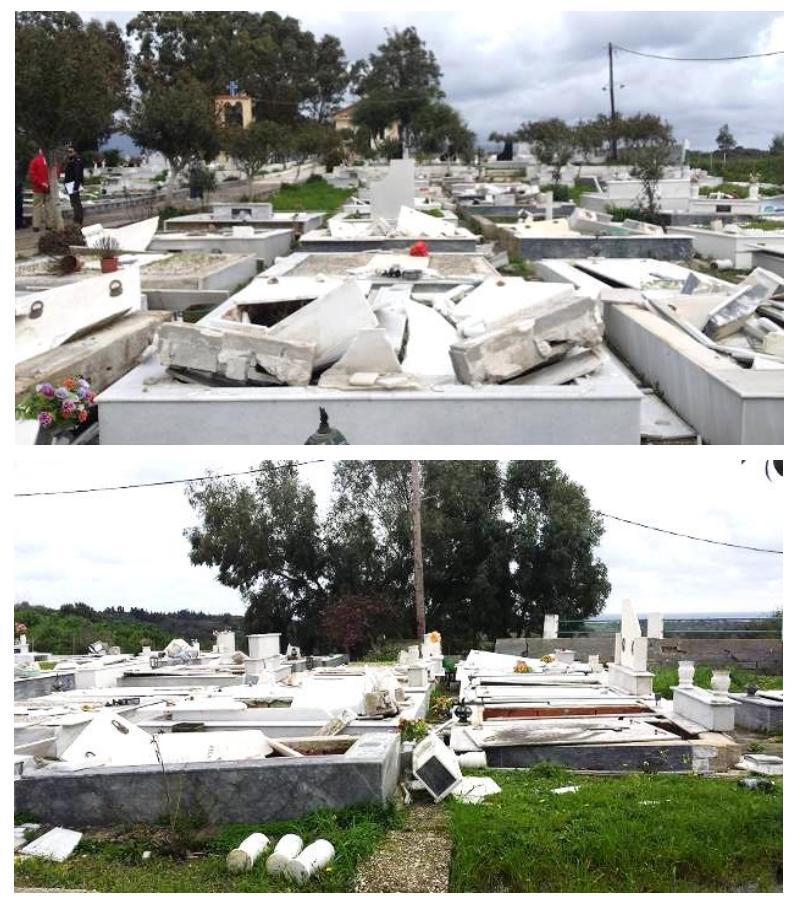
Nevertheless, the extent of damage of the cemeteries investigated is a clear evidence of the tremendous intensity of the ground motion, probably in all three components. This is compatible with the strong motions that were recorded in Lixouri and Chavriata (PGAs of the order of 0.6 to 0.7g, peak velocities reaching 120 cm/s in Lixouri). Since many cemeteries were often built on hills, it is reasonable to expect that topographic amplification has contributed to the intensity of ground motion in many cases. Strong evidence supporting this assumption was found at Chavriata cemetery, where 87% of tombs toppled (Fig. 9.2.9).

**Figure 9.2.9.** View of total destruction view at Chavriata cemetery [GPS: 38.183013, 20.389619]: broken marble panels, toppled artifacts, overturned headstones. Photos by NTUA team on 2/10/14.

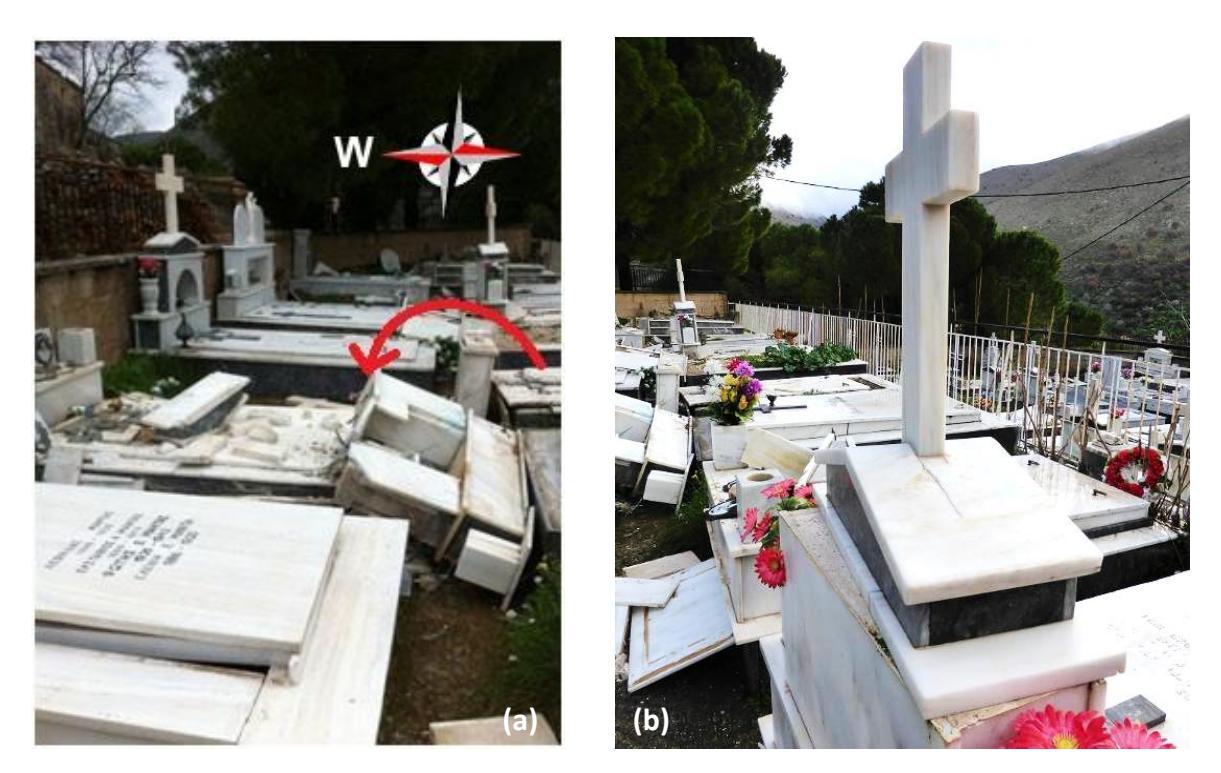
**Figure 9.2.10.** Two Kourouklata cemeteries [GPS: 38.243401, 20.474875] where: (a) 59% (north) and (b) 76% (south) of objects toppled. Photos by UPATRAS team on (a) 2/11/14 and (b) 2/8/14.

At the main part of Paliki (e.g., at the village of Kourouklata [GPS: 38.243401, 20.474875], objects toppled at a rate of 76% and 59% at the two cemeteries (Fig. 9.2.10). Cemeteries on the east side of the island were not significantly affected. Overall, it is clear from our reconnaissance that adjacent cemeteries could exhibit markedly different responses. Figure 9.2.11 presents an overview the cemetery object toppling rates in Paliki peninsula.

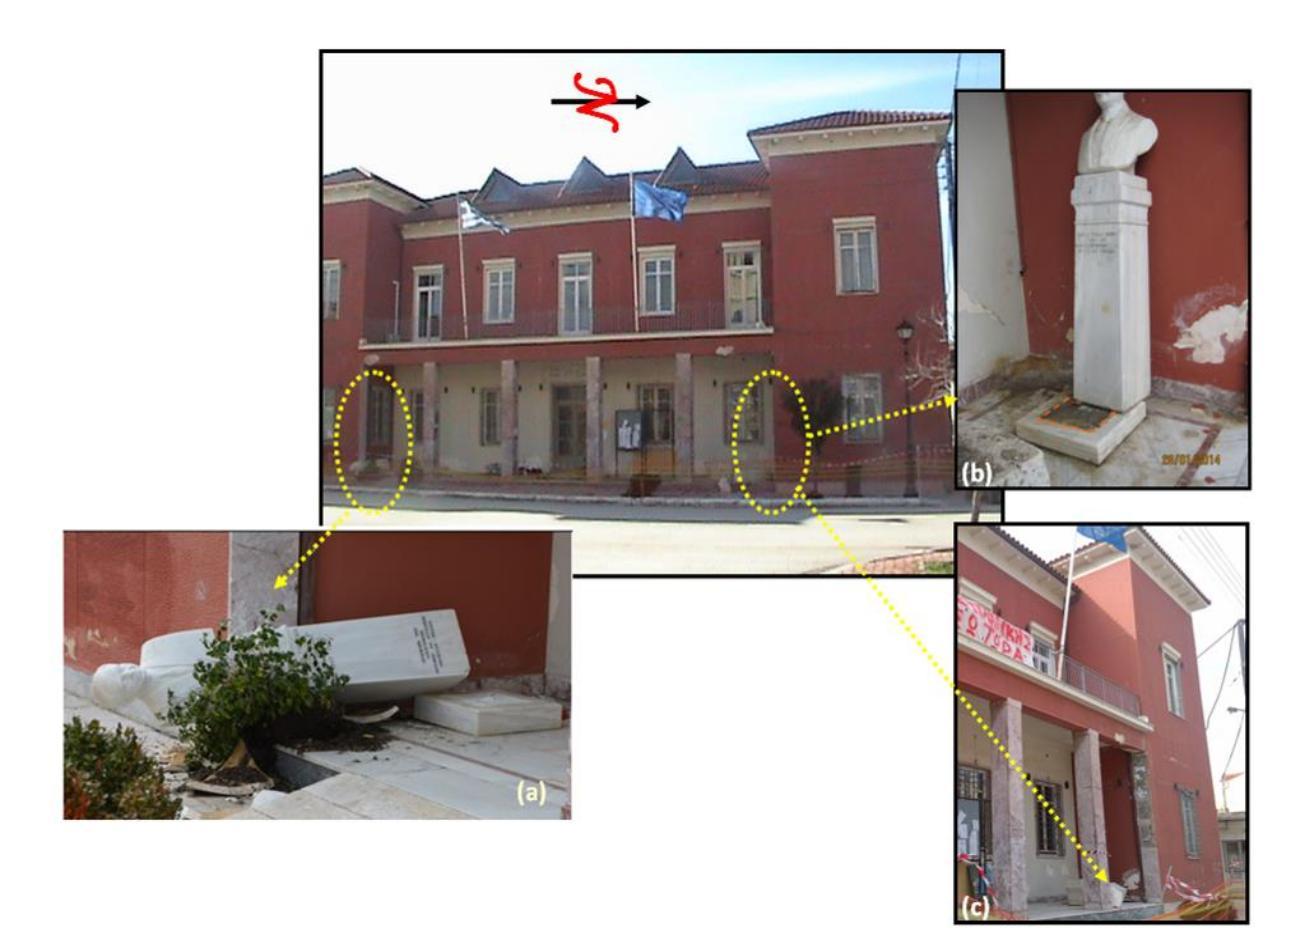
Two marble statues standing opposite to each other at the entrance of Lixouri City Hall were of particular interest (Fig. 9.2.12, 38°12'3.53"N, 20°26'14.92"E). Following the 1<sup>st</sup> event, the statue located north of the building entrance (Fig. 9.2.12b) displaced and slightly rotated towards the North without collapsing, since it was supported by the wall behind it. The trace of the original location of its base is visible, indicating an almost uniaxial displacement of approximately 40 cm. The top portion of the statue eventually toppled after the 2<sup>nd</sup> event towards the SE direction (Fig. 9.2.12c). A similar response was recorded (Fig. 9.2.12a) for the opposite standing statue (south of entrance), which also overturned in the same (SE) direction.

**Figure 9.2.12.** Two marble statues standing opposite to each other at the entrance of Lixouri City Hall (38°12'3.53"N, 20°26'14.92"E). (a) Overturned statue south of entrance recorded by UTH after  $2^{nd}$  event; (b) Displaced but still standing statue north of entrance after  $1^{st}$  event (ITSAK photo, 1/28/14); (c) Top of statue toppled after the  $2^{nd}$  event (Photo by ITSAK – AUTH-LSDGEE teams on 2/11/14).

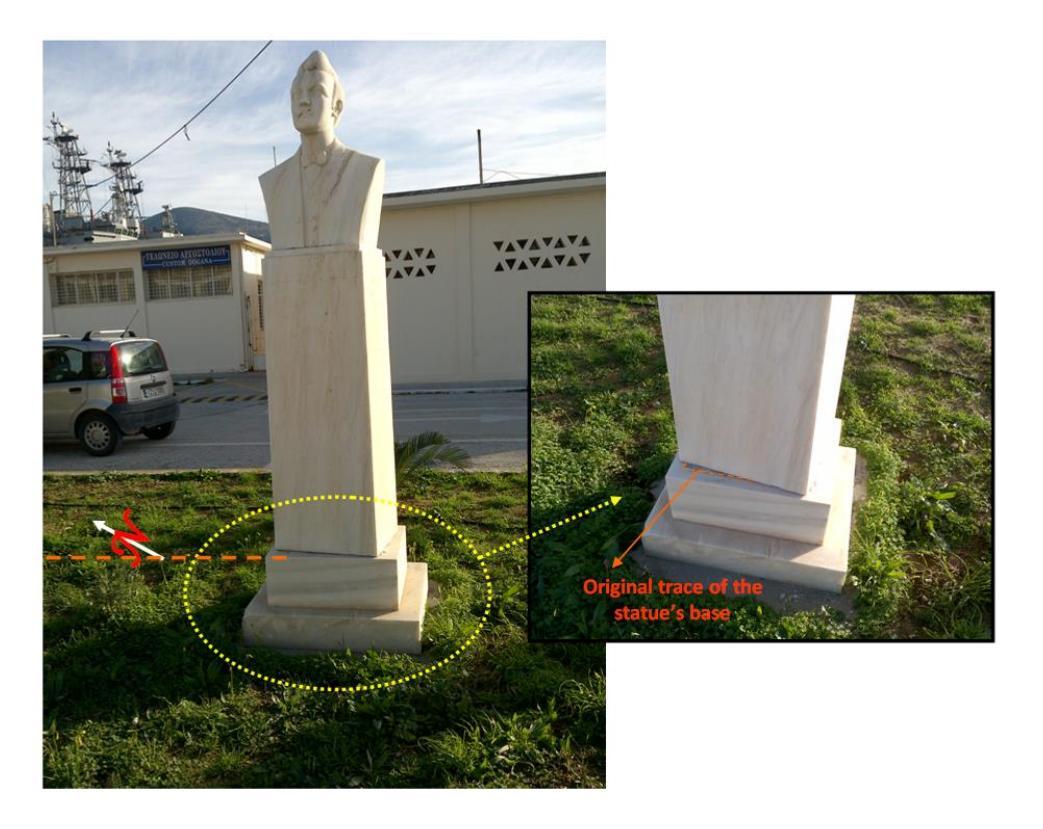
**Figure 9.2.13.** Marble statue close to Argostoli Customs building (38°10'47.94"N, 20°29'22.47"E): Slight base rotation. Photo by ITSAK – AUTH-LSDGEE teams on 2/11/14.

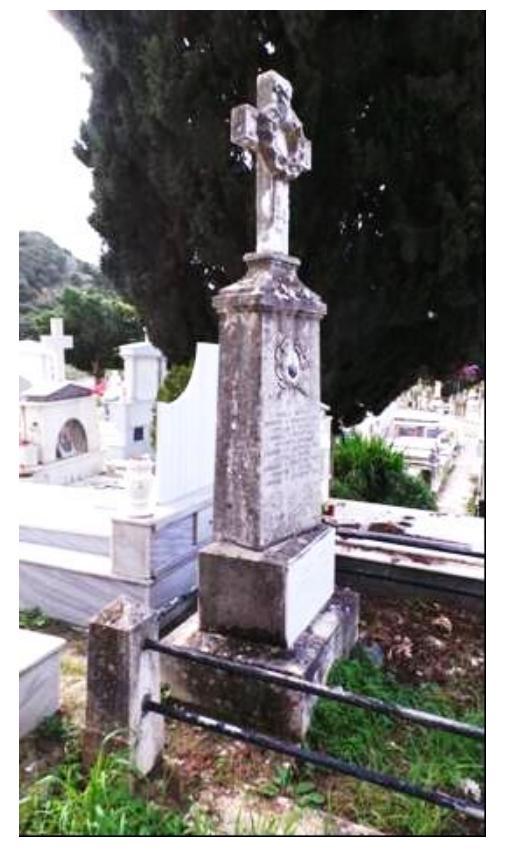
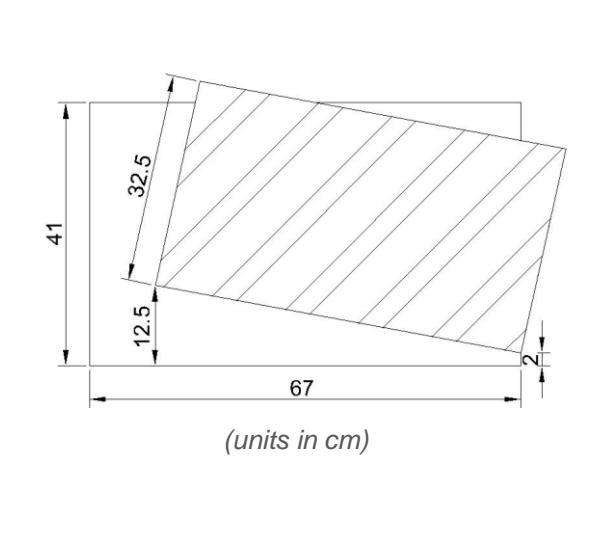
**Figure 9.2.14.** Monument of Ilias Antipas mainly rotated (38.18305° N, 20.50030°E). The rectangular sketch shows rotated part at its base (in cm). Photo by UPATRAS teams on 2/8/14.

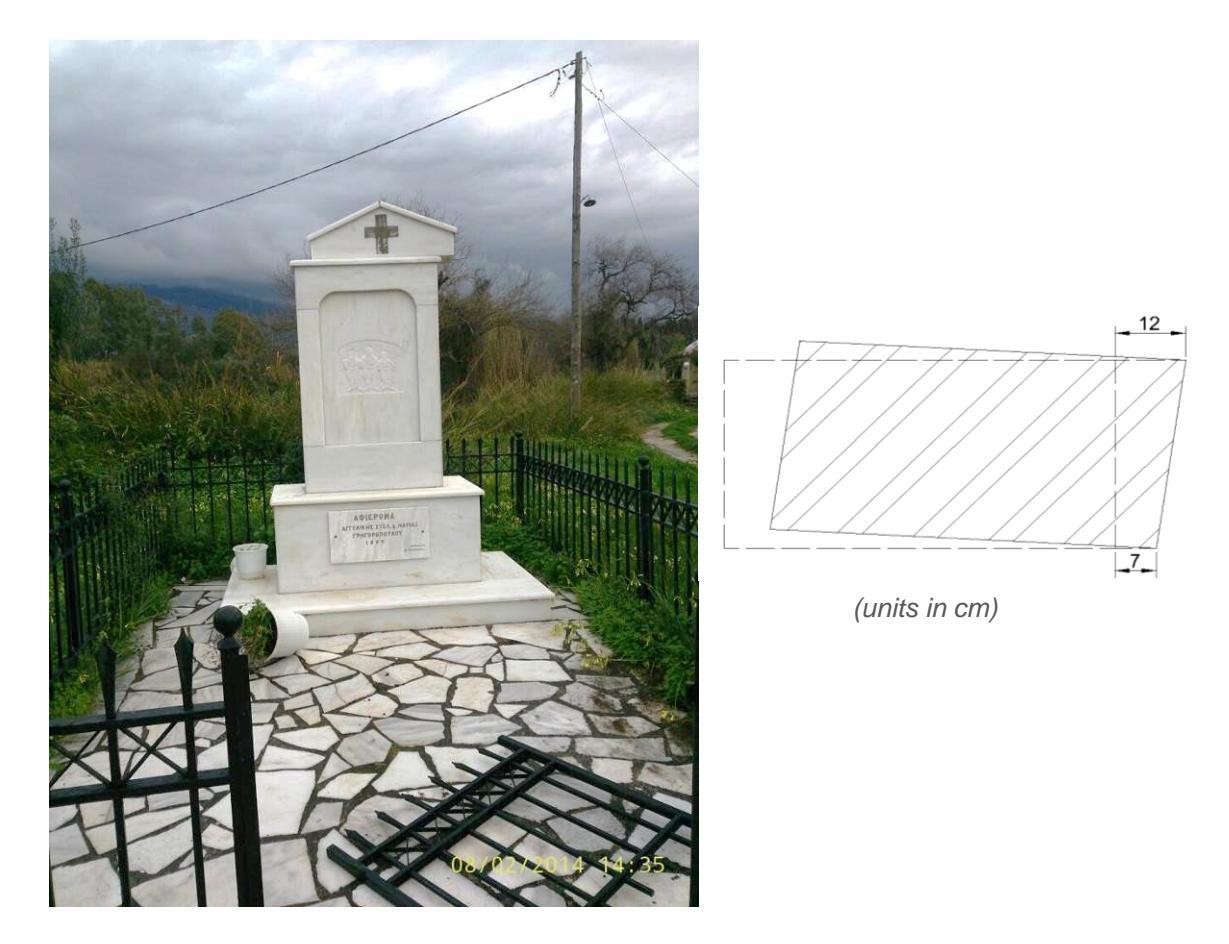
**Figure 9.2.15.** Marble monument near Lixouri (38°13'32.85"N, 20°25'46.42"E): Lateral displacement without significant rotation (dimensions in cm). Photo by UPATRAS team on 2/8/14.

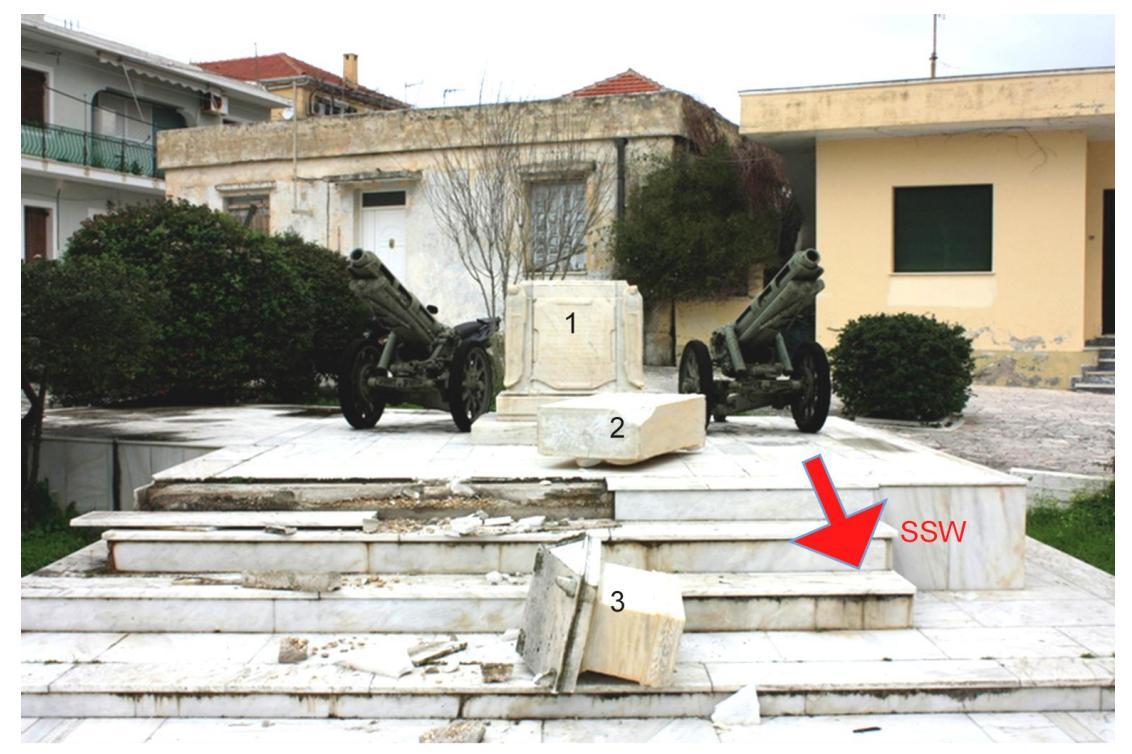
**Figure 9.2.16.** Marble monument at Lixouri (38°11'51.7"N, 20°26'17.3"E). Dislocation and toppling of upper two marble blocks towards S-SW direction. Photo by LSDGEE-AUTH team on 2/11/14.

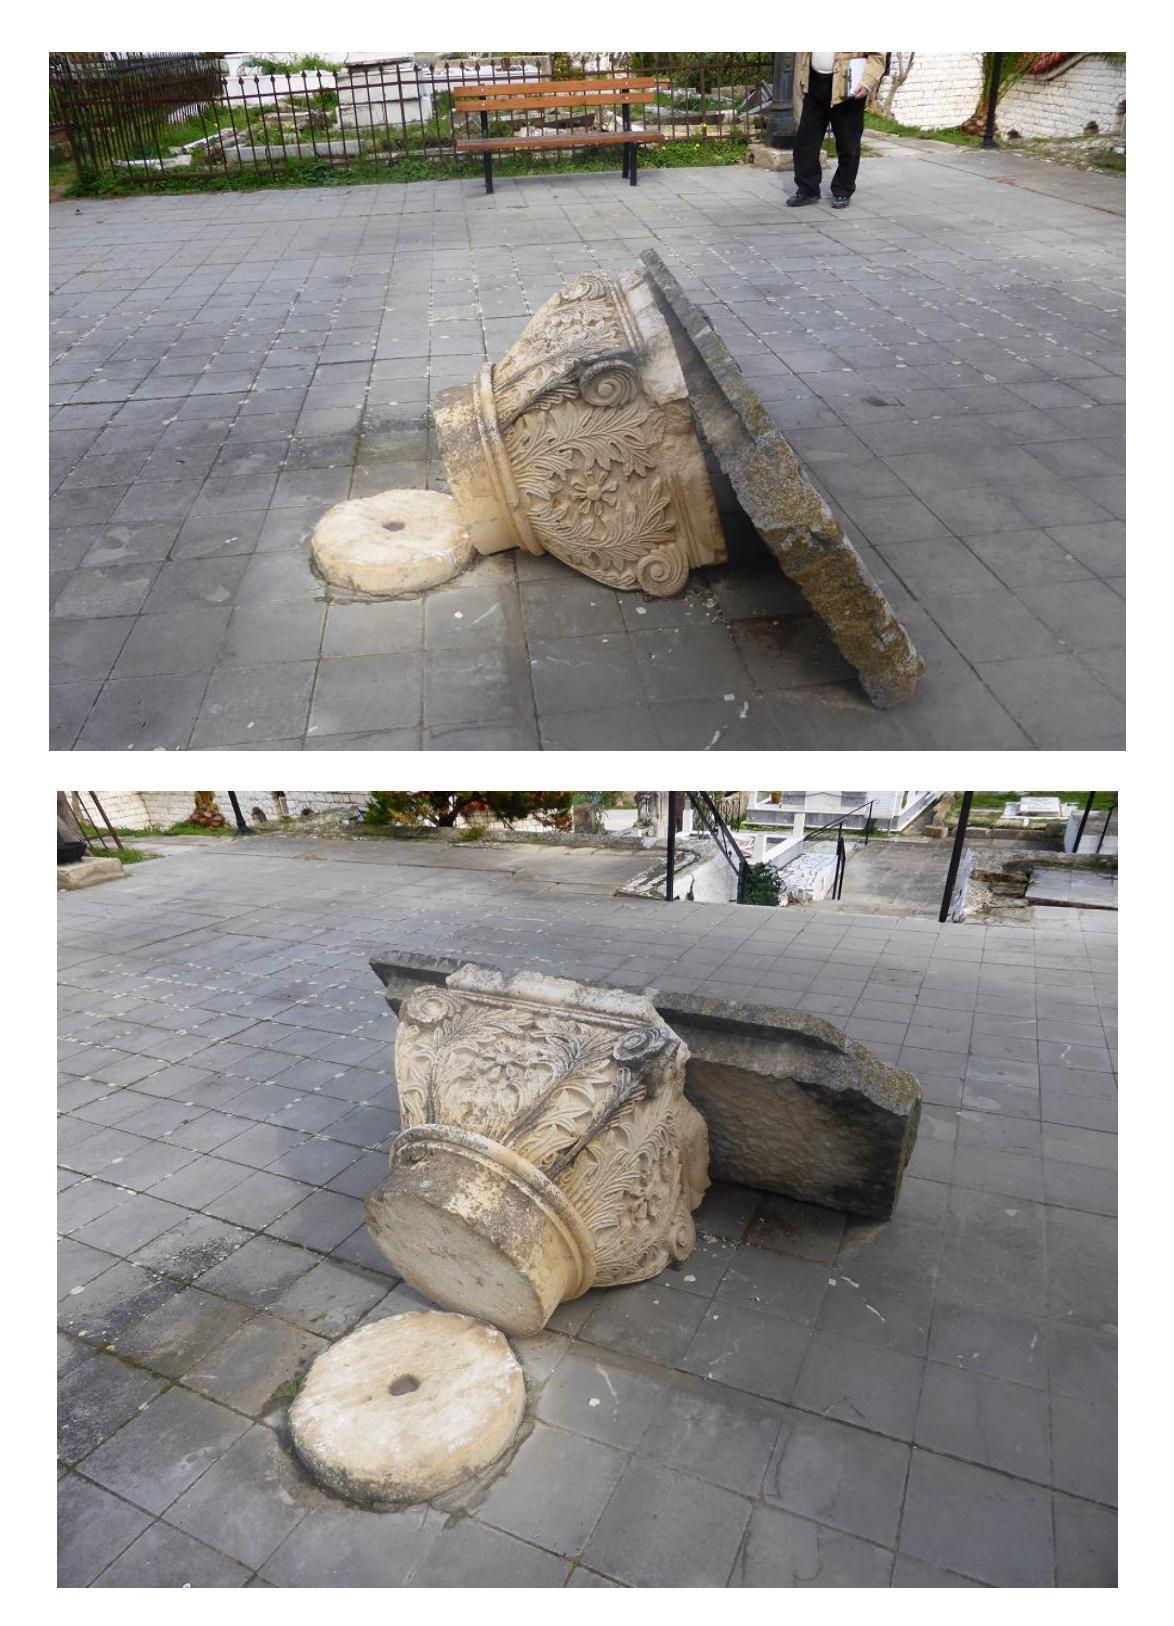
**Figure 9.2.17.** Overturning of massive Corinthian-type capital carrying a heavy top slab in Lixouri (GPS coordinates: 38.192713, 20.43]. Photo taken by NTUA team on 2/9/14.

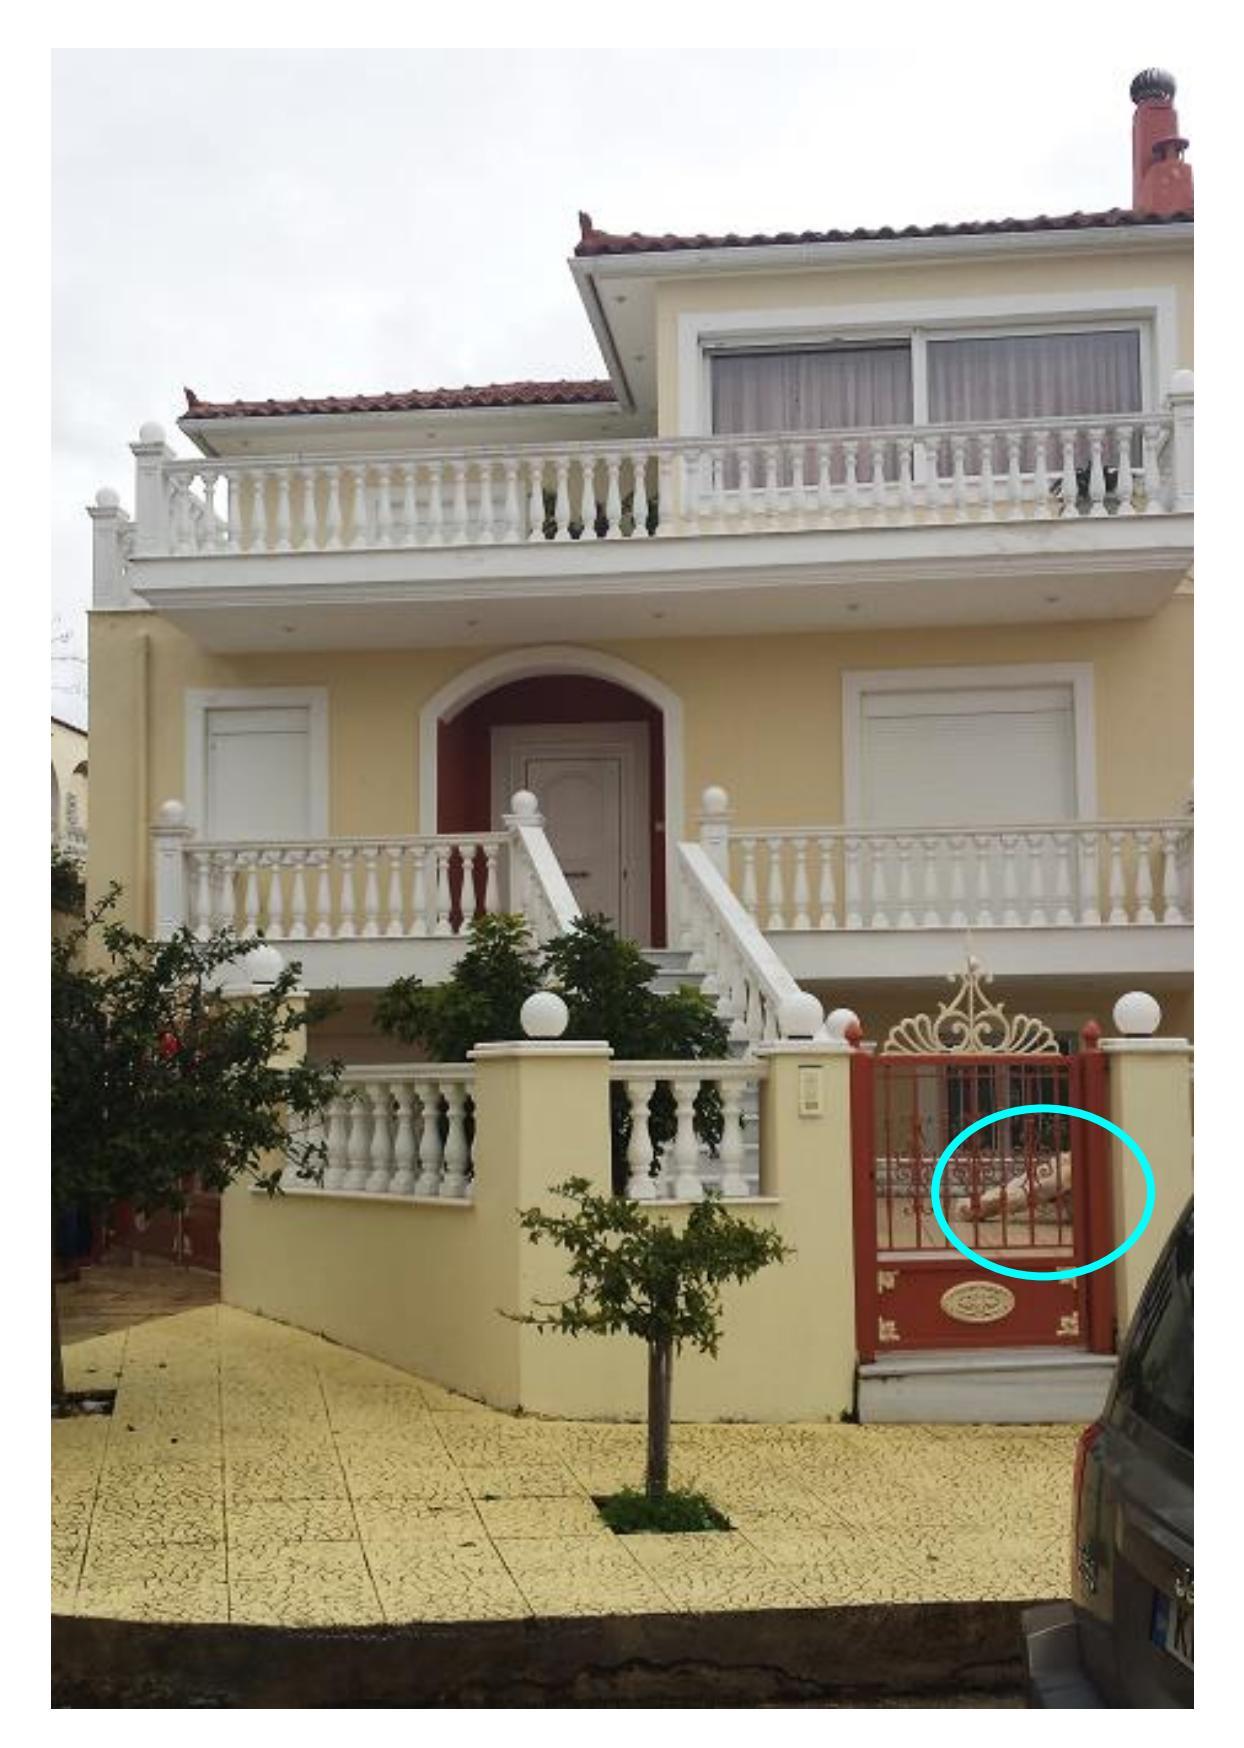
**Figure 9.2.18.** The house across the street of the Public Library of Lixouri. No damage is noticed, but a statue overturned (marked with turquoise circle). Photo by NTUA team on 2/10/14.

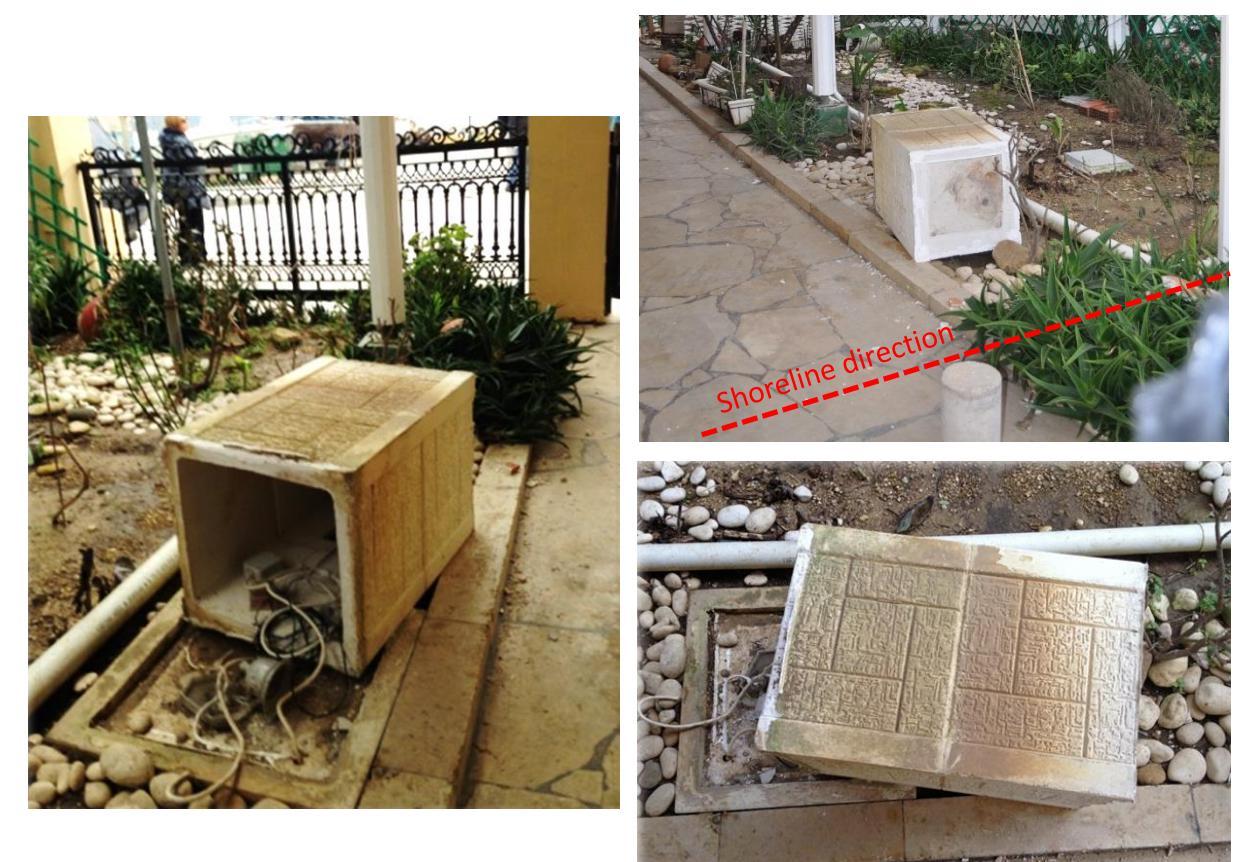
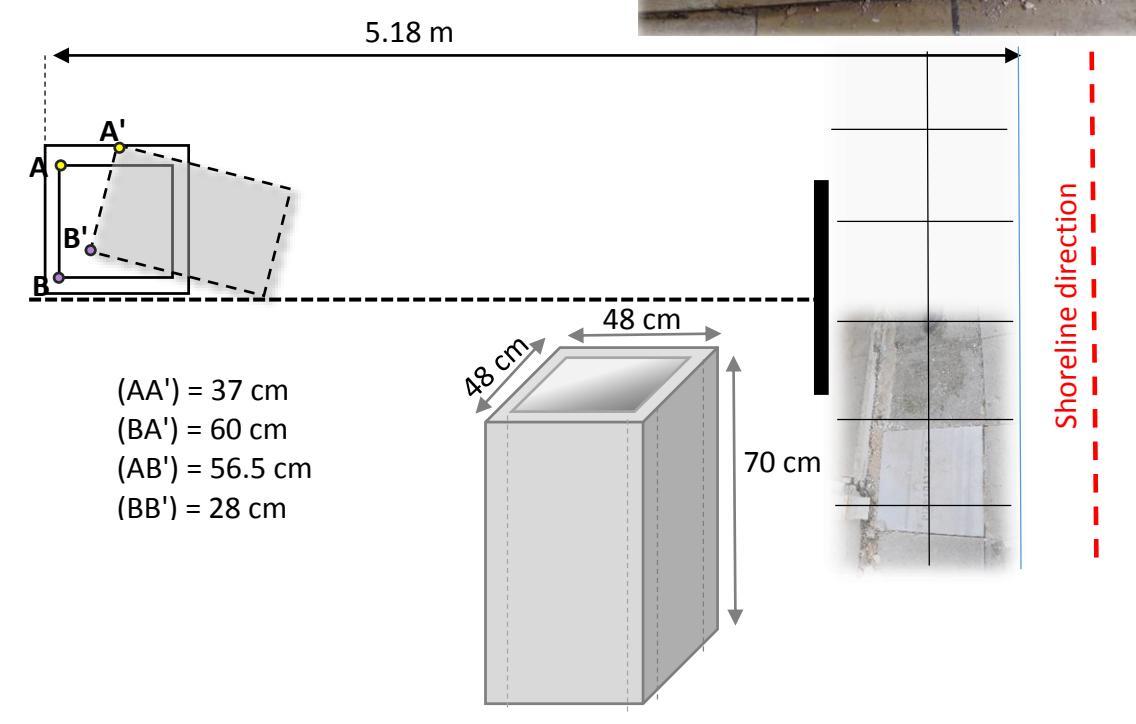
Toppling and slight rotation of a rigid masonry hollow block was observed in a shoreline road house in Lixouri, adjacent to the local branch of the National Bank of Greece located (Fig. 9.2.19). These blocks, called "little churches of the souls," are often seen in Greece in memory of deceased (usually at locations of car accidents).

**Figure 9.2.19.** Toppling and rotation of rigid block at a shoreline road house next to Lixouri National Bank [38°12'9"N, 20°26'19.8"E]. Measurements by Diatonos Mechaniki; MRCE photos, 2/10/14.
