CHAPTER 10 Infrastructure Networks

GEER/EERI/ATC Cephalonia, Greece 2014 Report Version 1

10.1 Potable and Wastewater Networks

10.2 Transportation Road Network

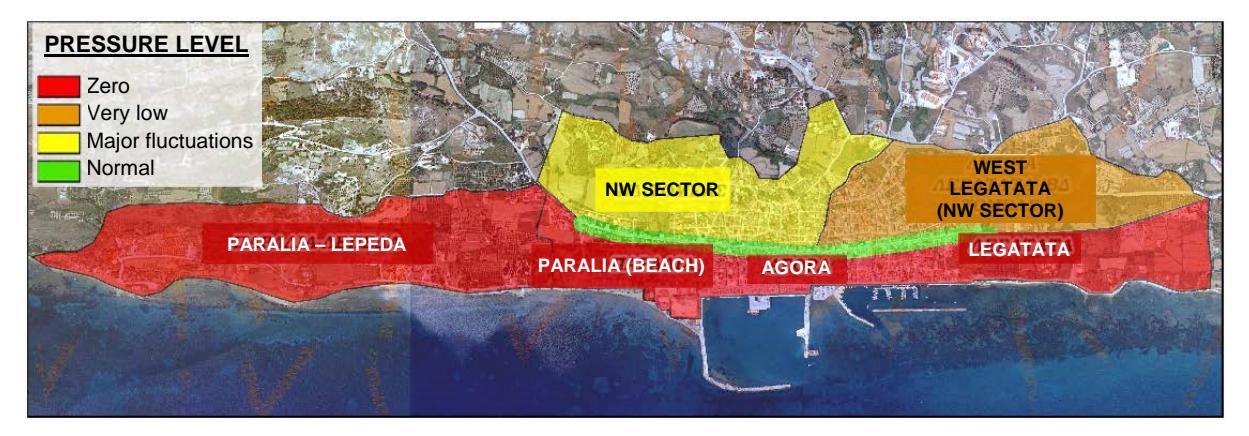
As shown in Table 10.1.1, the material of these pipes consist of PVC by 42.3%, Asbestos Cement by 30.5%, Polyethylene by 25.8%, and steel by 1.4%. A map of the network is shown in Fig. 10.1.4. The assessment of the first day is shown on the map of Fig. 10.1.5, color coordinated as follows: **Green** – normal operation; **Yellow** – significant fluctuations in pressures; **Orange** – very low pressure; and **Red** – zero pressure.

Figure 10.1.5. Rapid network assessment at the end of the first day (EYDAP, 2014)

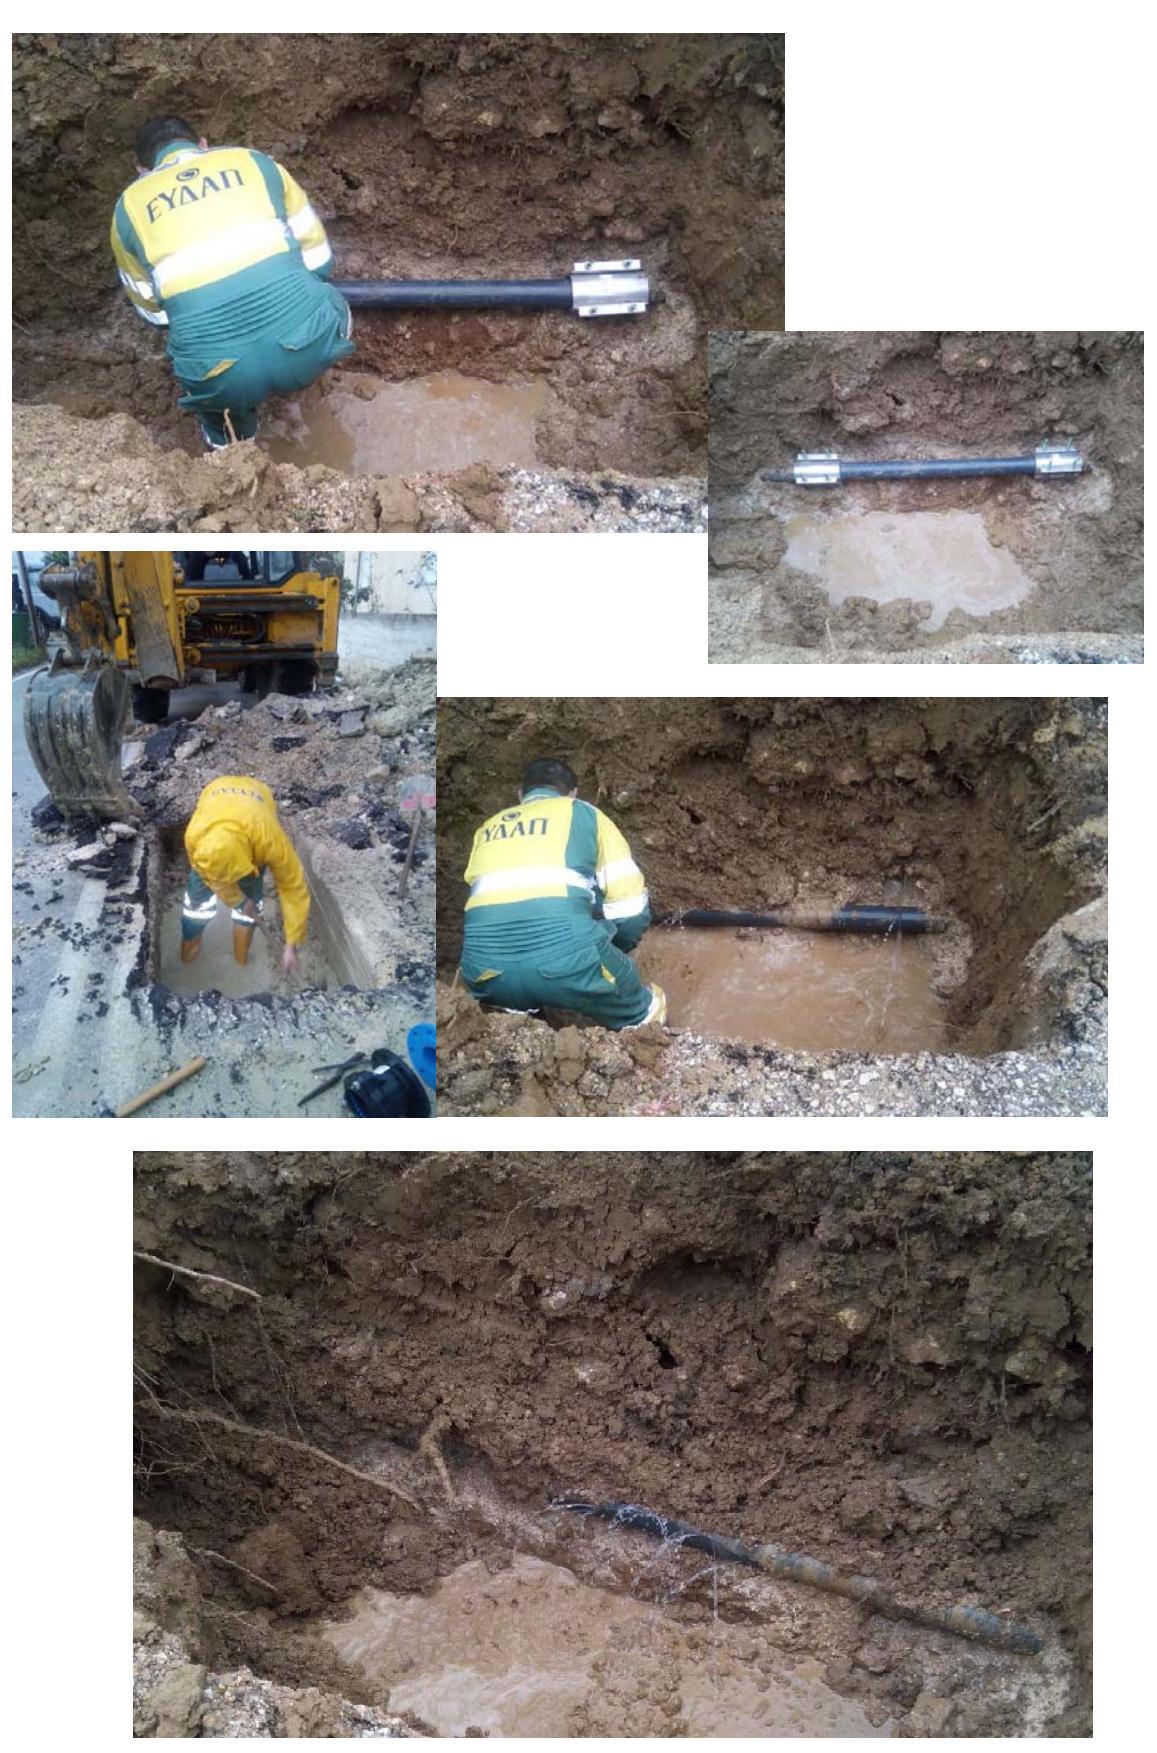
<u>Day 1:</u> A second subgroup was responsible for detecting and repairing the visible damages and leaks. Photos of the repair activities during Day 1, a 24-hr shift, are shown in Fig. 10.1.6. Due to large number of leaks, most of the system could not maintain its pressure, so nineteen additional valves were installed for the control of the water supply in the various areas (Fig. 10.1.7). As shown in Fig. 10.1.8, at the end of the first day normal water supply was secured inland.

Figure 10.1.6. Examples of the numerous repair of leaks repaired (EYDAP, 2014).

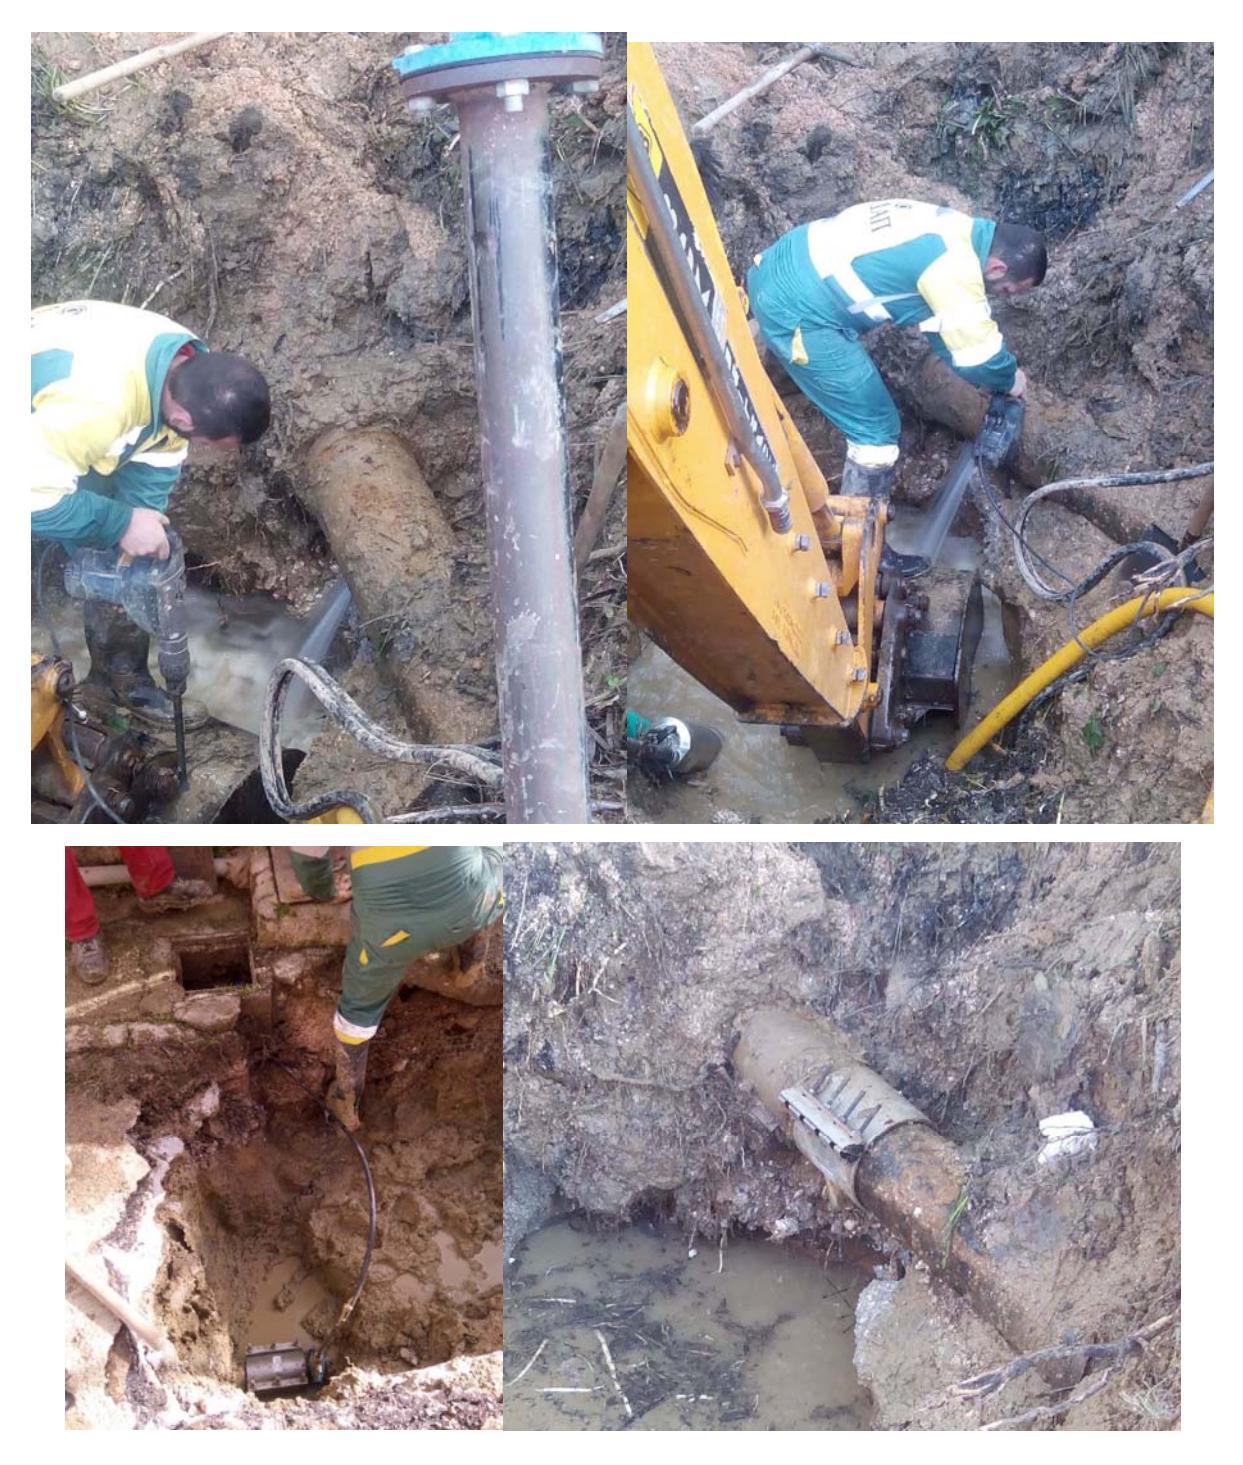
<u>Day 2:</u> The EYDAP teams gradually connected areas to the network and performed leakage tests. Once the system achieved positive pressures, "invisible" leaks were detected using acoustic methods as well as hydraulic numerical simulations that were employed to identify unexpected drops of the piezometric line and help in the detection of leaks (Fig. 10.1.9).

Figure 10.1.9. EYDAP Personnel repairing leaks during Day 2 (EYDAP, 2014).

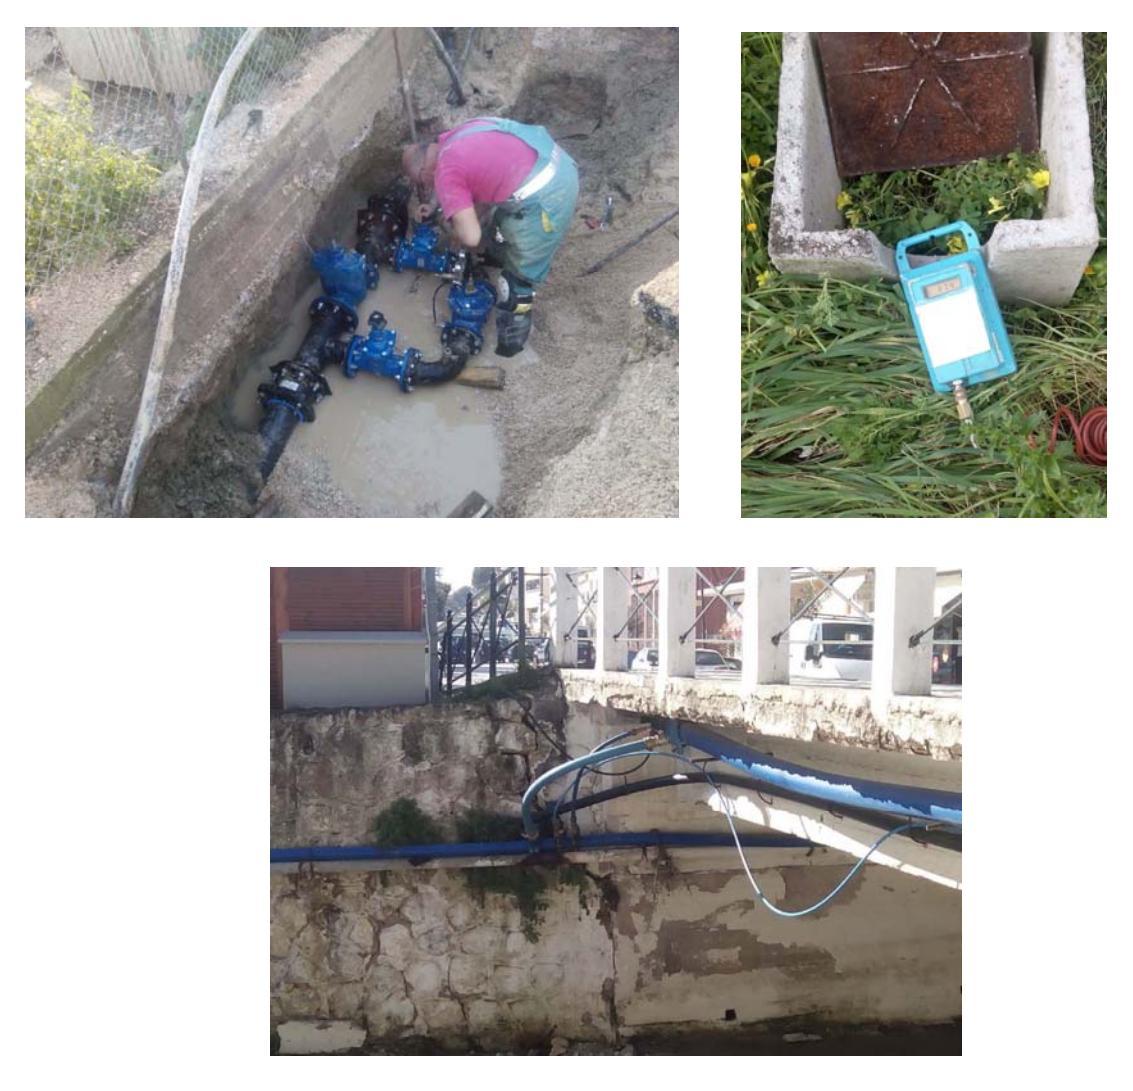
<u>Days 3 to 12</u>: During Days 3 to 12, the EYDAP teams inspected the water reservoir (tanks, pipes), repaired damages and performed continuous adjustments in order to ensure stable service. A bypass of the network pipes and alternative supply took place in areas where the repair would have been too difficult or where the upgrade in supply was significant. For the protection of the asbestos cement pipe network, a pipe rupture valve was installed since the repair of the leaks would result in increase of pressures in the already distressed network, which would likely cause new leaks. At the same time, in situ chemical analyses were performed (regular and residual chlorine) to ensure the water quality and also to check for leaks (which would decrease the quantity of the residual chlorine). The network pressures upon completion of these activities were normal, as shown in Fig. 10.1.11. Since Saturday February 8th 2014, 100% of the network in Lixouri and the surrounding areas was fully restored.

Figure 10.1.10. EYDAP Personnel repairing leaks Days 3 to 12.

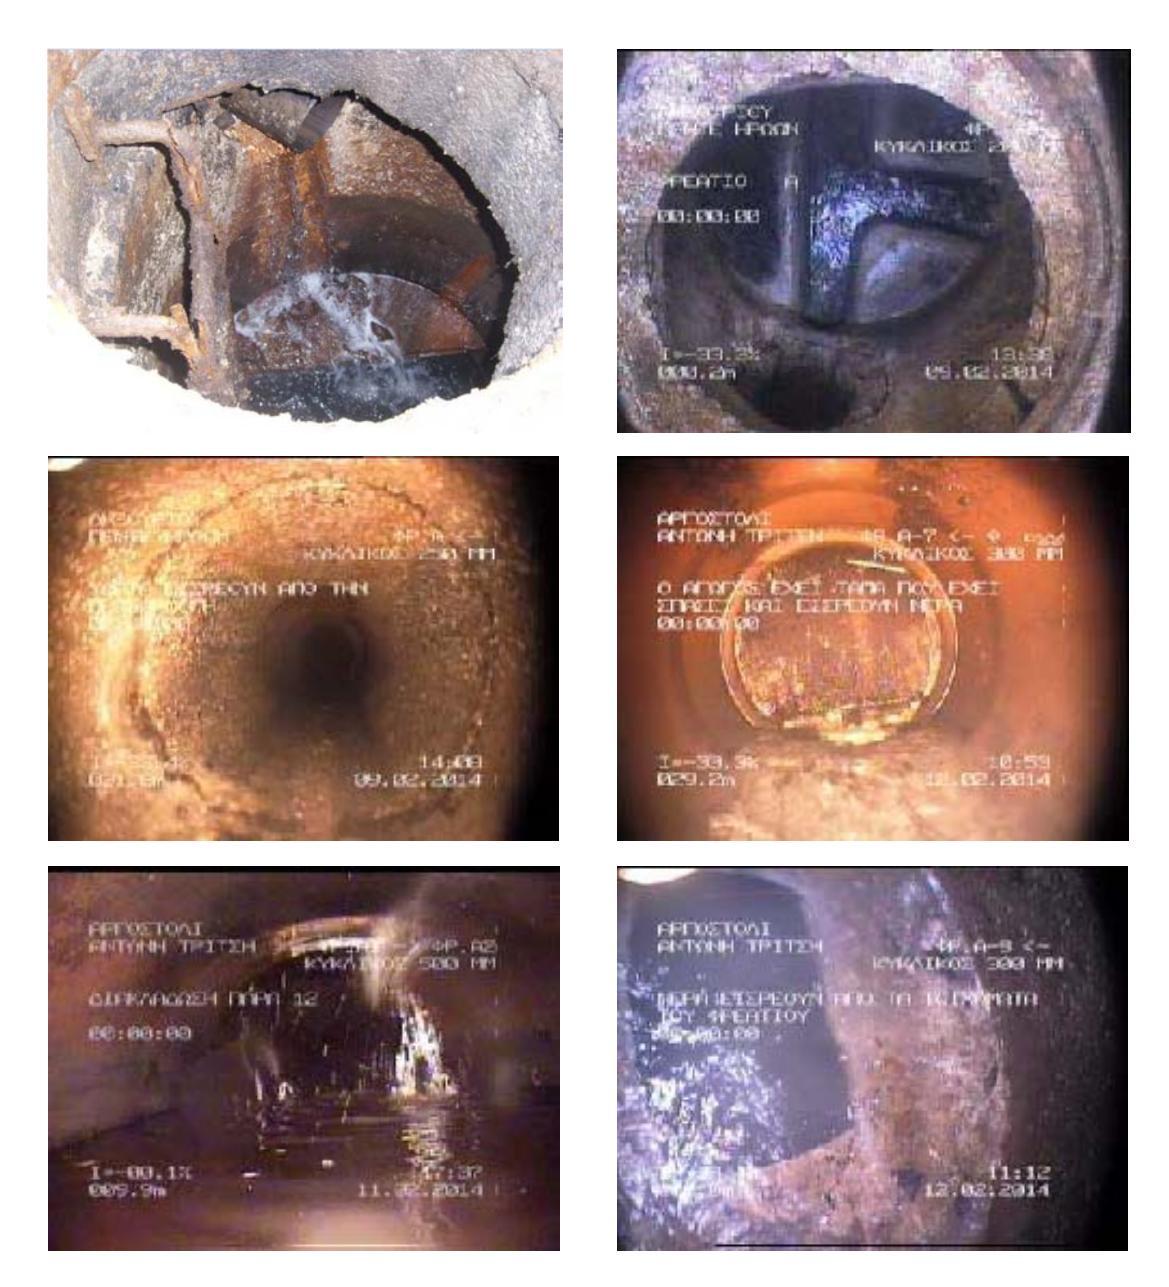
The investigation and repair wastewater network teams and the General Manager of Preventative Maintenance Office, Mr. Elias Karambelas, in coordination with the local agencies immediately assessed the existing conditions and started in-situ as well as video inspections. More than 4 km of wastewater pipes were inspected in the towns of Lixouri and Argostoli and 700 m of wastewater pipes were video inspected. Fig. 10.1.14 shows photos provided by EYDAP from these the field operations. Fig. 10.1.15 present examples of damage identified using the video inspection information.

Figure 10.1.15. Video inspection shots (EYDAP, 2014).

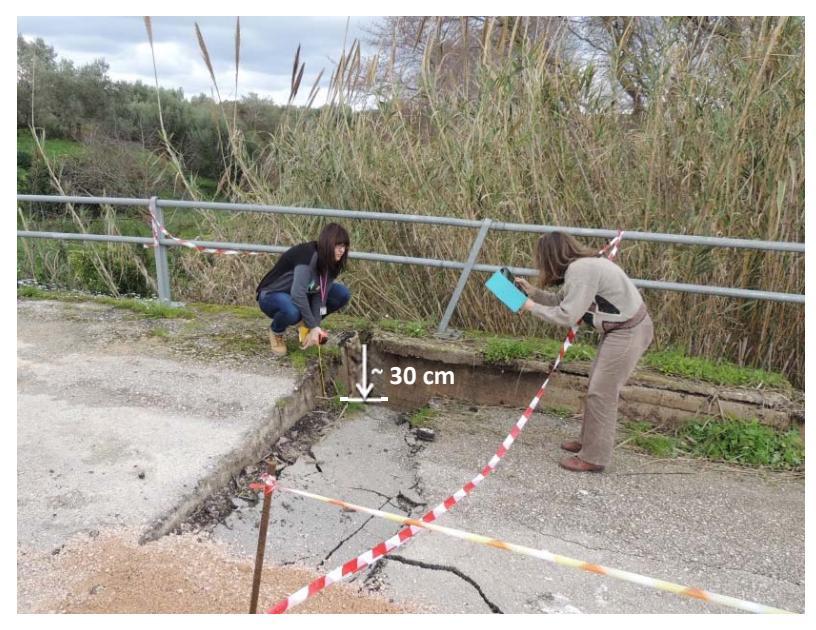
The performance of the road transportation network was mostly affected by the response of road embankments and retaining walls and less of the bridges. Overall, the (small) bridges of the island responded well to the two main events and their aftershocks and none of the bridges collapsed or suffered severe enough damage to close down traffic. The only exception was observed in the Havdata bridge (38°12'10.30"N, 20°24'16.05"E), where traffic was partly interrupted due to excessive settlements in both access embankments, as shown in Fig. 10.2.2. For more details on bridge behavior, see Section 8.5.

Figure 10.2.2. Settlement of western embankment of Havdata bridge, recorded by reconnaissance team members S. Nikolaou and M. Moretti (38°12'10.30"N, 20°24'16.05"E).

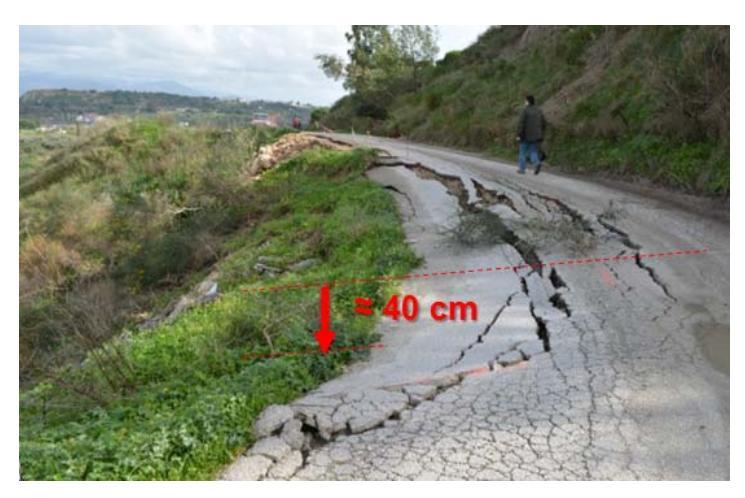
Livadi villages (see Section 8.6.1). Figure 10.2.3 presents the large downslope displacement of a circular sliding mass in clayey soil on the order of 40 cm in the vertical direction that affected a country road embankment north of Soullari village. Note that a detailed map with a list of towns with their coordinates can be found in Section 2.2.

Figure 10.2.3. North of Soularoi road embankment sliding, as viewed from the pavement (38°11'21.51"N, 20°24'45.80"E).

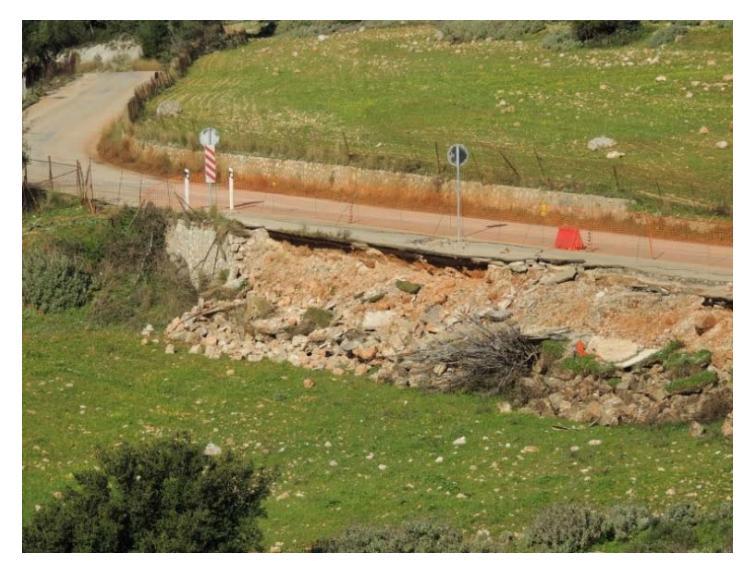
Moderate roadway embankment damage was also related to total collapse of the masonry walls and was recorded along the main asphalt road connecting Argostoli to Lixouri, and to the NW of the village of Kardakata. Figure 10.2.4 shows the collapsed masonry wall which had supported the road embankment, as seen from the downhill side after the 2nd event. In addition, there were numerous road embankments along the eastern portion of the main asphalt road connecting Argostoli and Lixouri which suffered minor longitudinal cracks and small settlements of the asphalt pavement that caused only some local traffic diversions.

Figure 10.2.4. Masonry wall collapse in NS direction of Kardakata road embankments after 2nd event (38°17'34.61"N, 20°27'8.16"E).

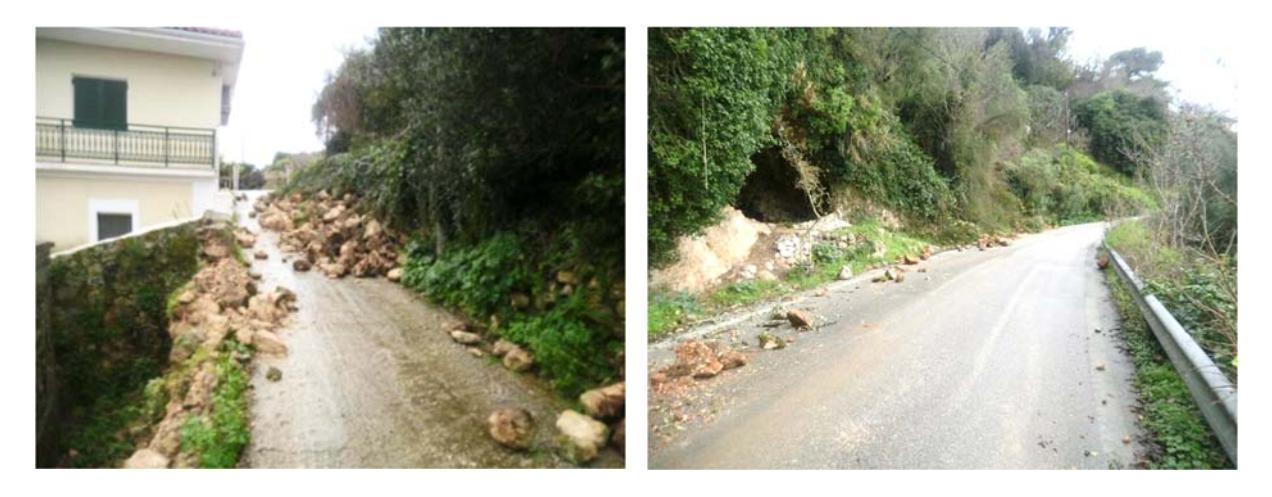
Traffic problems were caused not only by damage in bridges and road embankments, but also due to rockfalls and slope instabilities which, in most cases, partially covered the pavement interrupting traffic as shown on Fig. 10.2.5 from the Aghia Thekla village road (38.25°N, 20.3833°E). Several rockfalls were observed north of Argostoli bay (e.g., 38°17'13.43"N, 20°26'52.89"E) and on the road from Argostoli to Sami (38°12'20.47"N, 20°36'25.76"E).

Figure 10.2.5. Rockfalls in Aghia Thekla village road (38.25°N, 20.3833°E from inkefalonia.gr).

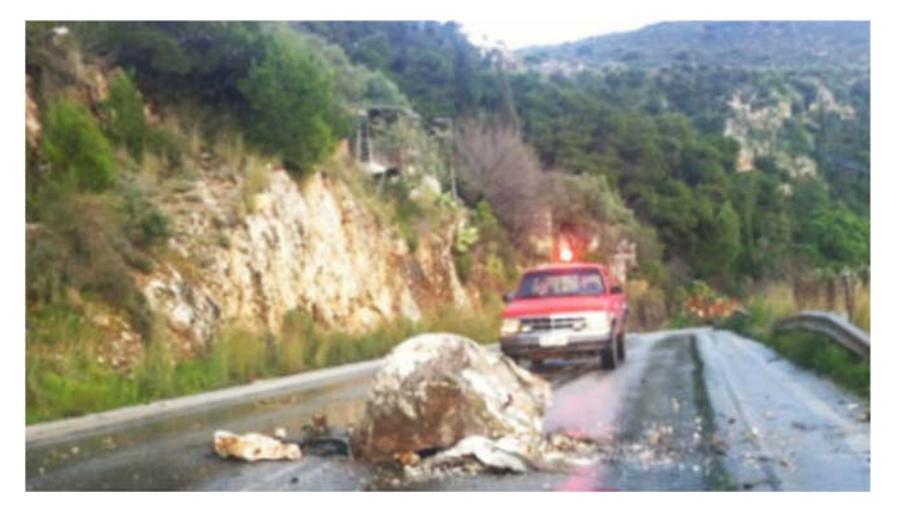
Figure 10.2.6. Rockfalls at main asphalt road connecting Lixouri to Argostoli. Web photo from $\underline{\text{madata.gr}}$ after the 1st event.

The most severe problems caused by rockfalls were observed at the main asphalt road connecting Lixouri to Argostoli (Fig. 10.2.6). Espectially the eastern portion which was closed to traffic for at least 15 days (since the 1^{st} event, 1/26/14, and at least one week after the 2^{nd} event, i.e. at least until 2/10/14) due to concerns of loose rocks falling on the pavement during aftershock activity. The road was uninterruptedly cleaned from debris during the shutdown period, and especially after intense aftershocks when additional minor rockfalls were recorded.

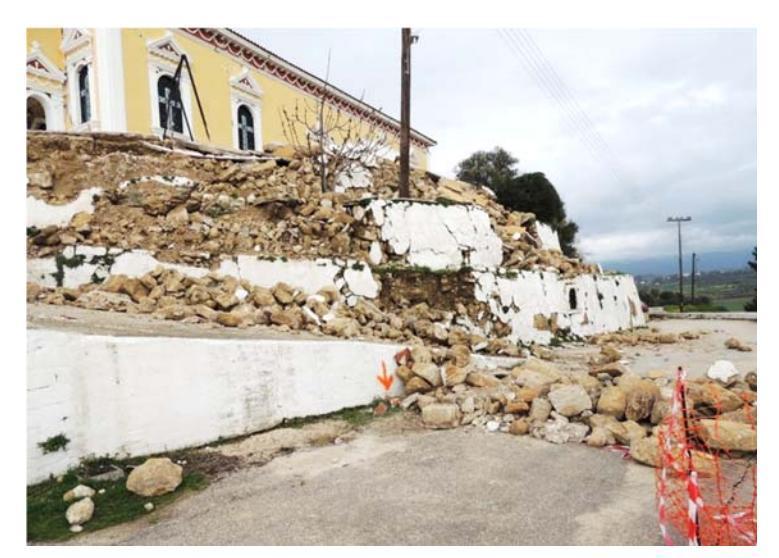
Along village roads, damage on buildings and retaining walls caused traffic interruptions, since these roads are very narrow. Examples of building damage-related closed roads were found in Havdata (38°12'14.80"N, 20°23'10.03"E) and Kourouklata villages. The retaining wall of The Virgin Mary church (Fig. 10.2.7) at Chavriata (38°10'57.32"N, 20°23'14.48"E) caused road closure (detailed observations on retaining walls are provided in Section 8.3). At these locations local authorities used road safety cones and "do not cross" lines to locally divert traffic. Debris collection from roads was in progress when our reconnaissance teams visited the island and no retrofit work was underway due to concerns of aftershock activity.

Figure 10.2.7. Collapse of masonry wall at courtyard of The Virgin Mary church at Chavriata, which caused local traffic disruption (38°10'57.32"N, 20°23'14.48"E).

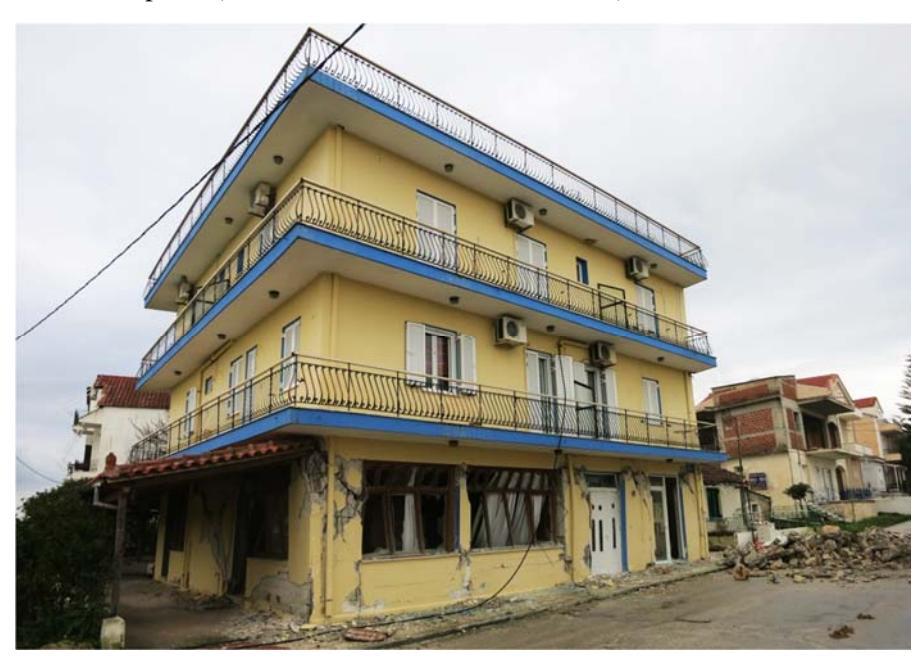
Figure 10.2.8. Traffic disruption due to nonstructural elements damage in Krasopatera Street, Lixouri (38°11'36.81"N, 20°26'11.42"E).

Nonstructural elements damage, including massive chimneys of large quantities roof tiles, interrupted traffic in urban areas. When the GEER reconnaissance terms visited the island only some of the debris had been removed from the roads to allow for pedestrian crossing, and in most cases it was still in place (e.g., in the narrow back-streets of Lixouri). An example is shown on Fig. 10.2.8 at Krasopatera Street in Lixouri (38°11'36.81"N, 20°26'11.42"E).
