CHAPTER 11 Structural Observations

GEER/EERI/ATC Cephalonia, Greece 2014 Report Version 1

11.1 Main Structural Observations

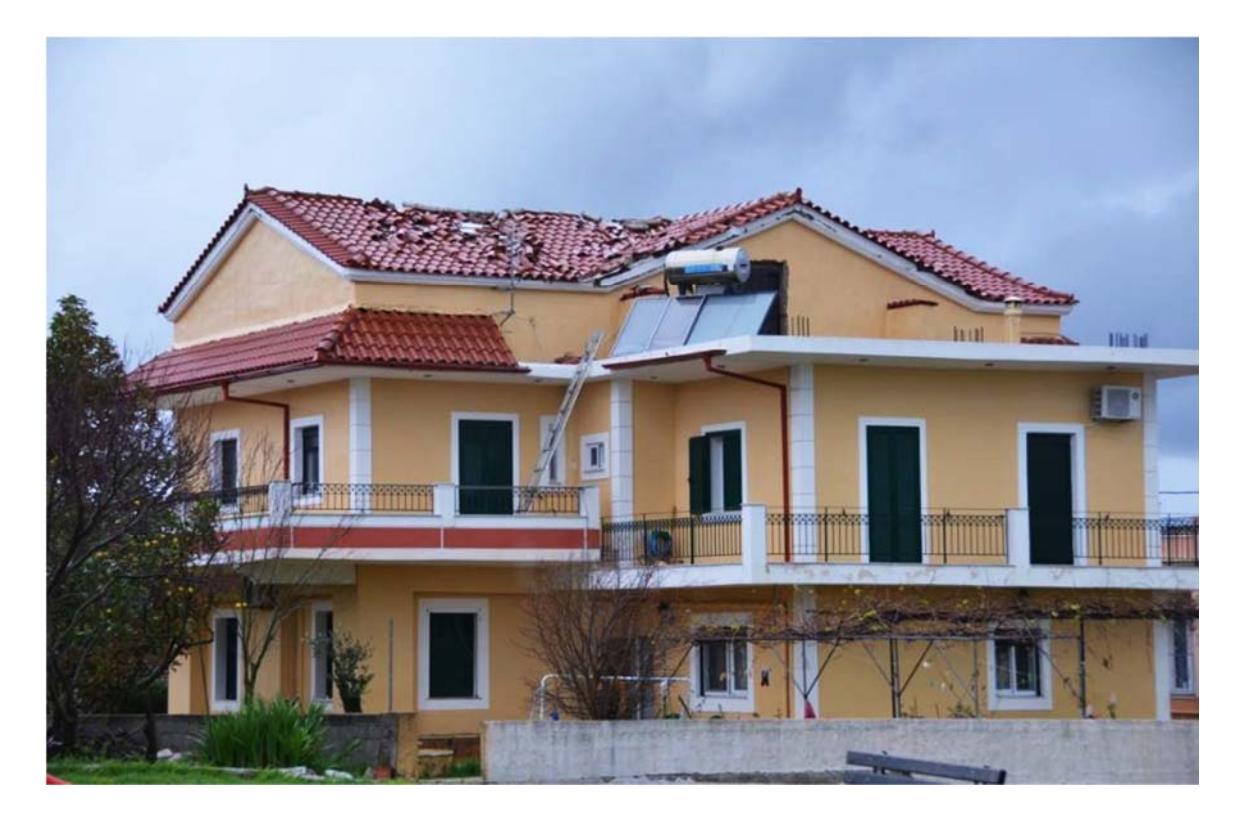
Figure 11.1.2. A two-story RC building in Livadi which performed well, despite the fact that at this area where several buildings suffered significant damage. Evidence of high accelerations if the dislocation of roof tiles observed in several structures throughout the meioseismal area.

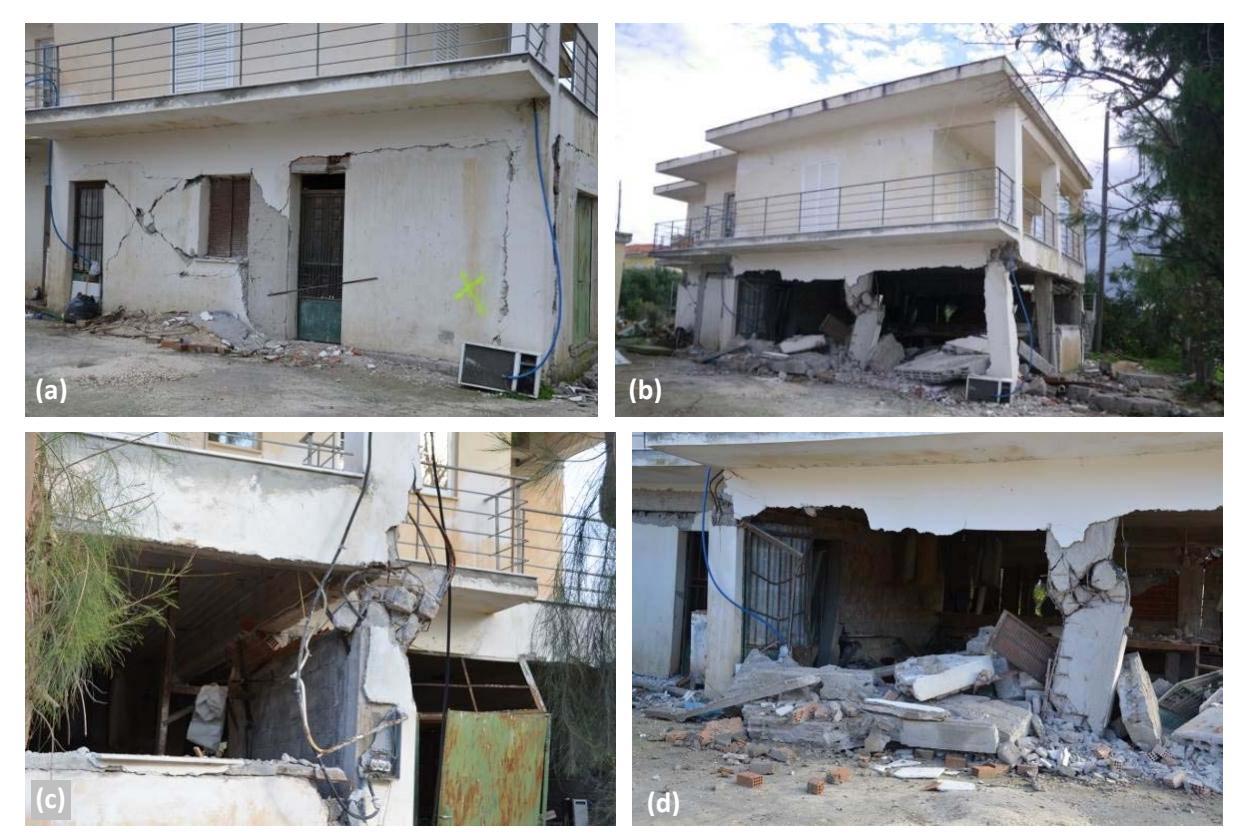
- Reinforced Concrete (RC) buildings designed under older seismic codes. Some characteristics that possibly have contributed to their damage are: the large tie (stirrup) spacing (> 300 mm), lack of confinement at beam-column joints, and poor detailing. Examples shown in the photos of Fig. 11.1.3 (coordinates 38°13'45.60", 20°25'47.40").

Figure 11.1.3. Damage of 2-story RC building in Aghios Dimitrios designed with older codes (GPS coordinates: 38.229444, 20.429722): (a,b) after 1st and 2nd events; (c,d) beam-column detail of (b).

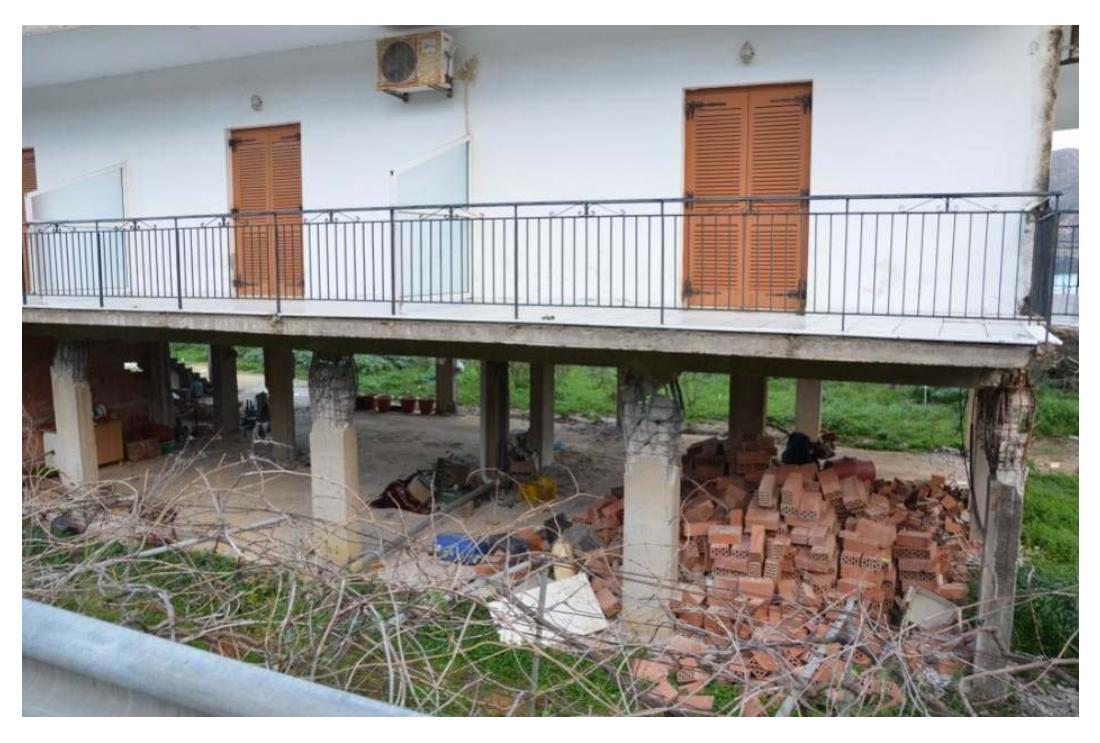
- RC buildings with a soft story at the ground level. Example on Fig. 11.1.4 in Aghios Dimitrios (38°14'36.51"N, 20°25'41.91"E).
- Mixed structural systems which usually include a masonry ground floor and a reinforced concrete upper floor, built in phases over the course of several years. An example is shown in Fig. 11.1.5 (GPS coordinates: 38.229444, 20.429722.)

Figure 11.1.4. Significant damage to the soft story columns of a two-story RC building in Aghios Dimitrios (38°14'36.51"N, 20°25'41.91"E). No damage was observed at the upper floor.

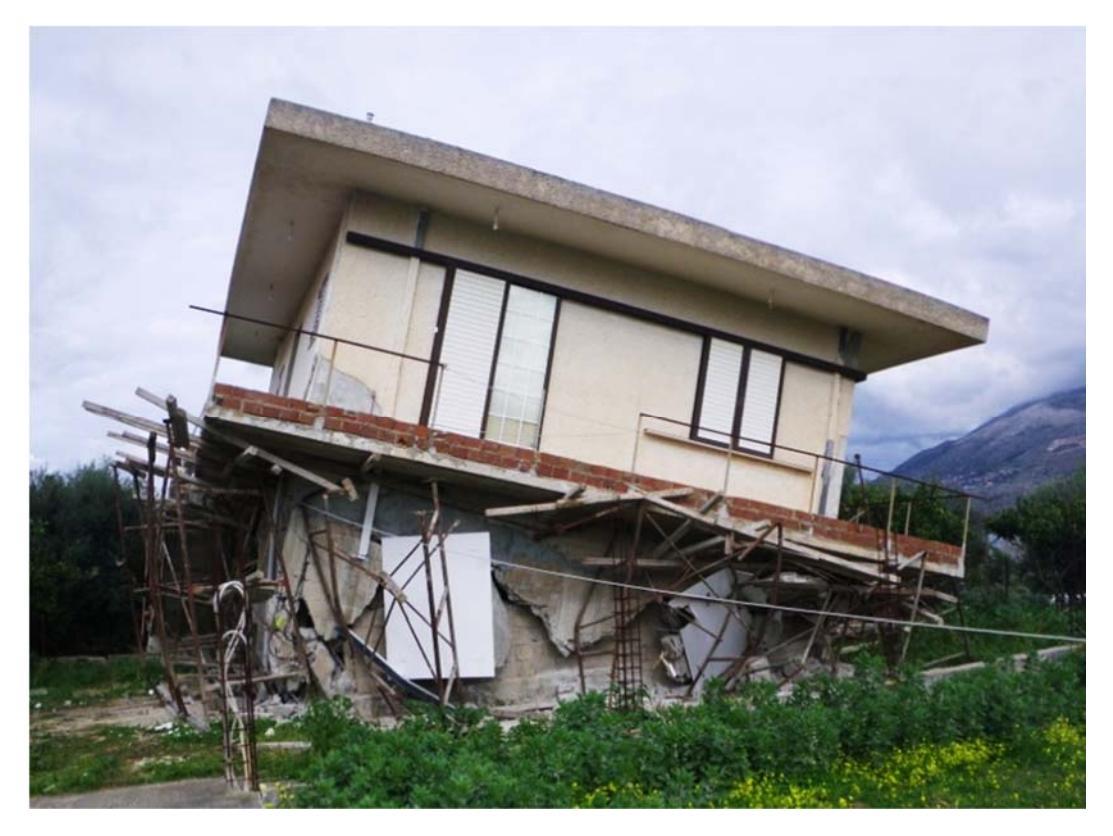
Figure 11.1.5. Collapse of the masonry ground floor of a two-story building in Aghios Dimitrios. The upper floor is a reinforced concrete frame, added several years after initial construction (GPS coordinates: 38.229444, 20.429722).

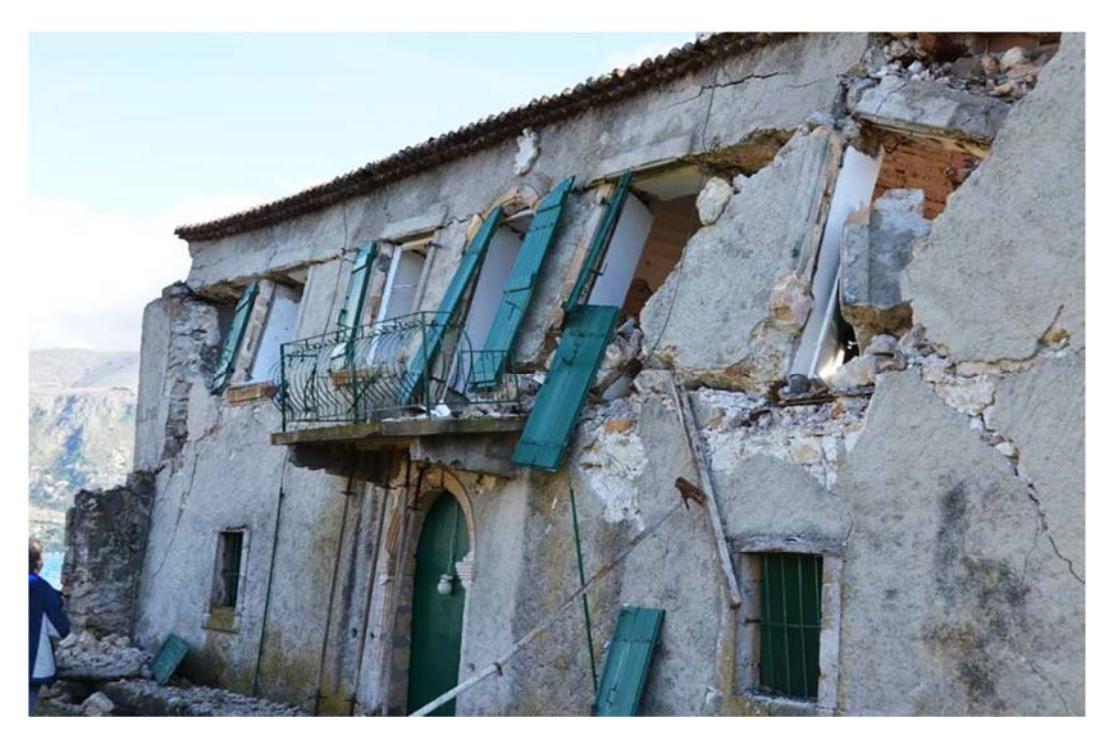
- Old masonry buildings which survived the 1953 earthquakes and had then been repaired (Fig. 11.1.6), including several churches discussed separately in a Section of this Chapter.

Figure 11.1.6. Partial collapse of a heritage masonry building in Samoli, close to Livadi village (see Fig. 11.1.1), which was probably built during the 17th century. The building had survived the 1953 earthquakes with some damage which had subsequently been repaired.

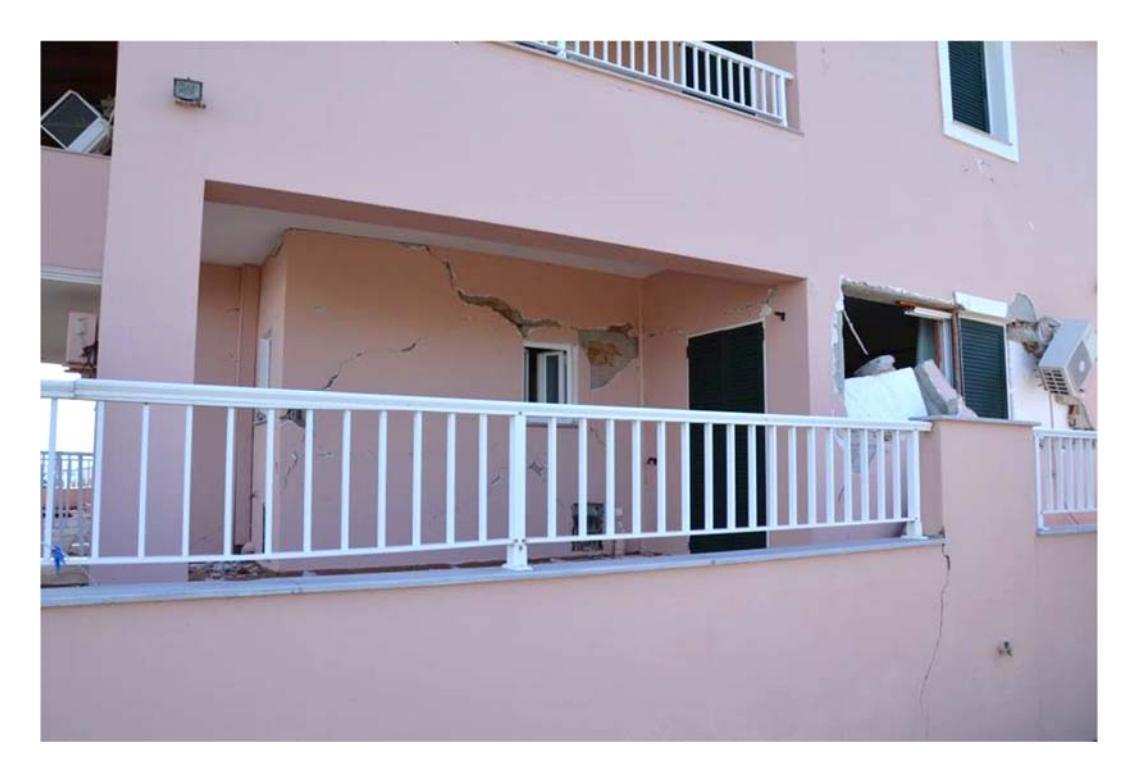
- RC buildings with masonry infill walls had minor damage on the RC structural frame and damage in the masonry infill walls. An example is shown in Fig. 11.1.7.

Figure 11.1.7. Severe damage of brick infill walls of a two-story RC building in Livadi (Fig. 11.1.1). The frame suffered only minor damage (38°13'48.19"N, 20°25'53.20"E).

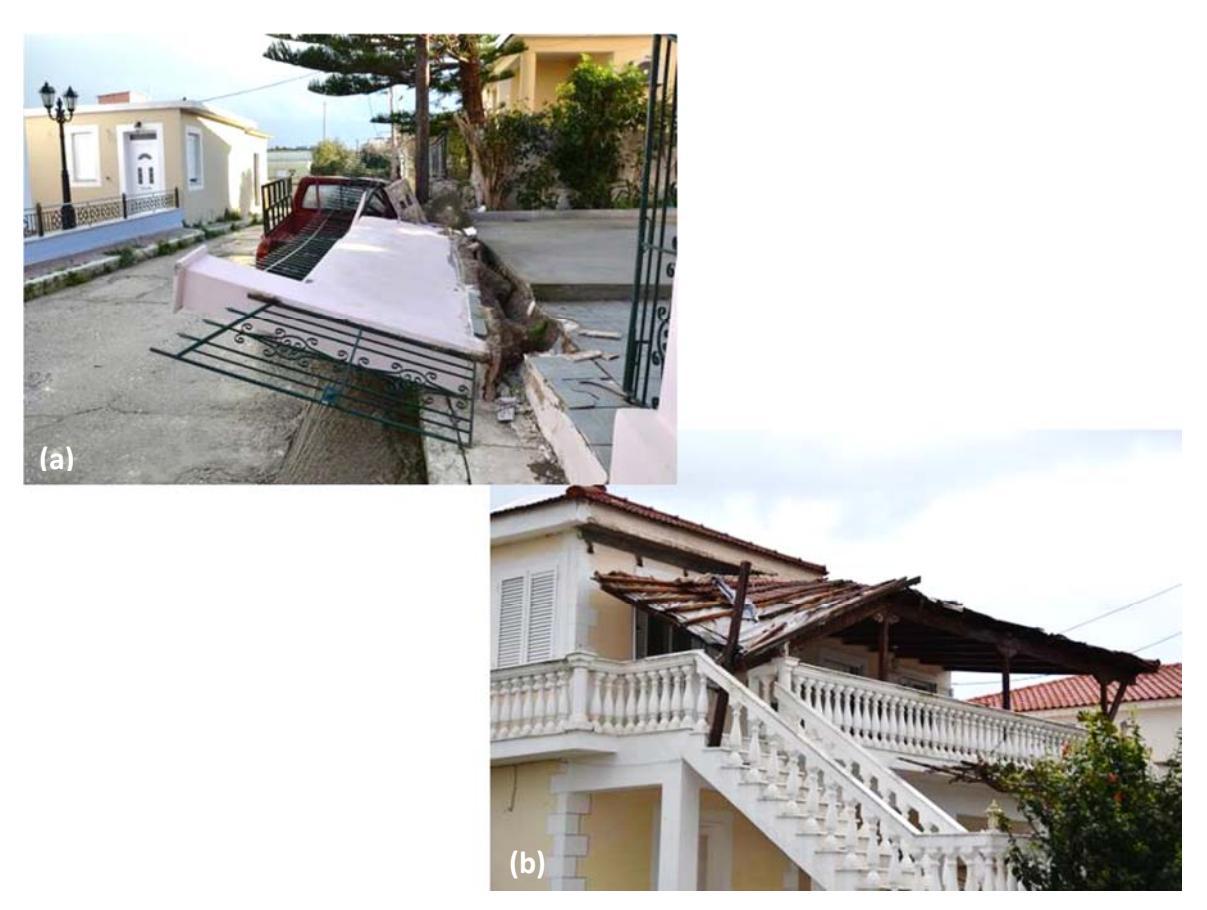
Although most buildings performed well, a large number of nonstructural components collapsed. While details can be found further into this Chapter (and in Chapter 9), typical examples of nonstructural architectural failures are shown on Fig. 11.1.9. The photos show representative failure of numerous masonry fences and pergolas that may be attributed to lack of seismic specifications or poor quality control during construction, which does not require professional engineering inspection.

Figure 11.1.8. Examples of nonstructural architectural components failure: (a) overturning of a masonry fence in Lixouri; (b) collapse of a pergola in Livadi.

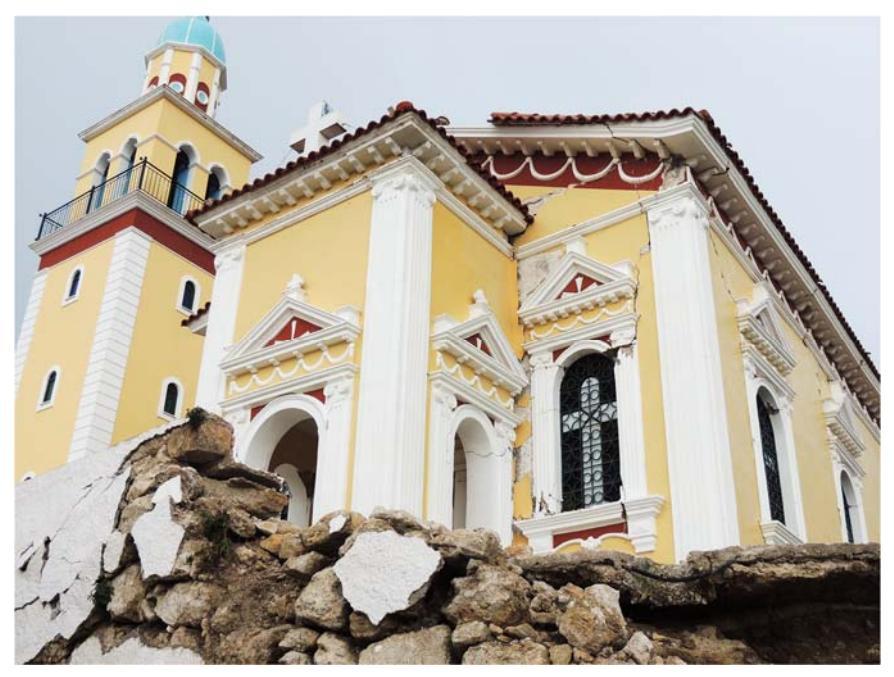
Figures 11.4.7 and 11.4.8 present severe damage observations after the 2nd event in the masonry church of Virgin Mary in Chavriata (38°10'57.52"N, 20°23'13.61"E). The damage pattern is affected by the damage after the 1st event and eventual collapse after the 2nd event of the stone masonry retaining wall as described in detail in Section 8.3.

Figure 11.4.7. Structural damage of the Virgin Mary masonry church in Chavriata (38°10'57.52"N, 20°23'13.61"E) after the 2nd event, affected by the stone masonry retaining wall collapse (Section 8.3).

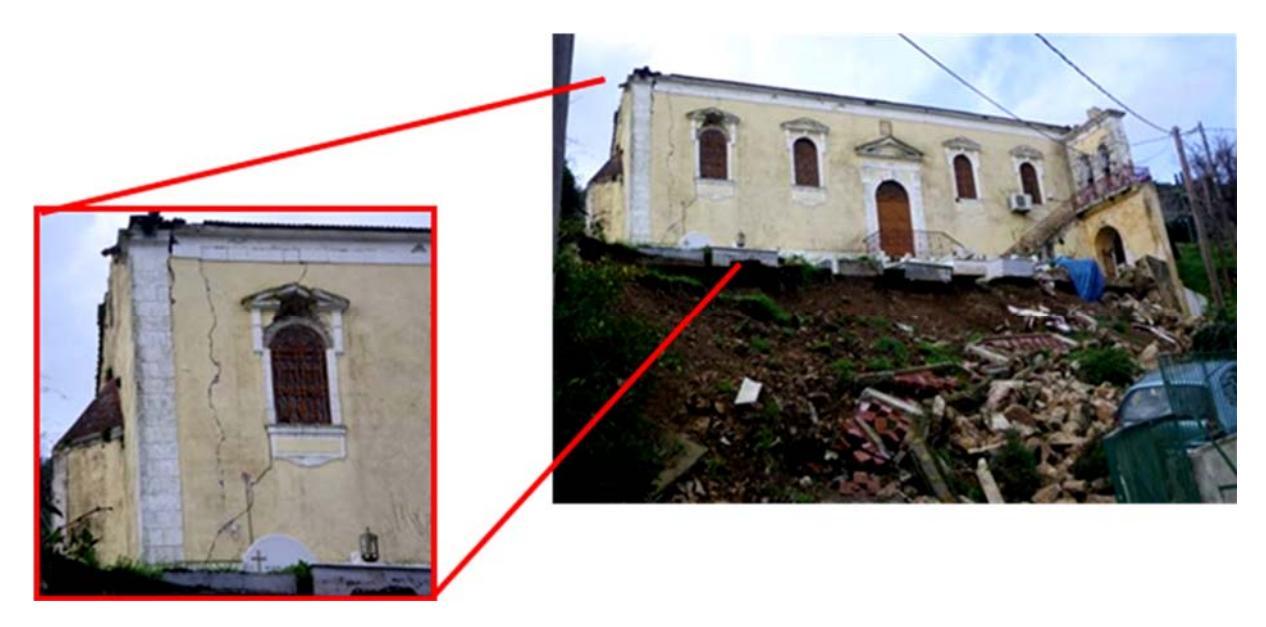
Typical shear and out-of-plane damage in the stone masonry church of Aghia Thekla (38°14′41″N 20°23′06″E) is shown on Fig. 11.4.9.

Figure 11.4.9. Typical shear and out-of-plane damage in the northeast corner of the stone masonry church of Aghia Thekla (38°14′41″N 20°23′06″E).

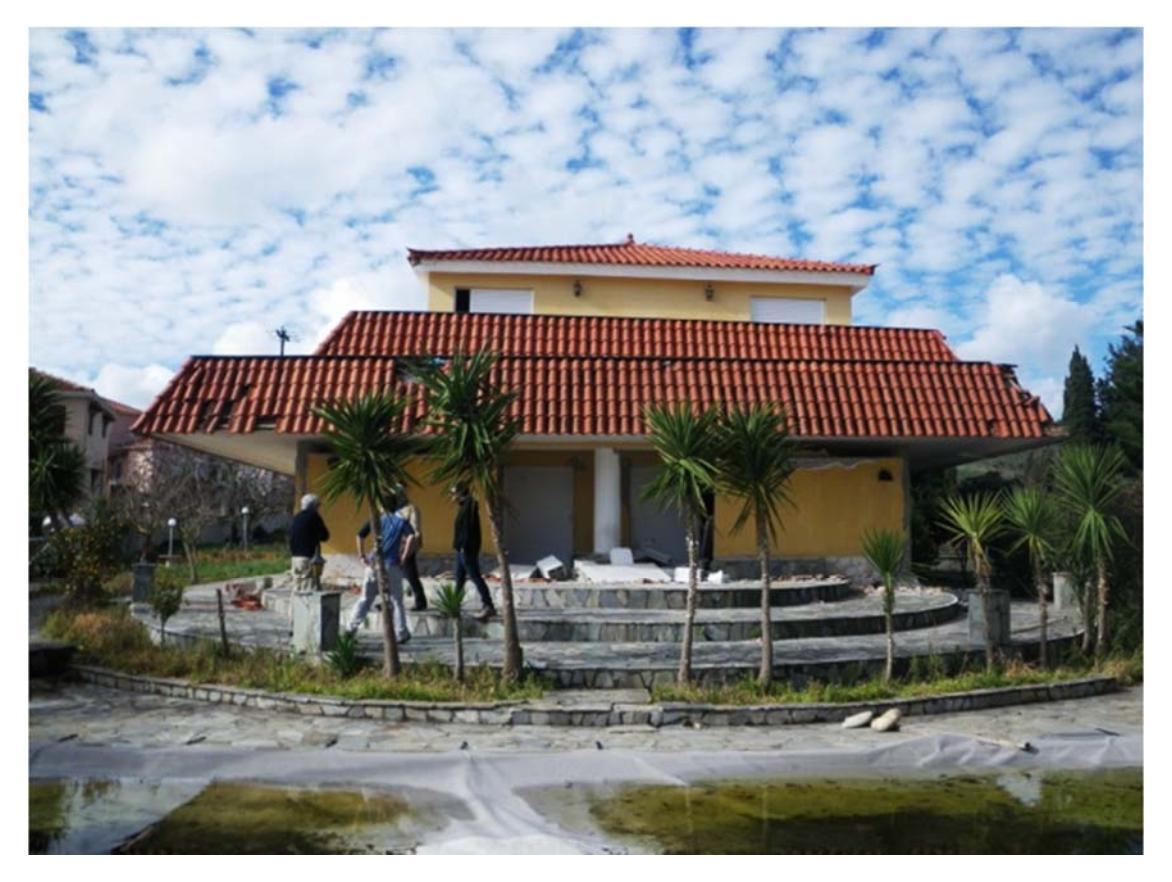
Figure 11.4.10. Collapse of intermediate story of 3-story RC building completed in 2007. (GPS coordinates: 38.258888, 20.424444).

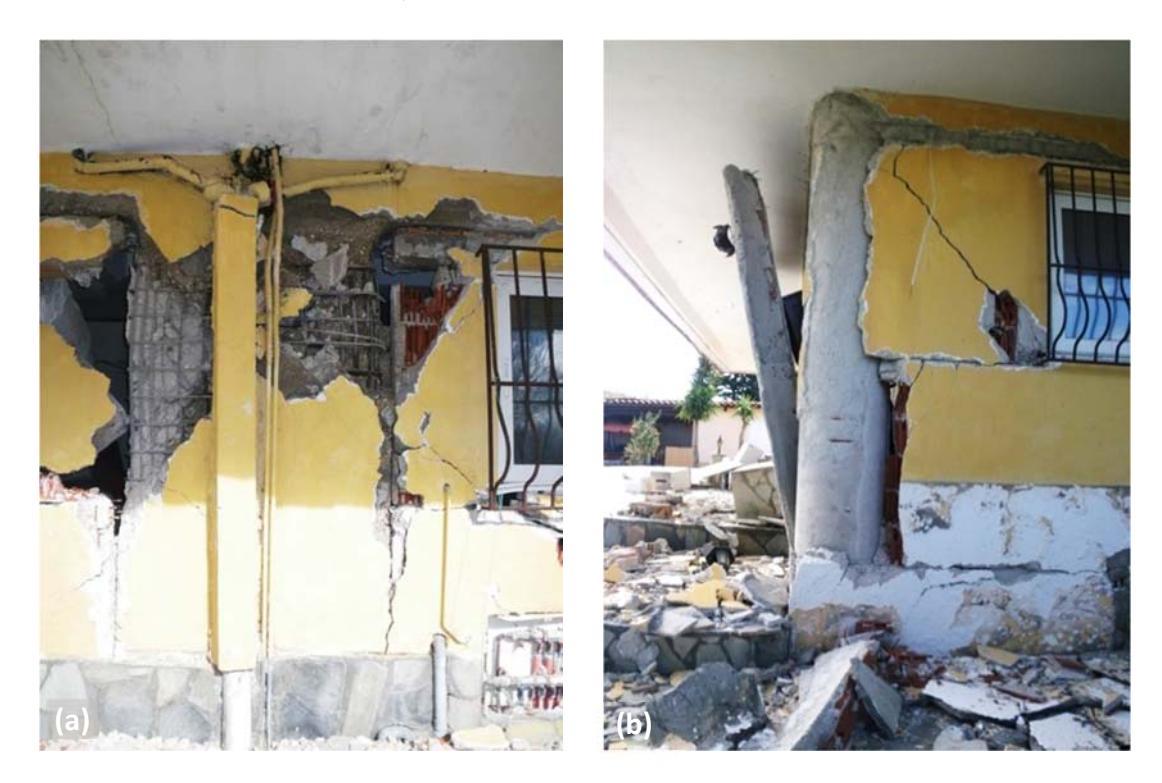
Figure 11.4.11. Building of Fig. 11.4.10 (GPS coordinates: 38.258888, 20.424444): (a) damage of RC bearing elements on ground floor; (b) indication of different ground motion in main building directions.

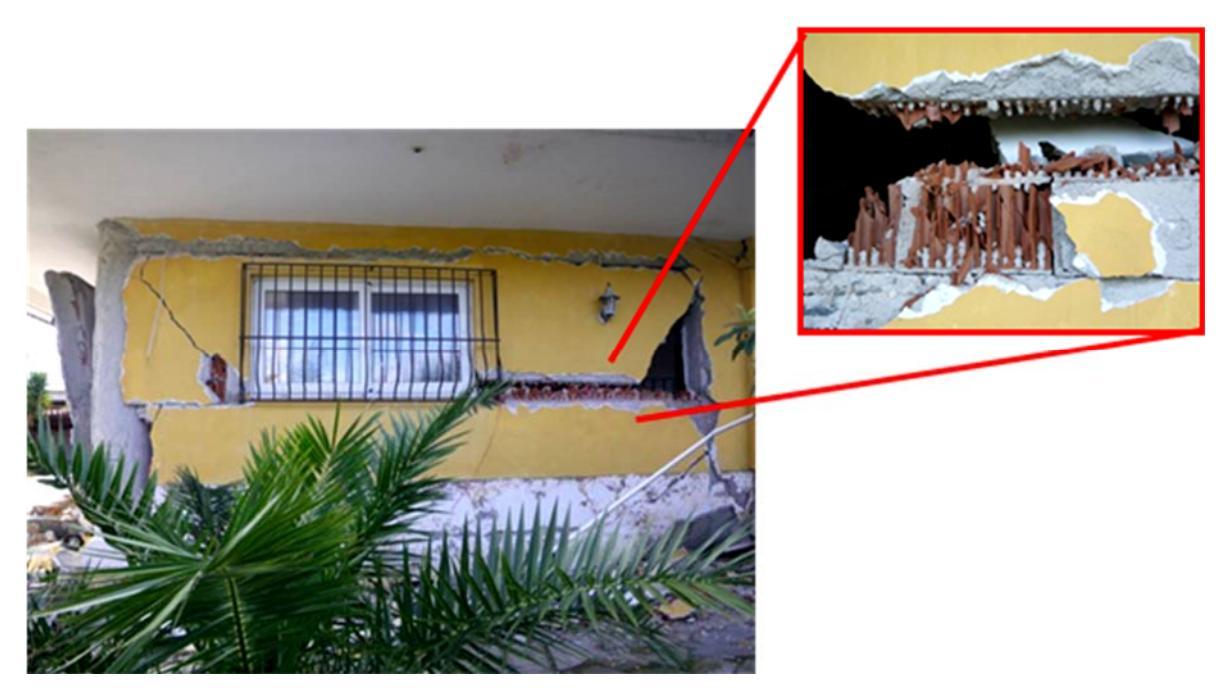
Figure 11.4.12. Poor behavior of infill walls with disintegration of vertically perforated bricks observed at the building of Fig. 11.4.10 (GPS coordinates: 38.258888, 20.424444).

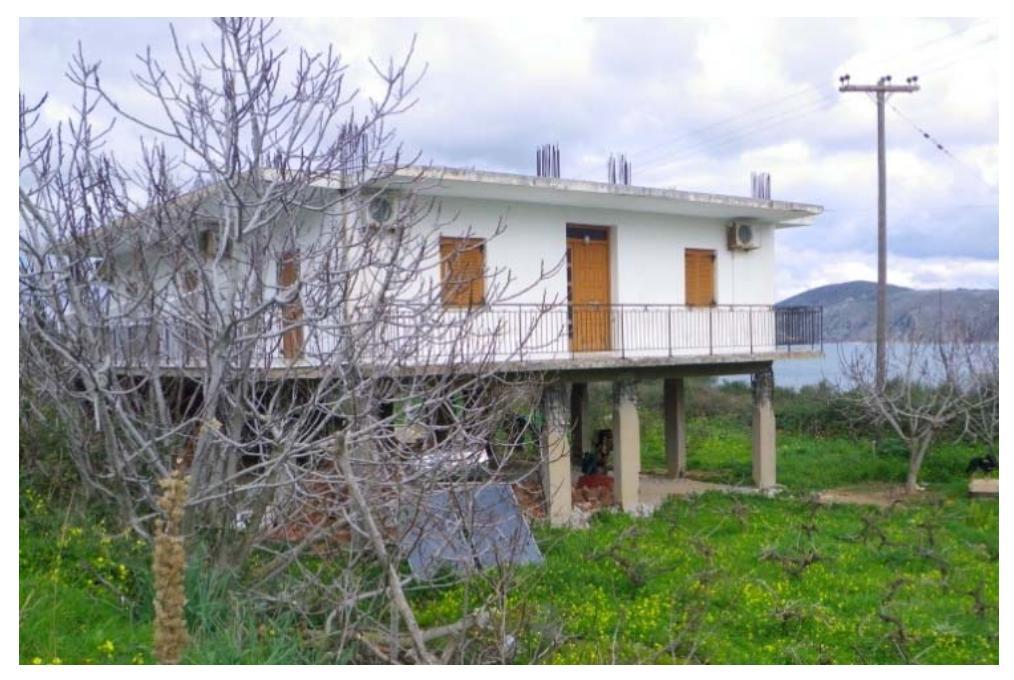
Figure 11.4.13. Two-story building that experienced typical soft story damage in Aghios Dimitrios (38°14'36.51"N, 20°25'41.91"E).

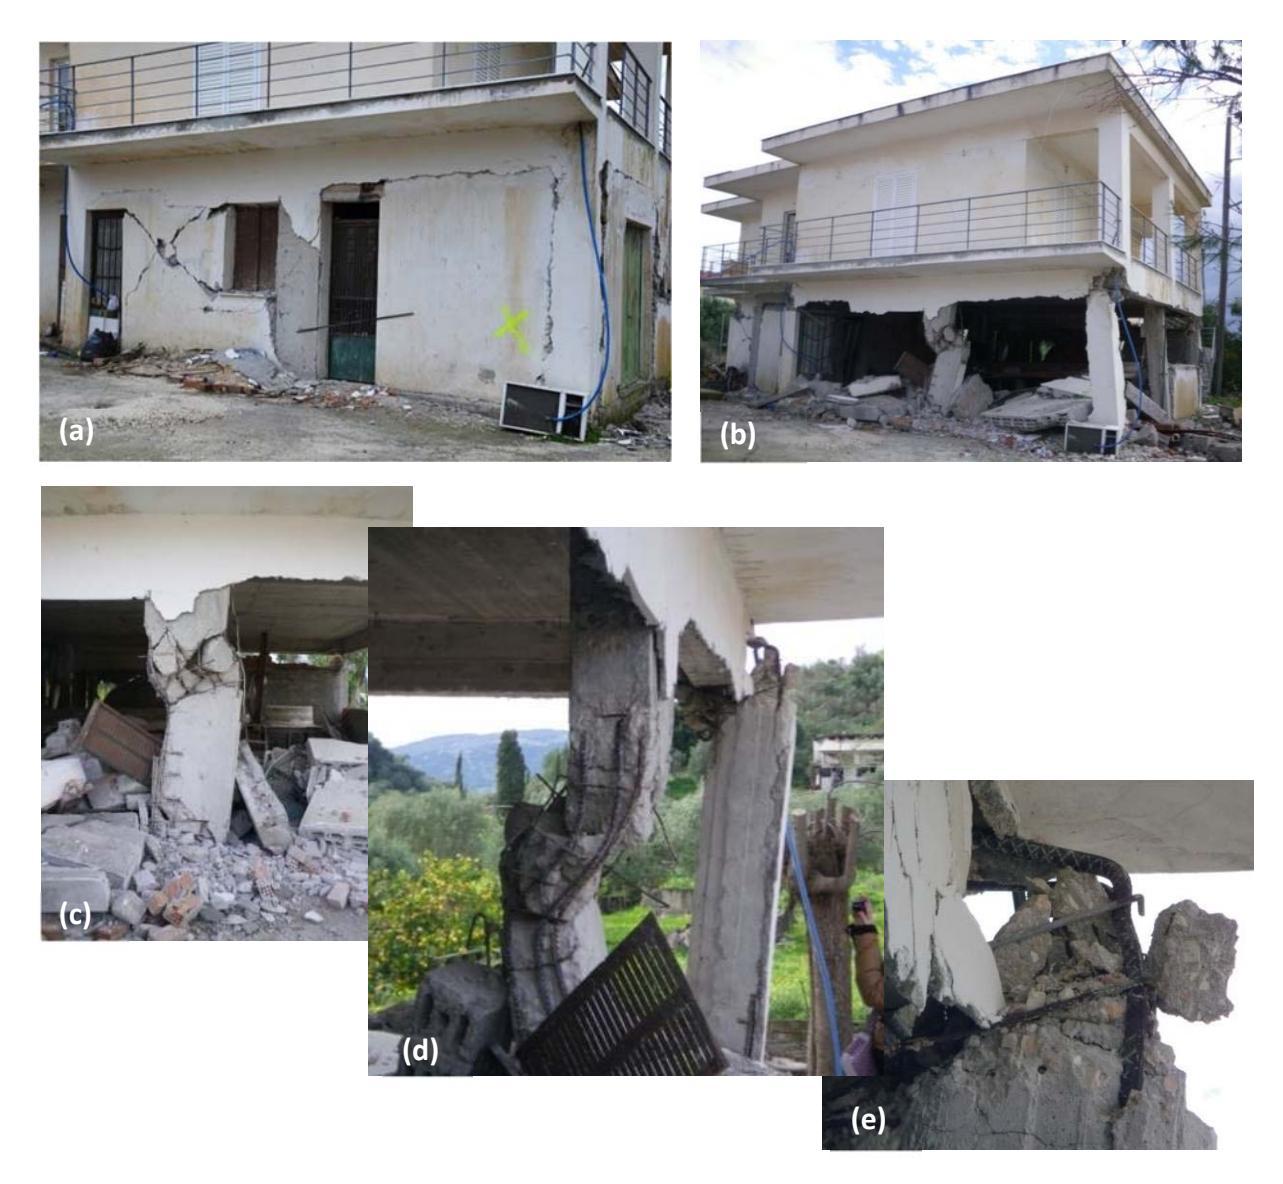
Figure 11.4.15. Damage of 2-story RC building in Aghios Dimitrios $(38^{\circ}13'45.6''N 20^{\circ}25'47.4''E)$: (a) shear cracks and separation of infills after 1st event; (b) failure of columns and joints after 2nd event; (c, d) detailing with single rectangular largely spaced hoops; and (e) detail of beam-column joint failure.

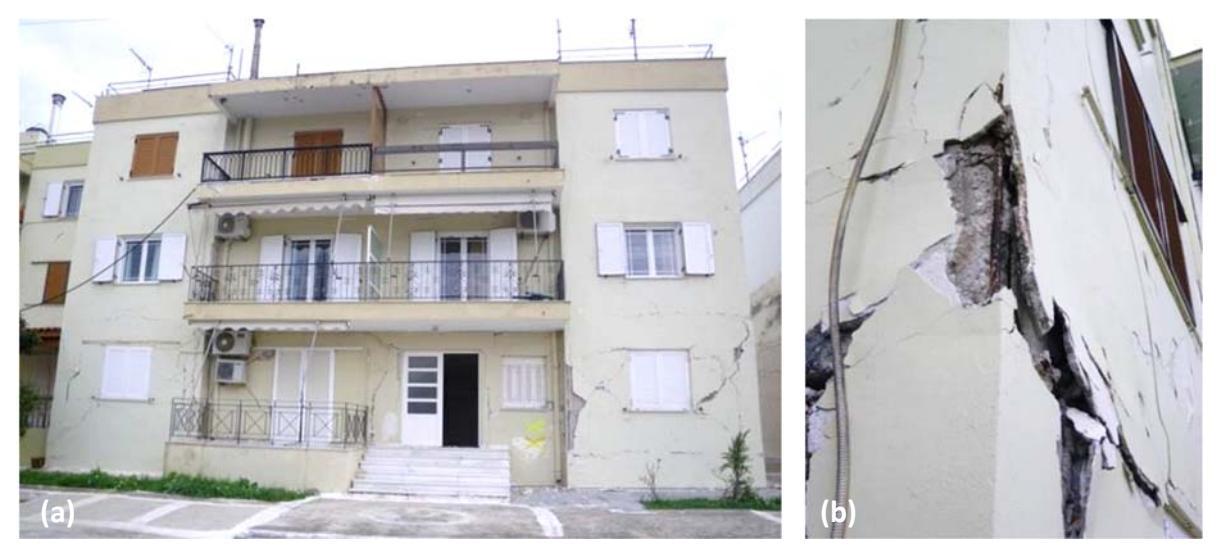
Figure 11.4.16. Residential 1962 "Arogi" public housing complex in Lixouri (GPS coordinates 20.434256, 38.21159) with: (a) extensive damage of infill walls and structural elements; (b) failure of a column. Note large spacing of single rectangular hoops.

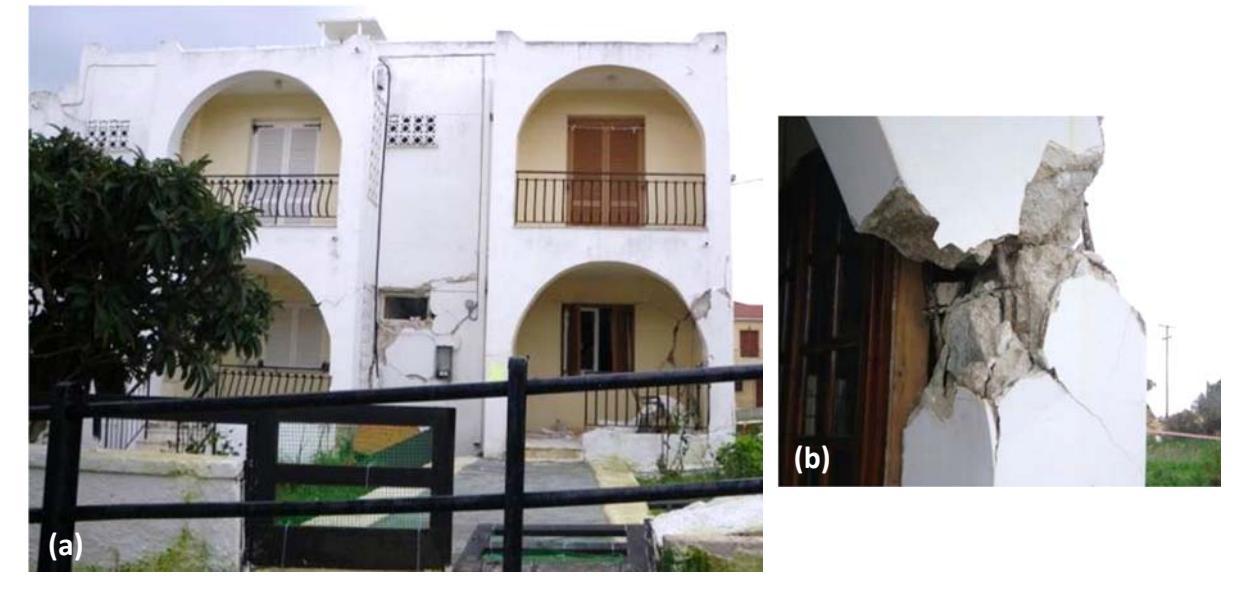
Figure 11.4.18. (a) Two-story residential buildings of 1978 with severe damage on the ground floor and minor damage on the upper floor; (b, c): Details of damage (coordinates 38.211567, 20.434134).

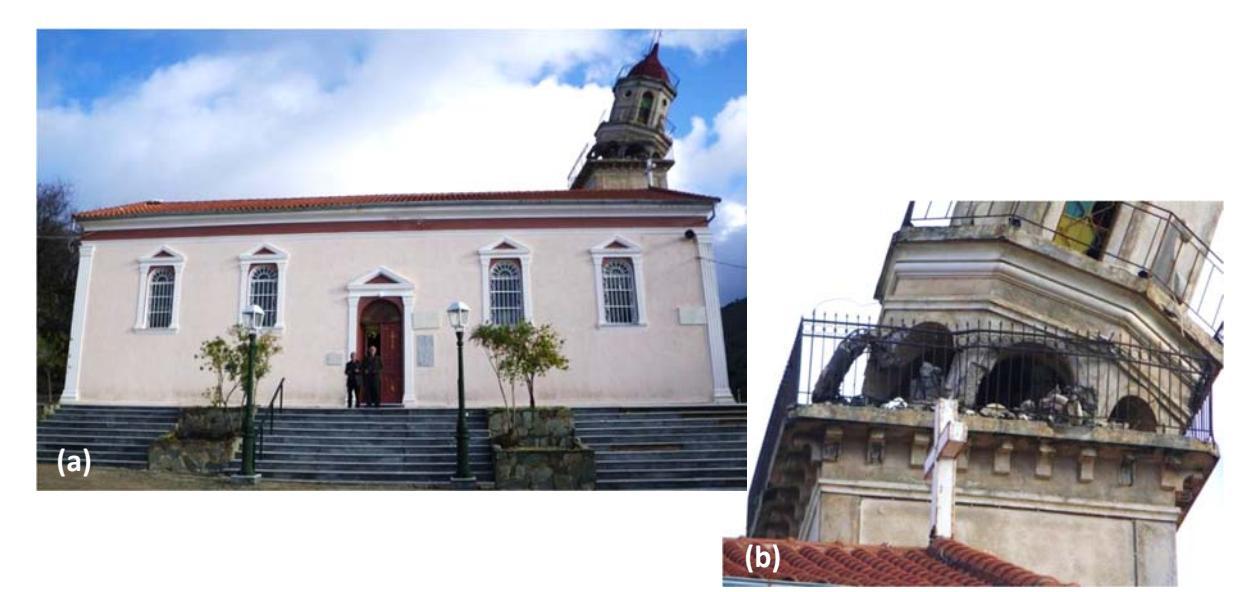
Figure 11.4.19. (a) Failure of upper part of the RC belfry of Aghios Ioannis church in Kourouklata (GPS coordinates: 38.242119, 20.473977); (b) detail showing poor detailing of rather short columns with stiff upper part, flexible lower part. Failure and crushing of concrete.

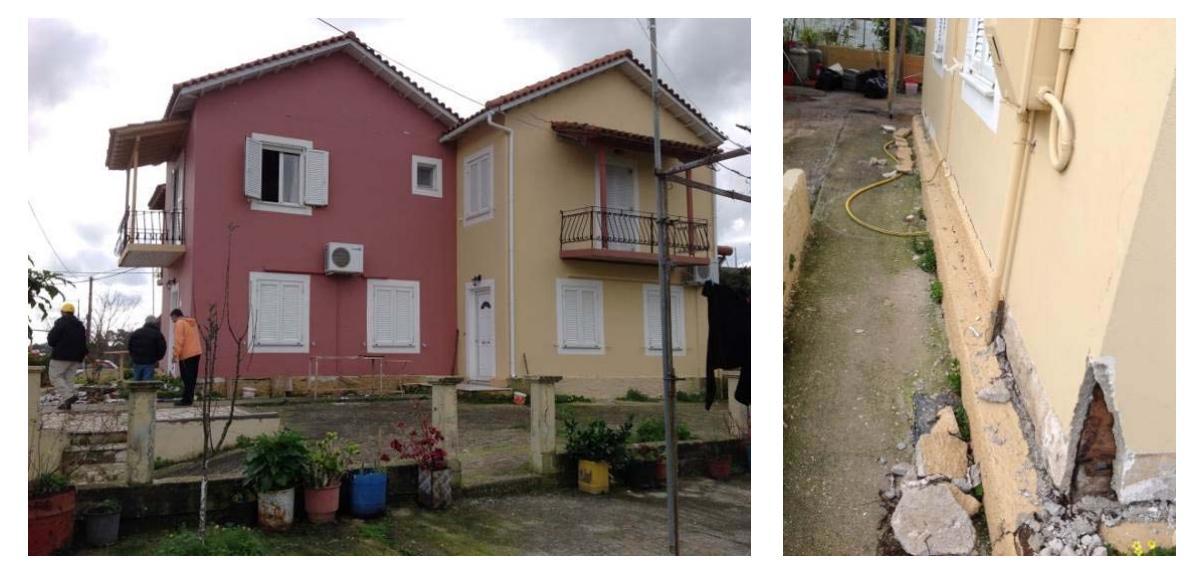
Figure 11.4.21. Two-story timber residential structures in Aghios Dimitrios. The only damage observed was a crack at the interface of the wood frame/walls with the concrete base slab.

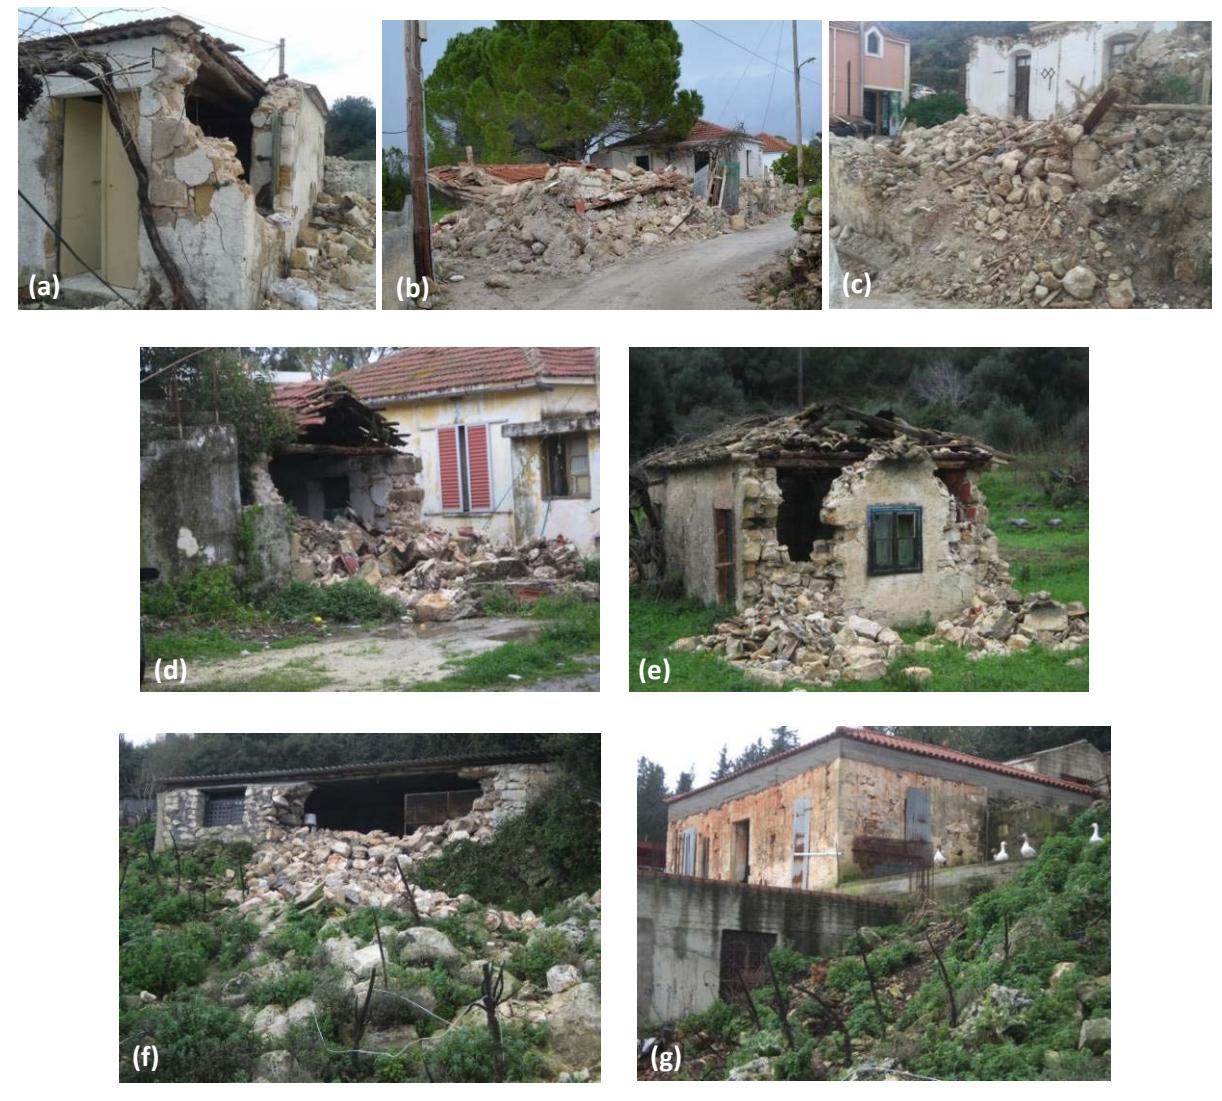
Figure 11.5.6. Pre-1953 masonry construction: (a) partial collapse of a Chavriata house (38°11'0.67"N, 20°22'54.93"E), 50 m from station CHV1; (b) collapse of building Chavriata; (c) collapse of 2-story house in Havdata (38°12'11.62"N, 20°23'09.01"E); (d,e) partial collapse of secondary-use buildings; and (f,g) adjacent buildings with no damage in (g) that had reinforced concrete ties at the top.

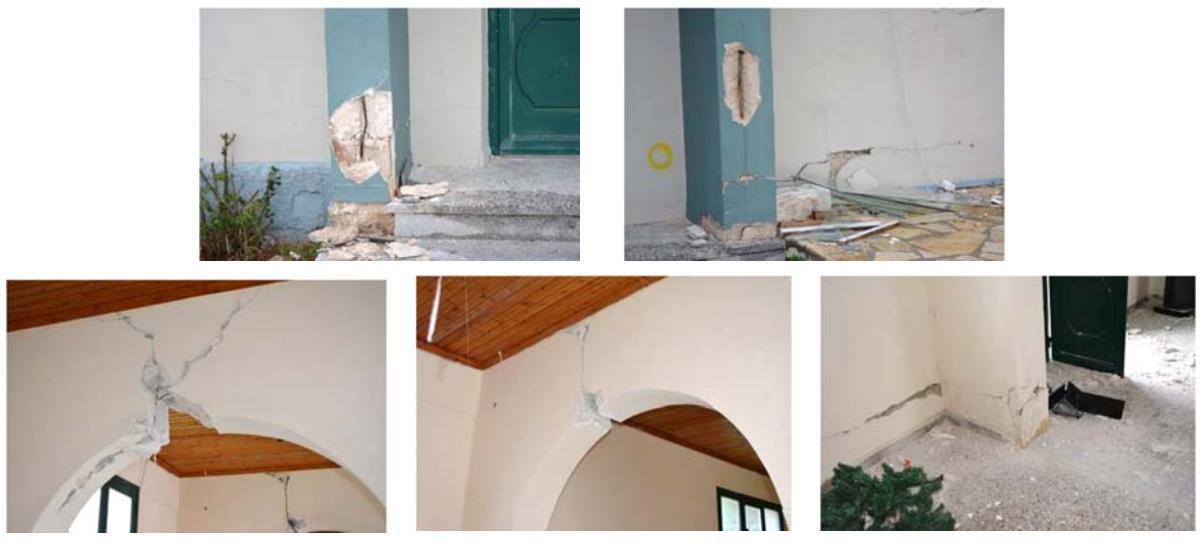
Figure 11.5.9. Exterior (top) and interior (bottom) damage of the old school building in Chavriata (38°11'00.67"N, 20°22'54.93"E) where the CHV1 accelerometer is located.

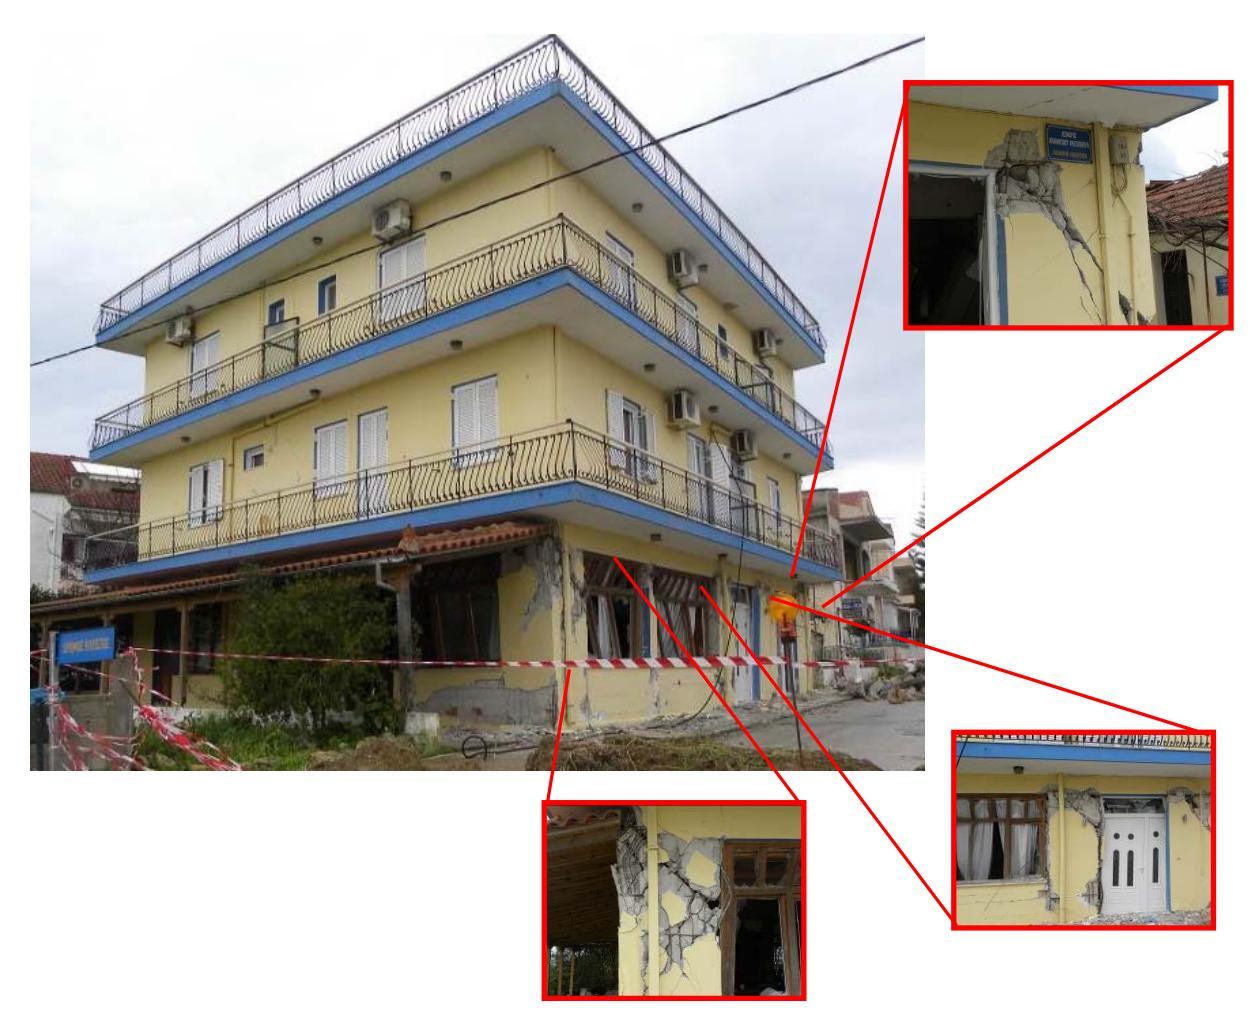
Figure 11.5.12. Three-story building in Lixouri (Aravantinou Krasopatera St., 38°11'36.81"N, 20°26'11.42"E), probably built before 1984. The two upper floors did not appear to suffer any structural or infill wall damage. The columns and shear walls (or wide columns) of the 1st floor were severely damaged (soft-story failure). The structure was later demolished.
Built between 1984-1995 (1959 seismic code, with 1984 supplementary provisions)

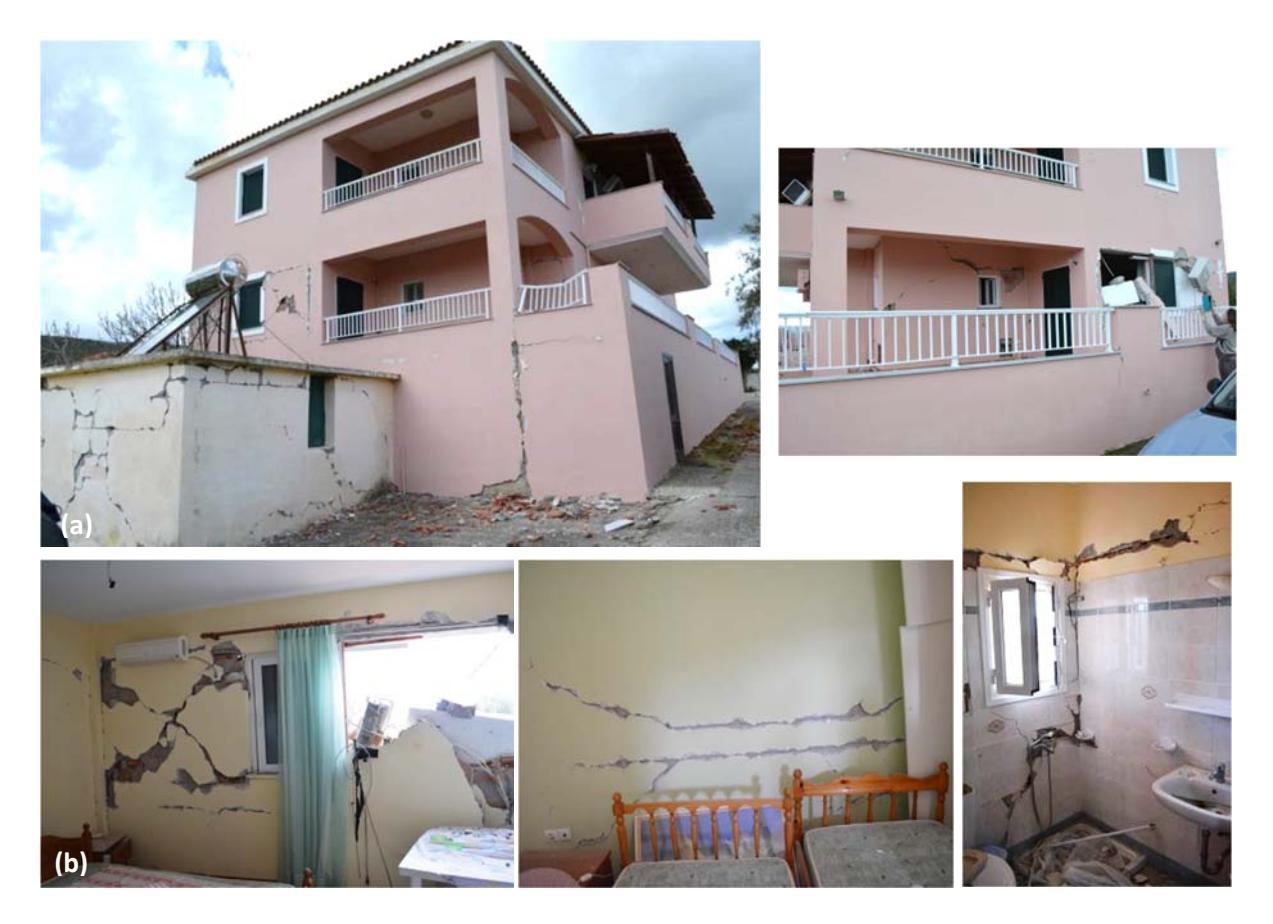
Figure 11.5.16. Two-story house in Livadi (38°15'24.81"N, 20°25'31.77"E), east of the Lixouri-Argostoli road. (a) infill wall cracking from the exterior; (b) infill wall failures from the interior.

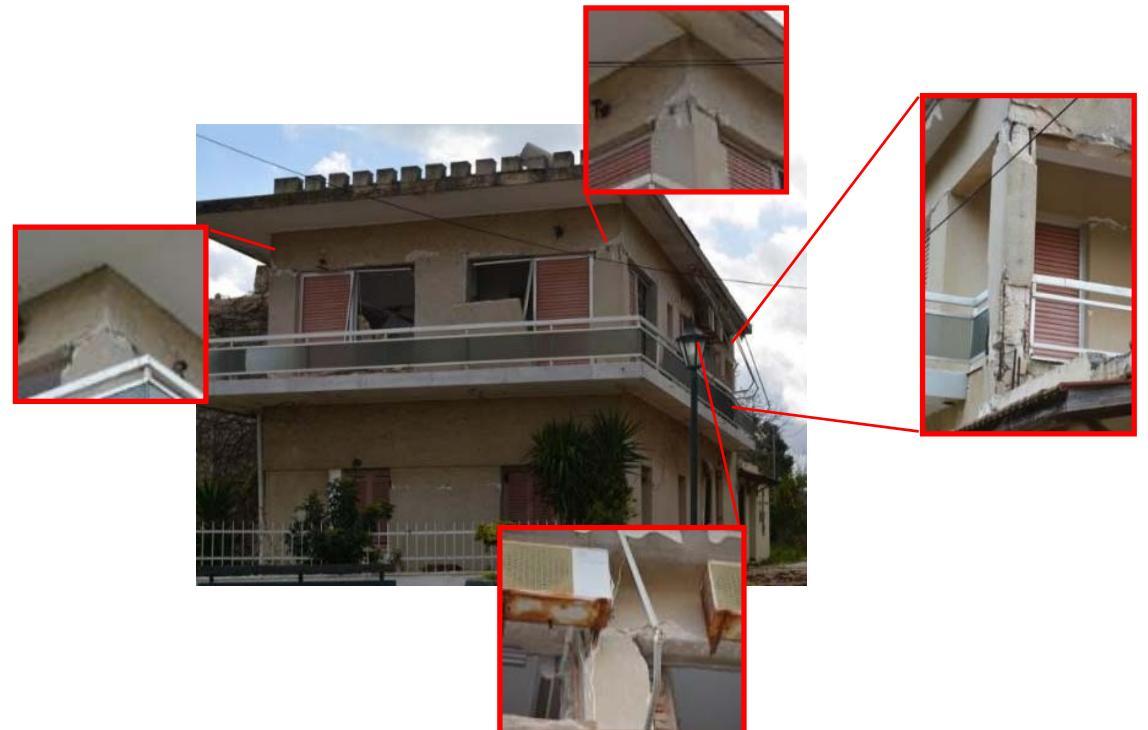
Figure 11.6.1. Two-story house in Livadi (38°15'26.13"N, 20°25'21.38"E). Damage is evident in every column of the 2nd floor and in some infill panels. No damage to the 1st floor was visible from the exterior.
