CHAPTER 11 Structural Observations

GEER/EERI/ATC Cephalonia, Greece 2014 Report Version 1

11.1 Main Structural Observations

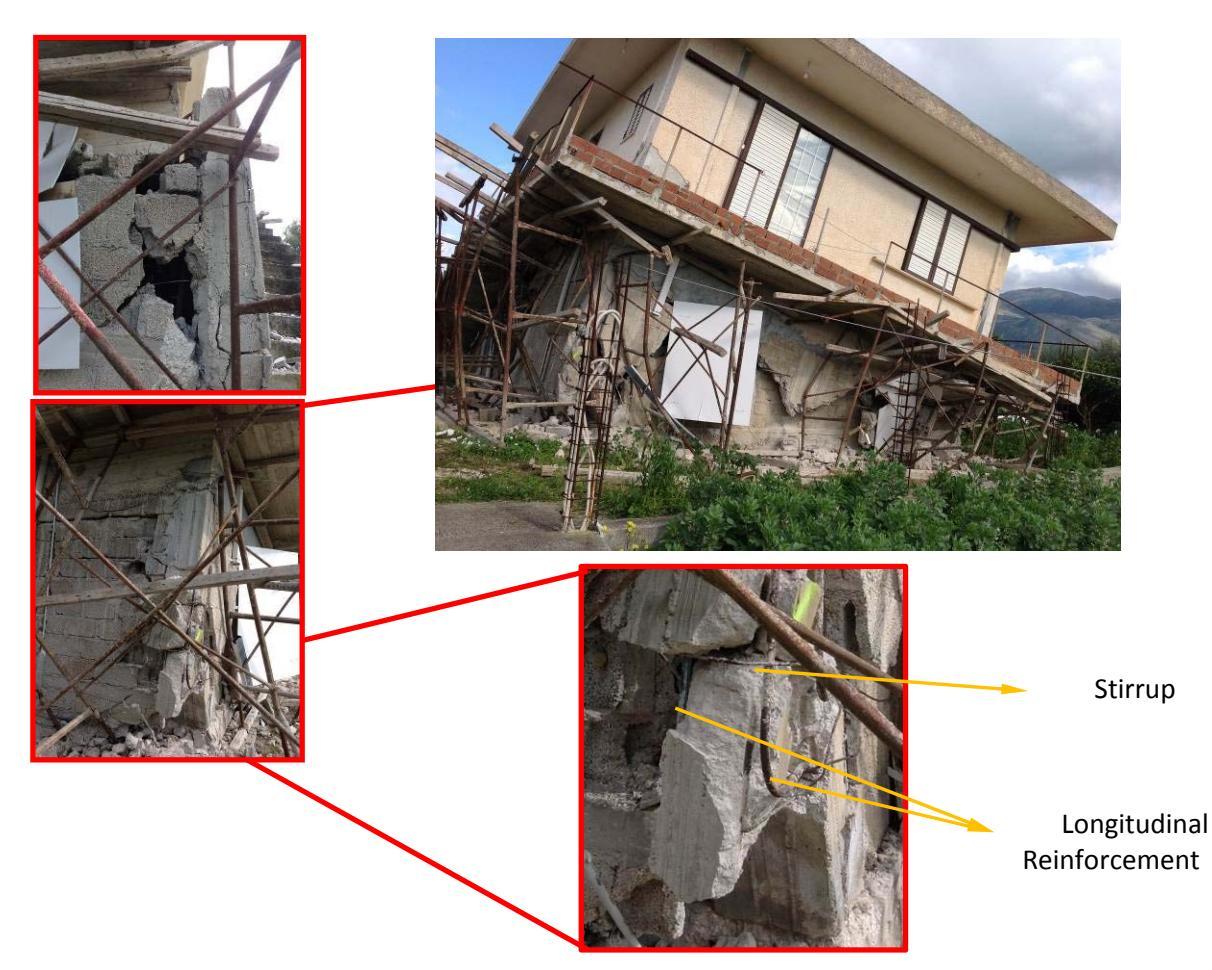
Figure 11.6.3. Tilted 2-story building in Aghios Dimitrios (Arogi house on 1st floor and 1978 RC claybrick infill frame on 2nd floor). Failed columns and walls of the 1st story showed few stirrups along the columns and only 4 longitudinal reinforcing bars in the cross section (38°13'50.45"N, 20°25'49.78"E).

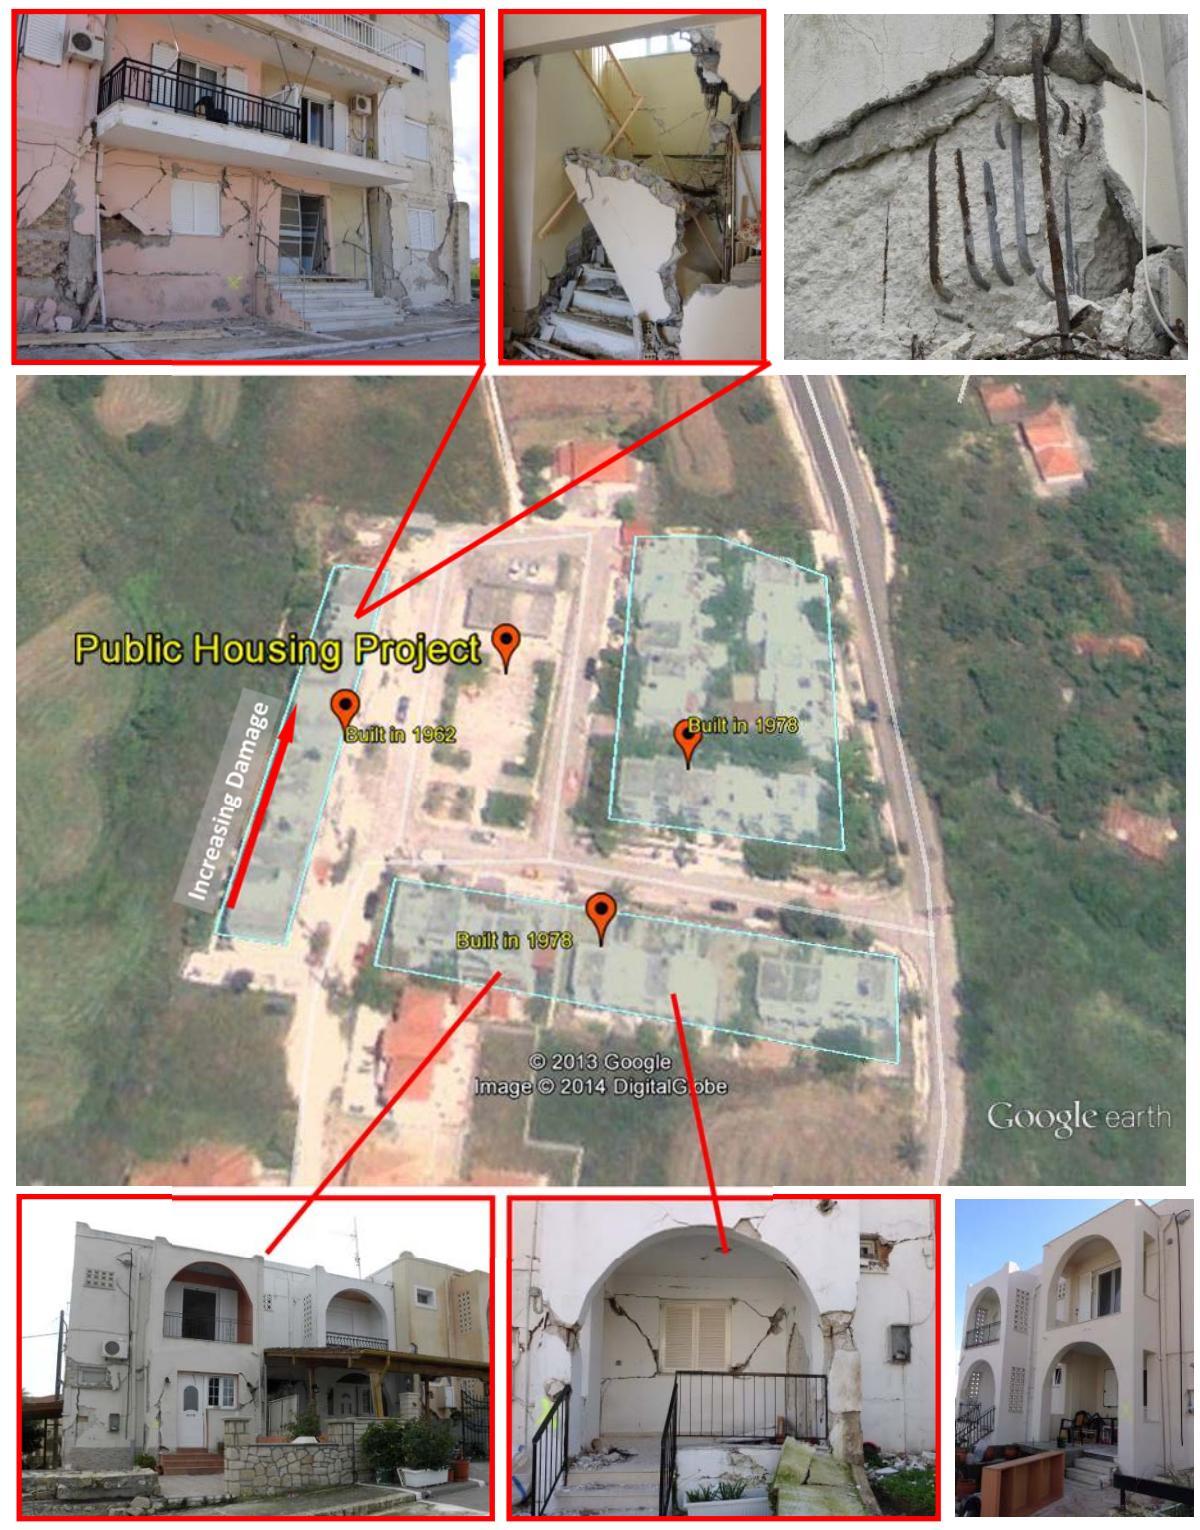
Figure 11.6.4. Public low income housing complex. Top: severe damage of the three story buildings built in 1962. Top right: lack of shear reinforcement. Center: public housing blocks/units. Buildings with red roof on the lower portion are undamaged two-story houses built after 2000 with the current seismic code. Bottom: Repairable damage at two-story buildings built in 1978.

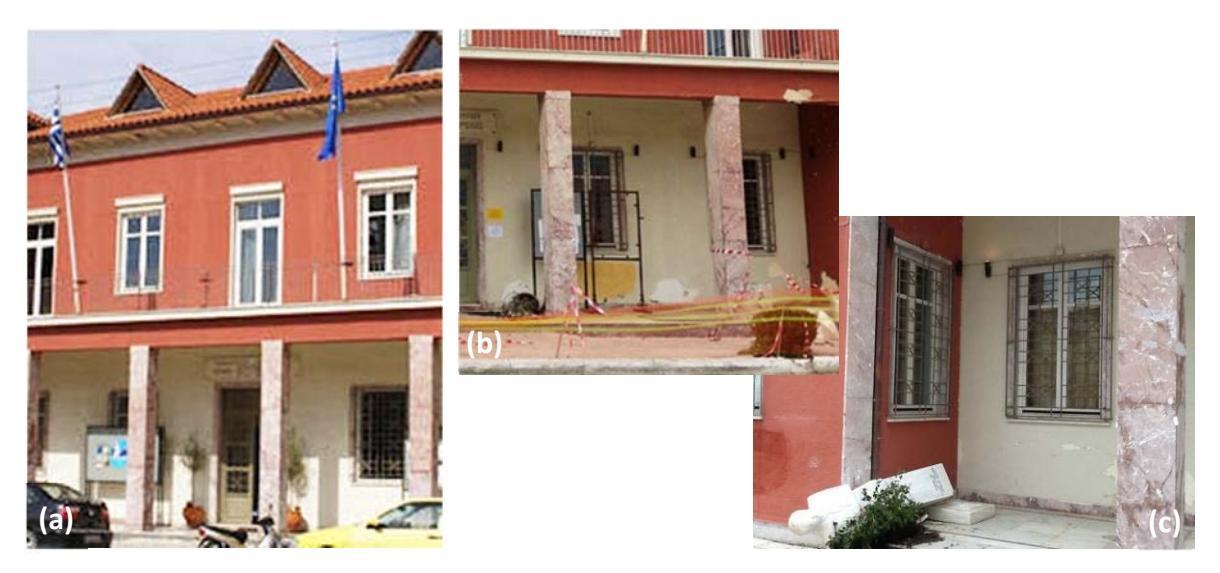
Figure 11.7.2. Lixouri Town Hall. (ID#3 in Table 11.7.1; coordinates 38°12'3.53"N, 20°26'14.92"E). (a) before the 2014 events; and after the 2nd event: (b) column damage; (c) overturning of statue.

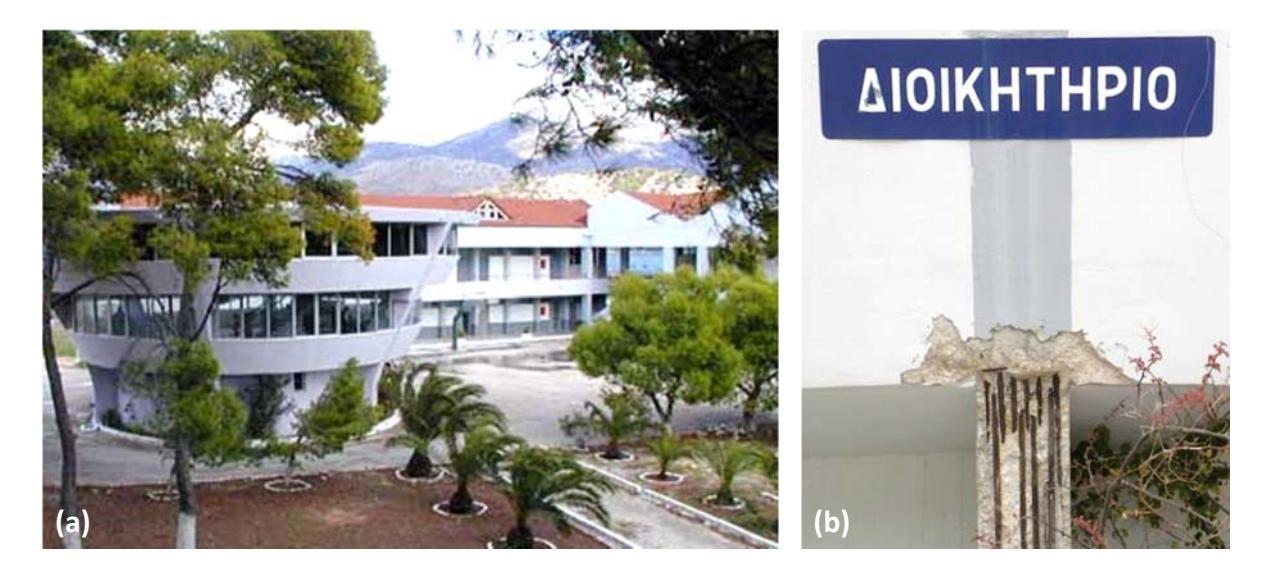
Figure 11.7.4. (a) Merchant Naval Academy building (ID#10 in Table 11.7.1) in Argostoli (coordinates 38°11'4"N, 20°29'9"E; photo from <u>kefalonia.net.gr</u>); (b) Observation following the 2nd event of lack of shear reinforcement and corrosion of rebars.

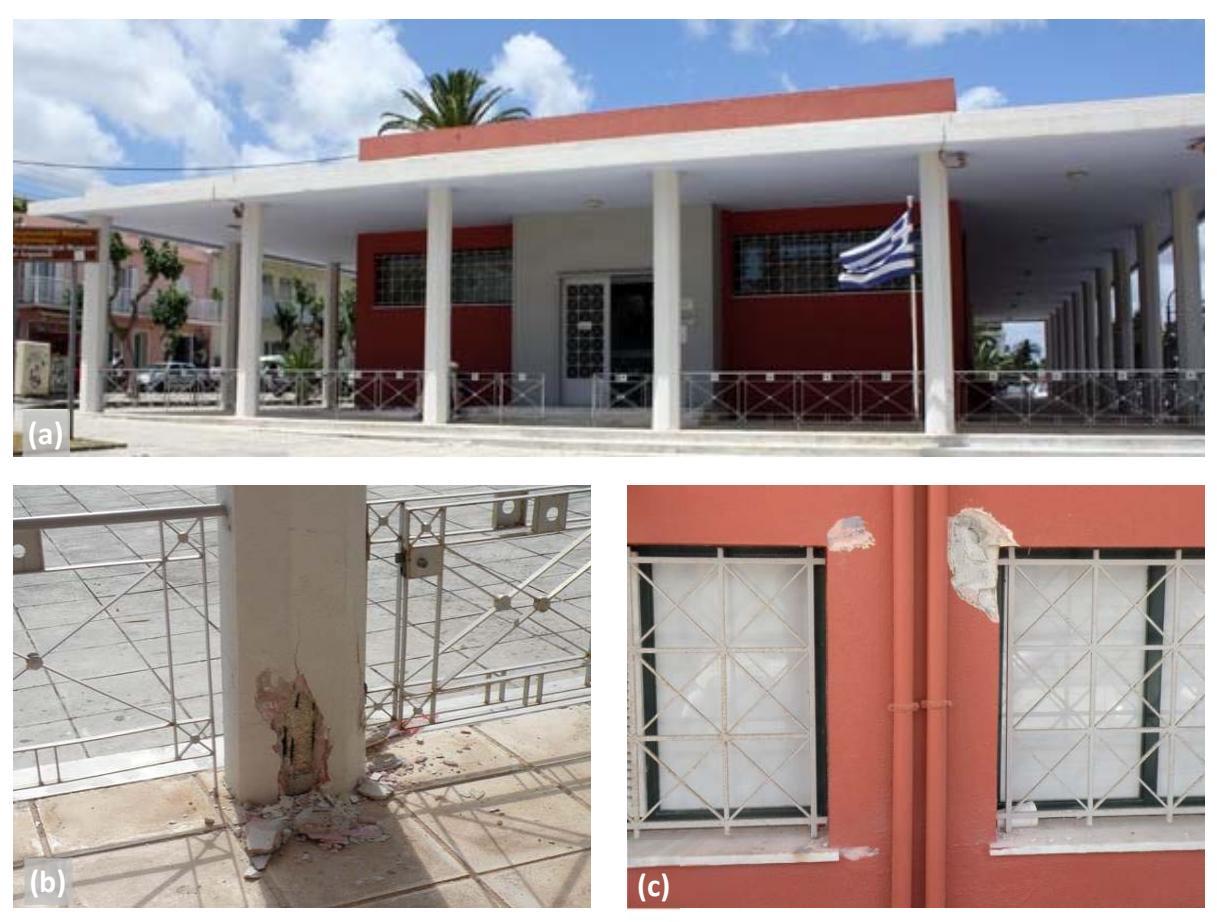
Figure 11.7.5. Argostoli Archeological Museum (ID#11 in Table 11.7.1; coordinates 38°10′40″N 20°29′17″E). (a) photo taken after the 2000 rehabilitation but before the 2014 events (<u>mygreece.travel</u>); (b) concrete spalling; and (c) minor cracking at short columns. Both photos taken after 2nd event.

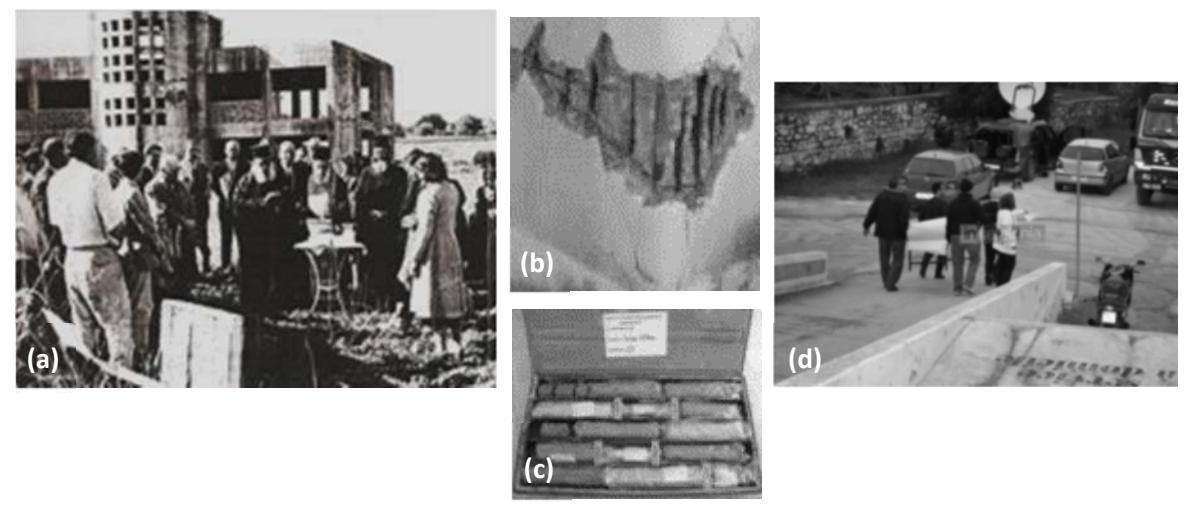
Figure 11.7.6. Lixouri "Mantzavinateio" General Hospital (ID #1, 38°10'44.8"N, 20°29'23.3"E): (a) historic photo of structural frame completion prior to 1953; (b,c) structural and geotechnical investigations for 2004-12 seismic retrofit; (d) evacuation after 1st event (inkefalonia.gr, 2014). Following assessment, the hospital was deemed safe and operations resumed few days after the 2nd event. Retrofit and historic information and photos a,b,c from Barthakis (2014).

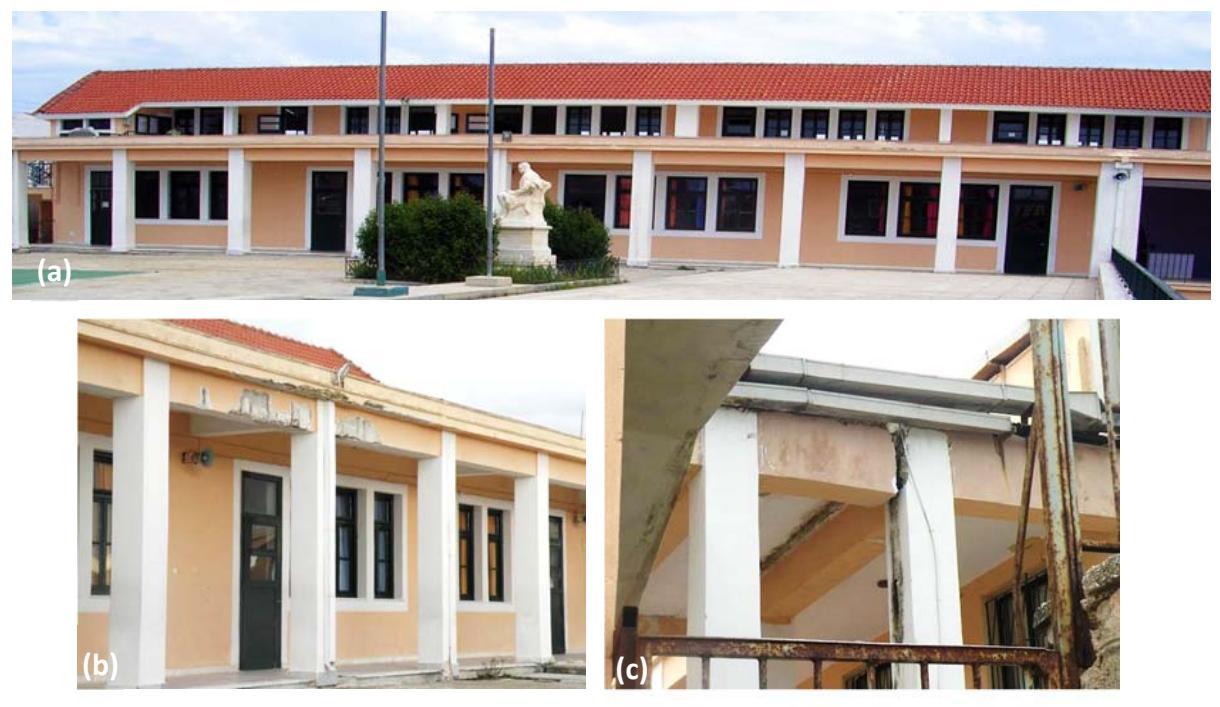
Figure 11.7.8. "Petritsio" high school, Lixouri (School ID#1, 38°12'12.87"N, 20°26'15.43"E): (a) prior to 2014; after 2nd event: (b) concrete spalling at external beam; (c) beam-column joint failure.

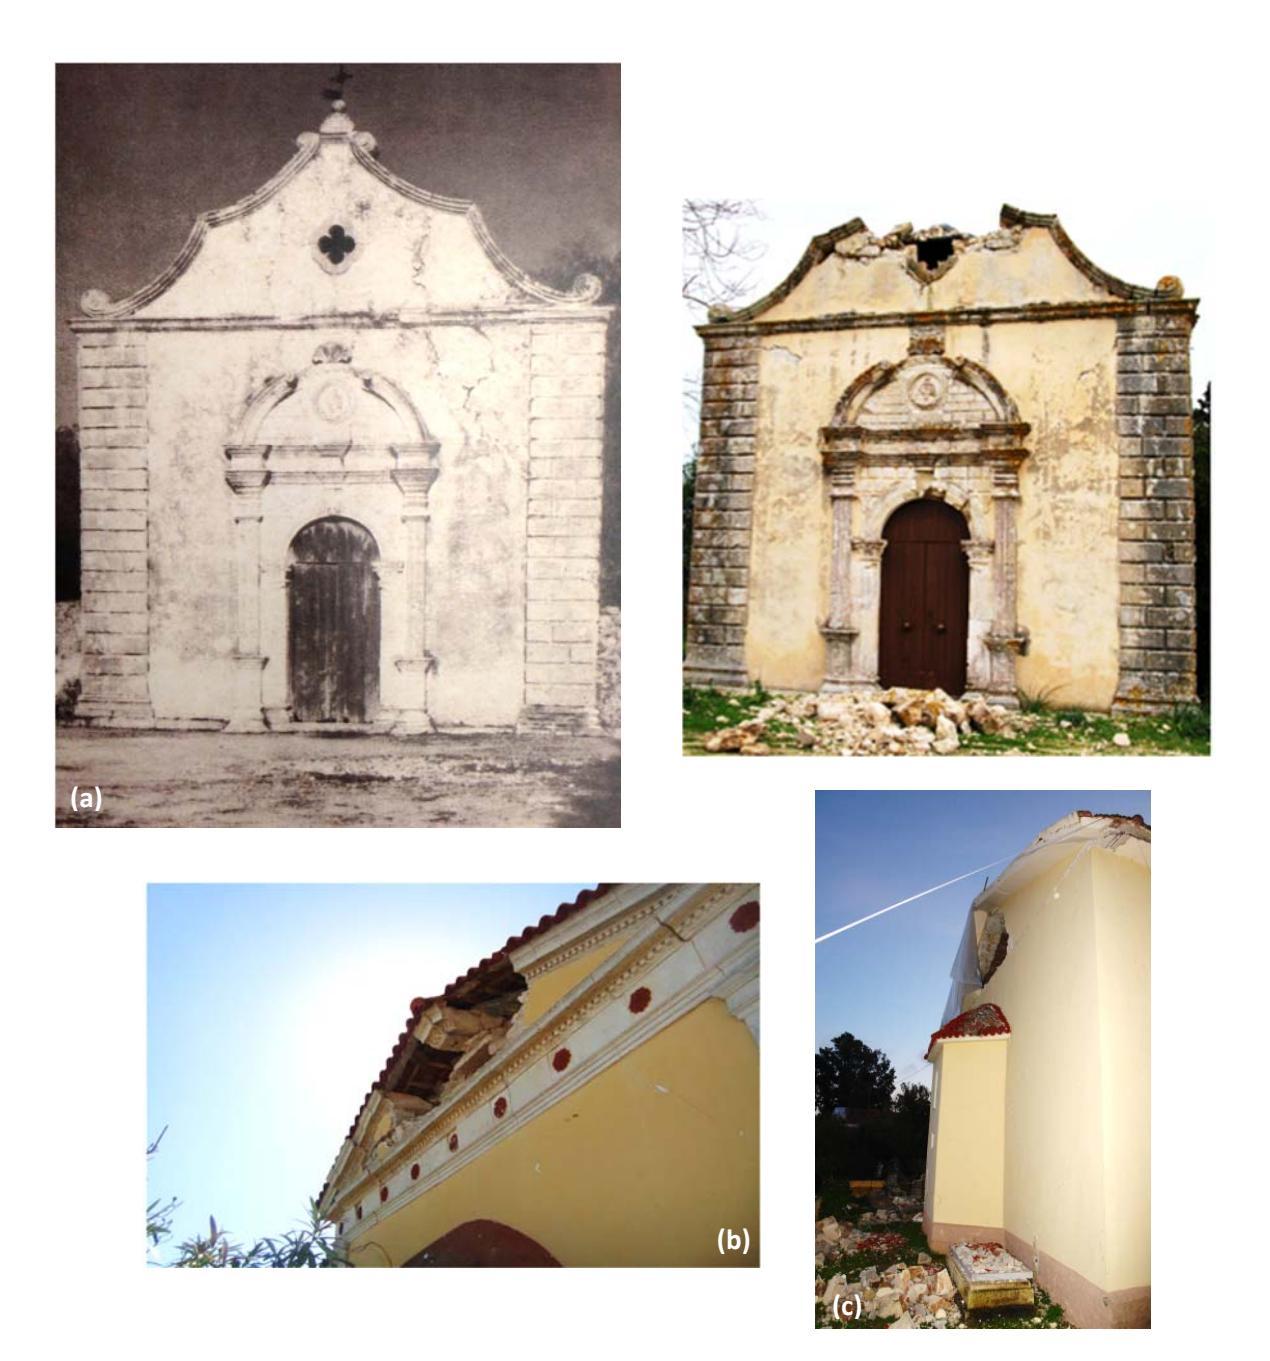
Figure 11.8.7. Typical damage of stone gables in the churches of: (a, b) The Virgin Mary of Rongoi (ID#9) – (a) shows original condition prior to the 1953 earthquakes; (b) The Virgin Mary at Kechrionas (ID#6); and (c) Aghios Ioannis Theologos at Kontogenada (ID#24).

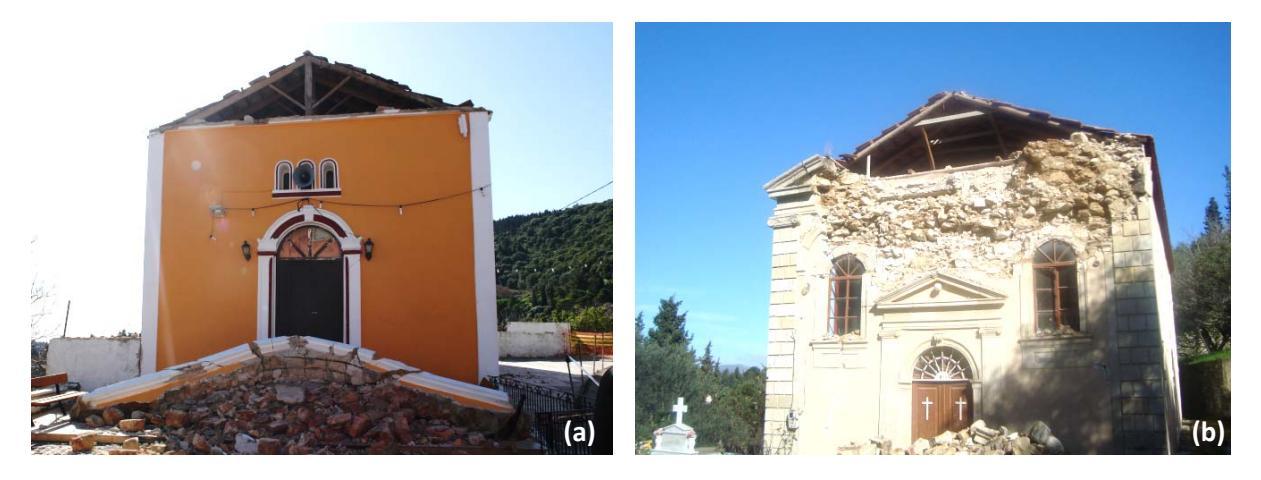
Figure 11.8.8. Collapse of stone gable due to loss of continuity between stone wall and gable through installation of a RC lintel in the churches: (a) Aghios Nikolaos at Aghia Thekli (ID#11); (b) Aghios Vlasios (Blaise) at Dematora (ID#11).

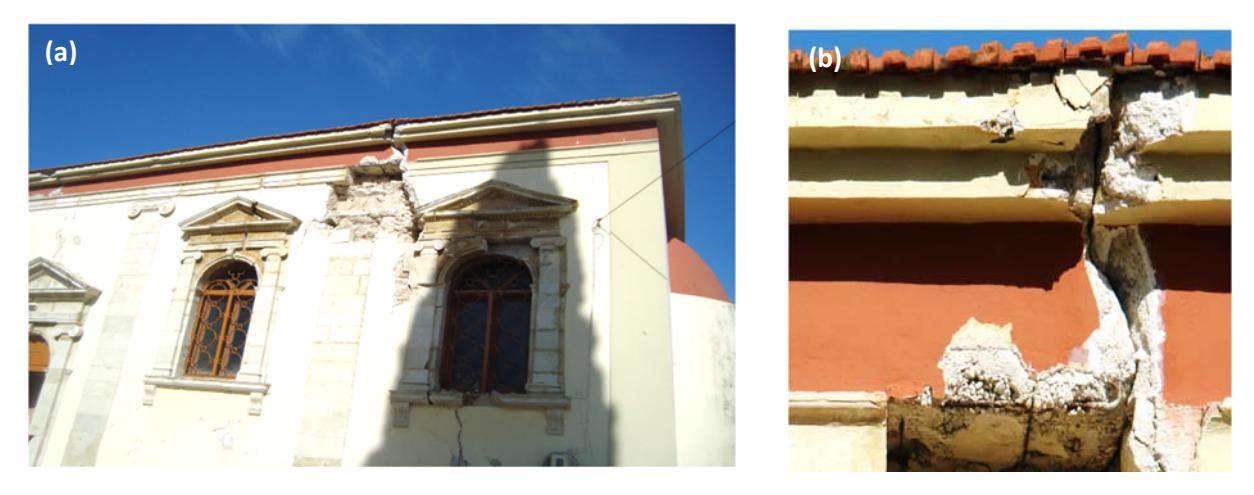
Figure 11.8.9. Typical damage to Category 4 (strengthened masonry) churches to the top part of the walls due to inadequate overlap of the lintel reinforcment.

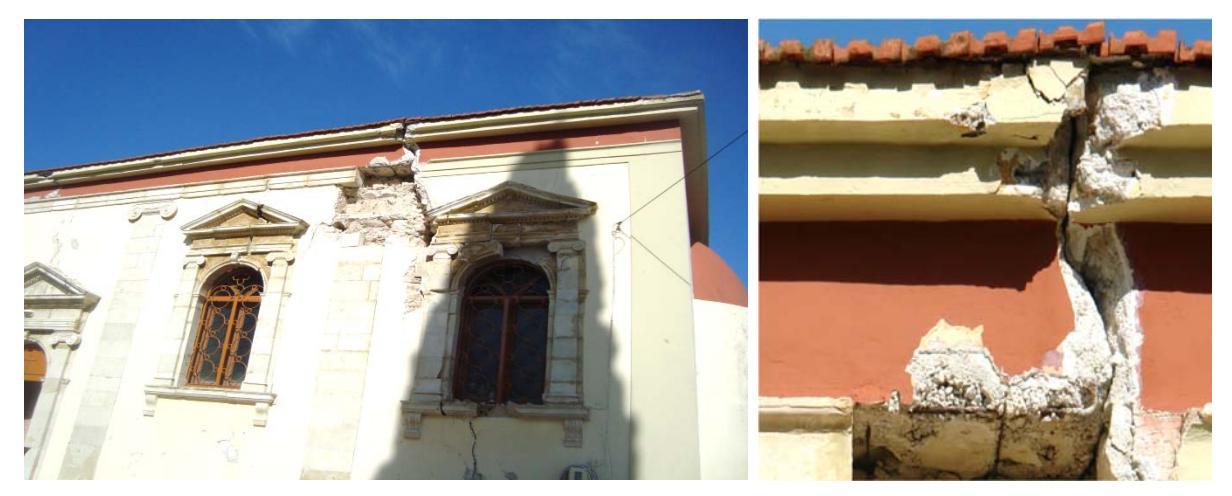
Figure 11.8.11. Typical damage to Category 4 churches at top part of the walls of a strengthened masonry church due to inadequate overlap of the lintel reinforcment.

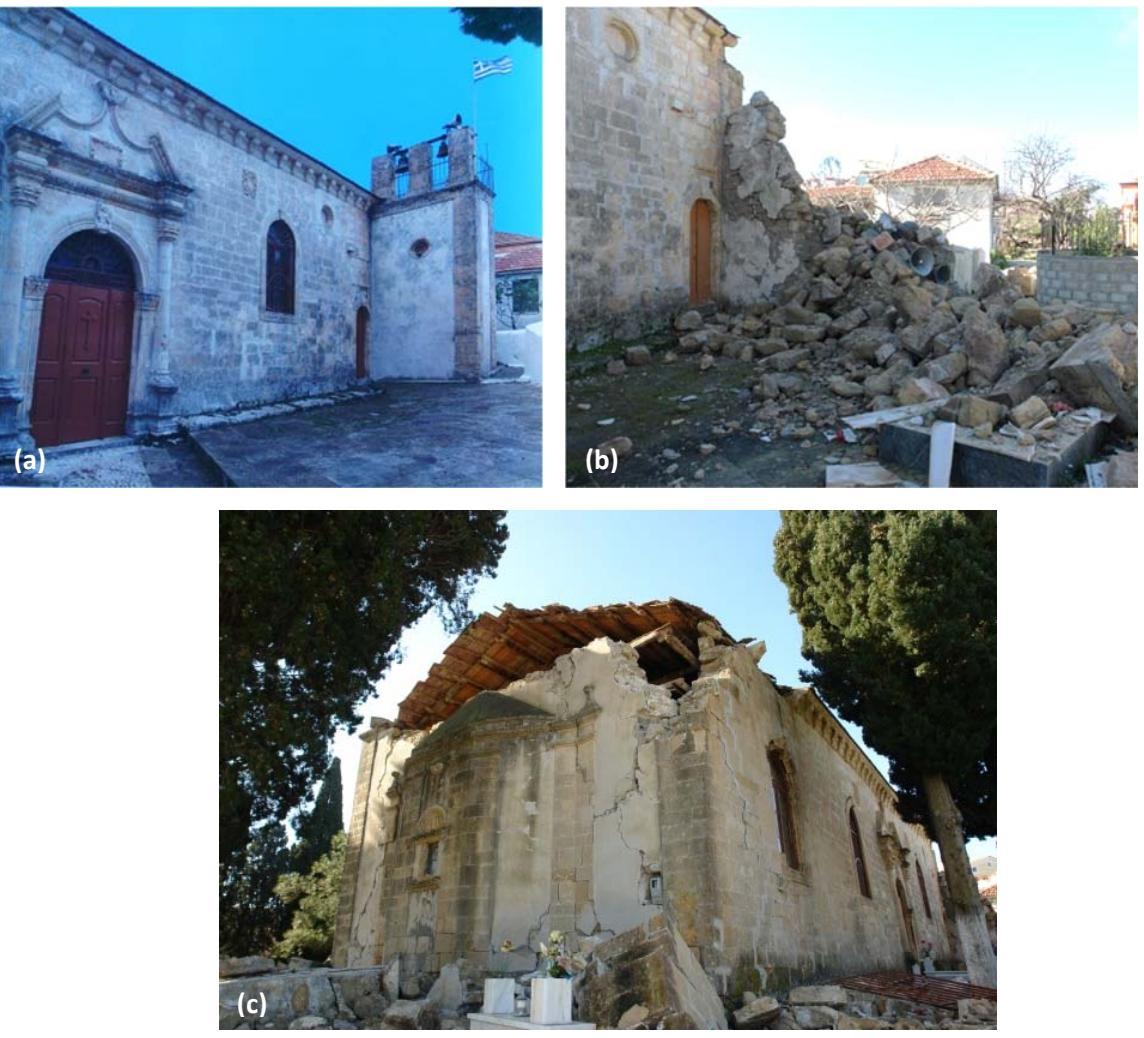
Figure 11.8.14. Category 1 Church of Aghia Marina at Soulari (ID#43): (a) before the earthquakes (b) Collapse of bell tower (c) Partial collapse of the east stone gamble.

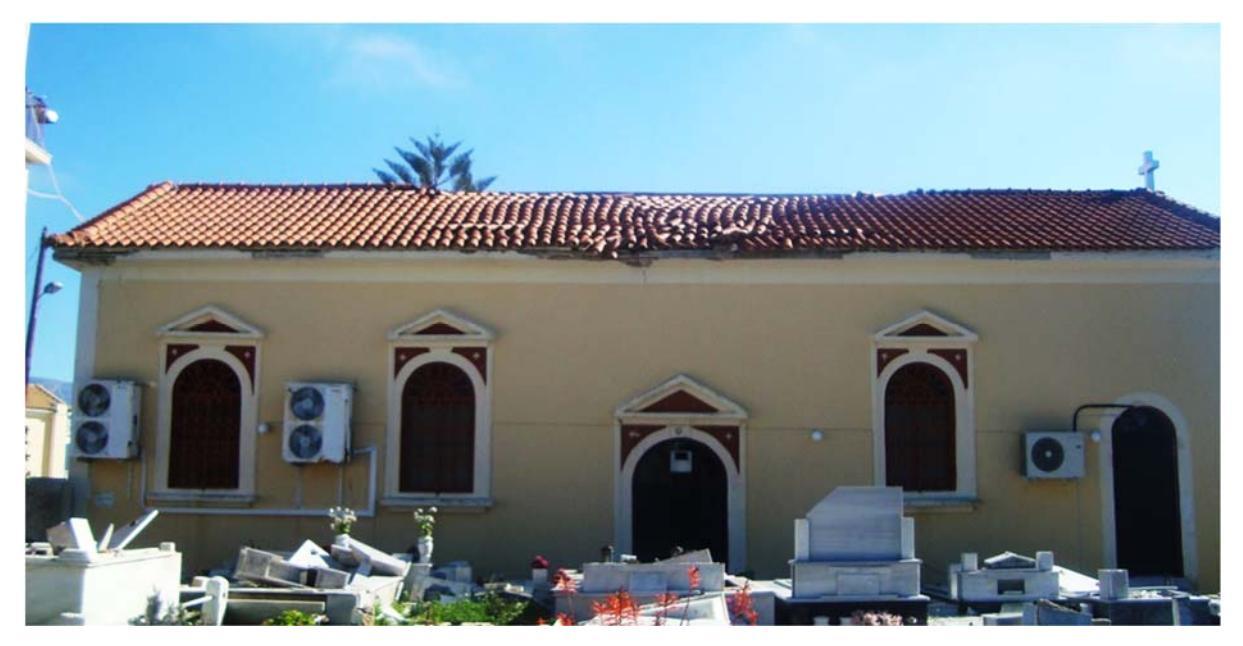
Figure 11.8.15. Category 6 church experienced moderate damage of the RC frame infills. The roof tiles located at center of the building were displaced but the ones closer to the edges remained intact.

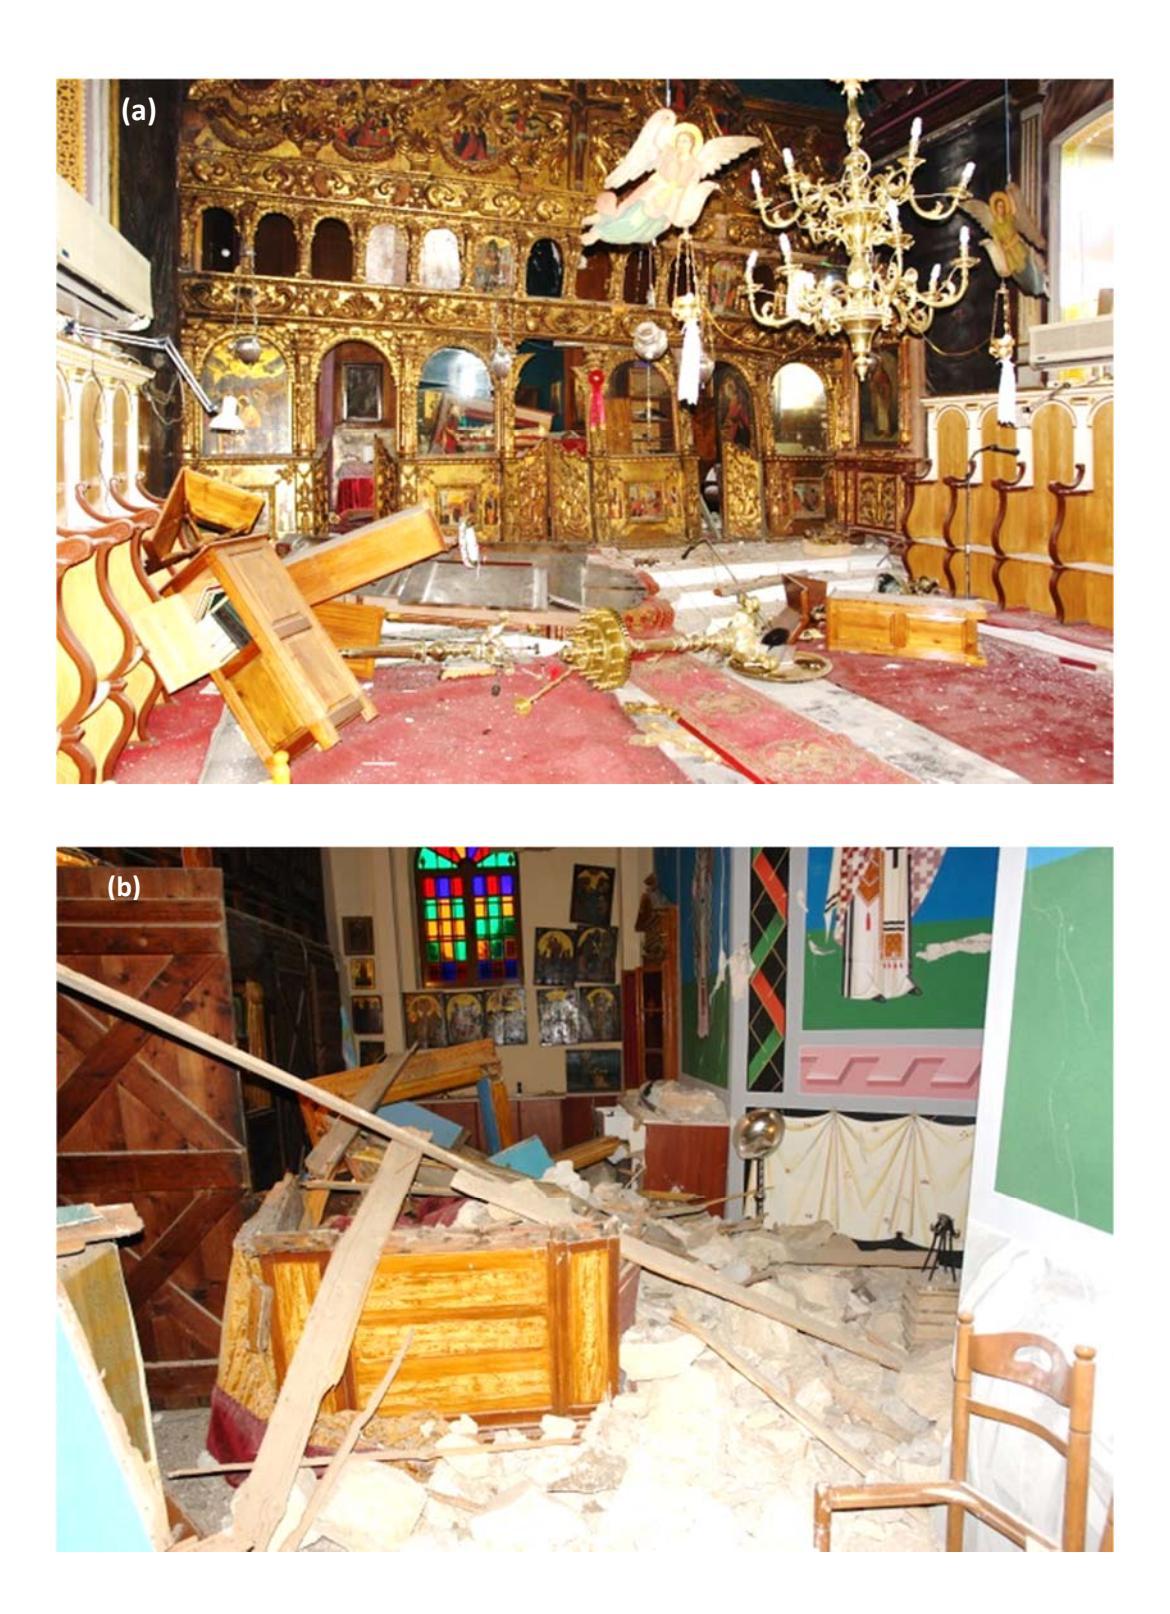
Figure 11.8.16. Severe nonstructural damage was observed in many churches: (a) fallen objects and out of plain deformation of iconostasis; (b) damage due to falling stones.

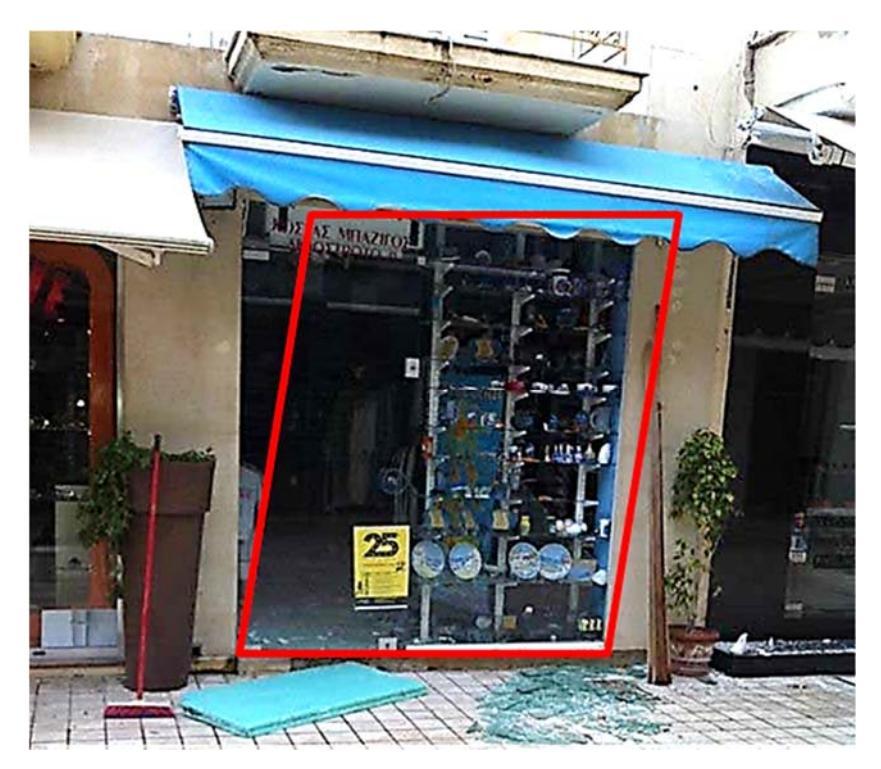
Figure 11.9.4. Glazing failure due to lack of proper design for lateral frame deformation.

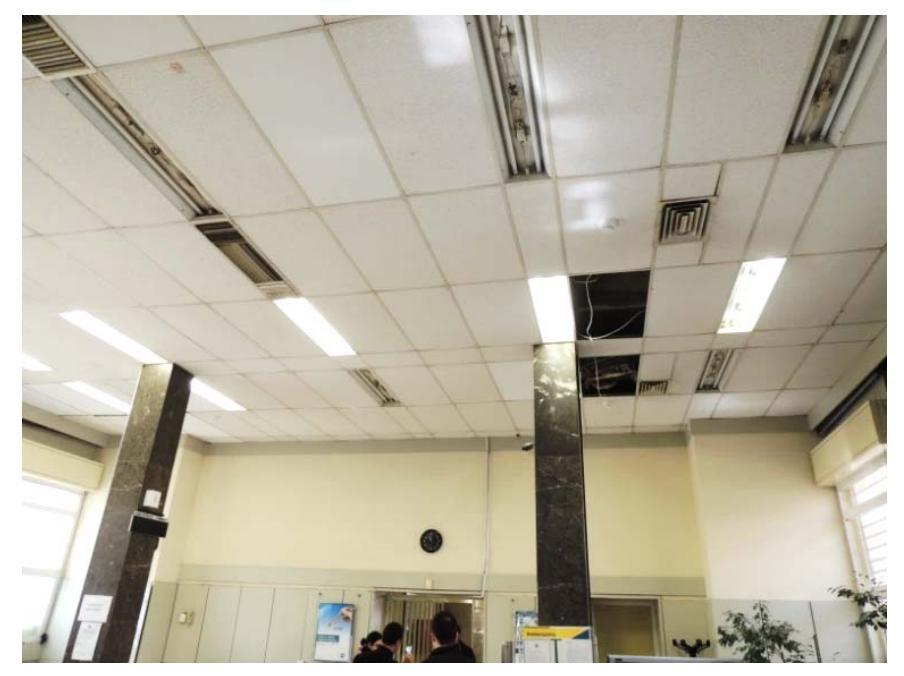
Figure 11.9.6. Lack of support for ceiling tiles and recessed light fixtures in the ground level of the National Bank branch of Lixouri. (GPS coordinates: 38°10'27.3"N, 20°29'26.4"E).

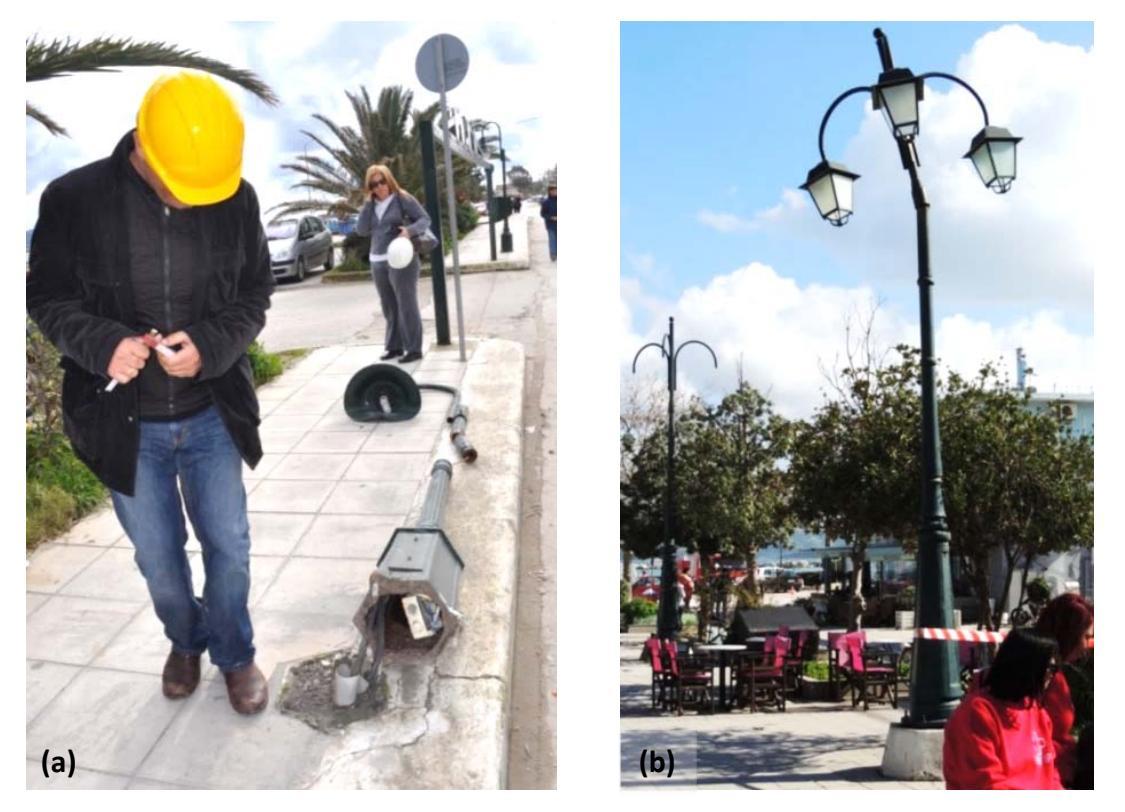
Figure 11.9.7. Poorly anchored sidewalk lighting columns in: (a) Lixouri port (Easy Facilities team members George Tsalakias and Angeliki Psychogiou in the photo) and (b) Argostoli (GPS coordinates: (a) 38°12'7.2"N, 20°26'18.2"E; (b) 38°12'1.0"N, 20°26'18.2"E).

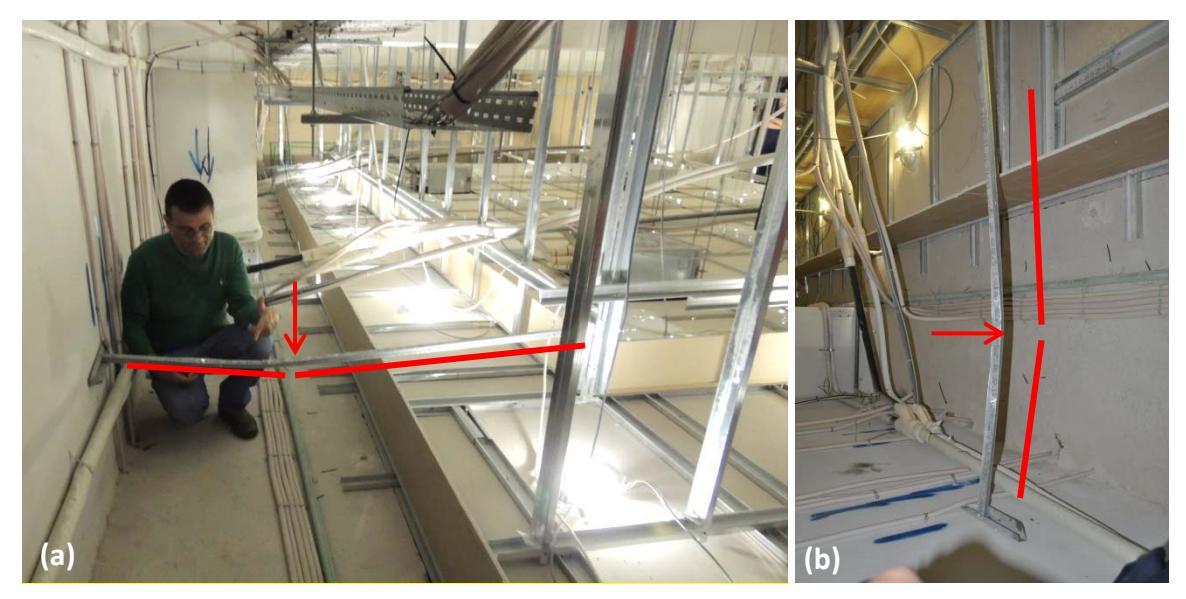
Figure 11.9.8. Ceiling brace buckling in the Eurobank branch of Argostoli: (a) horizontal strut and (b) vertical brace. (GPS coordinates: 38°10'29.4"N, 20°29'28.2"E).

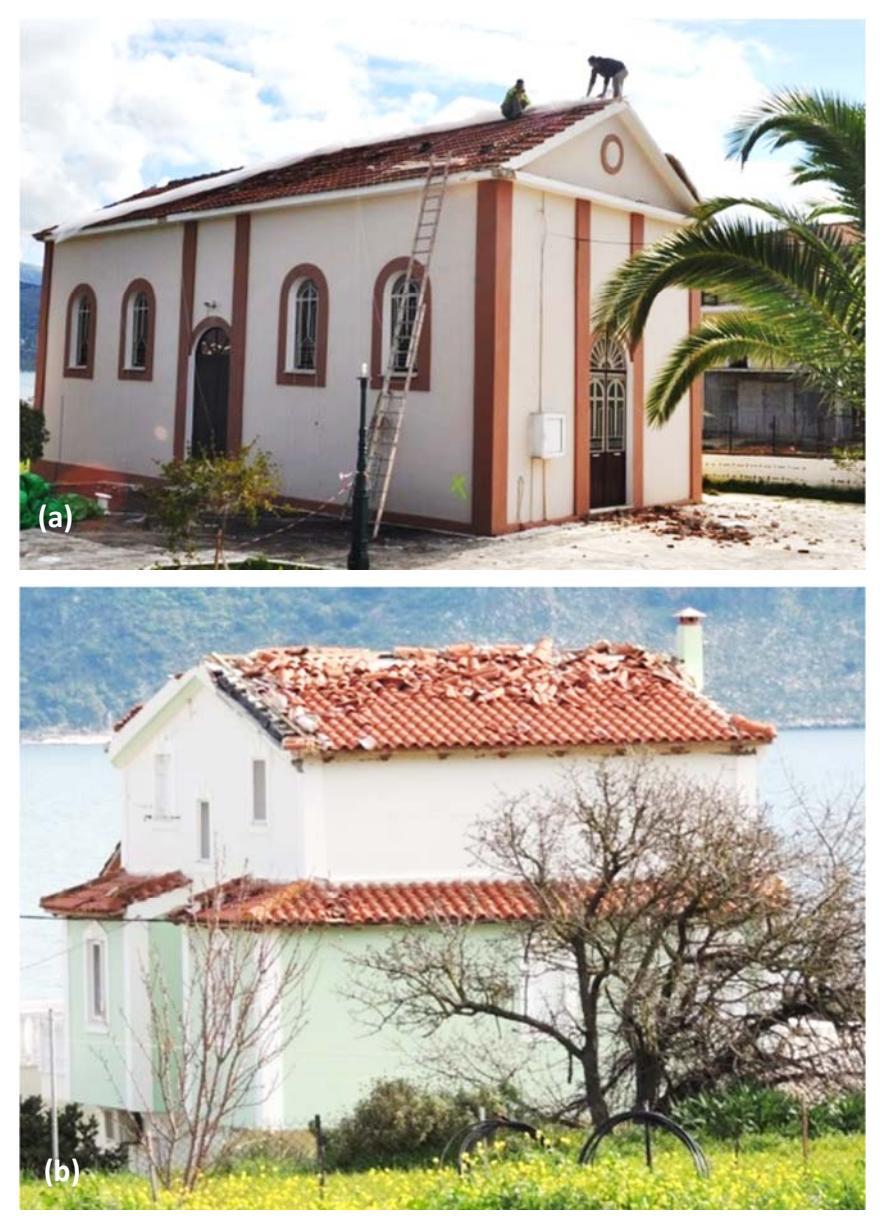
Figure 11.9.10. Roof tiles damage (GPS coordinates: (a) 38°13'46.2"N, 20°25'48.0"E; (b) 38°13'45.6"N, 20°25'48.7"E).

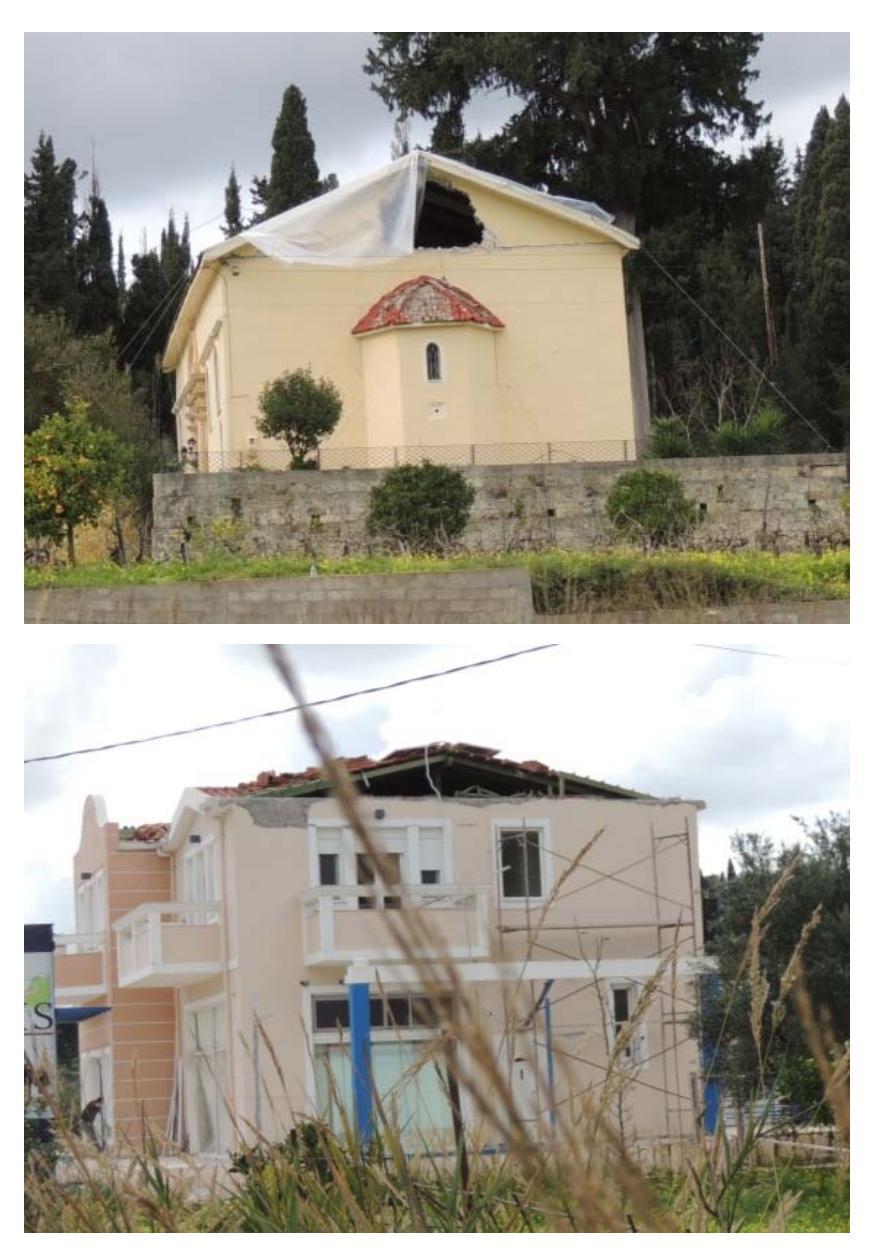
Figure 11.9.12. Typical parapet gable frame failures in Lixouri.

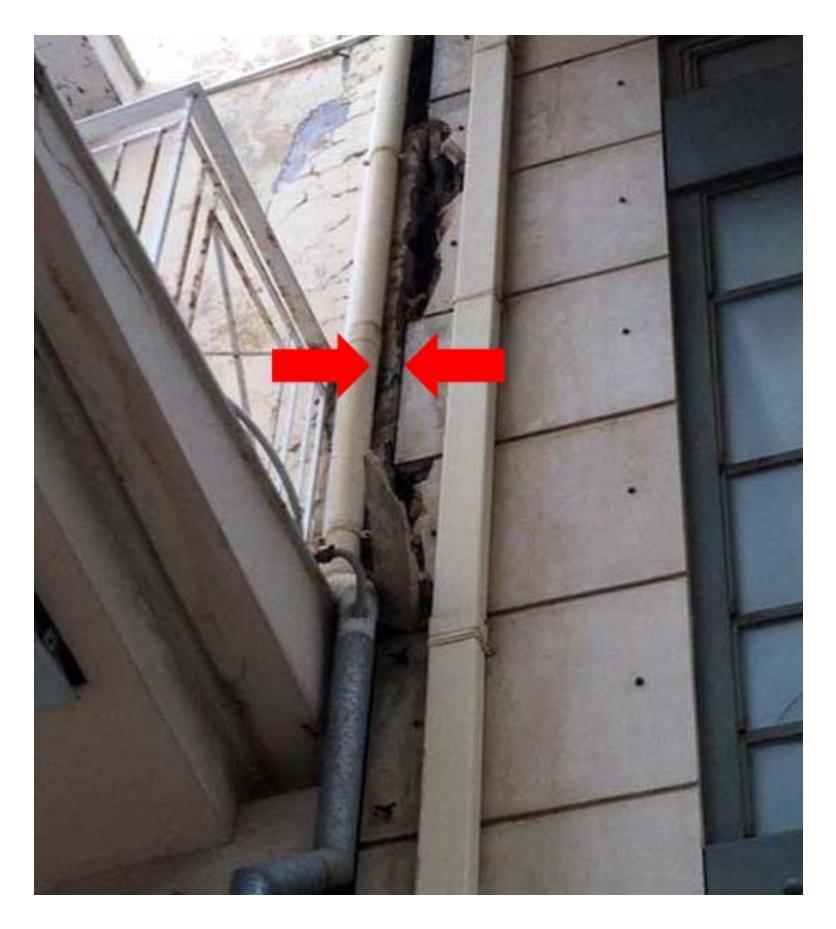
Figure 11.9.13. Architectural marble veneer damage due to building pounding.

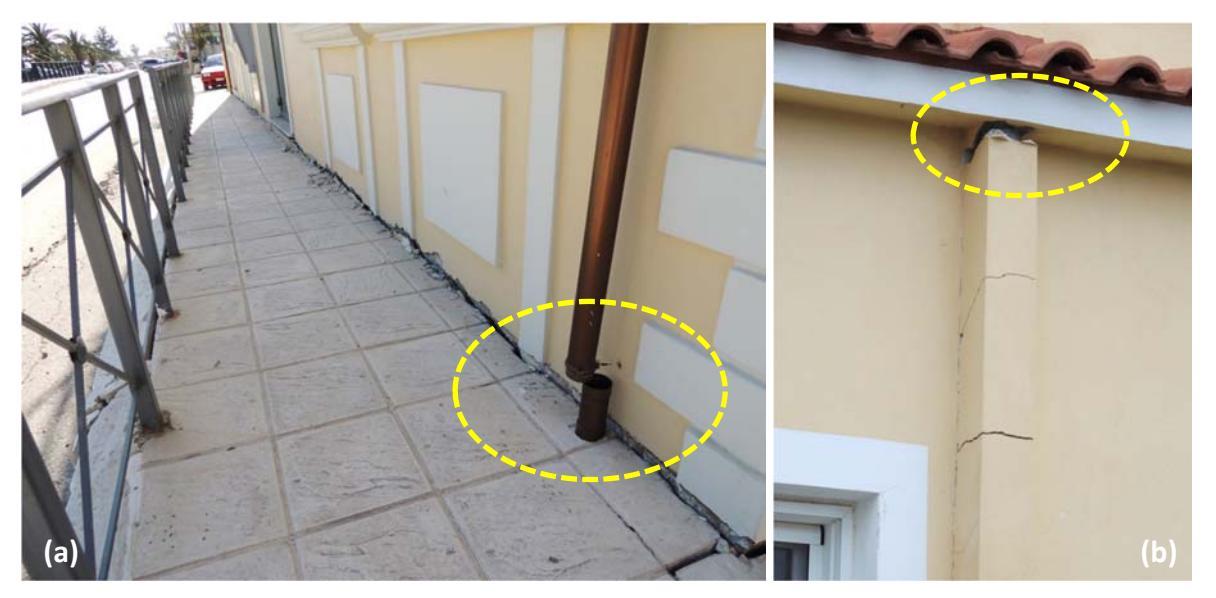
Figure 11.9.14. Improperly anchored gutter pipes with rigid connections. (GPS coordinates: (a) 38°12'7.2"N, 20°26'19.8"E; (b) 38°11'0.1"N, 20°22'55.9"E).

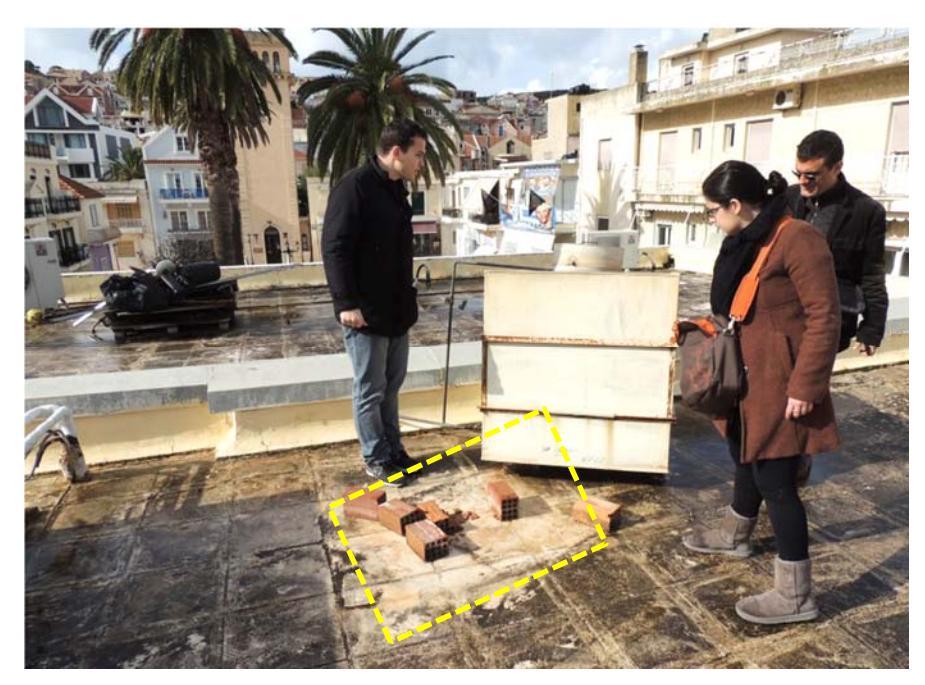
Figure 11.9.16. Rooftop AC unit that fell off brick supports. (GPS coordinates: 38°10'27.0"N, 20°29'26.5"E).
