CHAPTER 11 Structural Observations

GEER/EERI/ATC Cephalonia, Greece 2014 Report Version 1

11.1 Main Structural Observations

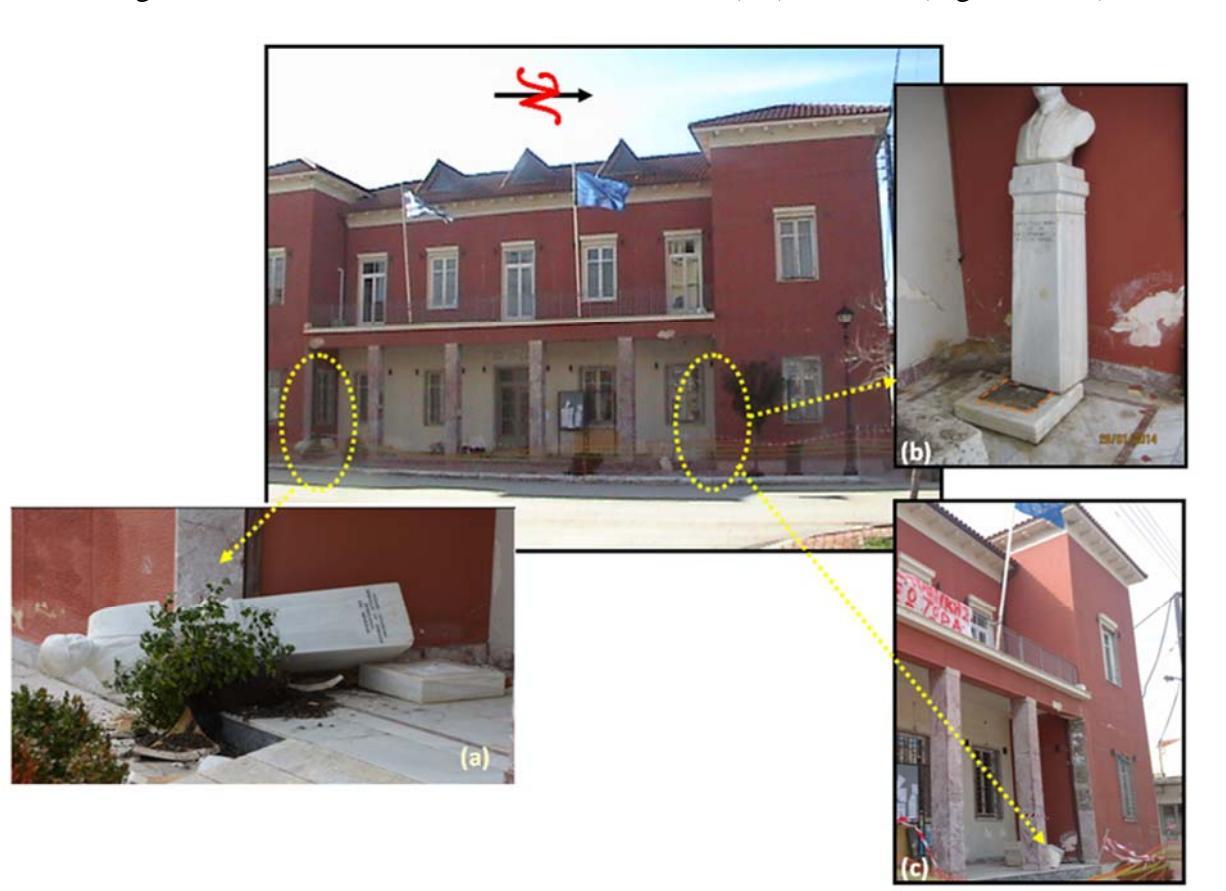
Figure 11.9.22. Overturned statues at the entrance of Lixouri City Hall. (GPS coordinates: 38°12'3.53"N, 20°26'14.92"E).

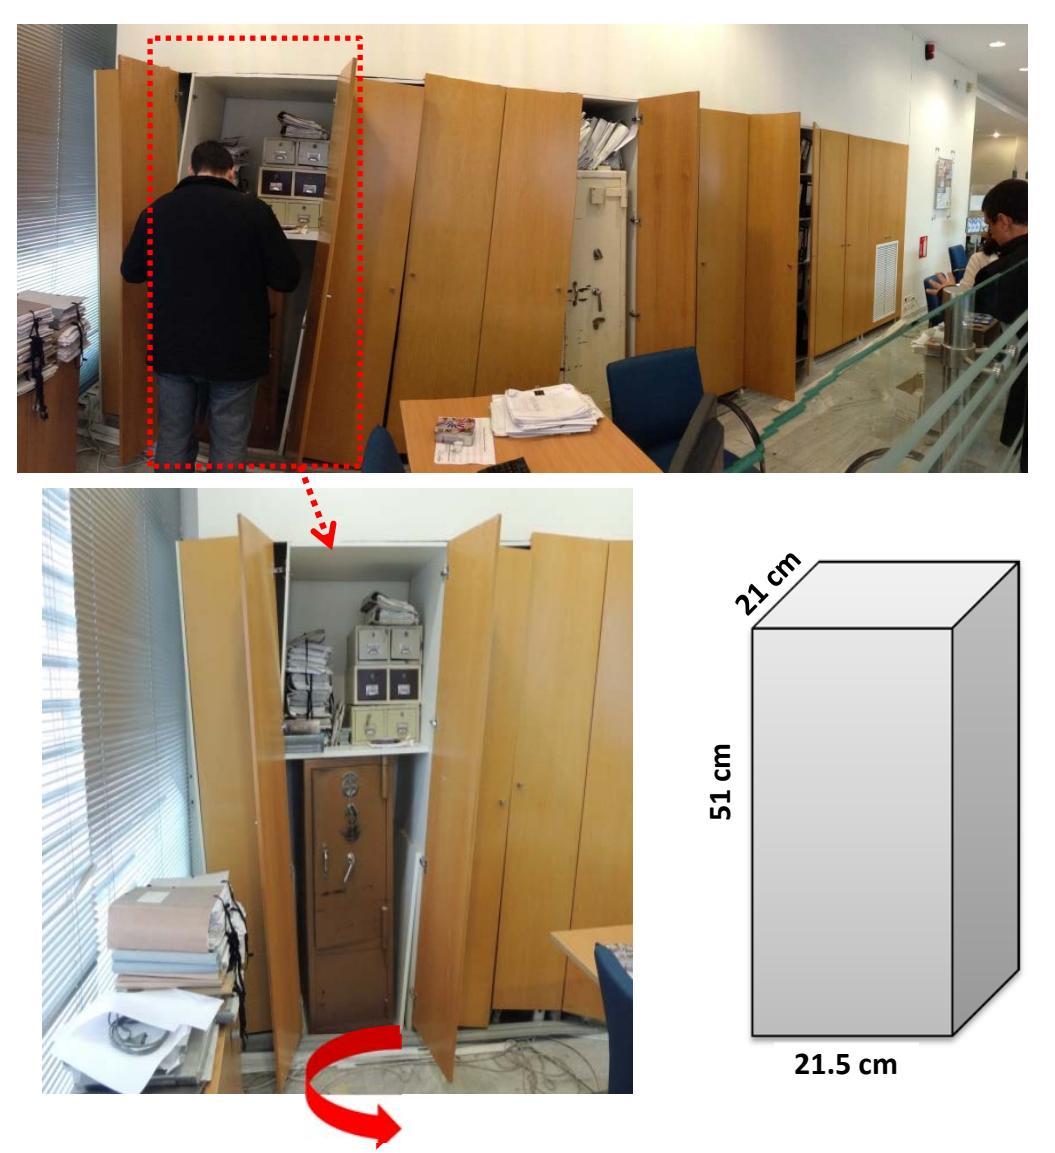
Figure 11.9.23. Sliding and rotation of aheavy bank vault with no anchorage on the floor or ceiling. (GPS coordinates: 38°12'7.8"N, 20°26'19.2"E).

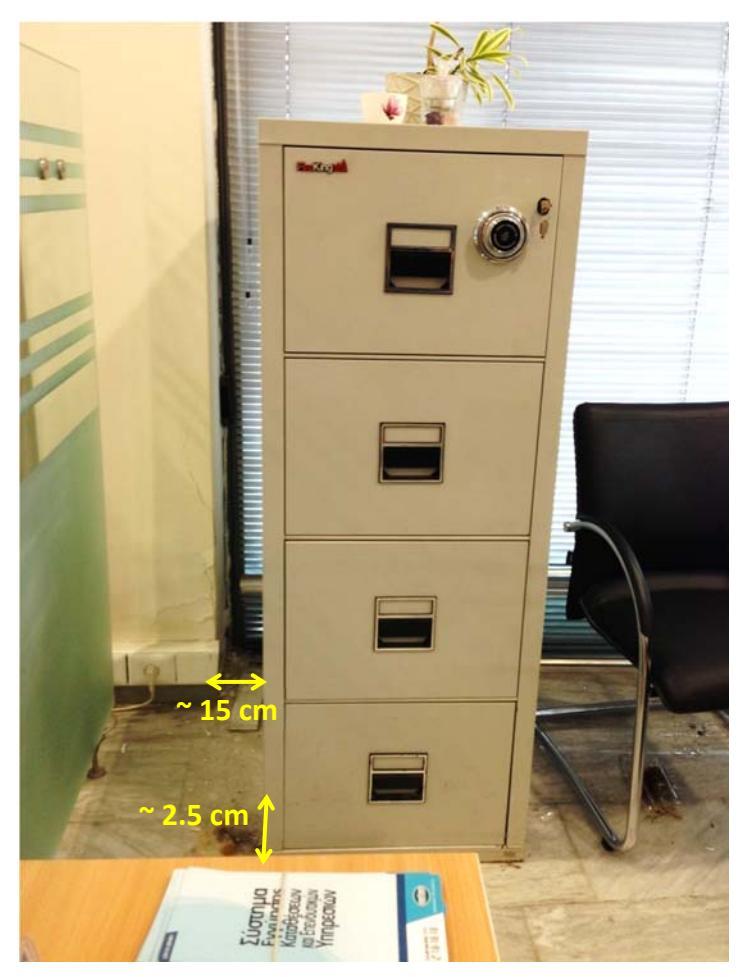
Figure 11.9.27. File cabinet with no anchorage (GPS coordinates: 38°12'7.8"N, 20°26'19.2"E).

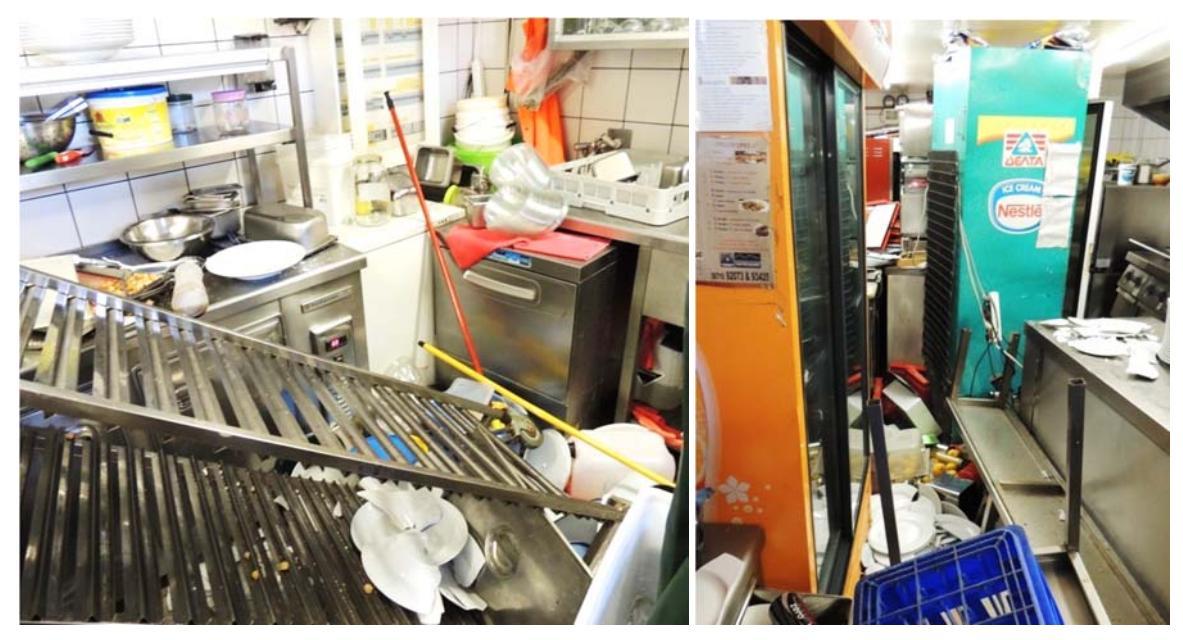
Figure 11.9.32. Lack of seismic protection for rolling restaurant shelves and refrigerator units in Lixouri.
