# Engineering Reconnaissance Following the October 2016 Central Italy Earthquakes Version 2

GEER Team Leaders: Jonathan P. Stewart and Giuseppe Lanzo

Geotechnical Extreme Events Reconnaissance Association Report No. GEER-050D 8 May 2017

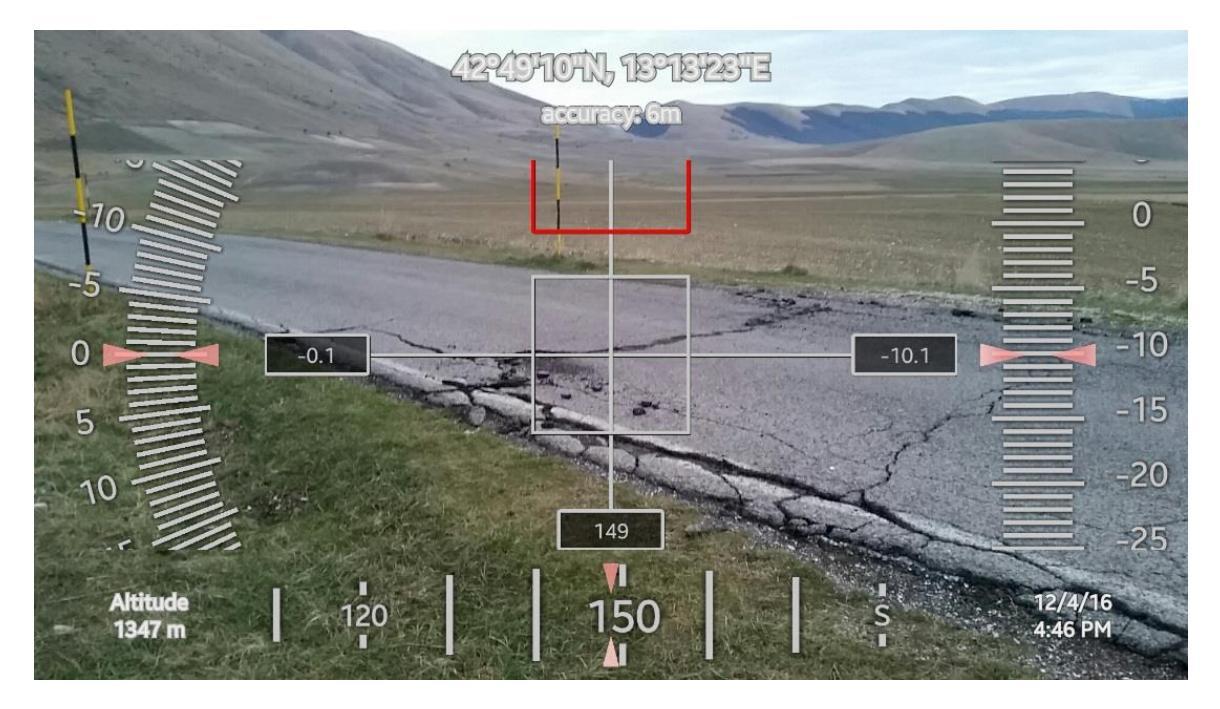
**Figure 2.20**. Secondary fault offset across a road on the Piano Grande at the base of the Mt. Vettore Massif. August 2016 event offset of 0cm. October 2016 event offset of 7 to 18 cm.

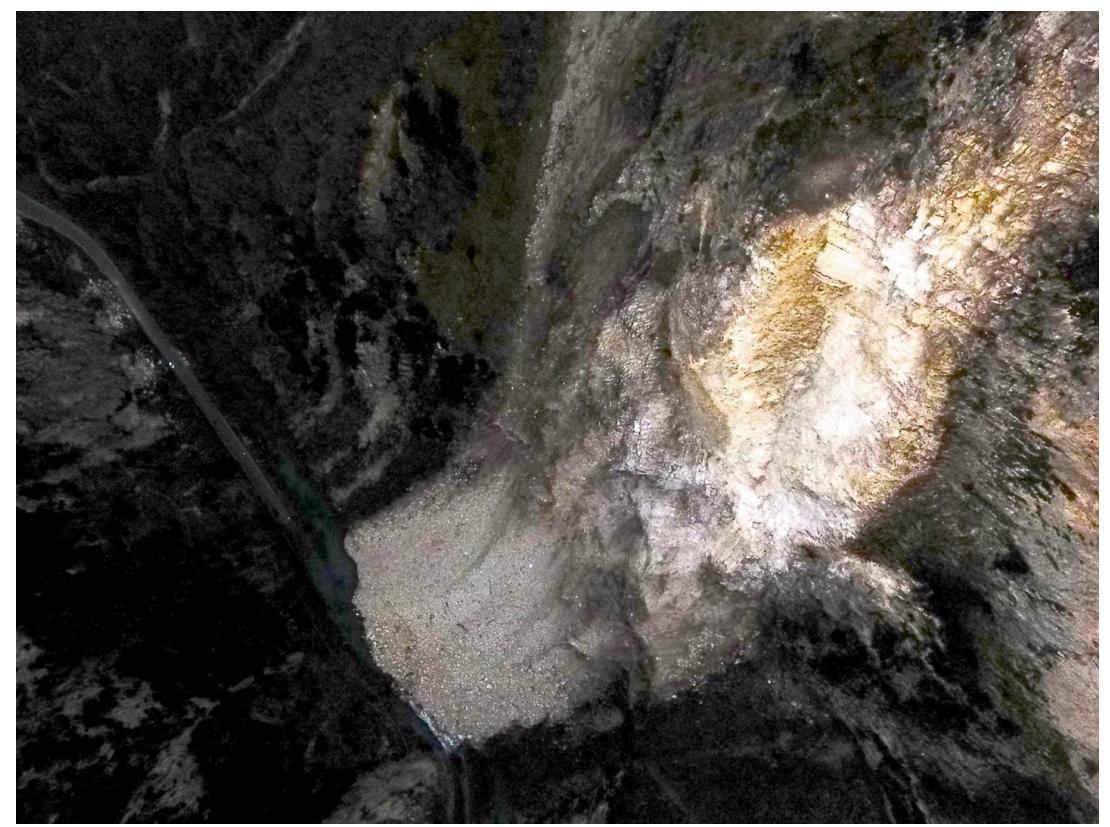
This large rock fall damaged national road SS-209 and formed a small landslide lake as shown in Figure 4.5. The rockfall severed road transportation between Visso and the Spoleto Valley. Access to Visso, the Nera river valley and the landslide was from the eastern Adriatic coast.

**Figure 4.5**. Nera rock avalanche photographed from the UCLA DJI Phantom 4 drone at an elevation of 400 meters above Route SS209. The primary rock-fall was a wedge that detached on the right side of the image and disintegrated into talus debris as it fell 330 meters to the river valley floor. The limestone bedding is visible in the scar of the wedge detachment Geology

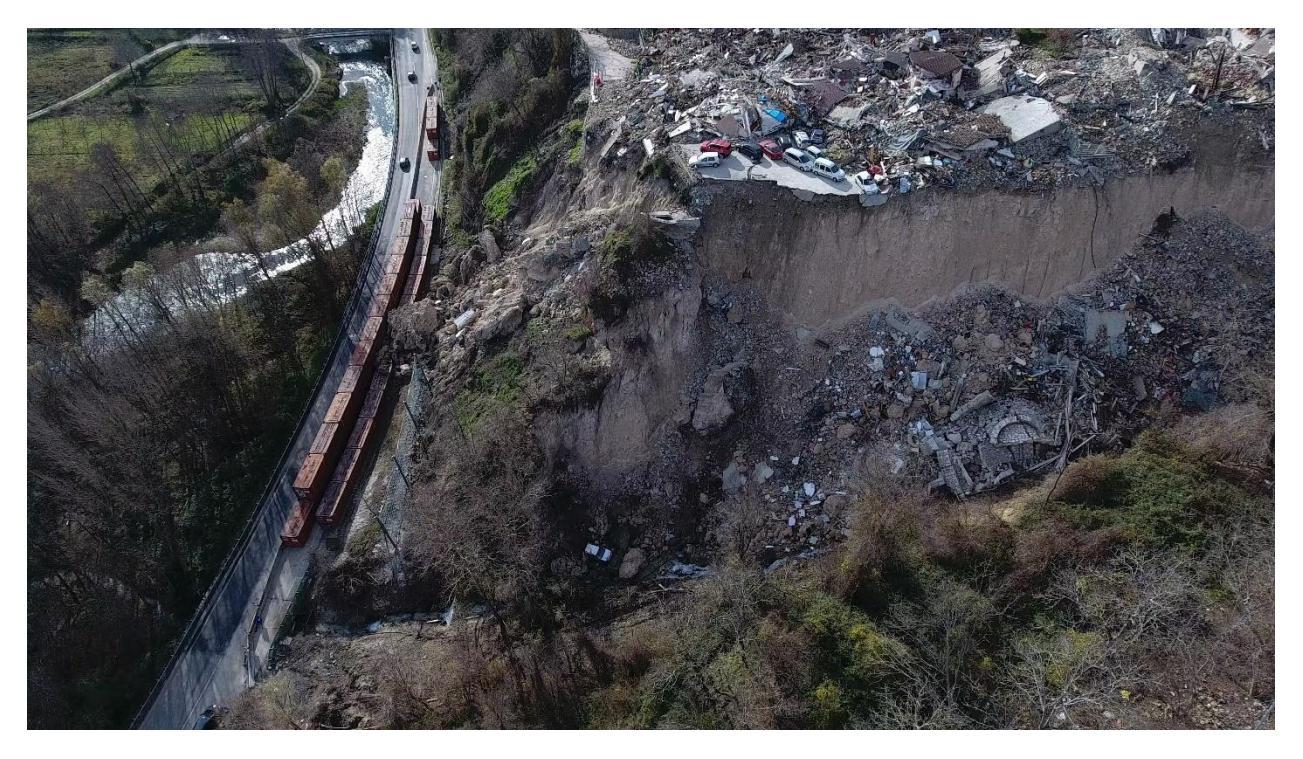
Figure 4.15. View of talus behind failed retaining wall by Strada Statale No. 4 (Location 3b).

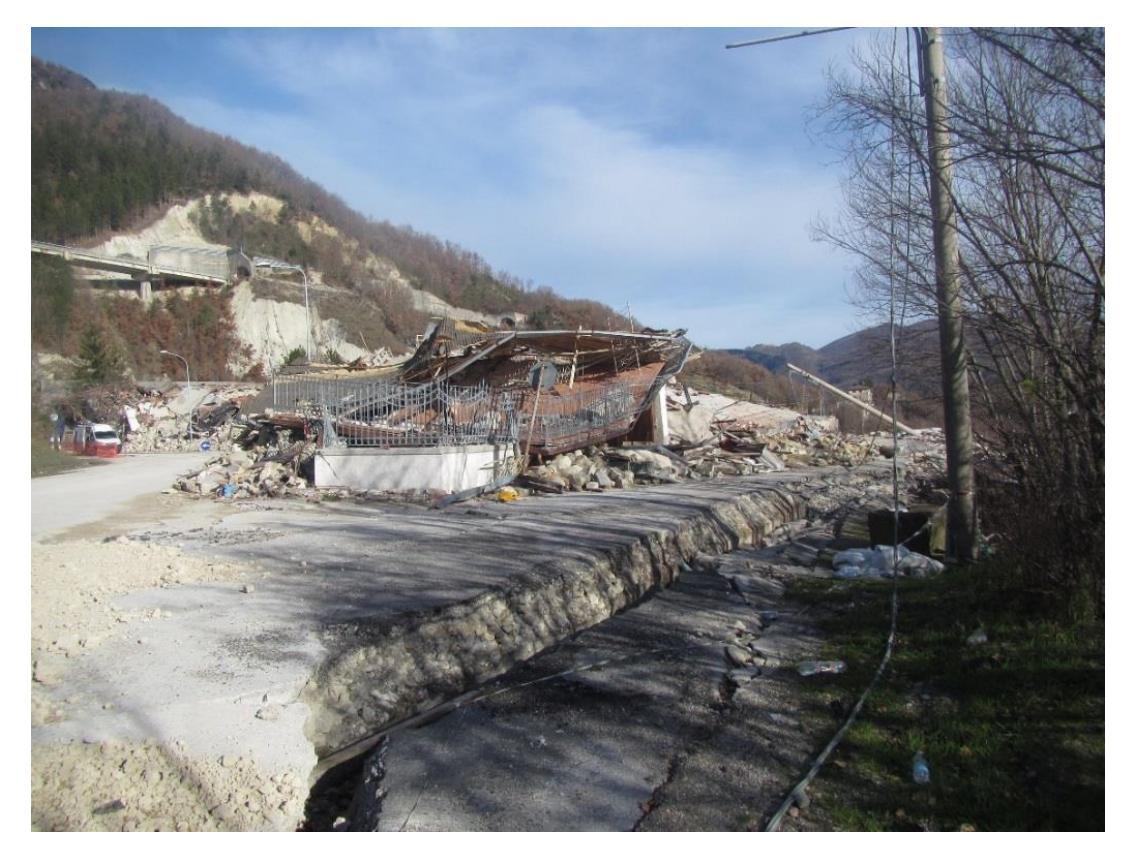
**Figure 4.16**. Pavement and road base damage induced by underlying stability failure of fill material (Location 3c).

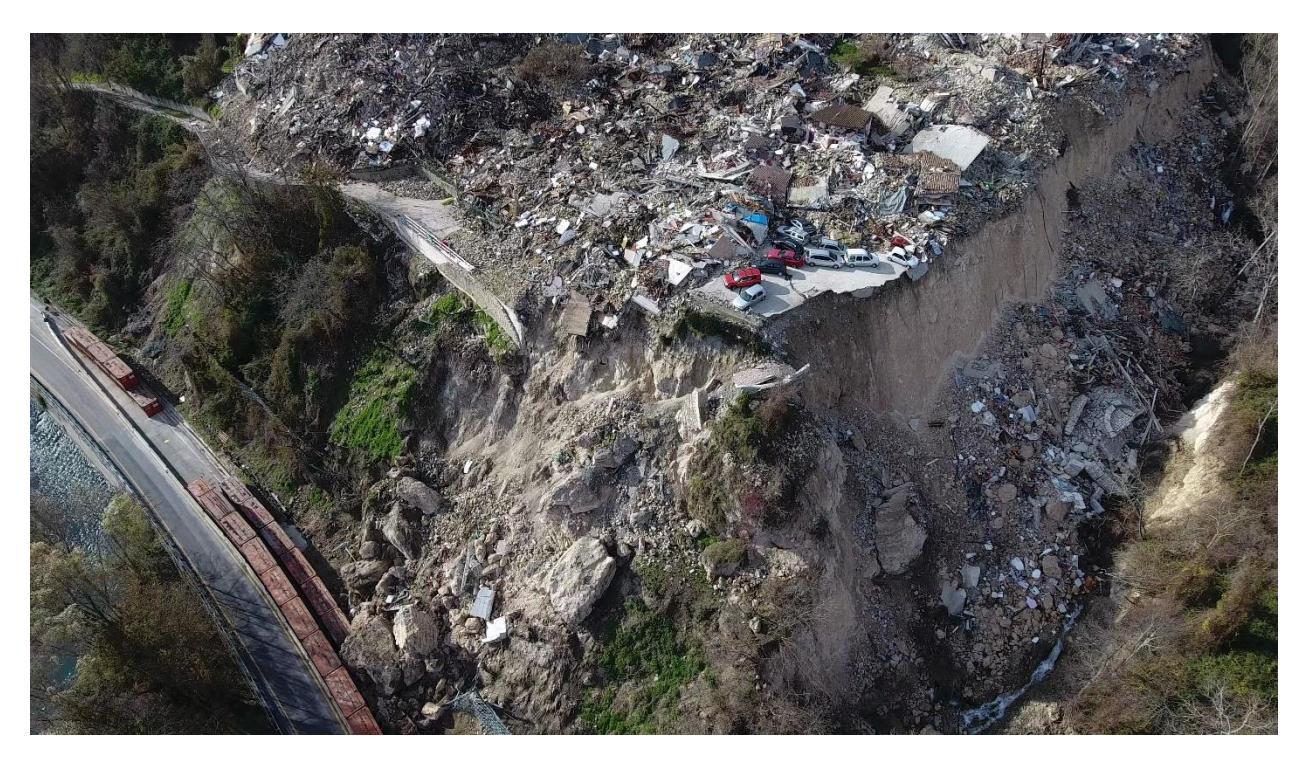
**Figure 4.18**. Aerial photograph of landslide impacting Strada Statale No. 4 below Pescara del Tronto (Location 3d).

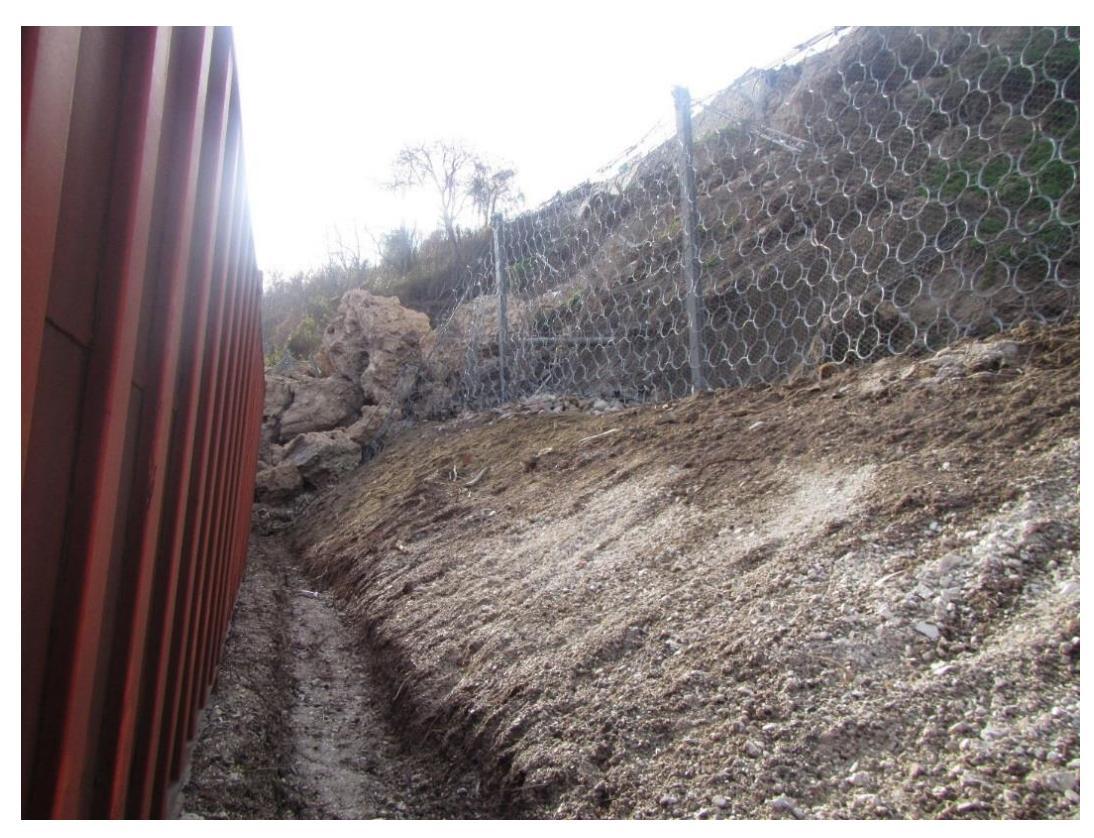
**Figure 4.19.** View of damaged rockfall netting caused by loose debris material from the landslide above Strada Statale No. 4 (Location 3d).

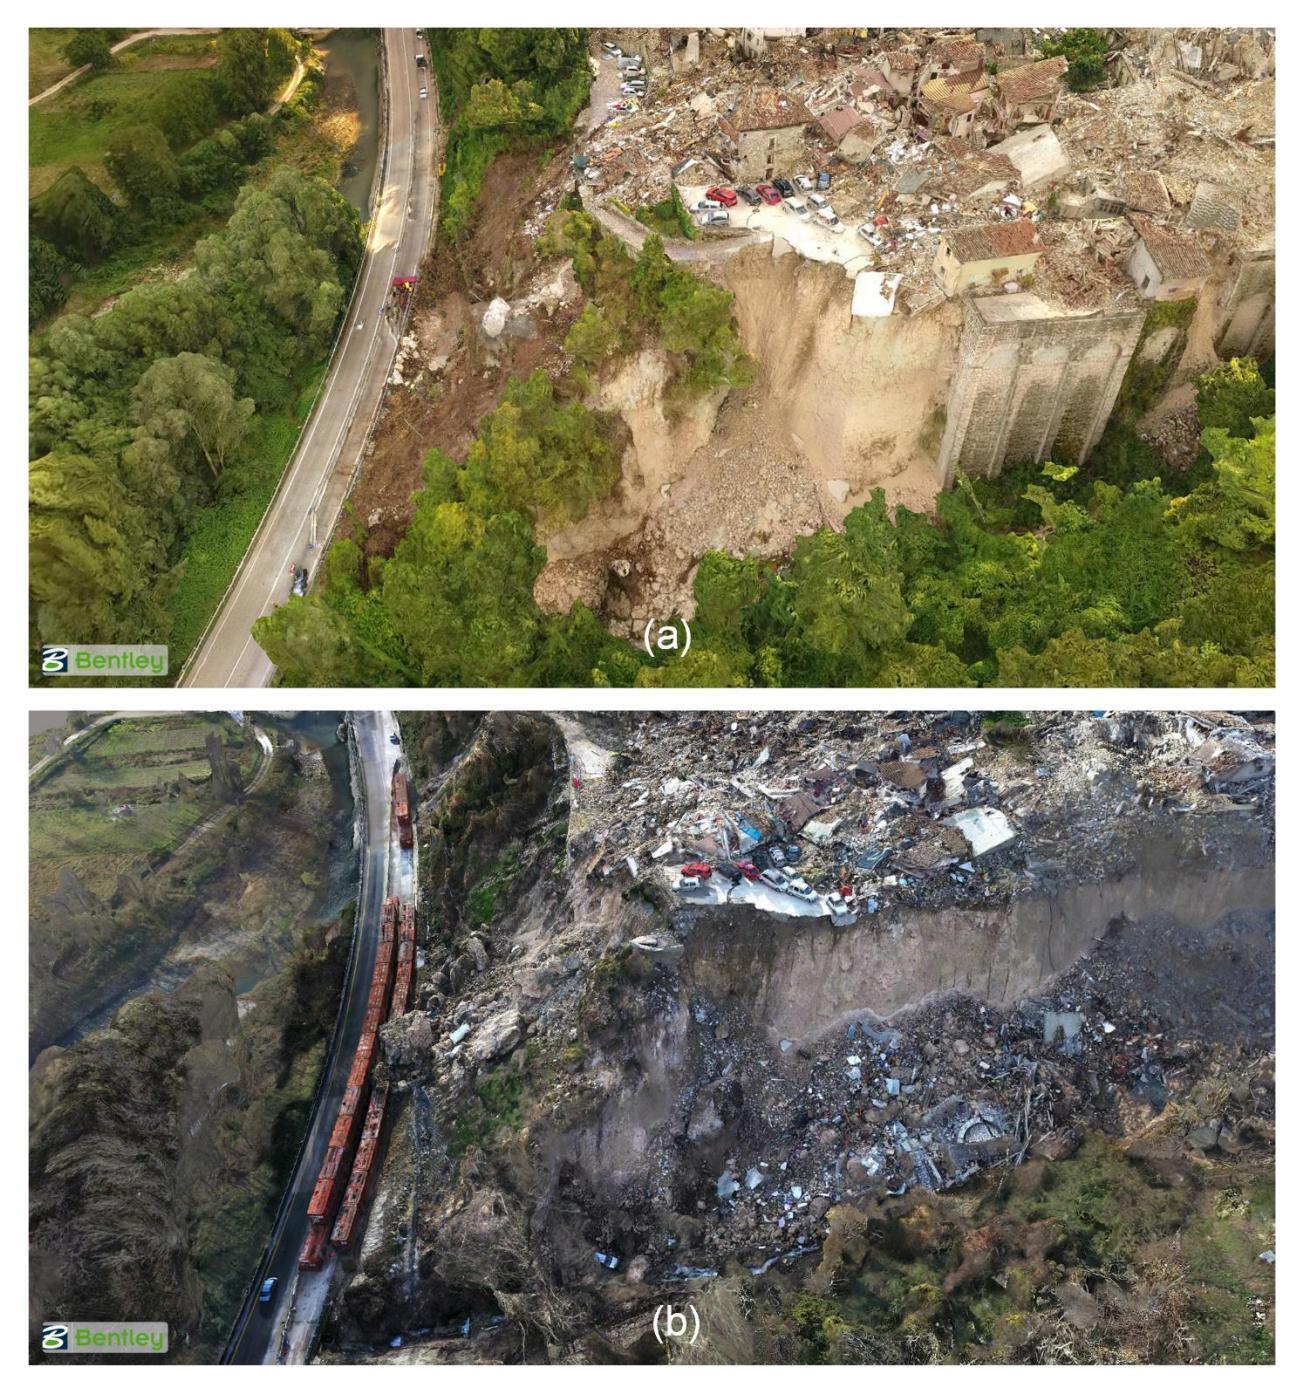
**Figure 4.24**. 3D model comparison of the failed retaining wall below Pescara del Tronto between September 2016 (a) and December 2016 (b).

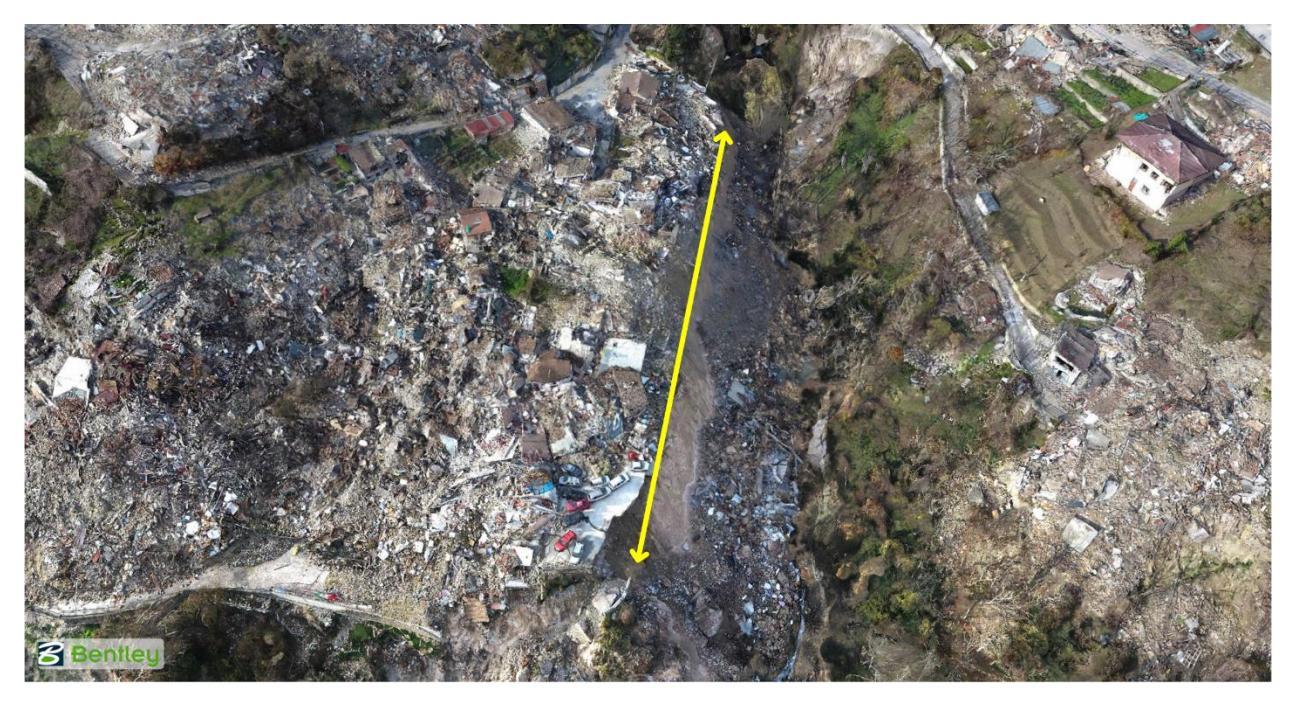
**Figure 4.25**. 3D SfM model view of scarp linearity behind failed lower retaining wall in Pescara del Tronto.

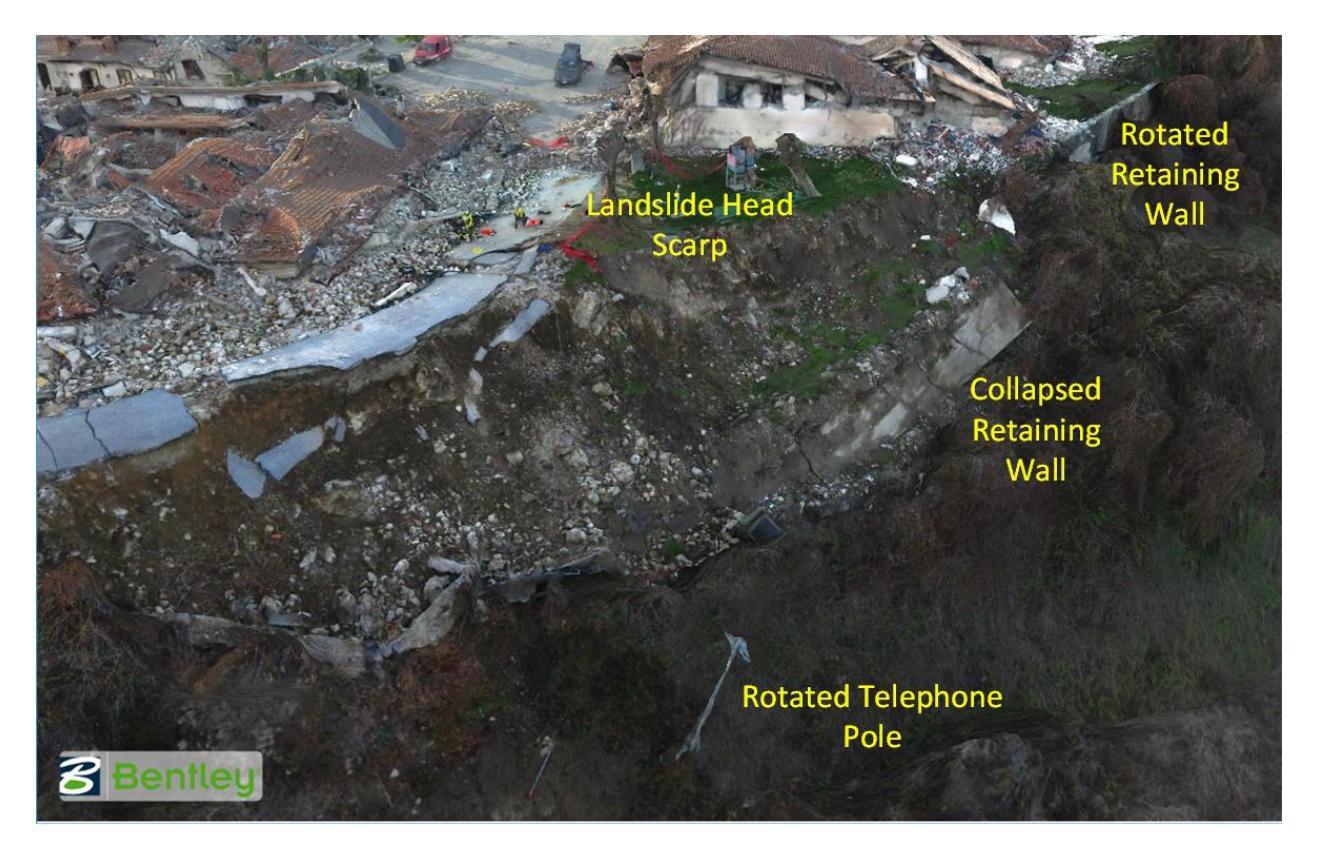
**Figure 4.32.** 3D model screenshot identifying objects of interest with the failed retaining wall and shallow slope failure at Point 4a.

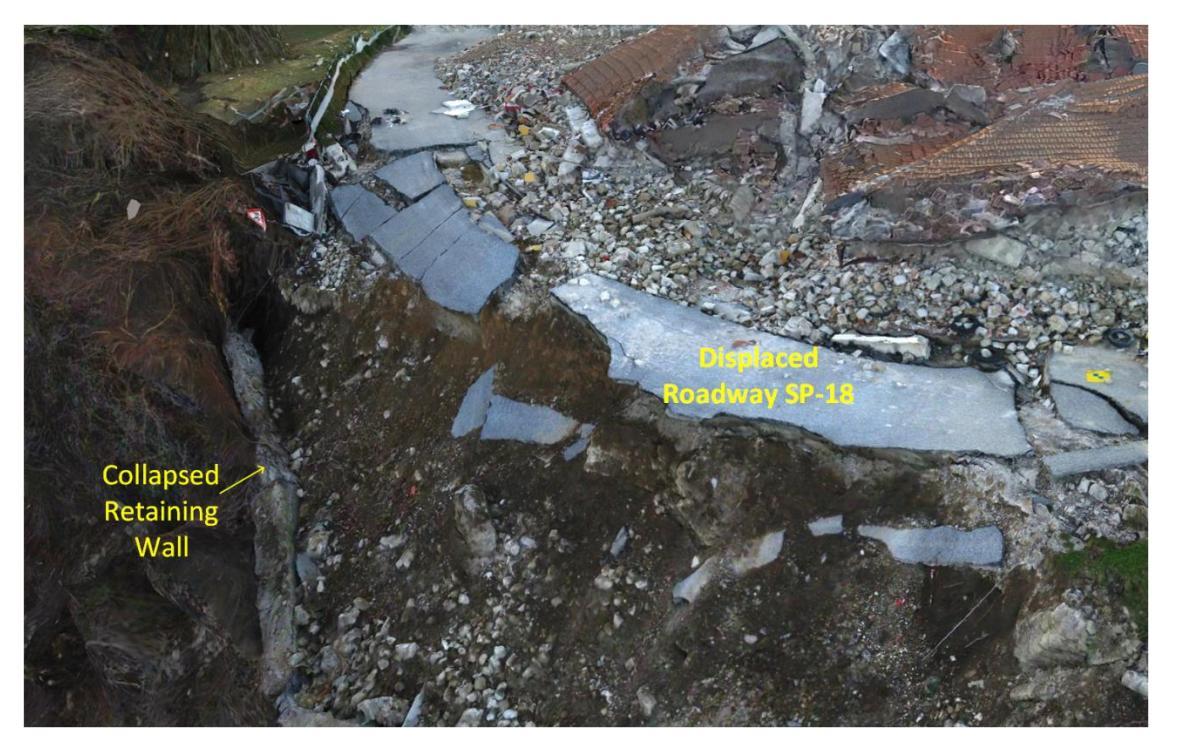
**Figure 4.33.** 3D model screenshot of the destroyed roadway Frazione Fonte del Campo (i.e., SP-18).

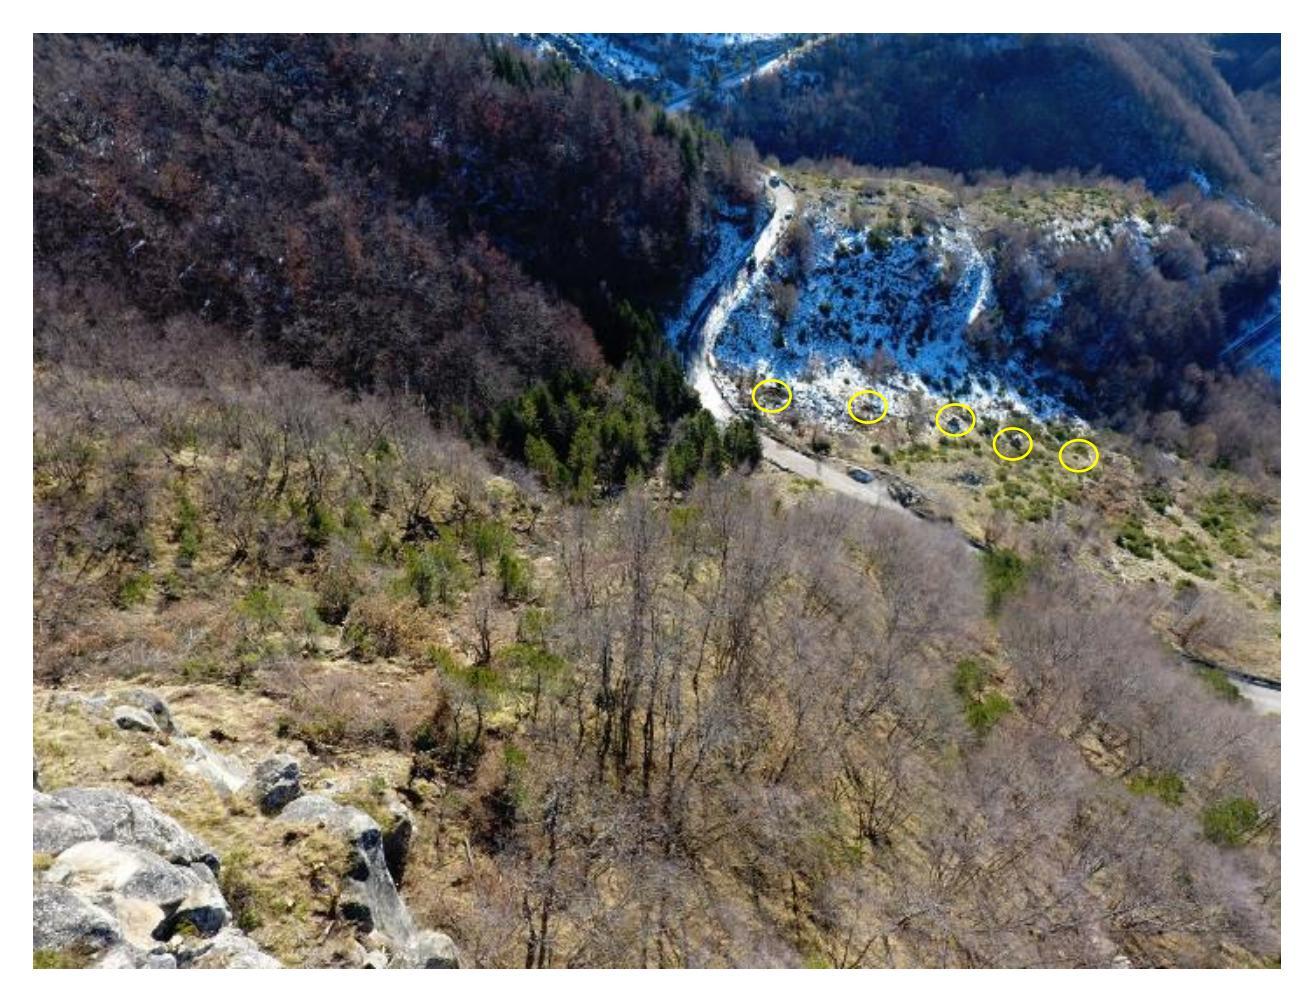
**Figure 4.51**. UAV image of rockfall site near Crognaleto village from the source area at the top of slope looking down to road along runout chute. Note several large 1 to 3 meter boulder fragments in the drainage below the road (yellow circles).

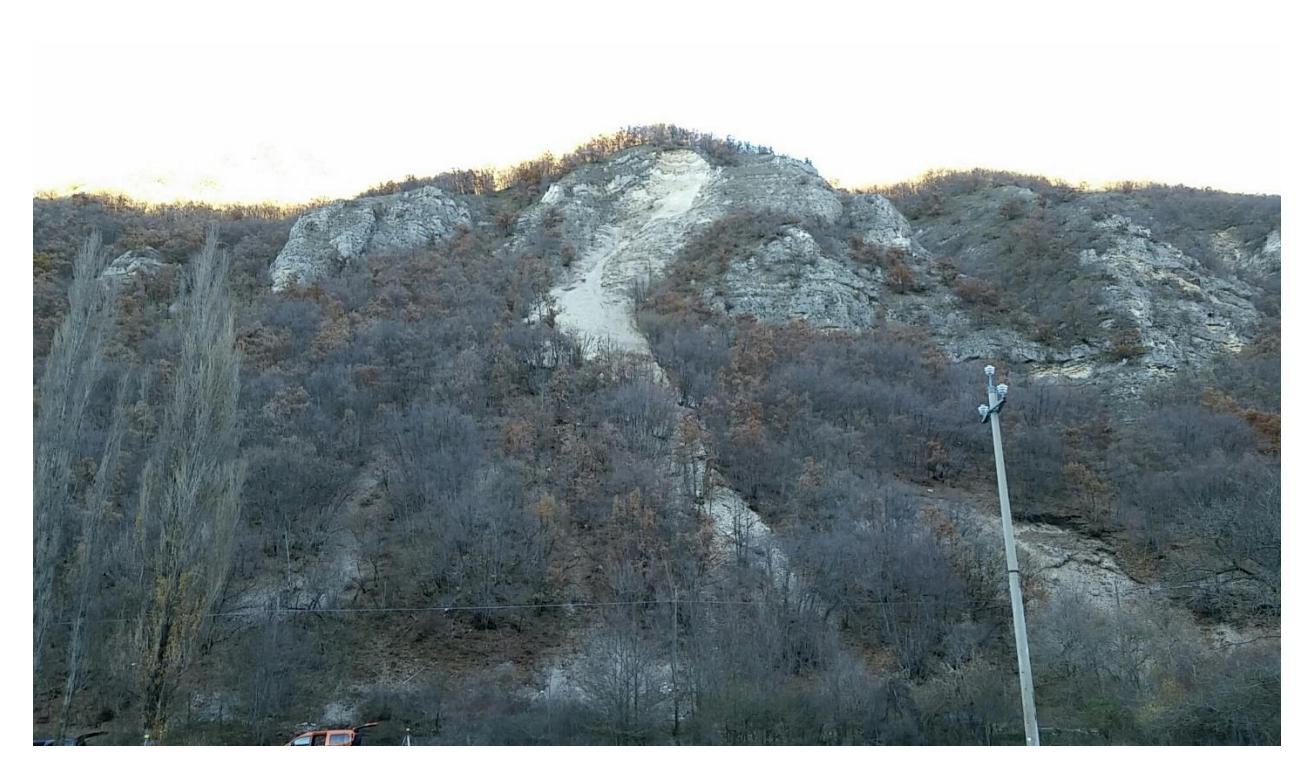
**Figure 4.60**. Pescia rockfall site 9b. Source area at top with runout damage. Not pictured: runout boulders across road and into field, corresponding to approximate 30 degree Fahrboeschung angles.

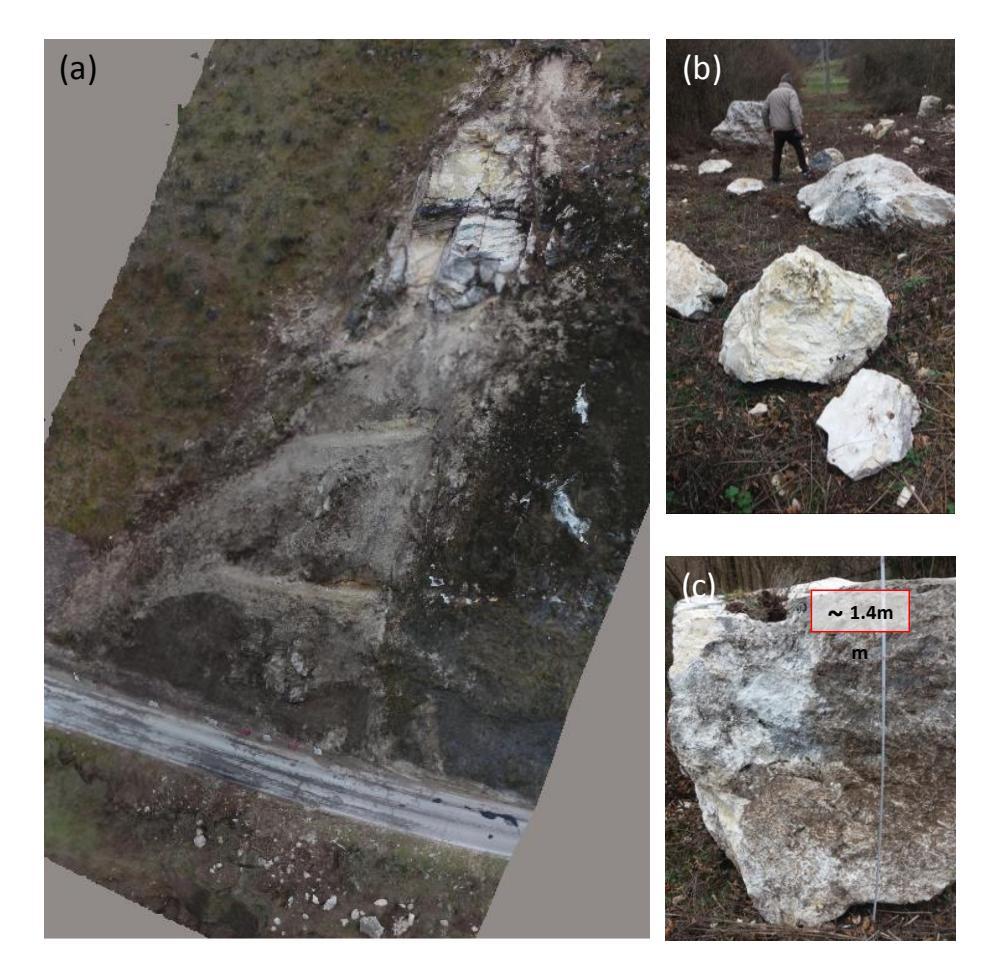
**Figure 4.64**. General oblique view from the drone of the rock slide on the right flank of the Nera valley (km 4 of SP134 motorway); the rock avalanche invaded the motorway and the valley bottom below for a stretch of about 70 m spreading large blocks (b-c).

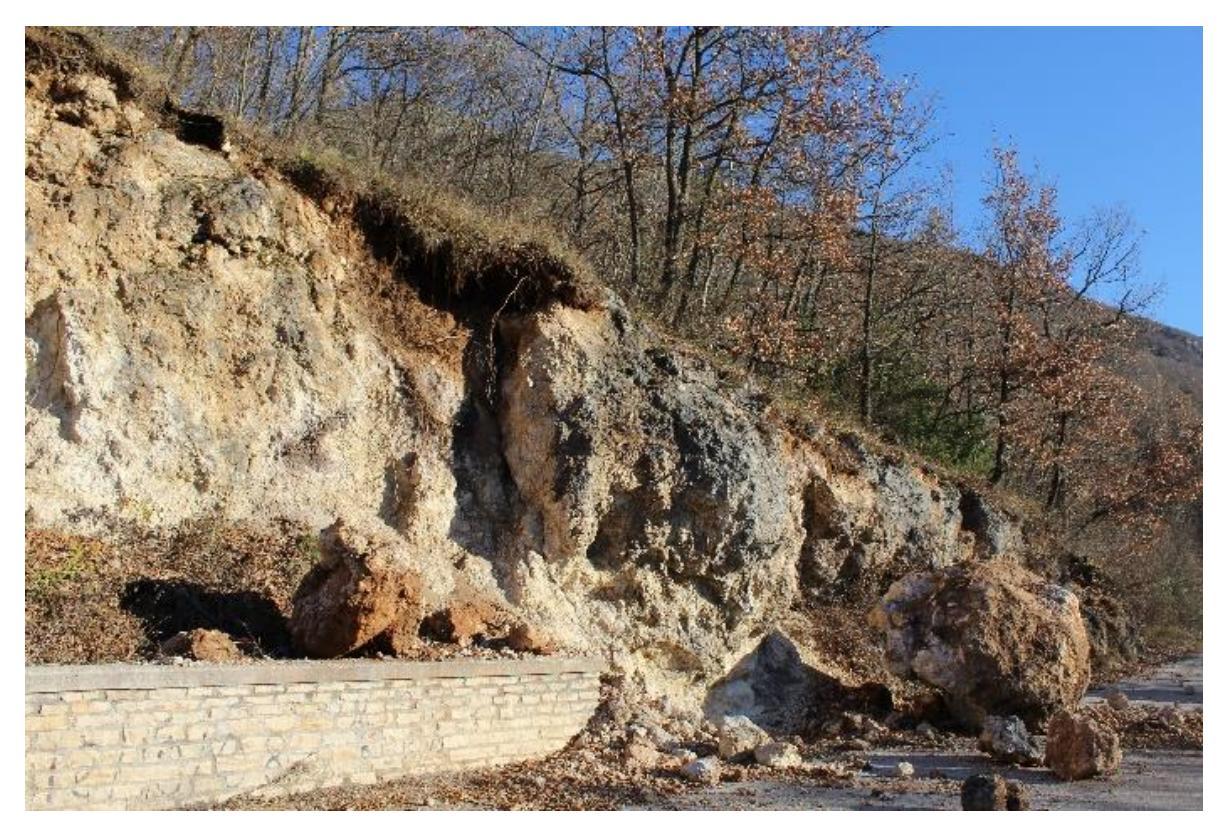
**Figure 4.74.** Rockfalls with boulders on the road.

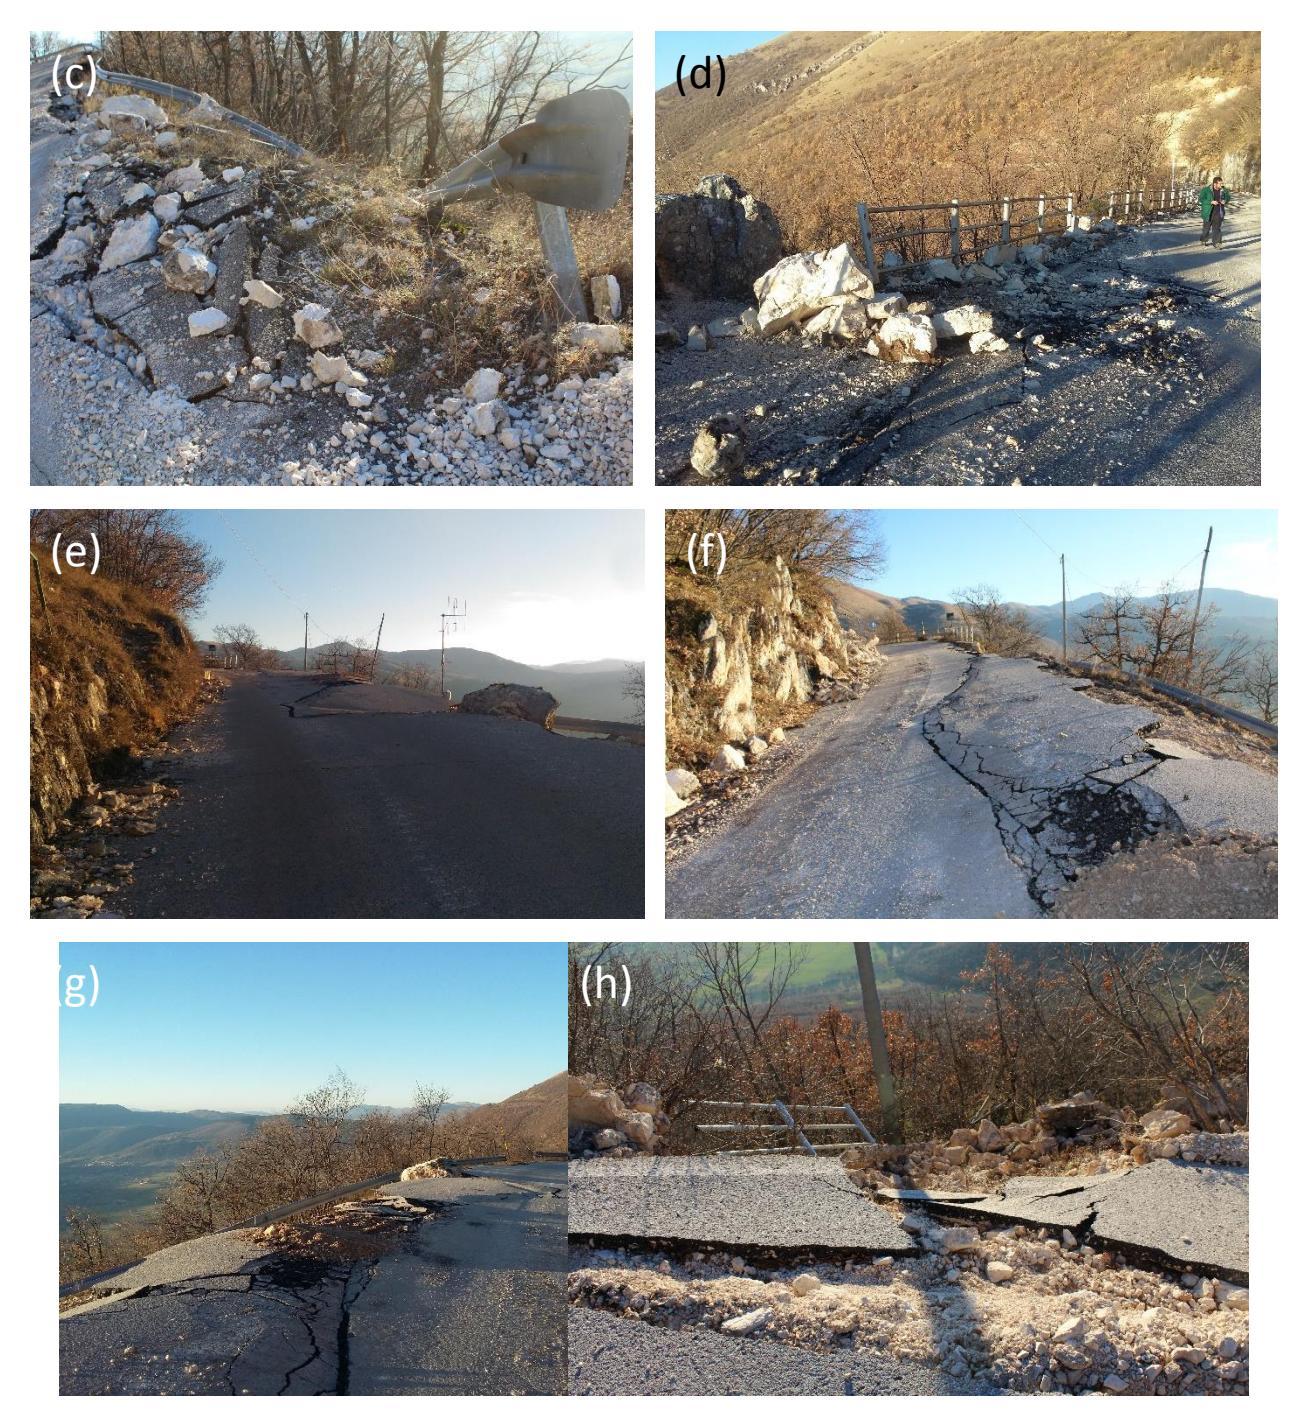
**Figure 4.79.** Fracture along the road, large vertical offset due to fracture and ultimate movement, damaged edge barriers and debris and boulders on the road surface.

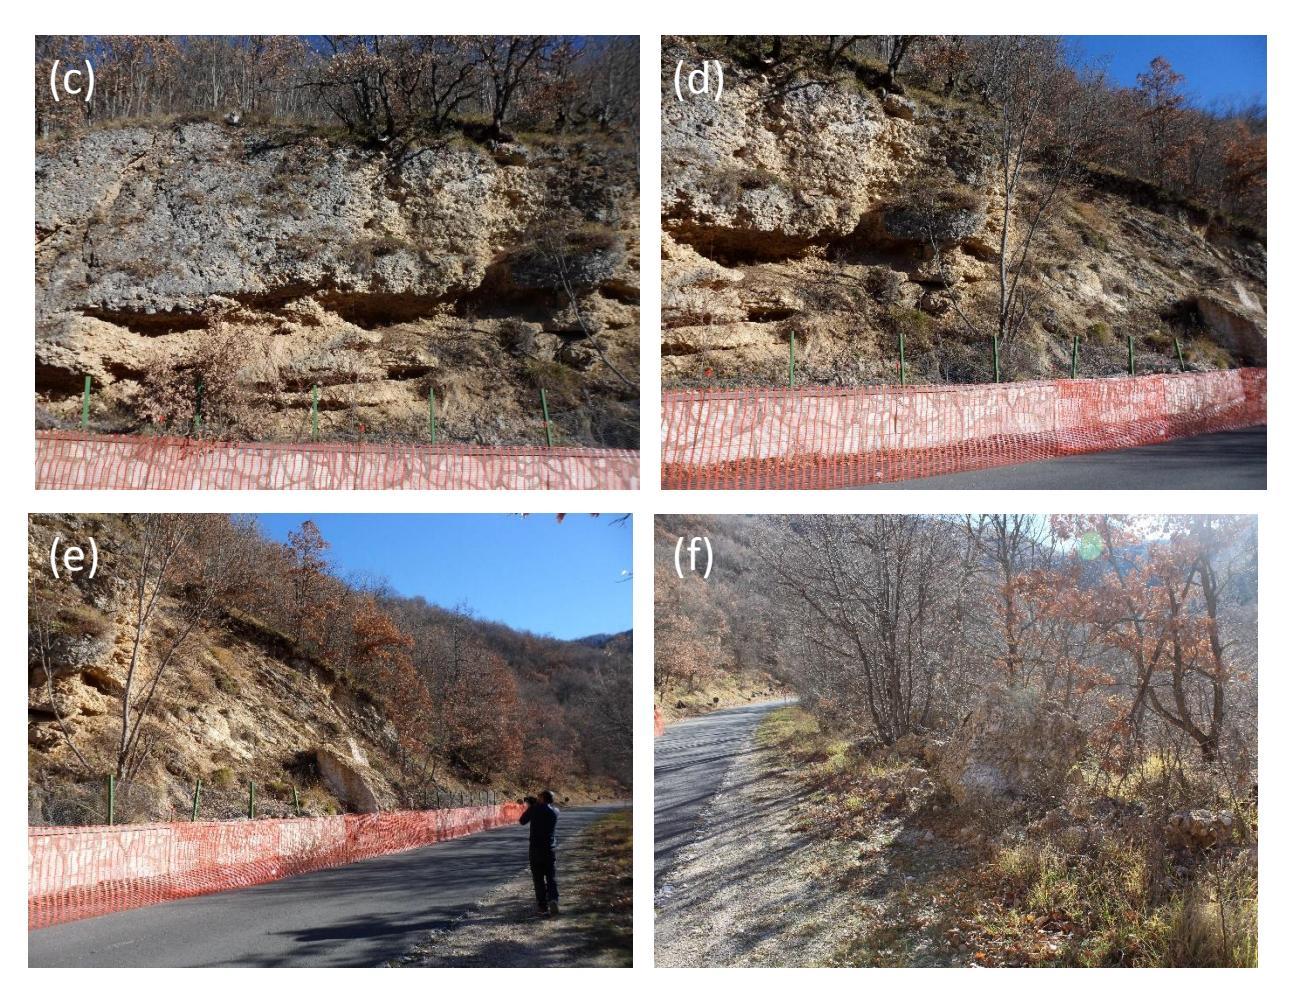
**Figure 4.89.** Failure in calcareous breccia between Cittareale and Norcia along the SP746: from (a) to (e) view of the all facade; (f) rockfall on the road.

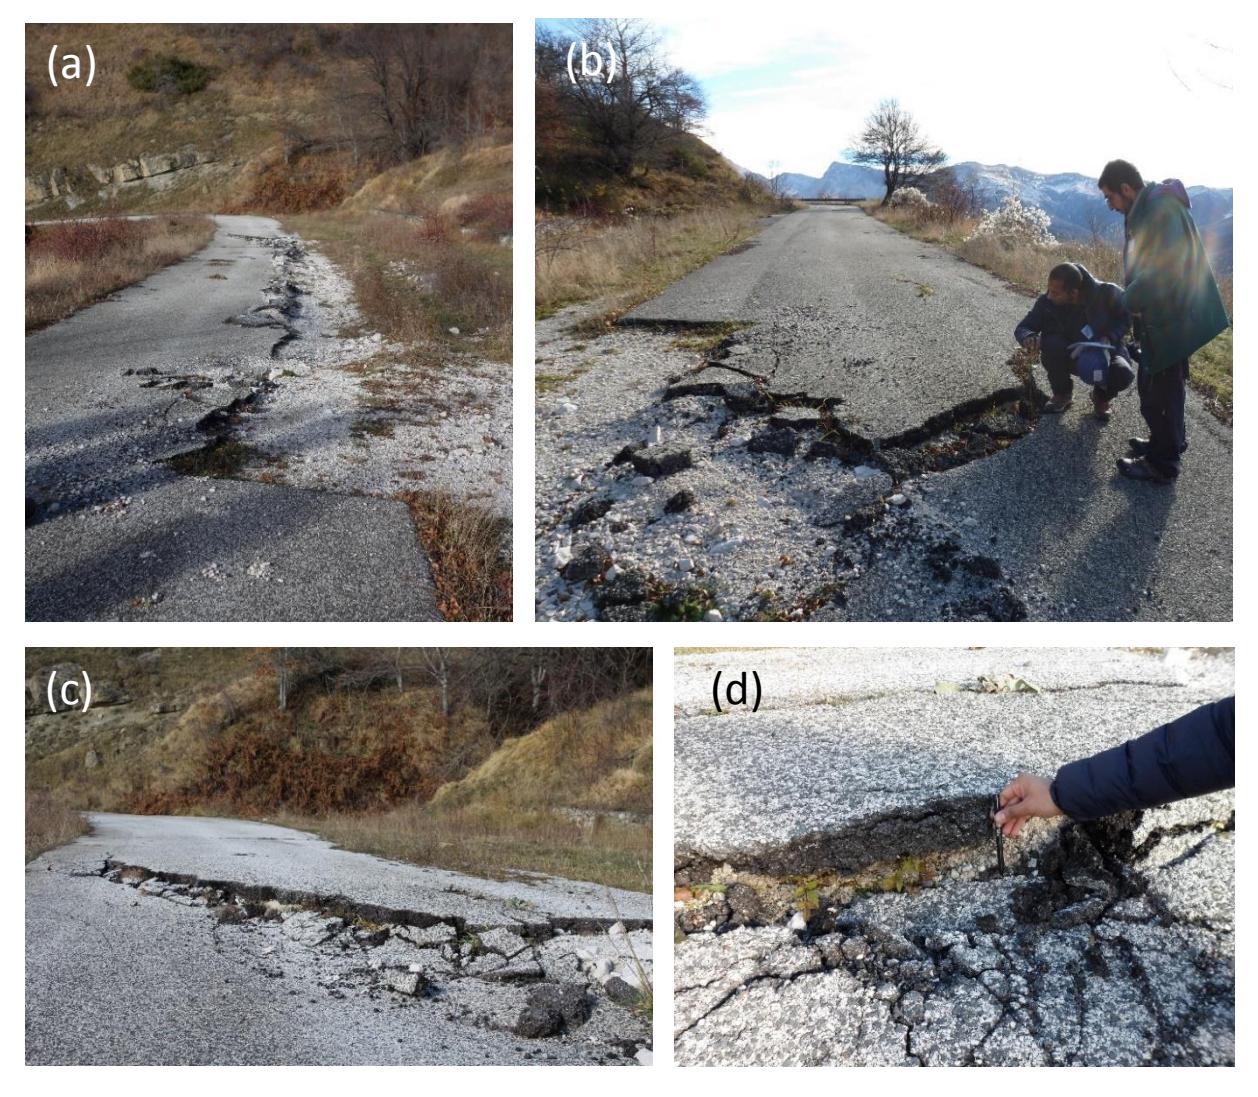
Figure 4.92. Cracks along the road.

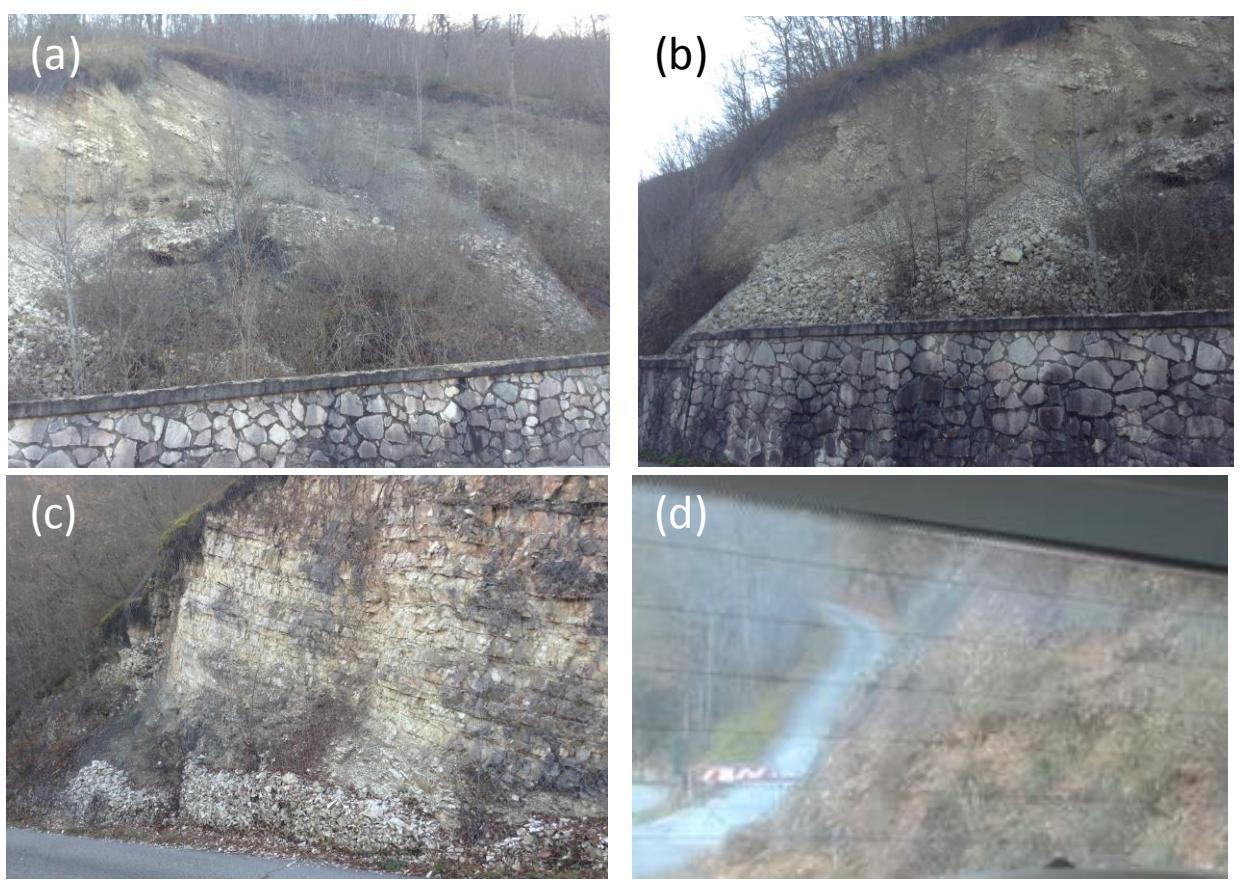
Figure 4.99. Observed rockfalls along SP476 (between Piedivalle and Preci).
