Engineering Reconnaissance of the 24 August 2016 Central Italy Earthquake. Version 2 GEER Team Leaders: Giuseppe Lanzo and Jonathan P. Stewart

Geotechnical Extreme Events Reconnaissance Association

Report No. GEER-050B

22 November 2016

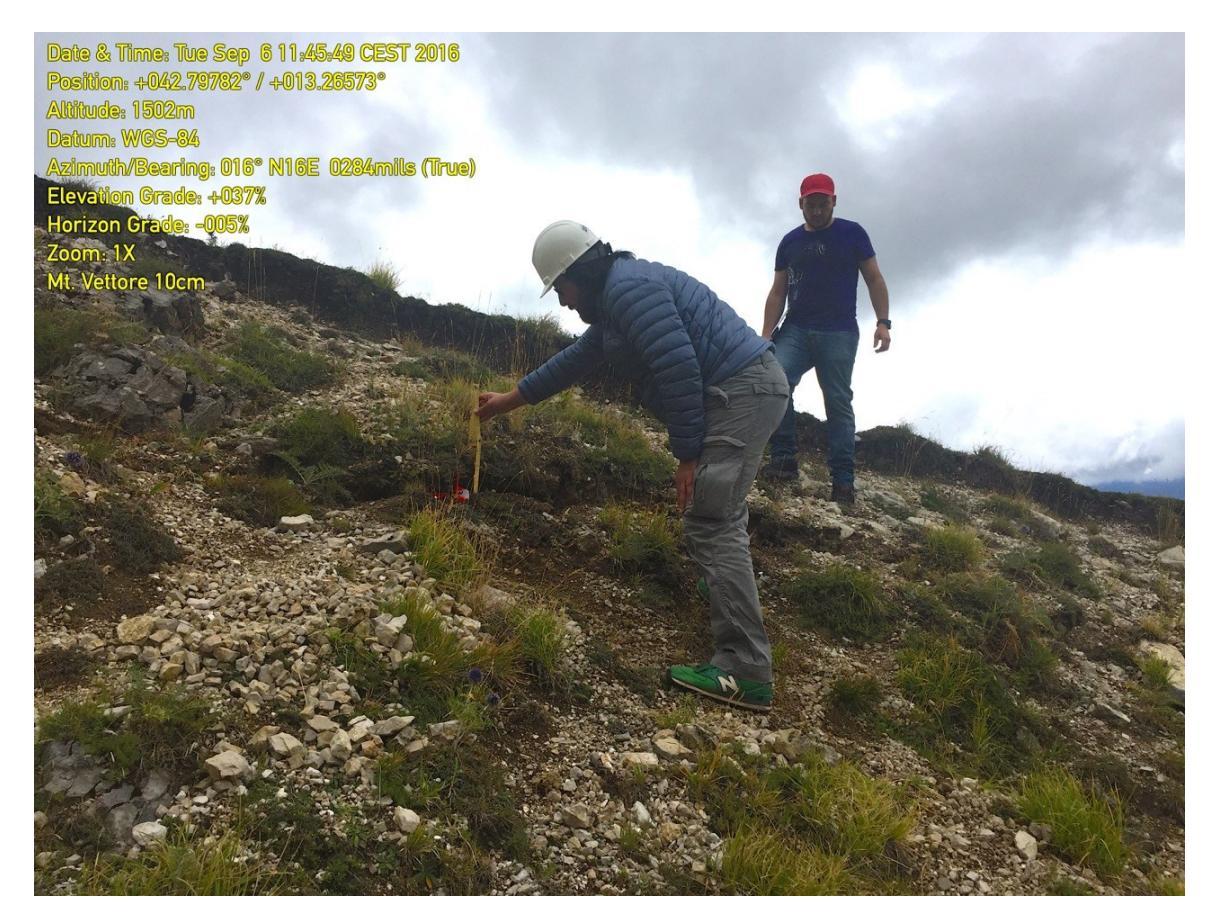
Figure 2.19c. Mt. Vettore fault Site 1 at a WGS84 ellipsoid elevation of 1502 m. The normal fault displacement at this site was 10 cm down toward the west (Latitude and Longitude are annotated on the image).

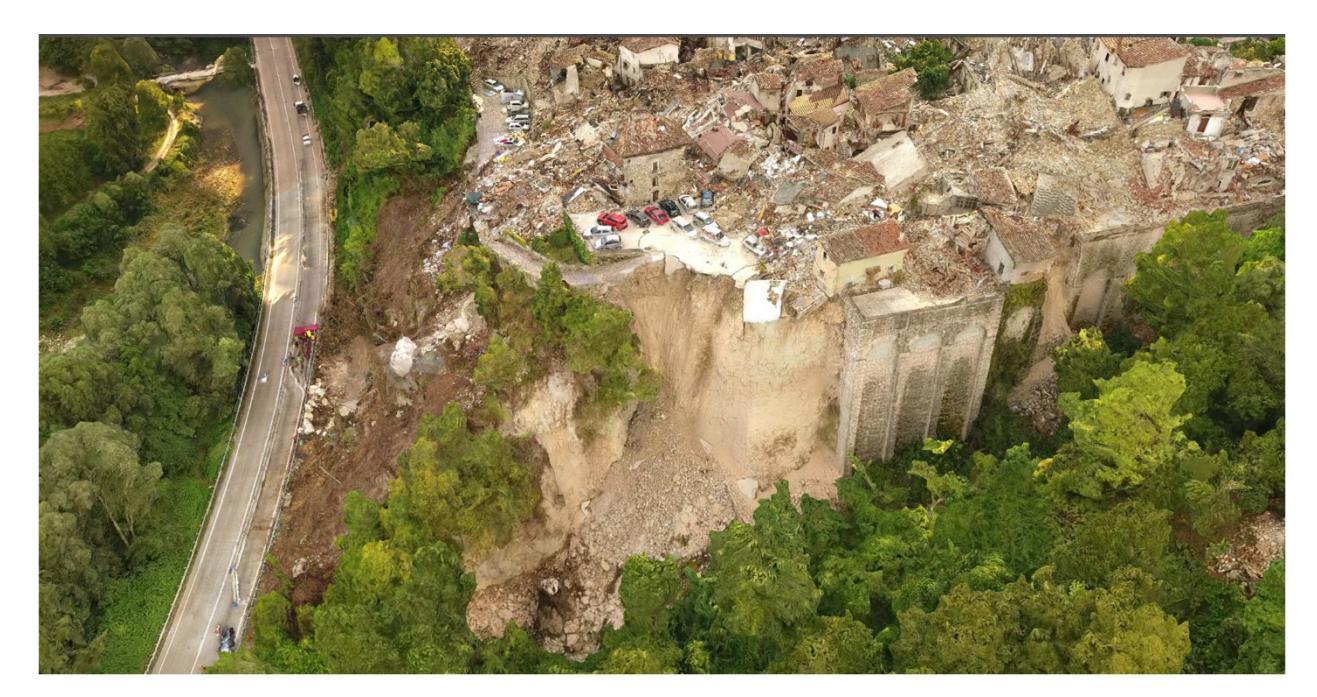
Figure 4.30. 3D model of a slope failure in Pescara del Tronto possibly caused by a retaining wall collapse (42.75109 N 13.27208 E).

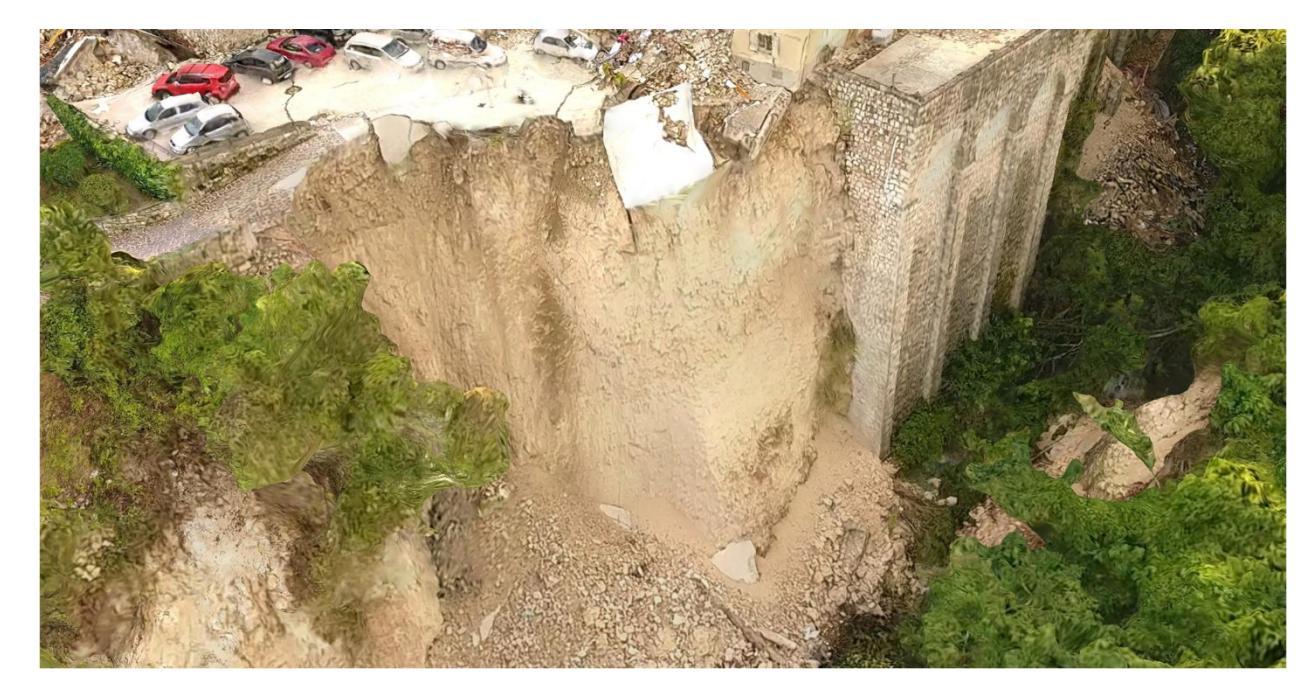
Figure 4.31. Model image of slope failure and possible retaining wall collapse (42.75109 N 13.27208 E).

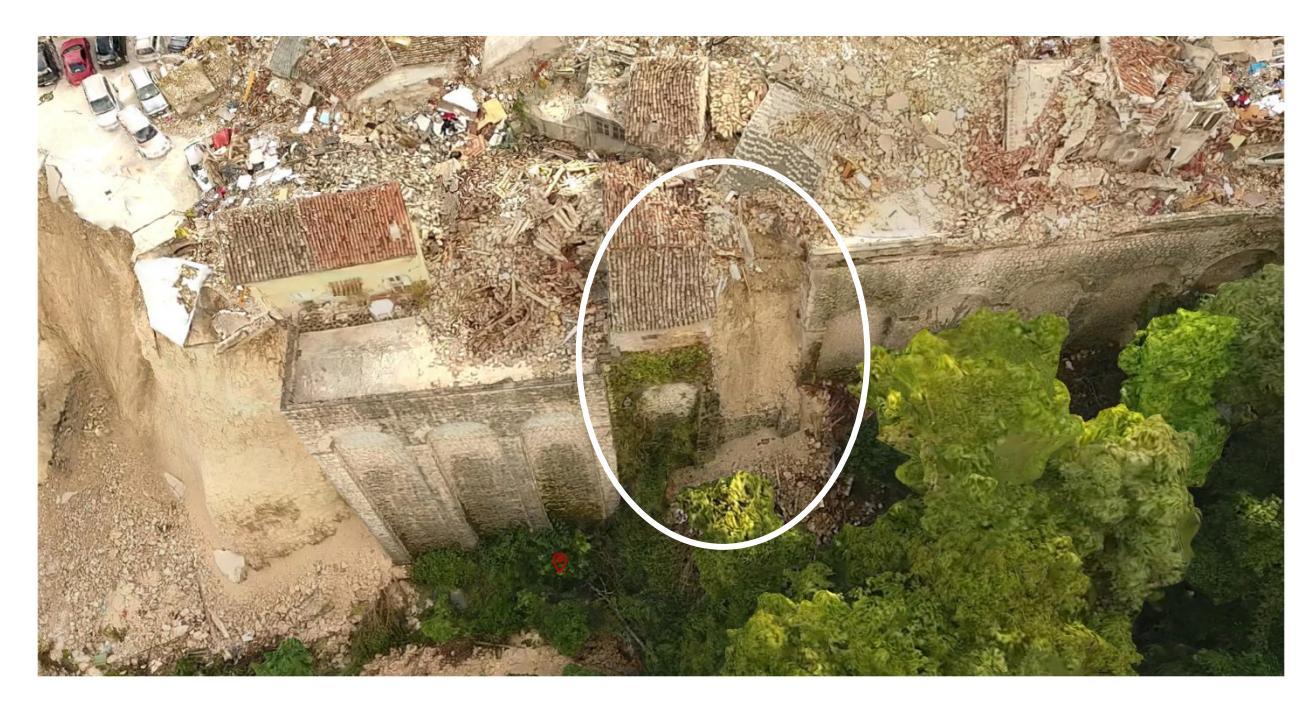
Figure 4.32. Model image of a smaller retaining wall failure and subsequent landslide in Pescara del Tronto (42.75136 N 13.27194 E).

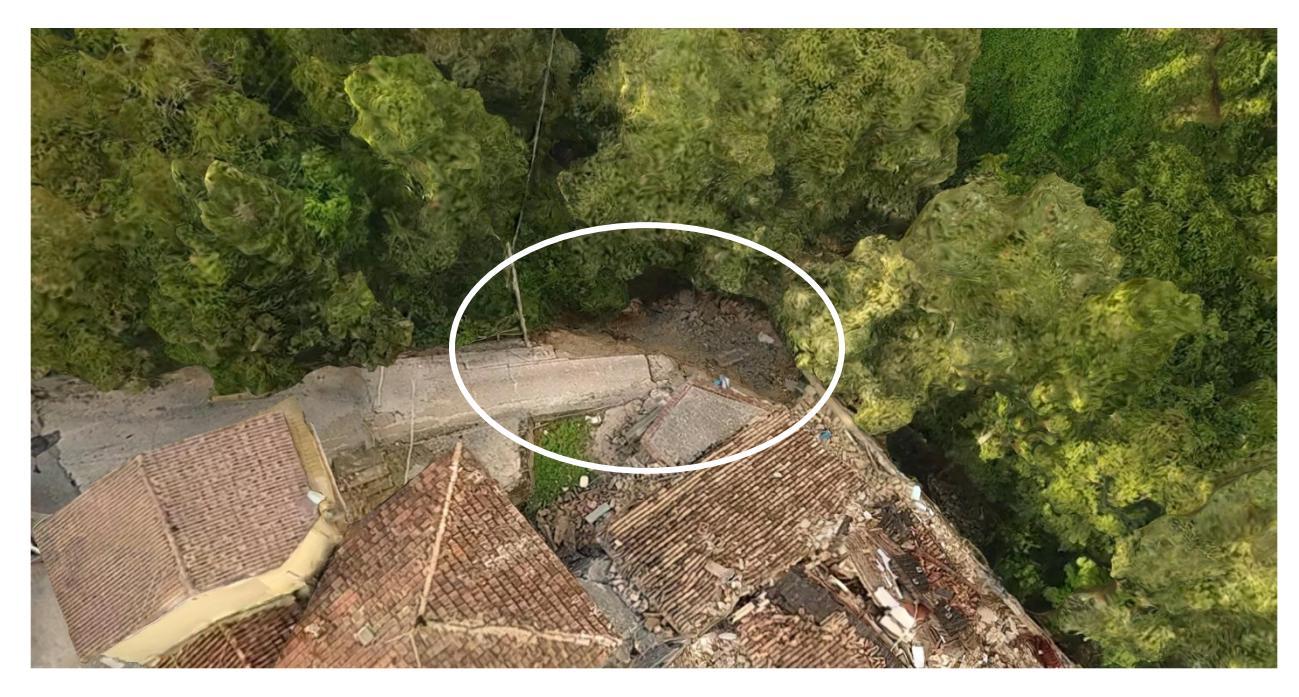
Figure 4.33. Model image of a landslide following a corner retaining wall failure in Pescara del Tronto (42.75166 N 13.27111 E).

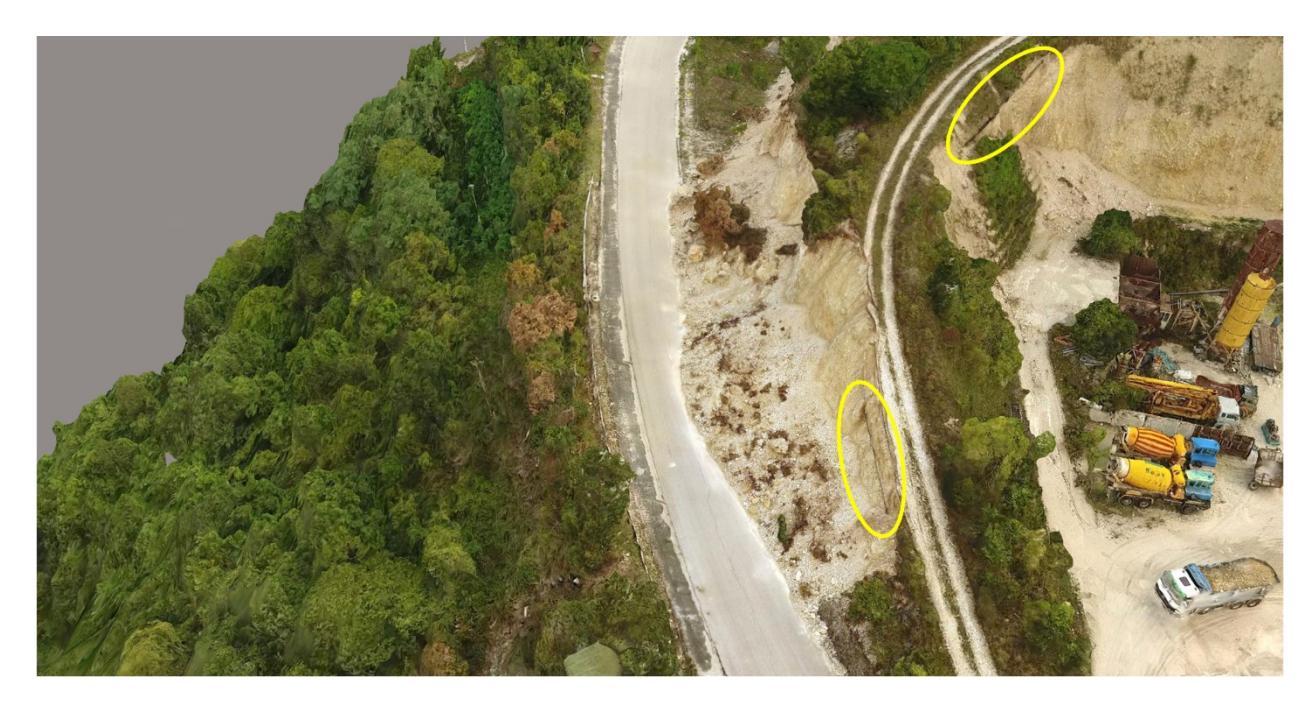
Figure 4.39. Landslides along dirt haul road in Pescara del Tronto, with exposed pipelines. The earthquake caused up portions of the slope up to 5 meters wide to fail, including portions of the dirt haul road itself.

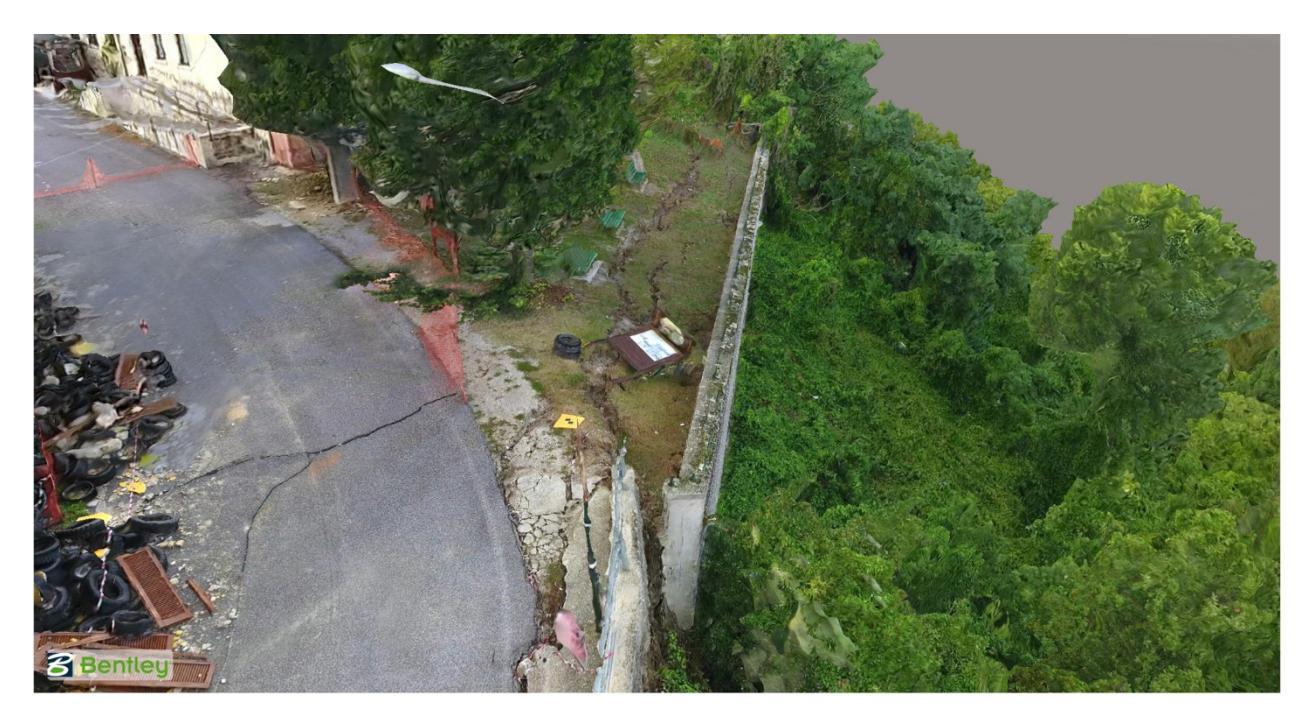
Figure 4.43. Rotated retaining wall and subsequent graben behind the wall. Soil settlement between 45-50 cm behind the wall, and formed cracks up to 45 cm in width (42.69446 N 13.24980 E).

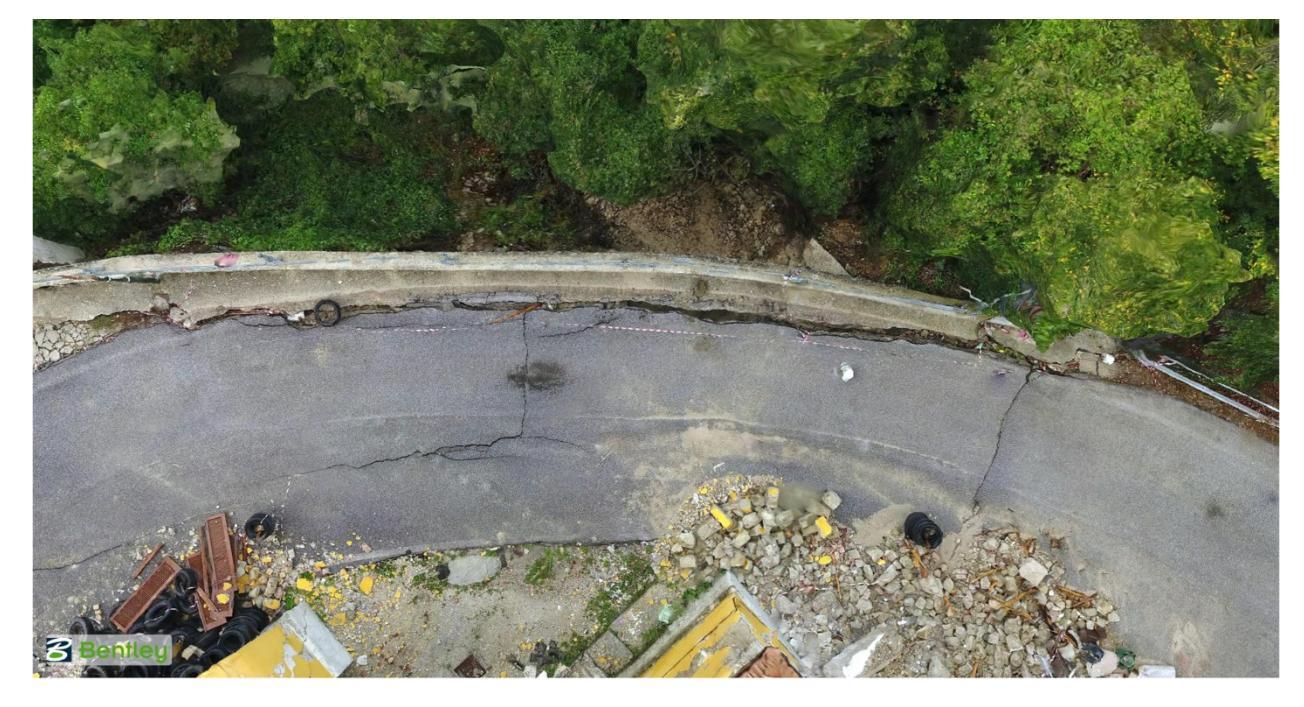
Figure 4.44. Rotated retaining wall below the road Frazione Fonte del Campo and subsequent cracks up to 25 cm in width (42.69438 N 13.24995 E).

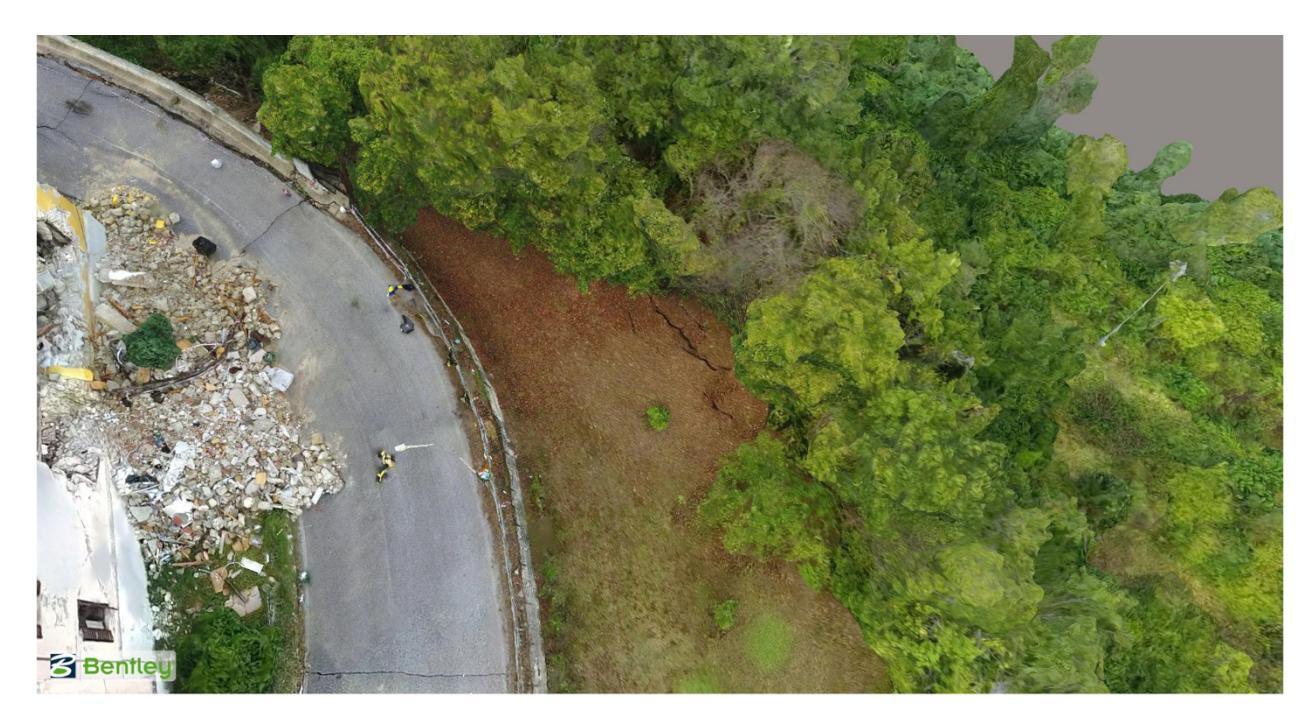
Figure 4.45. Model image of the cracks found in the silty-sandy fillslope located adjacent to the eastern walls of Accumoli. Crack widths range from 5 to 14 cm (42.69406 N 13.25019 E).

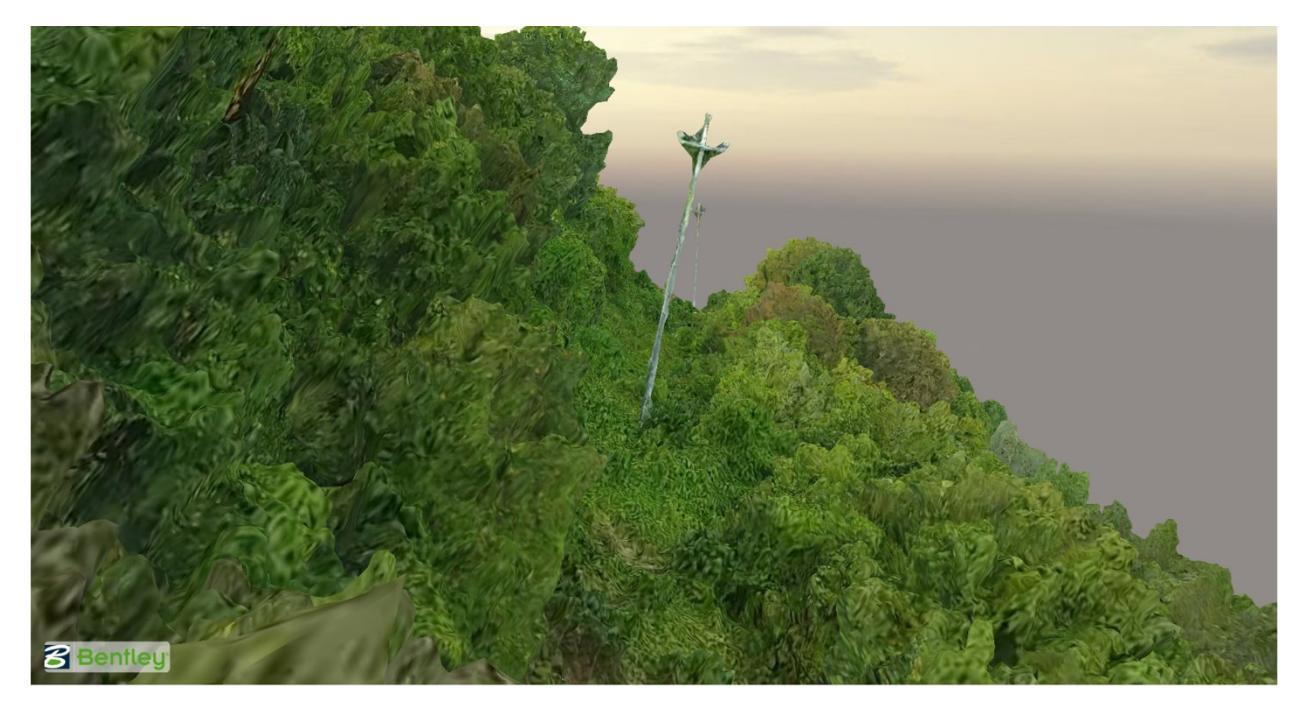
Figure 4.46. 3D model image of a rotated telephone pole in the slope below the cracks. The telephone pole is rotated 13 degrees from vertical, while the other telephone poles are approximately vertical.

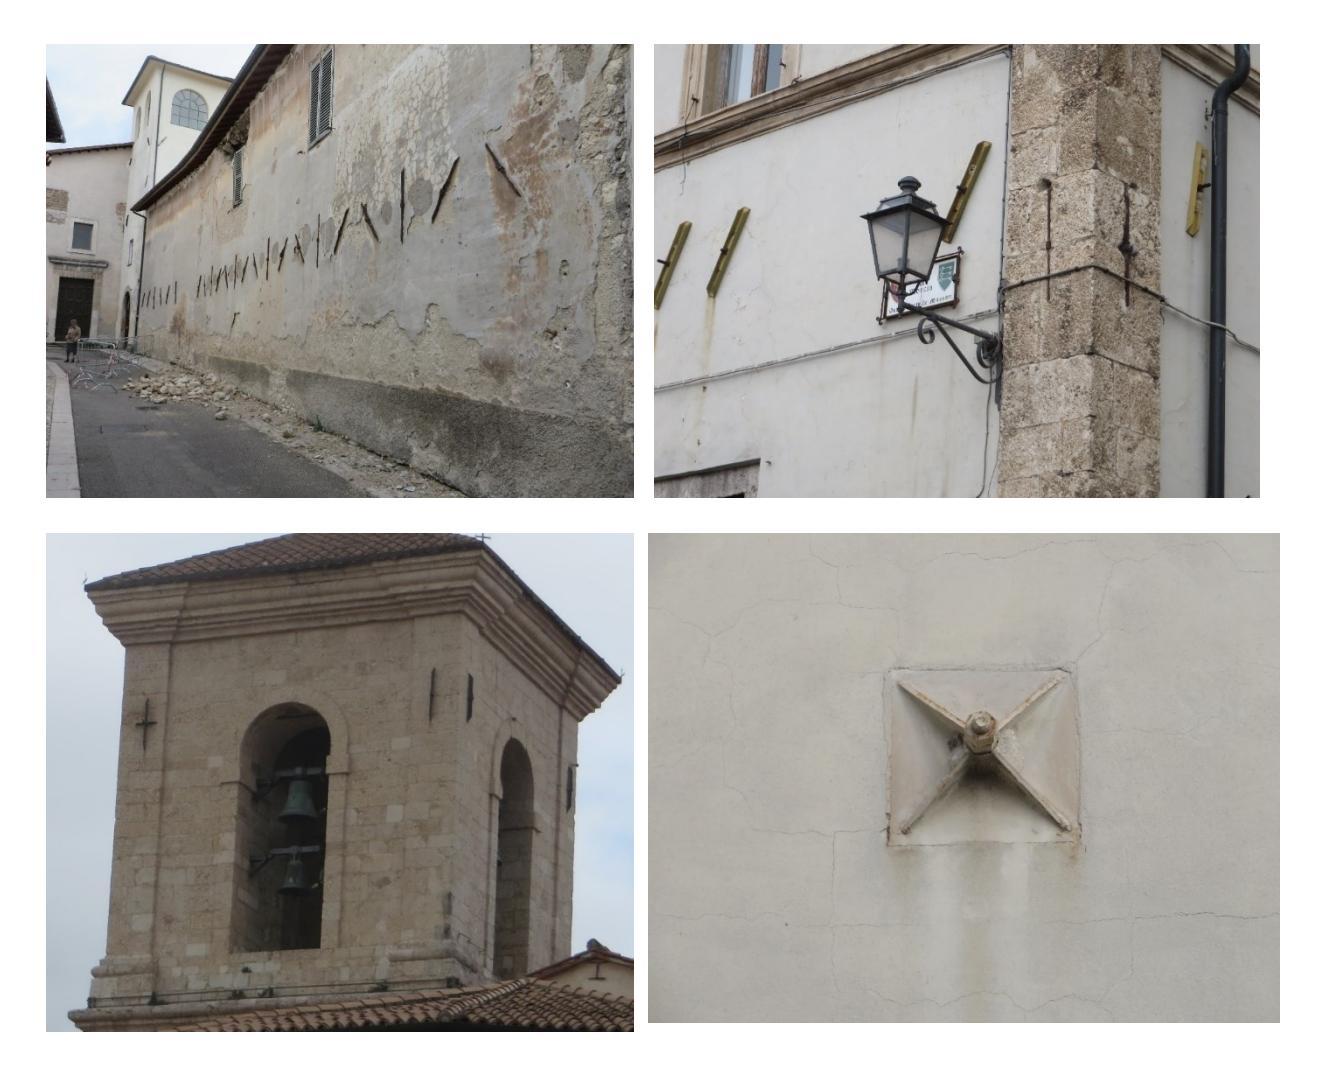
Figure 5.35. Buildings and towers retrofitted with cross-ties in Norcia.

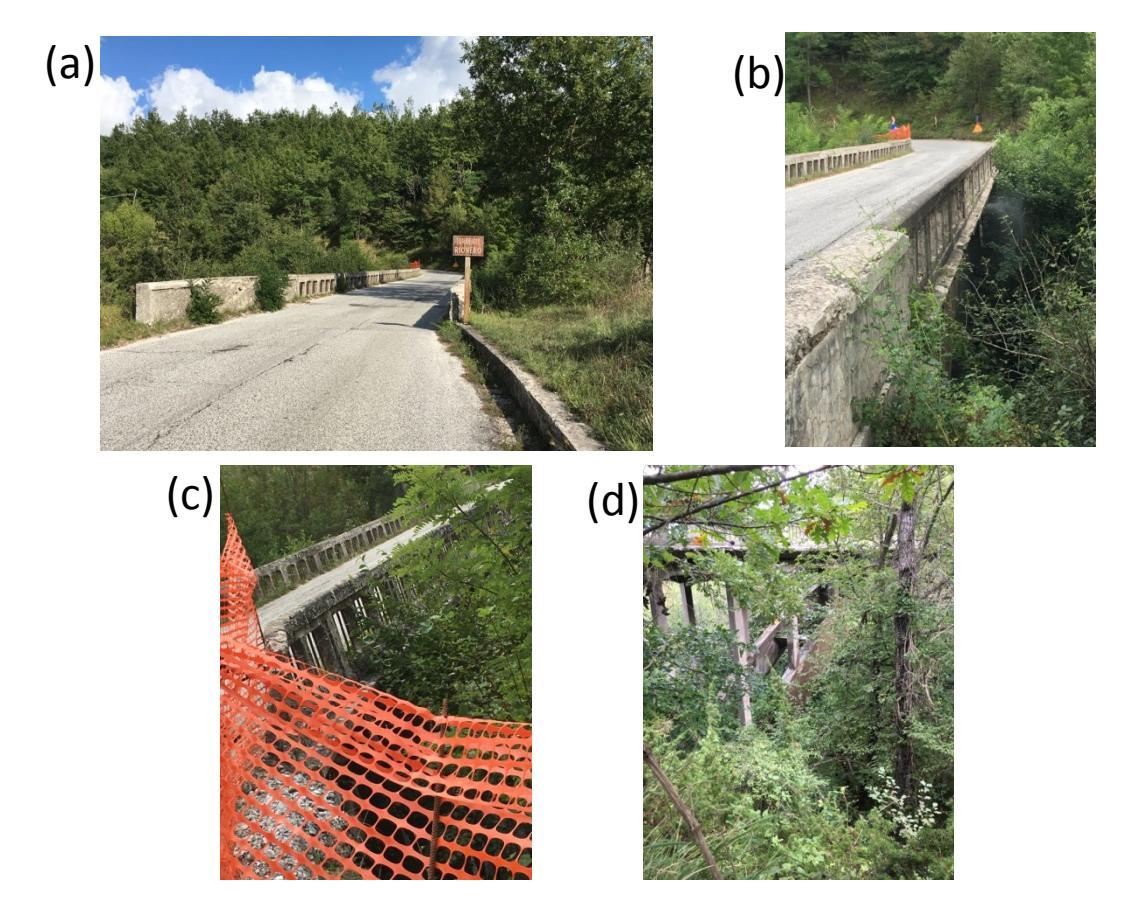
Figure 6.4. RC bridge along the SR577 Torrente Rionero (42.6172 deg, 13.3233 deg): overview of the bridge (a), rupture of the water pipeline on the bridge side (b) and view of the structure (c, d).

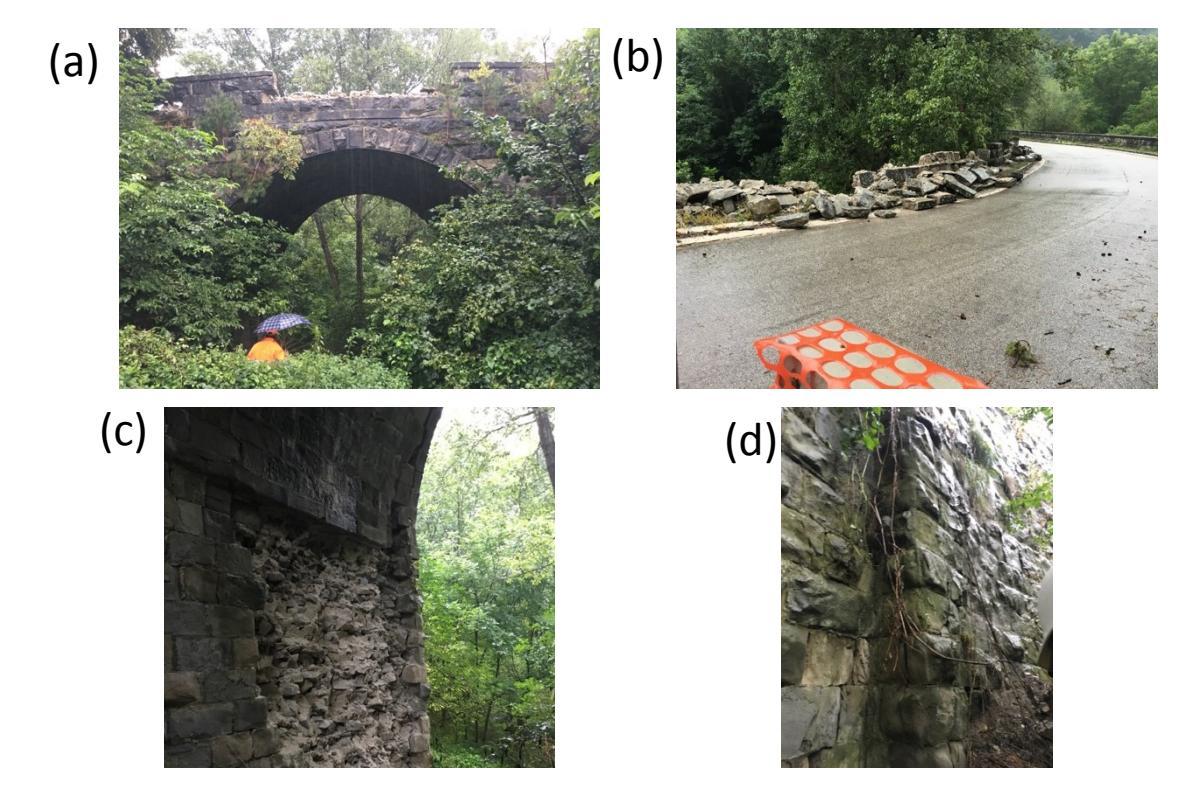
Figure 6.8. Central arch of the three arches masonry bridge along the Trisugo route (42.73538 deg, 13.253655 deg): partial collapse of the railing (a, b) spalling (c) and cracking (d) of some masonry elements.

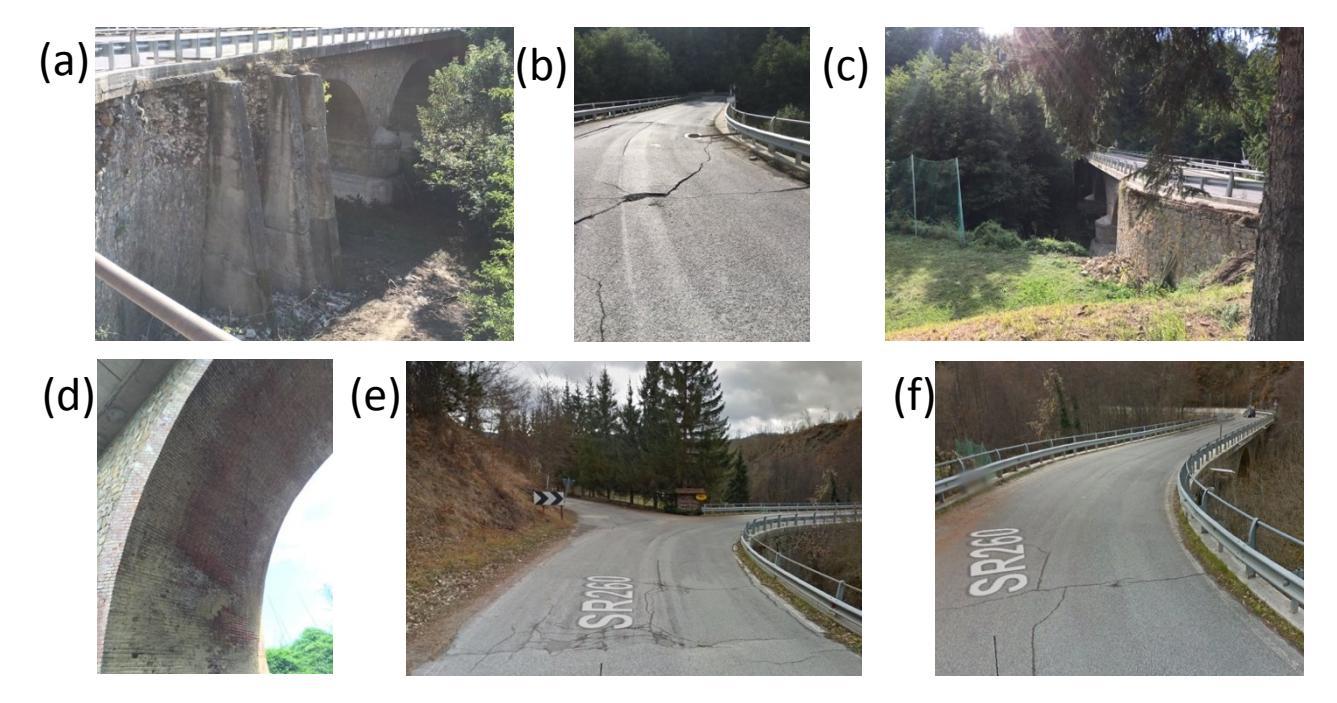
Figure 6.9. Ponte a Tre Occhi - Masonry bridge along the SR260 in Amatrice (42.620668 deg, 13.290176 deg): partial collapse of two side of the bridge (a, c), road settlement (b), cracks on the arch (d), preevent cracks along the SR260 (e) and bridge-abutment connection (f) (source (e) and (f): Google maps).

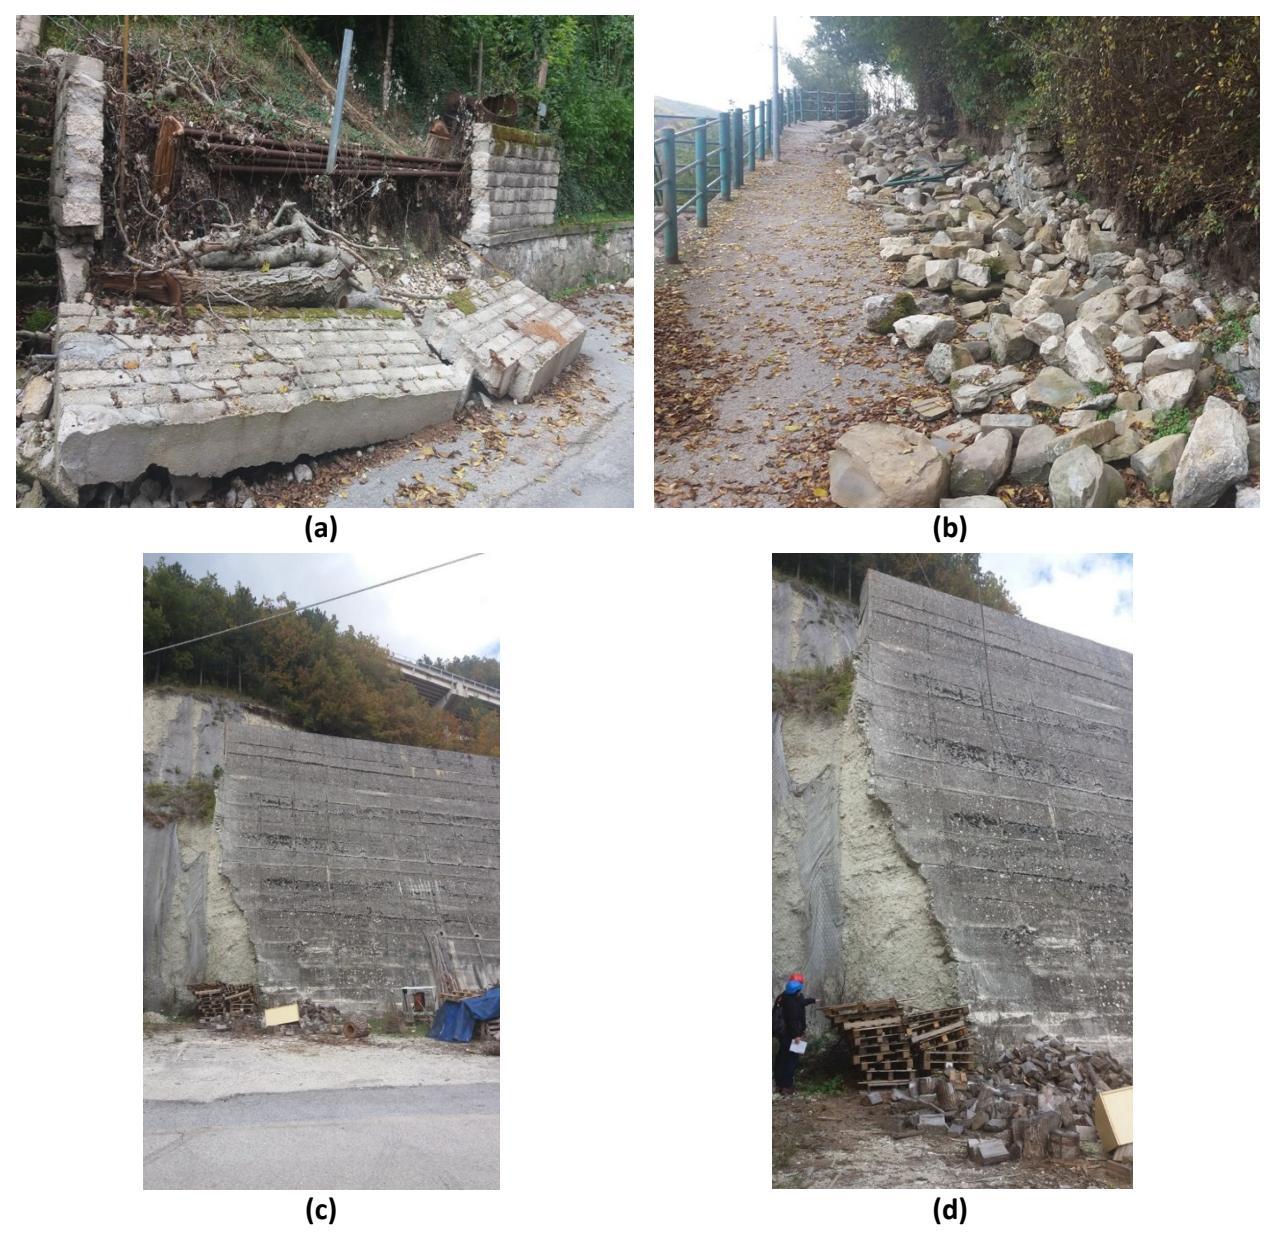
Figure 7.5. Retaining walls in Pescara del Tronto: (a) collapse of a concrete block masonry wall (42.751705N, 13.270562E), (b) collapse of a dry-stone masonry wall (42.751141N, 13.270889), (c) fence drapery breached by calcarenite rock blocks, (d) performance of the adjacent concrete wall (42.752331, 13.270207E).

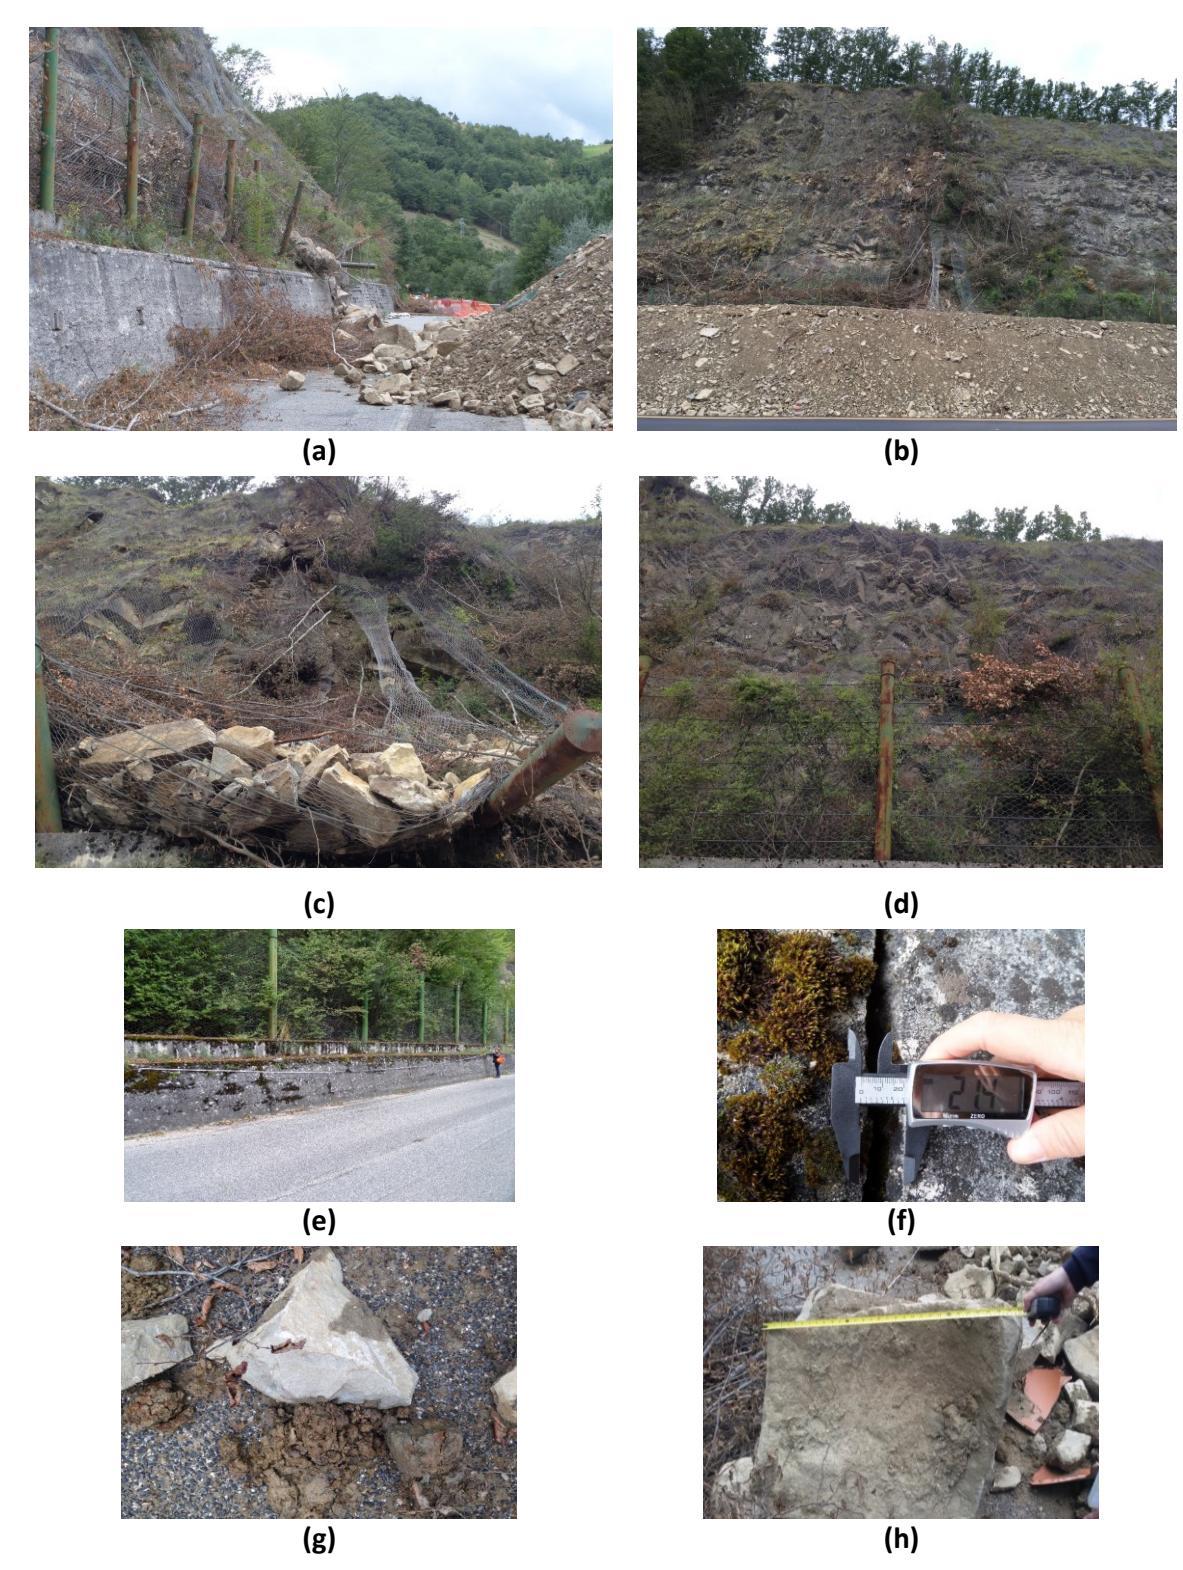
Figure 7.6. Damage to a rockfall protection system along the SS260 road (42.648203N, 13.274285E) in Amatrice municipality: (a) collapsed zone; (b) failed (left) and stable (right) parts of the slope with protection embankment in the foreground; bottom view of the failed (c) vs. stable (d) slope and barrier; concrete wall supporting the barrier (e) and previous crack (f) denoting the absence of reinforcement; (g) arenaceous block with silty matrix and (h) maximum size of the rock blocks fallen.

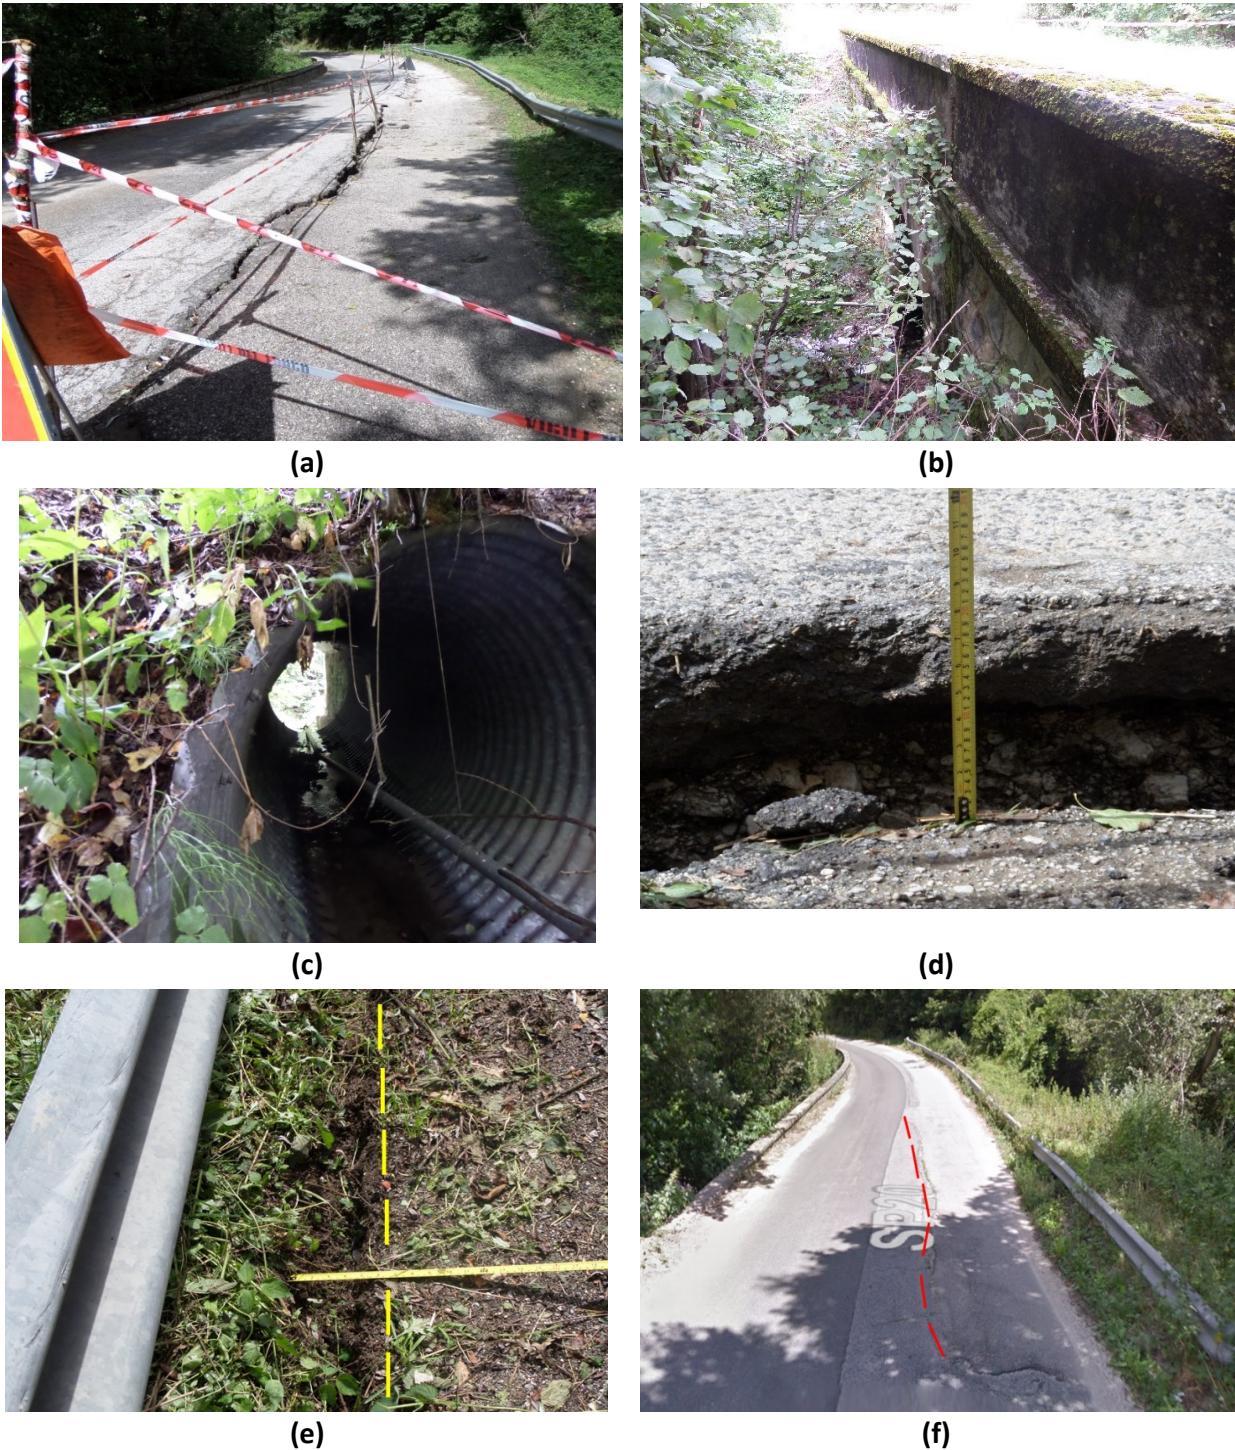
Figure 7.7. Embankment instability along the SP20 road between the villages of San Lorenzo e Flaviano and Sommati (42.660061N, 13.293697E): (a) longitudinal crack along the road surface after the earthquake;(b) downstream view of the crossing section; (c) view of the Armco tube underneath the embankment; (d) maximum vertical settlement at the bridge-embankment connection; (e) longitudinal crack at the border of the pavement surface; (f) previous conditions of the road branch before the earthquake (Google image dated July 2011).

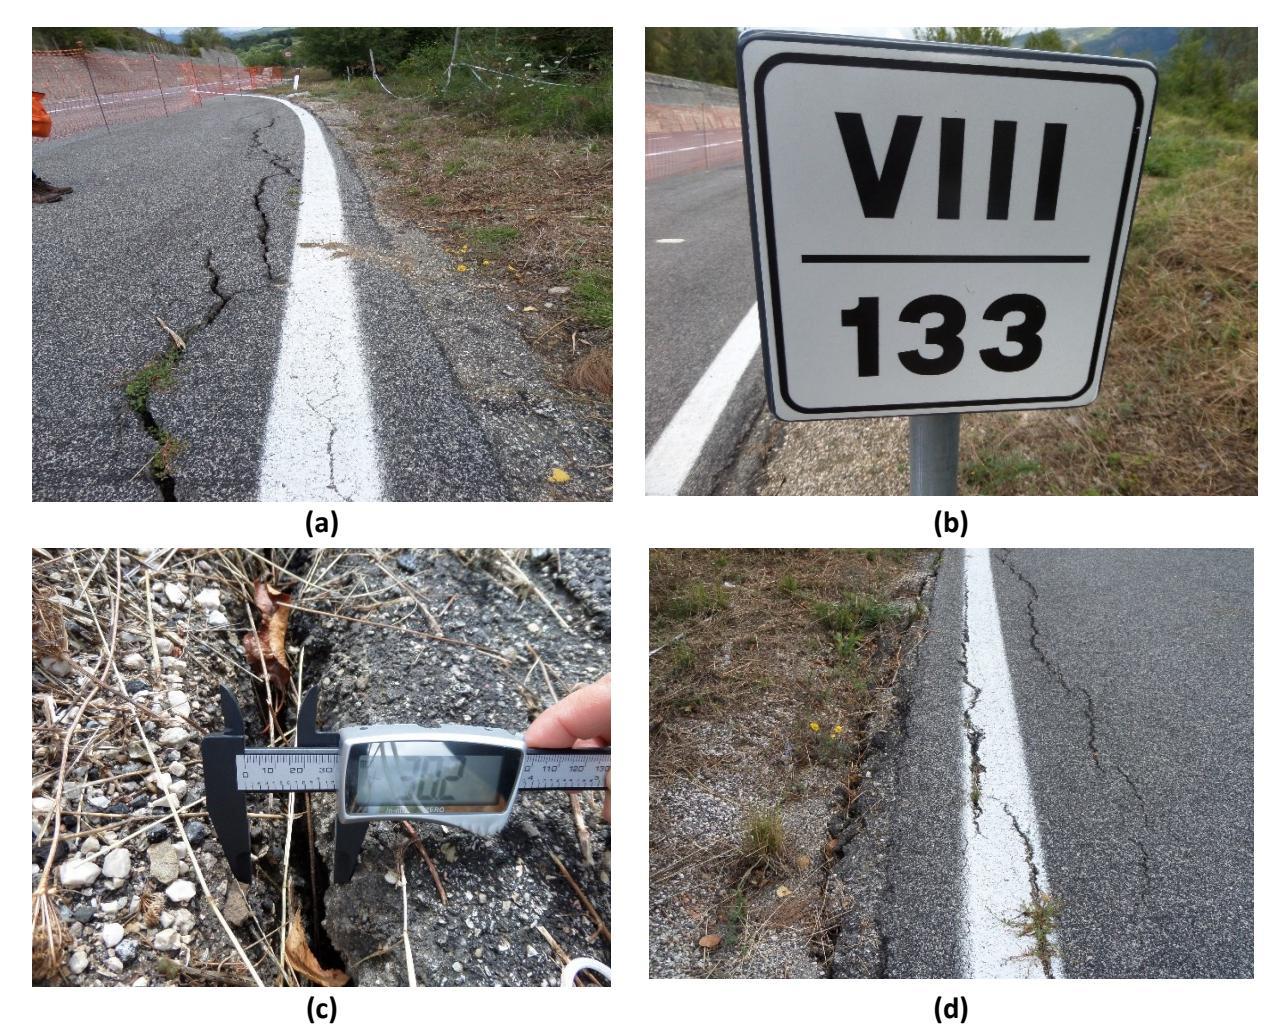
Figure 7.8. Embankment instability along the SS4 road at km 133 (42.650533N - 13.270442E): (a) longitudinal cracks along the whole rest area, (b) identification of the site location by road sign, (c) maximum horizontal opening of the longitudinal crack, (d) disconnection between the lateral slope and the road surface.
