The Hydraulic and Geotechnical Aspects of the South Carolina Floods of October 1-5, 2015 Related to Offshore Hurricane Joaquin

GEER Association Report No. GEER-052 December 19, 2016

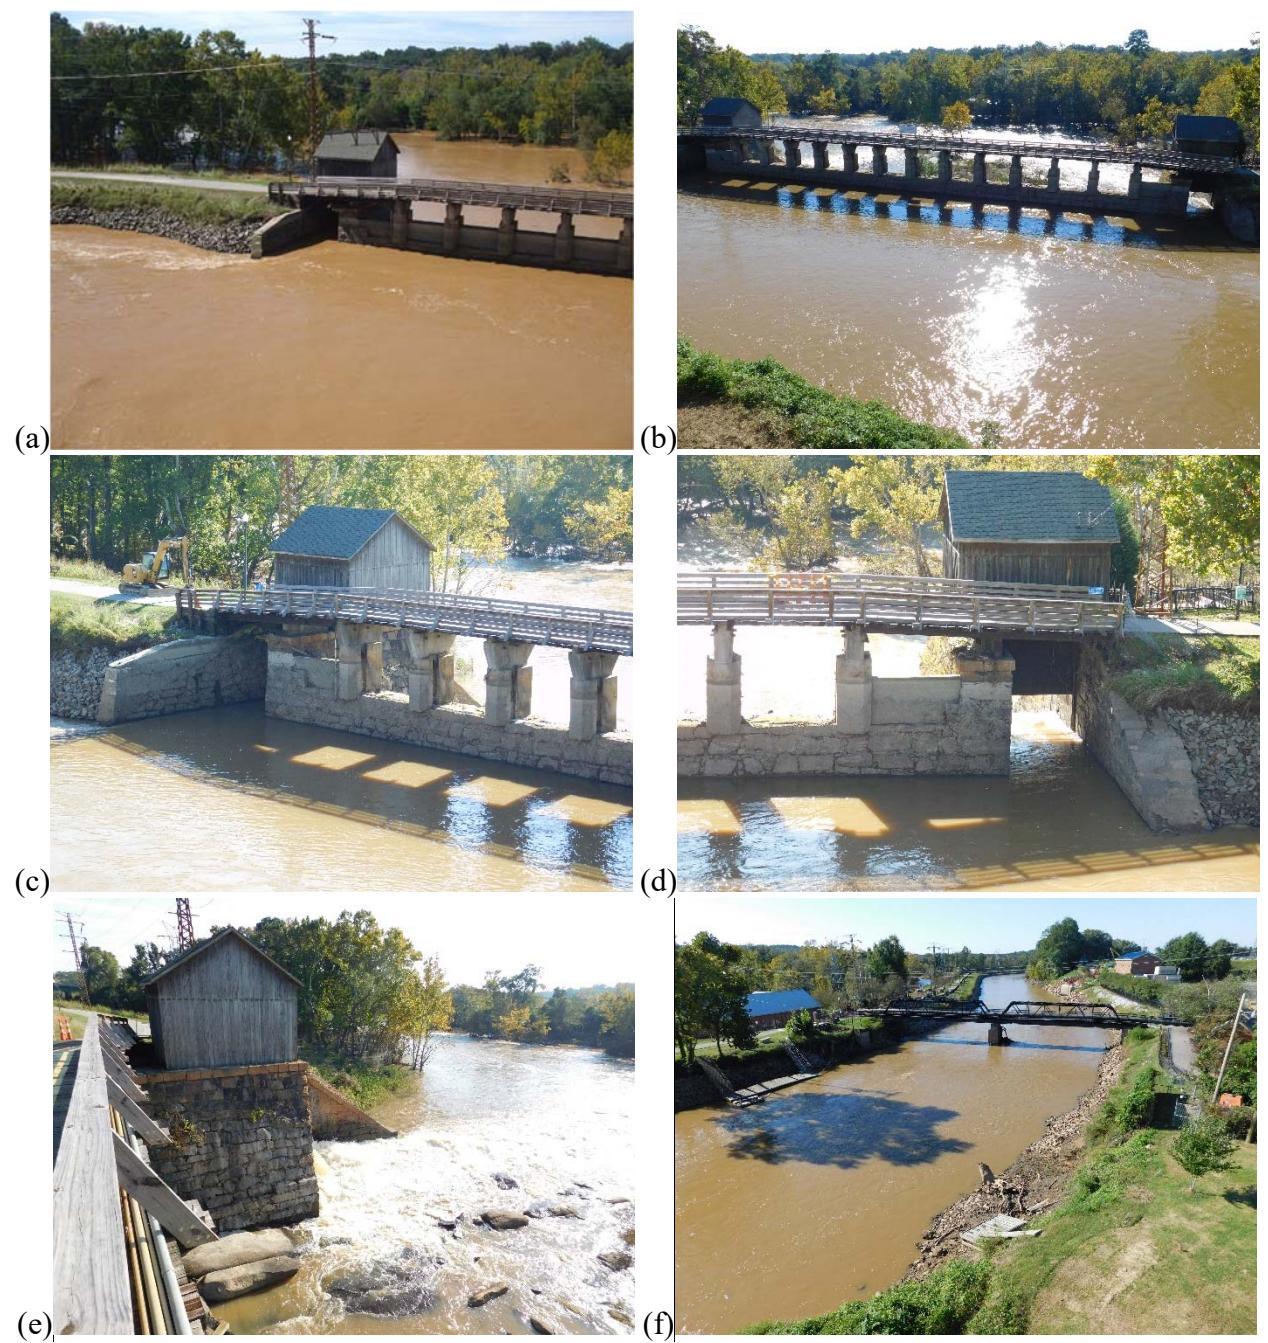
Figure 19. Spillway and Columbia Canal after the breach: (a) View of the spillway from the canal to the Broad River the Monday morning after the breach at 11:02 am on October 5, 2015. Note the still installed stoplogs raising the weir crest height up to 75% of the vertical adjustment slot height along the pillars visible since the water level dropped due to the downstream breach. (b,c,d) Spillway with stop logs removed in the 12 central side weir openings, while the lateral two side weirs are permanently cemented and the lateral sluice gates are fully open on October 11, 2015. (e) Downstream of the spillway with reduced Broad River water level on October 13, 2015. (f) Pedestrian bridge and canal upstream with significantly lowered canal water level on October 11, 2015 (N 34.00199°, W 81.05372°).

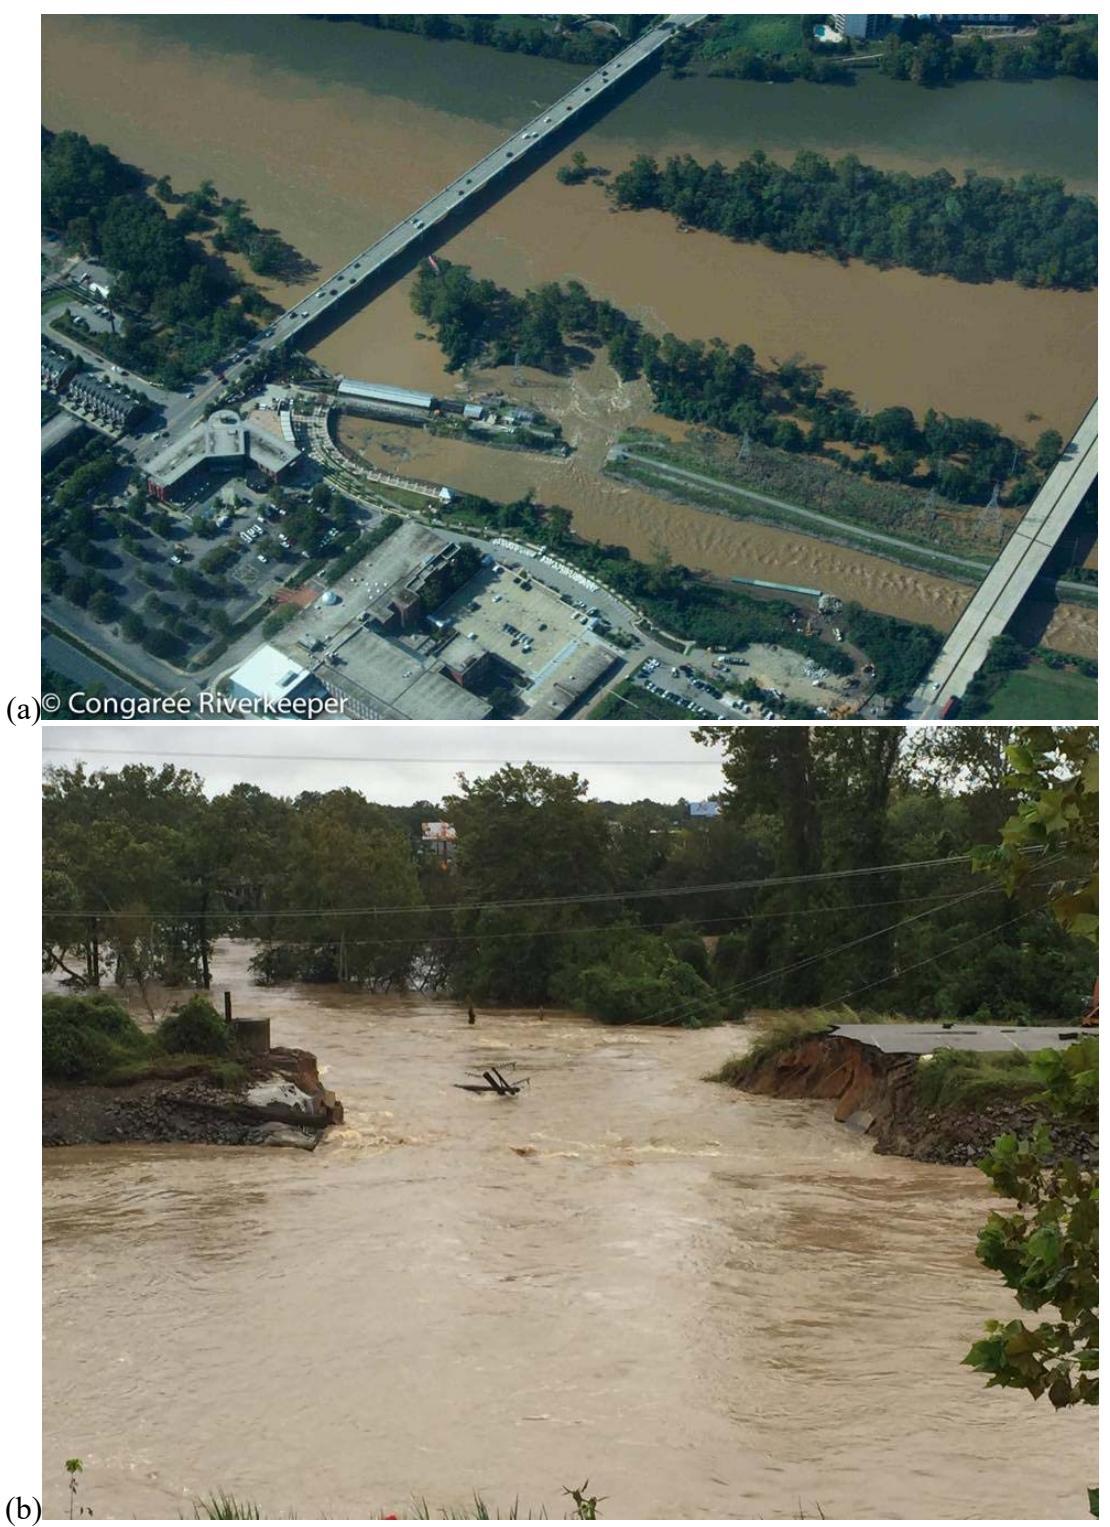
Figure 20. Initial Columbia Canal Levee Breach (N 33.99796°, W 81.05018°): (a) Aerial view of the Columbia Canal in the foreground with the Congaree River formed by the confluence of Broad River (sediment laden brown water) and Saluda River (blue water in foreground) on October 6, 2015. Note there is only the initial levee breach as cofferdam construction begins downstream of SC-12 Bridge, which will lead to the later horseshoe breach; (b) detail of the 26 m long dike breach some 20 m upstream of the Lockhart Power Substation #559 at 8am on October 5, 2015 (photos from Congaree Riverkeeper: www.congareeriverkeeper.org).

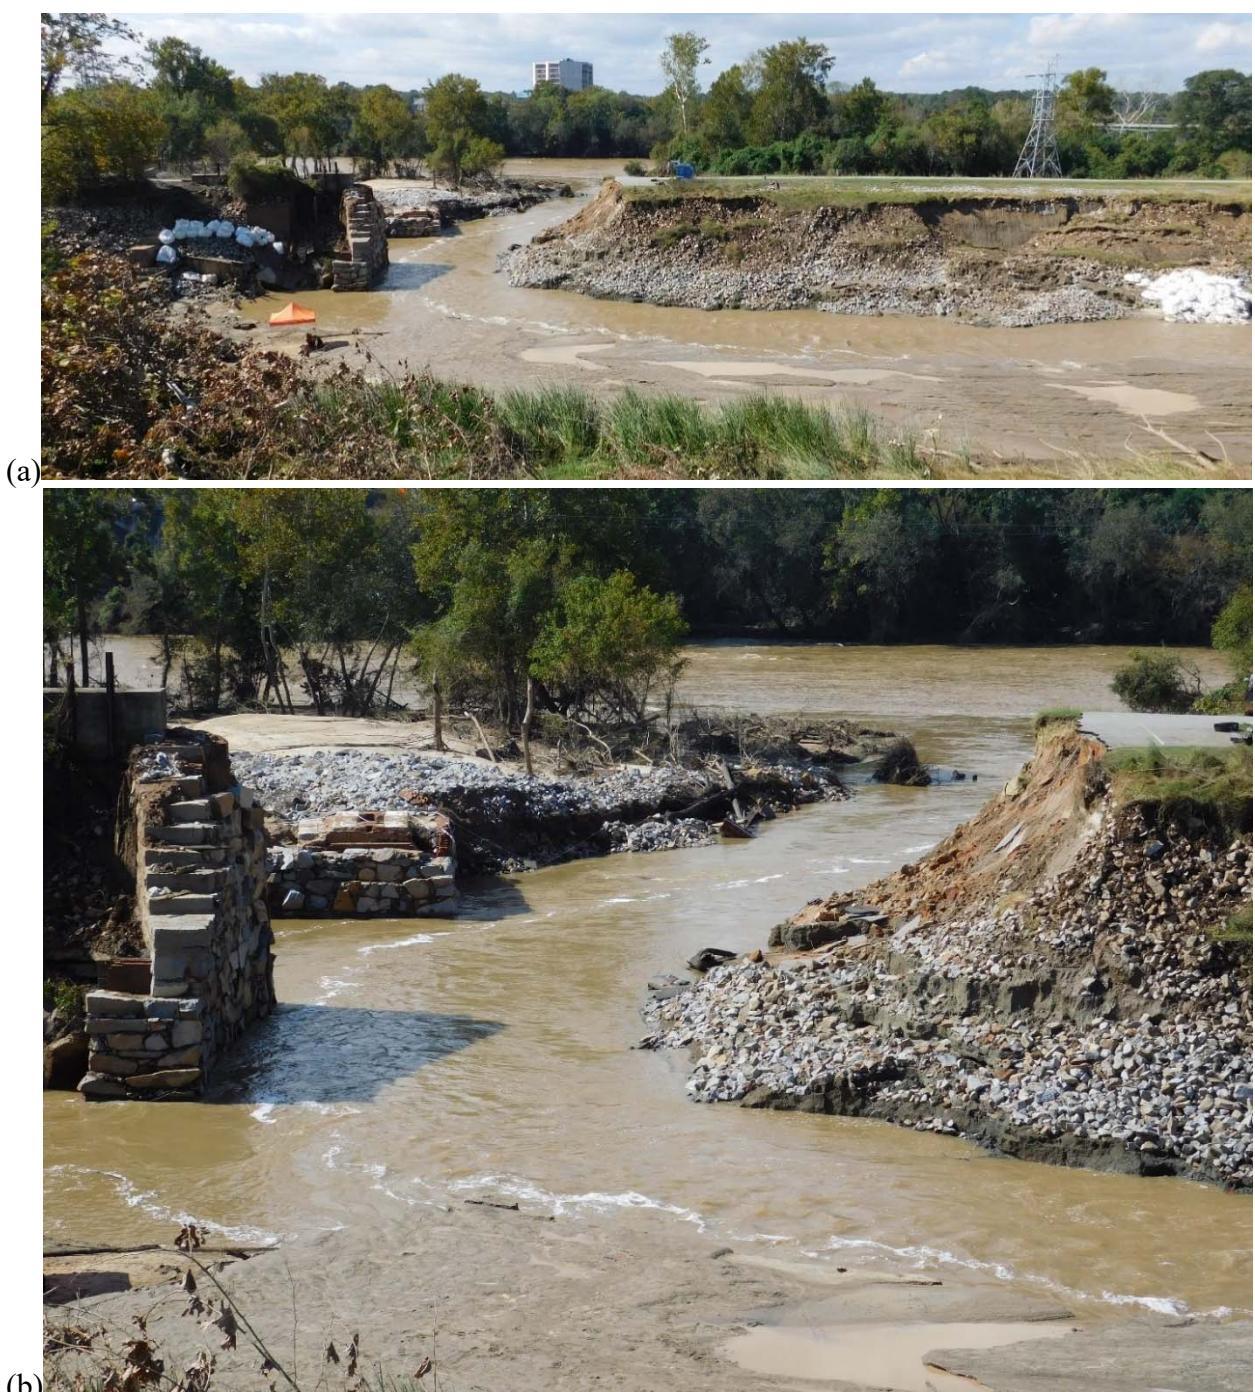
- (b)
- Figure 21. Columbia Canal dike breach of 3 am on Monday October 5, 2015 some 20 m upstream of the Lockhart Power Substation #559 and 80 m upstream of the power house: (a) Panoramic southwest-ward view of the levee breach with both upstream and downstream drawdown slumps on the Canal side; (b) detail of the dike breach at the downstream rock wall with a breach length of 26 m at the crest and 12 m at waterline with the water surface 9 m below the dam crest (photos: October 12, 2015; N 33.99796°, W 81.05018°).

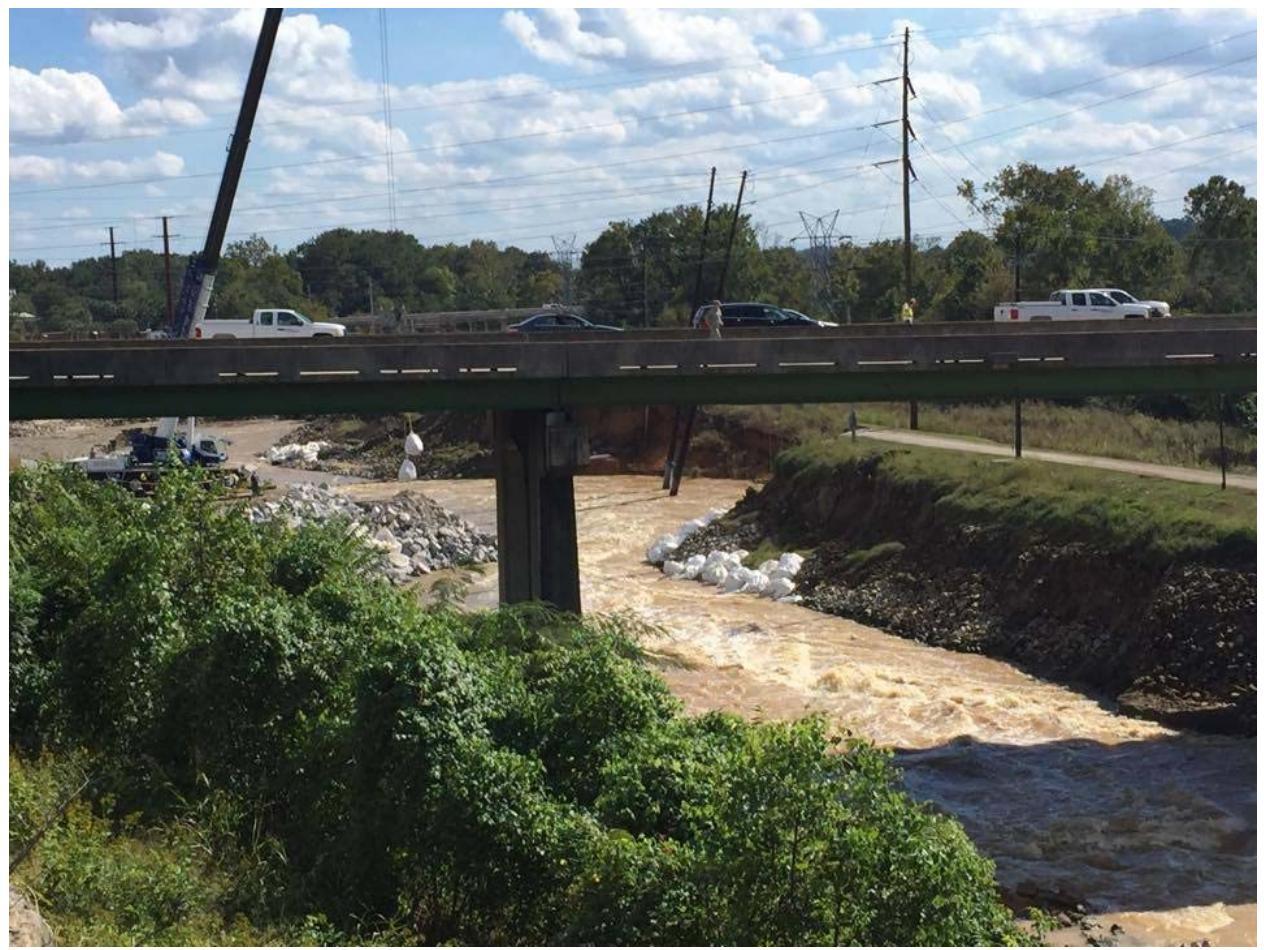
An 80 m long horseshoe-shaped feature formed in the Columbia Canal levee some 90 m upstream of the initial breach shown in Figure 26. Two damaged power poles can be seen in the center of the second breach. A third power pole, at the upstream edge of the breach later fell due to continued erosion of the levee fill (Figure 27). The cofferdam construction initially proceeded only from the landward left Canal bank towards the levee. The cofferdam penetrating from the landward side during construction led to a constriction of the Canal thereby convectively accelerating the still rushing Canal discharge, which carved out the horseshoe from the opposing levee. Apparently the canal intake gates could not completely limit inflow. The levee was completely cut through at this location, but the decreasing discharge and the dropping of sand bags from helicopters and rock-fill from trucks off the SC-12 Bridge stabilized the levee enough to prevent Canal water from flowing through the horseshoe breach back into the Broad River (Figure 28). Finally, after a weeklong engineering and construction struggle the rock-fill cofferdam was completed upstream.

Figure 26. Second horseshoe breach fully formed in the Columbia Canal levee during the one-sided attempt to construct the cofferdam from the landward side by October 8, 2015 (photo from Congaree Riverkeeper: www.congareeriverkeeper.org via their Twitter and FB (N 34.00012°, W 81.05154°).

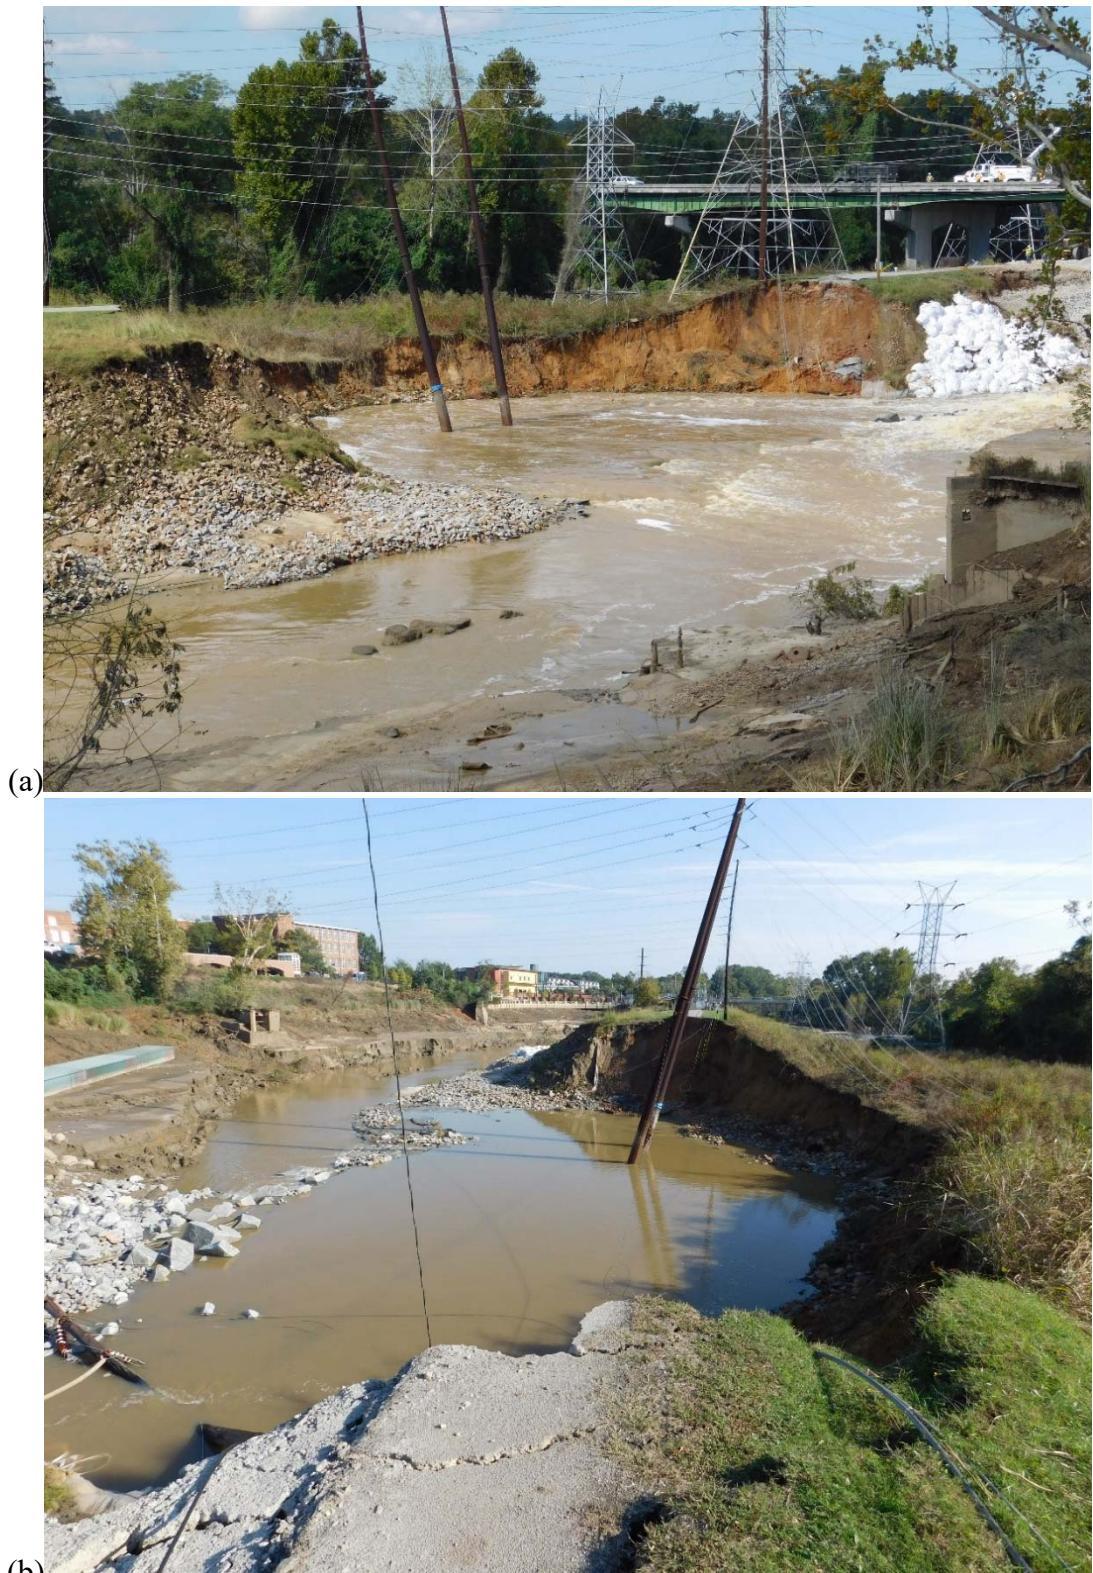
(b)
Figure 27. Second horseshoe breach formed in the Columbia Canal levee during construction of the cofferdam: (a) On October 12 during cofferdam construction; (b) with cofferdam installed upstream on October 13, 2015 (N 33.99915°, W 81.05112°).

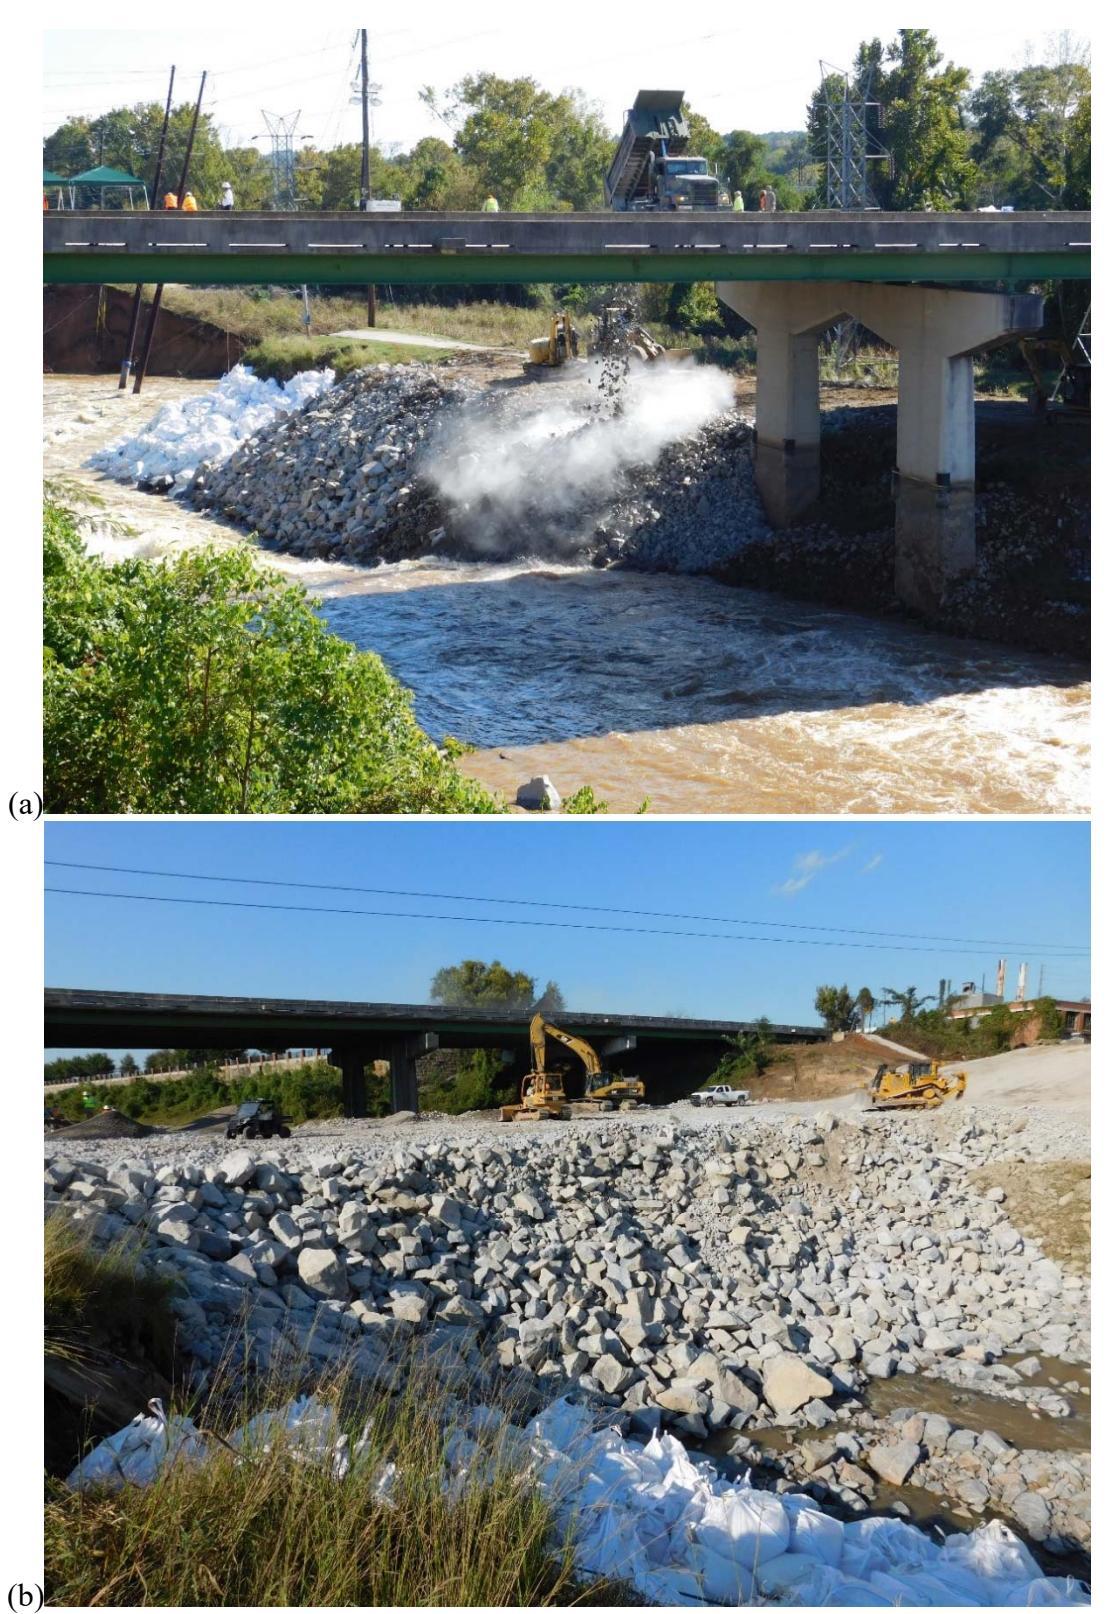
Figure 28. Columbia Canal cofferdam: (a) construction of the cofferdam upstream of the horseshoe breach by dumping rock-fill from the SC-12 Bridge on October 11, 2015; (b) cofferdam installed on October 13, 2015 (N 34.00012°, W 81.05154°).

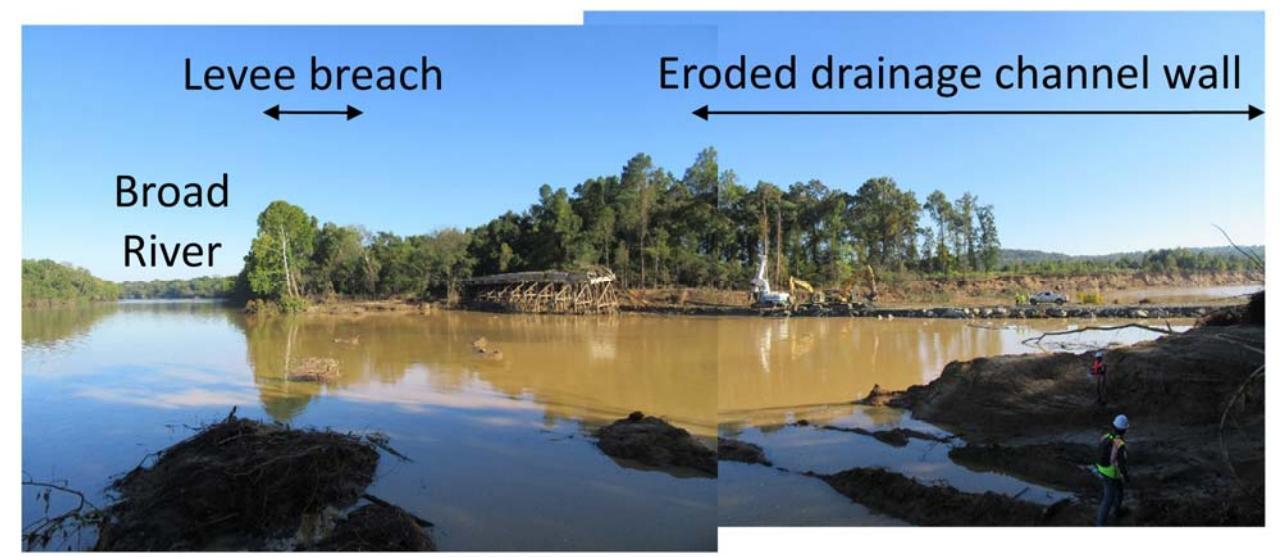
The levee breach and the damaged Norfolk Southern Railroad trestle near the Martin Marietta rock quarry are shown in Figure 30. The construction crews on the newly build gravel dike are working on setting up pump stations to pump the flood water out of the engulfed quarry. The dike also serves the initial stages of trestle repair. Landward of the newly built dike, a near vertical wall of exposed levee and overbank sediments can be seen. This wall of exposed natural sediments was created by flood waters from the Broad River flowing down a pre-existing drainage into the rock quarry. A sample of levee materials collected near where the persons are standing in the foreground of Figure 30 consists of dark yellowish brown sand with silt.

Figure 30. Upstream view of the 200 m long levee breach on the Broad River and damaged Norfolk Southern Railroad trestle on October 14, 2015. Note the newly built gravel dike with construction equipment working on setting up pump stations to pump the flood water out of the engulfed quarry along with the initial stage of trestle repair (N 34.11447°, W 81.11935°).

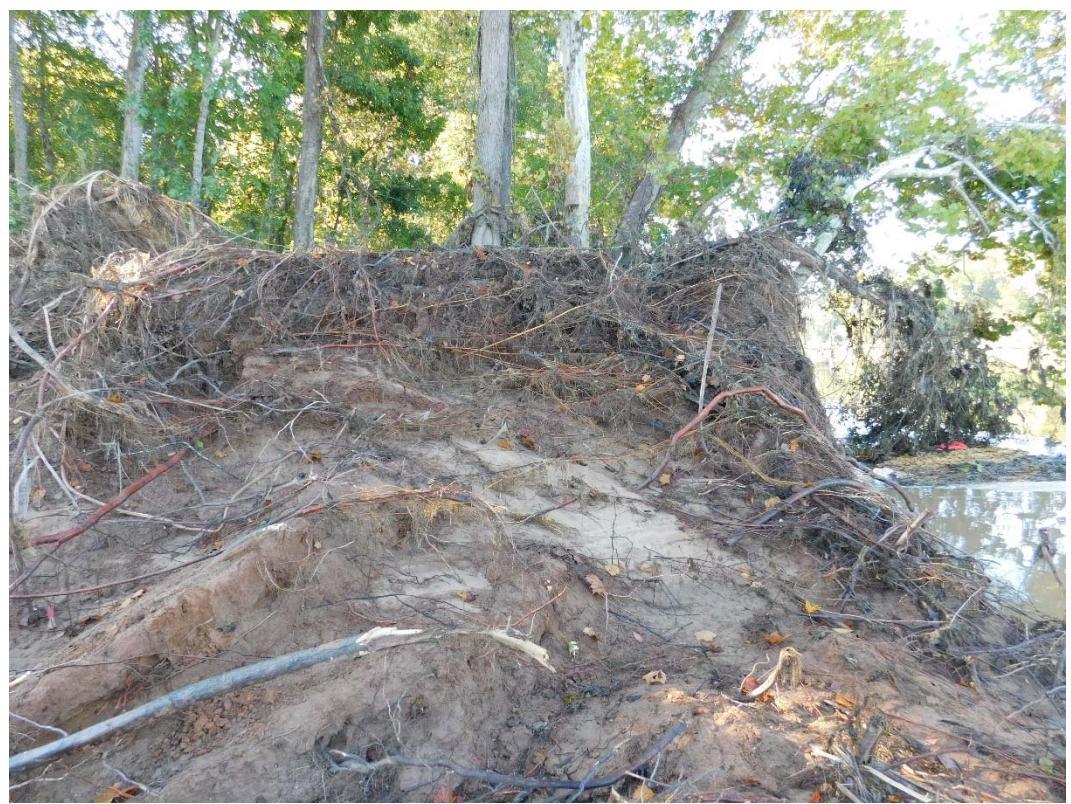
High water marks were observed in the form of wrack lines and rafted debris at the base of tree stems on the downstream end of the breach as shown in Figure 31. The high water marks indicate the river discharge reached the crest height. Analysis of pre- and post-flooding satellite imagery highlights the 300 m long railroad bridge at the location of the breach. Both upstream and downstream of the breach the railroad runs on the levee. Hence overtopping river discharge breached a 200 m long levee segment, destroyed two thirds of the railroad bridge and flooded the North Columbia Quarry shown in Figure 32. The amount of water in the quarry is estimated to be 3.5 billion gallons (corresponding to 13 million m³). It will take a few months of pumping to remove the flood water from the quarry.

Figure 31. Embankment at downstream end of levee breach along the Broad River with high water marks at the base of tree trunks and wracklines, which indicate the river discharge reached the crest height and breached the lower levee section due to overtopping (photos: October 14, 2015; N 34.11380°, W 81.11971°).

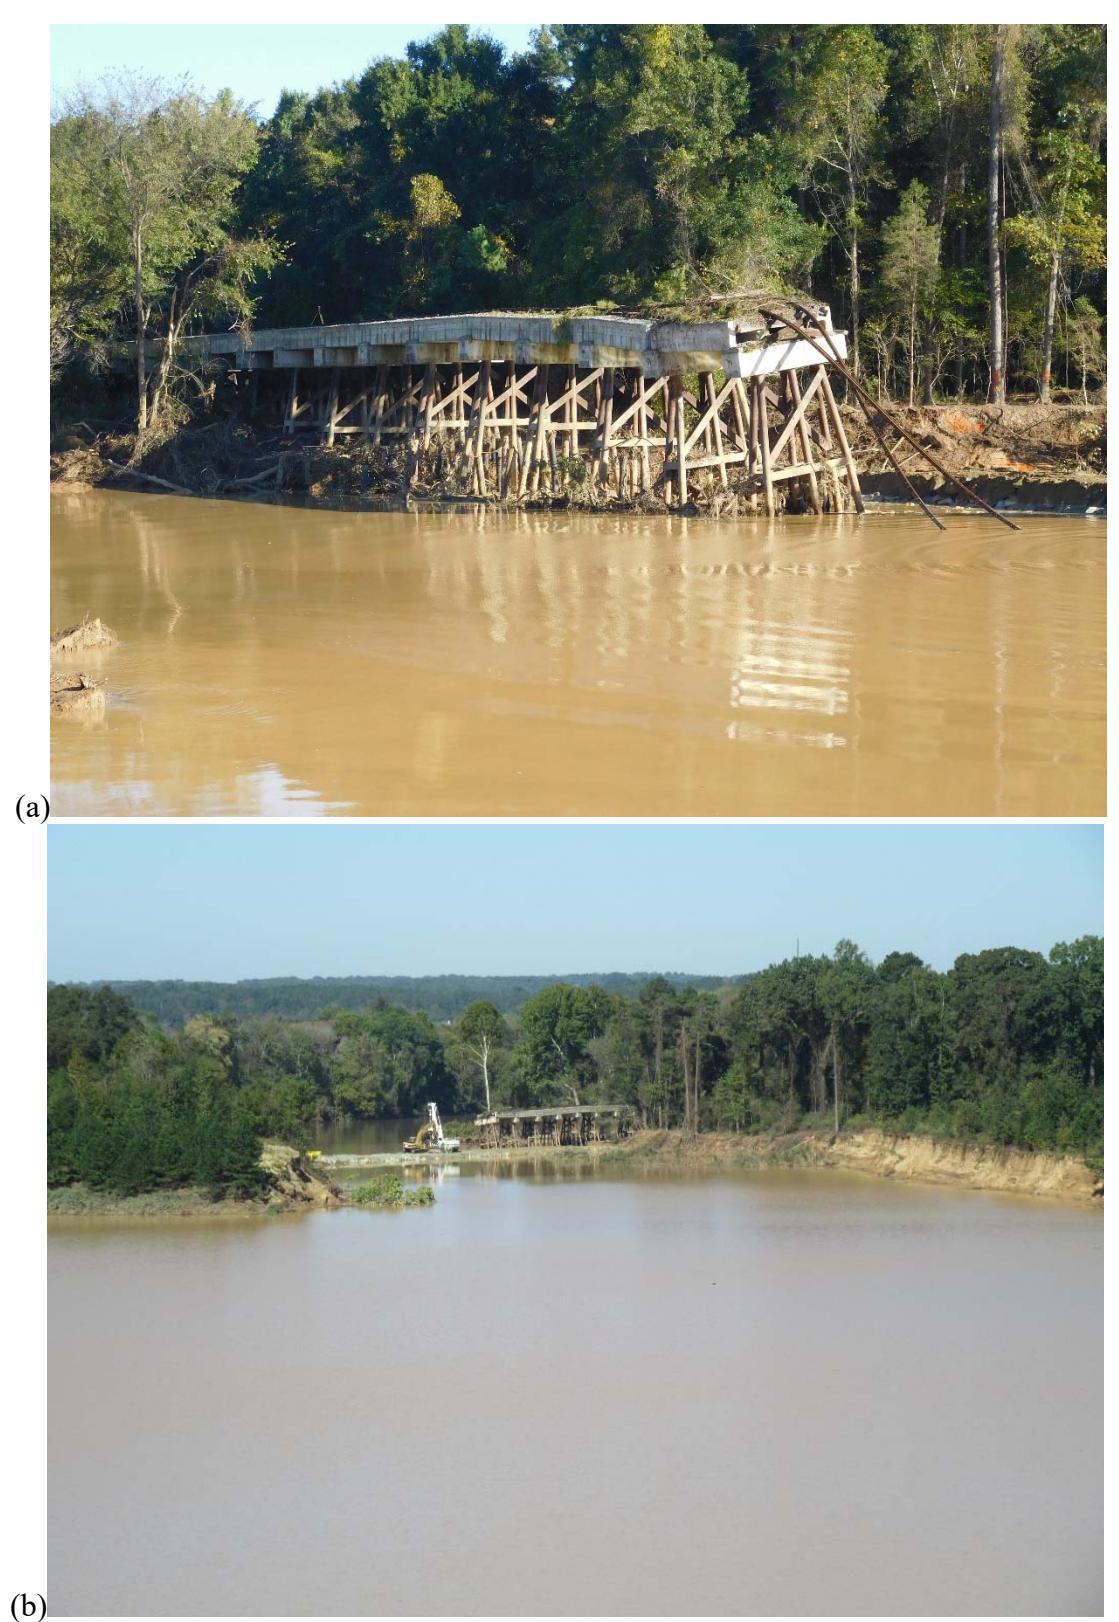
(b)
Figure 32. Levee breach on Broad River: (a) Destruction of two thirds of a 300 m long bridge of a Norfolk Southern Railroad trestle; (b) north end of flooded quarry (photos: October 14, 2015; N 34.11447°, W 81.11935°).

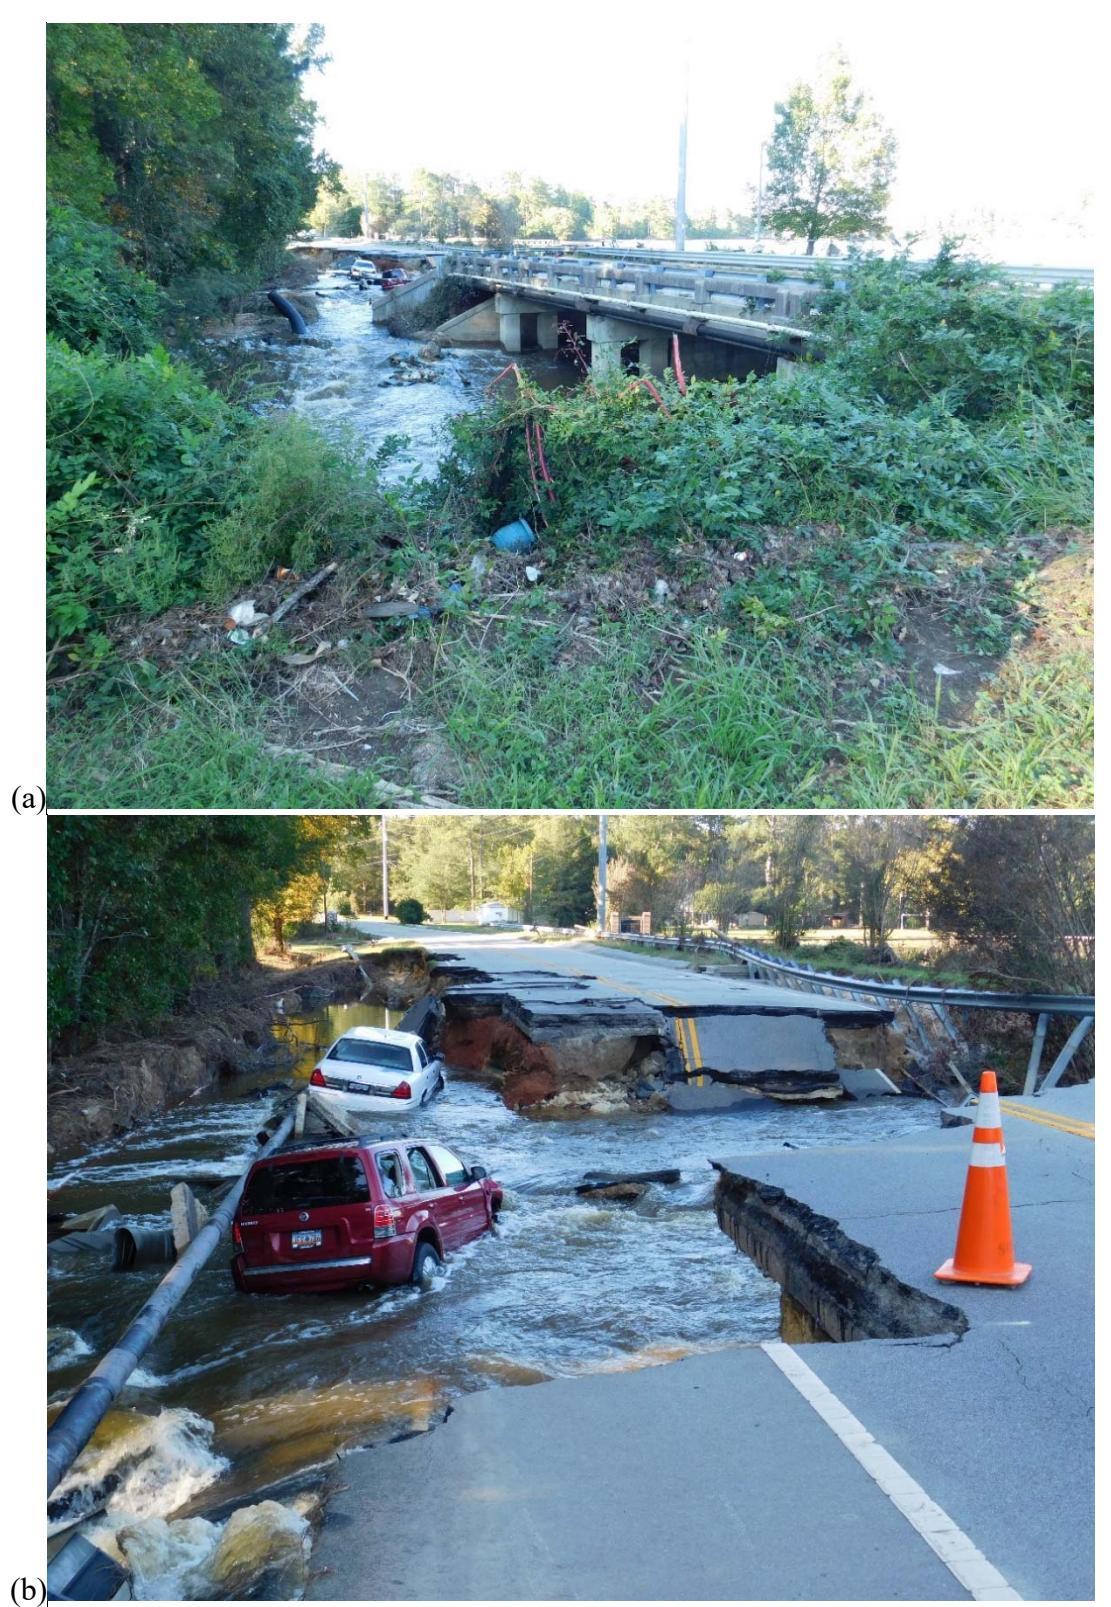
Figure 34. Lake Elizabeth Dam breach : (a) US Route 21 bridge over Crane Creek with dam breach directly adjacent to the north; (b) two cars washed off the road and stranded downstream (photos: October 11, 2015; N 34.11253°, W 80.98766°).

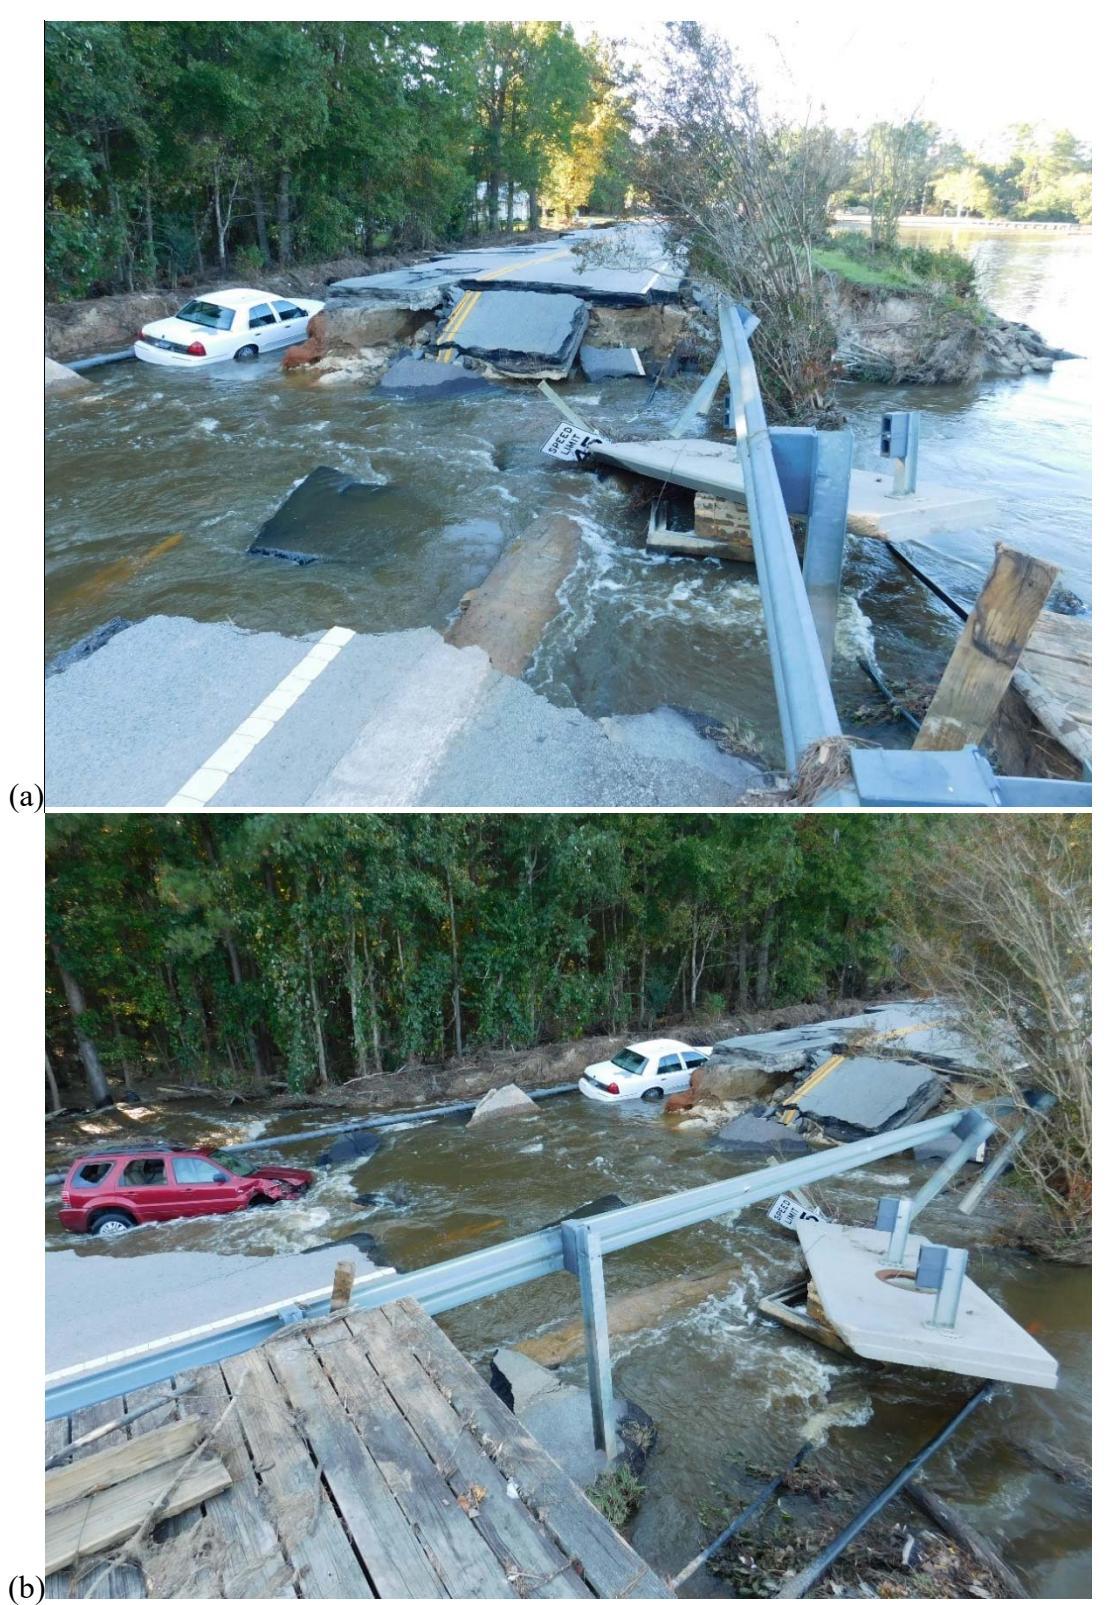
Figure 35. Lake Elizabeth Dam breach: (a) US Route 21 and dam breach; (b) two cars (Mercury Mariner and Mercury Grand Marquis) washed off the road and stranded downstream (photos: October 11, 2015; N 34.11253°, W 80.98766°).

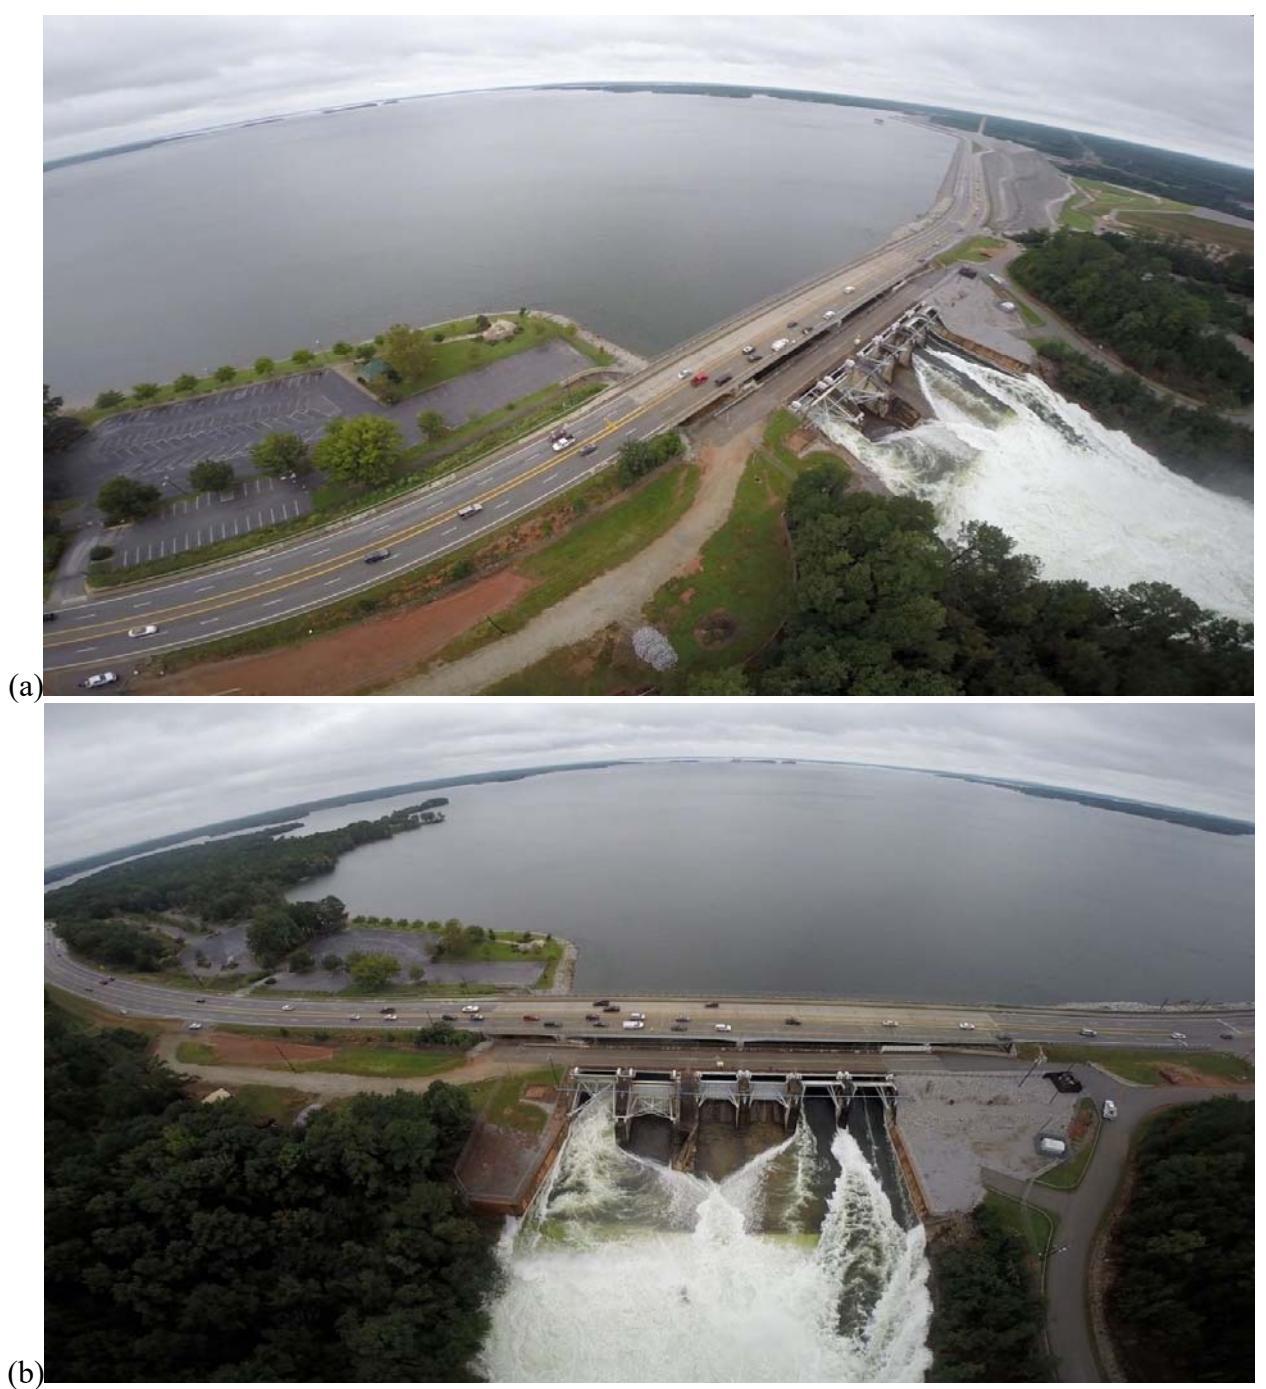
Figure 43. Drone aerial views of the activated emergency spillway located 150 m south of the Saluda Dam at Lake Murray: (a) Spillway with South Carolina Highway 6 on top of the earthen Saluda Dam from 1930 with 2005 roller compacted concrete (RCC) backup dam at the toe for seismic remediation; (b) spillway with 3 of the 6 Tainter gates open on October 5, 2015 (drone photos: Ebben M. Aley via NWS; N 34.04035°, W 81.21579°).

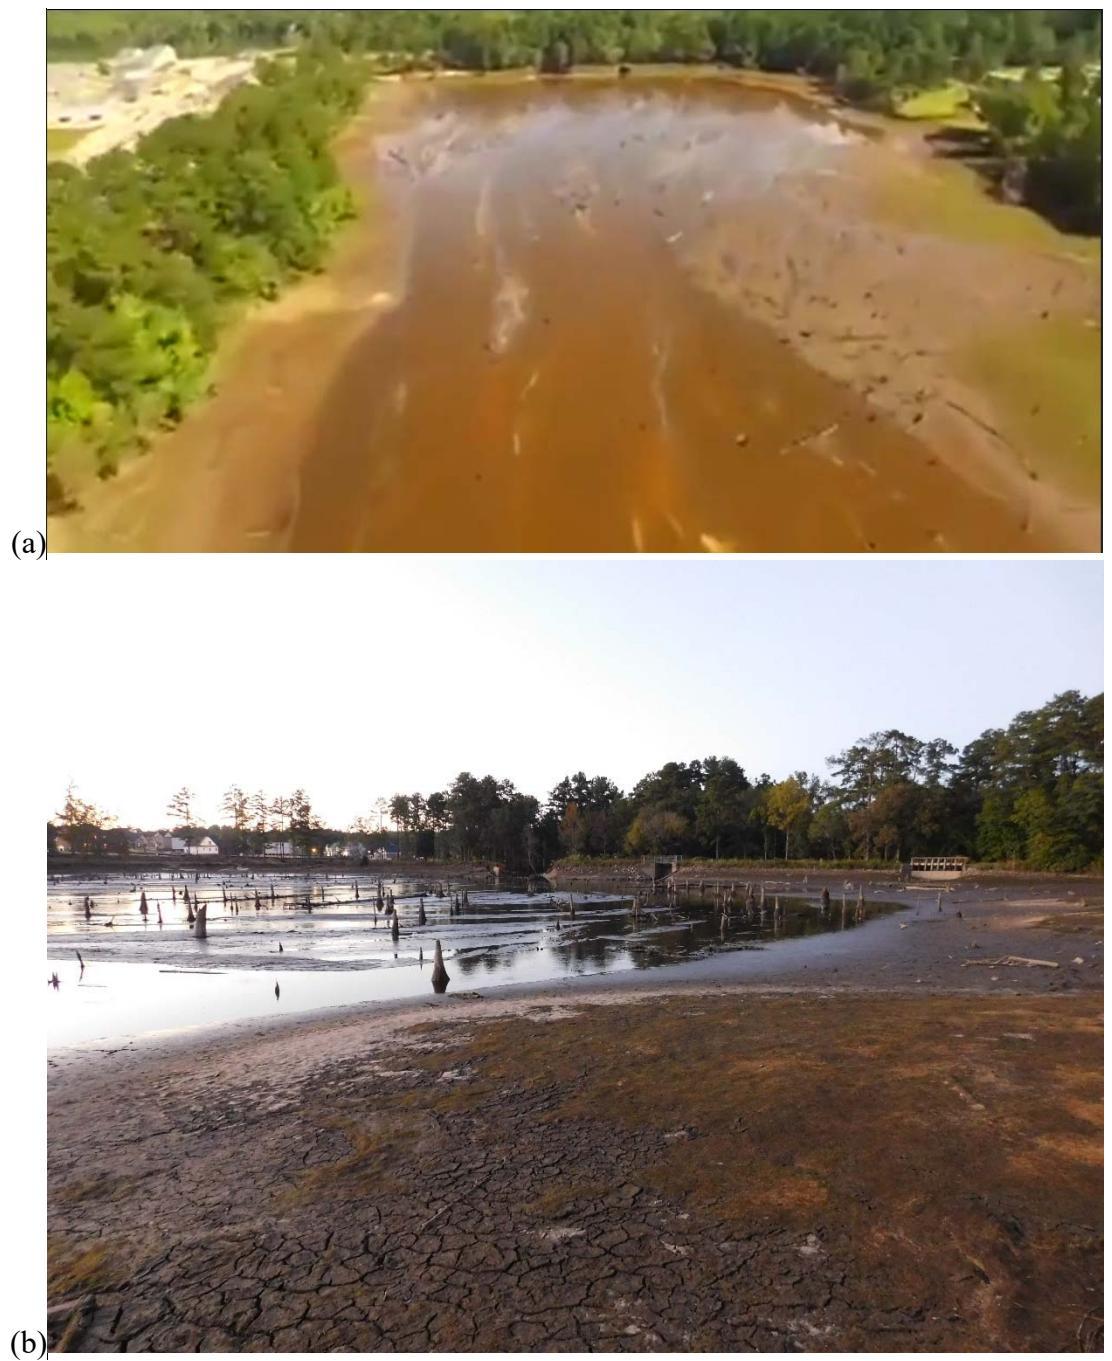
Figure 46. Barr Lake Dam breach with empty reservoir: (a) Drone view towards the dam on the northeast side of the lake on October 6, 2015 (<u>https://www.facebook.com/LexingtonPD/videos</u>); (b) location of the dam breach is the western (left) most opening with the normal outflow 40 m to the east (right) and the spillway 100 m to the east (photo: October 12, 2015; N 33.95876°, W 81.26025°).
