The Hydraulic and Geotechnical Aspects of the South Carolina Floods of October 1-5, 2015 Related to Offshore Hurricane Joaquin

GEER Association Report No. GEER-052 December 19, 2016

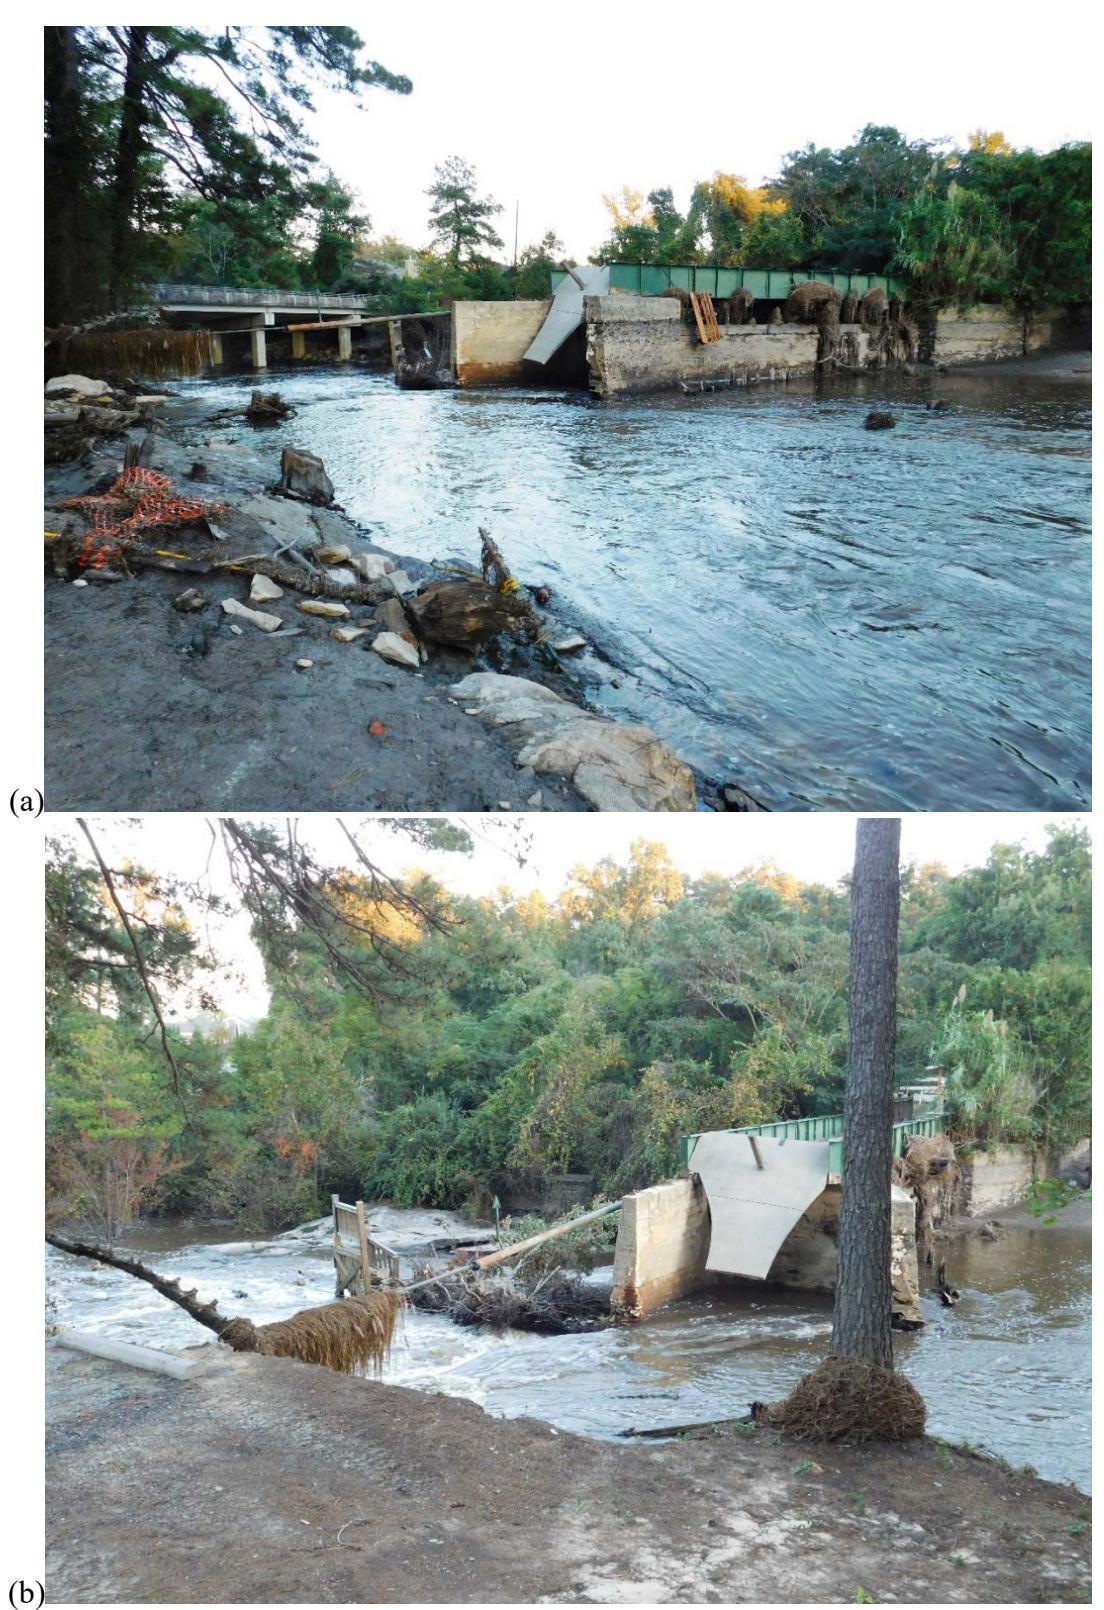
Figure 50. Gibsons Pond Dam breach on the northern (left in flow direction) abutment: (a) partial debris damming weir opening under the steel bridge; (b) tree stem with wrack from overtopping (photos: October 12, 2015; N 33.96949°, W 81.24360°).
5.4 Old Mill Pond Dam on Twelve-Mile Creek

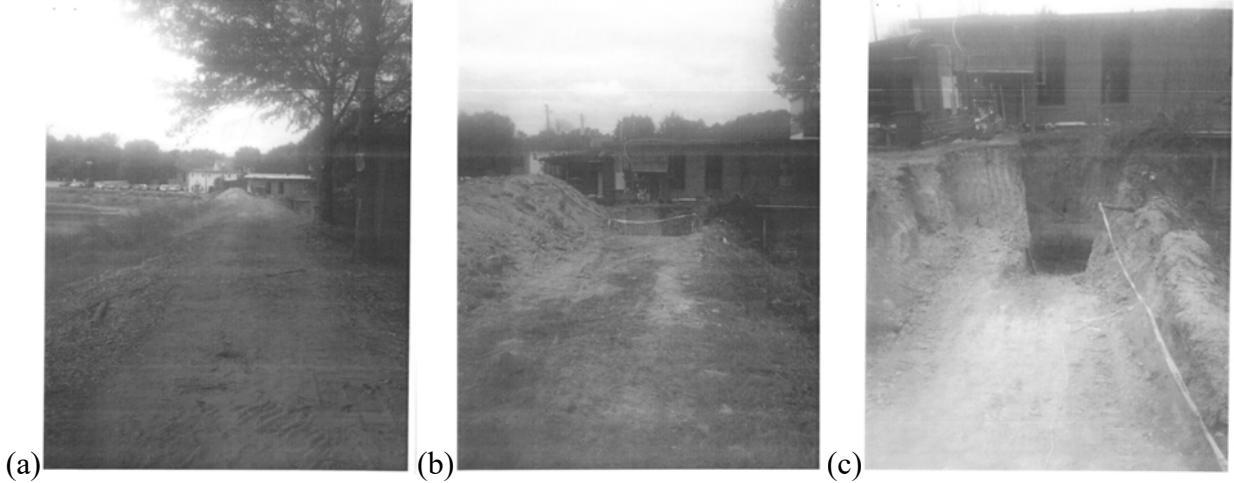
Pond Dam. Old Mill Pond reservoir has a surface area of 30 acres (0.12 square km). The Old Mill Pond Dam is 475 ft (144.8 m) long and 20 ft (6.1 m) high. Old Mill Pond Dam is classified by S.C.-DHEC into category C1, which means that failure may cause loss of life or serious damage to infrastructure. Old Mill Pond Dam (D-0958) underwent routine inspection on April 4, 2014 by the South Carolina Department of Health and Environmental Control (S.C.-DHEC). It was concluded that the dam is in fair condition. Some of the recommendations in the 2014 inspection report include: Evaluation of flow outside discharge pipe near the building (possible channeling around pipe), evaluation of tree removal, upstream slope rip-rap for wave protection and grass cover on crest should be established, main spillway gate should be checked for functionality. The situation of the conditions at the dam rapidly deteriorated in 2015. An S.C.-DHEC inspection on June 9-10, 2015 concluded that the dam is in unsatisfactory condition. The main additional concern was the sinkhole forming near the gate to the penstock requiring lowering the reservoir level below the intake. This triggered the hiring of Schnabel Engineering and the application for repair work. A follow-up S.C.-DHEC site visit on September 23, 2015 (one week before the beginning of the October rainfall event) verified that the water is not impounding (empty reservoir) and construction started. The sinkhole area next to the building was removed exposing the outlet pipe, which was corroded and penetrated by the earth mover during excavation as shown in Figure 52. The reservoir water level was requested to be lowered by 5 m for the repair work and was empty at the time of last S.C.-DHEC inspection.

Figure 52. Old Mill Pond Dam S.C.-DHEC inspection photos from September 23, 2015: (a) empty pond reservoir; (b,c) excavation in the sinkhole area on the downstream slope abutment exposing the penstock next to the Old Mill textile mill building turned shopping mall (N 33.97683°, W 81.22961°).

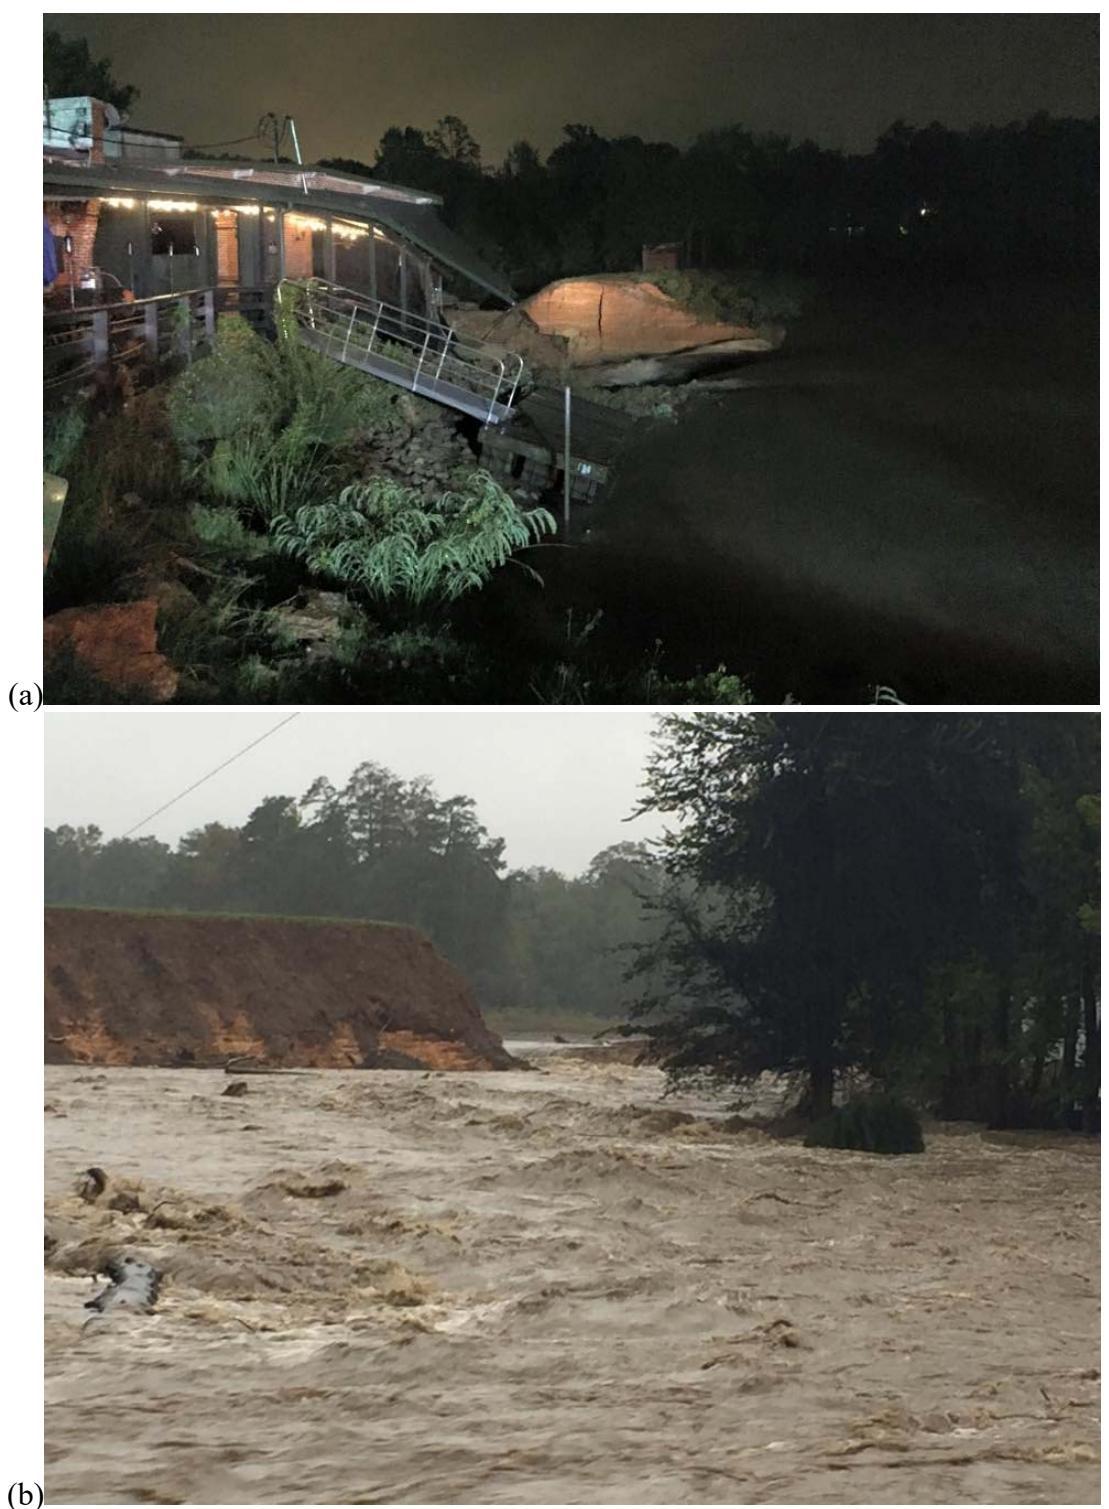
The dam breached at the location of the northern abutment of the earthen fill towards the Old Mill building with the intake and the penstock undergoing repair work. The first mobile photo uploaded at 6:44am (dawn at 6:55am) on October 4, 2015 by the Lexington Police Department shows a fully developed breach with an outflow water level at half the dam crest elevation shown in Figure 53(a). The water level continued to drop in the following hours: Flood discharge through the breach at 9:39am (Figure 53b) and significantly lowered water level in the pond at 12:47pm (Figure 54a). The discharge overwhelms the two box culverts under Highway 1 (US-1) and flooding overtops the highway bridge shutting down Lexington's Main Street shown in Figure 54(b).

(b) Figure 53. Old Mill Pond Dam breach on Sunday October 4, 2015: (a) Breach already fully formed at 06:44am adjacent to Old Mill building at penstock location (N 33.97683°, W 81.22961°); (b) breach widened and reservoir water level significantly lowered in upstream view from US-1 towards downstream slope of earthen fill dam at 09:39am (N 33.97730°, W 81.22813°; photos: https://www.facebook.com/LexingtonPD/photos).

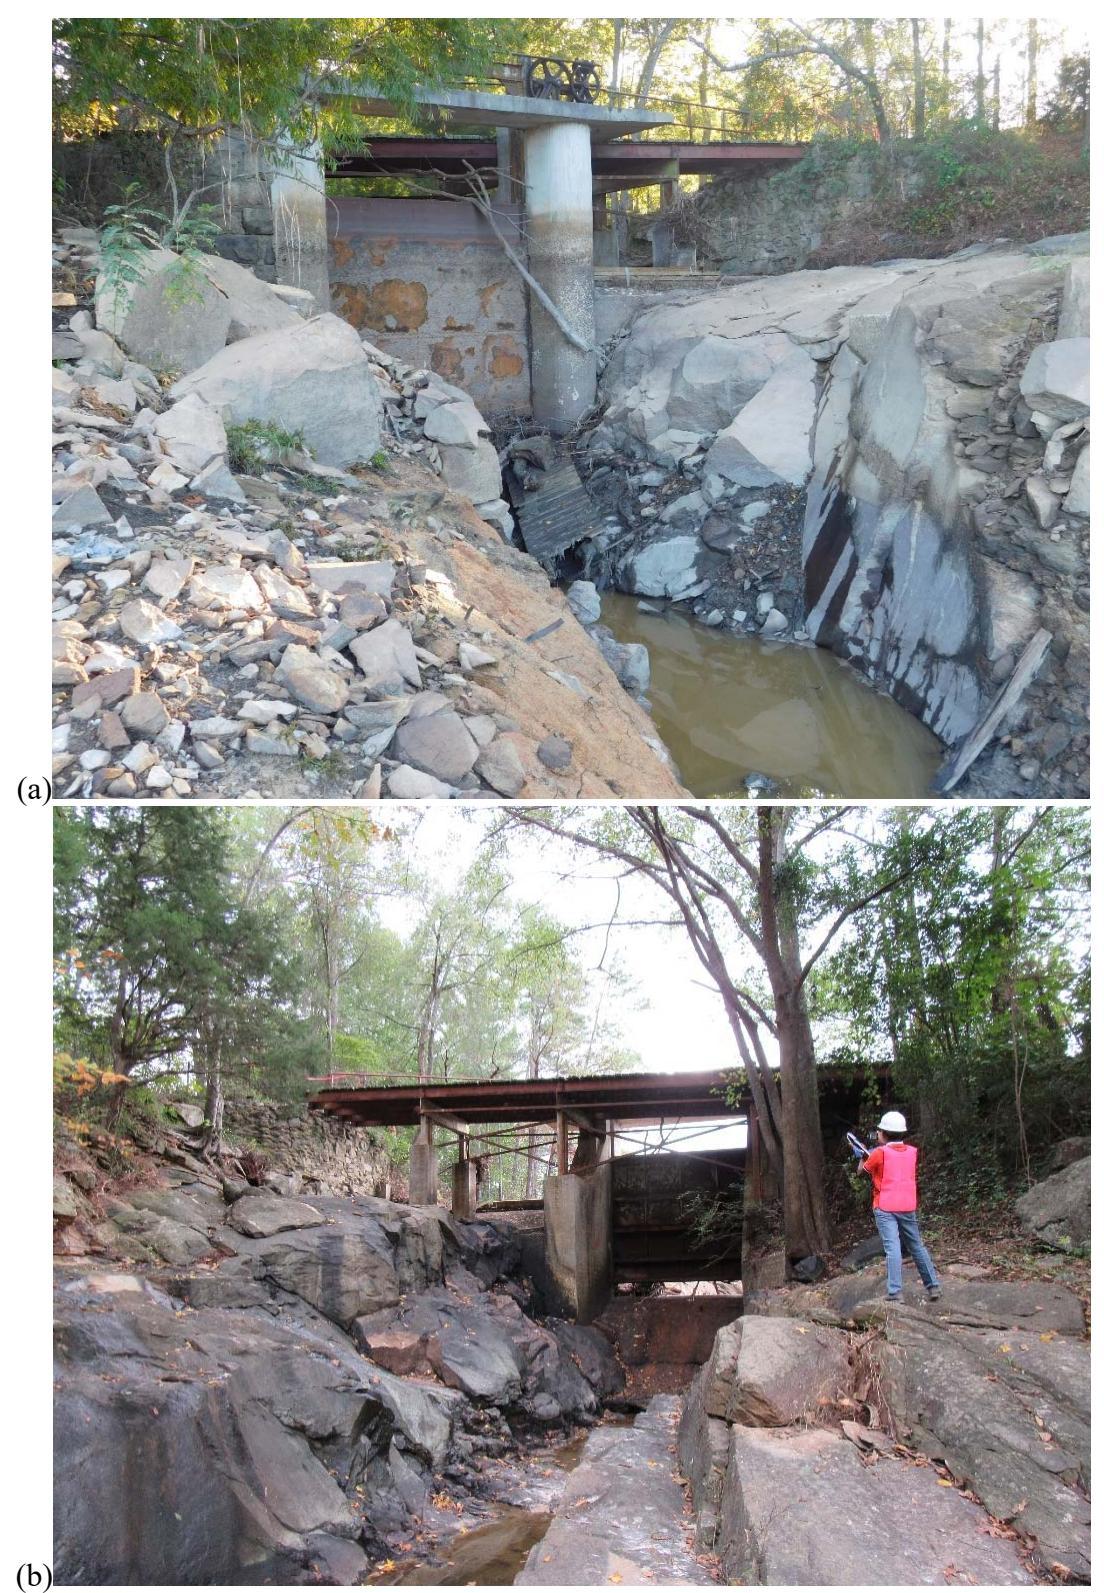
(b)
 Figure 55. Spillway intake with sluice gate and two emergency overflow weir crests at southern (right) abutment of Old Mill Pond Dam: (a) downstream view of intake channel excavated into bedrock with sluice gate almost closed and some debris damming; (b) upstream view (photos: October 12, 2015; N 33.97640°, W 81.22908°).

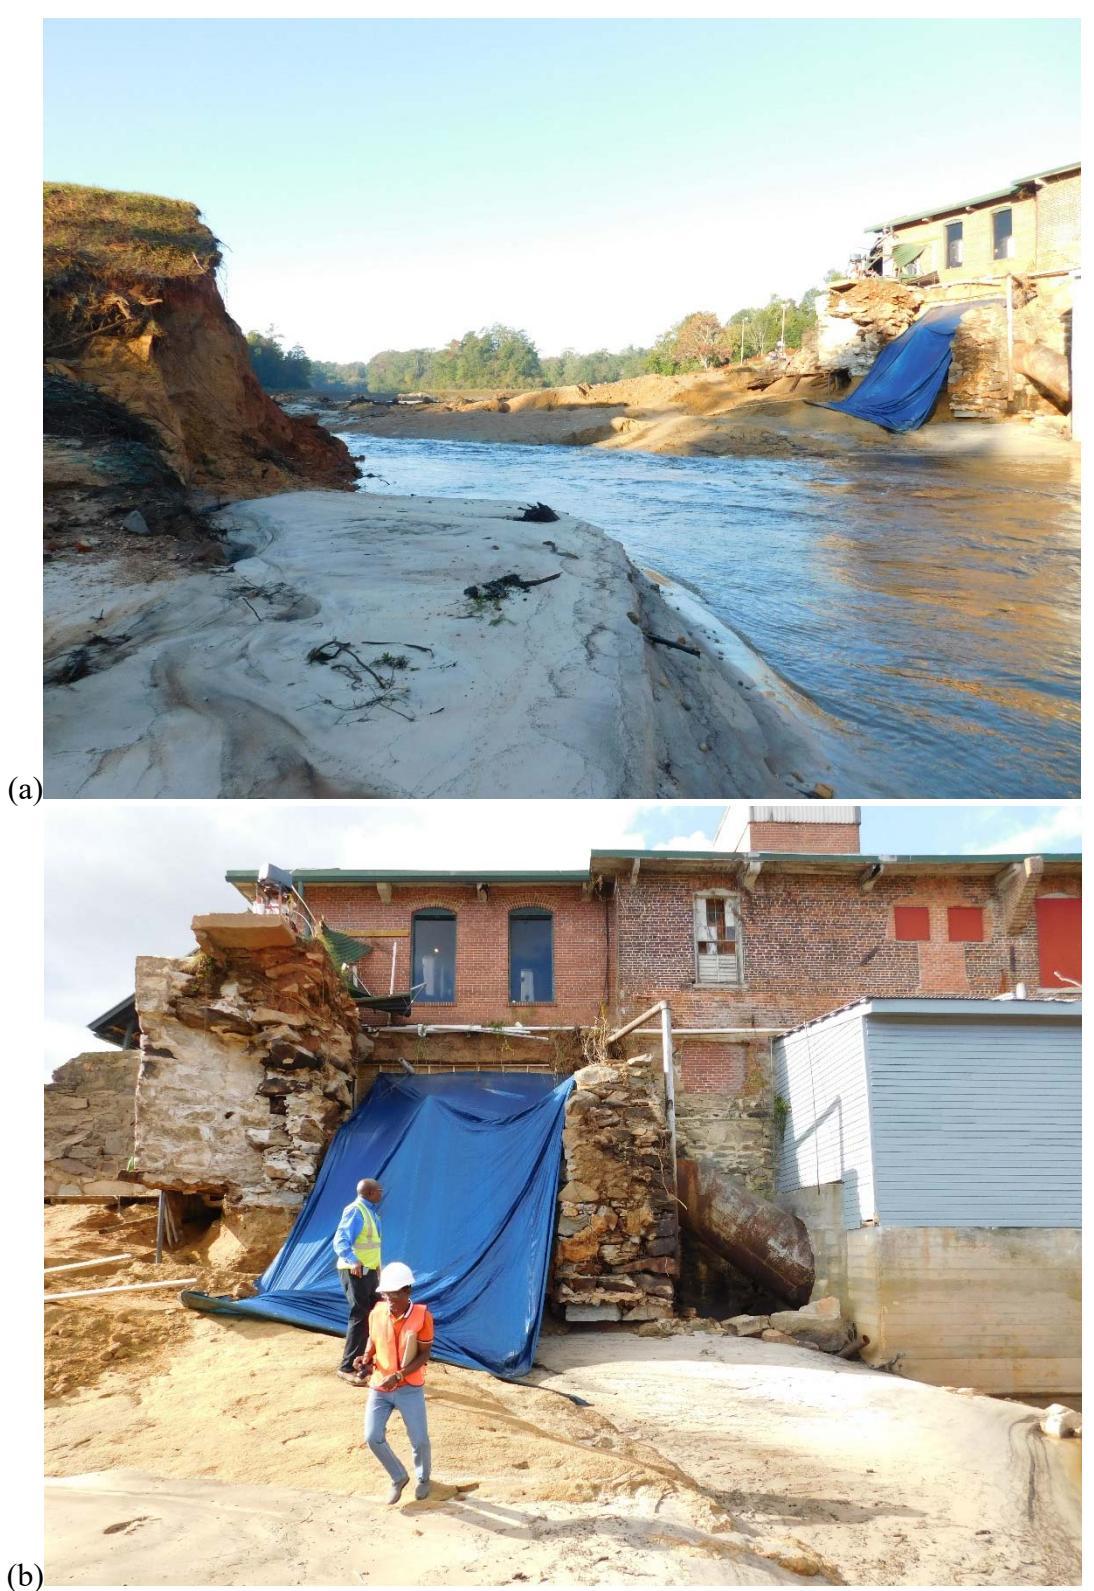
(b)
 Figure 56. (a) Upstream view of breach with exposed penstock at Old Mill on right; (b) northern (left) abutment of earth fill dam with intake to penstock at Old Mill, which had been partially excavated on downstream side for repair work before flooding event (photos: October 12, 2015; N 33.97683°, W 81.22961°).

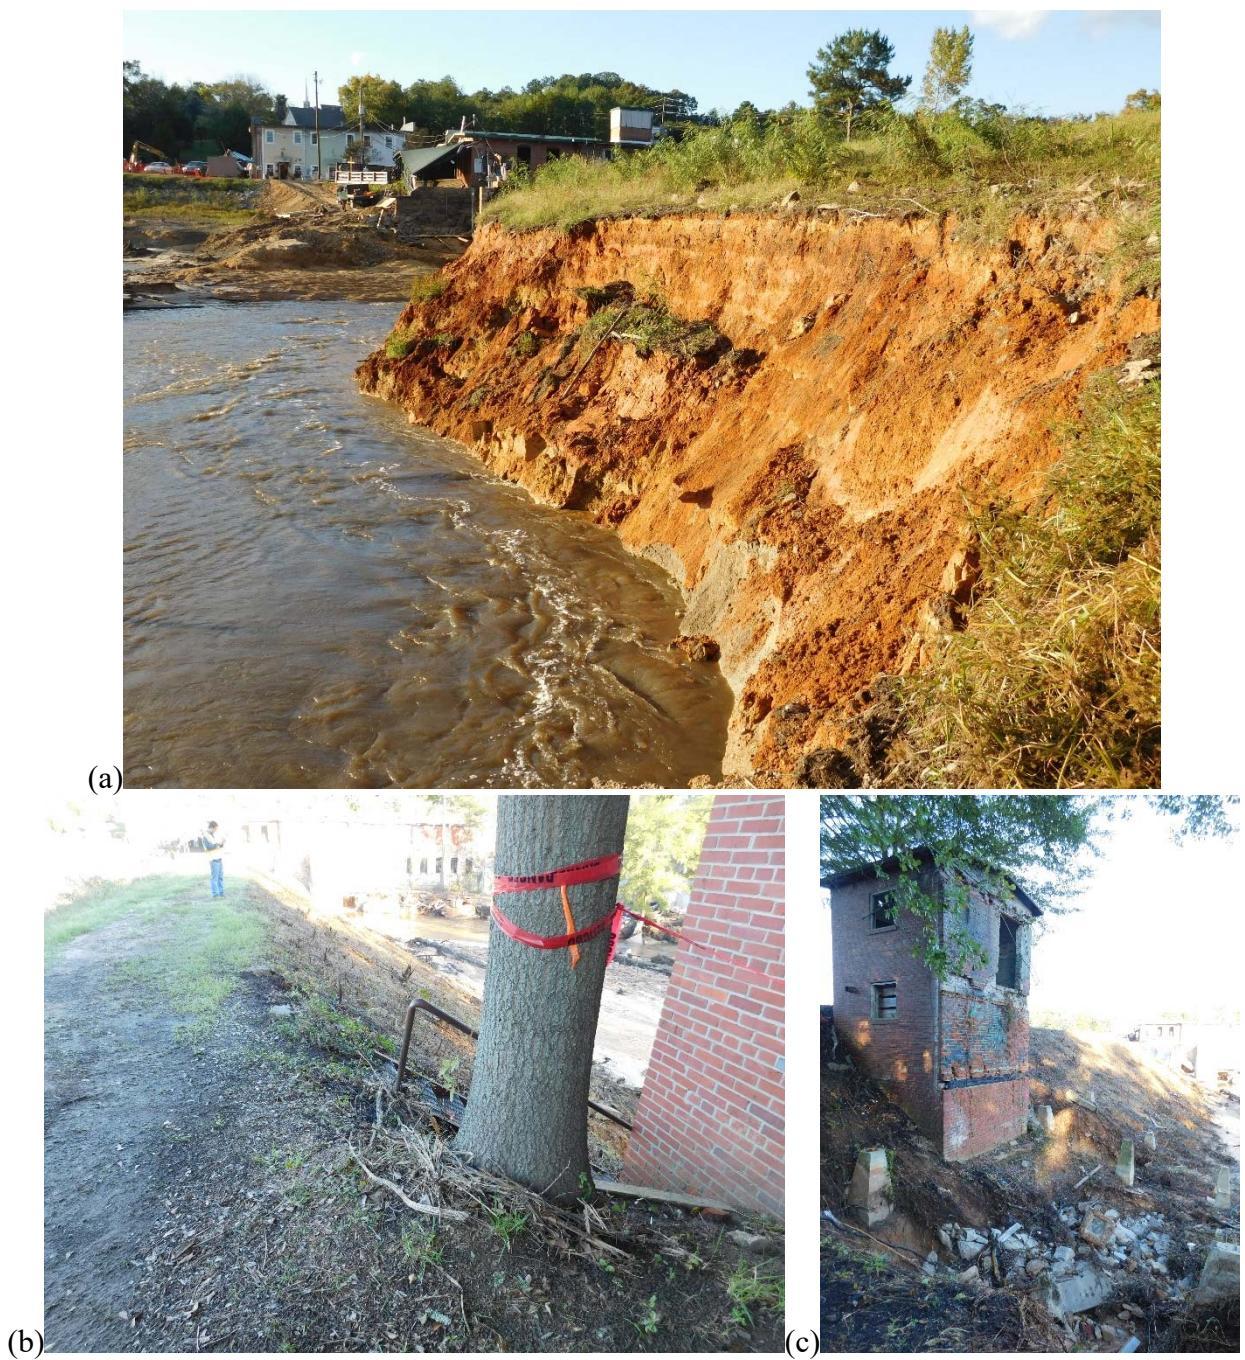
Figure 58. (a) Erosion of upstream slope on Old Mill Pond Dam; (b) wrack wrapped around tree stem at dam crest due to overtopping; (c) scour at the building and erosional features on the downstream slope due to overtopping (photos: October 12, 2015; N 33.97653°, W 81.22921°).

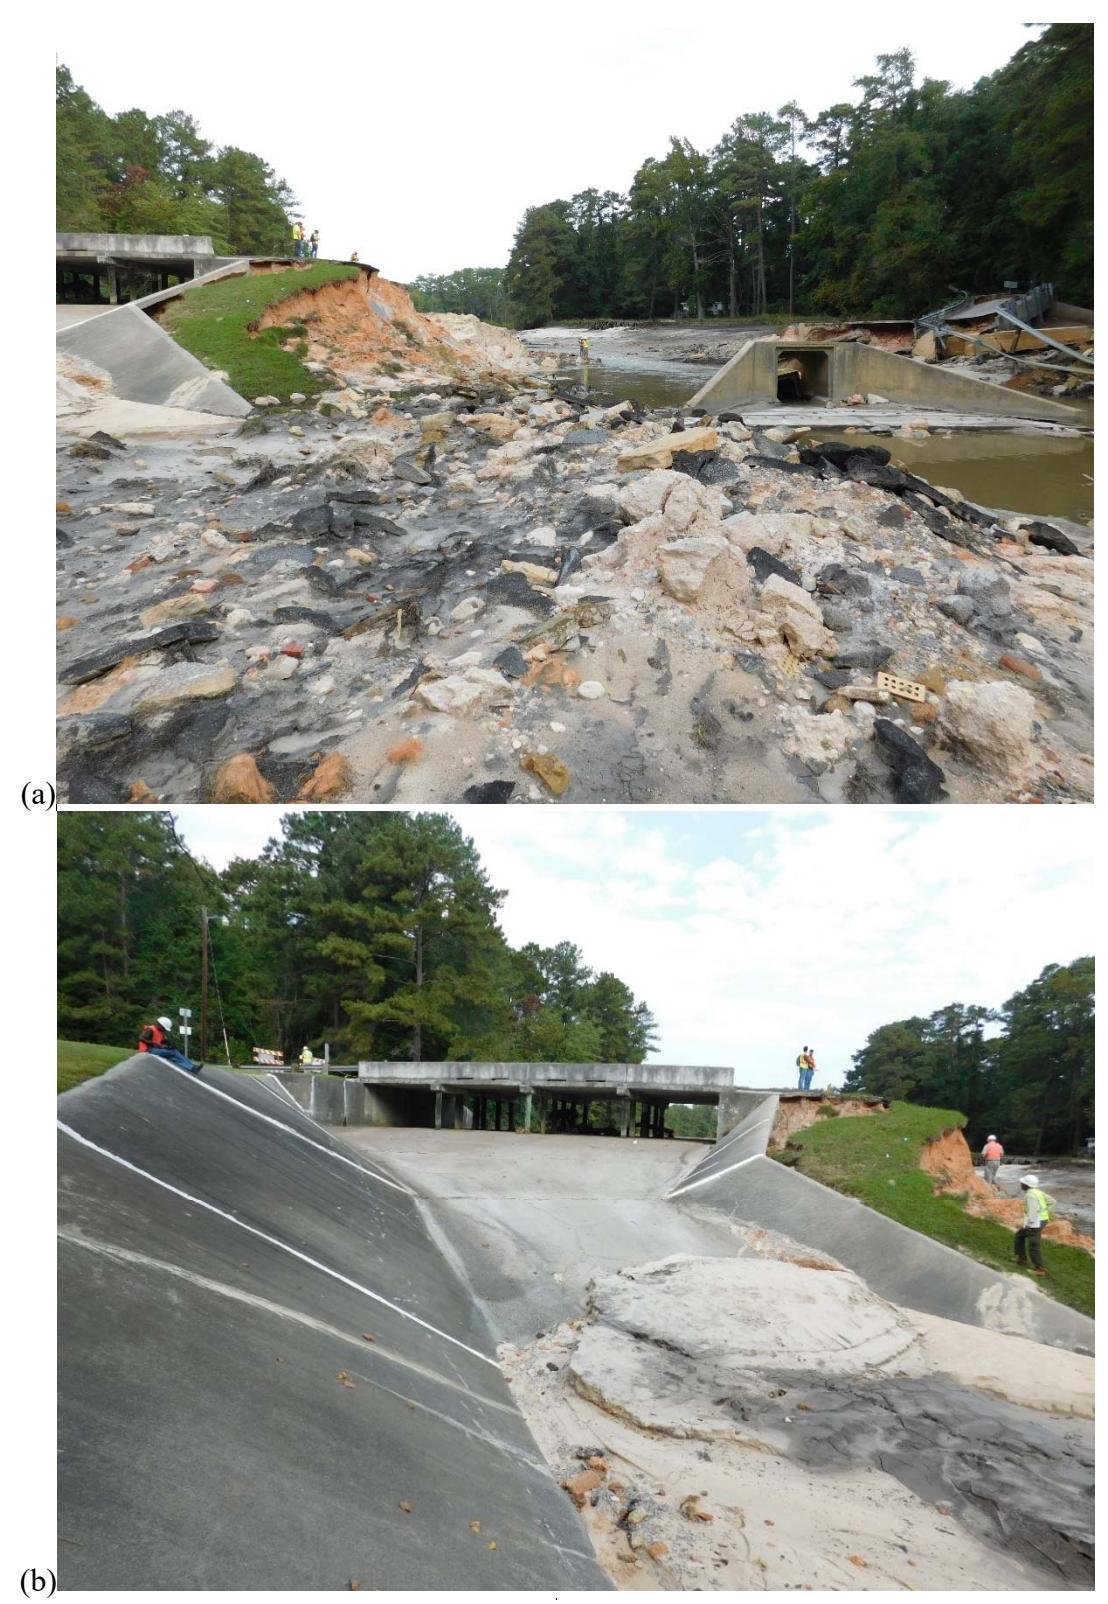
Figure 77. Cary's Lake Dam breach: (a) Upstream view of dam breach with remnants of low level box culvert, trapezoidal outlet structure; (b) upstream view of large western spillway (right in flow direction, left in image) with concrete lining and roadway bridge (photos: October 13, 2015; N 34.04866°, W 80.95764°).

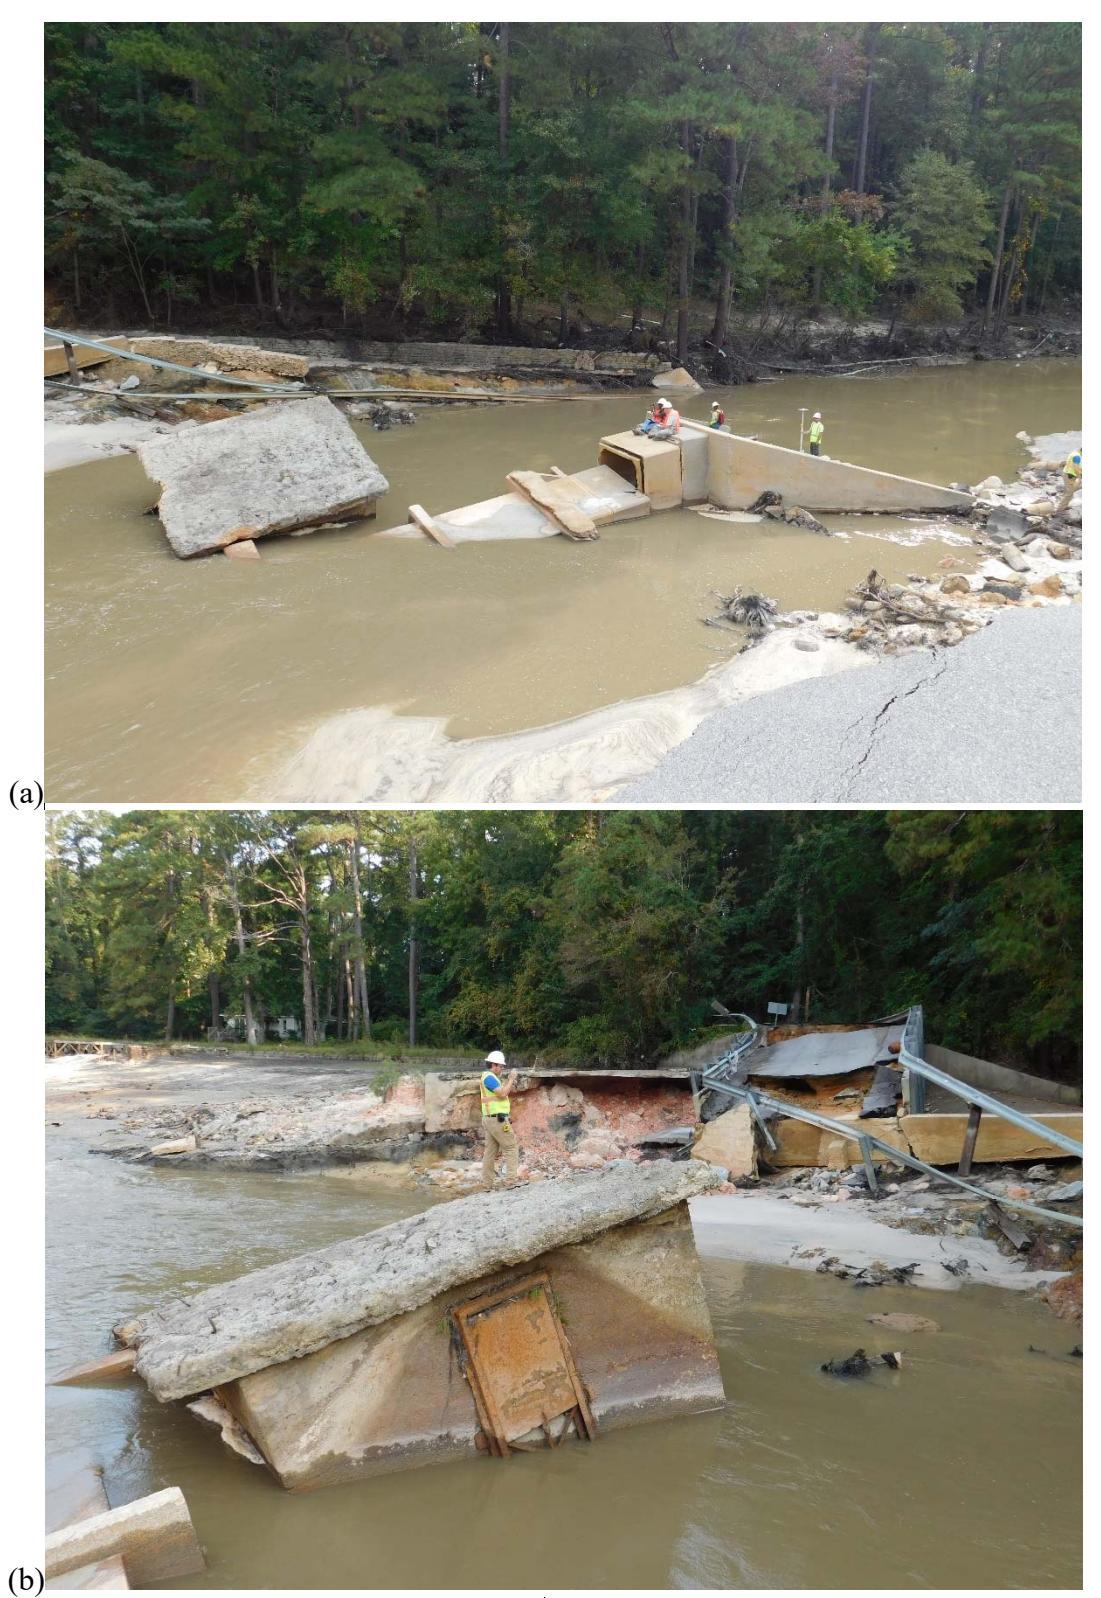
Figure 78. Cary's Lake Dam breach: (a) Low level bottom 6.5' x 6.5' box outlet with overturned drop box inlet;
(b) upstream view of the overturned 12' x 12' drop box inlet with a closed bottom outlet sluice gate facing downstream, which was originally on upstream side (photos: October 13, 2015; N 34.04866°, W 80.95764°).

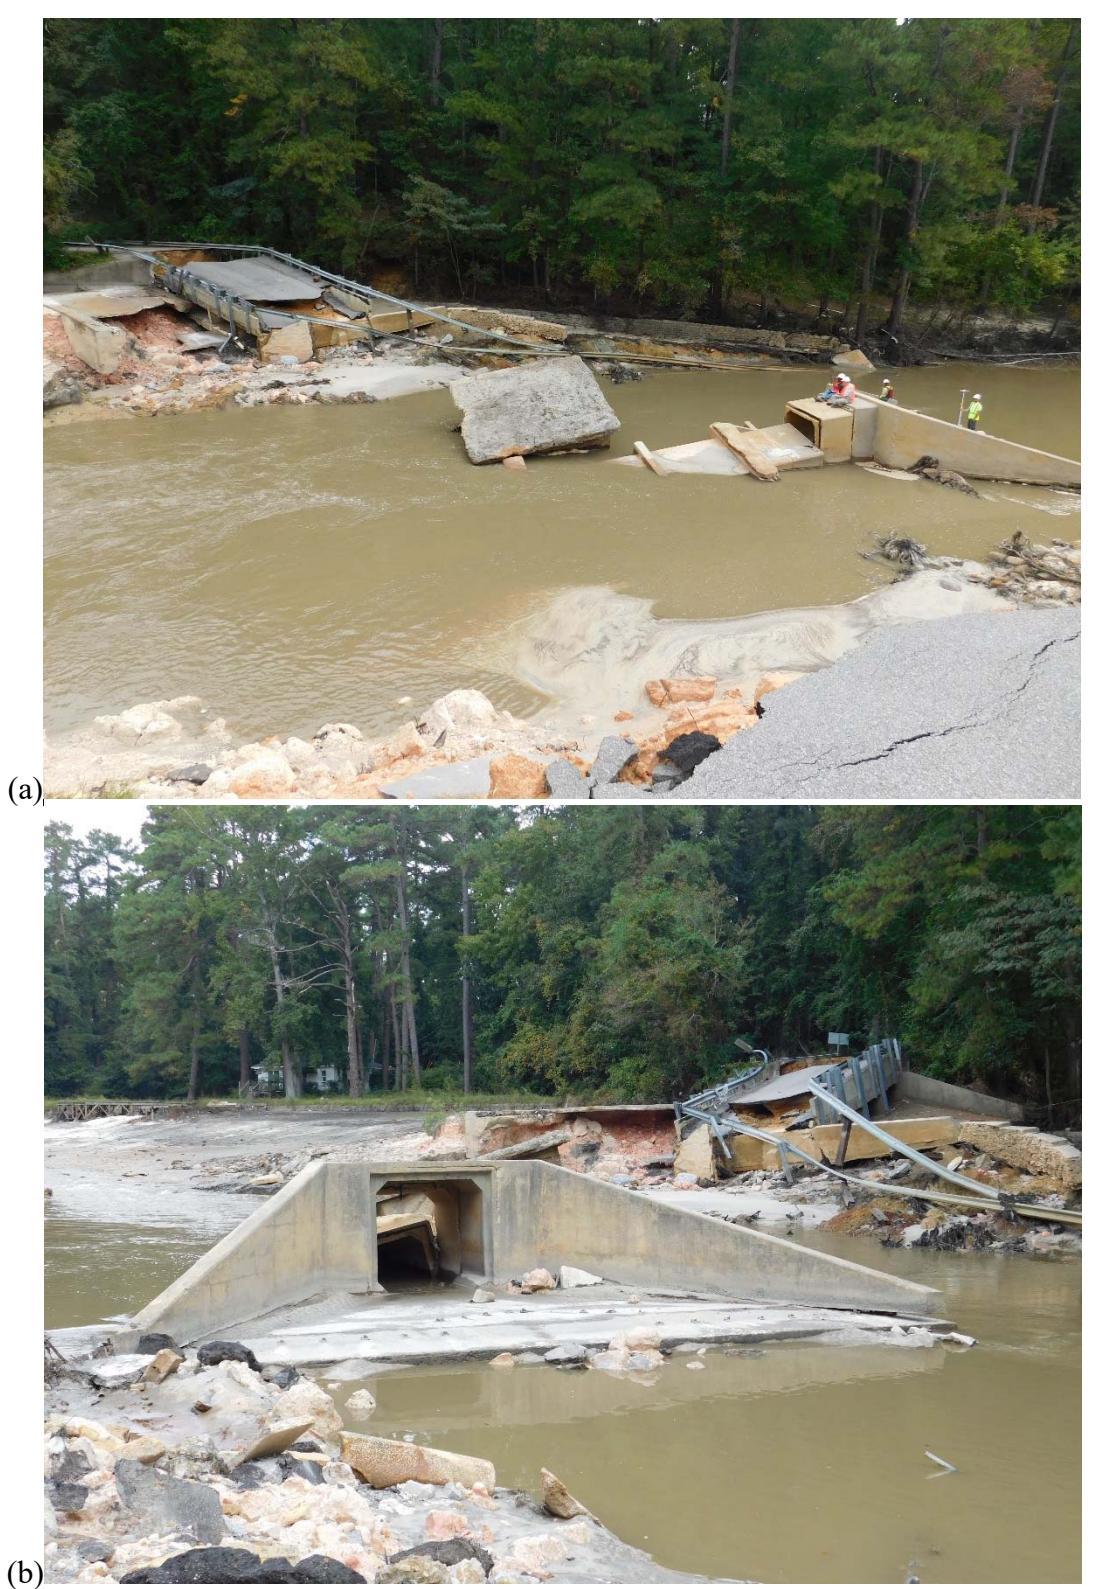
Figure 79. Cary's Lake Dam breach with collapsed road crossing over the damaged and smaller spillway at the eastern or left abutment in the background: (a) downstream and (b) upstream view (photos: October 13, 2015; N 34.04866°, W 80.95764°).

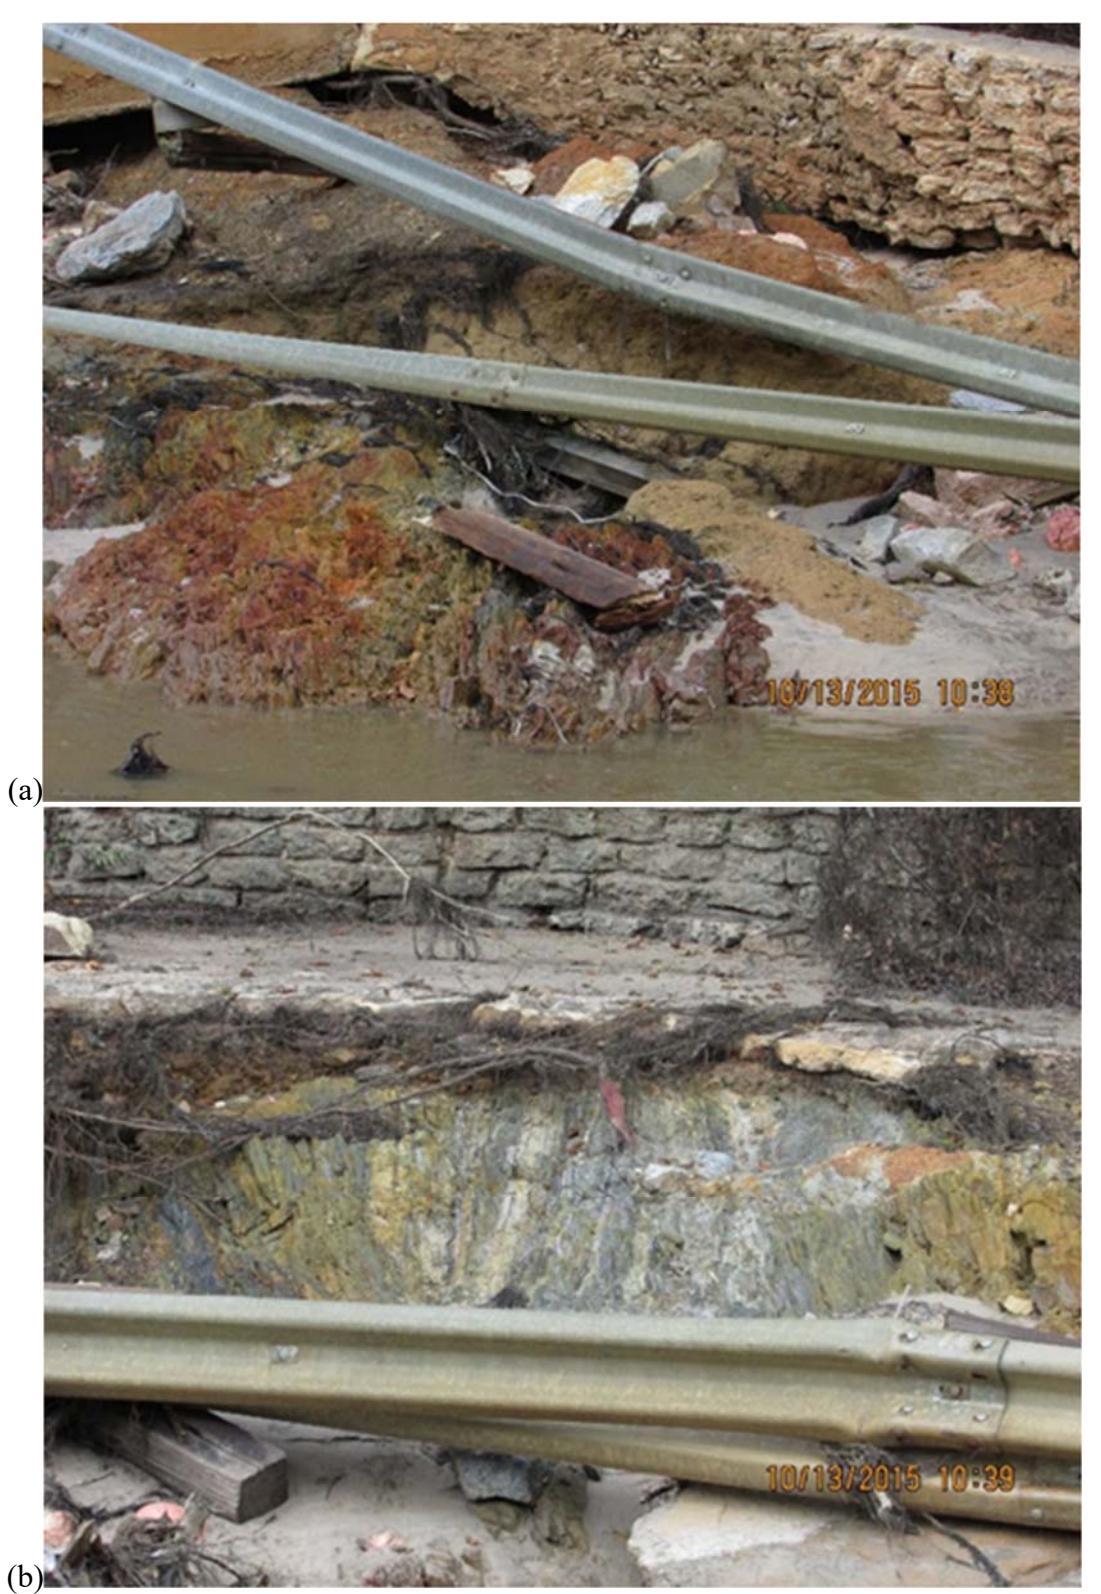
Figure 80. Cary's Lake Dam breach: Saprolite foundation soils exposed at the left abutment below the smaller spillway (photos: October 13, 2015; N 34.04866°, W 80.95764°).

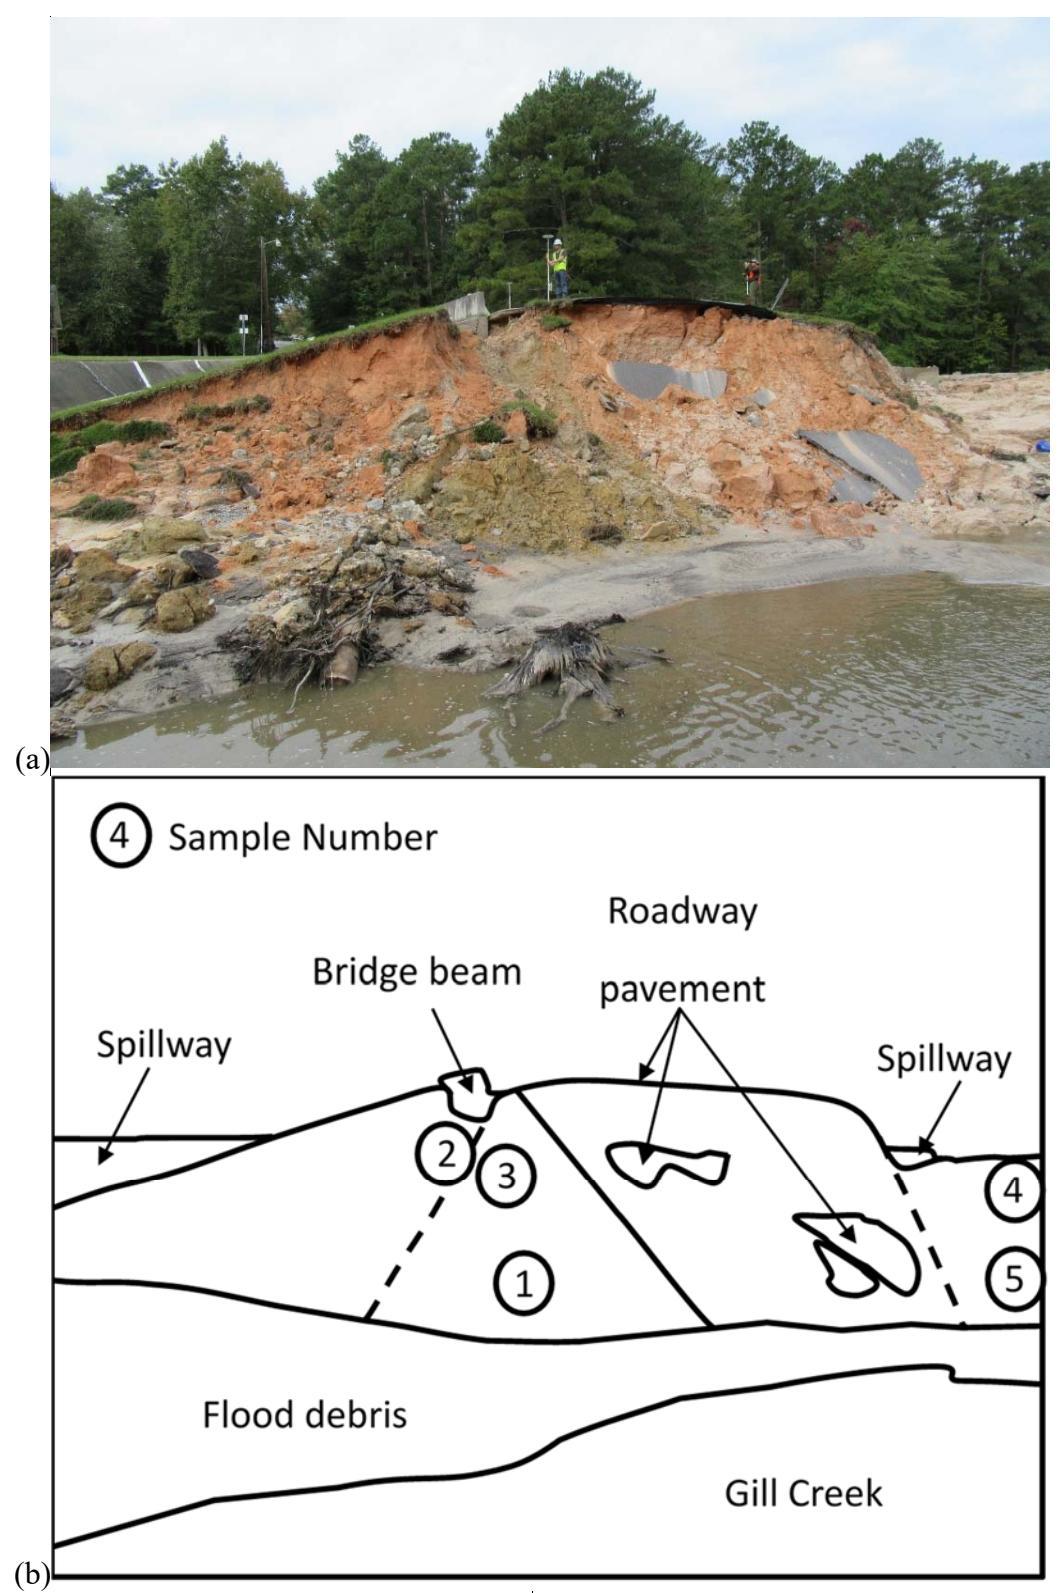
Figure 82. Cary's Lake Dam breach: (a) Exposed earth fill making up the dam taken facing the large spillway and right abutment; (b) corresponding interpretive sketch with soil sampling locations (photo: October 13, 2015; N 34.04866°, W 80.95764°).

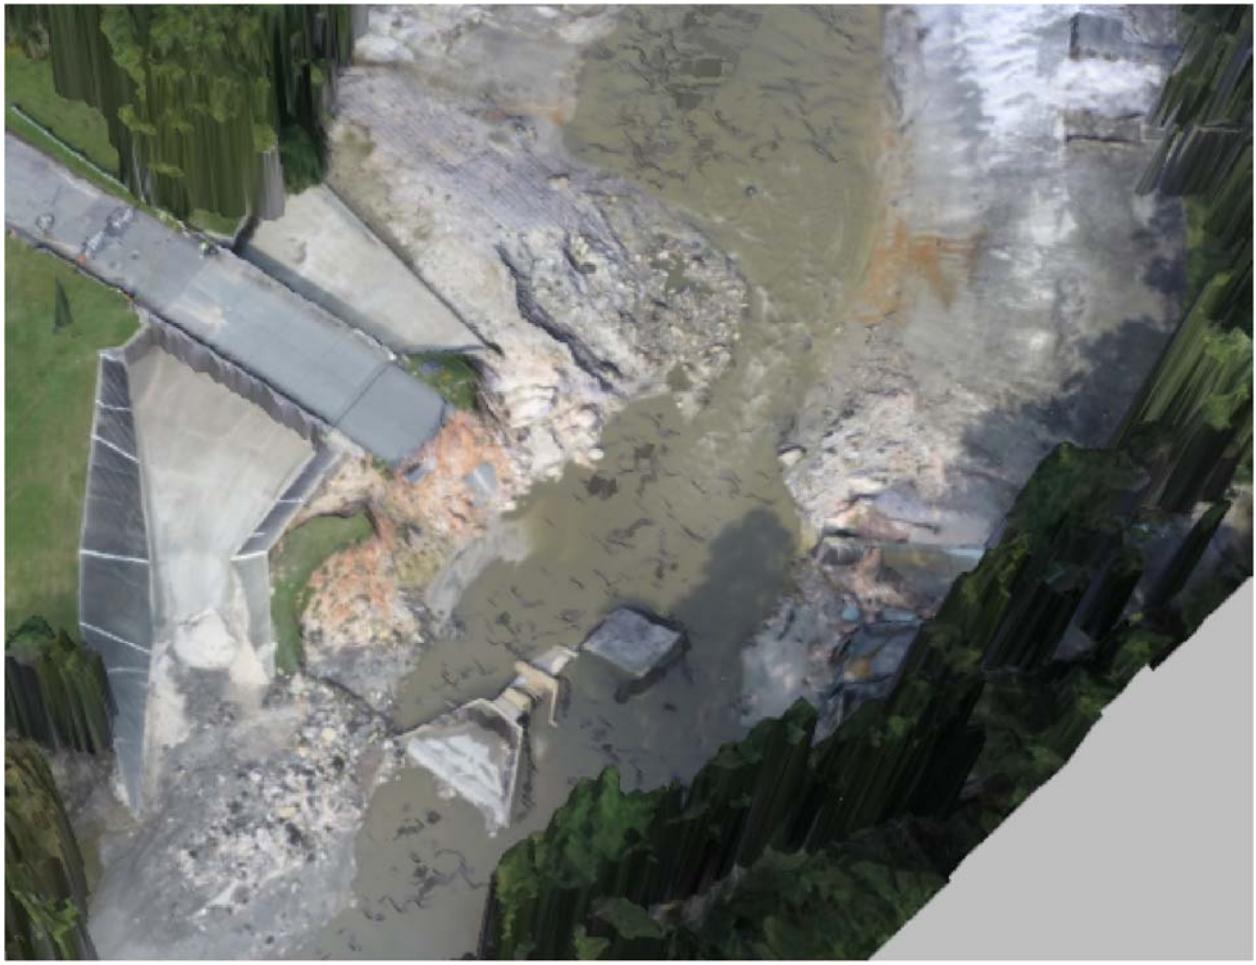
Figure 84. Downstream 3-dimensional view of the Cary's Lake Dam breach based on SfM-reconstruction from the octo-copter drone survey (N 34.04866°, W 80.95764°).

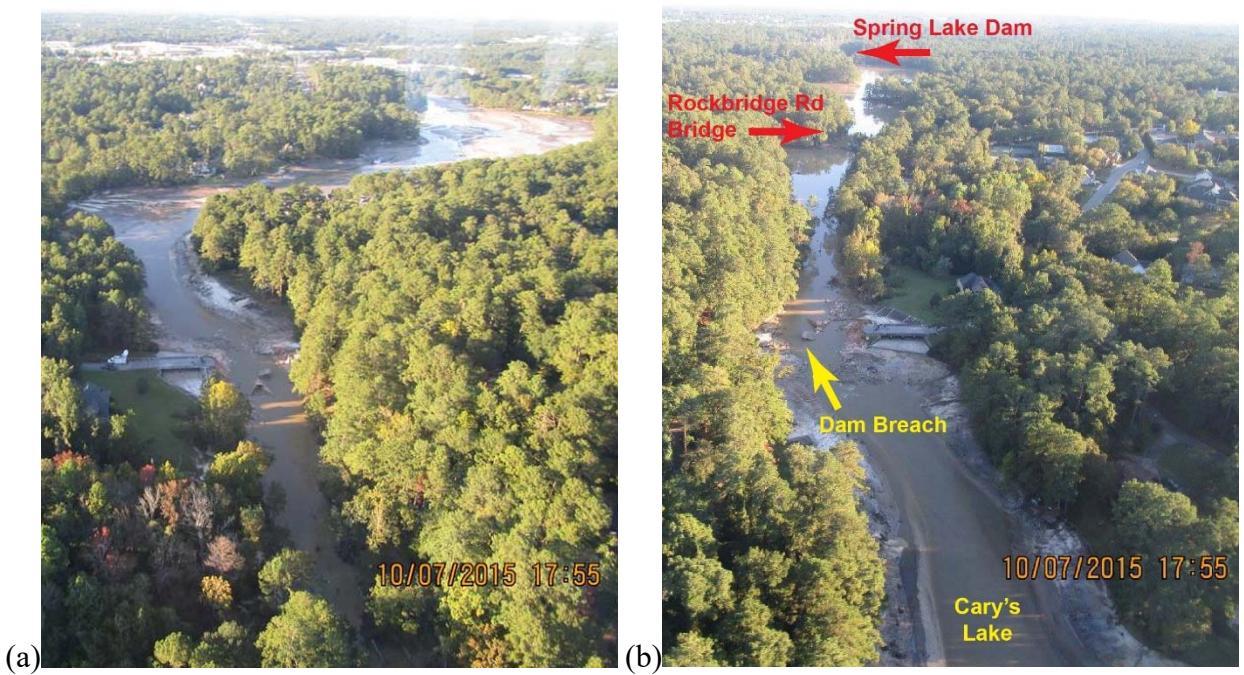
Figure 85. Cary's Lake Dam breach in aerial views on October 7, 2015: (a) upstream (northward) view of the breached dam with intact right (western) spillway and empty Cary Lake bed in the background; (b) downstream (southward) view of the breached dam with intact right (western) spillway and Jackson Creek with the washed away Rockbridge Rd Bridge and Spring Lake in the background (photos from Gills Creek Watershed Association via: www.facebook.com/GillsCreekWatershedAssociation; N 34.04866°, W 80.95764°).
