The Hydraulic and Geotechnical Aspects of the South Carolina Floods of October 1-5, 2015 Related to Offshore Hurricane Joaquin

GEER Association Report No. GEER-052 December 19, 2016

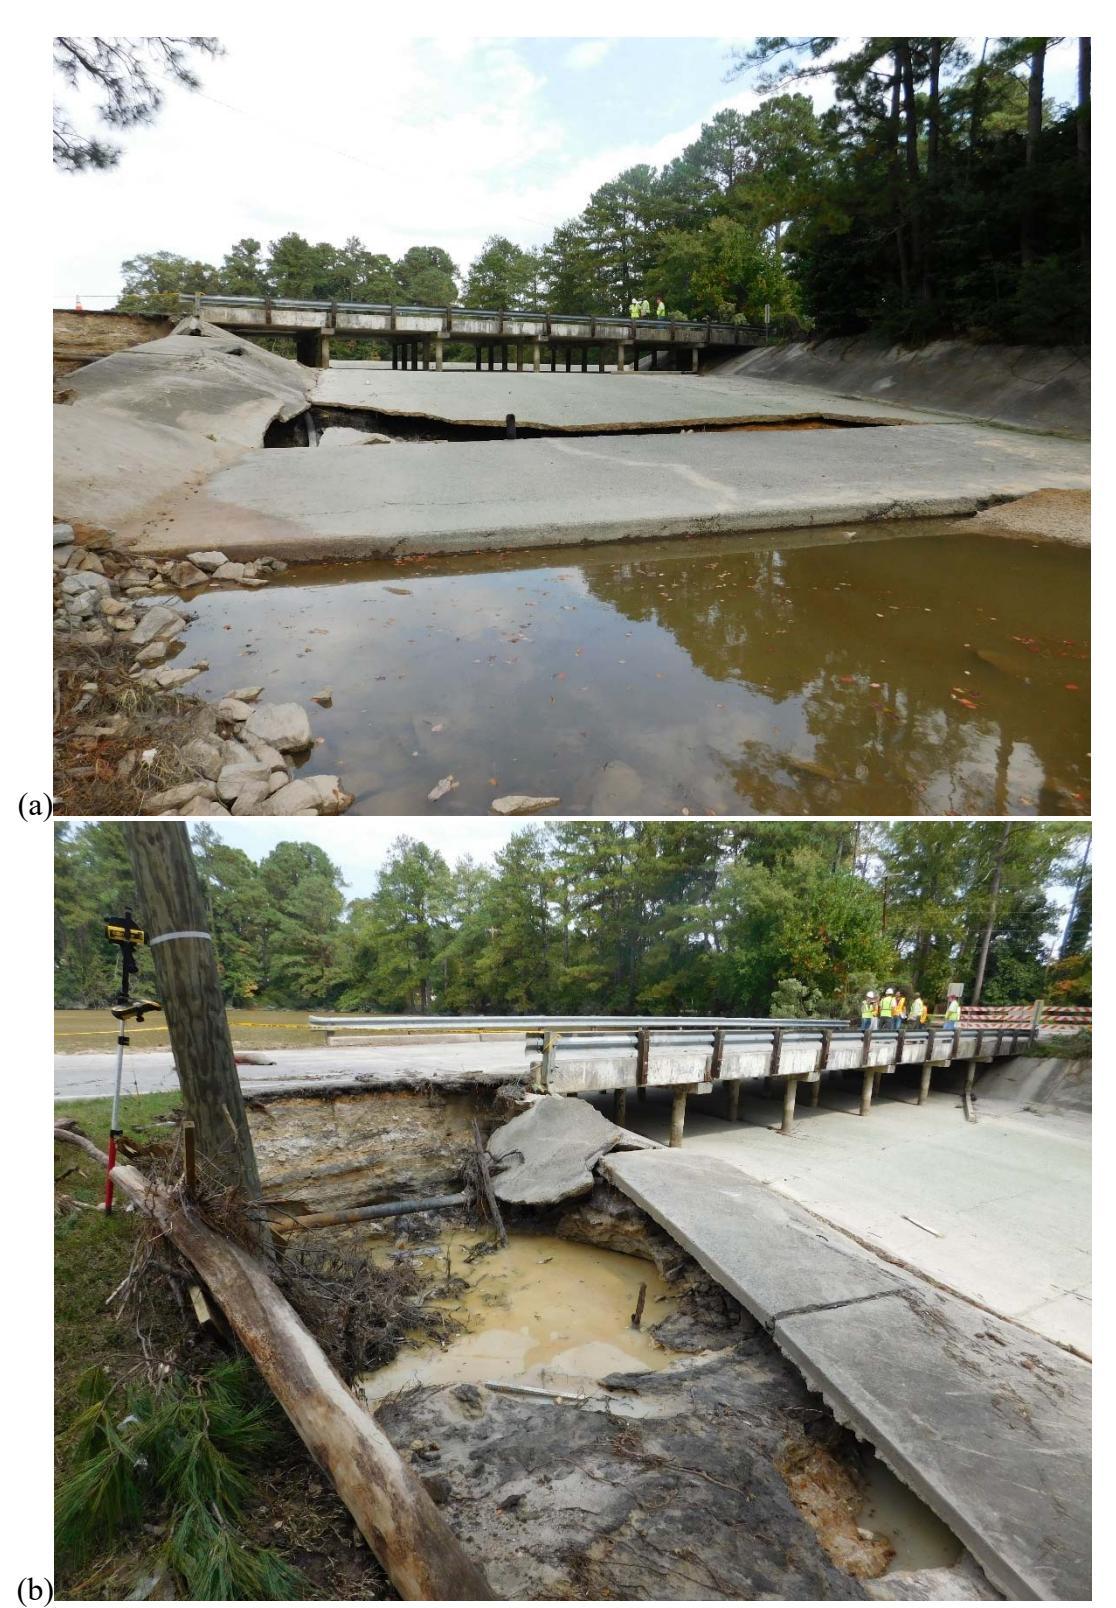
(b) Figure 87. Spring Lake Dam: (a,b) Damage to concrete spillway and embankment dam (photos: October 13, 2015; N 34.03708°, W 80.95531°).
