Geoengineering and Seismological Aspects of the Iwate Miyagi-Nairiku, Japan Earthquake of June 14, 2008

GEER Web Report 2008 v.1

September 12, 2008

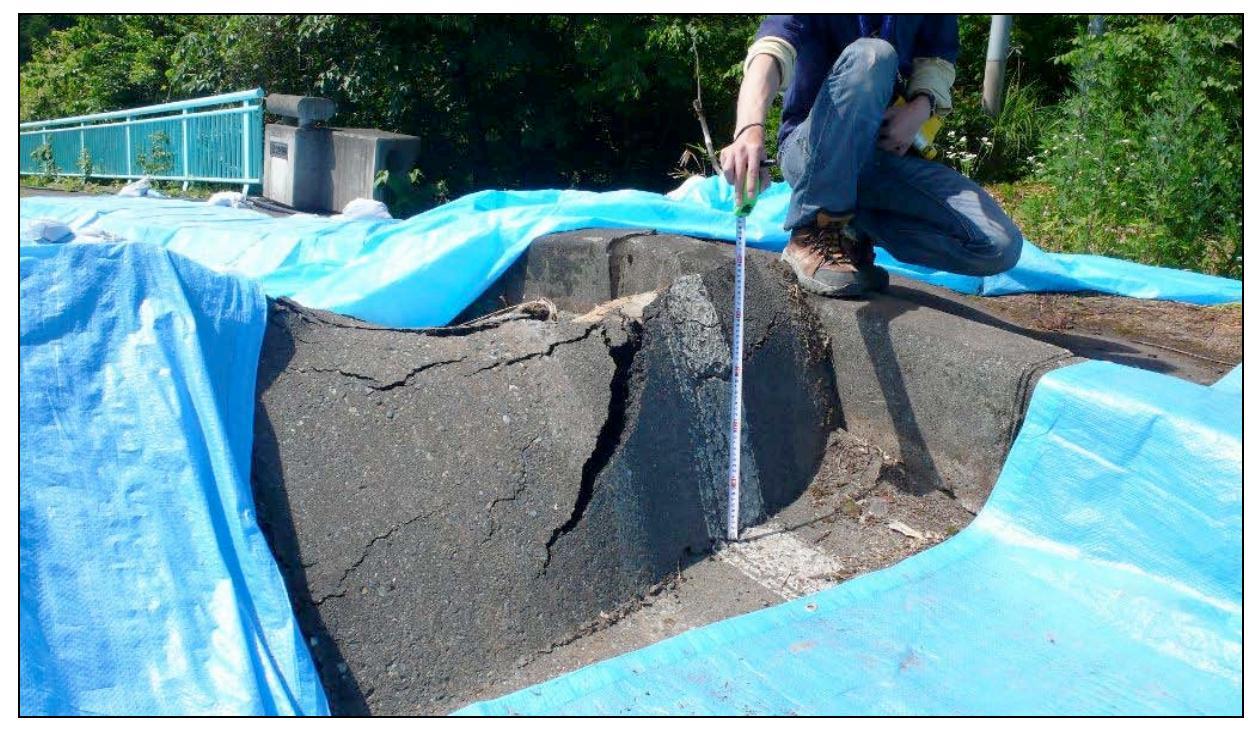
Figure 3.5. Asphalt pavement pushed up against bridge abutment.

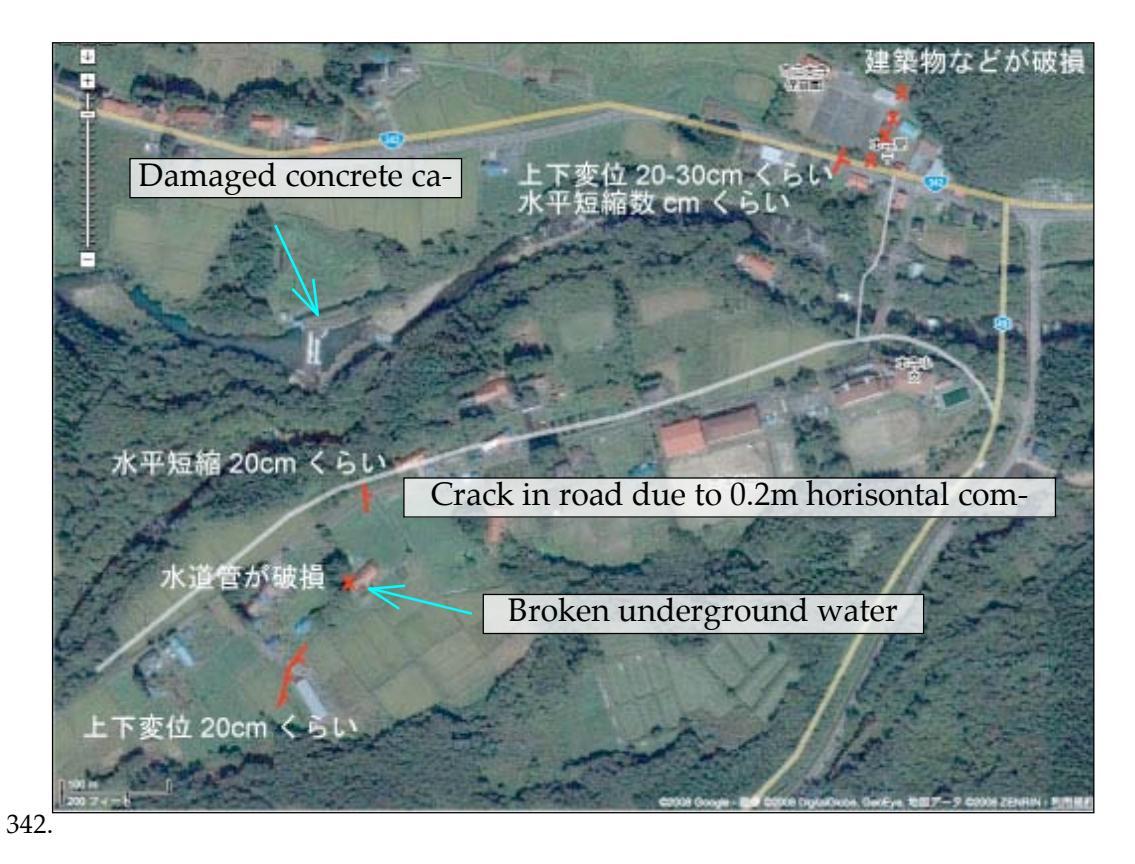
At point 3, Ichinoseki City Ookayama (), an underground water pipe was broken [3] and concrete canal was damaged (see Figure 3.7). According to the AFRC some buildings were also damaged just north of National Road

Figure 3.6. Point 3, Ichinoseki City Ookayama. Surface fault damaged a concrete canal and broke a underground water pipe.

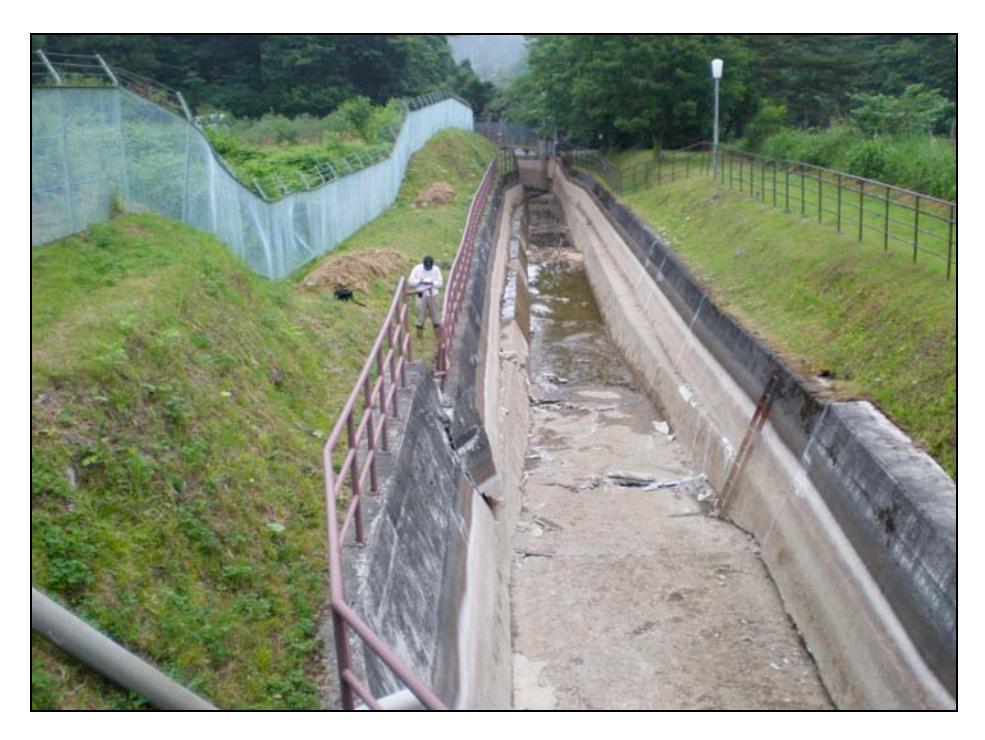
Figure 3.7. Concrete canal broken by surface fault. (photo by [5]).

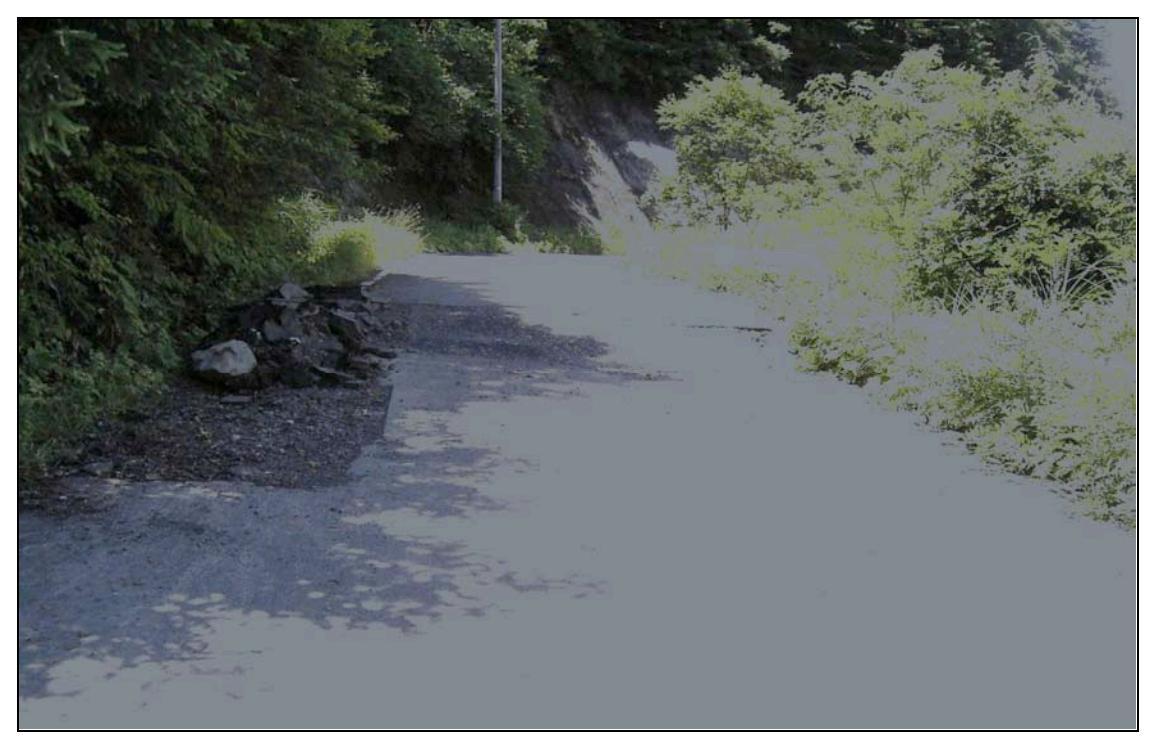
Figure 3.10. Road damage due to surface faulting (?) just south of Aratosawa dam. See text for explanation of question mark. Observe the bent guard rail.

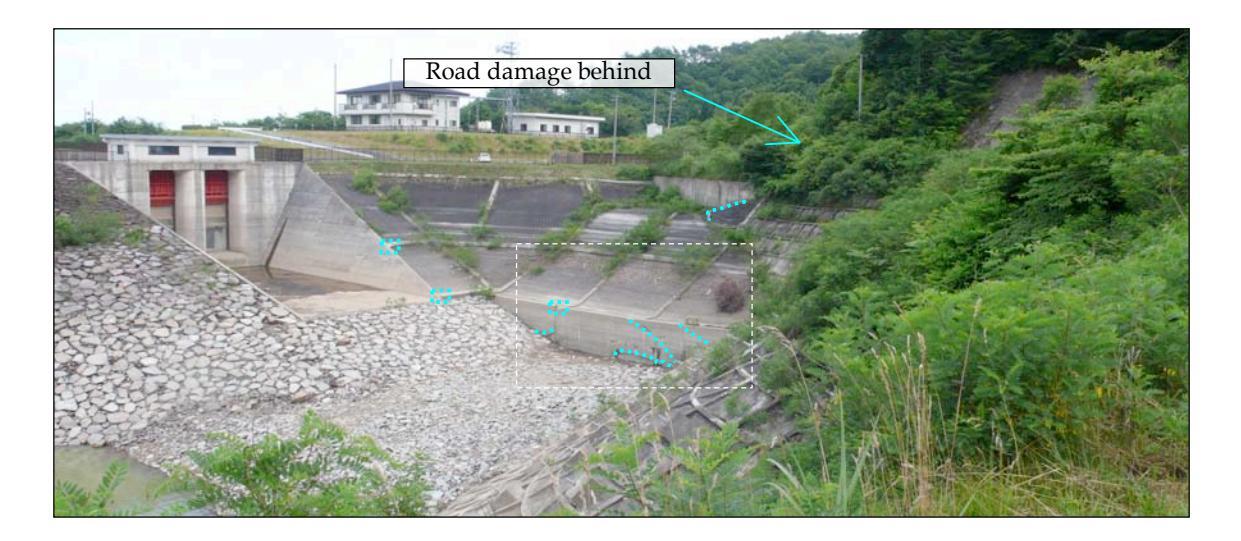
Figure 3.11. Spillway Concrete structures cracked by ground deformation possibly related to surface faulting. Blue lines and boxes mark cracks. Dashed thin white line marks location of close-up photo in Figure 3.12.

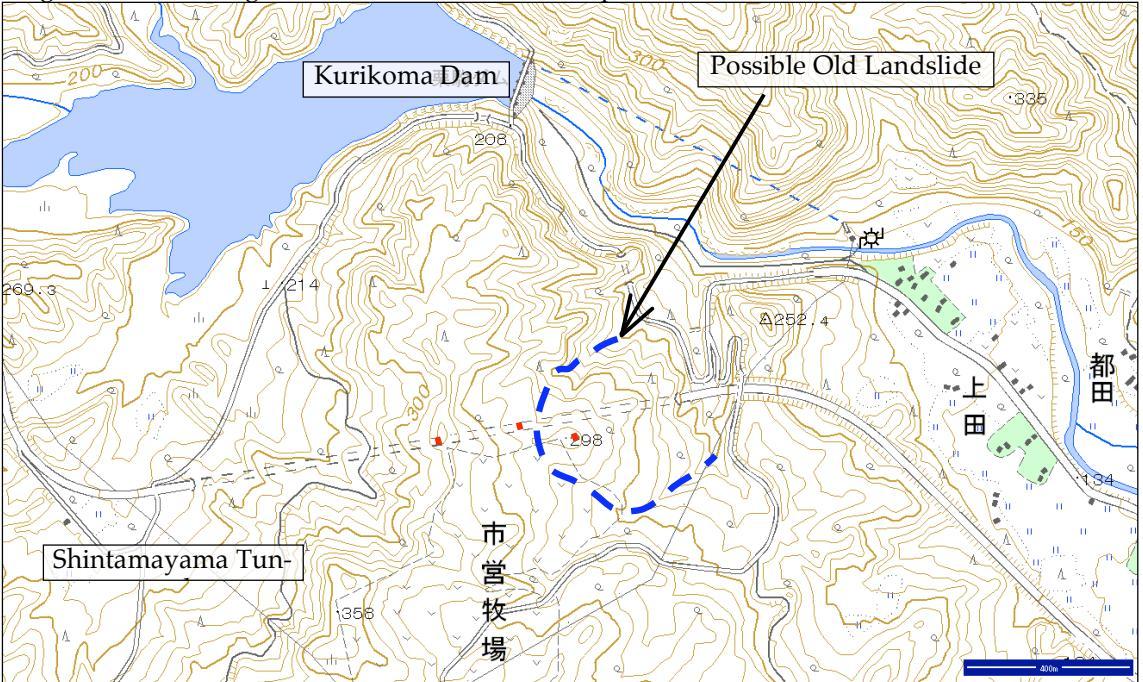
The Shintamayama tunnel is located some 20km to the east of Ichinoseki City, on prefectural route 42, just to the south of the Kurikoma dam (see Figure 3.13). The 1220 m long 10.25m wide, and 4.7m high tunnel consisted of 97 12.5m long segments (see Figure 3.15). It sustained cracks some 20 mm wide at 250m, 1-3 mm at 400m, and cross section compression at 600m (segment 20, 32, 48) from the East mouth respectively, shown by red marks in Figure 3.13 and in detail in Figure 3.15. A detail of the cracks at segement 20 and 21 are shown in Figure 3.14. There most of the cracks were extensional. Blue arrows show that the eastern segment moved down with respect to the western segment, while red ones show the opposite. Numbers in parentheses show these relative displacements in mm. The 50 meter portion closest to the east mouth was extended with openings 5mm up to 2cm wide between the segments (see Figure 3.15.)

Figure 3.13. Shintamayama tunnel with possible old landslide that may have been reactivated. The red marks show major crack locations, at 250m, 400m, 600m (segment 20, 32, 48) from the East mouth respectively.

We also went on top of the hill , through which the tunnel crosses, however we found no cracks or other signs of major landsliding and/or surface faulting. (Figure 3.16 shows the GPS tracks.) There was only some shallow surface failure and stones that had jumped out of their locations. As of this writing it seems that the induced damage is more likely due to a landslide as indicated with blue dashed line in Figure 3.13, than related to the a possible surface fault. Therefore if the cause is a deep-seated landslide, long-term monitoring will be a must for rational repairs.

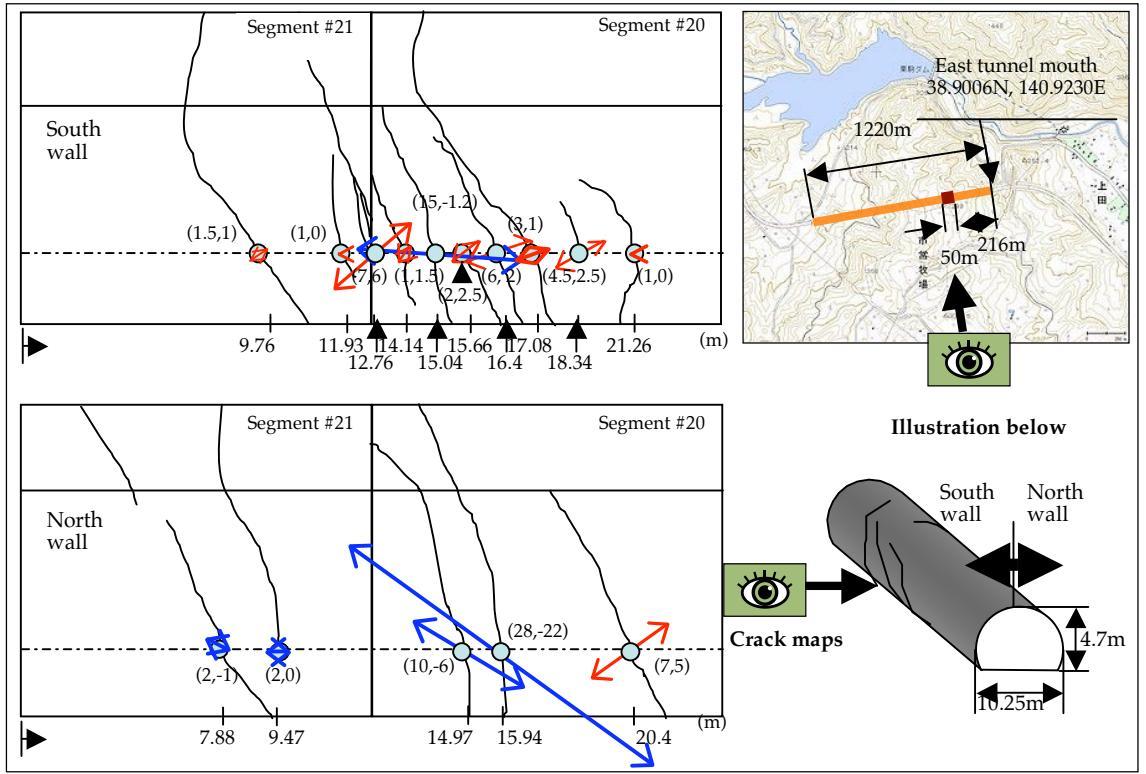
Figure 3.14. Cracks in Shin-Tamayama Tunnel: A 36m-long segment 216m inside the eastern mouth (38.9006N, 140.9230E) of the total 1220-m-long tunnel was diagonally cracked. The above two figures show projections of the cracked south and north walls on a virtual screen put north behind the tunnel.

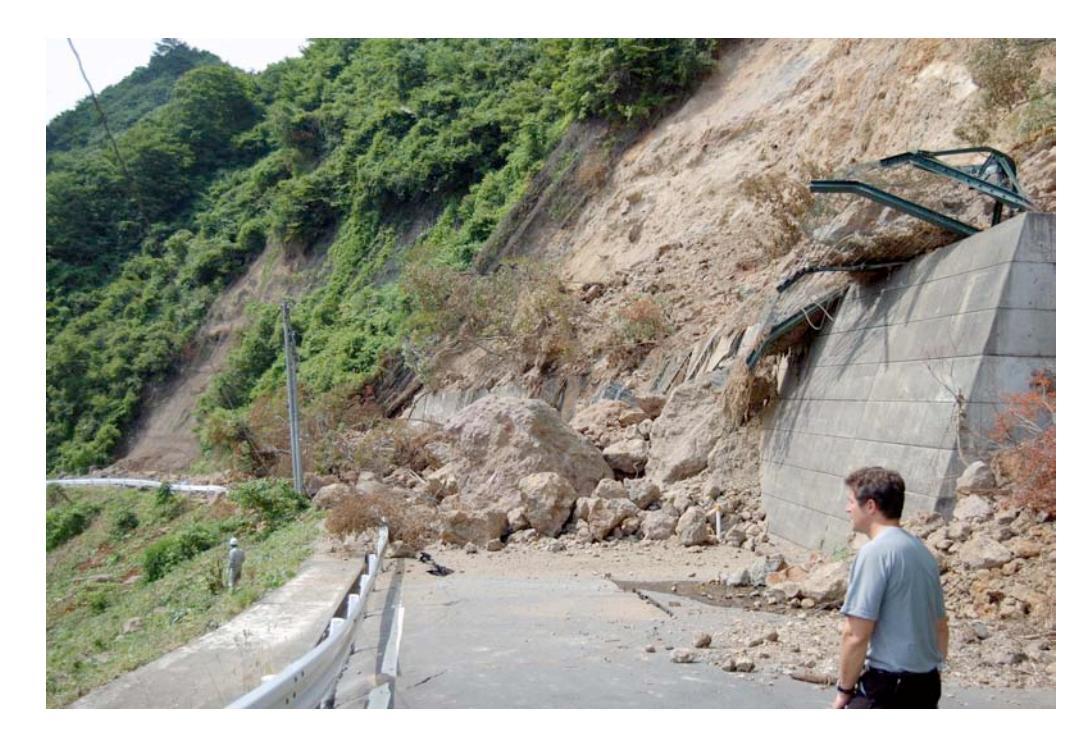
Figure 4.4: A moderate sized rockfall closed route 37 at Site 40. The slide contained car sized boulders of weather rock (Site S40, N39.0993° E140.97252°, 6/28/08 12:08).

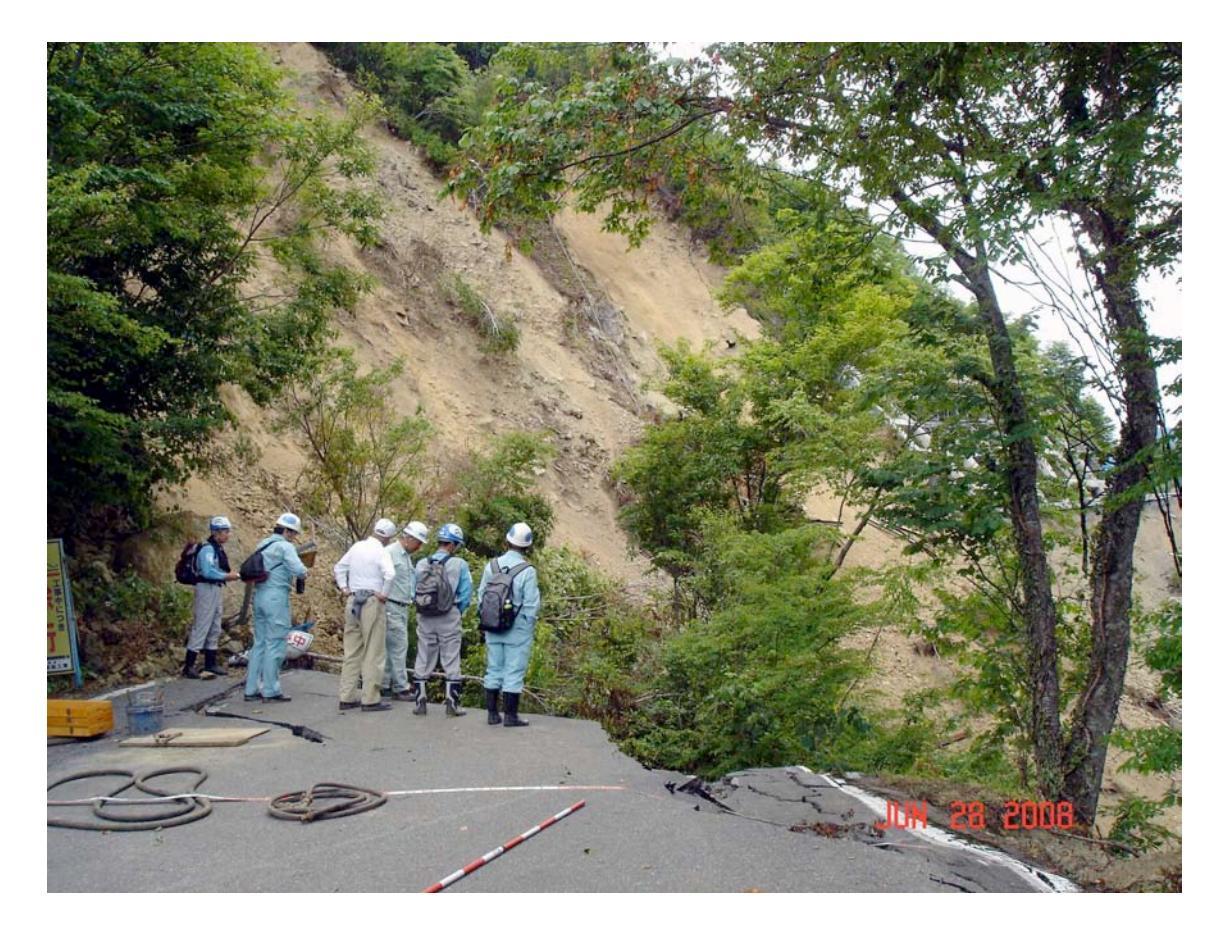
Figure 4.5: A large but shallow regolith slide of weathered soil closed a portion of Route 342, Iwate Prefecture (Site S31, N39.00532° E140.84219°, 6/28/08 9:45).

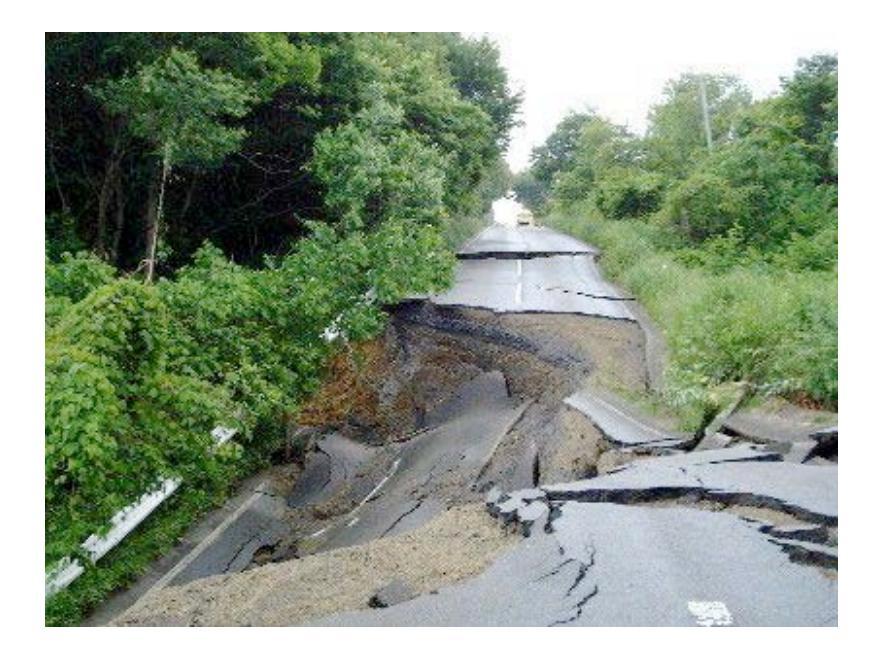
Figure 4.6: Site 79 A typical small embankment failure along Route 342. Photograph courtesy of the Iwate Prefecture Government Office, Morioka, Japan.

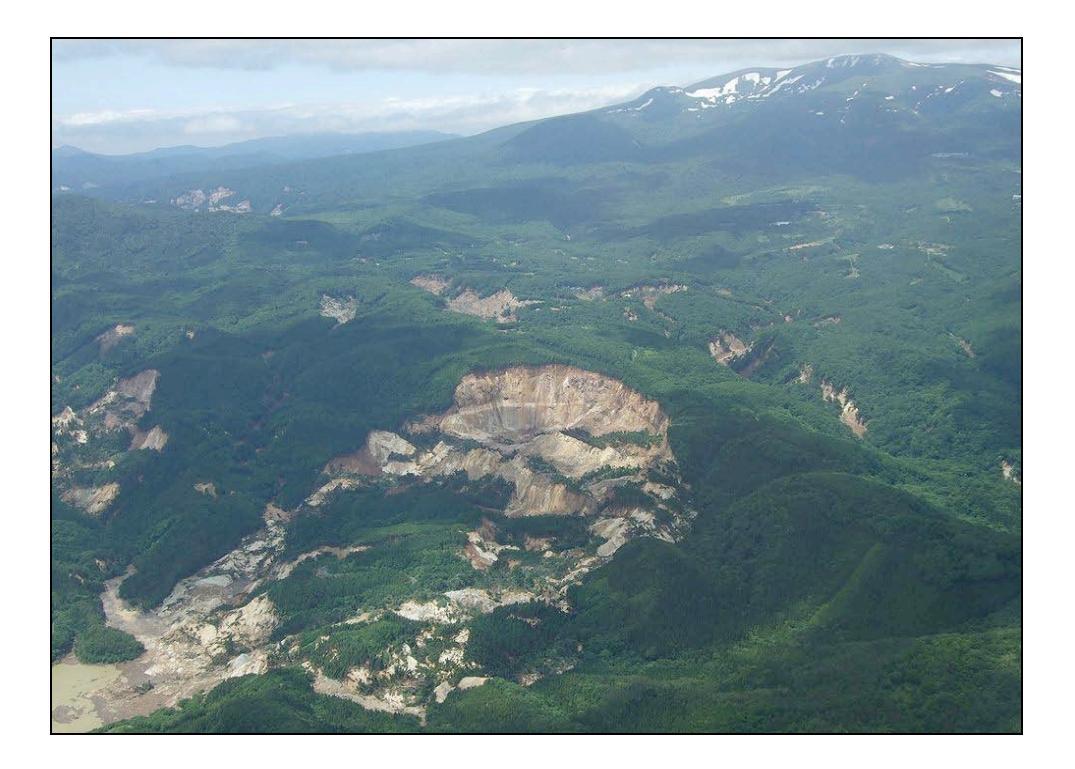
Figure 4.7. Landslide at Aratosawa dam: Aerial photo of the largest landslide with Kurikoma Volcano rising behind. The terrain here is suggestive that similar historic landslides have been reactivated. A large and almost horizontal laminated structure of lose volcanic sands and ashes is being exposed on the escarpment. When wet, some pieces of light-gray
rock fragments taken at the toe of the landslide mass smelled strongly of hydrogen sulfide [1].

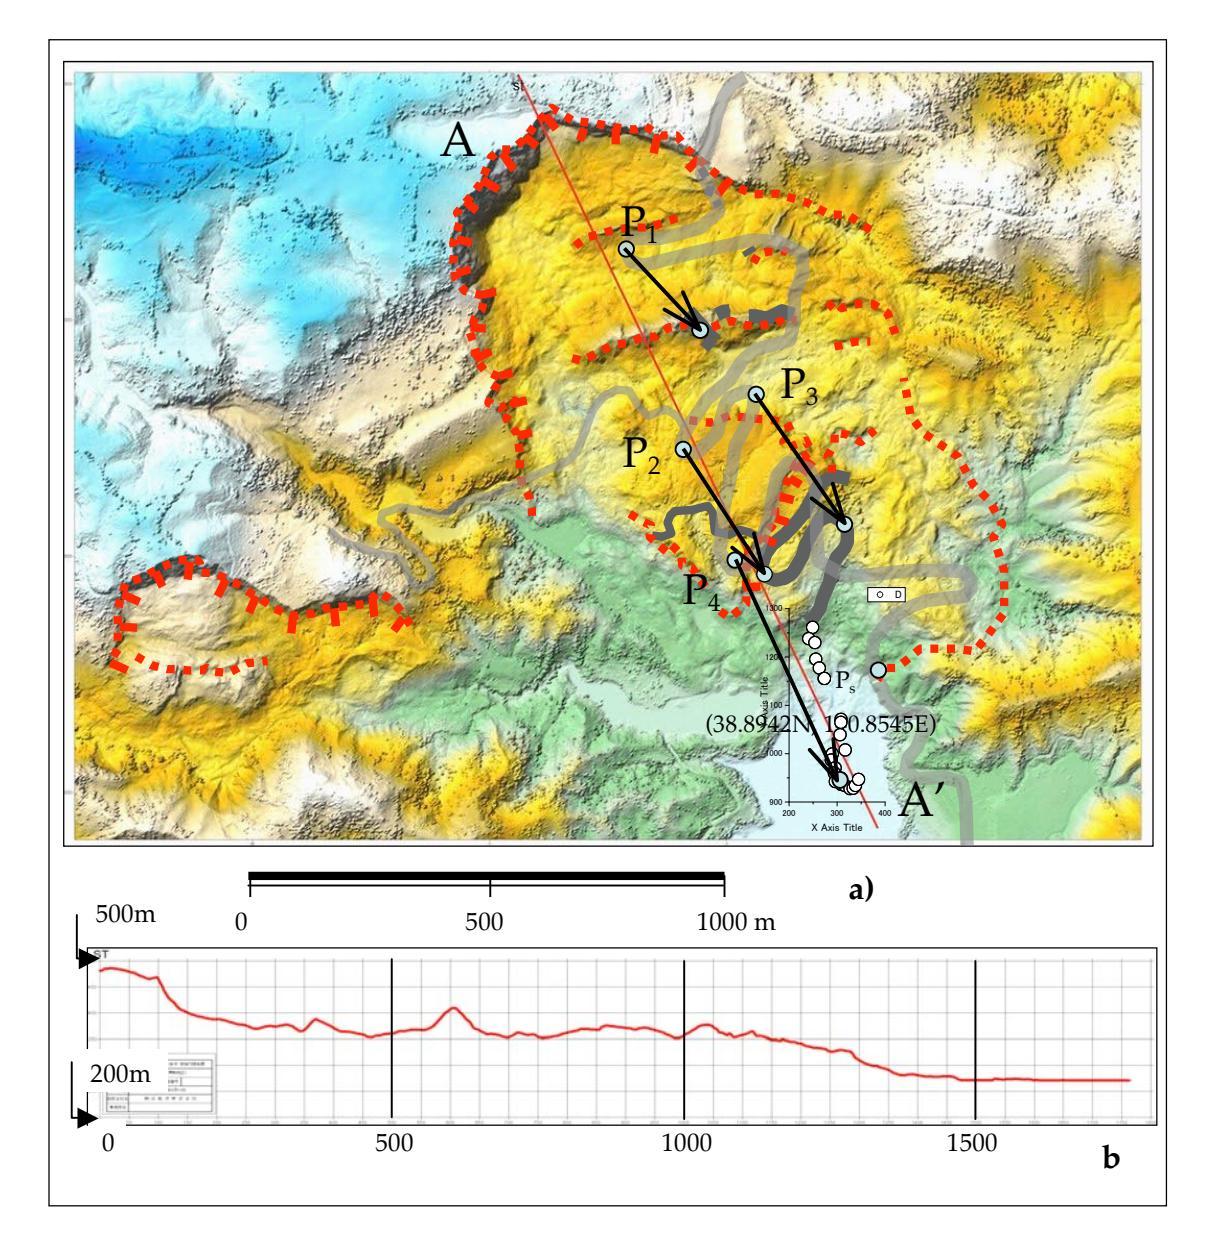
Figure 4.11. Landslide at Aratosawa dam. The road locations after and before (gray) the earthquake drawn upon the DEM. Even though the base slope was very gentle the soil masses have moved some 200 to 500 meters. (Aero Asahi Co. Provided the digital elevation model).

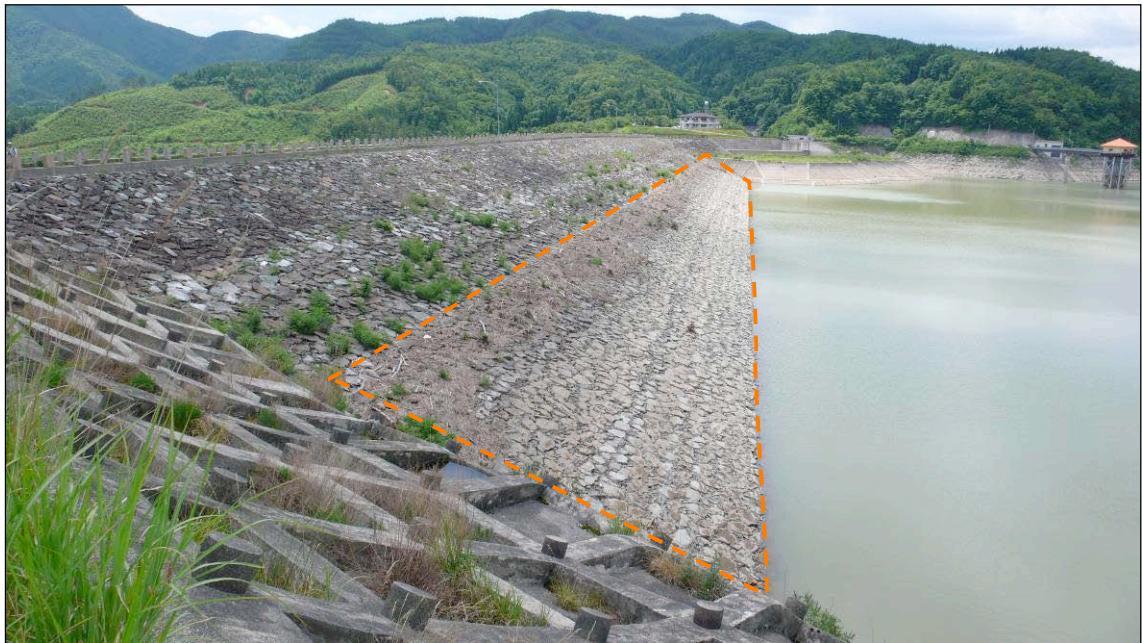
Figure 4.14. Sedimentation of fine particles on the lower part of the dam covers vegetation and indicates a minimum seiche height. Old reed grass in the top part of orange rectangle appear to have been deposited by seiche.

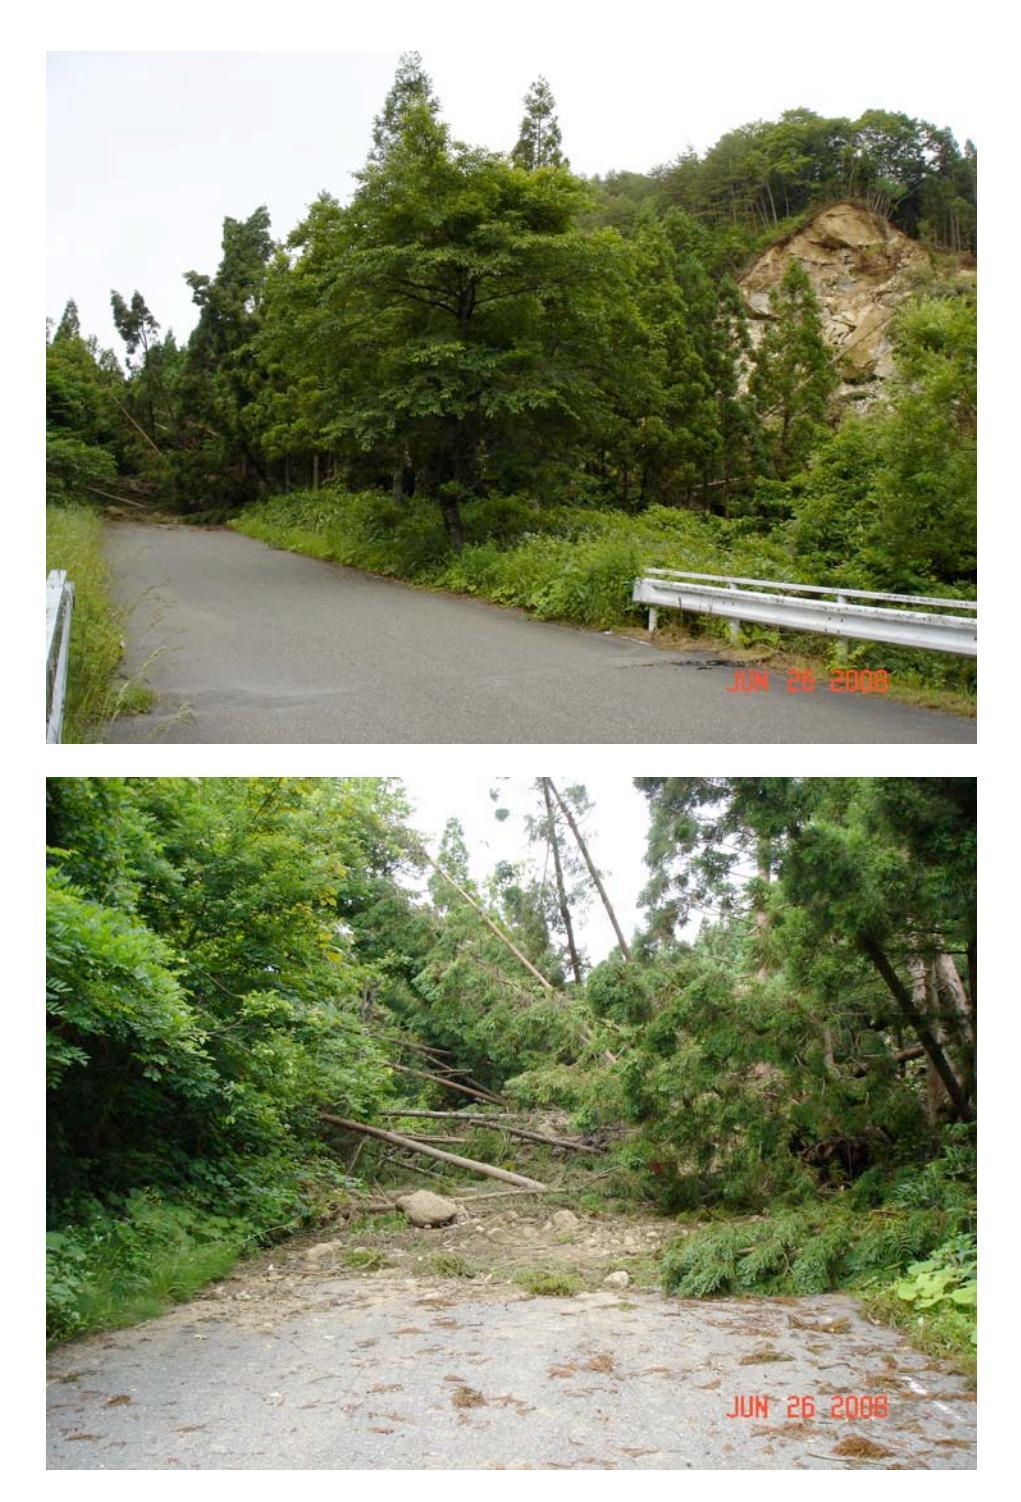
Figure 5.1: Landslide/rockfall debris covering Rt. 49 approximately 2 km south of the Iwate-Miyagi Prefecture border. The parent material and the blocked road can be seen in the top picture. A close-up view of the debris blocking the road can be seen in the bottom picture. The slide originated on the east-side of the road, ran down into a ravine and then upslope onto the road, indicating significant velocity. A small pond was actively building behind the failure. The slide was approximately 40-m high and 60-m wide and consisted primarily of rock with little soil (Site S16, N38.91498° E140.9068°, 6/26/08 16:30).

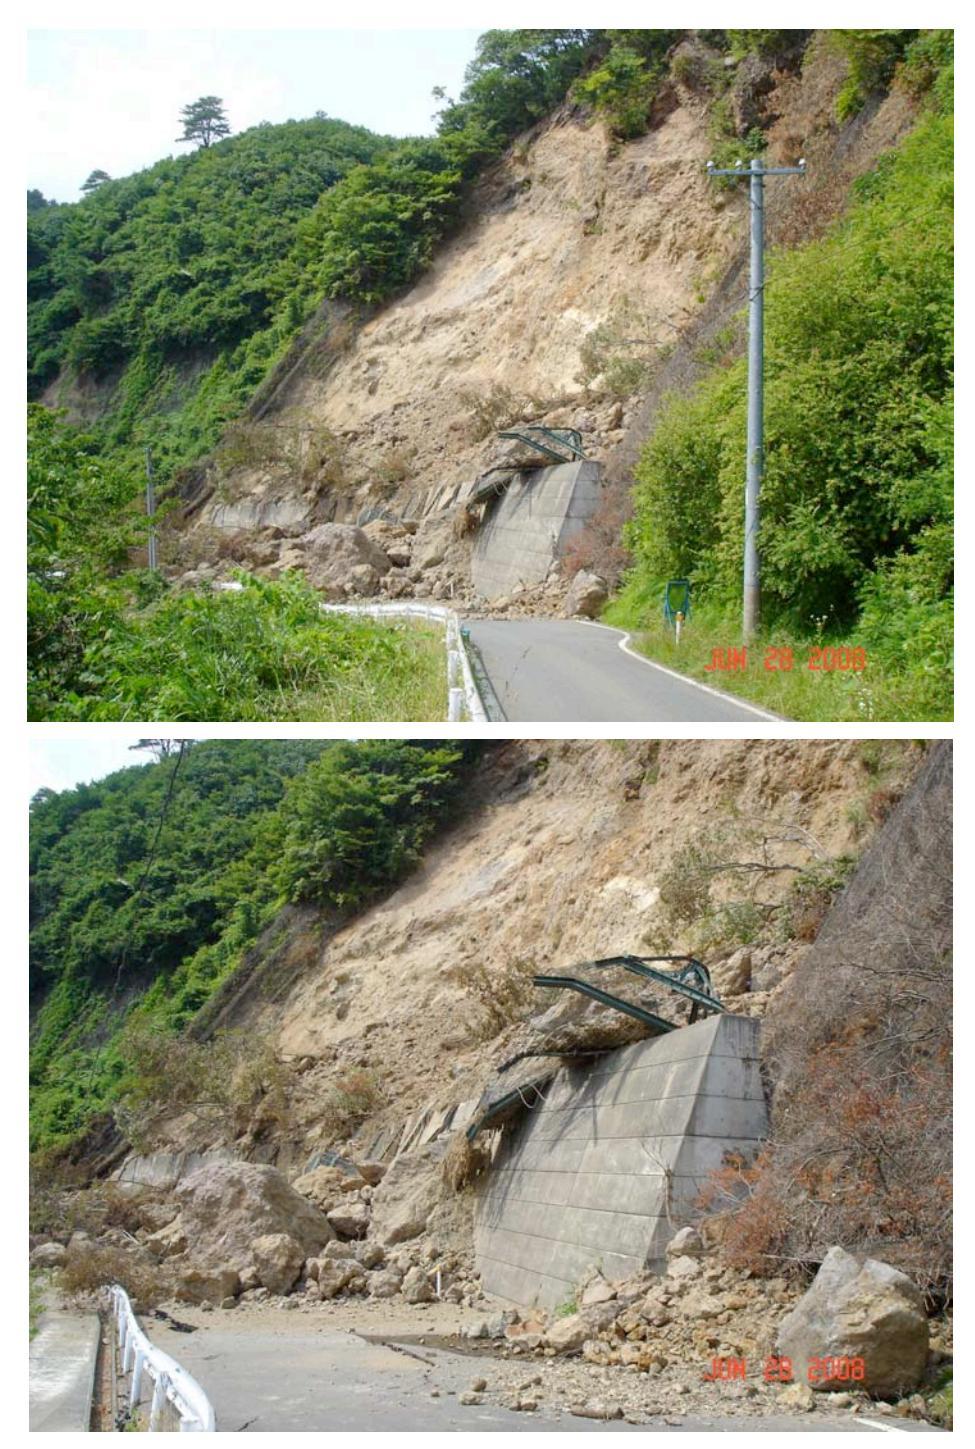
Figure 5.2: Landslide/rockfall debris covering Rt. 37 south of its intersection with Hwy 397. The parent material and the blocked road can be seen in the top picture. A close-up view of the debris blocking the road can be seen in the bottom picture. The slide originated on the north-side of the road and took out a rockfall barrier consisting of steel I-beams and chain-link fence. From a distance, the concrete gravity wall supporting the rockfall barrier did not appear to move. The slide was shallow, and approximately 15-m high by 50-m wide (Site S40, N39.0993° E140.97252°, 6/28/08 12:08).

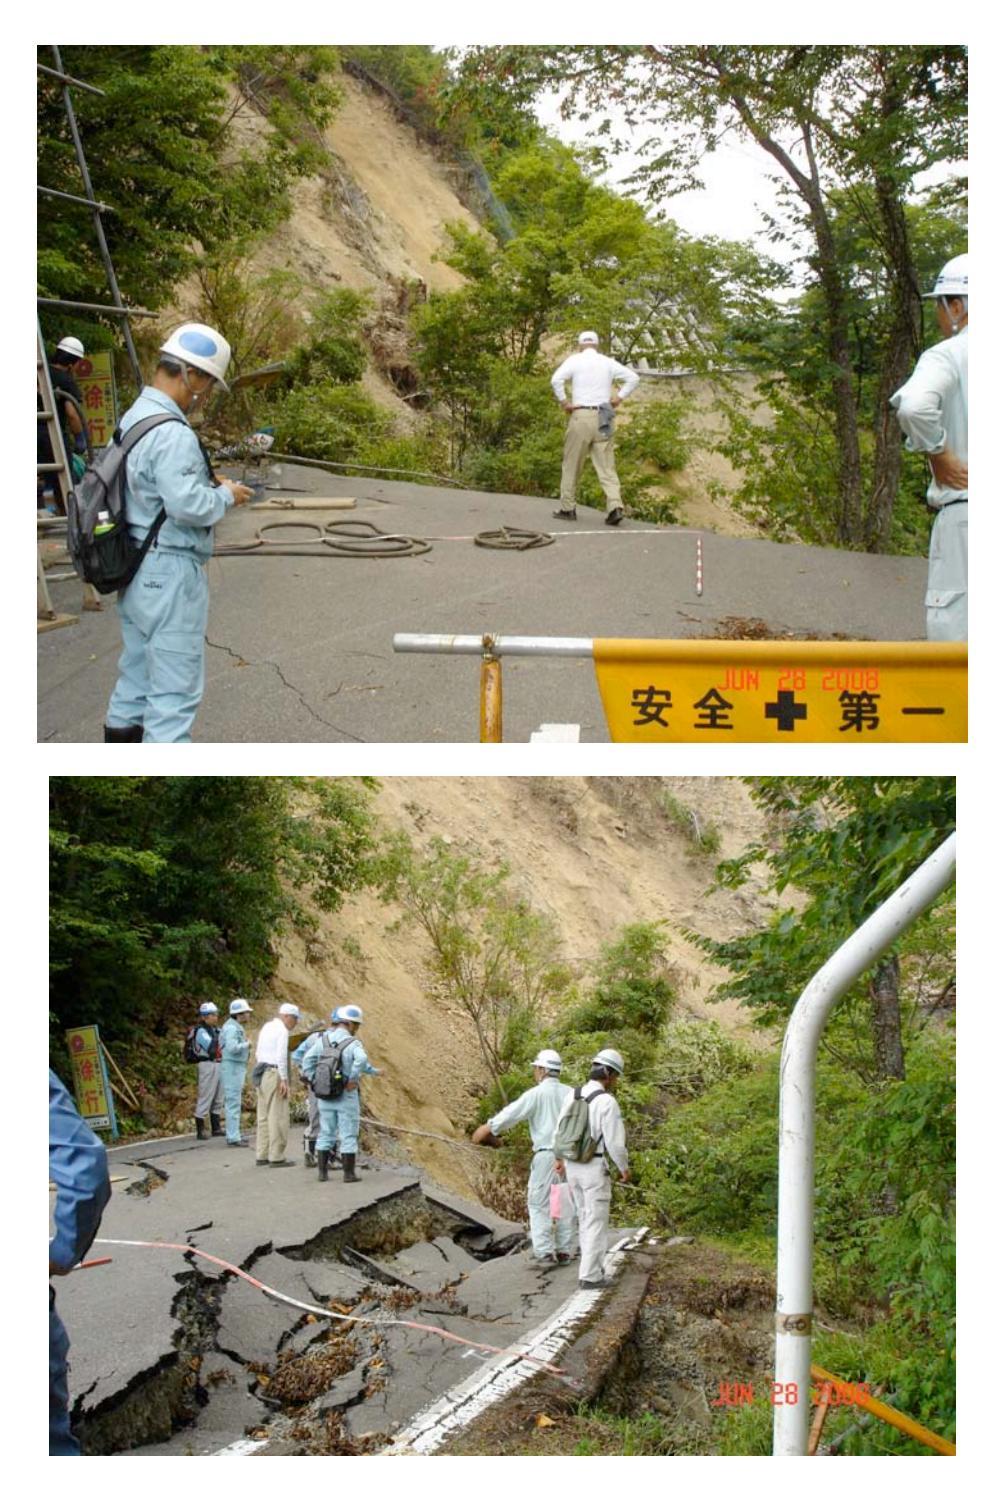
Figure 5.3: Hwy 342 was swept away by a landslide (pictures taken from the south-east side of the failure). The top picture shows the abrupt end of the road with the remains of a tied-back earth retaining system in the background (concrete waler beams). The bottom picture shows a different view of the road failure from an offset angle. The tied-back wall above the former road indicates that this was a problematic slope before the earthquake. The slide was approximately 100-m wide at road level, and extended approximately 50-m above the road and 150-m below, to the bottom of the ravine (Site S31, N39.00532° E140.84219°, 6/28/08 9:45).

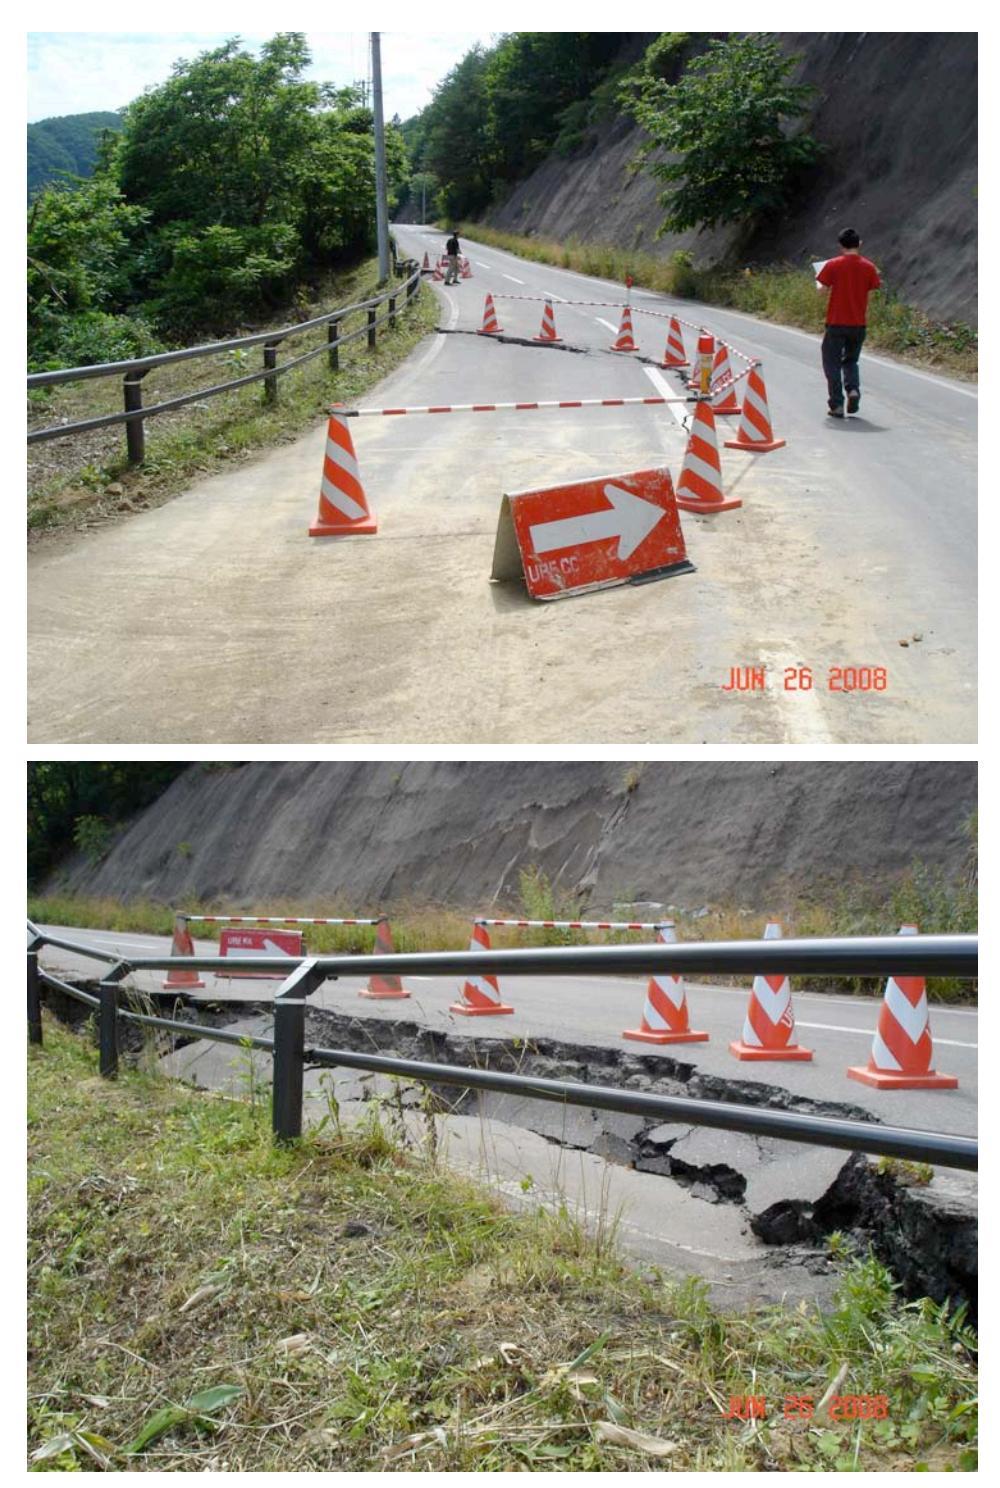
Figure 5.4: Embankment damage on Hwy 342 (pictures taken from the south-east side of the failure). The top picture shows minor settlement and extensional slumping of the embankment (~ 15 cm) in the foreground with another failure in the background indicated by the dipping rail and second set of cones. The bottom picture shows a close-up view of the second part of the embankment failure with vertical displacements ranging from 50 - 80 cm (Site S2, N38.97426° E140.9843°, 6/26/08 13:30).

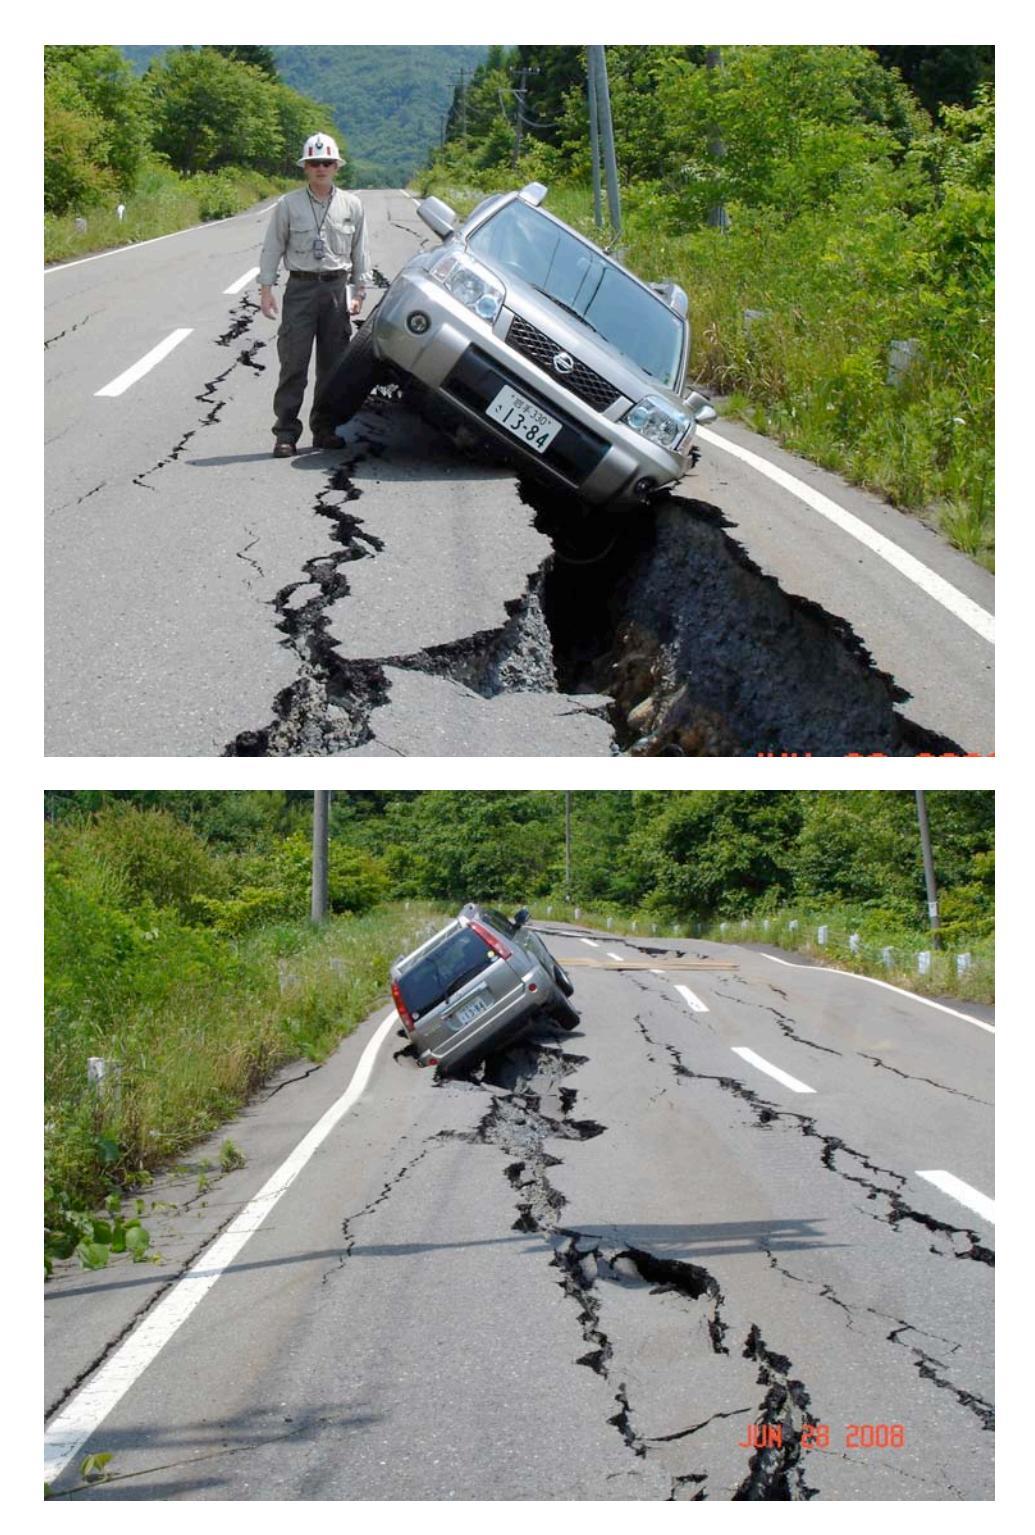
Figure 5.5: Road embankment damage on Hwy 342 caused by lateral slumping to the south. The top picture is a view of the failure from the west, while the bottom picture is a view of the failure from the east. Long extensional cracks developed in both lanes of the roadway. The fissure that the SUV tipped over in is more than 1-m deep and 1-m wide (Site S34, N39.01288° E140.86688°, 6/28/08 10:15).

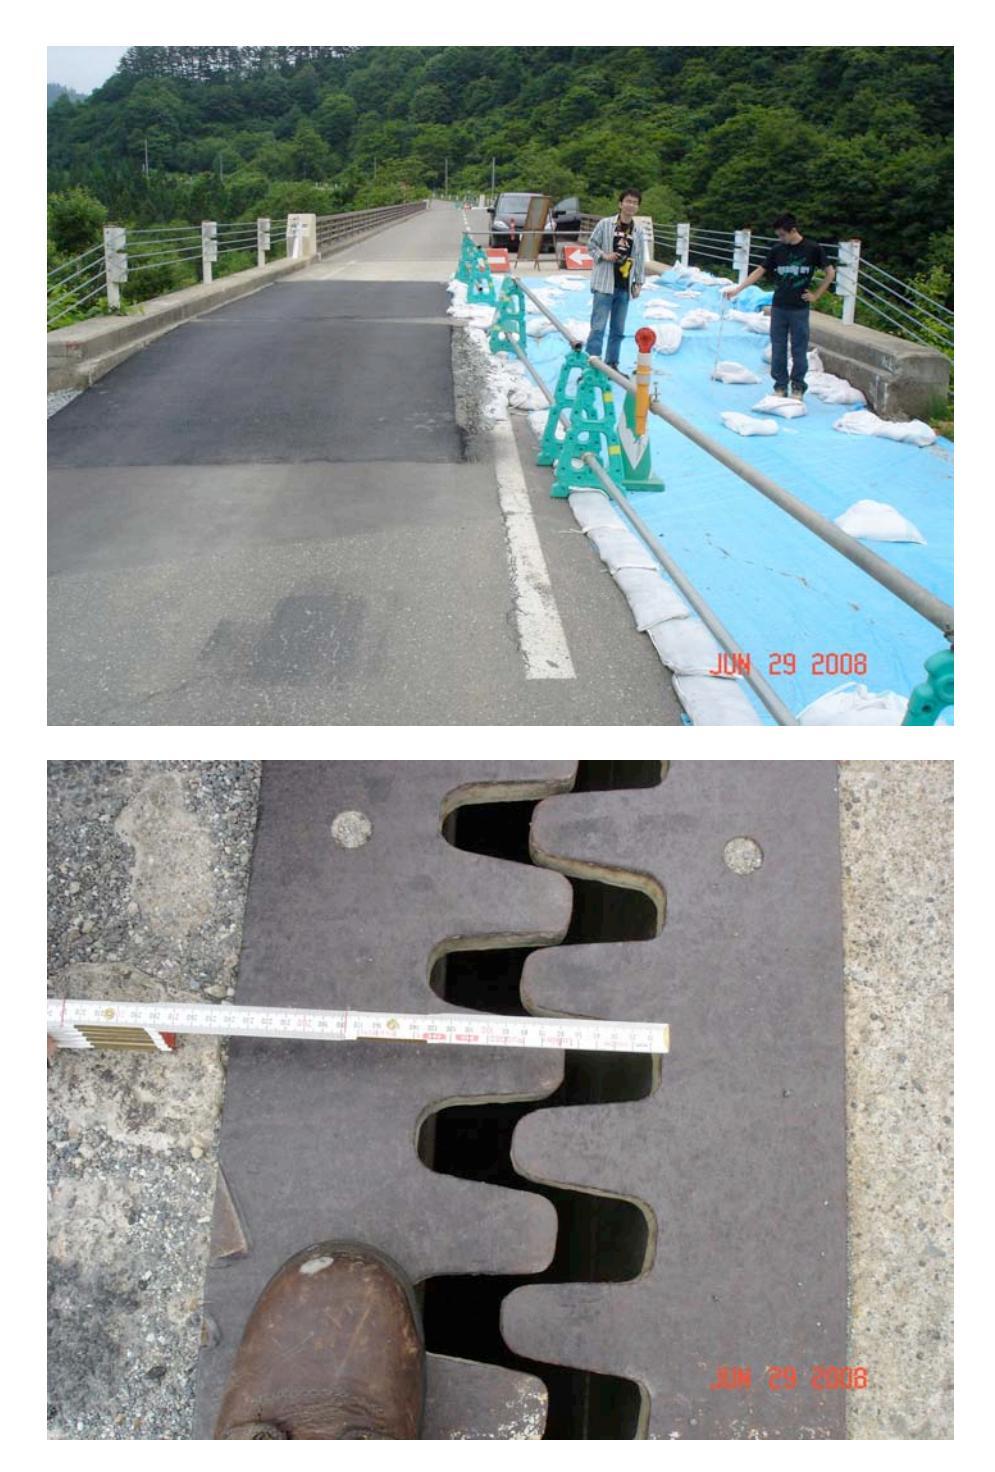
Figure 5.6: Settlement of a bridge approach fill on Hwy 342. The top picture is a view of the bridge from the south, showing the temporary ramp onto the bridge constructed in one lane. The bottom picture shows the expansion joint on the north side of the bridge which had opened up 6 cm out of its 8 cm of possible travel. The approach fill on the north-side of the bridge settled 23 cm, while the approach fill on the south-side settled 32 cm. The concrete bridge was approximately 80-m long and appeared to have no structural damage (Site S48, N39.03768° E140.72435°, 6/29/08 11:25).
