Geoengineering and Seismological Aspects of the Iwate Miyagi-Nairiku, Japan Earthquake of June 14, 2008

GEER Web Report 2008 v.1

September 12, 2008

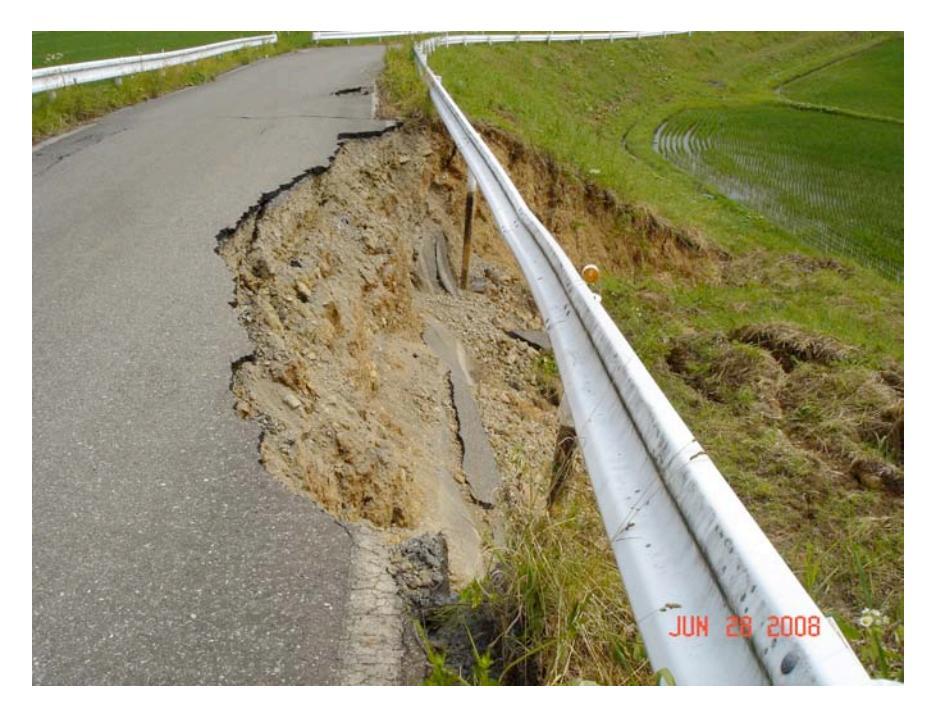
Figure 5.7: Slope failure of an approximately 3-m high embankment on a country road south of Rt. 37. The failure was approximately 5-m wide at road level and slumped/rotated into the rice field below (Site S41, N39.09119° E140.98671°, 6/28/08 14:24).

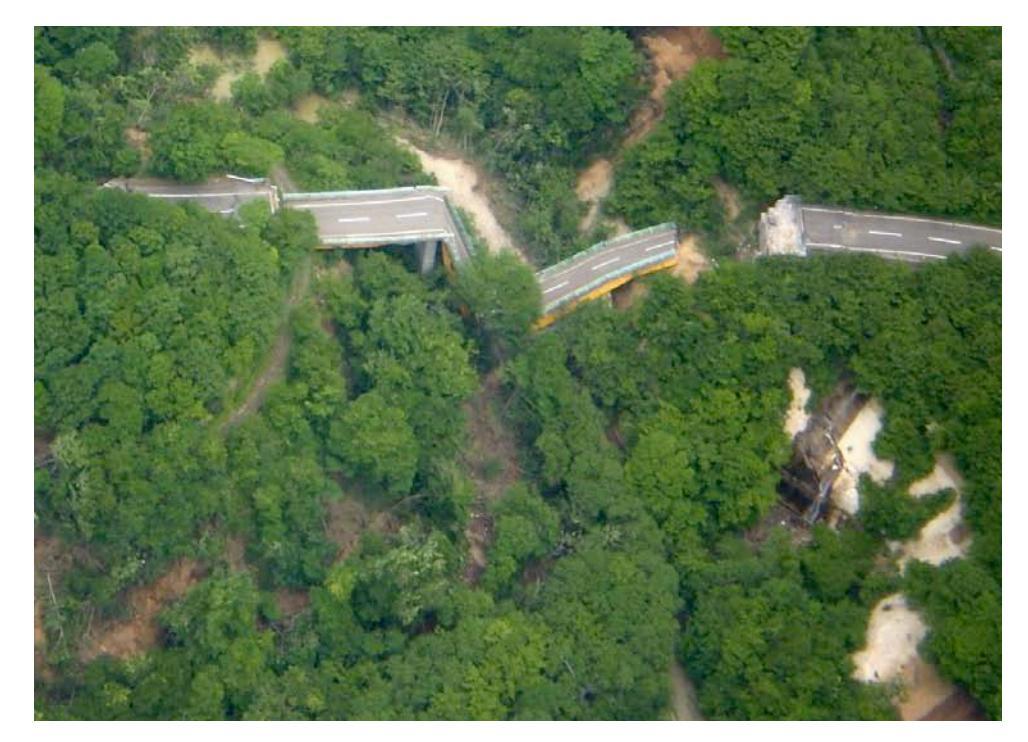
Figure 5.8: Aerial view of the bridge collapse on Hwy 342. The picture was taken looking from south to north with the western abutment located on the left-hand side of the photo (Site S36, N39.0146° E140.87862°, 6/28/08 10:33).

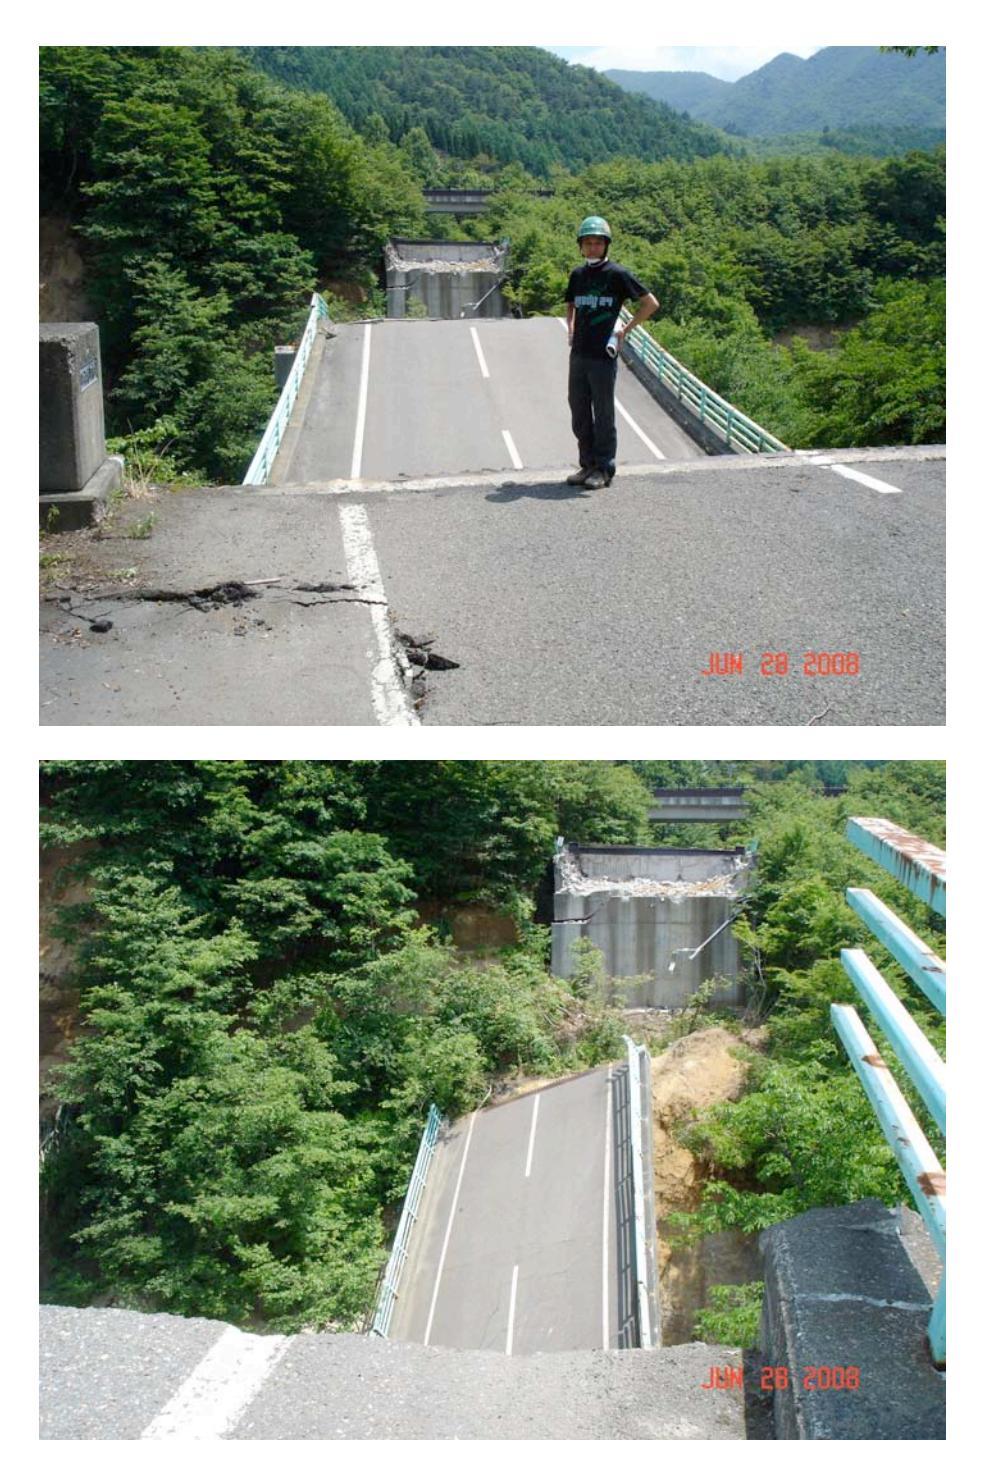
Figure 5.9: Collapse of a two-span, steel girder bridge on Hwy 342. The top picture was taken from the western abutment and shows the western span in the foreground (which dropped approximately 3 m when it fell off of the western abutment supports) and the missing eastern span in the background (which was pulled off of the eastern abutment supports into the ravine as the bridge buckled over the center pier). The bottom picture was taken from the center pier and shows the eastern abutment and the collapsed eastern span of the bridge in the ravine below (Site S36, N39.0146° E140.87862°, 6/28/08 10:33).

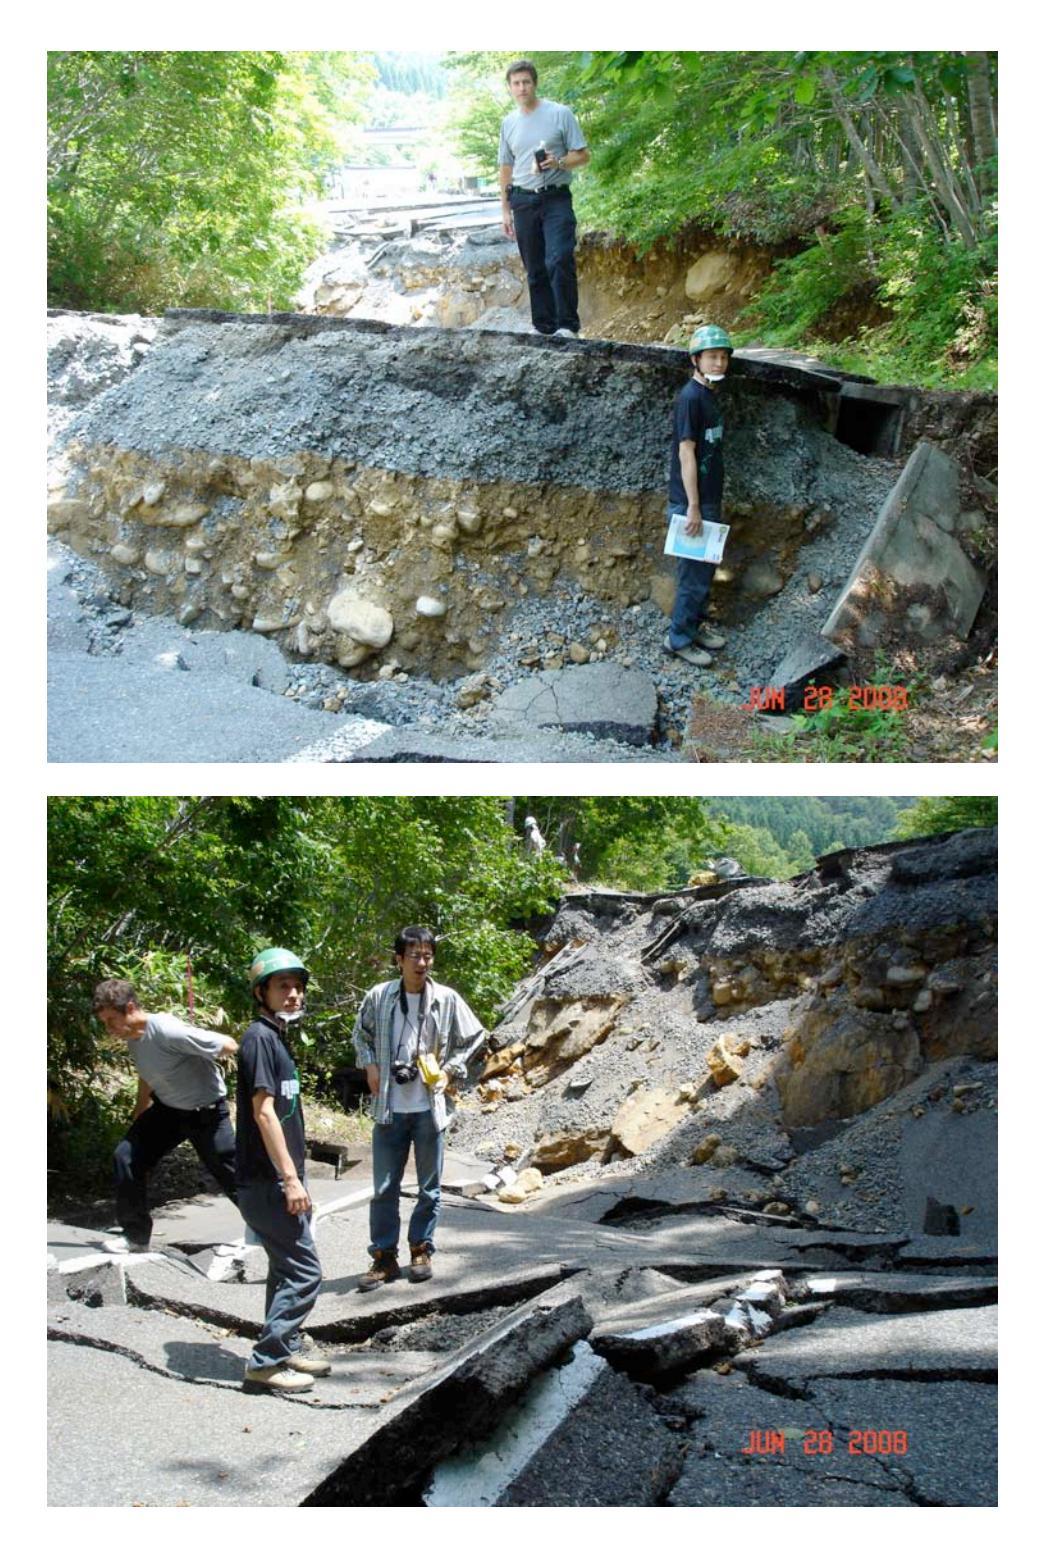
Figure 5.10: Severe road distress on Hwy 342 leading up to the western abutment of the bridge collapse shown in Figure 5.8. The road was pulled apart in the form of extensional grabens over a distance of approximately 100 m leading up to the bridge. The grabens had vertical faces ranging from 2 - 3 m high (Site S35, N39.01449° E140.87741°, 6/28/08 10:23).

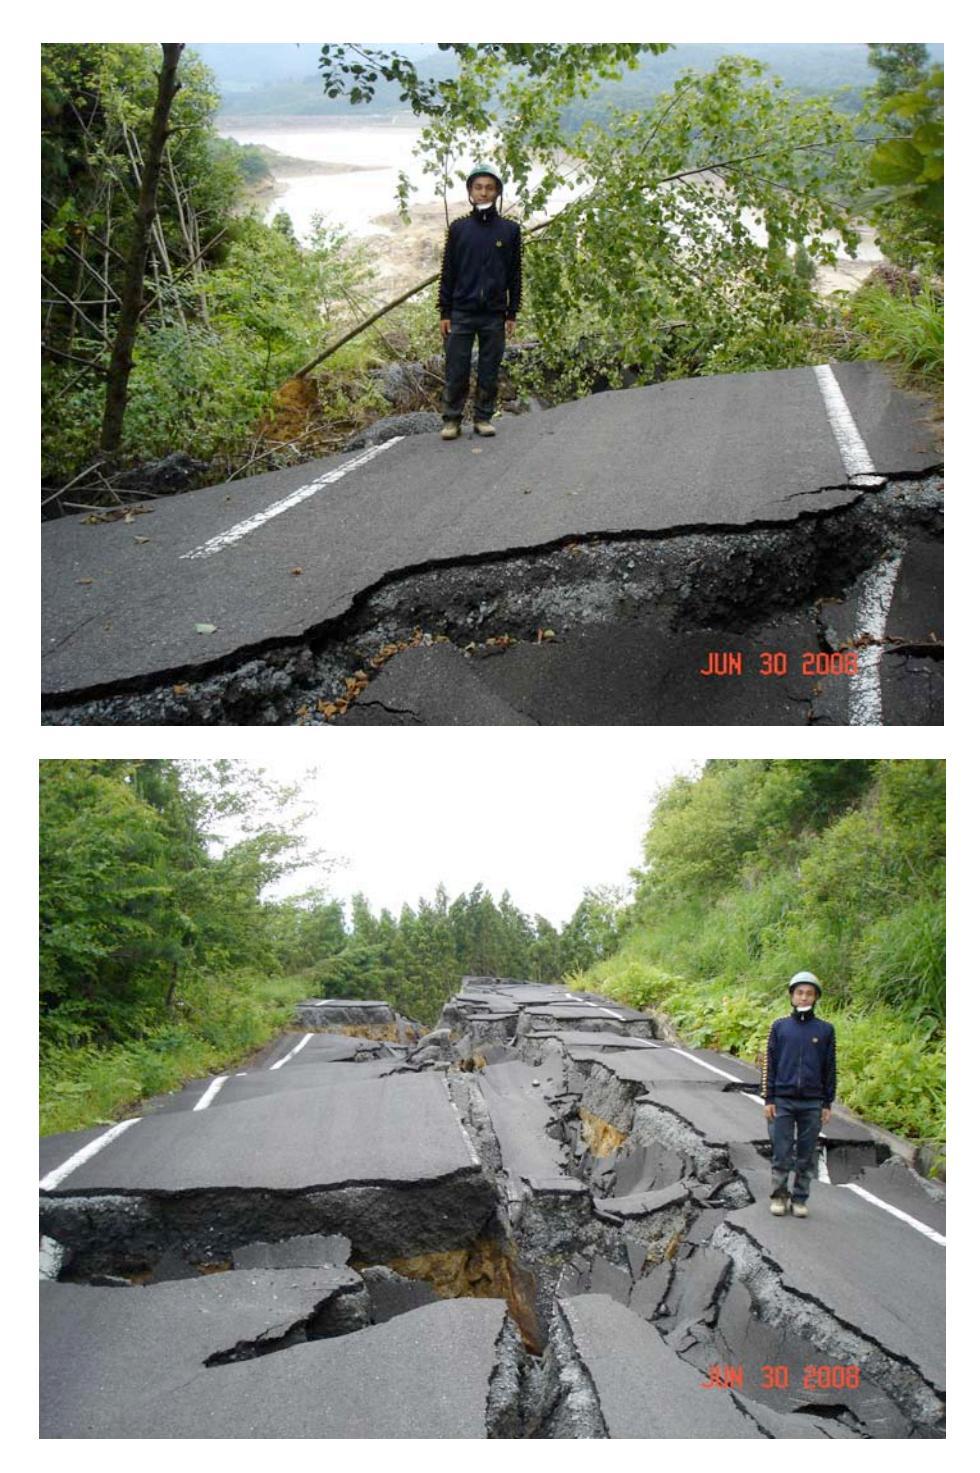
Figure 5.12: Photographs showing the condition of the road along the set of switch-backs that remained relatively intact after being displaced approximately 300 m to the southeast by the Aratozawa Dam landslide (the switch-back portion of the road can be seen in the center of the post earthquake photograph in Figure 5.10). The top photograph is a view looking due south from the southern-most tip of the intact switch-back section. The reservoir can be seen in the background. The bottom photograph was taken in the middle of the switch-back section (Site S72, N38.89557° E140.8531°, 6/30/08 16:30).

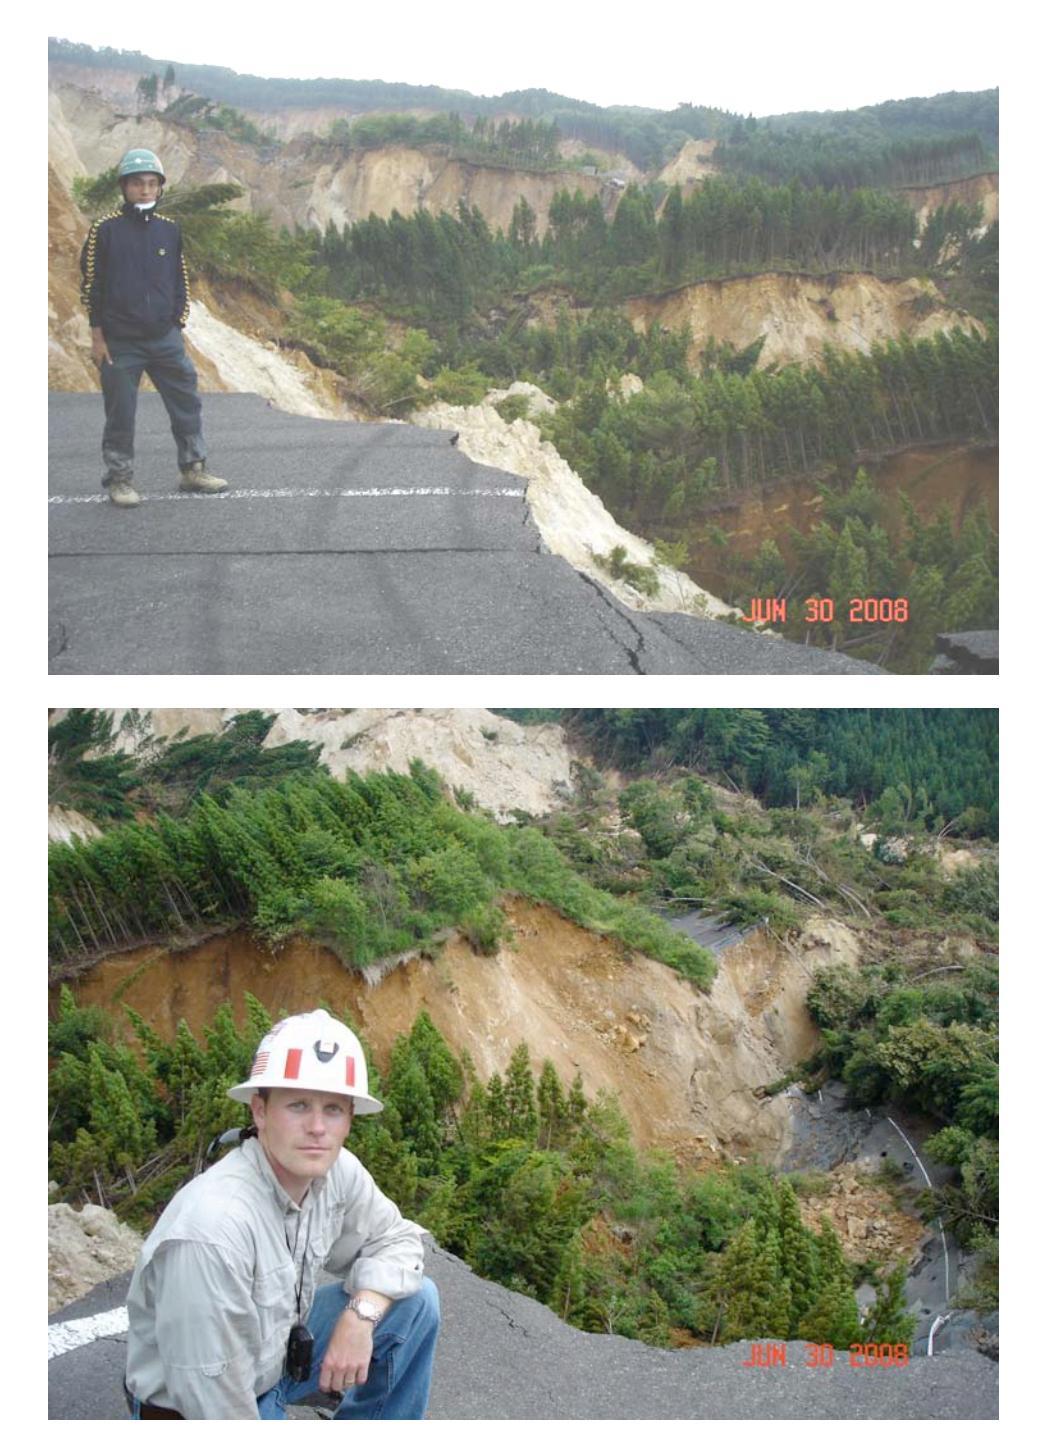
Figure 5.13: Photographs showing the condition of the road along the set of switch-backs that remained relatively intact after being displaced approximately 300 m to the southeast by the Aratozawa Dam landslide. The top photograph is a view looking due north from the northern-most tip of the intact switch-back section. Multiple large blocks within the landslide can be seen in the background. The bottom photograph was taken at the same location; however, it shows a view to the east along the travel path of the former roadway. The road at this point was displaced downward by approximately 50 m. Sections of the road can be seen in the background

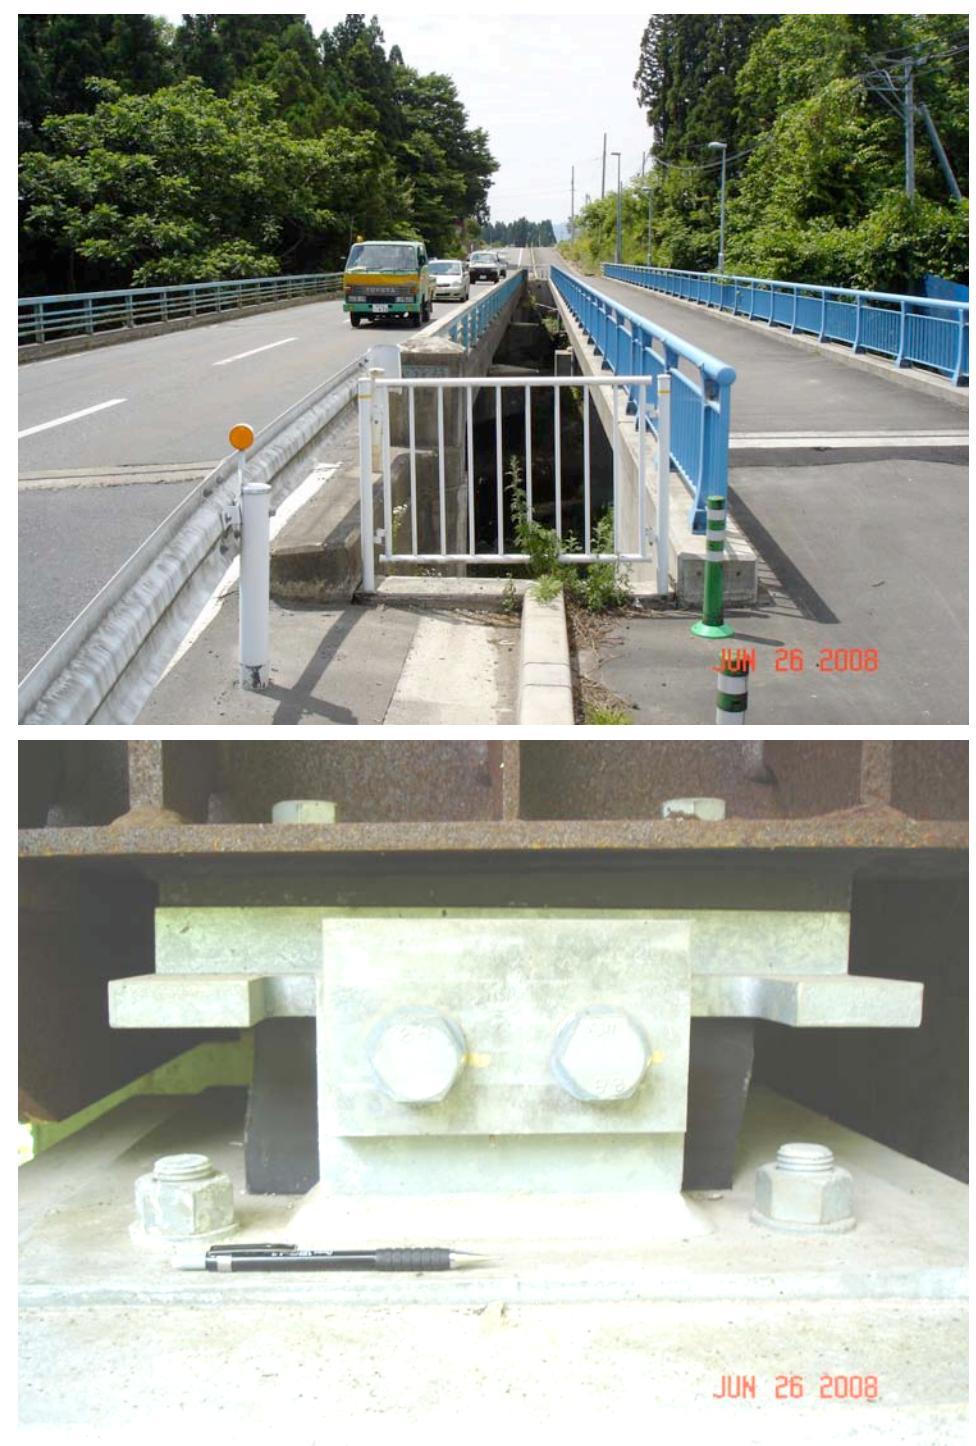
Figure 5.14: Nudo bridge on Hwy 342 (top photo) showed no signs of damage following the earthquake. However, the elastomeric bearings (bottom photo) on each side of the newer pedestrian foot bridge (blue handrails on the right-hand side of the top photo) showed permanent lateral offset of approximately 1 cm over the 10-cm bearing height. The older automobile bridge was not supported on elastomeric bearings and showed no signs of distress (Site S1, N38.96254° E141.00877°, 6/26/08 13:08).

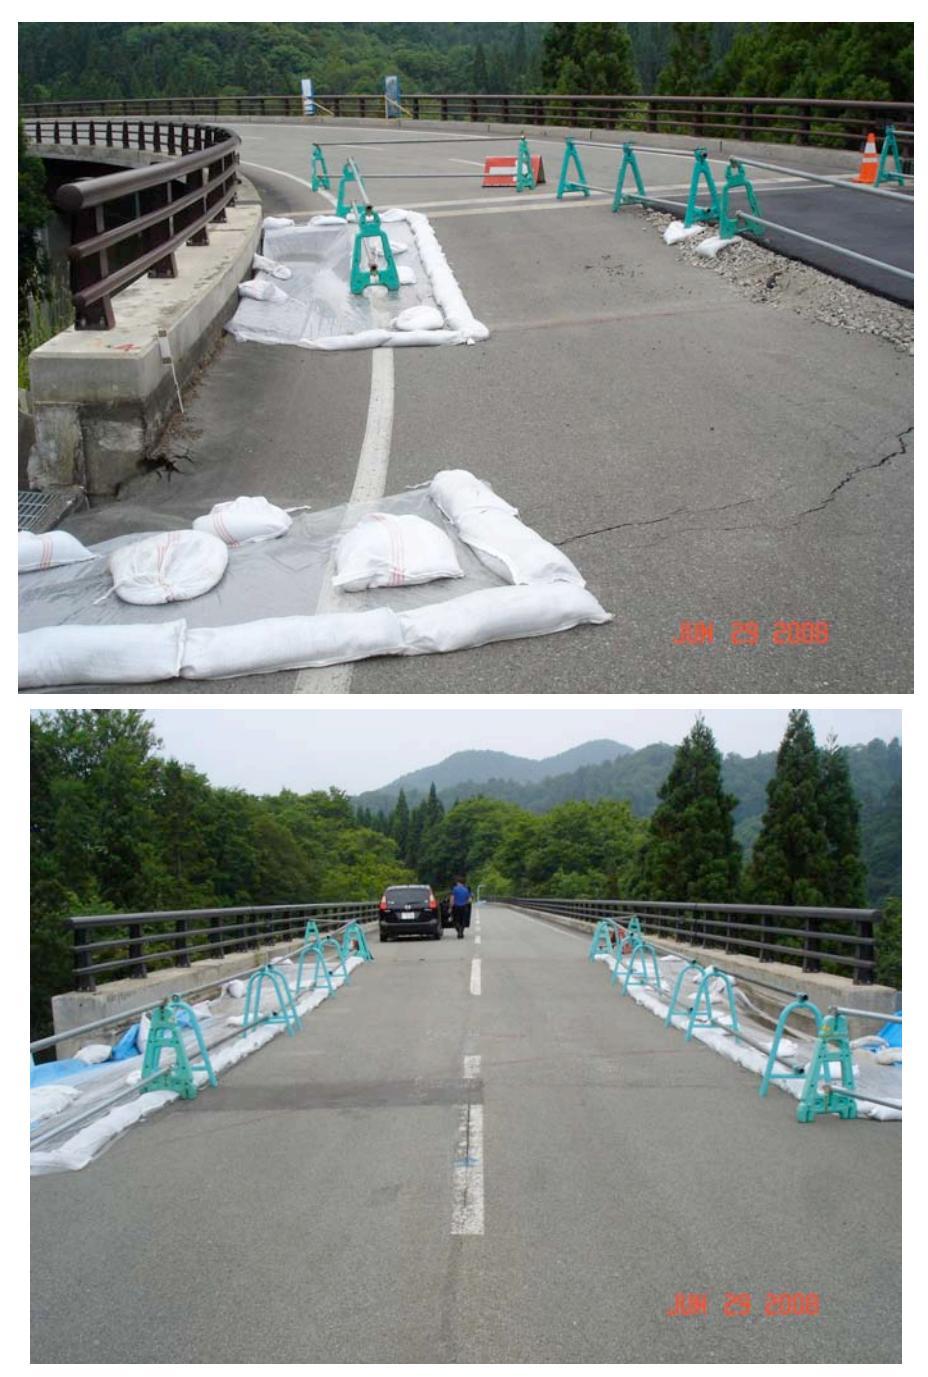
Figure 5.15: Approach fill settlement (seismic compression) occurred on the uphill (northern) embankment on three bridges in close proximity to one another on Hwy 398. The vertical displacements ranged from 23 - 20 cm on each of the three uphill embankments yet were minimal on each of the three downhill (southern) approach fill embankments. Both of the photographs shown above were taken looking from north to south. The top photo shows settlement at one of the three bridges that required a temporary ramp to be constructed onto the bridge, while the bottom photo shows settlement of a similar magnitude on another bridge that was more spread out laterally and did not require a temporary ramp (Site S54, N38.98401° E140.7041°, 6/29/08 13:07).

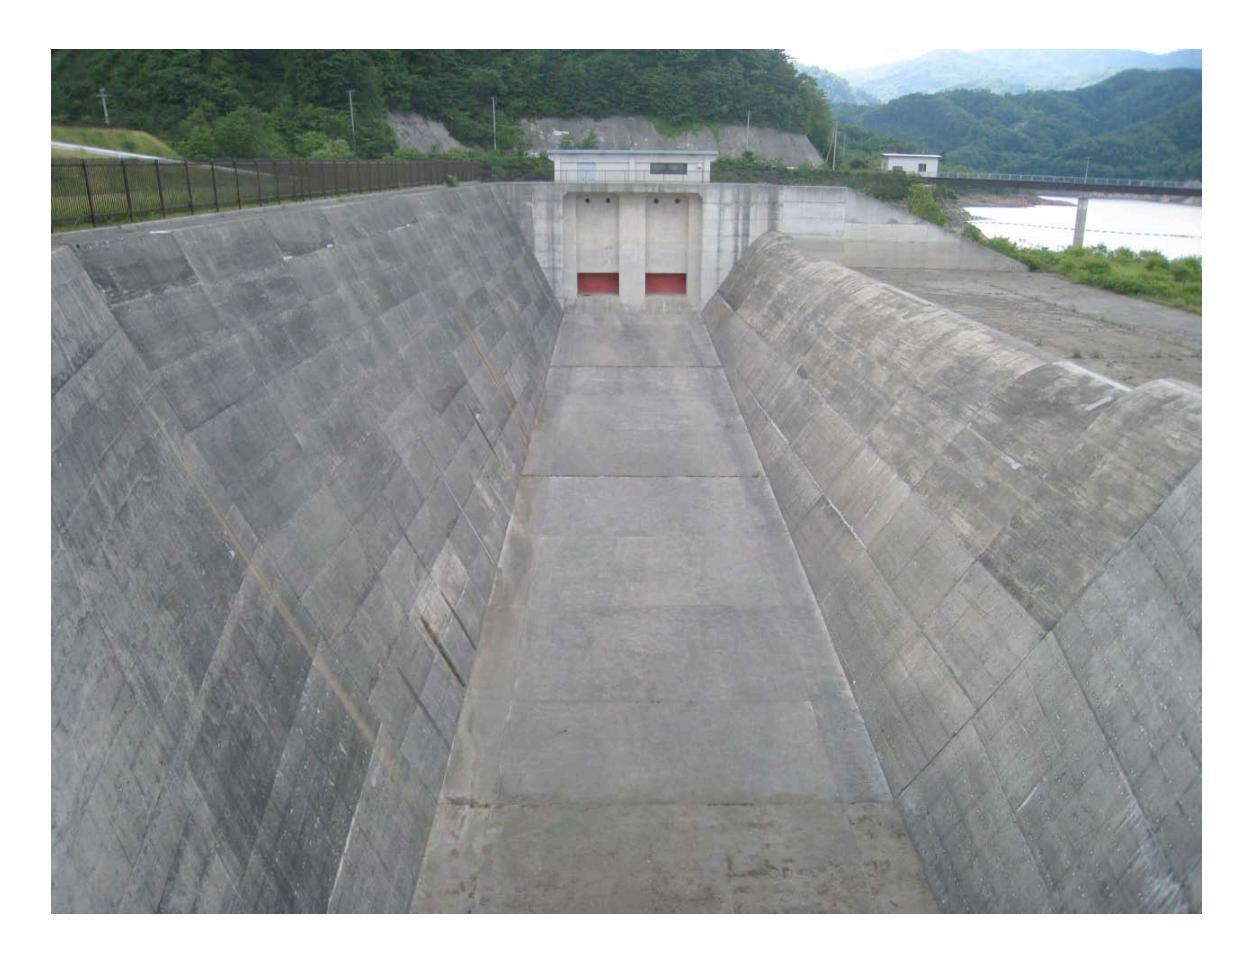
Figure 6.3 Spillway on the south end of Aratozawa dam. The seiche from the landslide entering the reservoir on the north arm sent water over the top of the spillway on the right, and down the concrete water line.

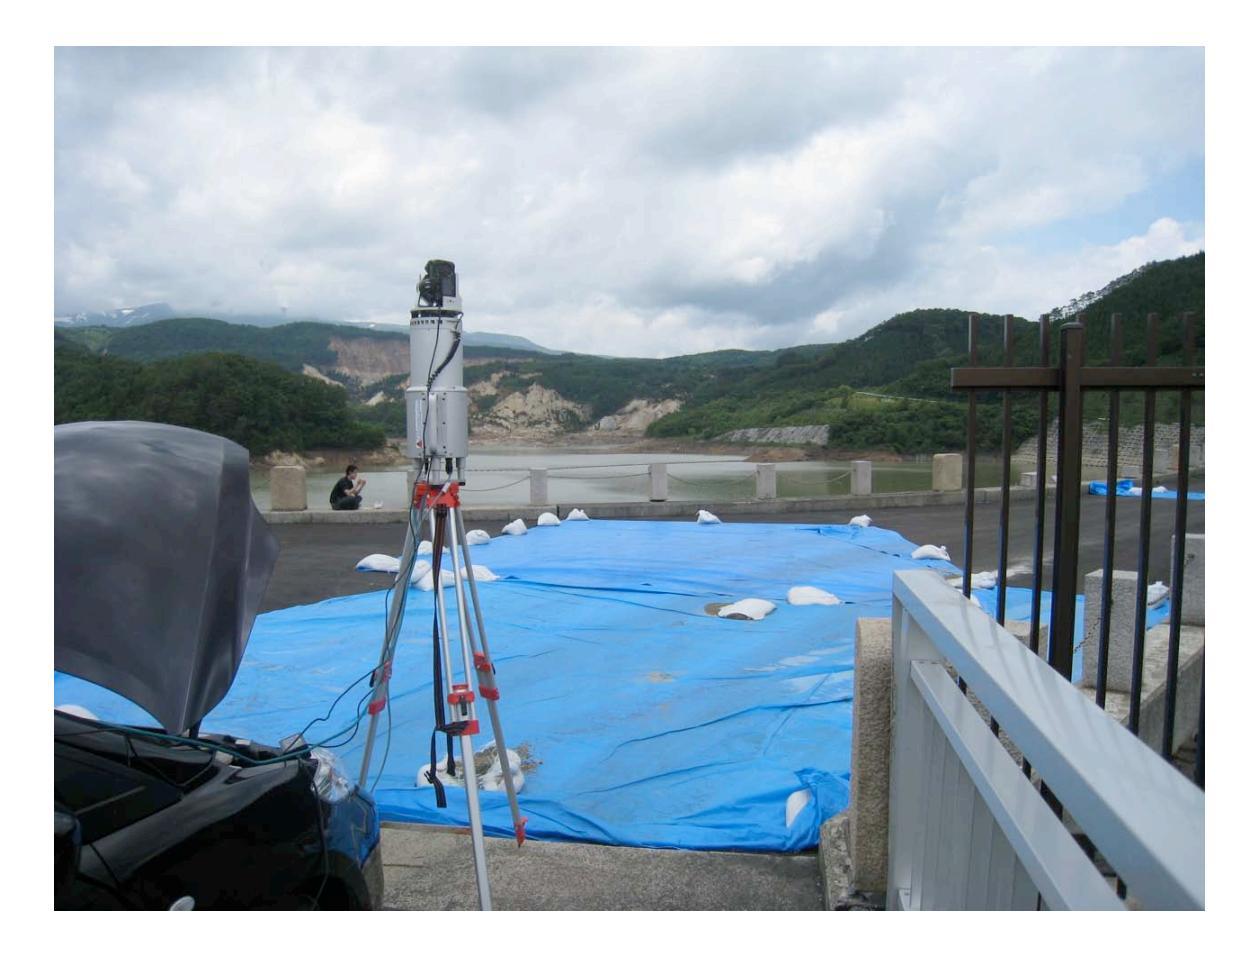
Figure 6.4 Blue tarps on the south end of the crest of the Aratozawa dam adjacent to the spillway. The tarps cover cracks in the pavement. Soil settled along the crest at the edge of the spillway resulting in a step at edge of the concrete and tarp.

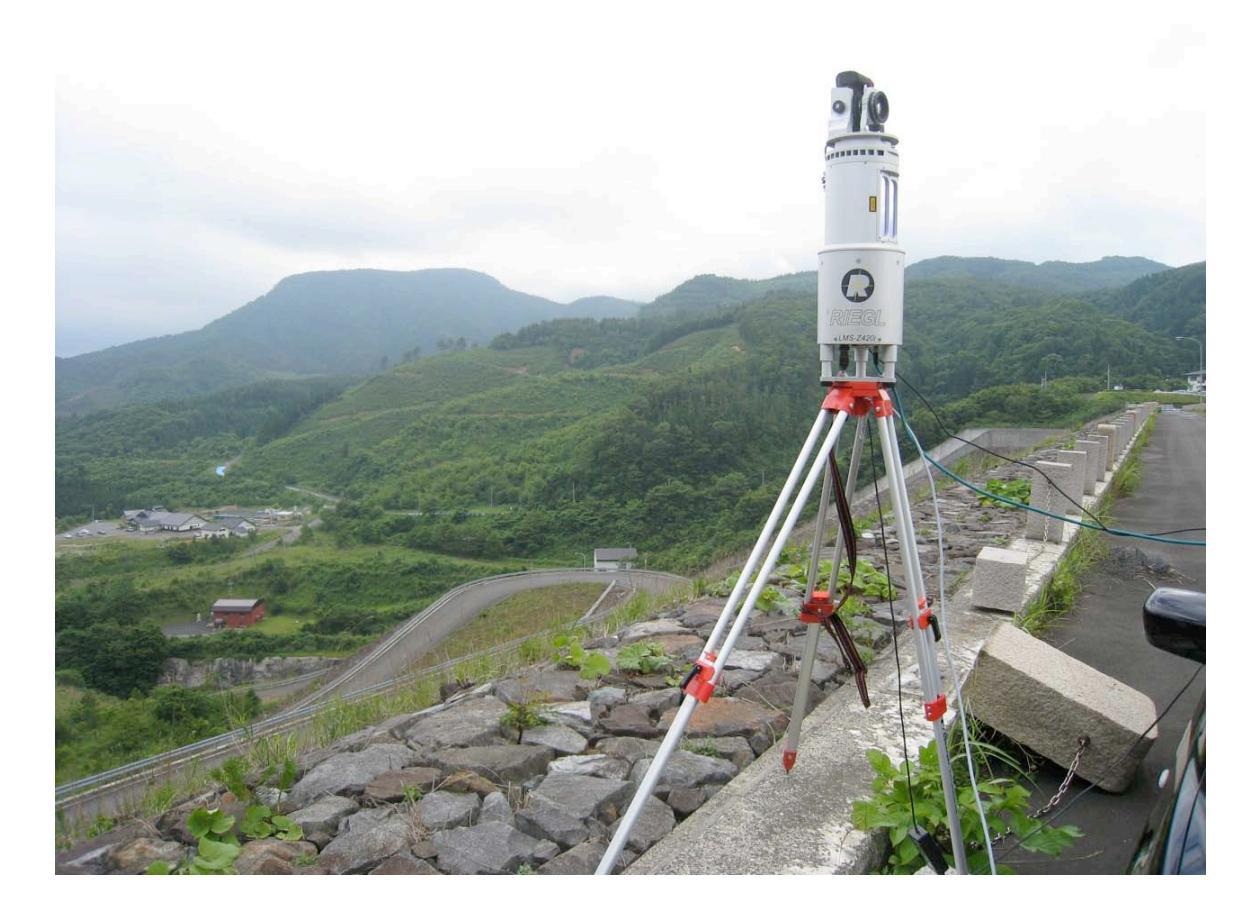
Figure 6.5 Lidar scanner on the northern end of the dam crest, looking east toward the downstream side of the dam. Granite monuments line the roadway of the dam crest and are anchored by a rebar peg. Along the crest, several monuments pulled free of the pegs and collapsed in random directions.

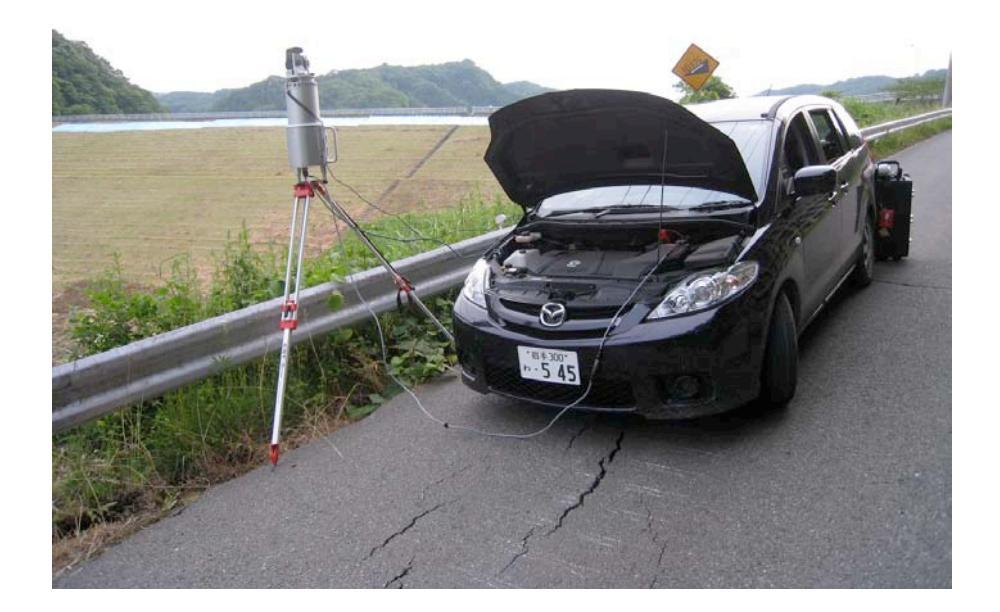
Figure 6.6 Downstream face of Masawa dam, Iwate Prefecture, site 42. Blue tarps cover embankment cracks below the dam crest. The Lidar scanner is imaging the east face of the dam.

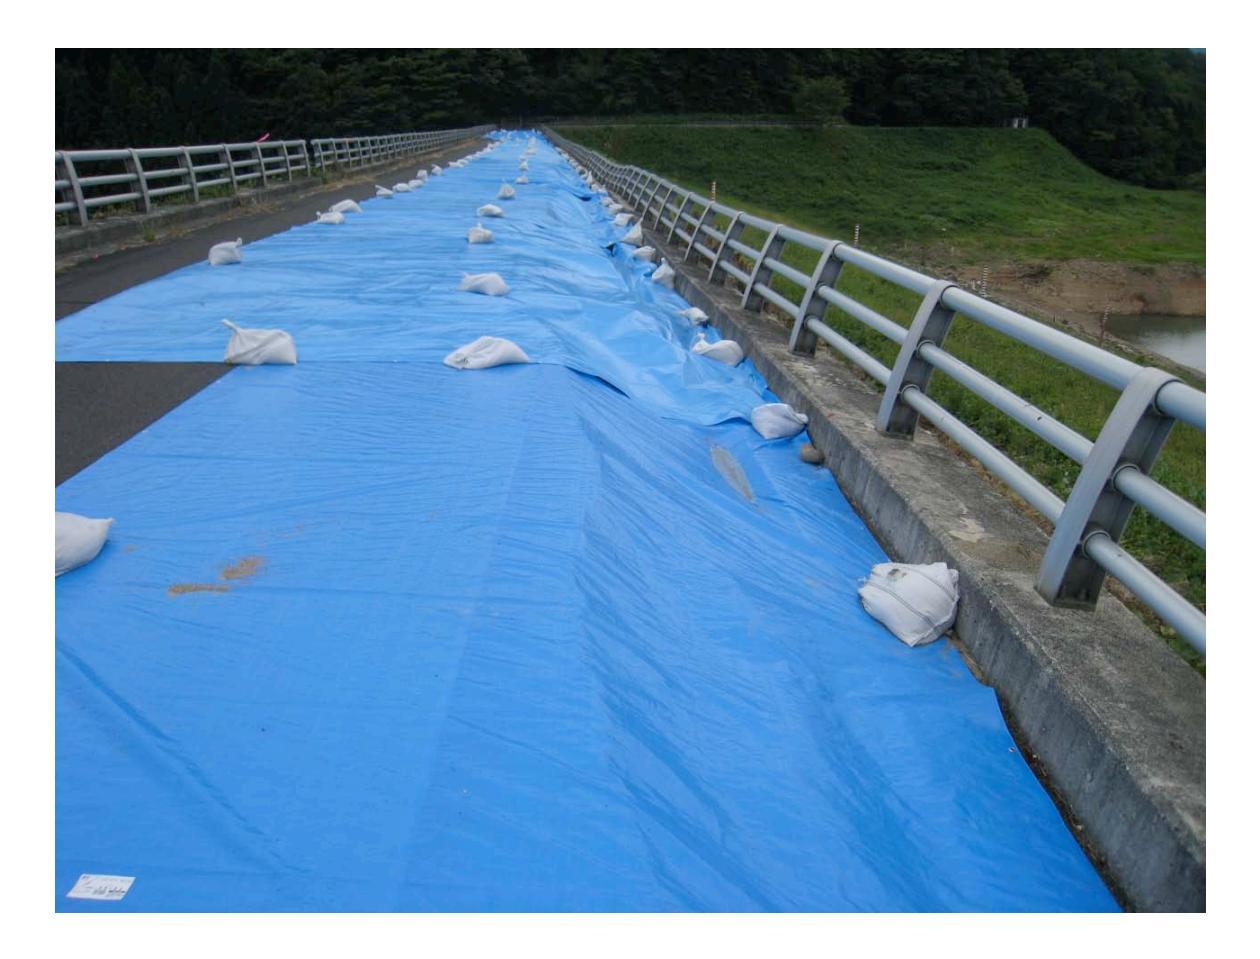
Figure 6.7 Damaged crest of Masazawa dam, the reservoir side is on the west (right). The upstream side of the crest road slid downslope carrying the curb and guard rail.

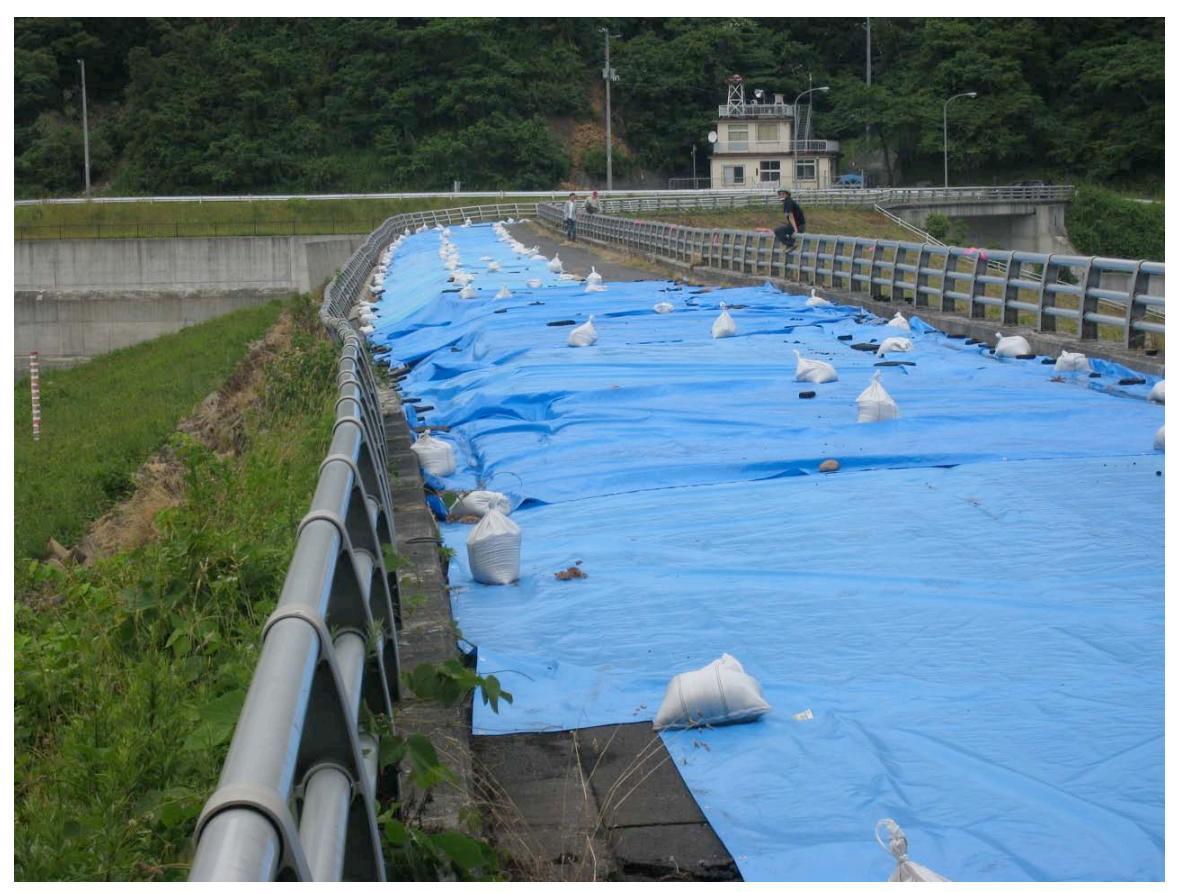
Figure 6.8 The failed upstream side of Masazawa dam crest covered by blue tarps.

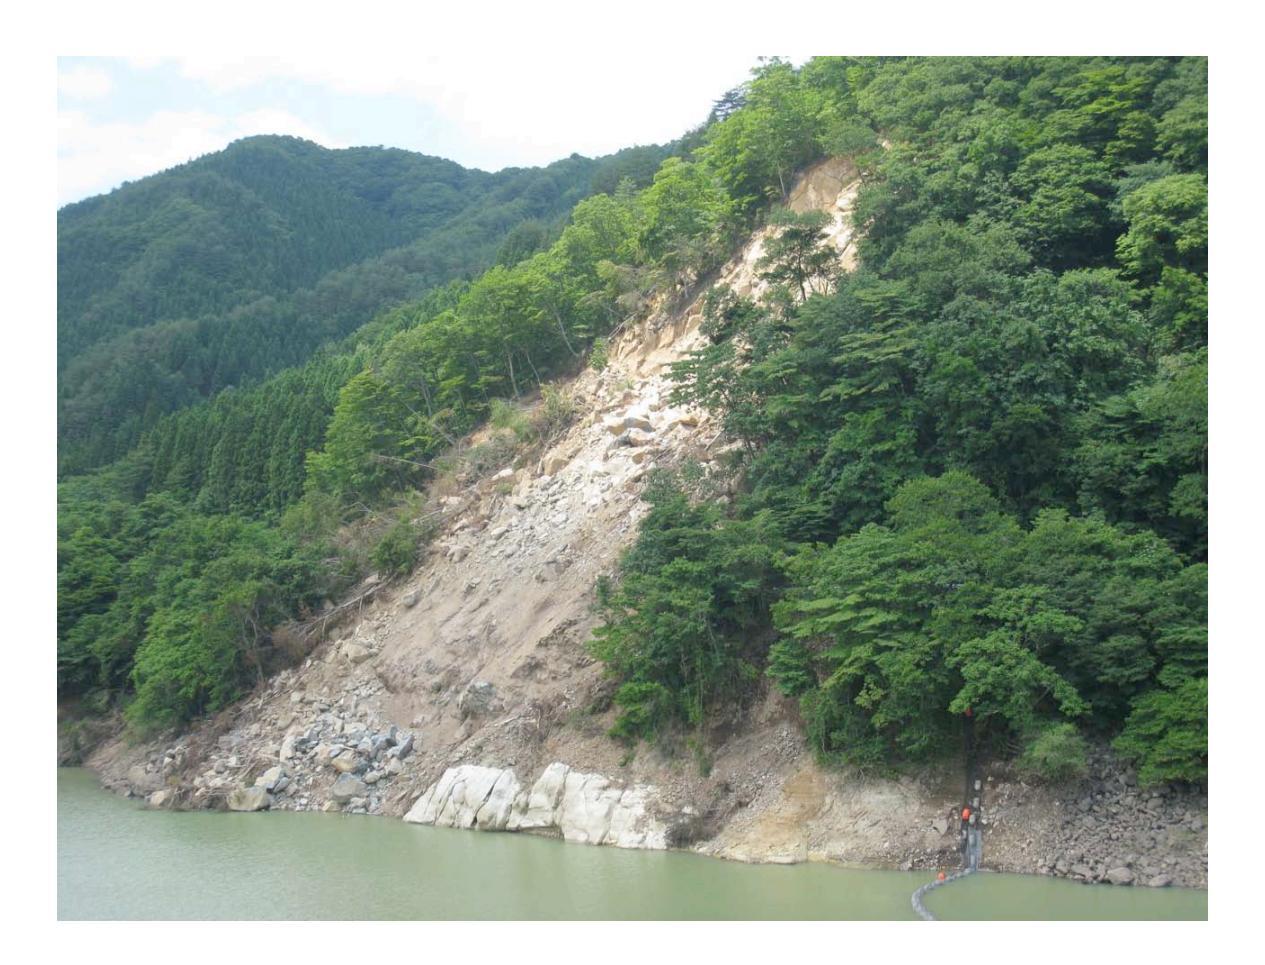
Figure 6.11 A landslide entered the reservoir of Kurikama dam, approximately 150 meters north of the dam.
