# The Geotechnical Aspects of the September 3, 2016 M5.8 Pawnee, Oklahoma Earthquake

Patricia Clayton, George Zalachoris, Ellen Rathje (Univ. of Texas at Austin) Tejo Bheemasetti, Santiago Caballero, Xinbao Yu (Univ. of Texas at Arlington) Scott Bennett (USGS)

Report Date: October 17, 2016

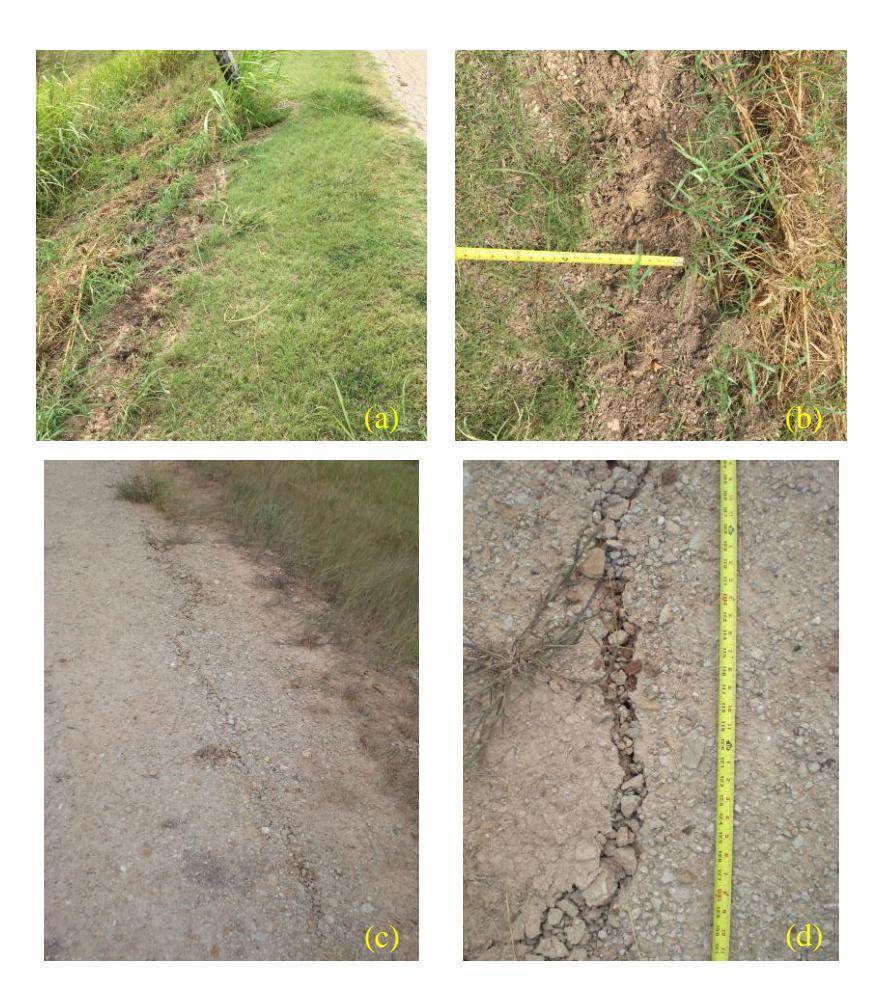
The GEER team visited several earthen dam/levees across the area (Figure 2). In general, the performance of the dams/levees was deemed to be satisfactory. In most cases, no damage was observed. Nonetheless, in two cases (Pawnee Lake Dam and a watering pond dam north-west of the earthquake epicenter), cracks along the downstream slope of the dams were observed. These cracks seemed to have been formed recently, but they cannot be attributed to the September 3<sup>rd</sup> earthquake with absolute certainty.

Figure 6 shows photographs of the cracks observed at the Pawnee Lake dam (Figures 6a and 6b) and the watering pond dam (Figures 6c and 6d). The Pawnee Lake dam is an earthen (sand and gravel) dam along the south side of the Pawnee Lake, which is located just north of the town of Pawnee. A concrete spillway lies at the east side of the dam. Despite the abundance of vegetation along the slopes, and thus the associated difficulty to make observations, a crack on the downstream slope (south side) was visible (Figure 6a). The crack ran approximately one-third of the length of the levee (~50 m) and was roughly 10-20 cm wide. No damage to the concrete spillway was observed. A similar crack was observed at a small earthen dam (sand and gravel) for a cattle watering pond, located on a property north-west of the earthquake epicenter (Figure 6c). The crack ran longitudinally along the downstream (or "dry") slope of the dam. The crack was approximately 15-20 m long and 1-2 cm wide.

Figure 6: Photographs of observed damage on levees/dams: a) Pawnee Lake dam (Latitude: 36.358459°, Longitude: -96.803296°), b) Pawnee Lake dam (Latitude: 36.358647°, Longitude: -96.803036°), c) Watering pond dam (Latitude: 36.436149°, Longitude: -96.963198°), d) Watering pond dam (Latitude: 36.436185°, Longitude: -96.963083°)

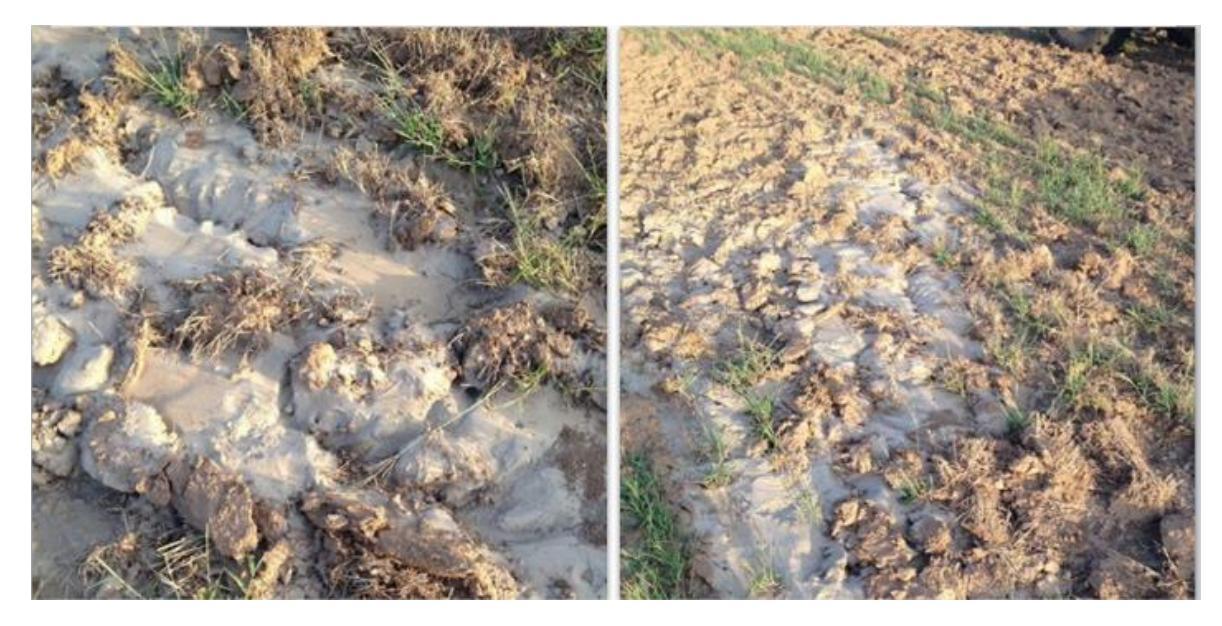
Figure 7: Cracking and sand blow and ejecta located 3.8 km north of earthquake epicenter, just north of Arkansas River (approx. Latitude/Longitude: (36.4640°, -96.9307°)) (photo by Rick Rice – property owner)

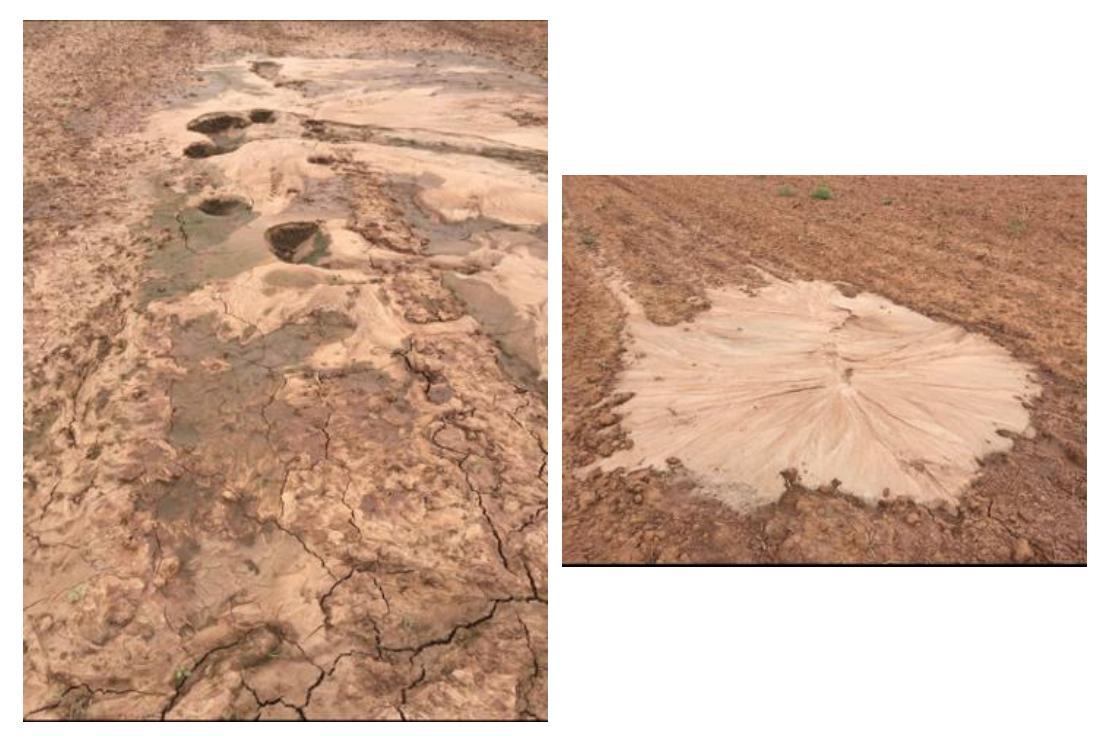
Figure 8: Cracking and sand blow and ejecta located 9.4 km south-east of earthquake epicenter, (approx. Latitude/Longitude: (36.3466°, -96.9307°)) (photo provided by Prof. Todd Halihan – OSU)

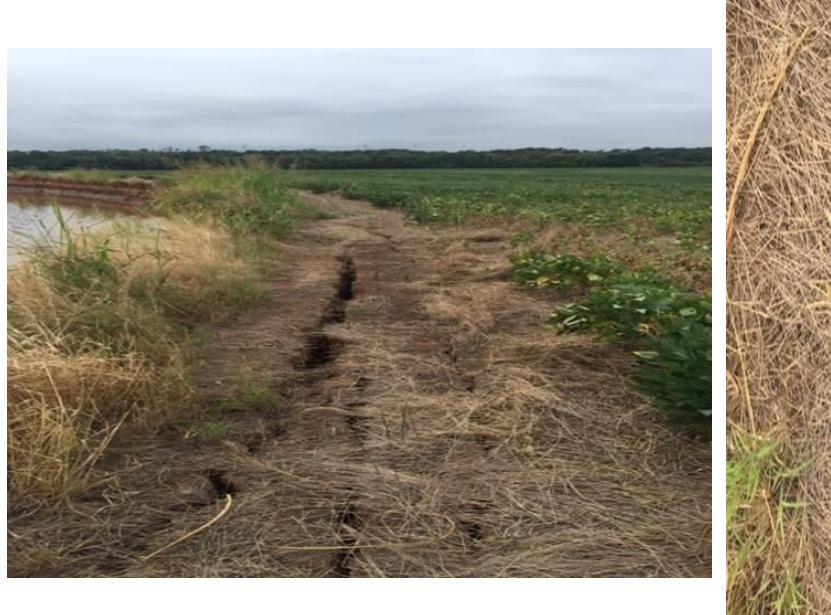
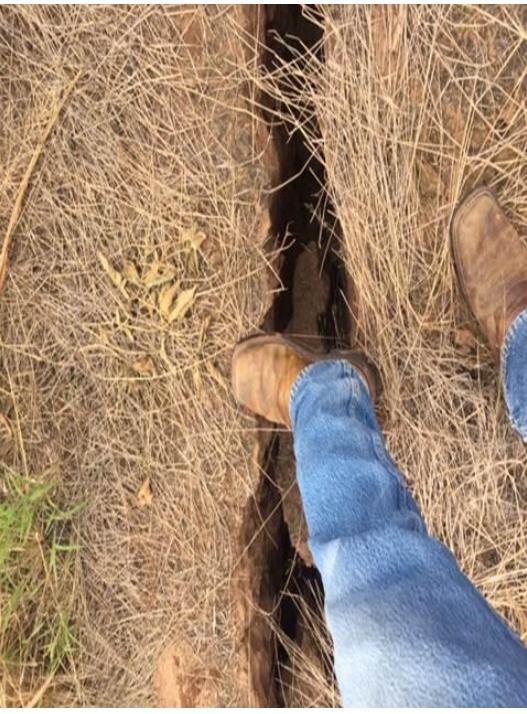
Figure 9: Cracking and lateral spreading along river branch (approx. Latitude/Longitude: (36.4701°, - 96.9926°)) (photo by Martin Williams – property owner)

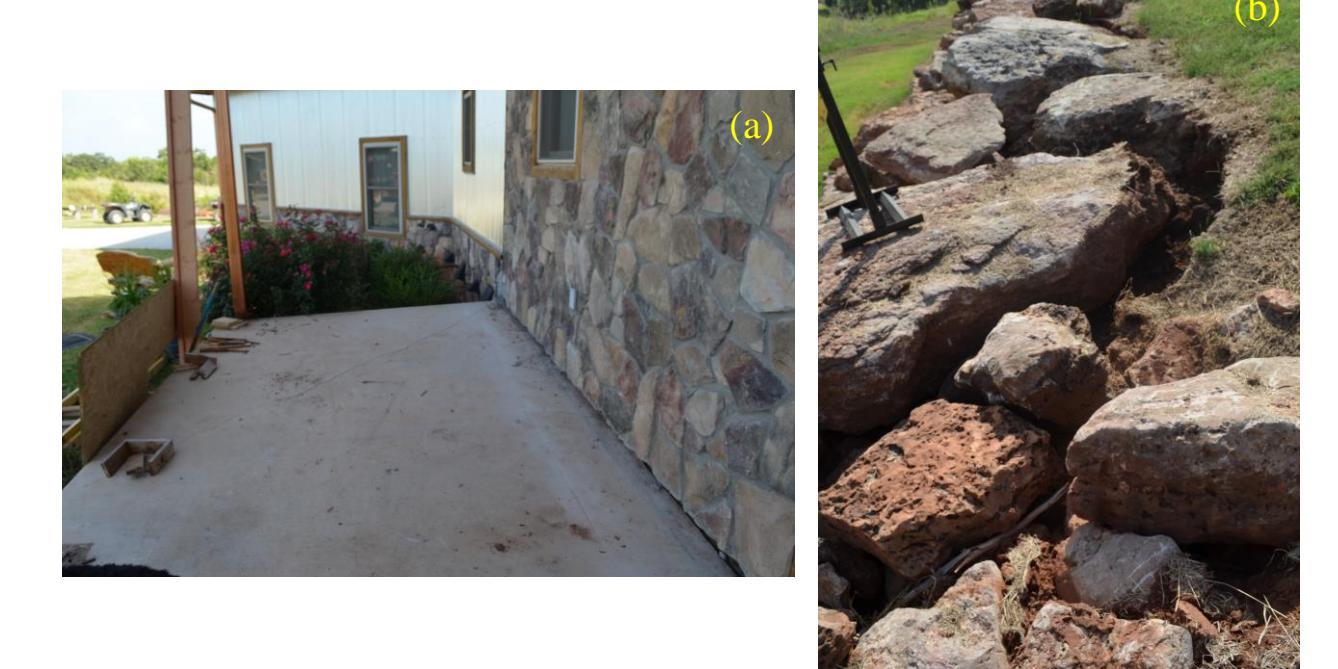
Finally, another ground-related failure was observed at a residential property located approximately 4 km south-east of the earthquake epicenter (Figure 10). The single family house is built on a small slope of approximately 1.5 m high with the first floor against the slope on the back. The site, which consisted primarily of a clayey soil layer of approximately 1 m underlain by lime stone bedrock on a mild slope (~5-8%), experienced ground displacement. It was communicated to us by the property owner that the site was experiencing slump failure before the earthquake,

which was exacerbated by the ground motion. Lateral cracks were identified along the slope on which a residential building is built (Figure 10b). As a result of the slump failure along the slope, the porch of the residency settled by approximately 4 cm (Figure 10a), and cracks were observed on the foundation slab of the garage.

Figure 10: Observations at residential building 4 km south-east of earthquake epicenter (Latitude/Longitude: (36.395482°, -96.909038°)); a) Porch settlement, and b) slope failure on the back of the property

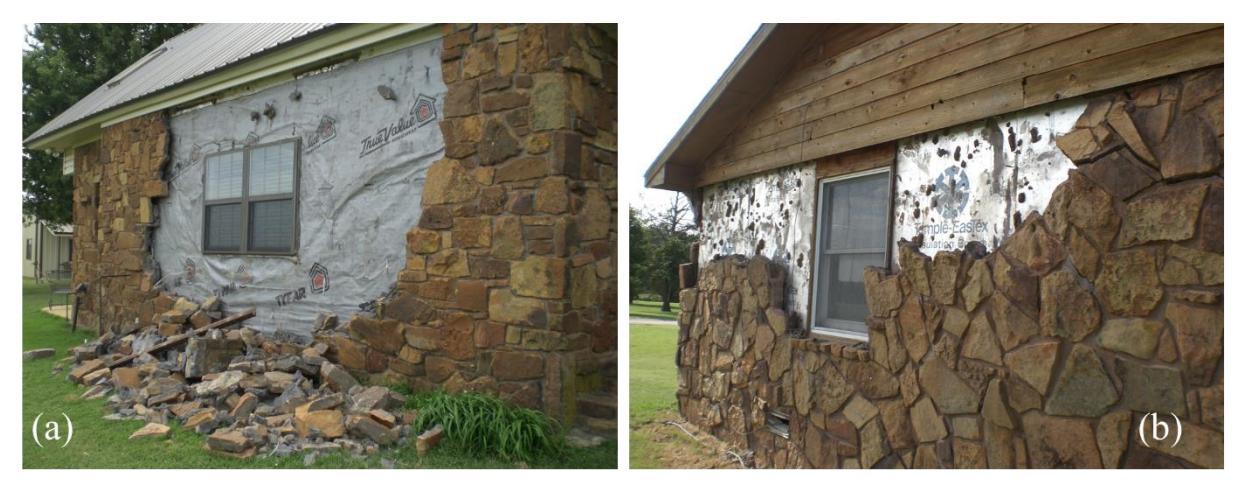
It is worth noting that stone façades are common for residential buildings in the area. Several examples of stone façade collapse or partial collapse were observed. The façade in Figure 11a did have some metal strap anchors sporadically spaced at 1 to 3 m intervals; however, these anchors did not provide adequate bracing and remained attached to the structure after failure of the façade. In other observed instances of façade failure (e.g., Figure 11b), the stone façade was constructed as a free standing wall adjacent to the house, with no mechanical anchorage to the structure. Local residents indicated that this is a common construction practice in the area. One residence located approximately 2.5 km north-east of the epicenter had, according to the owner, a foundation built on clay and experienced widespread damage to the unanchored rock façade. The owner indicated that the neighboring home to the north, which is located on top of a hill and had a foundation on rock (according to the homeowner's observations during construction), had no observable damage to its brick façade. Despite the difference in façade construction between the two homes, this anecdotal observation may provide evidence of site effects, with more severe damage being observed to the house on the clay site.

Figure 11: Observations of rock façade failure: a) Latitude/Longitude: (36.5038°, -96. 8592°); b) Latitude/Longitude: (36. 3723°, -96. 883°)

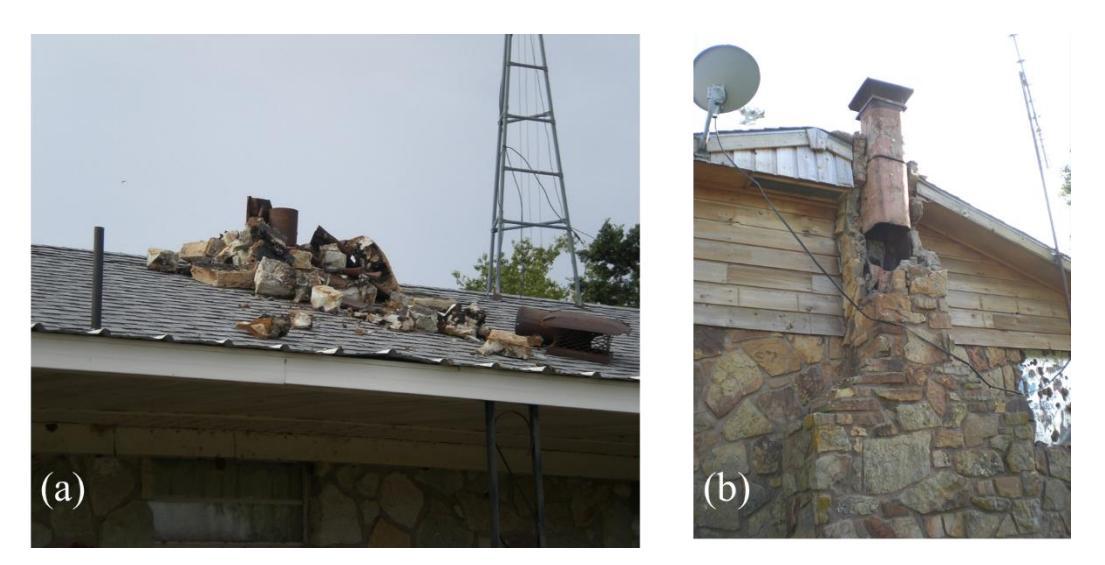
Figure 12: Observations of chimney failure: a) Latitude/Longitude: (36. 4350°, -96. 9269°); b) Latitude/Longitude: (36. 3723°, -96. 883°)

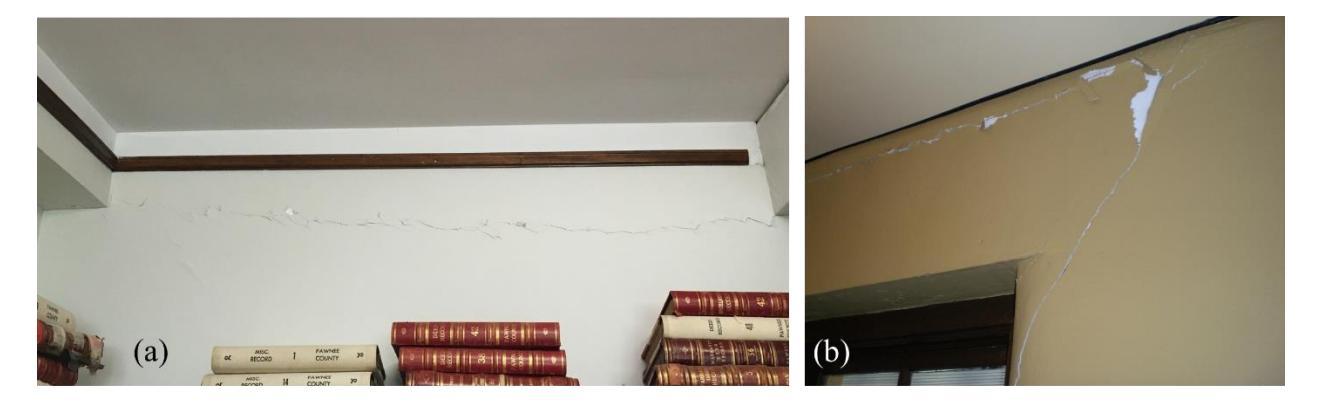
Figure 13: Observations of cracking of interior plaster finishes: a) in the historic Pawnee County Courthouse (Latitude/Longitude: (36. 3385°, -96. 8028°)) b) in a historic Pawnee Nation building (Latitude/Longitude: (36. 3347°, -96. 7904°))

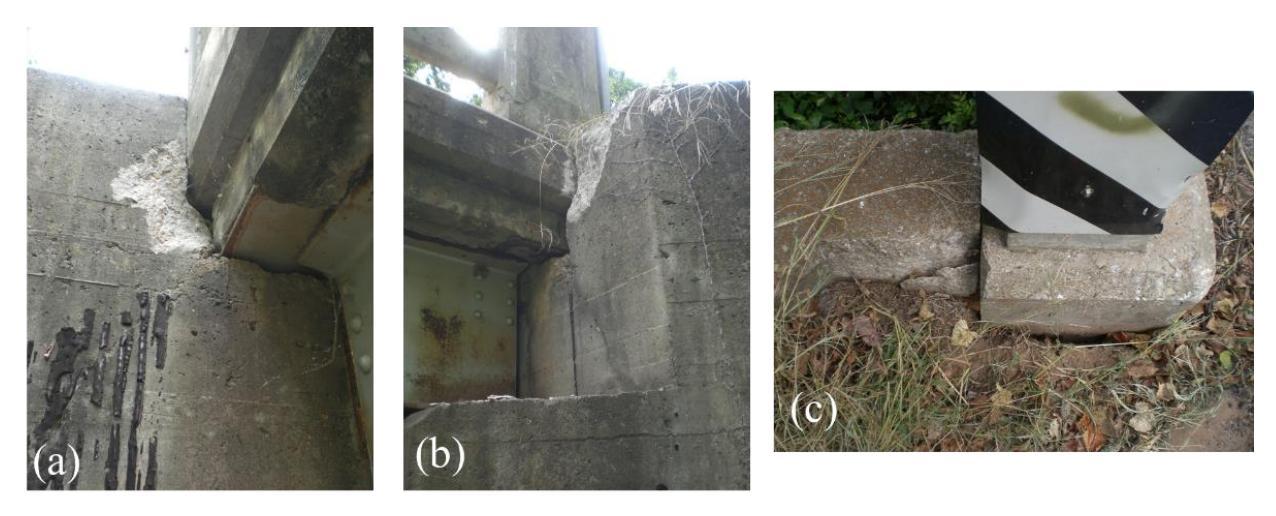
Only one bridge that the GEER team visited was observed to have relatively minor damage. This bridge was and old (ca. 1927) steel truss bridge, locally known as the "Belford Bridge," that crossed the Arkansas River (Latitude/Longitude: (36.5039°, -96.8441°)). Some spalling of cover concrete was observed on top of the abutments (Figures 14a and b), which may be attributed to pounding between the bridge deck and abutment. There was also evidence of gapping between the backfill soil and the abutment backwall as shown in Figure 14c. Cracks of approximately 1 to 2 cm in width were also observed in the soil beneath the bridge at both abutments. The cracks were parallel to the abutments and were approximately 1.3 m from the abutment walls as shown in Figure 15.

The west abutment has steel plate bearings supporting the simply-supported steel girder approach spans, while the east abutment has steel pin bearings supporting the pony-truss approach span. The condition of the bearings at both abutments were consistent with the age of the bridge and expected weathering. In general, due to the age of the bridge, it was difficult to tell what, if any, of the bearing condition was affected by the earthquake.

Figure 14: Observations of damage at the West Abutment of Belford Bridge (Latitude/Longitude: (36.505°, -96. 8493°)): a,b) concrete spalling of abutment; c) approx. 4 cm wide gap between backfill soil and abutment

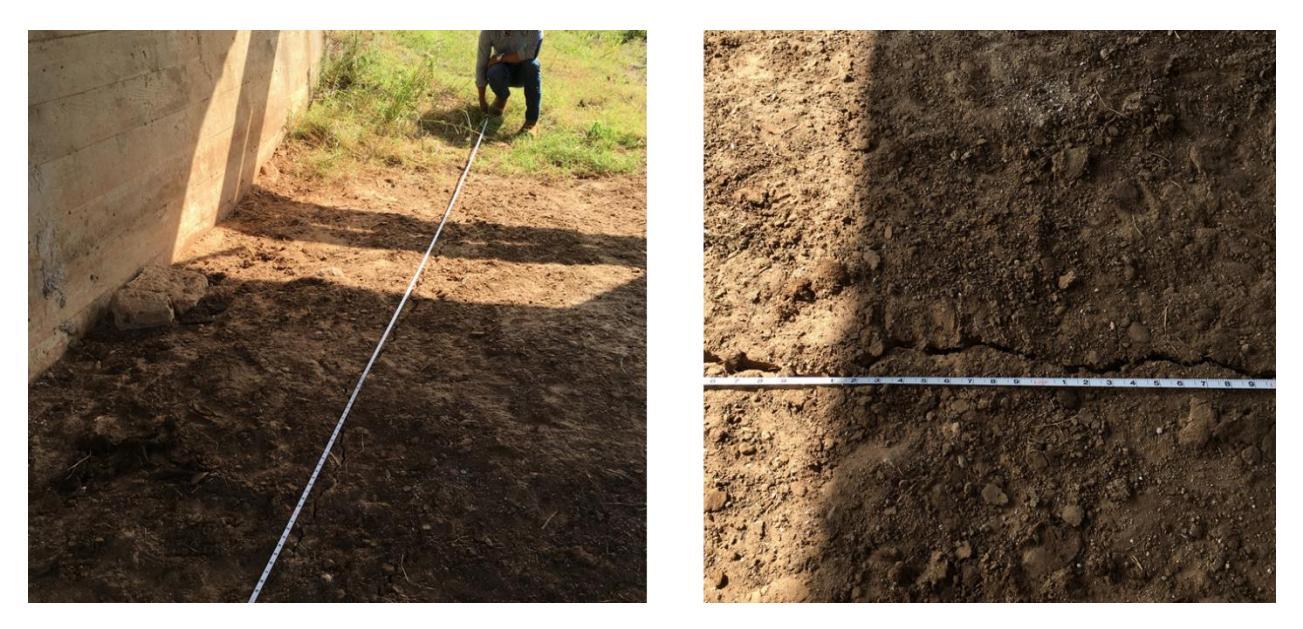
Figure 15: Observations of soil cracking at the East Abutment of Belford Bridge (Latitude/Longitude: (36.5032°, -96. 8424°))
