# **CHAPTER 12**

## **Community Preparedness & Response**

**GEER/EERI/ATC Cephalonia, Greece 2014**  
**Report Version 1**

# 12 Community Preparedness and Response

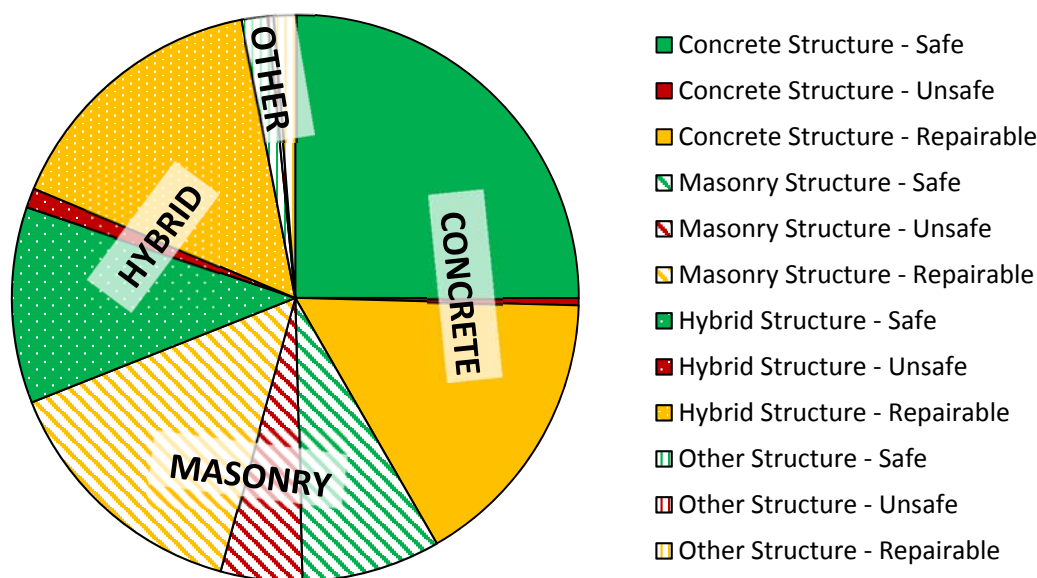
**Figure 12.1.** Results of detailed assessment of 2,770 buildings (see Chapter 11 for details).

During the 2014 two main seismic events of January 26<sup>th</sup> (M<sub>w</sub> 6.1) and February 3<sup>rd</sup> (M<sub>w</sub> 6.0), some structural damage occurred, mostly during the 2<sup>nd</sup> earthquake. Damage assessment survey efforts were led by the Greek Seismic Rehabilitation Agency (YAS) in two phases: rapid (in 4,865 buildings) and detailed (in 2,770 buildings), mostly by teams of structural engineers who work for public agencies, explained in detail in Chapter 11. According to the Hellenic Earthquake Rehabilitation Services (HERS), the detailed assessment (shown in Fig. 12.1) tagged 46% of the buildings as safe (green), 48% as temporarily unsafe (yellow), and 6% as unsafe (red). Of the 180 red buildings, 5% were made of reinforced concrete, 73% were masonry, 17% were hybrid concrete-masonry, and 5% were other types, which indicated that masonry buildings suffered the most. Geographically, 76% of the red and 60% of the yellow buildings were in the Paliki peninsula area. By use and occupancy, 52% of the red buildings were farm storage, warehouses, stables, etc., or had been abandoned, 39% were residential buildings and 9% were commercial buildings such as offices.
