#### 4. LIQUEFACTION AND LATERAL SPREADING

A distinctive feature of the  $M_w$ 7.1, 4 September 2010 and the  $M_w$ 6.2, 22 February 2011 earthquakes was the severity and spatial extent of induced liquefaction in native soils (e.g., Cubrinovski et al., 2011a,b; Green et al, 2012). Figure 4-1 shows the areas that liquefied in both events and the associated fault ruptures. While both earthquakes induced extensive liquefaction, the February event was more devastating to central and eastern Christchurch due to the close proximity of the fault rupture. Immediately after the 22 February 2011 earthquake (i.e., from 23 February to 1 March) an extensive drive-through reconnaissance was conducted to better map the severity of liquefaction in a consistent and systematic manner. The resulting liquefaction documentation map is shown in Figure 4-2. Three areas of different liquefaction severity are indicated: (a) moderate to severe liquefaction (red zones), (b) low to moderate liquefaction (yellow zones), and (c) liquefaction predominantly on roads with some on properties (pink zones). Traces of liquefaction were also observed in other areas. The suburbs to the east of the CBD along the Avon Ri

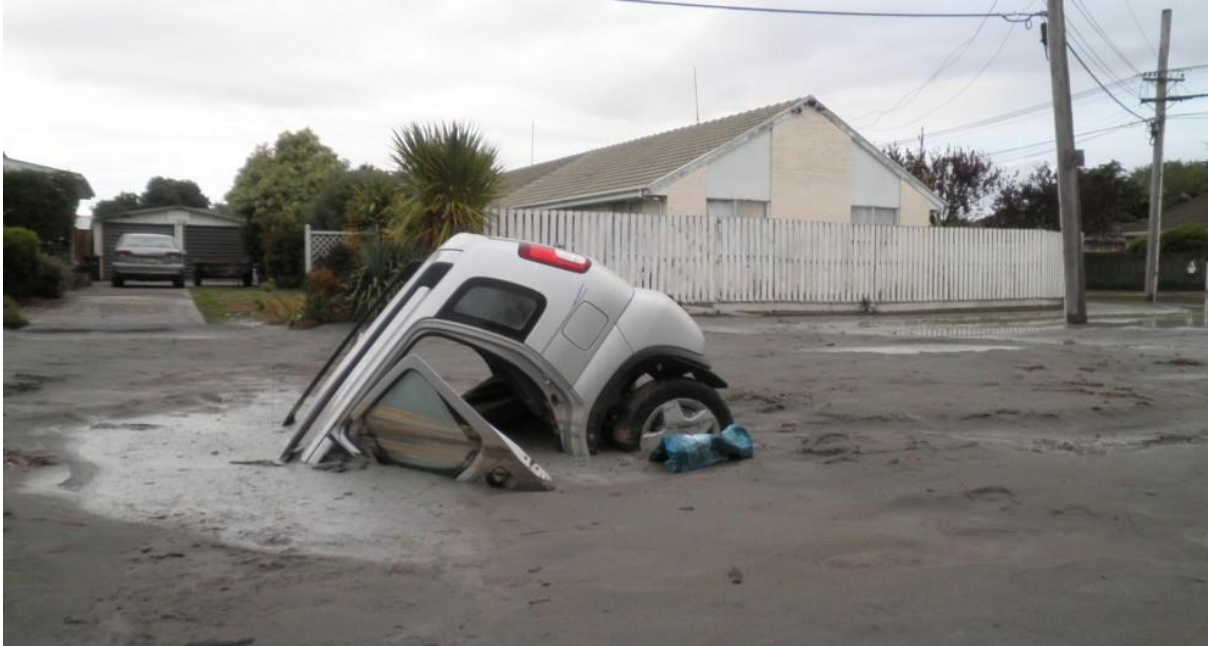
Figure 4-4. Example of severe liquefaction near the intersection of Shortland St and Rowses Rd in the eastern suburb of Aranui. Note the high water marks on the car door window. (-43.521919°, 172.701885°, photo courtesy of Mark Lincoln, nzraw.co.nz)

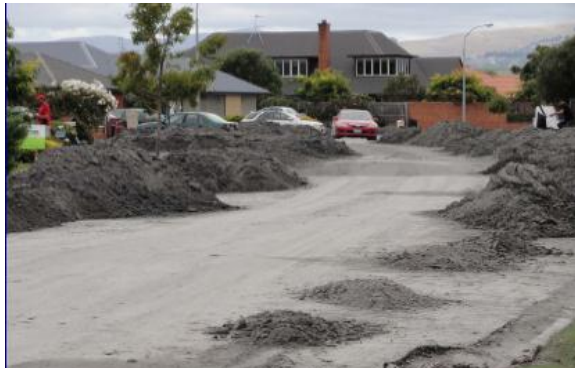
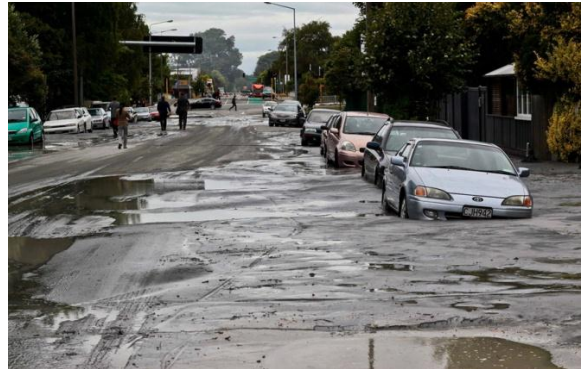
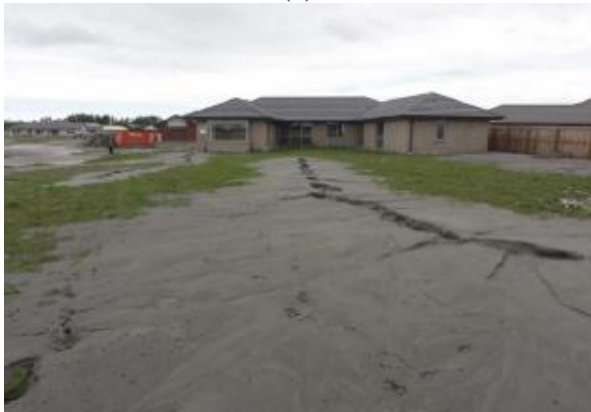
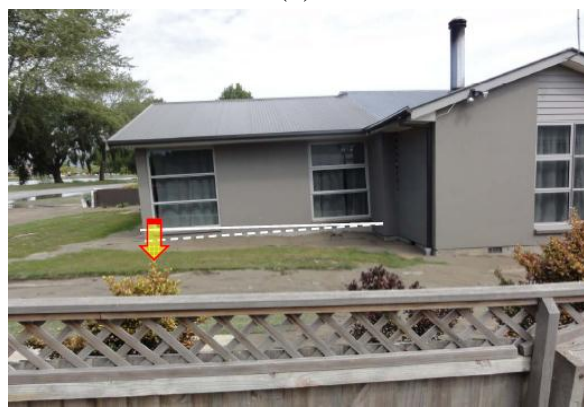
Examples of damage as a result of liquefaction in the residential areas are presented in Figure 4-5, with the volume of ejected material in residential properties indicated by the piles of sand in Figure 4-5a, a typical view in many streets following the Christchurch earthquake. Figure 4-5b provides a good indication of the flooding and ejected material in the streets themselves immediately following the earthquake. The large sand boils in Figure 4-5c, about 20-30 m long

and 10-15 m wide, indicate both a large severity and extent of liquefaction throughout the depth of the deposit. Figure 4-5d shows typical differential settlement and damage to the building due to separation of walls as a result of loss of bearing capacity of the liquefied foundation materials.

Figure 4-5. Typical manifestation of liquefaction in residential areas.

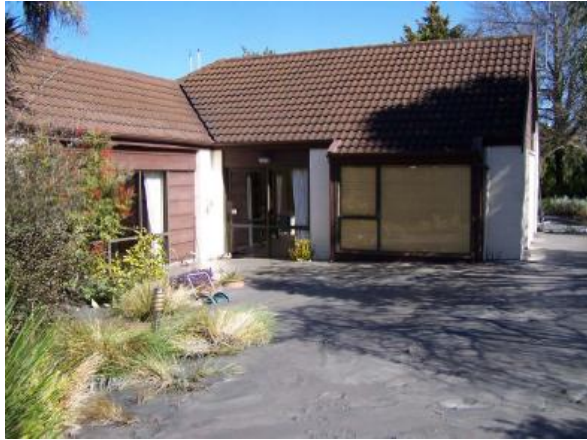
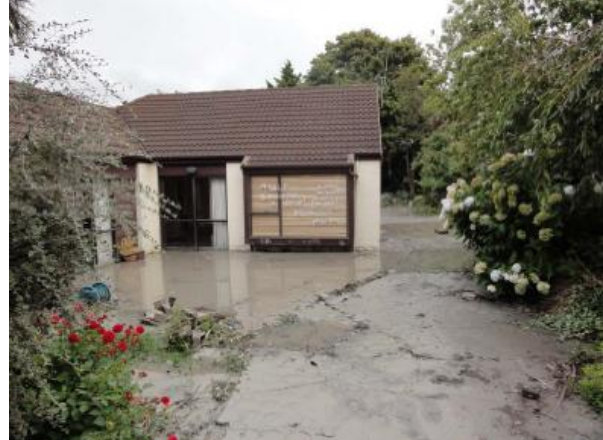
Figure 4-6 shows the damage to a residence in North Kaiapoi after both the Darfield and Christchurch earthquakes. Following the Darfield earthquake there was large settlement of the ground and house, and approximately 40 cm of ejected material covering the ground surface. Site investigations performed following the Darfield earthquake indicated loose/soft soils up to depths of 9 m. Ground motions were largest in Kaiapoi during the Darfield earthquake and lesser in the Christchurch earthquake (PGA's of approximately 0.33 g and 0.21 g, respectively). Despite this, Figure 4-6b shows that the volume of ejected material following the Christchurch earthquake was again significant, and highlights the potential for repeated liquefaction during multiple earthquakes of the typical soil deposits in the region. A smaller volume of ejected material was again evident at this site following the 13 June 2011 earthquakes.

Figure 4-6. Illustration of a house in North Kaiapoi which sustained liquefaction in both the (a) 4 September 2010 Darfield; and (b) 22 February 2011 Christchurch earthquakes. (-43.38535°, 172.6701°)

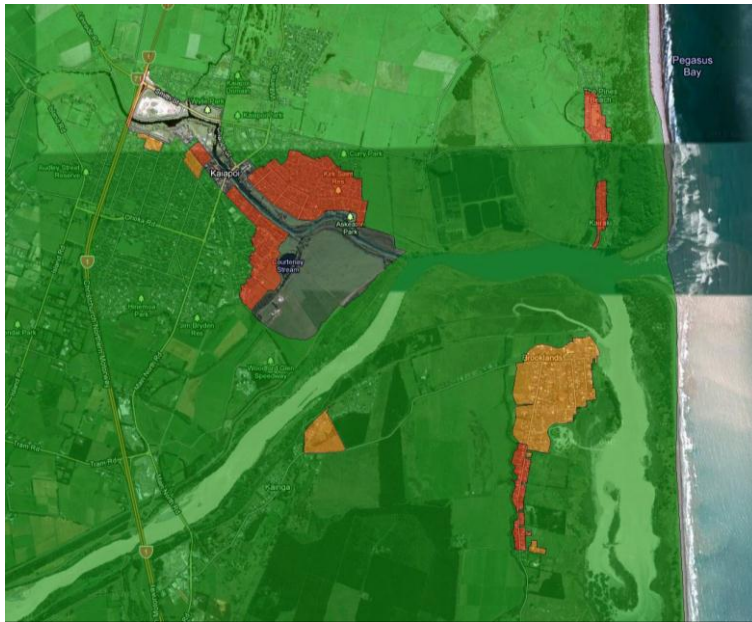
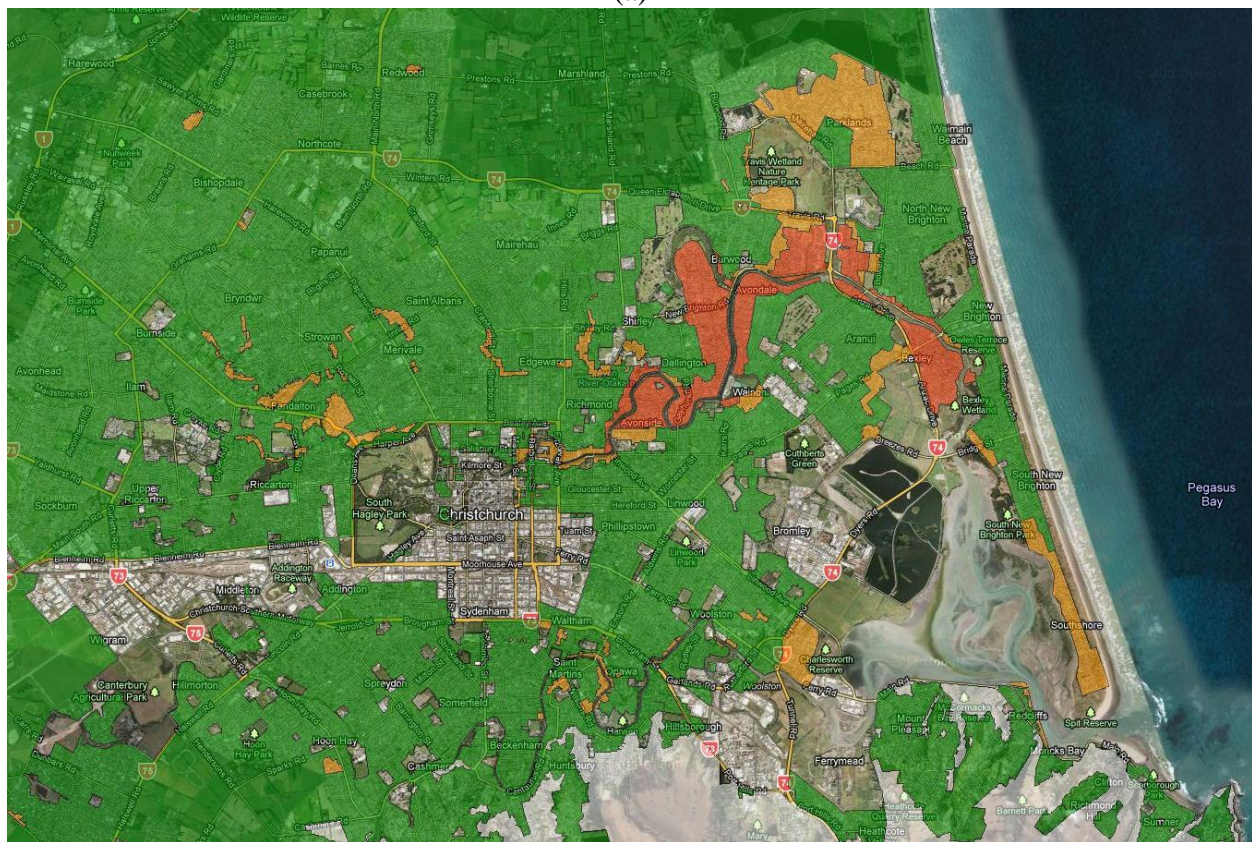
Due to the continued threat of the recurrence of liquefaction, the Canterbury Earthquake Recovery Authority (CERA) has divided Christchurch and its environs into four zones: Red, Orange, Green, and White. The zoning was based on observed performance during the earthquake sequence and in-situ geotechnical tests. Detailed information about each of the zones is copied and pasted from the CERA website below. However, in brief, Red Zone = uneconomical to rebuild at this time; Orange Zone = further assessment is required prior to rebuilding; Green Zone = rebuild at will; and White Zone = area not yet assessed. Maps of the zones for Christchurch and Kaiapoi are presented in Figure 4-7. As may be observed from comparing Figures 4-1 and 4-7, there is a close coincidence in the Red Zones marked in Figure 4-7 and areas that are identified in Figure 4-1 as having liquefied during both the Darfield and Christchurch earthquakes. In Christchurch, these areas largely lay along the Avon River and its abandoned channels (i.e., the neighborhoods of Avonside, Dallington, Burwood, Avondale, and Bexley). Additionally, the subdivision of Bexley also is designated as a Red Zone. This subdivision was built on fill and experienced up to 1 m of subsidence during the February earthquake, significantly increasing the flood hazard for the neighbourhood. In Kaiapoi, these areas lay along the Kaiapoi River and Courtenay Stream and their abandoned channels (Wotherspoon et al., 2011).

Figure 4-7. Rebuilding zonation maps: (a) Kaiapoi, and (b) Christchurch.  
(<http://cera.govt.nz/static/land-zone-map/>)

Green Zones: Land classified as green means that homes are suitable for repair and rebuild. If your property is categorised as green, key points to note are:

- Land generally suitable for houses to be repaired or rebuilt;
- Property owners should talk directly with their insurer or EQC about repairs;
- Property owners no longer have to wait for the results of any area-wide land assessment reports by EQC or their engineering consultants Tonkin & Taylor;

- There will be some isolated exceptions where geotechnical assessments will be required due to major land damage;
- Repair and rebuilding work should take into consideration the risk of ongoing aftershocks, so some finishing tasks such as brick and driveway concrete laying should be delayed until that risk decreases.

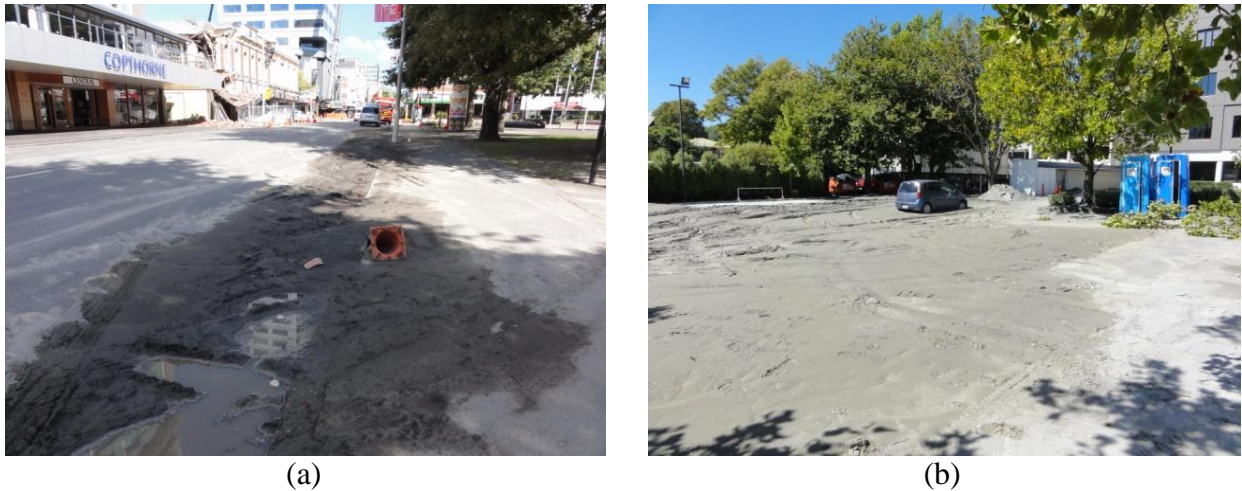
Figure 4-11. Representative areas of: (a) moderate liquefaction (7 Mar 2011;  $-43.52791^{\circ}$ ,  $172.63653^{\circ}$ ), and (b) severe liquefaction within the CBD principal liquefaction zone (4 Mar 2011;  $-43.52604^{\circ}$ ,  $172.63839^{\circ}$ ).

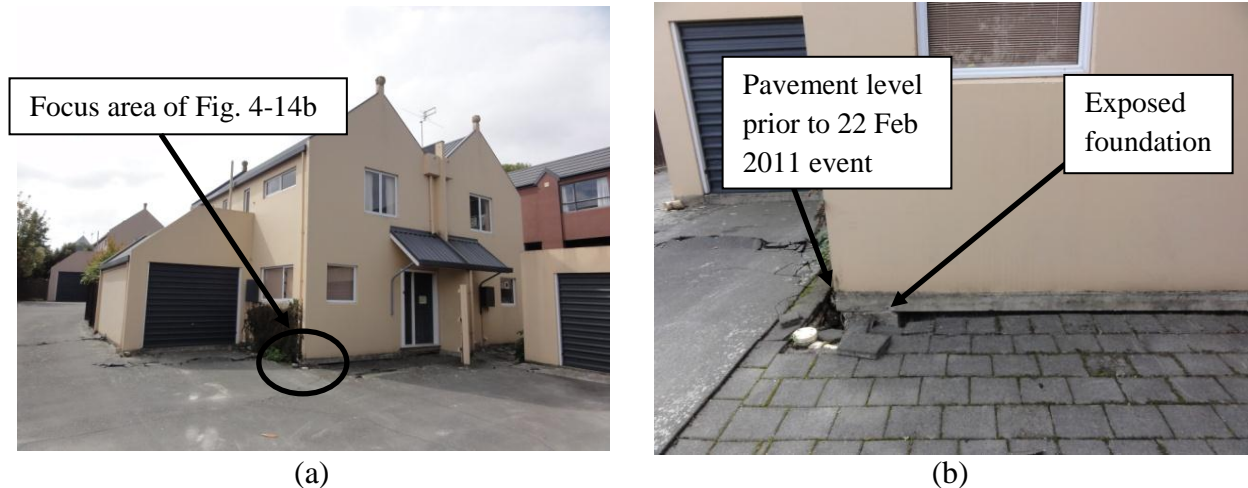
Adjacent to these buildings is another complex of three identical buildings, which are structurally different buildings from the former set. Their locations relative to the abovementioned geomorphic feature is identical, but these buildings are two-storey duplexes that are apparently supported on different foundations. Figure 4-14a shows the middle building with clear evidence of pavement distortion, cracking and settlement of the surrounding ground. The settlement of the building was likely not significant, but the ground settled about 20 cm exposing the top of the foundation at the southwest corner (Figure 4-14b).

Figure 4-14. Duplex housing complex: (a) looking north at center building, and (b) close-up of ground settlement next to center building (16 Mar 2011;  $-43.52399^{\circ}$ ,  $172.64417^{\circ}$ ).

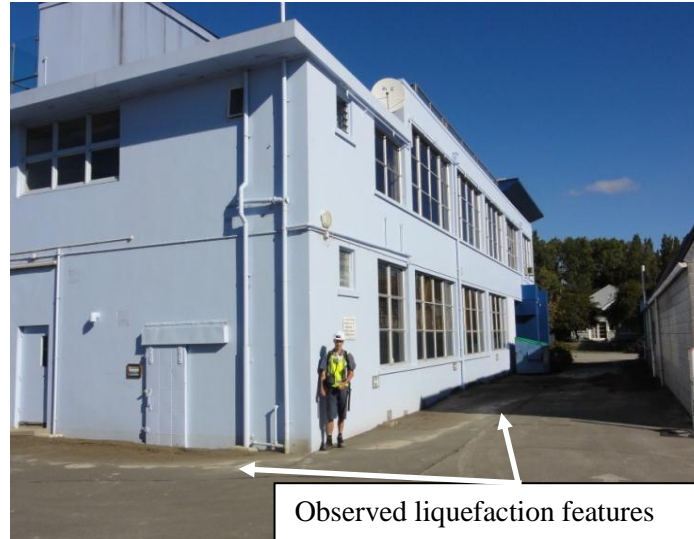
Several buildings with shallow foundations located within the liquefied zone underwent punching settlements with some undergoing significant differential settlements and bearing capacity failures. An example of such performance is shown in Figure 4-15 for a two-storey industrial building located 200 m south-west of the buildings discussed previously. There are clear marks of the mud-water ejecta on the walls of the building indicating about 25-cm-thick layer of water and ejected soils due to the severe liquefaction. Note the continuous sand ejecta around the perimeter of the footing and signs of punching shear failure mechanism in Figure 4-15. At the front entrance of the building large ground distortion and sinkholes were created due to excessive pore water pressure and upward flow of water. Settlement of the building around its perimeter was evident and appeared substantially larger than that of the surrounding soil that was unaffected by the building. The building settled approximately 25 cm relative to a fence at its southeast corner and settled 10-20 cm relative to the ground at its northwest corner. The ground floor at the entrance was uplifted and blistered which is consistent with the pronounced settlement beneath the walls along the perimeter of the building.

Figure 4-15. Two-story building that underwent liquefaction-induced punching movements (7 Mar 2011;  $-43.52506^\circ$ ,  $172.64176^\circ$ ).

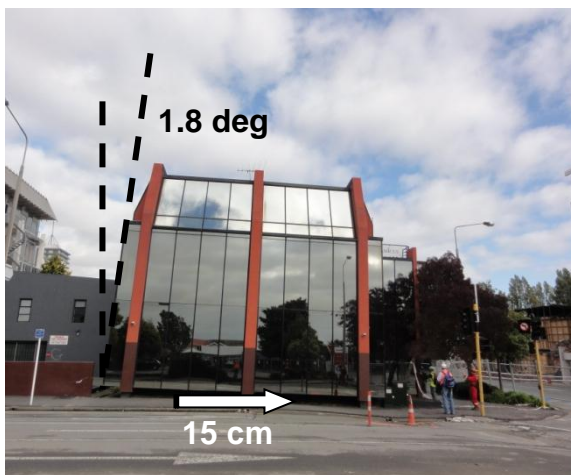
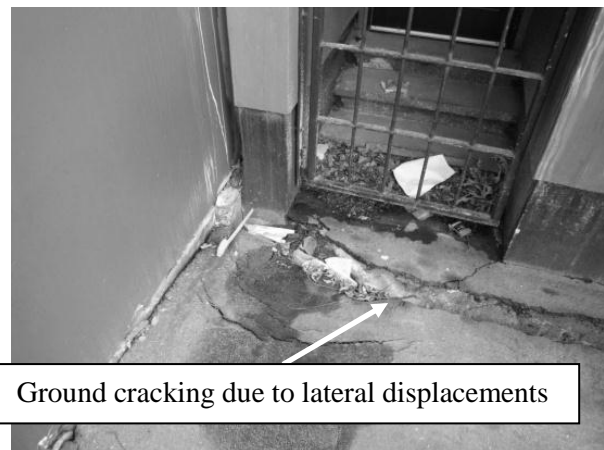
The building shown in Figure 4-17 is a three-storey structure on shallow foundations that settled substantially at its front, resulting in large differential settlements that tilted the building about 2 degrees. The building was also uniformly displaced laterally approximately 15 cm toward the area of significant liquefaction near the front of the building (i.e., to the north). There was a large volume of sand ejecta at the front part of the building with ground tension cracks propagating east of the building and in the rear car-park that are consistent with the lateral movement of the building toward the north.

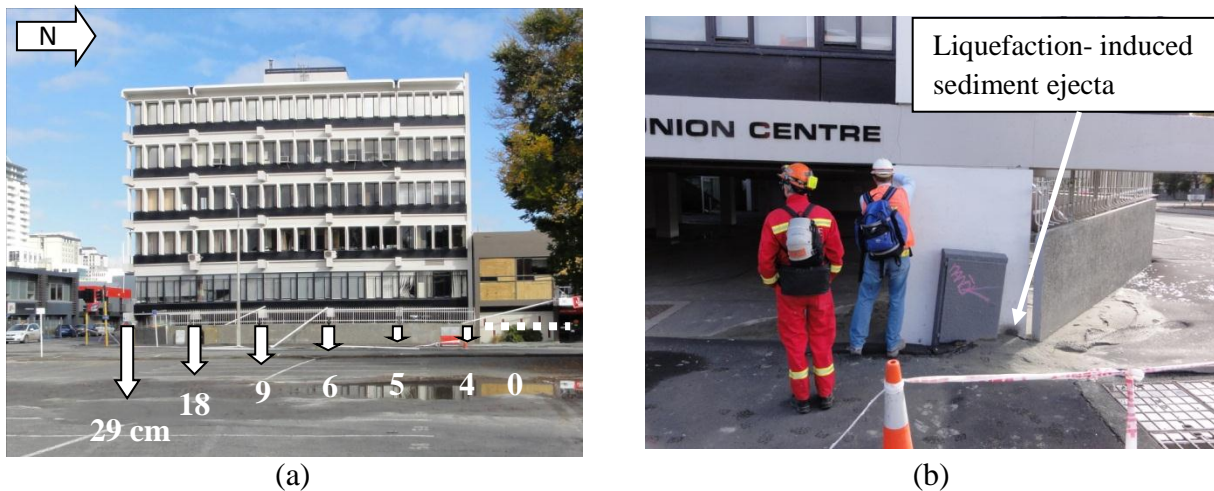
the final three spans. This results in an overall differential settlement across the structure of 25 cm, with 20 cm of it occurring across the two southernmost spans. A strong tie beam that was 0.6 m wide and 1.2 m deep was used between the footings for the first two northernmost spans, whereas the tie beams between the footings for the remaining spans were only 0.3 m wide and x 0.45 m deep. This foundation detail, together with the fact that the observations of liquefaction were most severe at the southeast corner of the building and diminished across the footprint of the building toward the north, led to substantial differential settlements and pronounced structural distortion and cracking. Both buildings were considered uneconomical to repair and were demolished after the February earthquake.

Figure 4-18. Building undergoing significant liquefaction-induced differential settlement due to part of it being founded on the liquefaction feature in this area (24 Mar 2011;  $-43.52878^\circ$ ,  $172.64252^\circ$ ).

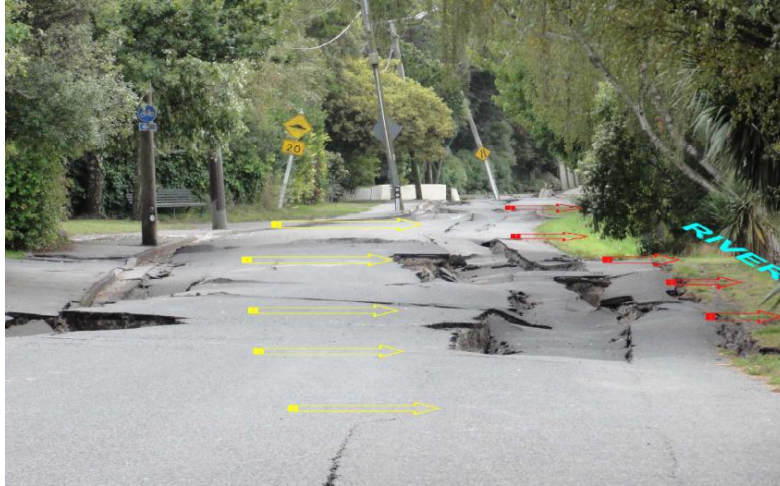
Along the Avon River, particularly to the east of CBD, lateral spreading occurred, causing horizontal displacements at the river bank on the order of several tens of centimeters to more than two meters. At ten locations along the Avon River, where lateral spreading measurements were conducted after the September 2010 earthquake, measurements of lateral spreading displacements were carried out again after the February earthquake. It was found that the permanent lateral displacements were two to three times the displacement measured after the September earthquake, indicating increased spreading movement which is in agreement with the more severe liquefaction observed in these areas during the February event. Ground surveying indicated that ground cracks associated with lateral spreading extended as far as 100-200 meters from the river, while other aerial observation methods suggest that the effects of spreading might have been even beyond these distances. An example of lateral spreading along the Avon River is shown in Figure 4-23.

Figure 4-23. Example of lateral spreading along the Avon River.

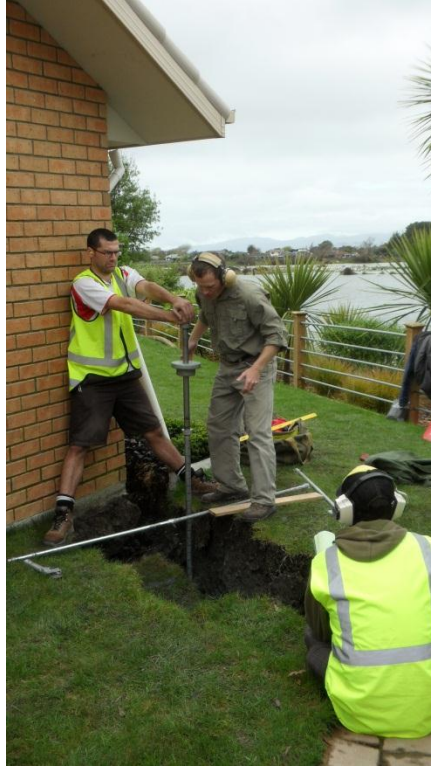
Figure 4-24. DCP test being performed adjacent to a house in Bexley after the  $M_w 7.1$ , 4 September 2010 Darfield earthquake. Brady Cox is working the hammer. (13 Sept 2010,  $-43.51837^\circ$ ,  $172.72205^\circ$ )

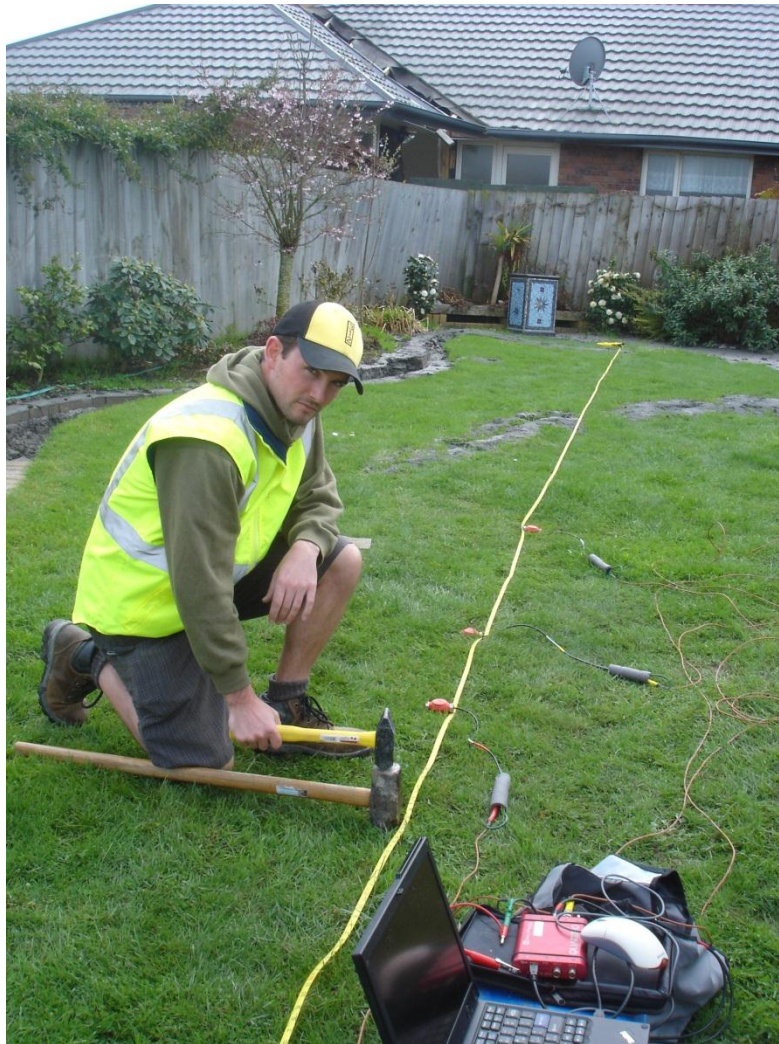
Figure 4-27. SASW setup at a site in South Kaiapoi. Liam Wotherspoon working the hammer. (12 Sept 2010;  $-43.39001^\circ$ ;  $172.66264^\circ$ )

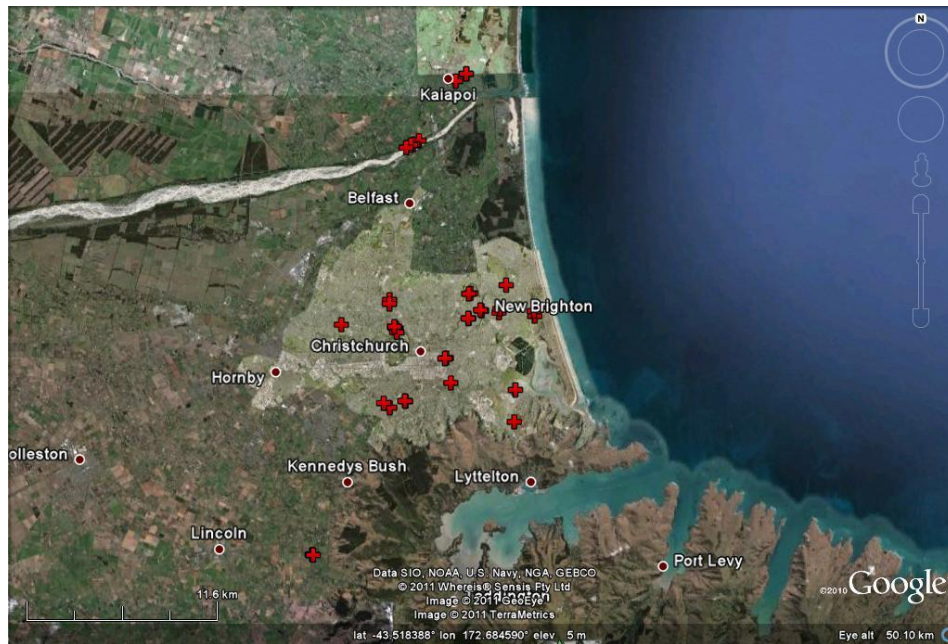
where shallow  $V_s$  profiles are desired. At most locations, receiver spacings of approximately 0.61, 1.22, 2.44, 4.88, 6.10, and 12.20 m were used to collect surface wave data. These tests took less than 45 minutes per location and typically enabled  $V_s$  profiles to be generated down to 6.1-9.1 m below the surface. In total, 36 SASW tests were performed across Christchurch and its environs after the Darfield and Christchurch earthquakes. Figure 4-28 shows the locations of the SASW test sites.

Figure 4-28. Locations of SASW test sites performed after either the Darfield or Christchurch earthquakes.

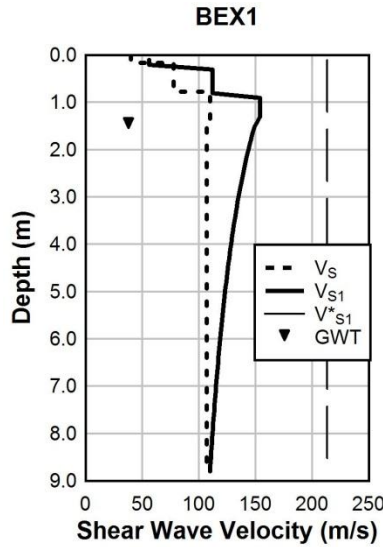
Figure 4-29. Measured  $V_S$  and corrected  $V_{S1}$  profiles for a test site in Bexley. Also shown is the theoretical limiting upper-bound value of  $V_{S1}$  for liquefaction triggering ( $V^*_{S1}$ ) for soil having  $FC = 9\%$ .

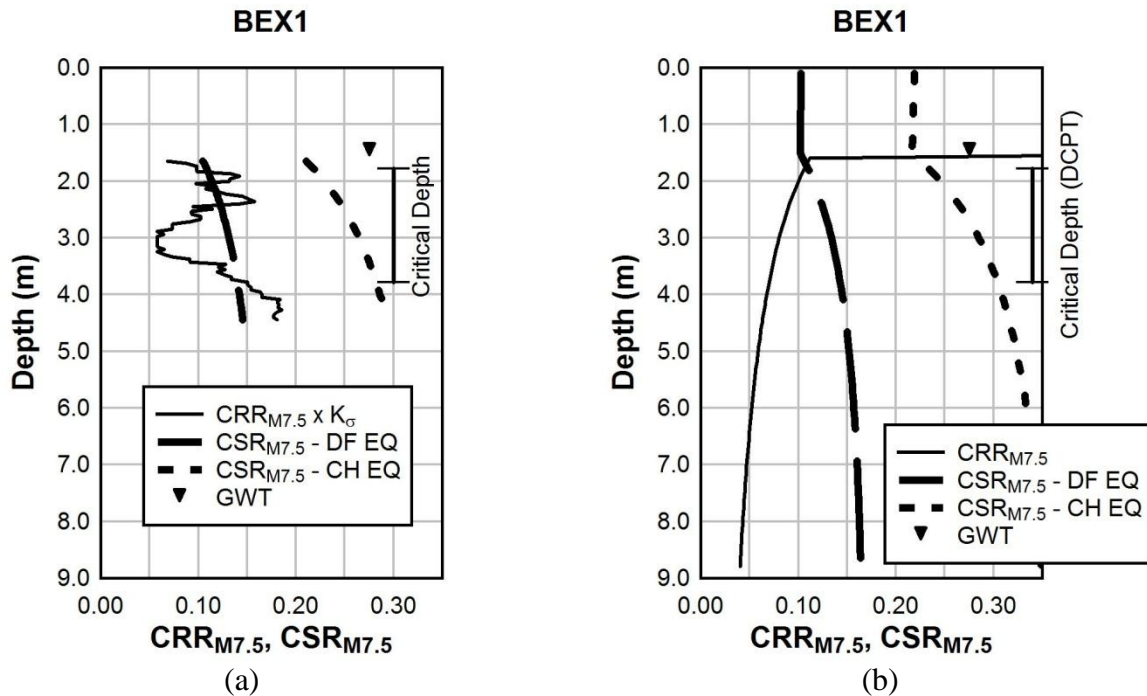
thinnest for cases of lateral spreading with no ejecta, intermediate for lateral spreading with ejecta, and thickest for large sand boils with no associated lateral spreading. For example, the profile shown in Figure 4-30a laterally spread (see Figure 4-24) and there was a significant amount of ejecta that vented to the ground surface nearby. Using this information, and trends in the  $N_{DCPT}$ , shown in Figure 4-25b, the selected critical layer was  $\sim 2$  m thick, as indicated in Figure 4-30a. Once the critical layers were determined for each test site, the  $N_{1,60cs-SPT_{equiv}}$  values,  $CSR_{M7.5}$ , and  $CRR_{M7.5}$  were averaged over these depths. The results were plotted along with Youd et al. (2001) SPT  $CRR_{M7.5}$  curve in Figure 4-31a.

Figure 4-30. Comparison of  $CSR_{M7.5}$  for the Darfield and Christchurch earthquakes with  $CRR_{M7.5}$  for a site in Bexley (FC = 9%): (a) profiles for DCP test; and (b) profiles for SASW test.

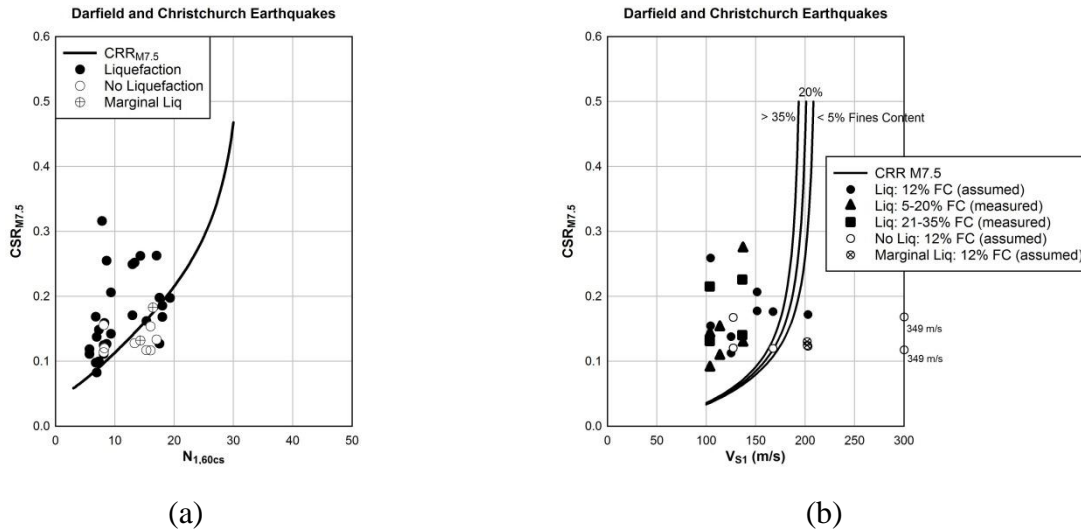
Using the same critical layers as selected for DCP test liquefaction evaluations,  $V_{s1}$ ,  $CSR_{M7.5}$ , and  $CRR_{M7.5}$  were averaged over the critical depths for each test site profile. The results were plotted along with Andrus and Stokoe (2000)  $CRR_{M7.5}$  curves in Figure 4-31b.

Figure 4-31. Comparison of predicted versus observed liquefaction: (a) DCPT test; and (b) SASW test.

Also from Figure 4-31, it can be noted that most of the DCP and SASW tests were performed at sites that liquefied, with a paucity of data from sites that did not liquefy. The reason for this is
