## 2. GEOLOGICAL ASPECTS

## The 4 September 2010 Darfield (Canterbury) earthquake

### **Characteristics of the surface fault rupture**

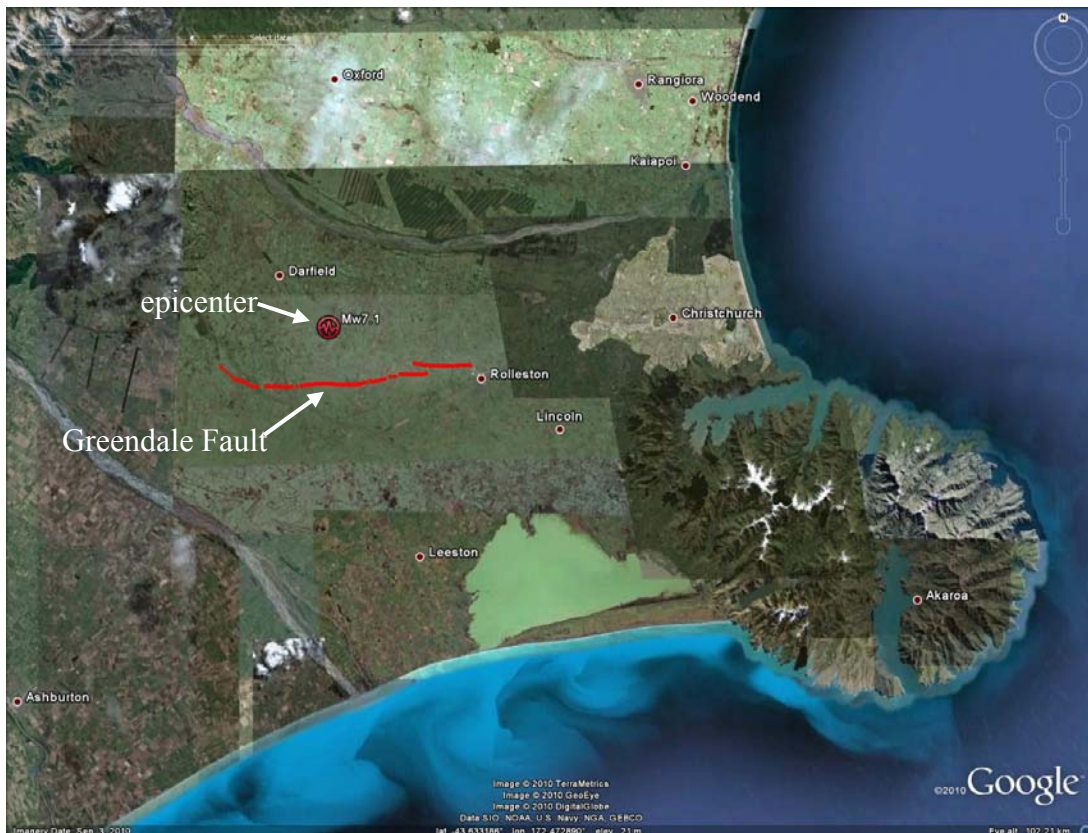
Figure 2.2 Aerial image of the Christchurch area with the surface fault rupture and the epicenter of the Darfield earthquake are denoted. The image is  $\sim 117$  km across.

The epicenter of the earthquake was located approximately 10 km southeast of the town of Darfield (Figure 2.2) with a focal depth of  $\sim 10$  km. Preliminary USGS and global centroid moment tensor solutions indicated the mainshock was associated with almost pure dextral (right-lateral) strike-slip slip on a subvertical nearly E-W striking fault plane. The event produced a  $\geq 28$ -km long, dextral strike-slip surface rupture trace, aligned approximately west-east (Figure 2.2). Using data from New Zealand national and strong-motion seismic networks, GNS seismologists have proposed that the rupture process involved a component of reverse faulting at depth. In the month following the mainshock, the region has incurred thousands of aftershocks of  $M_L > 2$  including eleven aftershocks of  $M_L \geq 5.0$ . A  $M_L$  5.2 aftershock on 8 September (NZST) located  $\sim 7$  km southeast of the city center at a depth of  $\sim 6$  km caused further damage to city infrastructure. The frequency of  $M_L > 2$  aftershocks has decreased by an order of magnitude since the days immediately following the mainshock although the possibility of  $M \geq 5$  earthquakes still remains, as the region adjusts to the crustal deformation associated with the mainshock.

The zone of identified surface rupture extends from ~4km WNW of the hamlet of Greendale for about 28 km to an eastern tip ~2 km NW of the town of Rolleston (Figure 2.2). Offsets and fracture patterns reveal up to 4.6 meters of displacement, with an average displacement of ~2.3 m across the entire rupture. Figure 2.3 shows comparisons of the average and maximum fault displacements with global fault data compiled by Wells and Coppersmith (1994). As may be observed from these comparisons, the average and maximum displacements are slightly larger, but very close to, the best fit line of the global fault data. The displacement on the Greendale Fault during the Darfield earthquake was dominated by dextral (right lateral) movement (Figure 2.4). Vertical offsets of up to ~1m occur at constraining or releasing bends. Oblique east-side down slip on the NW-striking western portion of the fault resulted in partial diversion of the Hororata River. The gross morphology of the fault is that of a series of E-W striking, NE-stepping surface traces that in detail consist of ESE-trending Riedel fractures with right-lateral displacements, SE-trending extensional fractures, SSE- to S-trending Riedel' fractures with left-lateral displacements, and NE-striking thrusts and folds. Offsets as small as 1-5 cm were able to be mapped due to the numerous straight features (e.g., roads, fences) crossing the fault. As a consequence, the Greendale Fault surface rupture length (SRL) has been measured to a high level of confidence. However, when the SRL is plotted against Moment Magnitude ( $M_w$ ), and compared to global fault data (Figure 2.5), the Greendale SRL seems remarkably short for an  $M_w$  7.1 earthquake. This is likely because much of the fault rupture occurred beneath the surface without any clear surface topographic expression. An ENE trending,  $\geq 6$  km long line of broken fences and roads ~2 km south of Prebbleton may indicate the presence of another fault that ruptured coincident with the Greendale Fault; this hypothesis is currently being tested with further geological mapping and shallow crustal geophysics. The eastern tip of the fault is also creeping slowly, suggesting it is possible that the subsurface extent of the Greendale Fault extends further to the east than the surface rupture. Ongoing research and mapping of

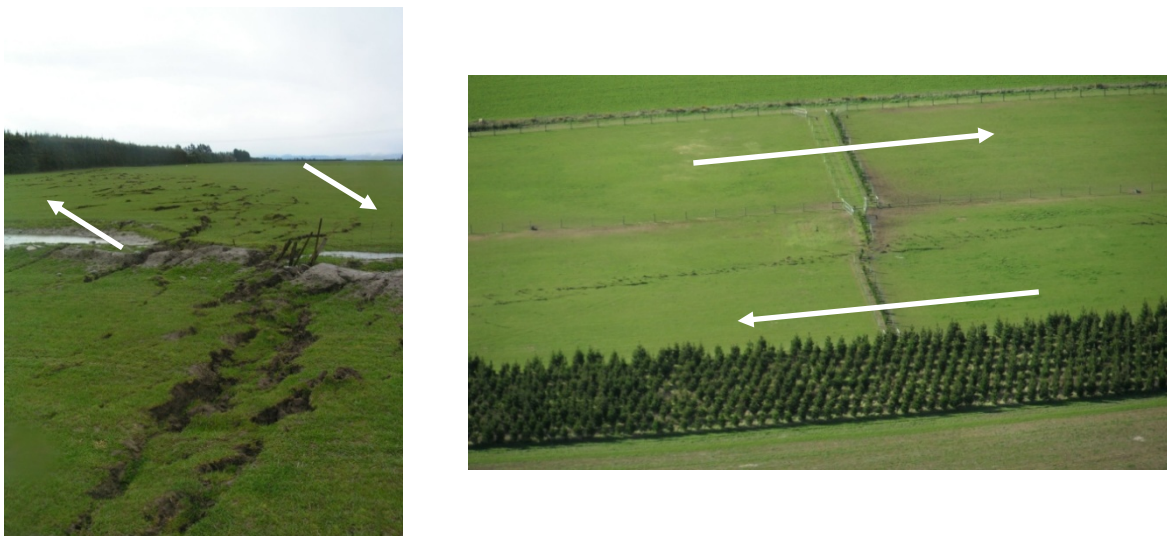
Figure 2.4 Photographs of surface fault rupture on the Greendale fault (left photo: <http://daveslandslideblog.blogspot.com/2010/09/images-of-darfield-canterbury.html>).

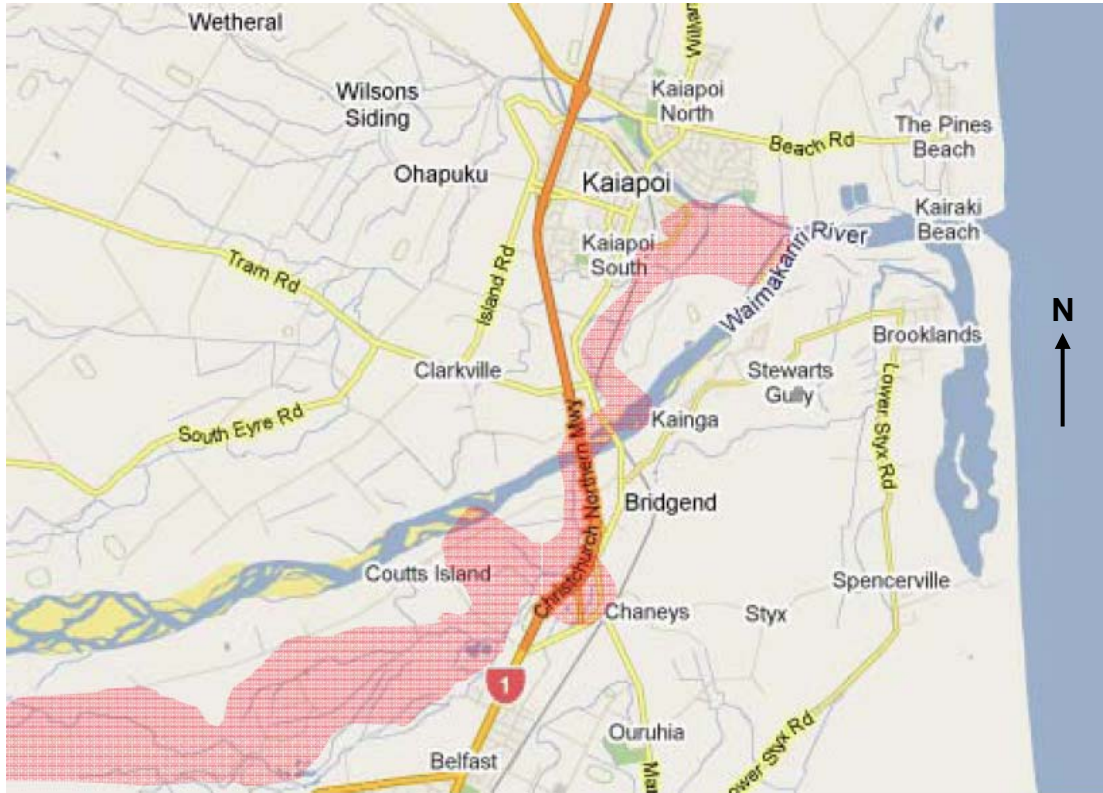
Figure 2.9 Present day Kaiapoi with position of 1865 river channel highlighted in red. The distance from the left to right edges of the map shown is ~13 km. (Google Inc. 2010)

The 1865 position of the south branch of the Waimakariri River is superimposed onto the present day map of the region in Figure 2.9. The old channel covers a large area on the eastern side of South Kaiapoi, coming from the south along the present-day railway line. South of the present-day Waimakariri River, the old channel covers a large part of the Coutts Island area on both sides of State Highway 1, extending west across farms and golf courses on the landside of the present day levees. The implications of the location of the old river channel on the observed liquefaction

and lateral spreading that occurred during Darfield Earthquake are discussed in subsequent chapters.
