5.0 DAMAGE PATTERNS

5.1 Introduction

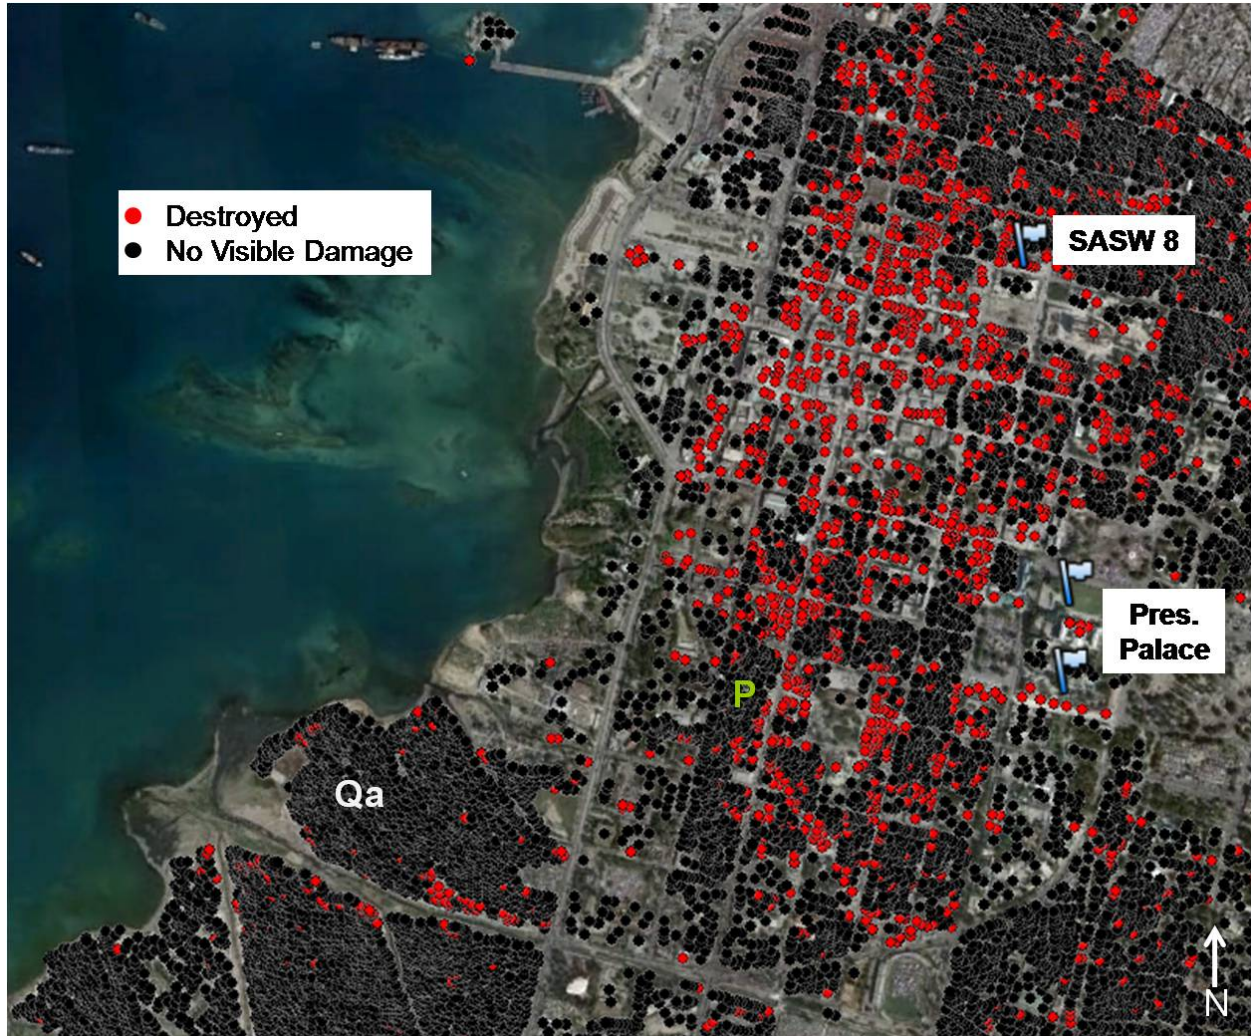
Figure 5.7 Buildings classified as No Visible Damage and Destroyed in the UNOSAT survey for the boxed area specified in Figure 5.6. Notice the heavily damaged zone lying on P deposits to the north and west of the Presidential Palace and the lightly damaged zone lying on Qa deposits in the lower left-hand corner. Most of the buildings in the heavily damaged zone were larger, multi-story, reinforced concrete structures, while most of the buildings in the lightly damaged area were smaller, densely spaced Shanty's with tin roofs (refer to the text for more detail).

One intensely damaged zone noticed on the GEER reconnaissance was an area located due west and north of the Presidential Palace. This area is boxed in pink in Figure 5.6 and shown in Figure 5.7 along with the buildings that were categorized as either Destroyed (red dots) or No Visible Damage (black dots) in the UNOSAT survey. Also shown are three flag markers where Spectral Analysis of Surface Waves (SASW) testing was performed to investigate the near-surface soil layering and stiffness in the area. It is clear that nearly every building on some of these blocks was completely destroyed (particularly just west and south of SASW 8). However, it is also clear that other areas nearby (e.g. the extreme left-hand bottom corner of Figure 5.7) had very few destroyed buildings. Interestingly, according to the published geologic map, the heavily damaged area lies on Pliocene deposits, while the lightly damaged area lies on younger (presumably softer) Quaternary deposits. However, the revised interpretation of the Quaternary/Pliocene contact (see Section 5.2) would place both of these areas within Quaternary alluvium. One reason for these differences in damage may be building type. Most of the buildings in the heavily damaged zone were larger, multi-story, reinforced concrete structures, while most of the buildings in the lightly damaged area were smaller, densely packed Shanty's with tin roofs (note the difference in density of black dots in the two areas). Several pictures of the type of structures and damage encountered in the heavily damaged zone near SASW 8 are shown in Figure 5.8.

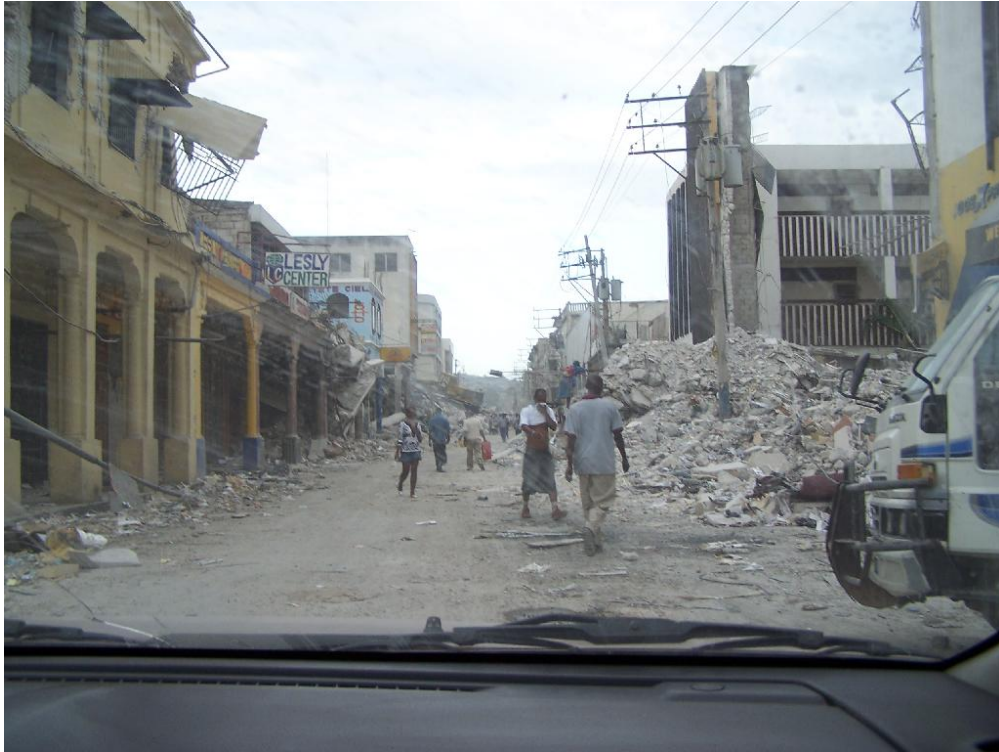
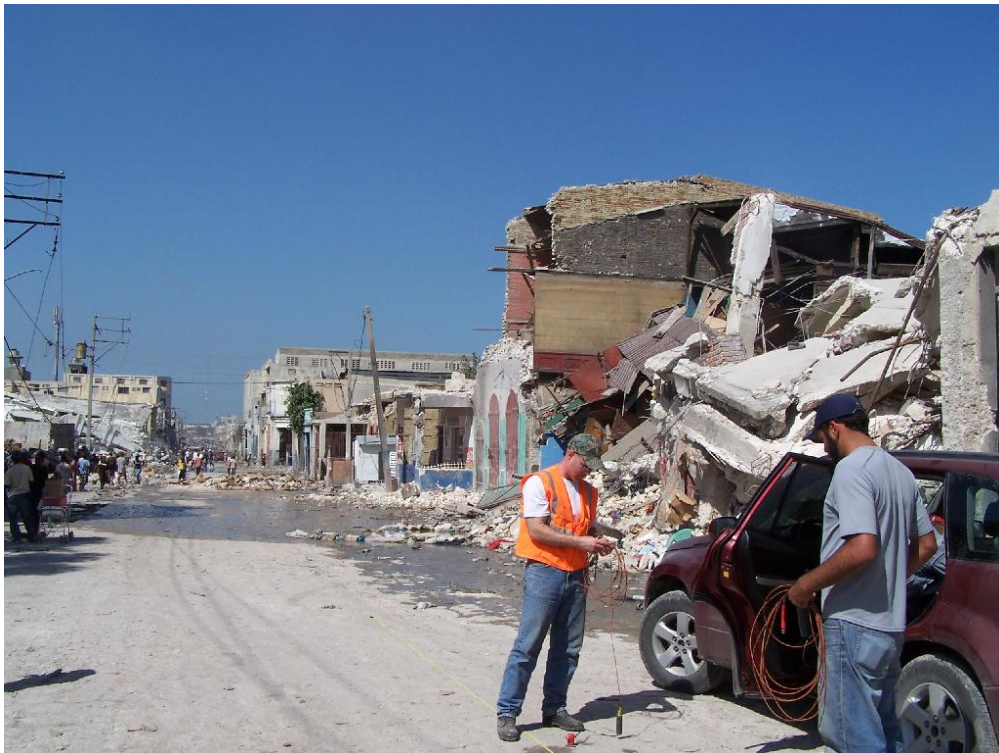
Figure 5.8 Typical types of structures and damage found within the heavily damaged zone near SASW 8 (N18.550210°, W -72.339638°).

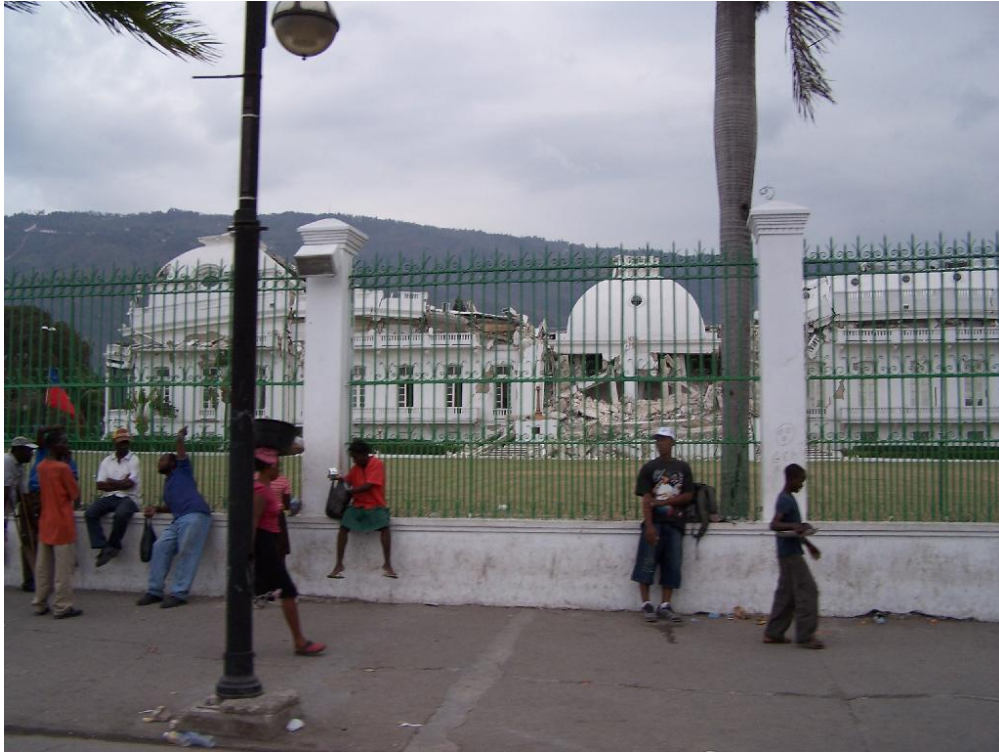
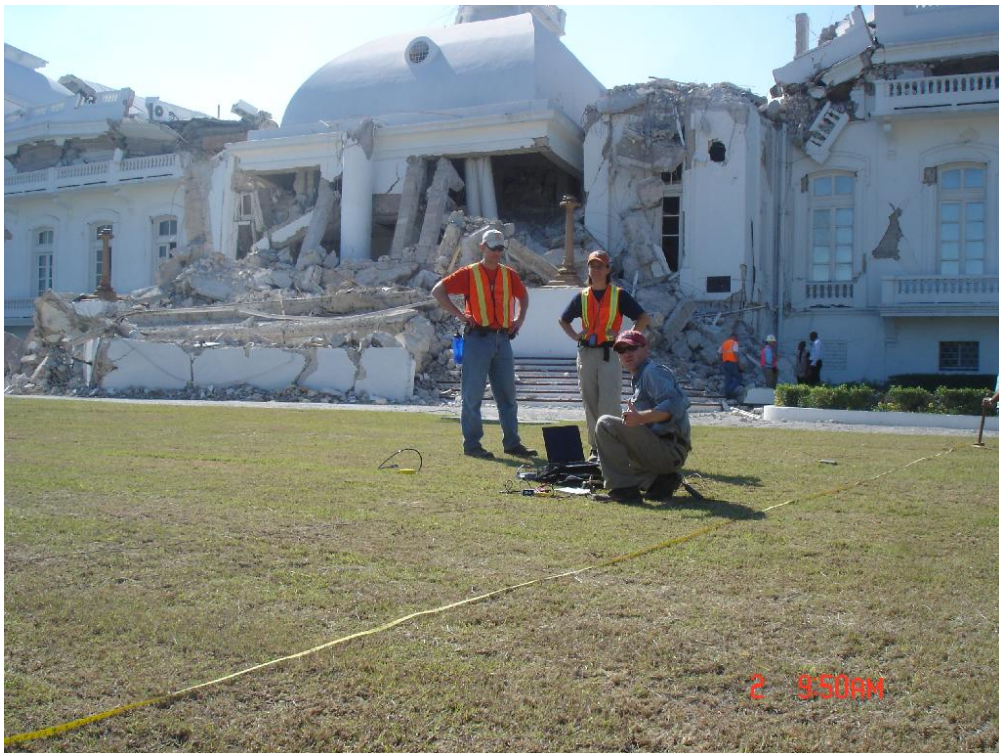
Figure 5.9 The Presidential Palace lies within the heavily damaged zone noted above. Two SASW tests and one H/V Spectral Ratio test were conducted here (N 18.543633°, W - 72.338905°).

The Presidential Palace also lies on the eastern edge of this heavily damaged zone. The damage to the Presidential Palace (Figure 5.9) was documented by many news crews covering the aftermath of the earthquake due to its symbolism for the widespread, devastating destruction throughout the city. The GEER team conducted two SASW tests (SASW 6 and SASW 7) and one H/V Spectral Ratio test on the grounds of the Presidential Palace. These results have not been fully processed yet, but will be made available as soon as they are complete.

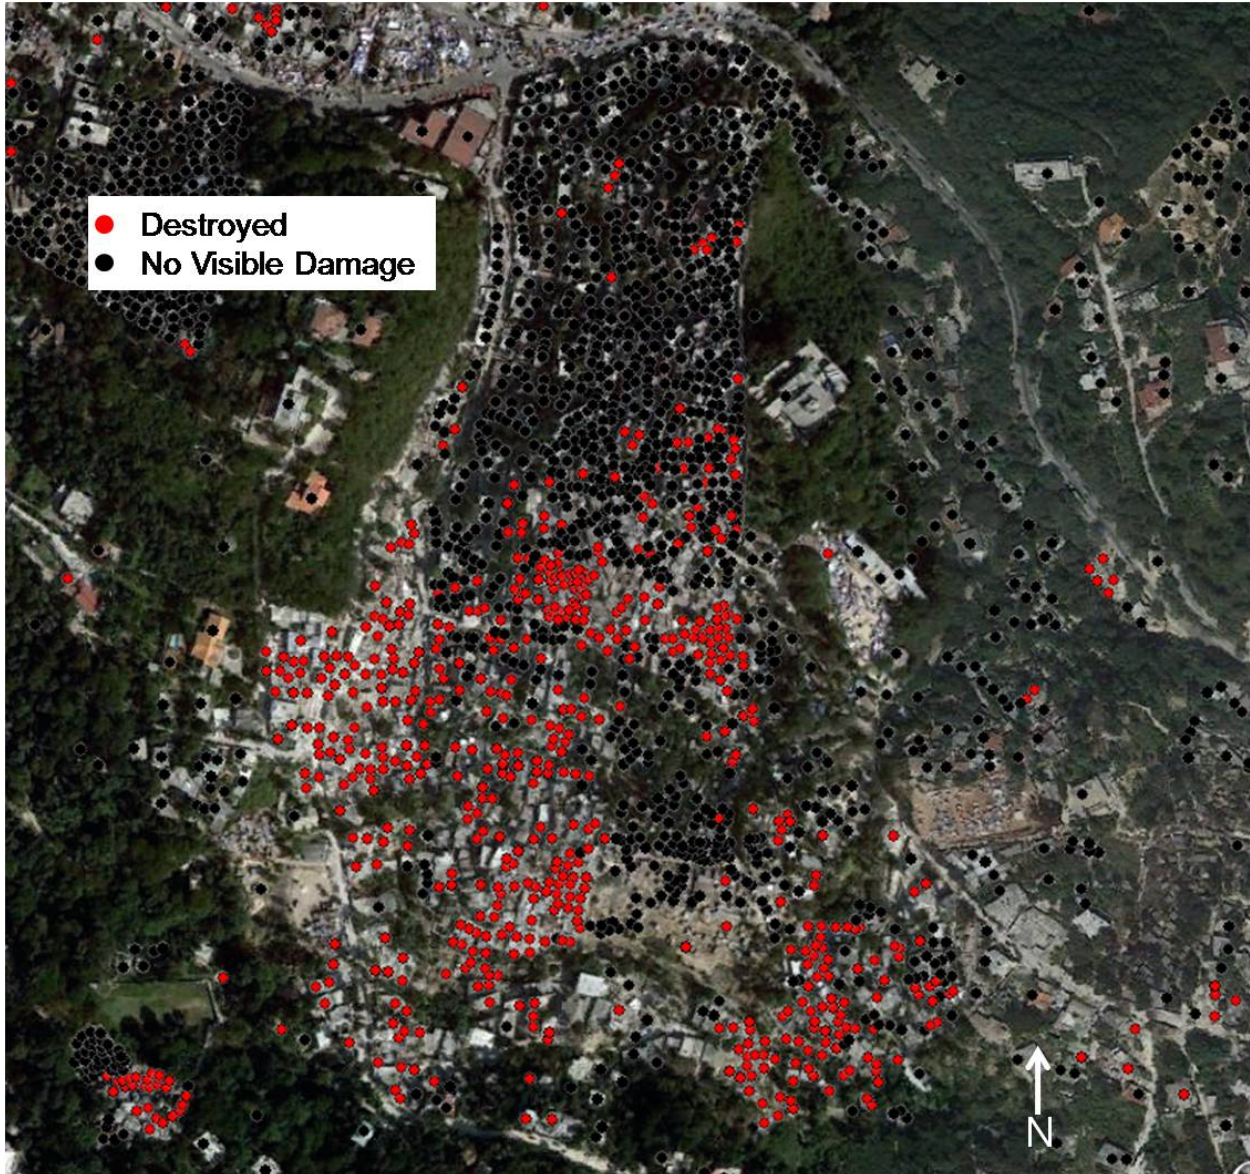
Figure 5.11 Buildings classified as No Visible Damage and Destroyed in the UNOSAT survey for the boxed area labeled as Area 1 in Figure 5.10. Notice the clear north-south separation between no visible damage and destroyed buildings that bisects the ridgeline east-to-west. All of these buildings appear to be Shanty-type structures with similar construction (refer to the text for more detail).

One interesting area lying on steep topography is shown in Figure 5.11 along with the buildings that were categorized as either Destroyed (red dots) or No Visible Damage (black dots) in the UNOSAT survey. This zone is labeled as Area 1 in Figure 5.10. There is almost a distinct line that could be drawn from east-to-west that separates heavy damage to the south from almost no visible damage to the north. When one zooms in on this area there appears to be no significant difference in the type of structures. All of them appear to be densely packed Shanty-type buildings. It is possible that the steepness of the slope affected this pattern, but no conclusive evidence is known at this time.
