## **Appendix D: Ground Deformation in the Very Near Fault Region**

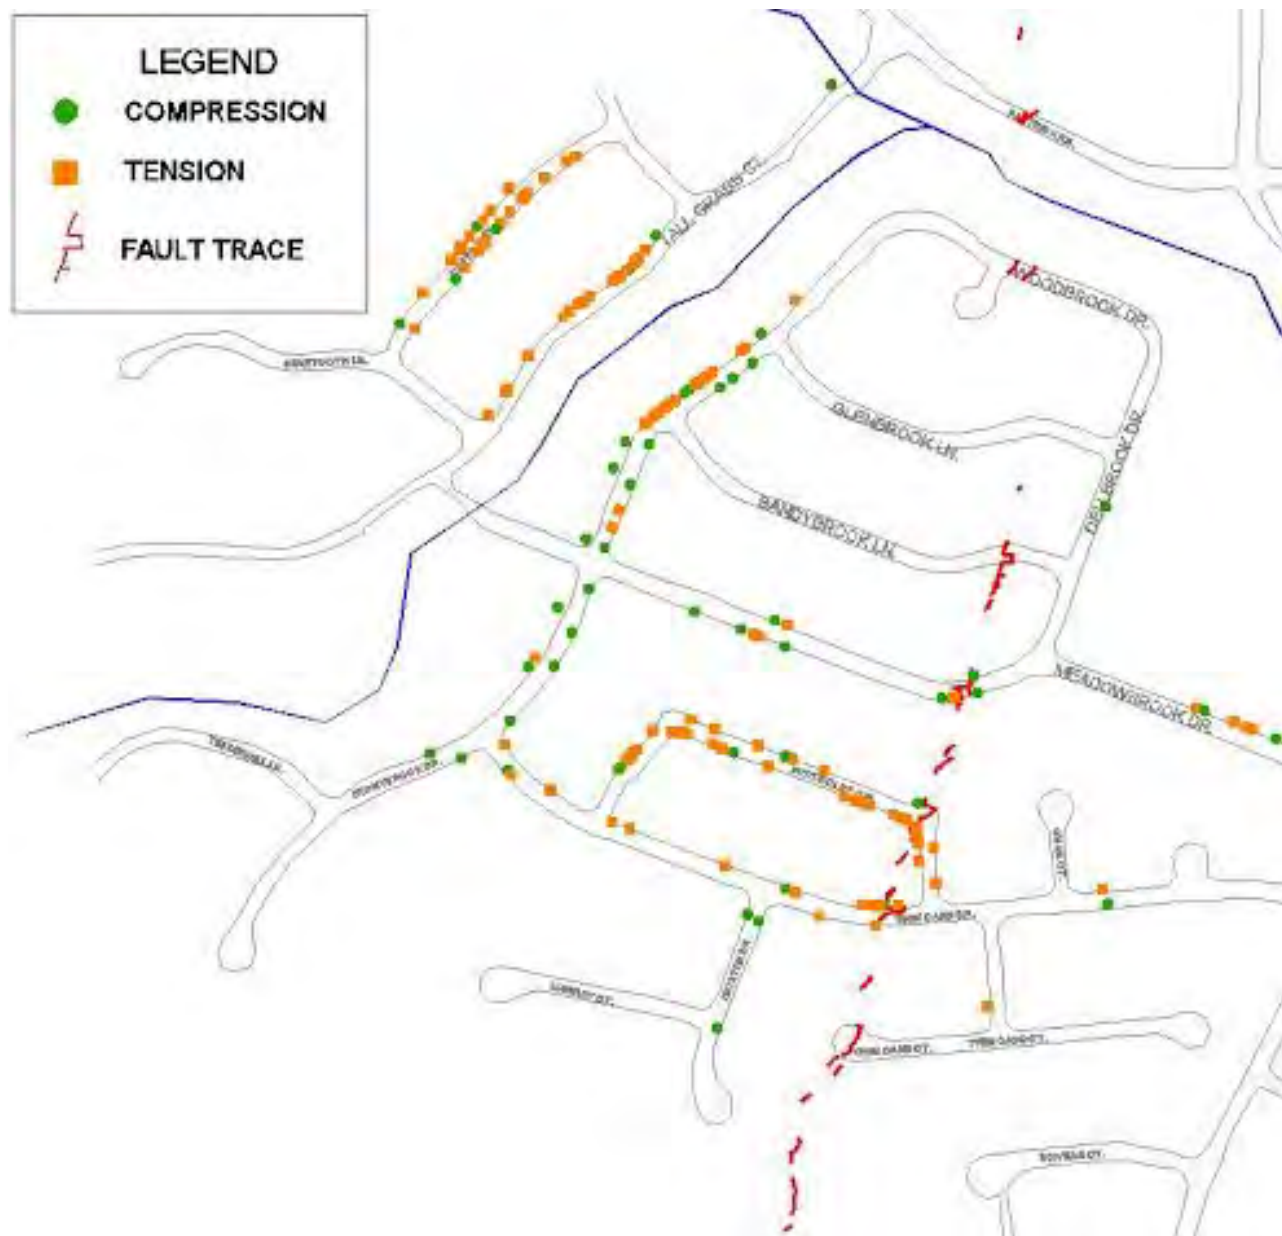
Figure D-2: Observed and measured tension (orange) and compression (green) locations; produced in AutoCAD; [NSF-GEER; Luque, R.; Wagner, N.; processed 9/5/14]

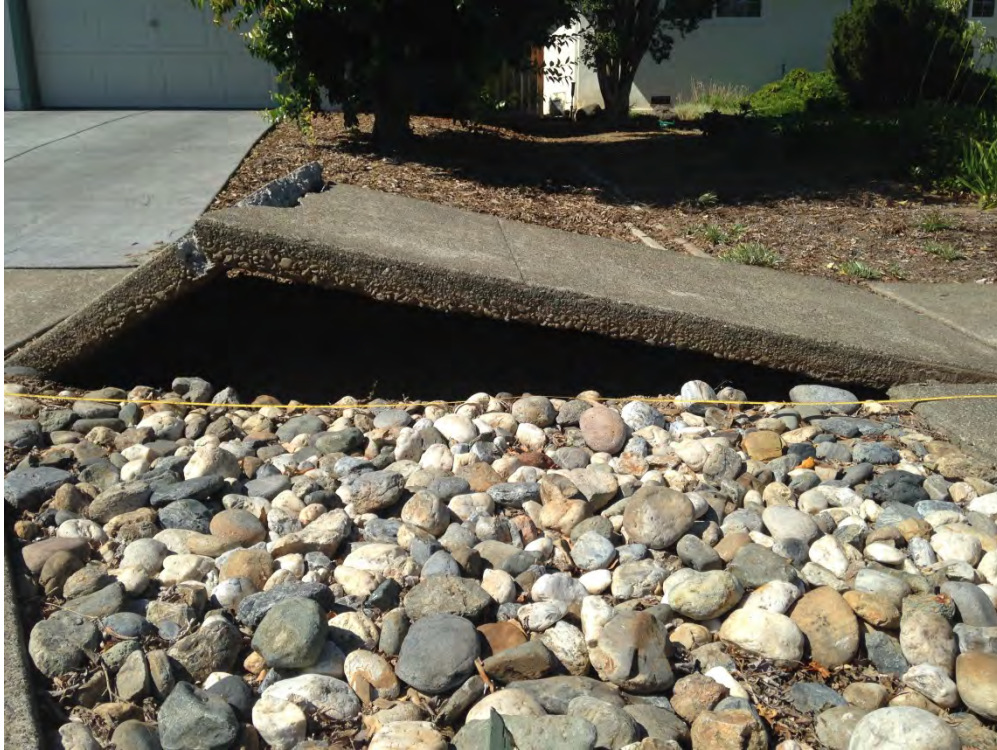
Figure D-3: Typical buckled compression zone in pavement perpendicular to fault, near observed fault trace [NSF-GEER; N 38.3039 W 122.3430; 8/26/2014 15:24]

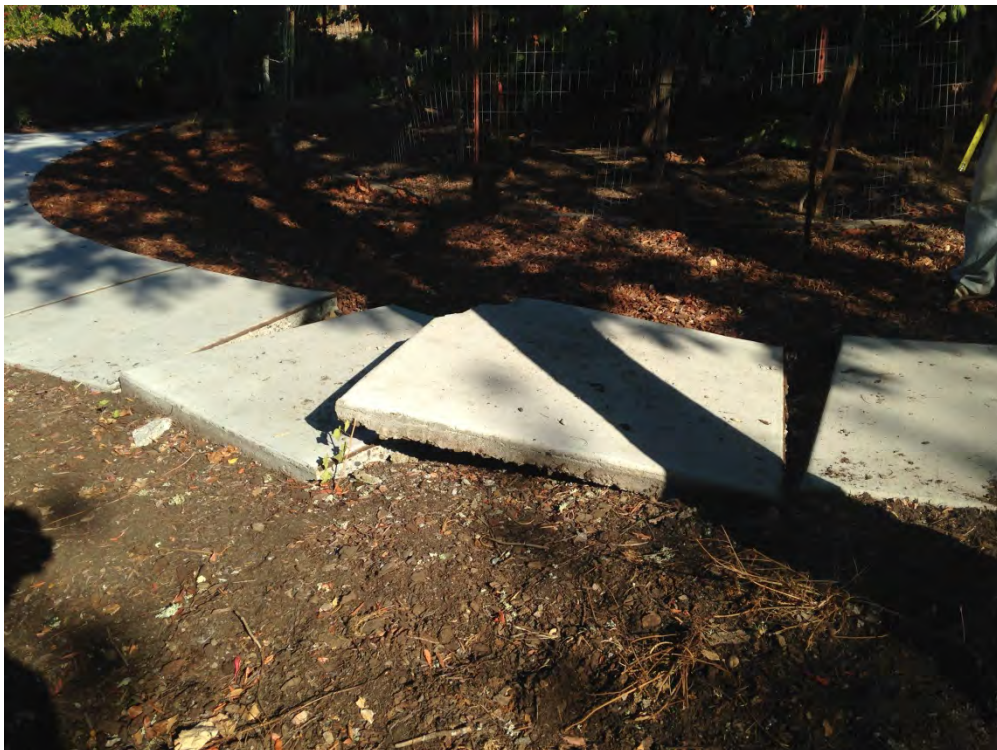
Figure D-4: Overlapping compression zone in pavement parallel to fault, near road crossing [NSF-GEER; N 38.3054 W 122.3455; 8/26/2014 17:20]

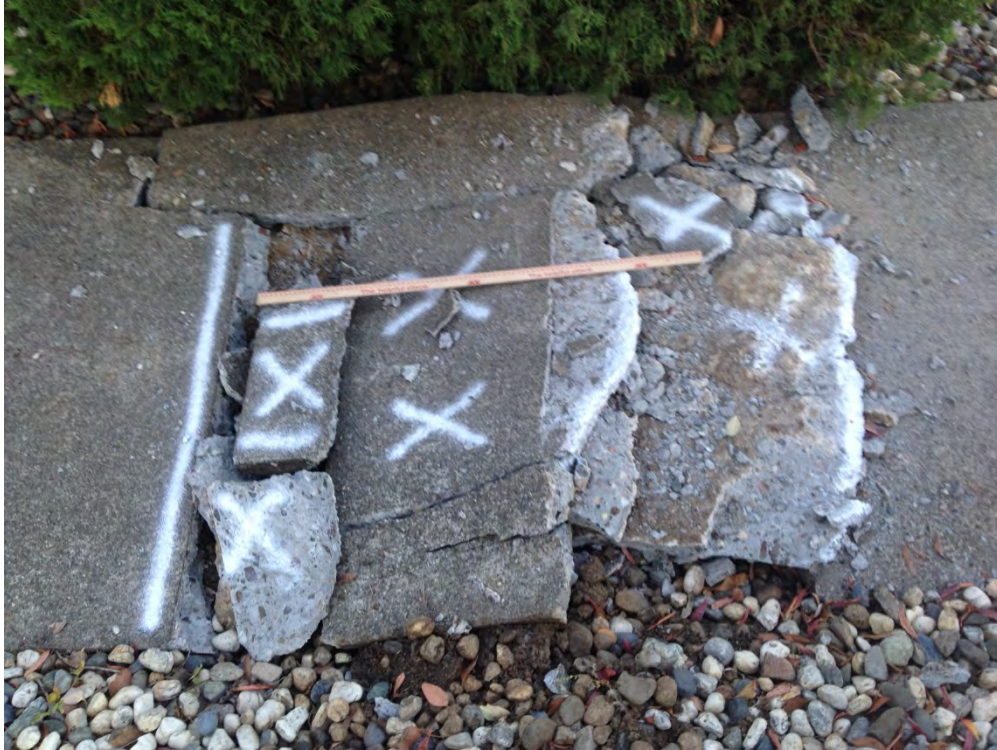
Figure D-5: Buckled and crushed compression zone in pavement parallel to fault [NSF-GEER; N 38.3048 W 122.3460; 8/26/2014 18:52]

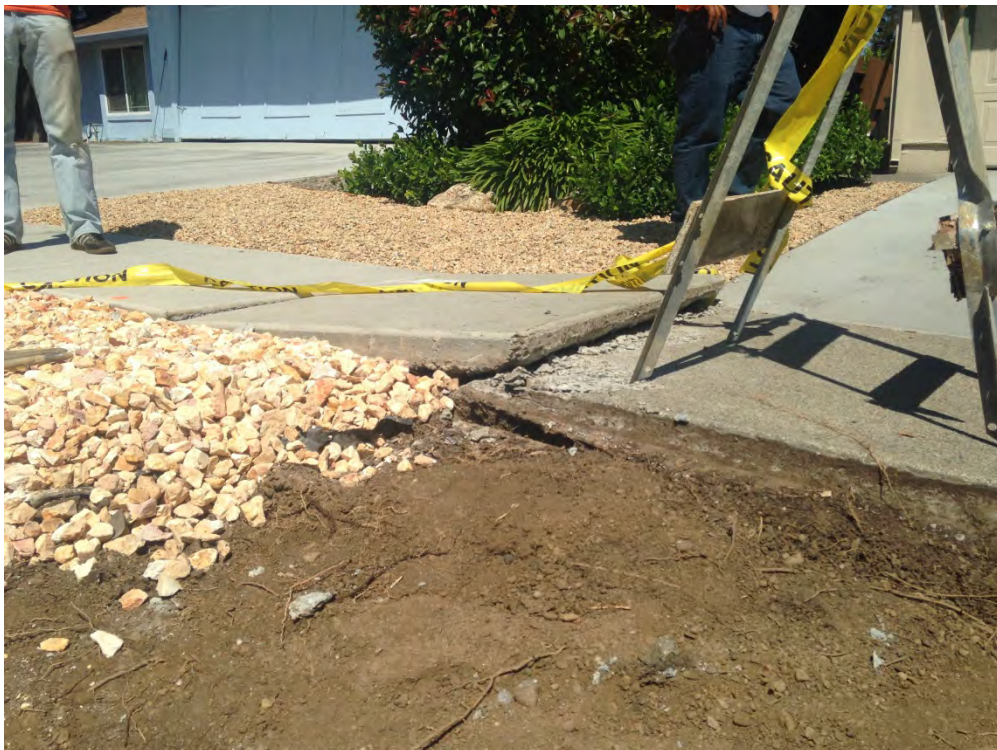
Figure D-6: Overlapping compression zone in pavement perpendicular and adjacent to fault [NSF-GEER; N 38.3025 W 122.3436; 8/27/2014 12:01]

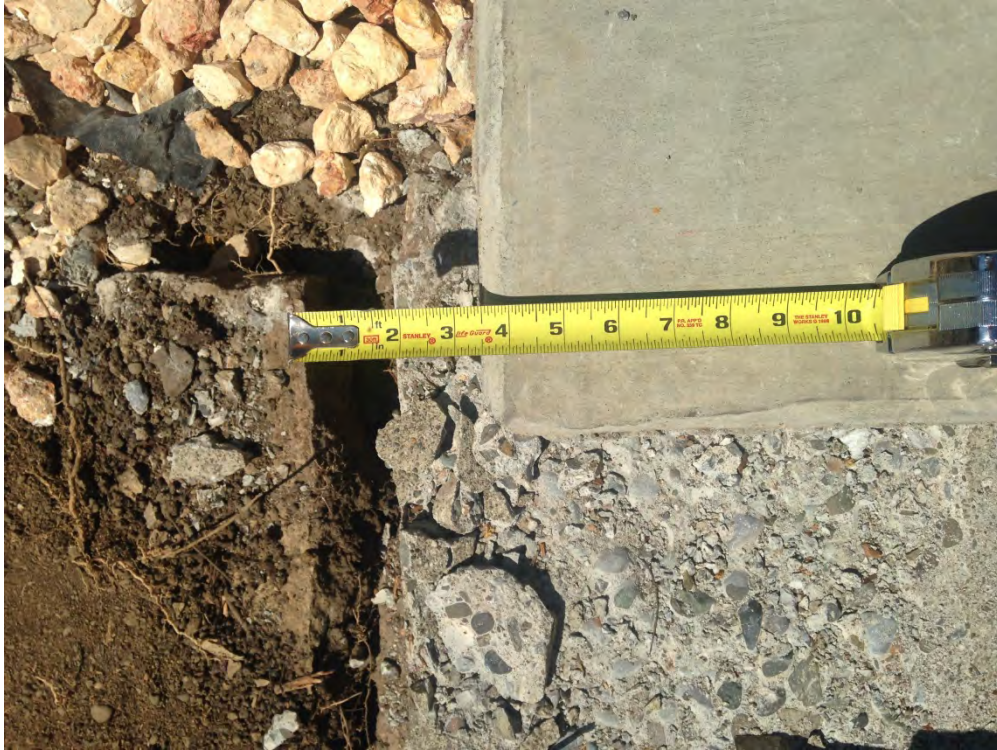
Figure D-7: Lateral offset of overlapping compression zone in pavement perpendicular and adjacent to fault; offset is parallel to fault [NSF-GEER; N 38.3026 W 122.3437; 8/27/2014 12:02]

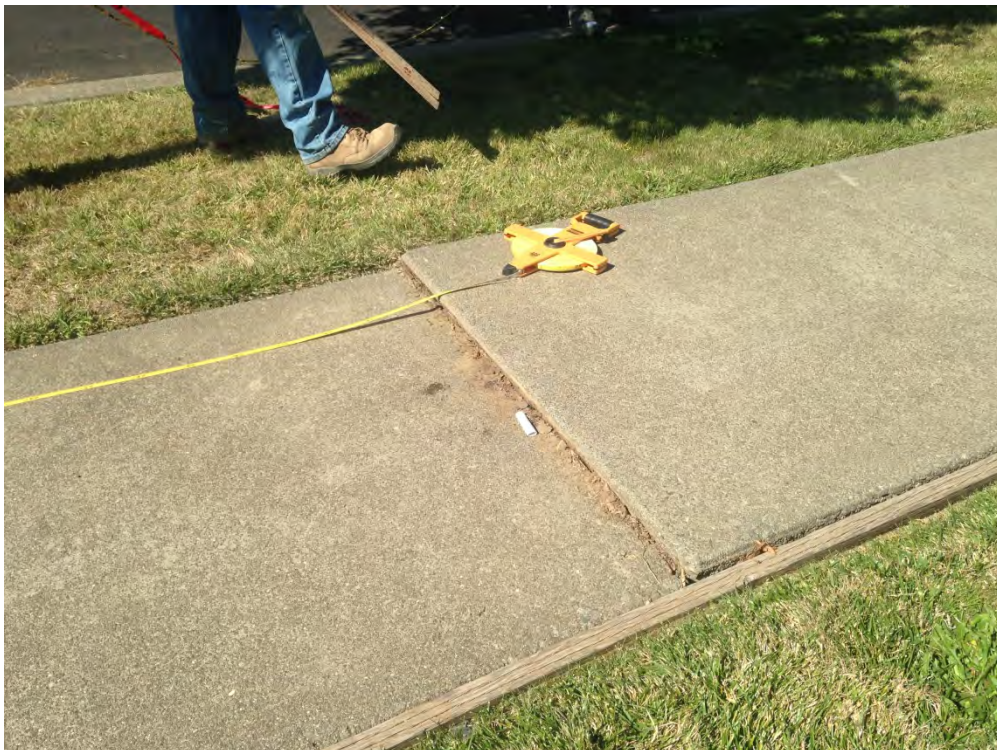
Figure D-8: Slight uplift in compressed zone of pavement perpendicular and near fault [NSF-GEER; N 38.3037 W 122.3430; 8/26/2014 15:48]

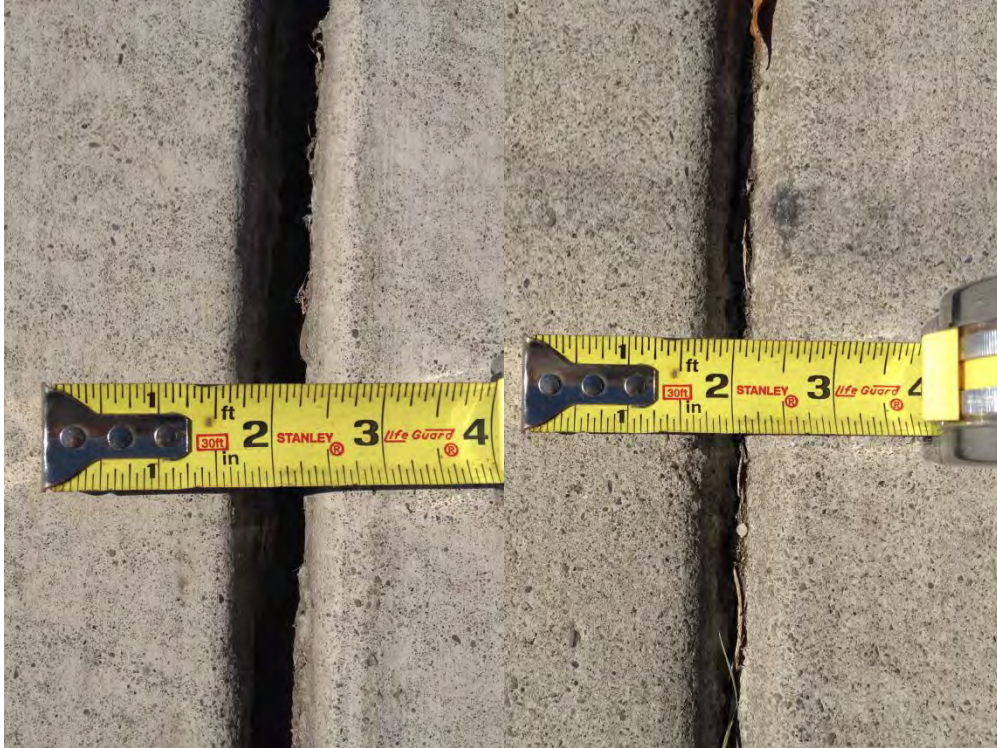
Figure D-9: Typical extension cracks in thermal joints of sidewalk pavement parallel to fault; ~13mm gap (left), ~7mm gap (right) [NSF-GEER; N 38.3067 W 122.3464; 8/28/2014 15:18]

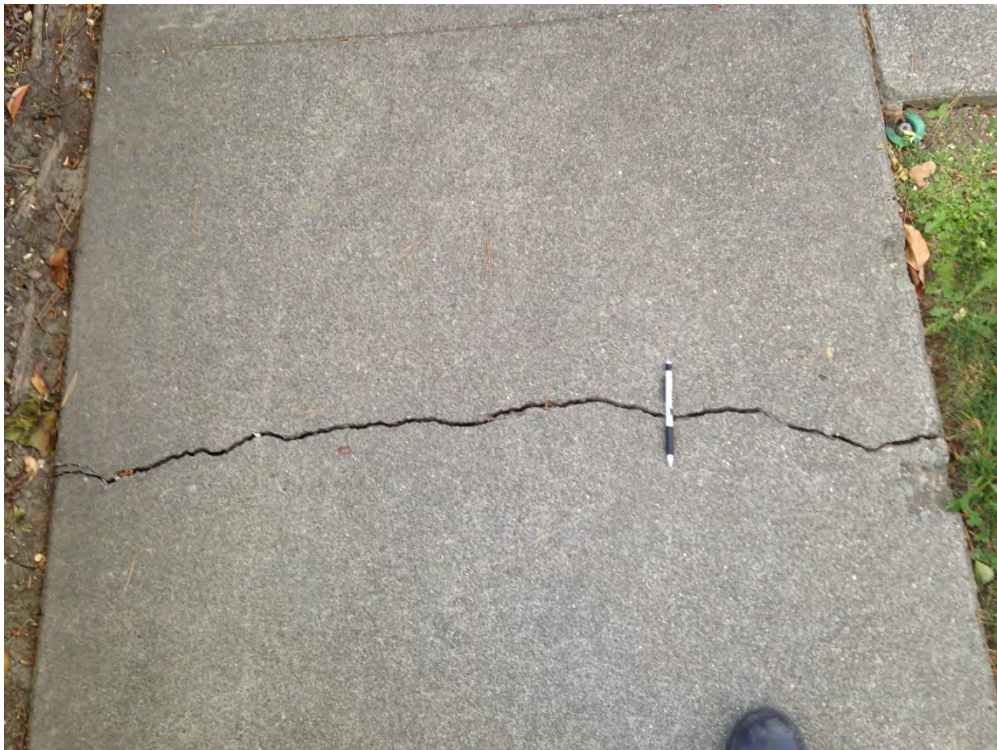
Figure D-10: Extension crack in sidewalk pavement parallel to fault; ~3mm gap [NSF-GEER; N 38.3055 W 122.3454; 8/26/2014 18:30]

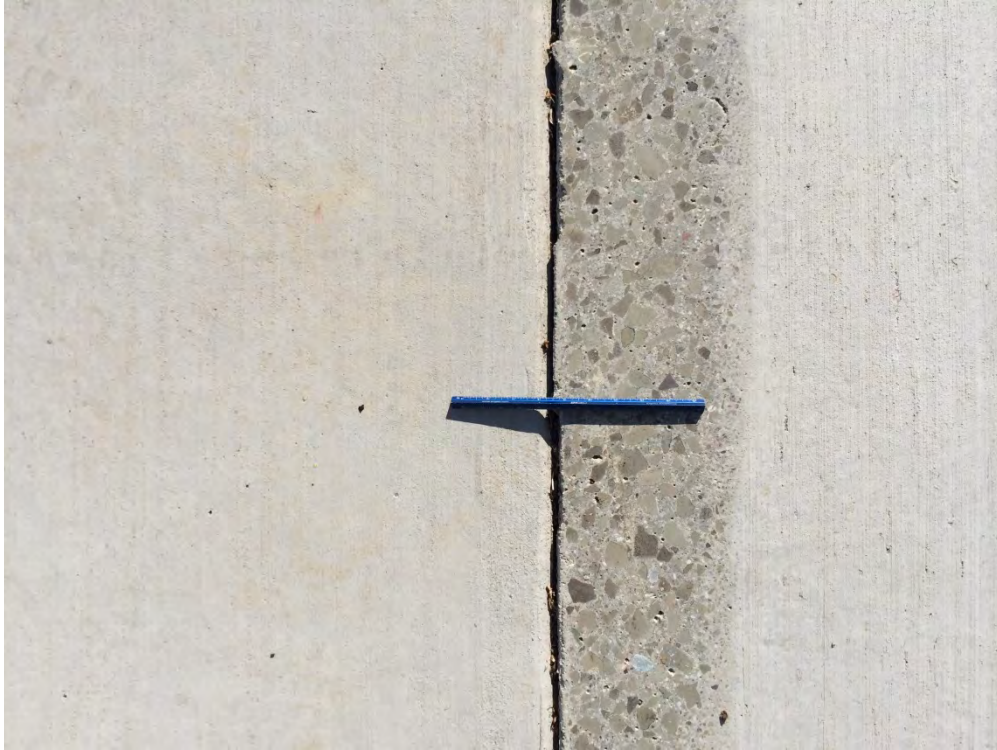
Figure D-11: Example of extension crack not considered due to shaved concrete [[NSF-GEER; N 38.3021 W 122.3430; 8/28/2014 09:17]

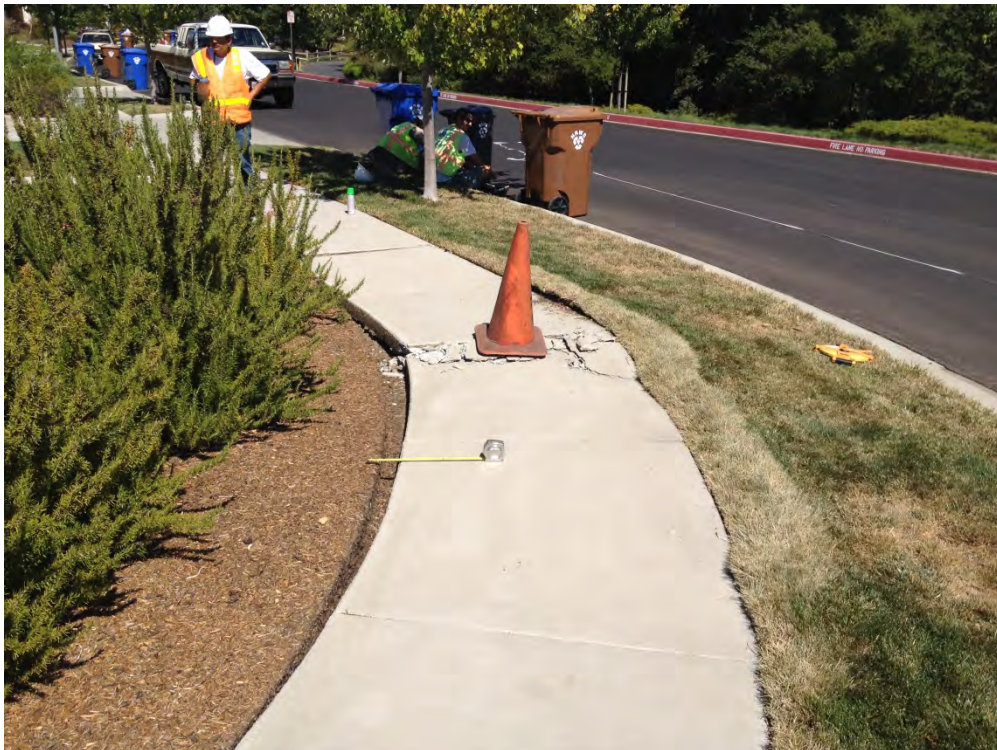
Figure D-12: Crushed section in pavement parallel to fault with compression features in curb strip perpendicular to fault, across from creek [NSF-GEER; N 38.3055 W 122.3467; 8/28/2014 14:30]

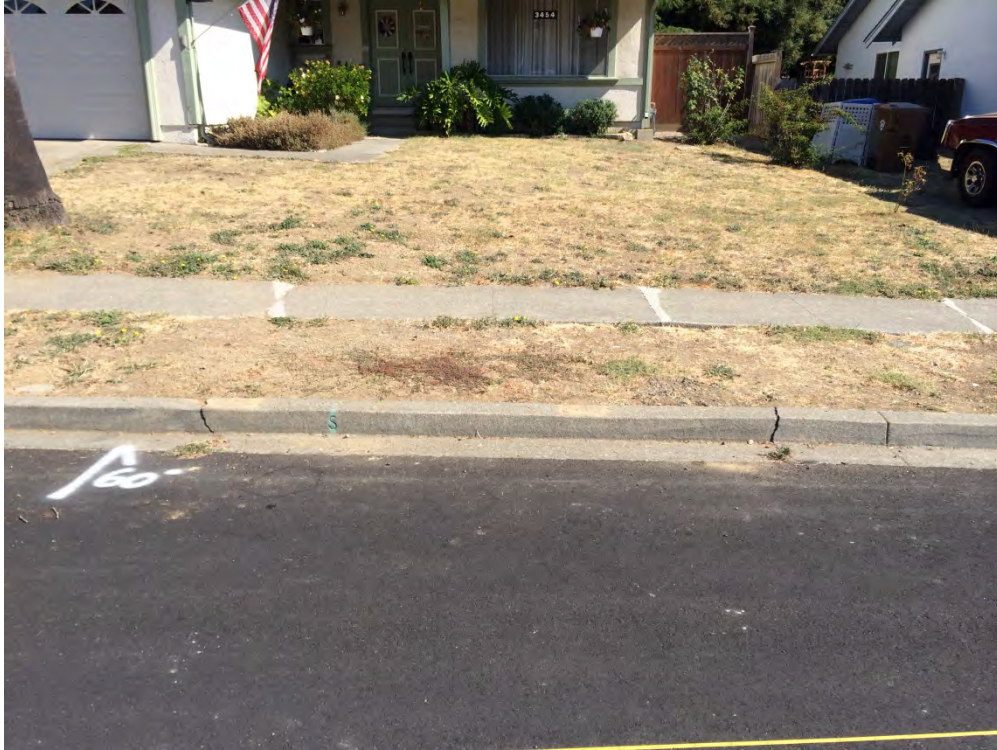
Figure D-19: Buckled curb adjacent to pavement perpendicular to fault trace; visible cracking in soil aligns with cracks in curb [NSF-GEER; N 38.3027 W 122.3407; 8/28/2014 10:25]

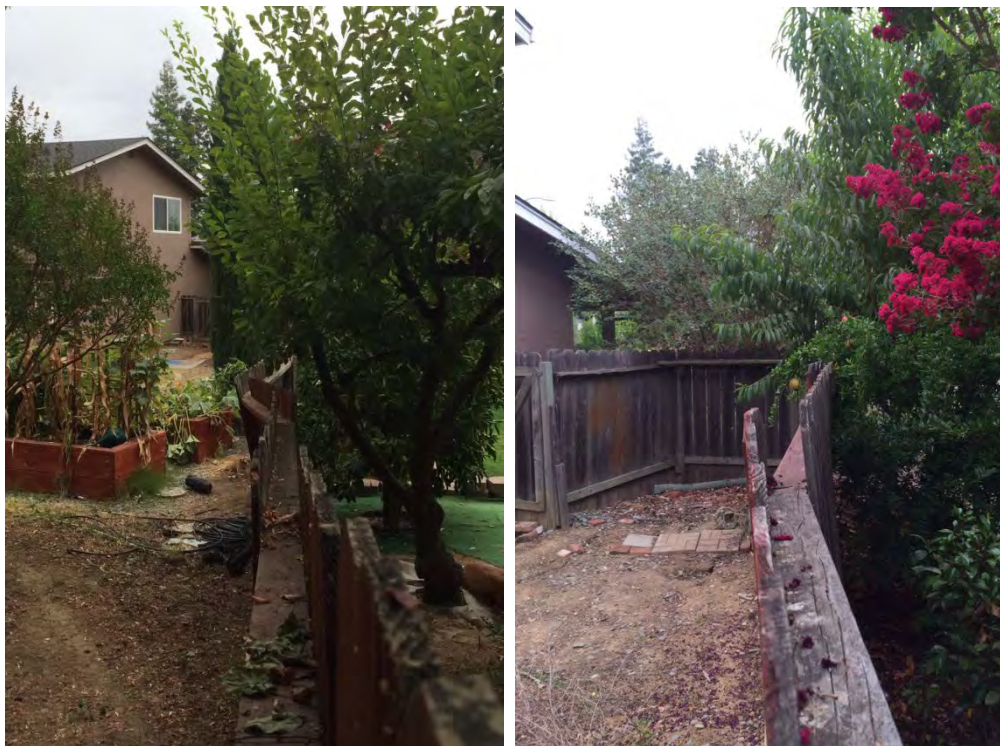
Figure D-20: Buckled section of fence for strain measurements [NSF-GEER; N 38.3015 W 122.3442; 8/25/2014 09:57]
