# **Investigating Liquefaction Effects in Christchurch, New Zealand**

**Jonathan Bray, Ph.D., P.E., NAE**

**with M. Cubrinovski, J. Zupan, C. Markham,  
C. Beyzaei, R. Luque, M. Riemer, M. Stringer & M. Taylor**  
*University of California - Berkeley & Univ. of Canterbury*

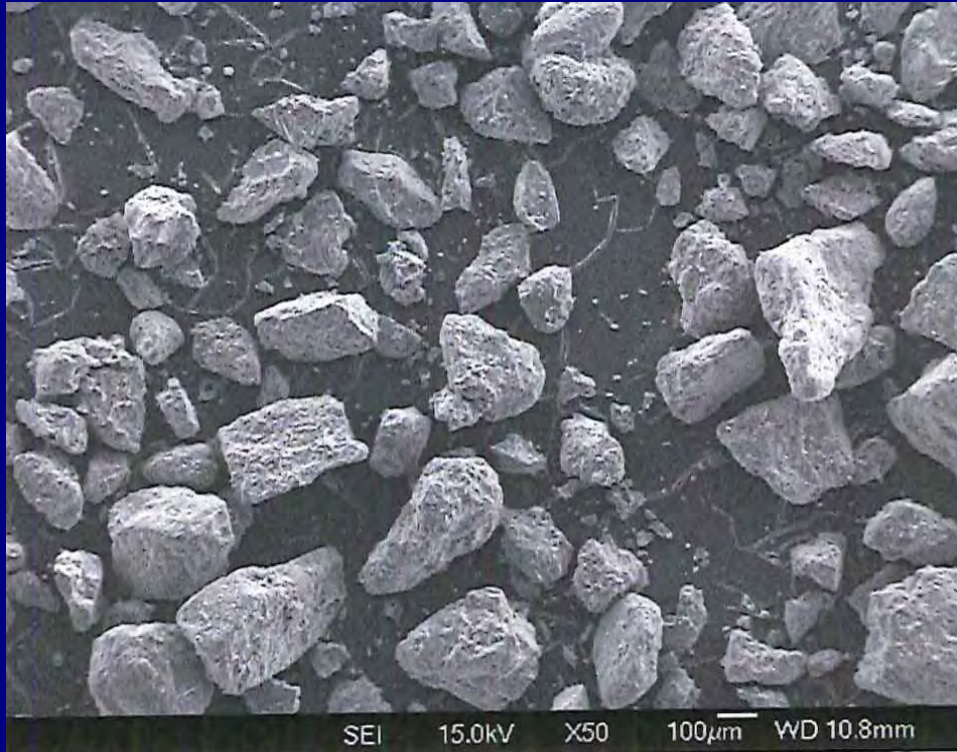
Soil sample Site 3 Natural Soil Panel 1 at -1.76m R.L at 50x magnification.

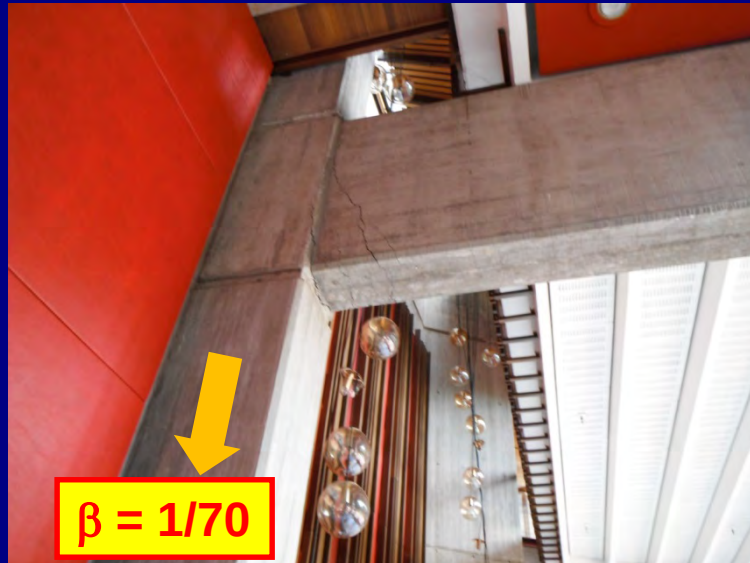
Settlement of Ground next to Piled Bldg.

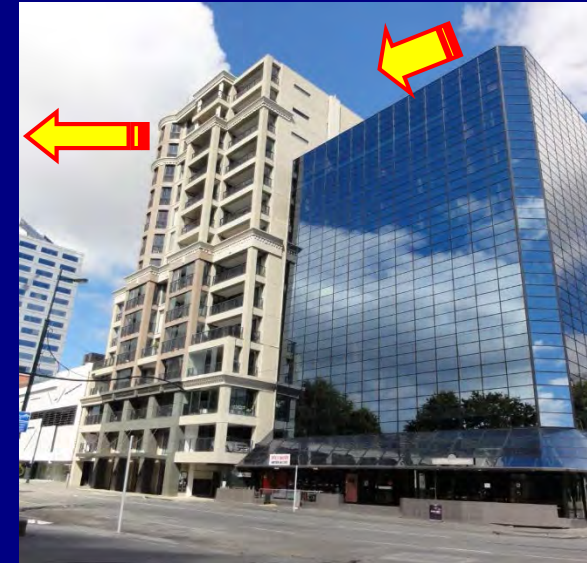
Cracking due to Differential Settlement

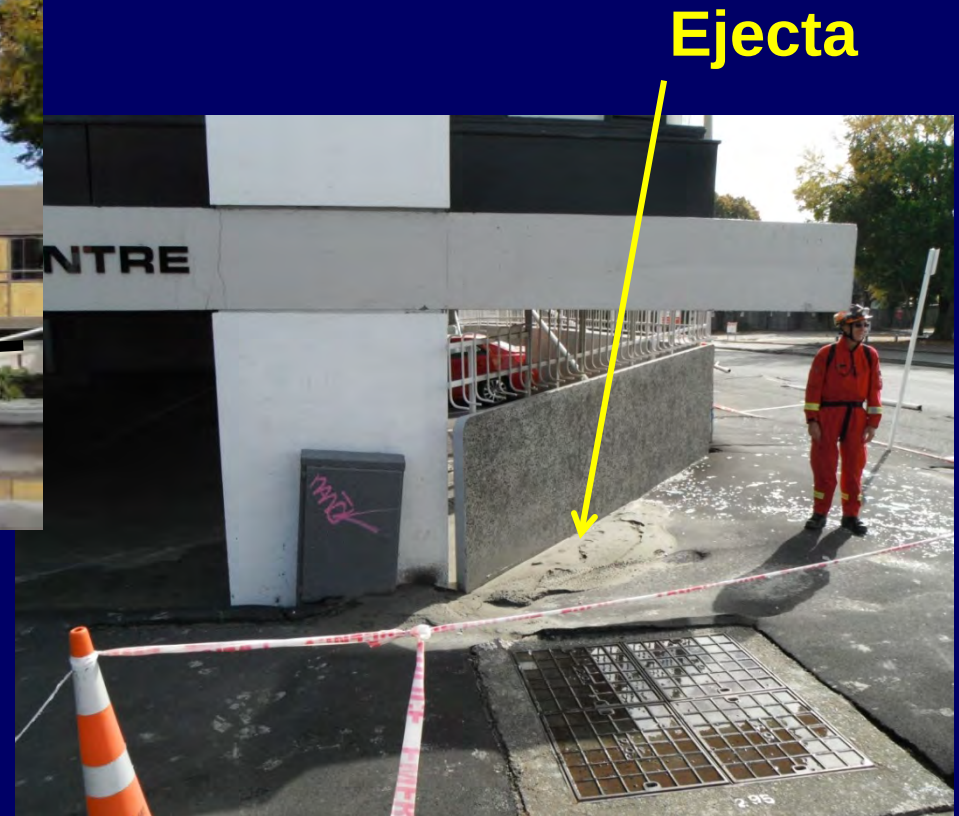
# CTUC Building

## Liquefaction-Induced Differential Settlement Induces Distress

**Building Settlement (cm)**  
Maximum Angular Distortion  $\approx 1/50$

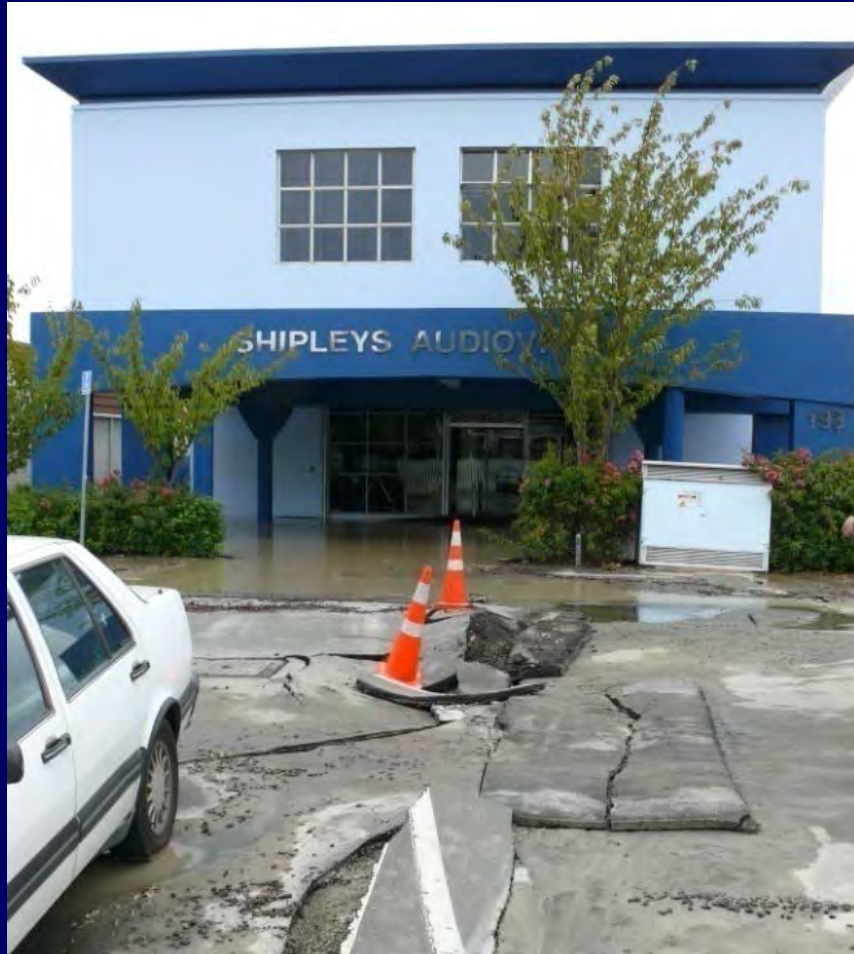
# SA Building

## Liquefaction-Induced Differential Settlement

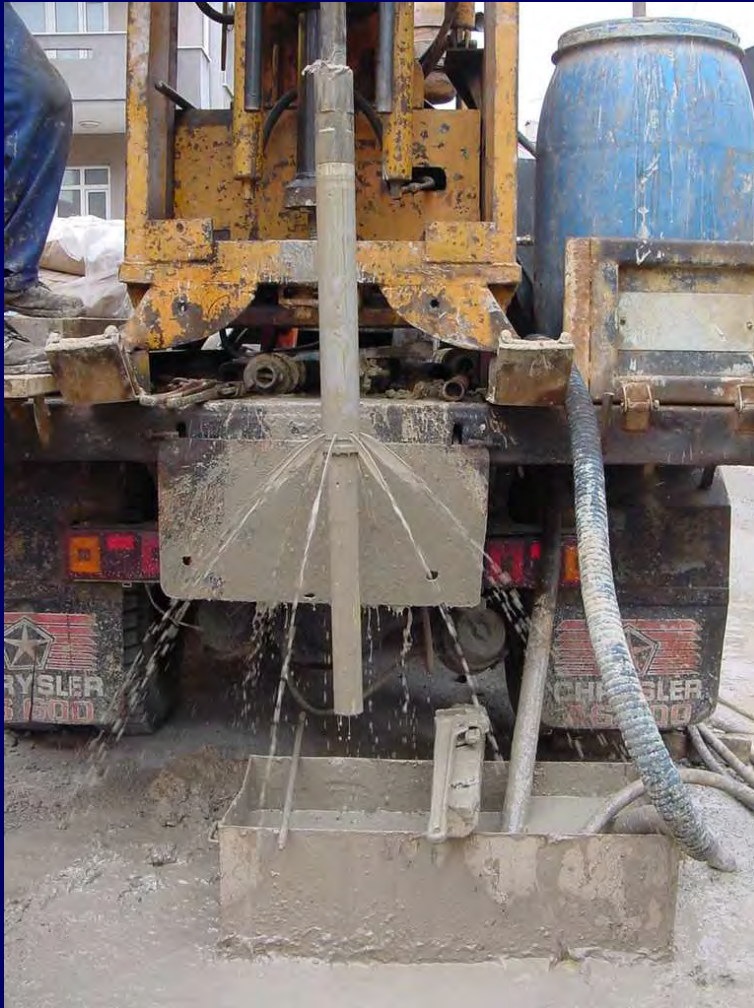
## D&M Thin- Walled Piston Sampler

Careful Handling

Cut

Extrude

Test
