CHAPTER 8 Geotechnical Observations

GEER/EERI/ATC Cephalonia, Greece 2014 Report Version 1

8.1 Site Effects

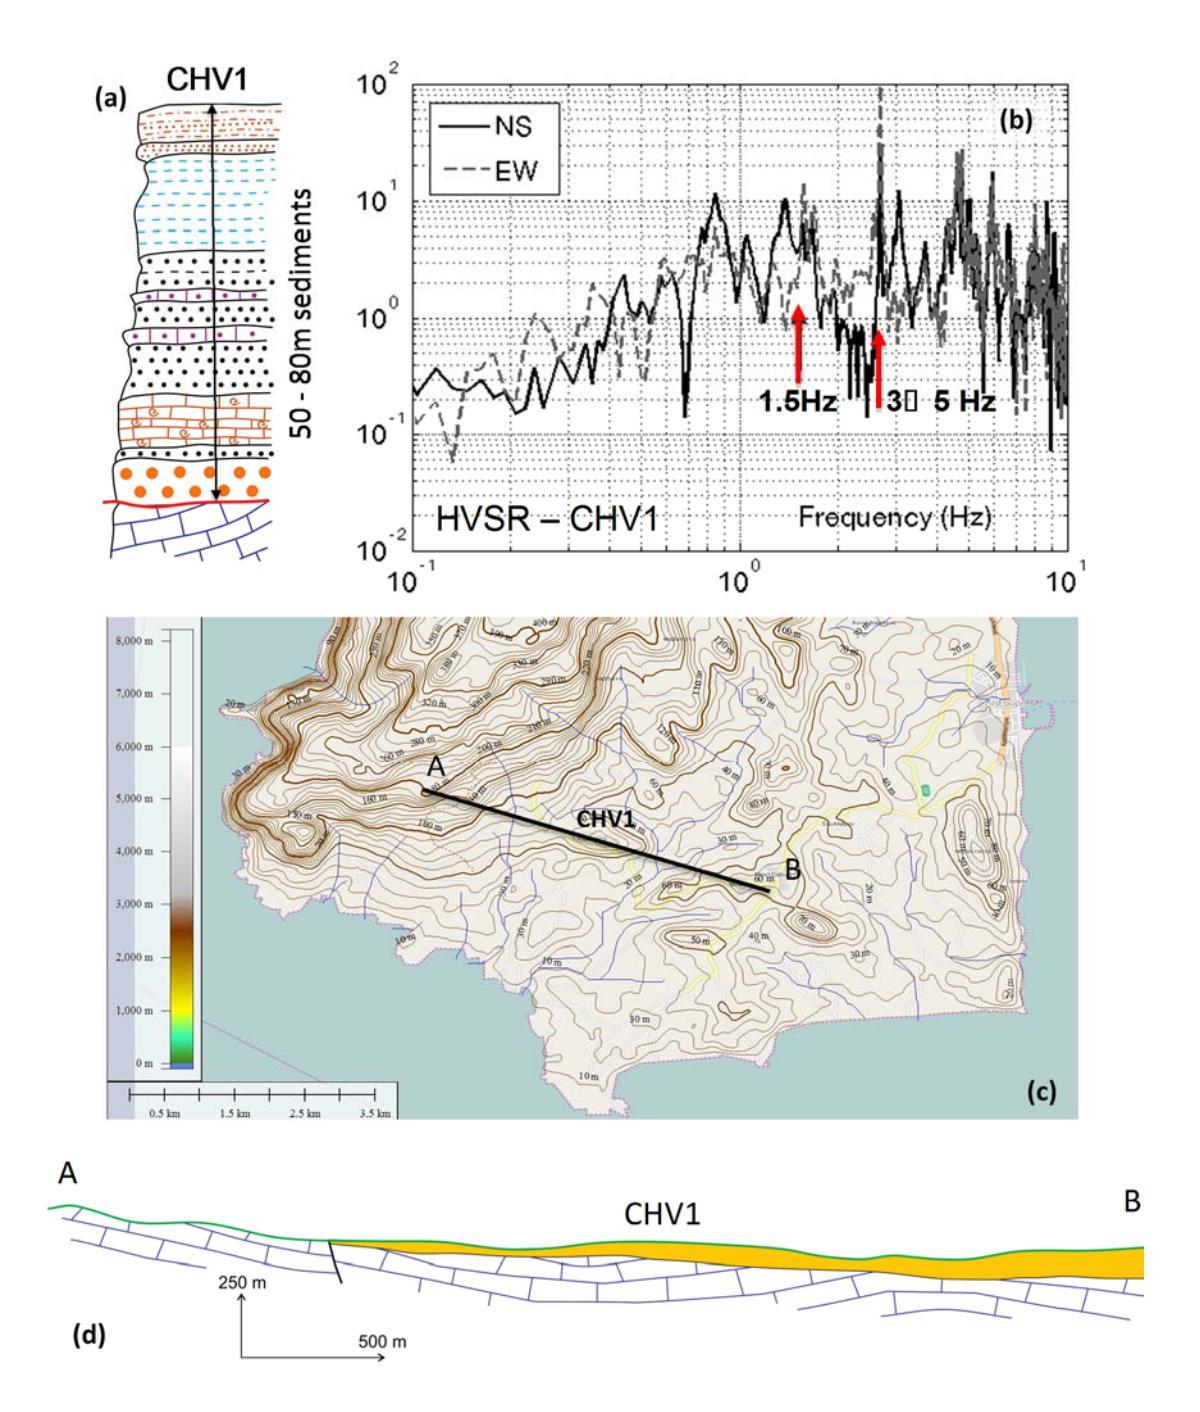
Recent studies on the relative contribution of site amplification and topography effects at sites with similar surface and subsurface geologic features as CHV1 suggest that the simultaneous triggering of site and topography effects (referred to as 3D site effects) can generate accelerations much higher than what would have been predicted by mere superposition of the effects of topography and 1D site response (Assimaki et al., 2005; Assimaki & Jeong, 2013). Moreover, several studies have shown that for ground motions levels above 0.5g recorded at sites with soft sediments such as CHV1, 1D nonlinear site response frequently fails to physically explain how the soil can sustain ground motion amplitudes that supersedes its strength in simple shear (Andrews et al., 2007).

Figure 8.1.8. (a, b) HVSR at station CHV1 (Chavriata), revealing consistent site response modes with the 50-80m sedimentary structure underlying the region; (c, d) topographic map and cross section across Chavriata, clearly showing irregular surface and subsurface topography that may have contributed to the large recorded ground accelerations.

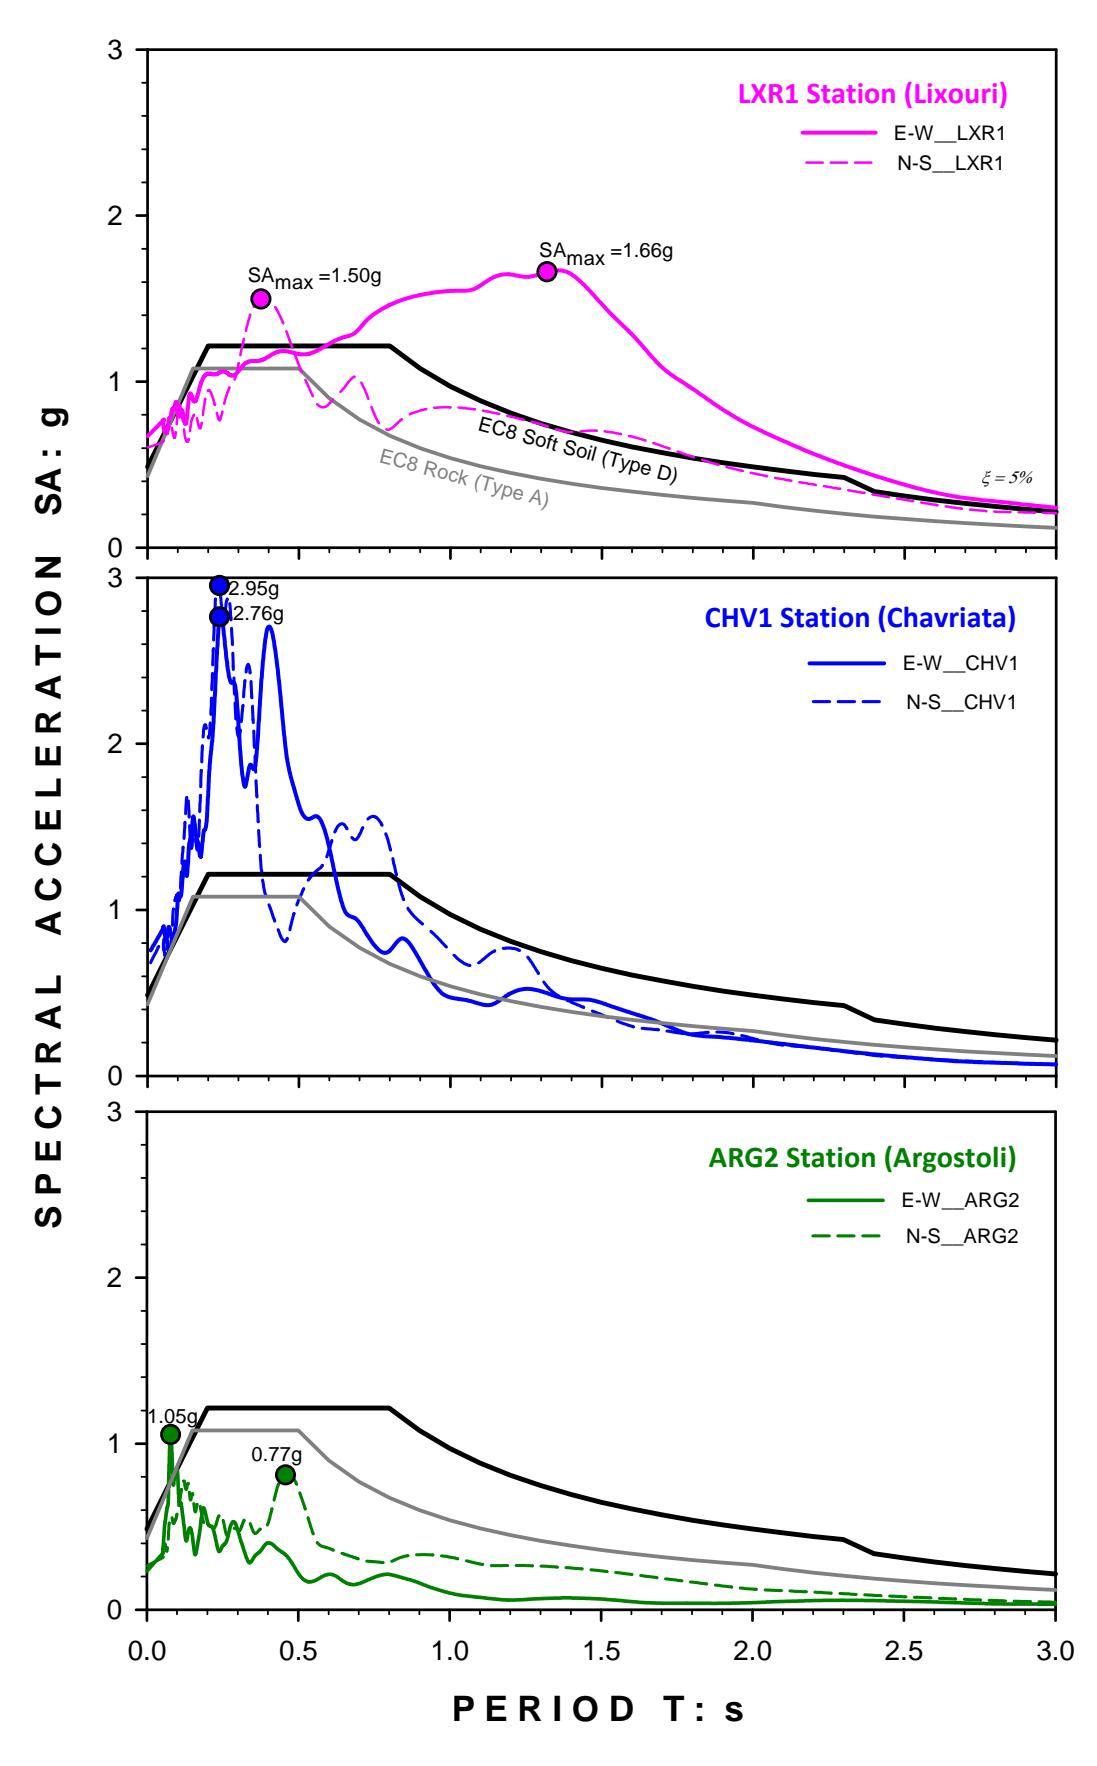
Figure 8.1.11 compares acceleration response spectra of three records from the 2nd event at the stations of LXR1, CHV1, and ARG2 stations (at Lixouri, Chavriata, and Argostoli) to the EC-8 spectra for ground types A (rock) and D (soft soil). Both components of the CHV1 record and the EW component of the LXR1 record far exceed code-based spectra in the structural period range of less than 1 s (CHV1) and greater than 0.8 s (LXR1). As discussed earlier in this section, local site effects and directivity have likely contributed to these high amplification effects that need to be confirmed with pertinent in-situ testing. The ARG2 station response spectra are lower than the code-based spectra, which can be expected since this station is farther away from the epicenter and is on stiffer site conditions as compared to the other two stations.

Figure 8.1.11. Comparison of acceleration response spectra of recorded Cephalonia motions at (a) LXR1, (b) CHV1, and (c) ARG2 stations with EC-8 design spectra.

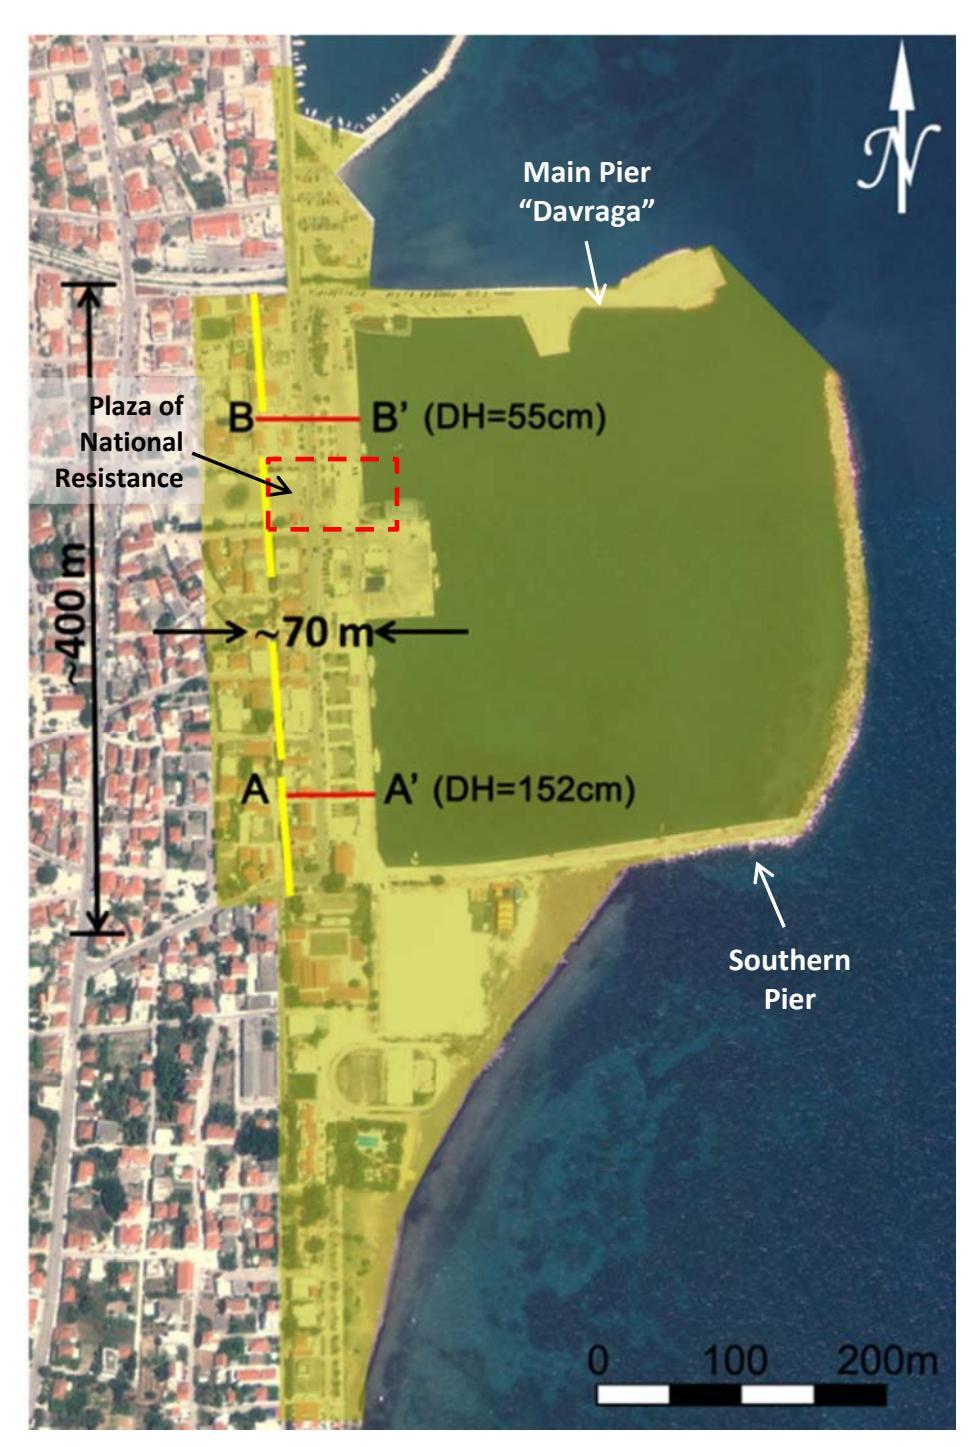
The Lixouri port seafront is approximately 400 m long (Fig. 8.2.2). It was reportedly constructed by reclaiming part of the sea using debris generated following the destructive M7.2 earthquake of 1953.

Figure 8.2.2. Google Earth photo of the Lixouri Port Area (GPS coordinates 38.20°, 20.44°).

The yellow line in Fig. 8.2.2 outlines the location of the first cracks based on reconnaissance after Event 2 that appears to coincide with the coastline prior to the 1953 earthquake. Liquefaction and lateral spreads in the Lixouri port and waterfront area were first observed during Event 1. Eye witnesses in the port area reported that during Event 1 ejected material reached a height of 1.5 m. Liquefaction and lateral spreads in the Lixouri port and waterfront area were more extensive during Event 2.

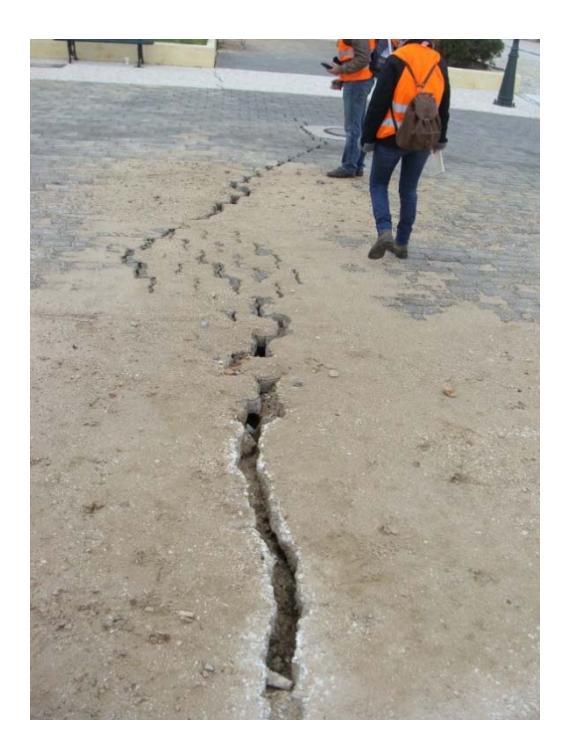
Figure 8.2.6. Soil ejecta with gravel size particles along the Lixouri port waterfont after Event 2. Note gravel size particles in the ejecta (GPS coordinates 38.19873°, 20.43934°).

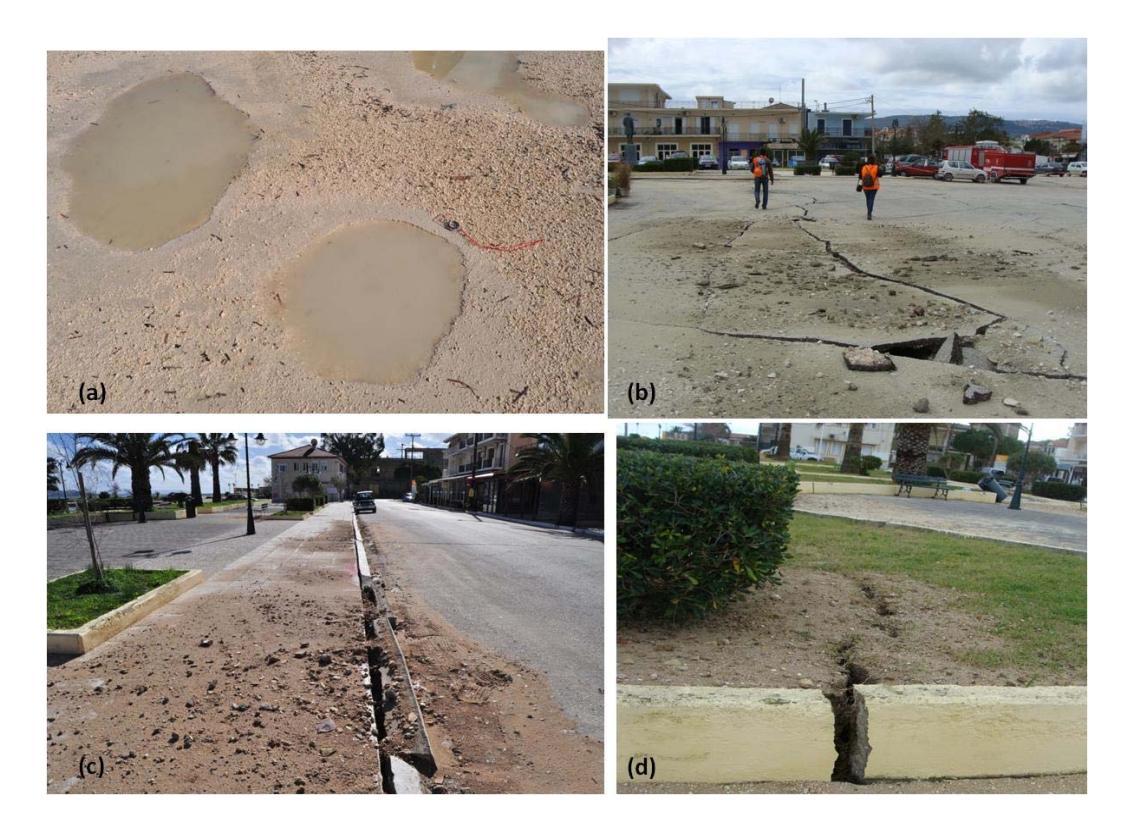
Figure 8.2.7 Typical liquefaction ejecta in Lixouri port [GPS coordinates: a-(38.197531°, 20.439784°), b-(38.19988°, 20.43969°), c-(38.19922°, 20.43928°), d-(38.19873°, 20.43934°), 2/8/2014].

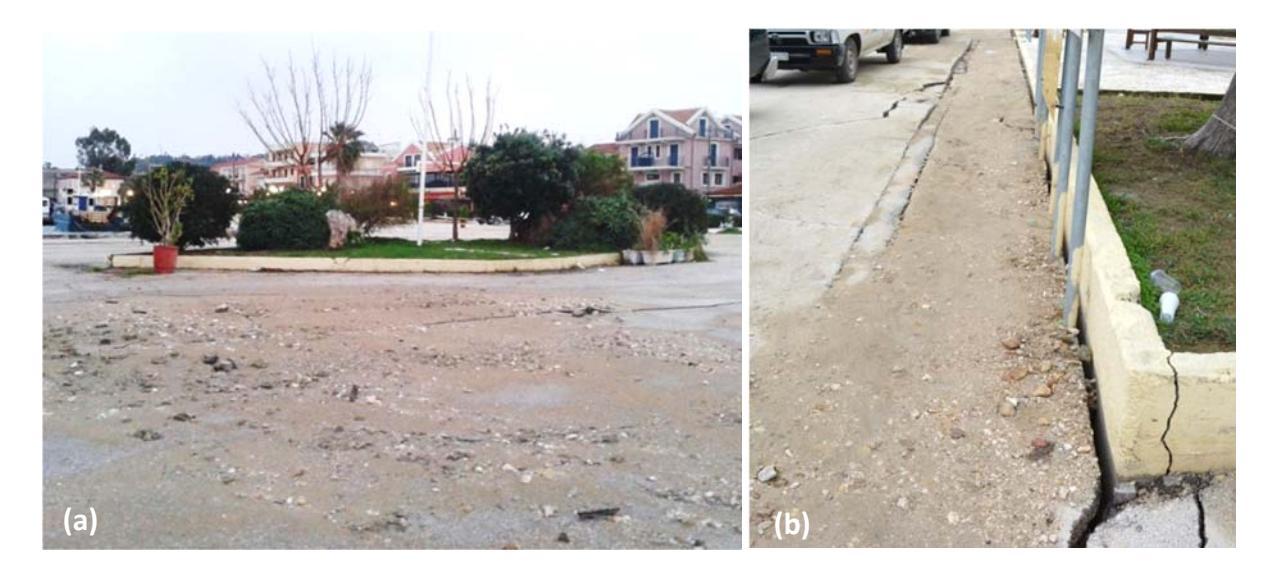
Figure 8.2.9. Extensive evidence of coarse-grained ejecta in the area of Lixouri port: (a) at quay wall (38°12'0.02"N, 20°26'22.62"E), and (b) towards the first row of buildings parallel to the shoreline (38°11'59.82"N, 20°26'21.76"E).

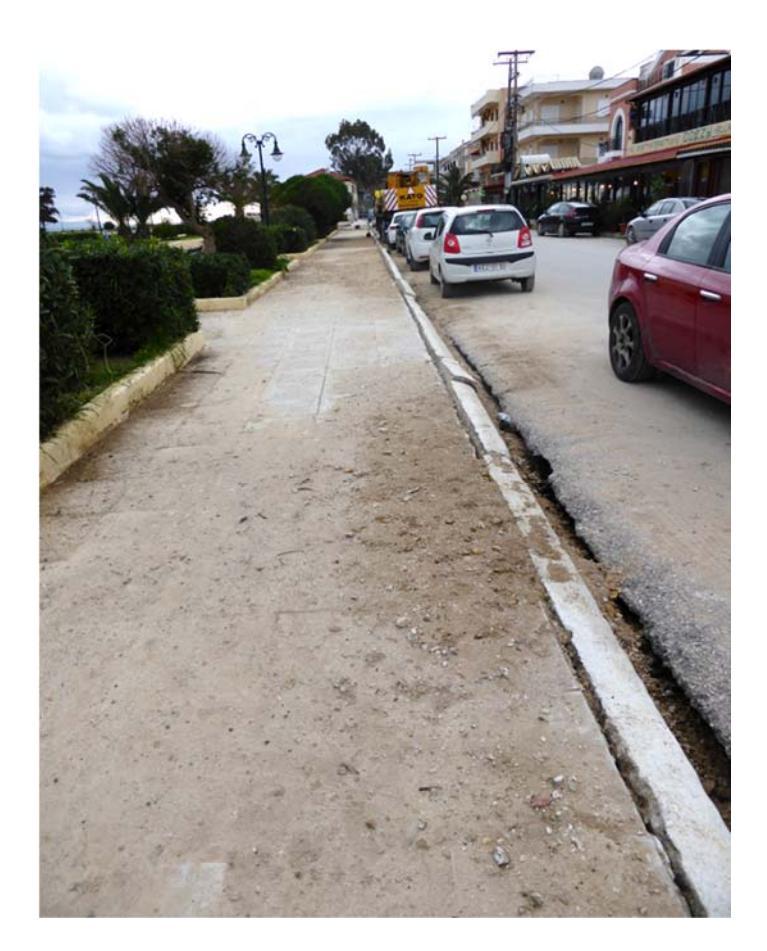
Figure 8.2.10. Remnants of liquefaction on the Lixouri coastal sidewalk (GPS coordinates: 38.199444, 20.439166).

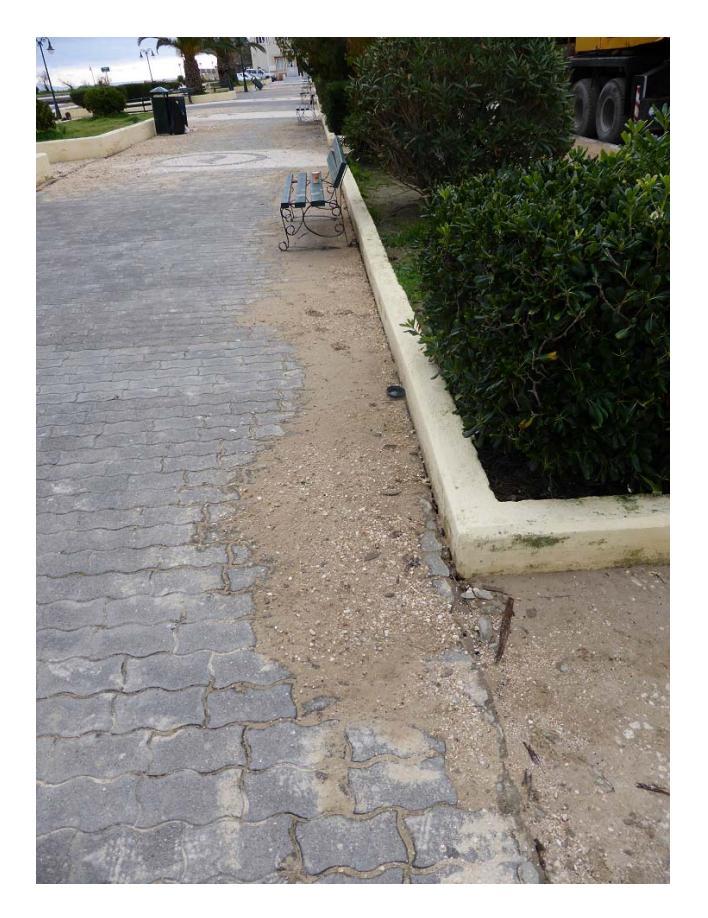
Figure 8.2.11. Ejecta on Lixouri coastal sidewalk tiles (GPS coordinates: 38.199166, 20.439166).

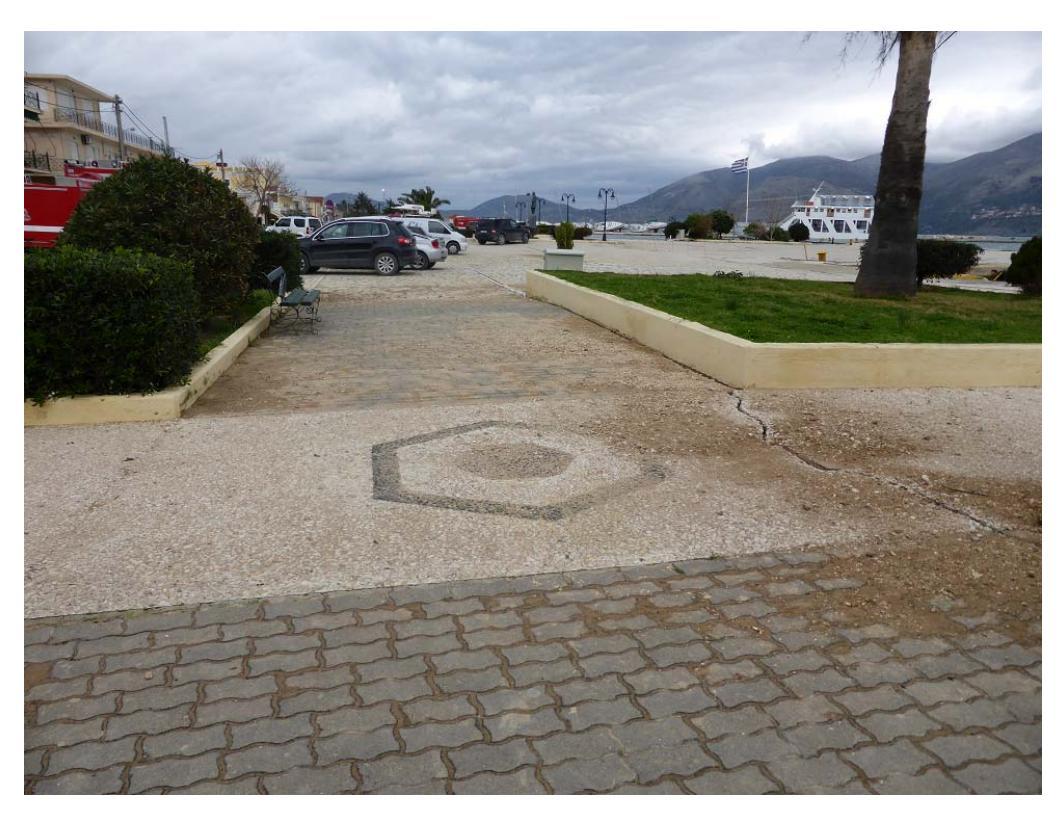
Figure 8.2.12. Evidence of liquefaction at Lixouri coastal sidewalk (GPS coordinates: 38.199166, 20.439166).

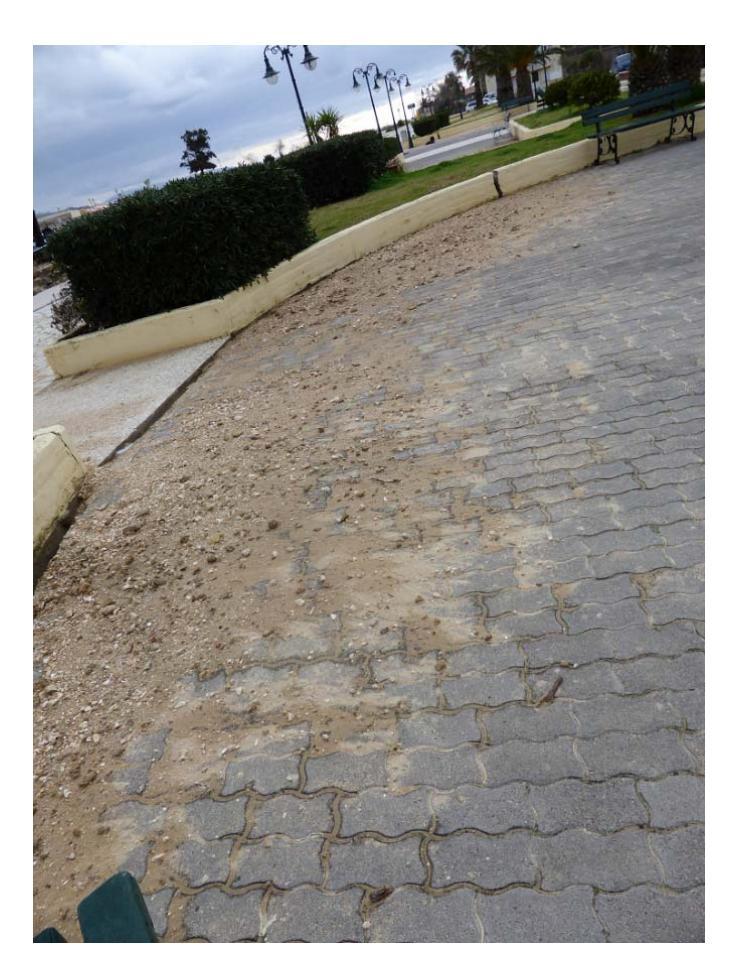
Figure 8.2.13. Evidence of liquefaction at a Lixouri coastal sidewalk (GPS coordinates: 38.199166, 20.439166).

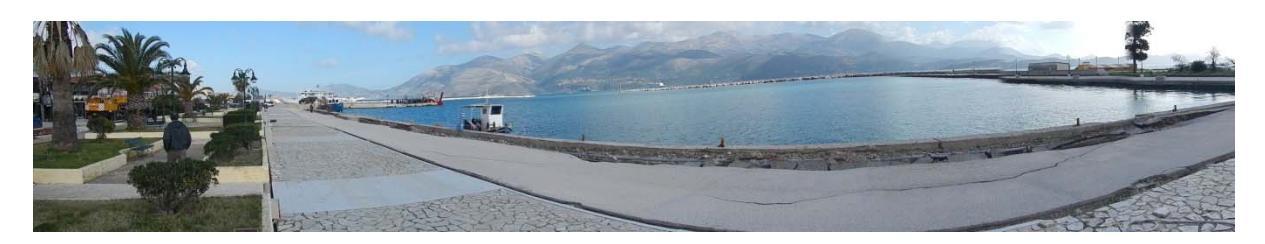
Figures 8.2.14 through 8.2.33 present examples of displacement patterns observed at the Lixouri port seafront. Measurements of cumulative horizontal displacement were performed by the UPatras team along several cross-sections perpendicular to the shoreline, whose results are currently being analyzed. Figure 8.2.20 shows two example cross-sections with corresponding values of total horizontal displacement. Soil cracking observed in the Lixouri coastal zone extended inland from the Lixouri waterfront to a maximum of two to three blocks spanning about 100 m. Displacement measurements were made along cross-sections A-A' and B-B', presented in Figs 8.2.32 and 8.2.33, respectively. The locations of the cross sections are shown in Fig. 8.2.2. Cumulative horizontal displacement measured along these cross-sections from points A and B are shown in Figs. 8.2.34 and 8.2.35, respectively. Total horizontal displacement towards the sea estimated along cross-sections A-A' and B-B' and 0.55 m, respectively. Longitudinal cracks parallel to the seafront were observed as far as 100 m inland from the Lixouri waterline. However only small amount of these displacements are due to lateral ground spreading, they are mostly due to inertia sliding

Figure 8.2.14. 180 degrees panorama view of the displacement patterns at the Lixouri port in location: 38°11'53.53"N, 20°26'22.23"E.

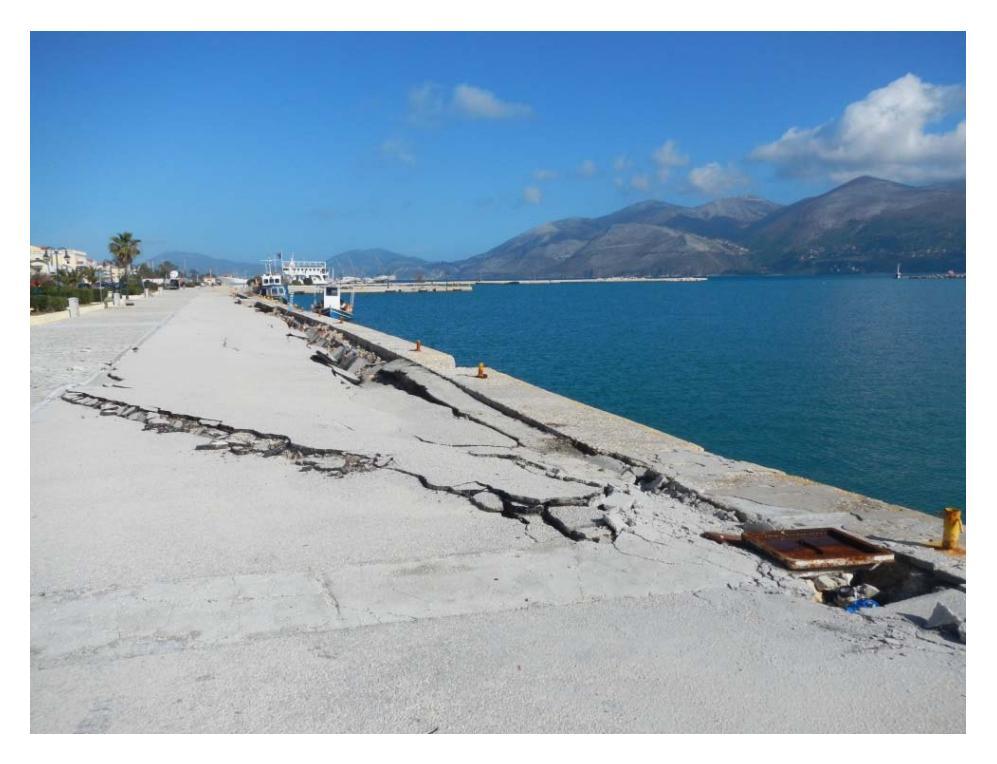
Figure 8.2.15. Example of the displacement patterns at the Lixouri quay wall (38°11'52.99"N, 20°26'22.48"E).

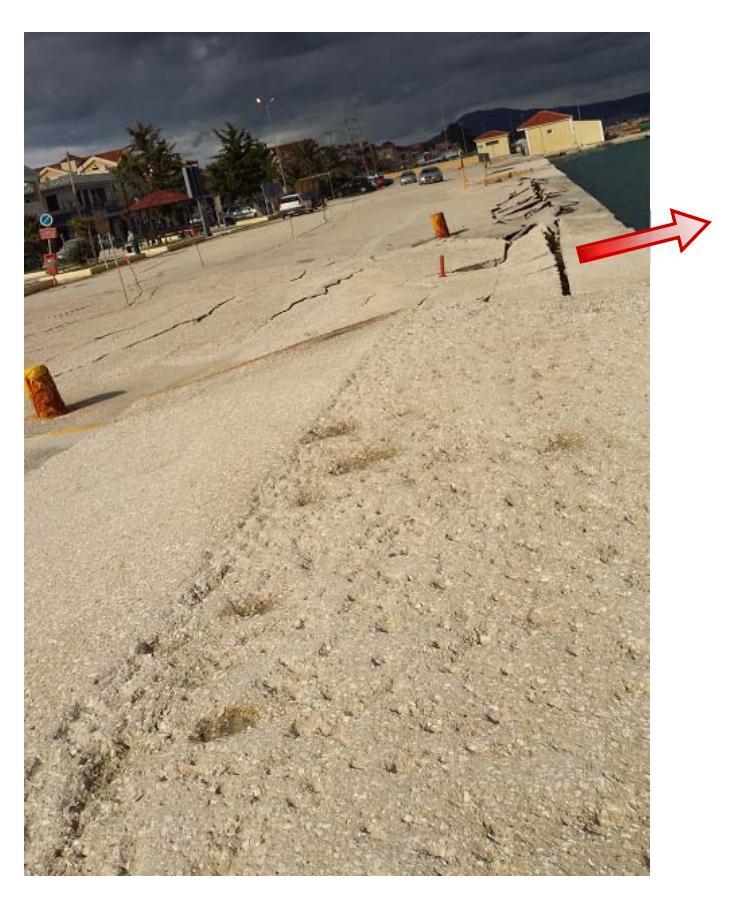
Figure 8.2.16. Lateral displacement of the quay wall, and ejected liquefied soil. This is abundant where the wall has not displaced horizontally due to the small perpendicular wharf restraining it. (GPS coordinates: 38.199444, 20.439166).

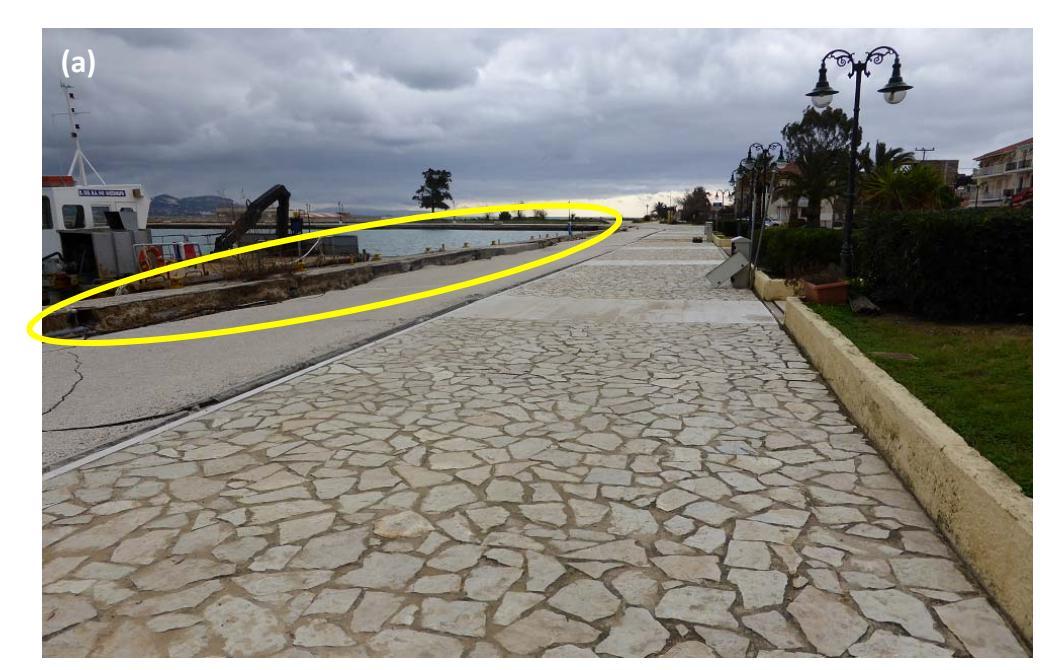
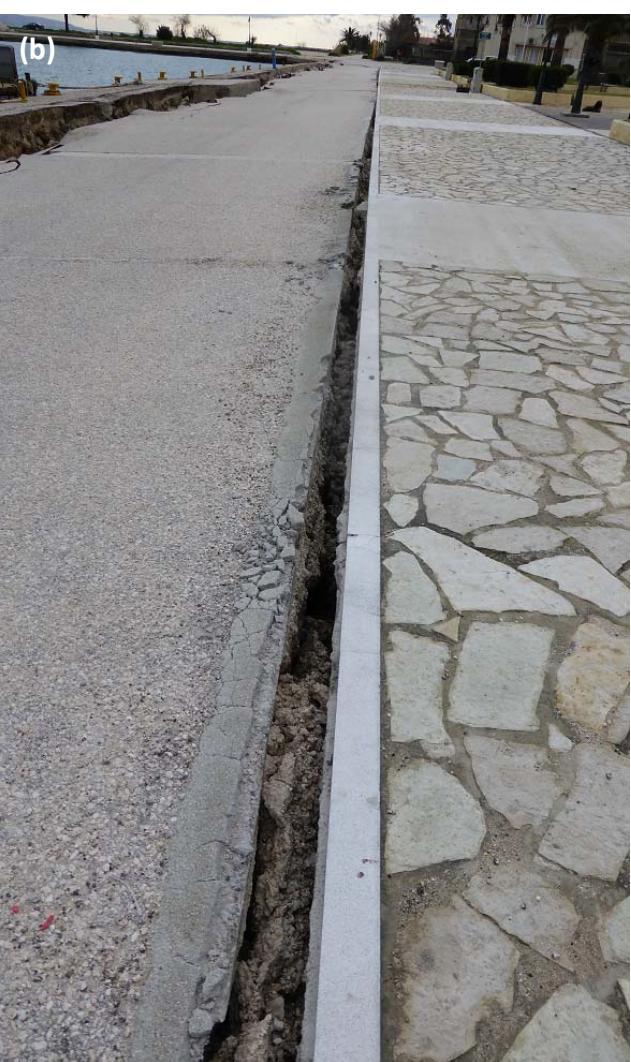
Figure 8.2.17. Vertical displacement observed behind the wavefront (marked with the yellow curve) and opening of a road-pavement joint (GPS coordinates: 38.199166, 20.439444).

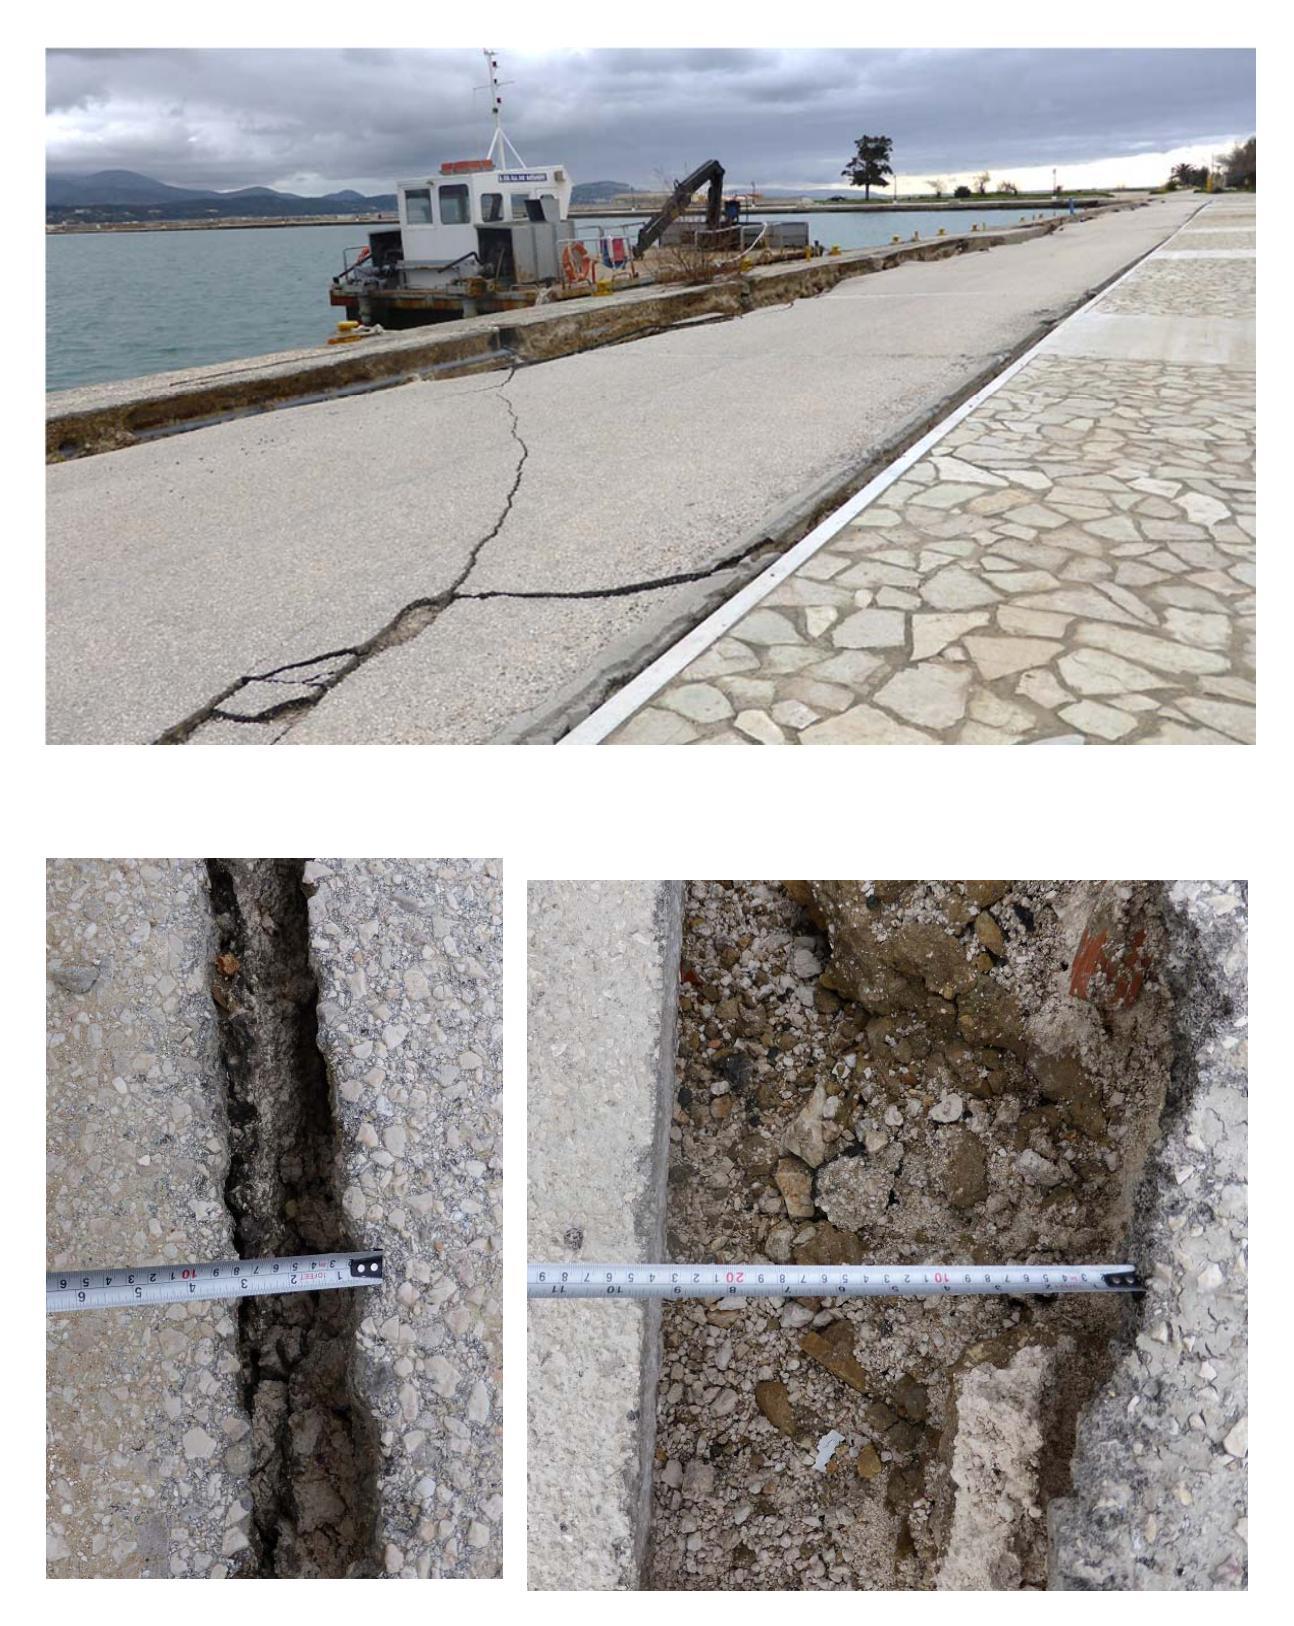
Figure 8.2.20. Lateral displacement of the quay wall towards the sea (GPS coordinates: 38.199166, 20.439444).

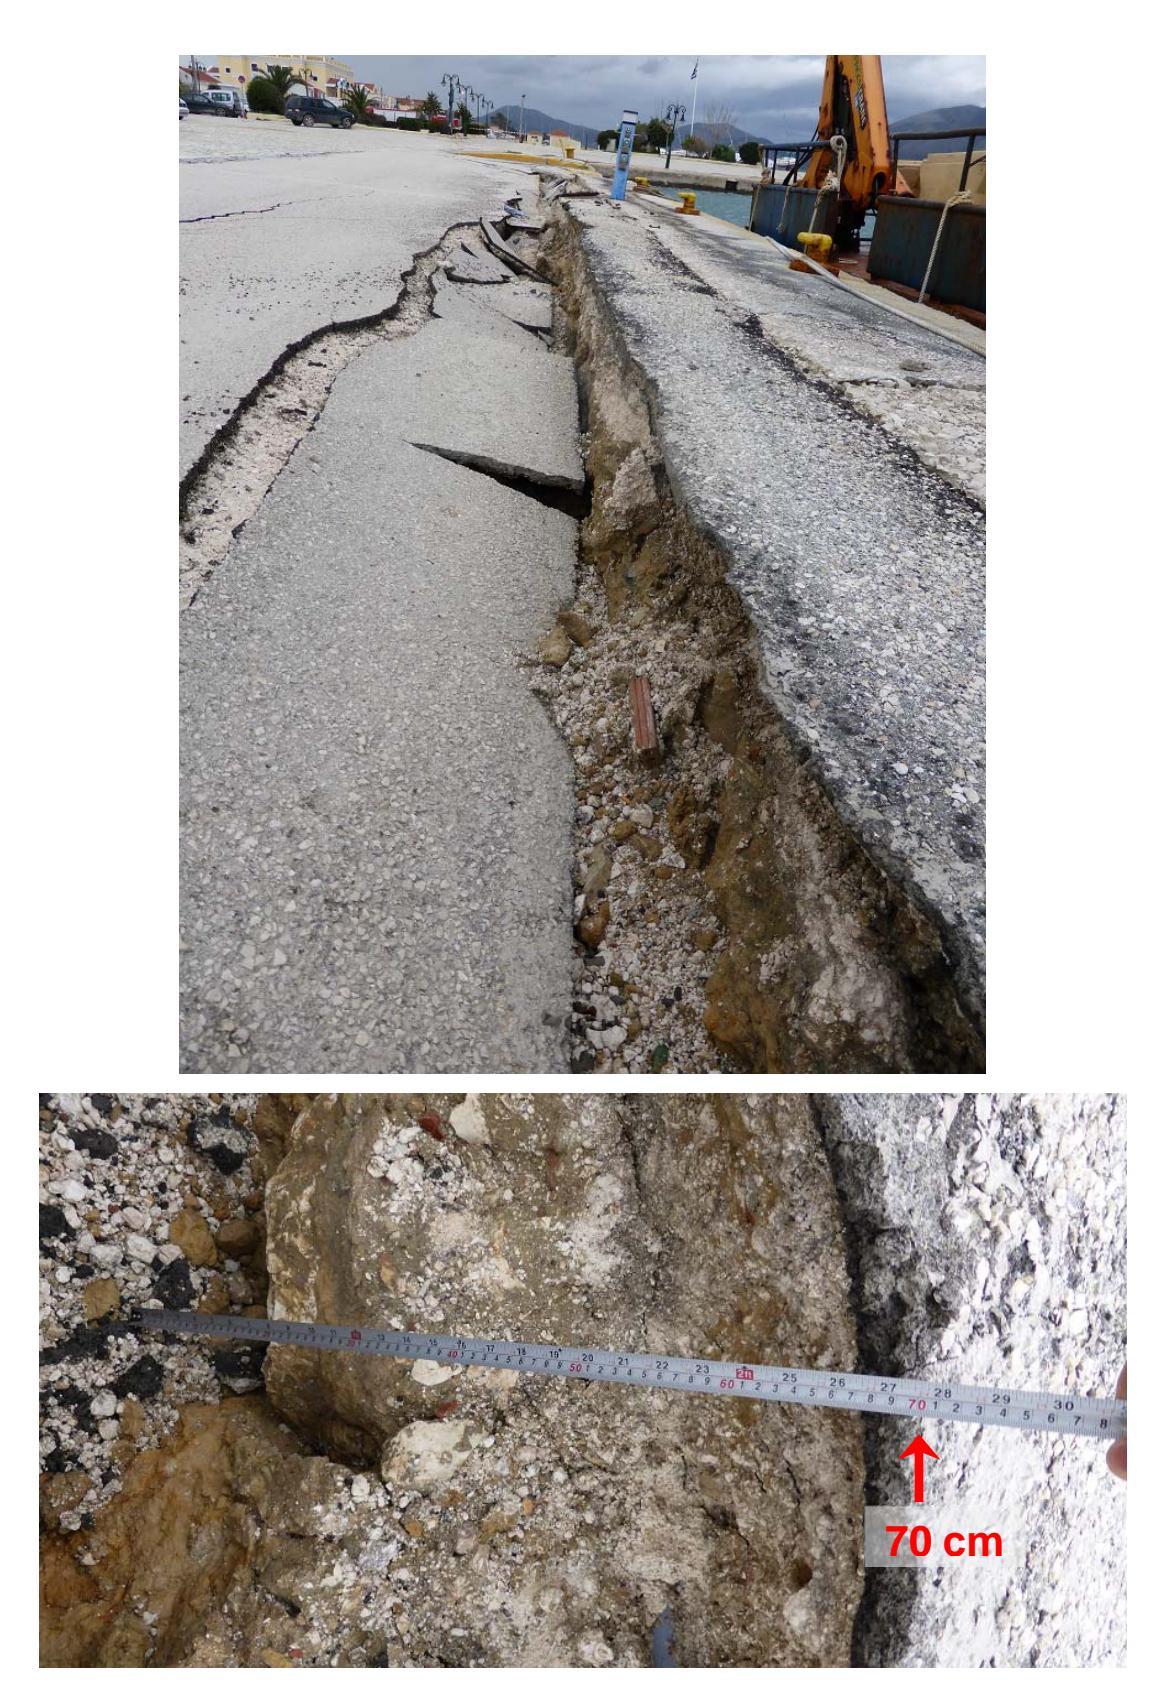
Figure 8.2.21. Vertical settlement behind the quay wall reaching 70 cm (GPS coordinates: 38.199166, 20.439444).

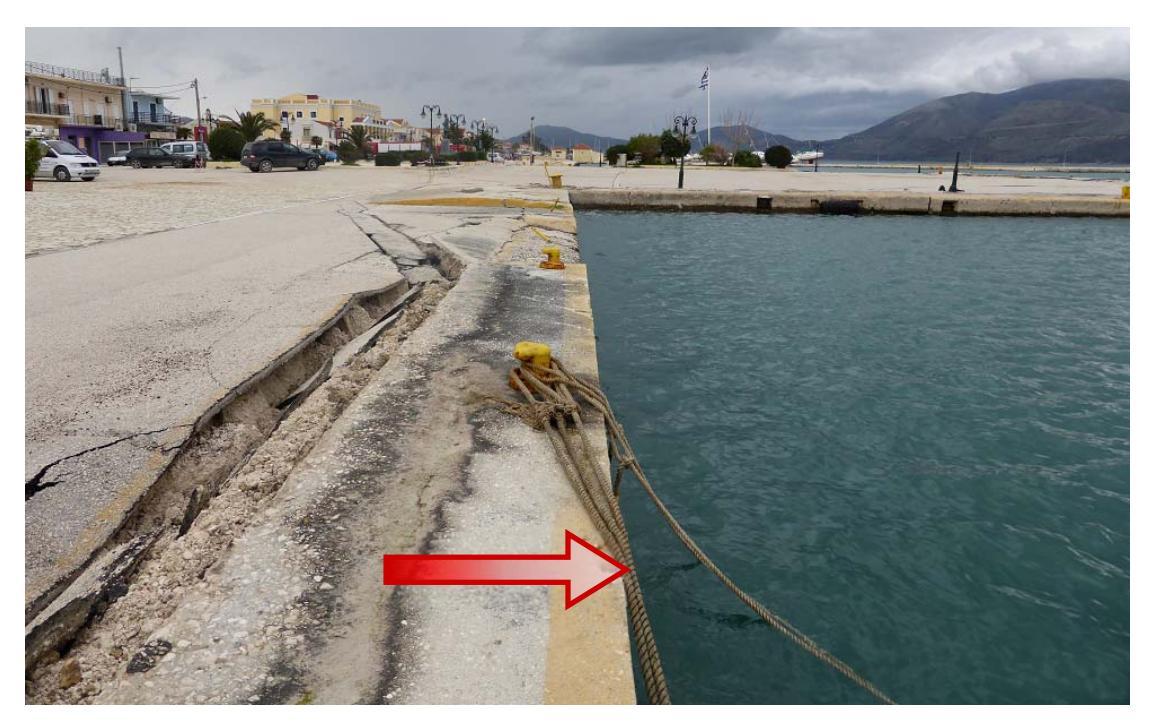
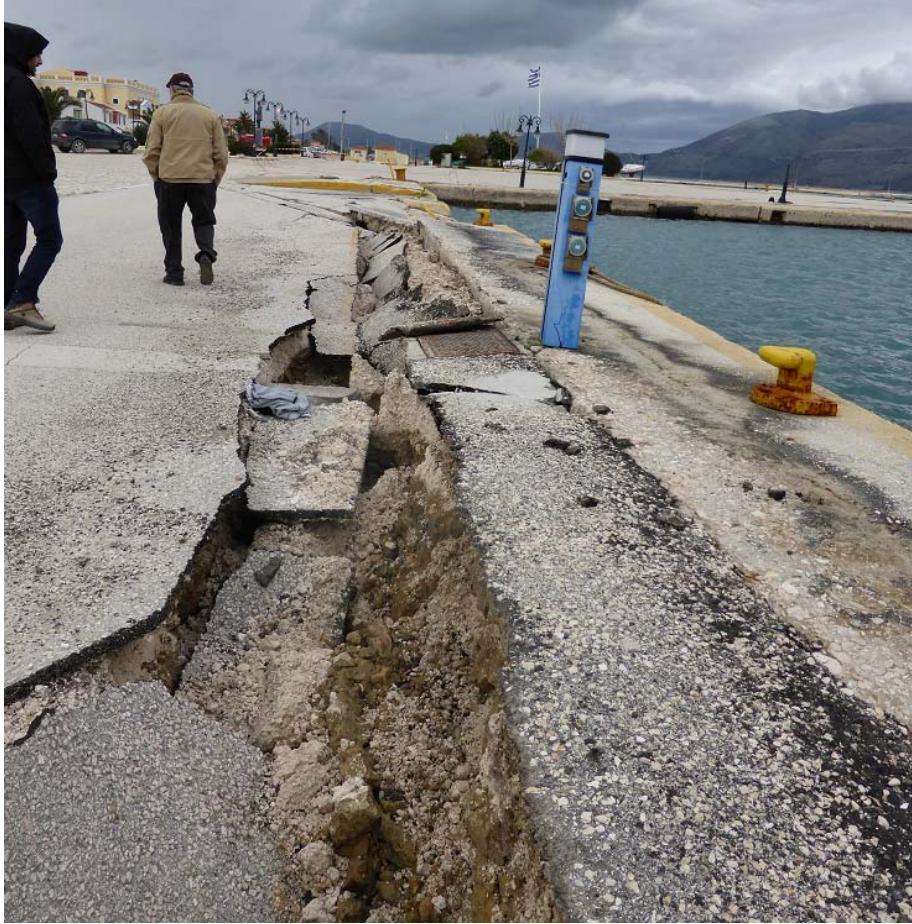
Figure 8.2.22. Across the Plaza of National Resistance (shown in Fig. 8.2.2), damage consisted mainly of lateral quay wall displacement and road cracks (GPS coordinates: 38.199444, 20.439444).

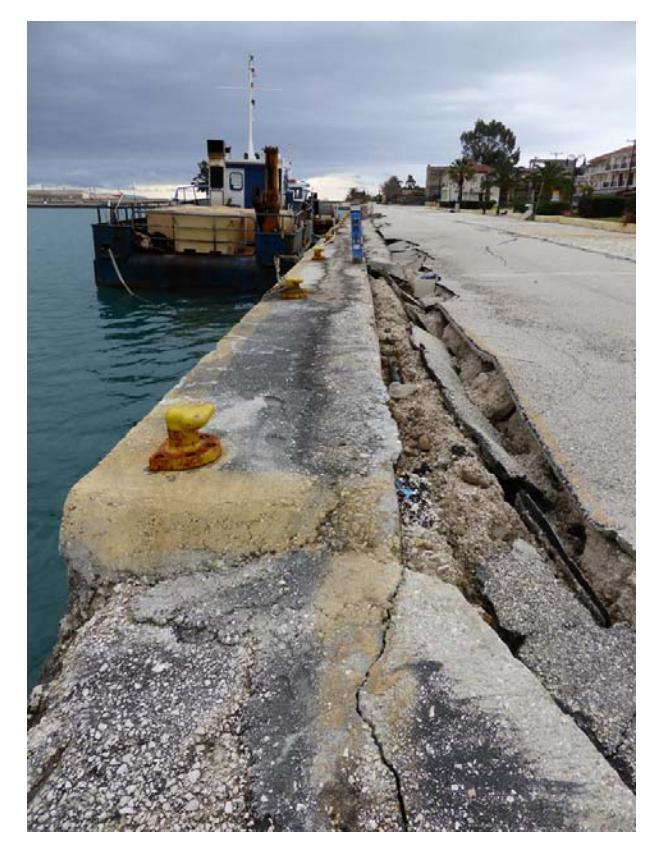
Figure 8.2.23. Lateral quay wall displacement and road cracks in the southern part of Lixouri port (GPS coordinates: 38.199444, 20.439444).

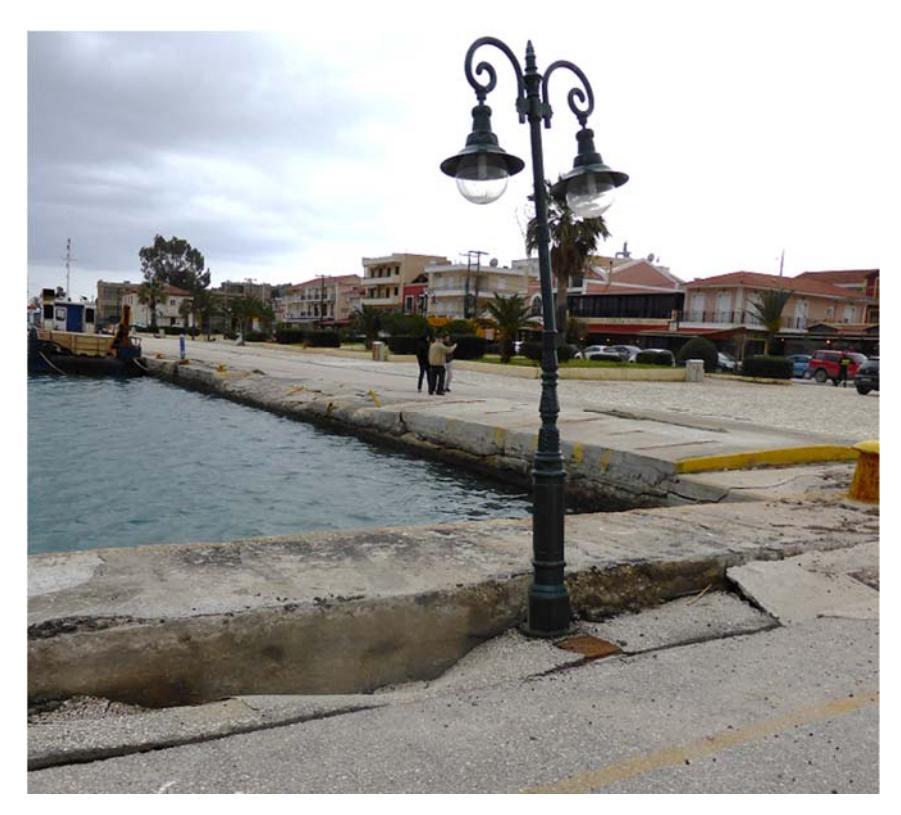
Figure 8.2.24. Settlement behind the quay wall (GPS coordinates: 38.199722, 20.439722).

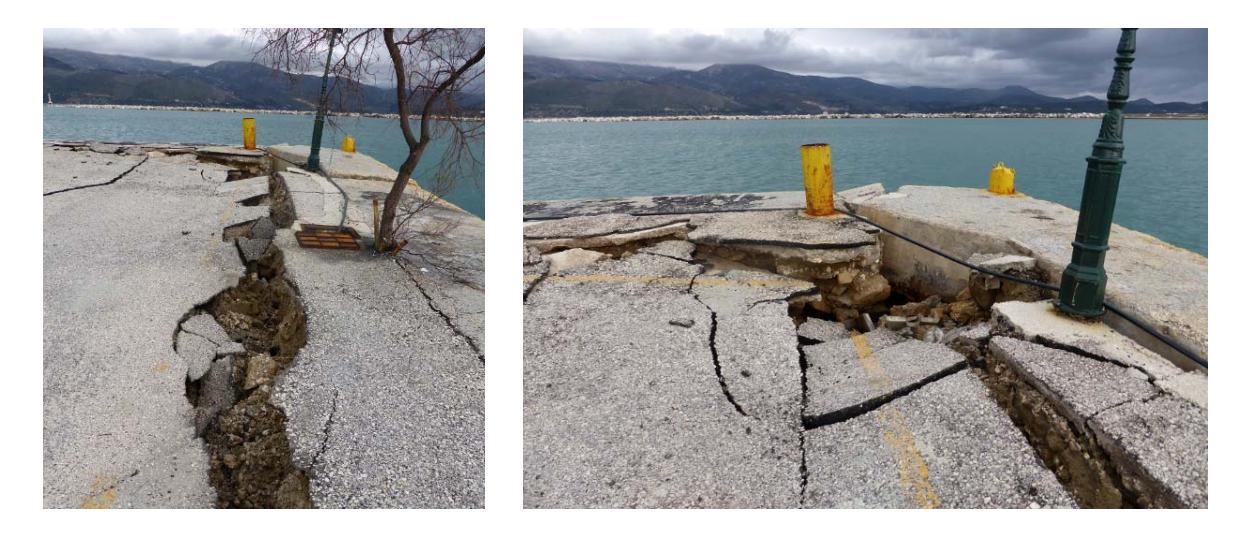
Figure 8.2.26. Settlement and cracks behind the quay wall (GPS coordinates: 38.199558, 20.439852).
