CHAPTER 8 Geotechnical Observations

GEER/EERI/ATC Cephalonia, Greece 2014 Report Version 1

8.1 Site Effects

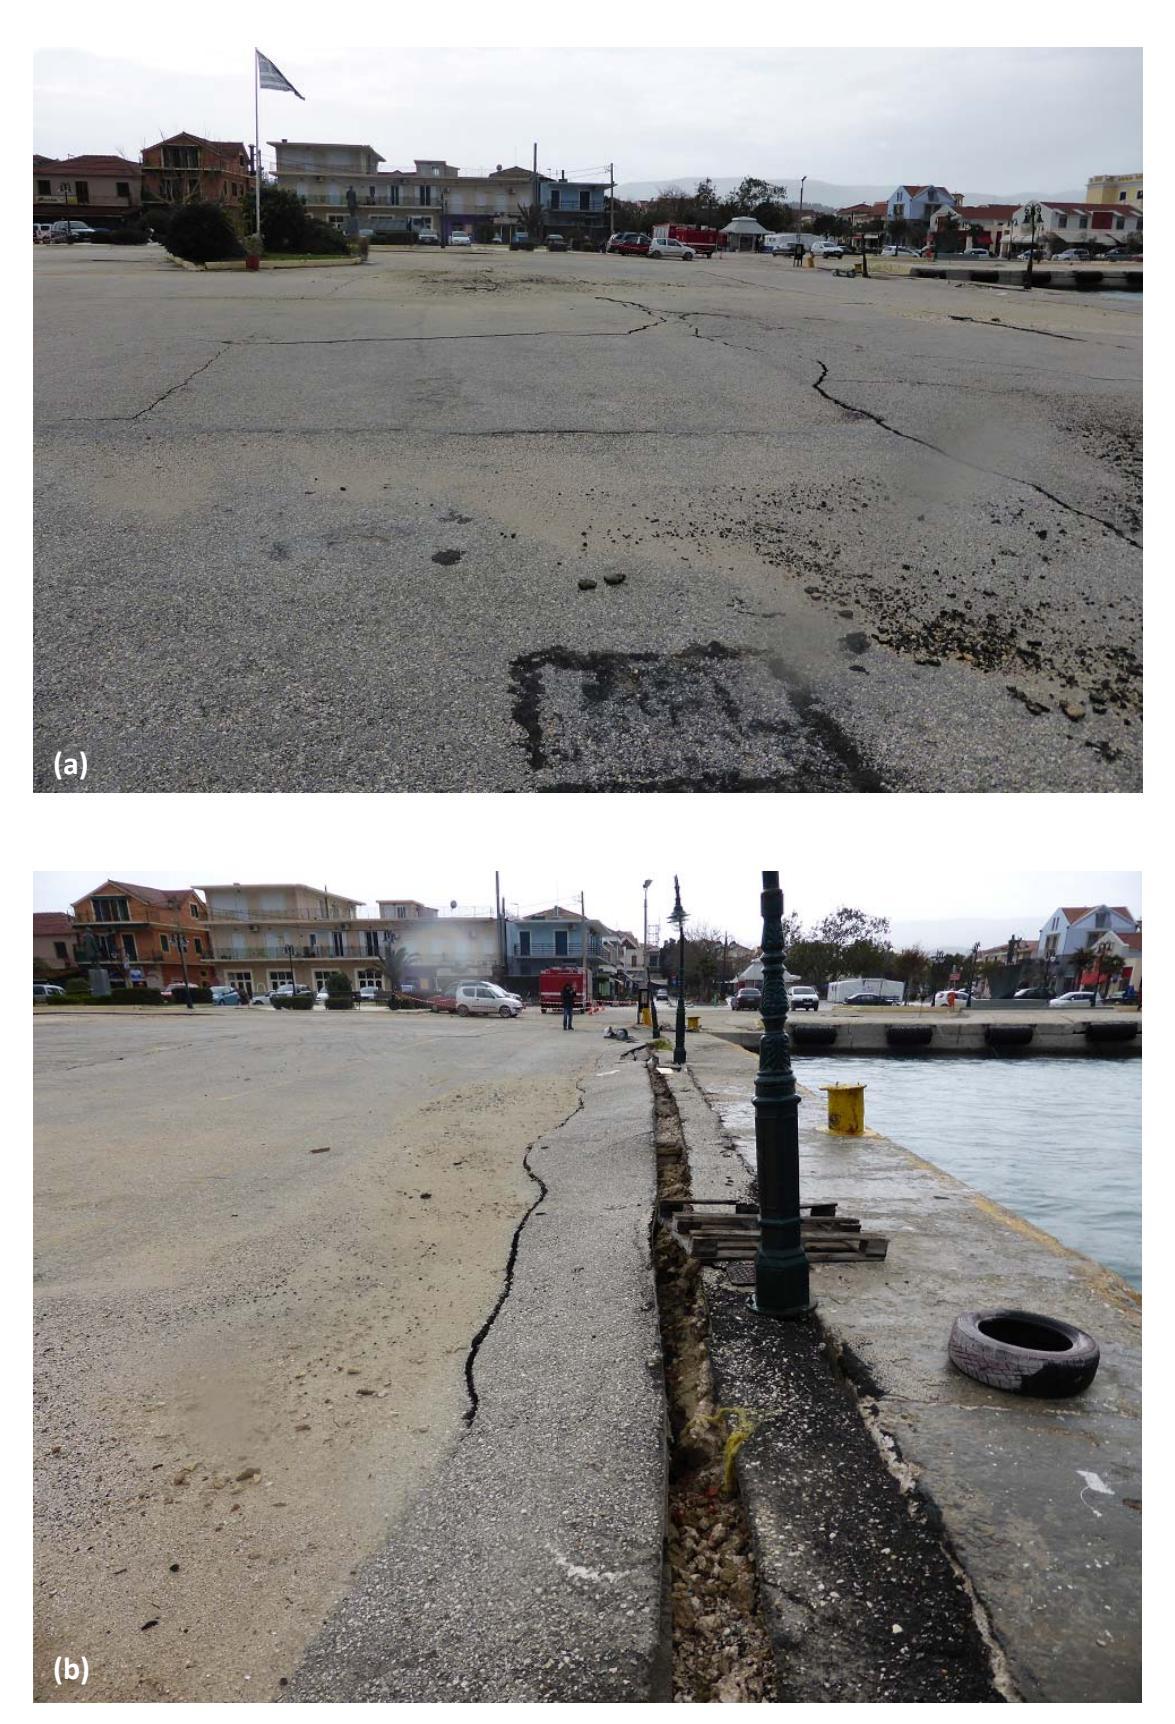
Figure 8.2.28. Light brown color sand liquefaction ejecta (GPS coordinates: 38.200000, 20.440000).

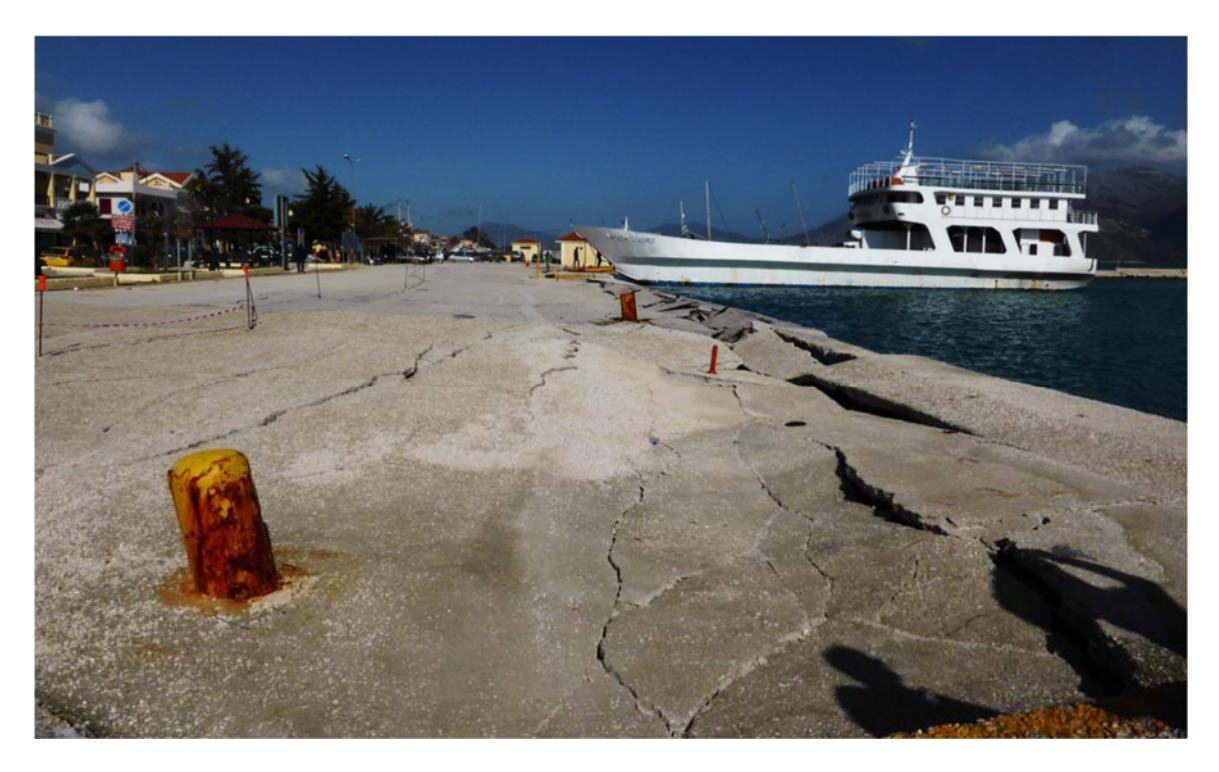
Figure 8.2.29. Soil liquefaction remnants behind the quay wall and lateral displacement towards the sea front (GPS coordinates: 38.200277, 20.439383).

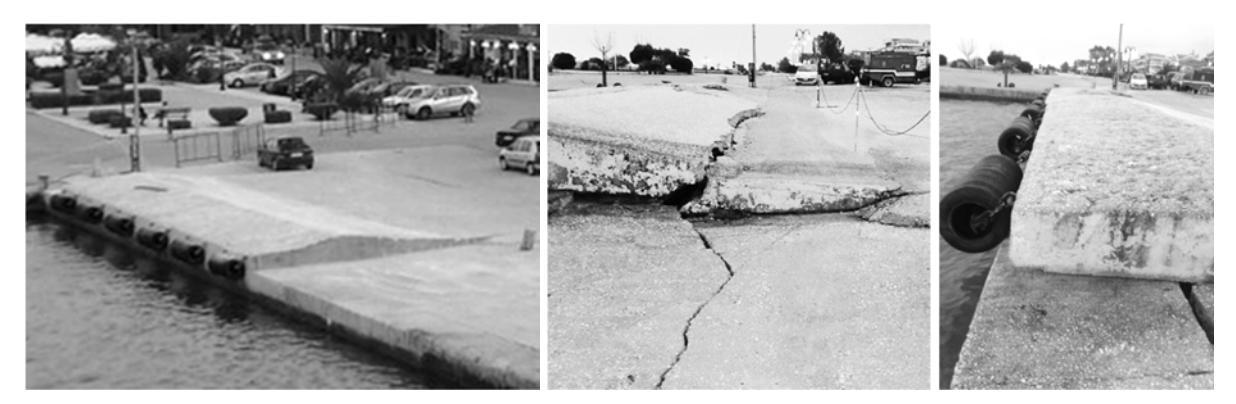
Figure 8.2.31. Auxiliary dock on quay wall, located to the north of main dock in the port of Lixouri: (a) from 2011 archives {<u>www.panoramio.com/photo/3072045?source=wapi&referrer=kh.google.com</u>}; and after the 2^{nd} event: (b) front and (c) back ($38^{\circ}12'1.39"N$, $20^{\circ}26'21.85"E$).

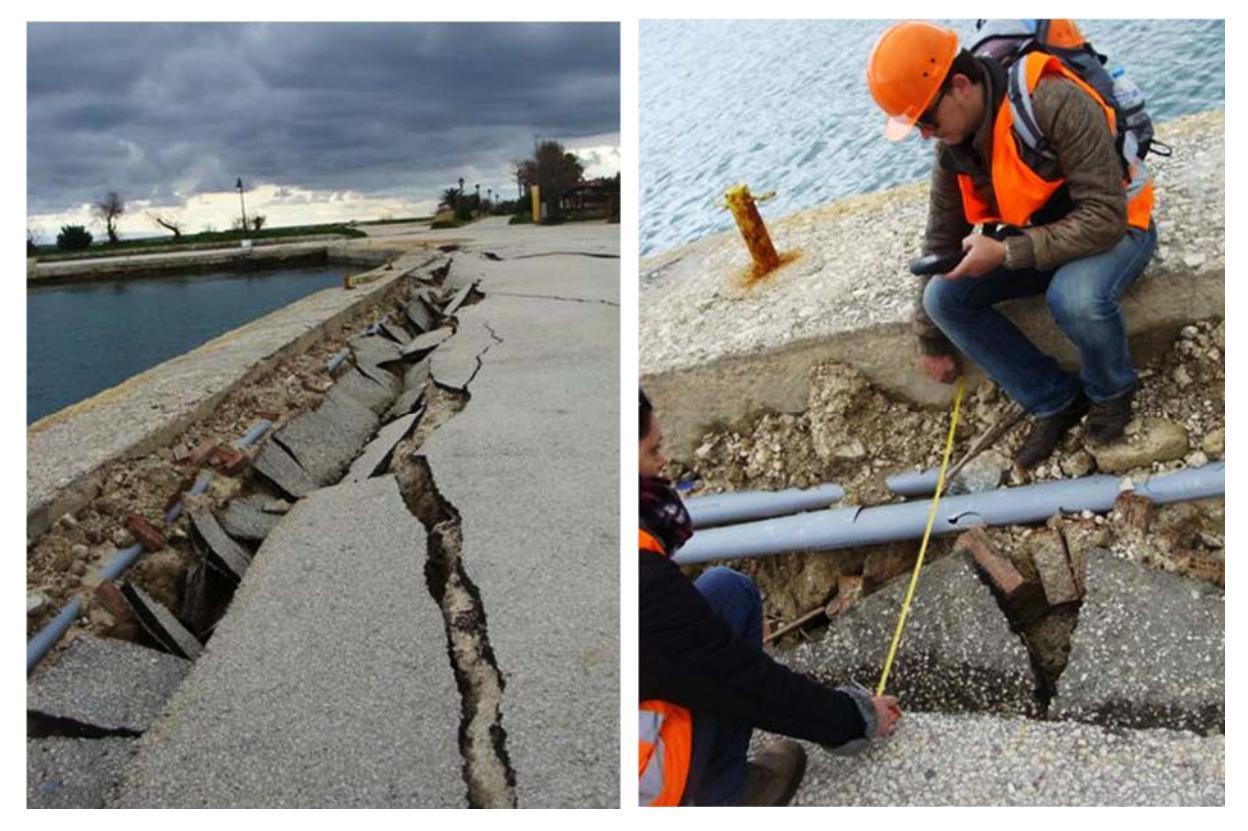
Figure 8.2.32. Lateral movement in Lixouri port along section A-A' of Fig. 8.2.2 being measured by Tasos Batilas and Xenia Karatzia of UPatras on 2/8/14 (GPS coordinates 38.19842°, 20.43956°).

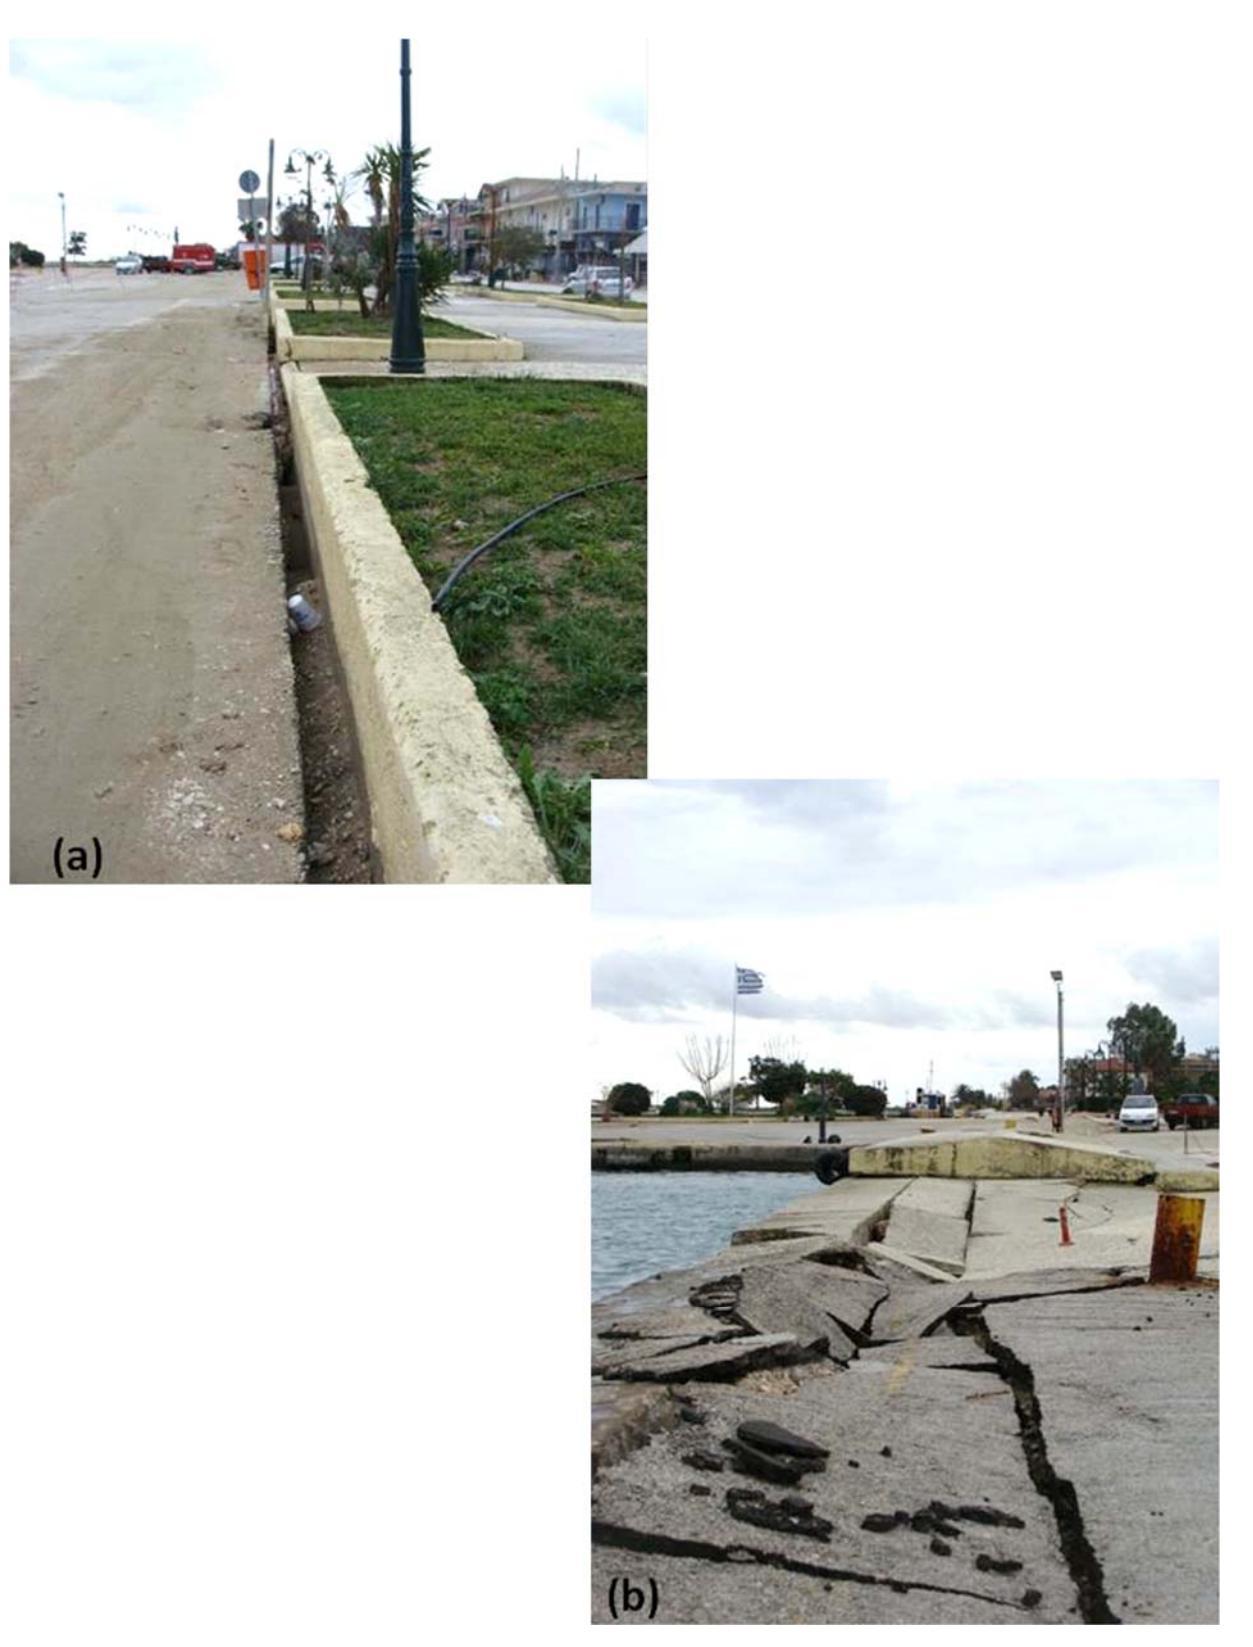
of the blocks constituting the quay wall, as well as, the differential settlement at the base of the quay wall. Displacements due to lateral spreading were extending over a zone of about 15 m behind the quay wall (Fig. 8.2.34). Whereas, displacements that can be attributed to inertia-induced sliding and differential settlement (i.e. rotation) of the qual wall develop over a very short distance from the quay wall, as shown in Fig 8.2.34 and 8.2.35 by the steep increase observed in cumulative displacement near the quay wall.

Figure 8.2.33. (a) Lateral spread in Lixouri port along section B-B' and (b) movement of quay walls (GPS coordinates: a-(38.20072°, 20.43920°), b-(38.20077°, 20.43940°), 2/8/14).

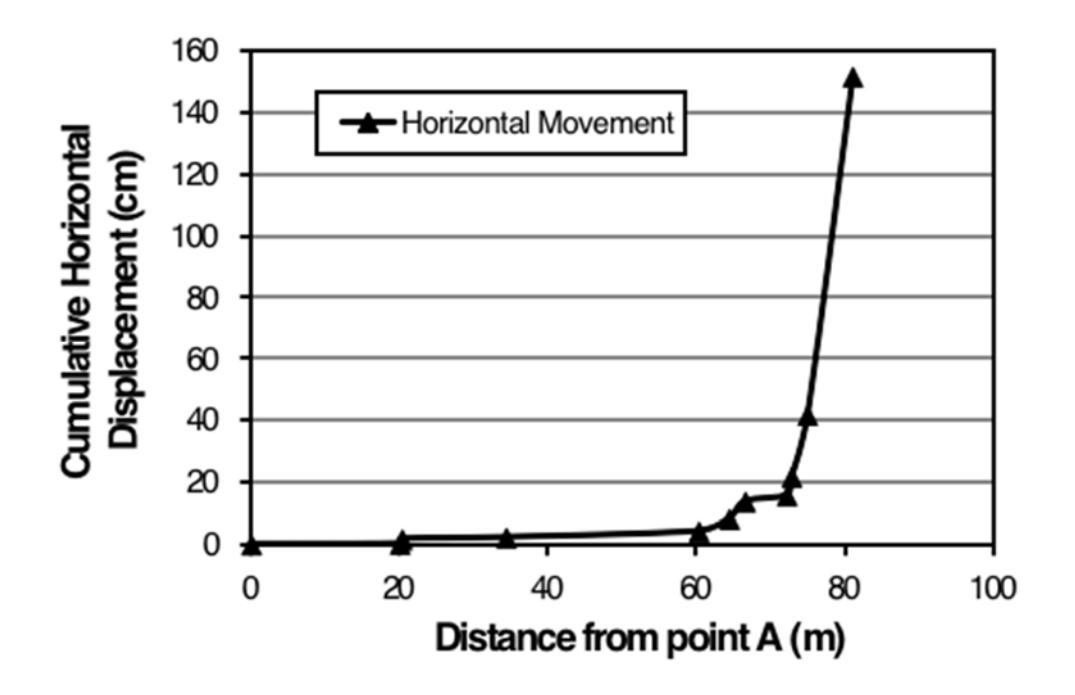
Figure 8.2.34. Plot of cumulative horizontal displacement vs. distance from point A (as shown in Fig. 8.2.2) at Lixouri port.

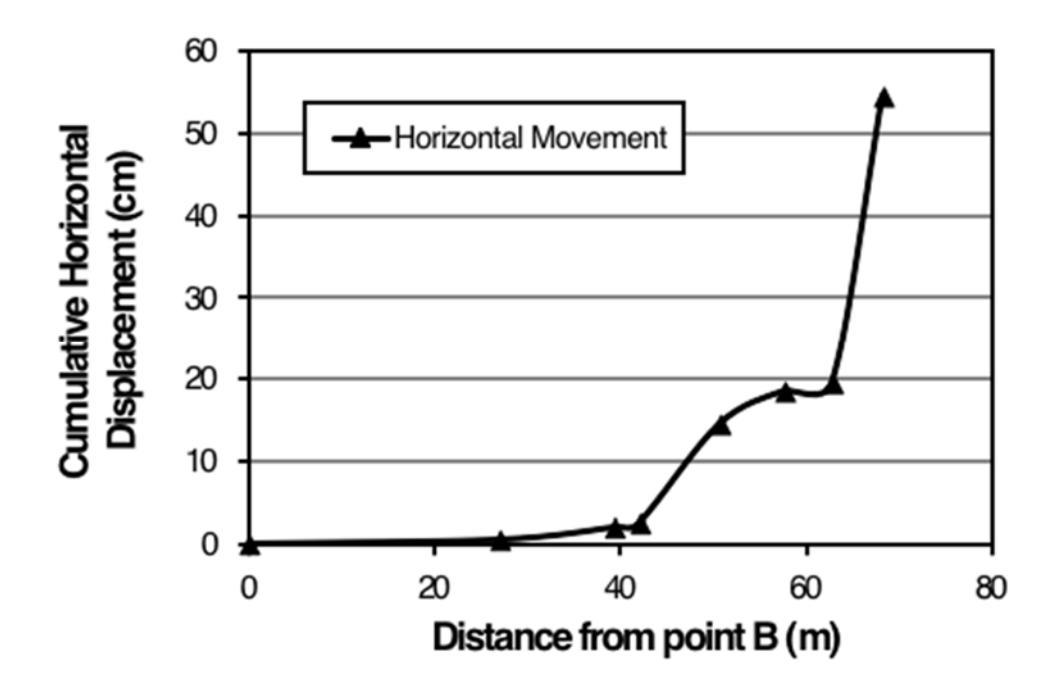
Figure 8.2.35. Plot of cumulative horizontal displacement vs. distance from point B (as shown in Fig. 8.2.2) at Lixouri port.

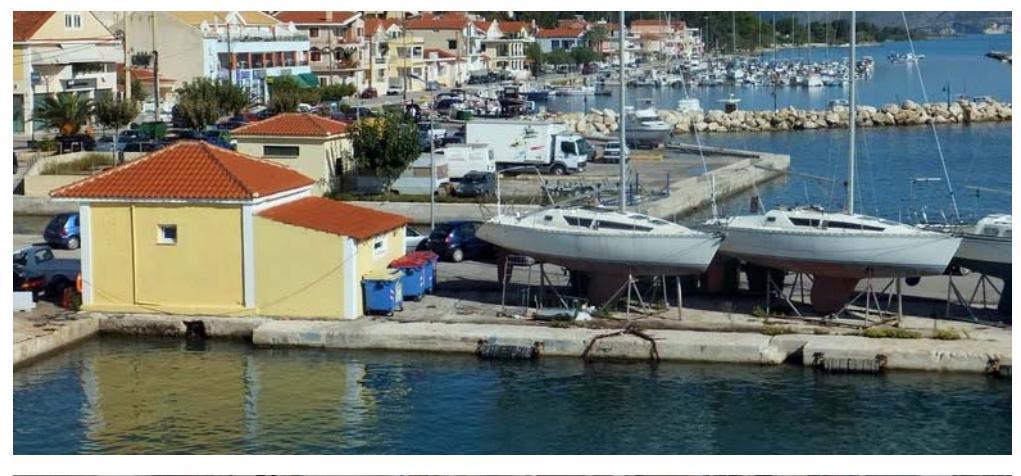
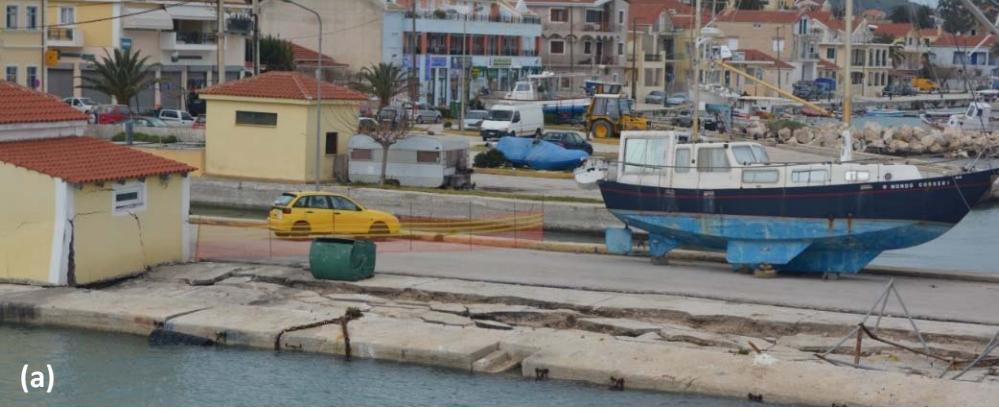
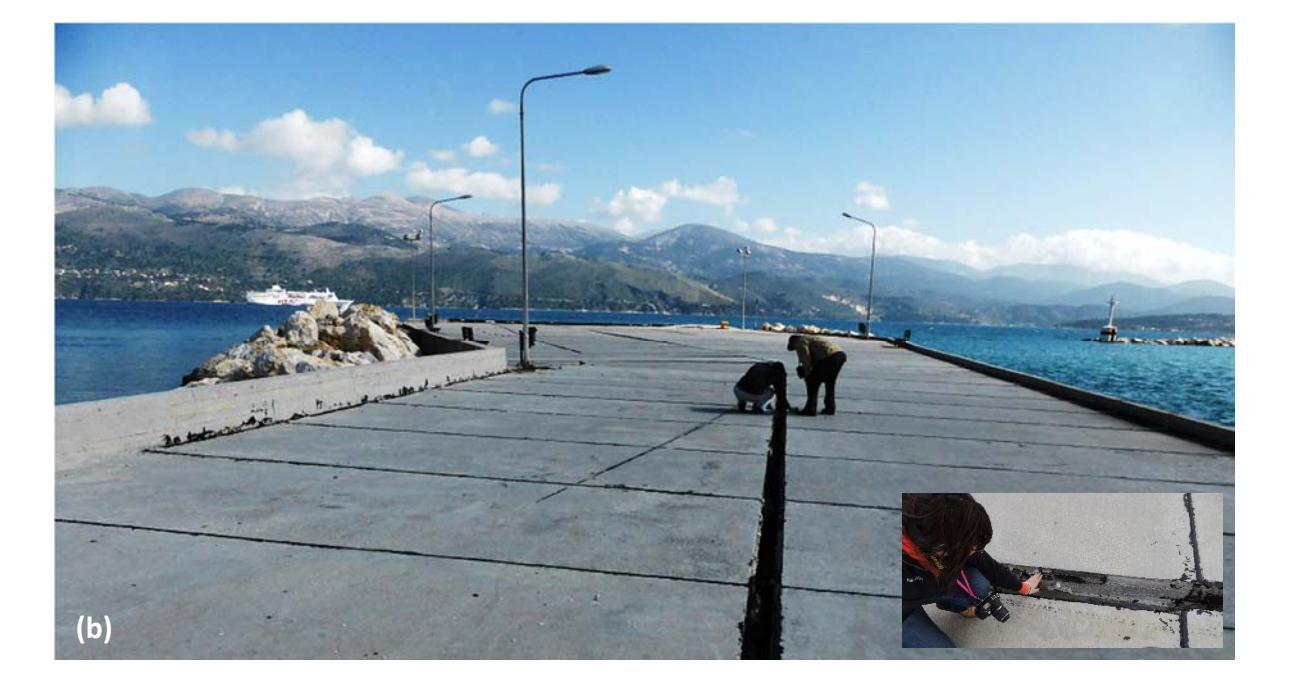
Figure 8.2.40. State of the main (Davraga) pier in Lixouri port): (a) Before the 2 events, from 2011 archives {<u>www.panoramio.com/photo/59409701?source=wapi&referrer=kh.google.com</u>}; (b) after the 2^{nd} event ($38^{\circ}12'5.02"N$, $20^{\circ}26'21.73"E$).

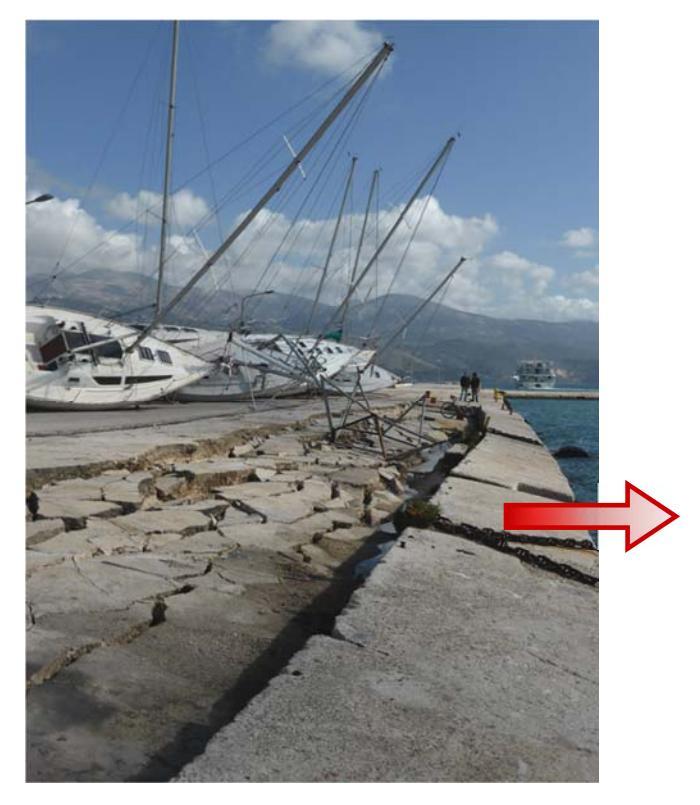
The largest outward displacement was observed in the main pier Davraga (Fig. 8.2.41 through Fig. 8.2.52). The initial portion of the pier, of about 50 m in length, exhibited the largest displacement of about 1.5 m. The following 50 m portion displaced much less, perhaps less than 0.5 m, apparently due to the much greater width of its blocks. Damage of this portion took place only on the south side, since the north side, which serves as breakwater, had a very shallow water depth and was supported by huge rock blocks (monoliths) playing the role of the tripods that are used in major breakwaters.

Figure 8.2.43. Horizontal displacement and rotation of wall of main pier (GPS coordinates: 38.201483, 20.439452).

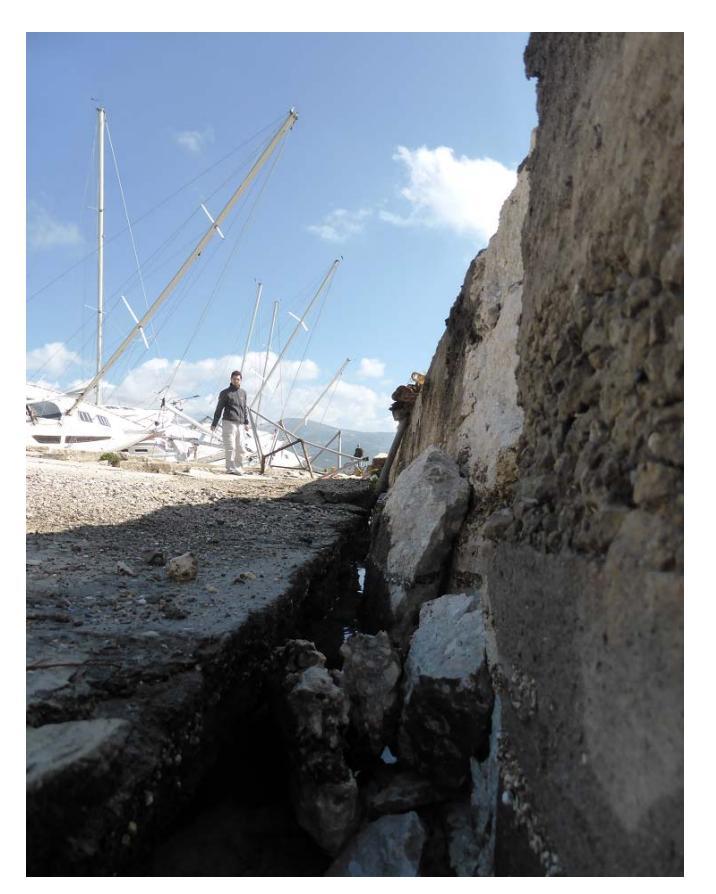
Figure 8.2.44. Vertical settlement behind the wall of photo 8.2.43 (GPS coordinates: 38.201397, 20.439511).

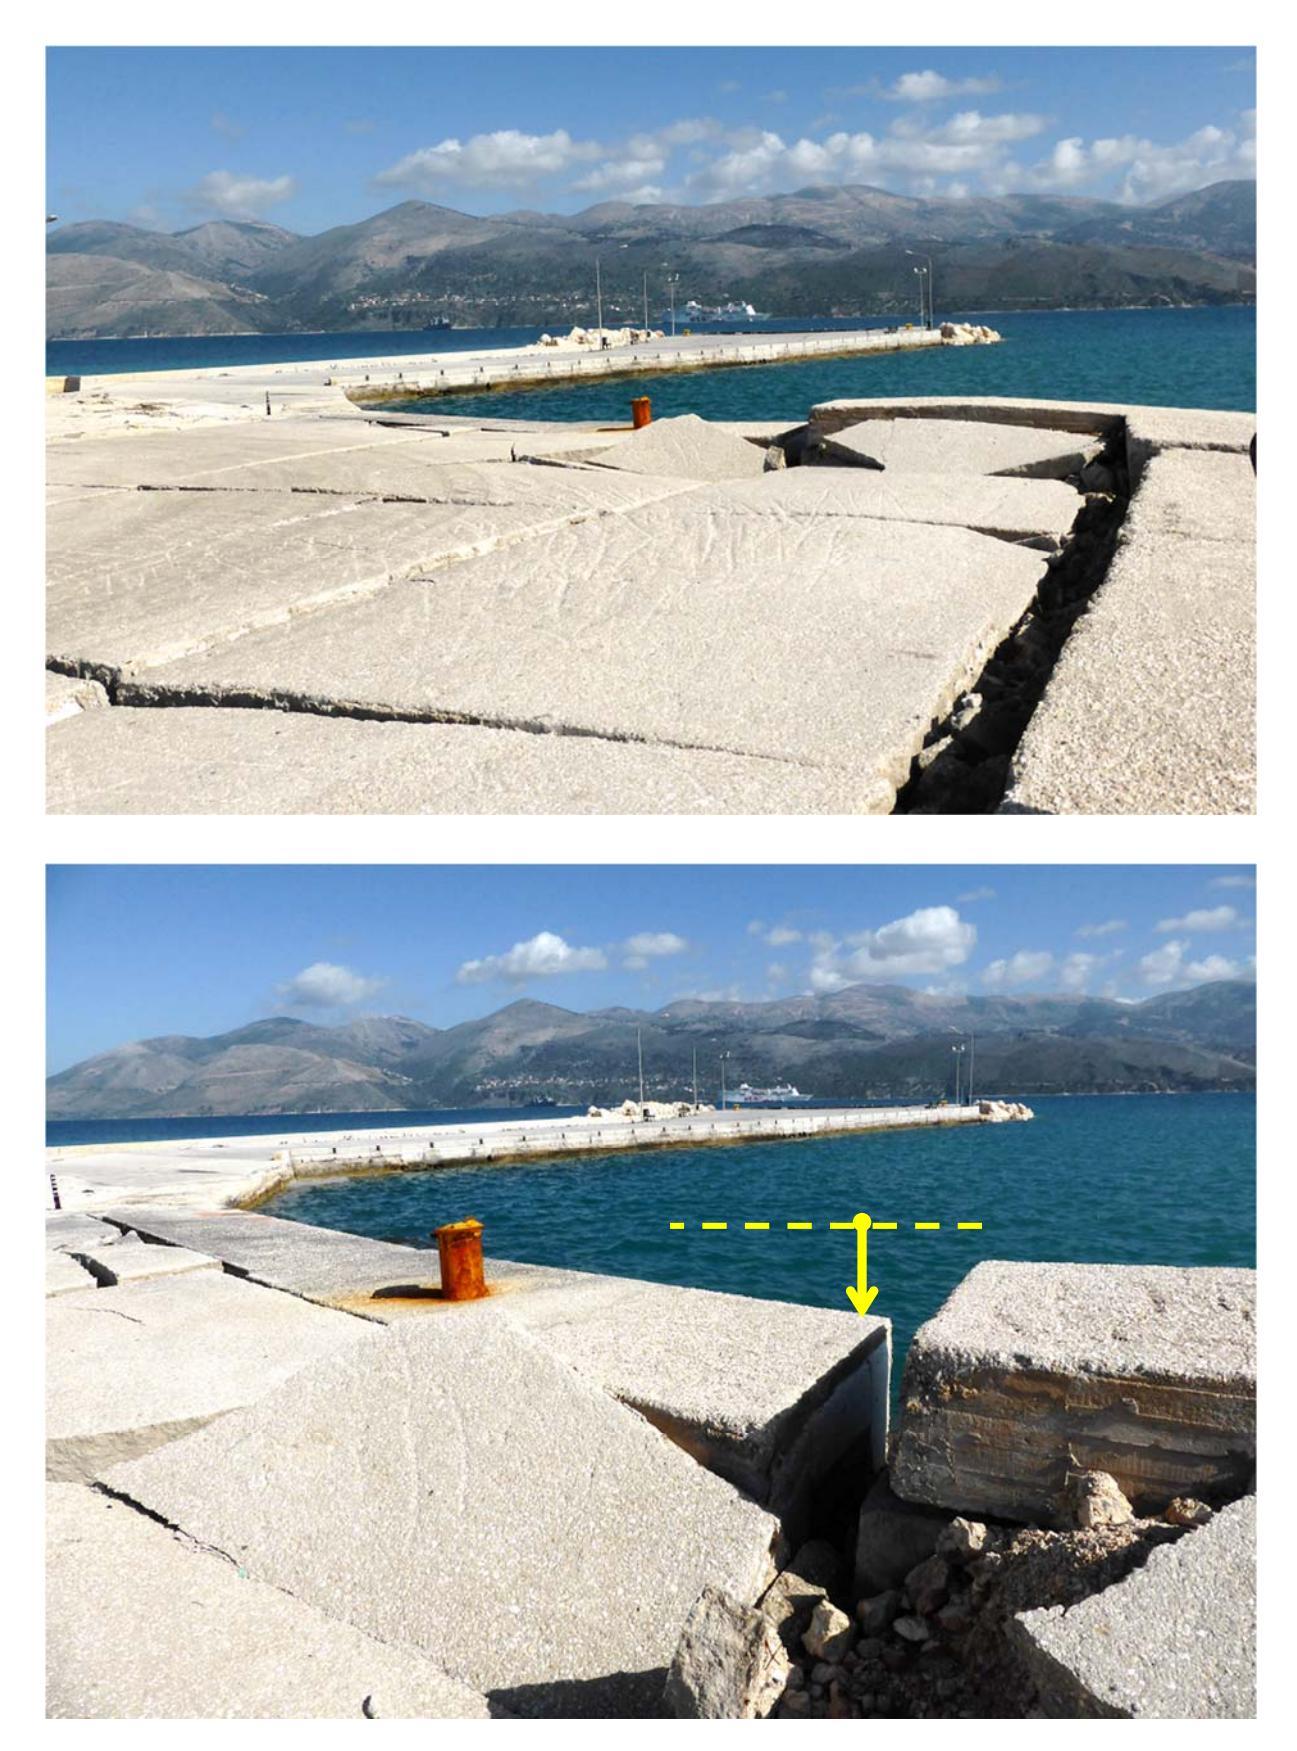
Figure 8.2.49. Vertical displacement of main pier marked with yellow arrow (GPS coordinates: 38.201269, 20.440977).

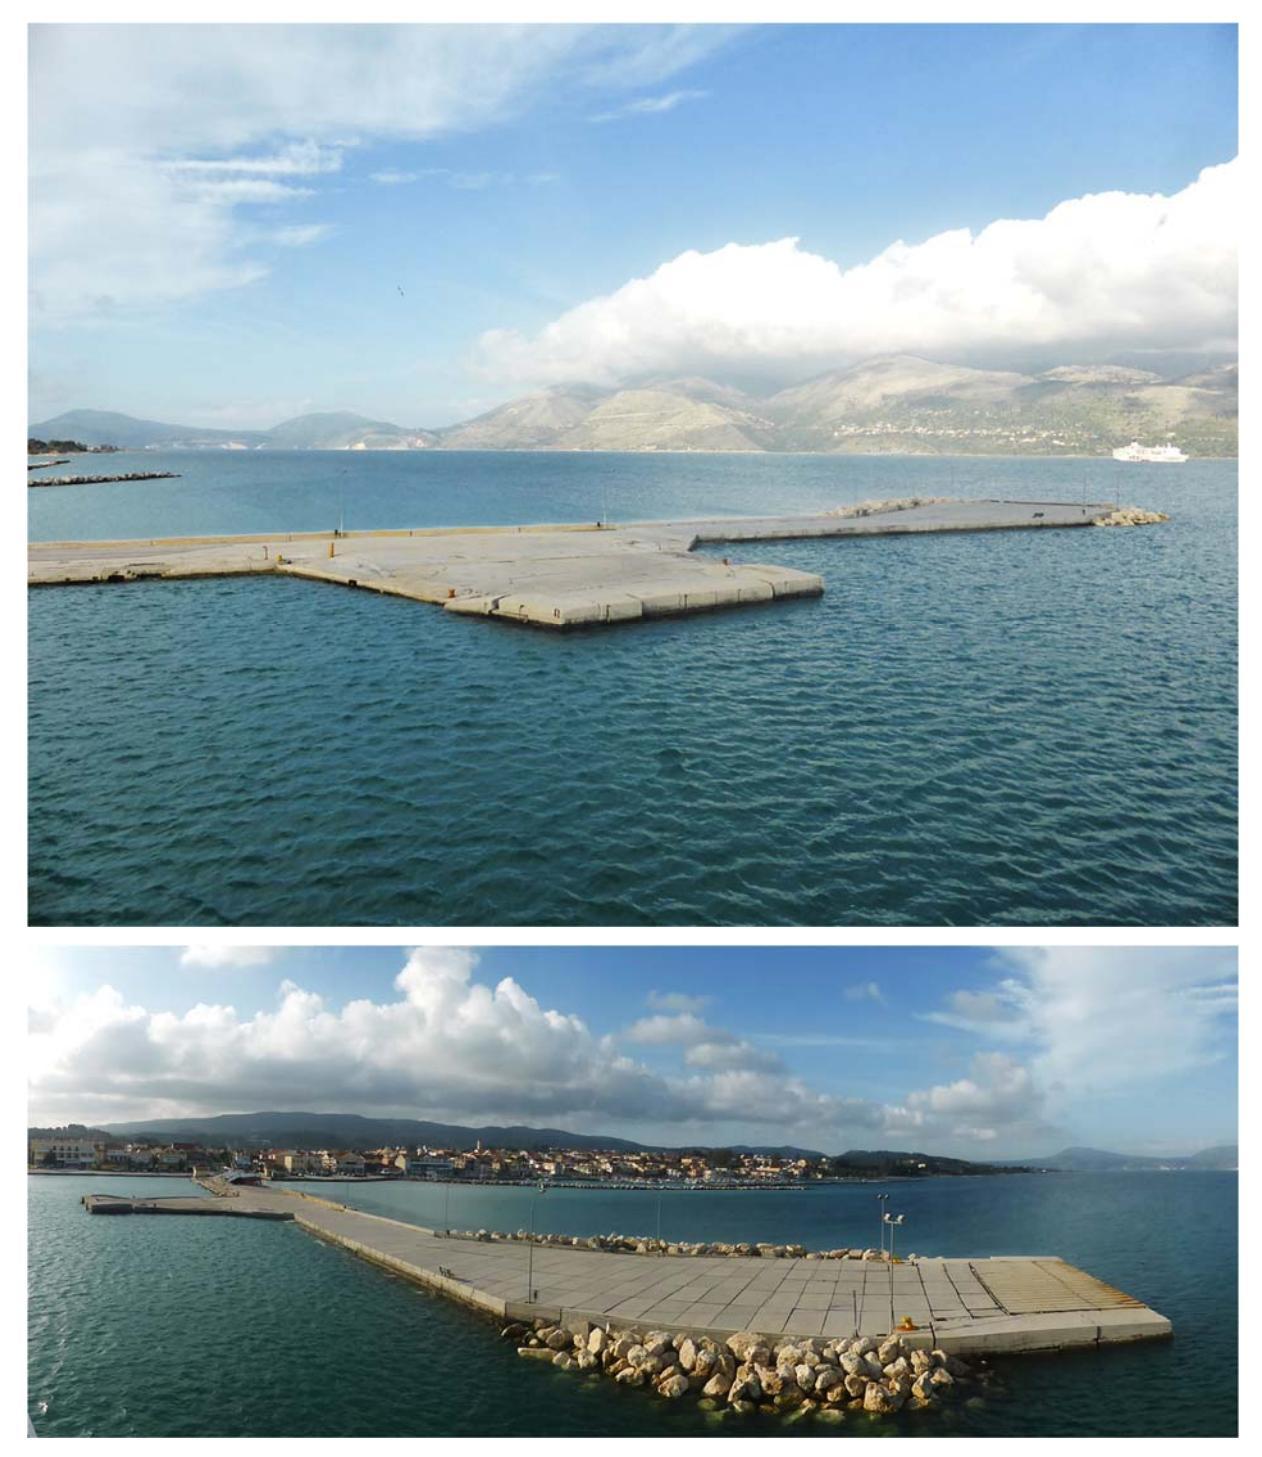
Few years ago, the protection slab at the foot of the pier at its easternmost section was accidentally damaged by a jack up drilling vessel that penetrated 2 m under the slab and ruptured the geotextile, in an effort to keep the vessel stable during rough weather. The edge column in that location fell during the earthquake, but it is unknown to what extent failure is associated with this specific damage. Overall, however, this portion of the main pier has moved much less than the other sections of the pier.

Figure 8.2.50. Panoramic views of the eastern-most section of Davraga pier.

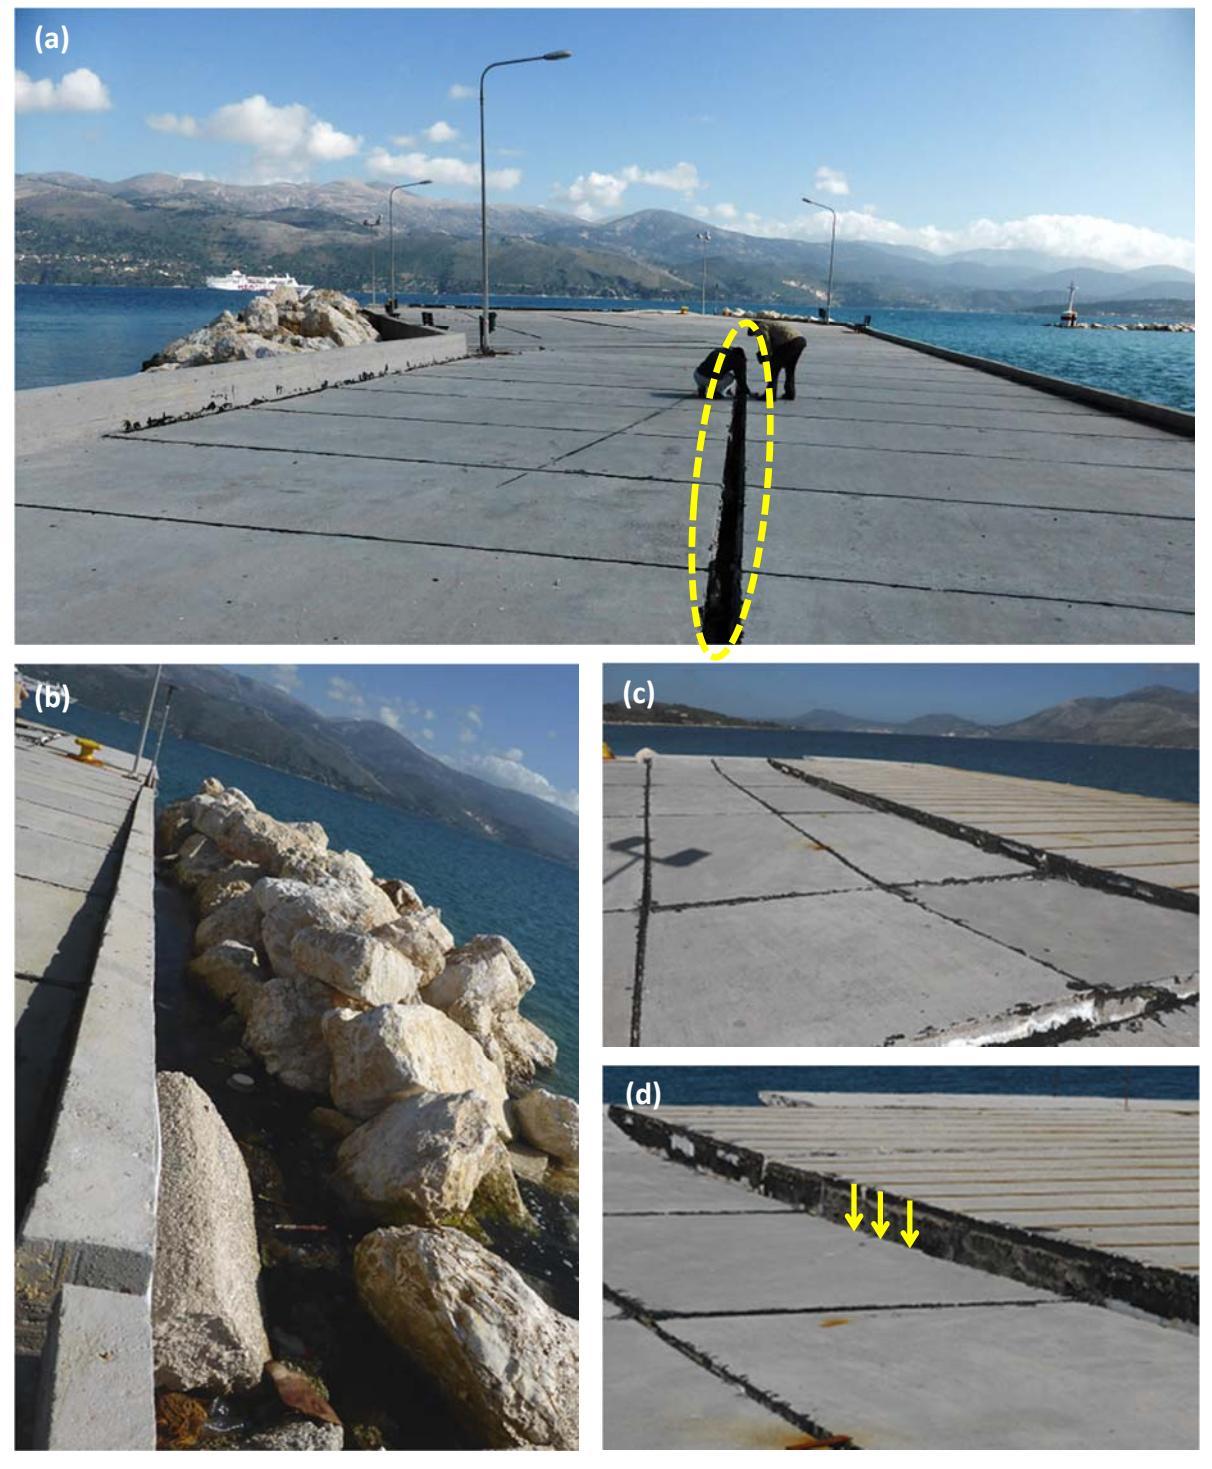
Figure 8.2.51. Main pier: (a) opening of horizontal joint; (b) monolith breakers constraining lateral movement; (c) concrete slabs settlement; and (d) detail of vertical settlement in yellow arrows (GPS coordinates: 38.201611, 20.442094).

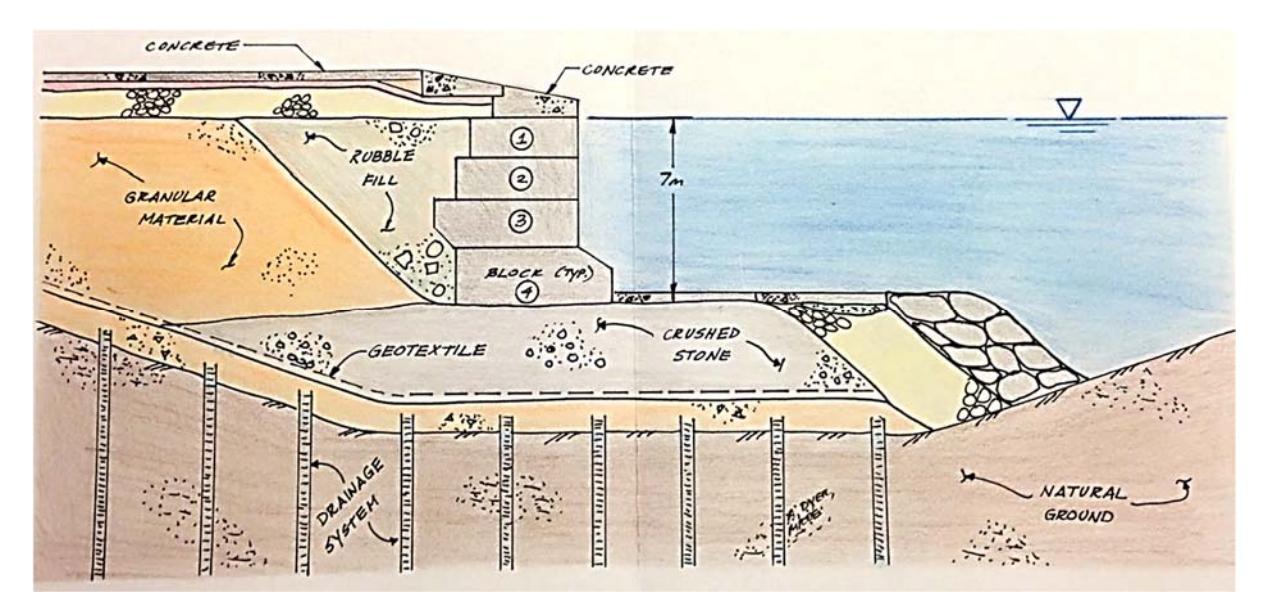
Figure 8.2.53. E-W cross section of eastern-most section of main pier of Lixouri Port. Data collected by Kostas Rouchotas of NTUA team. Sketch by Adam Dyer of MRCE.

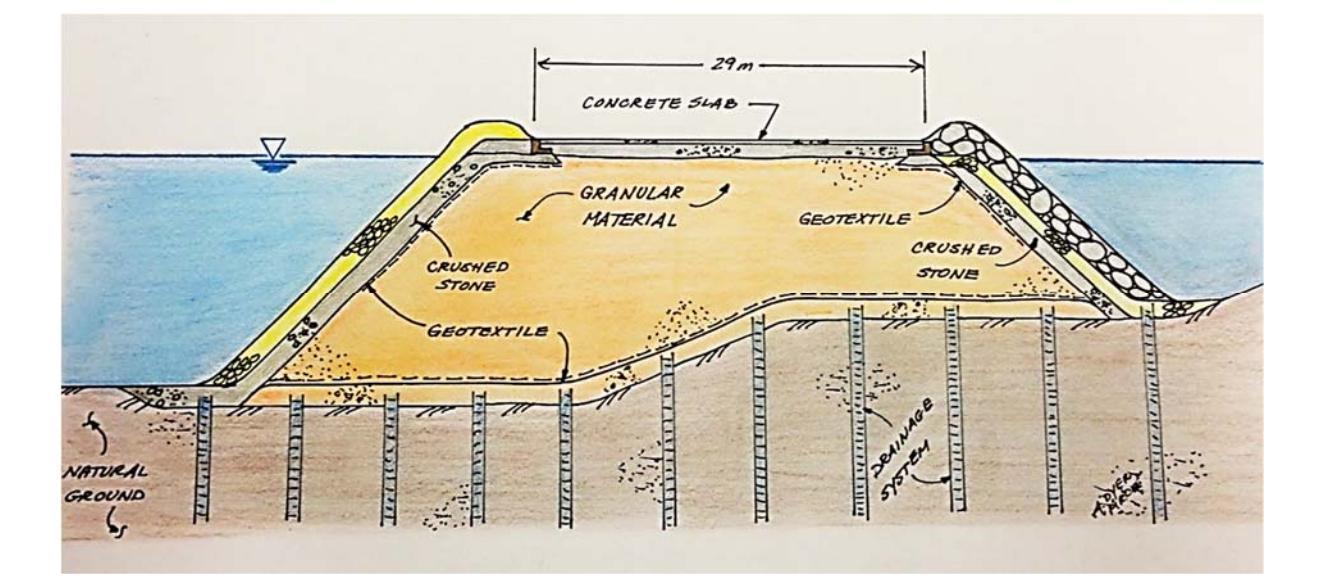
Figure 8.2.54. N-S cross section of eastern-most section of main pier in Lixouri Port. Data collected by Kostas Rouchotas of NTUA team. Sketch by Adam Dyer of MRCE.

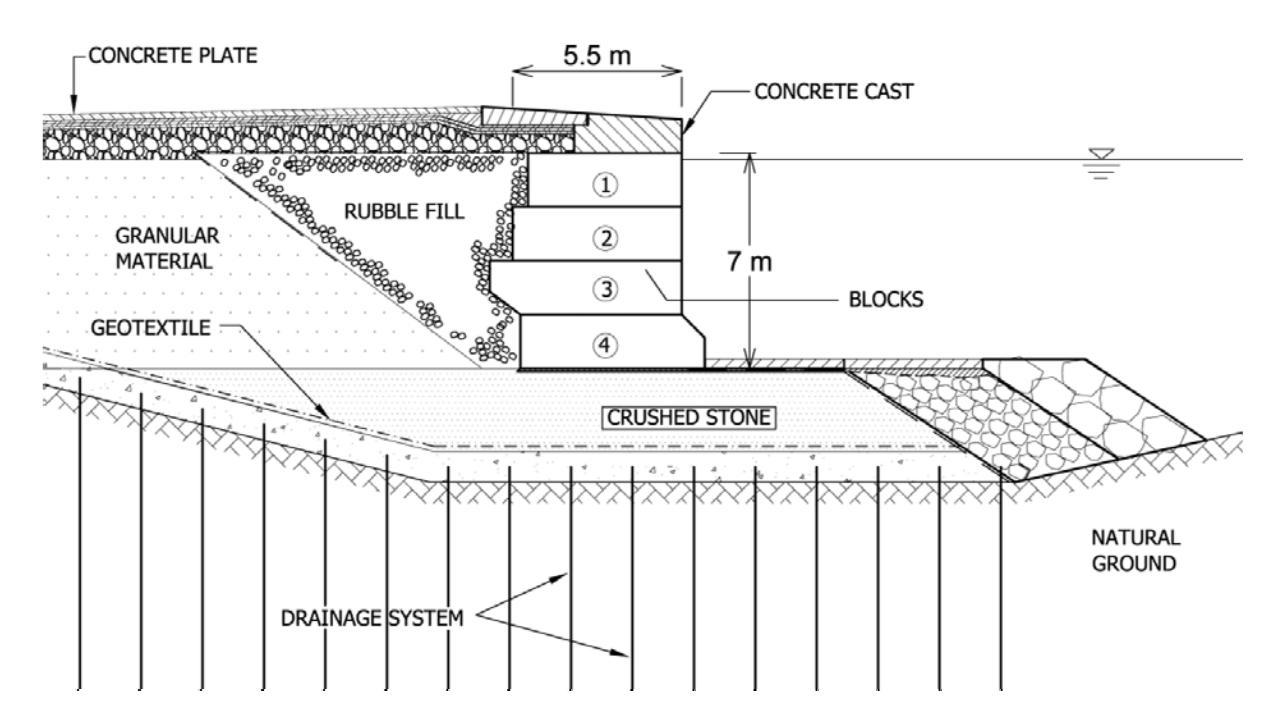
Figure 8.2.55. Detailed drawing of the sketch of Fig. 8.2.53 developed from data by Kostas Rouchotas of NTUA team showing E-W cross section of eastern-most section of main pier of Lixouri Port.

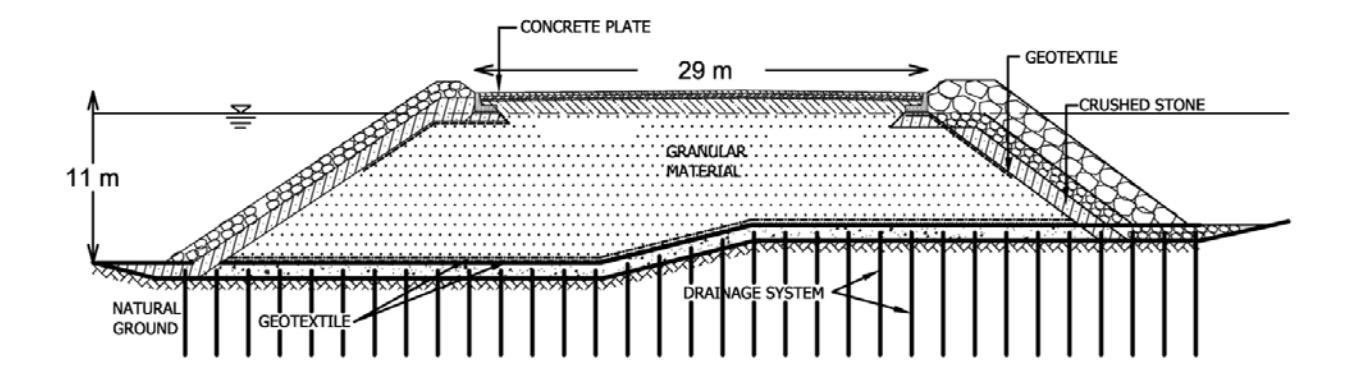
Figure 8.2.56. Detailed drawing of the sketch of Fig. 8.2.54 developed from data by Kostas Rouchotas of NTUA team showing N-S cross section of eastern-most section of main pier in Lixouri Port.

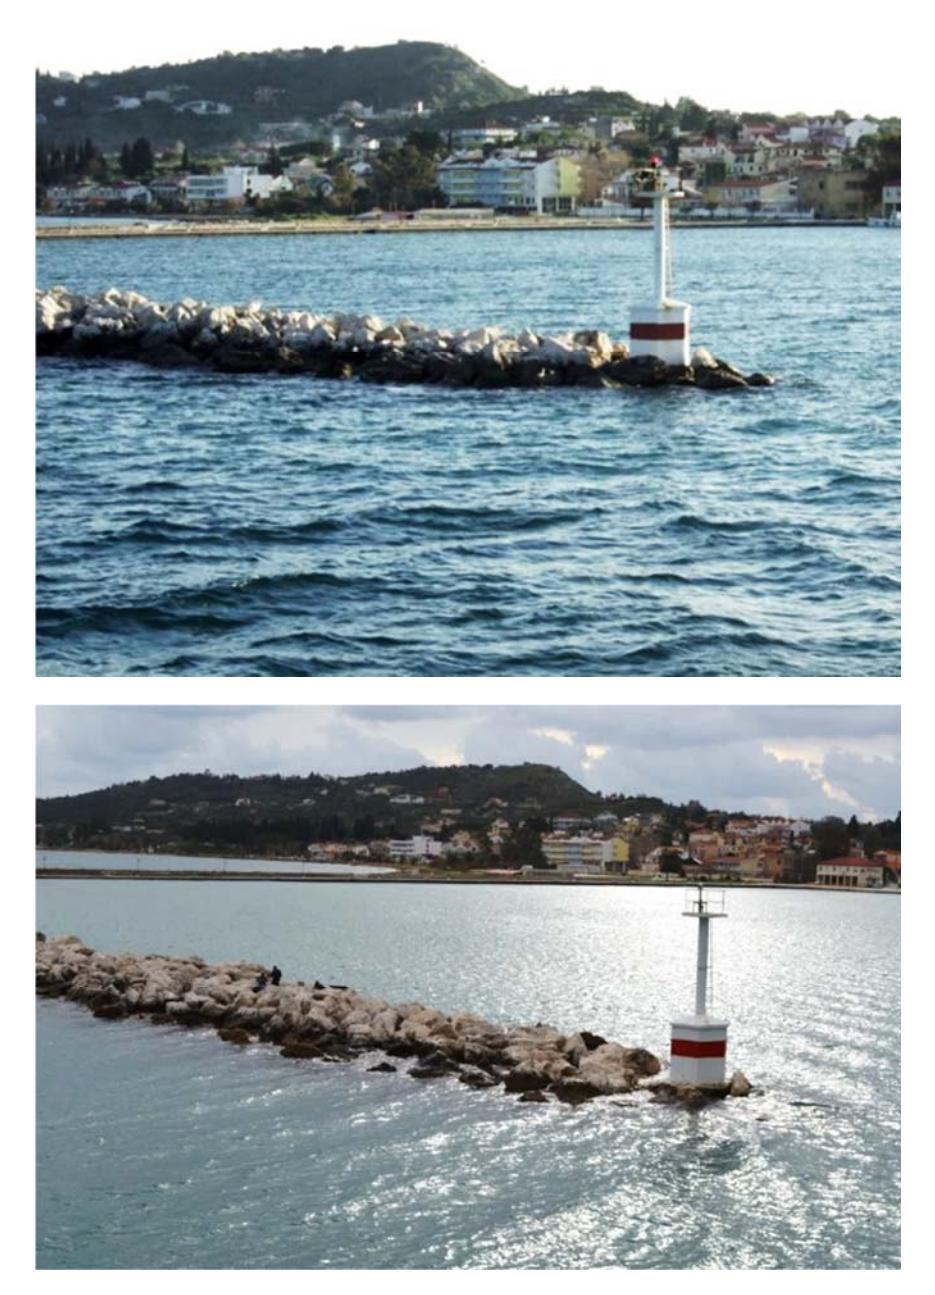
The seismic settlement of the breakwater and lighthouse at the south entrance of the Lixouri port is also of interest. As shown in Figs. 8.2.57 to 8.2.60, the lighthouse and the supporting rip-rap appear to have settled. Discussions with the lighthouse operator, photos prior to the earthquakes, and measurements indicate that: (a) the lighthouse had been settling since its construction and (b) additional (currently unquantified) settlement took place during Event 2.

Figure 8.2.57. State of lighthouse at Lixouri breakwater tip: (a) from 2011 archive photo $\{\underline{\text{www.panoramio.com/photo}/50853069?\text{source=wapi&referrer=kh.google.com}\}$, and (b) after the 2nd event (38°12'3.70"N, 20°26'35.41"E).
