CHAPTER 8 Geotechnical Observations

GEER/EERI/ATC Cephalonia, Greece 2014 Report Version 1

8.1 Site Effects

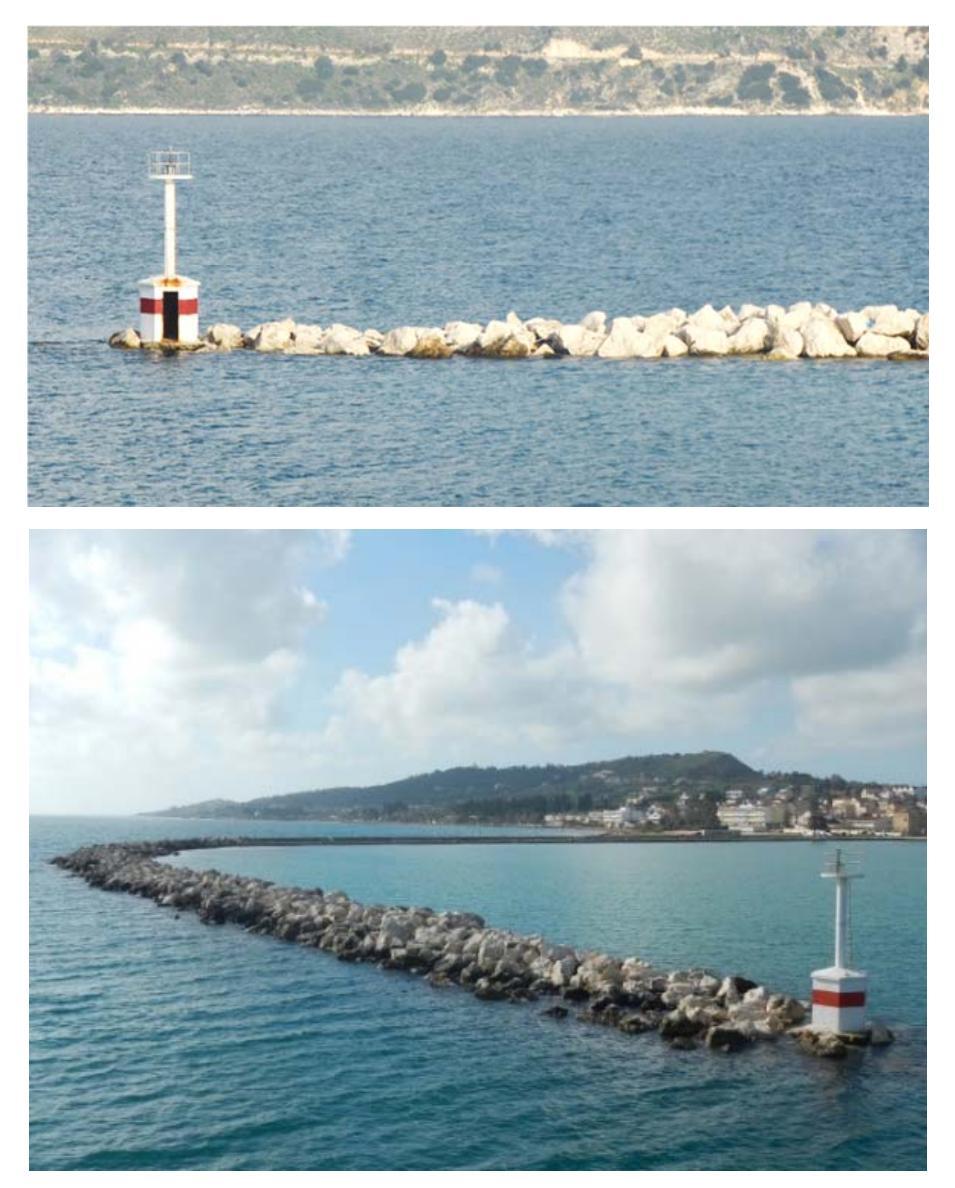
The seismic settlement of the breakwater and lighthouse at the south entrance of the Lixouri port is also of interest. As shown in Figs. 8.2.57 to 8.2.60, the lighthouse and the supporting rip-rap appear to have settled. Discussions with the lighthouse operator, photos prior to the earthquakes, and measurements indicate that: (a) the lighthouse had been settling since its construction and (b) additional (currently unquantified) settlement took place during Event 2.

Figure 8.2.58. View of breakwater with the lighthouse (left: 38°11'53.97"N, 20°26'22.06"E; right: 38°12'4.90"N, 20°26'37.09"E).

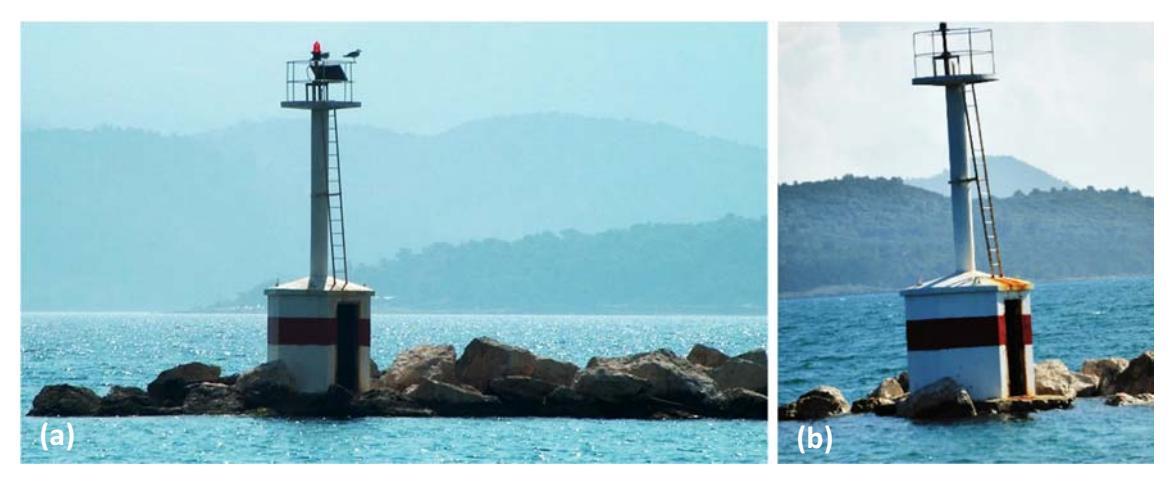
Figure 8.2.59. Detailed view of the light-house's settlement (a) From an online picture dated 5/8/09; and (b) after the 2^{nd} event (GPS coordinates: 38.200897, 20.443222).

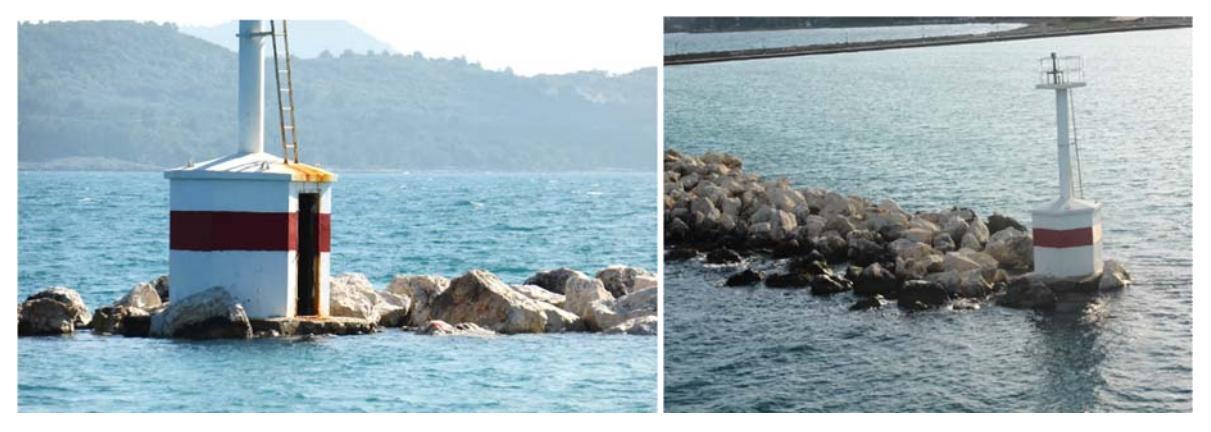
Figure 8.2.60. Light house settlement views (GPS coordinates: 38.200897, 20.443222).

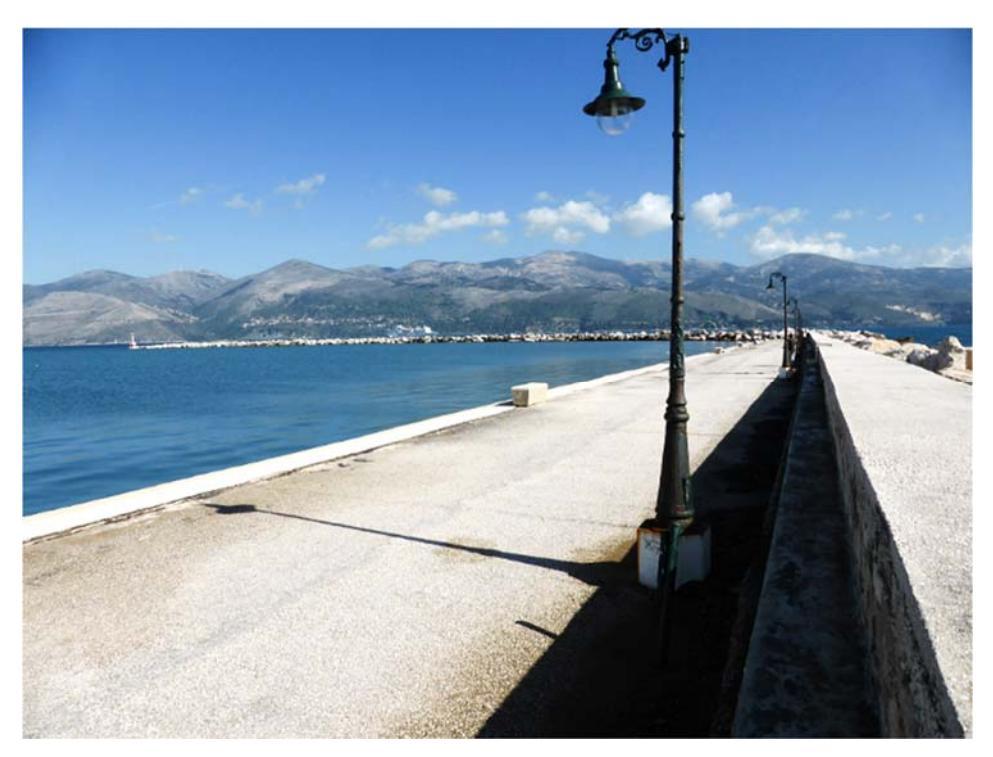
The southern arm of the port serves as a small-boat marina and experienced from negligible to minor damage. As shown in Figs. 8.2.61 and 8.2.62, in the first part of this marina, the quay wall had neither cracks nor seaward displacement, apparently as a result of shallow water depth of less than 2 m. In the most damaged section part of the marina (Figs. 8.2.63 and 8.2.64), cracks appeared accompanying a 20 to 30 cm seaward displacement of the quay wall. The displaced main quay wall and the liquefaction of the fill over a substantial distance from it contributed to lateral spreading, and was demonstrated with cracks in the pavement and the sidewalks over a distance of 2 blocks (Fig. 8.2.65).

Figure 8.2.61. Southern part of Lixouri port that experienced only minor cracks (GPS coordinates: 38.197944, 20.441044).

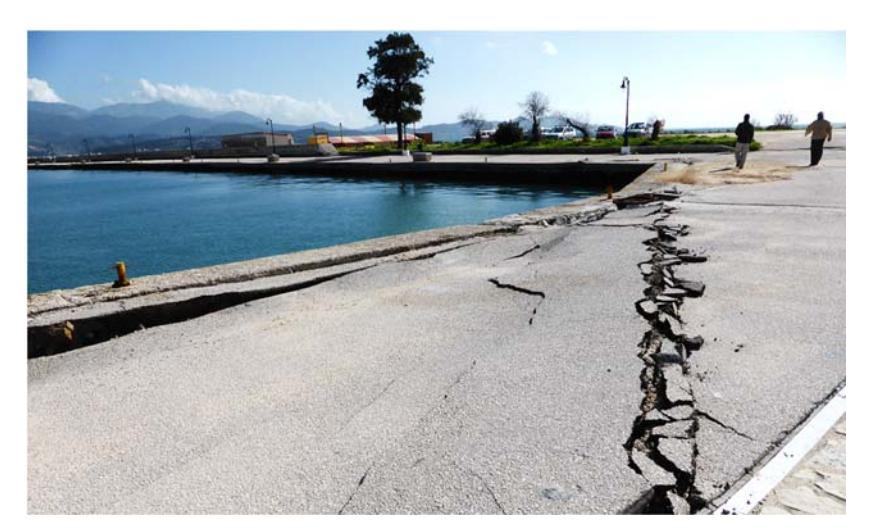
Figure 8.2.63. Settlement of the coastal road and cracks on road surface (GPS coordinates: 38.198372, 20.439483).

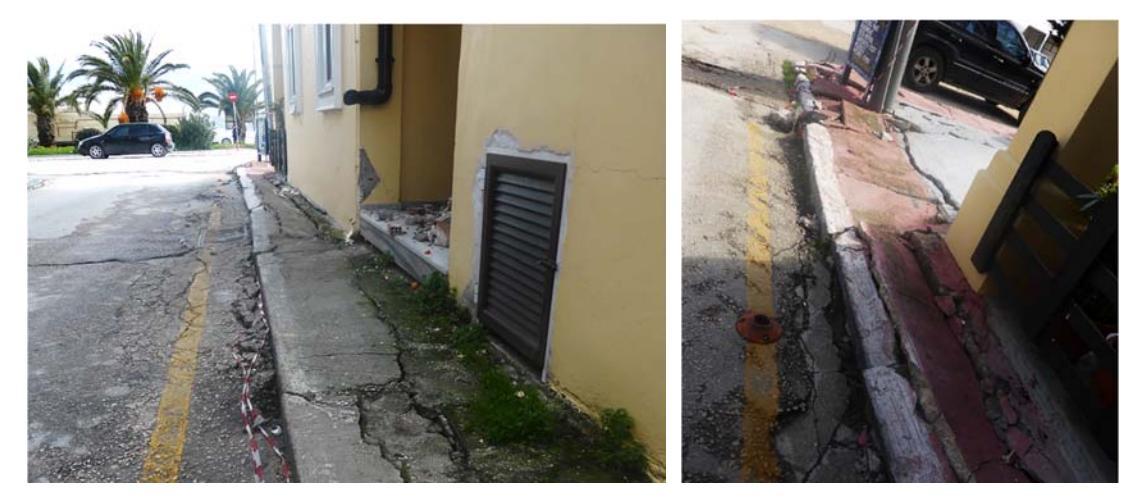
Figure 8.2.65. Sidewalk, pavement cracks and road settlement (GPS coordinates: 38.201102, 20.438855).

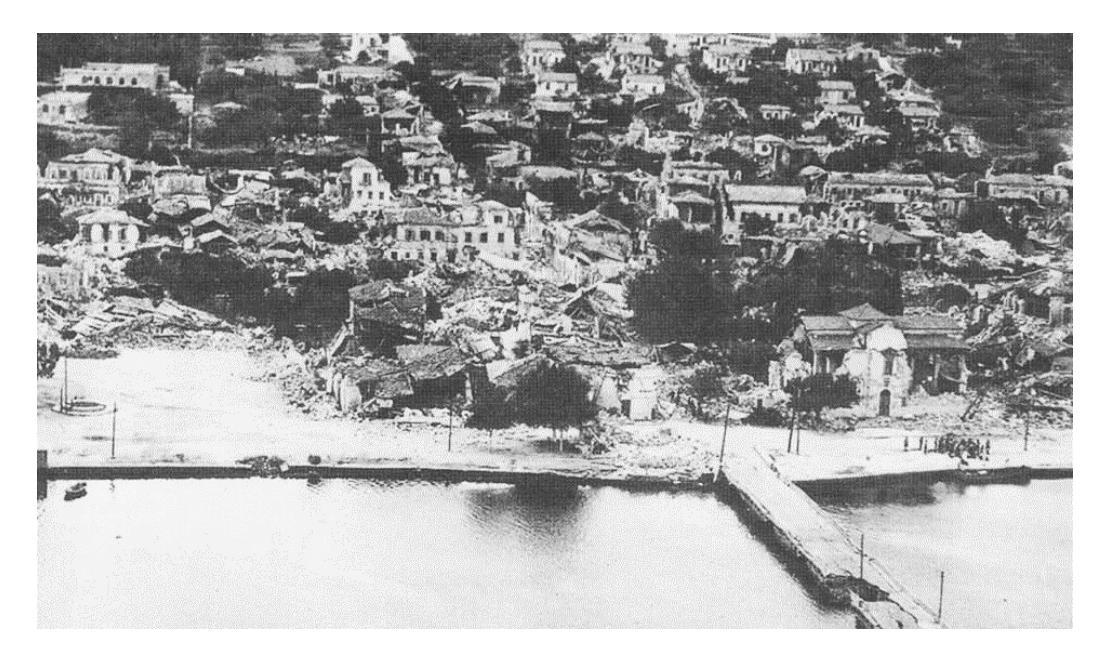
Figure 8.2.68. Argostoli port after the 1953 earthquake, looking west from above the town bridge (Bittlestone, 2005).

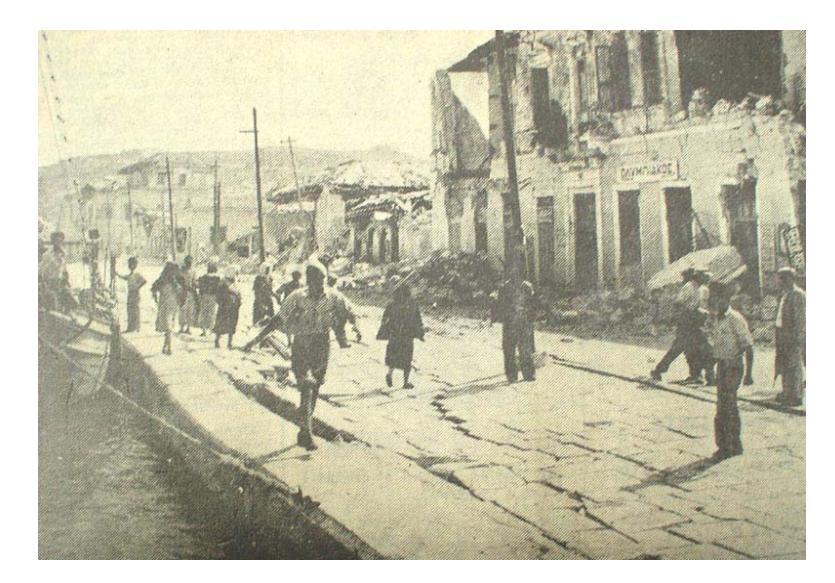
Figure 8.2.69. Argostoli quay wall damage after the 1953 event (Papathanassiou & Pavlides, 2011).

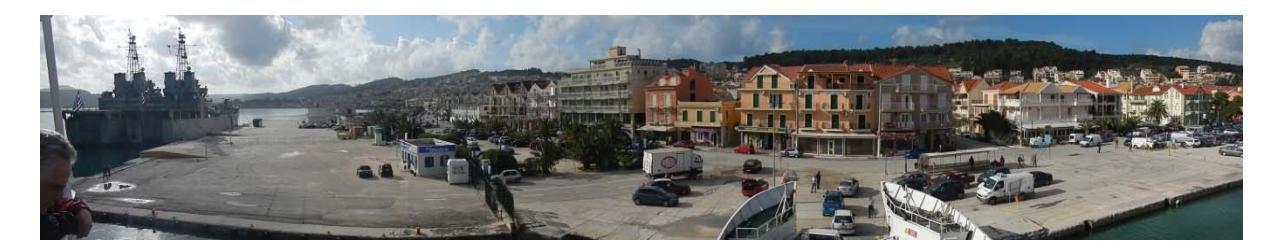
Following the 2014 earthquake events, the Argostoli port (Fig. 8.2.70) and adjacent coastline experienced liquefaction and lateral spreading. The town's waterfront is approximately 1.1 km in length. Soil liquefaction was observed throughout the Argostoli waterfront, most evident in particular areas. In general, the damage in the Argostoli port was less severe than the damage in the Lixouri port, which was closer to the earthquake epicenter. Liquefaction was manifested by soil craters and ejecta, and cracks in paved surfaces surrounded by large amounts of ejecta (Fig. 8.2.71). No signs of liquefaction were observed beyond an inland distance of 100 m from the waterfront.

Figure 8.2.70. Panoramic view of the Argostoli port following the two 2014 seismic events.

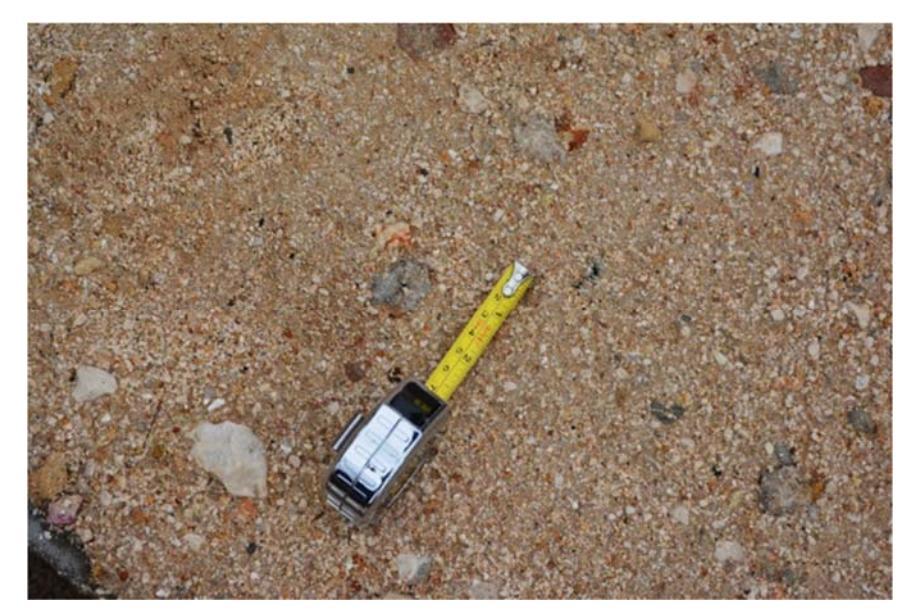
Figure 8.2.73 presents evidence of ejecta in the area of the Port Authority complex of Argostoli, where the abundance of gravel and the existence of even small cobbles (maximum diameter of 3 cm) was observed. This is not typical for ejecta, which usually consist of finer particles. However, it is not clear at this point, whether the gravelly soil did indeed liquefy or if the gravelly particles were ejected out under the high water pressure. In any case, these particle sizes are very uncommon for ejected material.

Figure 8.2.73. Evidence of ejecta in the Port Authority building area at Argostoli (38°10'47.85"N, 20°29'24.42"E).

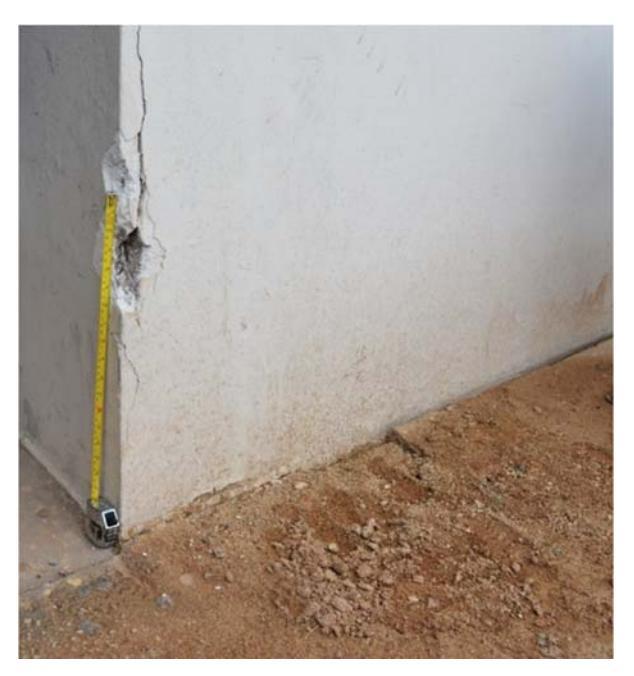
Figure 8.2.74 presents evidence of the maximum height of ejected soil-water mixtures in the perimeter of one the Port Authority complex buildings at Argostoli. The measurement reads clearly a height of 35 cm of ejecta, with finer soil mark evidence reaching a height of 50 cm, indicative of the high pore water pressures.

Figure 8.2.74. Evidence of maximum height of ejected soil-water mixtures against the wall of a Port Authority building at Argostoli (38°10'47.50"N, 20°29'23.43"E).

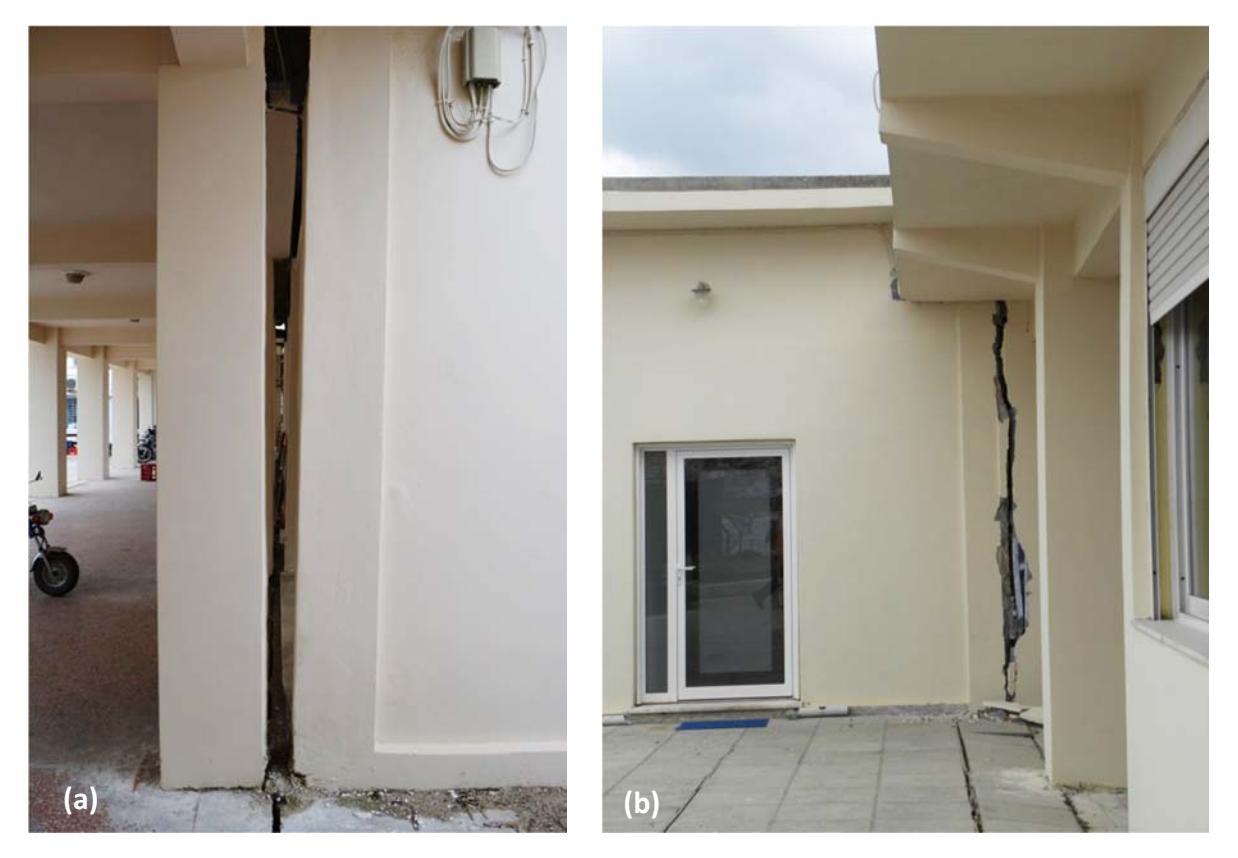
Evidence of rigid body rotation due to differential liquefaction-induced settlements is presented in Fig. 8.2.75 for a single story R/C frame building at the Port Authority complex in Argostoli. The settlement is greater towards the sea (i.e., to the east), and led to rigid body rotation of about 1° without causing structural damage. Additional settlement observations are discussed in the Settlement and Soil-Structure Interaction section of this chapter.

Figure 8.2.75. Rigid body rotation of a single story R/C frame building (at left) due to differential liquefaction-induced settlements at Port Authority complex in Argostoli (38°10'47.91"N, 20°29'23.47"E): (a) view towards the south, (b) view towards the north.

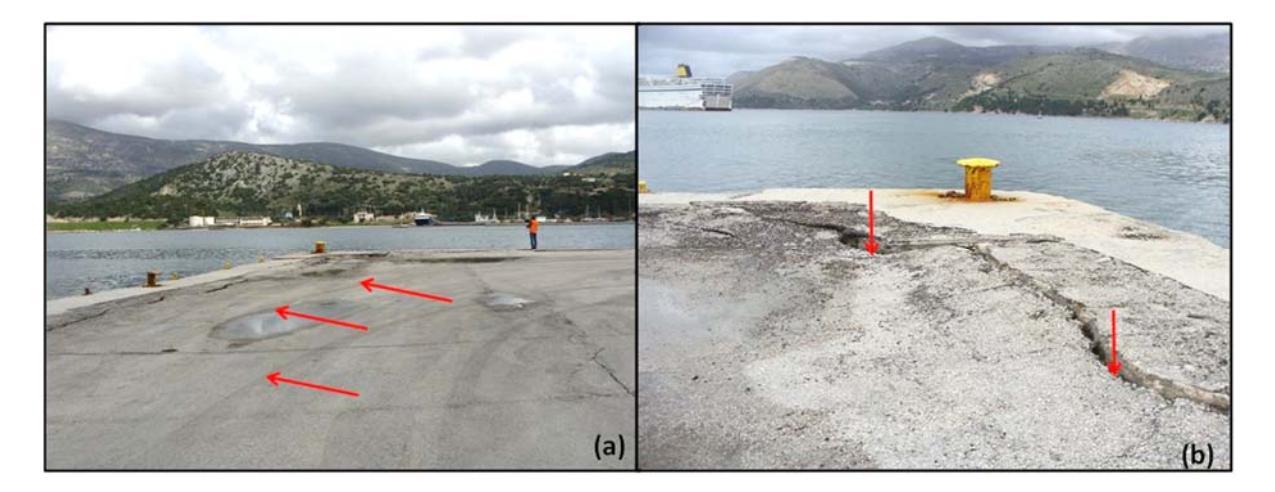
Figure 8.2.79. (a) Photograph of lateral movement and (b) settlement of ground behind the quay wall (GPS coordinates 38.18137°, 20.48980°, 9/2/2014)

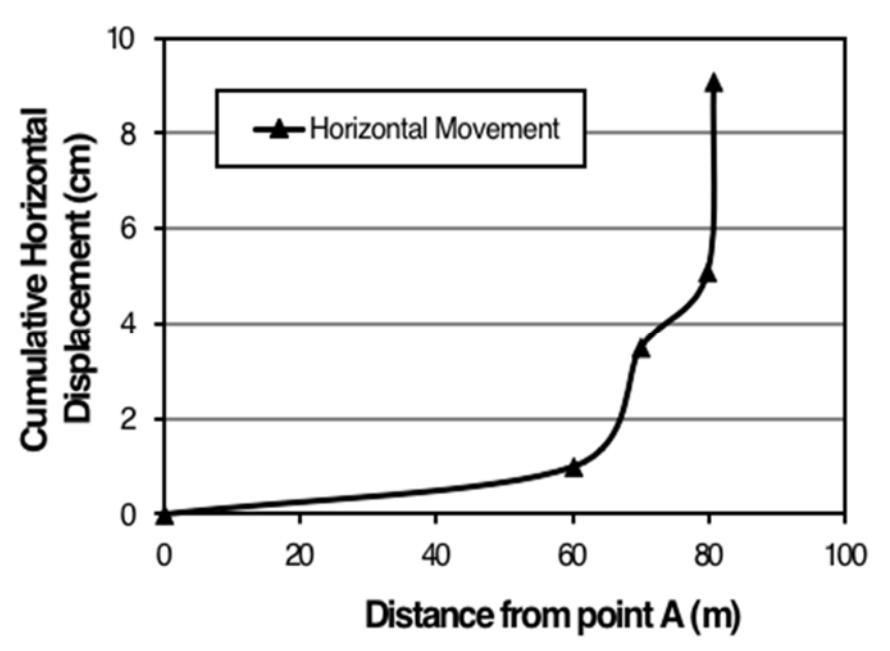
Figure 8.2.80. Argostoli port cumulative horizontal displacement vs. distance from A (see Fig. 8.2.75).

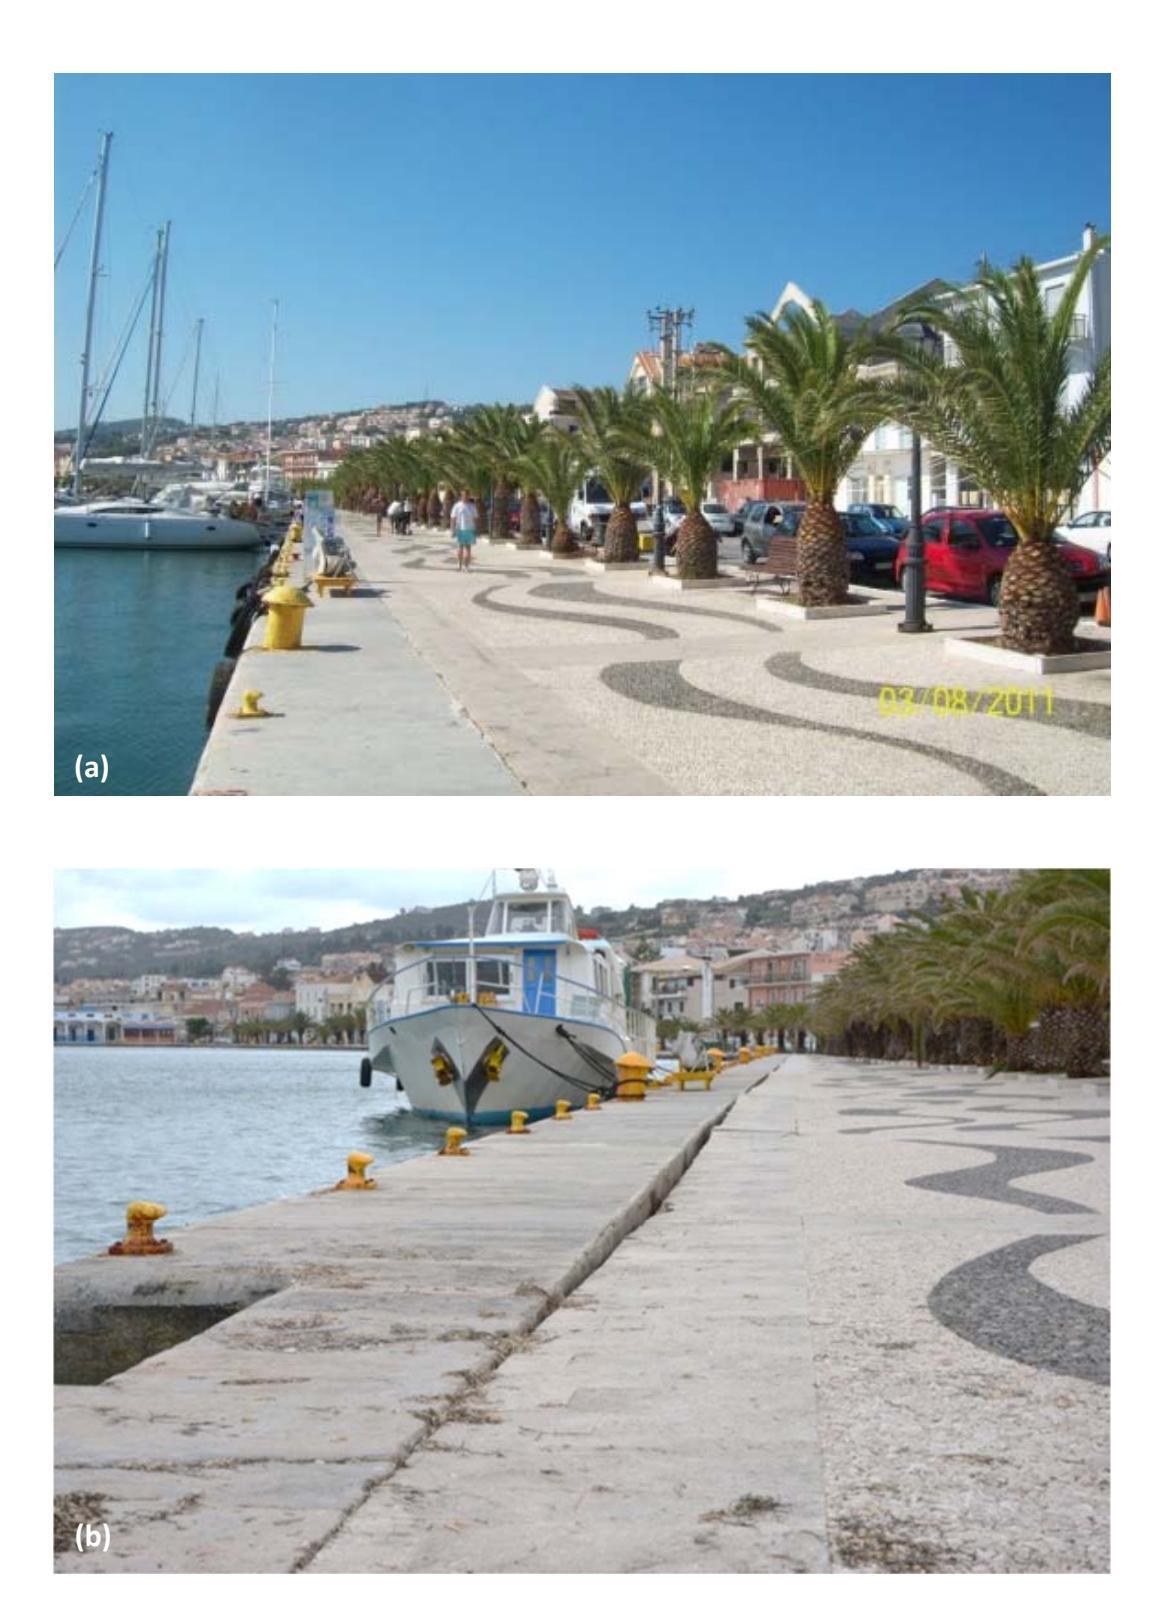
Liquefaction and damage associated with lateral movement of the seafront was also observed beyond the central dock, as shown in Fig. 8.2.81, and measurements have been collected. The port quay wall displaced about 10 cm on average, creating a gap and separating from the sidewalk, as shown in Figs. 8.2.82 through 8.2.84. The performance of the port quay wall can be considered satisfactory given the PGA (Peak Ground Acceleration) levels in excess of 0.35g that was recorded at the Customs building of the port.

Figure 8.2.82. Quay wall view south of the Argostoli Port Authority building complex: (a) from 2011 archives {<u>www.panoramio.com/photo/57109645?source=wapi&referrer=kh.google.com</u>} and (b) after the 2^{nd} event (38°10'45.96"N, 20°29'22.51"E).

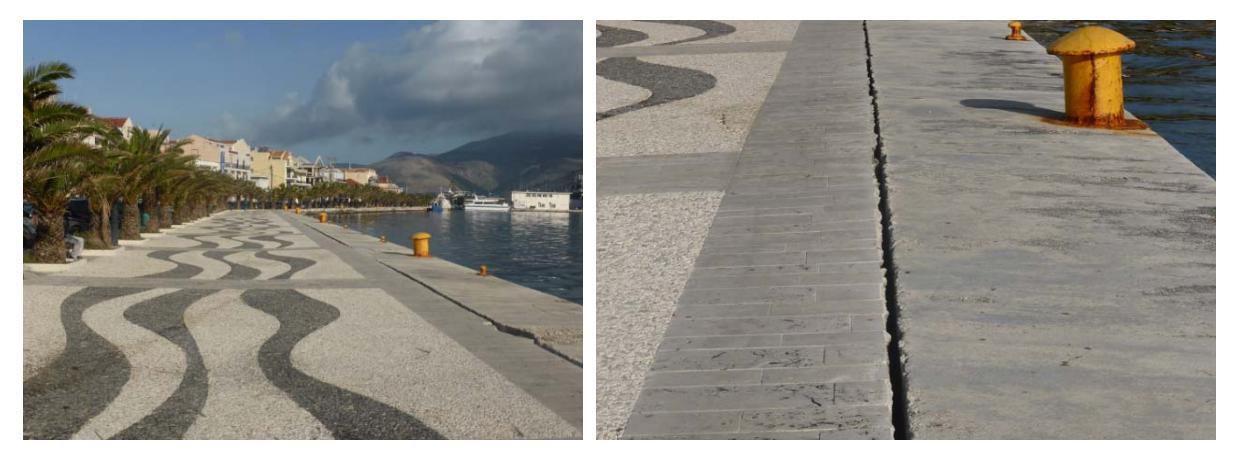
Figure 8.2.83. Minor displacement of quay wall (GPS coordinates: 38.176938, 20.490008).

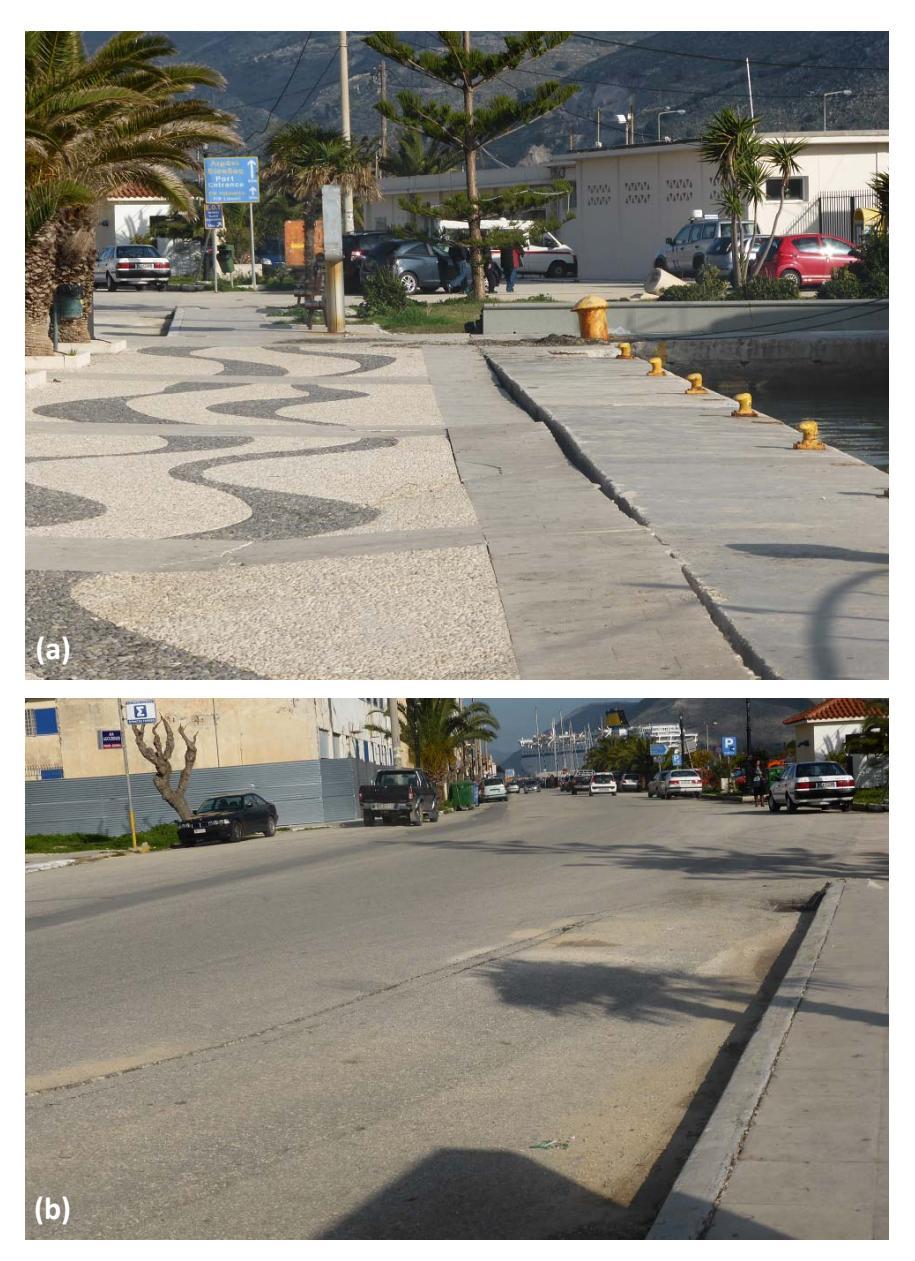
Figure 8.2.84. (a) Vertical settlement of the backfill soil and (b) signs of liquefaction on the road surface (GPS coordinates: 38.179525, 20.489597).

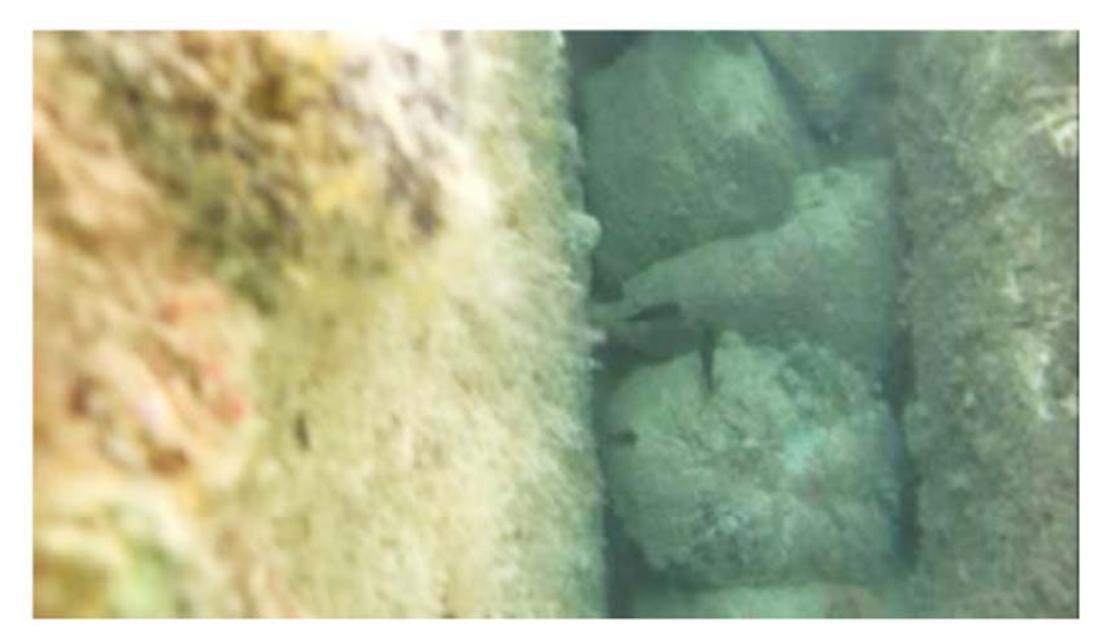
An underwater camera survey conducted following the earthquakes in the Lixouri and Argostoli ports (provided by team member Kostas Rouchotas of NTUA), identified that the quay wall blocks were as far as 30 cm apart (see Figs. 8.2.85 and 8.2.86), significantly higher than the general acceptable range for seismic design between 2 and 5 cm.

Figure 8.2.85. Underwater view of a 30-cm gap between blocks in Argostoli quay wall.

Granular material from the backfill may have passed through these gaps and gradually washed out, generating cavities in the retained mass that were stable under static conditions possibly due to soil arching, but collapsed during earthquake shaking. It is also likely that during the earthquake shaking, the high pore pressures generated in the liquefied soil backfill were released through these openings. This mechanism would explain the settlement of the backfill immediately adjacent to these blocks and the lack of sand boils on the ground surface. In addition, block movements in the two ports were apparently aggravated due to the surveyed scour depth of 10 to 20 cm, extending as far as 1 m under the base blocks (Fig. 8.2.87).

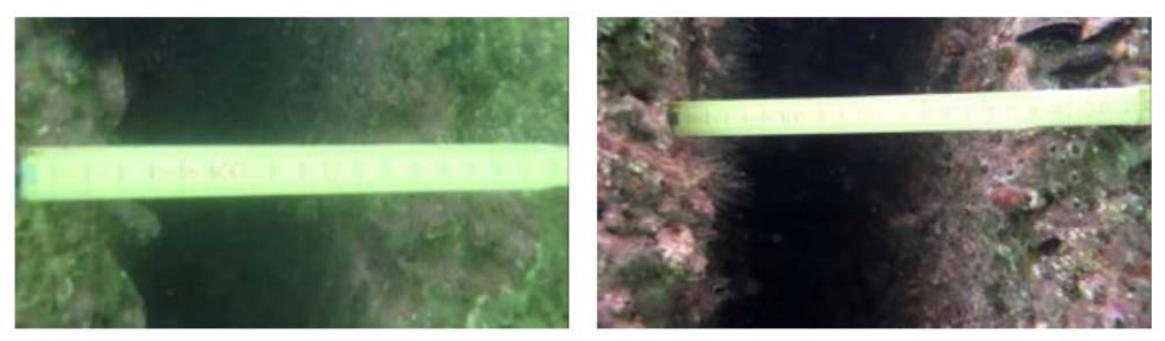
Figure 8.2.86. Underwater view of 20-cm gaps between blocks in Argostoli quay wall.

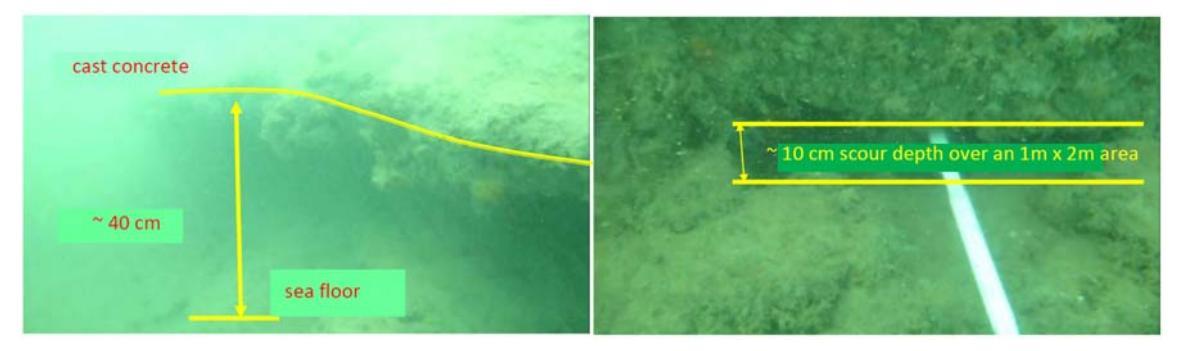
Figure 8.2.87. Underwater view of scour under base block in Argostoli quay wall.

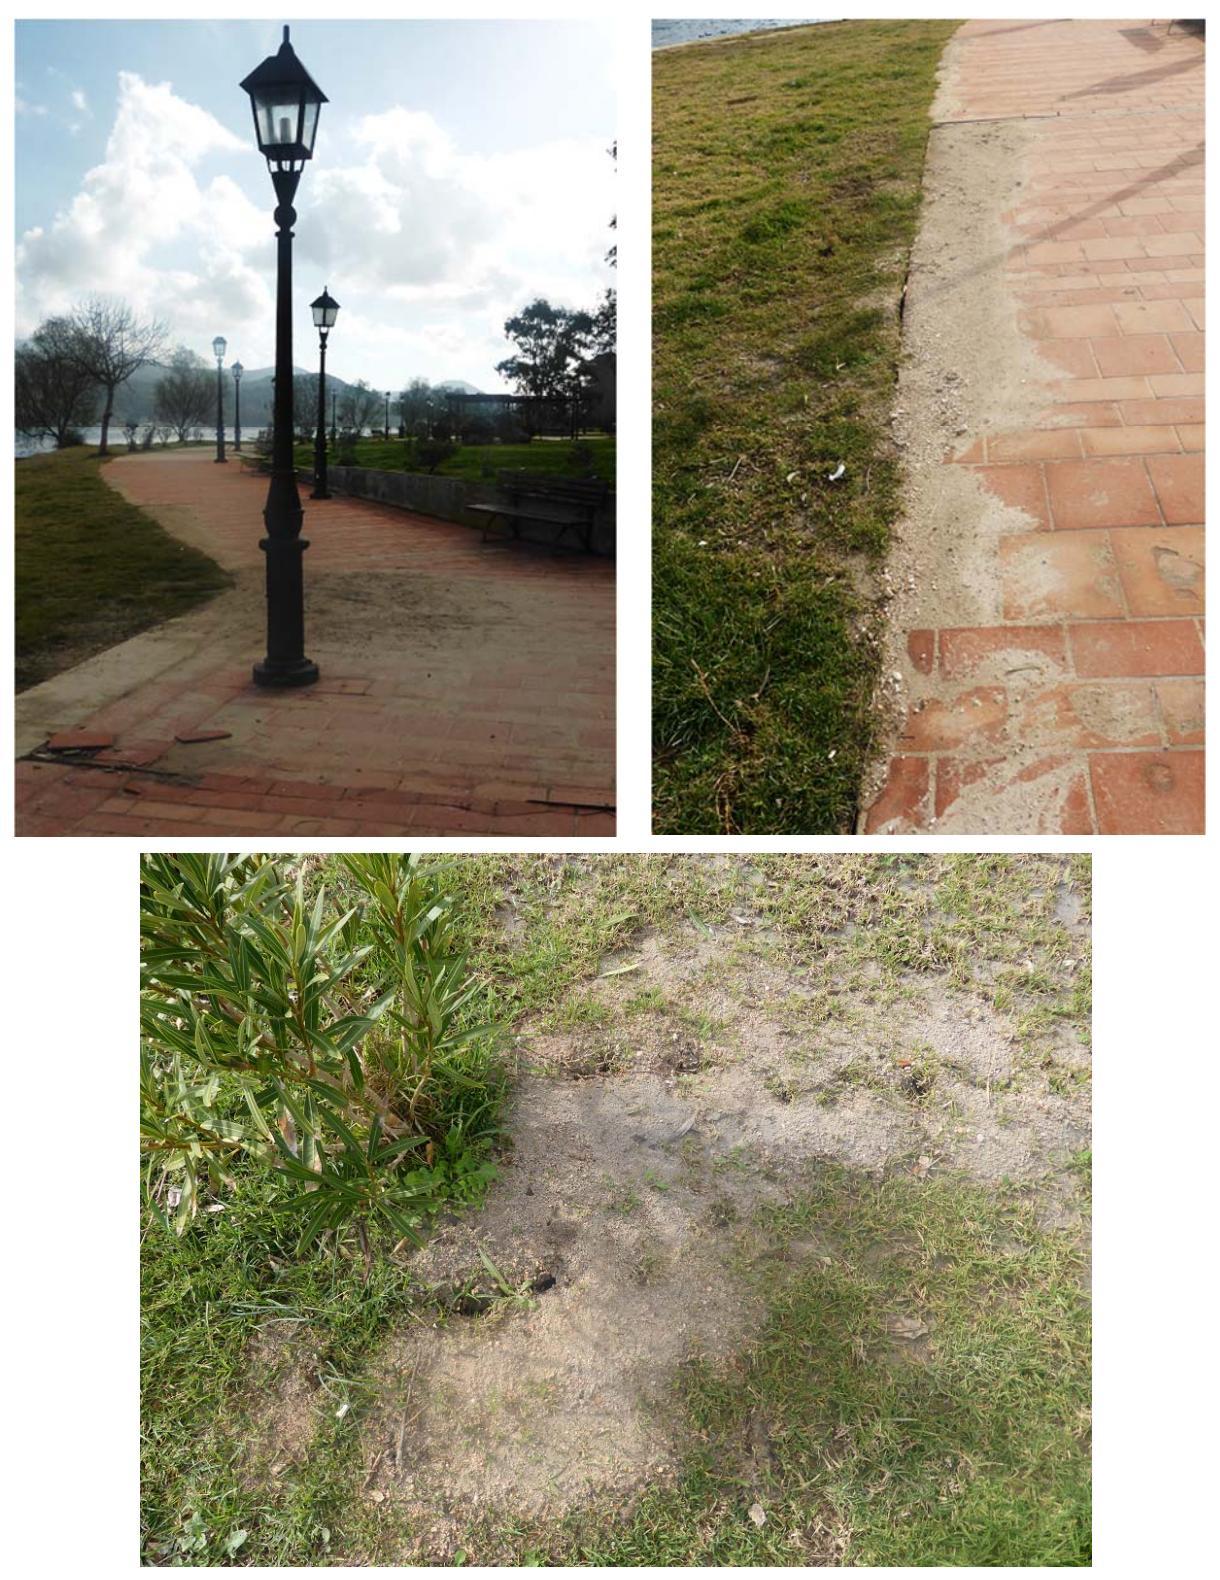
Liquefaction was also evident on the ground surface on the south coast where the water depth is of the order of 1 m, and the wall hardly displaced at all. The consequences were not significant (Figs. 8.2.88 through 8.2.90).

Figure 8.2.89. Sand boils on the free surface, southeast part of Argostoli port (GPS coordinates: 38.171100, 20.495930).

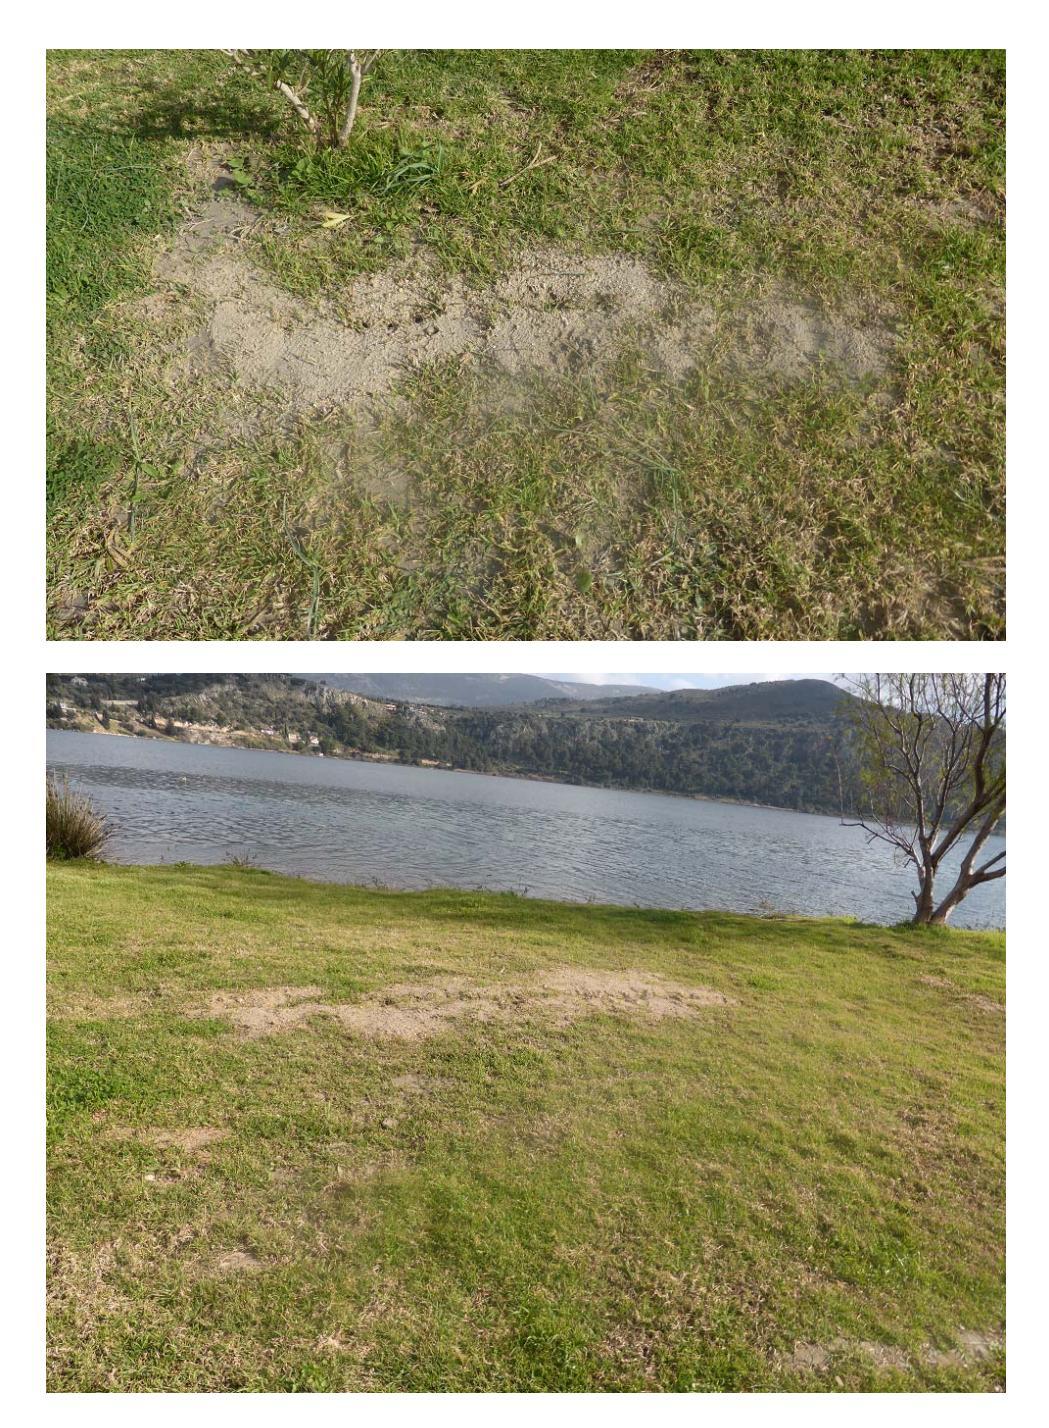
Figure 8.2.90. Sand boils on the free surface in the southeast part of Argostoli port (GPS coordinates: 38.171166, 20.496000).

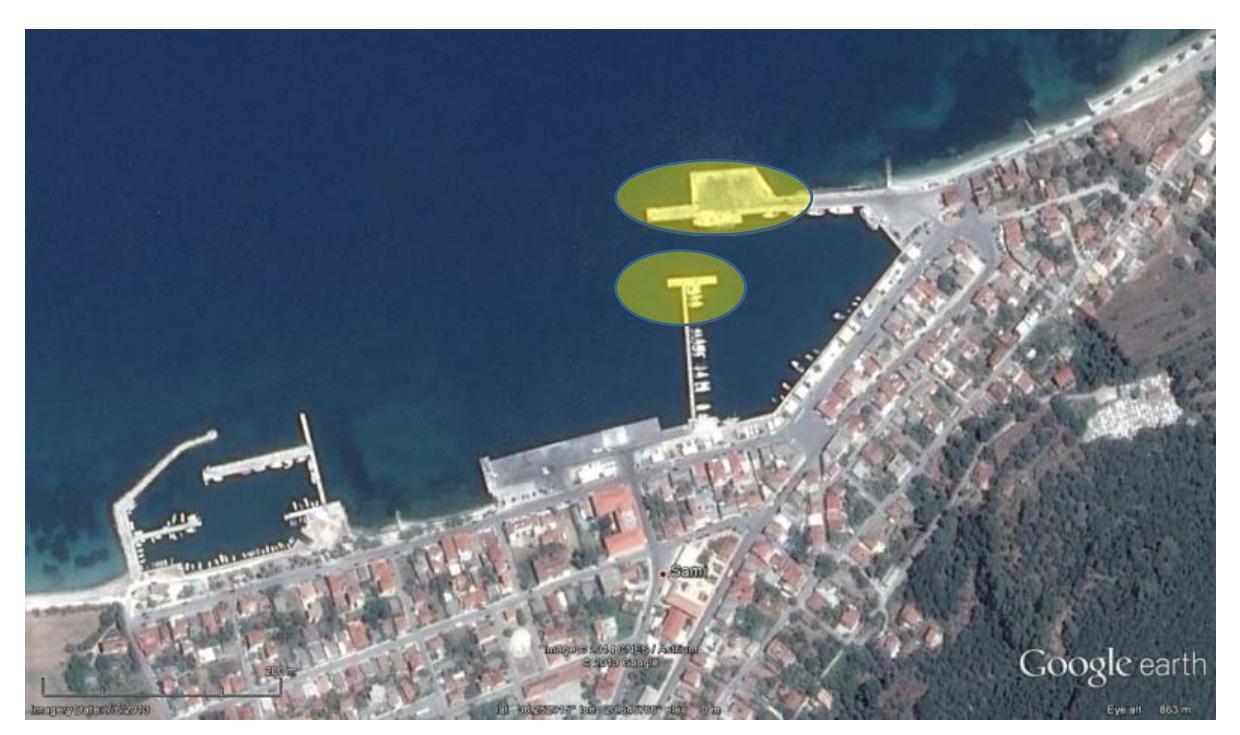
The effects of earthquake shaking during both events in Sami port, at an epicentral distances greater than 25 km, were less severe to those observed at the Lixouri and Argostoli ports that were closer to the epicenters (less than 10 km). Minor damage was observed in the yellow-shaded areas of Figure 8.2.91.

Figure 8.2.91. Port of Sami. Detailed damage shown on Fig. 8.2.92 for the area in lower annotated circle, and in subsequent figures for the upper circle area which experienced more significant damage.

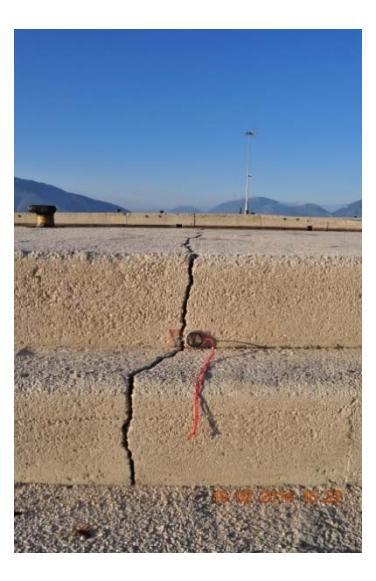
Figure 8.2.92. Post-earthquake damage observation in the lower annotated circle area of Fig. 8.2.91 at the Sami port.

Liquefaction-induced phenomena were not clearly observed in the port area of Sami. Only minor displacements, opening of joints between concrete pier blocks and formation of new cracks associated with settlement of pier blocks were observed and traces of what appeared to be minor soil liquefaction (Figs. 8.2.91 to 8.2.94). Possible evidence of ejecta may have been washed out due to significant rainfall in the days preceding the reconnaissance in this area.

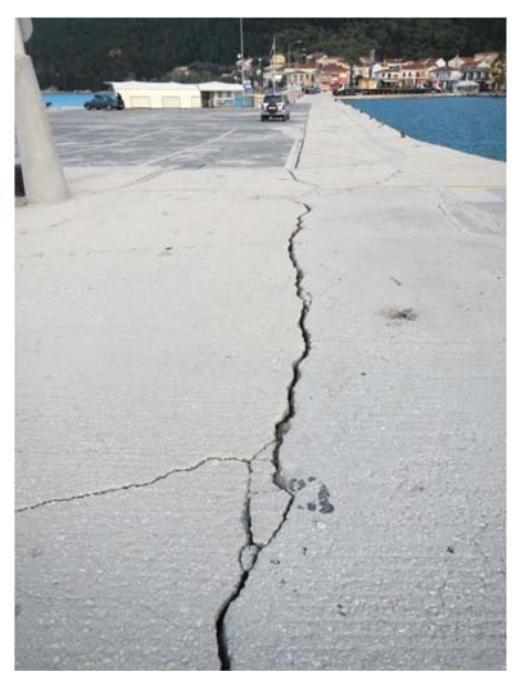
Figure 8.2.93. Crack following the 2nd event at Sami port main pier (38°15'14.97"N, 20°38'50.56"E).

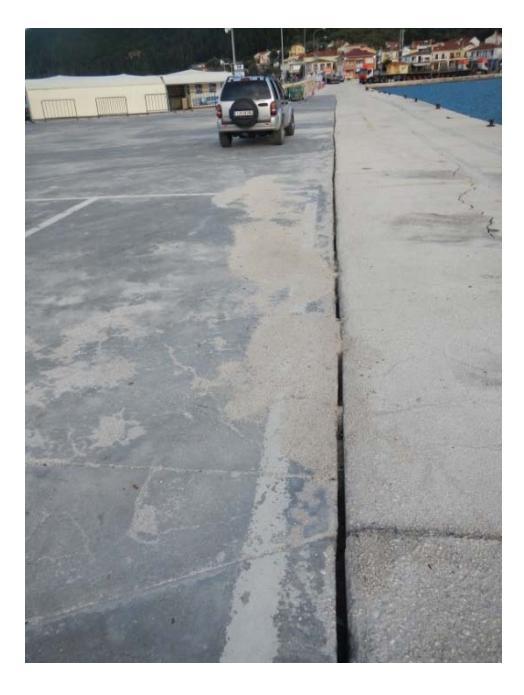
Figure 8.2.94. Joint opening between blocks at Sami port pier with possible ejected sandy soil material at the deepest water area of the pier. This was the only location where these questionable sandy ejecta were identified (38°15'14.93"N, 20°38'51.60"E).

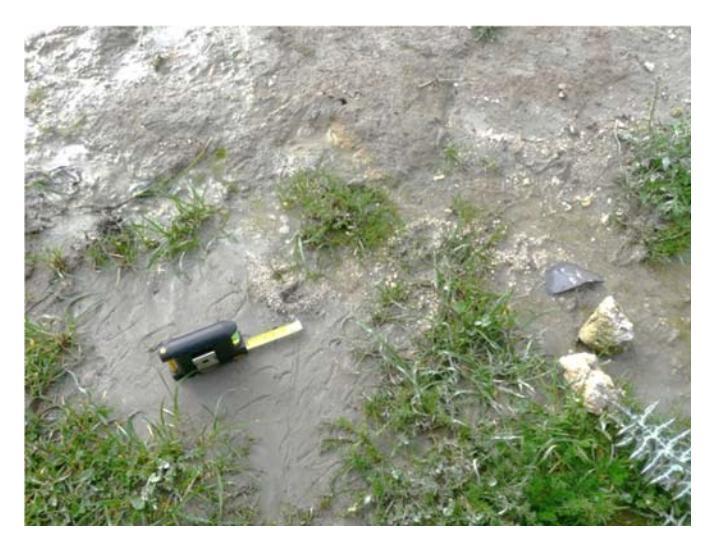
Scattered limited liquefaction phenomena were identified at three locations of Paliki peninsula:: (i) a sand crater with diameter less than 5 cm in a stream bank that crosses pliopleistocene sediments was observed in Soulari (Fig. 8.2.95); (ii) brown coarse sandy material ejected through a crack at the edge of a paved road in Kounopetra of south Paliki peninsula (Fig. 8.2.96a); and (iii) a small amount of coarse sandy material ejected through a fissure with width less than 2 cm inside a field between the villages of Atheras and Livadi (Fig. 8.2.96b).

Figure 8.2.95. Evidence of liquefaction in Soulari (38,18996; 20,41198).
