CHAPTER 8 Geotechnical Observations

GEER/EERI/ATC Cephalonia, Greece 2014 Report Version 1

8.1 Site Effects

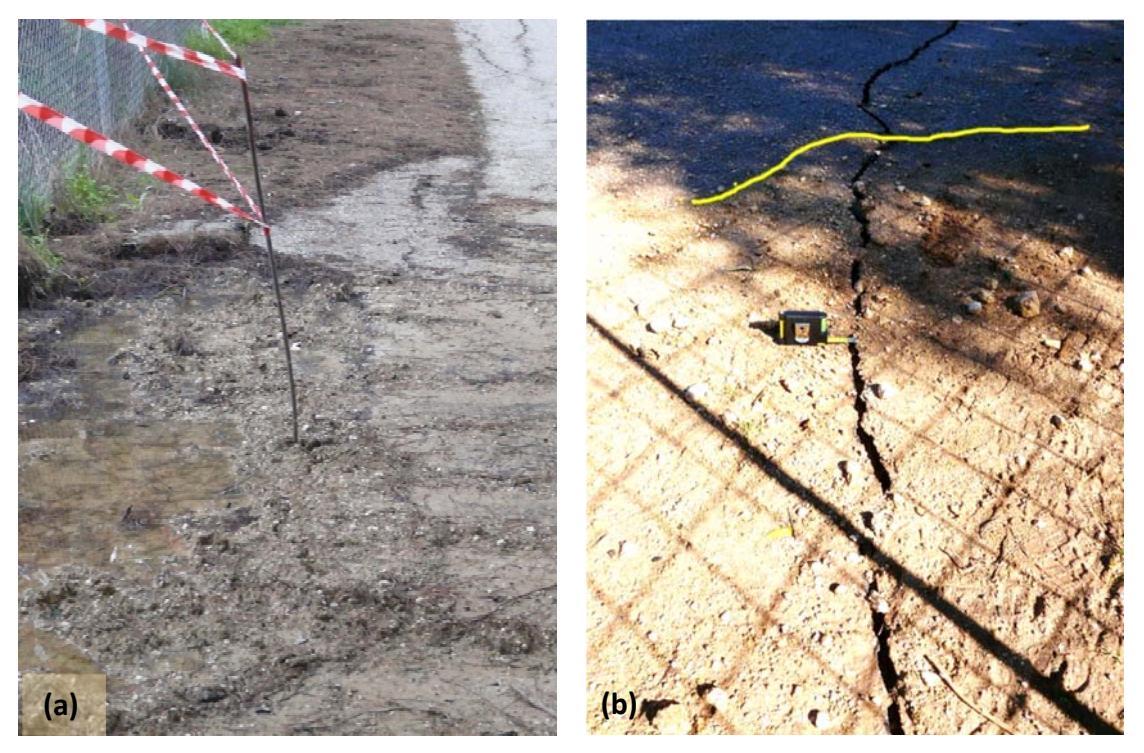
Scattered limited liquefaction phenomena were identified at three locations of Paliki peninsula:: (i) a sand crater with diameter less than 5 cm in a stream bank that crosses pliopleistocene sediments was observed in Soulari (Fig. 8.2.95); (ii) brown coarse sandy material ejected through a crack at the edge of a paved road in Kounopetra of south Paliki peninsula (Fig. 8.2.96a); and (iii) a small amount of coarse sandy material ejected through a fissure with width less than 2 cm inside a field between the villages of Atheras and Livadi (Fig. 8.2.96b).

Figure 8.2.96. (a) Evidence of liquefaction in Kounopetra (38,15726; 20,38534). (b) Ground cracking with limited evidence of sand boils in a field between Atheras and Livadi (38,298547; 20,418600).

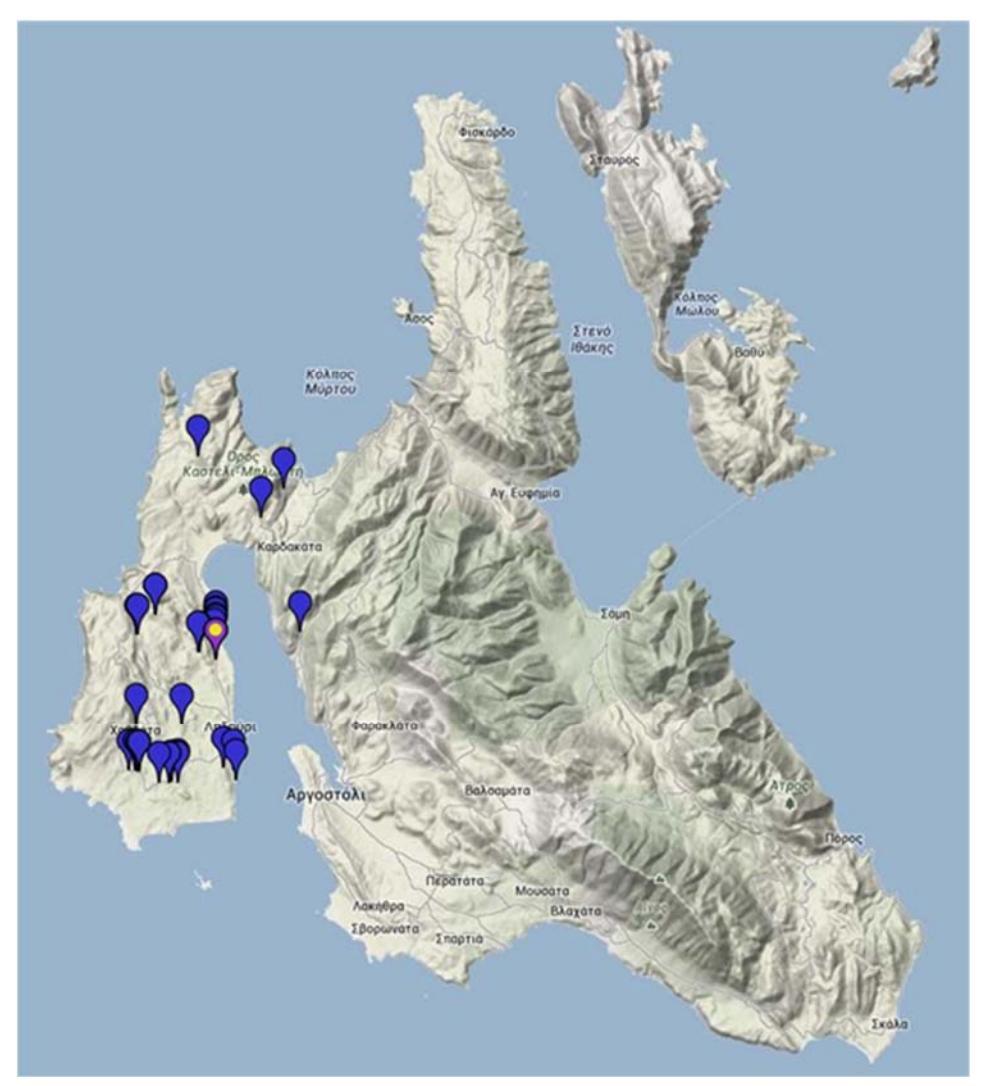
This section summarizes reconnaissance observations made by the UPATRAS, NTUA, ITSAK, DUTH, AUTH-LSDGEE and UTH teams during the periods of 27-30 January, 4-5, 8-12, 18-20 and 22-23 February of 2014. A total of 36 seismically-induced failures on retaining walls were recorded mainly in the Paliki peninsula after the 1st event (EPPO-ITSAK, 2014) and the 2nd event. The spatial distribution of recorded failures is shown on Fig. 8.3.1.

Figure 8.3.1. Geographical distribution of 36 retaining wall failures following the 1^{st} and 2^{nd} events. Original figure shows stone masonry retaining walls (*to be updated in next version*).

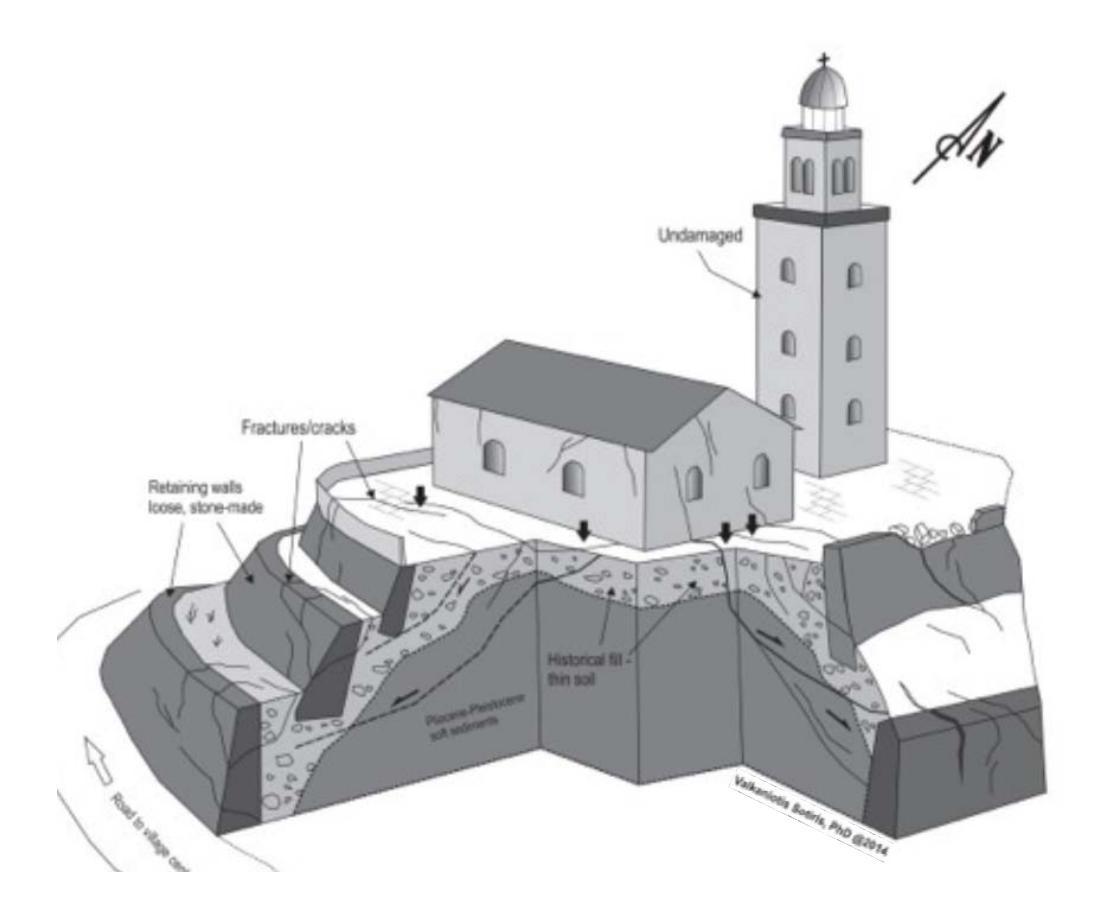
A multi-tiered wall supporting a backfill in Chavriata village is shown in Fig. 8.3.2 with a schematic in Fig. 8.3.3. The Panayia Agriliotissa church was partially supported by the backfill. Fig. 8.3.2a depicts the condition of the wall prior to the 2014 earthquakes from a 2007 archive. The three-tiered wall sustained some damage during the 1^{st} event (Fig. 8.3.2b) and was significantly damaged and actually collapsed during the 2^{nd} event (Fig. 8.3.2c). As a result, lateral displacement and settlement of the backfill retained by the wall resulted in heavy damage of the church. This retaining wall is in close proximity (about 200 m) to a strong motion instrument that recorded a peak horizontal ground acceleration PGA of ~0.74 g during the 2^{nd} event. Fig. 8.3.4 and 8.3.5 are close-up views from the southwest and south, respectively.

Fig. 8.3.3. Schematic of the Panayia Agriliotissa Church, prepared by S. Valkaniotis (modified from Papathanasiou et al., 2014).

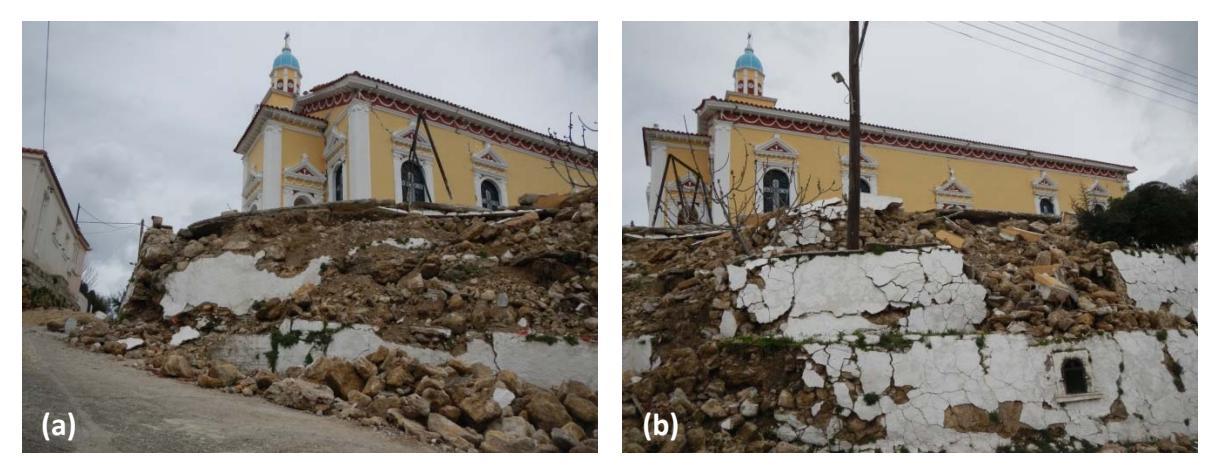
Figure 8.3.4. View of the retaining wall and church (a) from the southwest; and (b) from the south following the 2^{nd} event (38°10'57.52"N, 20°23'13.61"E).

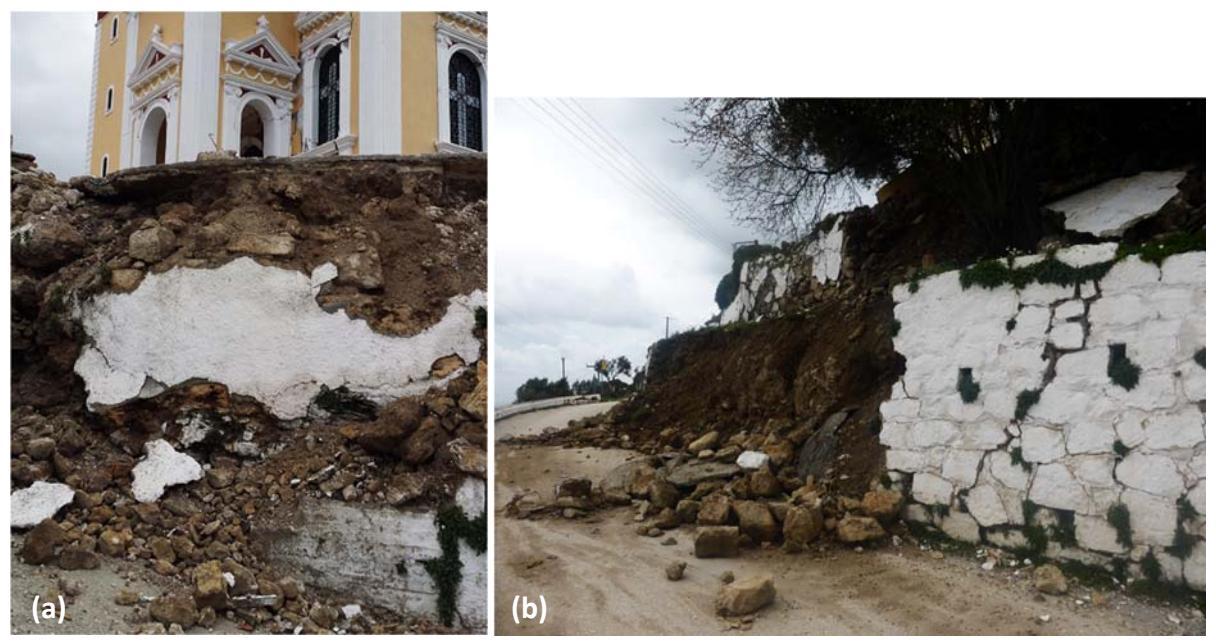
Figure 8.3.5. Closer views of the damaged wall (GPS coordinates: 38.182500, 20.387222).

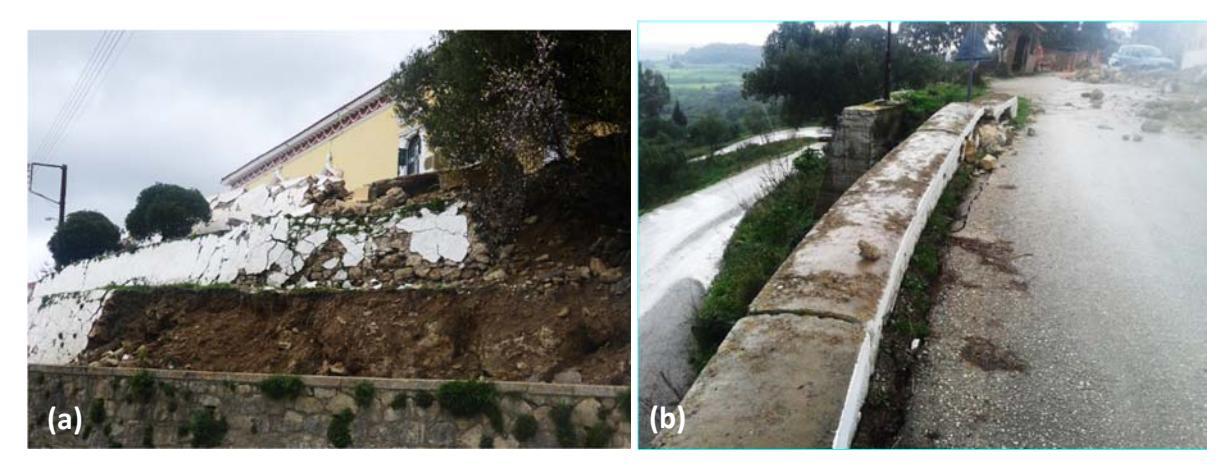
Of interest is also that immediately downhill of the failed multi-tiered masonry wall of Figures 8.3.2 to 8.3.5 are two approximately 5-m high masonry walls with significant cement between blocks that responded much better to the two events, despite being subjected to the same intense shaking (Fig. 8.3.6).

As shown in Figure 8.3.6b, the first wall, in the foreground, is directly downhill the failed multi-tiered masonry wall (note its debris to the right), while the second one, in the background, starts at this location and is running towards the west, in parallel, but further to the west of the wall in the foreground. The second wall displaced horizontally and as a result a longitudinal crack to the pavement was observed. This wall is quite long, and its behavior further to the west of the church is presented in the section of concrete retaining walls below. The longitudinal crack also continued behind the first wall with smaller dimensions.

Figure 8.3.6. View of the masonry retaining wall, just downhill of the three-tiered plastered masonry wall in Chavriata (38°10'57.52"N, 20°23'13.61"E).

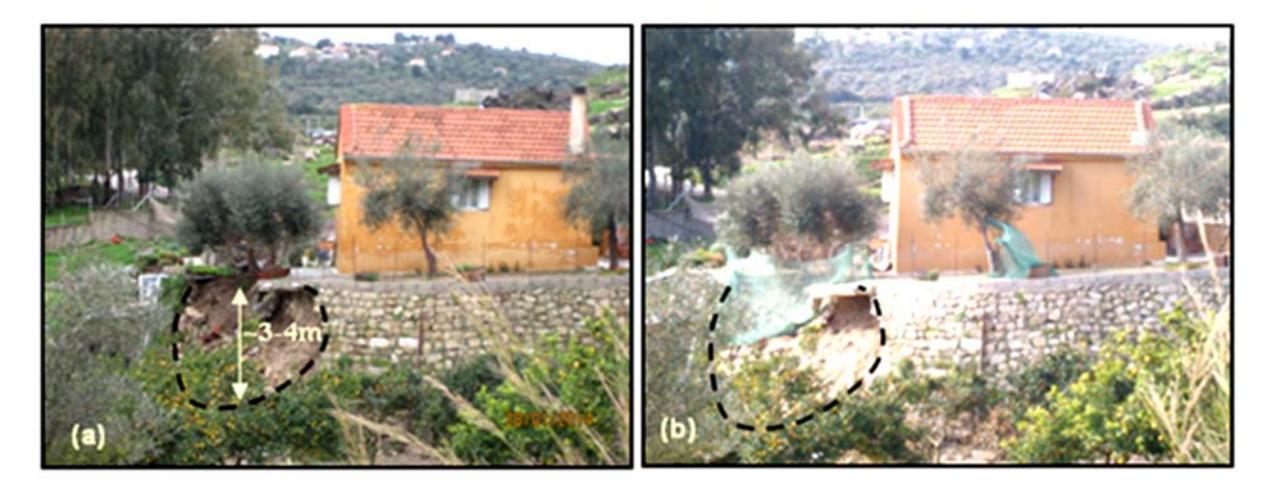
Figure 8.3.9. Single-story building close to Kouvalata village (38.234484° N, 20.419554° E): (a) failure of stone masonry retaining wall followed by local landslide of the supporting bearing soil after the 1^{st} event, and (b) progression of failure after the 2^{nd} event.

Failure of masonry wall was recorded following the 1st event near the Kouvalata village (38.234484° N, 20.419554°E). The wall retained a natural slope upon which a single-story structure was founded (Figure 8.3.9). The failure of the wall was accompanied with settlement of the retained backfill that became more pronounced following the 2nd event. The heavy rainfall that occurred during that period probably contributed to the evolution of this failure.

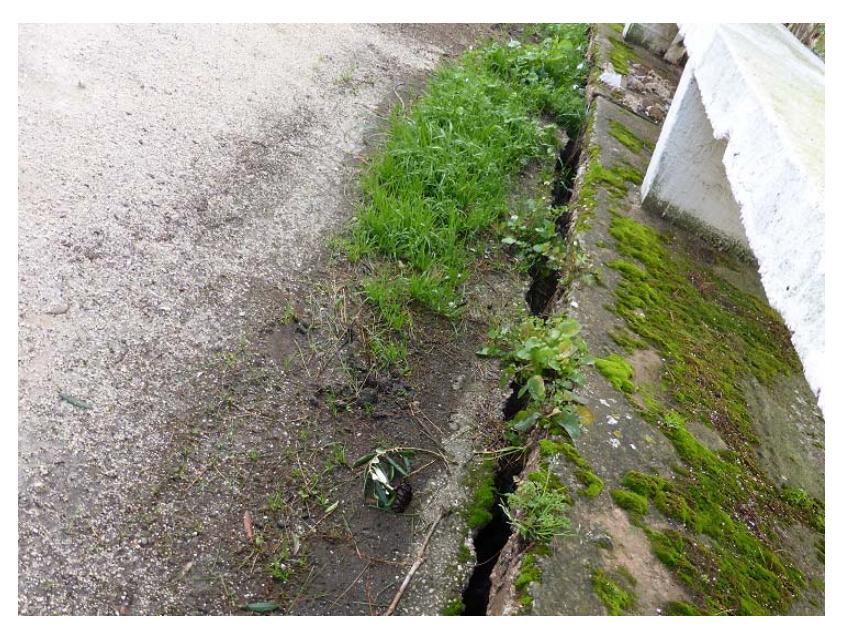
The church's yard is retained by the masonry wall, which is flanked by concrete retaining walls. It appears that the entire masonry wall moved and the backfill movement occurred only behind the section retained by the masonry wall (Figs. 8.3.10, 11). The cracked ground parallel to the wall was 24 m long. The cumulative vertical displacement of the ground was 20 cm in the vertical direction (Fig. 8.3.12) and 21 cm in the horizontal direction. Interestingly, next to the church lies a cemetery that is almost entirely destroyed by the earthquakes with toppling observed in almost two thirds of the tombs.

Figure 8.3.11. Lateral soil movement, at Kourouklata's church front yard (38.242113, 20.473955).

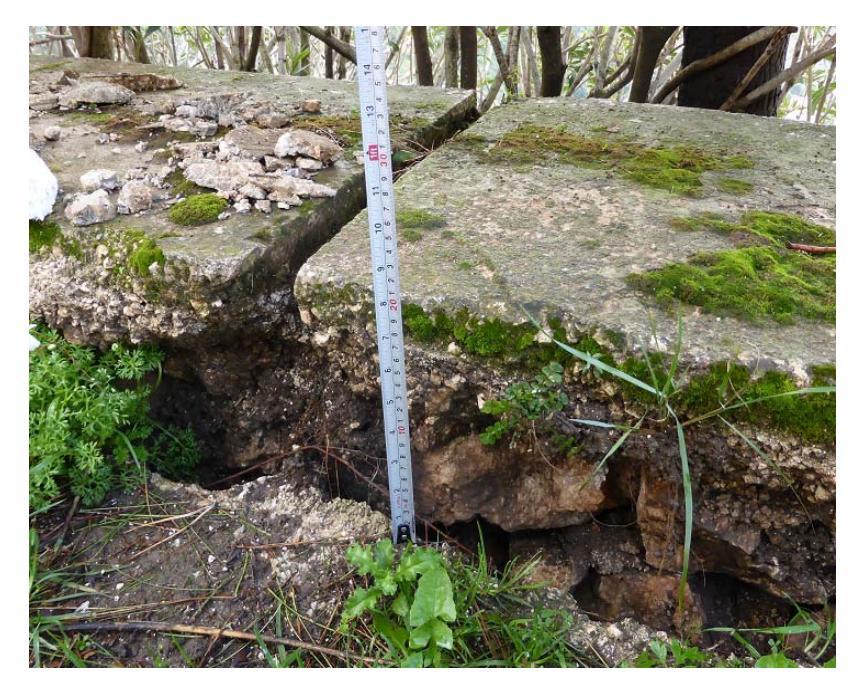
Figure 8.3.12. Vertical settlement of 20 cm behind the retaining wall (38.242113, 20.473955).

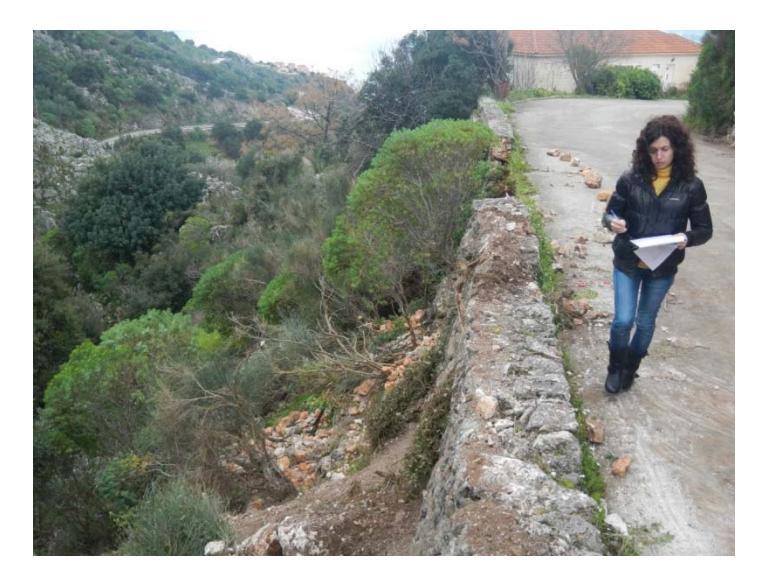
On the road towards the Kourouklata village, there were also a few additional interesting failures of stone masonry walls. A pair of failures is shown in 8.3.13 and 8.3.14. One was located on the uphill side of the road, whereas the second one is located in the downhill side of the road just a few meters apart from each other. Fig. 8.3.13 shows a view of the uphill wall, which is 4.20 m high and has collapsed leaving the road pavement cantilevered. Fig. 8.3.4 shows a side view of the downhill wall. The natural stones were cemented. The wall has a maximum height of 2.8 m and a thickness of 45 cm. A series of additional failures of short retaining walls are shown also in Fig. 8.3.15 and 8.3.16.

Figure 8.3.14. Another masonry wall damage towards Kourouklata village (38°14'26.29"N, 20°28'35.14"E).

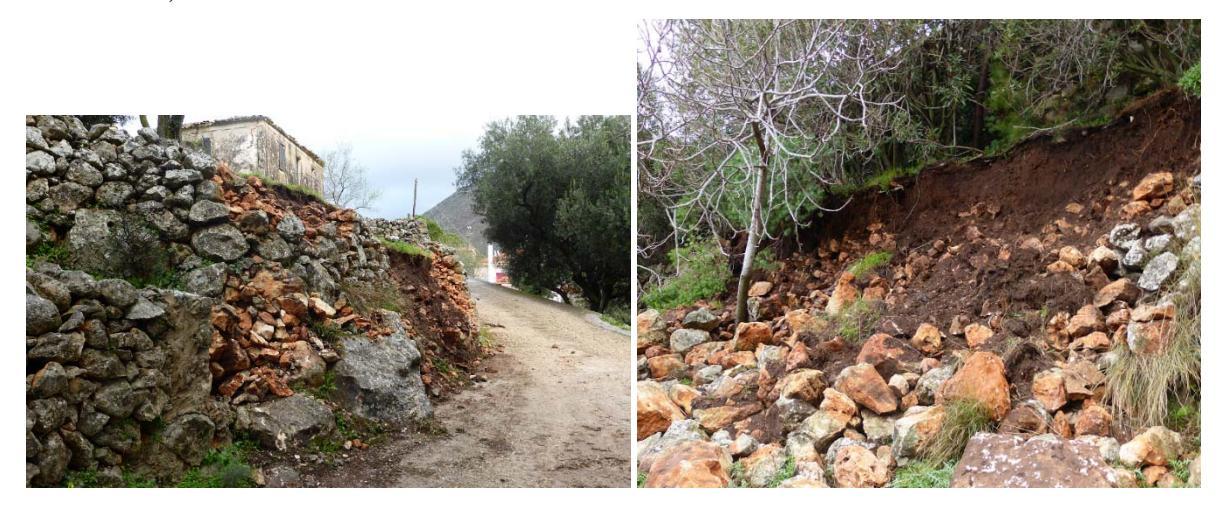
Figure 8.3.16. Collapse of stone retaining wall in Kourouklata village. (38.241797, 20.473677).

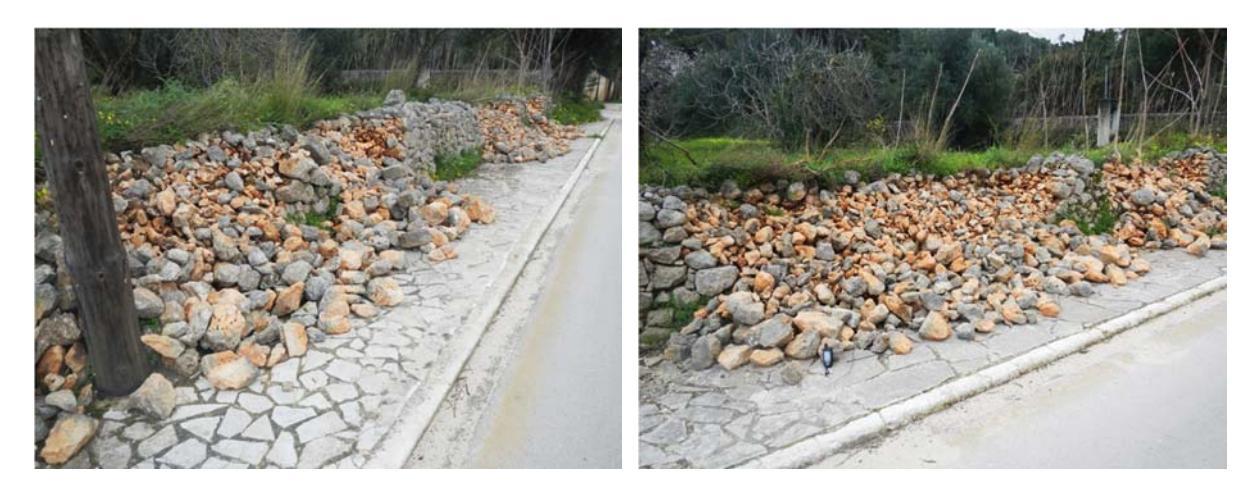
A case of a relatively short, 1.2-m high, wall is shown on Fig. 8.3.18 near Argostoli. Despite its low height, this wall was damaged as a result of earthquake shaking. However, it is not known which of the two events caused the failure.

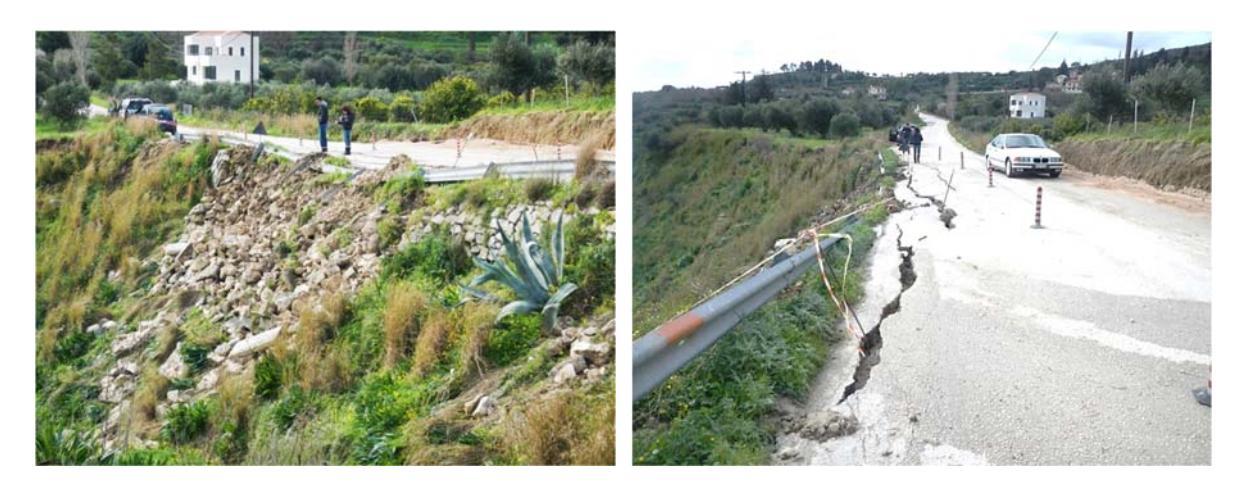
Another example of masonry wall failure near Lixouri is shown on Figure 8.3.19. A stone/masonry wall failure in a cemetery in Livadi village is shown on Figure 8.3.20 and two retaining wall failures in the cemetery of Lixouri are shown on Figures 8.3.21 and 8.3.22. Another small wall failure at the Theotokos Kipouraion Monastery is shown on Figure 8.3.23 and a few failures in Aghia Thekla village, as shown on Figures 8.3.24 to 8.3.27.

Figure 8.3.19. Failure of masonry wall supporting roadway outside of Lixouri (38°12'21.05"N; 20°24'54.89"E).

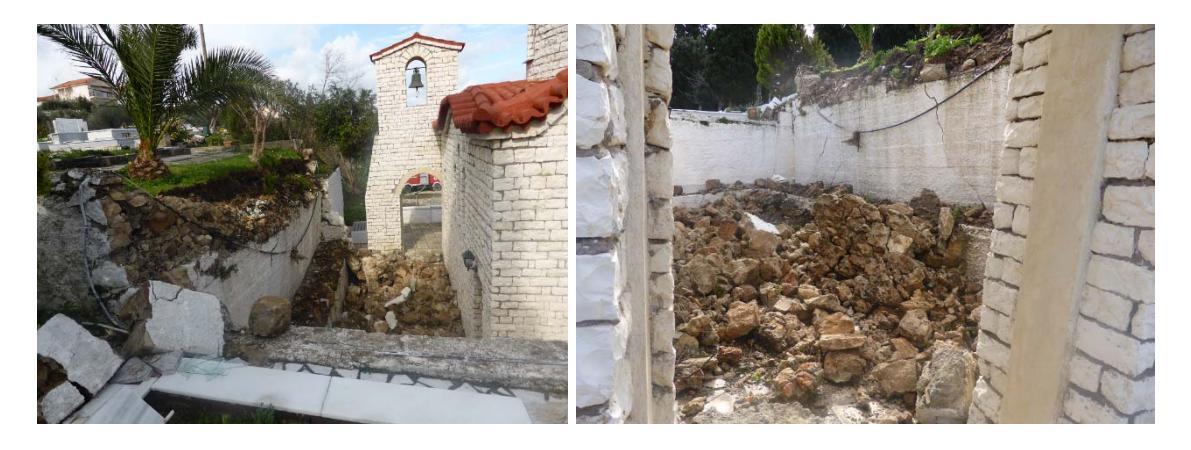
Figure 8.3.22. Failure of a small retaining wall at the back yard of the Lixouri cemetery's church (GPS coordinates: 38.192911, 20.438625).

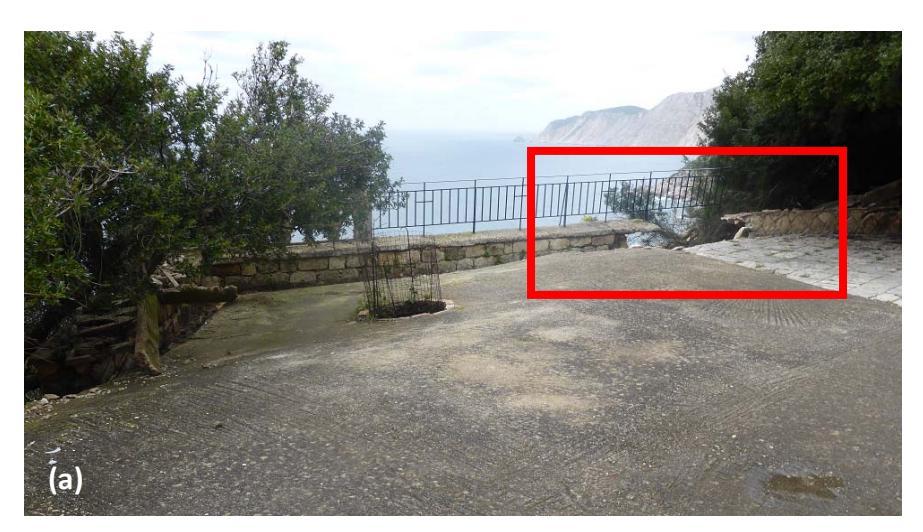
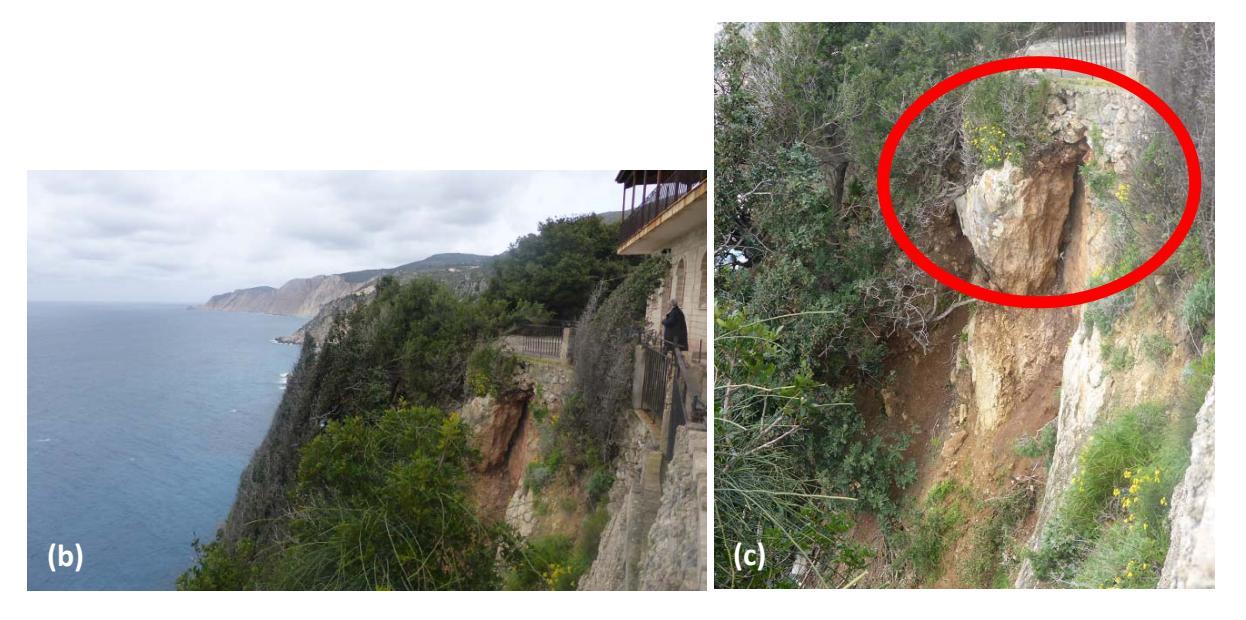
Figure 8.3.23. Partially failed small retaining wall in the backyard of the Theotokos Kipouraion Monastery (38.203194, 20.348219); (b, c): View from the backyard: collapse of retaining wall marked with red circle. (38.203327, 20.347747).

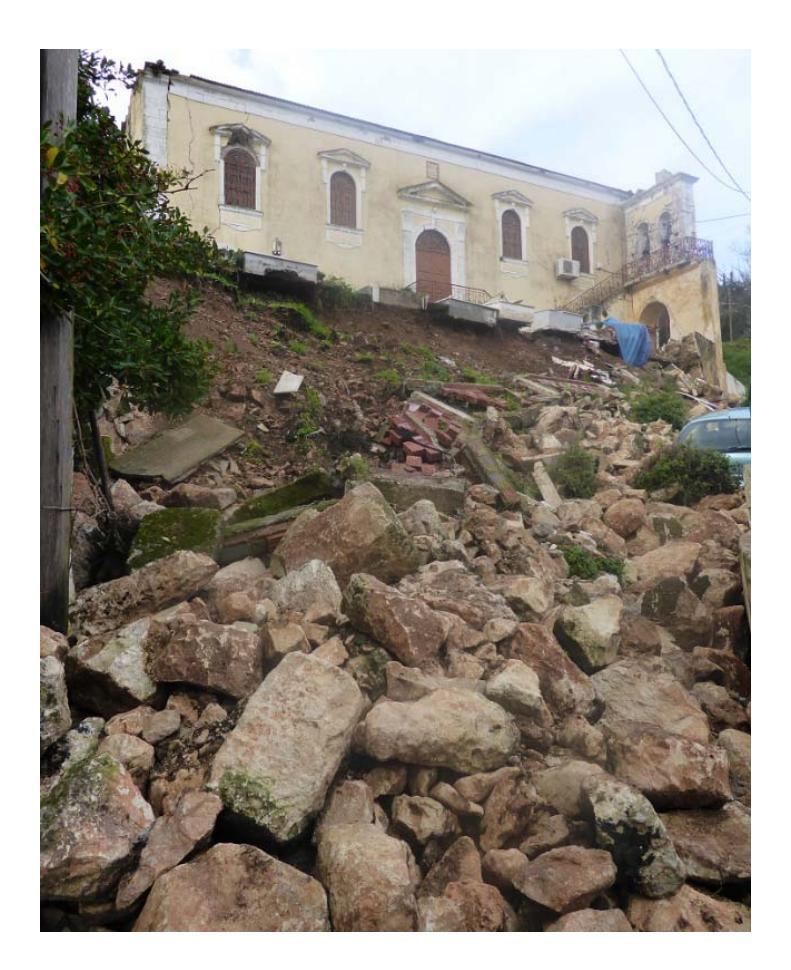
Figure 8.3.24. Retaining wall collapse in front of the "new" Aghia Thekla church (GPS coordinates: 38.245202, 20.384422).

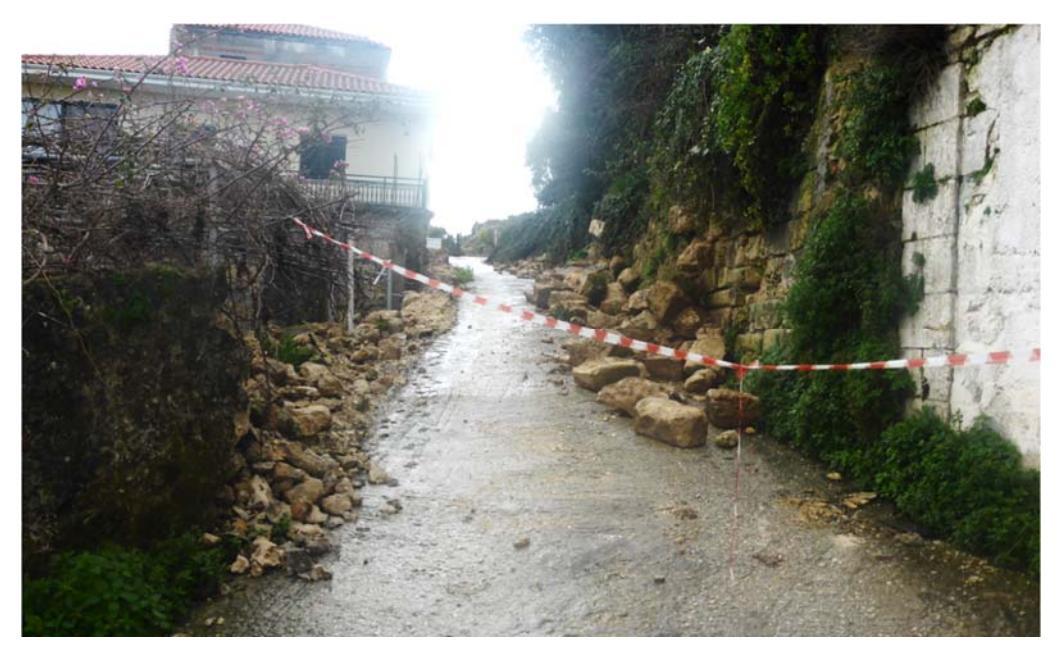
Figure 8.3.25. Damage of stone walls in Aghia Thekla village (GPS: 38.245202, 20.384422).

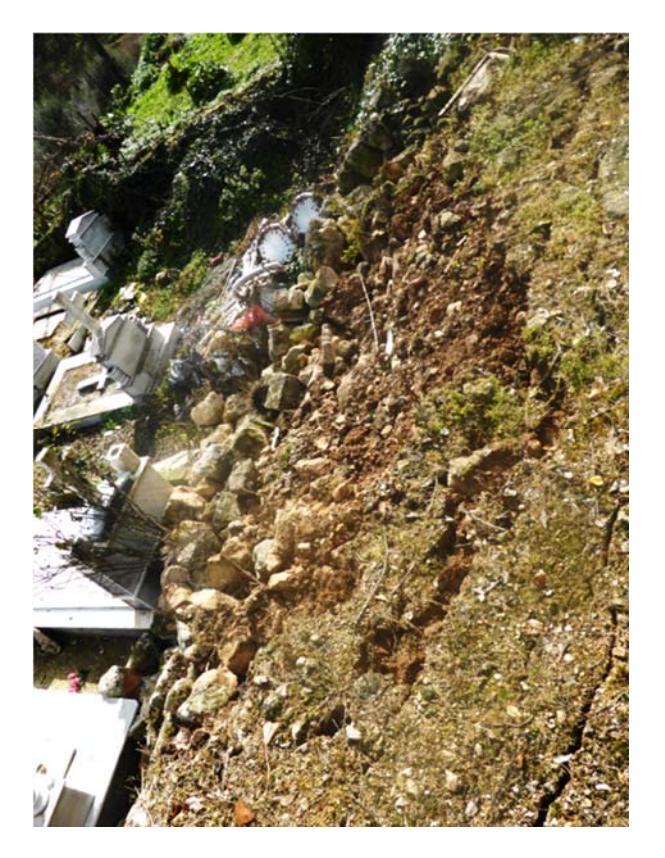
Figure 8.3.27. A small retaining wall failure at the old Aghia Thekla church cemetery (GPS coordinates: 38.244944, 20.386433).

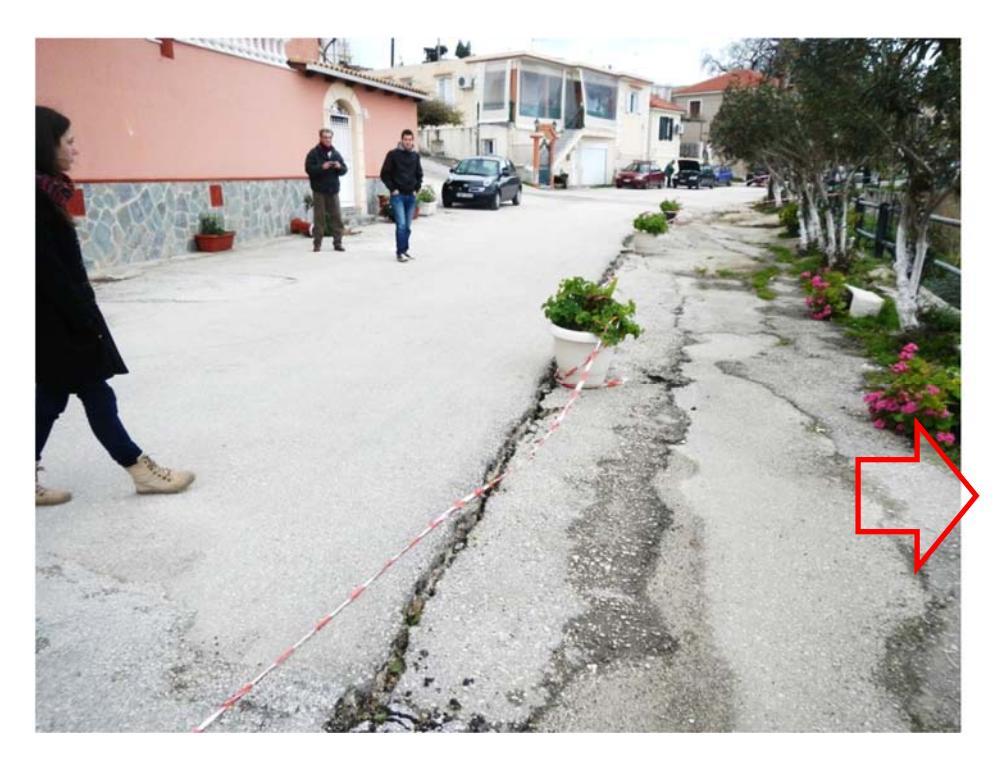
At the same location, another reinforced concrete wall with a length of approximately 250 m and a height ranging from 3.2 m to 3.9 m retains the main paved road of the town (Fig. 8.3.29). The axis of the wall is curved in plan and has a general East-West strike. The wall did not show signs of distress. A long section of the road retained by the wall was cracked and settled vertically by 5 to 15 cm and displaced horizontally by about 3 to 7 cm.

Figure 8.3.29. Cracked pavement due to wall movement with retaining wall on the left. (38°10'57.83"N, 20°23'9.40"E).

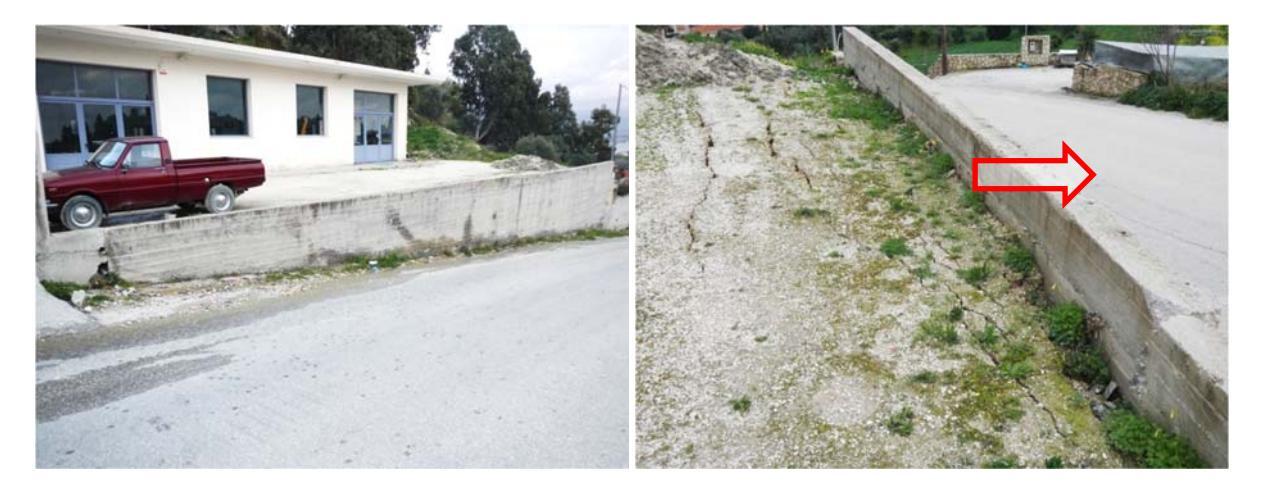
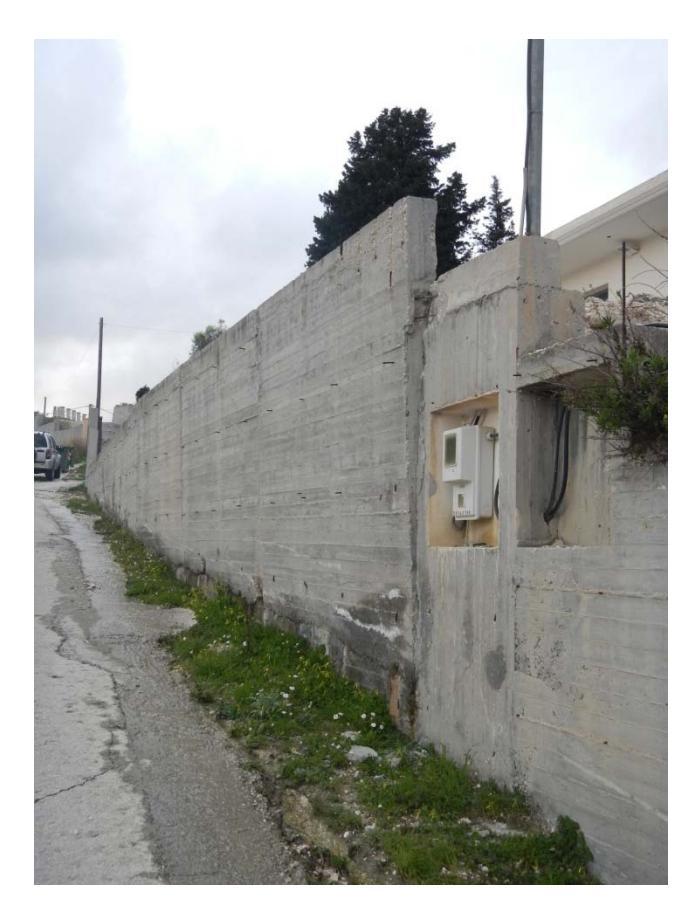
A case of a distressed cantilever type retaining wall is shown on Figure 8.3.30. The wall is located on the roadway between Havdata village and Lixouri. It is not known whether this wall was damaged during the Event 1 or Event 2. The wall is retaining a backfill, forming the yard of a car body shop and has variable height ranging from 0.66 m to 3.1 m. The portion of the wall with the maximum height tilted outwards and the backfill moved laterally about 12 cm and also settled, defining the sliding plane. Water drains were provided close to the base of the wall.

Figure 8.3.30. Tilted cantilever retaining wall of variable height on the roadway between Havdata and Lixouri. (38°12'21.05"N, 20°24'54.89"E).

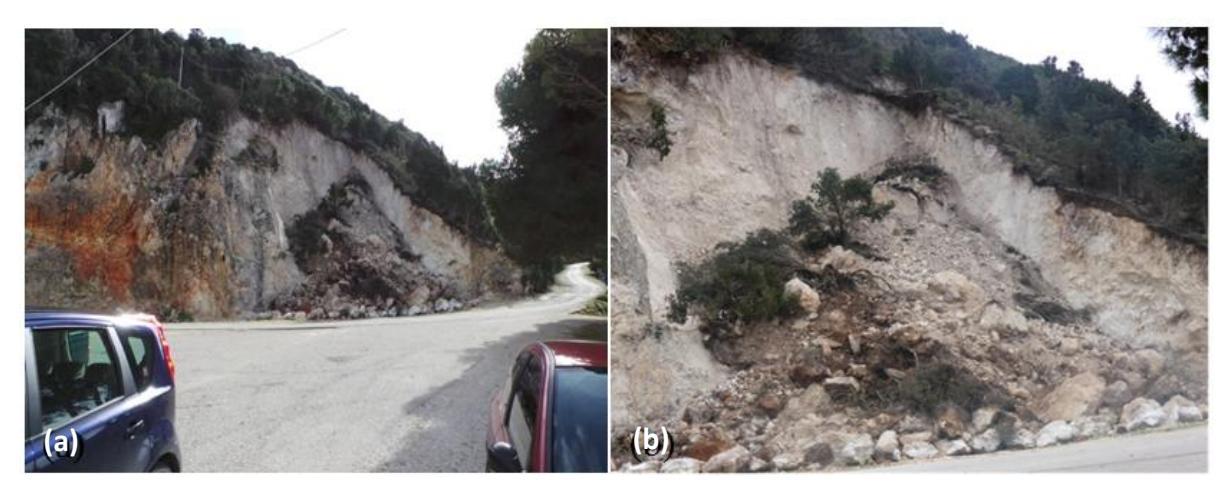
Along the paths in Figs. 8.4.1(b,c,d), the reconnaissance teams observed one major rock fall with debris slide in steep cliffs (Fig. 8.4.4) and a major deep-seated bedrock slump in a natural slope undercut by a road (Fig. 8.4.2). In addition, numerous minor rock falls were spotted along the road cuts, ranging from simple block falls to more extended rock falls within various types of limestones (blocky, fractured and/or weathered).

Figure 8.4.2. Rock slope failure in limestone in Monastery of Theotokou Kipouraion (38.202517° N, 20.348083° E, (a) UPatras team, 2/9/14, (b) NTUA team, 2/10/14).

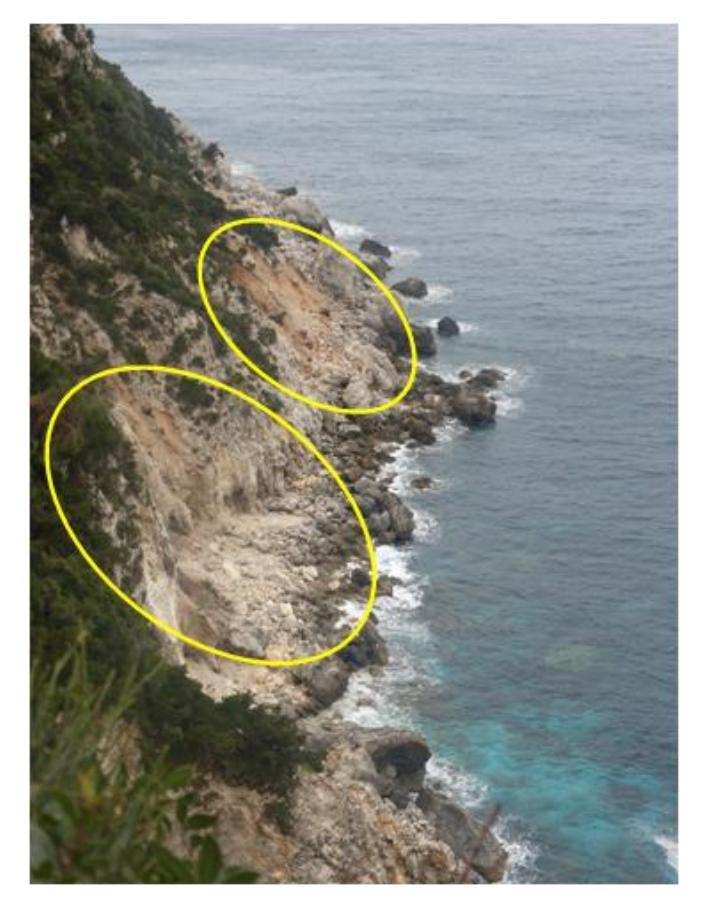
Figure 8.4.3. Numerous weathered rock landslides/rock falls along the shore near Monastery of Theotokou Kipouraion. (38.203327° N, 20.347747° E, NTUA team, 2/10/14)

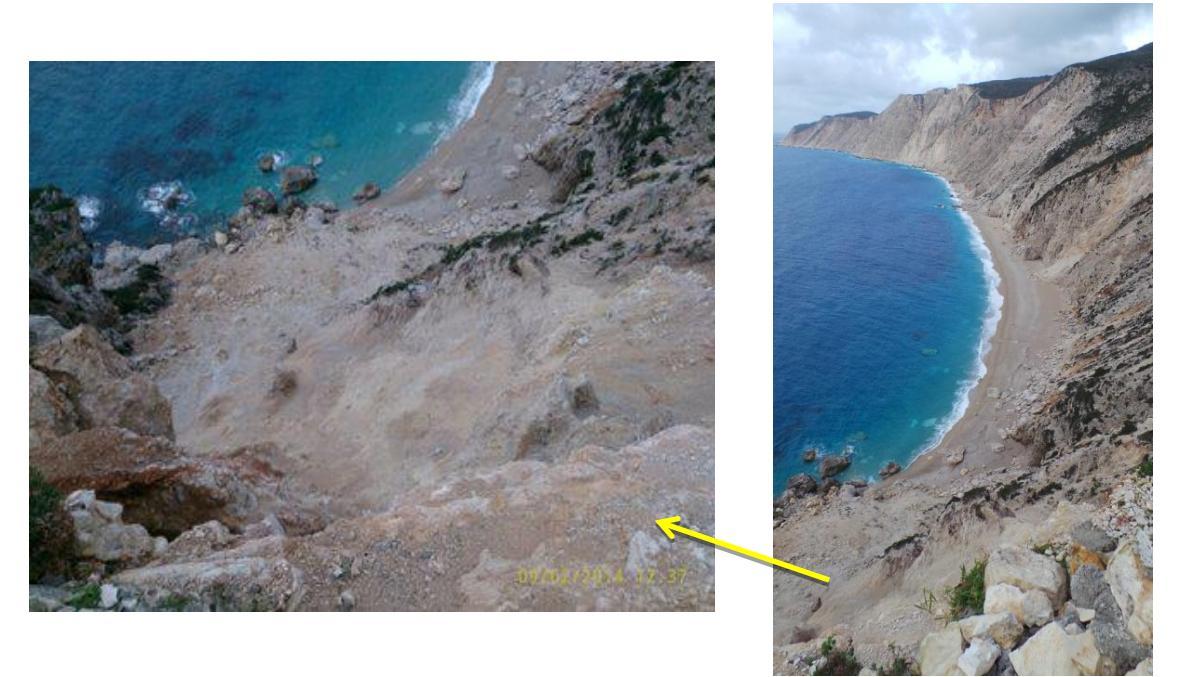
Figure 8.4.4. Rock fall with debris slide in steep cliffs in Platia Ammos beach (38.213883°N, 20.353017° E, UPatras team, 2/9/14).

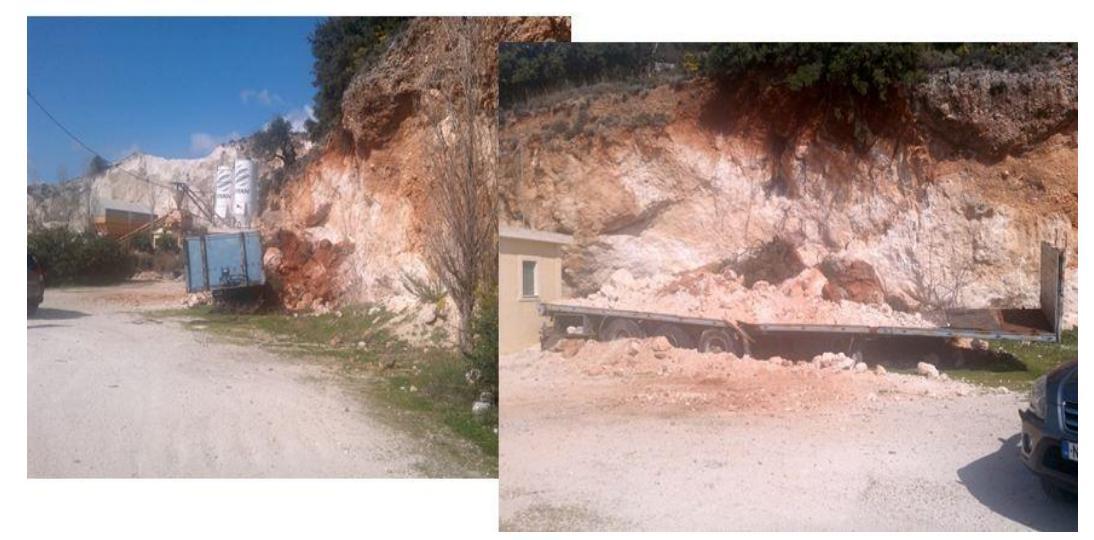
Figure 8.4.5. Rock failure of conglomeratic or breciatic limestone on a cut slope between Moussata & Vlachata villages on the Poros-Argostoli road axis (38.126874° N, 20.616777° E, DUTh, 2/22/14).

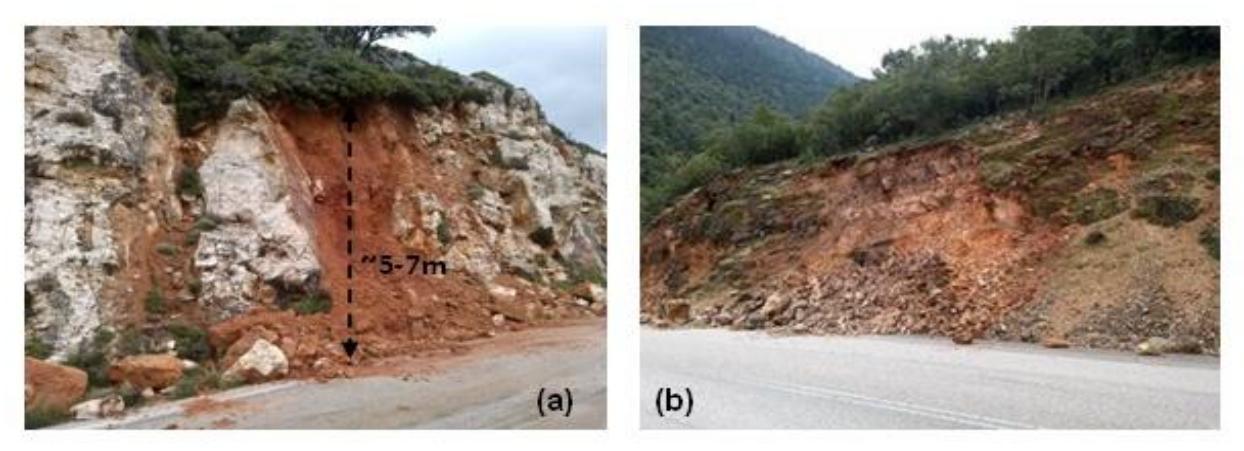
In total, over 30 rock falls were recorded in the Argostoli–Katochori–Myrtos Bay path, over 10 in the western part of the Paliki Peninsula and a limited quantity (possibly only 2) in the eastern part of the island (Fig. 8.4.1). Indicative cases of local rock slides in consolidated red conglomerates formations were observed north of Argostoli Bay close to Kardakata Village (38.280957°N, 20.445637°E) and along the road network connecting Argostoli and Sami village (38.205687°N, 20.607155°E), inducing damage to the road (Figs. 8.4.5, 8.4.6). In the same region of Argostoli bay, rock slides were also observed (38.287065°N, 20.448024°E) in cracked limestone formations (Fig. 8.4.7). These rock slides were significantly magnified after the 2nd event of 2/3/14.

Figure 8.4.6. Rock slides in red consolidated conglomerate formations recorded at (a) Northern part of Argostoli bay close to Kardakata Village (38.280957°N, 20.445637°E) and (b) road network between Argostoli and Sami village (38.205687° N, 20.607155° E, ITSAK team, 1/28/14).

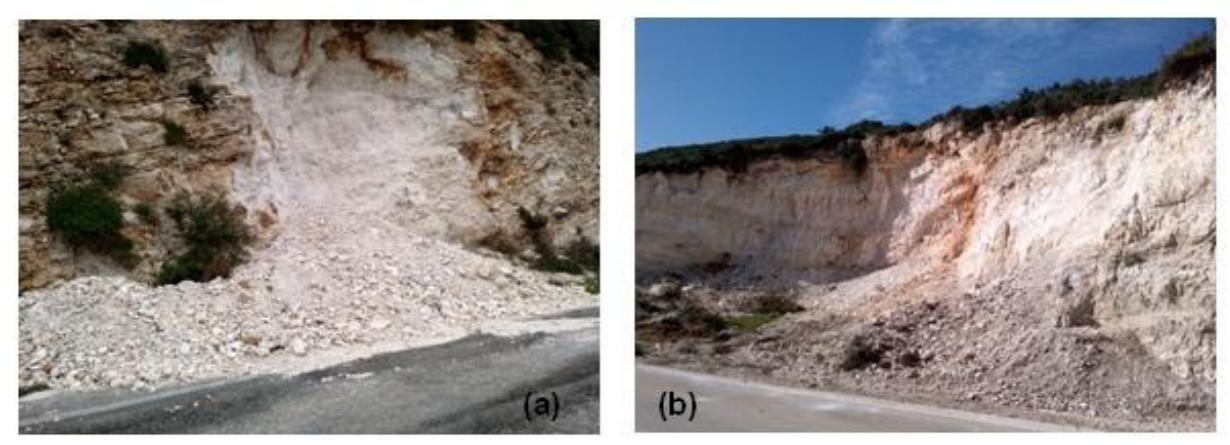
Figure 8.4.7. Rock slides in cracked limestone formations recorded at Northern part of Argostoli bay

following the (a) 1^{st} event (38.287065° N, 20.448024° E) and (b) 2^{nd} event (38.287018° N, 20.448027° E). Photos by ITSAK team on 1/28/14(a) and 2/10/14(b).

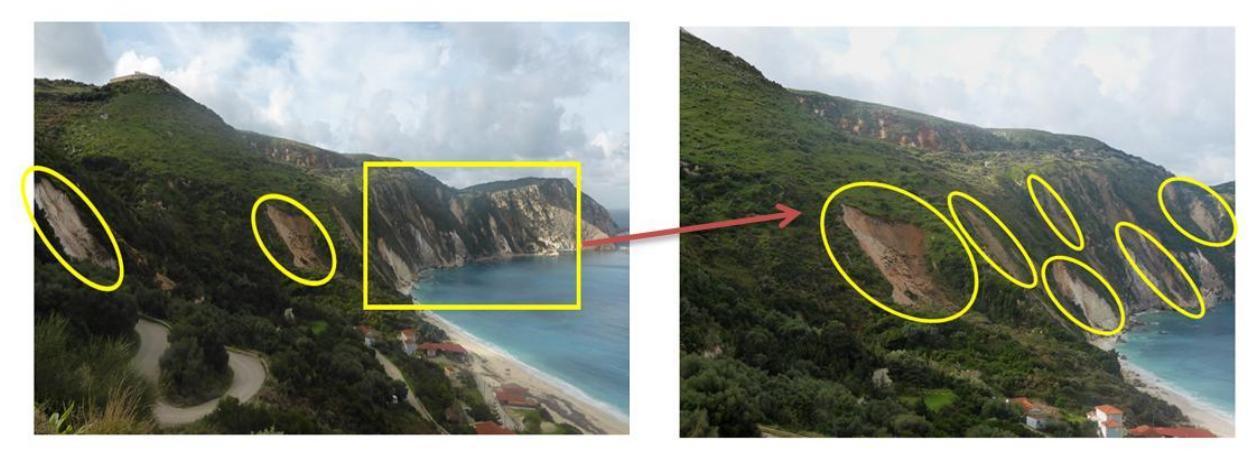
Many shallow rock failures, both minor and major, were observed along the steep cliffs lining the west coast of Paliki (Figure 8.4.8). The more pronounced rock failures seemed to be several disaggregated slides with debris flow observed at the Petani shoreline (38.260941°N, 20.377410°E). One of these slides resulted in the closure of the road towards the seashore. It should be mentioned that an indeterminate number of the high steep cliffs above beautiful white beaches on the west side of Paliki are in a state near limit equilibrium, most probably due to shallow decompression joints parallel to their slope and weathering. Failure of these slopes followed by debris slides does not require intense seismic accelerations, as opposed to slides - such as those shown on Figures 8.4.2 and 8.4.4 - which indicate the action of intense accelerations.

Figure 8.4.8. Disaggregated slides with debris flow observed at the Petani shoreline $(38.261705^{\circ} \text{ N}, 20.380166^{\circ} \text{ E})$. Photo by NTUA team, 2/9/14.
