CHAPTER 8 Geotechnical Observations

GEER/EERI/ATC Cephalonia, Greece 2014 Report Version 1

8.1 Site Effects

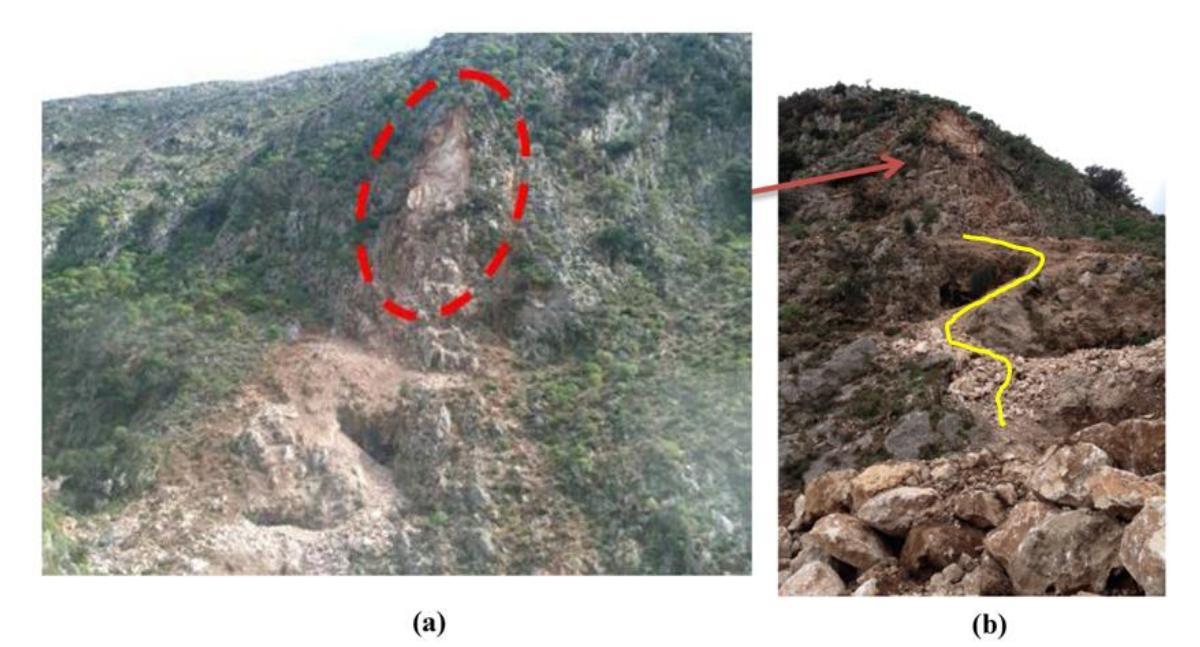
A shallow rock slide with debris flow of weathered and severely fragmented limestone was observed (Figure 8.4.9) on the local road of Argostoli between Kourouklata and Kontogourata village (38.251408°N, 20.466813°E). The local road from Kardakata to Zola village (en route to Aghia Kyriaki Bay) suffered numerous rock planar slides along the limestone's bedding. On the right side of the road, the orientation on the road cuts favored rock planar sliding (Figure 8.4.10b), while on the left side only occasional wedge failures emerged (Figure 8.4.10a) and no rock toppling or rock fragment detachments were observed.

Figure 8.4.9. A shallow rock slide of a weathered and fragmented limestone with debris flow $(38.251408^{\circ} \text{ N}, 20.466813^{\circ} \text{ E}, (a)$ Date of picture taken by DUTh team is 2/22/14, and (b) by UPatras team is 2/8/14) along the local road from Kourouklata to Kontogourata).

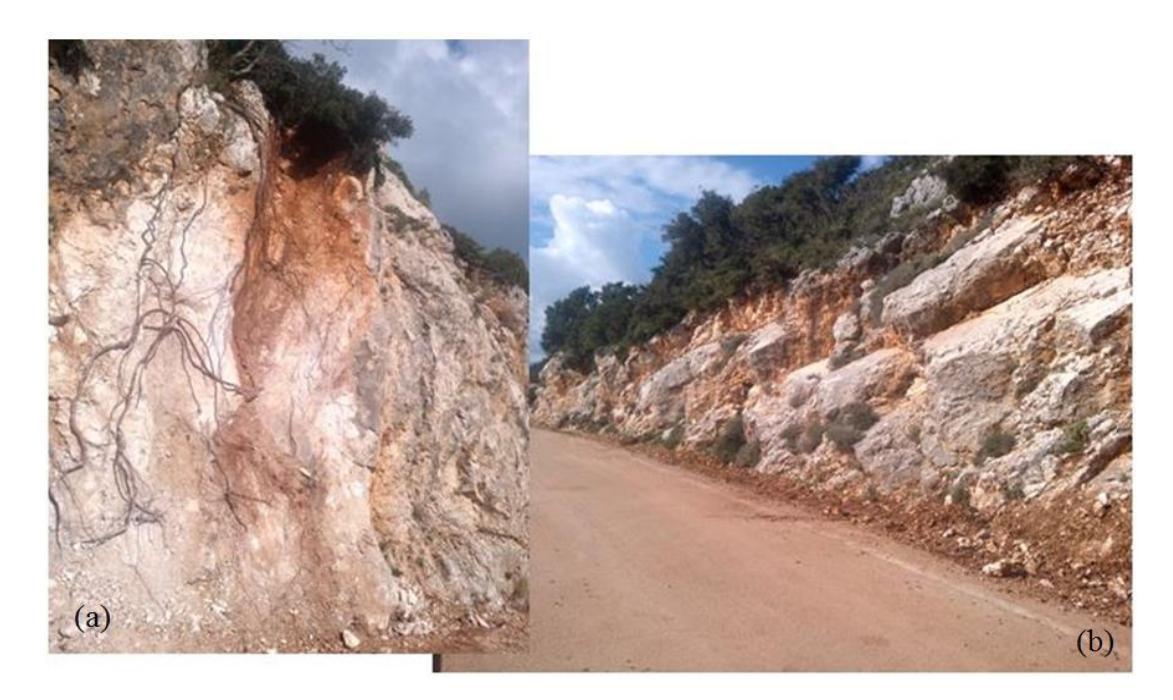
Figure 8.4.10. Rock failures (mostly planar slides along limestone's bedding and only occasionally wedge failures) along road cuts on the way from Kardakata to Zola village in Aghia Kyriaki bay area (from 38.287181° N, 20.457548° E to 38.310356° N, 20.469258° E, DUTH team, 2/22/14).

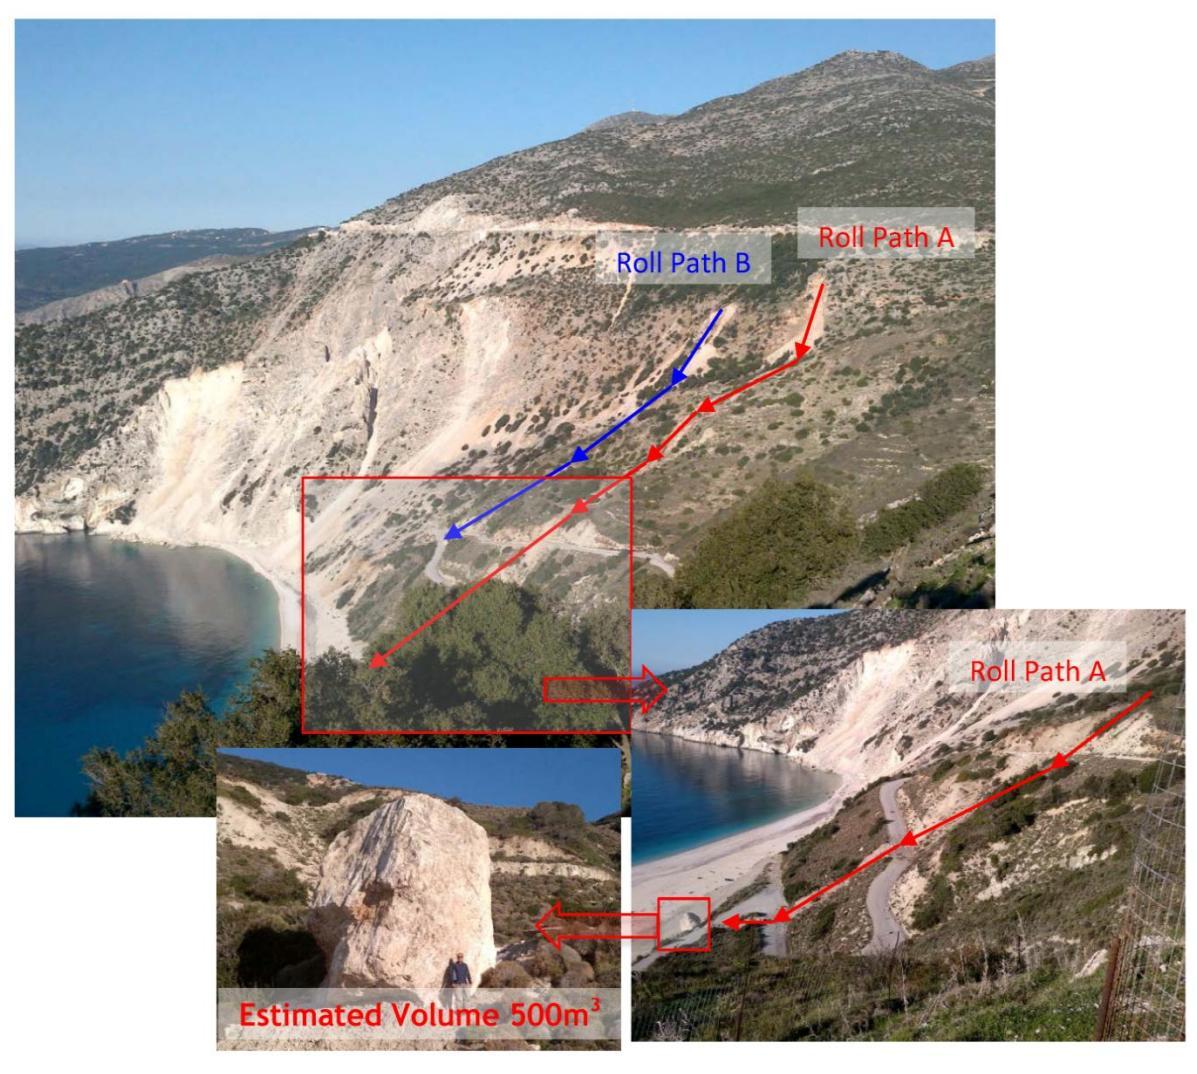
More important seemed to be the rock slope failures in Myrtos Bay, where four important shallow disaggregated slides with debris flow occurred at the north and south part of the Bay. On the east slope, two large blocks from the overtopping limestones rolled down westwards on soil-topped slopes, causing total destruction of the descending road at three points (38.337833°N, 20.532317°E). New movements were observed at the crest of the slope on old slide mobilization planes, likely due to blocky limestone overlaying softer material. Figure 8.4.11 shows the Myrtos bay area with debris flows at the North part (center), a wedge type failure of crashed material (top left), two major rock blocks that rolled down (bottom right) and the access road destruction from the 2nd rock block (top right). The arrows indicate the location of the details mentioned. Roll paths of the two large rock blocks are shown in Fig. 8.4.11. Interestingly, cemetery monuments at a small distance (~700 m) from Myrtos Bay had no damage at all. Similar shallow debris flows were observed in various locations along the steep cliffs on the west coast of Paliki. One such shallow debris flow was observed in Platia Ammos (Fig. 8.4.4), north of the Theotokou Kipouraion Monastery.

Figure 8.4.12. Roll paths A and B of the two rock blocks of estimated volume of 500 m³ each at Myrtos Bay (38.337833°N, 20.532317°E, ITSAK team, 2/19/14).

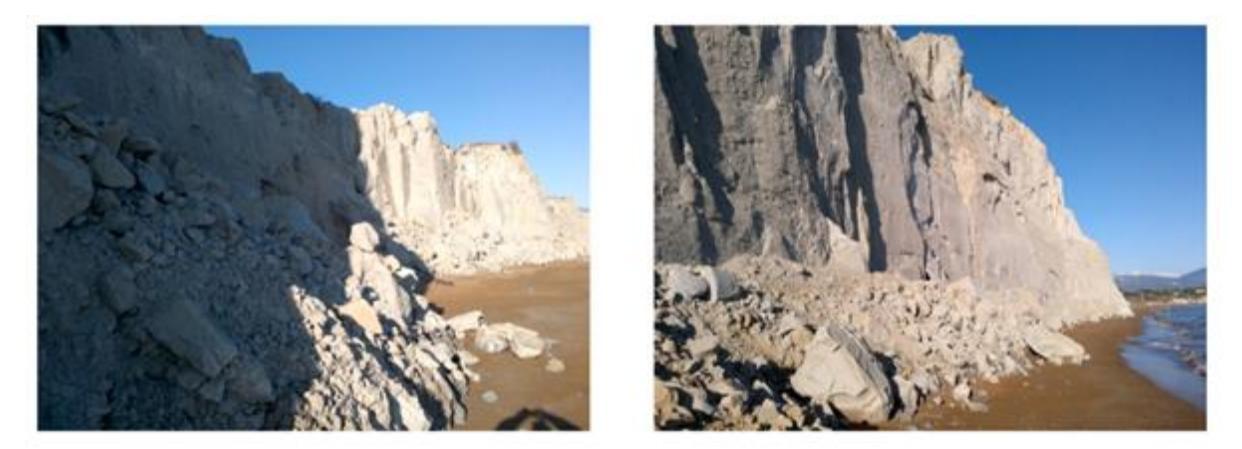
Figure 8.4.14. Shoreline of Xi area (from 38.159537° N, 20.410148° E to 38.160405° N, 20.413083° E) south of the Paliki peninsula where an extended slide (almost 250 m long) of a sandy marl escarpment was observed (ITSAK team, 02/19/2014).

An extended rock slope-type failure (almost 250 m long) of a sandy marl escarpment was observed in the Xi area shoreline (from 38.159537° N, 20.410148° E to 38.160405° N, 20.413083° E) south of the Paliki peninsula (Fig. 8.4.14). Along the local road from Sami to Poros, only two rock slides were observed with limited debris flow (Figs. 8.4.15 and 8.4.16).

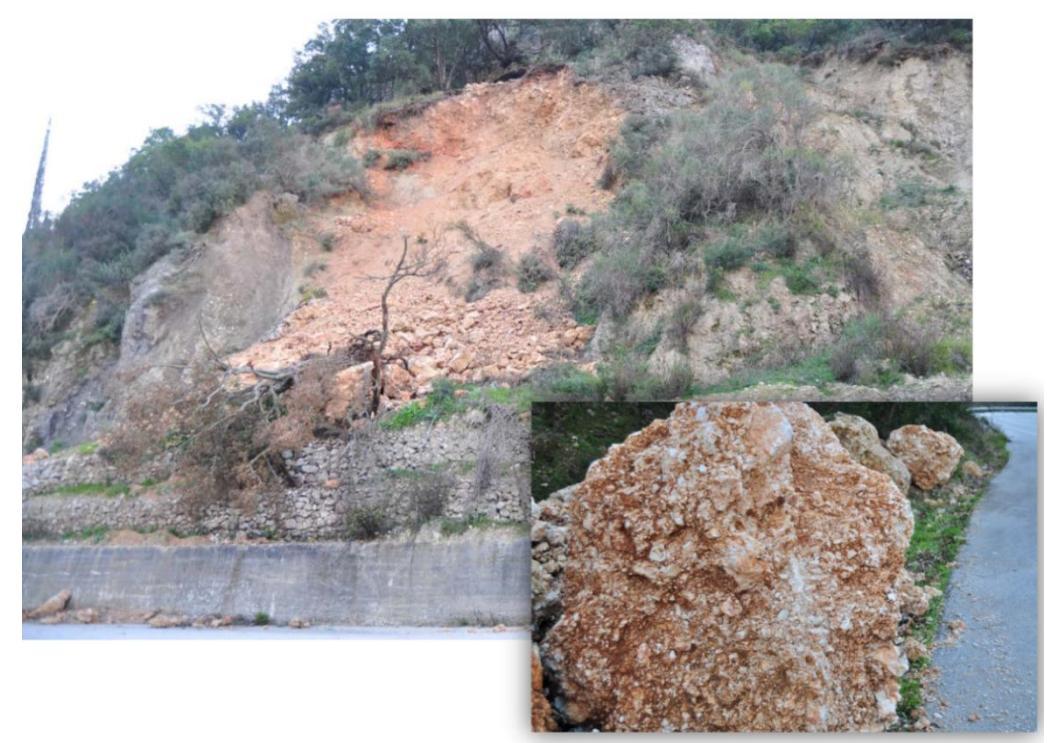
Figure 8.4.15. Rock slope failure in road cut with gabions in fractured/weathered limestone. Detached rock block crossed the road (eastern part of island: 38°11'33.51"N, 20°40'39.04"E, UPatras, 2/19/14).

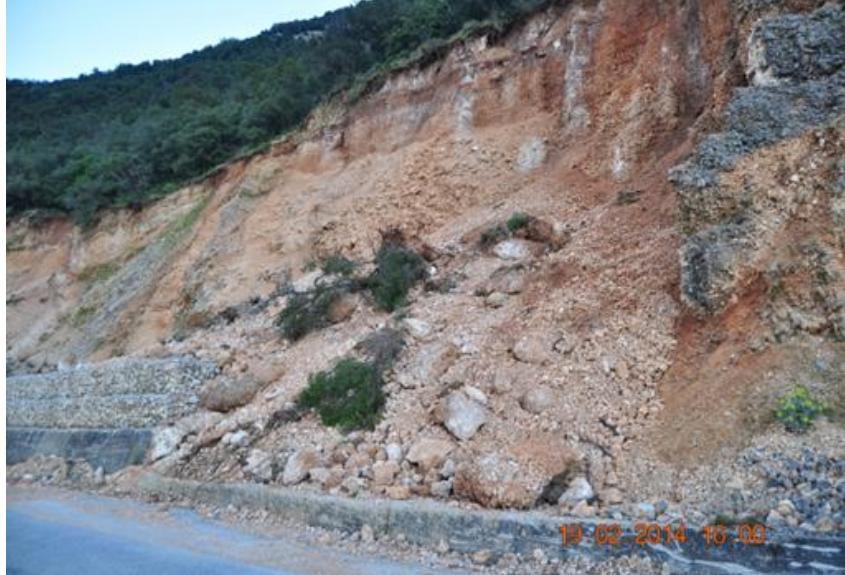
Figure 8.4.16. Rock slope failure in a road cut with gabions in weathered/fractured limestones (eastern part of island, 38°11'52.99"N, 20°40'21.80"E, UPatras team, 2/19/14).

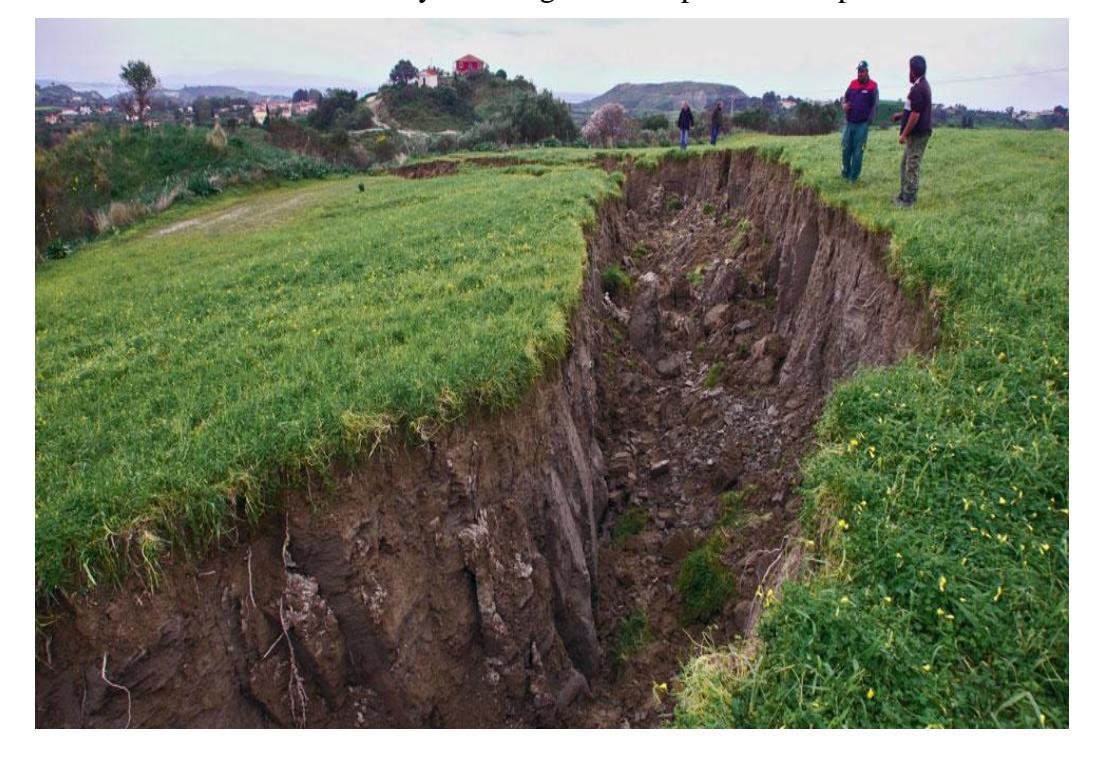
Only two major earth landslides were observed; the first one, in the Soulari area, is more developed with an important crack formation at the crest of the slope (Fig. 8.4.17). According to locals, the specific landslide presented signs of instability due to rainfalls prior to the earthquakes and may have existed for a long time. Thus, the slope was likely near limit equilibrium and the observed patterns and displacements (~ 2.5 m) were related to the earthquakes events reactivating an older slide plane. The second is an extended incipient failure involving road embankment settlement and local stone retaining walls destruction (Figs. 8.4.18, 19). The wider area of that slope was creeping even before the earthquake, and had forced the construction of a heavy retaining wall and pavement repairs.

Figure 8.4.17. Major earth landslide in Soulari (38°11'5.66"N, 20°24'57.82"E, UPatras, 2/17/14.

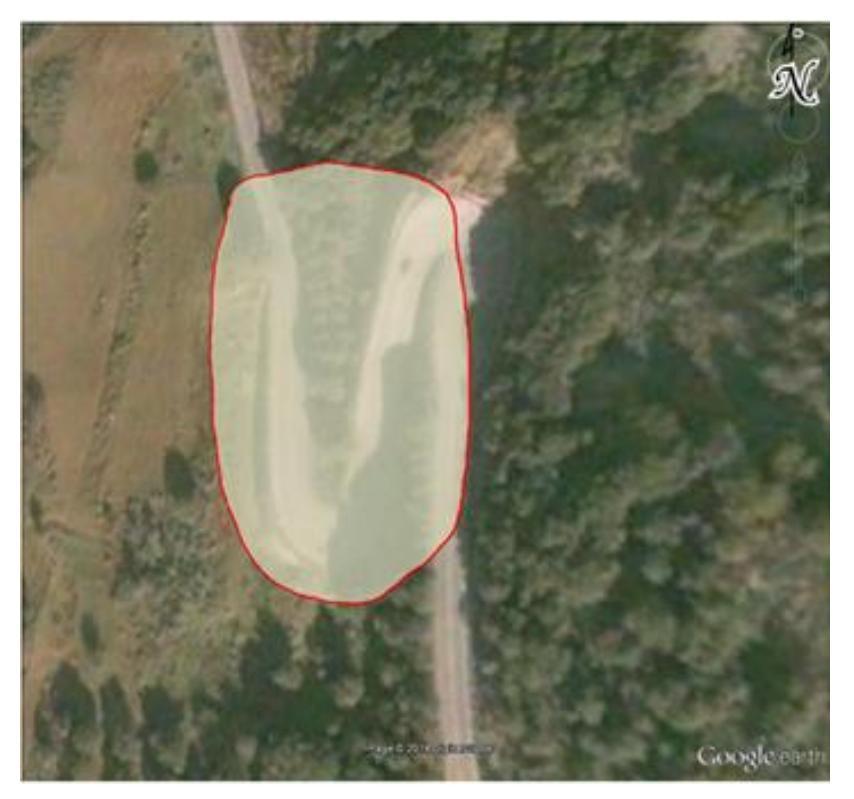
Figure 8.4.18. Plane view of the incipient landslide failure.

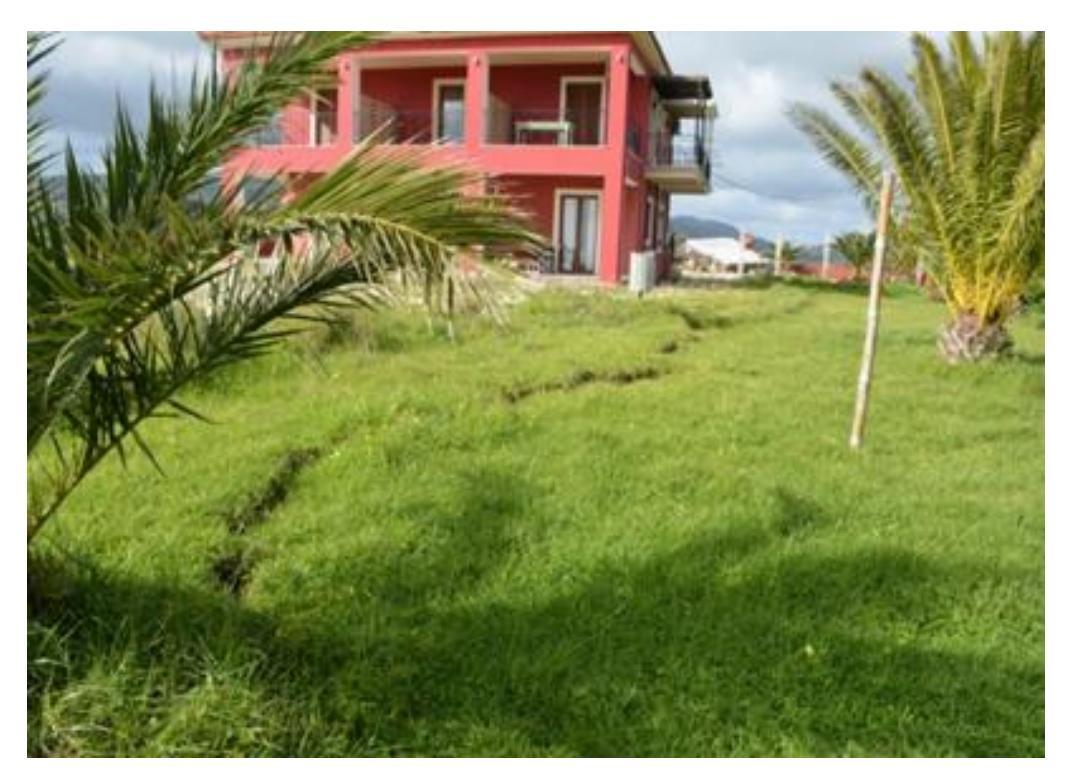
Few other minor cases of slope movement were observed in the Soulari area. The first case of mild slope movements in soils was observed at an isolated 15m high clayey hill in the vicinity of the village of Soulari at the southern part of the Paliki Peninsula (Figure 8.4.20). Measurements at the crest of the slope showed horizontal displacement of 15 cm towards the East, and vertical displacement (settlement) of approximately 8 cm. Of interest in this case is the fact that the 2-story reinforced concrete building adjacent to the slide suffered no damage

Figure 8.4.20. Crest of circular type of slope movement on a 15 m high hill near Soulari village (38°11'19.73"N, 20°24'45.10"E), with slippage towards the East direction, (date 9/2/14).

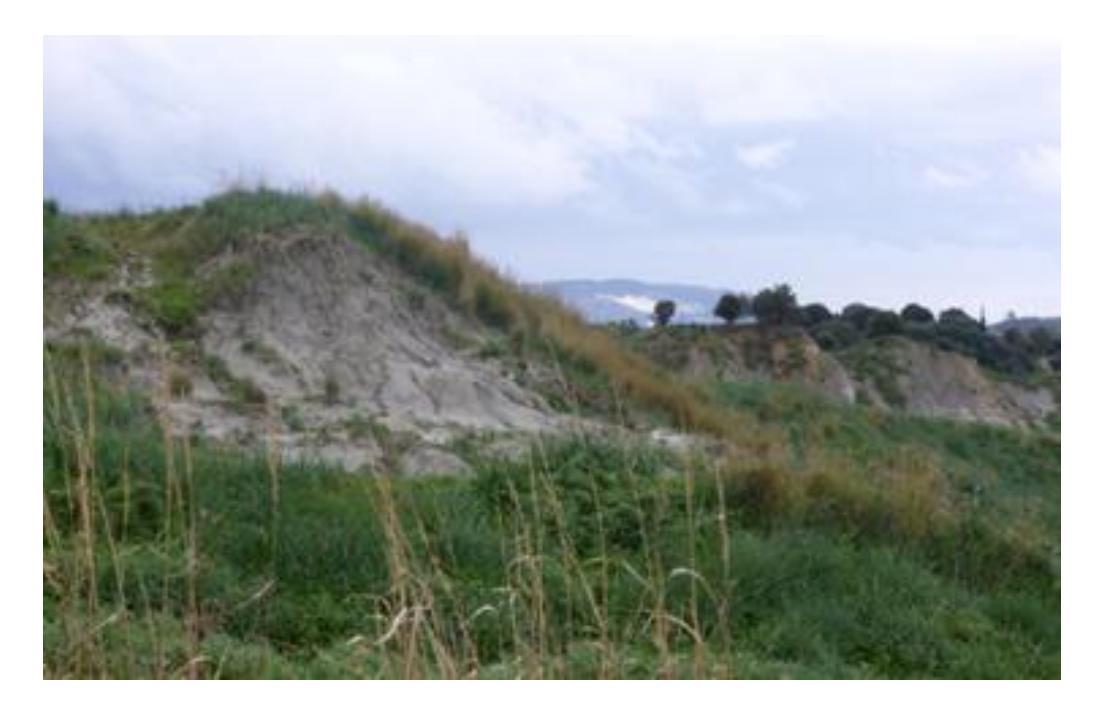
(not even cracks in plaster covering the masonry infills). Another example of a small landslide in a stiff-clayey slope outside of Soulari village is presented in Figure 8.4.21.

Figure 8.4.21. Small landslides in stiff-clayey slopes, 400 m outside Soulari village. (38.184444° N, 20.411388° E, NTUA team, 2/10/14).

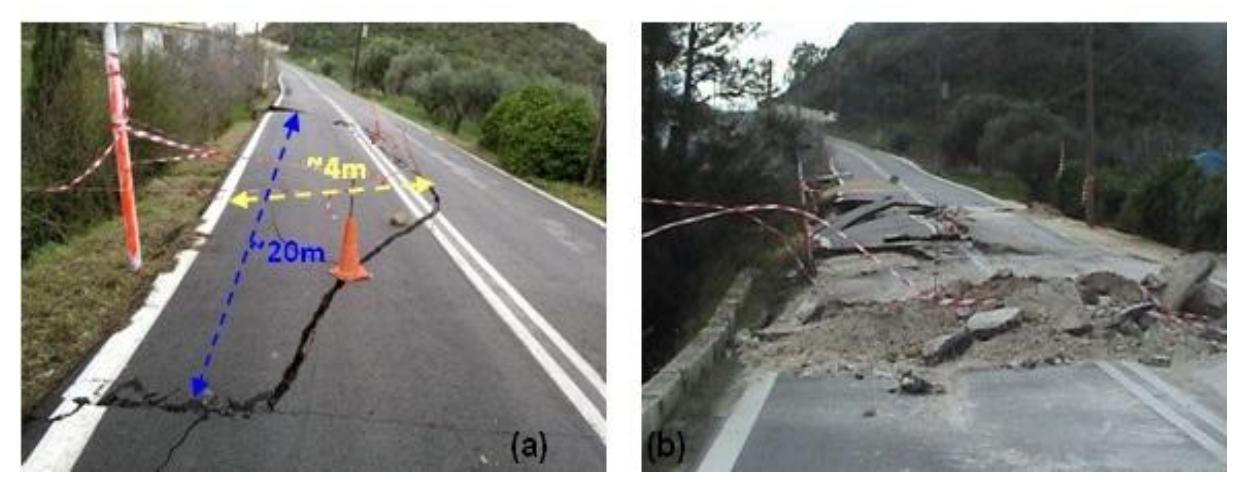
Extensive road cracking and road embankment failure (Figure 8.4.24) were also observed on the road network connecting Chavriata and Vouni villages in the south part of the Paliki peninsula (38.287065°N, 20.448024°E) after the two major events.

Figure 8.4.24. Road network connecting Chavriata and Vouni villages at the south part of the Paliki peninsula $(38.17856^{\circ} \text{ N}, 20.40081^{\circ} \text{ E})$; extensive road cracking and road embankment failure observed, respectively, after the: (a) 1st and (b) 2nd events. Photos by ITSAK team on 1/28/14 (a) and 2/5/14 (b).

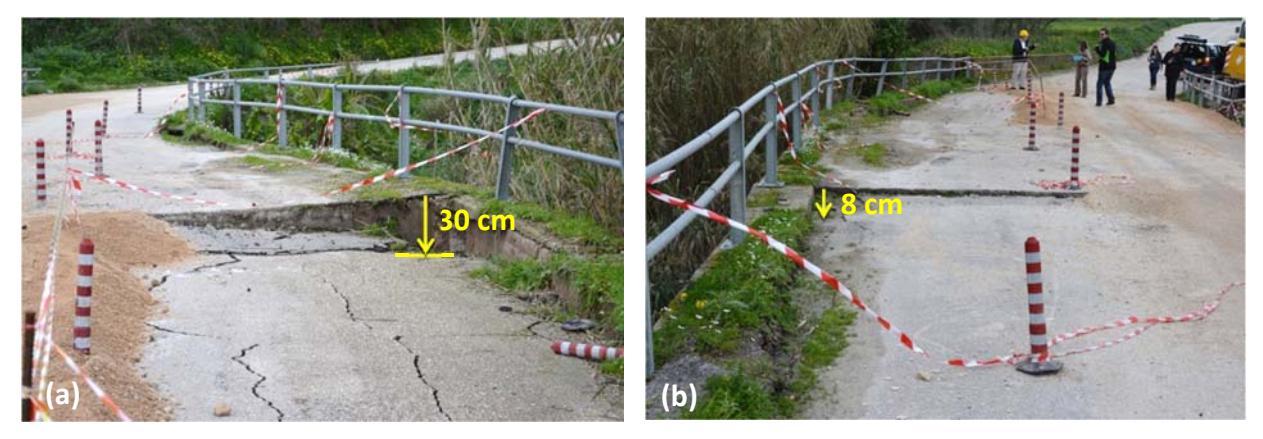
Fig. 8.5.2(a) shows longitudinal pavement cracking and severe settlement at the location where the western access embankment adjoins the reinforced concrete bridge. Fig. 8.5.2(b) shows the much less settled pavement at the respective location of the eastern access embankment.

Settlements occurred at the southern side of the bridge, i.e., towards the downstream of the overpassed creek. We observed significant differential settlement of neighboring access embankments: up to 30 cm at the western embankment, versus a maximum of 8 cm at its eastern counterpart. Settlements diminish at a transverse distance of 2.5 m from the downstream side of the bridge (i.e., at the centerline of the road), whereas in the longitudinal direction they essentially diminish at the end of the access embankments (almost 12 m from the overpass edges).

Figure 8.5.2. Havdata bridge (38°12'10.30"N, 20°24'16.05"E): (a) western access embankment and (b) eastern access embankment.

Hence, settlements and pavement cracks appeared all along the embankments, reaching maximum values at the connection to the bridge. The different settlement response in the two access embankments can be attributed to the observation that the (southern) retaining wall of the western embankment suffered downstream outward displacement of a maximum of 19 cm,

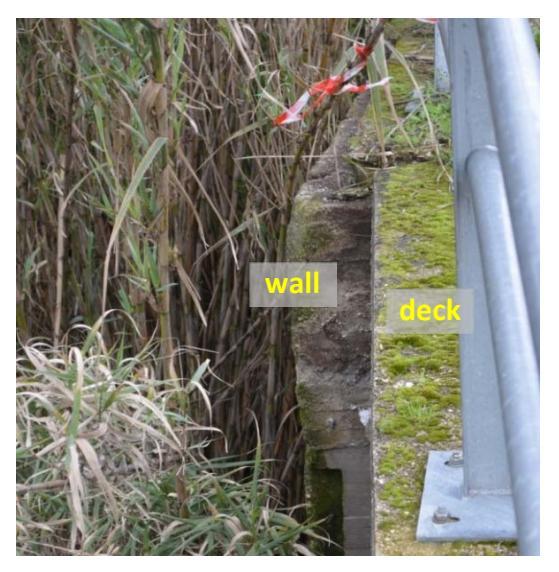
at the location where it adjoins (cold joint) the bridge (Fig. 8.5.3), whereas there was no dislocation of its counterpart at the eastern embankment.

Figure 8.5.3. Havdata bridge (38°12'10.30"N, 20°24'16.05"E): Side view of outward (downstream) displacement of southern retaining wall of western access embankment.

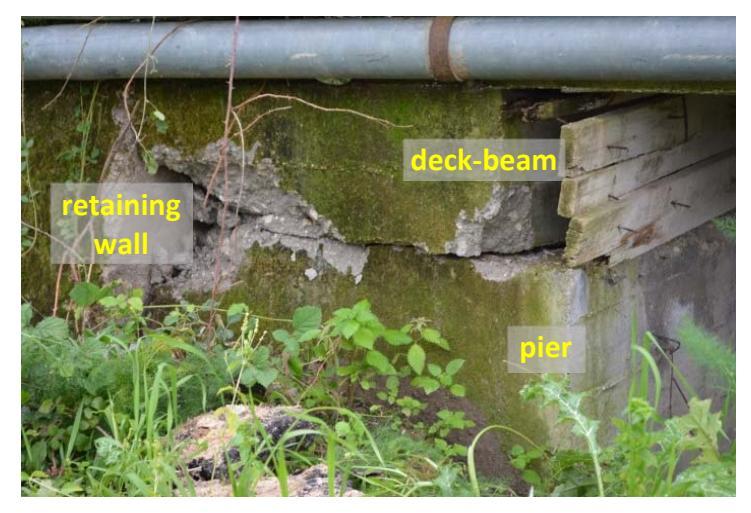
From a structural point of view, the reinforced concrete Havdata bridge consisted of the pier (with width equal to that of the deck) and the deck, which included a transverse beam. The deck-beam section that rested on top of the pier has undergone small permanent drift, at least in the southern embankment shown in Fig. 8.5.4. Whether there are steel studs between the two bridge sections is unknown, but there is definitely no bearing (rubber or otherwise). Also, there could have been some pounding between the retaining wall and the deck-pier and pier sections, since the edges of the reinforced concrete sections had been chipped off.

Figure 8.5.4. Havdata bridge (38°12'10.30"N, 20°24'16.05"E). Side view of connection of southern pier to deck-beam sections of the bridge.

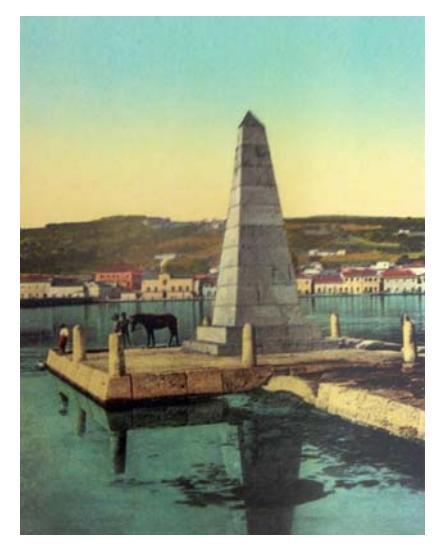
Figure 8.5.8. Obelisk "Kolona" monument (GPS coordinates 38°10'26.25"N, 20°29'45.59"E) in early 1900's sketch (Poulaki-Katevati, 2009). The upper drum toppled after the 2nd 2014 event (Fig. 8.5.7d).

The only damage within the opening of the bridge was observed at the multi-drum stone obelisk monument locally known as "Kolona." The monument was erected in 1813 in appreciation of Great Britain by the local Cephalonian government (see 1900's sketch of Fig. 8.5.8, modified from Poulaki-Katevati, 2009). While the monument remained intact after the 1st event of January 24, 2014, its upper drum toppled following the 2nd event of February 3, 2014 (Fig. 8.5.7d).

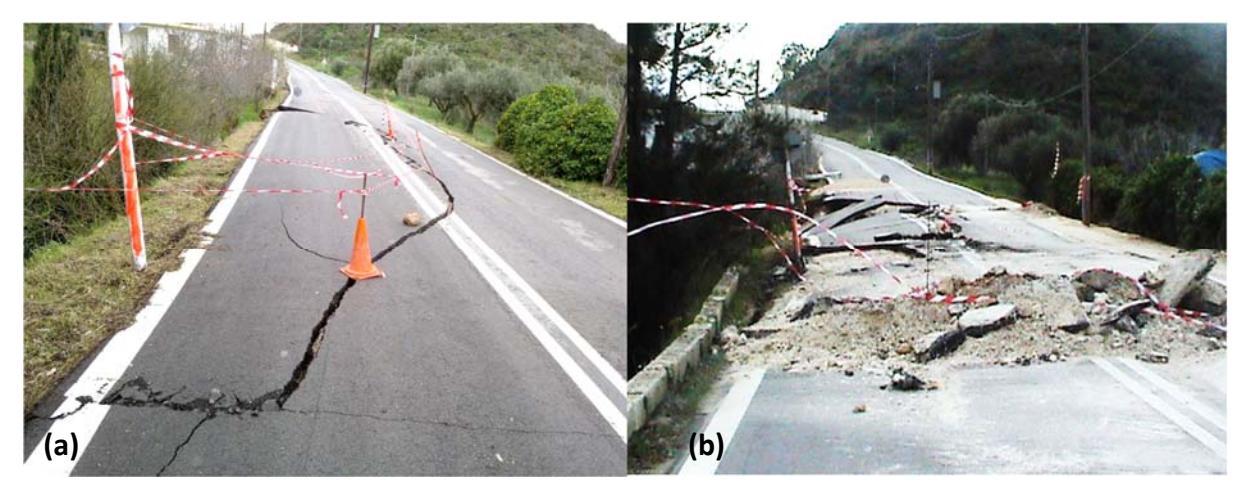
Figure 8.6.2 shows the road embankment at location A (38°10'42.84"N, 20°24'2.96"E) after: (a) the 1st event and (b) the 2nd event. It appears that initiation of slope stability failure after the 1st event set the ground for failure of the paved road observed after the 2nd event. Similarly, severe damage was observed at Location B along the road connecting Chavriata and Vouni villages (38°10'39.79"N, 20°23'50.90"E), just 320 m away from Location A (Fig. 8.6.3). The severe damage at Location B could be attributed to failure or total collapse of the masonry walls on both the SE and NW sides of the embankment. The estimated height of the retaining walls ranged from 6 to 8 m. These wall failures induced failures on both sides of the road embankment. Intensive horizontal cracks along the roadway, 20 to 80 m in length, with horizontal and vertical displacements from 5 to 30 cm were observed. Interestingly, no damage was observed at an adjacent reinforced concrete retaining wall.

Figure 8.6.2. Location A $(38^{\circ}10'42.84"N, 20^{\circ}24'2.96"E)$ on the road connecting the Chavriata and Vouni villages. (a) Circular type of sliding observed after the 1st event. (b) Embankment failure that affected the whole width of the road after the 2nd event.

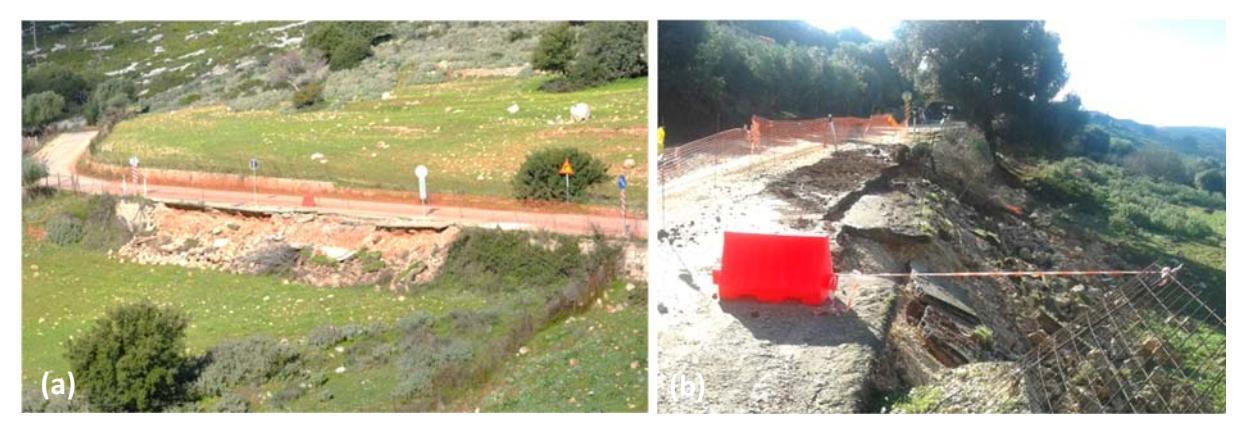
An example of moderate roadway embankment damage location was recorded along the main asphalt road connecting Argostoli to Lixouri, and to the NW of the village of Kardakata. Figure 8.6.4a shows the collapsed masonry wall which had supported the road embankment, as seen from the downhill side. Figure 8.6.4b shows the effects on the pavement of a similarly collapsed masonry wall for the same road embankment (just 160 m apart).

Figure 8.6.4. Off-Kardakata road embankments at an inter-distance of 160 m after 2nd event: a) masonry wall collapse in NS direction (38°17'34.61"N, 20°27'8.16"E), b) masonry wall collapse in EW direction (38°17'30.81"N, 20°27'11.80"E).

The GEER investigators noted that the former wall collapsed in an NS direction, while the latter wall collapsed in an EW direction, both following the downhill direction of the surface topography. The wall section in between the two failed walls suffered no damage, possibly due to height or construction quality differences. Figure 8.6.5 compares the state of the latter failed

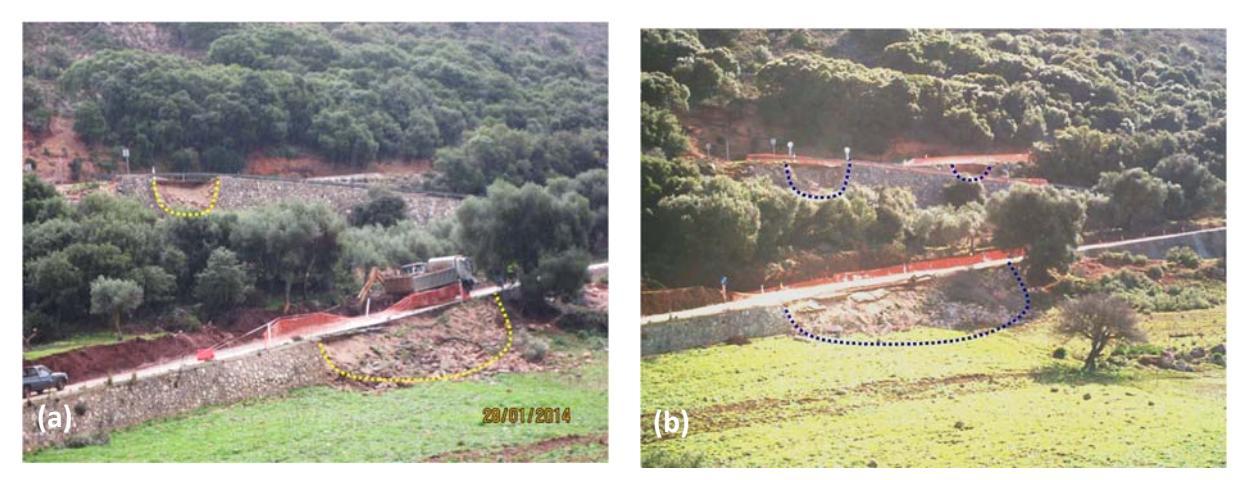
masonry wall (that failed in an EW direction) after the 1st event (1-26-14) in subplot (a) and after the 2nd event (2-3-14) in subplot (b). Observe in this figure that the 2nd event increased considerably the length of the failed masonry wall at this location, and also deteriorated the state of the road embankment just uphill from the failed masonry wall section. Just 30 m up the road from the failed masonry wall section (Figs 8.6.4b and 8.6.5), the same road embankment was retained satisfactorily by reinforced concrete walls that suffered no damage and practically zero displacement (the undamaged reinforced concrete wall can be observed to the right of the failed masonry wall section in Fig. 8.6.5b).

Figure 8.6.5. Overview of the broader area of the off-Kardakata road embankment failure of Figure 8.6.3b (38°17'30.81"N, 20°27'11.80"E): a) after the 1st event and, b) after the 2nd event.

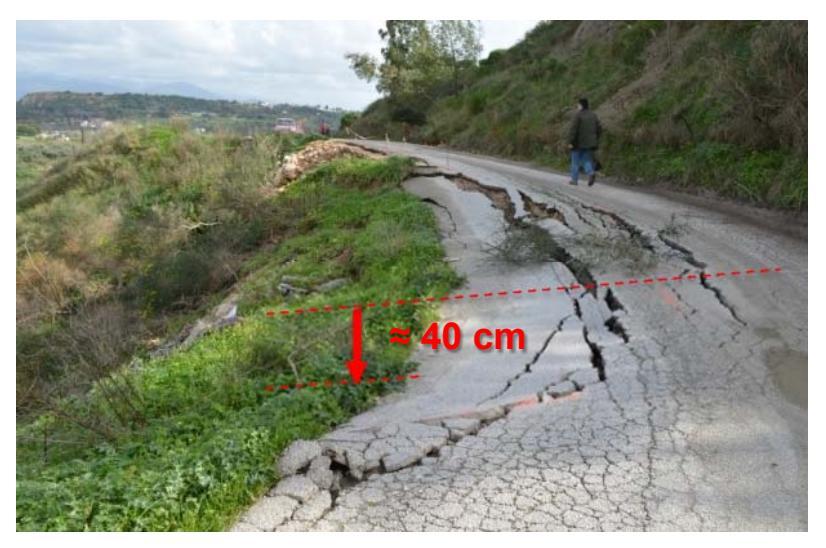
Figure 8.6.7 presents the large downslope displacement of a circular sliding mass in clayey soil that affected a country road embankment in the vicinity (north) of Soularoi village in Paliki peninsula. The sliding occurred in an approximately NS direction, and the maximum vertical settlement of the pavement was on the order of 40 cm.

Figure 8.6.7. North of Soularoi road embankment sliding, as viewed from the pavement (38°11'21.51"N, 20°24'45.80"E).

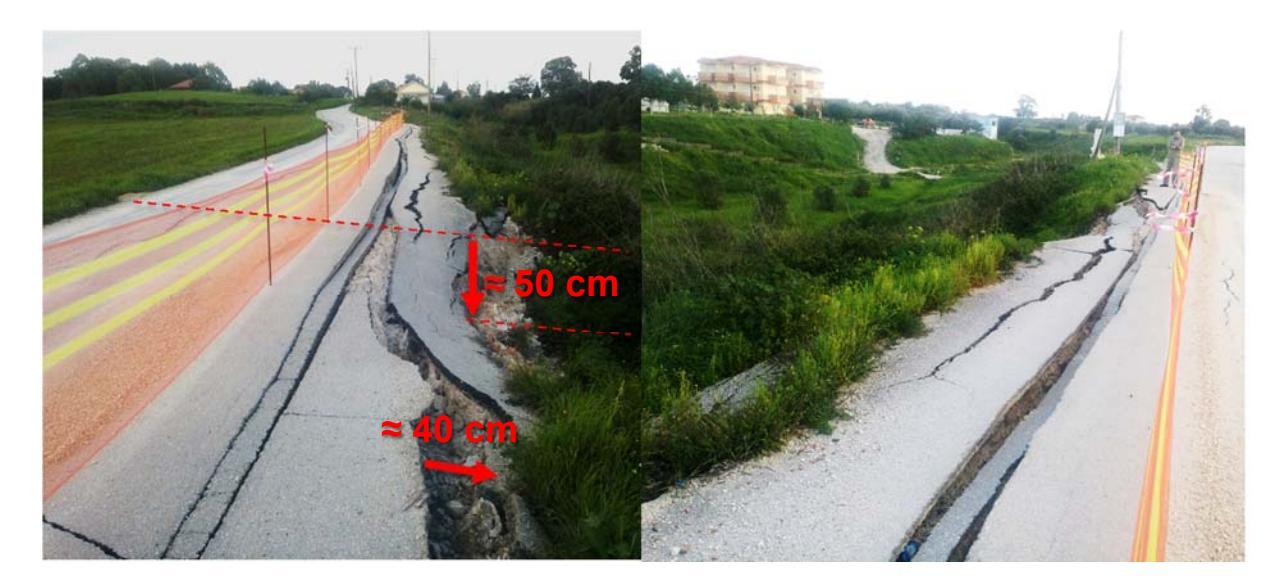
Figure 8.6.8 presents a road embankment failure on the local road axis from Soularoi going south towards Megas Lakkos (southeastern part of Paliki peninsula) at a site called Xontiches $(38^{\circ}10'43.69"N, 20^{\circ}25'13.87"E)$. This road embankment failure is the larger among others of less importance along this road. The damaged embankment is roughly 5 to 6 m tall, with slope inclination estimated at (Vertical to Horizontal) V:H = 2:3. The failure presents as longitudinal horse shoe shaped tensile crack almost 50 m long with horizontal displacements of 30 to 35 cm and vertical displacements from 40 to 50 cm near the central part (around 15 m) and significantly less movement close to the failure edges (Figure 8.6.8). Damage could be attributed to poor compaction of the embankment soil.

Figure 8.6.8. South of Soularoi road embankment failure due to slope sliding (38°10'43.69"N, 20°25'13.87"E).

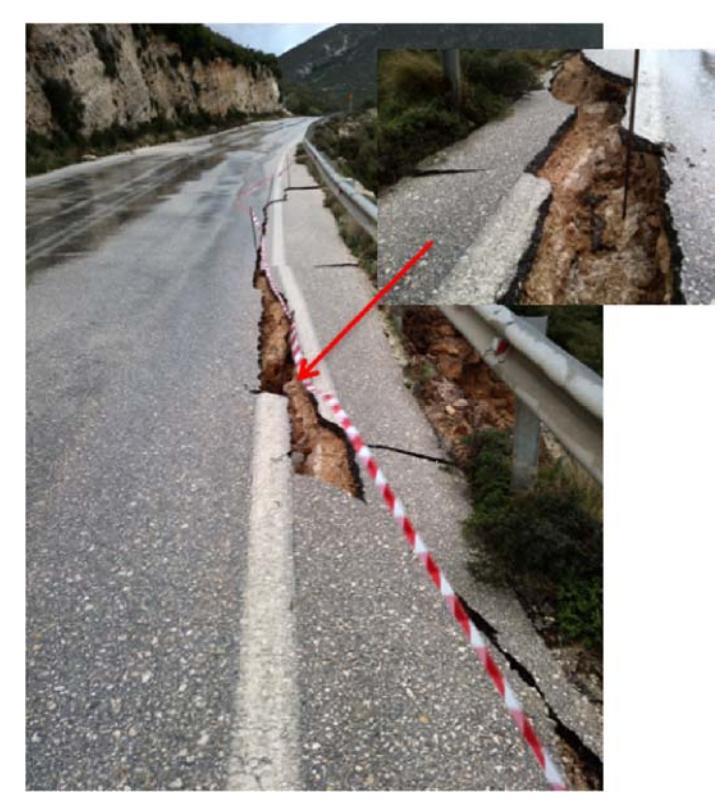
damage was observed on the eastern leg of the main asphalt road connecting Argostoli to Lixouri, just north of Katochori village (38°17'8.28"N, 20°27'8.25"E) and is presented in Figure 8.6.9. The GEER investigators observed that pavement cracks affected just the edge of the embankment material, and allowed traffic in almost the full width of the road.

Figure 8.6.9. Pavement cracks and settlement at the edge of the road embankment located at $38^{\circ}17'8.28"N$, $20^{\circ}27'8.25"E$ close to Katochori village. Photo was taken after the 1^{st} event.

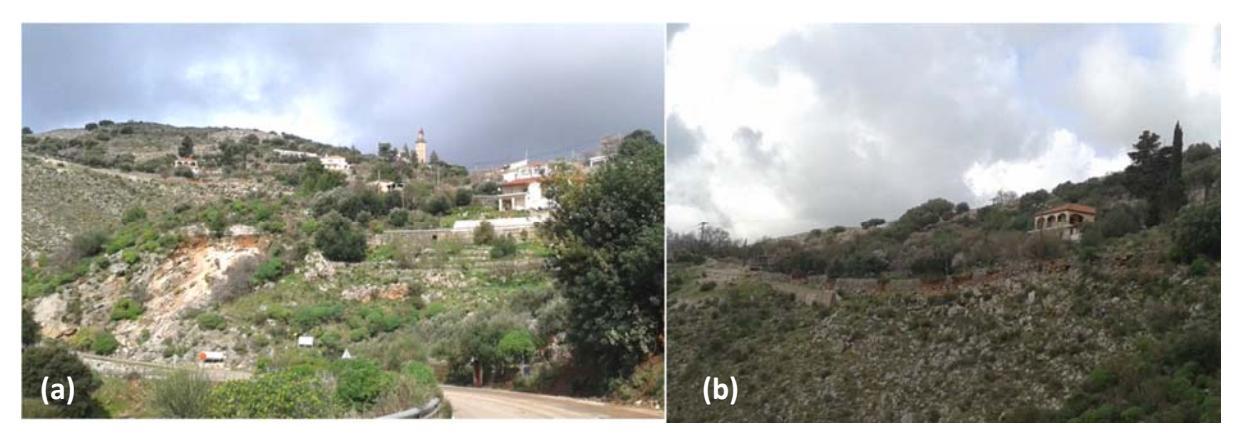
A typical example of minor damage involving a masonry wall was observed on the eastern leg of the main asphalt road connecting Argostoli to Lixouri at the village of Kourouklata in the north of the island (Fig. 8.6.10). In particular, Fig. 8.6.10a shows the collapsed masonry wall in the foreground, while it also shows in the background, another similar (partial) collapse at a higher altitude on the same winding road, whose detail is presented in Fig. 8.6.10b. Both of the two collapses occurred along the NS direction (moving downslope towards the south), and neighboring locations showed no damage, possibly due to height or construction quality differences. Similar minor damage was observed in this area (e.g., at 38°14'26.29"N, 20°28'35.14"E), where this type of road embankment construction is common.

Figure 8.6.10. Kourouklata road embankments: a) lower altitude masonry wall collapse (38°14'23.77"N, 20°28'30.29"E), b) higher altitude masonry wall collapse (38°14'28.20"N, 20°28'24.87"E) (also visible in a, is the failed bell tower of Kourouklata.)

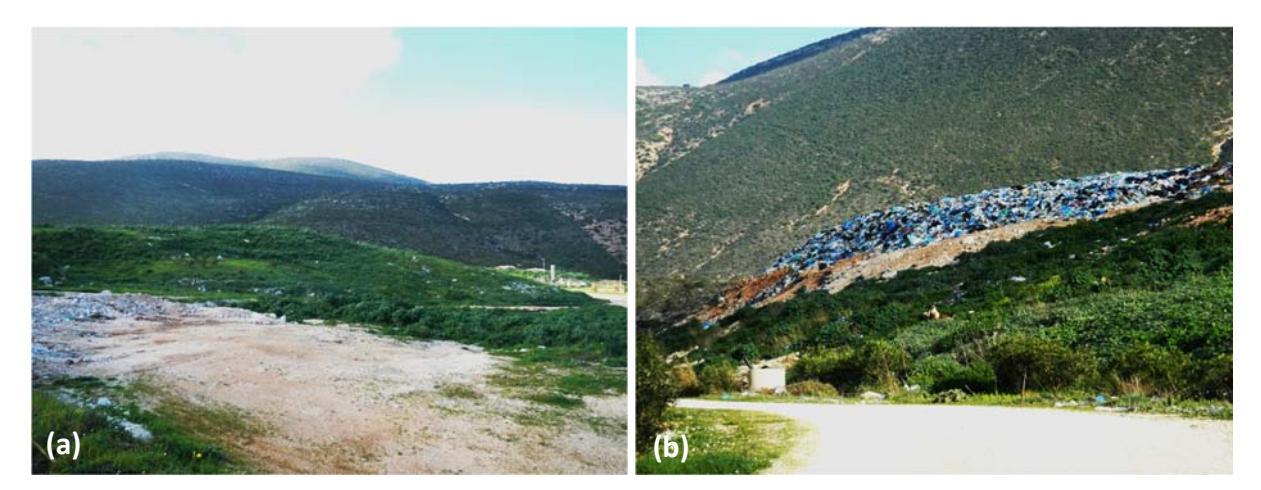
Fig. 8.6.12a presents the presently well vegetated old landfill and Fig. 8.6.12b shows the new landfill. According to the landfill operator and an on-site GEER visit on 2/10/14, the landfills performed well with no cracking, displacements or any other damage observed following the earthquakes. However, the investigators note that the height of the lined landfill was on the order of 10 m (30 ft), which, compared to typical modern landfills of height 60 m (200 ft) or more, is relatively short and thus likely to be resilient against slope stability failures.

Figure 8.6.12. View of the (a) unlined landfill (vegetated, in the background; $38^{\circ}18'33.15''N$, $20^{\circ}26'30.44''E$) and (b) lined landfill ($38^{\circ}18'36.94''N$, $20^{\circ}26'29.02''E$).

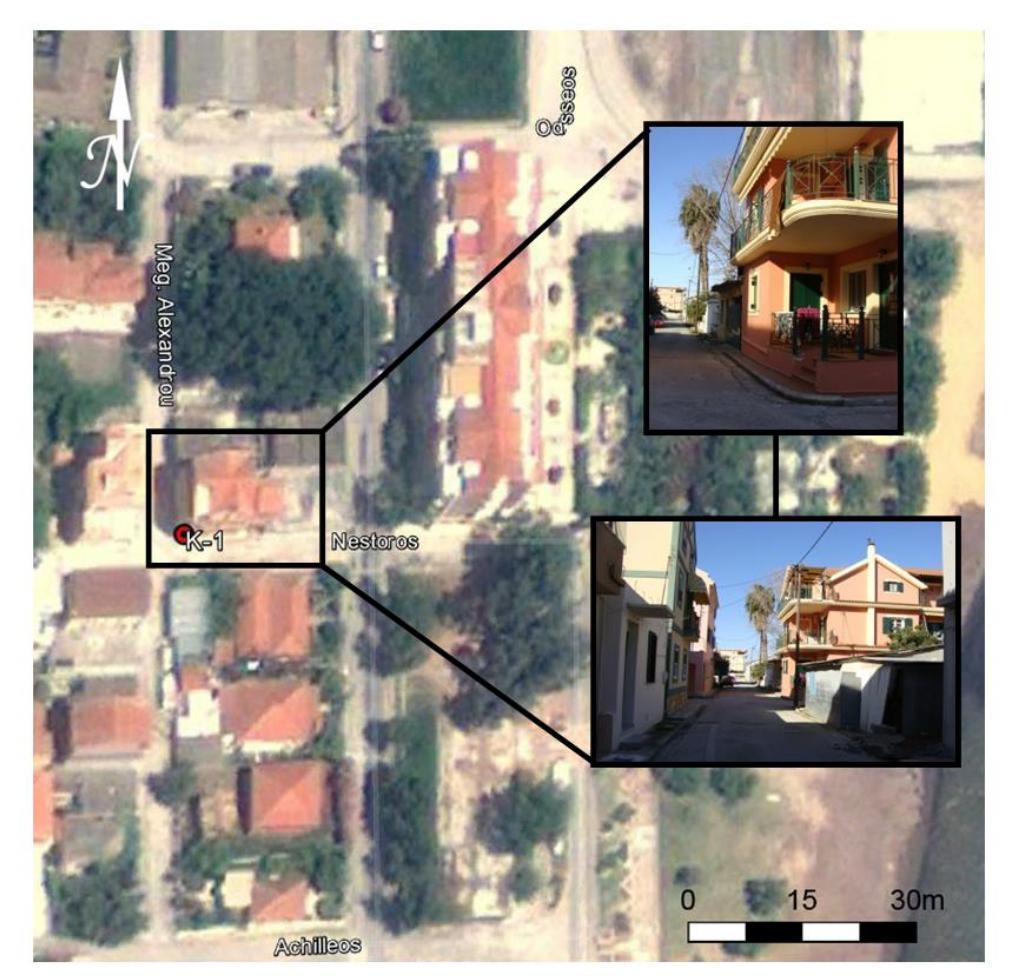
The pavement surrounding the 3-story residential structure at the corner of Nestoros & Megalou Alexandrou Streets (GPS Coordinates 38°11'45.50"N, 20°26'18.84"E), as well as the structure's porch appear to have settled without causing damage to the remaining structure (Fig. 8.7.1). Measured settlements were 11 cm on the SE corner, 1 cm in the southwest corner, and 8.5 cm in the NW corner of the porch.

Figure 8.7.2. Case 1: 3-story structure at the corner of Nestoros and Megalou Alexandrou Streets (GPS Coordinates 38°11'45.50"N, 20°26'18.84"E, 2/18/2014).

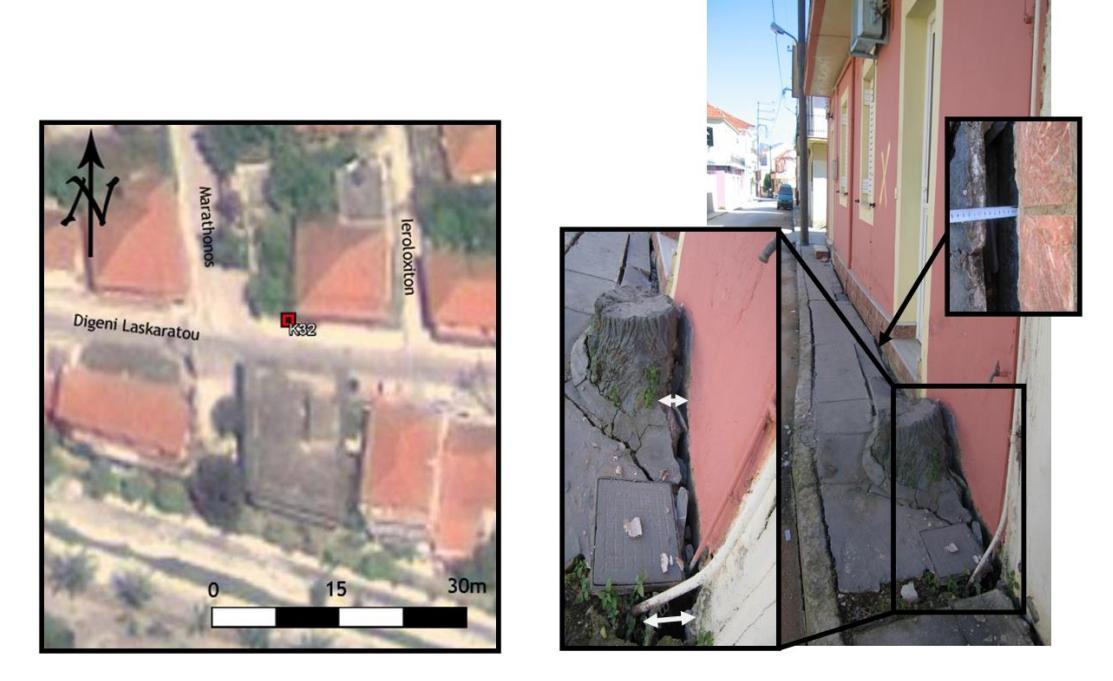
The 2-story residential building (Fig. 8.7.2) at the corner of Marathonos and Digeni Laskaratou Streets (GPS Coordinates 38°12'7.47"N, 20°26'12.99"E) had no obvious signs of cracking due to differential settlements. The reconnaissance teams consider this to be a typical case of buildings with no obvious settlement-related structural damage.

Figure 8.7.3.Typical 2-story building with no damages due to settlements. The pavement suffered significant displacements (GPS Coordinates: 38°12'7.47"N, 20°26'12.99"E, 2/18/14).

However, in the particular structure of Fig. 8.7.2, the pavements in the perimeter subsided, most likely due to lack of compaction or uncontrolled nature of the subsurface material, as this area is built on reclaimed land generated by debris of the 1953 earthquake. The unusually shaped pipes deformation and the position of the tree trunk indicate deformations of the pavement, rather than of the building itself. Horizontal and vertical displacements of about 7 cm were measured. No liquefaction ejecta were observed in the perimeter of the building.

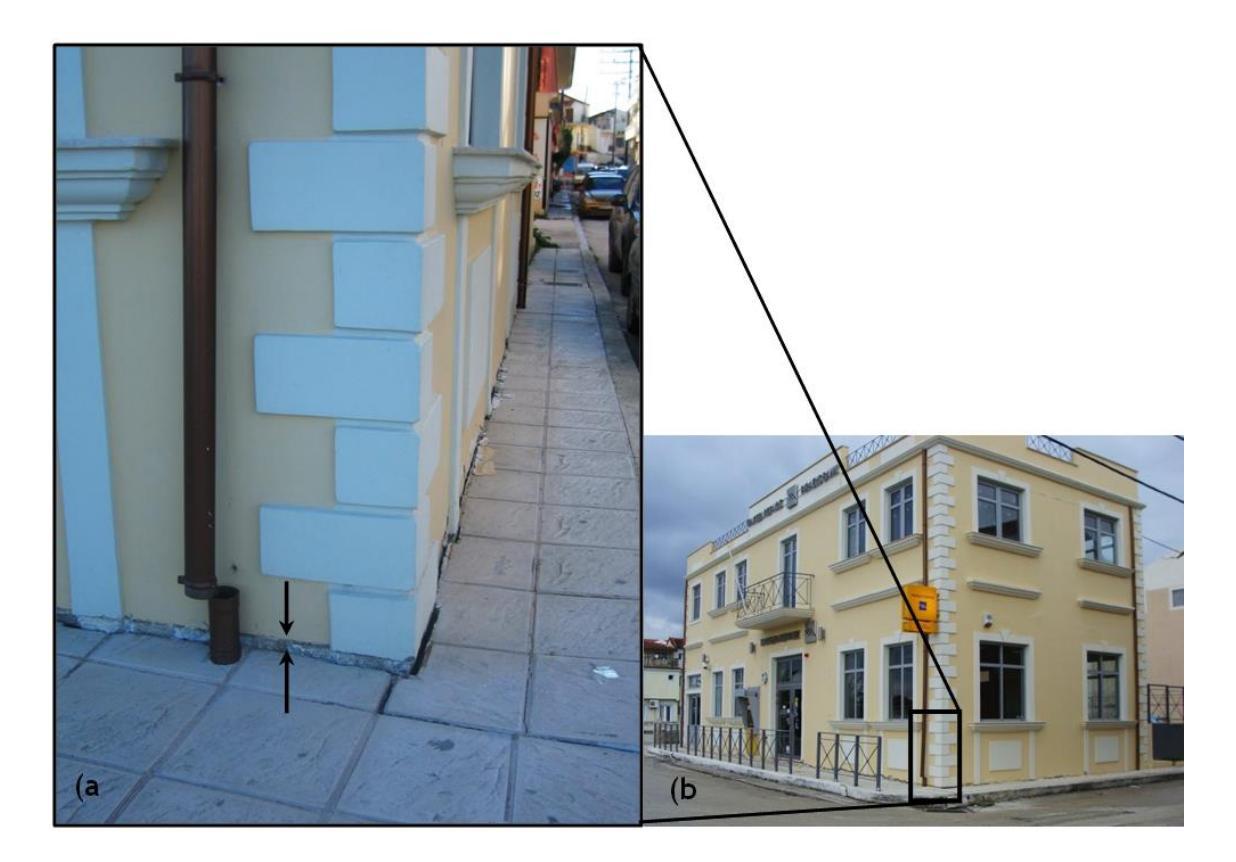
The 2-story structure (GPS Coordinated 38°12'7.65"N, 20°26'19.70"E) is supported by a grid of 20 steel piles, 1 m in diameter and 15 m in length. The structure appears to have stayed in place without any displacement at two of the corners. Measured settlements reached 2.4 cm at the entrance of the building, and 4.2 cm settlement at one corner (Fig. 8.7.4). Although it seems that the ground has settled, the structure remained in place. Observations of non-structural components damage in several bank structures are presented in the Chapter 11.

Figure 8.7.4. Case 3: Lixouri Branch of Piraeus Bank (38°12'7.65"N, 20°26'19.70"E, 2/18/14).
