CHAPTER 8 Geotechnical Observations

GEER/EERI/ATC Cephalonia, Greece 2014 Report Version 1

8.1 Site Effects

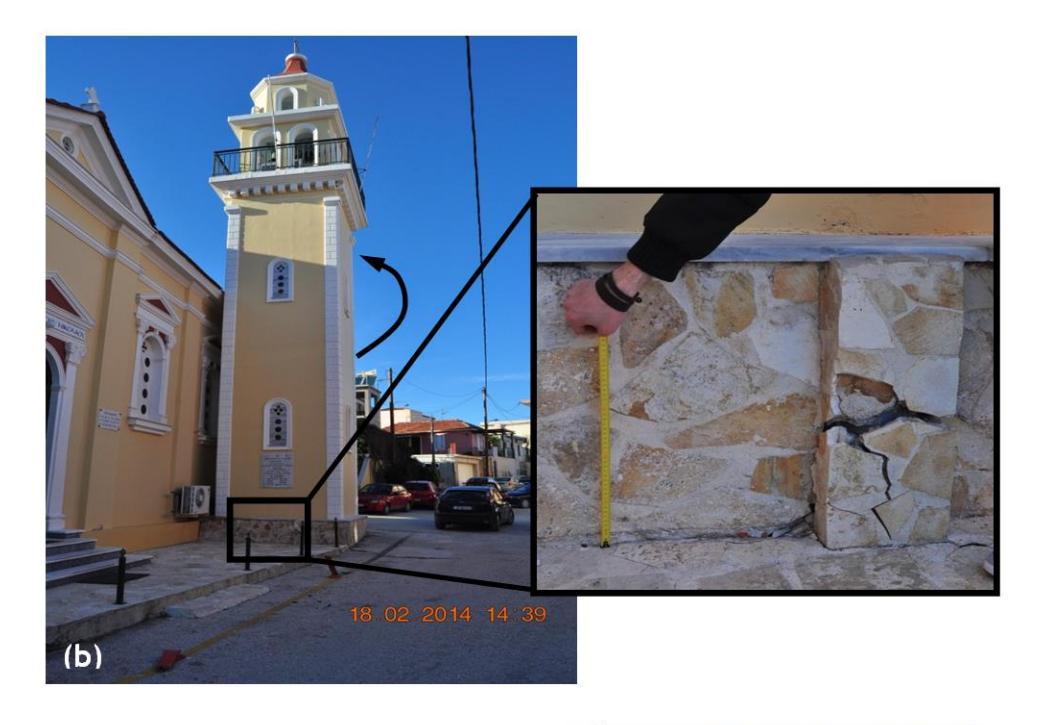
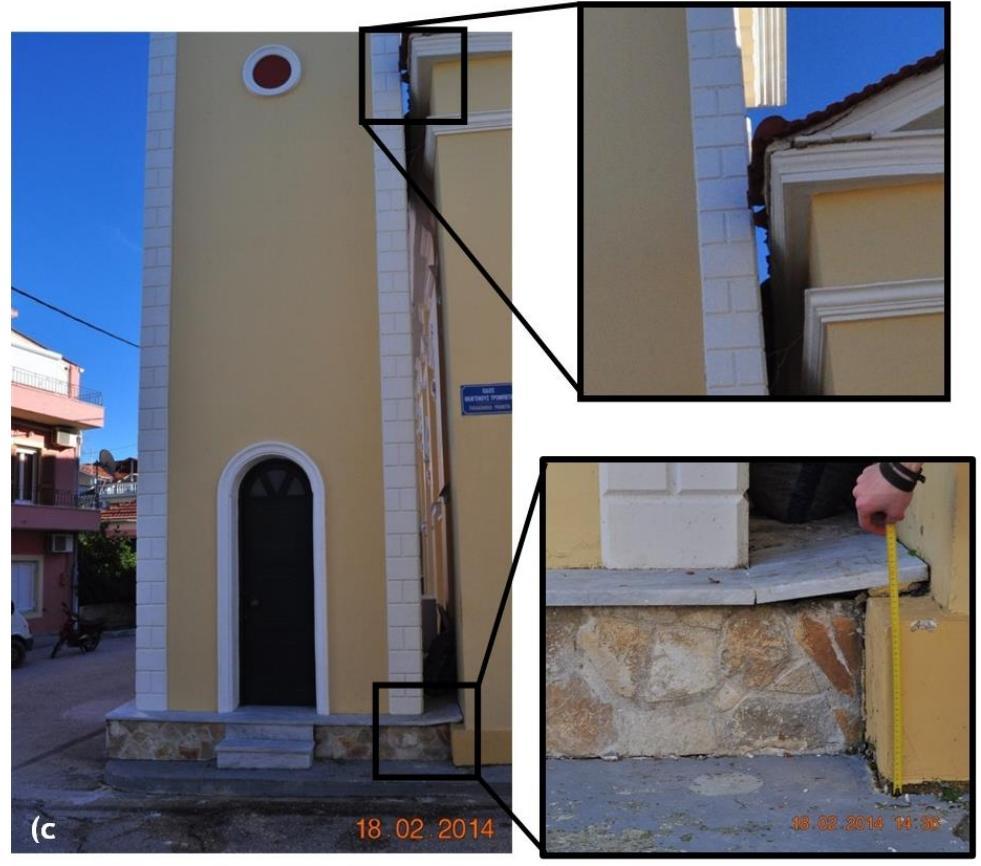
The bell tower of St. Nicholas church (GPS coordinates 38°12'9.43"N, 20°26'17.63"E; see Fig. 8.7.5) appears to have suffered differential settlement. Settlement at the west side and uplift at the east side of the building resulted in the tower tilting toward the church (Figs. 8.7.6b,c).

It can also be seen that the bell tower has leaned against the church structure adjacent to it (Fig. 8.7.6c, insert), damaging the church roof. Settlements of 2 cm were measured at the SE and NE corner. No settlements were observed at the perimeter of the church.

Figure 8.7.6. Case 4: St. Nicholas Church Bell Tower differential settlement (38°12'9.43"N, 20°26'17.63"E, 2/18/14).

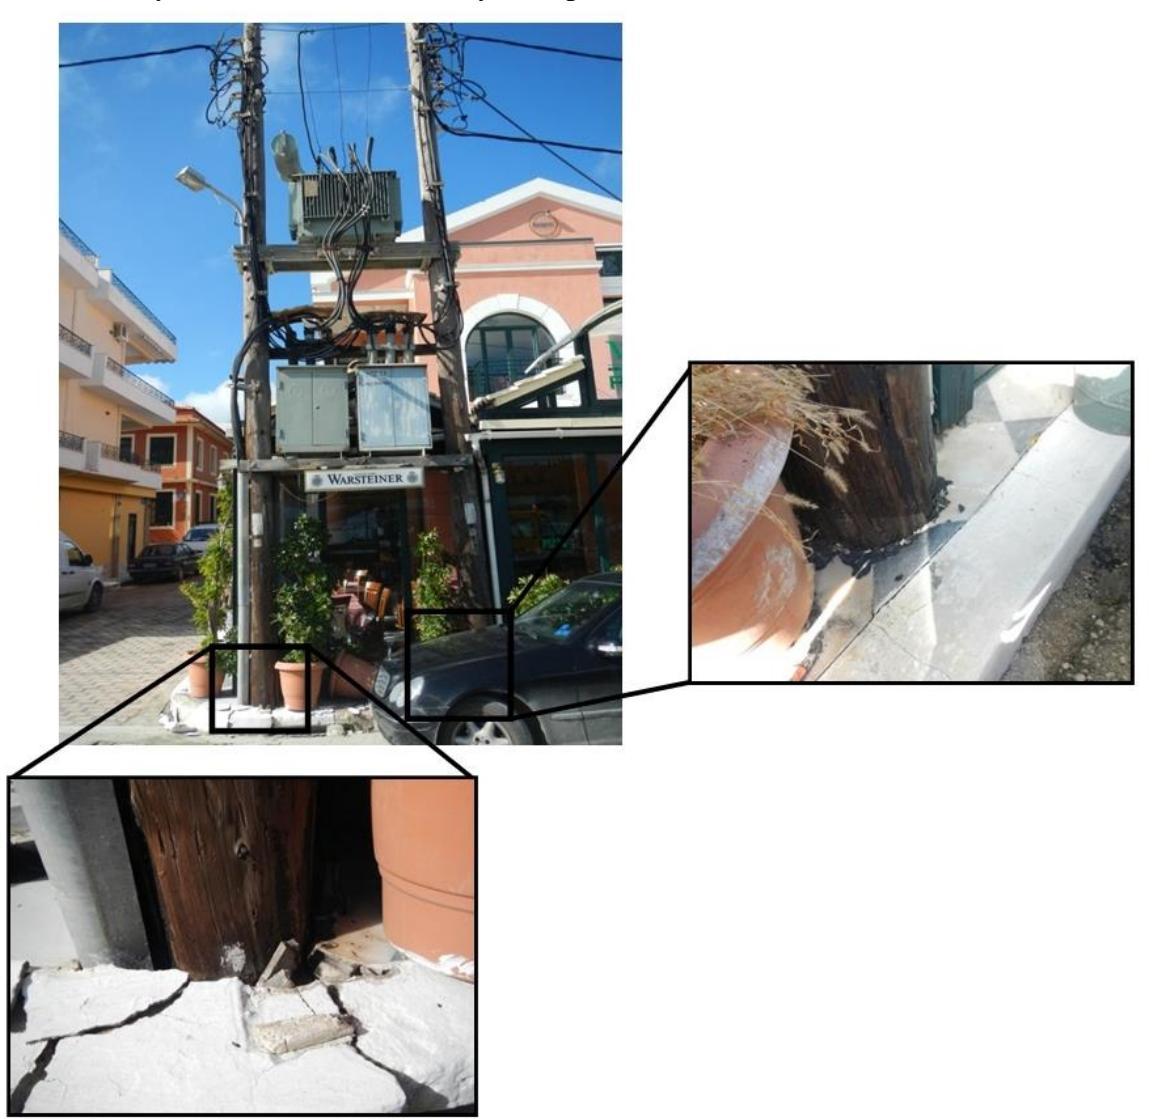
A power transformer pillar in Lixouri (38°11'55.63"N, 20°26'20.56"E) suffered differential settlement. One of the support columns appeared to have punched in the ground for 1.7 cm, while the other one remained in place. This behavior could be attributed to structural response influenced by SSI, with verification by site specific studies.

Figure 8.7.7. Case 5: Power transformer pillar differential settlement (38°11'55.63"N, 20°26'20.56"E, 2/19/14).

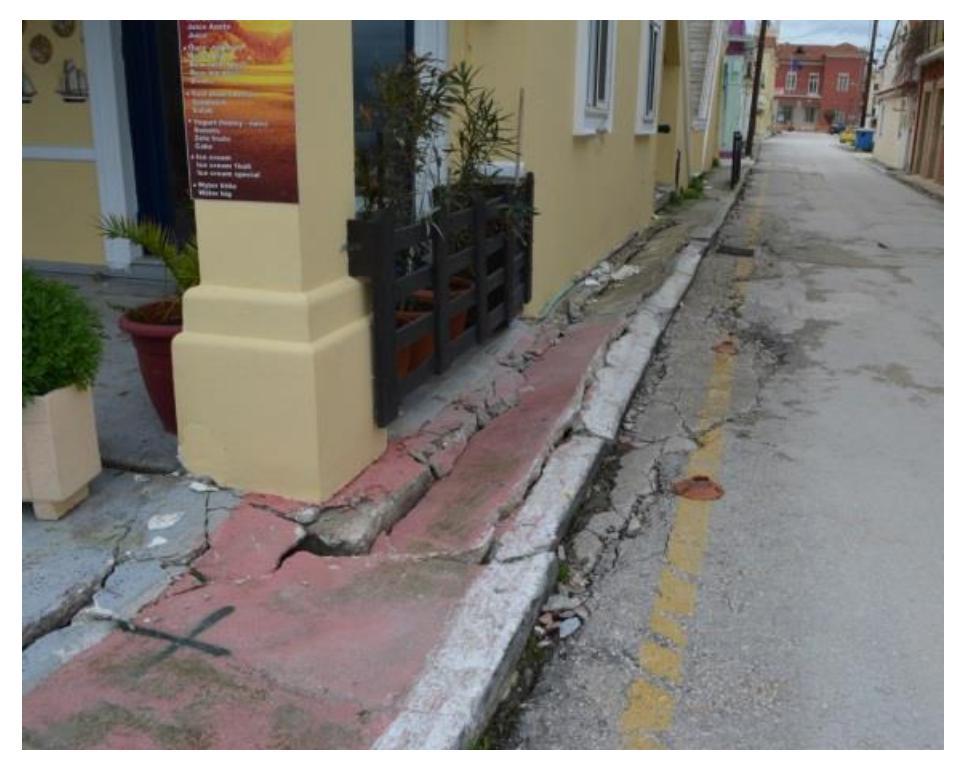
Figure 8.7.9. NE corner of Café "Aen Plo" NE corner ground failure (2/19/14).

In the NE corner of the structure, 3.8 cm of vertical and 1.9 cm of horizontal displacements were measured (Fig. 8.7.9). It appears that the structure remained in place, but the ground moved towards the seafront as the result of liquefaction. The owner confirmed that no sand boils were observed during or after the earthquakes near the structure and on the road in front of it.

However, the settlements at Café "Aen Plo" could be attributed to liquefaction occurring deep below the ground surface, which did not lead to bearing capacity failure or excessive settlements due to the existence of a "protective cap" of unsaturated fill on top of the liquefied ground at some depth. This layer of non-liquefiable material may exist due the topography of the area, which has a mild inclination towards the sea, thus incurring a deepening of the ground water level with distance from shore.

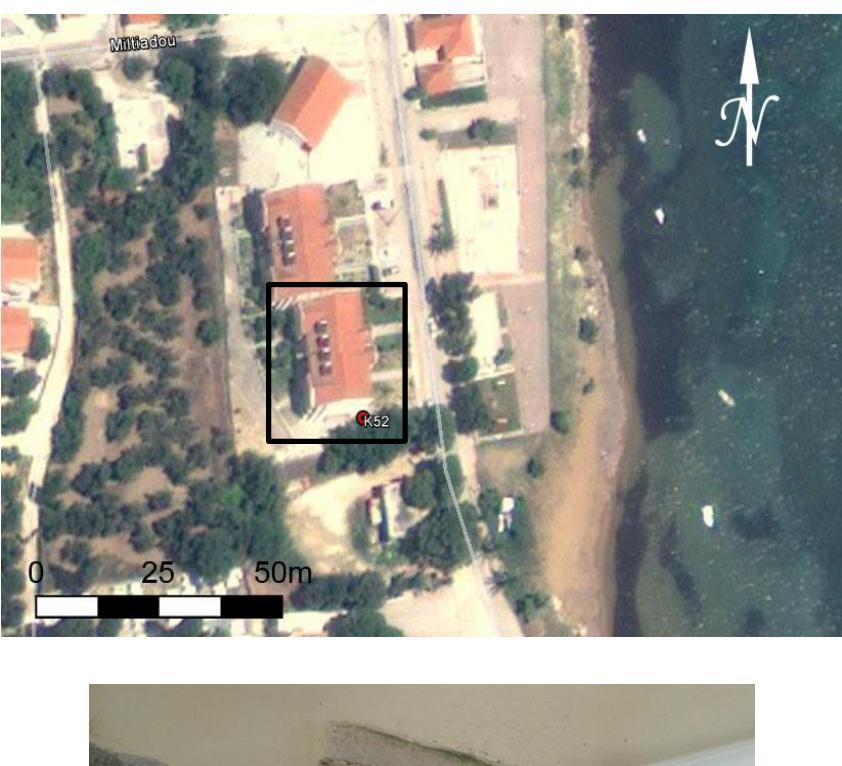
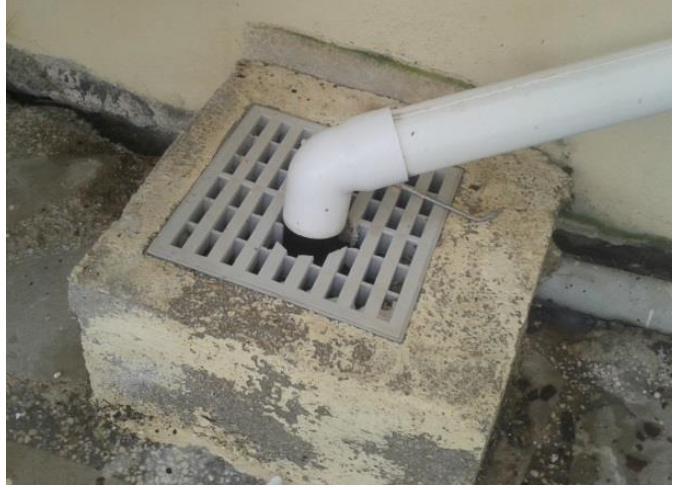
As shown on Fig. 8.7.10, the soil around the building settled uniformly by about 3 cm. As a result, the (uncracked) mortar of the building was dislocated from the paved ground.

Drainage pipes (were also dislocated from their collective pool as the result of surrounding ground settlement. The observations could be attributed to cyclic softening and subsequent settlement of the unsaturated fill set around the building.

Figure 8.7.10. Case 7. Ground settlement in the perimeter of 2-story R/C building south of Lixouri. Location at the top part of this figure (GPS Coordinates 38°11'36.08"N, 20°26'19.90"E, 2/19/14).

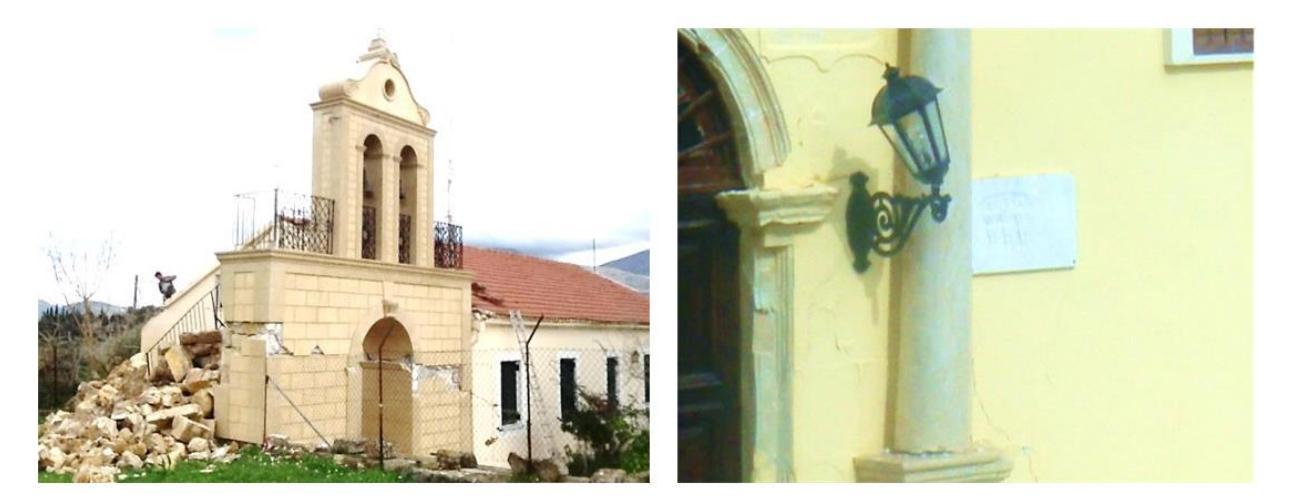
An interesting observation illustrated in Figures 8.7.11 - 8.7.14 is the structural and nonstructural failure that occurred primarily along the E-W direction (i.e., in-plane shear cracks of the front garden gate, fall of non-structural elements and evident rotation of the main gate lights). While the NS and EW components of the earthquake motions contained potential directivity effects (see insert of Fig. 8.7.12 from the 2^{nd} event), within the assumed structural period of interest between 0.1 and 0.3 seconds, the spectral accelerations did not vary significantly. This would make the Kechrionos Monastery an interesting future case study to study potential site effects, directivity and, possibly, SSI.

Figure 8.7.11. Case 8: Kechrionos Monastery. Shear failure on external gate (left) and rotation of exterior lights (right), both along the EW direction (38°13'26.19"N, 20°25'43.36"E, 2/8/14).

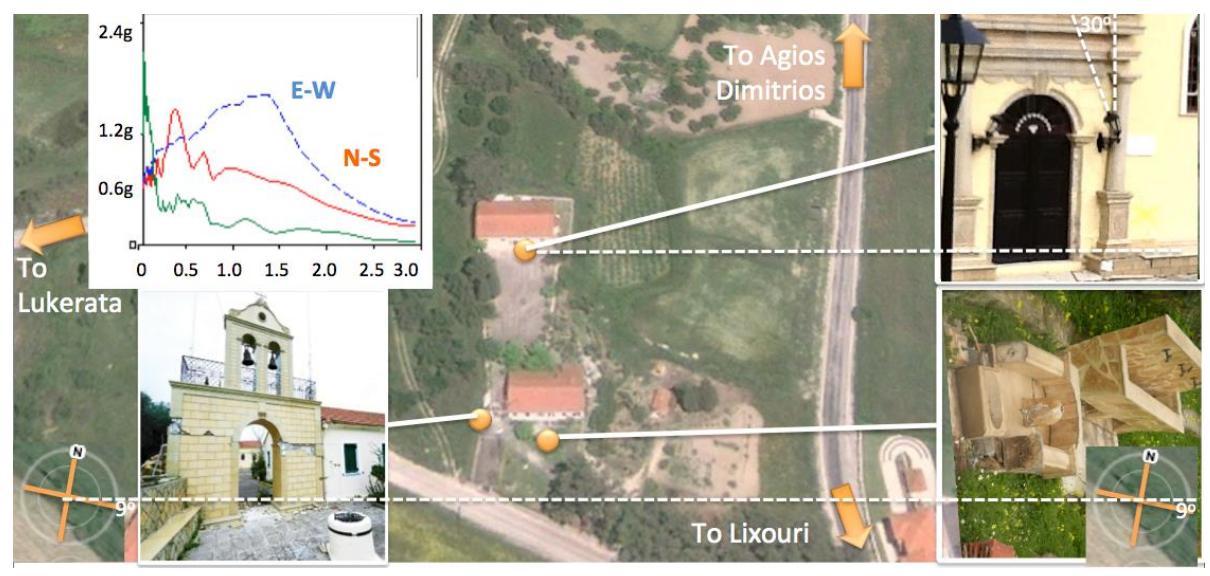
Figure 8.7.12. Orientation of structural and nonstructural damage relative to the EW direction. $(38^{\circ}13'26.19"N, 20^{\circ}25'43.36"E, 2/8/14)$. Insert: the 3 components of spectral accelerations in the 2nd event.

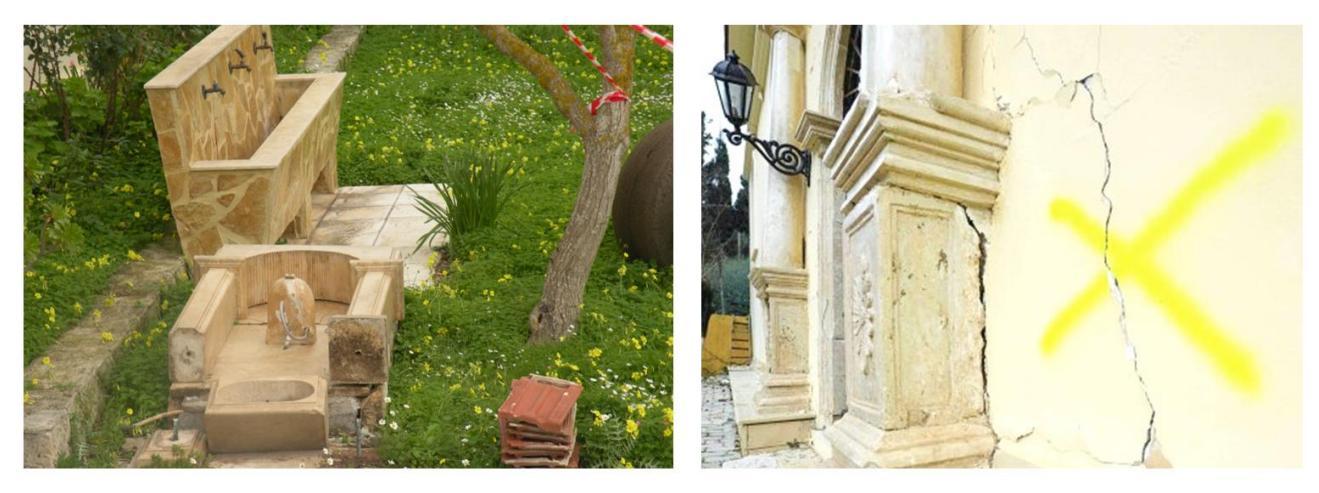
Figure 8.7.14. Case 8: Kechrionos Monastery. Out-of-plane collapse of non-structural elements (left). Close view of the main gate pillar dislocation together with diagonal cracks of the external masonry.

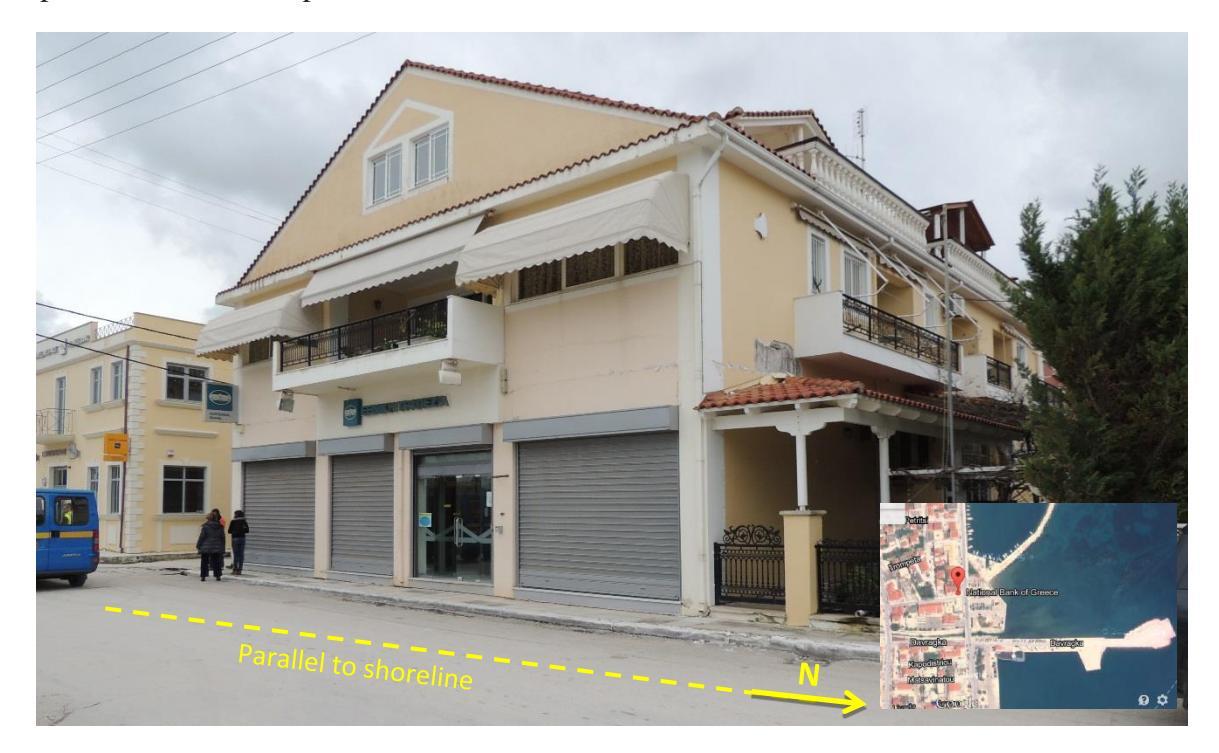
The Lixouri branch of the National Bank of Greece (Fig. 8.7.15), is located in the front row of buildings parallel to the port shoreline (GPS Coordinates: 38°12'7.8"N, 20°26'19.8"E) and is adjacent to Case 3 (Piraeus Bank branch). The building experienced significant structural and non-structural damage that resulted in closing this branch. Details on these types of damage is presented in the Chapter 11.

Figure 8.7.15. Case 9: National Bank of Greece, Lixouri Branch located in the front row of buildings parallel to the shoreline (GPS Coordinates: 38°12'7.8"N, 20°26'19.8"E).

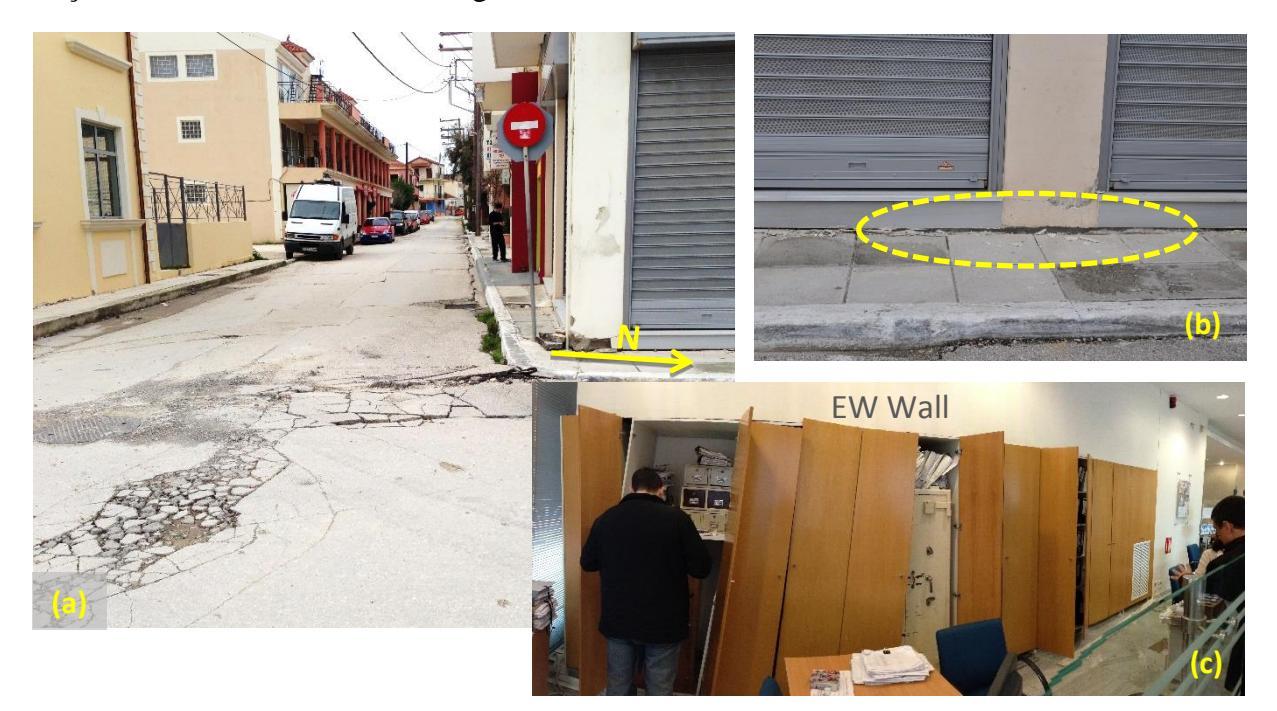
Significant ground deformations were observed towards the inland EW direction due to potential liquefaction or ground deformations of the uncontrolled fill below the pavements, most evident at the SE corner of the bank (Fig. 8.7.16a). The reconnaissance teams observed lateral and vertical deformations between the base of the structure and the sidewalk. The maximum vertical settlements (or dislocation between the base of the structure and the sidewalk) was about 4 cm (Fig. 8.7.16b), while the lateral deformations between the base and sidewalk or sidewalk and road pavement were generally 1 cm or less. A summary of the vertical deformations between the base of the base of the sidewalk along the façade of the bank is shown on Fig. 8.7.17.

Figure 8.7.16. Case 9: Observations of deformations of the: (a) ground; (b) sidewalk connection to base of building; and (c) cabinets of interior EW wall. (GPS: 38°12'7.8"N, 20°26'19.8"E, 2/9/14).

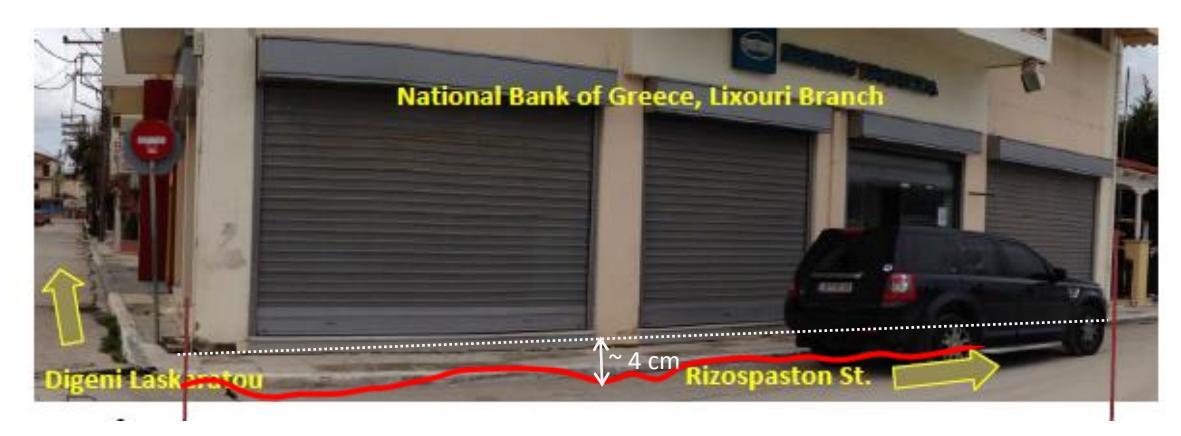
Figure 8.7.17 Case 9: Summary of vertical (exaggerated) deformations between base of building and its connection to the sidewalk along the façade of the bank. (GPS: 38°12'7.8"N, 20°26'19.8"E, 2/9/14).

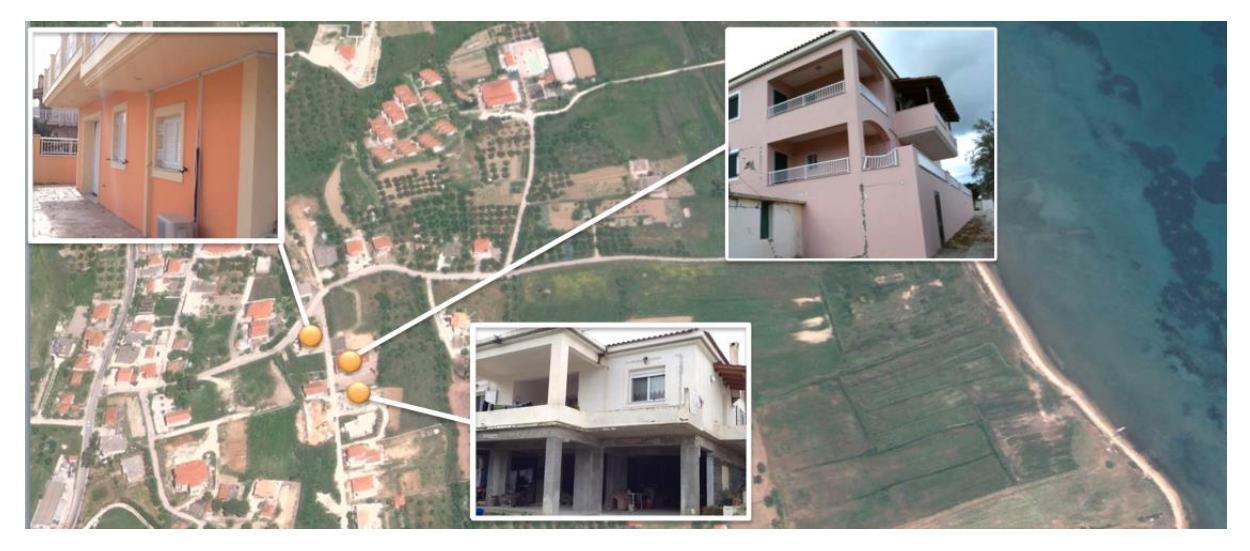
Building damage is systematically presented in the Chapter 11 as a function of the seismic code that it was designed for. In this section, we bring the attention to a series of newly constructed structures that may be worth investigating with reference to their SSI effects, shown on Figs. 8.7.18 and 8.7.19. They are 3-story Reinforced Concrete (R/C) buildings, designed in accordance with the latest Greek Seismic Code (EAK2000).

Figure 8.7.18. Case 10. Locations of the 3-story structures designed with the latest seismic code EAK2000. (GPS coordinates 38°13'48.19"N, 20°25'53.20"E, 2/9/14).

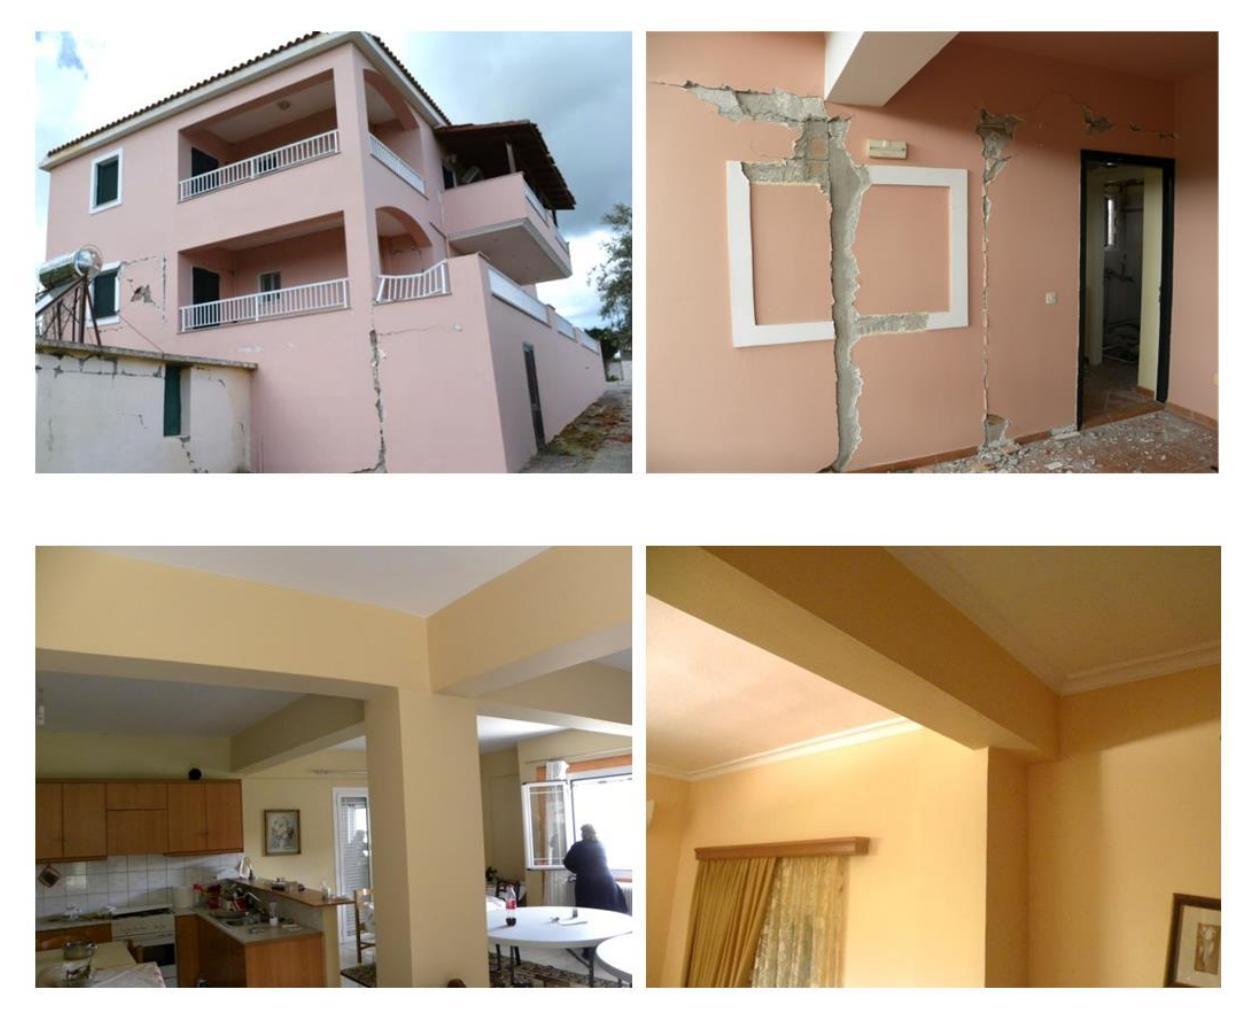
The design base shear of these buildings was approximately equal to $V_{sd} = (a_g \times 2.5/q) \times W = 0.36g \times 2.5 \times W / 3.5 \approx 0.25 \text{ g W}$ (where a_g is the seismic coefficient and q is the force reduction factor as per EAK2000). The recorded spectral acceleration at the fundamental period of the structures (estimated around 0.25 sec) was about 0.7 g (for 5% damping), which generated a base shear that exceeded the design value by almost 3 times.

It appears that the lateral load resisting systems of these structures responded elastically during both the 1st and 2nd main events. Although in some cases extensive damage of the infill masonry was observed, the load bearing system remained intact. The impressive lack of damage may be attributed to different factors that either increase the available strength of the buildings (such as inherent over-strength due to the use of minimum, code-prescribed reinforcement and minimum dimensions, statistical over-strength of materials, and the beneficial, seismic energy absorbing role of the masonry walls), and/or to factors that have possibly reduced the imposed base acceleration due to site effects or SSI phenomena. The high demand-to-nominal capacity ratio, small distance from the shore (less than 500 m) and the presence of settlements in nearby structures makes these desirable case studies.

Figure 8.7.19. Cases of buildings designed to EAK2000 experienced no damage to their load bearing system due to multiple sources of over-strength. Possible beneficial effects of SSI could have played a factor and should be studied further (38°13'48.19"N, 20°25'53.20"E, 2/9/14).
