# **CHAPTER 9 Rigid Blocks**

GEER/EERI/ATC Cephalonia, Greece 2014 Report Version 1

## 9.1 Overview and Key Observations

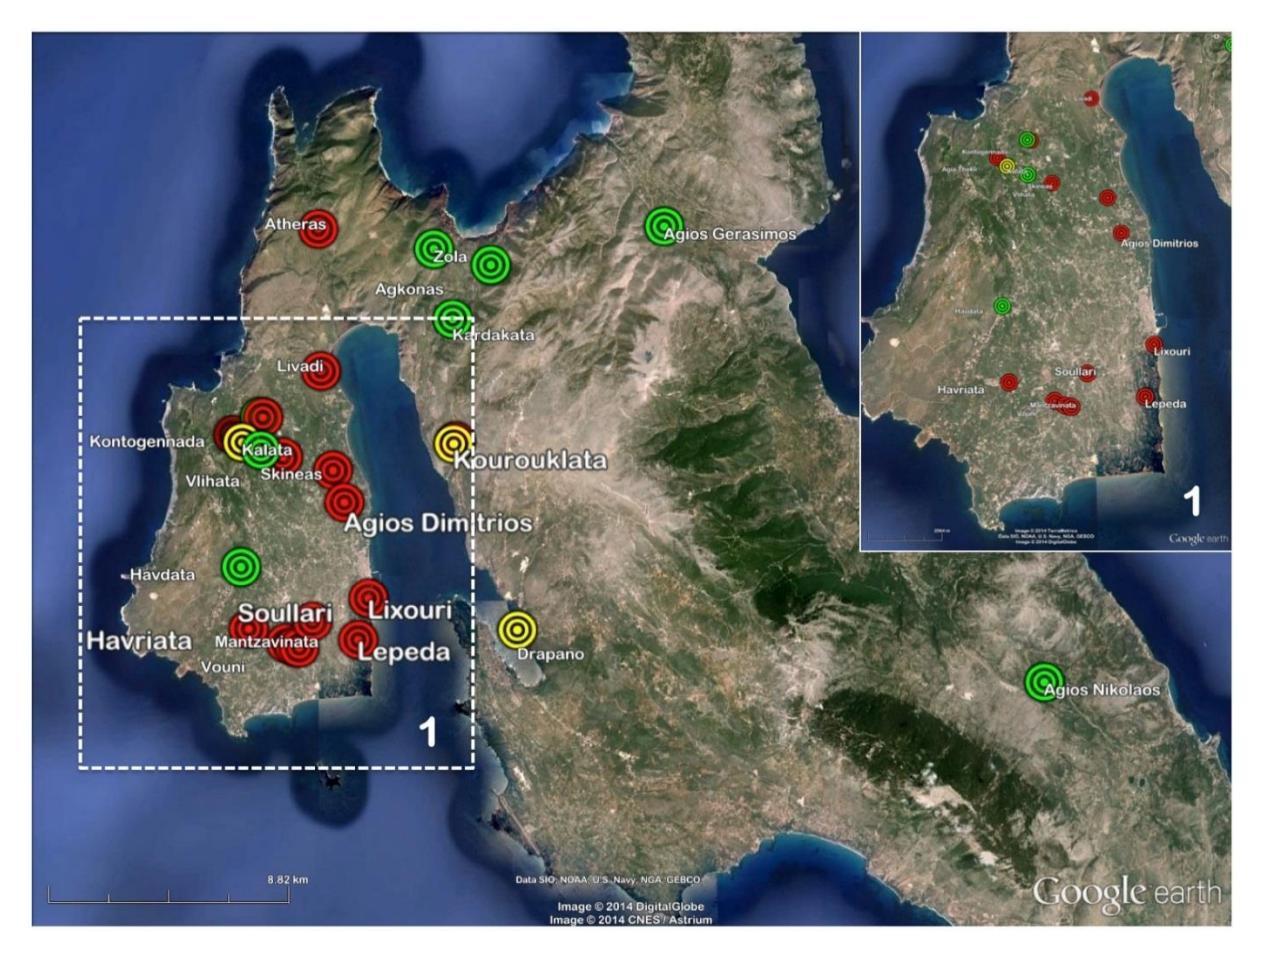
Figure 9.1.1 Locations of 27 cemeteries inspected during reconnaissance.

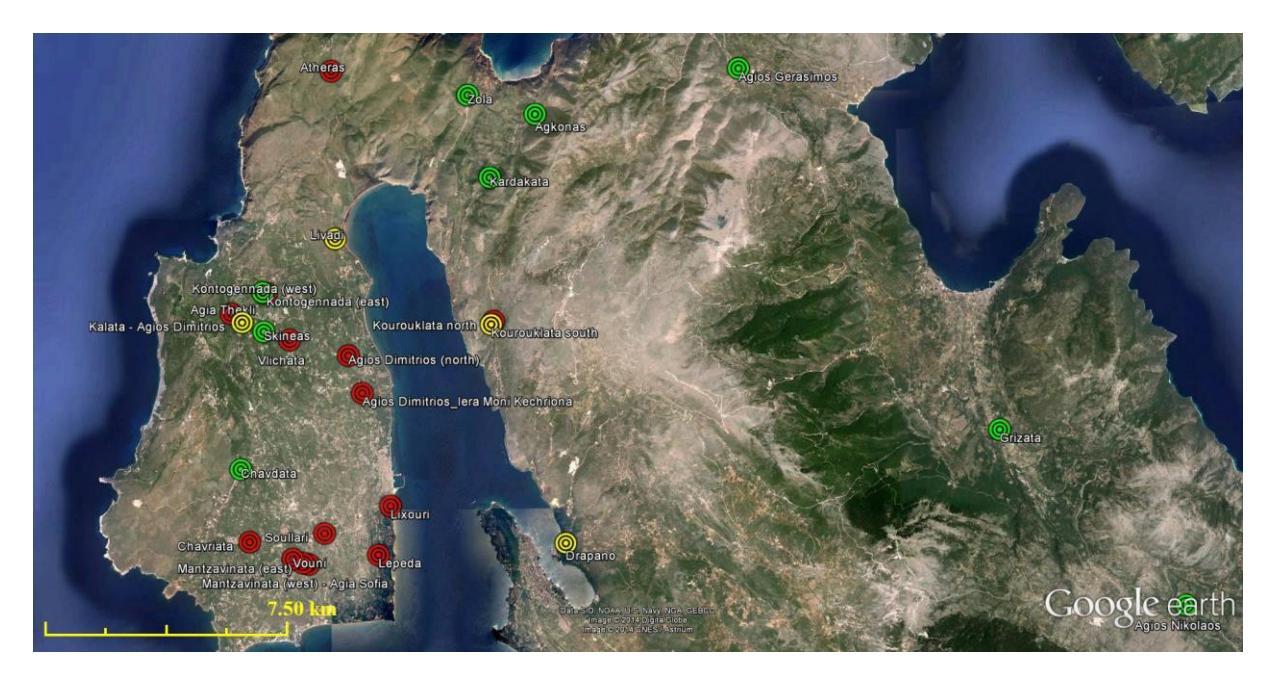
**Figure 9.2.1.** Reconnaissance of 27 cemeteries in Cephalonia. Colored dots indicate percentage of toppled tomb objects: red for more than 65%, yellow 30-65%, and green less than 30%.

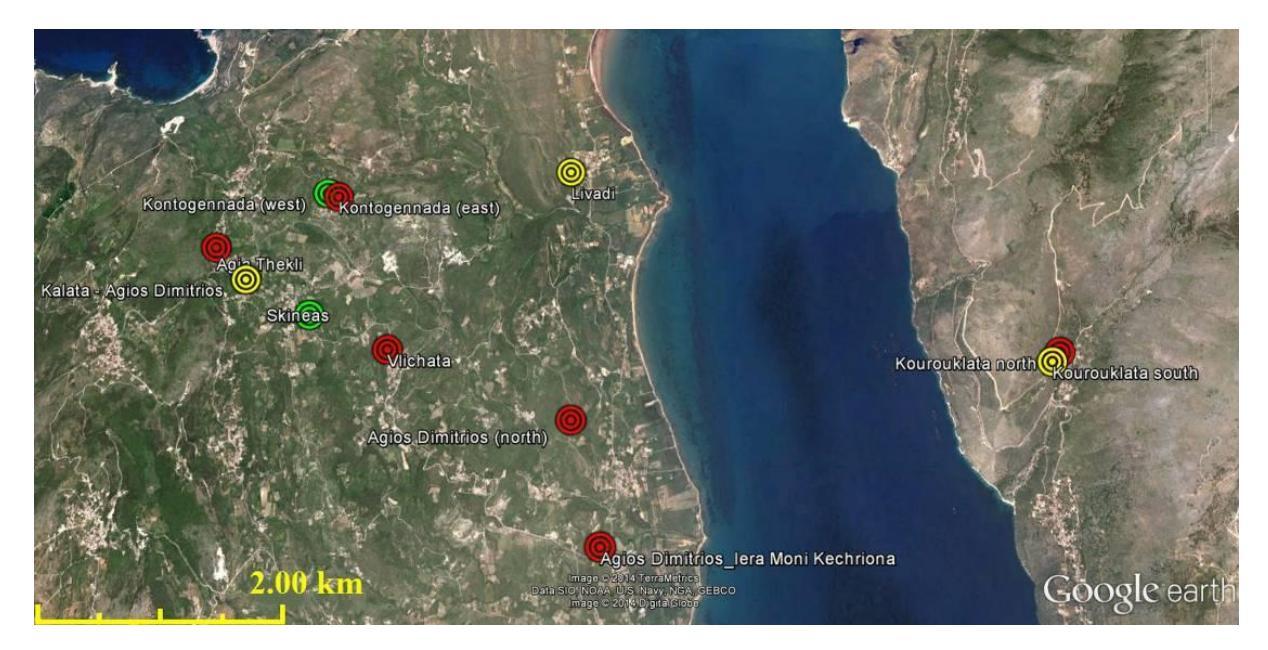
At the main part of Paliki (e.g., at the village of Kourouklata [GPS: 38.243401, 20.474875], objects toppled at a rate of 76% and 59% at the two cemeteries (Fig. 9.2.10). Cemeteries on the east side of the island were not significantly affected. Overall, it is clear from our reconnaissance that adjacent cemeteries could exhibit markedly different responses. Figure 9.2.11 presents an overview the cemetery object toppling rates in Paliki peninsula.

**Figure 9.2.11.** Cemetery reconnaissance at North Paliki peninsula. Red dots indicate object toppling rate greater than 65%, yellow from 30-65% and green with less than 30%. Observations indicated that adjacent cemeteries could exhibit markedly different response.

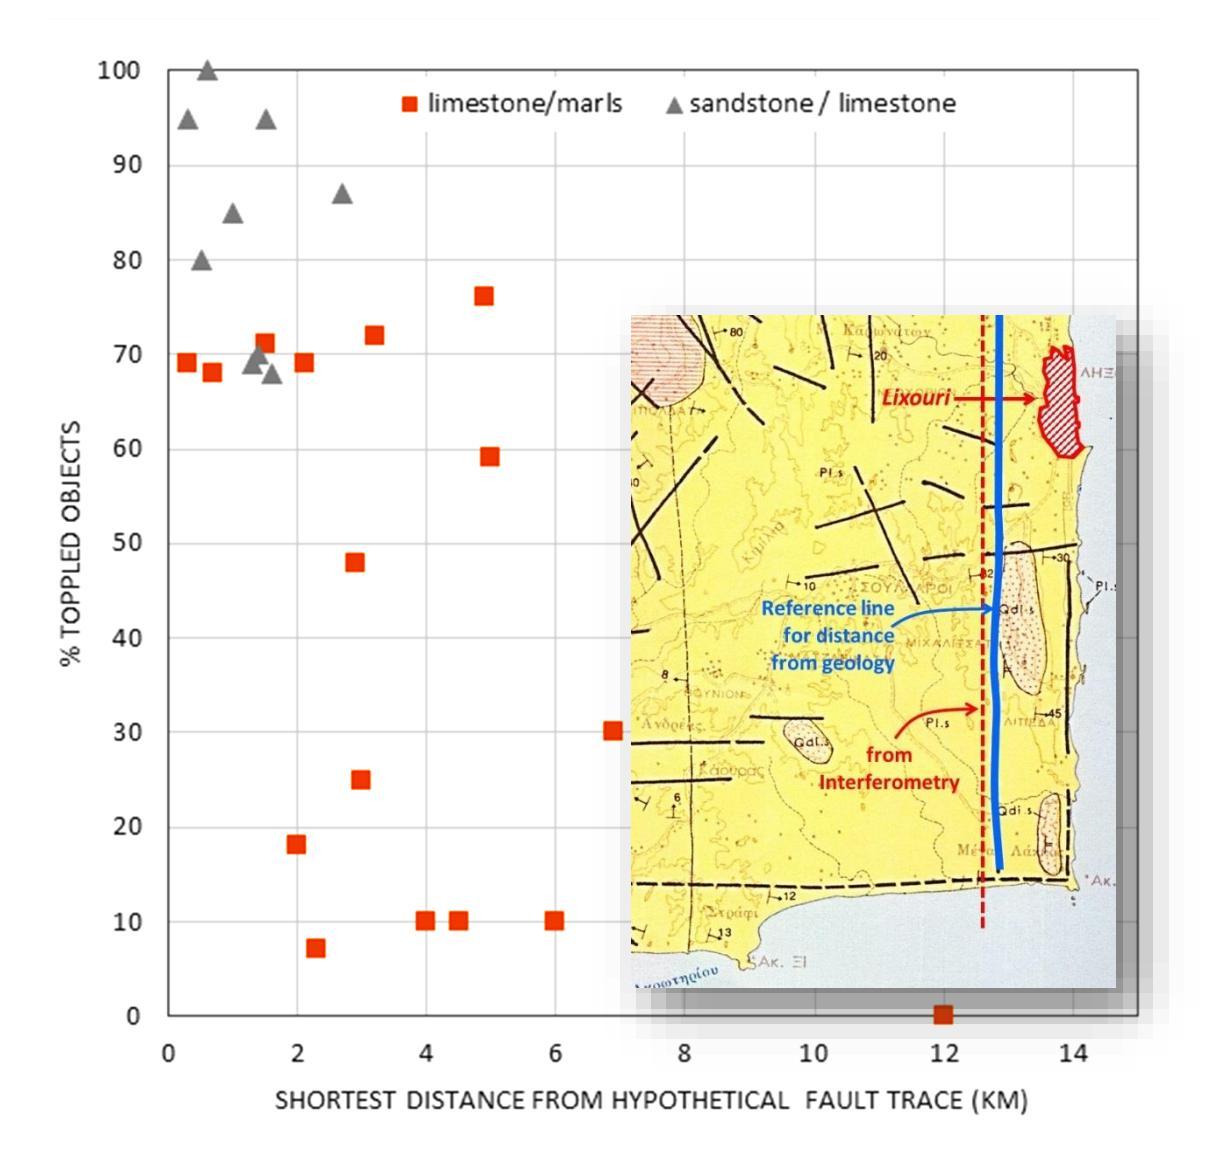
Fig. 9.3.1 shows the toppling rate correlated with the (approximate) shortest distance from the hypothetical extension of the fault trace of the 2<sup>nd</sup> event, which runs almost in the NS direction, from immediately West of Atheras village [GPS: 38.311280,20.418498] to immediately East of the Soullari village [GPS: 38.185414,20.415757]. Our preliminary assumption is supported by the interferometry map of Section 7.3 and the tectonic setting of the area (insert of Fig. 9.3.1).

- 1. Four cemeteries (Aghios Dimitrios north & south, Lixouri and Lepeda) at the eastern coast of the Paliki peninsula exhibited the largest toppling rates, with average greater than 95%.
- 2. There was surprising low toppling rate at in the vicinity of the fault, at Kontogennada (west) and Skineas, 18% and 7% respectively.
- 3. Adjacent cemeteries presented significantly different toppling rates. In the two (western and eastern) cemeteries of Kontogennada, 18% and 69% toppling rate was witnessed, respectively. In Skineas the rate was 7% and in Vlichata, less than 1 km away, the rate was 71%. In both cases, the general geologic setting and altitude were roughly the same.
- 4. The correlation shows significant scatter, which is an indication of the many parameters that influence the performance of the rigid blocks.

**Figure 9.3.1.** Correlation of damage in all cemeteries inspected to the shortest distance from the (hypothetical) trace on the surface of the seismogenic fault of the  $2^{nd}$  event. Insert: geologic IFME map showing in blue the preliminary reference line used to calculate the distance to the cemeteries.
