CHAPTER 10 Infrastructure Networks

GEER/EERI/ATC Cephalonia, Greece 2014 Report Version 1

10.1 Potable and Wastewater Networks

10.2 Transportation Road Network

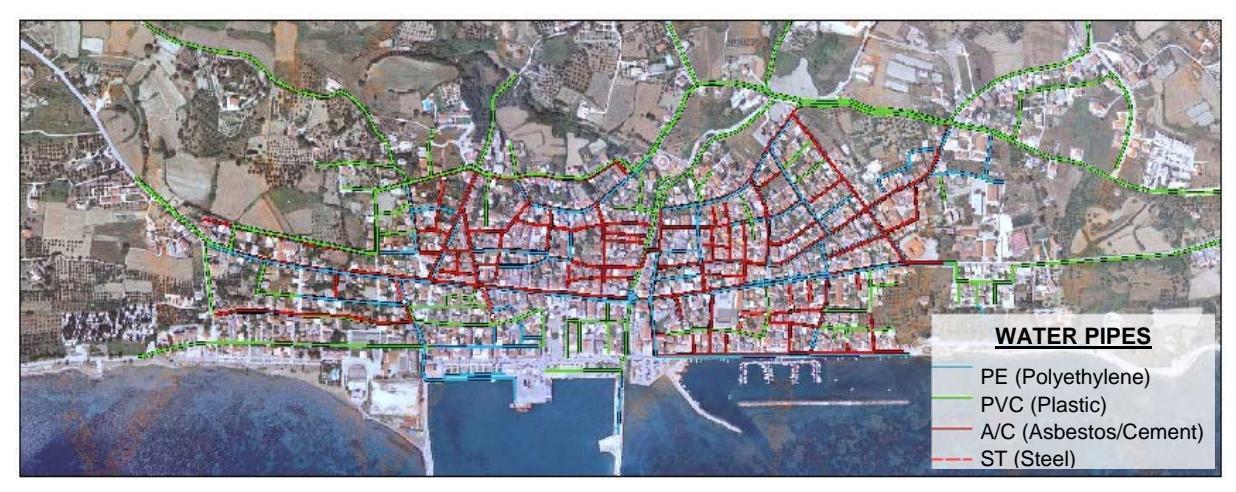
Rapid Assessment. The investigation and repair teams, in coordination with the local agencies performed a rapid assessment. Just 3 hours upon arrival to the island, the EYDAP teams were planning for the investigation and restoration activities. Fig. 10.1.4 shows a GIS map of the water network. The mapping involved a total of 36,191 m of pipes.

Figure 10.1.4. GIS mapping of a total of 36,191 m of potable water network pipes (EYDAP, 2014).

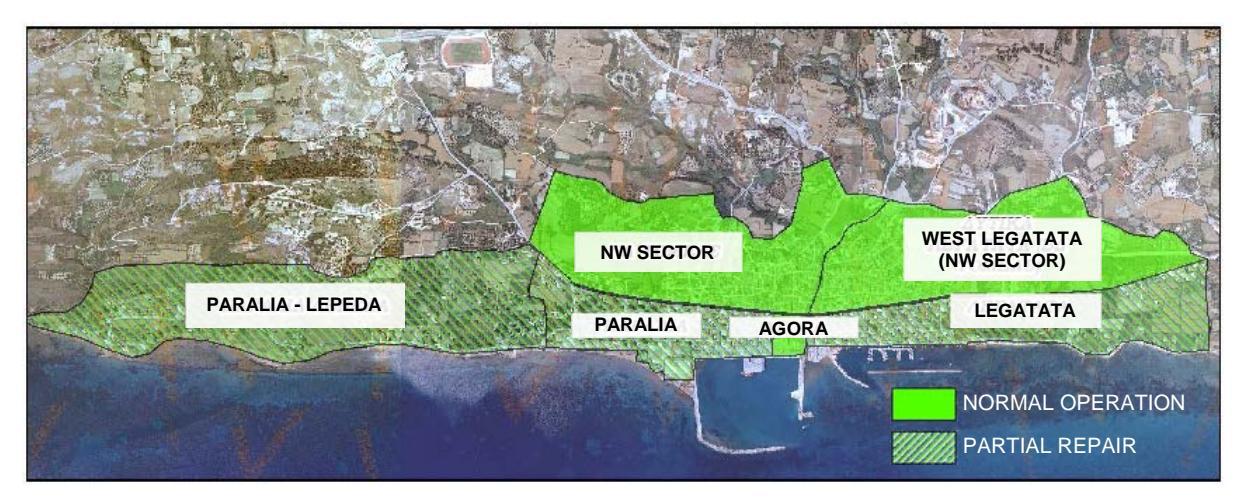
<u>Day 1:</u> A second subgroup was responsible for detecting and repairing the visible damages and leaks. Photos of the repair activities during Day 1, a 24-hr shift, are shown in Fig. 10.1.6. Due to large number of leaks, most of the system could not maintain its pressure, so nineteen additional valves were installed for the control of the water supply in the various areas (Fig. 10.1.7). As shown in Fig. 10.1.8, at the end of the first day normal water supply was secured inland.

Figure 10.1.8. Progress made at the end of the first day (EYDAP, 2014).

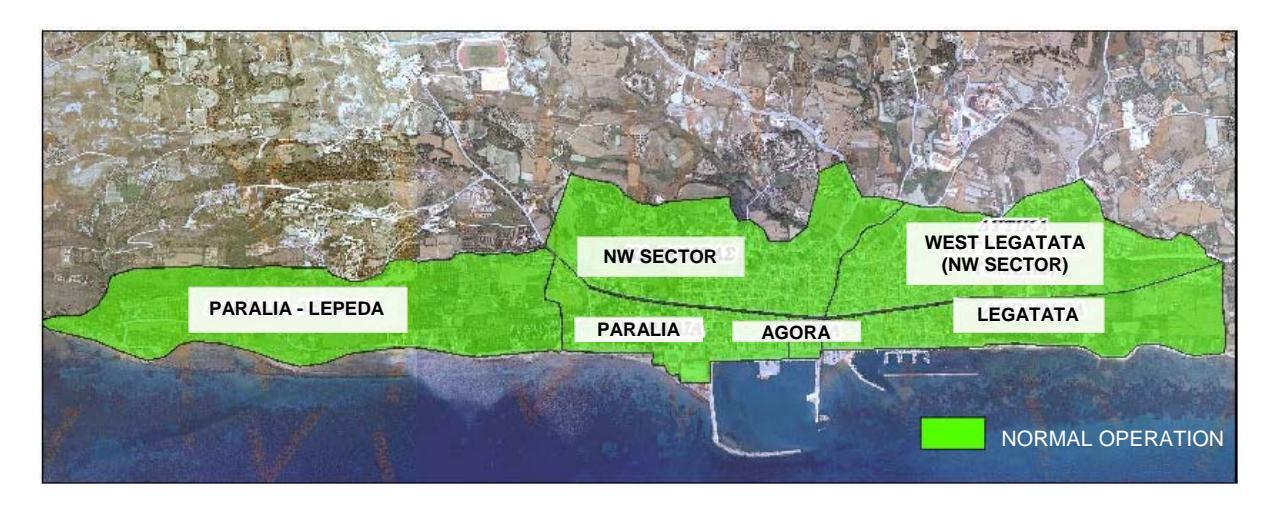
<u>Days 3 to 12</u>: During Days 3 to 12, the EYDAP teams inspected the water reservoir (tanks, pipes), repaired damages and performed continuous adjustments in order to ensure stable service. A bypass of the network pipes and alternative supply took place in areas where the repair would have been too difficult or where the upgrade in supply was significant. For the protection of the asbestos cement pipe network, a pipe rupture valve was installed since the repair of the leaks would result in increase of pressures in the already distressed network, which would likely cause new leaks. At the same time, in situ chemical analyses were performed (regular and residual chlorine) to ensure the water quality and also to check for leaks (which would decrease the quantity of the residual chlorine). The network pressures upon completion of these activities were normal, as shown in Fig. 10.1.11. Since Saturday February 8th 2014, 100% of the network in Lixouri and the surrounding areas was fully restored.

Figure 10.1.11. Potable water network fully functioning at the end of repair activities.

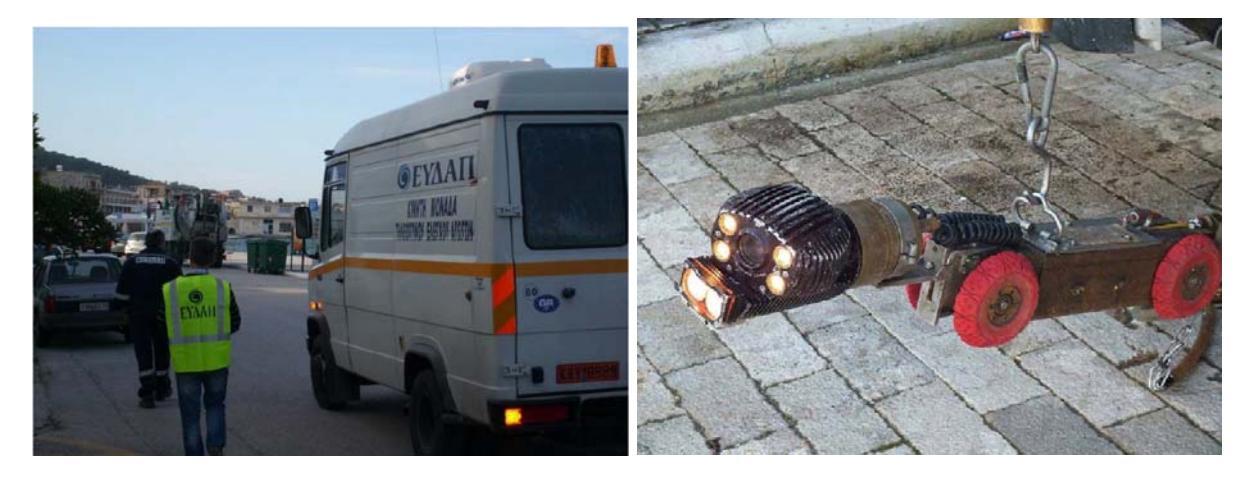
Mobile unit and robotic camera for imaging assessment of the sewer networks.
