CHAPTER 11 Structural Observations

GEER/EERI/ATC Cephalonia, Greece 2014 Report Version 1

11.1 Main Structural Observations

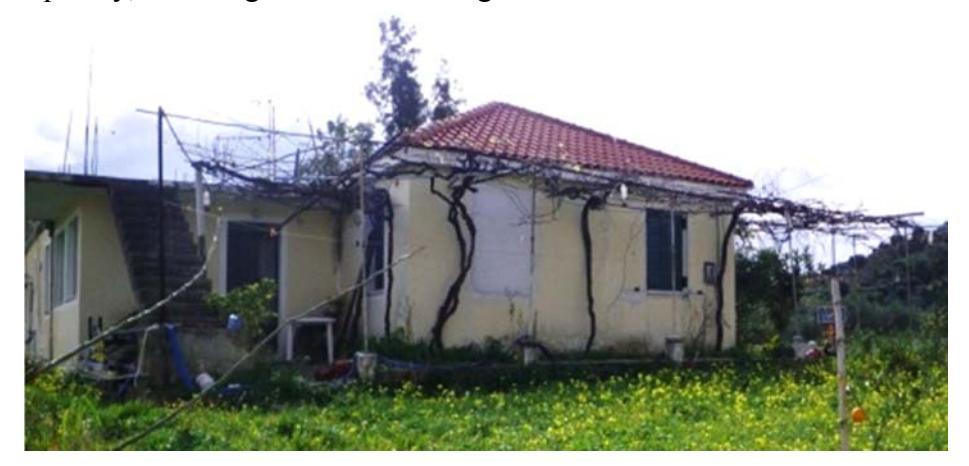
Buildings of this category typically have a single story and are constructed of cement blocks (Fig. 11.4.1), with Reinforced Concrete (RC) vertical ties/columns (at least at the corners of the structure), horizontal RC ties/beams (at least at the top of the walls), and timber roofs (see detail of Fig. 11.4.2). Most of the masonry buildings discussed in this category behaved adequately, suffering little to no damage.

Figure 11.4.1. Typical single-story masonry building constructed after the 1953 earthquake.

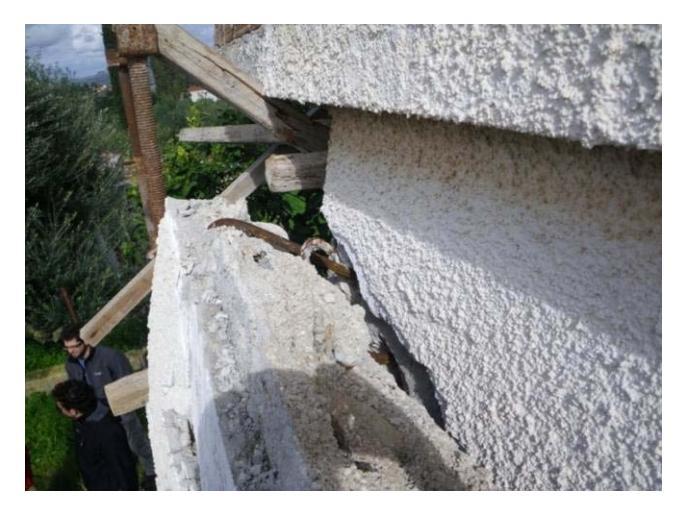
Figure 11.4.2. Smooth steel bars of a vertical Reinforced Concrete (RC) tie, typical for RC building construction during the 1950's and 1960's.

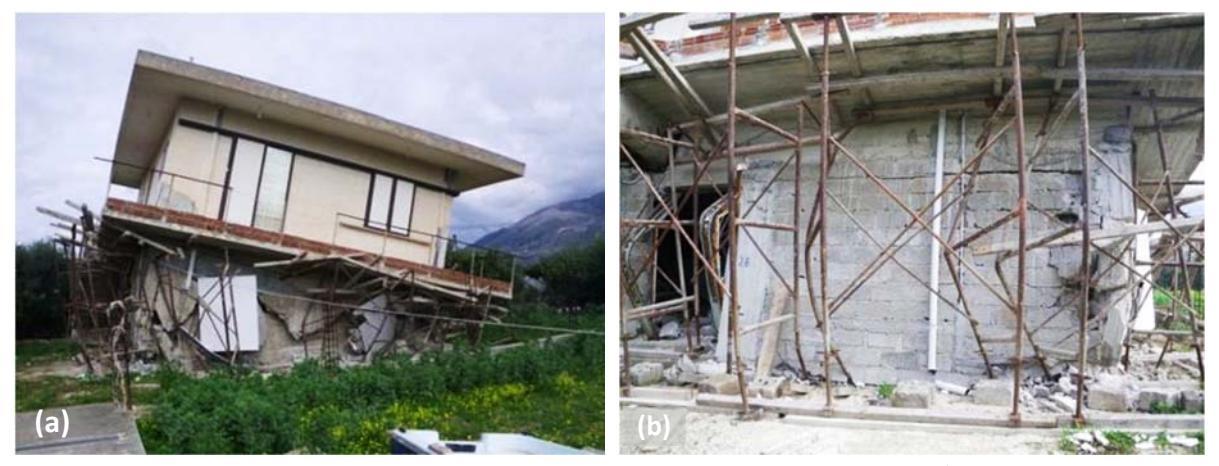
Figure 11.4.3 shows an example of an Arogi house built in phases, where a portion of it failed. In this case, the original (1950's) timber roof of the structure was removed and substituted with RC slab to accommodate a RC frame with clay brick masonry infills as a 2nd story, added in 1978. The added 2nd story did not appear to be damaged, but the masonry ground floor collapsed. The failure was probably caused due to excessive loading of the original ground floor. Sections 11.5 and 11.6 provide more cases and information on Arogi houses.

Figure 11.4.3. (a) Collapse of 1st story of a masonry Arogi building where a 2nd story was added more than two decades after the original construction. (b) Cement block masonry reinforced with vertical and horizontal RC ties (GPS coordinates 38°13'49.80"N, 20°25'49.80"E.)

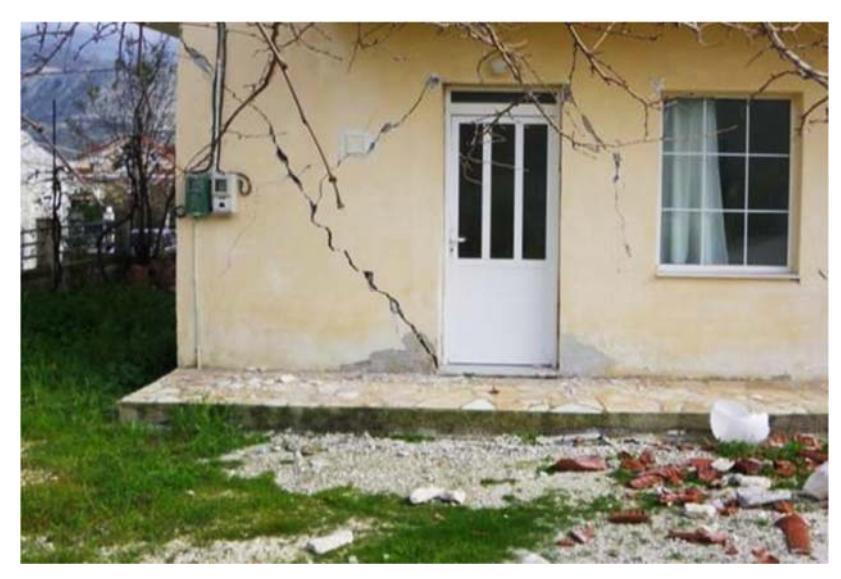
Figure 11.4.4. Typical bi-diagonal (shear) cracks in a masonry wall.

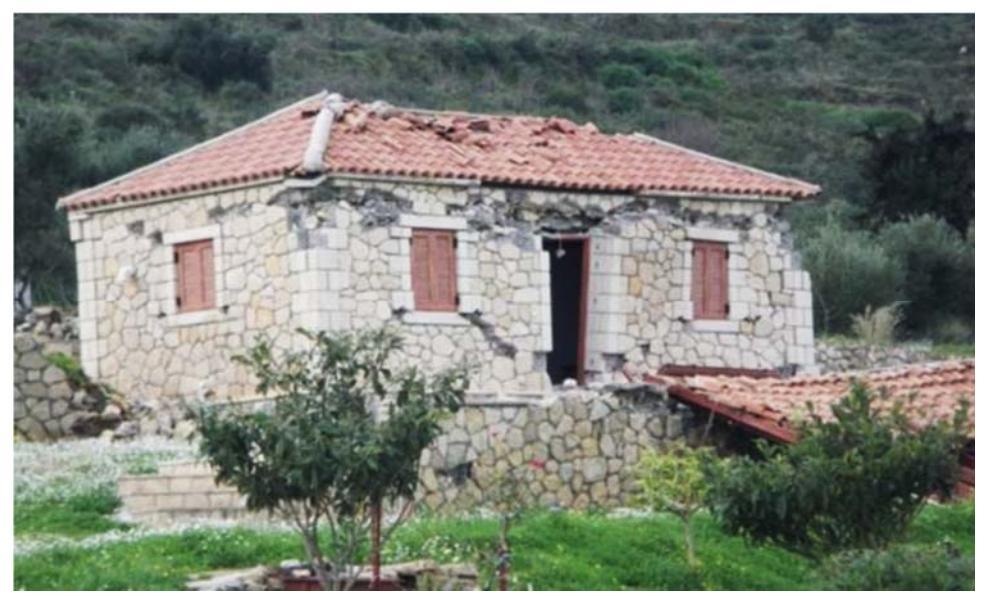
Figure 11.4.5. Shear failure of bearing walls and out-of-plane failure (corner of building and top of walls) of a single-story stone masonry building. Note the double-leaf construction of bearing walls and local disintegration of the outer leaf.

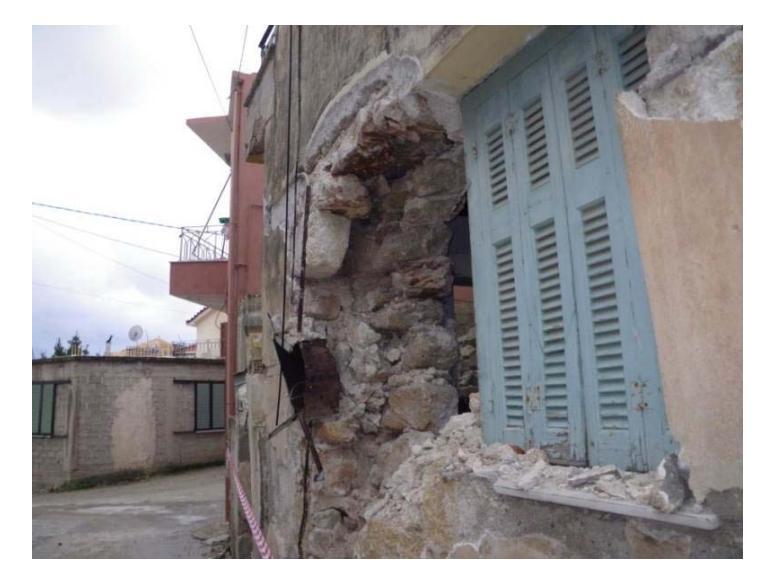
Figure 11.4.6 shows typical three-leaf stone masonry construction with two exterior stone masonry leaves and intermediate filling material of poor quality. Observed damage includes separation of leaves, which probably occurred before the earthquake, and partial collapse of the wall (more extensive for the exterior leaf) due to out-of-plane bending.

Figure 11.4.6. Typical three-leaf stone masonry construction. Damage includes separation of leaves, probably present before the earthquakes, and partial collapse of the wall due to out-of-plane bending.

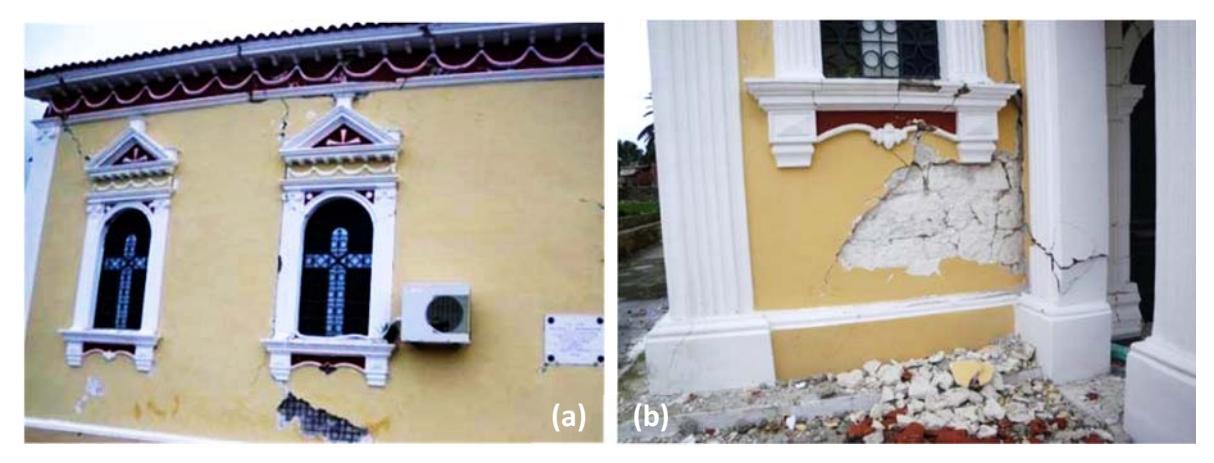
The shear and vertical cracks shown on Fig. 11.4.8 may be due to the displacement of the central part of the church towards the failed retaining wall. Prior to the 2014 events, some seismic retrofit was made using RC jackets shown on Fig. 11.4.8a (below the window). However, it seems that RC jackets were not installed throughout the entire perimeter of the church (Fig. 11.4.8b), and the contribution (positive or negative) of this intervention to the overall behavior of the church cannot be assessed at this stage without further data.

Figure 11.4.8. Observed cracks possibly due to church displacement towards the failed retaining wall. (a) Seismic retrofit RC jacket below window; (b) absence of jackets (38°10'57.52"N, 20°23'13.61"E)

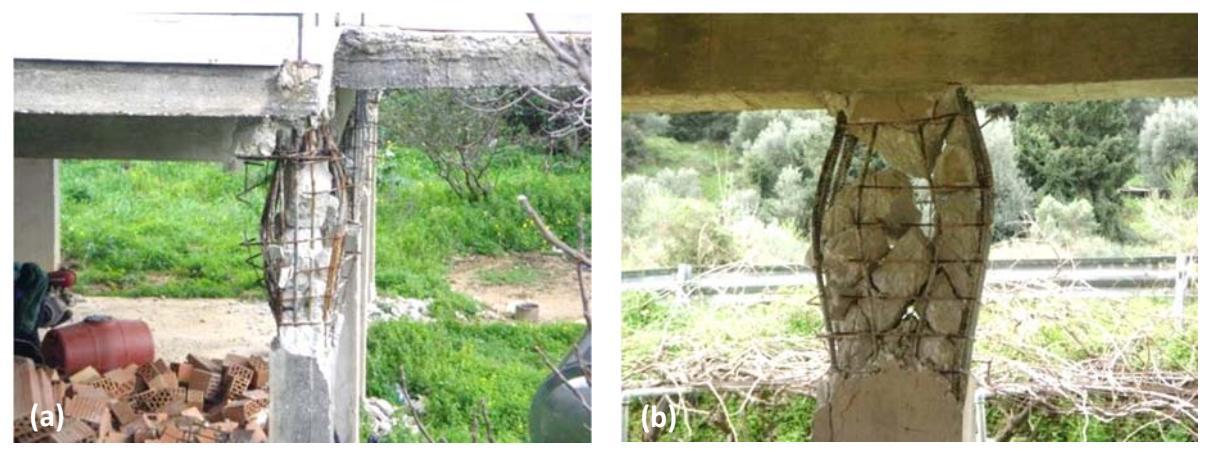
A two-story building in Aghios Dimitrios with load bearing system designed to accommodate at least three stories as indicated by the extending steel bars extending beyond the columns top is shown on Fig. 11.4.13 (38°14'36.51"N, 20°25'41.91"E). The ground floor columns failed due to soft story without infill walls. Figure 11.4.14 shows the crushing of concrete and fracture of the closely spaced, single rectangular hoops of the columns.

Figure 11.4.14. Crushing of concrete and fracture of closely spaced, single rectangular hoops of the columns of the two-story building in Fig. 11.4.13 (38°14'36.51"N, 20°25'41.91"E).

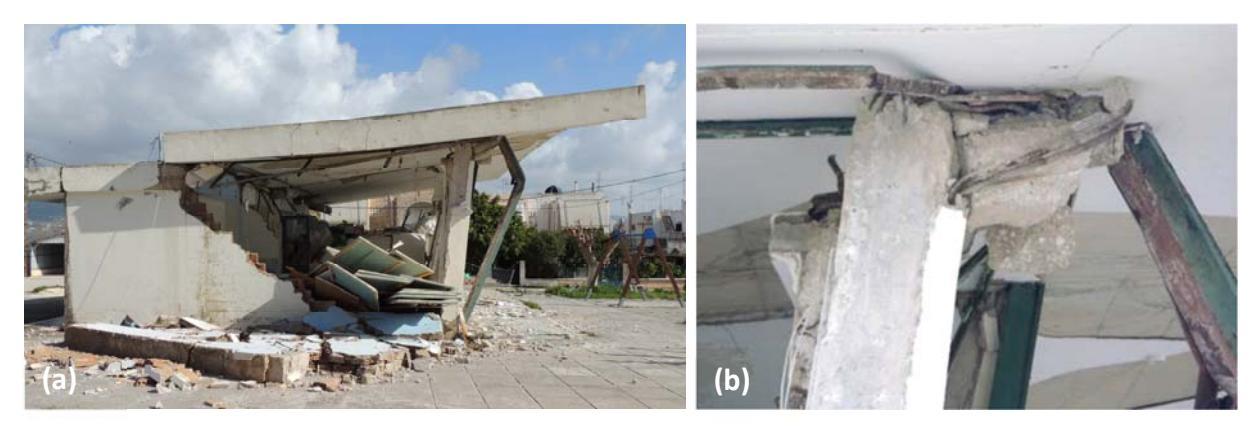
Figure 11.4.17. Single story building in the public housing complex of Fig. 11.4.16 without earthquake resisting frames: (a) damage to the columns; (b) detail of slab-column joint.

(Fig. 11.4.16). The adjacent single-story building, part of this complex, had no earthquake resisting frames and suffered severe damage to the columns and the slab-column joint (Fig. 11.4.17). Nearby, a 2-story residential building of 1978 had severe damage on the ground floor and minor damage on the upper story (Fig. 11.4.18, GPS coordinates 38.211567, 20.434134).

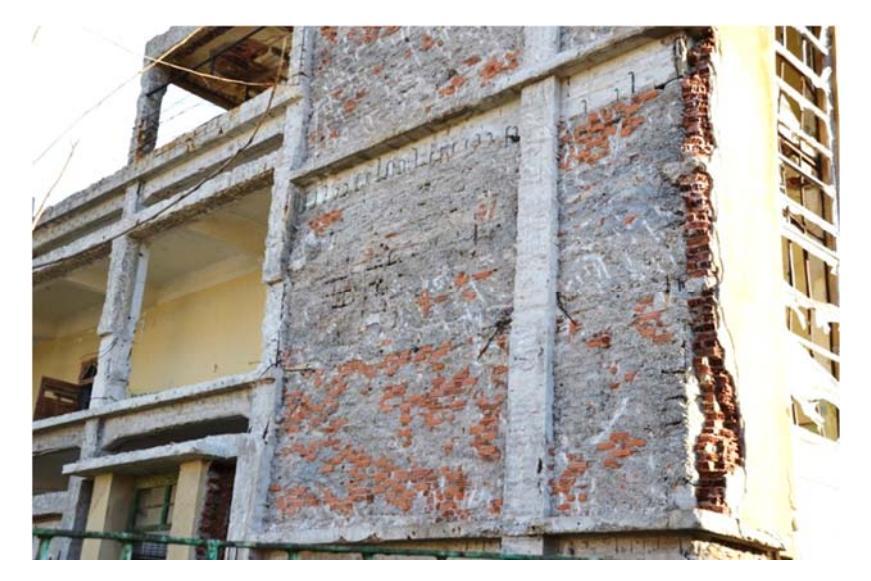
Figure 11.4.20. Typical infill wall construction from the 1960's that incorporates reinforcement with vertical and horizontal rebars that have likely contributed to satisfactory performance of many buildings of that time. This photo shows a building in Lixouri during rehabilitation.

Overall, RC buildings performed well and appear to have redundancy and reserved strength of individual structural members. The reconnaissance teams identified as beneficial factors the structural system regularity, good construction quality, and contribution of the infill walls with vertical and horizontal rebars (Fig. 11.4.20).

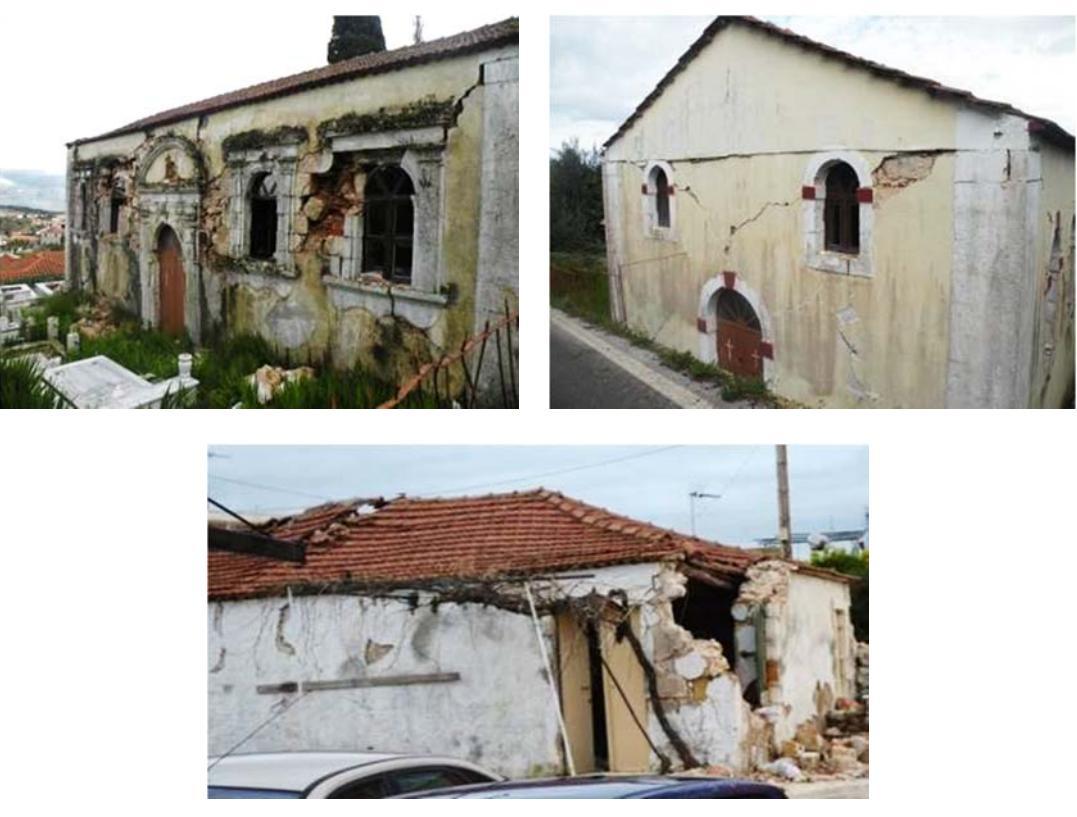
Figure 11.5.5. Typical pre-1953 masonry buildings in Cephalonia.

Damage observed in the pre-1953 buildings includes diagonal cracks on the bearing walls and/or partial collapses. In some cases, cracks were formed during previous earthquakes and were inadequately repaired with a different type of mortar and were aggravated by the 2014 earthquakes. After the 2nd event, many of these structures suffered major damage or collapsed (Fig. 11.5.5: Chavriata 38°11'0.67"N, 20°22'54.93"E; Havdata 38°12'11.62"N, 20°23'09.01"E). This observation was recorded in a small number of structures throughout the island and cannot be attributed to a particular area.

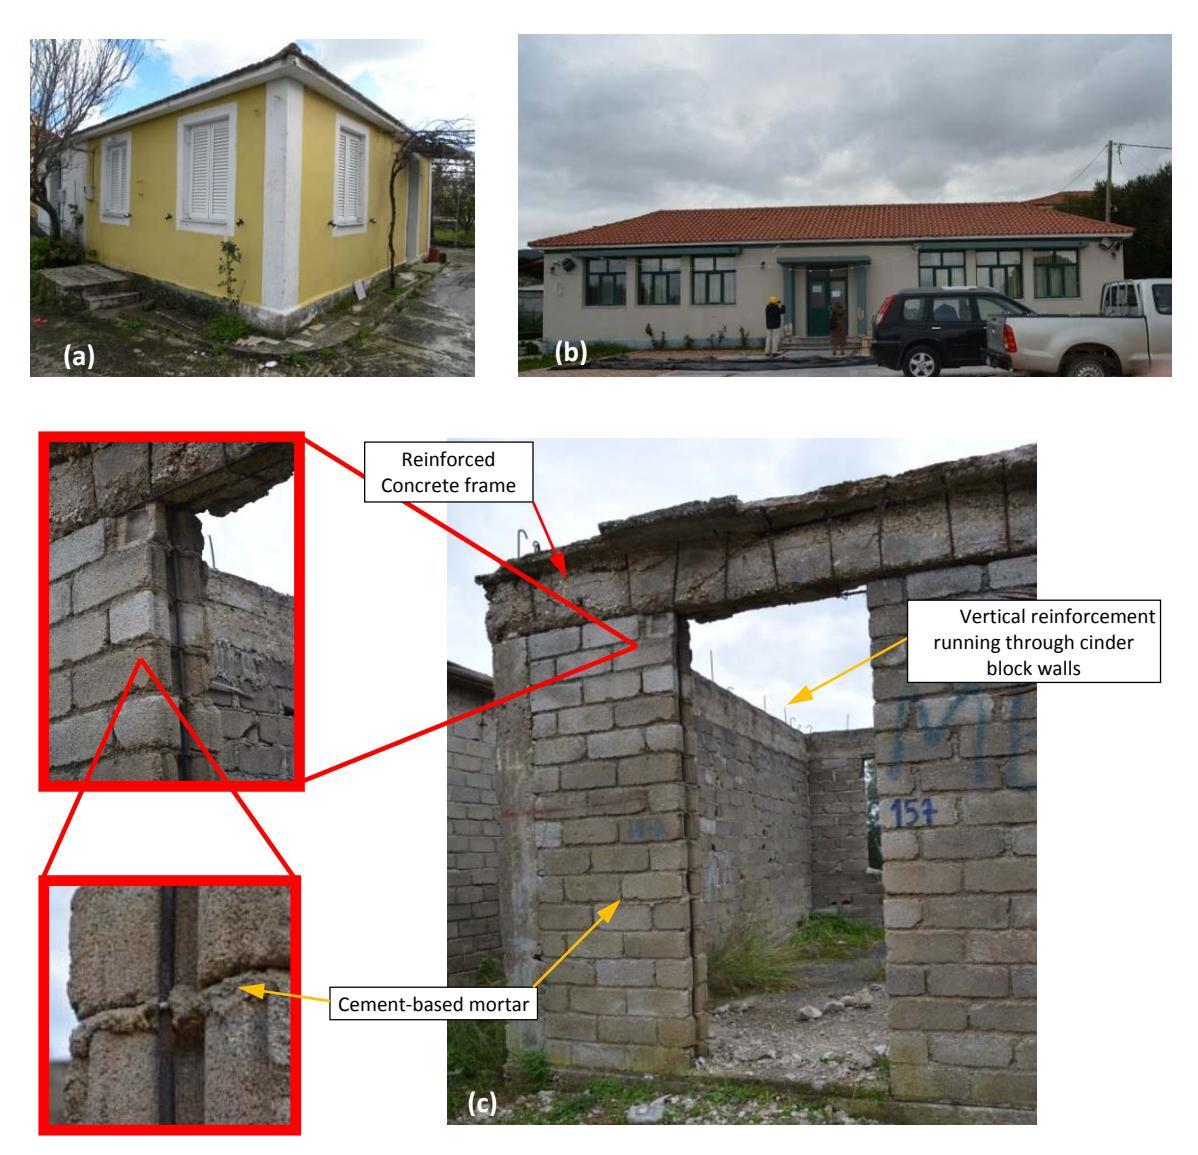
Figure 11.5.7. Arogi-type buildings post-1953: (a) typical Arogi house in Livadi; (b) Chavriata old school (38°11'00.67"N, 20°22'54.93"E) with cinder block construction with recording station CHV1; (c) details of encased reinforced cinder walls with cement based mortar.

Interestingly, the old school building in Chavriata (38°11'00.67"N, 20°22'54.93"E) shown on Fig. 11.5.7b, had the CHV1 station accelerometer installed that recorded a Peak Ground Acceleration PGA of 0.75 ·g with Spectral Acceleration (SA) of almost 3 g during the 2nd event (Fig. 11.5.4). The construction of this house is typical of the Arogi type (i.e., load carrying steel-reinforced cinder block walls). In a radius of 45 to 52 m from the CHV1 station (as shown on Fig. 11.5.8a), the following observations were made: (i) Arogi house of Fig. 11.5.7c (52 m away from the CHV1); (ii) partially collapsed masonry house showed of Fig. 11.5.8b; (iii) 2-story structure of Fig. 11.5.8b with no damage. Figure 11.5.9 shows the exterior and interior damage of the old school building in Chavriata, where CHV1 is located.

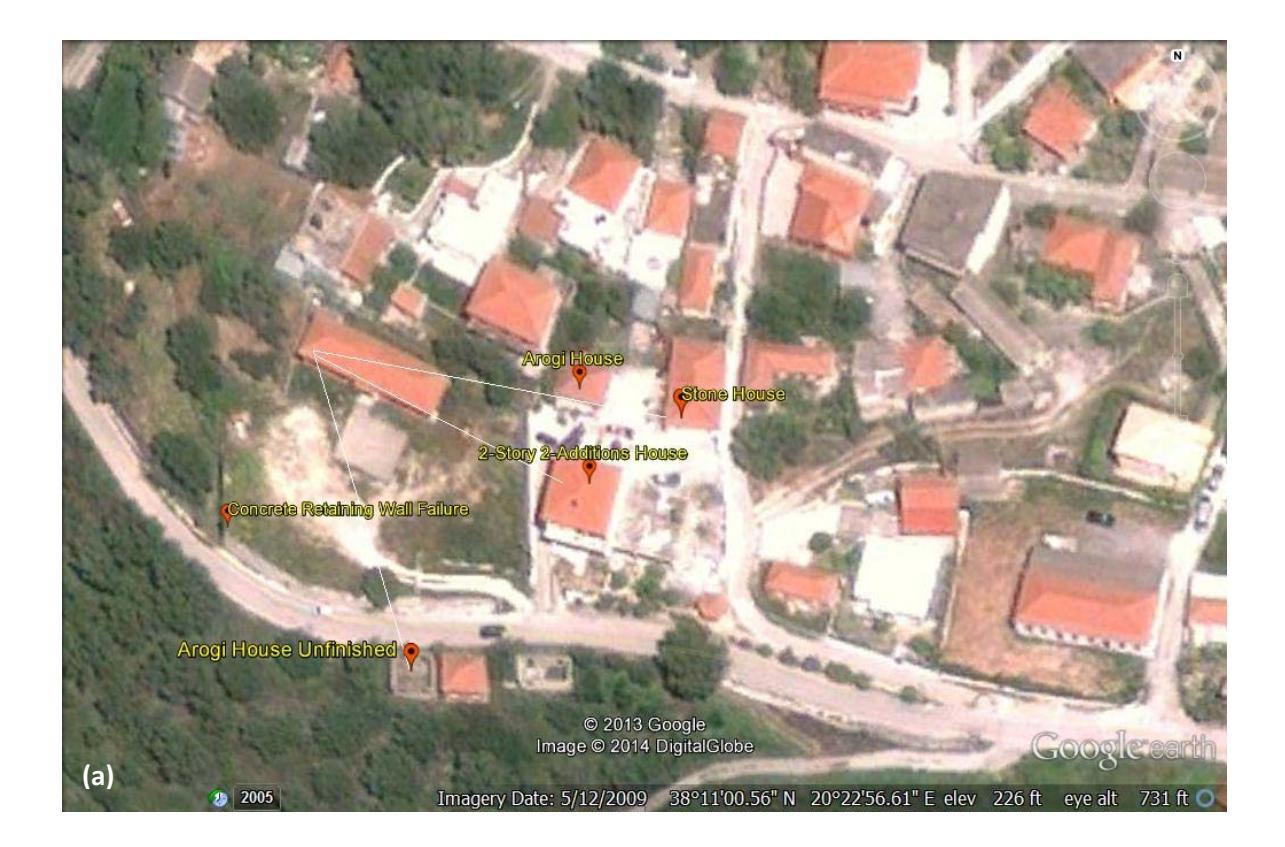
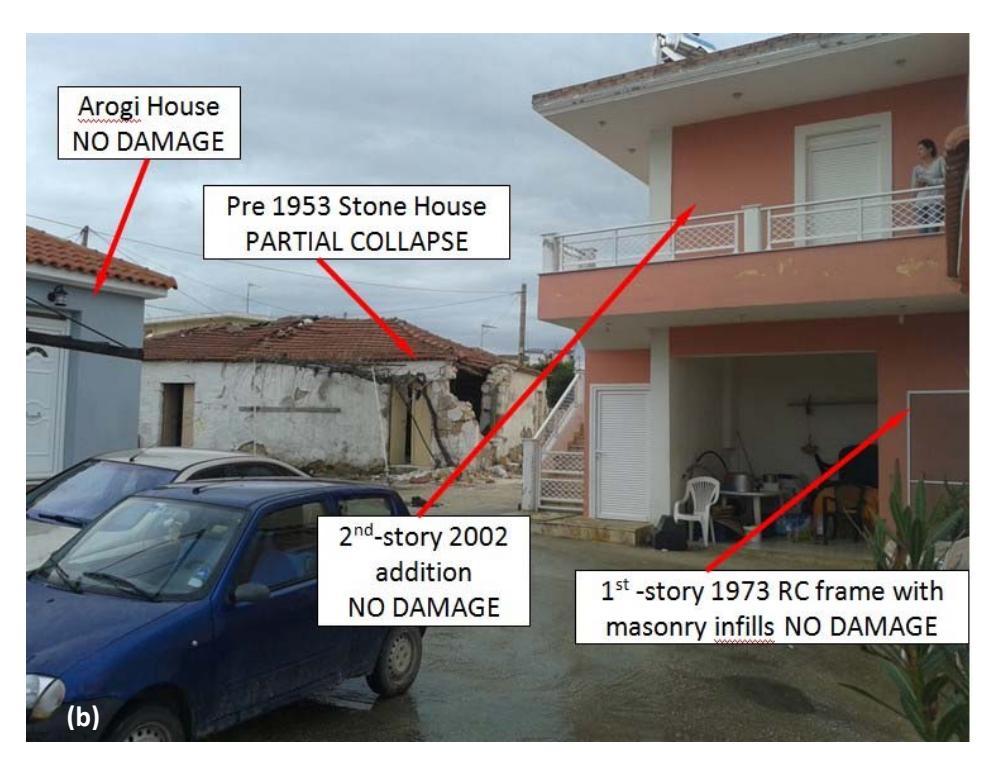
Figure 11.5.8. (a) Locations of CHV1 accelerometer in Chavriata old school building (38°11'00.67"N, 20°22'54.93"E) and four buildings within 45 to 52 meters around it; (b) three buildings east of CHV1: partially collapsed stone house, Arogi house, and two-story RC building.

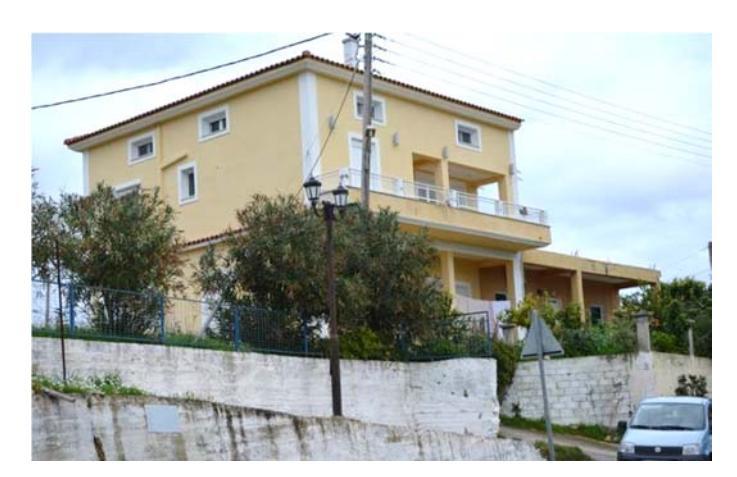
Figure 11.5.10. Two-story reinforced concrete frame building next to the old school in Chavriata, 45 m from the CHV1 station (38°11'0.67"N, 20°22'54.93"E) that experienced no structural damage.

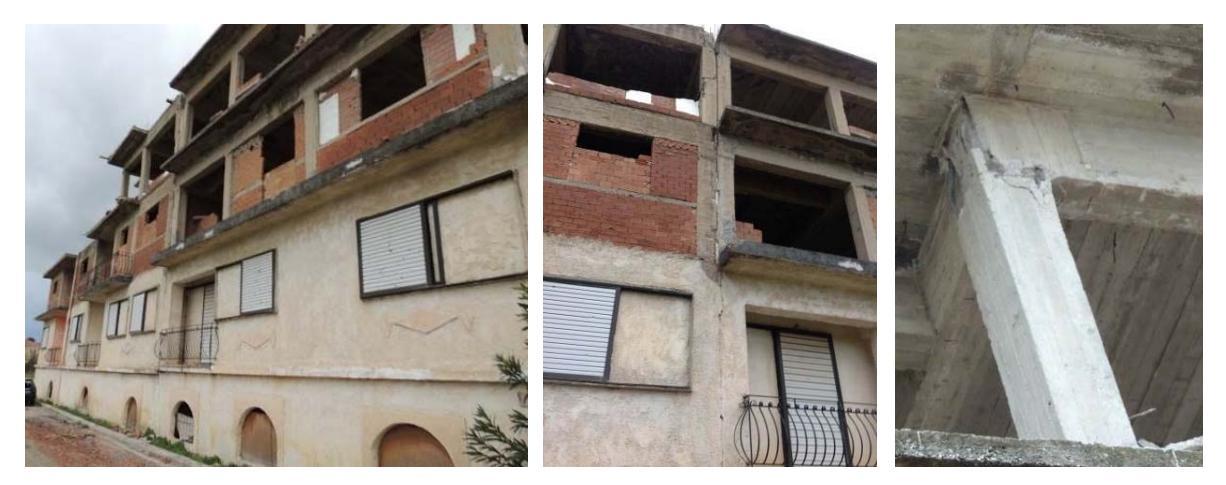
Figure 11.5.11. Three-story building in Lixouri (with partial 4-story extensions) probably constructed before 1984 following the 1959 code (38°12'14.17"N, 20°26'01.45"E). Collapse of some infill walls on 3rd and 4th floors (incomplete, no door/window frames) and cracks at column-beam joints on 4th floor.

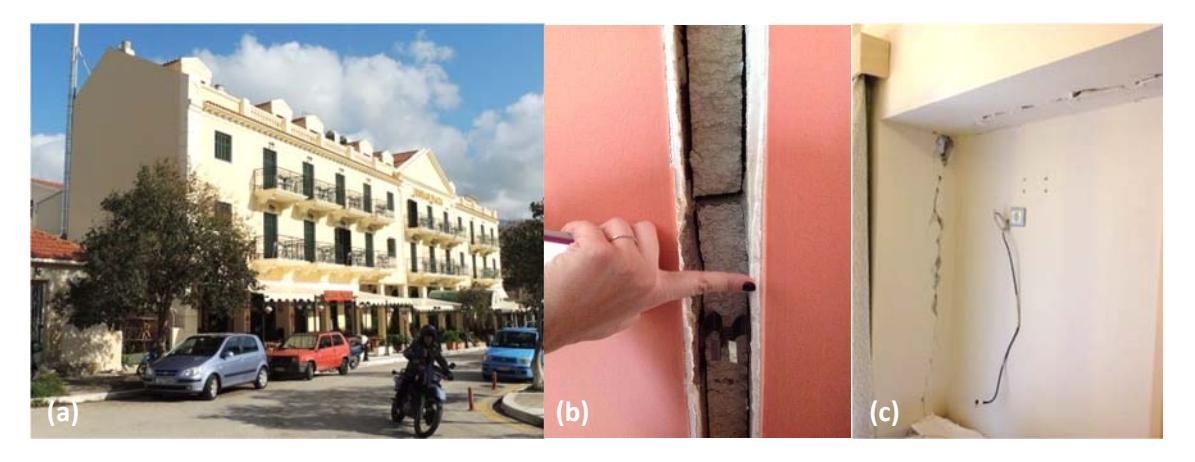
For example, Fig. 11.5.13 shows observations at the three-story Palatino Hotel in Argostoli $(38^{\circ}10'80.00"N, 20^{\circ}29'14.40"E)$. The three-story building has one basement level and it consists of two parts with dimensions $23m \times 12m$ and $23m \times 14m$, separated by a thermal expansion joint that opened during the earthquakes (Fig. 11.5.9b). The building had some nonstructural damage in contents and infill walls.

Figure 11.5.13. (a) Three-story hotel building in Argostoli ($38^{\circ}10'80.00"N$, $20^{\circ}29'14.40"E$) designed in 1989 using the supplementary provisions to the 1959 building code; (b) width of the construction join opening; (c) broadening of joint after the 2^{nd} event.

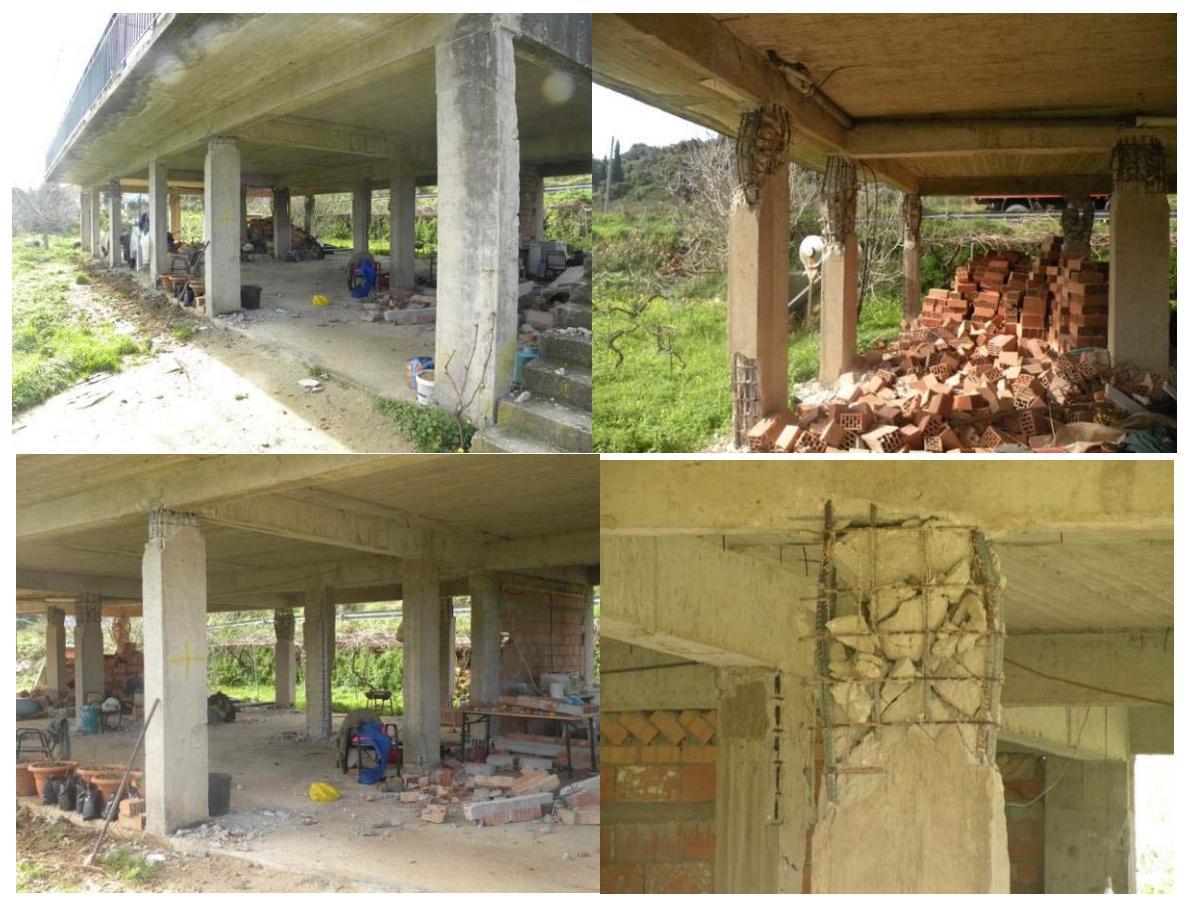
The two-story building of Fig. 11.5.14 is located in Aghios Dimitrios (38°14'36.51"N, 20°25'41.91"E). It has a reinforced concrete frame structure designed to accommodate three stories, although only two of them are built. The ground floor does not have infill walls (soft story). Reconnaissance teams observed soft story failure with disintegration of concrete and fracture of the closely spaced, single rectangular hoops of the columns. The further away columns were from the stair, the greater the building rotation and the column damage.

Figure 11.5.14. Two-story RC frame with infills in 2nd story in Aghios Dimitrios (38°14'36.51"N, 20°25'41.91"E). The building plan is rectangular with one side twice as long as the other.

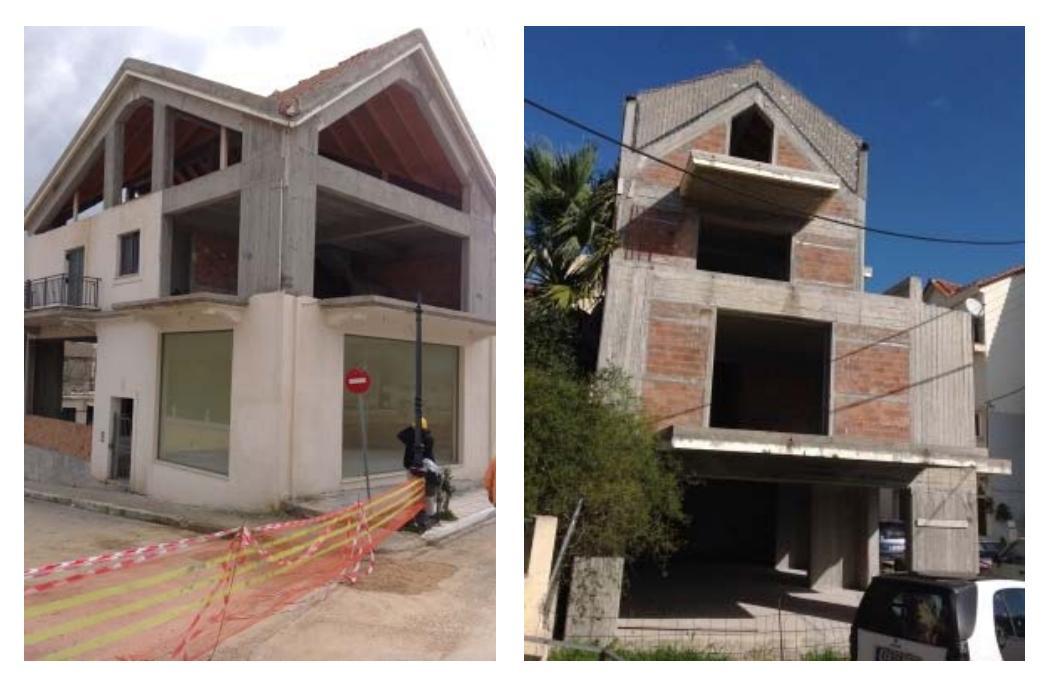
Given that Cephalonia is in the highest of the three seismic zones in Greece, the current seismic code EAK-2000 does not allow soft stories (open ground floors). The vast majority of structures built using the current code behaved well with practically no damage at all (including no damage to infill walls). Figure 11.5.15 shows typical examples of these newer buildings in Lixouri.

Figure 11.5.15. Typical buildings in the city of Lixouri designed according to the current seismic code EAK-2000 had no visible damage.

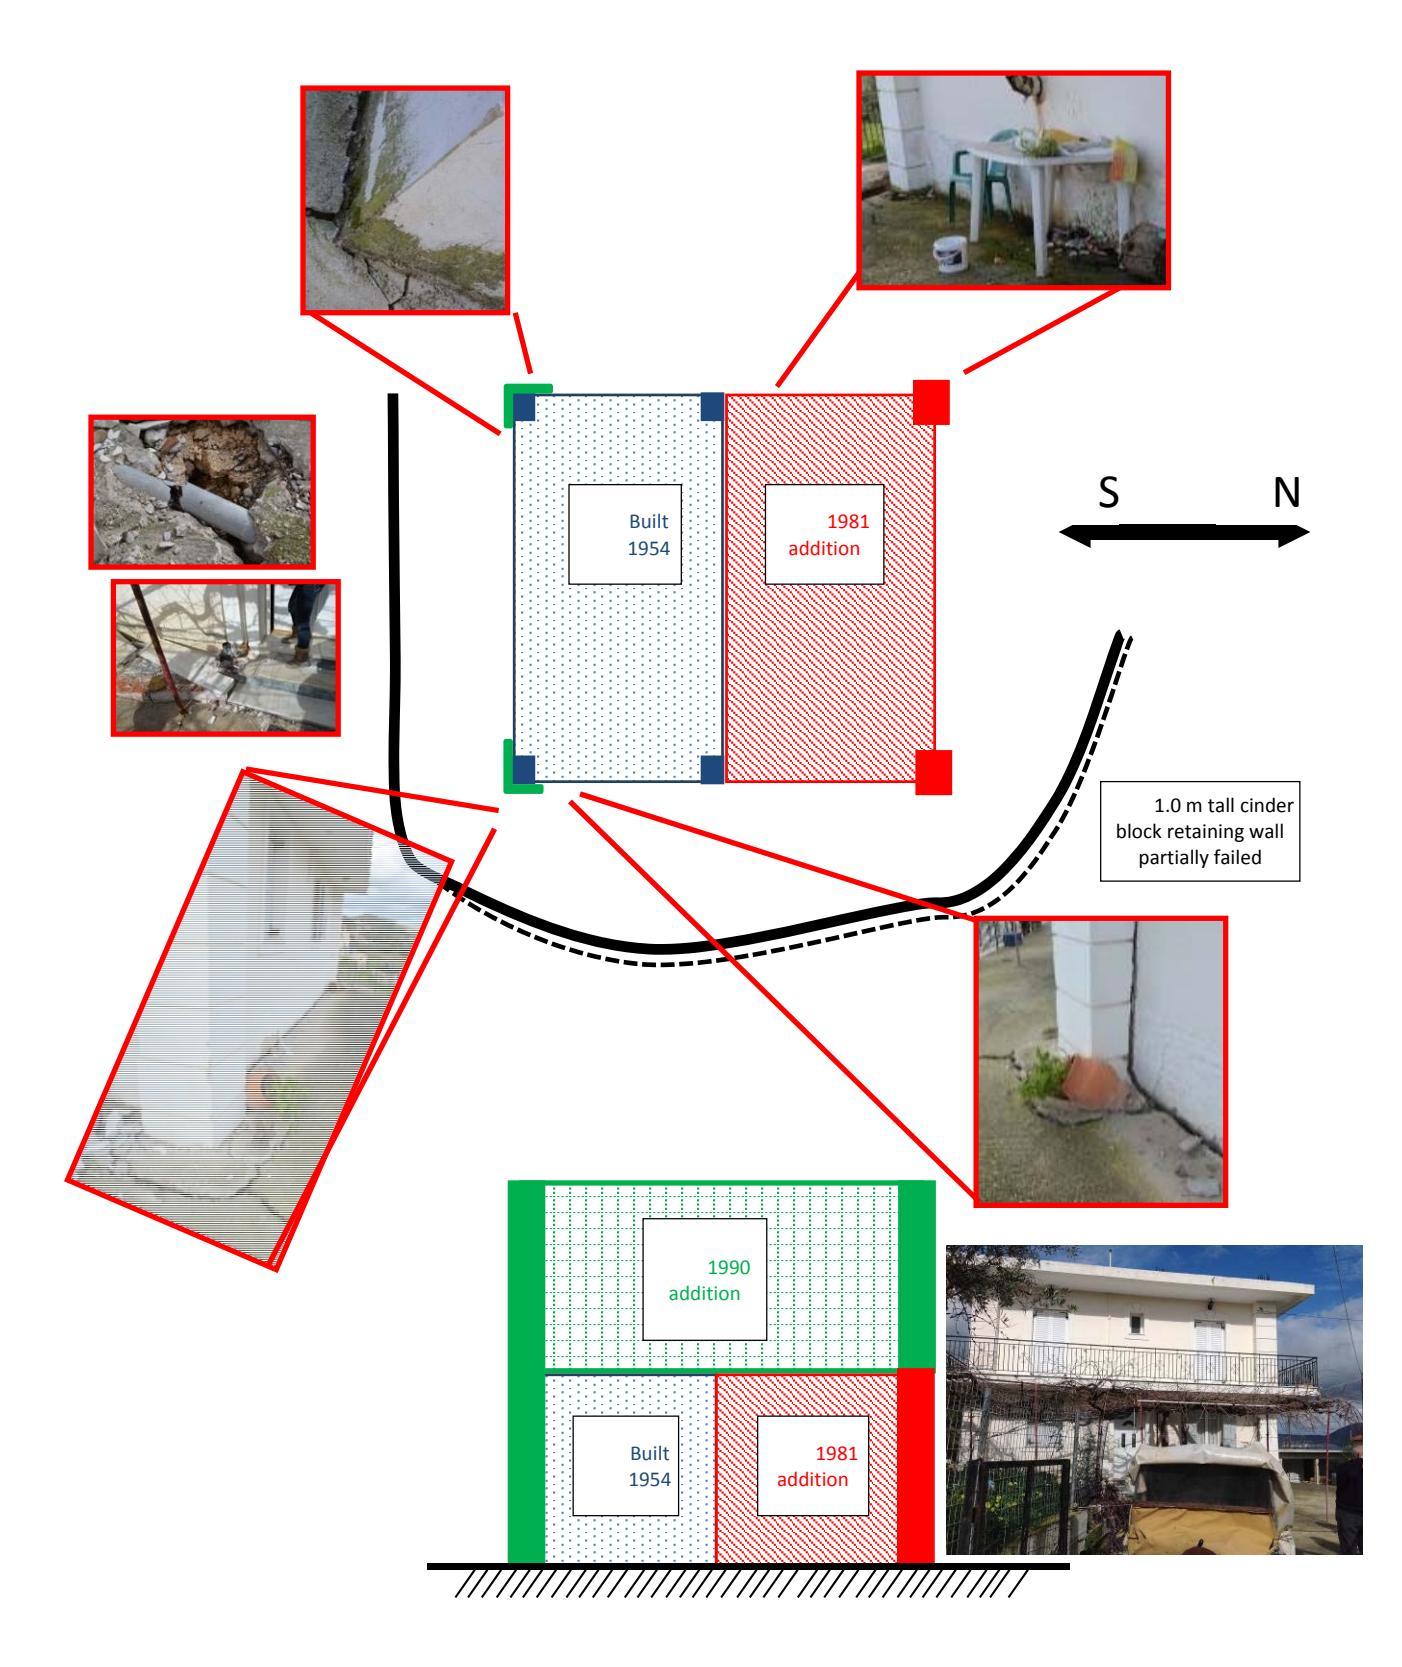
<u>Case 2:</u> Figure 11.6.2 shows photos and a sketch of the plan and side views of a building in Aghios Dimitrios (38°14'36.51"N, 20°25'41.91"E) which was constructed in three phases. The 1st phase was an Arogi house built in 1954, the 2nd phase was a lateral addition completed in 1981, and the 3rd phase was a 2nd floor addition built in 1990. This structure suffered no structural damage. It appears that the building was founded on backfill soil supported by a 1-m tall cinder-block retaining wall (black line on Fig. 11.6.2). The retaining wall failed and the whole structure displaced 1-2 cm towards the dashed line. Due to the fact that the L-shaped (green color) columns on the south side of the structure were founded on isolated spread footings, the columns were separated from the old Arogi house columns by approximately 1 cm at the bottom as shown on the lower left part of the figure.

Figure 11.6.2. Top: sketch of the building plan view in Aghios Dimitrios (38°14'36.51"N, 20°25'41.91"E) and pictures showing the structure and its connection to the foundation. Bottom: sketch of the building elevation. Colors indicate the three phases of the construction.

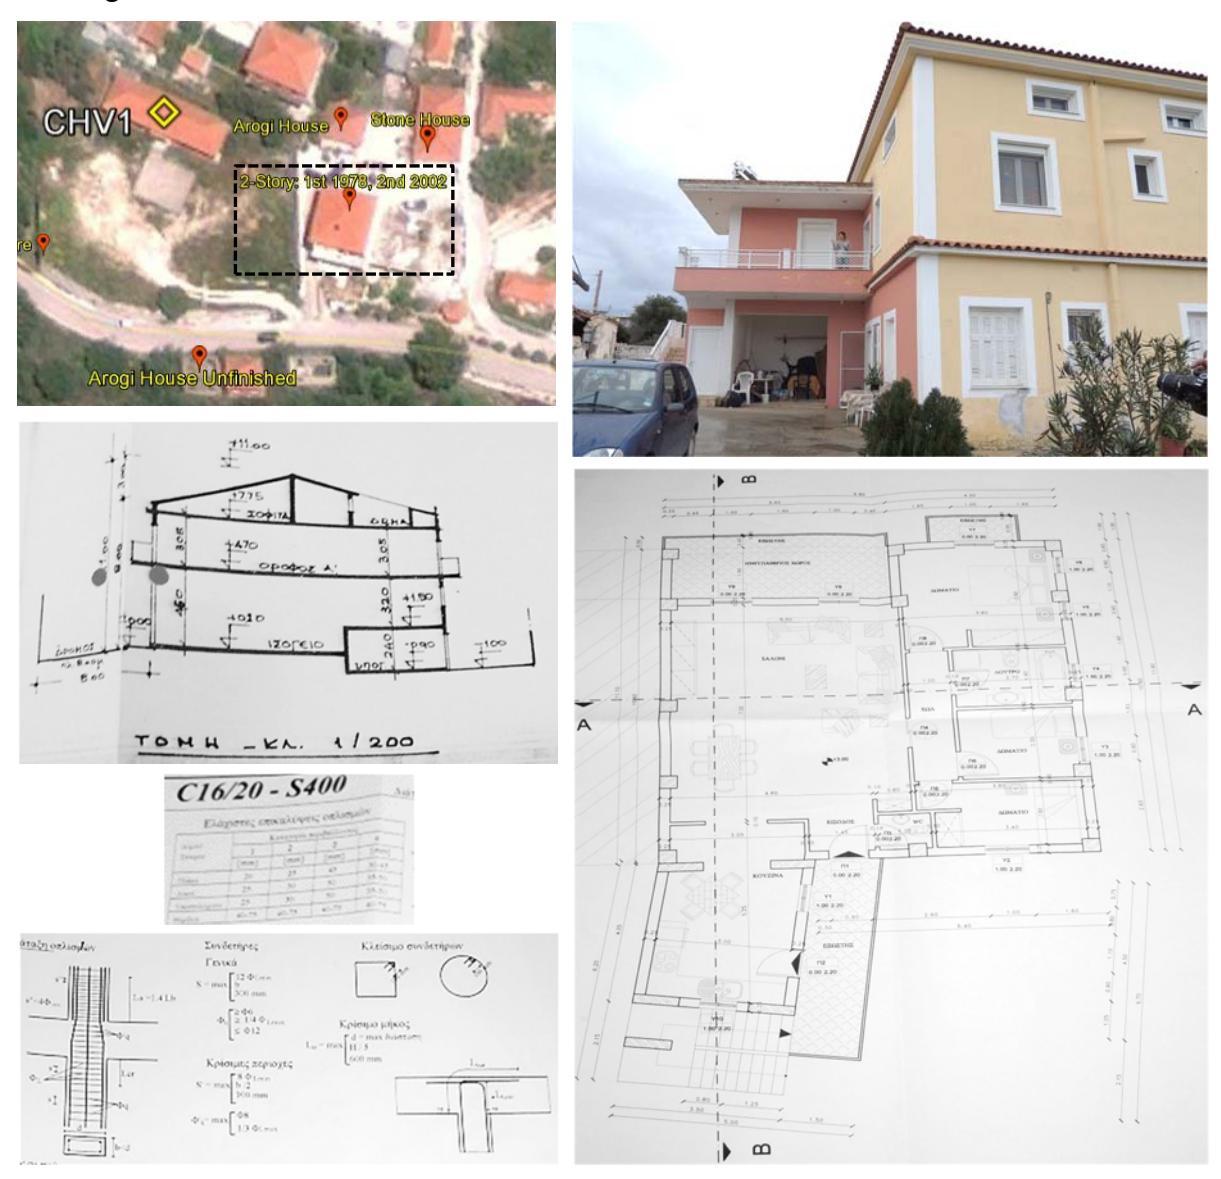
Figure 11.6.5. Typical drawings collected for the 2-story RC building shown on Fig. 11.5.7, about 50 m from CHV1 accelerometer in Chavriata (38°11'00.67"N, 20°22'54.93"E). Construction was done in two phases, in 1978 with an addition in 2000. The building suffered no visual structural damage.

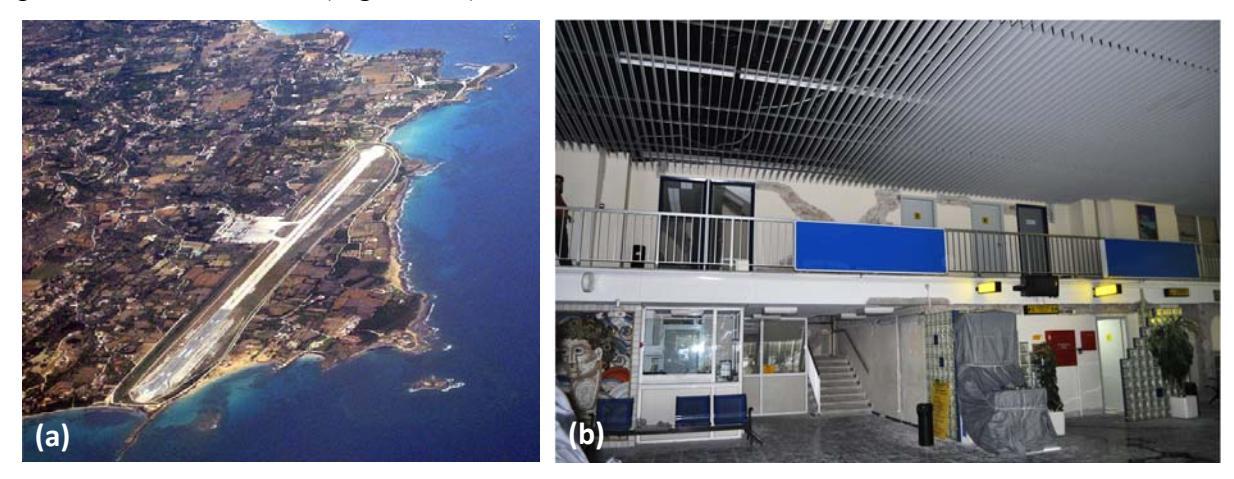
The Cephalonia International Airport terminal building (ID #14, coordinates 38°7'10.0"N, 20°30'17.7"E) suffered nonstructural damage, described in detail in Section 11.9. The interior masonry walls cracked and parts of the roof cladding fell. The terminal remained closed to the public for three weeks. (Fig. 11.7.1)

Figure 11.7.1. Cephalonia International Airport terminal building (ID #14, coordinates 38°7'10.0"N, 20°30'17.7"E): (a) aerial photo; (b) nonstructural damage after the 2014 events resulted in closing the terminal for three weeks.

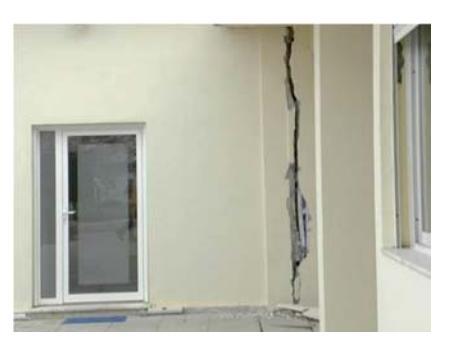
the overall bay area. Settlements of 5 to 10 cm and tilting of 0.7° were measured. Construction joints with adjacent buildings opened by up to 5 cm (Fig. 11.7.3).

Figure 11.7.3. Open construction joint at Argostoli Port Authority (ID#8 in Table 11.7.1; coordinates 38°10'44.8"N, 20°29'23.3"E).

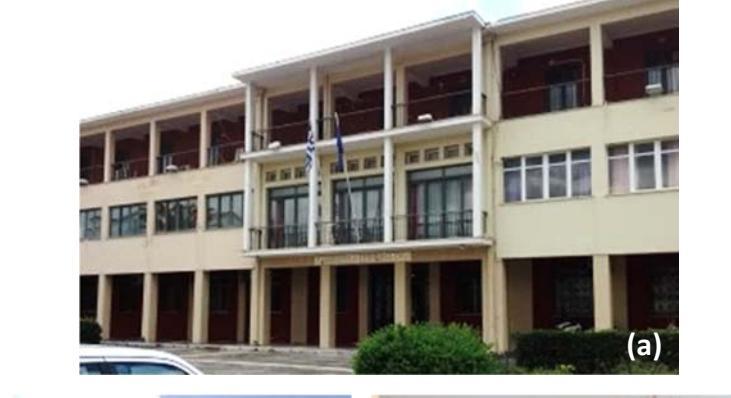
Examples of public buildings with satisfactory structural responses include a three-story building of the Prefecture (ID #13) constructed in 1957 which exhibited only a limited number of hairline cracks in the infill walls and a two-story building of the Court House in the center of Argostoli (ID #4, coordinates 38°10'37"N, 20°29'18"E), constructed in 1962 (Figure 11.7.7).

Figure 11.7.7. Examples of satisfactory behavior of Argostoli administrative public buildings: (a) Prefecture building (ID #13); and (b, c) Court House (ID #4, coordinates 38°10'37"N, 20°29'18"E).

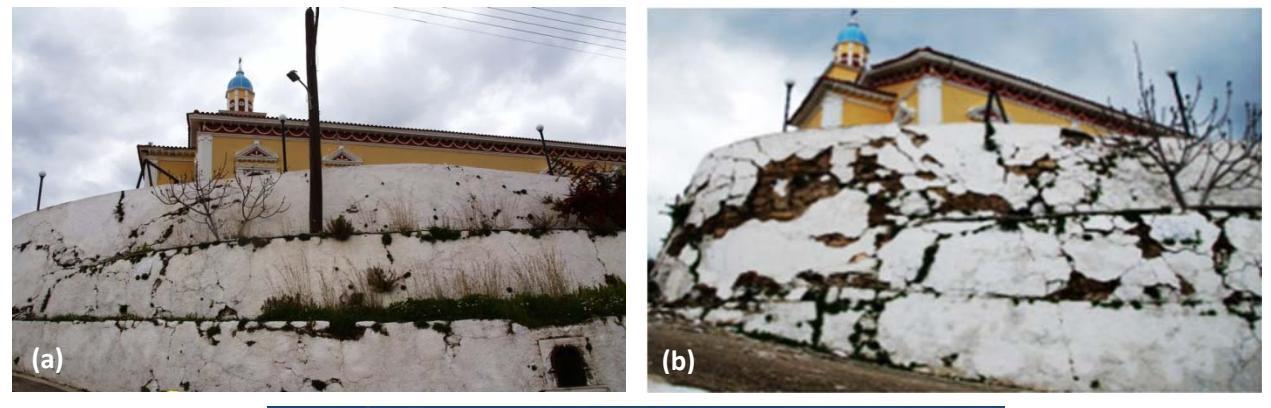
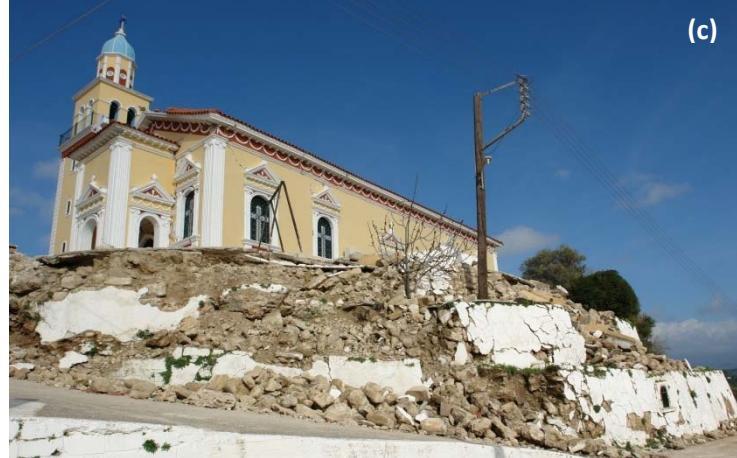
Figure 11.8.6. Collapse of masonry retaining wall at courtyard of The Virgin Mary church at Chavriata (ID#1 38°10'57.47"N, 20°23'14.4"E): (a) condition before the 2014 events; (b) damage after 1st event; (c) collapse after 2nd event.

Other general observations of damage include: (i) partial failure or collapse of retaining walls in the church perimeter (Fig. 11.8.6); (ii) complete or partial collapse of many belfries (Figs 11.8.13 and 11.8.14); (iii) moderate roof damage with falling tiles (Fig. 11.8.15) and severe nonstructural components damage (Fig. 11.8.16), which could have caused human injuries or loss of life that fortunately did not take place due to the time the earthquakes hit.

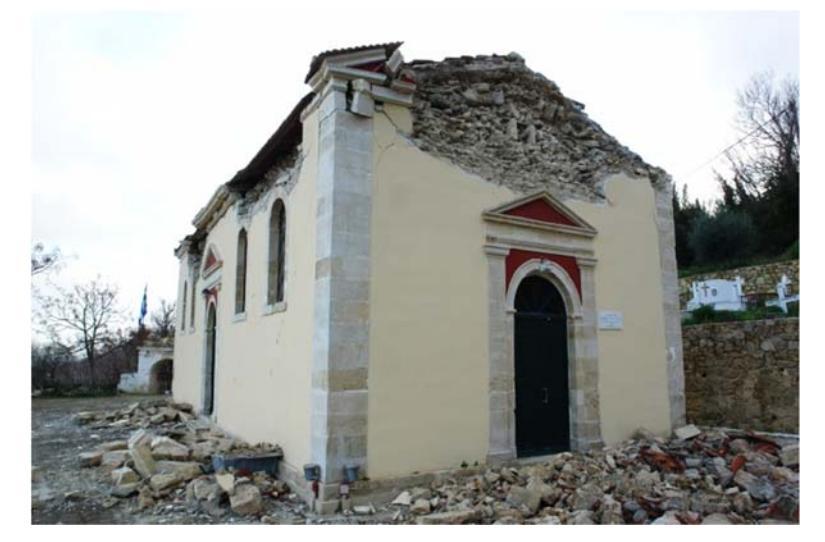
Figure 11.8.10. Typical damage in Category 5 churches: Collapse of the outer stone leaf of the west gable, at a church strengthened with internal RC wall.

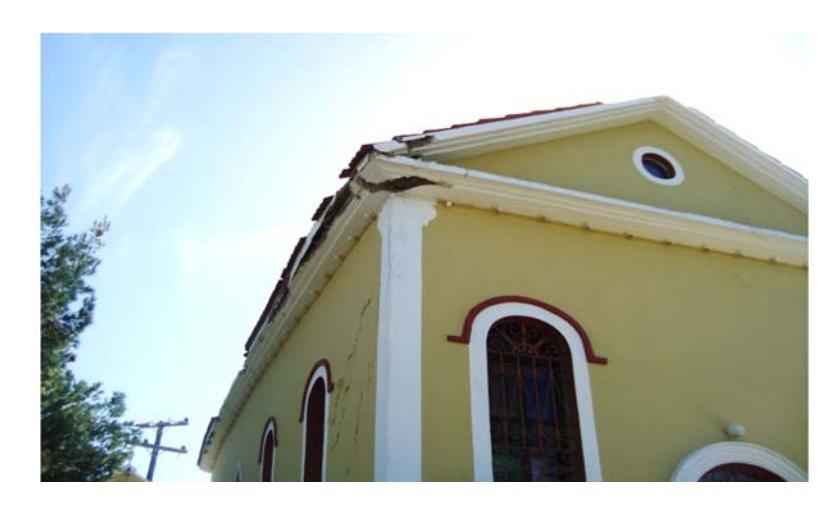
Figure 11.8.12. Damage in Category 7 church: Permanent out of plane displacement of approximately 7 cm at the top of the walls along the long sides of the structure.

- Category 6 churches suffered slight damage with shear cracks in the nonstructural walls.
- Category 7 churches typically experienced out of plane permanent displacement of the wall top along the long sides of the structure (Fig. 11.8.12).
