CHAPTER 11 Structural Observations

GEER/EERI/ATC Cephalonia, Greece 2014 Report Version 1

11.1 Main Structural Observations

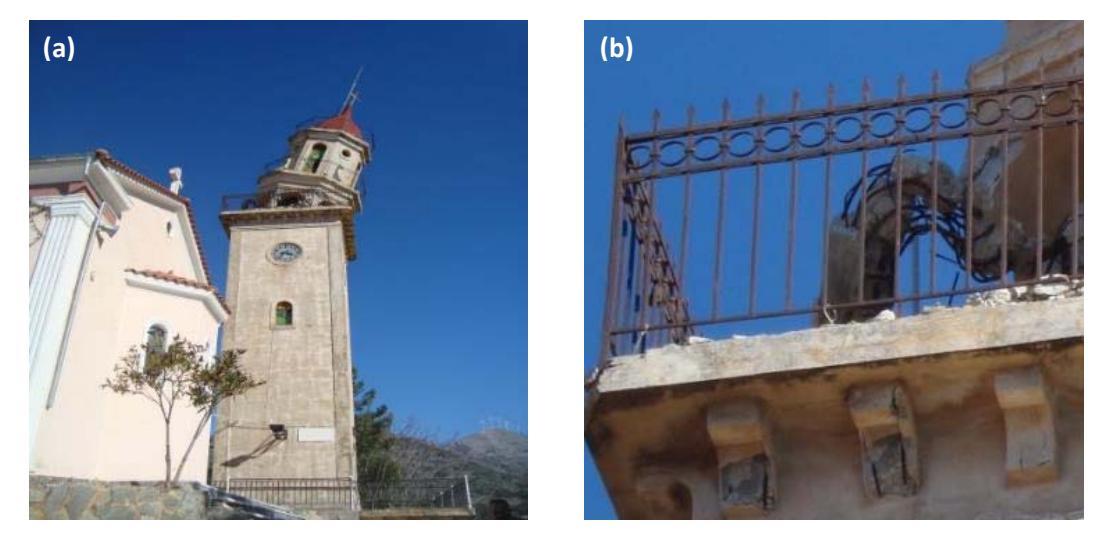
Figure 11.8.13. (a) Collapse of RC belfry top due to column failure (38°14'32.25"N, 20°28'26.40"E); (b) Detail of deformed rebars.

Other general observations of damage include: (i) partial failure or collapse of retaining walls in the church perimeter (Fig. 11.8.6); (ii) complete or partial collapse of many belfries (Figs 11.8.13 and 11.8.14); (iii) moderate roof damage with falling tiles (Fig. 11.8.15) and severe nonstructural components damage (Fig. 11.8.16), which could have caused human injuries or loss of life that fortunately did not take place due to the time the earthquakes hit.

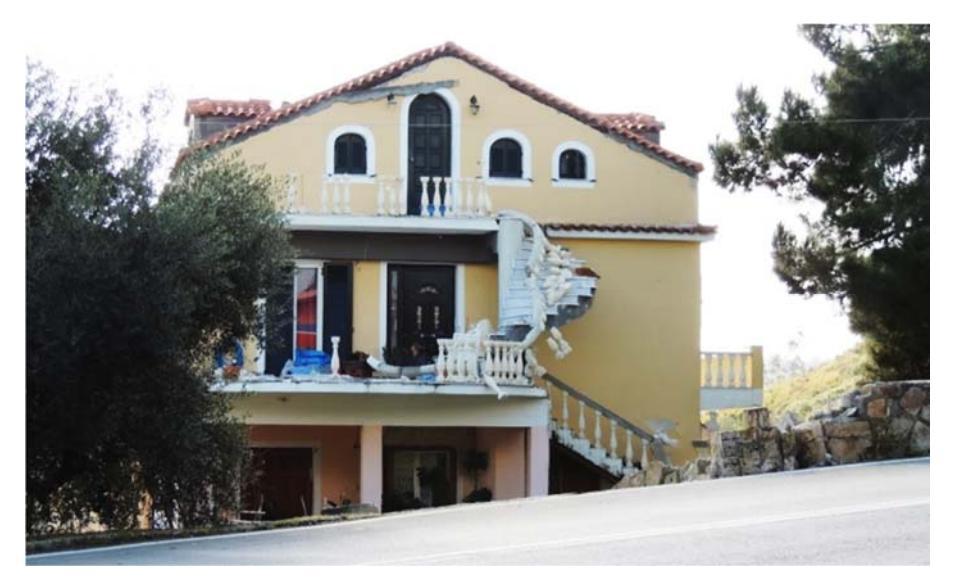
Egress Means – Stairs: As the primary means of egress, the performance of stairwells is critical following an earthquake. Observations of damage in stairways often involved lack of rolling supports at either end to accommodate interstory drift. Failure of base anchorage occurred in heavy railings, as shown in Figure 11.9.1.

Figure 11.9.1. Base anchorage failure at heavy stair railings in Lixouri.

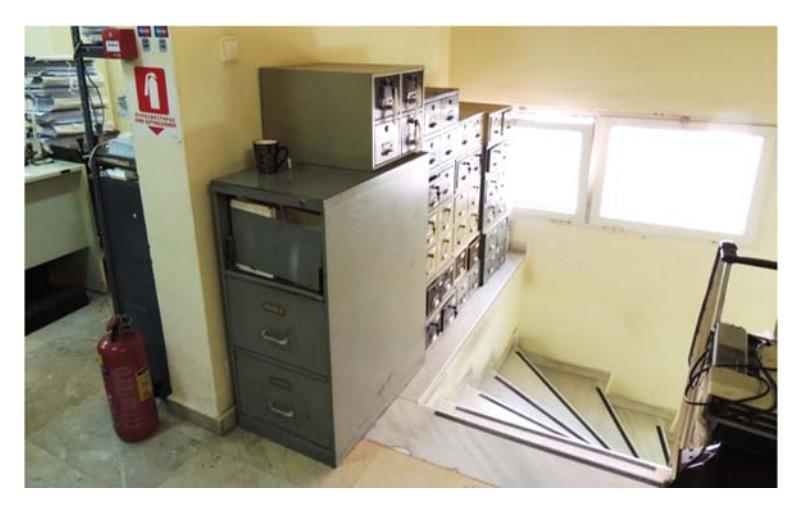
Large, heavy contents along egress routes could potentially fall over or block pathways and exits. Figure 11.9.2 shows a series of unbraced filing cabinets and storage units that could tip over and restrict access to the adjacent stairwell (38°10'27.3"N, 20°29'26.4"E).

Figure 11.9.2. Heavy, unbraced storage units with the potential to block means of egress in the National Bank branch of Lixouri. (GPS coordinates: 38°10'27.3"N, 20°29'26.4"E).

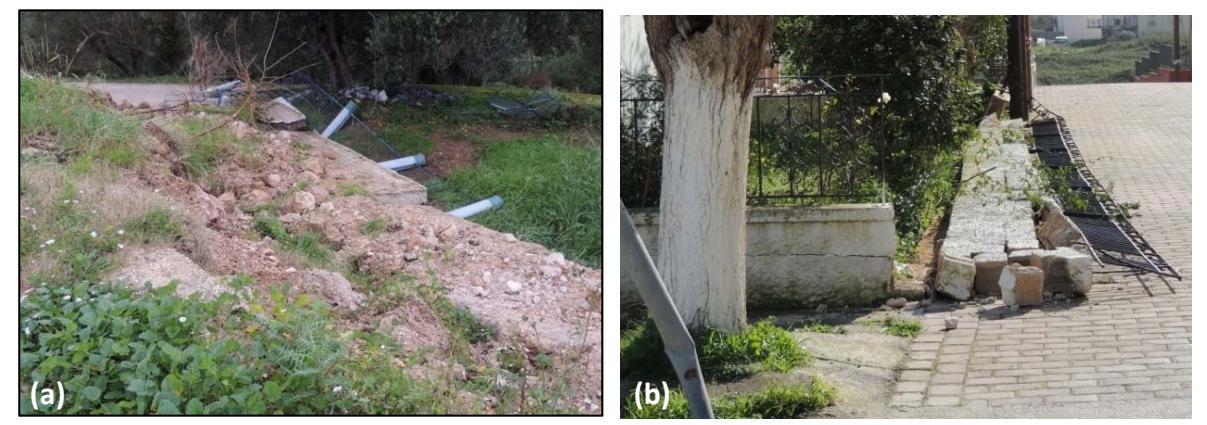
Freestanding fences experienced collapse from rotation due to lack of foundations or reinforcement. Figure 11.9.3 shows observed damage to fences not anchored to the ground.

Figure 11.9.3. Freestanding fences without foundations or reinforcement were damaged. (GPS coordinates: (a) 38°11'0.8"N, 20°22'53.9"E, (b) 38°12'41.0"N, 20°26'1.4"E).

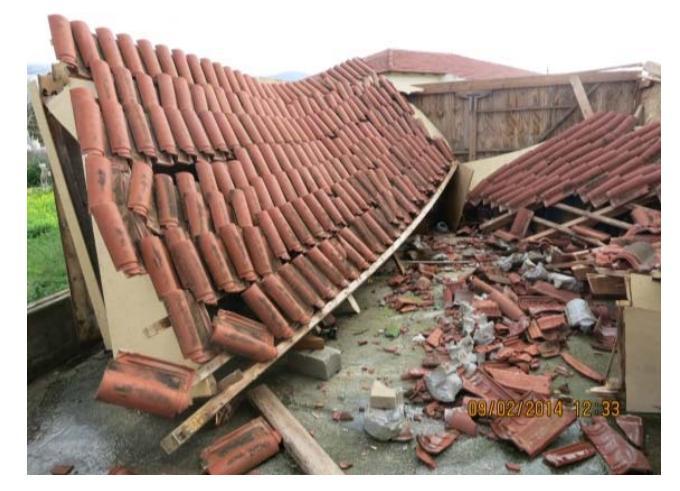
Figure 11.9.11. Collapse of tiled roof. Photo by V. Plevris of ASPETE team.
Significant damage to parapets due to lack of bracing and pounding with adjacent buildings during the earthquake events was observed in Lixouri as shown on Figure 11.9.12. Chimneys also typically did not have proper bracing or anchorage to withstand the shaking caused by the earthquakes.

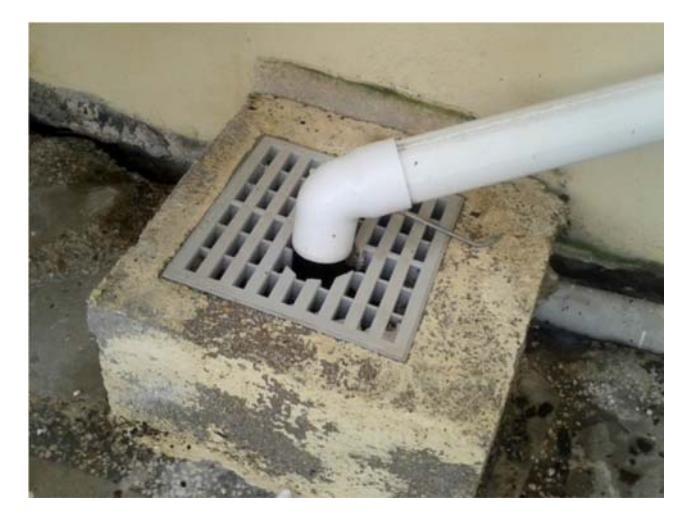
At a 2-story Reinforced Concrete (R/C) building located near the shore south of Lixouri (38°11'36.08"N, 20°26'19.90"E), free-field soil settlement was observed in addition to the collapse of its chimneys and roof tiles. Figure 11.9.15 shows a drainage pipe that was dislocated from its collective pool as a result of surrounding ground settlement.

Figure 11.9.15. Dislocated drain pipe at the perimeter of a 2-story R/C building located near the shore south of Lixouri. (GPS coordinates: 38°11'36.08"N, 20°26'19.90"E).

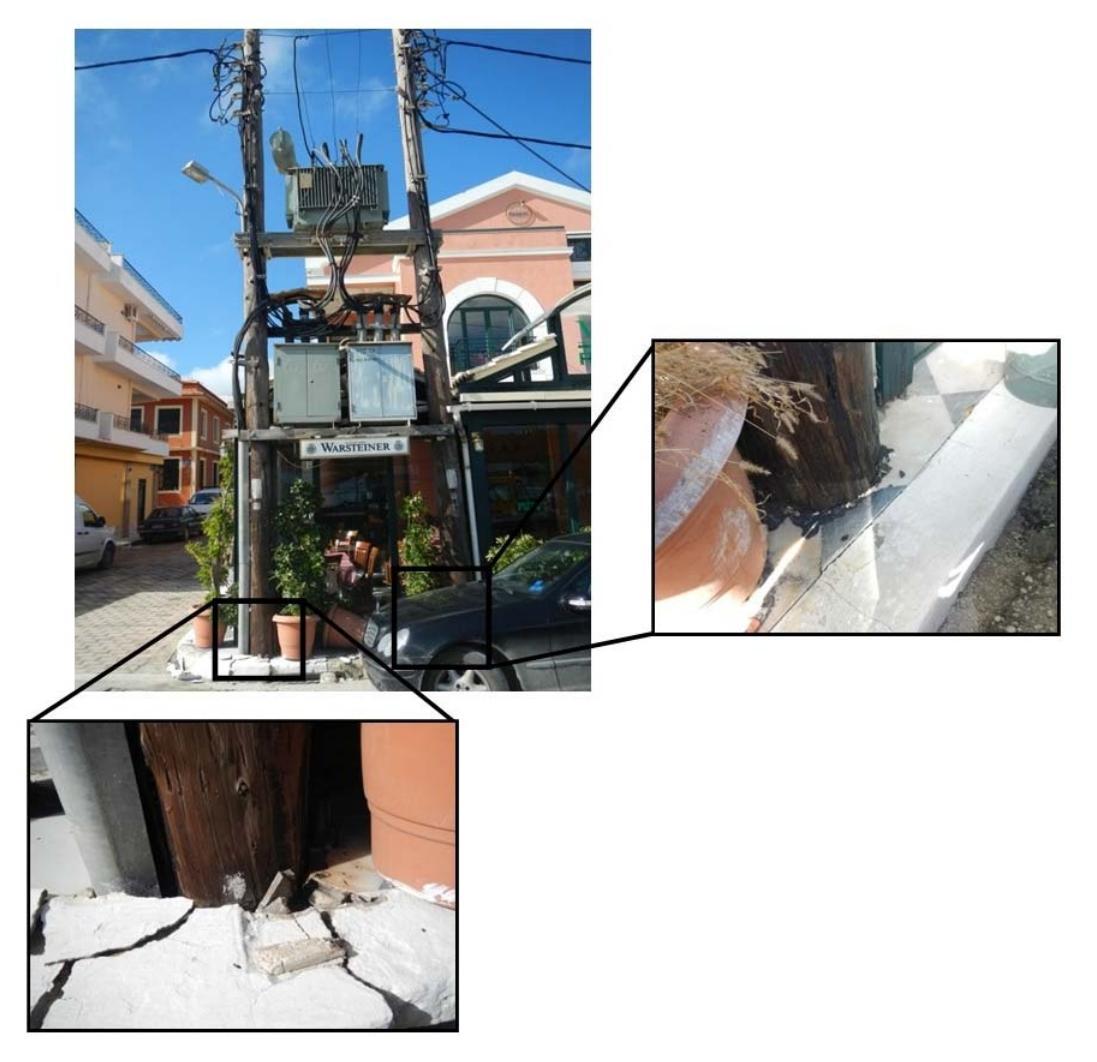
Transformers: A power transformer pillar in Lixouri (38°11'55.63"N, 20°26'20.56"E) suffered differential settlement (Fig. 11.9.19). One of the support columns appeared to have punched in the ground for 1.7 cm, while the other one remained in place. This behavior could partially be attributed to Soil-Structure Interaction (SSI) effects, as discussed in Chapter 8.

Figure 11.9.19. Differential settlement in power transformer pillar (GPS coordinates: 38°11'55.63"N, 20°26'20.56"E). See also SSI Section of Chapter 8.

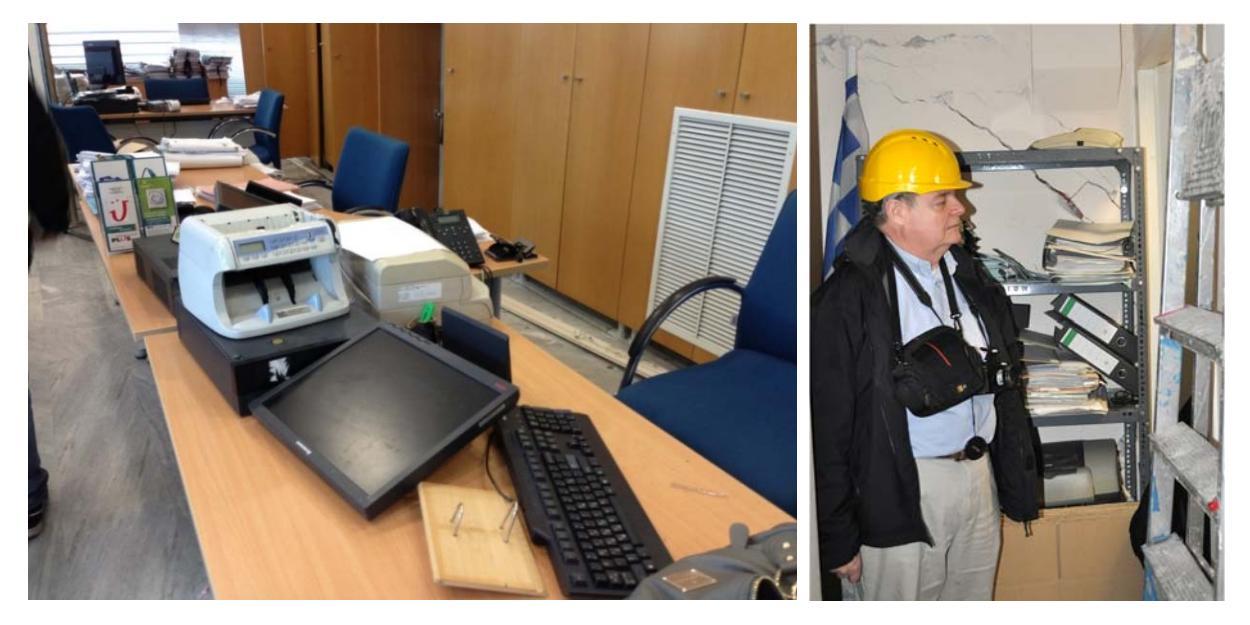
Desktop computers, printers, and other accessories were not anchored or tethered. Figure 11.9.20 (38°12'8.4"N, 20°26'17.4"E) shows how many of these items were displaced or fell onto one another.

Figure 11.9.20. Desktop computers and accessories without anchorage or support. Team member Ramon Gilsanz of GMS in the photo (GPS coordinates: 38°12'8.4"N, 20°26'17.4"E).

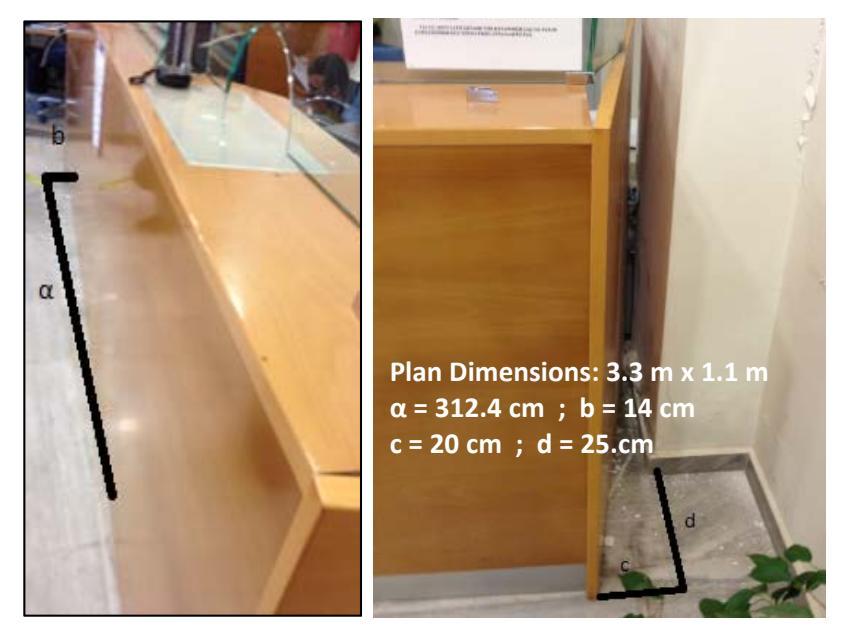
Heavy office furniture experienced rotational movement due to lack of floor connections. The displacement of a bank teller desk is calculated on Figure 11.9.22 and shows the dimensions of the unit and the direction of movement in relation to its original position.

Figure 11.9.21. Rotational movement of a heavy bank teller desk with no anchorage (GPS coordinates: 38°12'6.6"N, 20°26'17.4"N).

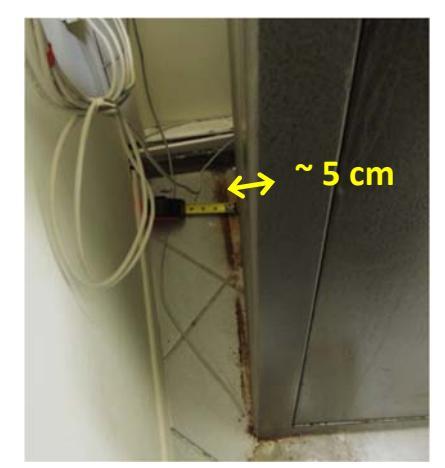
Figure 11.9.24. Rotational movement of heavy bank vault at the Eurobank branch of Argostoli. (GPS coordinates: 38°10'29.4"N, 20°29'28.2"E).

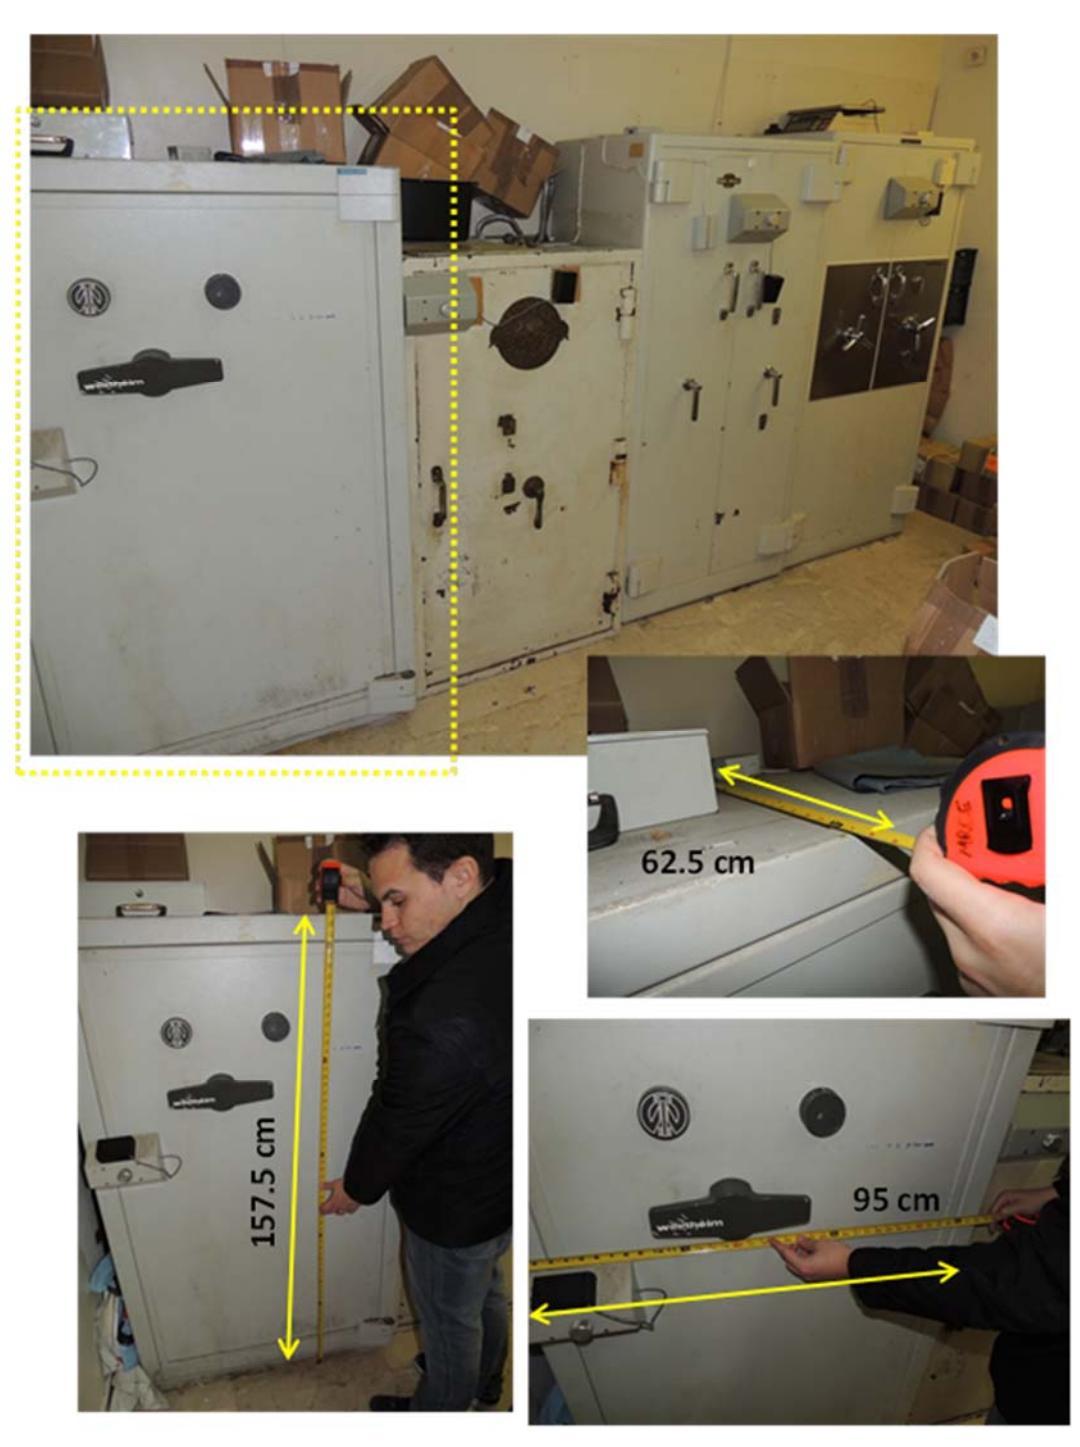
A row of heavy vaults at the Eurobank branch of Argostoli (38°10'29.4"N, 20°29'28.2"E) were not anchored or braced to one another and experienced rotational displacements of approximately 2.5 cm. The dimensions recorded for one of the vaults are given in Figure 11.9.25.

Figure 11.9.25. Measurements taken (by Dimitri Kopanos of Easy Facilities team) at a row of heavy vaults at the Eurobank branch of Argostoli show approximately 2.5 cm of displacement. (GPS coordinates: 38°10'29.4"N, 20°29'28.2"E).

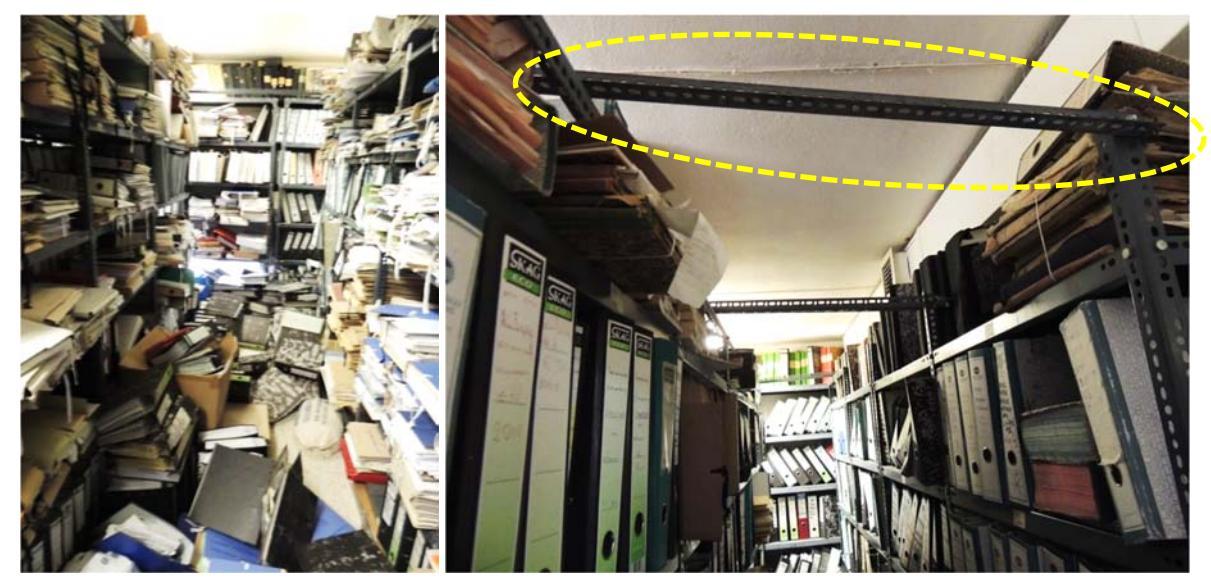
Bookcases were overturned in many locations due to lack of support or connections to adjacent walls. At the National Bank (38°12.139'N, 20°20.318'E), bookcases were laterally braced to one another at the top and did not fall over. Contents fell off the shelves, but as shown in Figure 11.9.26, the units were still standing.

Figure 11.9.26. Bookcases braced to one another for support but lacked shelving restraints. (GPS coordinates: 38°10'27.3"N, 20°29'26.4"E).

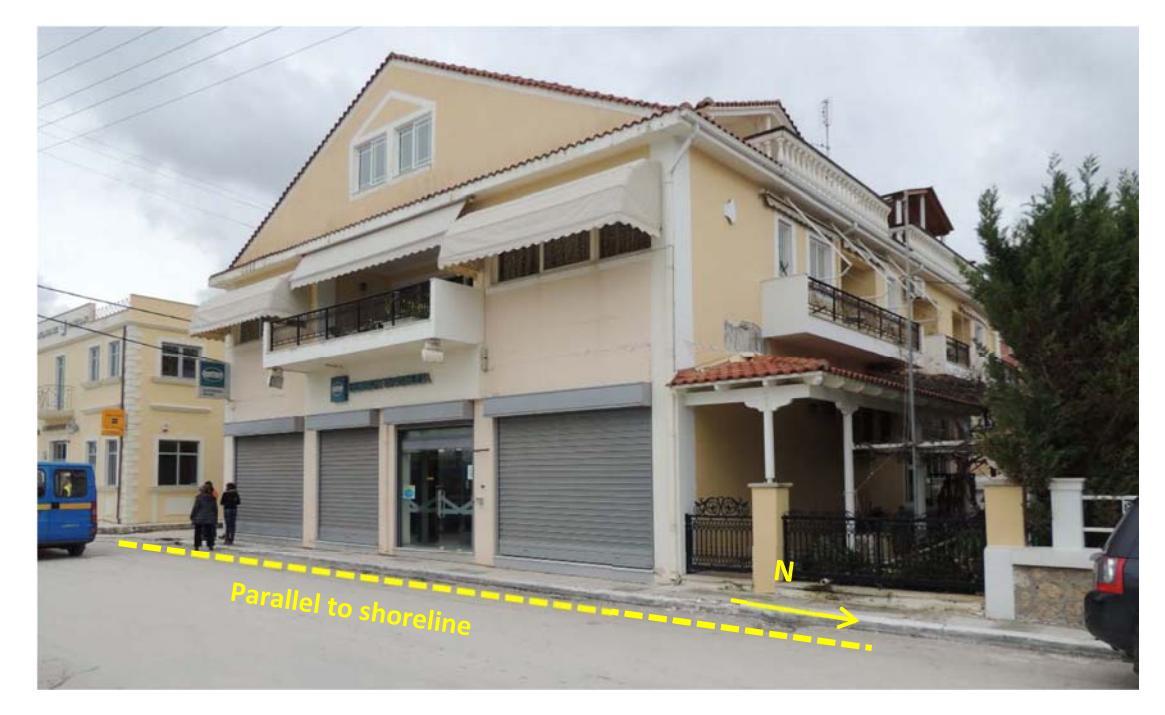
Figure 11.9.28. National Bank branch of Lixouri located in the front row of buildings parallel to the shoreline (GPS coordinates: 38°12'7.8"N, 20°26'19.8"E). See also Chapter 9 for this case study.

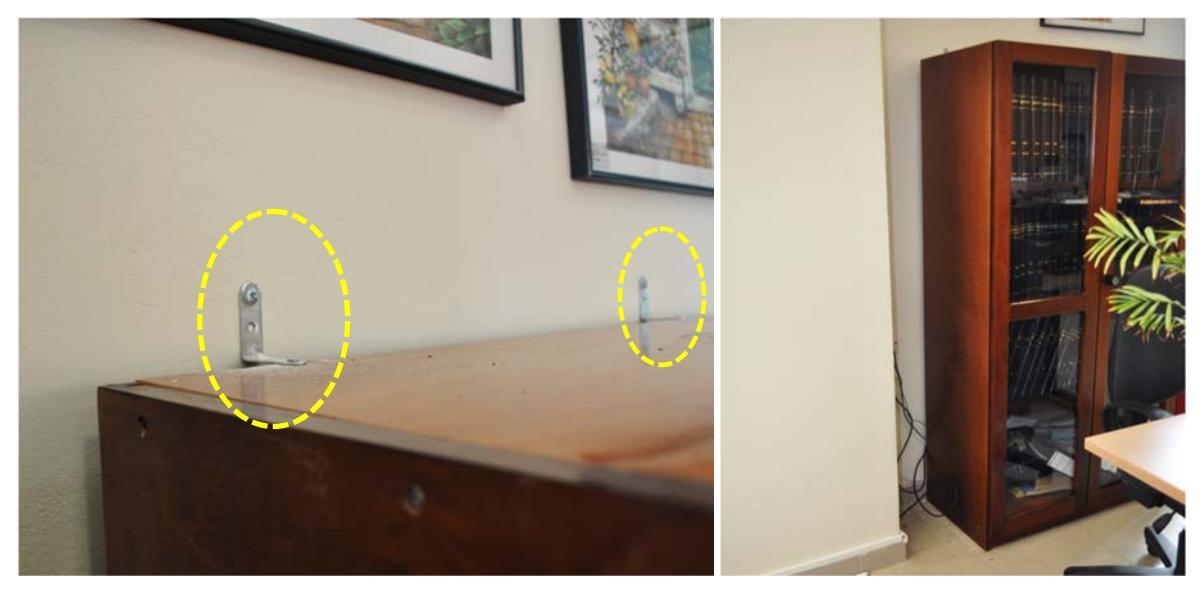
Following the 1st event on January 26th, the National Bank branch of Lixouri (38°12'7.2"N, 20°26'19.8"E) installed corner hooks to the back of large cabinets for wall support. As shown in Figure 11.9.29, this simple non-engineered solution prevented significant damage during the 2nd earthquake event of February 3rd.

Figure 11.9.29. Corner hooks installed after the 1^{st} event at top of large storage units and bookcases at the National Bank branch of Lixouri prevented movements in the 2^{nd} event. (GPS coordinates: $38^{\circ}12'7.2"N$, $20^{\circ}26'19.8"E$).

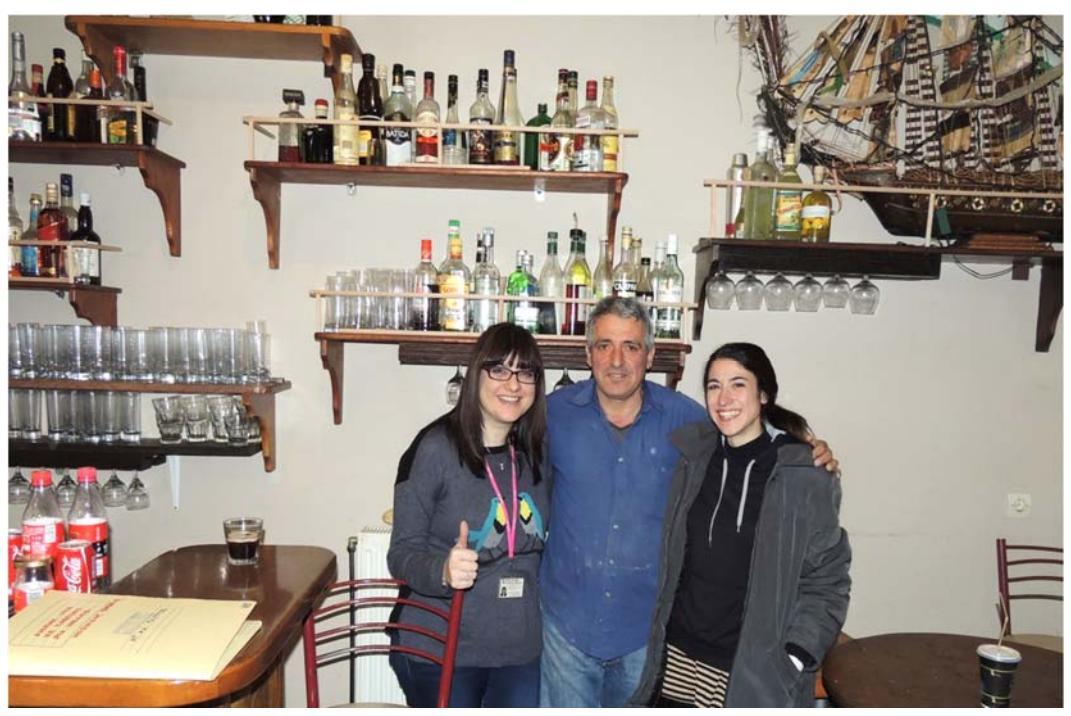
Objects on shelves fell and broke in many instances because items were not secured properly. Common sense solutions by the owners were adequate for most of these cases to prevent significant damage in restaurants and stores. Figures 11.9.30 and 11.9.31 show such examples in the areas that experienced the high levels of accelerations in Havdata village and Lixouri port, respectively.

Figure 11.9.30. Simple rod restraints installed by a restaurant owner (shown here with team members) at Havdata village prevented toppling of bottles. (GPS coordinates: 38°12'14.3"N, 20°23'12.0"E).

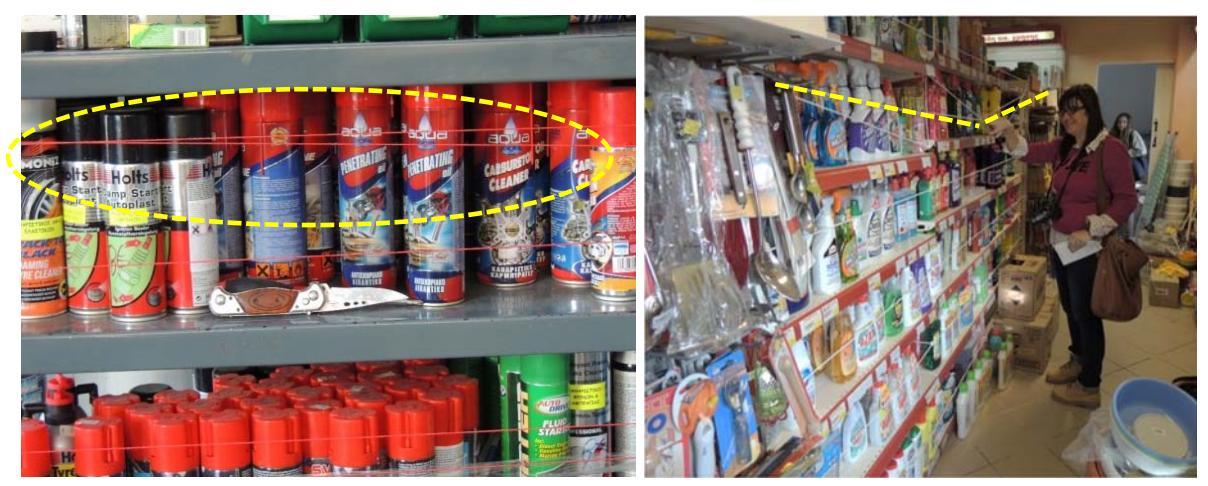
Figure 11.9.31. Shelving with simple string restraints at a gas station and supermarket in Lixouri.

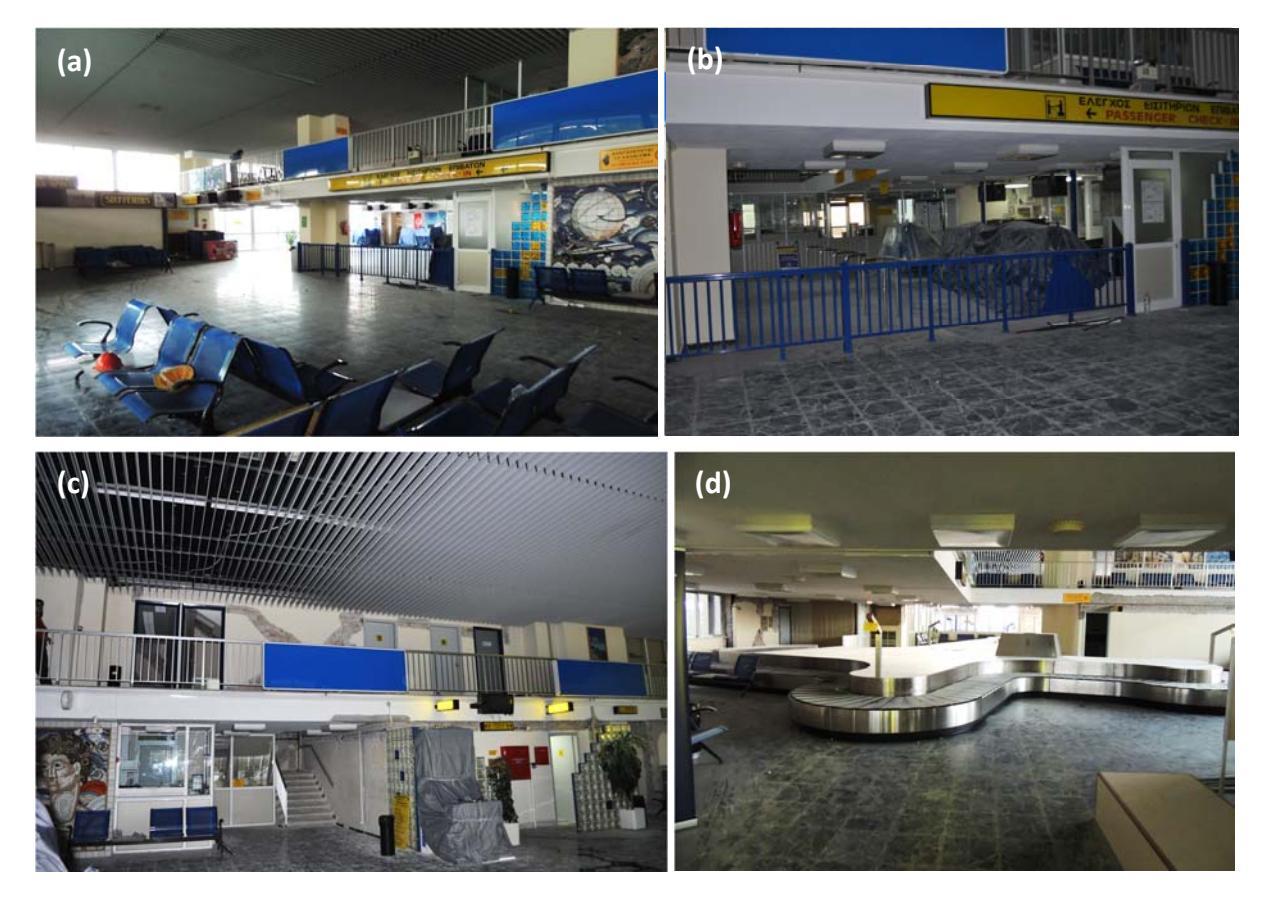
There is one (international) airport on the Cephalonia island that remained closed for more than 10 days following the earthquakes mainly due to non-structural damage since no significant structural damage was observed. Operations were limited with security checks done manually in open spaces near the runways and public buses used as waiting areas. Figure 11.9.34 shows the interior conditions of the airport and Figure 11.9.35 shows the exterior of the structure (38°7'10.0"N, 20°30'17.7"E).

Figure 11.9.34. Interior conditions of the airport. (GPS coordinates: 38°7'10.0"N, 20°30'17.7"E).

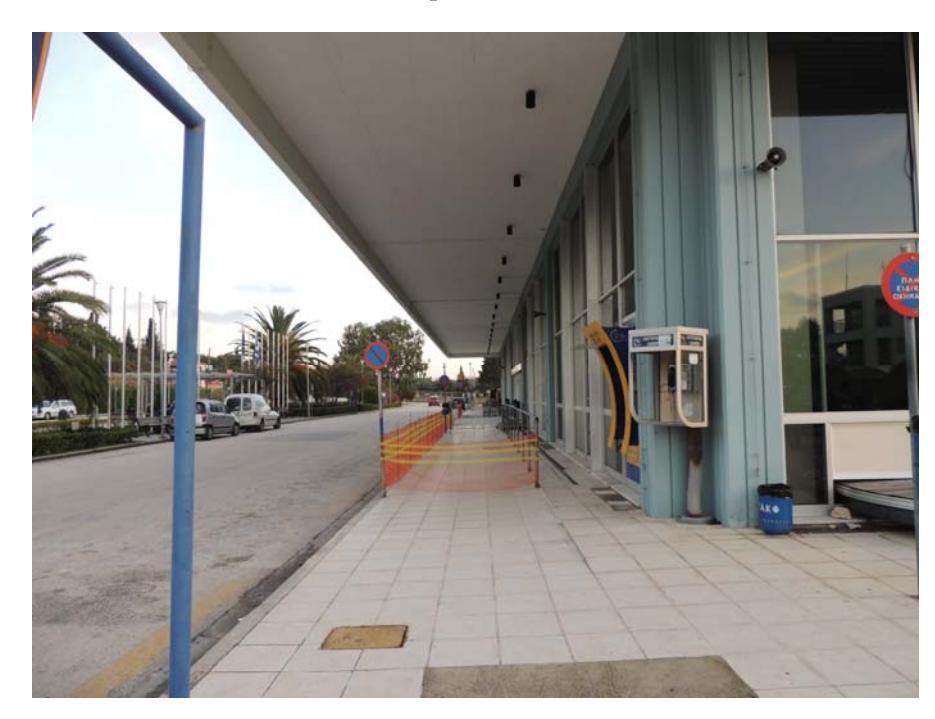
Figure 11.9.35. Exterior of the airport, no significant structural damage was recorded. (GPS coordinates: 38°7'10.0"N, 20°30'17.7"E)
