5. PERFORMANCE OF IMPROVED GROUND

The performance of four improved ground sites is discussed in this chapter. Three of the sites were treated with stone columns (i.e., Ferrymead Apartment Building, AMI Stadium, and Motorway Bridge Approaches). The last site (i.e., St. Andrews School) was “treated” with screw piles.

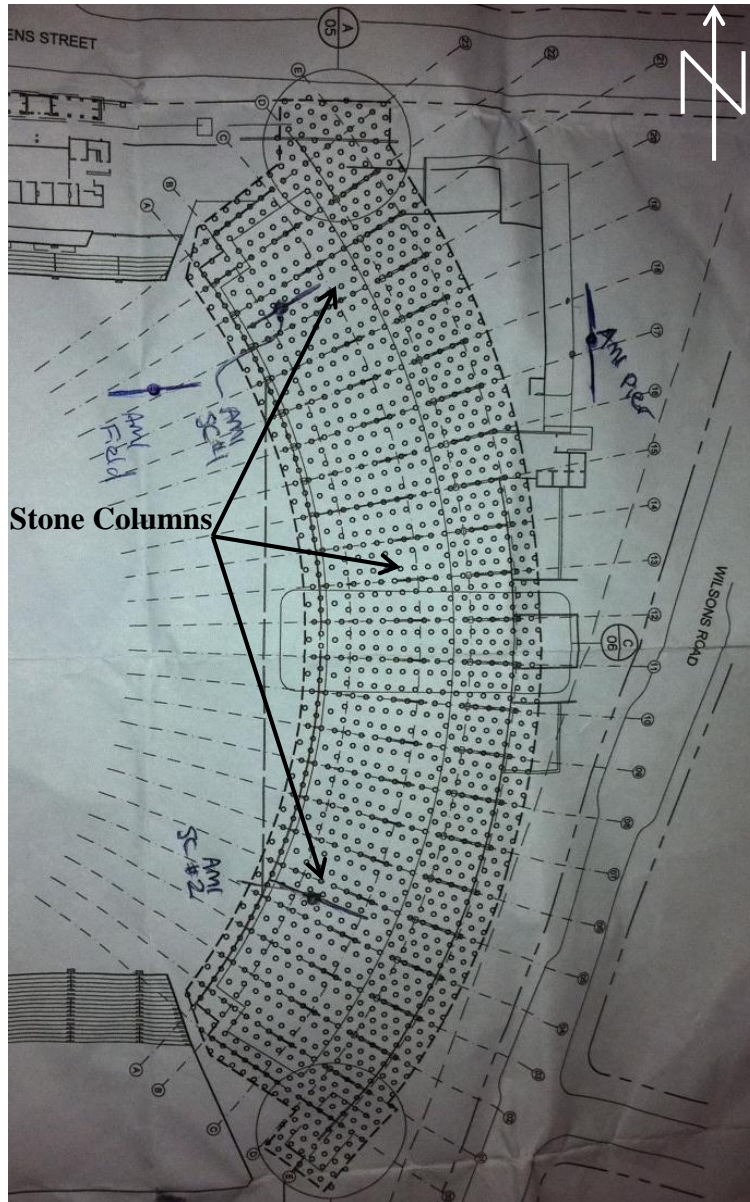
Both the Paul Kelly and Deans Stands were constructed on stone columns installed within their footprint. The Deans Stand has shallow foundations connected by grade beams built upon 8 m deep stone columns, while the Paul Kelly Stand has a slab foundation up to a meter thick founded on 9 m deep stone columns. Both stands suffered structural damage from differential settlements and the ground shaking, which was approximately 30% larger than design levels.

The Paul Kelly stand settled by up to 400 mm, with settlement variations of approximately 70 mm. The thick slab beneath the structure prevented any ejected material from coming up within the structural footprint. The Deans stand developed similar overall settlements, but with much larger variations in settlement across the structure of up to 300 mm. Stone columns (600 mm in diameter) were installed beneath the Deans Stand to a depth of 8-10 m below grade. The stone columns were installed on approximately 2.5 m c-c spacing in an arc pattern that extending slightly outside of the footprint of the stand (see Figure 5-7). No liquefaction was evident in the northern part of the Deans Stand, however, there was a large area with surface evidence of liquefaction beneath the southern part of this stand.

Figure 5-7. Stone column installation plan for the Deans Stand of AMI Stadium

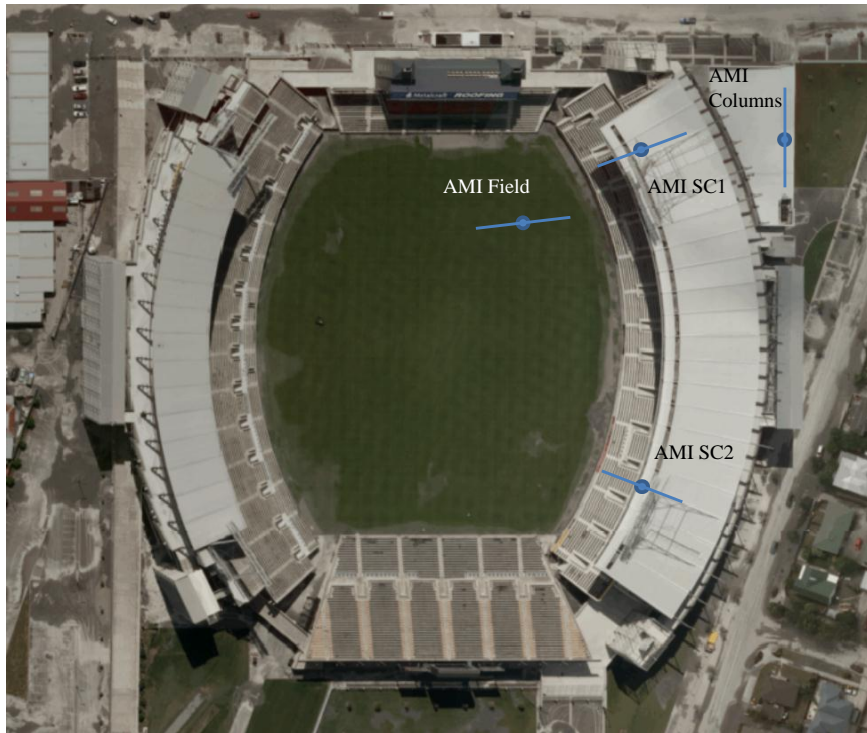
SASW tests were performed at four locations at AMI Stadium, one on the playing field (AMI Field), two under Deans Stand (AMI SC1 and AMI SC2), and one just outside of Deans Stand (AMI Columns). The locations where the SASW tests were performed are shown in Figure 5-9.

Figure 5-9. Aerial photo of AMI Stadium indicating the locations of four SASW arrays: AMI Field: -43.54161° , 172.65452° ; AMI Columns: -43.54128° , 172.65562° ; AMI SC1: -43.54138° , 172.65501° ; AMI SC2: -43.54236° , 172.65514° .

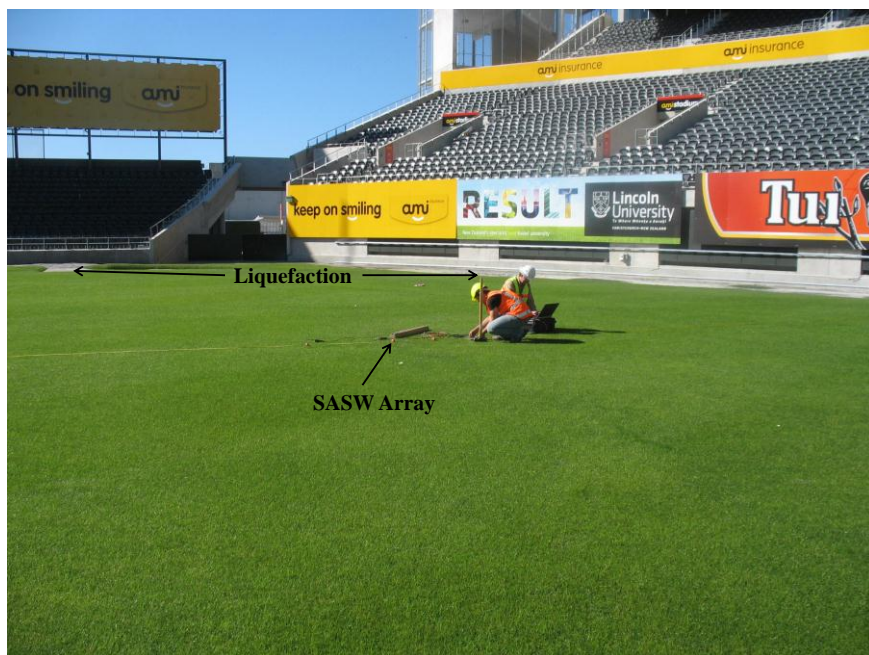
The SASW array at the AMI field test site was located on the northeastern portion of the playing field in an area surrounded by sand blisters and boils Figure 5-10. The results are presented in Figure 5-11 and Table 5-1.

Figure 5-10. SASW array at AMI Field. (-43.54161° , 172.65452°)

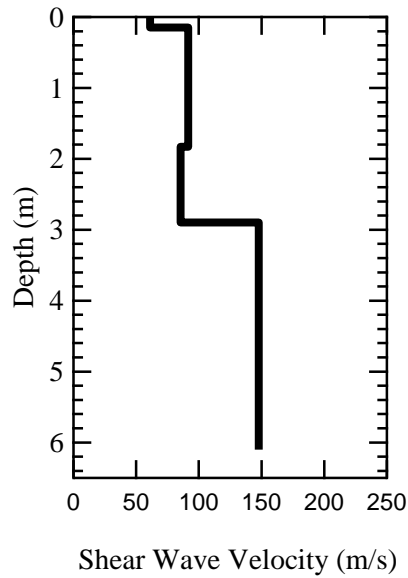
Figure 5-11. Shear wave velocity profile for AMI Field test site. (-43.54161°, 172. 65452°)

Layer No.	Thickness (m)	Depth to bottom (m)	P-wave velocity (m/s)	Shear wave velocity (m/s)	Poisson's Ratio	Unit Weight (kN/m ³)
1	0.2	0.2	110	60	0.30	13
2	1.7	1.9	170	90	0.30	13
3	1.1	3.0	1520	90	0.50	13
4	3.2	6.2	1520	150	0.50	14

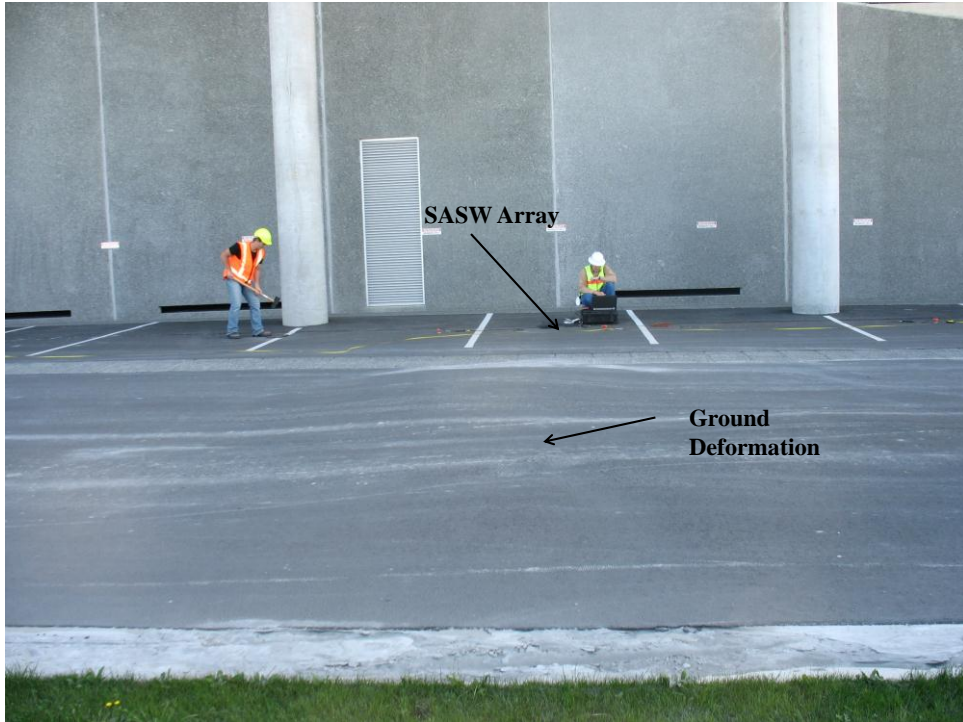
AMI Columns test site is located just outside the northeastern stadium walls. The array was located within 1 meter, and parallel to, a row of drilled shaft-supported columns (Figure 5-12). The columns were placed on approximately 7.5 m c-c spacing. Ground deformations were present around the columns and sand boils were present in and around the array. The results are presented in Figure 5-13 and Table 5-2.

Figure 5-12. SASW array at AMI Columns test site. (-43.54128°, 172. 65562°)

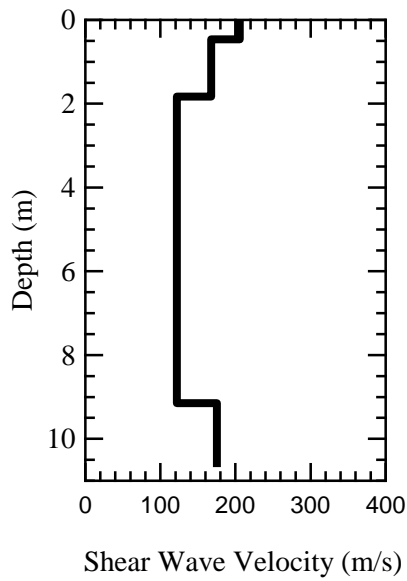
Figure 5-13. Shear wave velocity profile for AMI Columns test site. (-43.54128°, 172. 65562°)

Layer No.	Thickness (m)	Depth to bottom (m)	P-wave velocity (m/s)	Shear wave velocity (m/s)	Poisson's Ratio	Unit Weight (kN/m ³)
1	0.5	0.5	380	210	0.30	16
2	1.4	1.9	310	170	0.30	14
3	7.3	9.2	1520	120	0.50	14
4	1.5	10.7	1520	180	0.49	19

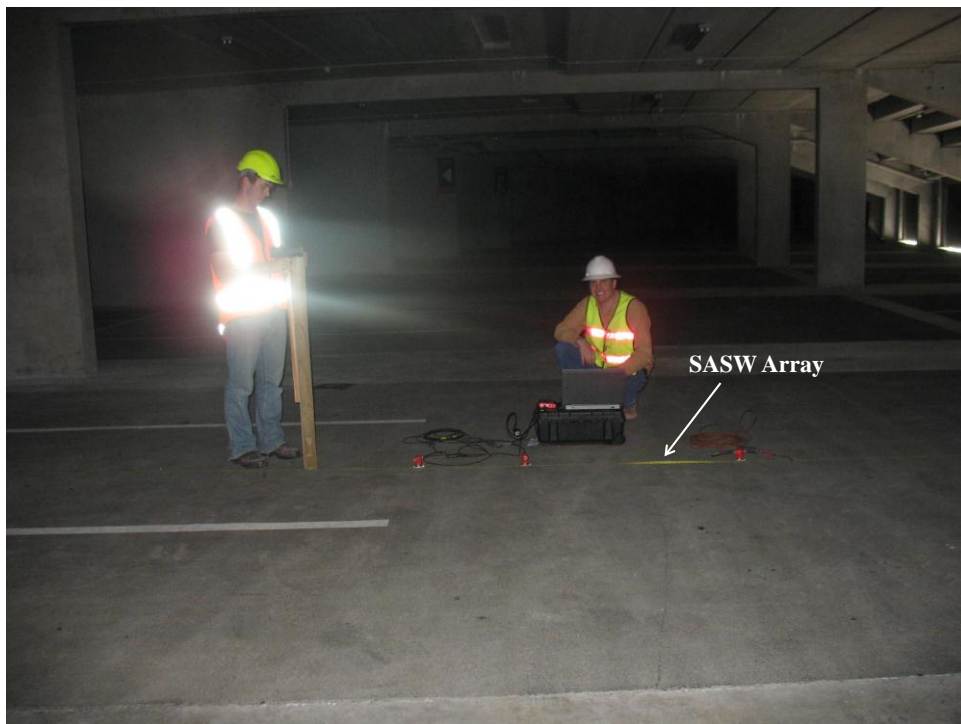
AMI Stone Columns 1 (SC1) test site was located under the north end of the Deans Stand in a parking facility. A photo of the array setup is shown in Figure 5-14. In this area, there was about 5-8 cm of asphalt pavement and 10 cm of base material. There was no evidence liquefaction around the array or in the most northern part of Deans Stand. The results are presented in Figure 5-15 and Table 5-3.

Figure 5-14. SASW array at AMI SC1 test site. (-43.54138°, 172. 65501°)

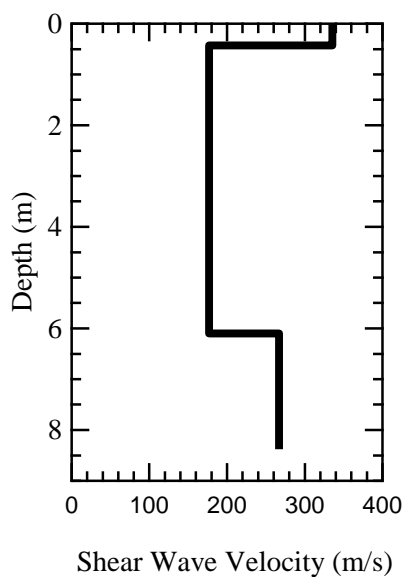
Figure 5-15. Shear wave velocity profile for AMI SC1 test site. (-43.54138°, 172. 65501°)

Layer No.	Thickness (m)	Depth to bottom (m)	P-wave velocity (m/s)	Shear wave velocity (m/s)	Poisson's Ratio	Unit Weight (kN/m ³)
1	0.4	0.4	630	340	0.30	19
2	1.4	1.8	330	180	0.30	16
3	4.3	6.1	1520	180	0.49	16
4	2.3	8.4	1520	270	0.48	19

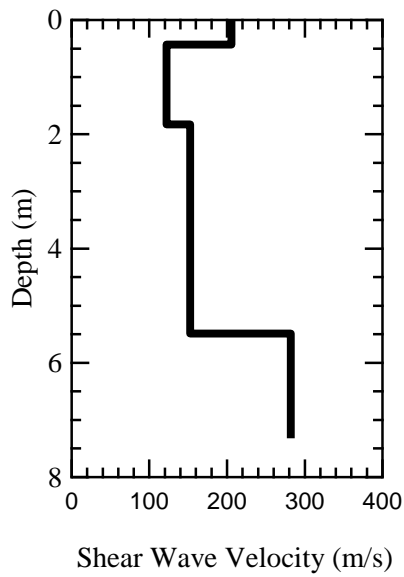
AMI Stone Columns 2 (SC2) test site was located under the south end of Deans Stand. Again, this area was treated with stone columns, as described above. However, significant liquefaction occurred in the area of this test site, as shown in Figure 5-16. The results are presented in Figure 5-17 and Table 5-4.

Figure 5-17. Shear wave velocity profile for AMI SC2 test site. (-43.54236°, 172. 65514°)

Layer No.	Thickness (m)	Depth to bottom (m)	P-wave velocity (m/s)	Shear wave velocity (m/s)	Poisson's Ratio	Unit Weight (kN/m ³)
1	0.4	0.4	380	210	0.30	16
2	1.4	1.8	230	120	0.30	14
3	3.7	5.5	1520	150	0.49	14
4	1.8	7.3	1520	280	0.48	19

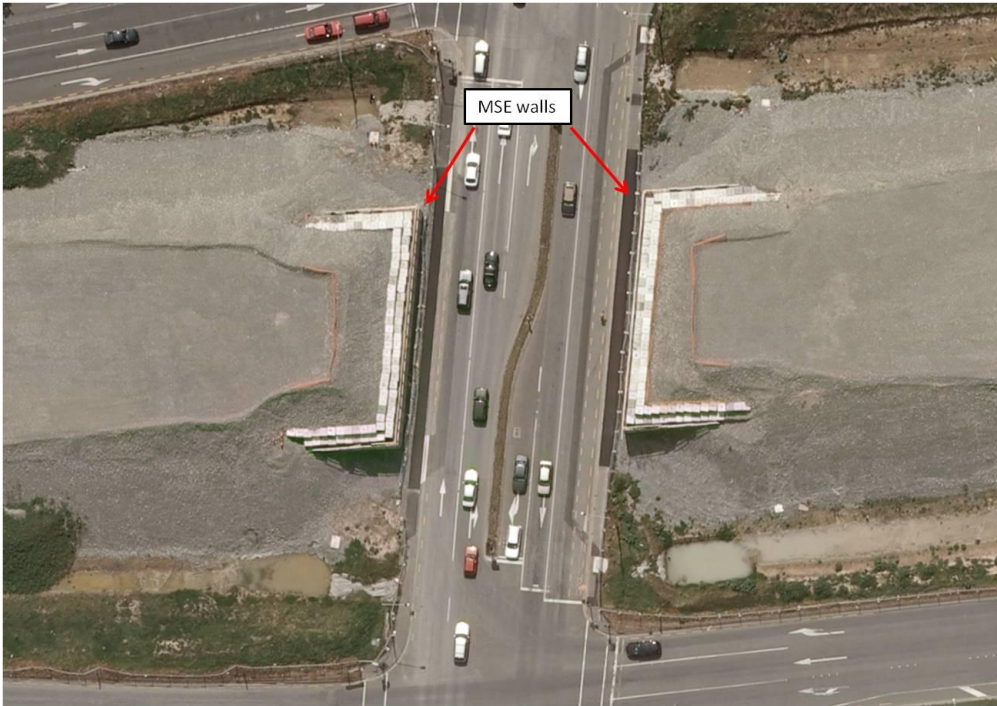
At Barrington St interchange, MSE wall construction had been completed and the embankments had been built up and were undergoing consolidation for approximately 6 months. Figure 5-18 shows the layout of the site; no damage to the MSE walls noted as a result of the earthquake. Curletts Rd interchange in Figure 5-19 not as far along, with the full height of the MSE walls yet to be reached on the western abutment (Figure 5-20), and construction had yet to commence on the walls of the eastern abutment. Preload had been placed and consolidation was underway on the western abutment, where up to 600 mm of settlement was expected at the western abutments at this site [NZTA 2011]. No damage was evident at this site and only minor surface slope movement occurred in the preload material.

Figure 5-18. Aerial view of Barrington St interchange MSE walls in later stages of construction. (-43.5480°, 172.6101°)

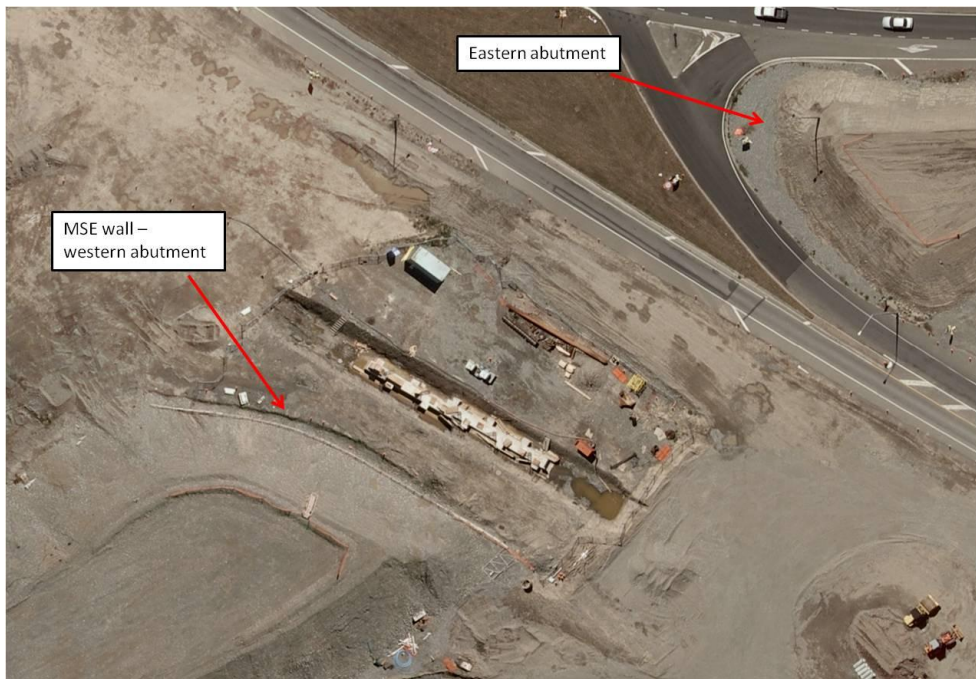
Figure 5-19. Aerial view of Curletts Rd interchange western abutment MSE wall in early stages of construction. (-43.5478°, 172.5789°)

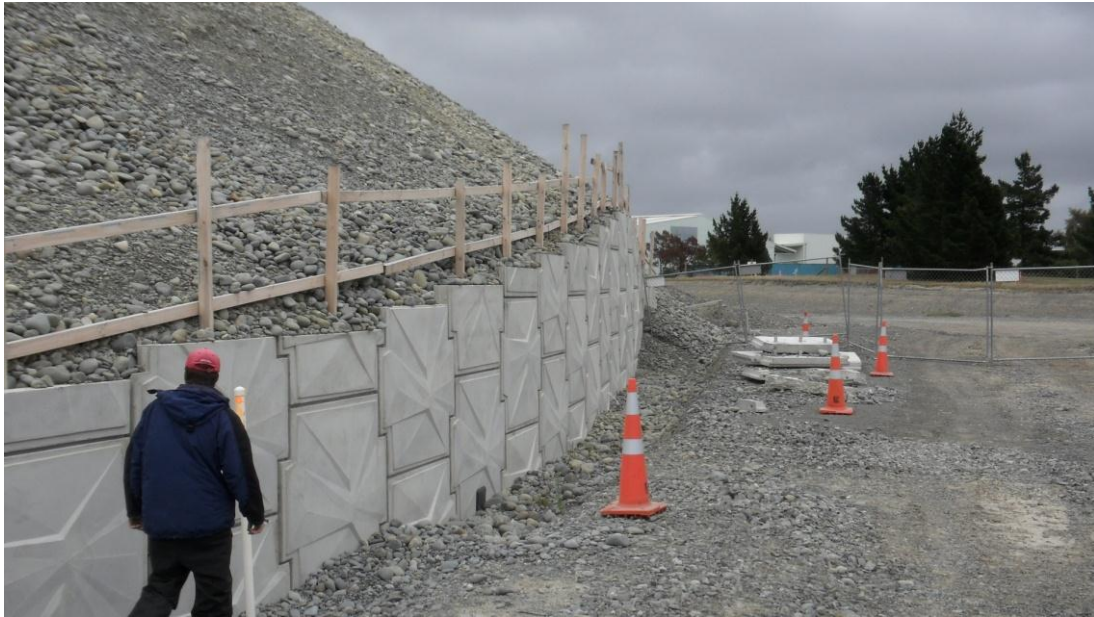
Figure 5-20. Partial construction of the MSE walls for the Curletts Rd interchange western abutment. (-43.5478°, 172.5789°)

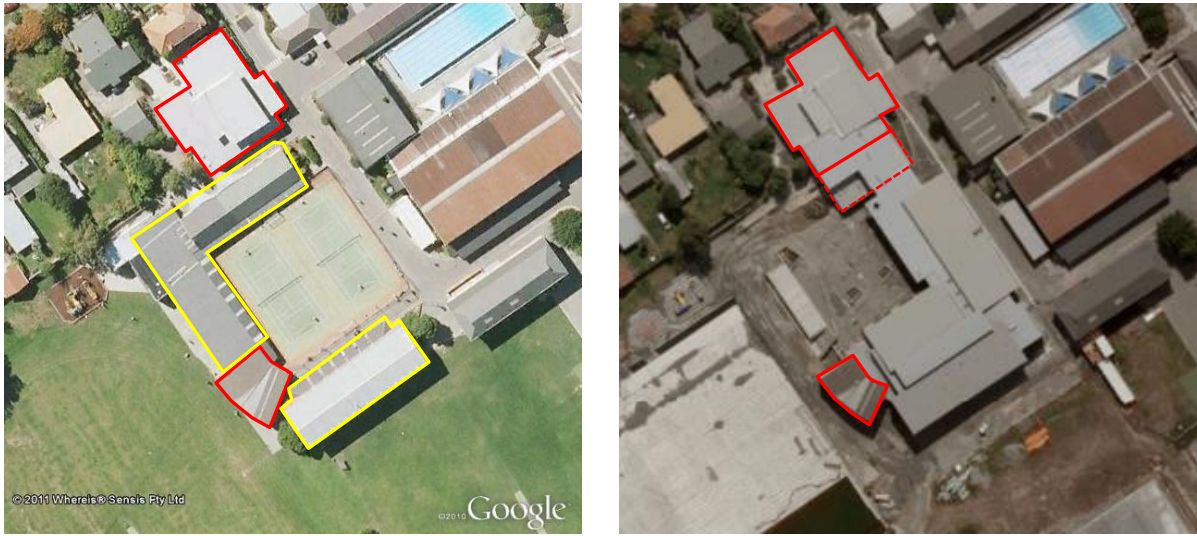
Prior to the 22 February event, renovation and demolition was carried out on the Preparatory School buildings at St Andrews. A new, two-storey structure was constructed that is founded on 18 m deep, 350 kN screw piles. This building connected two existing structures that are founded on shallow raft foundations. The layout of these structures is shown in Figure 5-22, both before and after the February earthquake. In Figure 5-22a, the buildings outlined in yellow were demolished as part of the renovations prior to the February event. However, these buildings were present at the time of the September event, with no evidence of damage or movement observed as a result of the earthquake. The buildings outlined in red in Figure 5-22a are the two structures that are founded on shallow raft footings that remained after the renovations, as shown in the post-renovation photo in Figure 5-22b. A schematic of the post-renovation layout of the structure is shown in Figure 5-23. (Note that this figure also shows the locations and directions of photographs presented subsequently in this chapter.). The ground to the northeast edge of structure was relatively flat, and sloped away gradually to the northwest. The ground to the southwest was level, before dropping down 2 m at the retaining wall shown in the figure. To the south the ground sloped down approximately 2 m from the southeast to the southwest corner.

Figure 5-22. St Andrews Prep School buildings (a) prior to renovation with buildings that remain outlined in red and those demolished in yellow (Google 2010); (b) post-renovation aerial image showing the new building that is founded on screw piles. Also shown in this image is an extension to shallow foundation sections of structure outlined in dashed red (LINZ 2011). (-43.508903°, 172.612942°)

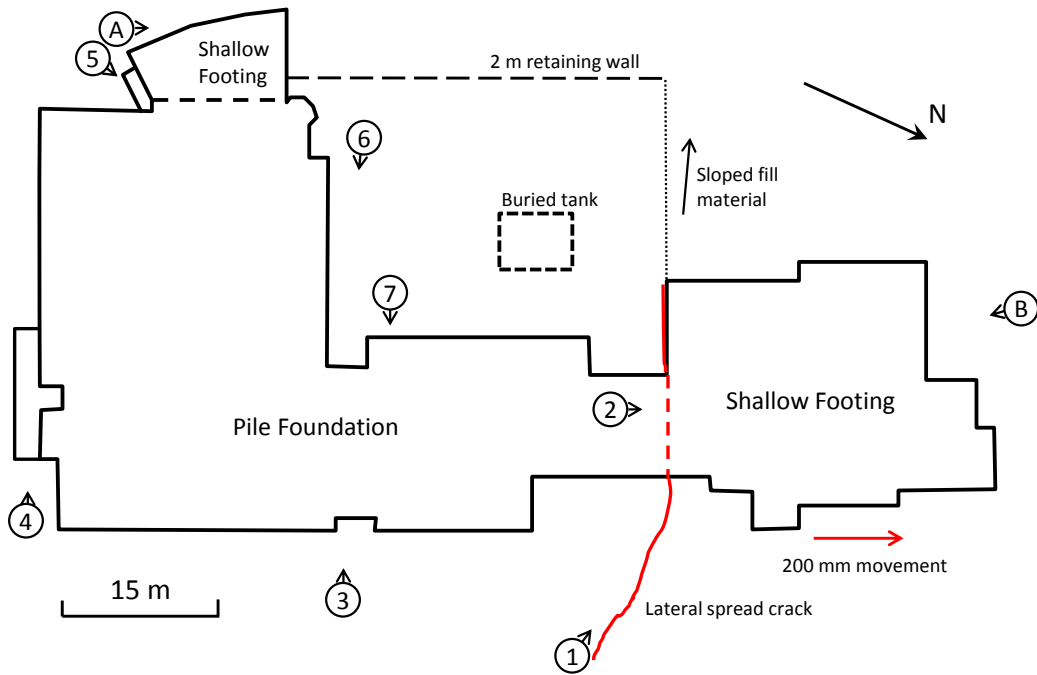
Figure 5-23. Layout of the Preparatory School indicating photo positions. (-43.508396°, 172.612766°)

Lateral spreading at the site was evident with movement to the northwest, as illustrated in Figure 5-23. A lateral spread crack passed underneath the building and resulted in the separation of an expansion joint between portions of the building founded on screw piles and raft foundation. The portion of the structure on the shallow foundation moved away from the pile founded portion by ~200 mm and settled by ~200 mm, while the piled portion of the structure remained in place. Internal and external photos of the gap formed by the spreading are shown in Figure 5-24. A ramp was constructed to account for the differential movement, as shown in Figure 5-25.

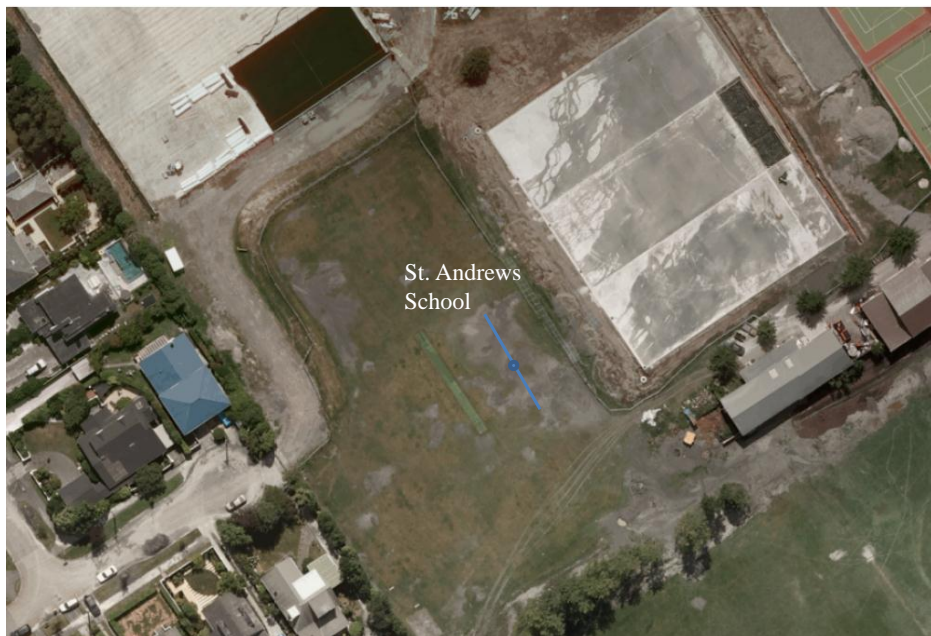
SASW and DCP tests were performed on a sports playing field at St Andrews School, as shown in Figure 5-31. As may be observed from this figure, the test site had sand blows throughout. A photograph of the SASW test array is shown in Figure 5-32, and the results from both the SASW and DCP tests are shown in Figure 5-33, with the SASW test data tabulated in Table 5-4. As shown in Figure 5-33, the ground water table is at a depth of approximately 1.3 m and the depth to the top of the liquefiable layer was around 2.84 m. (Note that a hole was hand augered to the top of the liquefiable layer and then the DCP test was started.).

Figure 5-31. Site photo of St. Andrews School (Post Christchurch EQ) showing the location of the SASW array. (-43.50953°, 172.61291°)

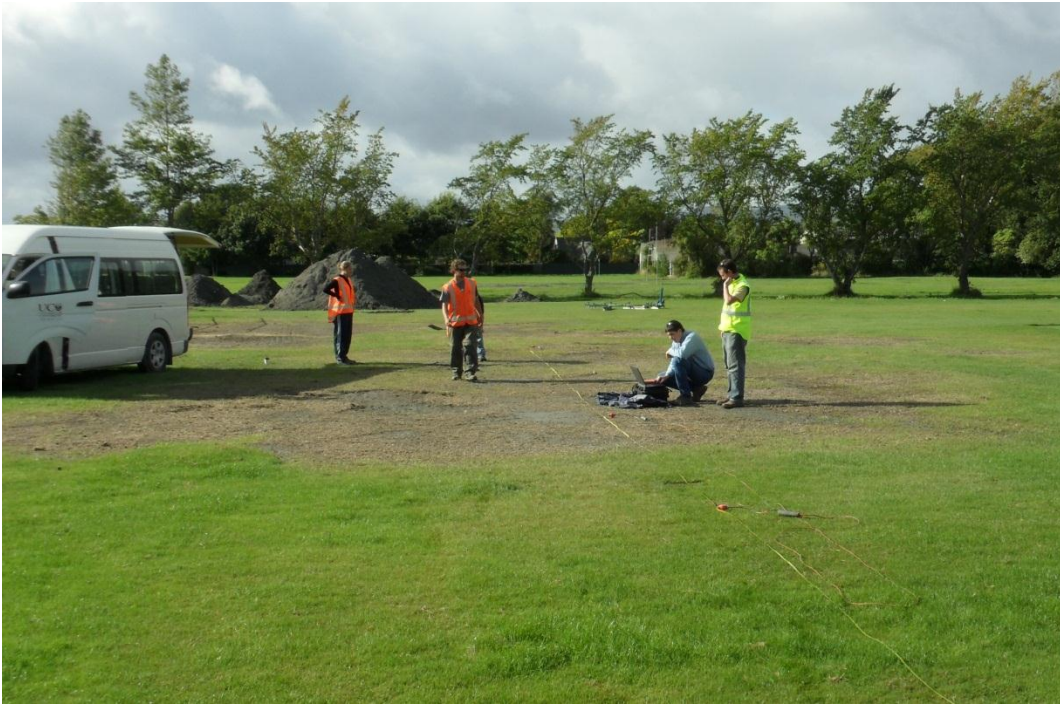
Figure 5-32. SASW array at St. Andrews School test site. (-43.50953°, 172.61291°)

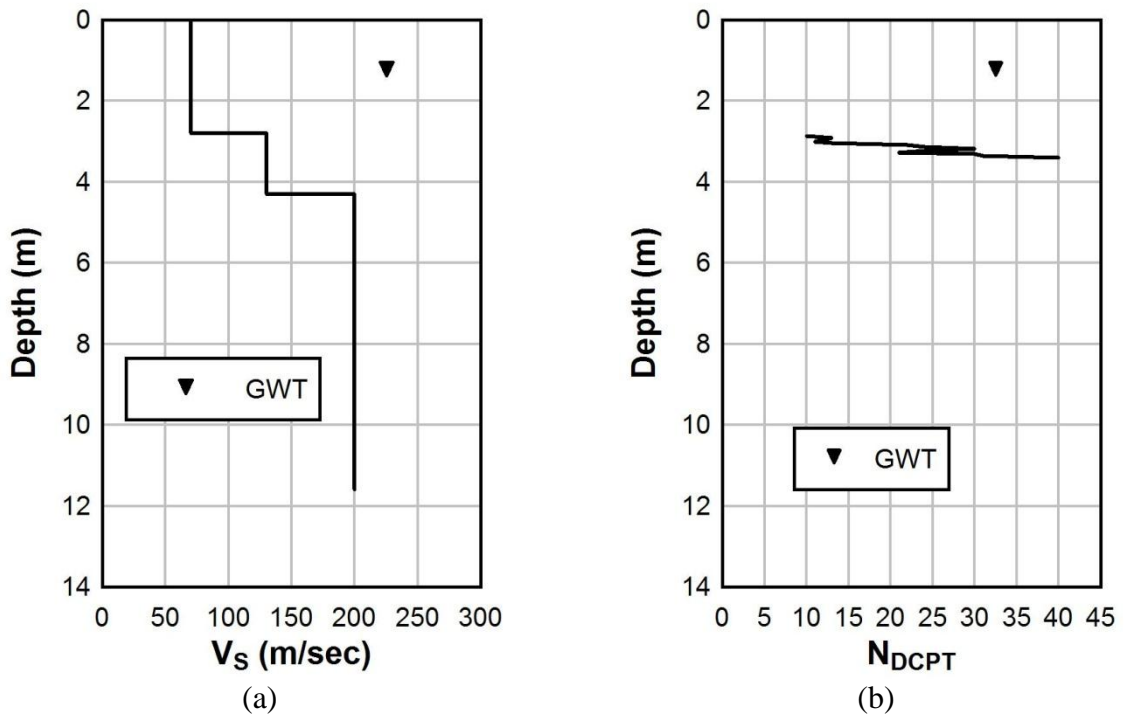
Figure 5-33. In-situ data from test site located on a sports field at St Andrews School: (a) SASW shear wave velocity profile; and (b) DCP blow count profile. (-43.50953°, 172.61291°)
