6. PERFORMANCE OF STOPBANKS

Seismic Performance of Stopbanks

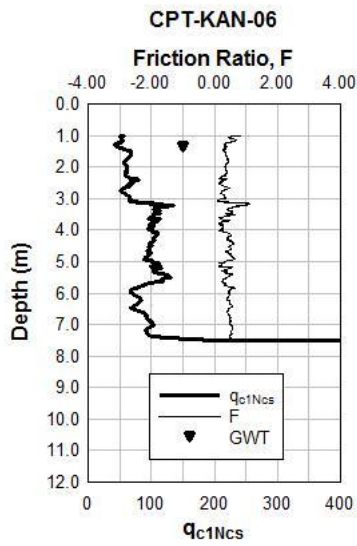
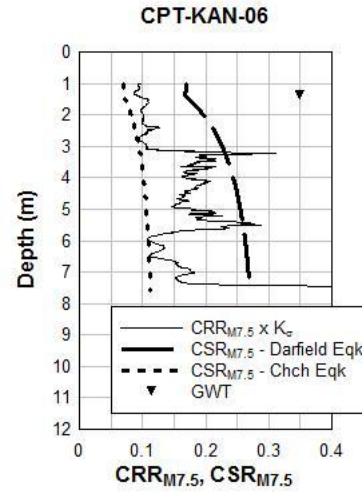
Representative CPT soundings from the north and south banks of the Kaiapoi River are presented in Figures 6-8a and 6-9a. From interpreting twenty seven such CPT logs, as well as available borehole data (Tonkin and Taylor, 2011), the soil profile along the north bank of the

Kaiapoi River east of the Williams Street Bridge is characterized by approximately 4 m of very loose to loose sand overlying approximately 4 m of loose to medium dense gravelly sand. Below approximately 8 m, the sand and gravel layers tend to be significantly denser than the overlying layers. The depth to the ground water table varies, but is approximately 1.5 m deep. On the south bank of the Kaiapoi River east of the Williams Street Bridge, the soil profile is characterized by approximately 6 m of very loose to loose silty sand/sand overlying an approximately 2-m thick layer of loose to medium dense sand/gravelly sand. Samples of the liquefiable soils taken adjacent to the levees on the north bank had fines contents around 15%, with the fines being non-plastic. Below approximately 8 m the sand and gravel layers tend to be significantly denser than the overlying layers. The ground water table is approximately 2 m deep.

Figures 6-8b and 6-9b show the results from the liquefaction evaluation for the two representative CPT soundings mentioned above. In these figures, the cyclic resistance ratio (CRR) for each profile and the CSRs for both events are plotted together, where both the CRR and CSR are adjusted to a $M_w 7.5$ earthquake. For liquefiable soils (i.e., gravels, sands and cohesionless silts), liquefaction is predicted to have occurred at depths where the $CSR_{M7.5} > CRR_{M7.5}$. Accordingly, for both profiles, liquefaction is predicted to have occurred during the Darfield earthquake for almost the entire depth from the ground water table to the top of the dense gravel/sand layer (i.e., to ~7.5 m and ~11 m for the north and south river banks, respectively). However, during the Christchurch earthquake, marginal liquefaction is predicted to occur at a few isolated depths within both profiles.

Figure 6-8. (a) Representative CPT sounding for the north bank of the Kaiapoi River; (b) Liquefaction evaluation of the site for both the Darfield and Christchurch earthquakes.

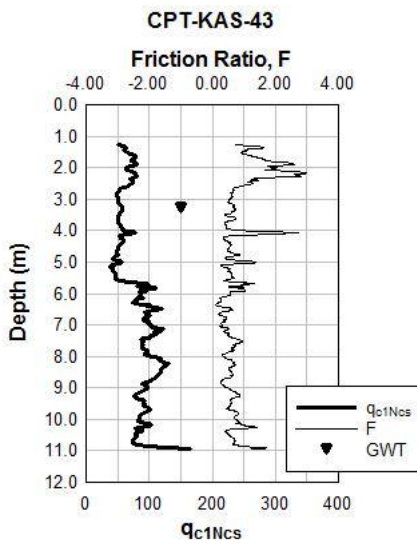
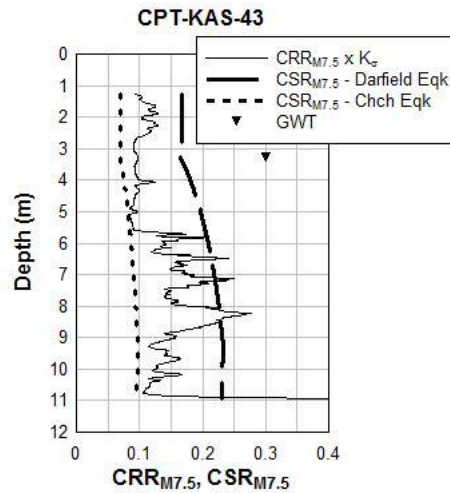
Figure 6-9. (a) Representative CPT sounding for the south bank of the Kaiapoi River; (b) Liquefaction evaluation of the site for both the Darfield and Christchurch earthquakes.

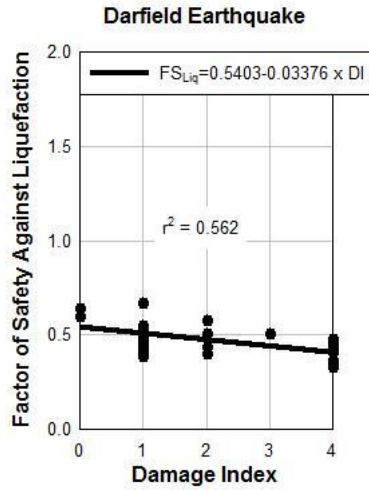
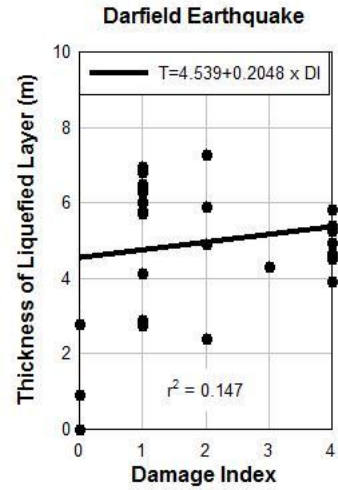
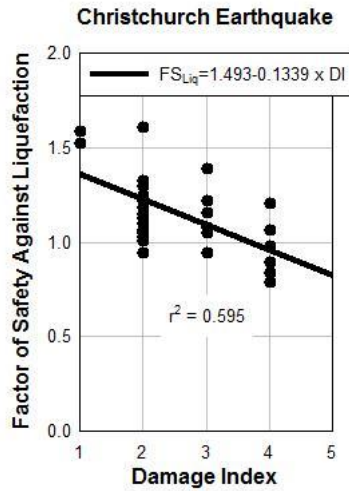
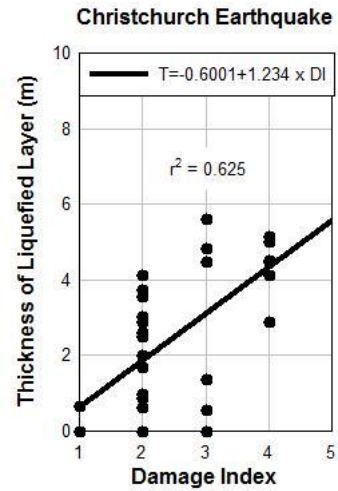
In an attempt to relate the severity of the observed levee damage to the liquefaction response of the foundation soil, plots of factor of safety against liquefaction versus damage index (i.e., FS_{Liq} vs. DI) and thickness of the liquefied layer versus damage index (i.e., T vs. DI) were made for the 29 CPT soundings analyzed. Note, damage index corresponds to the damage categories proposed by Riley Consultants (2010, 2011): 1 = No Damage, 2 = Minor Damage, 3 = Moderate Damage, 4 = Major Damage, and 5 = Severe Damage. Linear regressions were performed on the data, where first the data from the two earthquakes were kept separate (Figure 6-10) and then they were combined (Figure 6-11). In developing these plots, the sections of the levees that were under repair at the time of the GEER team's field inspections were assumed to have DI = 4. The basis for this is that the fact the sections were given high priority for repair implies that the sustained damage was significant. However, because the intensity of shaking during the Christchurch earthquake at these locations was significantly less than that during the Darfield earthquake, it is likely that the levels of damage induced by the Christchurch earthquake were less severe than that from the Darfield earthquake.

Expected trends can be identified in all plots (i.e., the damage index increases as the factor of safety against liquefaction decreases and as the thickness of the liquefied layer increases). However, the strength of the trends, as indicated by the correlation coefficients (r^2), varies between the two earthquakes when the data is treated separately. For example, for the Darfield earthquake, the lowest correlation coefficient ($r^2 = 0.147$) is for T vs. DI, but T vs. DI has the highest correlation coefficient ($r^2 = 0.625$) for the Christchurch earthquake. In contrast, the correlation coefficients for FS_{Liq} vs. DI are relatively consistent for both the Darfield and Christchurch earthquakes (i.e., $r^2 = 0.562$ and $r^2 = 0.595$, respectively). When the data from the two earthquakes are combined, $r^2 = 0.348$ and $r^2 = 0.578$ for T vs. DI and FS_{Liq} vs. DI, respectively.

Figure 6-10. Correlations relating factor of safety against liquefaction and damage index and thickness of the liquefied layer for the data from the Darfield and Christchurch earthquakes regressed separately. (Note that the low r^2 value in (b) indicates an extremely weak correlation between the thickness of the liquefied layer and damage index for the Darfield earthquake; hence a dotted line is used to show the results of the regression).

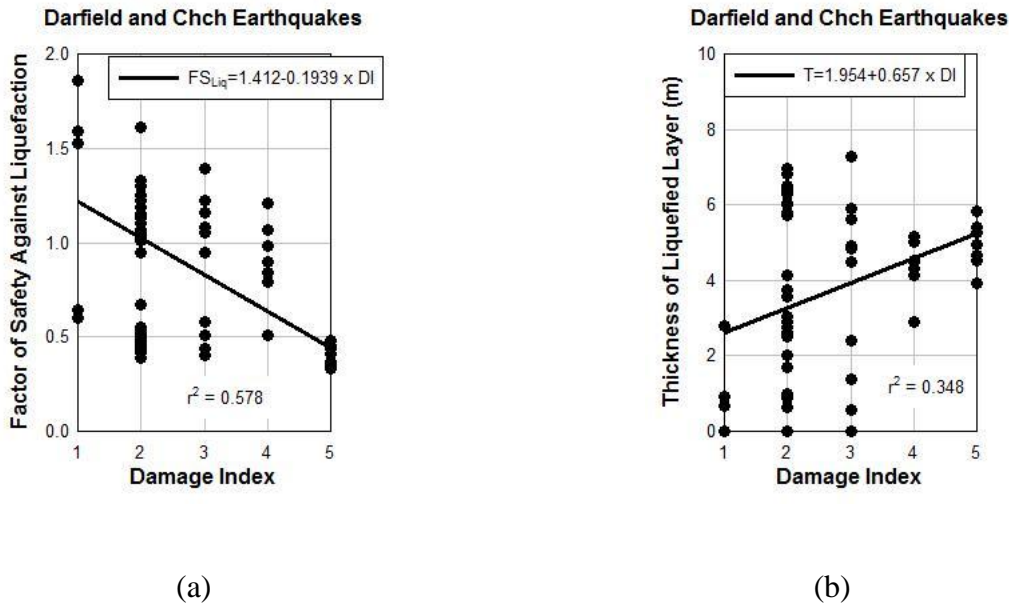
Figure 6-11. Correlations relating factor of safety against liquefaction and damage index and thickness of the liquefied layer for combined Darfield and Christchurch earthquake data.

From the correlation coefficients, the factor of safety against liquefaction appears to be a better index for damage severity than the thickness of the liquefied layer. This is not altogether surprising given that a lot of the damage to the levees resulted from lateral spreading, more so than deep seated slumping and settlement/bearing capacity failures. Of these three failure modes, lateral spreading can occur even if a relatively thin layer liquefies, while deep seated slumping and settlement/bearing capacity failures require a thicker layer to liquefy. This is likely the reason for the disparity between the r^2 values for the T vs. DI plots for the Darfield and Christchurch events. In the case of the Darfield earthquake, the levees were subjected to relatively intense shaking and the thickness of the liquefied layer was large. However, because lateral spreading can occur on even a thin liquefied layer, the r^2 value for the T vs. DI plot was very low (i.e., $r^2 = 0.147$). In contrast, the levees were subjected to less shaking during the Christchurch earthquake and the liquefied layers were relatively thin, where liquefaction occurred. However, even these relatively thin liquefied layers were thick enough for lateral spreading to occur, which resulted in damage to the levees and a relatively high value of r^2 for the T vs. DI plot (i.e., $r^2 = 0.625$). The implication of this is that liquefaction severity indices that account for both the factor of safety against liquefaction and thickness of the liquefied layer, such as the Liquefaction Potential Index (LPI) (Iwasaki et al., 1982), may not be appropriate for evaluating the risk of damage from liquefaction where lateral spreading is the primary failure mode.
