8. EFFECTS ON LIFELINES

This chapter includes the GEER-NZ Team’s observations for the transportation system (highways and rail and bridges are covered in separate chapters), water and wastewater systems, electric power, and waste management, as well as other lifelines.

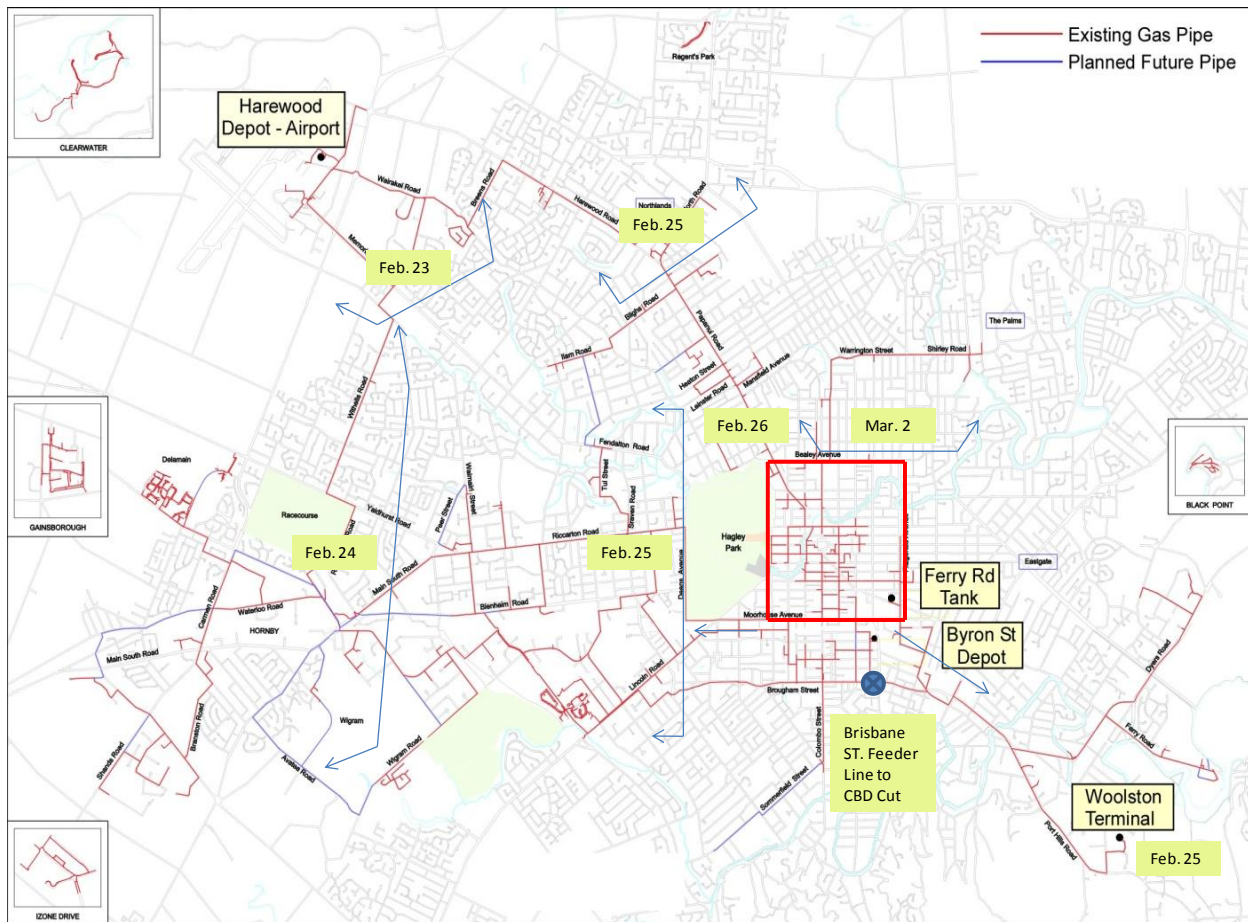
The natural gas pipeline system in Christchurch is owned by Contact Energy, and is operated under the name of Rockgas. The network is shown in Figure 8-10, in which the red and blue lines indicate streets with existing and planned future pipelines, respectively. A large portion of the gas pipeline network was located in areas that experienced large ground deformation and liquefaction.

Although two to three inline valves for the CBD feeder lines had been closed within hours of the event, Contact Energy employees also cut and capped the feeder lines at Petersborough/Victoria, Columbo/Petersbrough, Brisbane, and Fitzgerald streets to physically isolate the CBD within two to three days after the event. The isolated area can be seen as the dark red square in the center of Figure 8-10 around the CBD.

Rockgas crews also worked to restore service and continued to provide services immediately following the earthquake. This was done by doubling Rockgas' field staff to 22 people. Figure 8-10 depicts the dates and areas that services were restored to after the 22 February event. Rockgas provided hospitals and other critical infrastructure that were connected to the gas network with fuel via drop off cylinders until the network had been pressure tested and service restored.

Figure 8-10. Map of Christchurch gas distribution system.

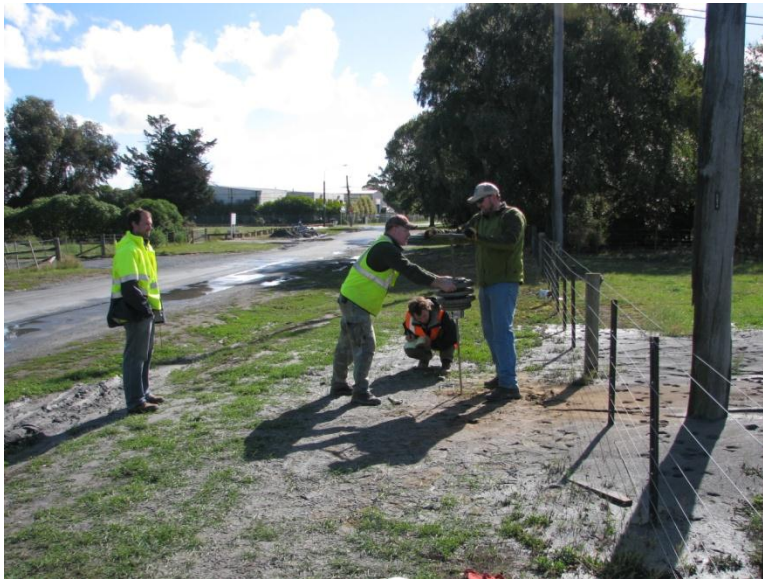
DCP and SWS tests were performed by the GEER team (Figure 8-13) and the data are presented in Figure 8-14. SASW data could not be collected due to the high voltage power line interference. As shown in Figure 8-14, the groundwater table was at depth of ~1.5 m and the top of the liquefied layer was at a depth of ~1.75 m. (Note that a hole was hand augered to the top of the liquefied layer, with the DCP being performed in the hole from then down to refusal).

Figure 8-13. Swedish Weight Sounding (SWS) Testing at Bromley Substation (-43.531534°, 172.697942°)

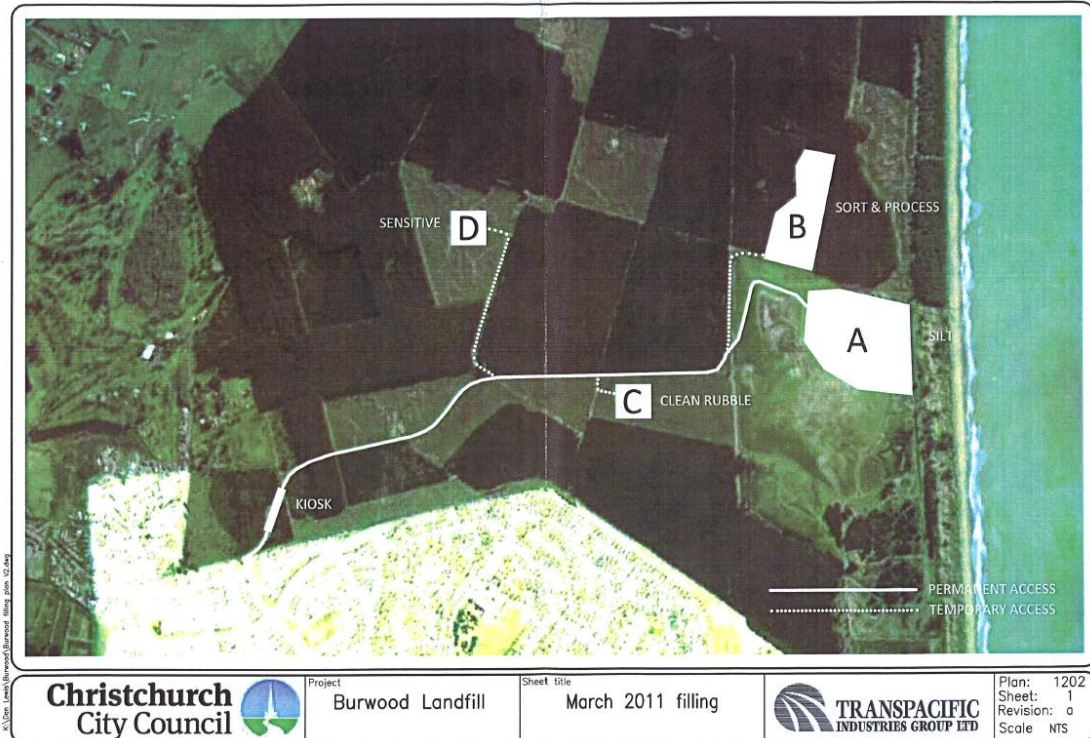
Figure 8-15. Aerial photo of Burwood Landfill depicting land use.

Area B in Figure 8-15 was being developed as a working pad for the recycling of demolition debris taken from the Central Business District in Christchurch and surrounding areas. The pad was under construction at the time that the team visited the landfill. CCC was expecting to receive in excess of 1.5 million tonnes of demolition debris. The area B pad was being developed as a recycling and processing centre where CCC would attempt to recycle as much waste as possible. Timber debris would be turned into hogfuel and a concrete crushing plant was also going to be installed at Pad B to assist with the recycling of the debris. It was estimated that it would take 5-10 years to recycle all of the waste but that the majority of the tonnage could be recycled (Pinkham, 2011).

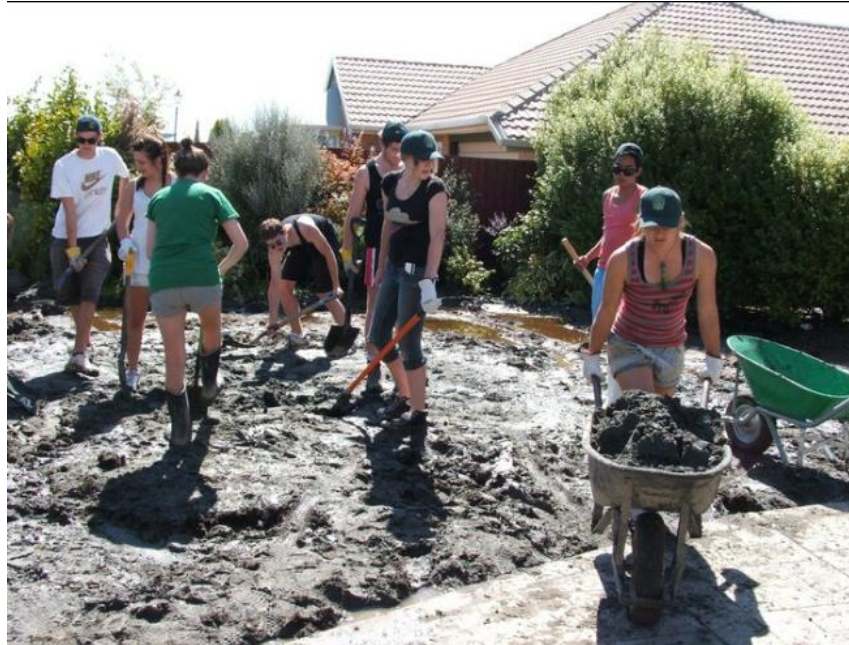
Figure 8-16. University of Canterbury Student Army at work (courtesy of Dan Neville).

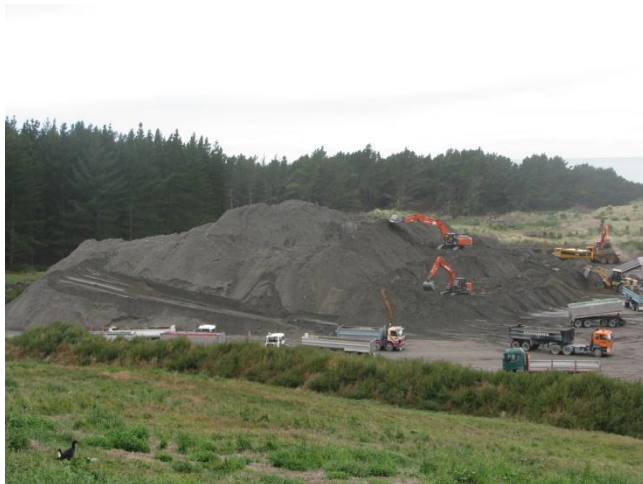
Area A was being used to dispose of ejected sand that was being cleaned up in city. CCC was expecting to accept 300-400,000 tonnes of ejected sand (Harris, 2011). The sand was being removed from residential, commercial, and public properties. The team witnessed the Student Volunteer Army collecting and moving the ejected sand into the streets by hand (Figure 8-16). Once the sand was placed in the streets it was collected with heavy equipment and transported to the Burwood Landfill, Pad A for disposal (Figure 8-17a). The team also found a large stockpile of ejected sand at the Bromley Waste Water Oxidation Ponds (Figure 8-17b).

Figure 8-17. (a) Ejected Sand Stockpile at Burwood Landfill, and (b) Ejected Sand Stockpile at Bromley Oxidation Ponds at Dyers Road.
