9. ROCKFALL AND LANDSLIDES

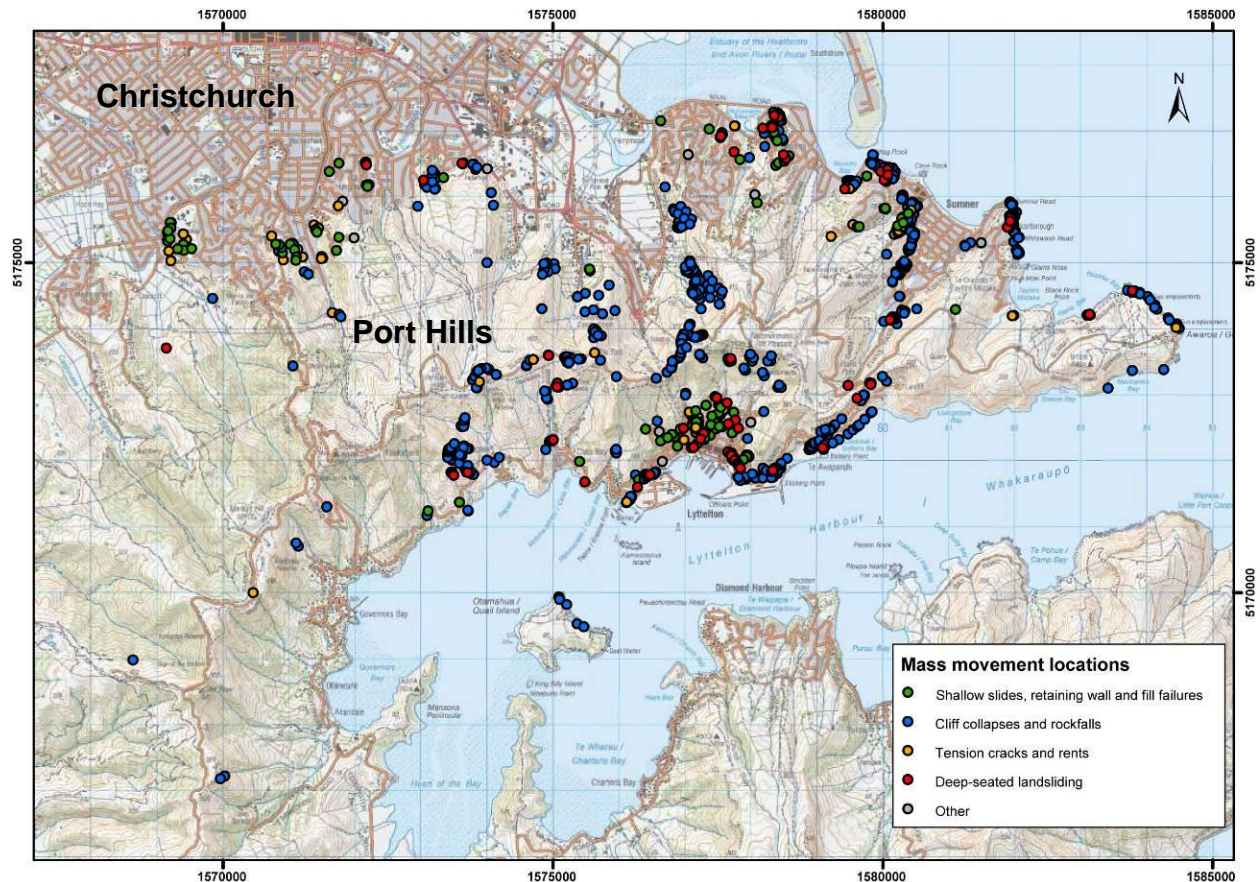
Figure 9-1. Map showing the distribution of the different types of mass movements in the Port Hills (Dellow et al., 2011).

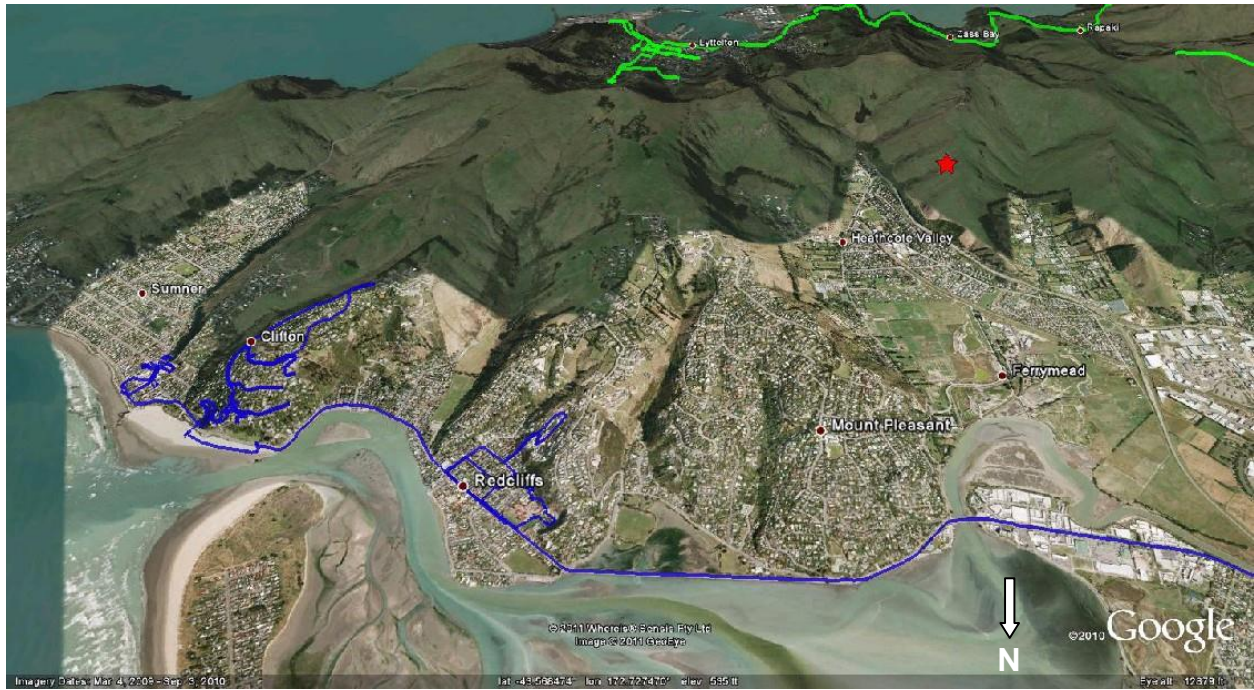
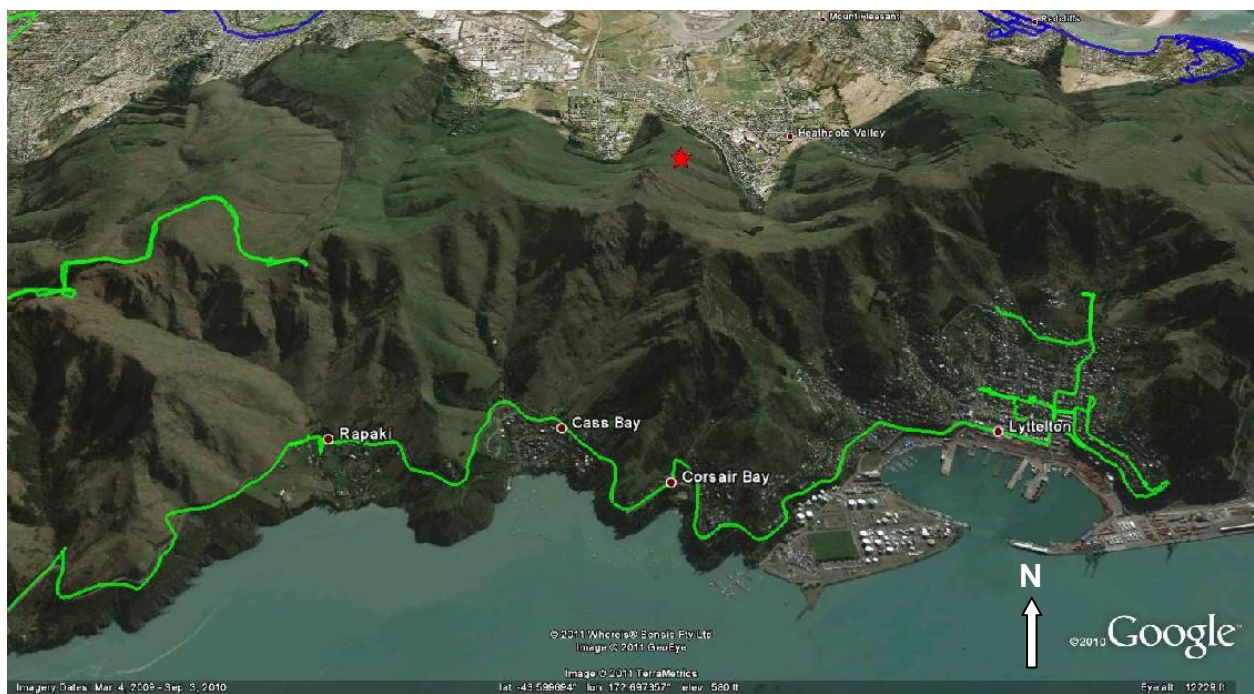
Figure 9-2. Oblique aerial views from Google Earth imagery. Red star is epicenter of 22 February 2011 earthquake (U.S. Geological Survey). Top – View from above New Brighton (eastern Christchurch) directly south across Port Hills, Blue line is GPS track from GEER team reconnaissance on 5 March 2011. Bottom – View from above Diamond Harbor and Quail Island

directly north across Port Hills. Green line is GPS track from GEER team reconnaissance on 4 March 2011.

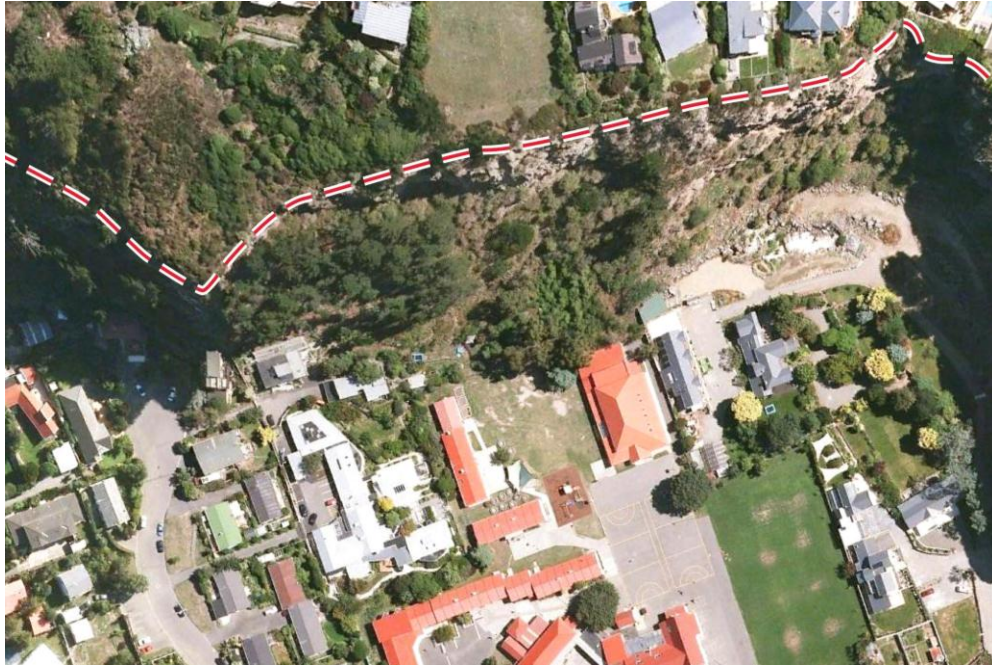
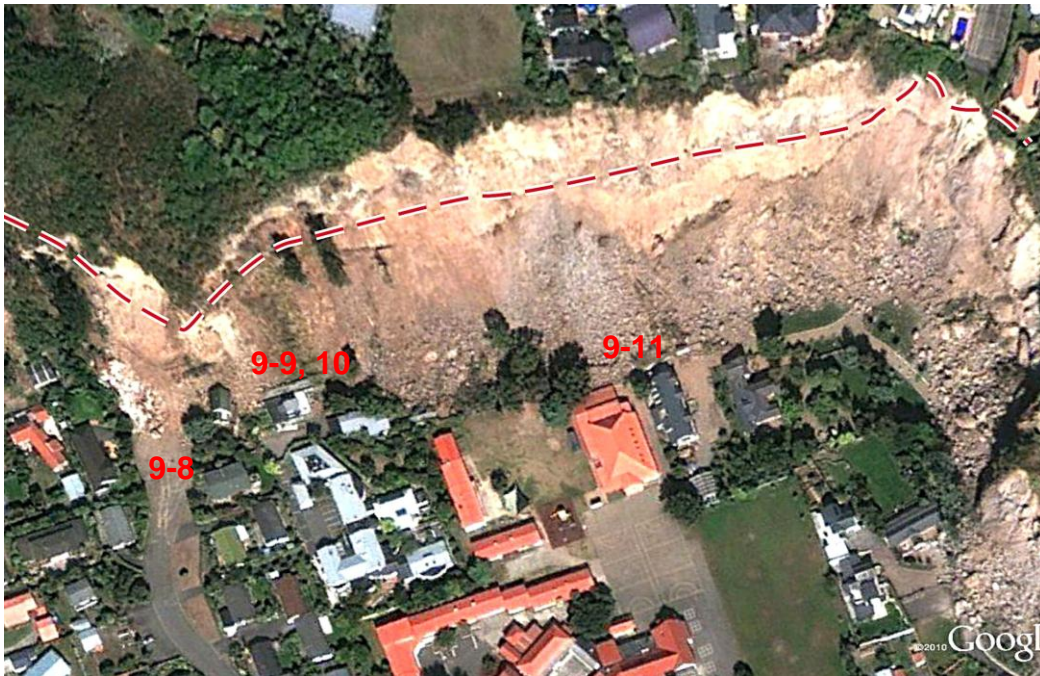
Darfield earthquake (the berm is not present on the 2009 pre-earthquake imagery; Figure 9-7 top). This berm was successful in protecting the schoolyard, as no rocks were observed in the area east of the fence beyond the rock berm (Figure 9-11).

Figure 9-7. Pre-Earthquake (4 March 2009; top) and post-earthquake (23 February 2011; bottom) Google Earth GeoEye imagery oblique views of cliff walls in Redcliffs. Red line shows approximate pre-earthquake top of cliff. Location of photographs on Figures 9-8 to 9-11 shown on lower image.

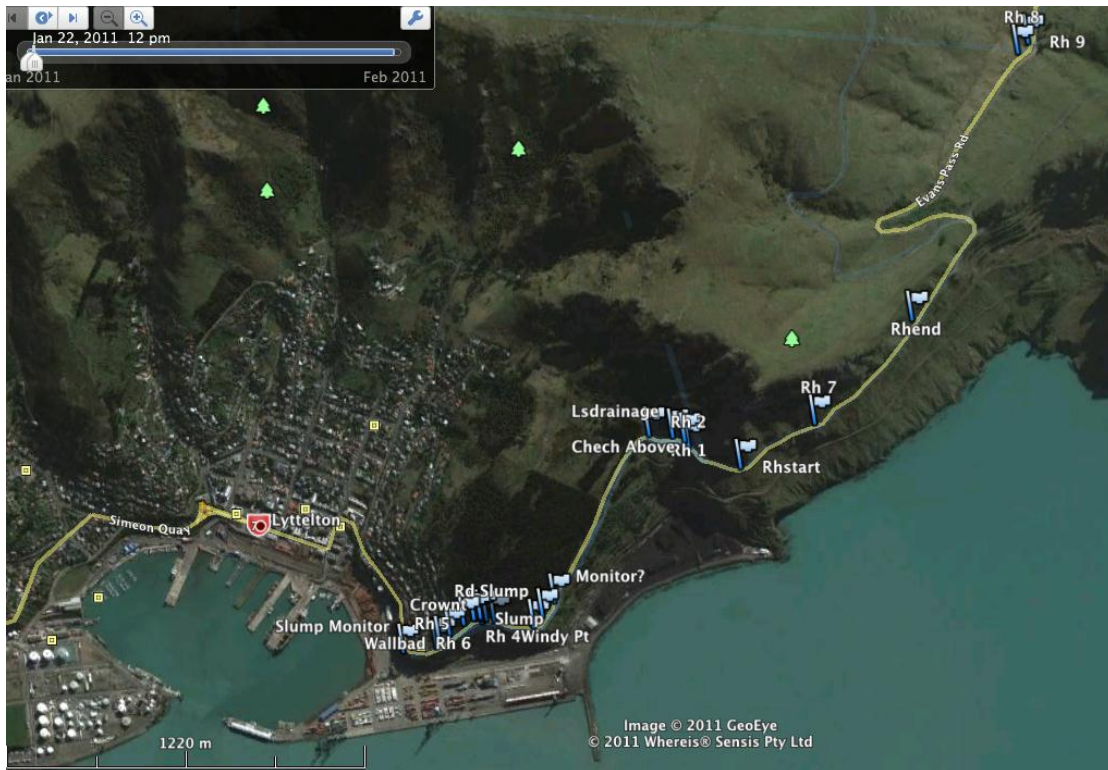
Evan's Pass road, the only direct transportation route and thus a lifeline between Sumner and the Port of Lyttelton, was closed due to rockfall blocking the road and trapping a transport truck. Rockfall and rock topples occurred on many of the over-steepened road cuts and from natural cliffs above the road alignment (Figure 9-12). These failures impeded delivery of relief supplies and critical transport between the port and the southern suburbs. In some locations, rockfalls occurred along bedding planes (e.g. Windy Point), however most rockfall occurred from cliffs composed of jointed columnar basalt and trachyte (Figure 9-13).

Figure 9-12. Evan's Pass Rd to Lyttelton and locations of Rockfall and slumping from reconnaissance on 25 Feb 2011.

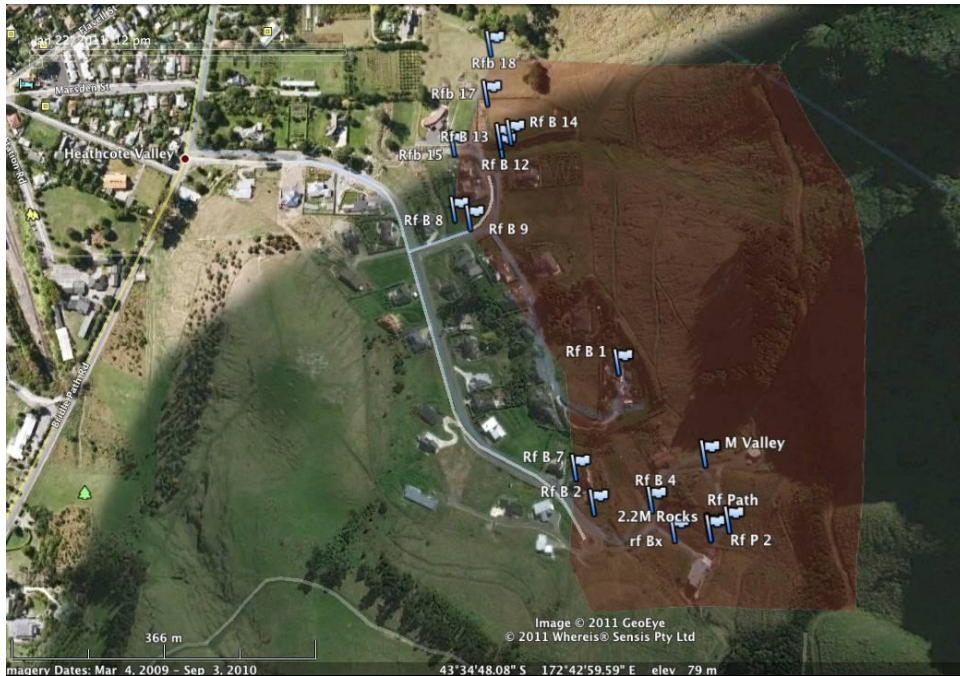
One location that was visited to conduct detailed mapping was Morgan's Valley above the Heathcote Valley, which had the highest recorded PGA during the 22 February earthquake. Detailed ground mapping was undertaken in Morgan's Valley to document rockfall occurrence and the potential for additional rockfall, as many of the homes remained inhabited post-earthquake. The rockfalls (individual boulders) caused by the 22 February event were located using GPS, and the mapping showed that at least six houses were hit by rockfall, with a number of additional near-misses (Figures 9-14, 9-15, 9-16, 9-17, and 9-18).

Figure 9-14. Boulder locations mapped 22-25 February 2011 in Morgan's Valley. Red shaded area was identified as the potential rockfall hazard zone.

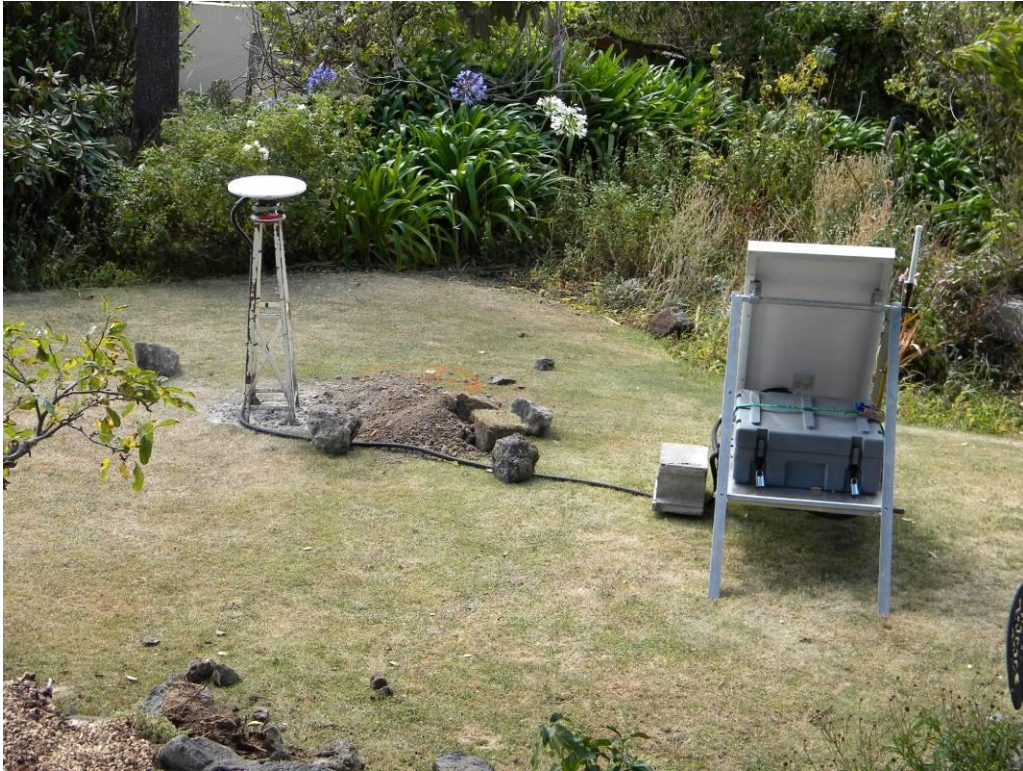
Figure 9-25. Continuous GPS monitoring station installed on Clifton Terrace by GNS to monitor post-earthquake slope movement (-43.56586° , 172.75272°).

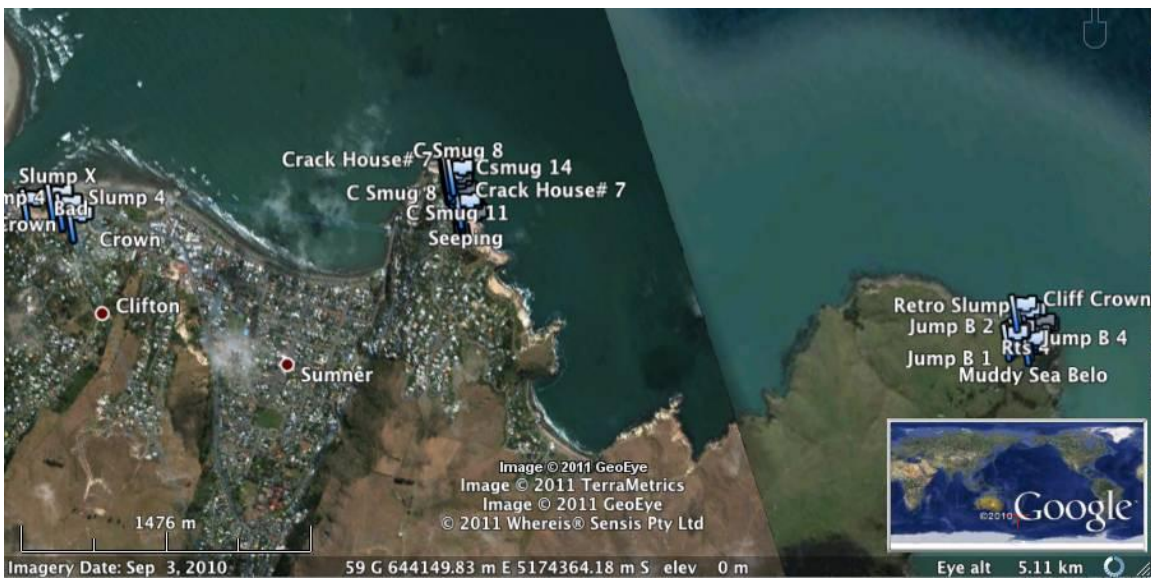
short duration of strong ground shaking. Generally these landslides were manifested as sets of open crown fractures or tension cracks that extended up to 500 m along the surface with vertical or steeply dipping scarps up to approximately one meter height. The fractures or cracks were tight to open, up to 50 cm wide and often ranged from 35 cm to several meters deep. The most impressive of these landslides was identified on Clifton Terrace above Sumner where cracks extended for hundreds of meters across many properties and through several houses (Figures 9-23 and 9-24). The GNS Science installed several continuous GPS monitoring stations to monitor potential post-earthquake movement (Figure 9-25). Similar crown fractures or tension cracks were found on Scarborough Terrace, with fractures/cracks extending through several homes above Taylor's Mistake. A number of crown cracks were also found at Godley Head (Figure 9-26).

Figure 9-26. Location of deep-seated landslides along headlands in the Eastern Port Hills.
