# Engineering Reconnaissance Following the October 2016 Central Italy Earthquakes Version 2

GEER Team Leaders: Jonathan P. Stewart and Giuseppe Lanzo

Geotechnical Extreme Events Reconnaissance Association Report No. GEER-050D 8 May 2017

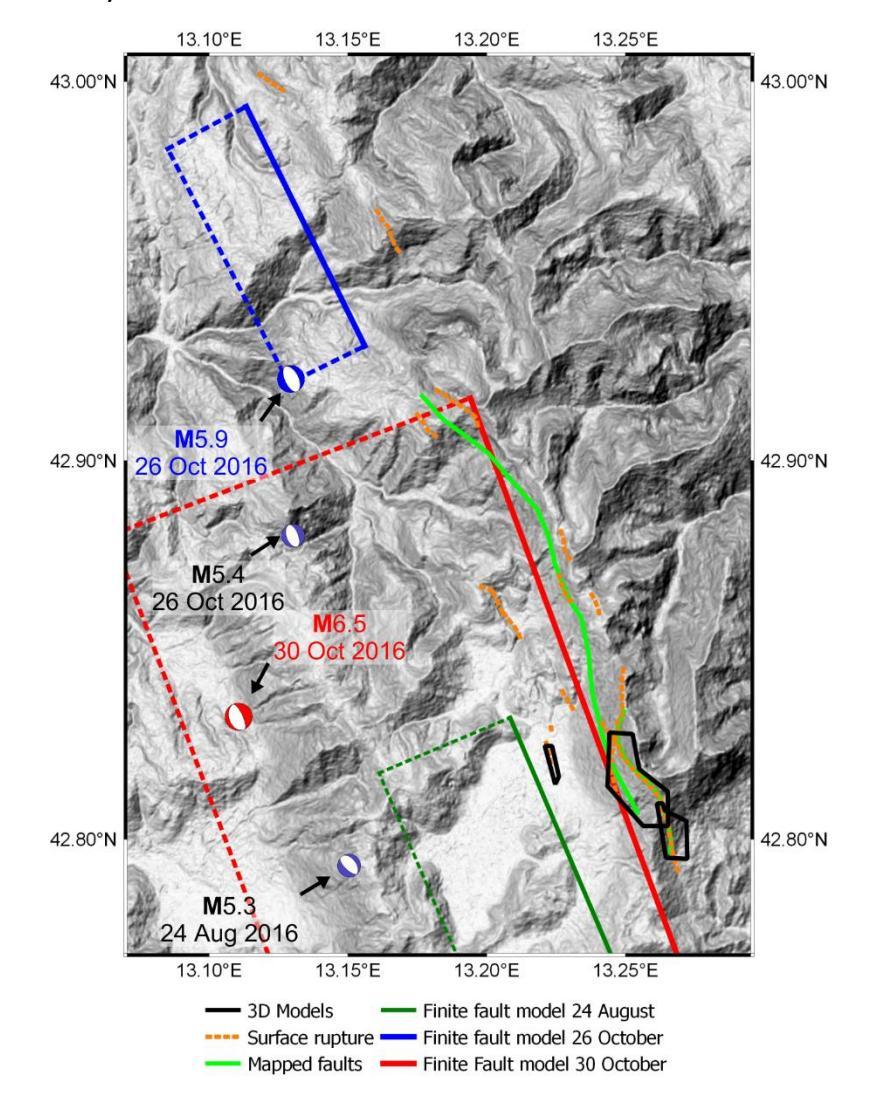
As shown on Figure 2.4, the locations of the observed surface ruptures coincide with a segment of the Mt. Vettore fault as mapped by Falcucci et al. (2016). This segment of the fault did not rupture in the 24 August event. No information about the last known rupture of this fault segment is available. It has likely ruptured during past events on the Mt. Vettore fault as identified by Galadini and Gali (2003) through paleoseismological studies.

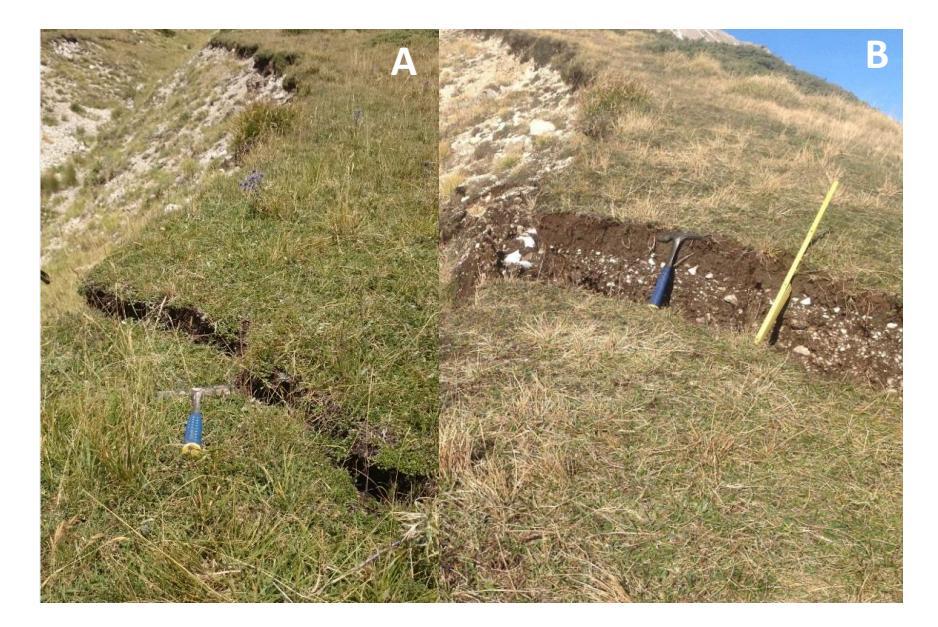
**Figure 2.5**. Comparative fault offset of 10cm. (a) Vertical offset from the August event, and (b) 30cm Vertical offset from the October 2016 events on the south face of Mt. Vettore near road SP477. Horizontal offsets were 0cm and 2cm. Lat = 42.79795, Long = 13.26607.

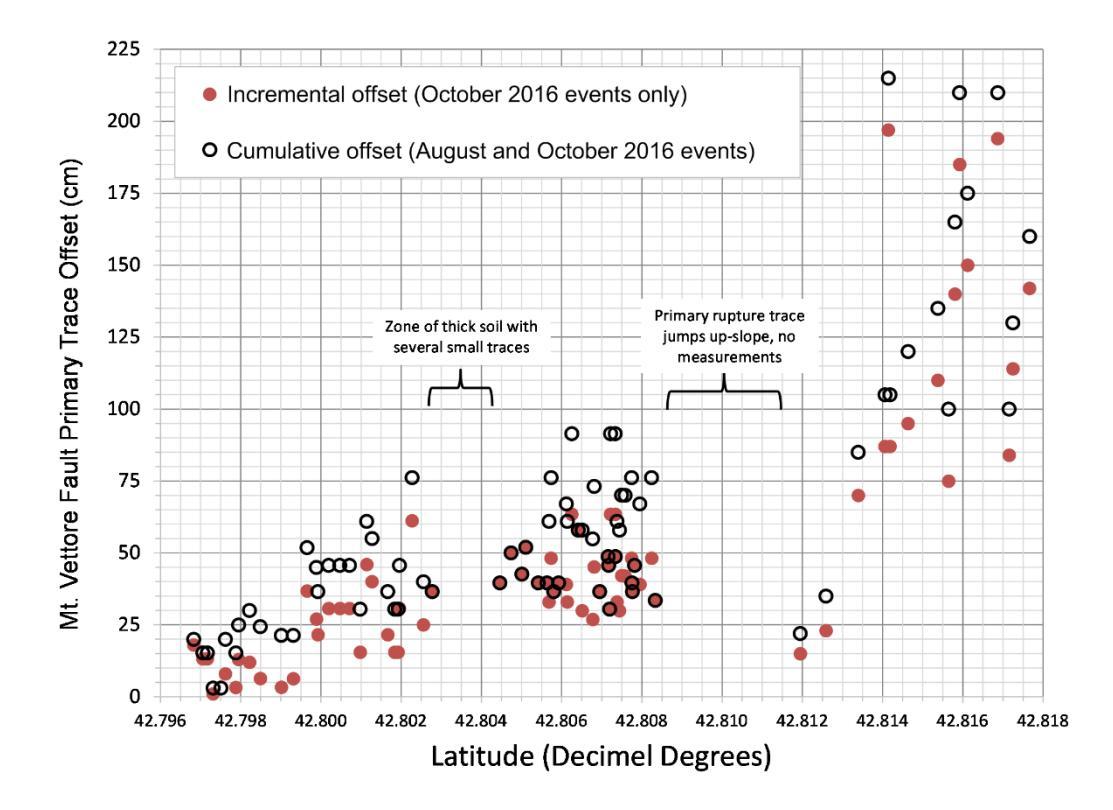
**Figure 2.6**. Distribution of incremental and cumulative fault offsets for the southern half of the Mt. Vettore fault. All data in this Figure from hand measurements.

In the southern portion of Mt Vettore fault, slip occurred on three segments. The primary segment is on the ridge of Monte Vettore at the contact between bedrock and thin overburden talus and alpine deposits. An apparently secondary segment occurs lower on the ridge, which ruptured in the 30 October event but not in the earlier events. Another secondary segment is in the lower-lying basin, Piano Grande, in lacustrine and alluvial deposits that have infilled the basin. Rupture on this segment was only observed following the 30 October event.

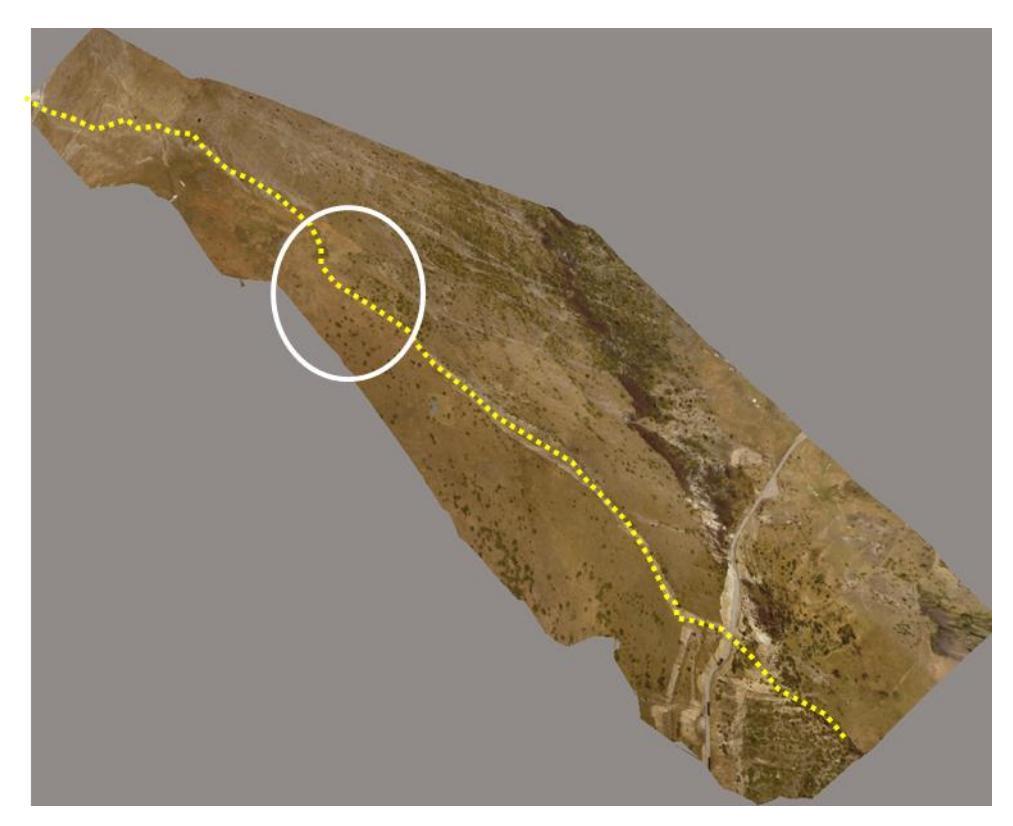
An interesting observation from both 3D point cloud and conventional mapping is that there is a zone of apparently thick and soft (ductile) soil sediment overburden on the slope where the distinct single fault rupture surface is defrayed into several smaller scarps. This area is shown in Figure 2.9. Above and below this area, the fault trace is singular and well defined. Within the

area, the fault splinters into 4 to 6 distinct, short, small displacement traces roughly parallel to one another.

**Figure 2.9**. 3D digital terrain model from merged SfM and LiDAR data of the Mt Vettore fault on the southern flank of the Mt Vettore Massif. Approximate main fault trace indicated in yellow. Looking from the west to the east. The upper left of the image is the top of the slope. Area of soft sediments where the fault trace breaks into several (4 - 6) small scarps is indicated in white.

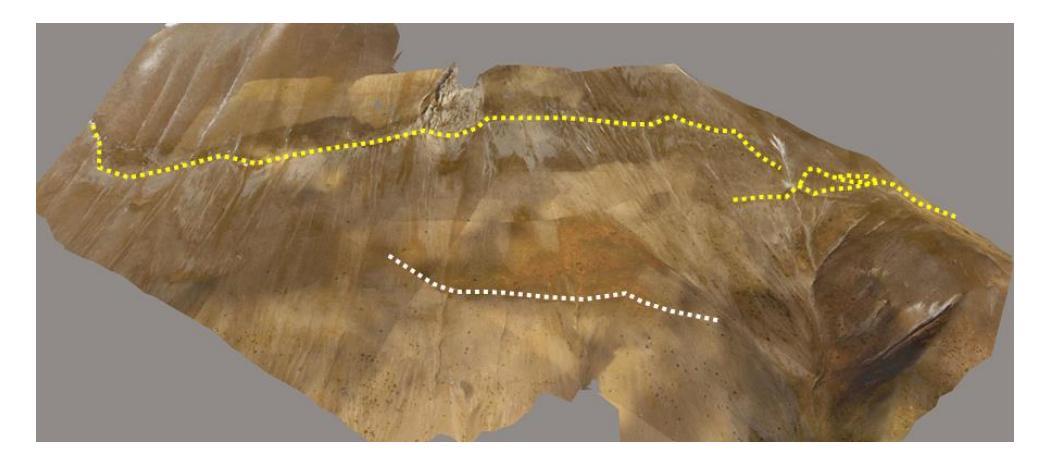
Rupture displacements increase as the fault extents to the north. Also, the rupture becomes more centralized to a single surface as the fault moves north between Figures 2.9 and 2.10. On the south (right) of Figure 2.10, the fault has several distinct rupture scarps that we have interpreted as fault scarps. Several other scarps were measured, mapped, and are shown in the 3D model. These other scarps are interpreted as minor slope instability scarps and are discussed in Chapter 4 (Section 4.2.10).

**Figure 2.10**. 3D digital terrain model from merged SfM and LiDAR data of the Mt Vettore fault on the western flank of the Mt Vettore Massif. Approximate main fault trace(s) indicated in yellow, a second visible trace of the "Western Trace" shown in white (See Figure 2.11 for more details). Looking from the west. The left of the image is to the north. The slope moves from top to bottom of the image.

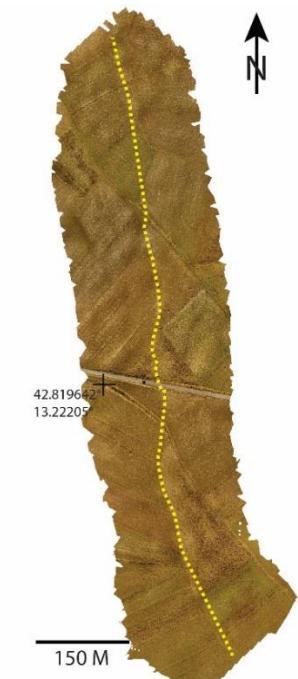
The final 3D point cloud model is from LiDAR imaging of the Piano Grande fault at the western foot of the Mt. Vettore Massif (location shown by the orange rectangle on left side of Figure 2.8). The Piano Grande fault has been interpreted as a secondary rupture surface. This fault was not observed after the August 2016 event. Figure 2.11 presents an image of this 3D model.

**Figure 2.11**. 3D digital terrain model from merged SfM and LiDAR data of the Piano Grande fault on the western toe of the Mt Vettore Massif. Approximate fault trace(s) indicated in yellow. Looking from the west. The left of the image is to the north. Mt. Vettore on the top of the image

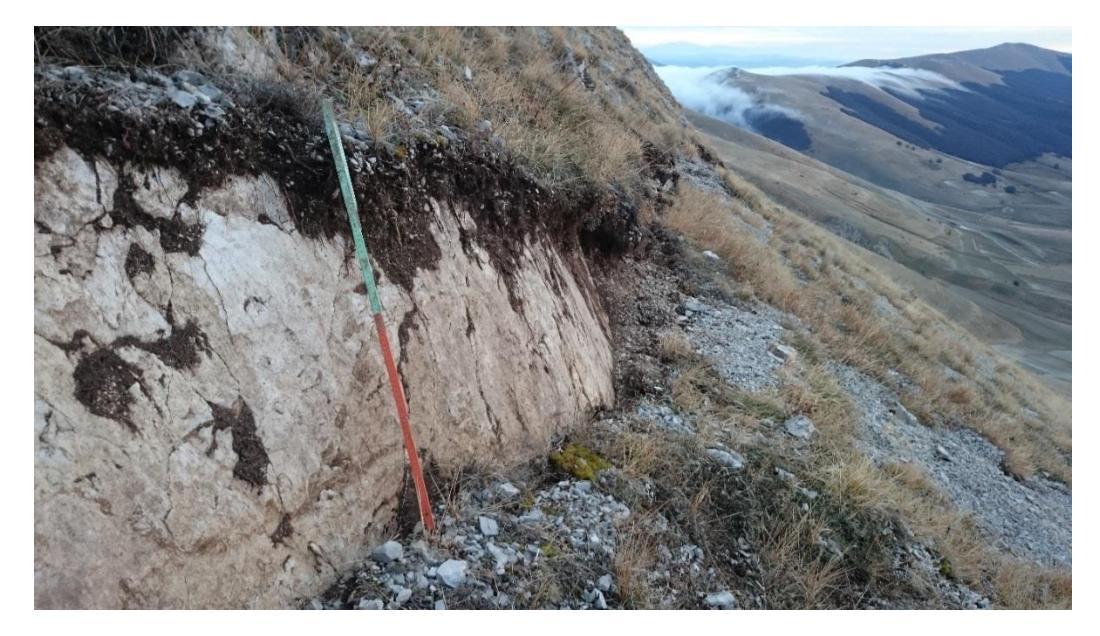
**Figure 2.12**. Fault offset measurements showing relative offset of August 2016 (0 cm) and October 2016 (70 cm) events on the lower or "western" fault trace in Figure 2.10 (shown in white). Lat = 42.812901, Long = 13.24626.

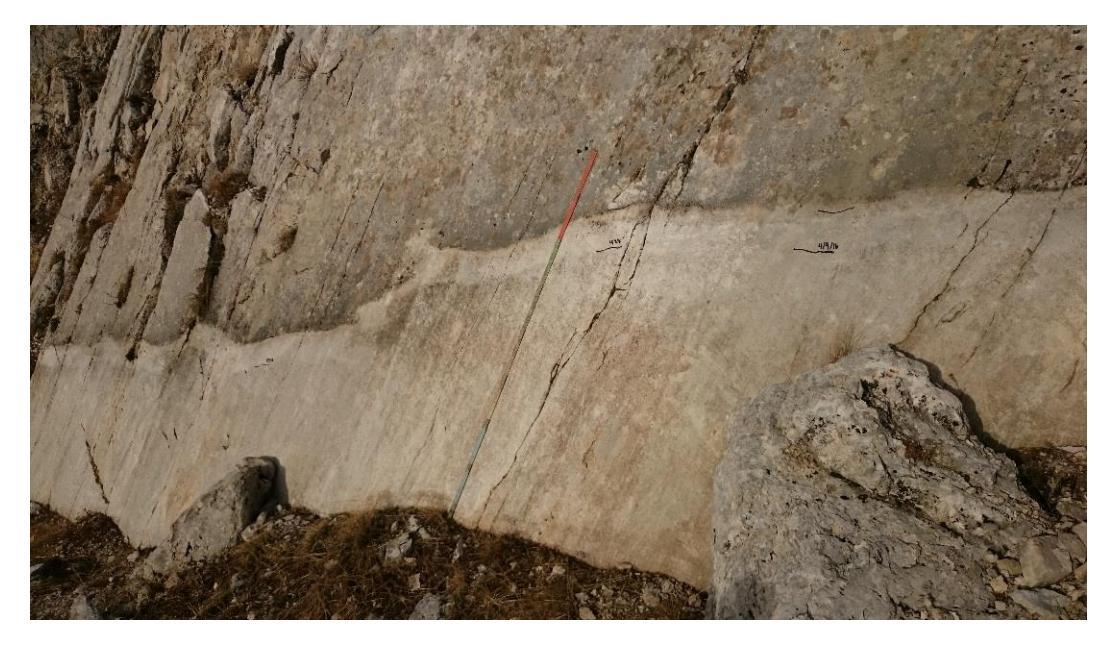
**Figure 2.13**. Fault slip measurements showing multi-epoch offsets from August 2016 (upper white band, 16 cm) and October 2016 (130 cm) events. Lat = 42.81724, Long = 13.25449.

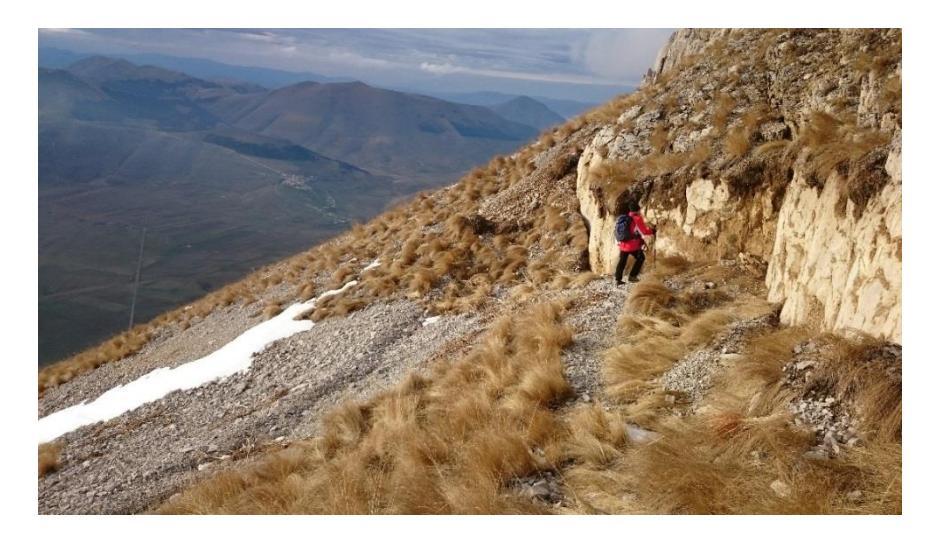
**Figure 2.14**. Location of maximum fault offset of 210 cm following October 2016 events. The August event offset at this location is estimated as 20 cm, based on nearby data points. Lat = 42.81687, Long = 13.25503.

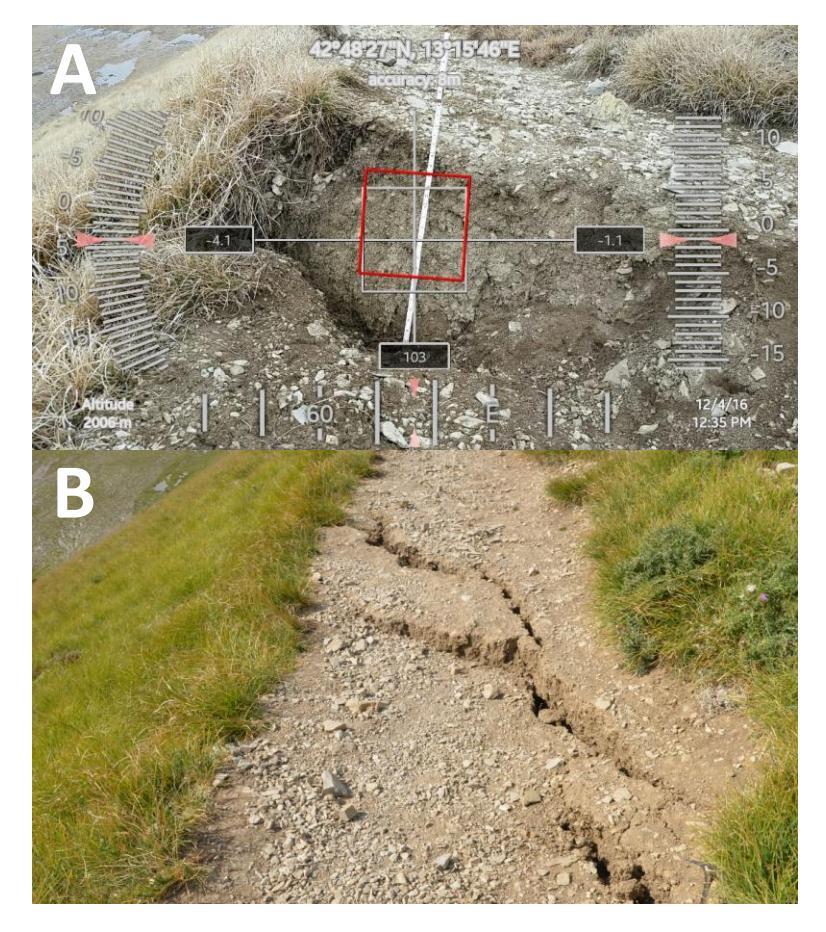
**Figure 2.15**. Fault offset measurement across the footpath on the west face of Mt. Vettore. Offset measured as 80 cm following October events (a). This offset was 30 cm following August events (b). Lat = 42.807379, Long = 13.262966.

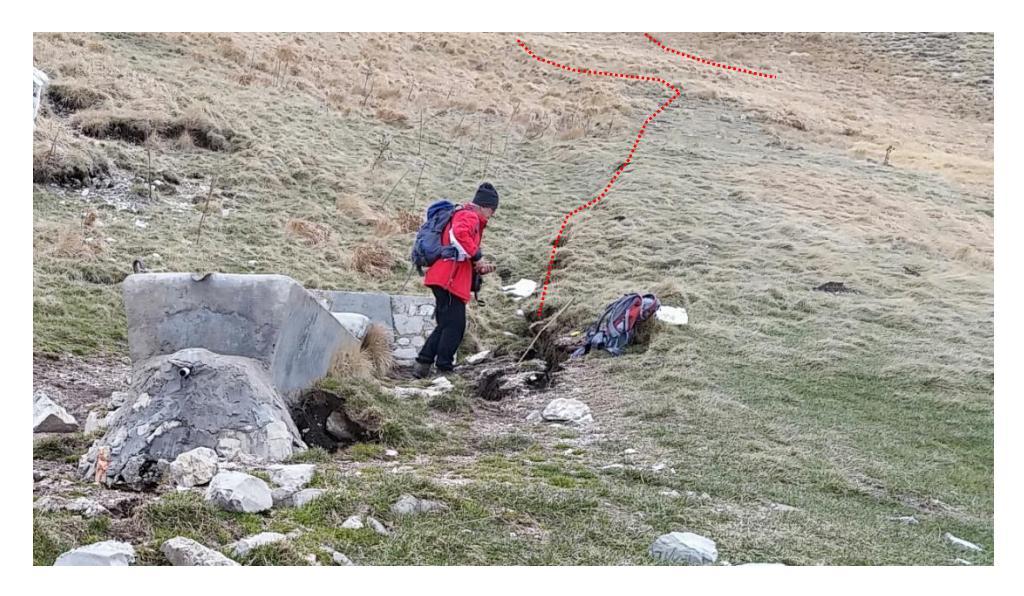
**Figure 2.16**. Fault trace on the south face of Mt. Vettore, where the fault has ruptured along the path of buried polyethylene pipe supplying the pictured spring. Rupture partially hidden by long grass. Offset measured at 45 to 65cm. August offset data nearby is 0 to 15cm. Trace(s) above the spring indicated in red. Lat = 42.80474, Long = 13.26441.

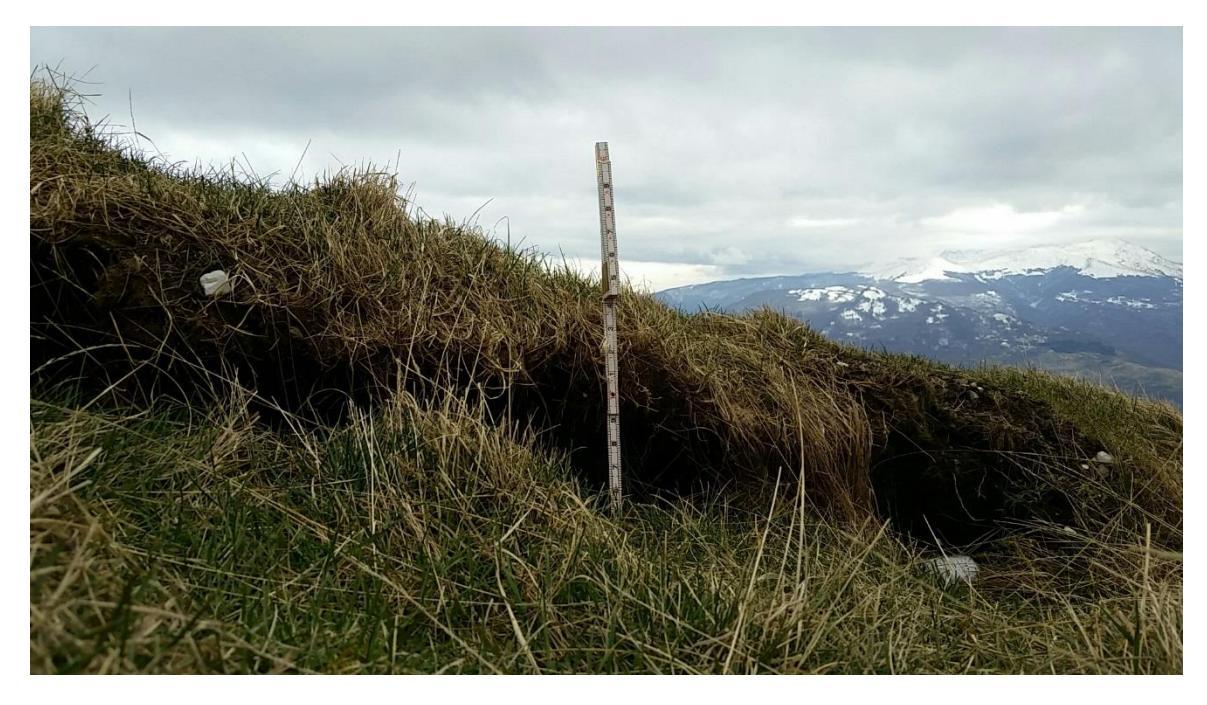
**Figure 2.17**. Fault offset measurement of one of several (4 to 6) small traces on the south face of Mt. Vettore in the area indicated in white in Figure 2.9. In this area surface soils are thick and ductile. Offset measured at 8 to 52cm on each trace. August offsets were 0 cm. Lat = 42.80483, Long = 13.26443.

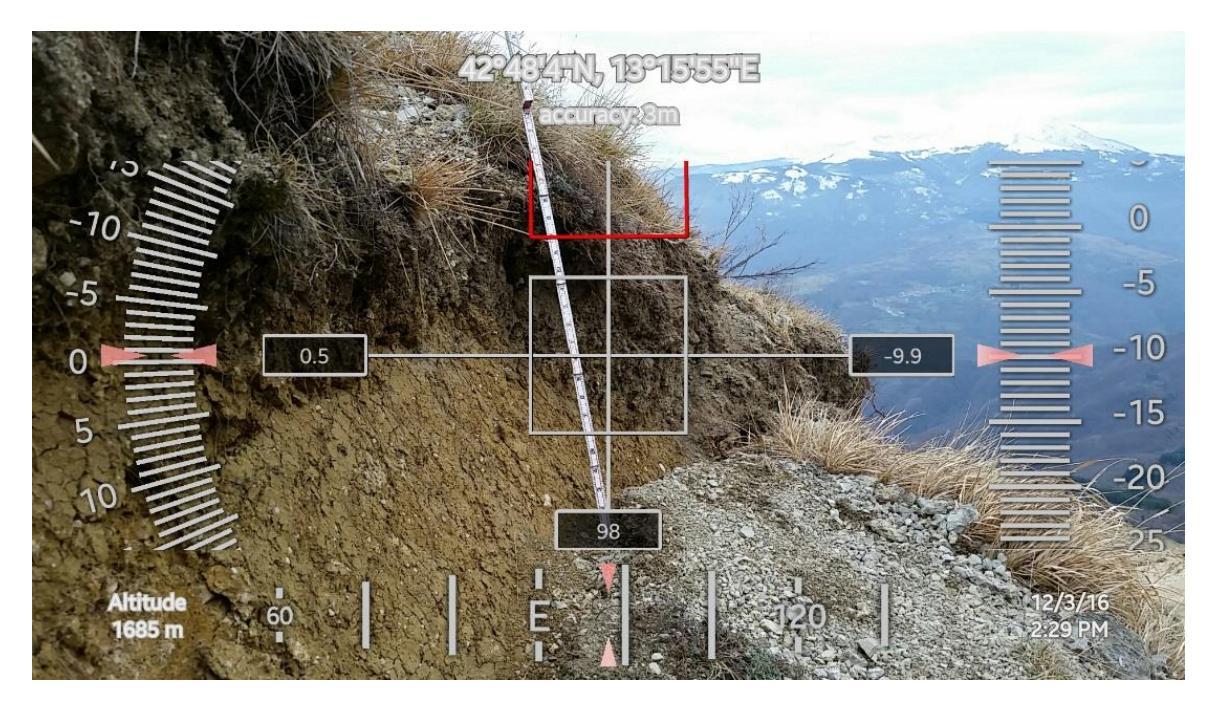
**Figure 2.18**. Fault offset measurement in gulley on south face of Mt. Vettore. Offset measured at 80cm. August offset data nearby is 15cm, indicating October 2016 offset of 65cm.

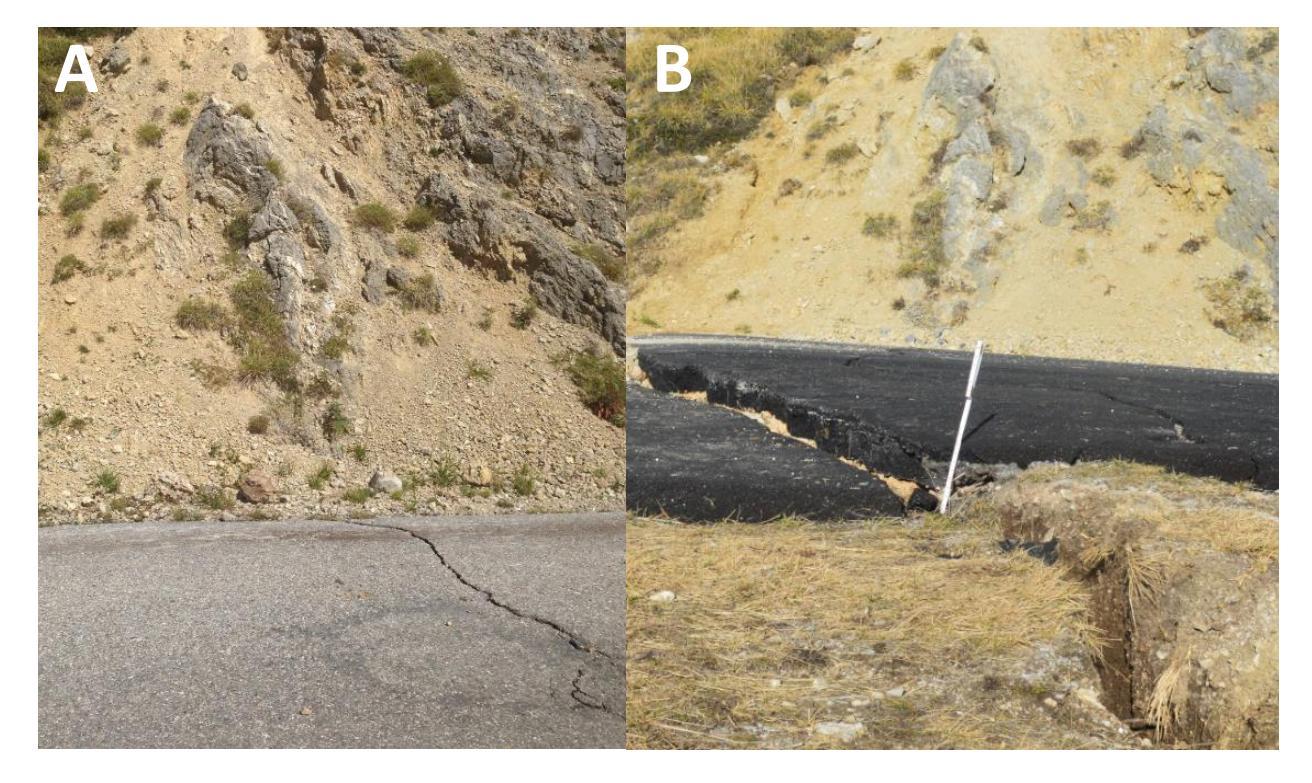
**Figure 2.19**. Fault offset measurement across SR477 on south face of Mt. Vettore. August offset data nearby is 2cm (a). Offset measured at 18cm to 20cm after October (b). Lat = 42.796829, Long = 13.265899.

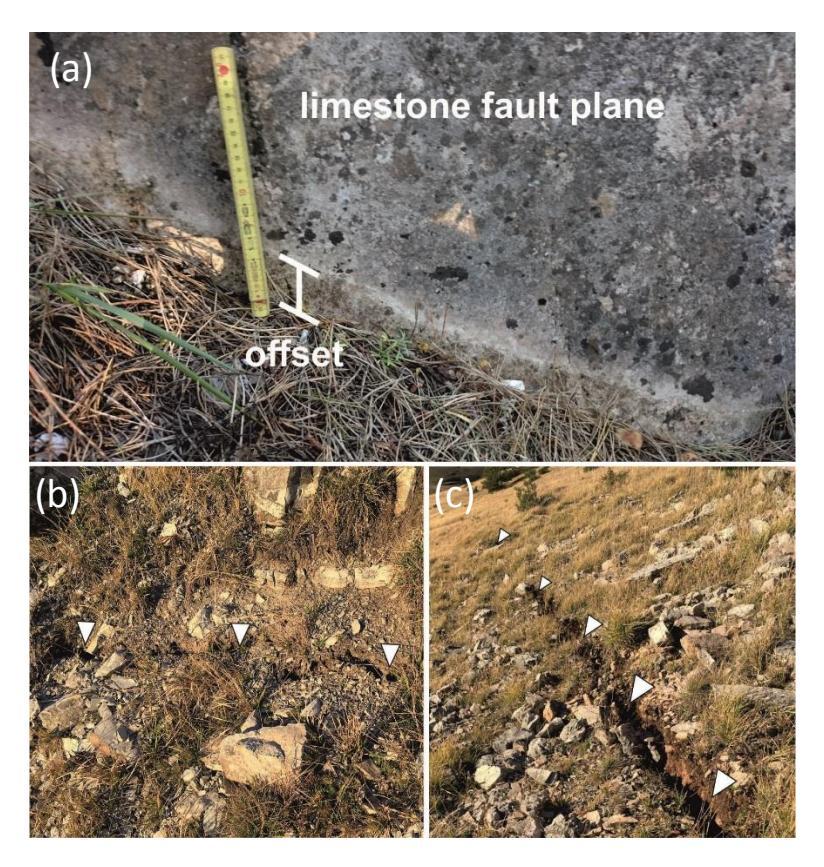
The Mt. Vettore fault crosses variable surficial geologies, with differences in fault rupture manifestation for each surface material type. Figure 2.21 presents three different images of the fault rupture. The fault occasionally followed a well-defined limestone fault plane. This was especially true in the "gulley" on the south face of Mt. Vettore and along much of the west face of the Massif for both the main and western splays of the fault. Measurements are relatively straightforward in these areas. In areas where a near-surface limestone fault plane was not present (i.e. thick soil sediment cover), the fault rupture often appears as shown in Figures 2.21a and 2.21b, with lateral gapping developing and the fault trace occasionally splitting into two or more traces. Displacements across these individual traces often sum to be as much as the displacement in adjacent areas with shallow or exposed limestone. For example, between latitudes 42.806 and 42.808, the fault trace splits into several traces, converges, and then diverges again before becoming a single distinct surface north of Latitude 42.808. In the locations of a single trace, the measured offset is 92 cm. In the nearby locations with 2 or 3 traces, the individual traces measure 30 to 40 cm, but the sum is very close to 90 cm.

**Figure 2.21**. Fault offset measurements along the south and west faces of the Mt. Vettore Massif showing differences in fault rupture offset through soil versus along the rock fault plane (where visible on the slope).

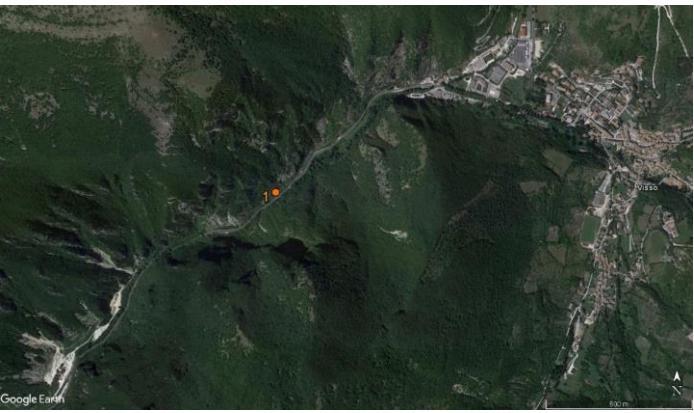
Figure 4.4. Location of the Nera landslide.

A large rockfall above the Nera River, a tributary of the Tiber River, occurred just downstream and 1 kilometer west of the town of Visso (Figure 4.4 and Table 4.1). No reports of slope instability at this location were made following the 24 Aug 2017 event nor the 26 October 2017 event. The landslide was witnessed by a passing car during the 30 October 2017 event (Visso resident), who had just passed through the Strade Provinciale 209 tunnel west of the site and saw the slide debris pass over the roadway in his rear-view mirror.

This large rock fall damaged national road SS-209 and formed a small landslide lake as shown in Figure 4.5. The rockfall severed road transportation between Visso and the Spoleto Valley. Access to Visso, the Nera river valley and the landslide was from the eastern Adriatic coast.

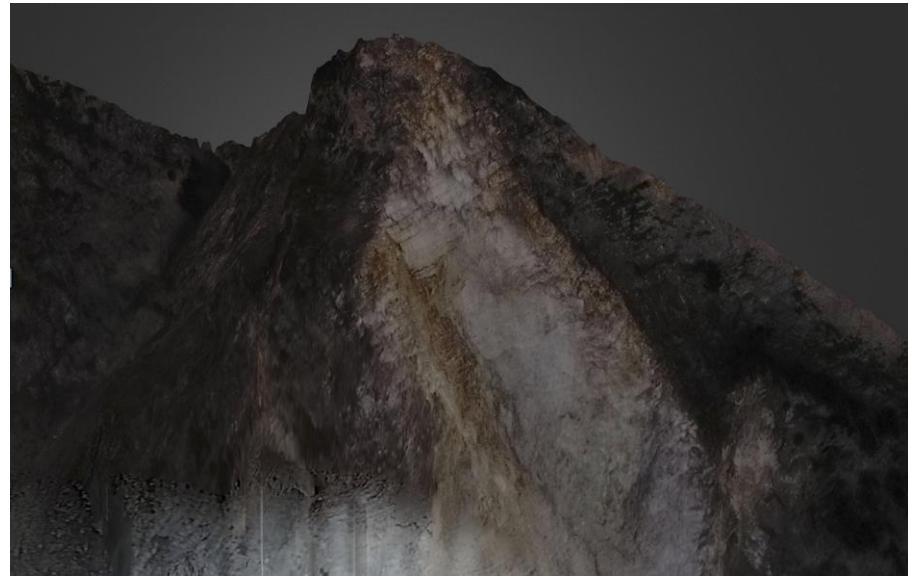
The upper detachment zone can be seen in the SFM imagery of Figure 4.6-4.7. In these images, the bedding is seen with an apparent dip towards the east of 20°-30°, and the wedge is apparently a double joint set orthogonal to the bedding. The failure occurred along the joint sets. Further analysis of the SFM data may resolve the strike and dip of the bedding and the joint sets that resulted in the detachment.

Figure 4.6. Headscarp of Nera rockfall.

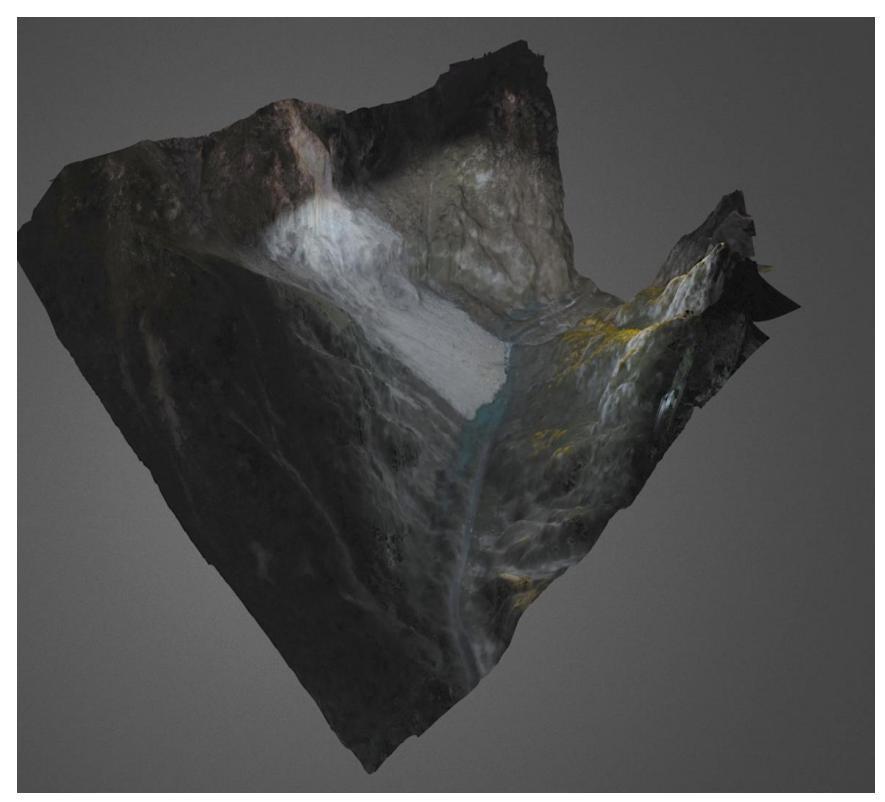
**Figure 4.7**. 3D Structure-from Motion (SFM) model of the Nera river valley at the rockfall. The Nera rock avalanche is seen here from the east (Visso) side of the rockfall. The light color on the midslope is from the setting sunlight on the SfM UAV imagery. Elevation difference from the crest of the headscarp to the river is 330m.

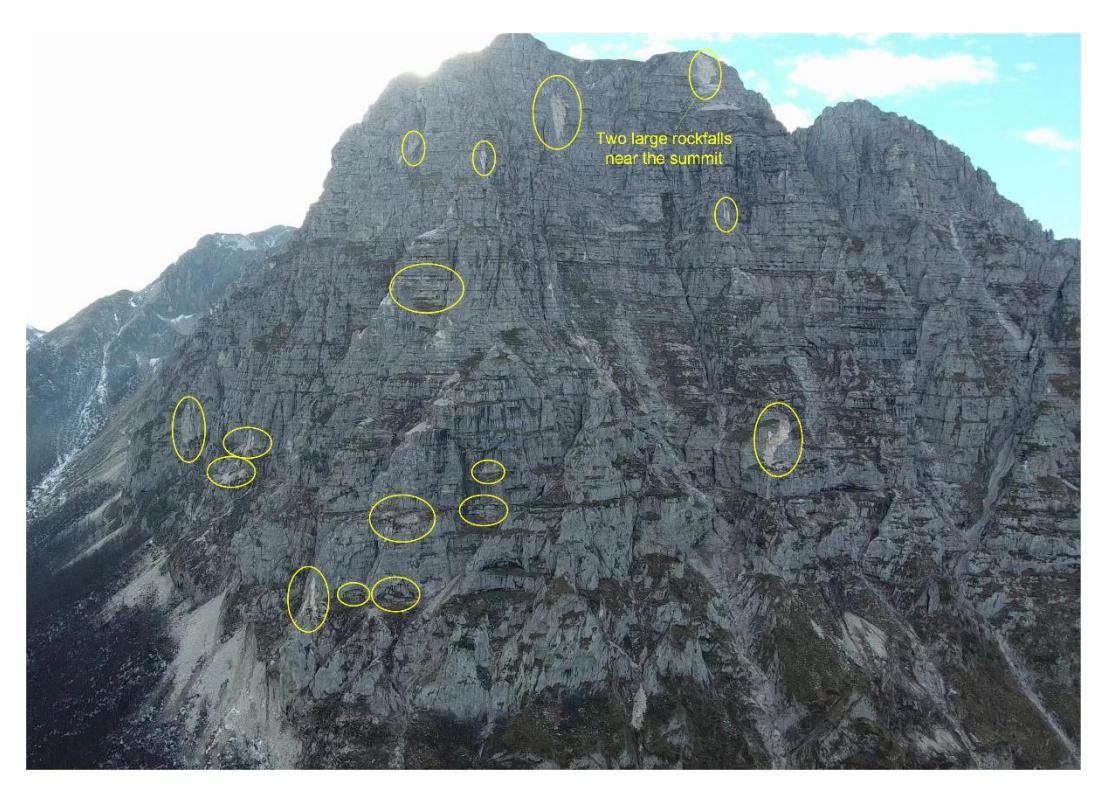
Numerous talus fields were visible along the base of Monte Bove, some of which are visible in Figure 4.9. These talus fields were located more than two kilometers from where the GEER reconnaissance team members were deployed, and could only be imaged from a distance. Suspected source areas for these talus fields were visible on Monte Bove by the lighter coloration of the freshly-exposed unweathered limestone (many circled in Figure 4.9). Two particularly large rockfalls were observed near the summit of Monte Bove, and are labeled in Figure 4.9. The upper rockfall was photographed using a 300 mm telephoto lens (Figure 4.10). The BYU Phantom 4 UAV was used to image as much of Monte Bove as possible, but flight altitude and distance-from-controller limitations prevented the UAV from clearly imaging the large rockfalls near the summit. Nevertheless, the captured UAV video was processed using SfM computer vision to develop a non-scaled 3D meshed surface model of the most of the mountain minus its summit. A screenshot of this model is presented in Figure 4.11. Links to the three-dimensional models resulting from this work are available at the <u>GEER web site (Appendices A1-A11)</u>, and at the <u>BYU-PRISM website</u> (last accessed 5 May, 2017).

Figure 4.9. Phantom 4 UAV image of Monte Bove. Suspected rockfall sources are circled in yellow.

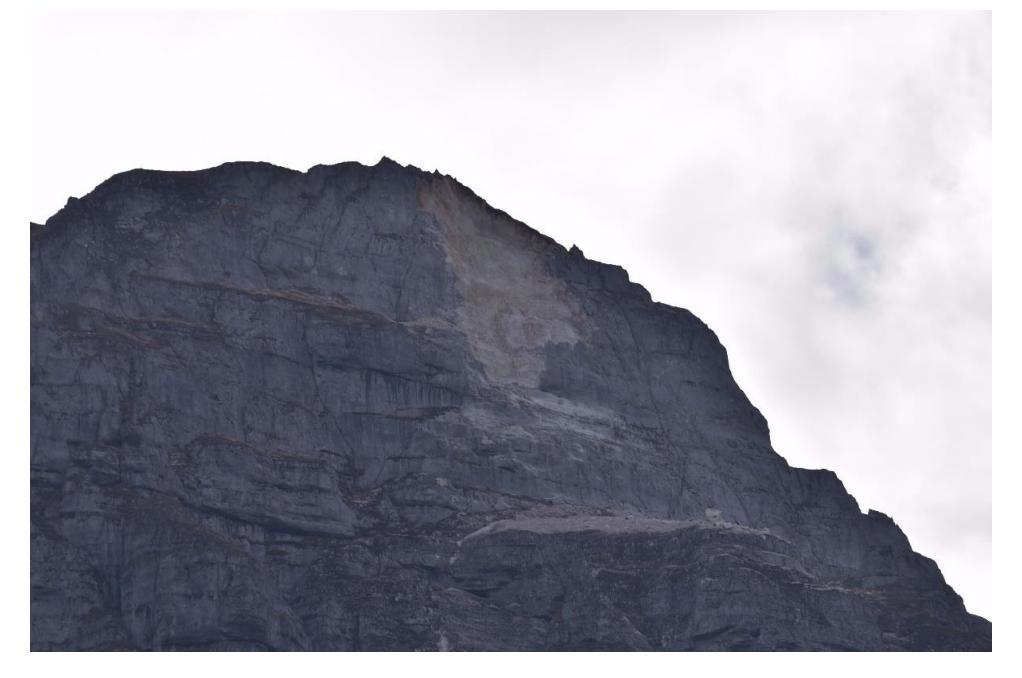
Figure 4.10. Photograph (300 mm) of the upper rockfall near the summit of Monte Bove.

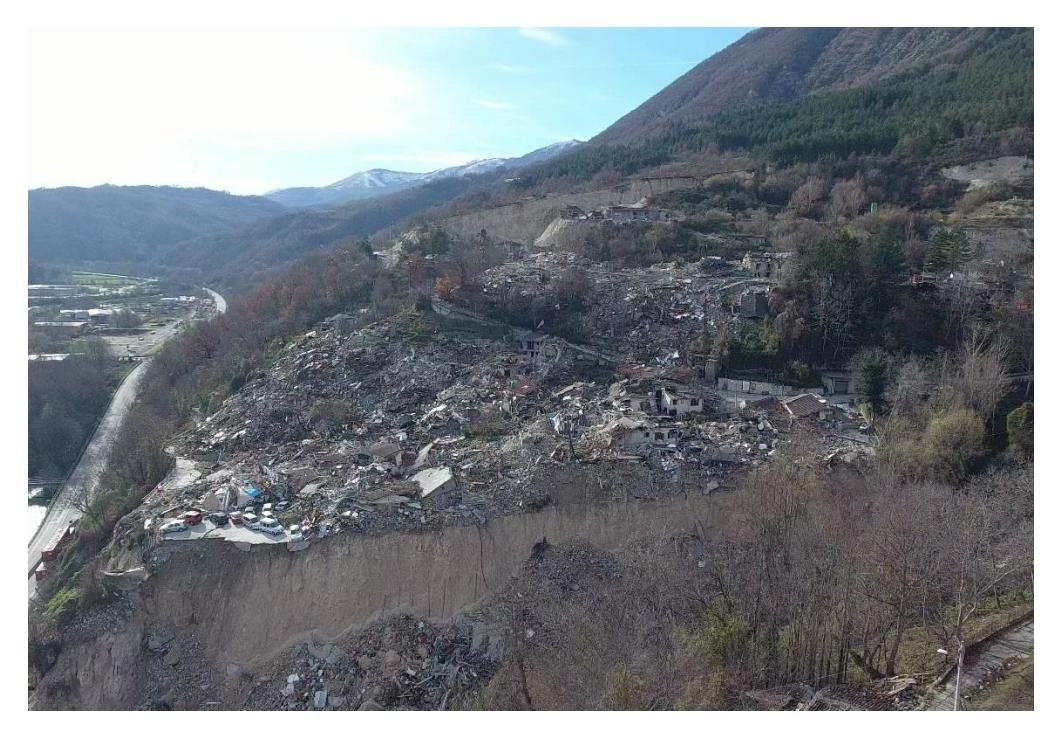
Figure 4.13. Pescara del Tronto aerial photograph taken from the Phantom 4 UAV.

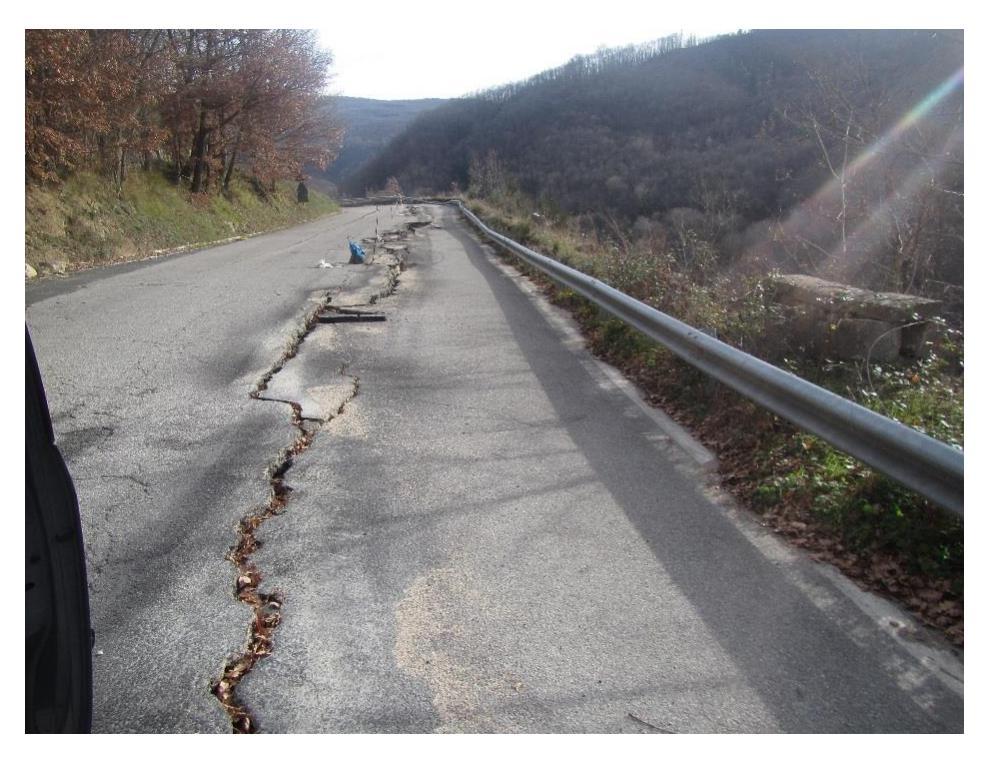
Moderate to severe damage was observed in most of the roads located adjacent to slopes and/or above retaining walls throughout Pescara del Tronto. An example of the typical damage that was observed is presented in Figures 4.16 and 4.17. Most of the damaged observed in the roads appears to be due to horizontal deformations in the fill material placed on the slopes (Figure 4.16) or behind the retaining walls (Figure 4.17). Observed damage typically consisted of long cracks in the pavement running parallel with the face of the slope or retaining wall, often with variable amounts of vertical offsets due to rotation of the retaining wall and/or settlement of the underlying fill.

**Figure 4.17**. Road damage induced by slight rotation of the underlying retaining wall and/or settlement of the retaining wall backfill.

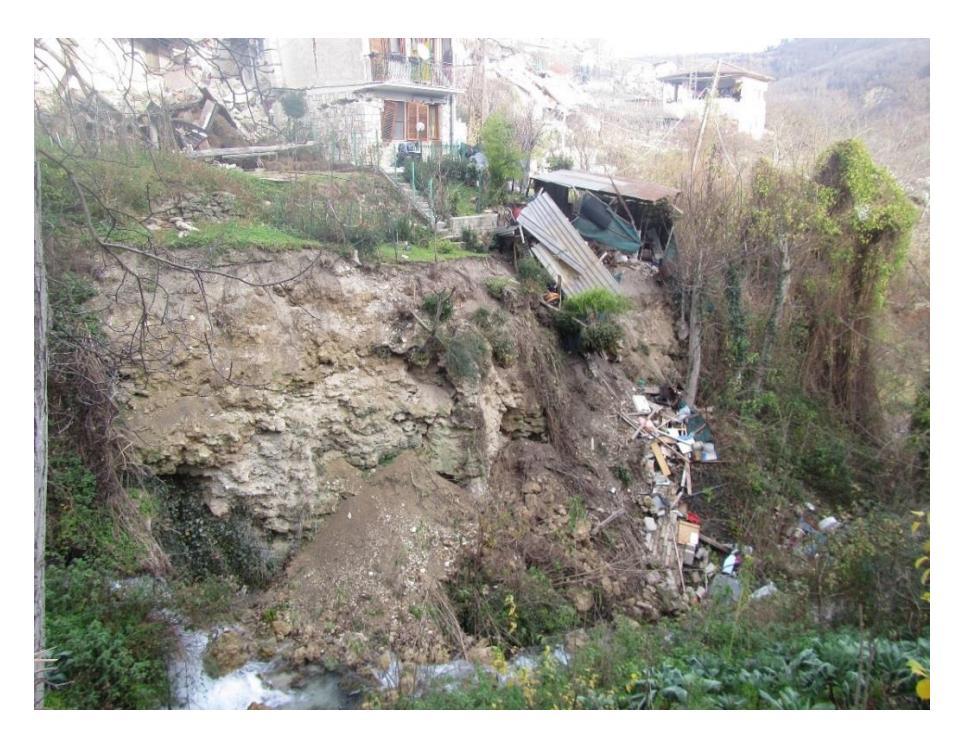
Within the village of Pescara del Tronto, there exists a natural creek that flows down a gulley located in the middle of the village. The presence of the gulley gives Pescara del Tronto the appearance of an inverted horseshoe shape or upside-down "U" when observed from the air (see Figure 4.12). During the December reconnaissance mission, GEER team members observed that portions of the gulley wall had failed in localized landslides, causing any overlying structures to fall into the gulley (Figure 4.20). The exposed scarps revealed talus comprised of heavily weathered limestone.

Figure 4.20. Failure of steepened talus gully wall material and crest area above (Location 3e).

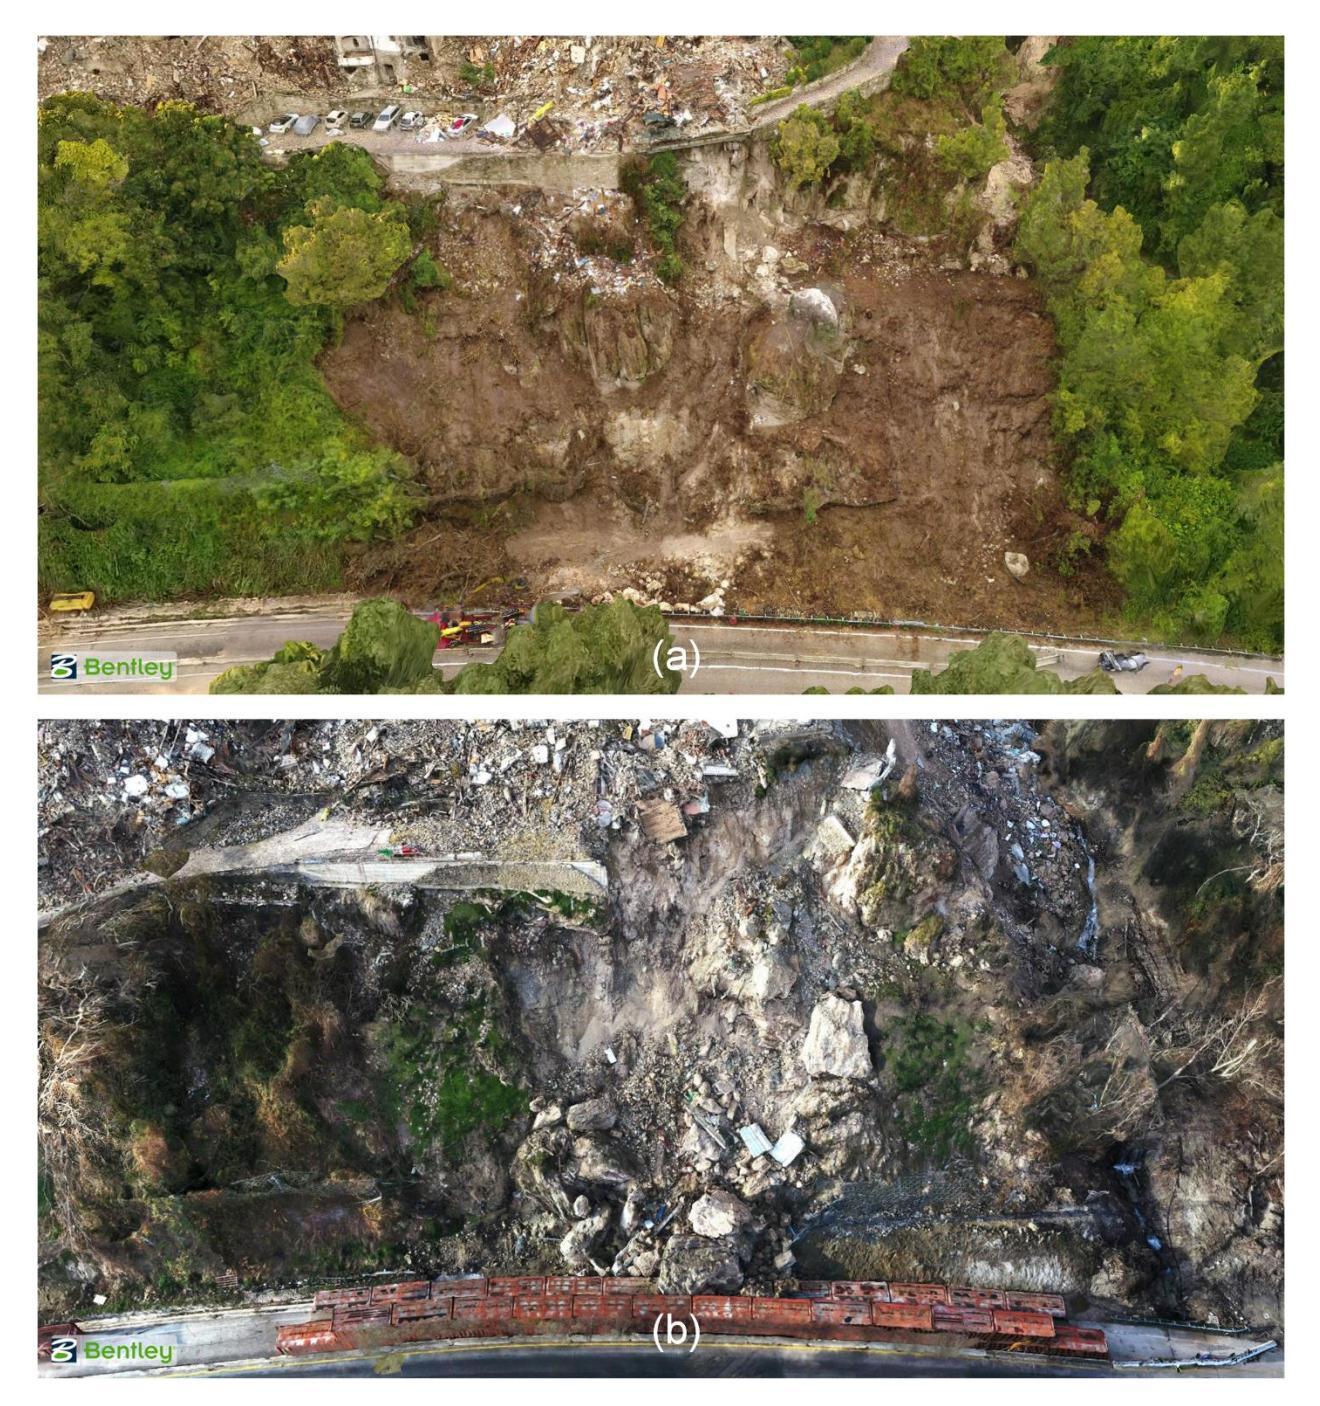
<u>Area 1: Landslide above Strada Statale No. 4:</u> As mentioned above, significant movement occurred on the landslide below Pescara del Tronto, directly above Strada Statale No. 4. This significant movement is apparent when comparing the landslide from September (Figure 4.22a) with the landslide from December (Figure 4.22b). Large portions of the road and supporting retaining wall that were standing in September collapsed with the landslide in December. It appears that the majority of the very large limestone boulders visible in December were dislodged from beneath the road.

**Figure 4.22**. 3D model comparison of the landslide below Pescara del Tronto between September 2016 (a) and December 2016 (b).
