# Engineering Reconnaissance Following the October 2016 Central Italy Earthquakes Version 2

GEER Team Leaders: Jonathan P. Stewart and Giuseppe Lanzo

Geotechnical Extreme Events Reconnaissance Association Report No. GEER-050D 8 May 2017

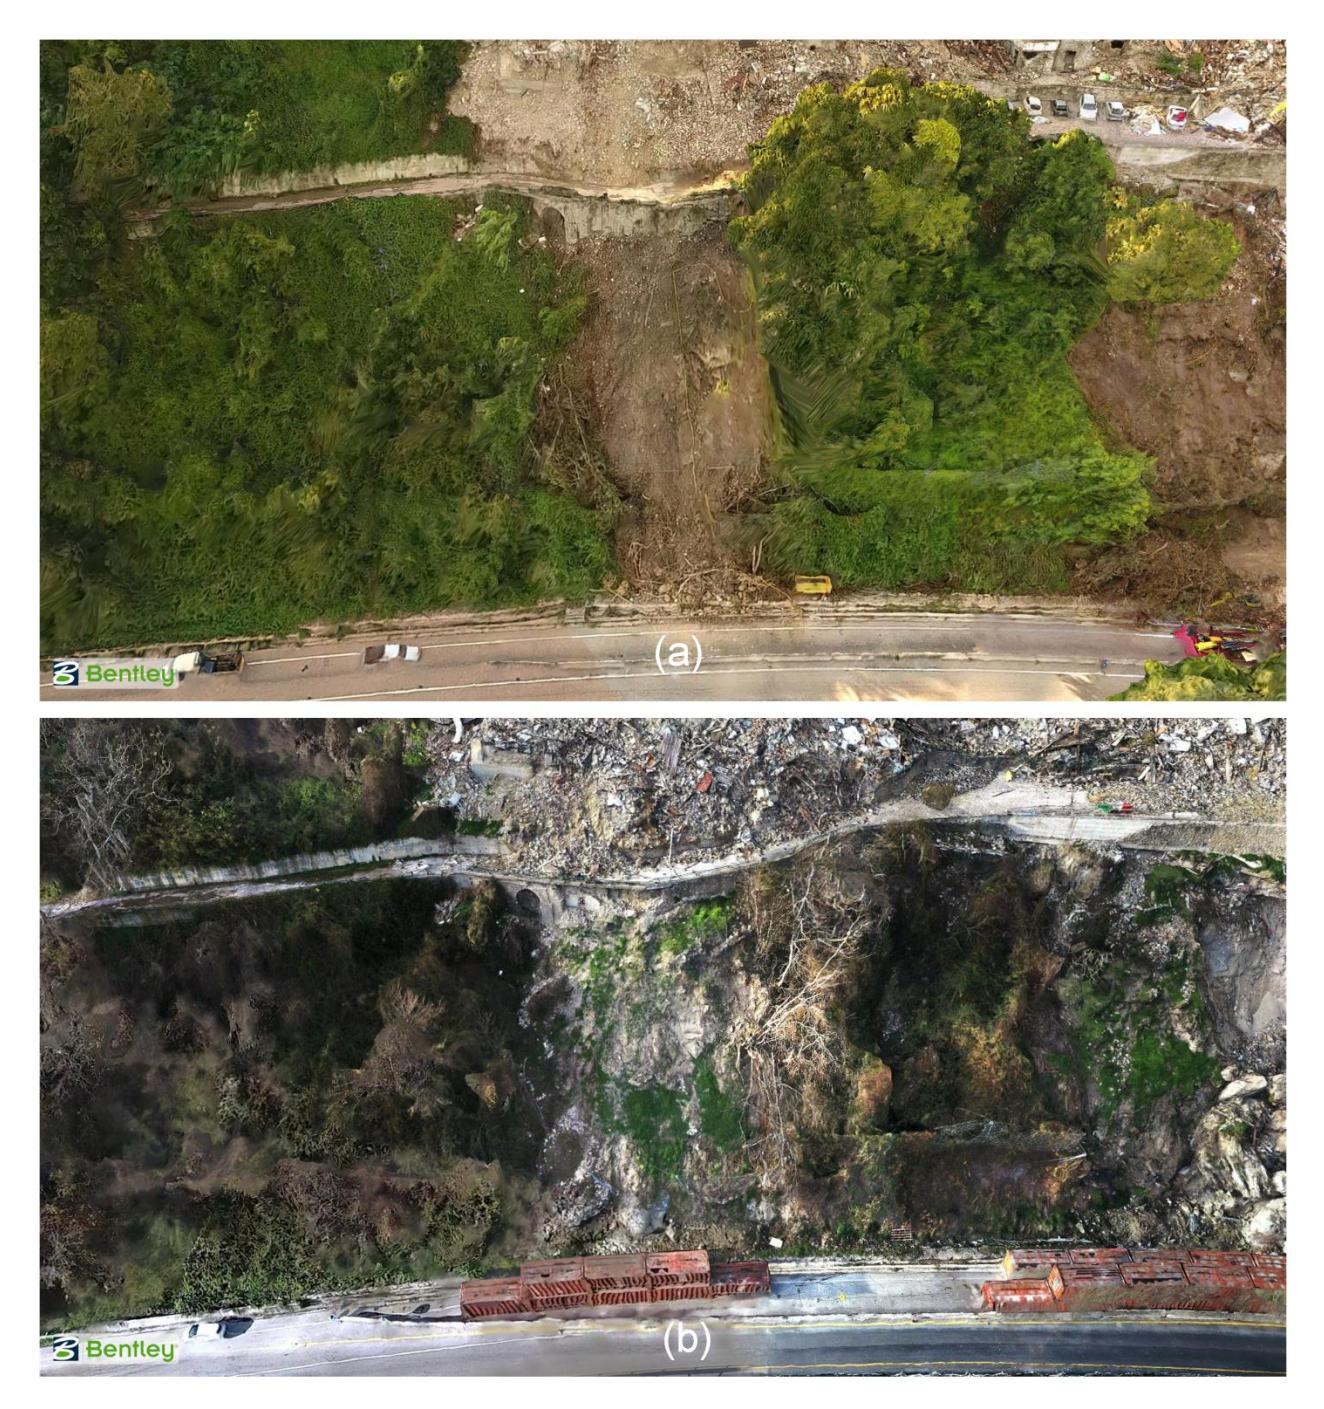
<u>Area 2: Smaller landslide above Strada Statale No. 4:</u> The smaller landslide just to the south of the landslide described as Area 1 was not observed to change significantly between September (Figure 4.23a) and December (Figure 4.23b). In this section, even the retaining wall supporting the road appeared to maintain its stability. However, significantly more structural debris from collapsed residences was observed at this location in December.

**Figure 4.23**. 3D model comparison of the smaller landslide below Pescara del Tronto between September 2016 (a) and December 2016 (b).

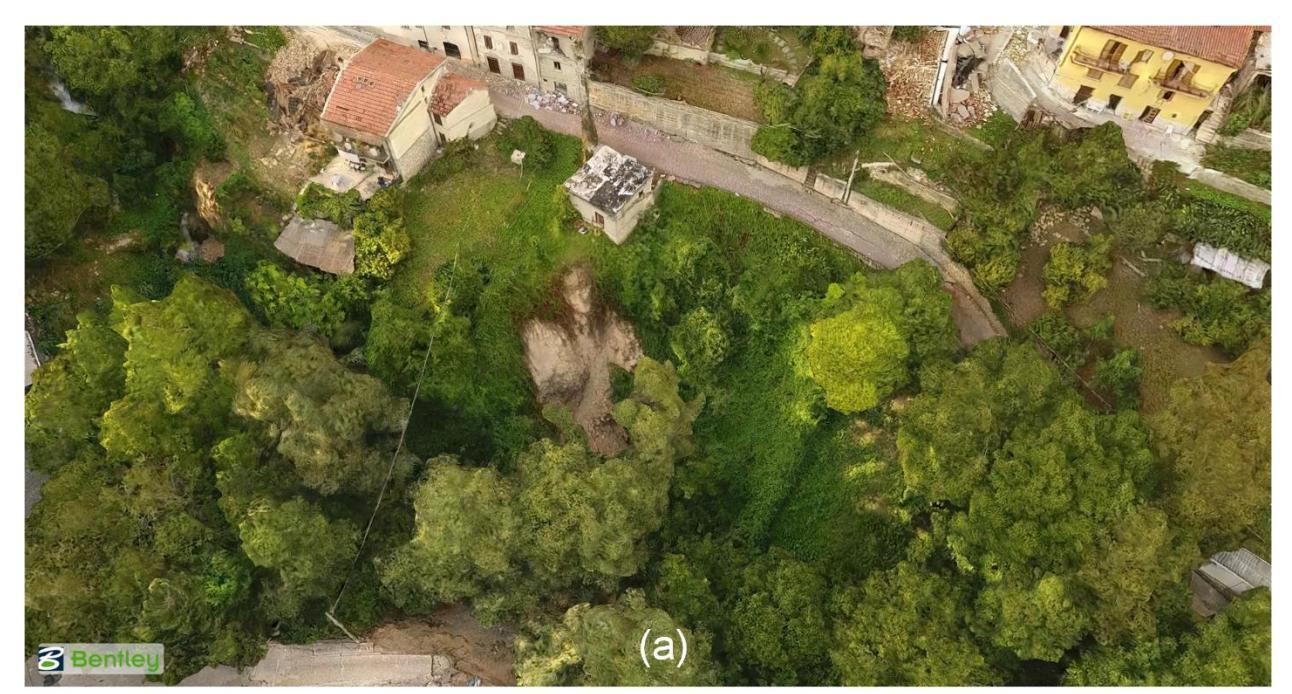
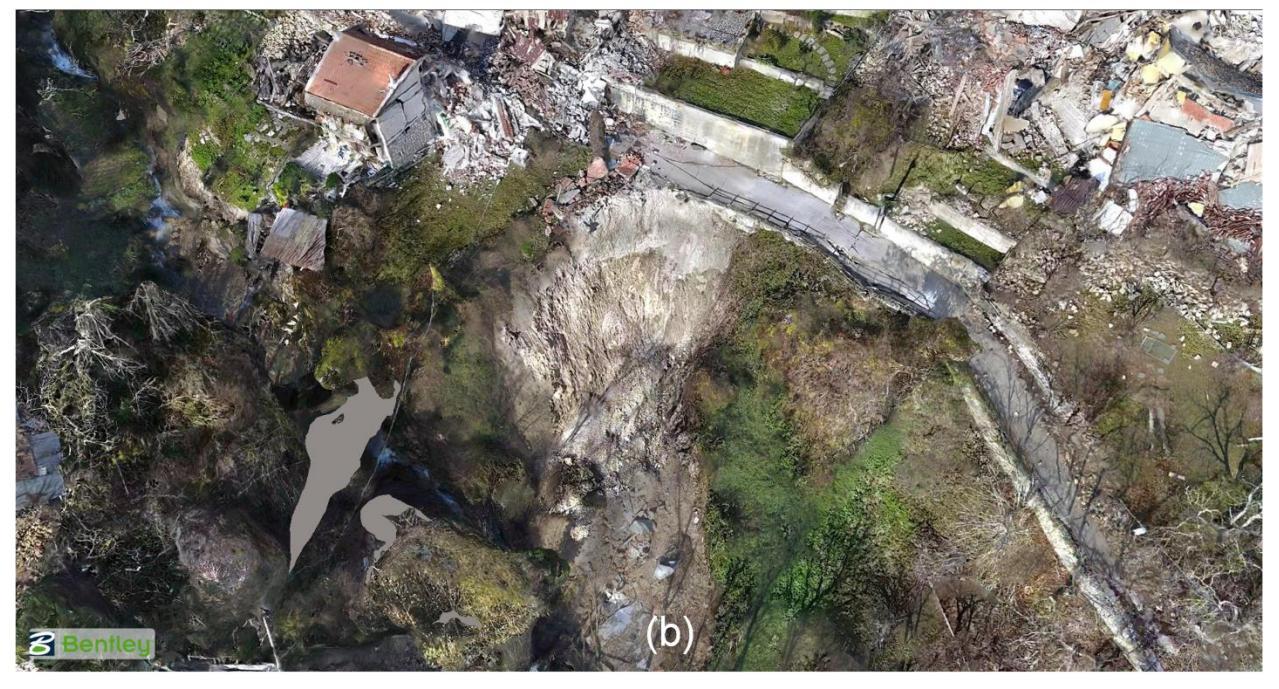
<u>Area 5: Landslide near the Head of the Gulley:</u> Following the 24 August event, a minor sloughing of the gulley wall was observed from the UAV imaging (Figure 4.26a). However, similar UAV imaging performed in December after the October earthquake events revealed that a section of the slope nearly 9 m thick and 20 m wide failed and slid into the gulley (Figure 4.26b). The remaining scarp is nearly 12 m in height and stands with at an angle of 52 degrees, remarkably similar to the same scarp angle that remains behind the failed lower retaining wall (i.e., Areas 3 and 4). A small residential structure that was observed to rest on top of the slope in September had plummeted into the gulley by December.

**Figure 4.26**. 3D model comparison of the landslide near the head of the gulley in Pescara del Tronto between September 2016 (a) and December 2016 (b).

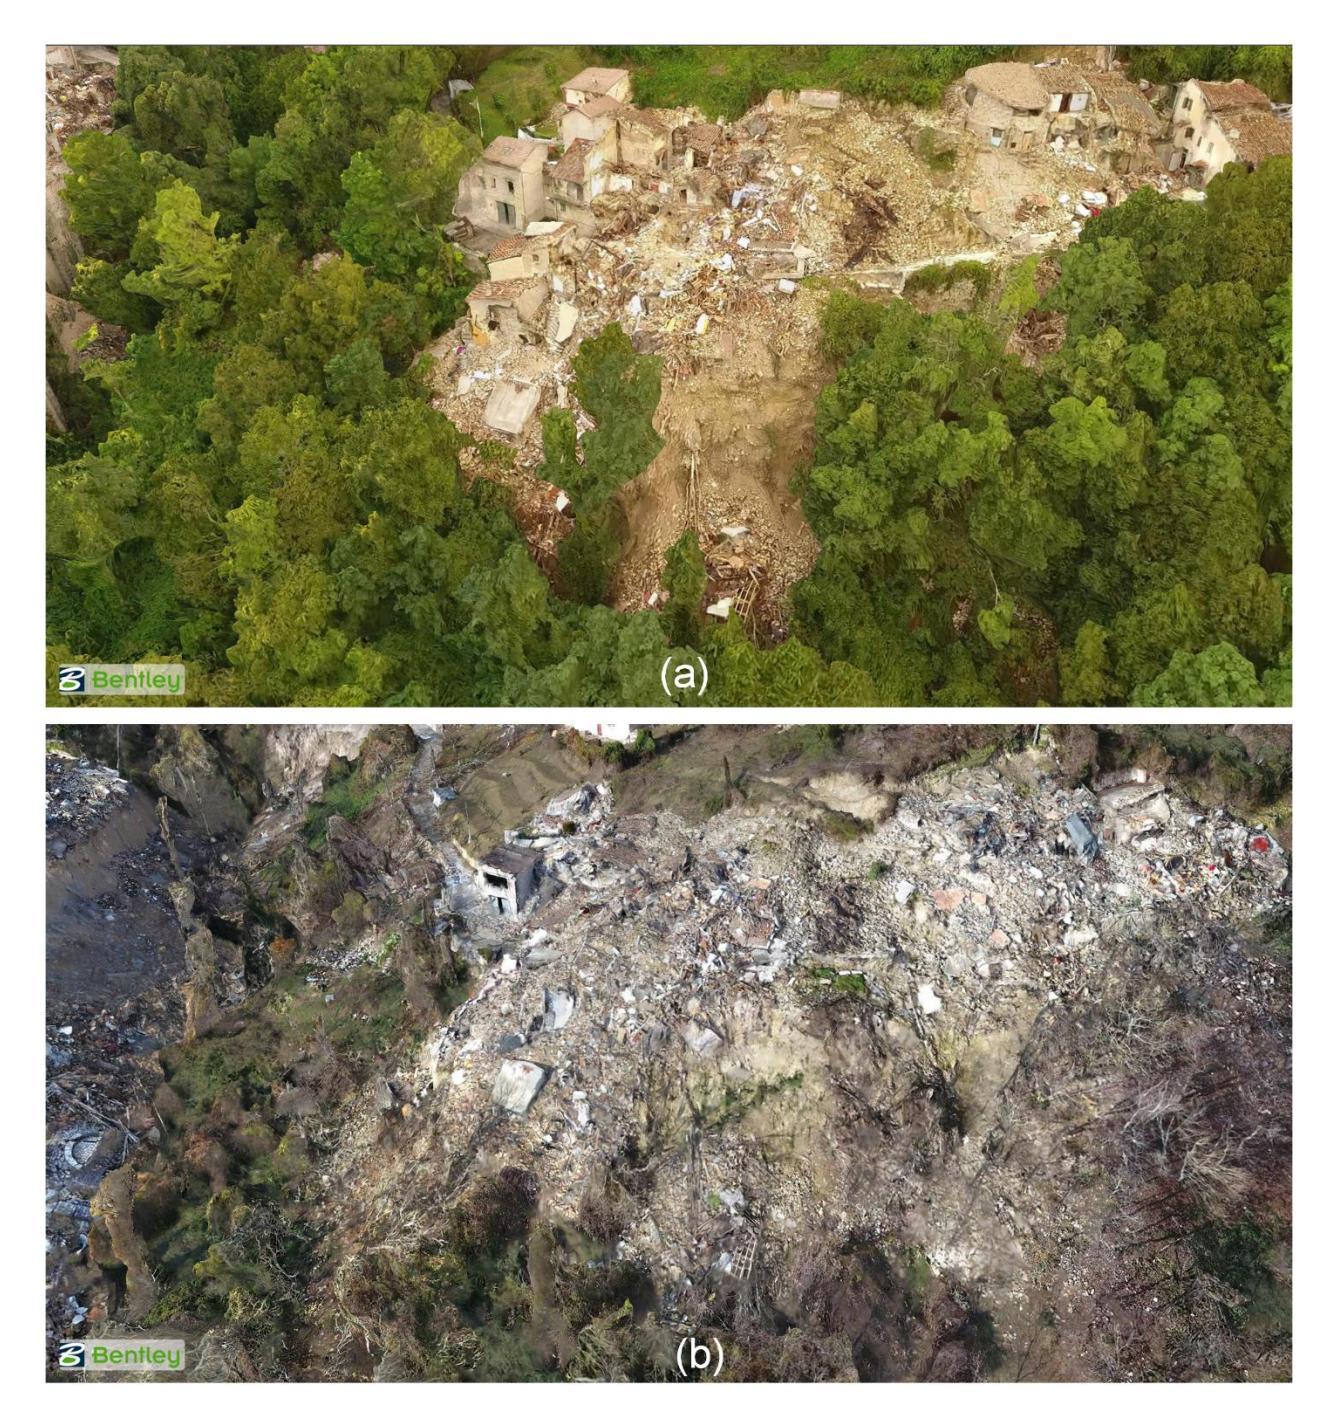
<u>Area 6: Landslide on the Northern Slope of the Village:</u> A shallow landslide was observed on the northern slope of the city following the 24 August event (Figure 4.27a). This landslide was observed to have exposed some tree roots and undermined a few residential structures. Investigation of the same slope in December following the October events revealed that the depth of the landslide remained relatively unchanged, but the width of the landslide appears to have expanded from 17 m in September to more than 36 m in December (Figure 4.27b). However, it is difficult to discern from the UAV images and 3D model whether the flattened trees along the slope are due to an expansion of the shallow landslide or due to structural debris from above the slope.

**Figure 4.27**. 3D model comparison of the landslide beneath the northern slope of Pescara del Tronto between September 2016 (a) and December 2016 (b).

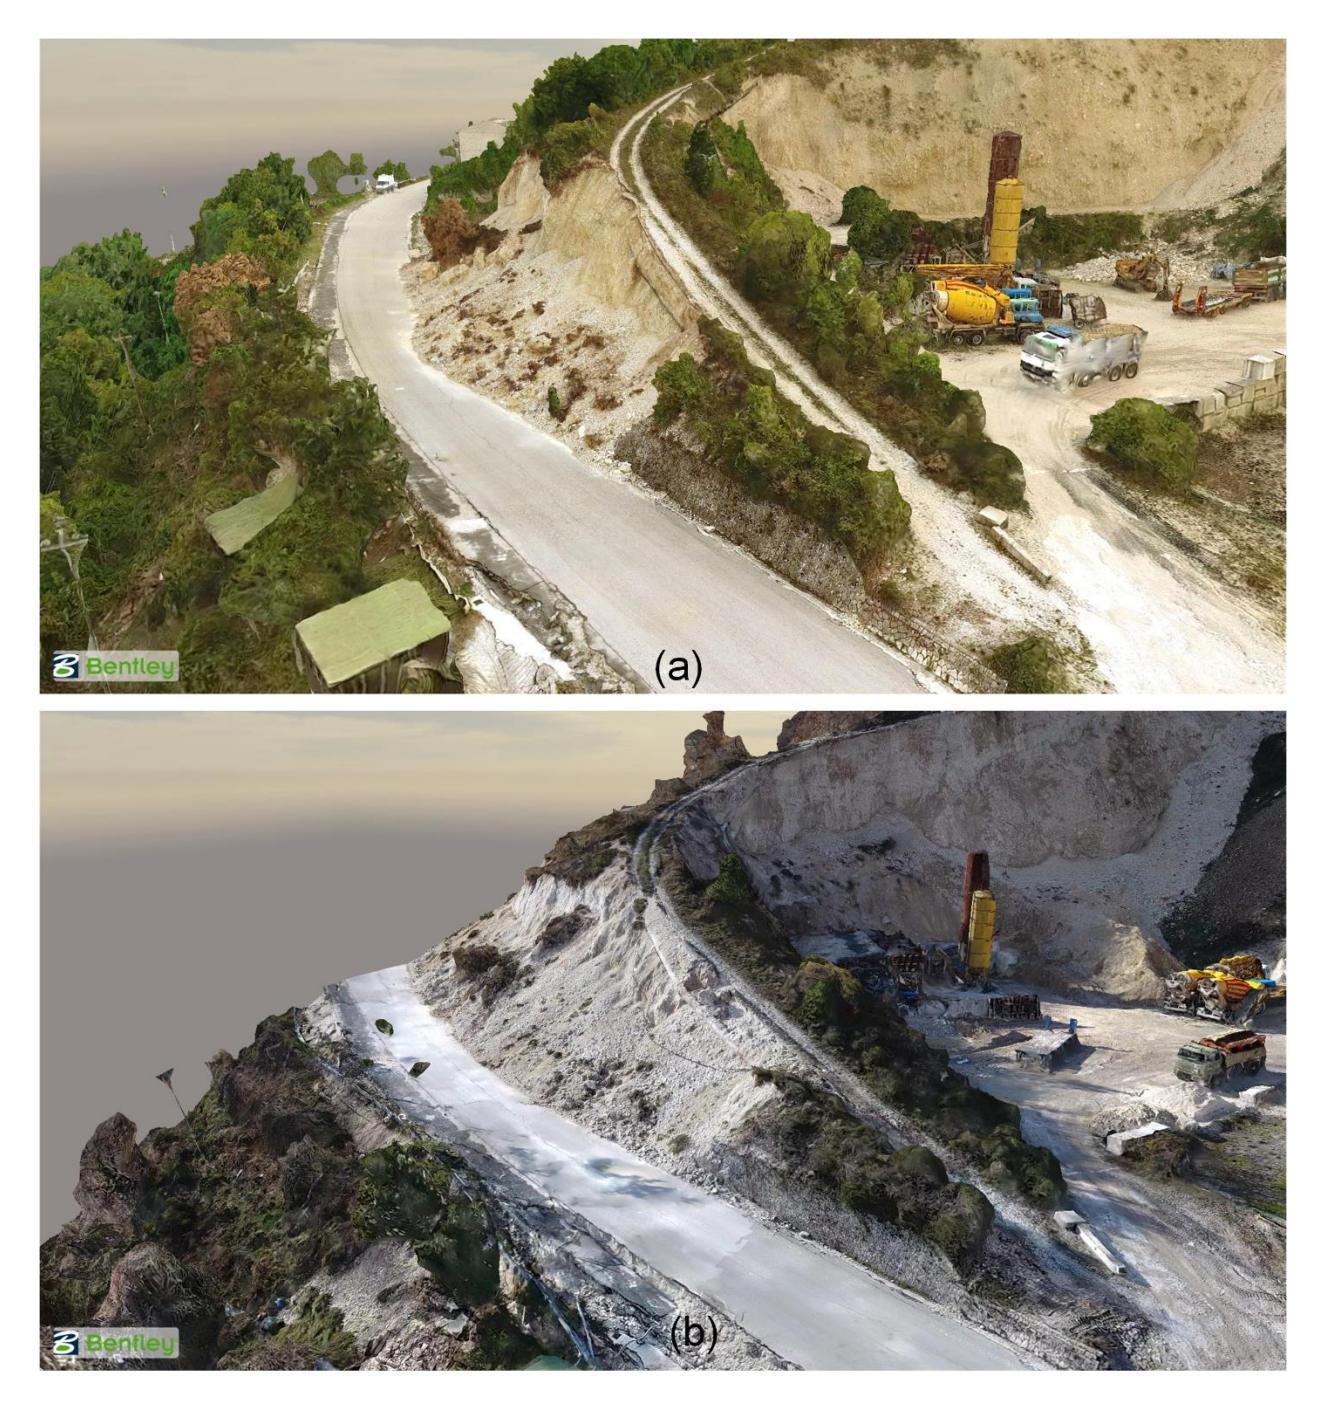
<u>Area 7: Haul Road and Exposed Pipeline near the Gravel Pit:</u> A small landslide was observed on the slope bounding the gravel pit on the southern portion of the village of Pescara del Tronto, adjacent to SP129, following the 24 August event (Figure 4.28a). This landslide was caused by the unraveling of weathered limestone and calcareous soils that were underlying a dirt haul road for the gravel pit. The landslide exposed approximately 15 m of a 50 cm-diameter pipeline. The

condition of the landslide remained largely unchanged following the October earthquake events (Figure 4.28b). The slope beneath the haul road degraded slightly more, causing nearly half of the haul road above the landslide to disappear. Additionally, approximately 8 more meters of the pipeline became exposed from the additional slope movements, causing the pipeline to apparently sag and bow slightly. Another smaller pipe of a few centimeters' diameter was also exposed and sagging substantially along the scarp.

**Figure 4.28**. 3D model comparison of the landslide near the gravel pit in Pescara del Tronto between September 2016 (a) and December 2016 (b).

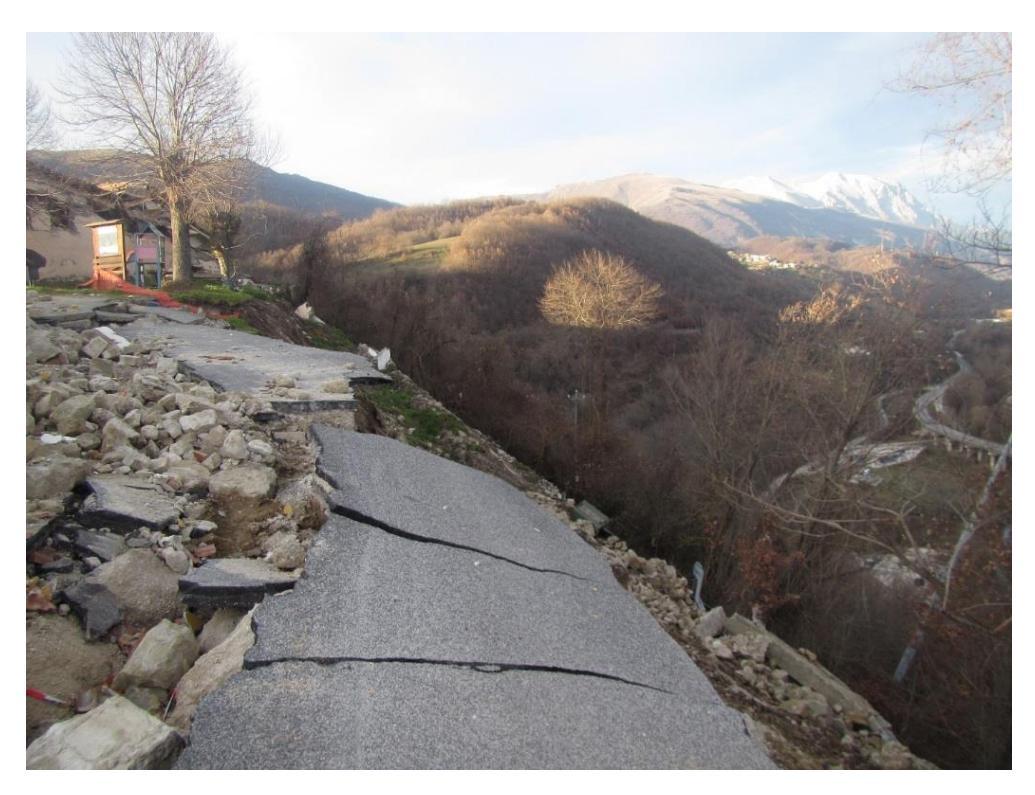
During the December GEER deployment, much more damage was observed. It appeared that a shallow landslide developed beneath the retaining wall and caused the entire structure to slide several meters down the slope. Figures 4.30 and 4.31 present photographs of the head of the shallow landslide showing the retaining wall's former location. Figure 4.32 presents an aerial screenshot of the 3D model developed from Phantom 4 UAV imagery of the site. Several features of interest are identified in Figure 4.32, and will be discussed below.

Figure 4.30. Failure of retaining wall due to shallow landslide (Point 4a, looking towards north).

The shallow landslide appeared to be limited to the upper corner of the slope, near the crown. The slide therefore likely occurred in the non-native fill slopes placed during the construction of the village. The scarp of the landslide appeared to follow the scarp of the soil graben observed behind the wall in September, suggesting that the graben may have been caused by more than just the rotation of the retaining wall. The landslide displaced the top of the wall between 5 to 6 m horizontally and between 3 to 4 m vertically downward. In total, approximately 50 m of the retaining wall below Accumoli failed and slid 5 to 6 m downslope. This loss of confinement resulted in significant horizontal and vertical deformations in the overlying roadway Frazione Fonte del Campo (SP18), as shown in Figure 4.33. The road was measured to have displaced horizontally between 0.1–1.6 m, and vertically downward 9–50 cm. Vegetation remained intact below the collapsed retaining wall, again suggesting that the landslide was likely shallow and limited to the upper limits of the slope. However, the rotated telephone pole located further down the slope, which was observed to have rotated 13 degrees in September, was observed to have rotated a total of 27 degrees in December. However, it is not clear whether this rotation was due to displacements of the heavily-vegetated soil slope or due to inertial effects on the pole from the earthquake.

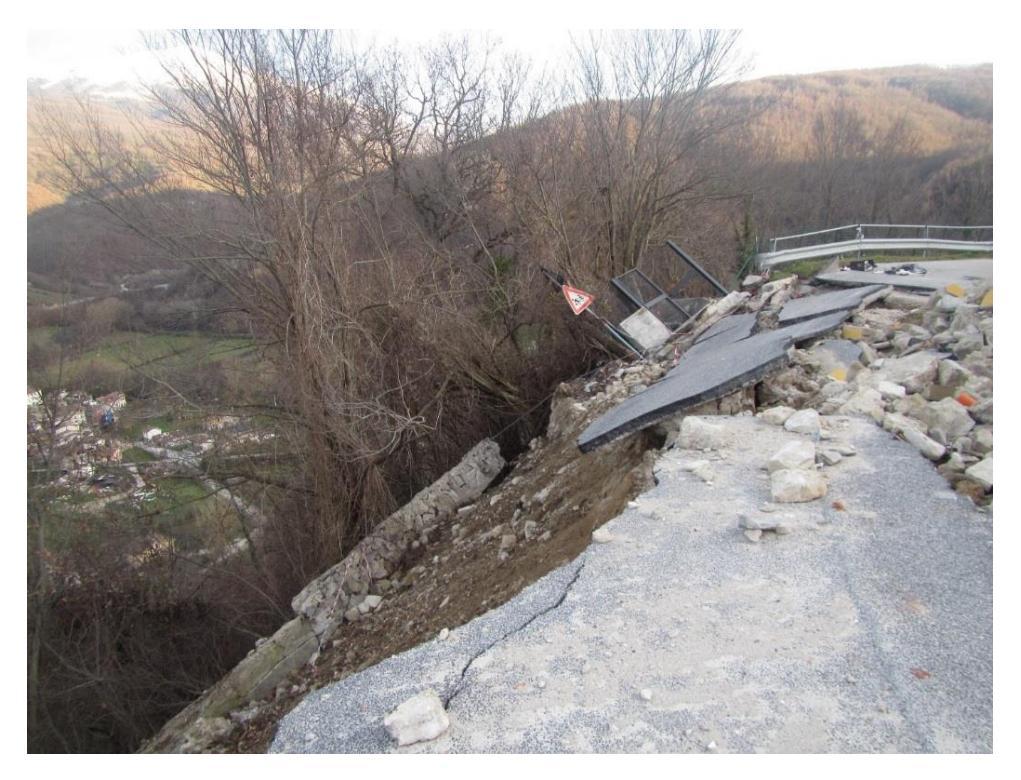
Figure 4.31. Failure of retaining wall due to shallow landslide (Point 4a, looking towards south).

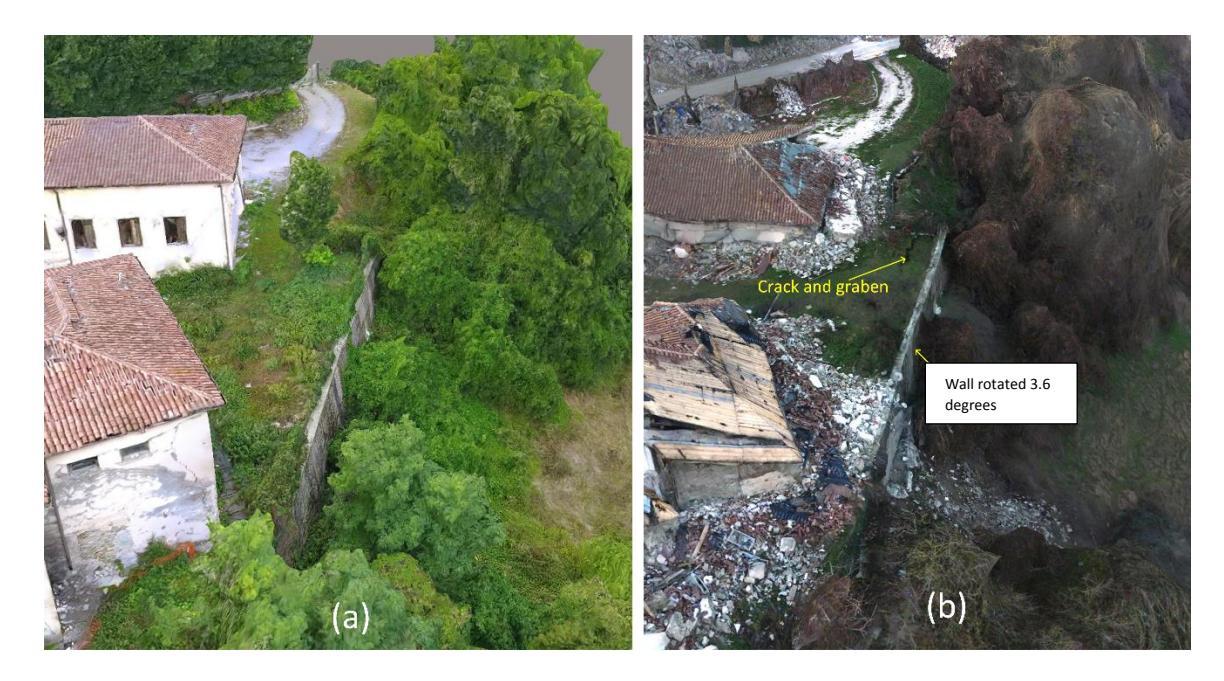
Figure 4.32 also shows a second damaged retaining wall located approximately 60 m to the northwest of the collapsed wall (42.6948 N 13.2496 E). 3D model screenshots of the wall in September 2016 and December 2016 are presented in Figure 4.34. In September, no rotation of

the wall or cracking in the soil were observed. The structure adjacent to the wall was damaged, but still standing. In December, the wall was observed to have rotated outward 3.6 degrees, with a 1.8 m-wide graben forming behind the wall. The soil in the graben was measured to have settled approximately 29 cm. The structure adjacent to the wall was completely collapsed. The similarities in the observed damages with this wall with the observed damages of the now-collapsed wall in September are remarkable, and suggest that another shallow landslide may have formed beneath this damaged wall.

**Figure 4.34.** 3D model screenshots showing a retaining wall beneath the northeastern slope of Accumoli (a) undamaged in September 2016, and (b) damaged in December 2016.

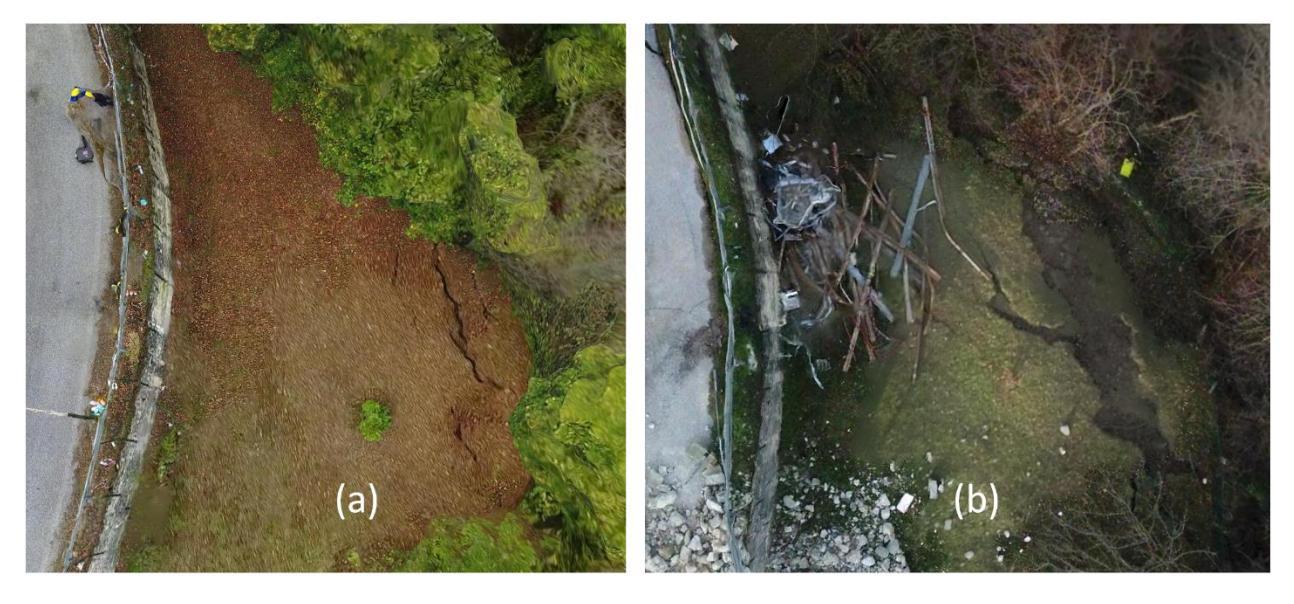
During the September 2016 reconnaissance, the GEER team observed a series of shallow cracks approximately 5–14 cm in width in the soil below the southeastern slope of the village (42.69406 N 13.25019 E). These cracks were believed to have been caused by shallow landslide displacements in the soft silty-sand located near the surface of the fillslope.

Much more deformation was observed by the GEER team in December 2016. Figure 4.35 presents 3D model images of the headscarp cracks in both September (Figure 4.35a) and December (Figure 4.35b). In general, the GEER team observed that the cracks developed in the 24 August event opened further from 5-14 cm to 0.8-1.9 m. The depth of the crack was measured from the 3D model as approximately 55 cm. However, beyond the widening of the cracks from the shallow landslide, no other significant damage was observed at this point.

**Figure 4.35.** 3D model screenshots showing cracking from a shallow landslide (a) during the September GEER reconnaissance, and (b) during the December GEER reconnaissance.

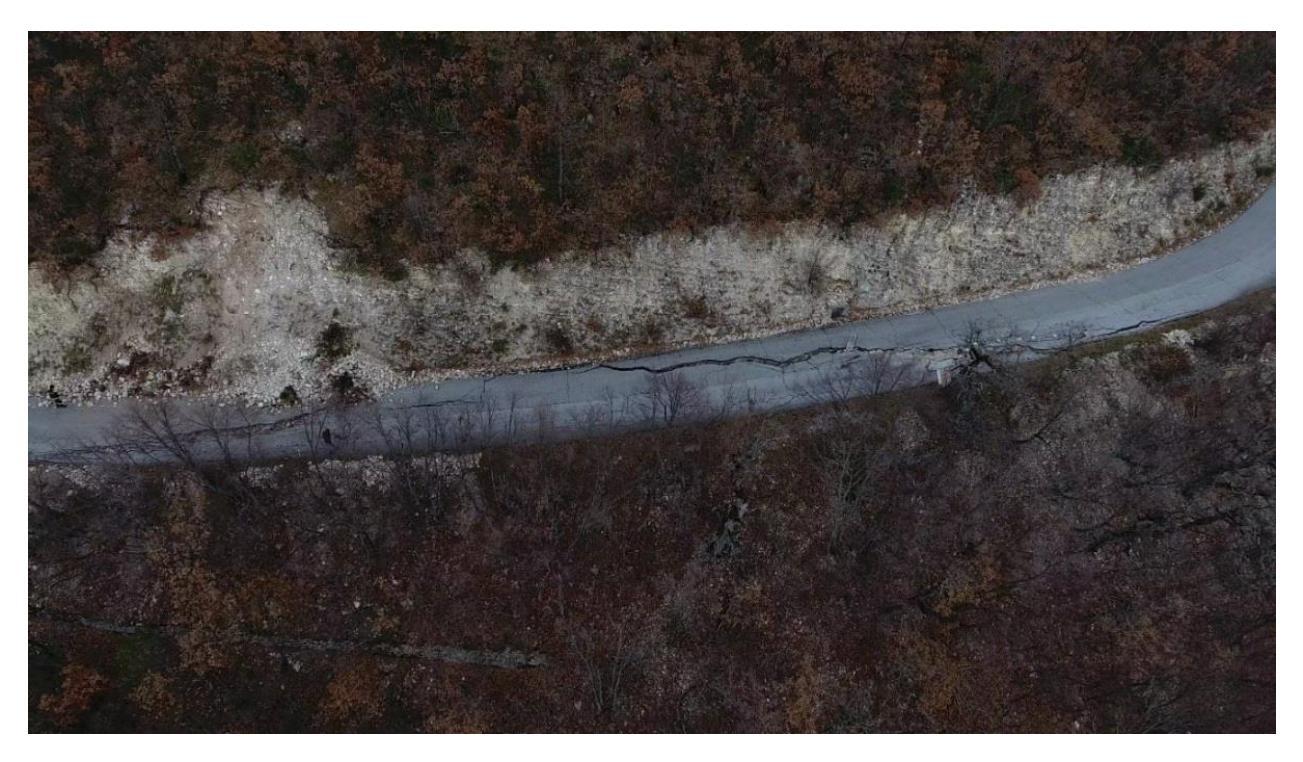
The first site encountered (Point 5a) was a landslide in the soil slope through and beneath the road. An aerial photograph of the landslide is shown in Figure 4.37 (note the fire fighter in the upper left corner for scale). The landslide was measured to be 55-60 m in width. While the head of the landslide was easily seen in the road pavement, no toe or side scarp of the landslide could be traced on the heavily vegetated slope below the road. On the road, the vertical offset measured in the pavement ranged from 10-70 cm, and the horizontal deformation ranged from 2-40 cm. The GEER team observed that the eastern portion of the landslide headscarp showed a distinct crack and displacement (Figure 4.38), while the western portion of the landslide headscarp appeared more gradual and showed more pavement cracking (Figure 4.39). This landslide was believed to have occurred in the shallow soils along the side of the mountain slope, and appeared limited in its extents.

Figure 4.37. Landslide encountered along mountain road in the Valle di Panico (Point 5a).

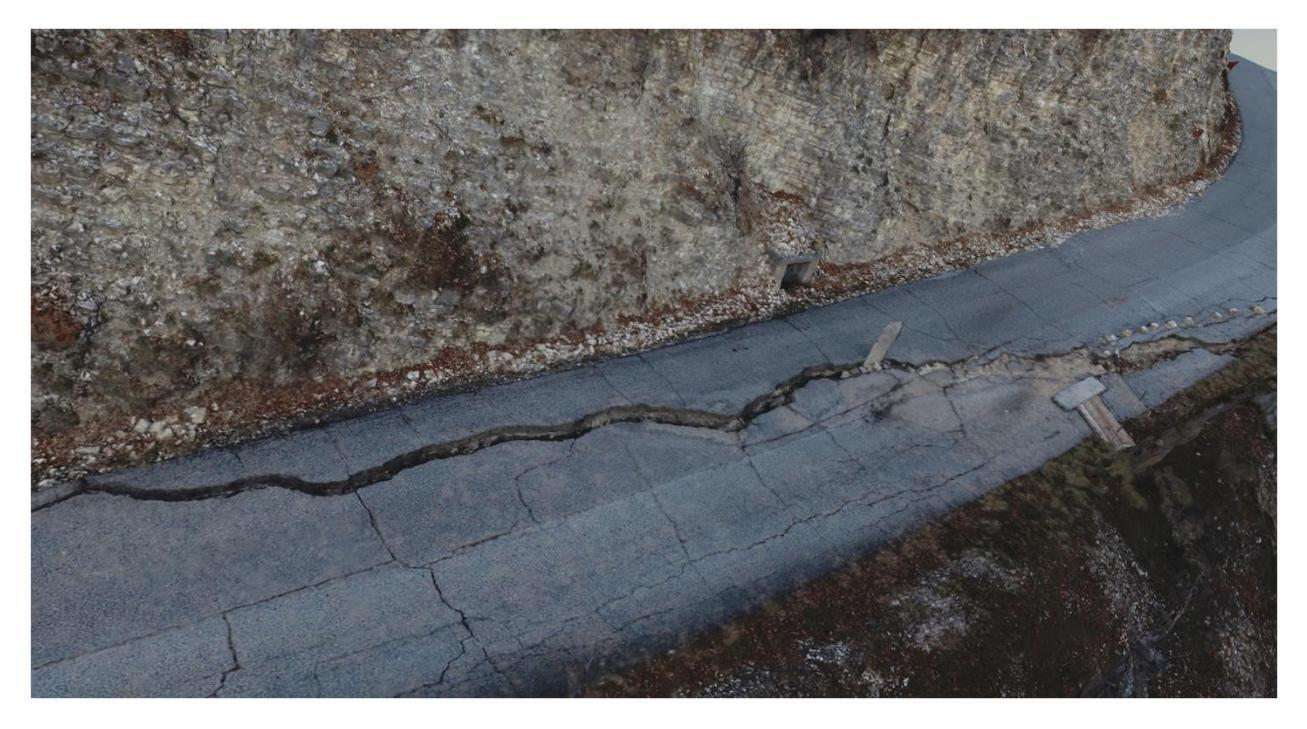
Figure 4.38. 3D model of the eastern half of the Valle di Panico landslide headscarp.

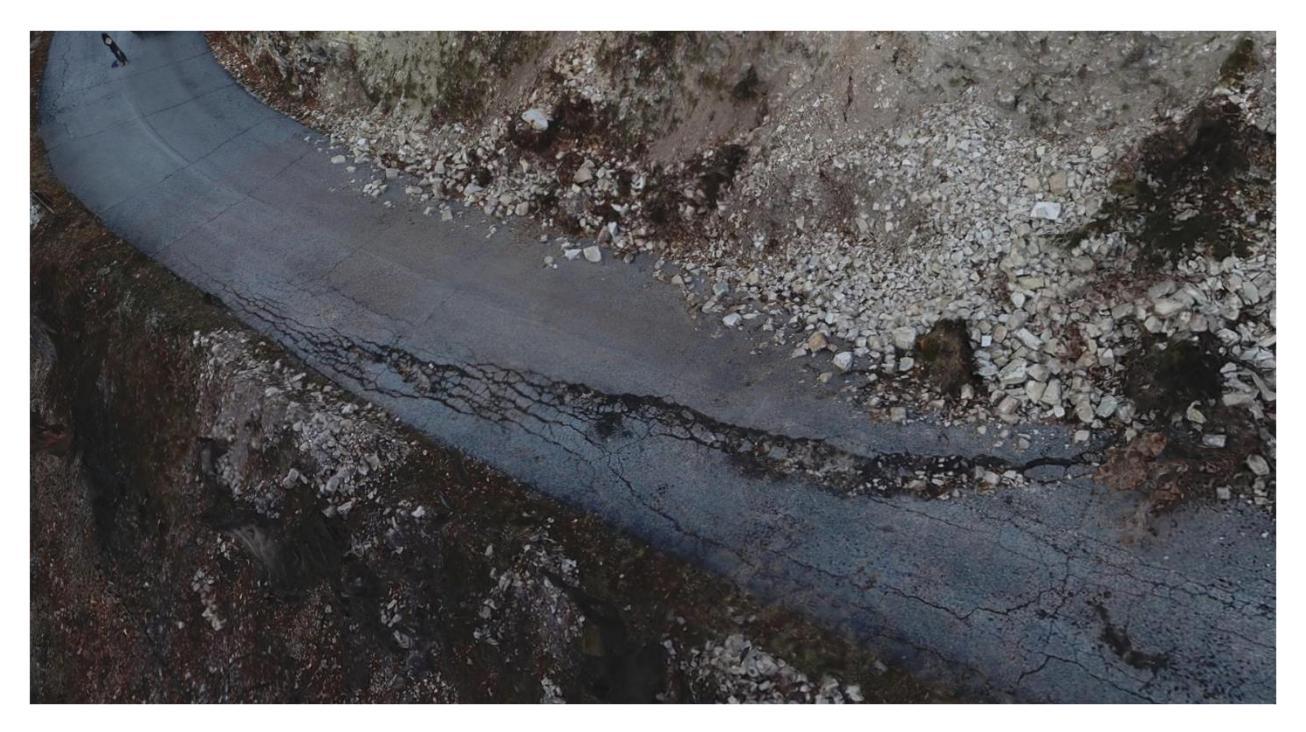
Figure 4.39. 3D model of the western half of the Valle di Panico landslide headscarp.

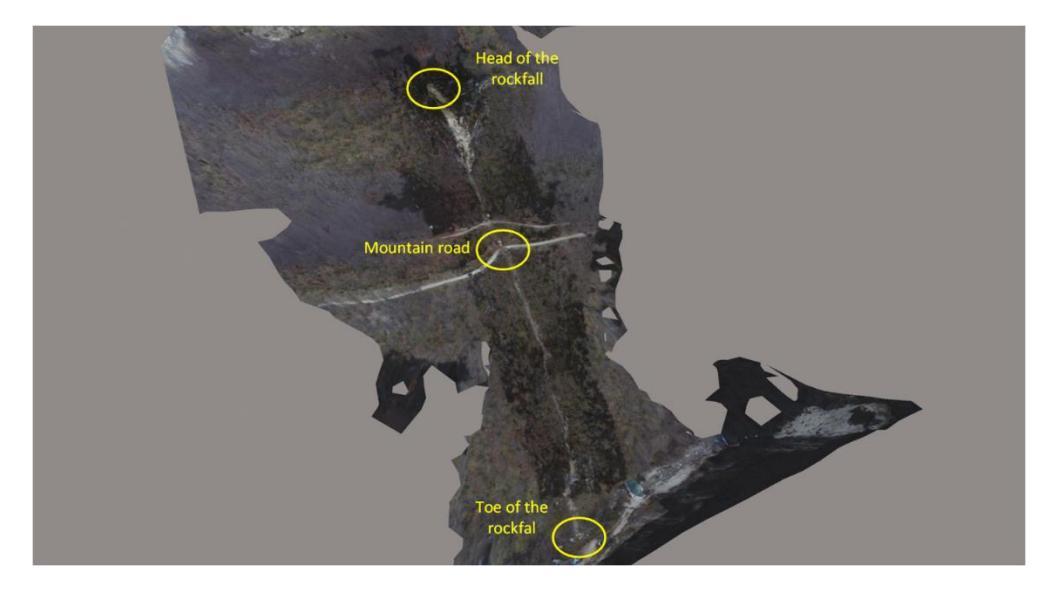
The second site encountered (Point 5b) was a rockfall nearly 419 m in length along the mountain road in the Valle di Panico. A 3D model of the entire rockfall is presented in Figure 4.40. The total change in elevation from the source of the boulder to the final resting place on the bottom of the valley is approximately 235 m. The sideslope of the valley was measured to rest at an angle of 34 degrees from the horizontal (1.5H:1V). Numerous boulder fragments ranging in diameter from gravel-size to over 3 m were observed and photographed along the entire rockfall length. The largest boulder fragment was observed to rest adjacent to the mountain road, and is pictured in Figure 4.41. The source boulder appeared to be approximately 11.2 m in length and to have broken free from a formation of heavily weathered and fractured limestone located 91 m above the mountain road (Figure 4.42). Much of the limestone boulder exploded into gravel-sized fragments in the first 90 m of the rockfall. The remaining parts of the boulder broke in larger fragments while tumbling to the bottom of the valley. At the bottom of the valley, over ten large boulder fragments ranging in diameter from 0.8-2.9 m were observed to rest at the valley floor just 13 m from what appeared to be a small pump or power house Figure 4.43). Amazingly, none of the boulders appeared to damage this small structure.

Figure 4.40. 3D model of the Valle di Panico rockfall.

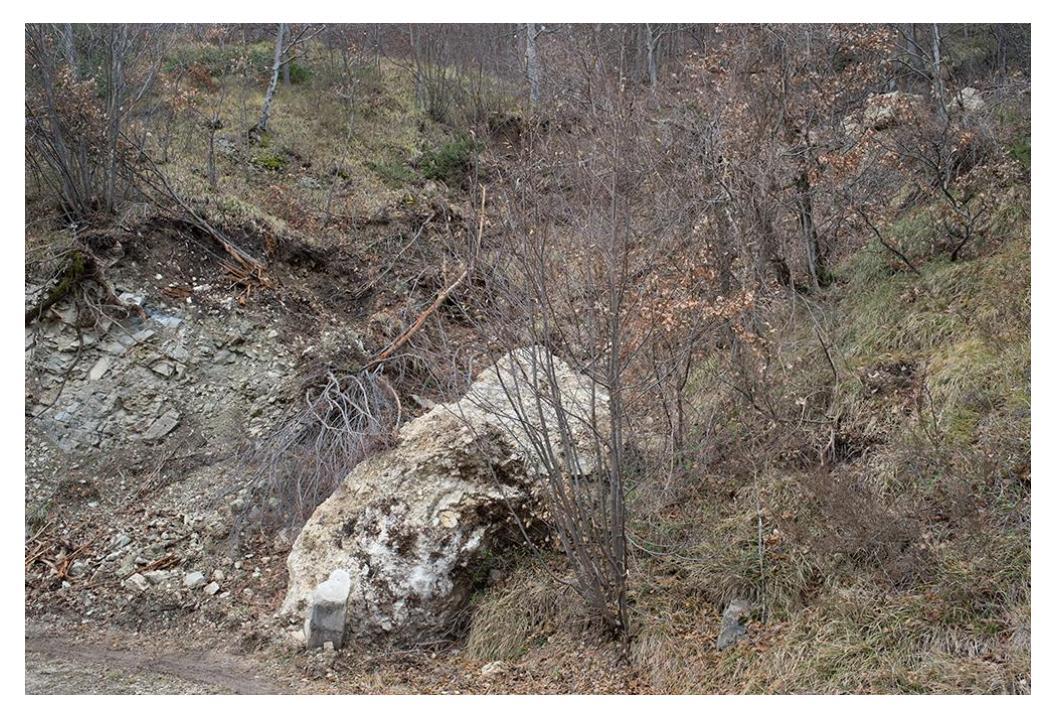
**Figure 4.41.** Photograph of the largest observed boulder fragment in the Valle di Panico rockfall. The boulder measured approximately 3.0 meters in diameter.

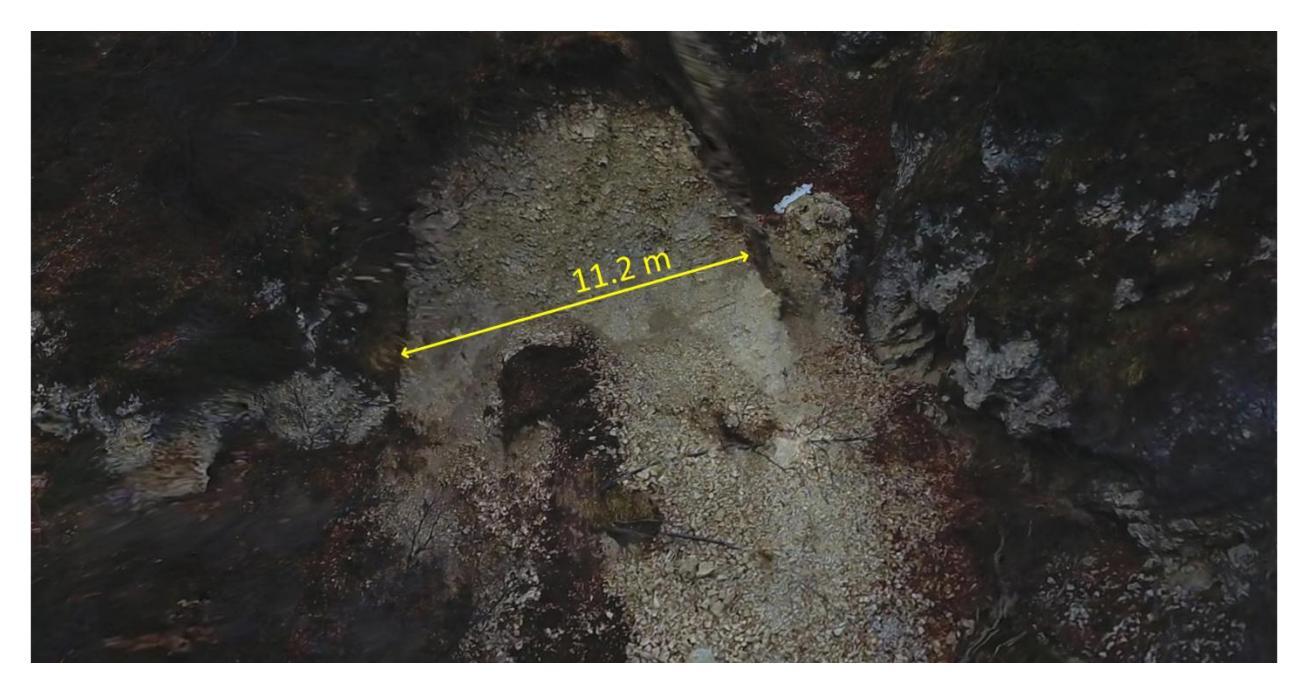
**Figure 4.42.** 3D model of the source of the Valle di Panico rockfall, located 90 meters above the mountain road.

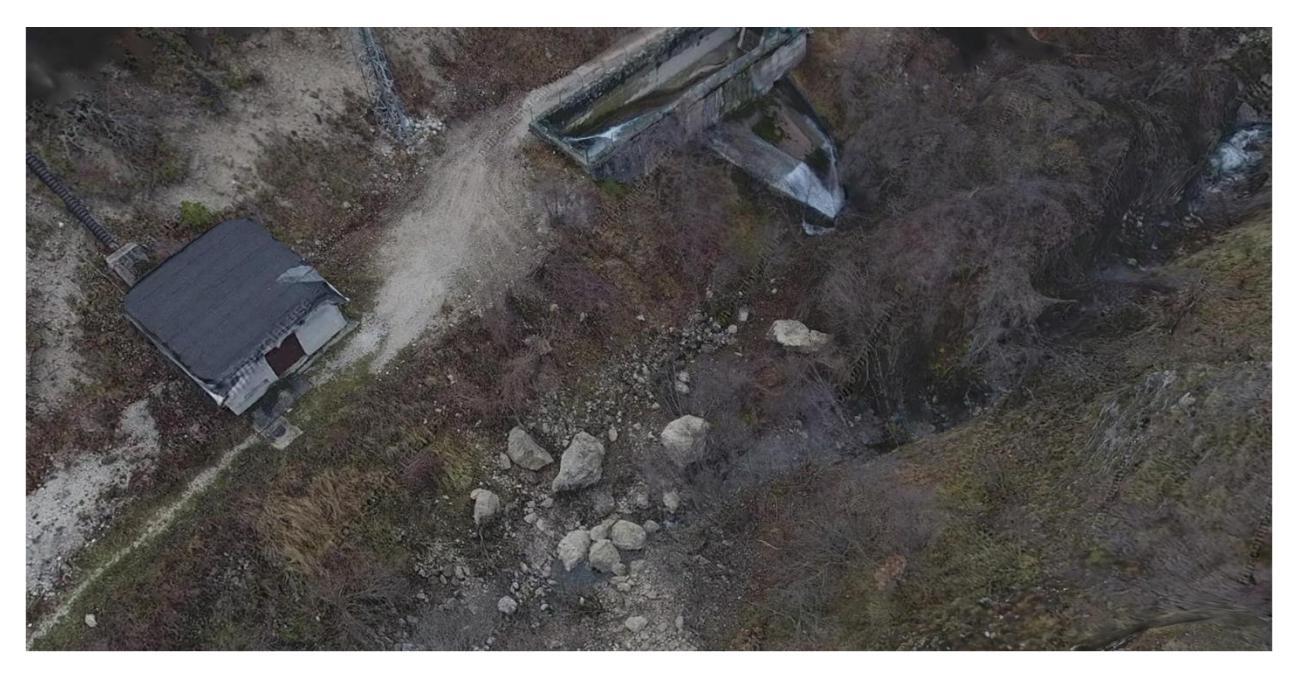
**Figure 4.43.** 3D model of the boulders and small power or pump house at the toe of the Valle di Panico rockfall.

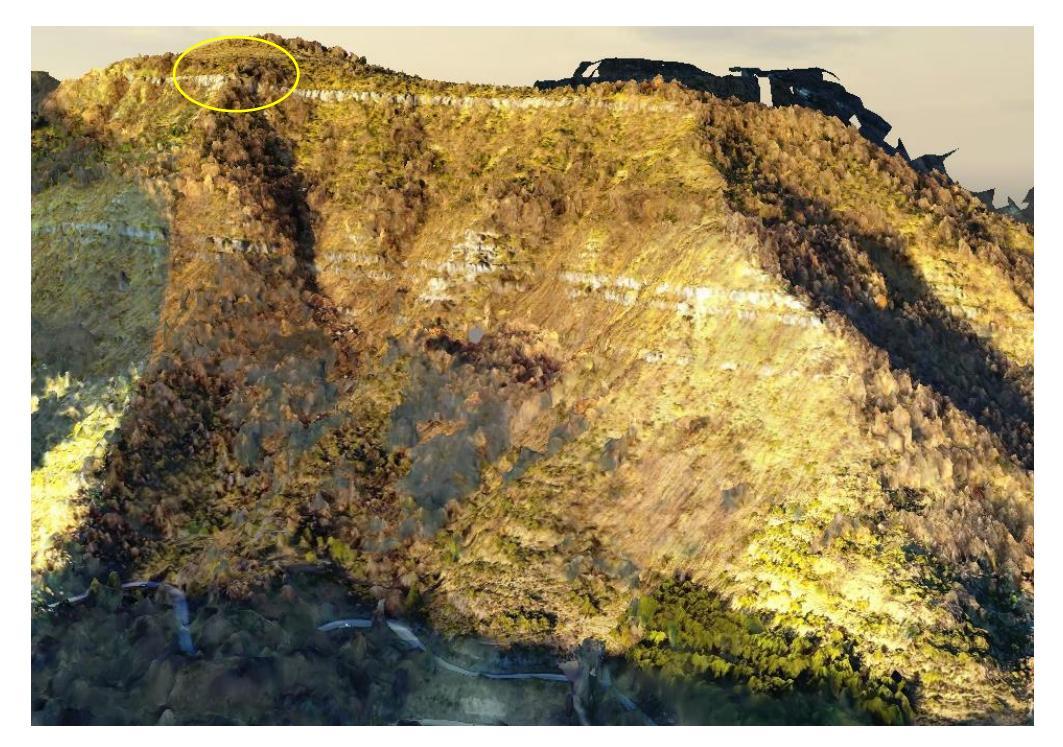
**Figure 4.45**. 3D SfM model of rockfall site near Cervaro village (Crognaleto). Primary rockfall source circled in yellow.

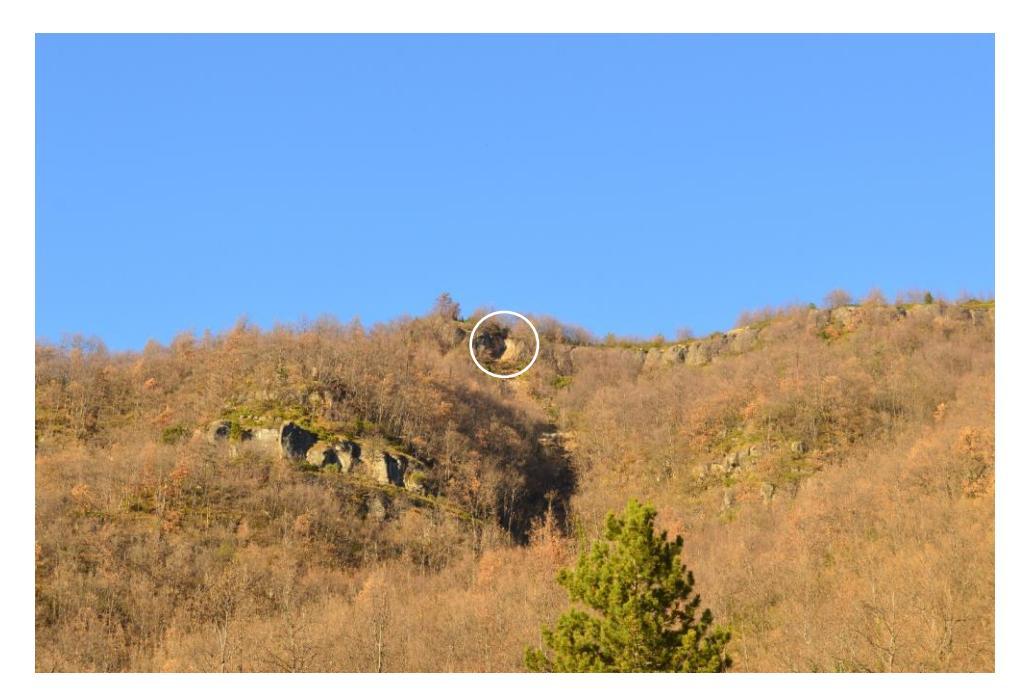
the mid-slope rock face. However, our data indicates that most of the boulders that reached near to the road came from the primary source area at the top of the slope. From the perspective of the Via Trieste, the photo in Figure 4.46 shows the mid-slope rock face and the source at the top of the slope from the rim-rock limestone exposure.

**Figure 4.46**. Source and runout chute of rockfall site near Cervaro village (Crognaleto) as seen from road at base of slope. Primary rock source circled in white.

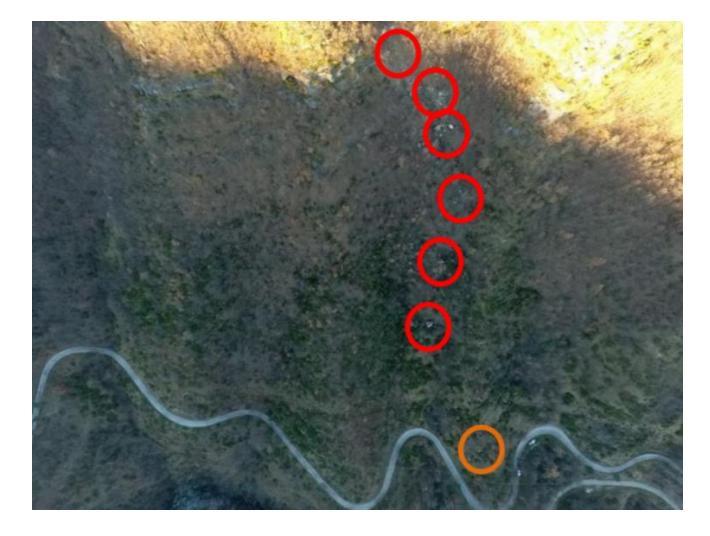
Below the primary rock source, the large rock mass(es) followed the path of a drainage feature to the bottom of the slope just above the Via Trieste where the final large boulder came to rest. Figure 4.47 shows an overhead photo from the UAV with large boulder fragments identified. It may have been that the source rock was already fractured prior to the earthquake into 1 to 4 m blocks that dislodged. It may also be that the rock dislodged in one or two large masses that broke apart on the runout down the slope towards the road. The final boulder is 4 m and is shown in Figure 4.48, with a 1.7 m tall GEER team member next to the boulder for size perspective.

**Figure 4.47**. UAV aerial image of rockfall path from source at top of slope to the road at bottom of slope. Red circles show boulder fragments larger than 1.5m. Last boulder fragment from rockfall near road at base of slope is circled in orange.

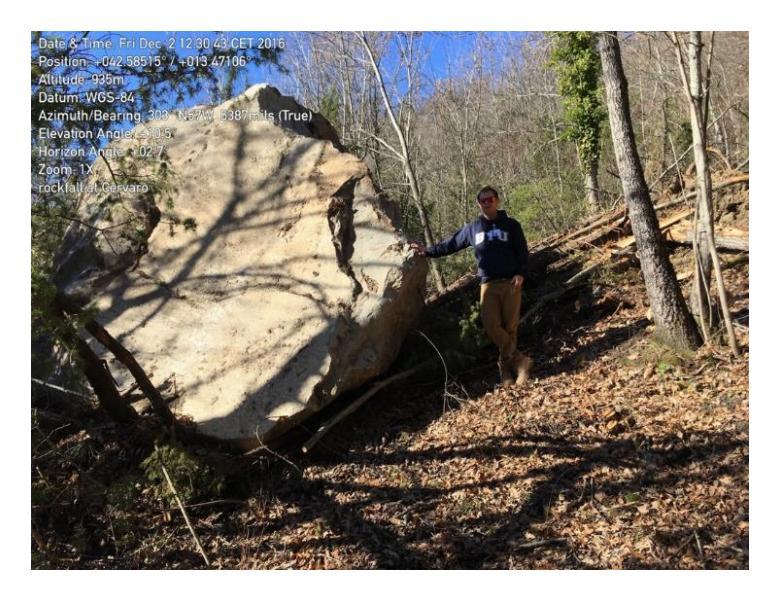
**Figure 4.48**. Last boulder fragment (4 meter) from rockfall near road at base of slope. Also pictured are freshly toppled trees from the boulder's roll to its final position.
