# Engineering Reconnaissance Following the October 2016 Central Italy Earthquakes Version 2

GEER Team Leaders: Jonathan P. Stewart and Giuseppe Lanzo

Geotechnical Extreme Events Reconnaissance Association Report No. GEER-050D 8 May 2017

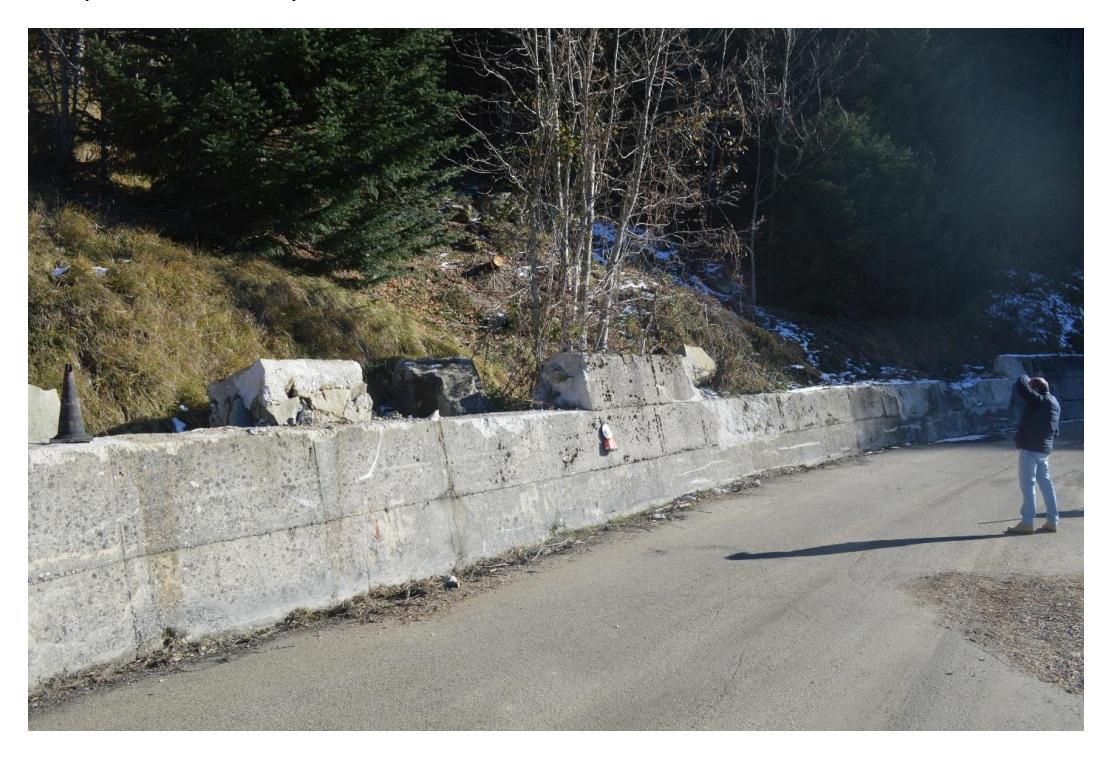
The local highway officials also cleared 9 pre-cast concrete retaining wall blocks off of the road after the earthquake. These large pre-cast concrete retaining wall blocks can be seen in Figure 4.52. Each block is 75cmx100cmx200cm and has some small amount of internal steel reinforcement. Two small steel bars connect the blocks in the wall as shear pins. Concrete blocks not damaged appeared to be in good condition, with minor surface weathering but no cracking. The wall is formed by stacking the blocks with shear pins in place and a thin mortar. The retaining wall runs along SP45a for several hundred meters with no damage from strong ground shaking or dynamic lateral earth pressures. Only at the location of the rockfall and boulder run-out does that wall have any damage. At the location of the boulder runout, it is clear that the boulders impacted the back of the retaining wall, dislodged or shattered the top blocks, and then fell onto or over the road. Figure 4.53 is a photo taken from SP45a looking up the runout chute towards the top of the slope over the damaged wall. A number of boulders are seen in this photo, two of which are the remains of a larger boulder blasted by local officials due to an unsafe resting position. Other, older rockfall boulders can be seen in Figure 4.53 covered in vegetation. This

**Figure 4.52**. Damaged segmented concrete block retaining wall at roadway. Blocks that fell on road have been removed by local officials prior to visit from GEER team.

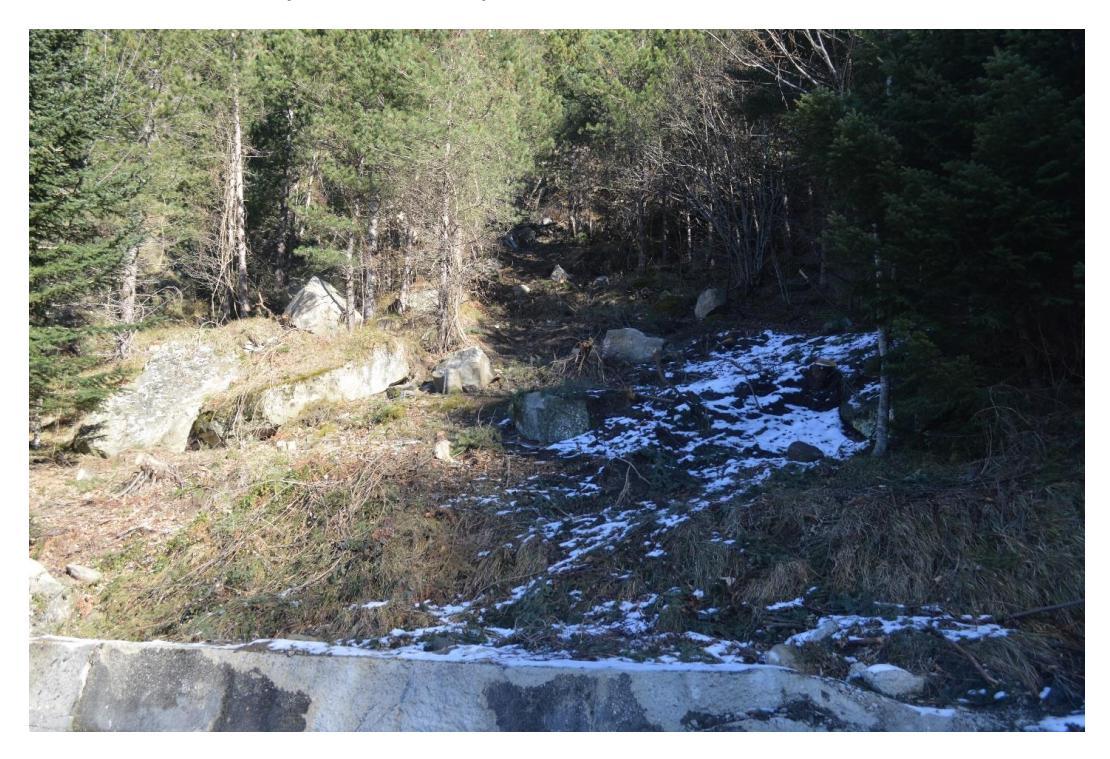
shows that the area has regular rockfall, and that strong ground shaking from the October 30, 2016 earthquake has merely accelerated the rate of rockfall at the site.

**Figure 4.53**. View upslope of damaged retaining wall, boulder fragments and runout chute from road at rockfall site near Crognaleto village.

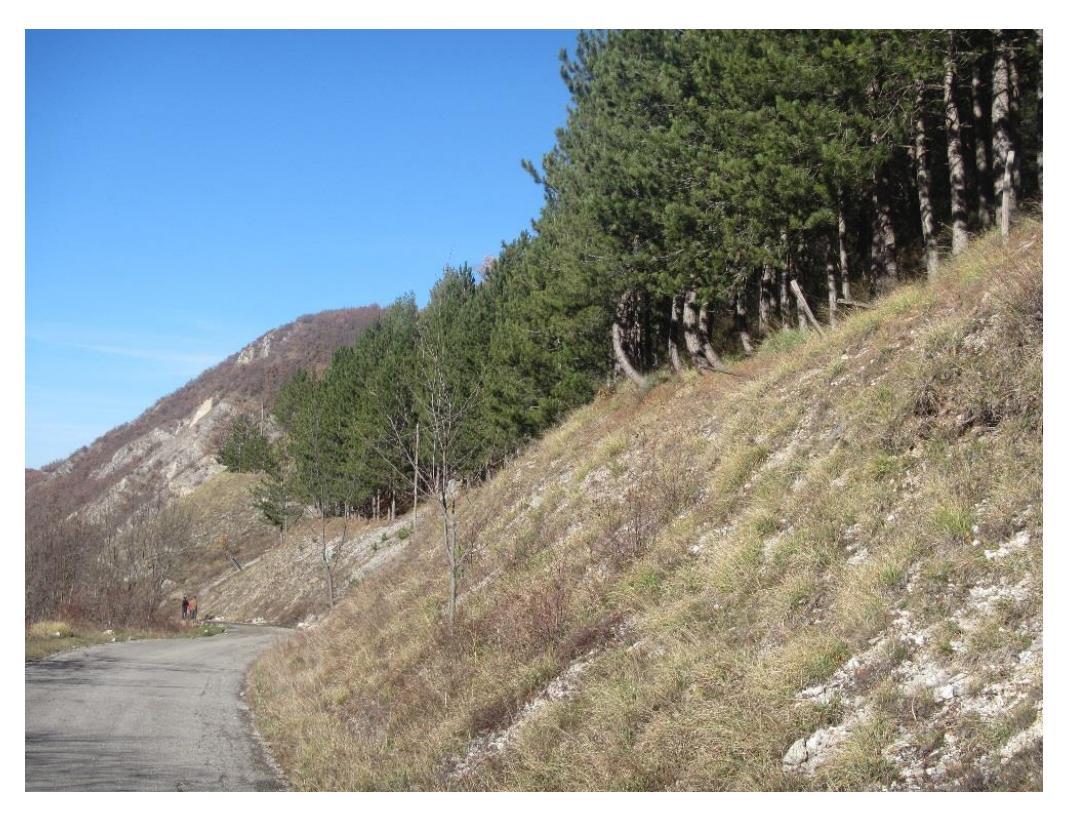
Figure 4.55. Pescia rockfall. Possible soil slope creep shown by tree trunks. (site 9a).

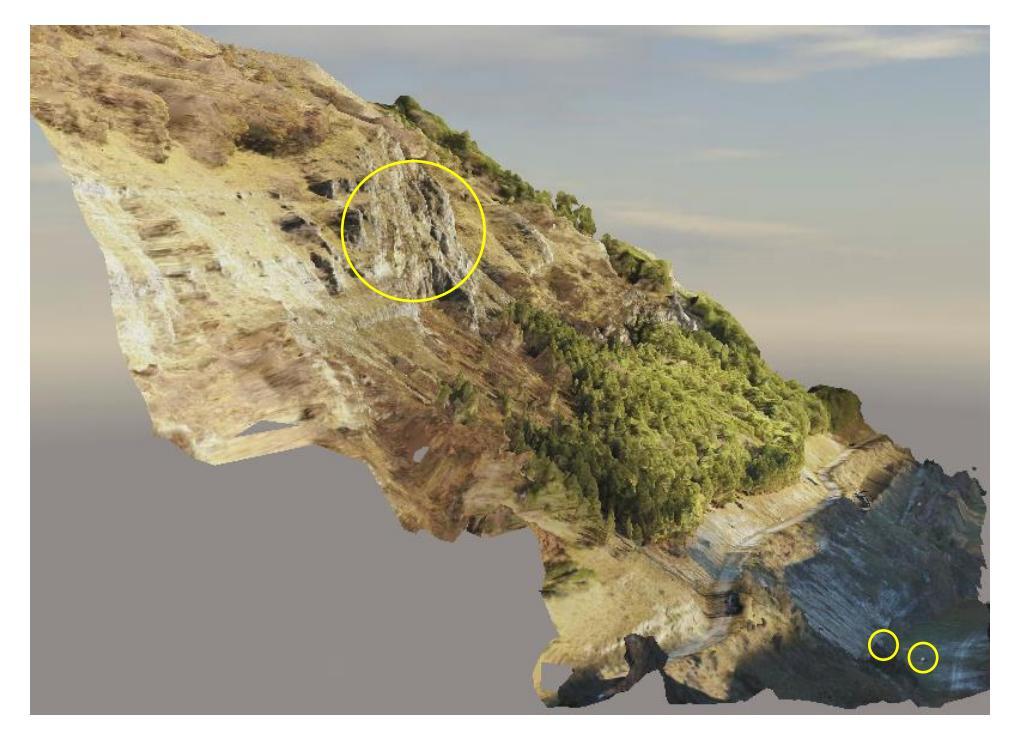
The 3D SfM model for site 9a is shown in Figure 4.56, while an orthophoto of the rock face and source of the rockfall are shown in greater detail in Figure 4.57. The rock face is approximately 90 m wide and 60 m high. The rock material that composes the face is a combination of limestone, argillaceous limestone, and Marlstone. The GEER team climbed the slope above Via del Passero and examined the intact rock at the rock face. The GEER team determined that the rock was at times laminated and at times massive. The limestone tended to be massive (and produce large boulders), while the Marlstone and argillaceous limestone was laminated to thinly bedded. All of the rock species were moderately weathered. The limestone was strong and resisted a geologist's hammer, while the other species of rock crumbled under a blow from a geologic hammer, but could not be peeled via a pocketknife. The limestone was hard, while the other species were moderately hard. Discontinuities were narrow joints with little infilling and spaced widely. Our assessment of the intact rock are that the conditions are ideal for rockfall with boulders up to 2.5 m. Boulders of this size were indeed observed on the slope, on Via del Passero itself, and at the bottom of the slope. Indicated on Figure 4.56 are two boulders of at least 2.5 m that reached the valley floor below Via del Passero. Boulder diameters were measured by hand, and compare well with the measurements performed via 3D SfM models. The boulders encountered below the tree line, on the road, and on the valley floor were all limestone. Boulders above the tree line were mostly the argillaceous limestone and marlstone.

**Figure 4.56**. Pescia rockfall site 9a 3D SfM model from UAV data. Rock source and 2.5 meter boulders circled in yellow.

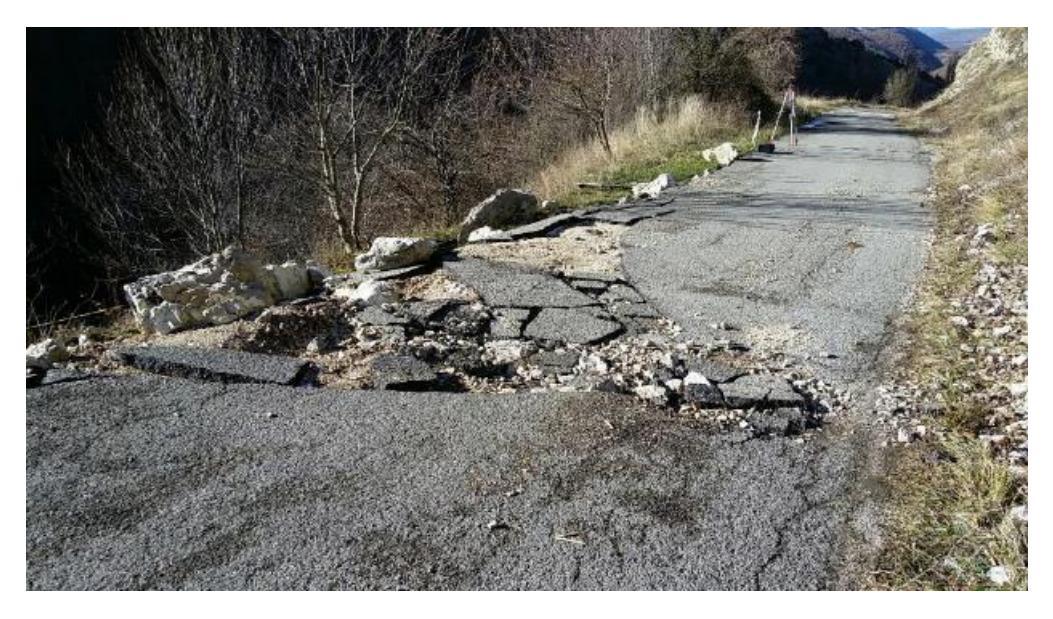
Damage to the pavements occurred between Sites 9a and 9b from boulder impacts. Figure 4.58 shows one such example. This photo was taken directly up-slope of the large 2.5 m boulders

shown in Figure 4.56. Still visible in Figure 4.58 is a smaller 1 m limestone boulder and several smaller 150-250cm boulders. The pavement was heavily damaged from multiple boulder impacts at this and several other locations.

**Figure 4.58.** Damage to road from 1-2.5 mm boulder impacts from rockfall between sites 9a and 9b.

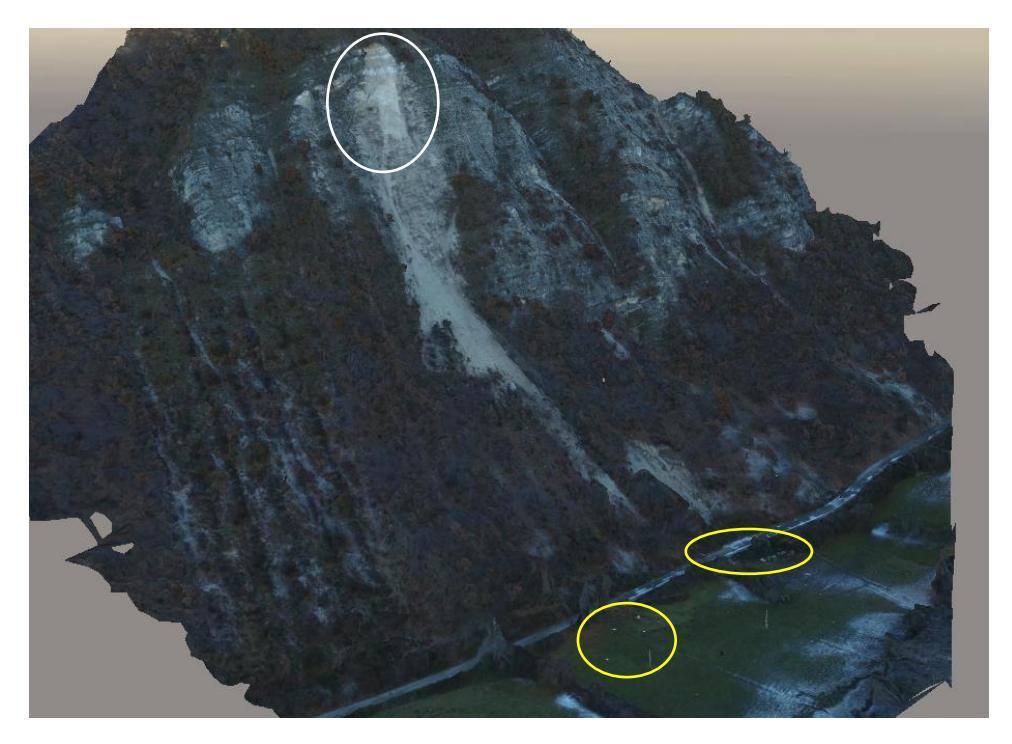
The larger landslide that occurred during the 30 October 2016 earthquake at site 9b was a rock avalanche. The site is shown in Figure 4.59 using a 3D SfM model othrophoto developed from UAV imaging. The source rock face is massive but weathered and jointed limestone is at least 50 m high. The source of the rock avalanche itself is 16 m wide and 32 m high. The slope below the rock face varies from 28° to 32° and is around 57 m from the rock face to the road. A flat field and Via del Passero lay at the bottom of the slope. The source is shown in Figure 4.59 as the light colored part of the rock face. We did not climb the slope to perform a close-up assessment of the rock at Site 9b. However, the limestone boulders that travelled to the base of the slope and out into the field below Via del Passero indicate the geology and rock type. These boulders were 0.75-1.25 m. Figure 4.60 shows the perspective of the rock avalanche from the field, where the runout down the slope is seen through the trees.

**Figure 4.59**. Pescia rockfall site 9b. 3D SfM model from UAV data. Boulders that have rolled into field below the road are circled in yellow. Source is indicated by white circle.

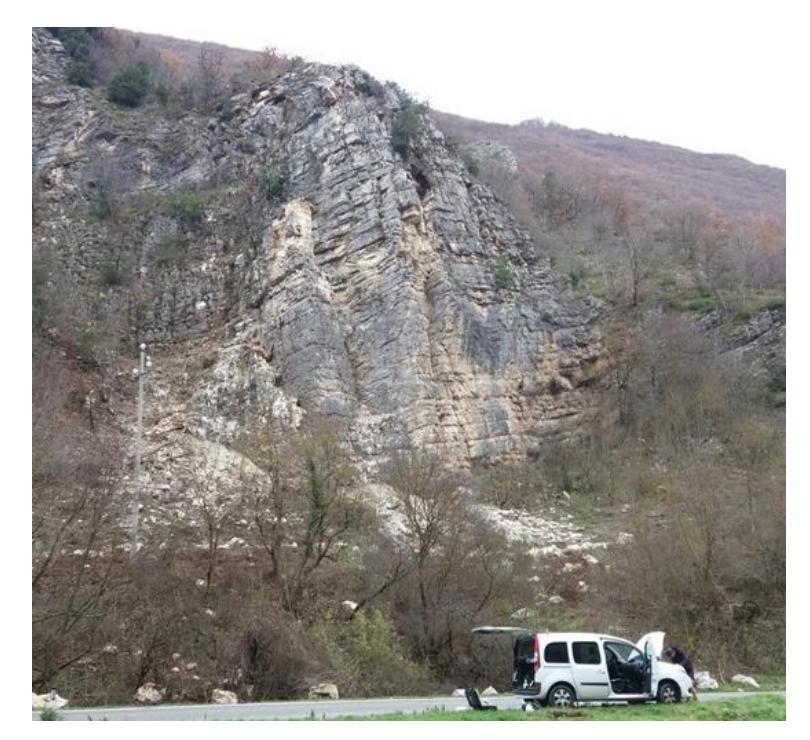
At km 3, a 23-m-high rock column consisting of regular sub-horizontal layers of *Maiolica* limestone experienced toppling of the prism cap (9 m high) and falls of blocks from the column walls and the cap itself (Fig. 4.61). The prism is isolated by very persistent joints belonging to two nearly-orthogonal sets, at about 45° with respect to the direction of the valley and its cap was intensely fractured and split in two parts by an opened joint before the 2016 seismic sequence.

Figure 4.61. Frontal view of the rock monolith at km 3 of SP134 motorway.

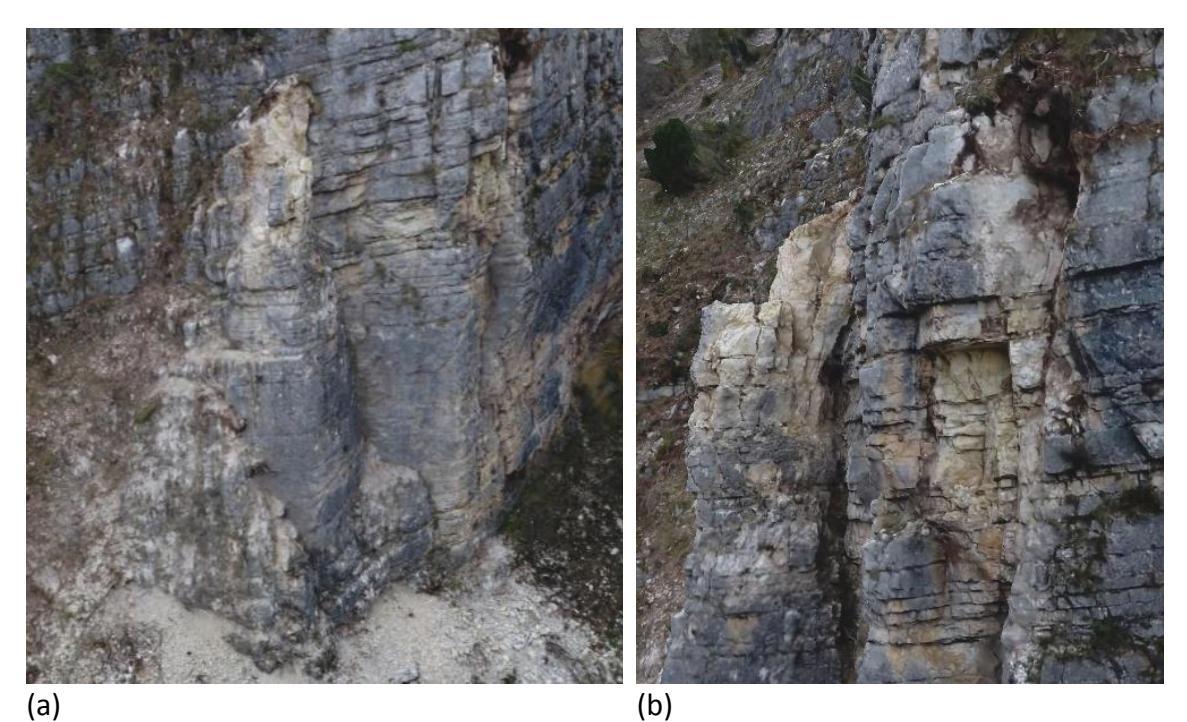
UAV surveys (Figure 4.62) suggest that one half of the cap collapsed and the other was damaged as a consequence of the shaking. Similarly, a 4-m-high hanging wedge (center-left of Figure 4.62b) and a 5-m-high wedge high (upper-left in Figure 4.62b) failed along a bedding joints and slid along two vertical joints, respectively.

**Figure 4.62**. Lateral view from the drone of the rock column at km 3 of SP134 (right valley flank) (a). The left part of the column cap collapsed producing two small avalanches towards the column front and along the column free side. Scars left from two wedges on the adjacent cliff (b). Leftward tilting of the column cap is also visible in figure 4.61.

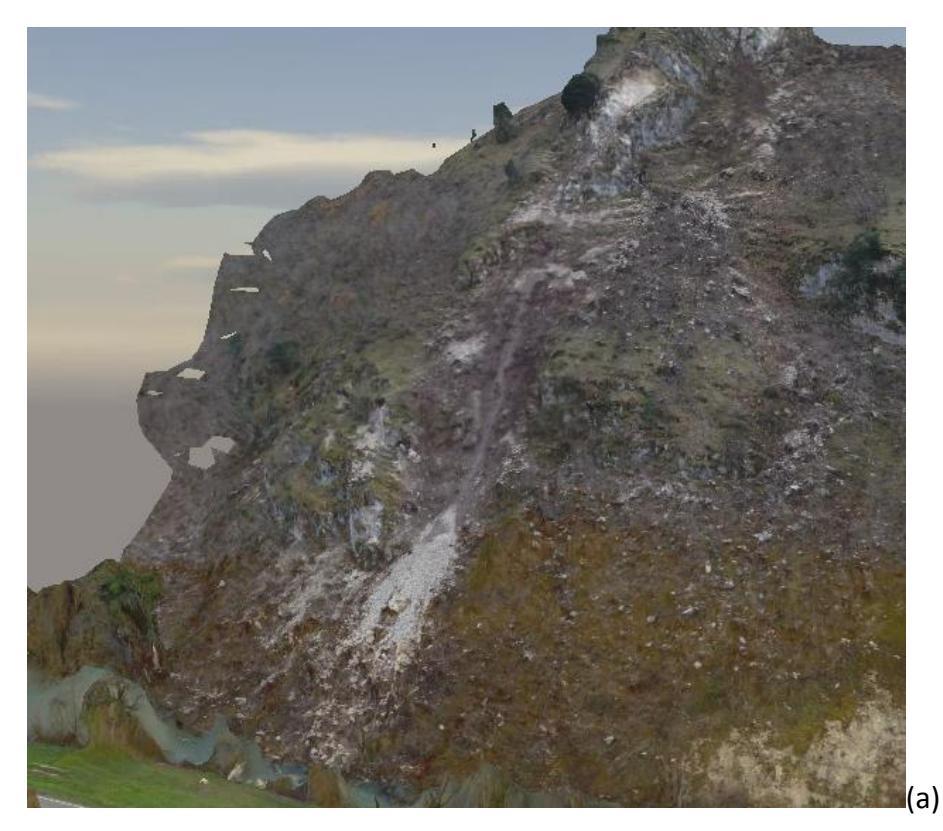
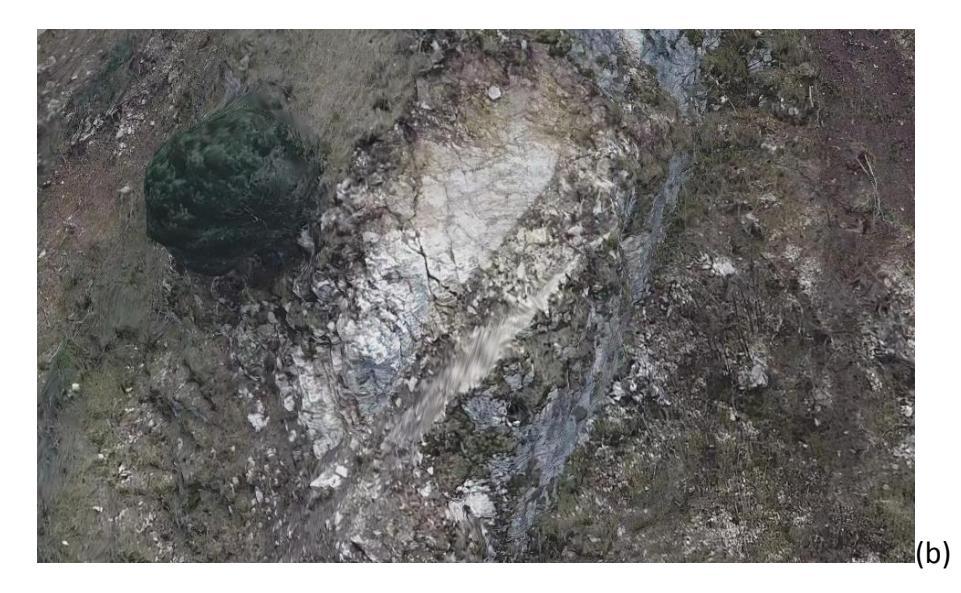
On the opposite valley flank a rock slide occurred at a height of about 100 m above the valley bottom and evolved into a small rock avalanche that fell into the Nera River (some blocks reached the opposite riverside). UAV drone surveys were instrumental in understanding landslide geometry, rock mass quality and failure mechanism. The oblique view in Figure 4.63a shows that the failed mass suffered intense fragmentation and eroded the slope with significant entraining of debris overlying the bedrock. Figure 4.63b indicates that sliding involved an intensely fractured wedge of Maiolica limestone delimited by two persistent joints.

**Figure 4.63**. General oblique view of the rock slide and subsequent rock avalanche on the left flank of the Nera valley (km 3 of SP134 motorway) (a); detail of the detachment area (b). Images taken from the 3D model generated by BYU on the basis of drone surveys.

The left joint (observing the slide from the opposite flank) was a sub-vertical, persistent, relatively smooth and striated fault plane, whilst the right joint seems a relatively planar joint dipping at low angle toward the valley. It is not clear if the mechanism was planar or three-dimensional. The wedge is sector-shaped with a height of 19 m and maximum transversal dimensions of 8m and 4 m respectively.

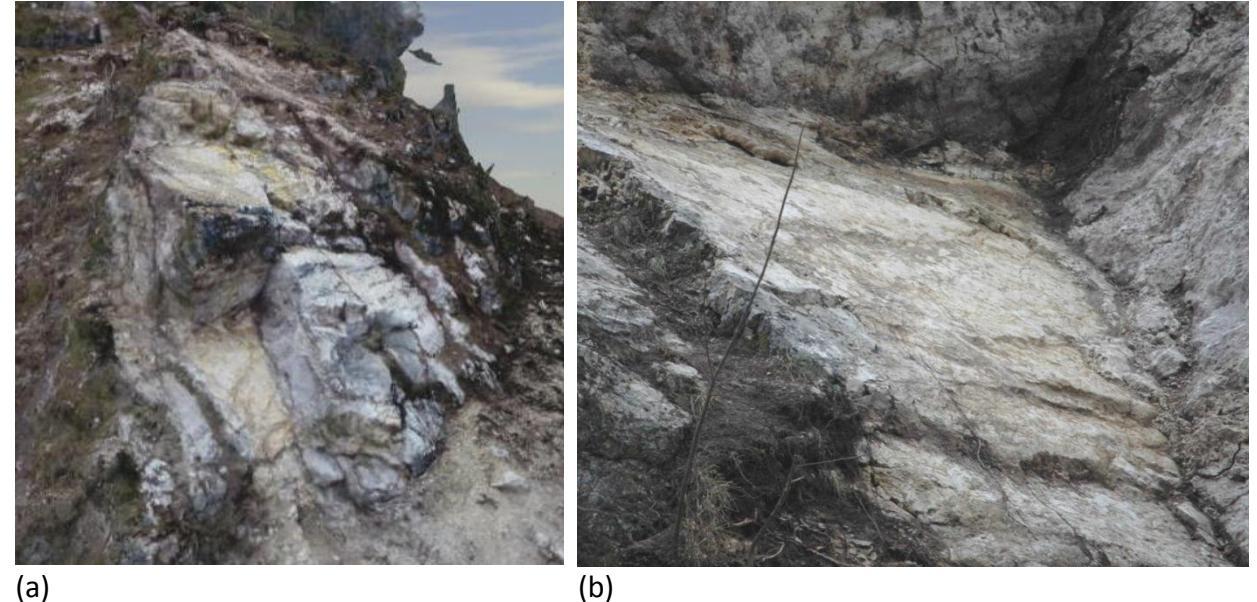
A major failure occurred on the northeast flank of the valley at km 4 of SP 134 within the Maiolica limestone formation (Figure 4.64a). The subsequent rock avalanche invaded the motorway and the valley bottom below for a stretch of about 70 m with large blocks (Figure 4.64b and Figure 4.64c). The main slide scar, located on a rock spur, suggests that the slide was planar and occurred along a surface composed of a number of bedding joints dipping parallel to the slope. Bedding dip progressively increases from top to bottom of the slide scar (about 15°). The sliding surface is stepped both longitudinally and transversally (Figure 4.65a) due to well-spaced joints of two sets roughly striking parallel and normal to the slope. On the left side (viewing from the opposite, southwest, valley flank) the slide had no confinement. Bedding joints are relatively planar and smooth with apparent signs of weathering and oxidation (Figure 4.65b). Weathering seems to affect also the sub-vertical joints. The rock mass appears to be loosened and the rock material intensely fractured.

**Figure 4.65**. Close-range drone image of the detachment area (a) and detail of a bedding joint forming the sliding surface taken from the slide foot (b).

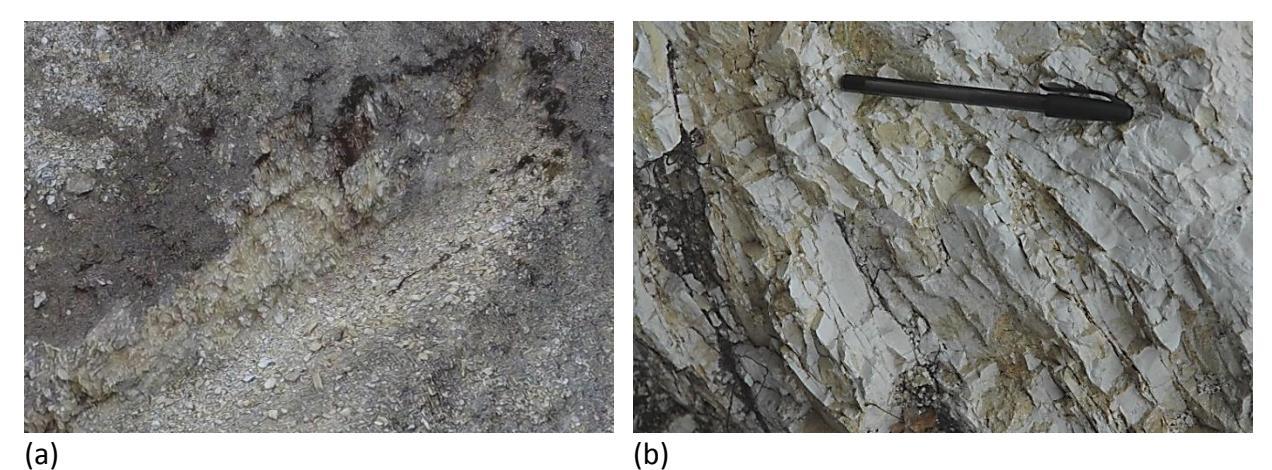
The height of the main slide scar is estimated from the 3D model as 20m. A layer of pervasively fractured rock below the main scar (Figure 4.66a), visible on close-range drone images, and the general ravinement of the lower half of the slope, suggest that the slide mass might extend downward and movement could be more complex. Apparent loosening of the rock mass, the pervasive fracturing of the rock at small scale (Figure 4.66b) indicate that the zone is tectonically disturbed and the slope underlying the slid rock spur was involved in the failure.

**Figure 4.66**. Drone image of a layer of cataclasized limestone located under the main slide scar(a) and detail of a pervasively fractured limestone block fallen from the slope (b).

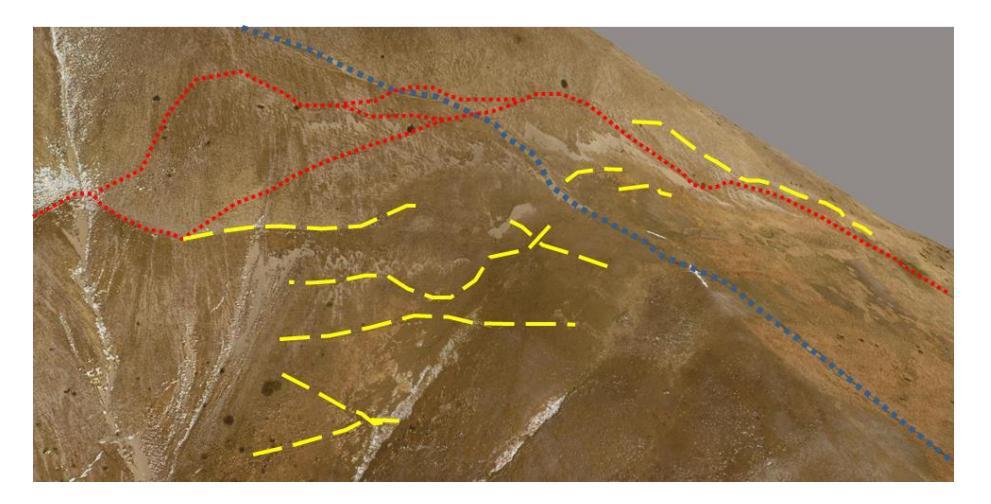
**Figure 4.68.** Excerpt from 3D SfM model from UAV data of the side of Mt. Vettore. The blue dashed line indicates the footpath. Red dashed line indicates scarps interpreted as the fault rupture trace(s). The yellow lines indicate scarps interpreted as minor slope instabilities. Looking from the west to the west face of Mt. Vettore. On the right of the image the slope descends on the south face towards road SR477.

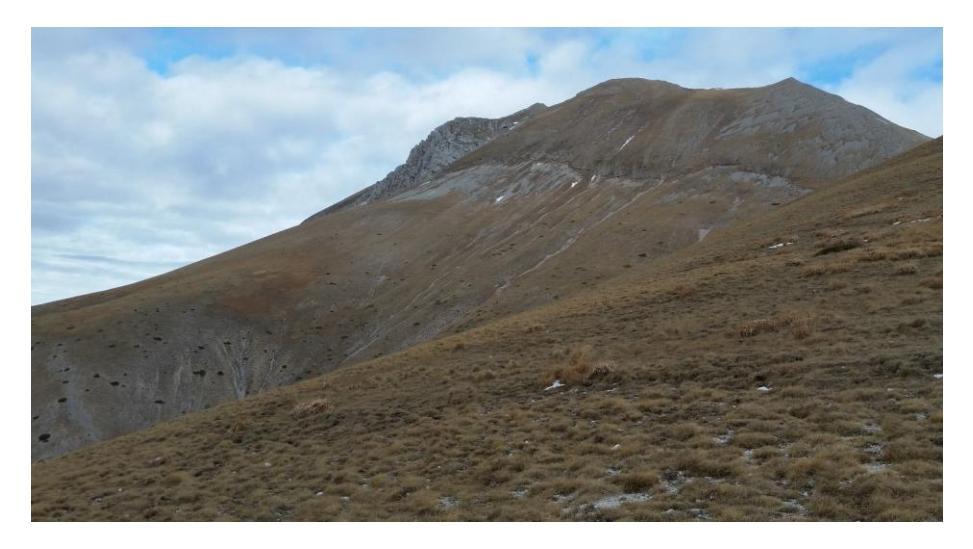
Figure 4.69 shows an image of the west flank of Mt. Vettore from the footpath. The fault can be seen as the linear feature that runs along the slope towards the large rock outcropping of Cima del Lago at the top left of the Massif in the image. Also seen are thick talus slopes below the fault. One of the key features that enables the distinction between faulting versus slope instability or talus compaction as the cause of the linear feature is the large fault offsets recorded at Cima del Lago. At Cima del Lago, limestone bedrock rises steeply to exposure at the surface. Below the limestone exposure is thick sediments without thick talus. At this location very few fissures, cracks, or scarps were identified aside from the fault trace. The only scarp lower on the slope at this location is the western trace of the Mt. Vettore fault, approximately half way down the face of the Massif to the Piano Grande plain below. No indications of slope instability, landsliding, or talus compaction were observed at Cima del Lago.

**Figure 4.69.** View of the east slope of Mt. Vettore showing talus slopes and fault rupture trace. Fault rupture displacements and strong ground shaking have caused densification and sliding of talus.

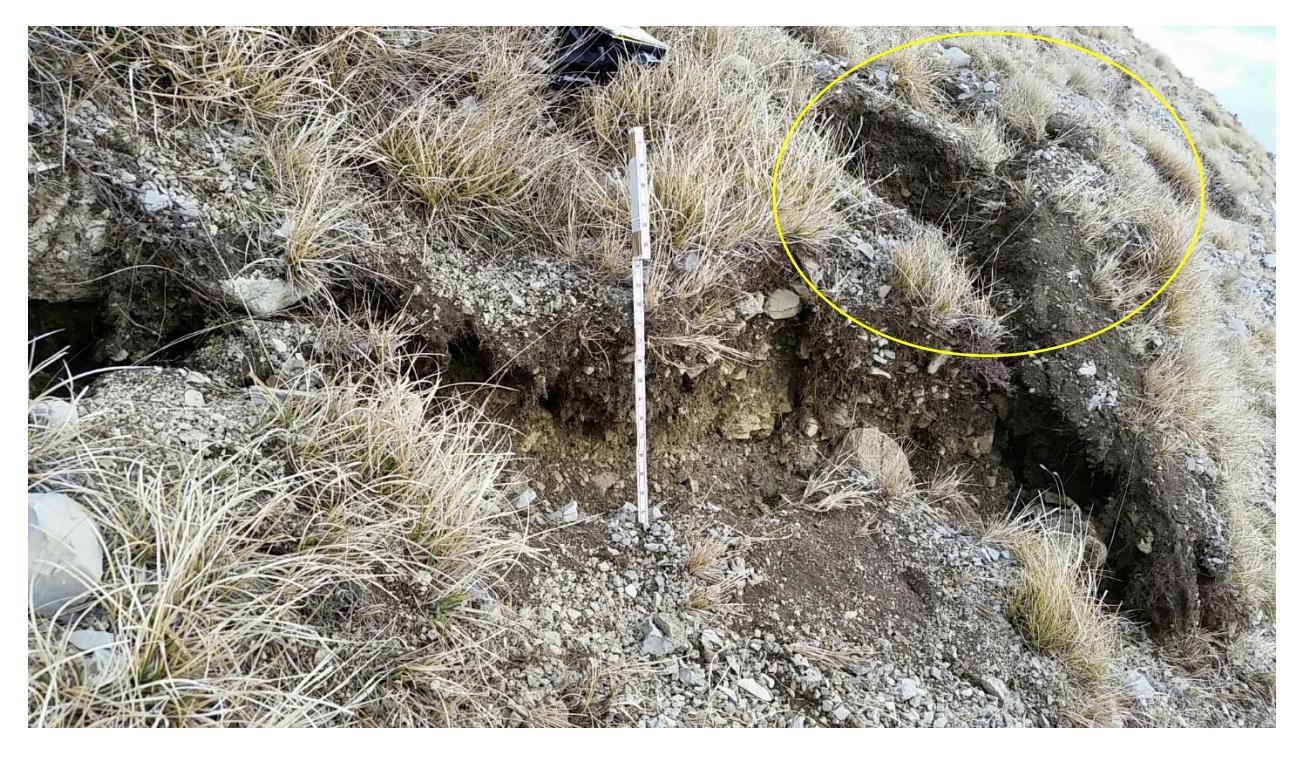
In very steep areas of the west flank of the Mt. Vettore Massif, fault rupture and slope instability were occasionally present together. Figure 4.70 shows an example, where the fault offset is being measured but above and below of the fault, blocks of soil have displaced. In some instances, the blocks that tumbled across the fault making measurements of the fault offset impossible. The slope in Figure 4.70 was approximately 40°.

**Figure 4.70.** Image of fault scarp and associated nearby slope instabilities (yellow). 4.2.11 Rockfall SP 477 Arquata-Castelluccio (reappraisal)

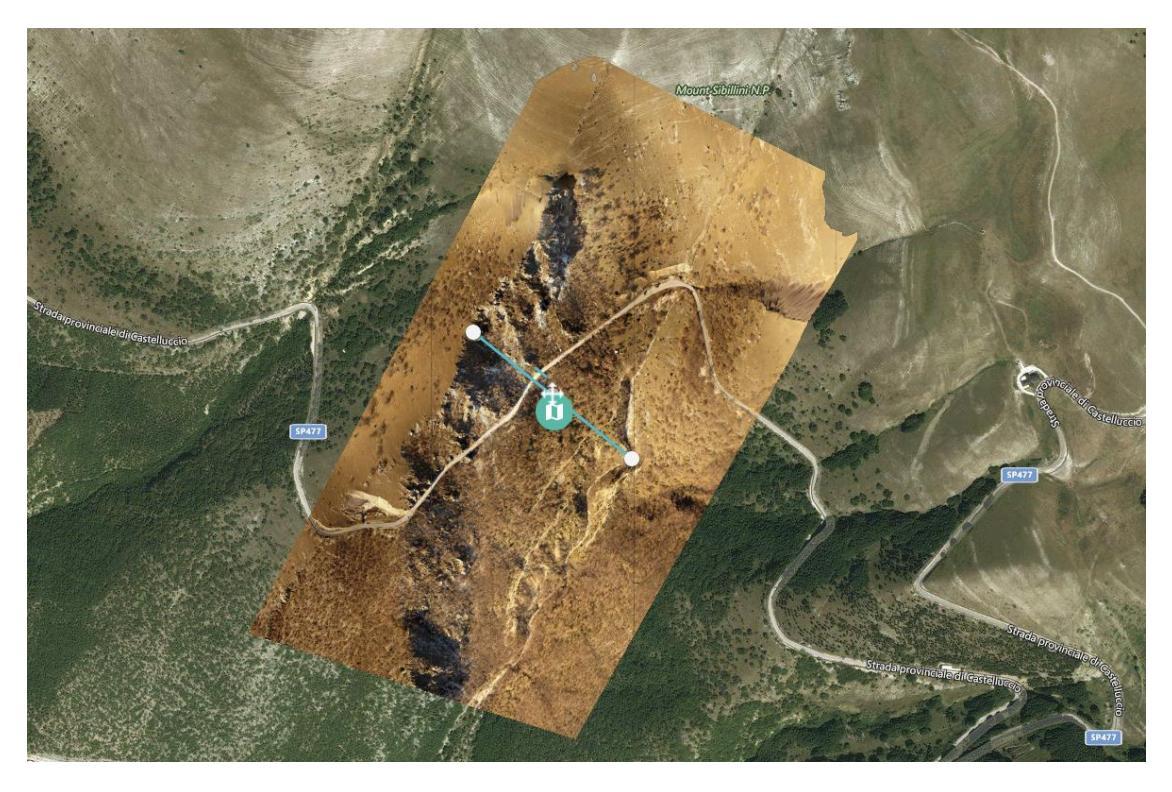
Rockfall in a layered limestone unit occurred along the SP477 route between Castelluccio and Norcia (Figure 4.71), showering the road with large blocks. The rockfall was observed following the 24 August event and again after the October events. All of the rockfalls were apparently the result of isolated blocks of limestone that detached from the outcropping bedrock above the highway. As with the August event, most of these blocks came to rest on the road, but individual boulders crossed the highway and descended a steep ravine. A UAV phantom4 was used to fly the outcrop bridge (Figures 4.72-4.73). Maximum block run out distances were on the order of 375 m, descending a net elevation change of 190-210 m.

**Figure 4.72.** Overlay of the UAV orthomosaic on top of the Google Earth image of SP477, the Castellucio-Norcia highway. Isolated boulders descended from the outcrop NE trending ridge on the left down to a ravine on the right side of the ortho mosaic, a maximum distance of approximately 375 m as indicated by the blue line. No other area along this highway had intense rockfall.

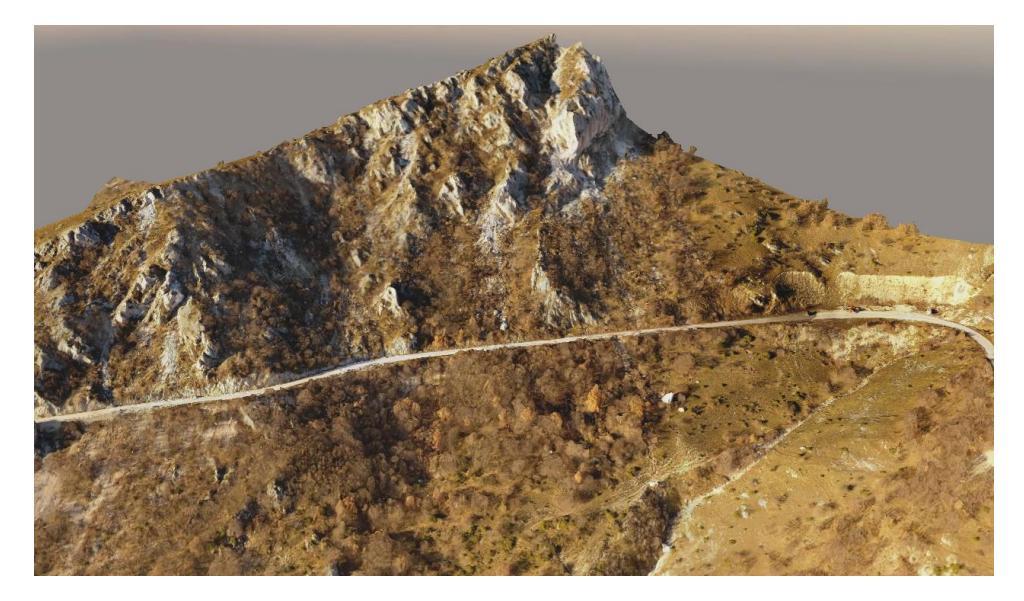
**Figure 4.73**. The most active area along Route SP 477 is below a large south facing ridge of limestone. The white areas near the top of the ridge are zones where fresh rock is exposed following collapse of blocks. This ortho mosaic is part of a three-dimensional model produced using a UAV phantom 4.

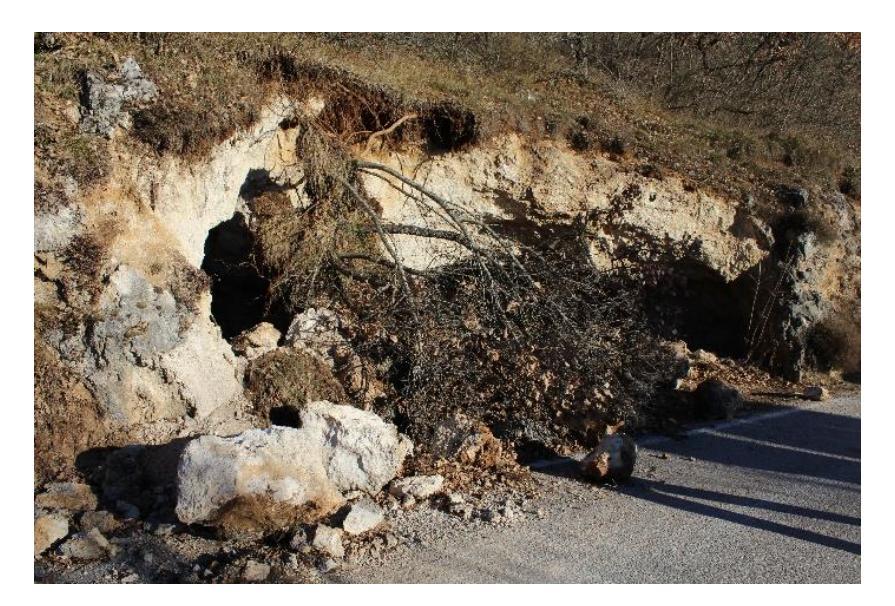
**Figure 4.75.** Rockfalls with boulders on the road.

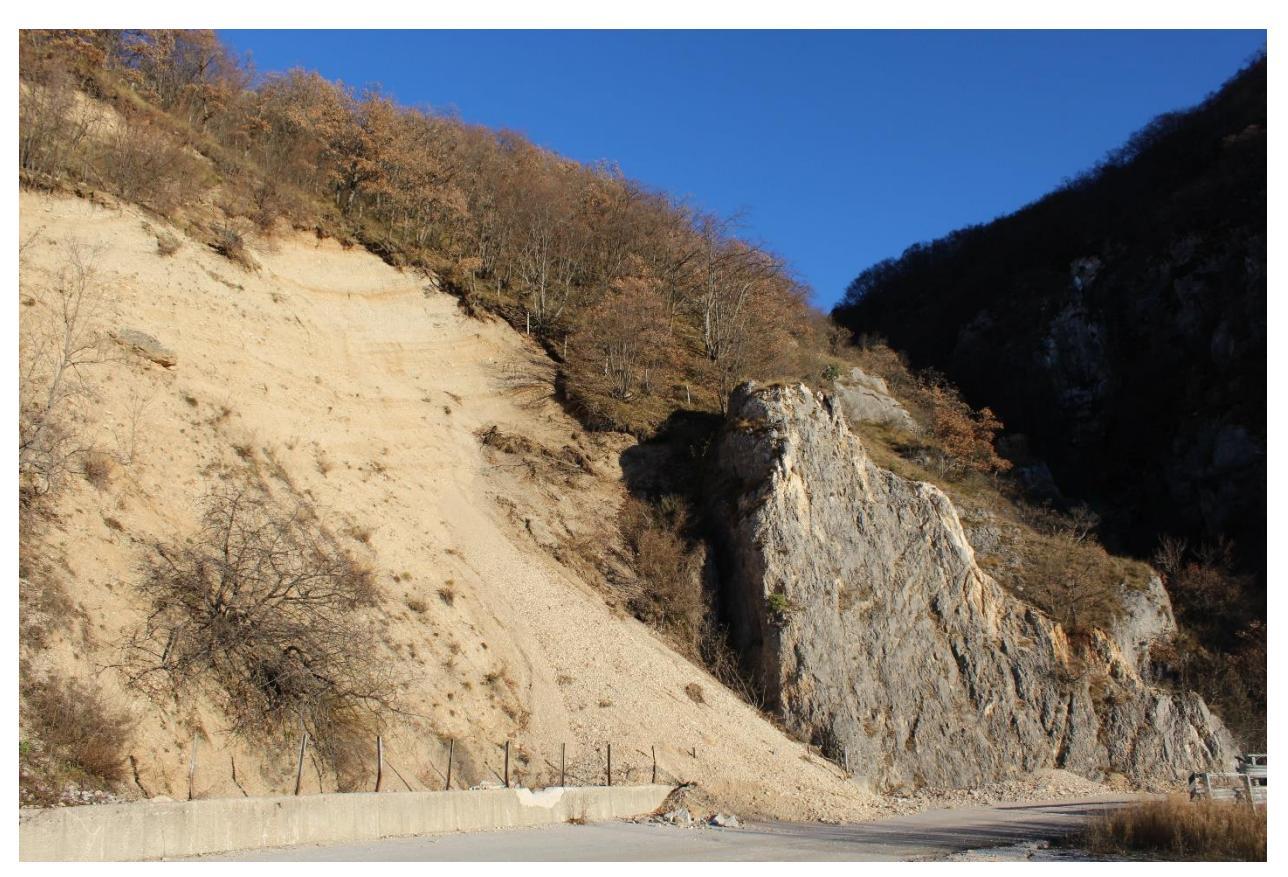
Figure 4.76. Debris avalanche along the scarp of a previous landslide.

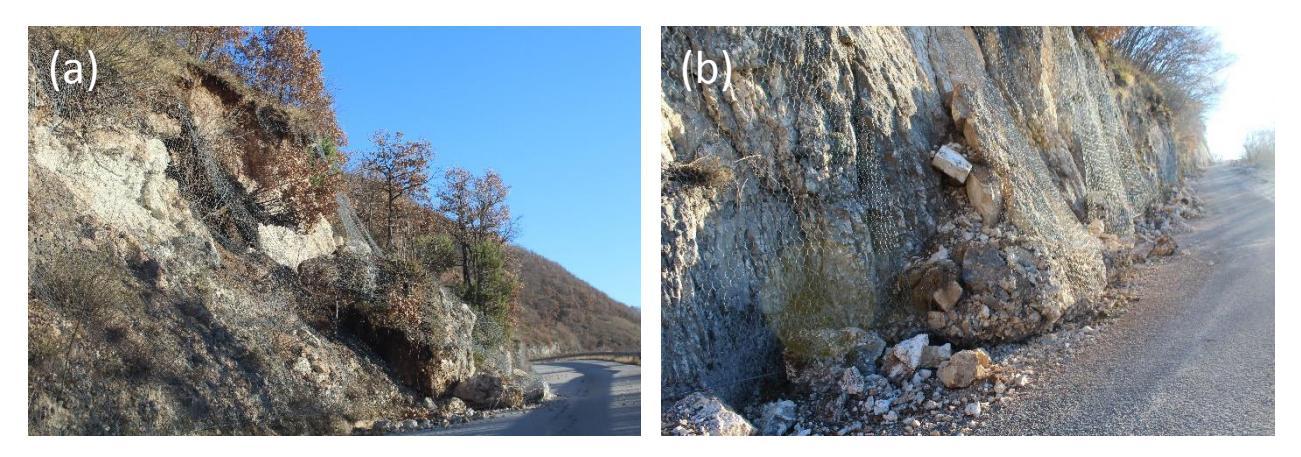
Figure 4.77. Debris and boulders captured by the rockfall protection nets.

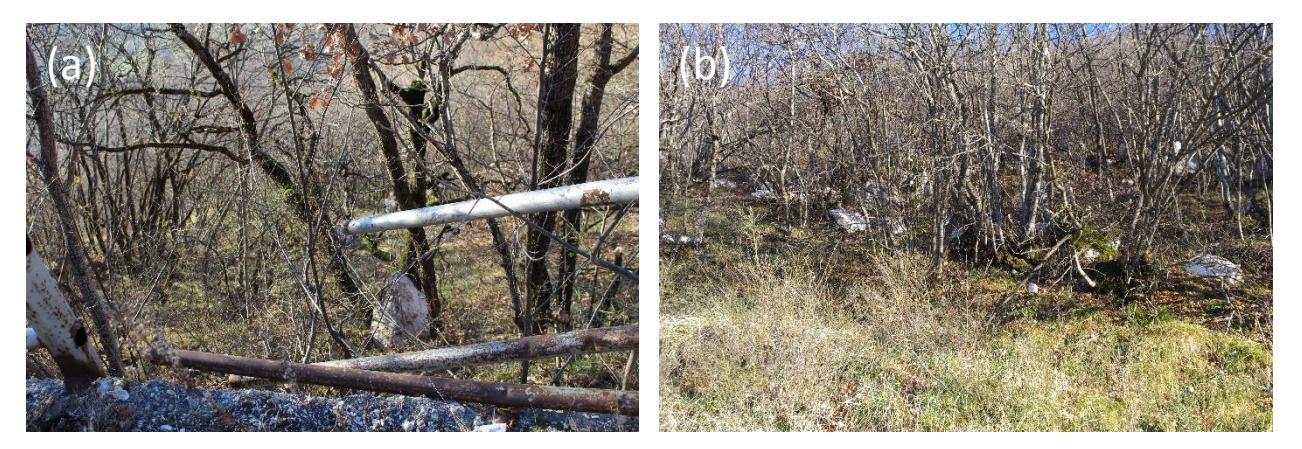
Figure 4.78. Boulders supported by the vegetation.

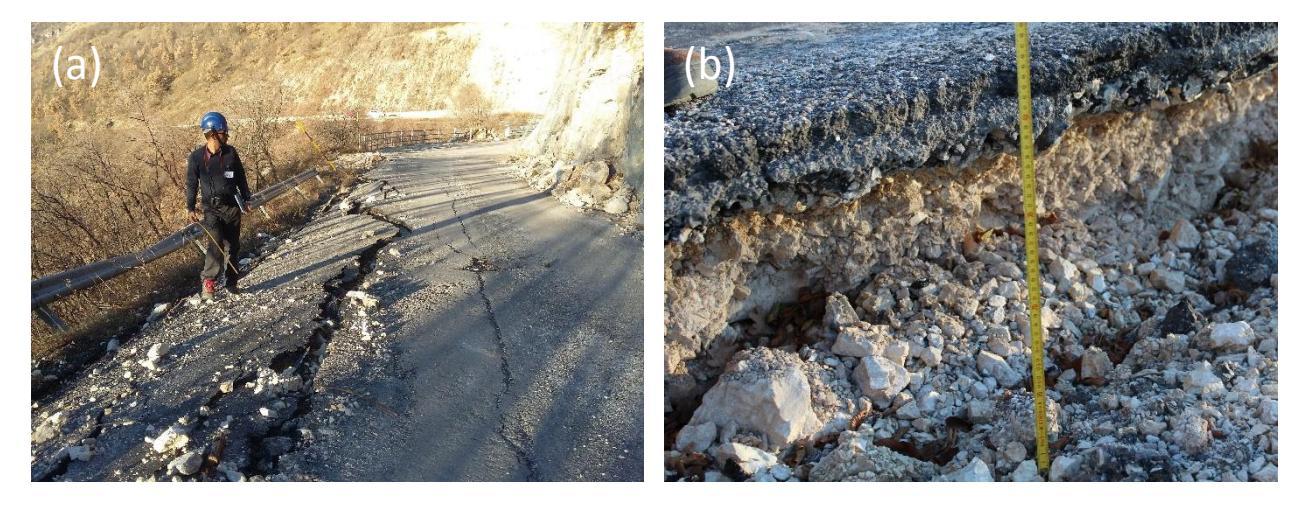
**Figure 4.79.** Fracture along the road, large vertical offset due to fracture and ultimate movement, damaged edge barriers and debris and boulders on the road surface.

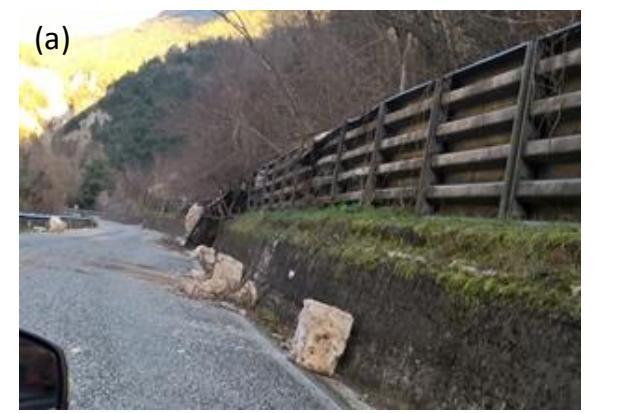
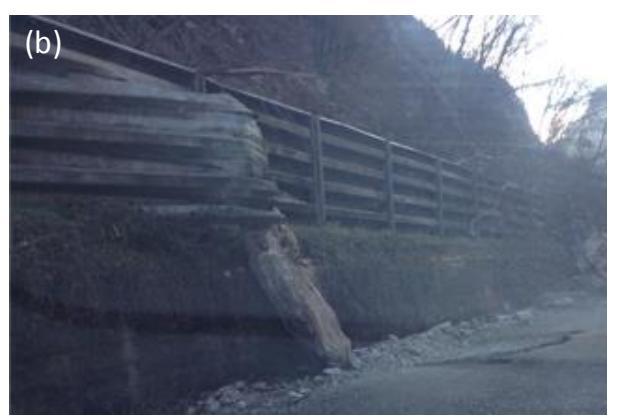
Figure 4.82 shows some of the rockfalls in the calcareous formations located on the left bank of the Nera river that we have identified after the 30 October 2016 earthquake. Many blocks, having a volume ranging from a dozen of cubic centimeters to a few of cubic meters, have been found on the shoulder or across the road. At the time of our reconnaissance, slide debris remained on the road and the highway was still closed.

Figure 4.82. Rockfalls along the SP209 between Triponzi and Visso.

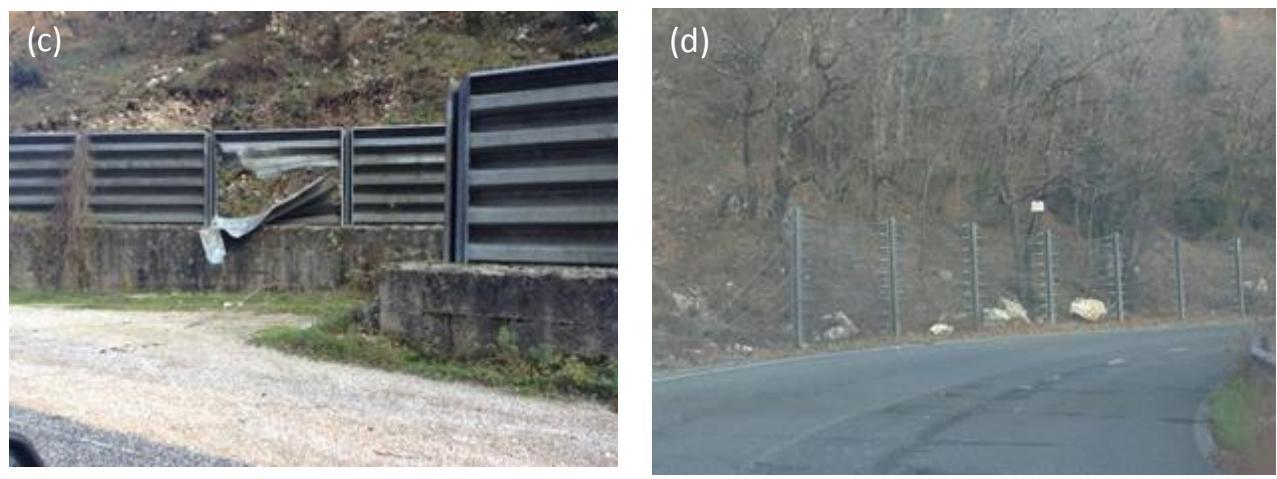
The area has been subjected to slump failures in the past. As a result, slope protections (i.e. rockfall nets, dynamic rockfall barriers or catch fences) are present along the road. Figure 4.83 shows many cases in which rock-nets have been passed over or damaged by boulders and rock-blocks. The slope located on the right bank of the Nera river has been interested by various slope instability events. They consisted of gravel debris. These features (Figure 4.84) are similar to those observed for the Nera landslide (Section 4.2.1) but very limited spatially and in volume.

Figure 4.83. Slope protection damaged by boulders and rock-blocks.

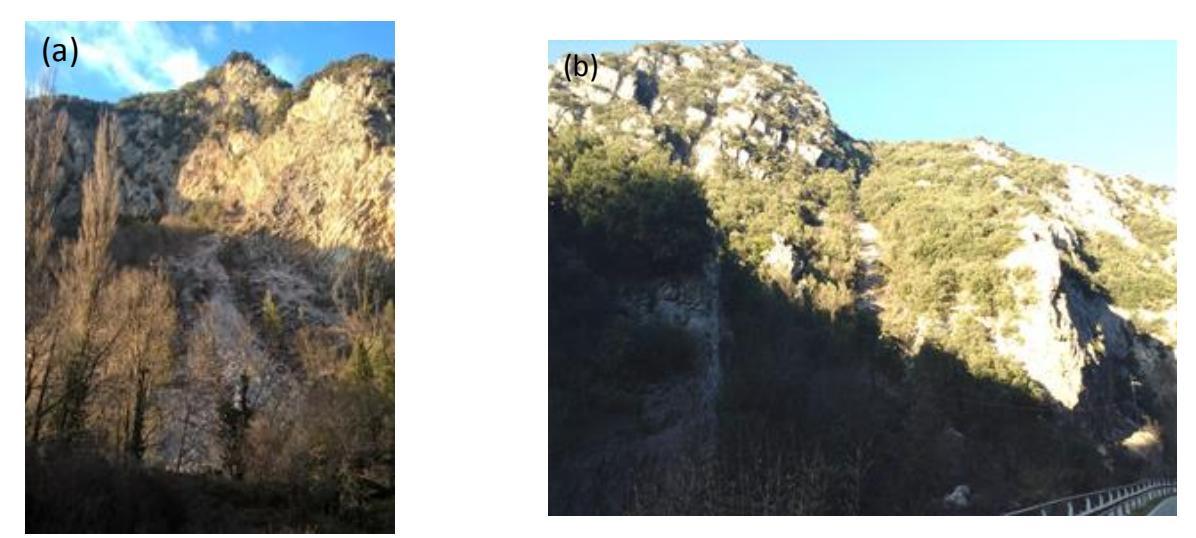
**Figure 4.84**. Debris occurred on the right bank of the Nera river along SP209 (lat 42.9157N, lon 13.0456E).
