# Engineering Reconnaissance Following the October 2016 Central Italy Earthquakes Version 2

GEER Team Leaders: Jonathan P. Stewart and Giuseppe Lanzo

Geotechnical Extreme Events Reconnaissance Association Report No. GEER-050D 8 May 2017

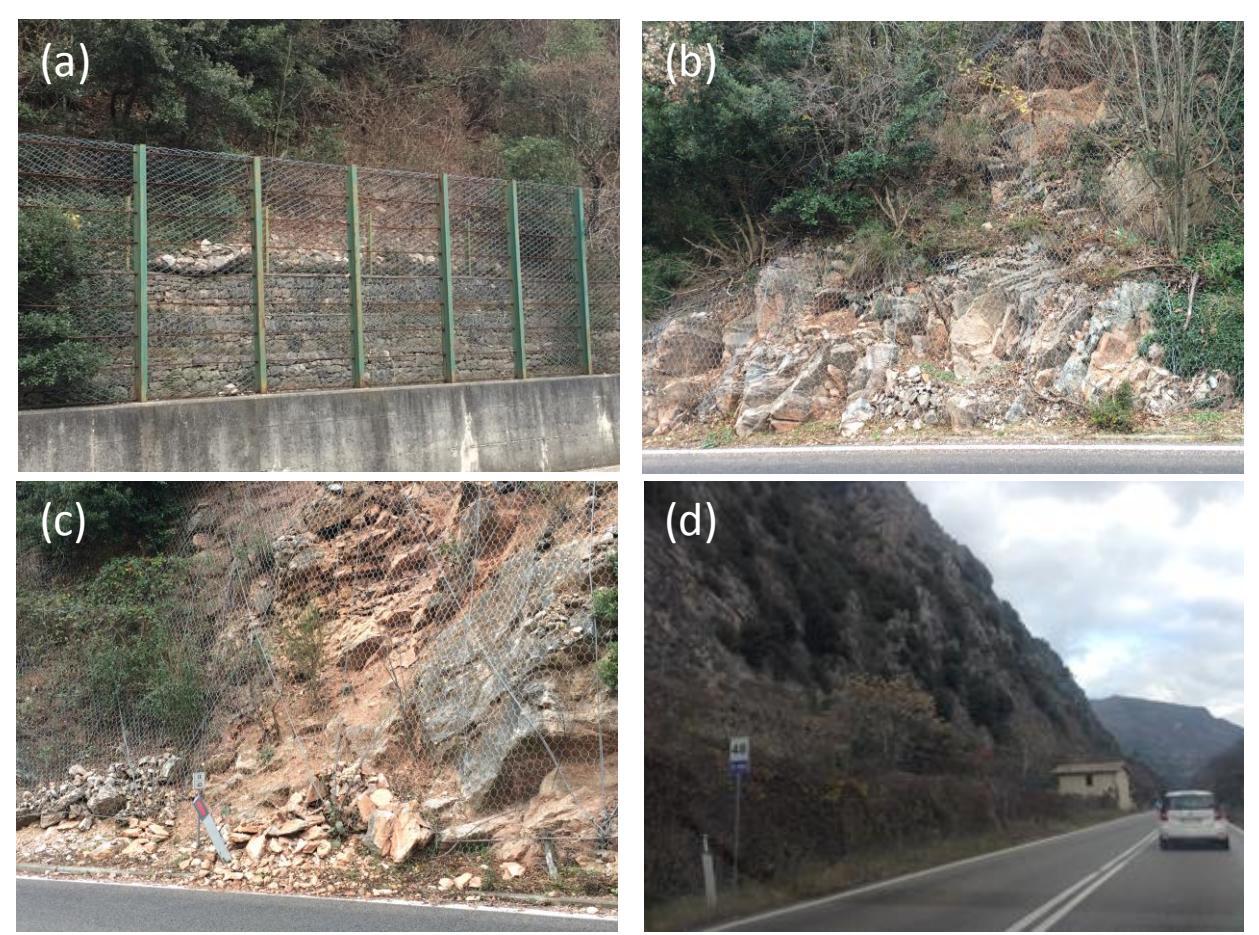
We observed several rock failures along the highway SS685 (also known as Tre Valli Umbre) between the villages of Piedipaterno and Borgo Cerreto (Figure 4.85). These features, shown in Figure 4.86, are mainly isolated rock falls having a volume ranging from a dozen of cubic centimeters to a few of cubic meters. The geology of the site is characterized by the presence of calcareous rock formations known as red flakes (*scaglia rossa*), and screes constituted by broken rock fragments variously sized. The IFFI landslide inventory (Figure 4.1b) classifies this area as subjected to widespread rock falls and slumps. We did not observe damages on the slope protections (i.e. rockfall nets, dynamic rockfall barriers or catch fences) present along the road.

Figure 4.86. Rockfalls between Piedipaterno and Cerreto along highway SS685.

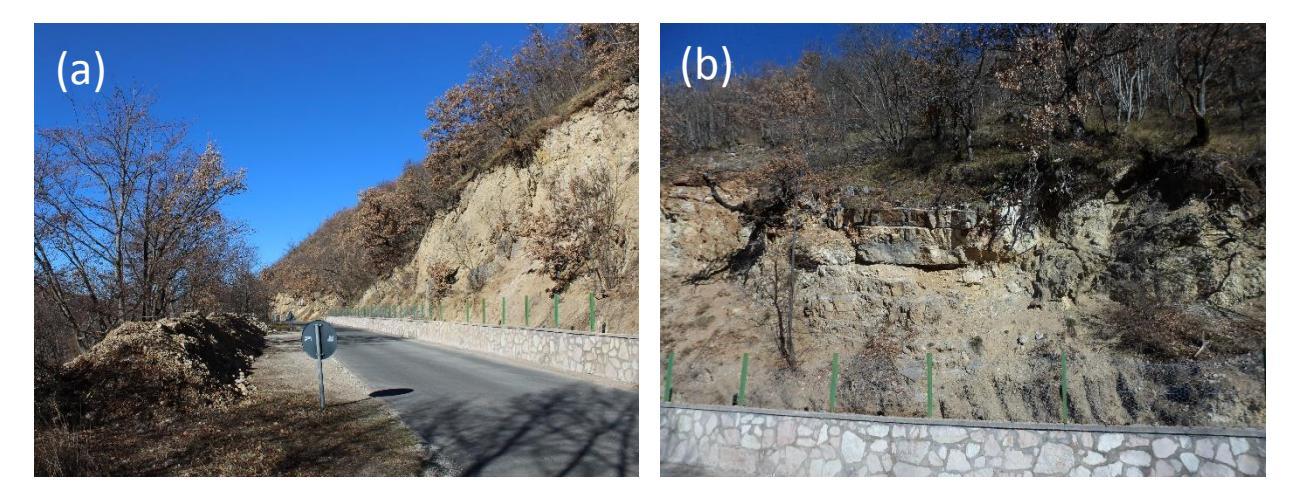
**Figure 4.88.** Landslide between Cittareale and Norcia along the SP746: (a) General view of the area; (b) Zoom on the crown and main body of the scarp.

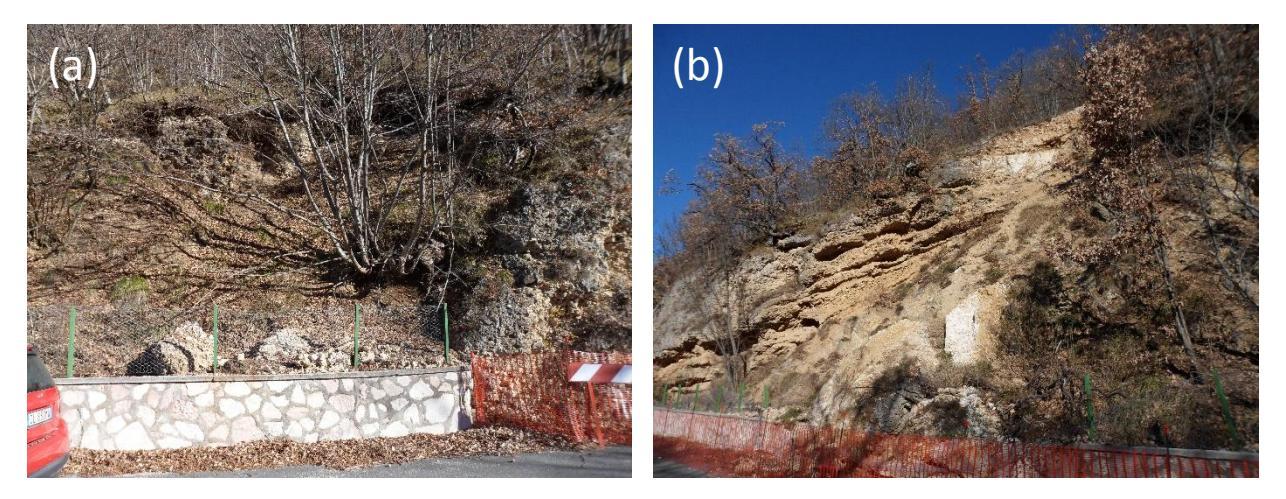
**Figure 4.89.** Failure in calcareous breccia between Cittareale and Norcia along the SP746: from (a) to (e) view of the all facade; (f) rockfall on the road.

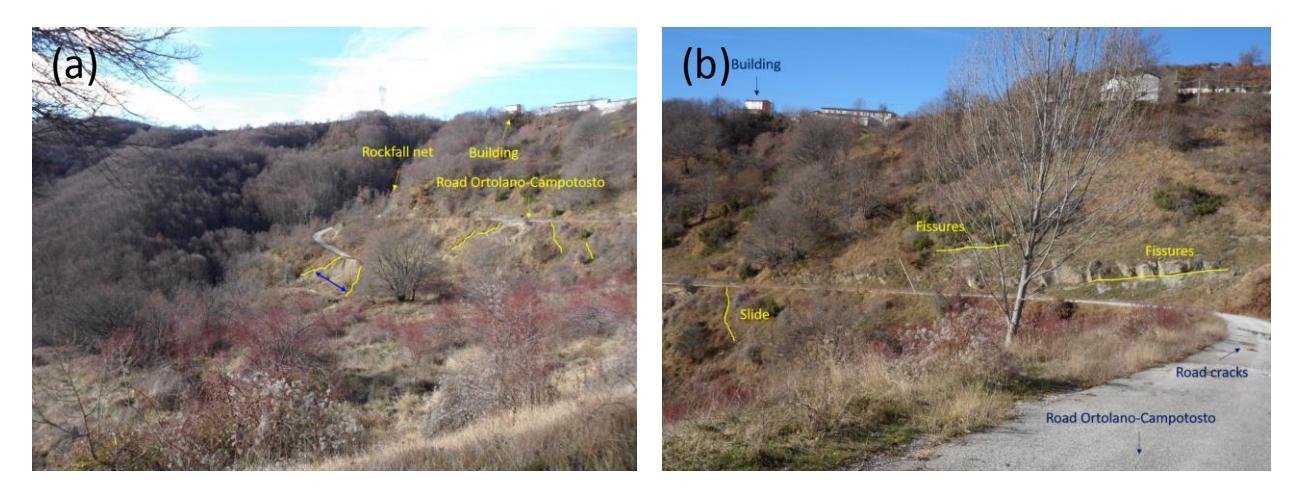
We observed a shallow landslide along the road of Ortolano-Campotosto (Figure 4.90). Figure 4.91 shows the extension of this feature. Along the whole longitudinal extension of the landslide, there is a cut and fill road. The landslide has a spatial extension, along the road of 100 m, with observed maximum vertical offsets of 3-5 m. According to the official geologic map of Italy (sheet 139, 1:100,000 scale; http://193.206.192.231/carta\_geologica\_italia/tavoletta.php?foglio=139, last accessed April 29, 0217) and the ISPRA geologic map (sheet 349, 1:50,000 scale; http://www.isprambiente.gov.it/Media/carg/349\_GRANSASSO/Foglio.html, last accessed April 29, 0217), the formation in this area comprises highly fractured sandstones and marly-clayey strata. The sandstone stratum, is buried by a weathered soil cover, which was affected by the observed landslide feature.

**Figure 4.91.** (a) Overview of the whole longitudinal extent of the landslide area; (b) close up view of the landslide-related features from the road Ortolano-Campotosto.

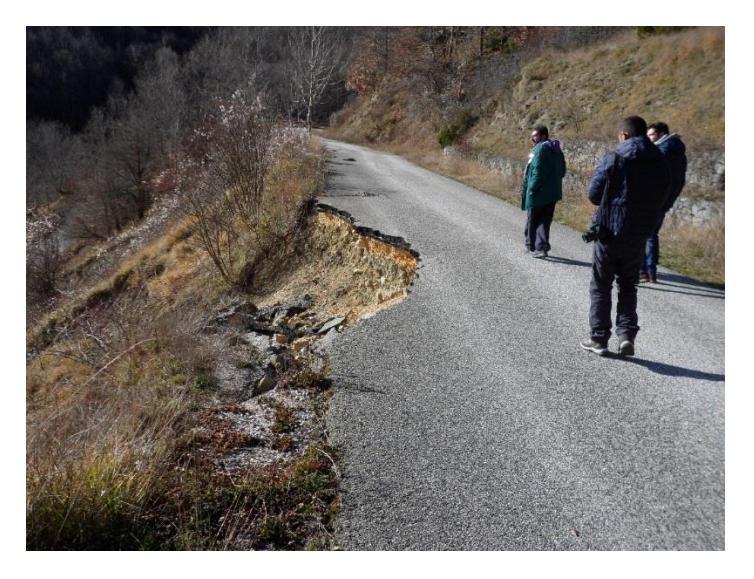
Figure 4.93. A slide observed on the fill slope.

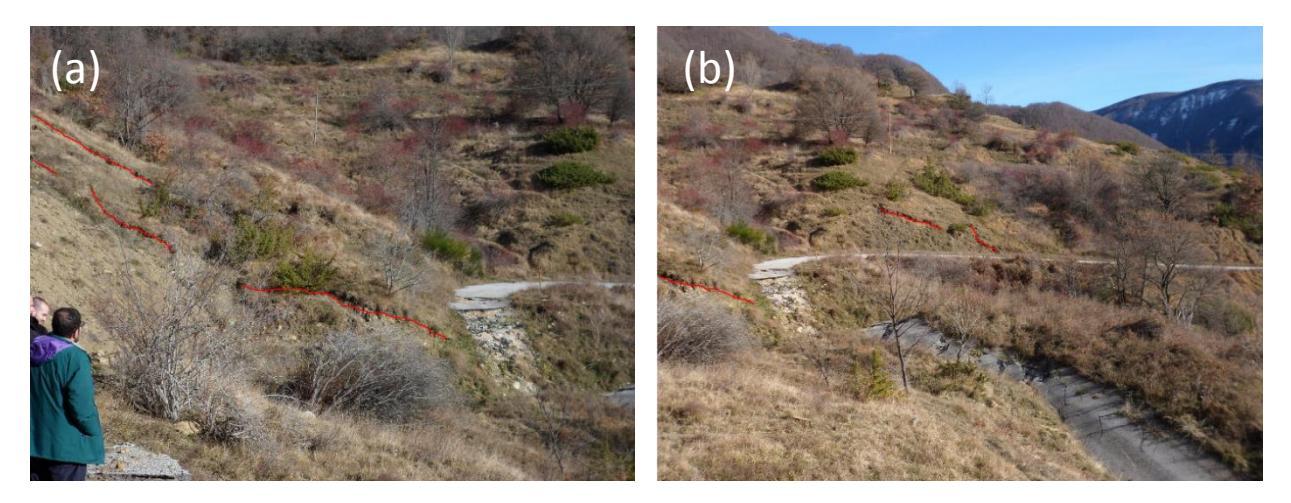
Figure 4.94. Fractures on the cut slope.

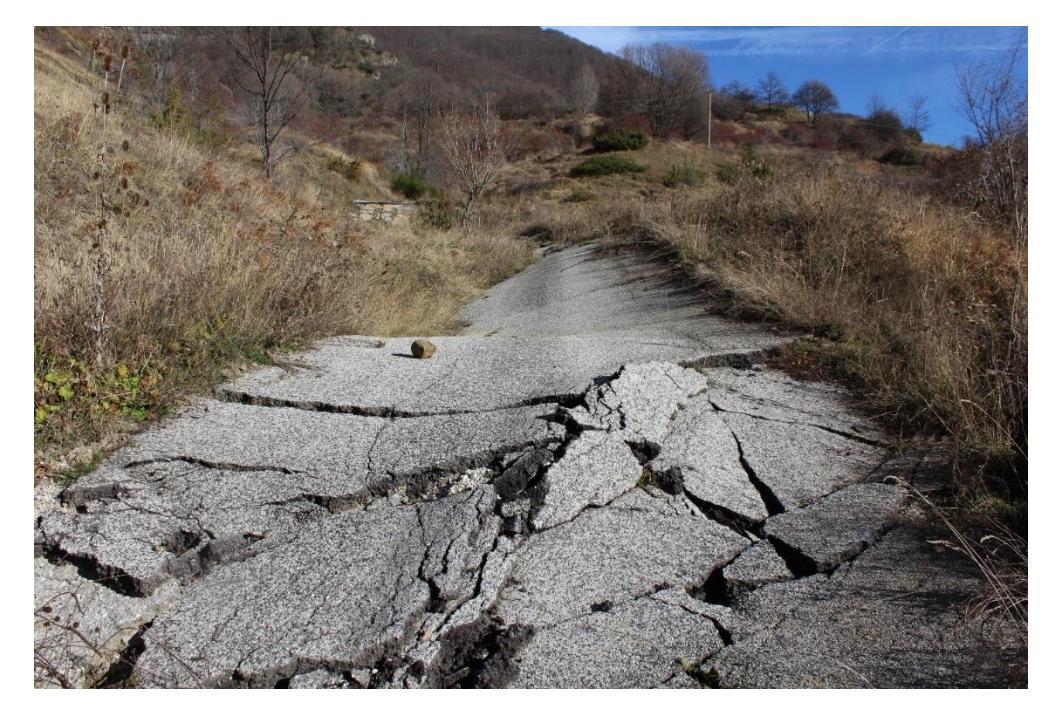
Figure 4.95. Damages along the road.

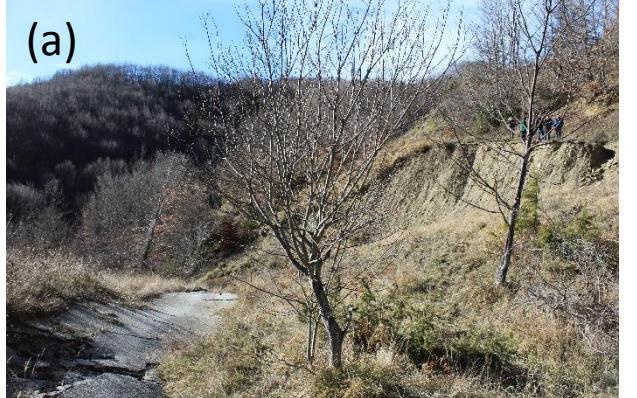
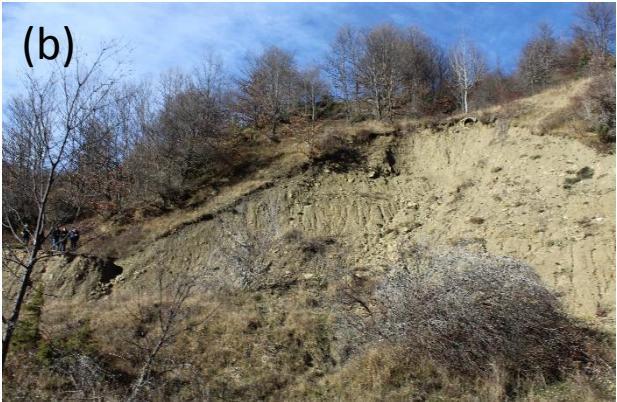
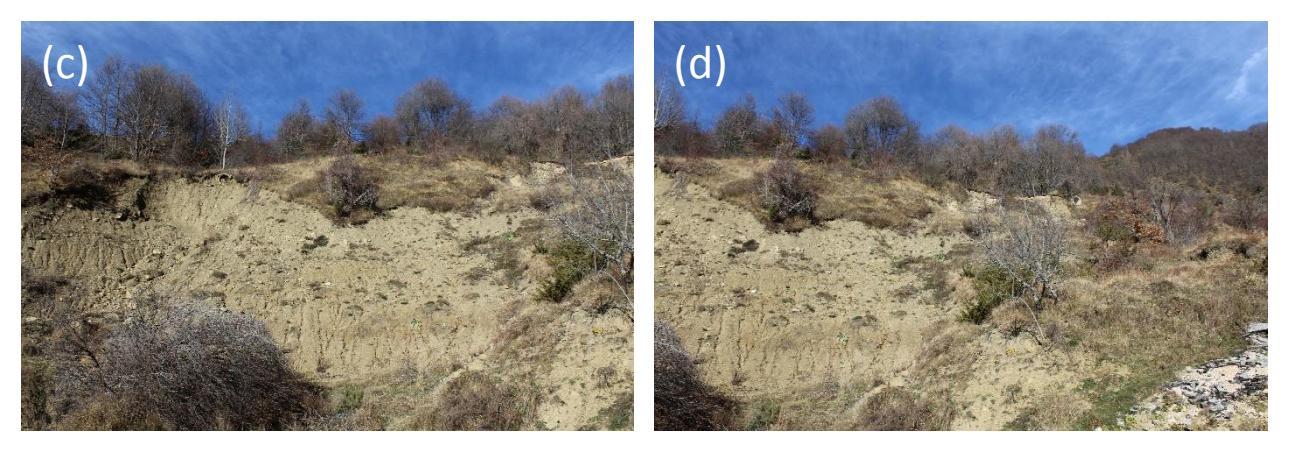
Figure 4.96. Minor scarps observed on the cut slope side of the road.

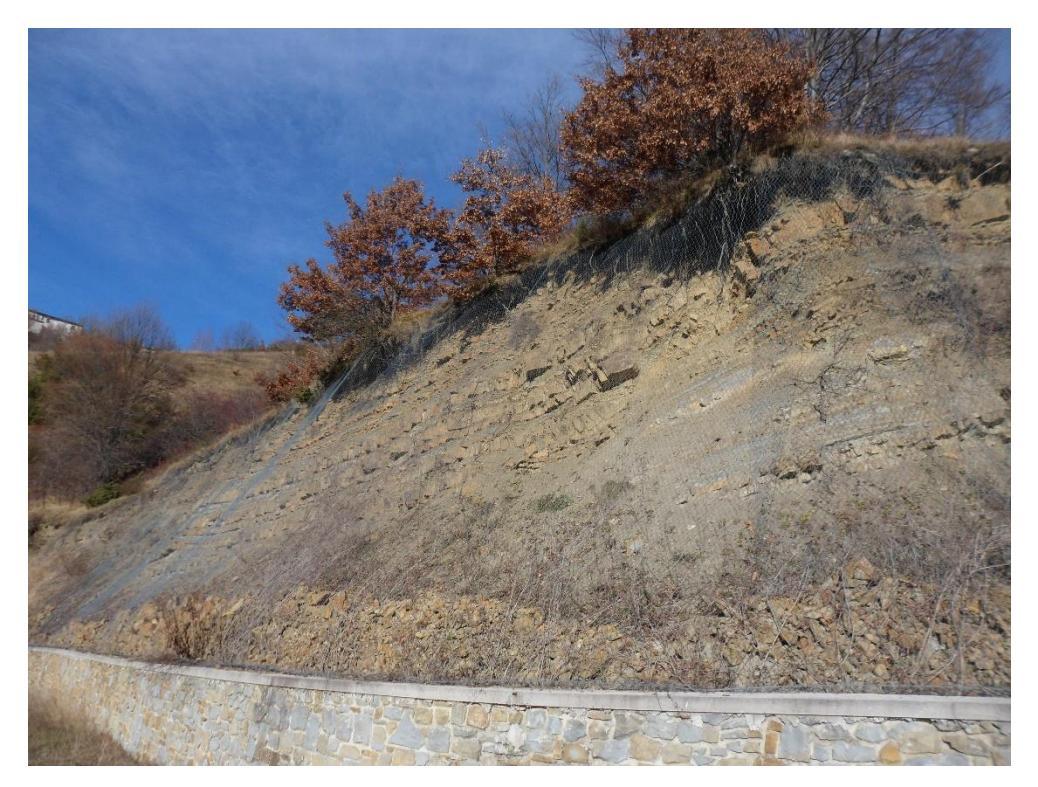
On the exposed surface of the landslide we observed silty clay with traces of sand, gravel, and cobbles. Figures 4.92-4.96 show several cracks on the road, fissures and minor scarps on the cut slope, and minor slide features on the fill slope. We did not observe major damages on the slope protections (i.e. rockfall nets) present along the road (Figure 4.97)

Figure 4.97. Rock-net protection with captured debris.

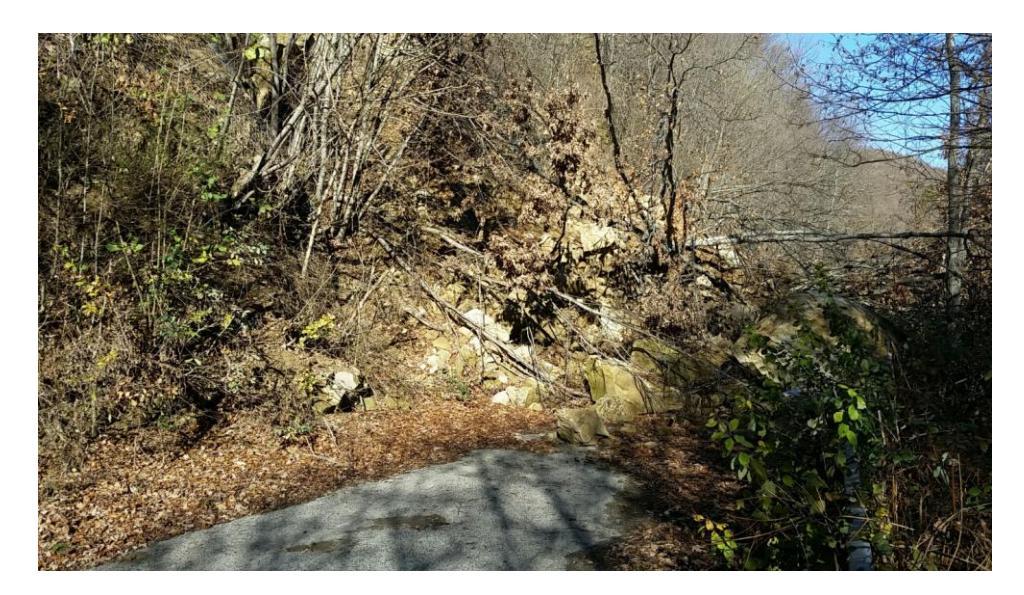
Figures 4.101 and 4.102 show the landslide. Several of the boulders from the landslide measured 2 m and appeared to be heavily weathered. Rock was limestone or dolomite (limited time at the site to assess rock type did not allow for more precise identification). Soil cover over the rock was thin (less than 30cm). The slide debris consisted of large amounts of vegetation, as would be expected given the heavy forestation of the slope. No seepage was observed at the bottom of the slide or within the slide mass. To the south and the north of the landslide the slopes are flatter (15° to 20°), while at the location of the slide, the inclination is approximately 34° as measured via a clinometer. Landslide width was estimated at 11 m.

**Figure 4.101.** Landslide debris covering the roadway. Boulders range in size up to 2 meters. Also pictured is rockfall netting used by local officials for minor rockfall control on the slope.

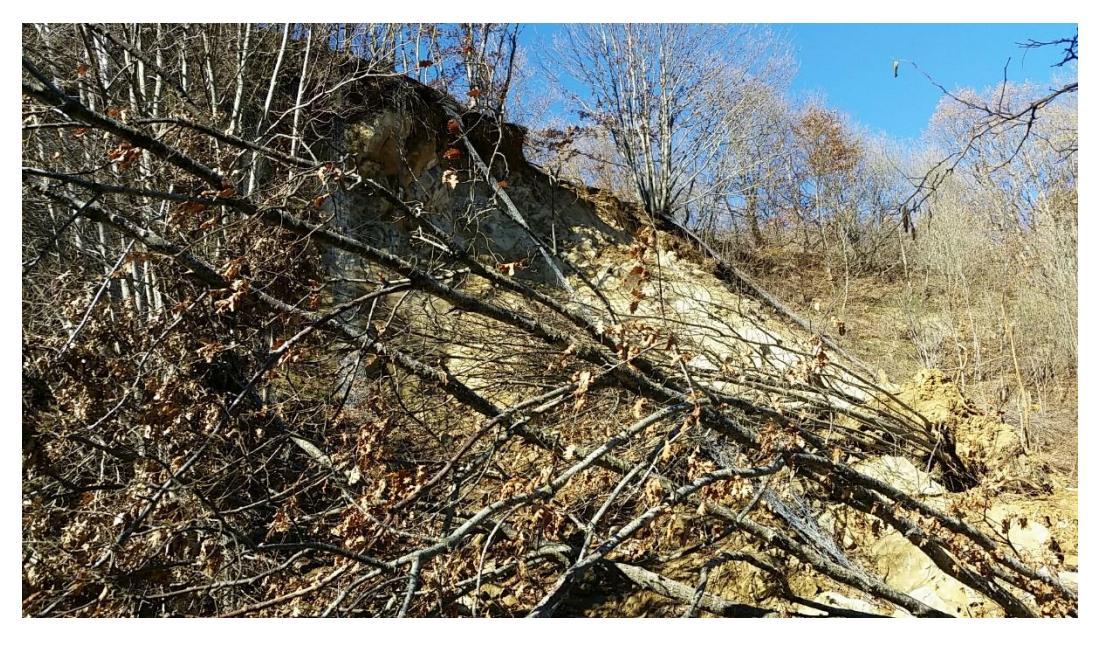
Figure 4.102. Landslide debris and head scarp. Also pictured is rockfall netting.

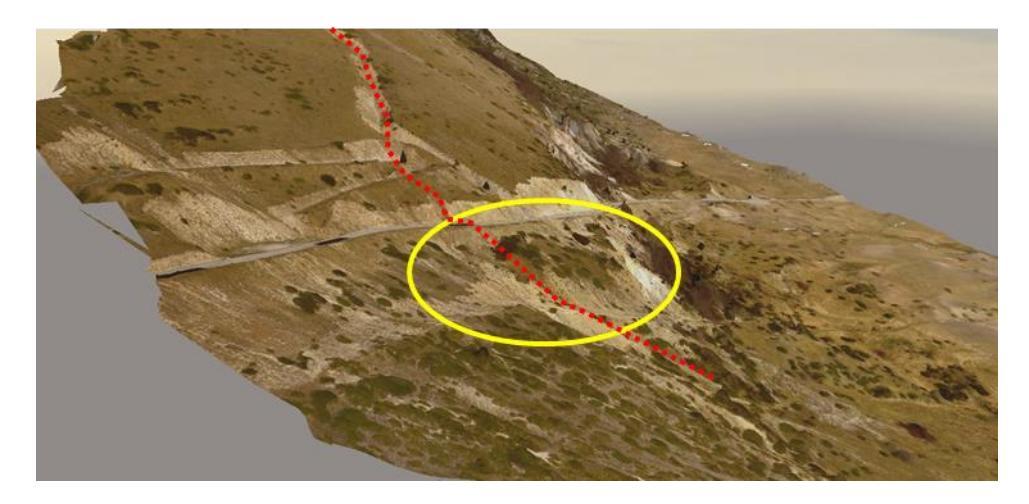
The fill embankment for Road SP477 running across the south face of Mt. Vettore was damaged in the 30 October event, occurring at the same location as the Mt. Vettore fault surface rupture (Figures 4.103 and 4.104). No reports of slope instability at this location were made following the 24 August event nor the 26 October event. Road embankment damage was parallel to the roadway, in the direction of the slope.

**Figure 4.104**. 3D SfM model of embankment fill damage area next to fault trace zone along SP477 road, Mt Vettore. Fill that has experienced 15 to 20cm lateral displacement circled in yellow. Observed fault rupture trace shown in red.

We visited the fault rupture and observed the embankment slope damage after documenting surface fault rupture offset. At the location of the SP477 road, strike displacements on the Mt. Vettore fault (in the direction of the embankment displacement down slope) were observed to be zero. Therefore, the GEER team concluded that the roadway embankment damage was from slope displacements rather than lateral fault rupture. Lateral displacement of the slope was estimated at 15cm to 20cm. Cracking parallel to the road along the top of the embankment is seen in Figures 4.105 and 4.106. The total height of the embankment slope was measured at 25-35 m from 3D SfM model (Chapter 2) for the south face of Mt. Vettore. The embankment fill

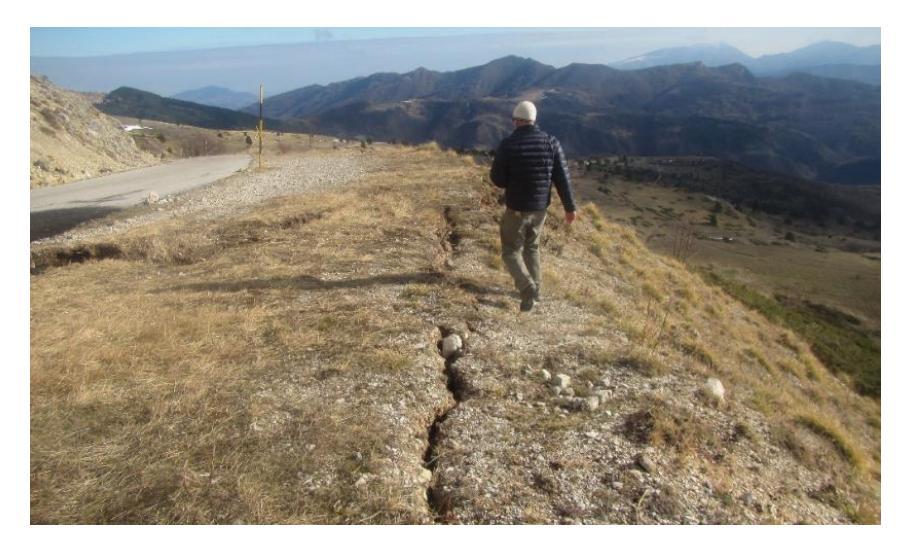
**Figure 4.105**. Road embankment damage along SP477 road, Mt Vettore (Location 19, viewing North). Note fault trace across road and black (new) bitumen repairs following previous (24 August 2016) earthquake.

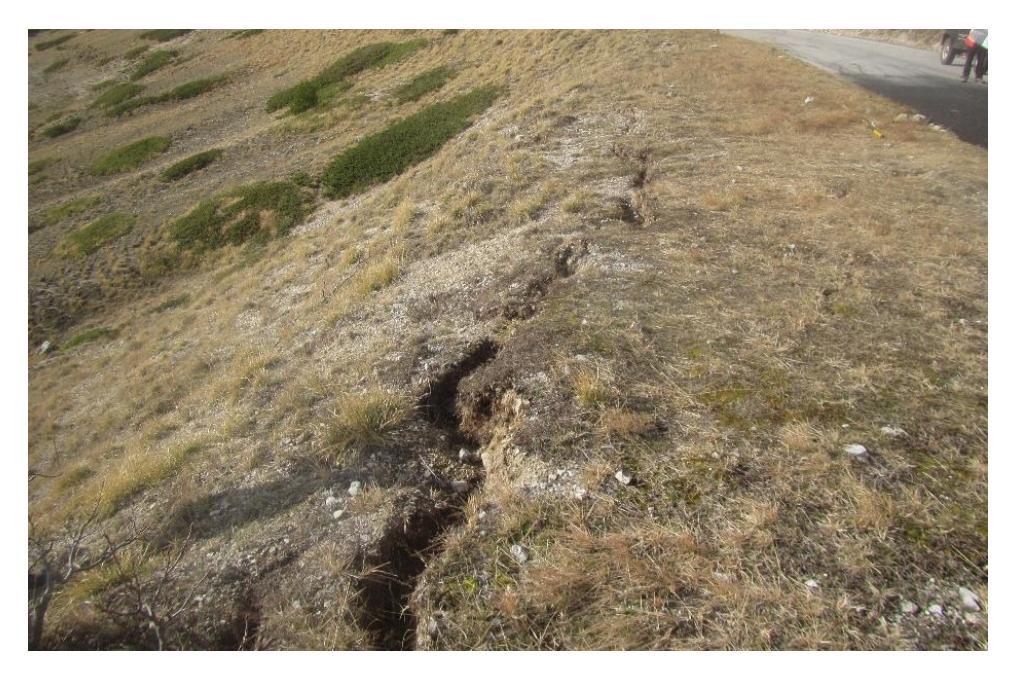
**Figure 4.106**. Road embankment damage along SP477 road, Mt Vettore (Location 19, viewing west).

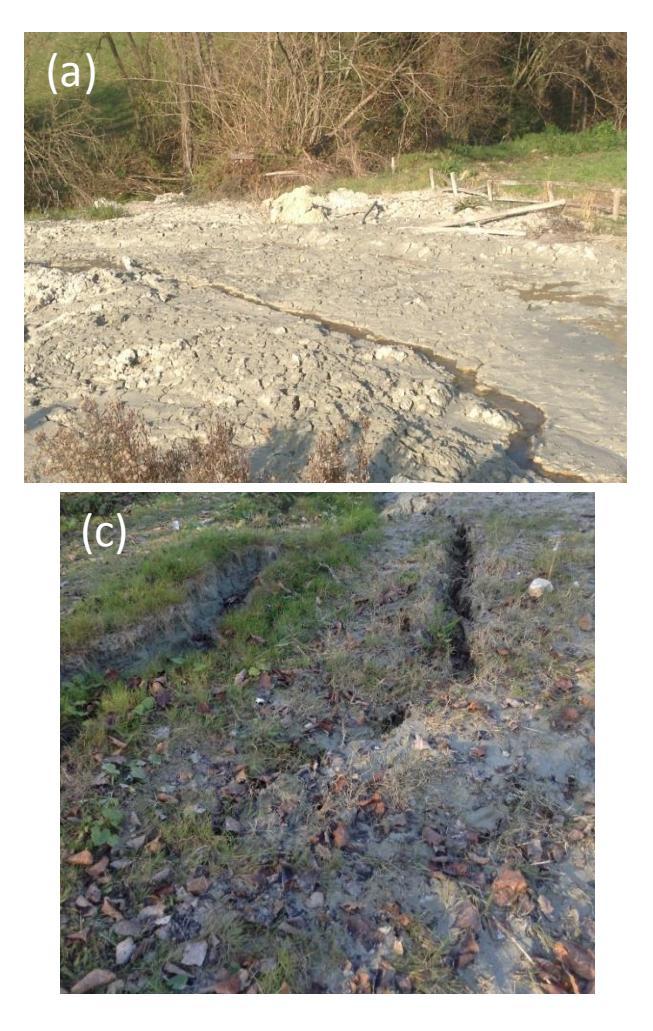
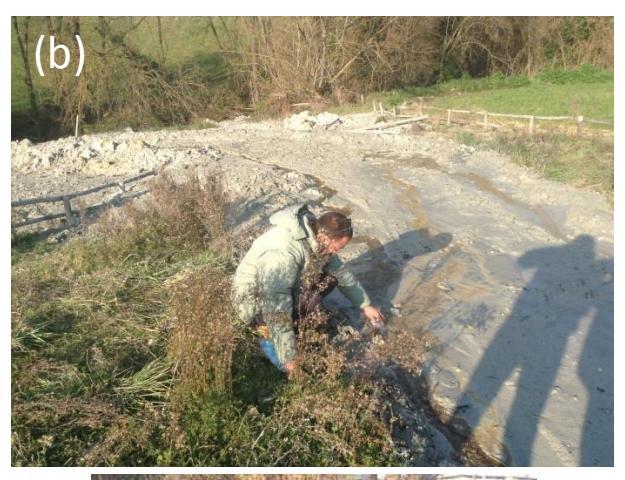
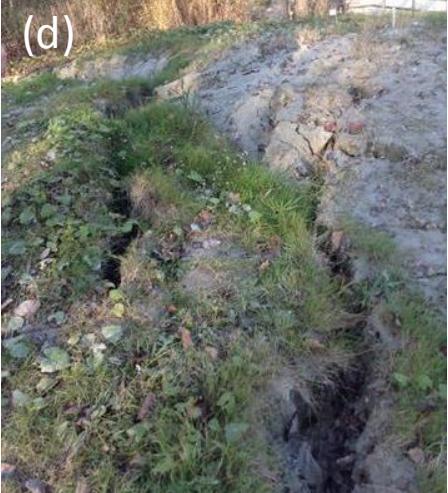
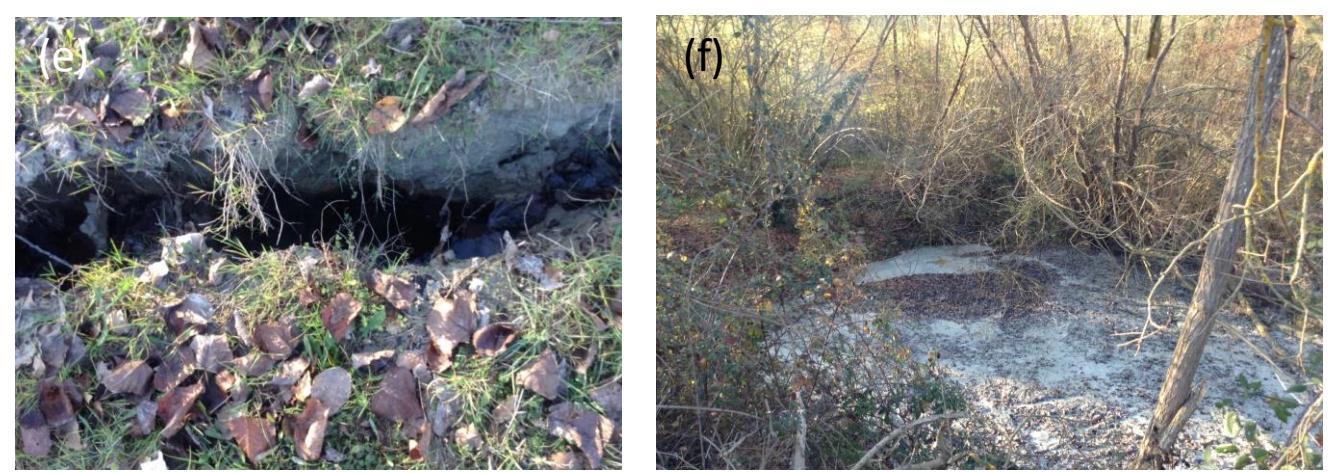
We inspected two mud volcanoes that erupted within one day from the **M**6.5 30 October earthquake event (Figure 5.3): (1) Santa Maria in Paganico (Figures 5.4a-b) and (2) Valle Corvone (Figures 5.4c-d-e-f). In both cases, we observed fresh deposits of ejected material. Both eruptions, are located within 45 km from the epicenter. During our reconnaissance activities, both mud volcanoes showed a reduced activity, with a small emission of water. We inspected the sites about one month after the INGV reconnaissance mission. We did not detect any new activity or variations in the soil surface conditions in the inspected area as shown in Figure 5.5. As shown in Figure 5.4c-d-e-f, the material erupted by the mud volcano located in Valle Corvone covered a wide area involving both the river and the pavement of the road. This mud volcano is characterized by radial fractures 140 cm long, 38 cm wide and 80 cm deep. This eruption partially blocked the Ete river's course (Figure 5.4f).

**Figure 5.4**. (a) overview of the mud volcano in Santa Maria in Paganico; (b) sampling activities in in Santa Maria in Paganico; (c) crack originated by the mud volcano in Valle Corvone, (d) mud volcano in Valle Corvone, (e) details of a crack in Valle Corvone, (f) close-up view of the material ejected in the Ete Vivo river (Valle Corvone).

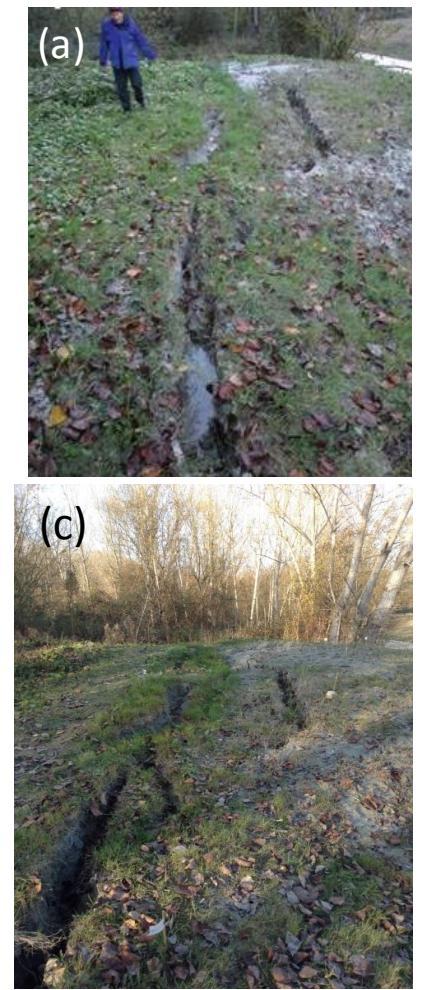
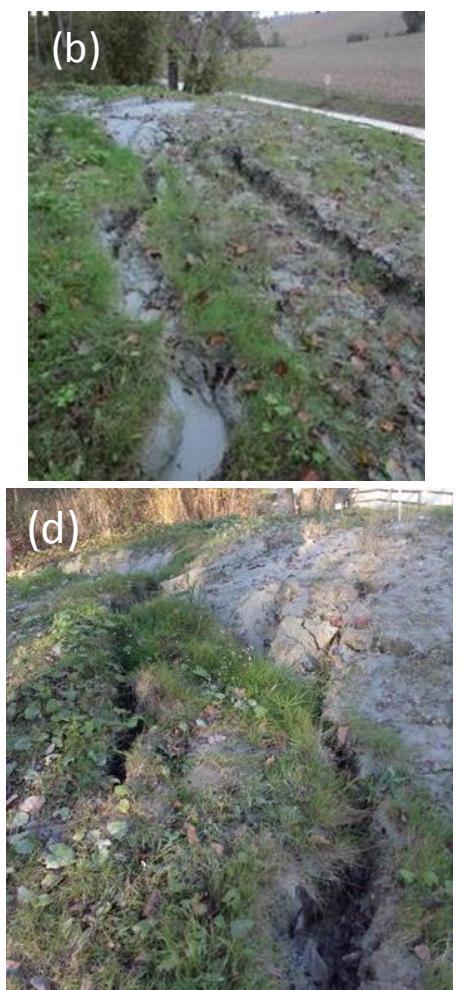
**Figure 5.5**. (a) and (b) photos of the mud volcano in Valle Corvone taken by INGV in November 2016 (INGV, 2016); (c) and (d) photos of the mud volcano in Valle Corvone taken from a common perspective by GEER in December 2016.

We inspected the newly formed volcano that erupted within one day from the **M**6.5 30 October earthquake event. Figure 5.8 shows the location of this eruption. Figure 5.9 shows photos taken during our reconnaissance. During our reconnaissance activities, the eruption showed a reduced activity, with a small emission of water. We inspected the site about one month after the INGV reconnaissance mission. We observed a substantial increase in the erupted material compared to the INGV reconnaissance (Figure 5.9).

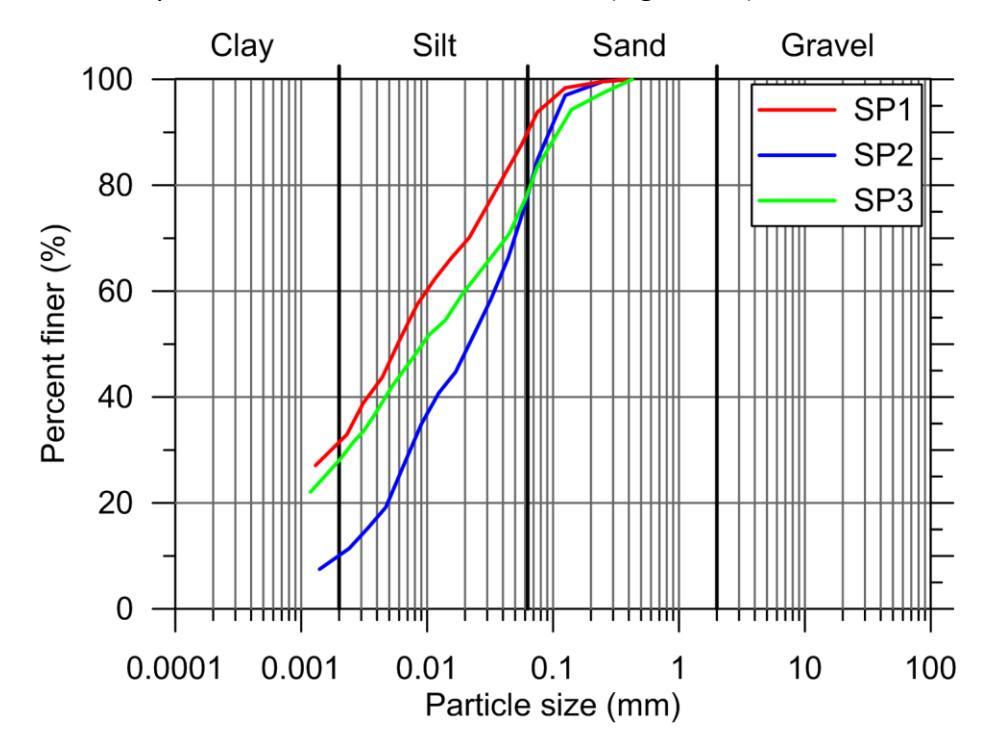
Figure 5.6 shows the particle size distribution for samples SP1 (Santa Maria in Paganico) and SP2 (Valle Corvone). The soil in sample SP1 is constituted of 57.4% brown silt, 31.6% clay and 11.0% sand. The fine-grained soil exhibits a liquid limit LL = 47.5%, a plastic limit PL = 17.8%, and a plasticity index PI = 29.7%. The plasticity chart (Figure 5.7a), shows that the soil of sample SP1 can be classified as inorganic clay (CL) or organic silts and clays of low plasticity (OL). For SP1, the activity of clay is 0.94 and is therefore defined as normal (Figure 5.7b). The values of the Atterberg limits are representative of clayey soils for SP1. For SP2, the silt fraction is 66.2%, the sand fraction is 23.7%, and the clay fraction is 10.1%. The Atterberg limits for SP2 are LL = 30.7%, PL = 18.7%, the plasticity index is equal to 11.9% and the fine-grained soil can be classified as inorganic clay (CL) or organic silts and clays of low plasticity (OL). The activity of clay for SP2 is normal (Fig. 5.7b). The Atterberg limits for SP2 are typical of silty soils

**Figure 5.6**. Particle size distributions of the mud volcano soils in Monteleone di Fermo and Santa Vittoria in Matenano.

We sampled soil erupted from the volcano in Santa Vittoria in Matenano (SP3). This sample was taken on 16 November, 2016. On this sample, we performed sieve analysis, along with Atterberg limits. Figure 5.6 shows the particle size distribution for samples SP3. It is consistent with those observed for the mud volcanoes in Monteleone di Fermo. The fine-grained soil exhibits a liquid limit LL = 33.0%, a plastic limit PL = 16.0%, and a plasticity index PI = 17.0%. The plasticity chart (Figure 5.7a), shows that the soil of sample SP3 can be classified as inorganic clay (CL). The clay can be classified as inactive (Figure 5.7b).

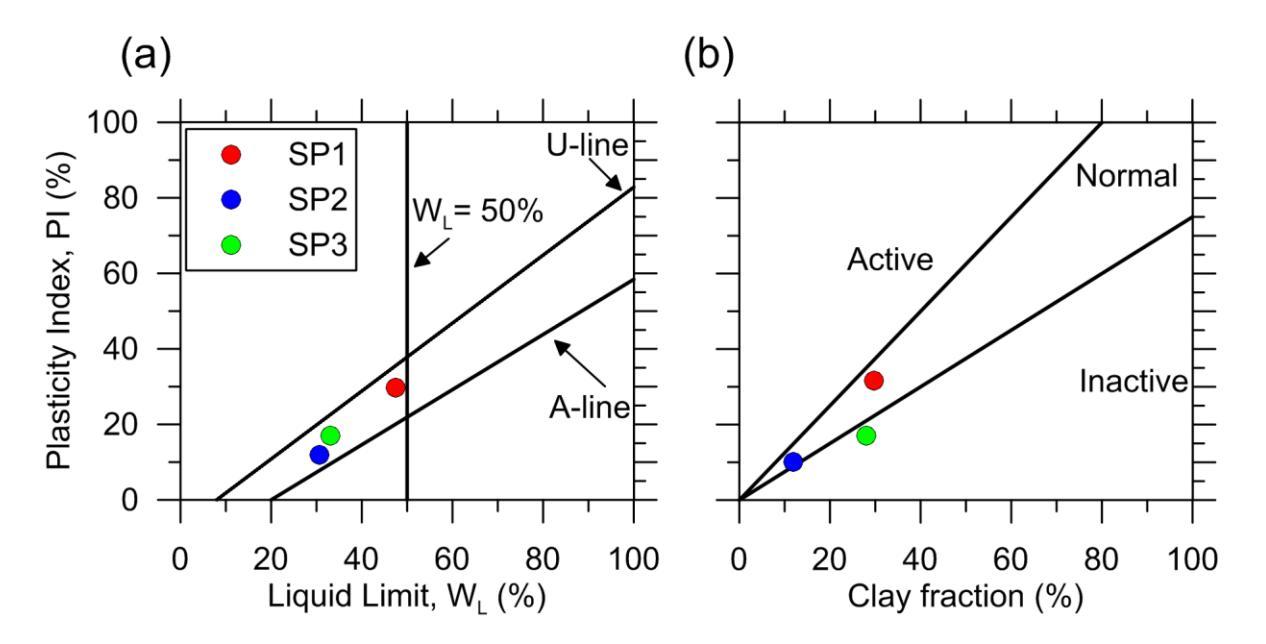
**Figure 5.7**. (a) Plasticity chart and (b) activity chart of the mud volcano soils in Monteleone di Fermo and Santa Vittoria in Matenano.

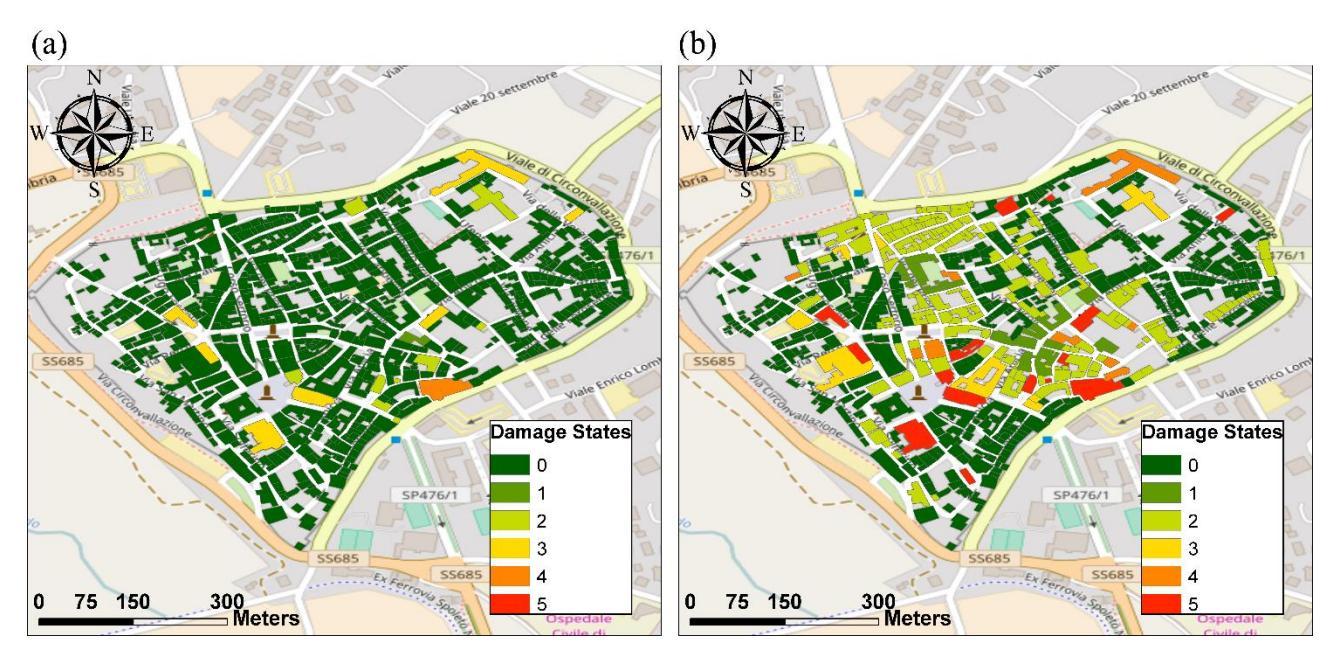
Norcia's buildings were not severely affected by the first event in August 2016. After the multiple October events, several structures suffered moderate-to-significant of damage or collapse. Figure 6.1 shows the evolution of damage between the two inspections. The distribution of Damage States among the buildings inspected in the red-zone of Norcia is shown in Figure 6.2. These figures show that the structural damage in Norcia was much more severe in the October events than in the earlier August events.

Even though the majority of the building stock is masonry, there is no disproportional damage observed between the first and the sequence of seismic events (Figure 6.1). This is because, unlike Amatrice (Section 6.1.3), the initial damage state of most buildings after the August earthquake was D0, hence the structures had adequate strength to resist the subsequent earthquakes. By focusing more carefully on Figure 6.2, it is also evident that the few structures that suffered damage during the first event, indeed presented a disproportional level of damage increase shifting from DS3 to DS5. Based on the above comparative assessment it can be concluded that masonry structures are particularly prone to failure under cascading seismic events provided that one event in the sequence initiates non-catastrophic damage, a fact that highlights the importance of quick visual inspection and reliable retrofit.

Figure 6.1. Evolution of damage after (a) the 24 August earthquake, and (b) the October events.

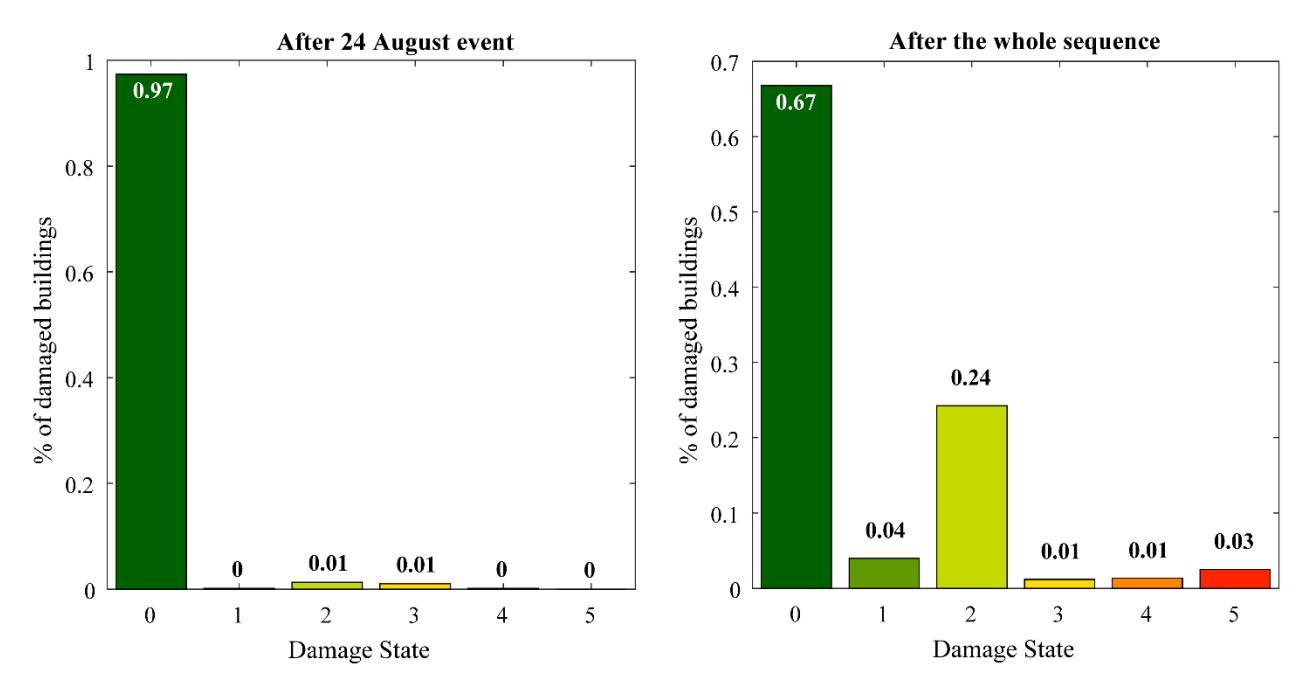
**Figure 6.2.** Percentage of damaged structures (a) in the aftermath of first event and (b) after the whole sequence.

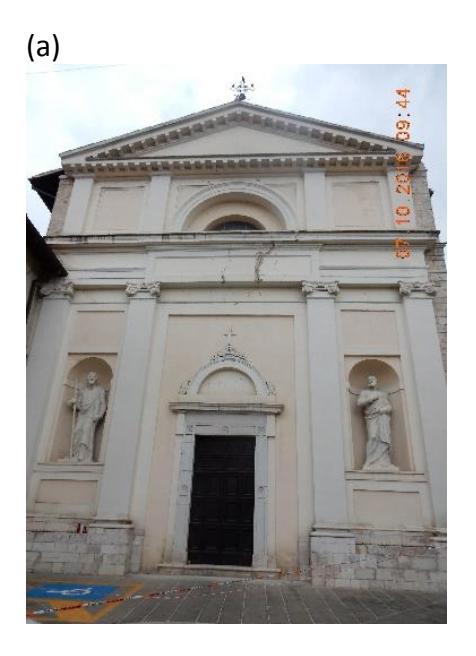
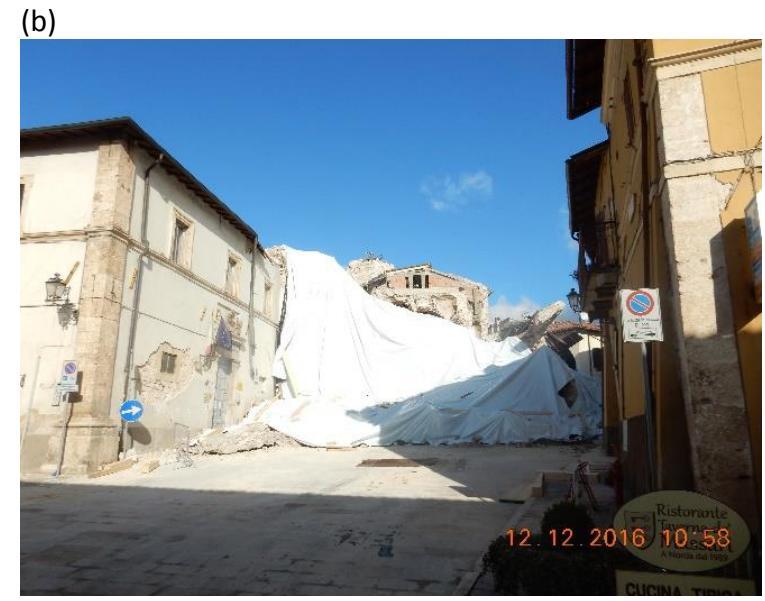
Figure 6.4. Building M1.

Apart from the wider assessment, a side-by-side comparison of significate structures with multi-epoch surveys is made. Figure 6.3 depicts the locations of the buildings presented. Figure 6.4 illustrates one of the churches that were slightly damaged by the first seismic event, but completely collapsed subsequently. Many historical churches in Norcia experienced the same kind of damage evolution. Figure 6.5 shows one exceptional case of a typical residential masonry building where the evolution of damage was rather moderate (damage state shifting from DS2 to DS3). Conversely, Figure 6.6 shows a residential building with irregular masonry construction. This group of buildings experienced an abrupt damage evolution, with an out-of-plane mechanism and increased in-plane damage. Finally, Figure 6.7 depicts the out-of-plane failure of an historical monastery leading to partial loss of support of the roof. Notably, the wall failure was concentrated at a level higher to that of the seismic retrofit, thus highlighting that local interventions should not be only localized on the ground level but also take into consideration the reduced axial load and weak diaphragm action of the masonry walls at higher levels.

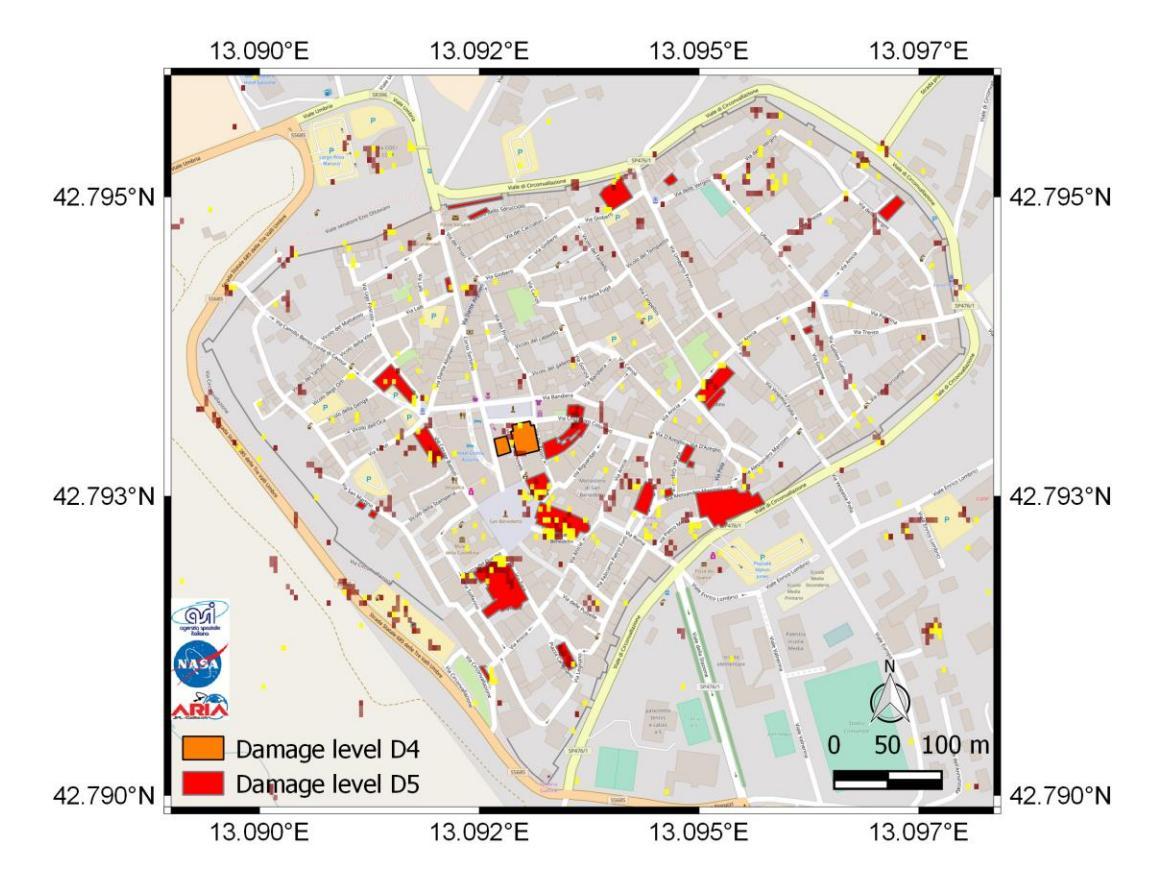
After the 30 October M6.5 earthquake, a detailed DPM for the city center of Norcia was released (aria-share.jpl.nasa.gov/events/20161030-Italy\_EQ/DPM/, last accessed 26 February, 2017). This DPM has a relatively limited spatial extent, but high resolution. Figure 6.15 shows the DPM produced after the 30 October event, superimposed on the map of the city center of Norcia, along with all structures that have been classified, through on-site visual inspection, as completely collapsed (for which a damage level D5 has been assigned), and selected D4 structures.

**Figure 6.15.** Damage proxy map of Norcia, along with all structures with assigned damage level D5, and selected structures with assigned damage level D4.
