# Engineering Reconnaissance Following the October 2016 Central Italy Earthquakes Version 2

GEER Team Leaders: Jonathan P. Stewart and Giuseppe Lanzo

Geotechnical Extreme Events Reconnaissance Association Report No. GEER-050D 8 May 2017

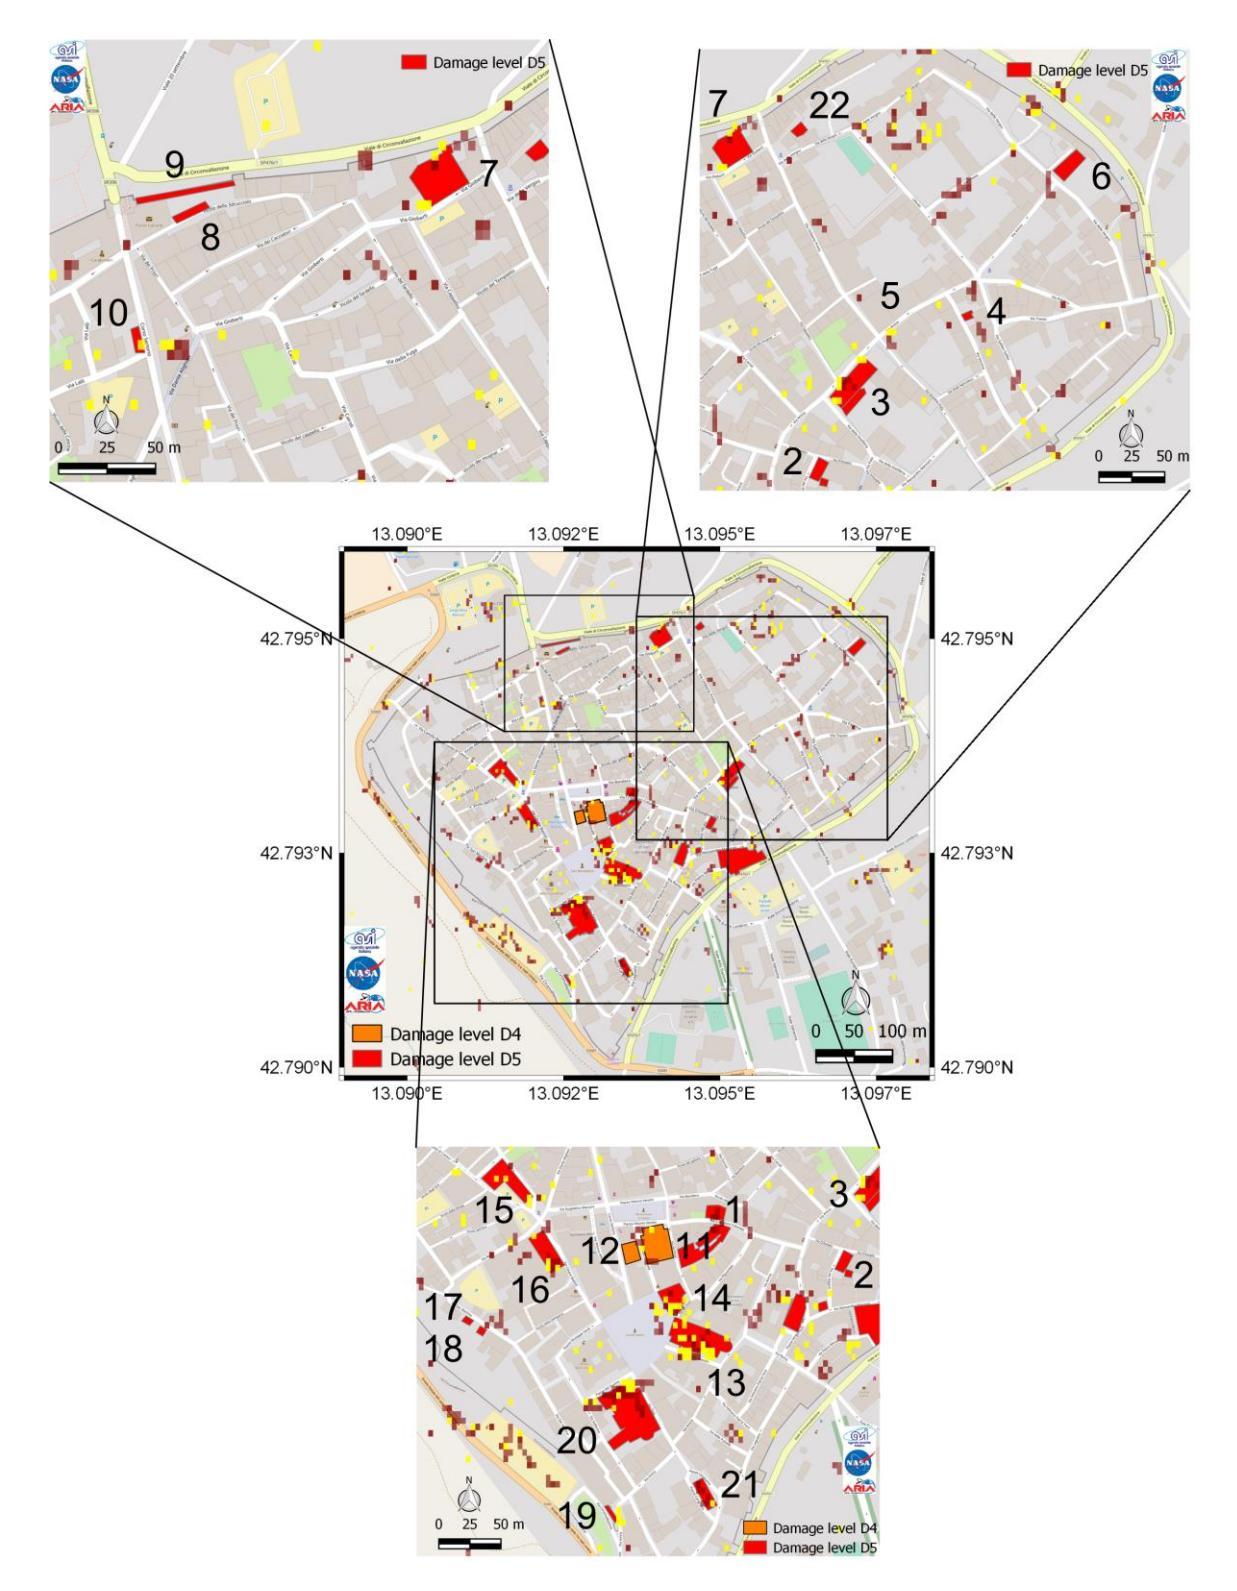
We analyze 22 structures assigned damage levels D5 and D4; within this group is the full inventory of D5 structures as identified in our field inspections. Figure 6.16 shows the spatial distribution of these structures, along with their identification numbers.

In order to provide a sense for the damage in Norcia at these sites, Figure 6.17 shows representative pictures taken during the on-site inspection performed following the 30 October **M**6.5 earthquake event. By comparing the locations of these mapped structures and damage zones per the ARIA imaging, we find good agreement. For all structures with assigned damage level D5, the DPM shows a concentration of red and dark red zones, representing areas in which substantial deformations occurred.

**Figure 6.16.** Zoom-in of the damage proxy map of Norcia, along with the identification numbers of all structures with assigned damage level D5 from field inspections and available high-quality on-site information and photos.

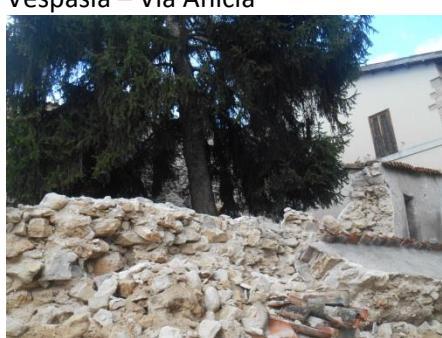
N. 8 Collapsed wall

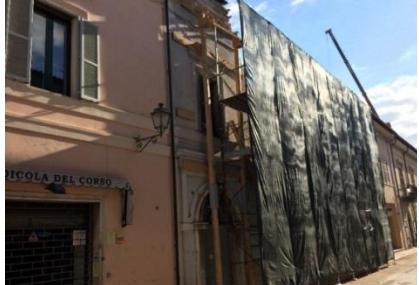
N. 12 Corso Sertori

**Figure 6.17.** Pictures of all structures with assigned damage level D5 in the city center of Norcia, along with their identification numbers.

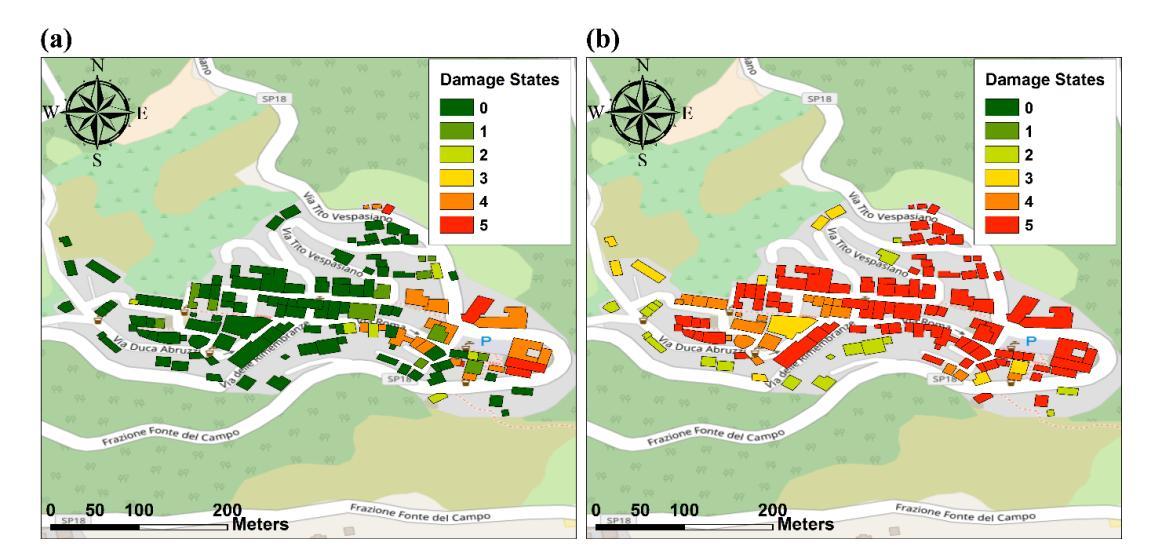
The seismic sequence in October caused total devastation of the village. As shown in Figure 6.18, the vast majority of the buildings that were damaged during the August earthquake, eventually collapsed. The evolution of damage after multiple seismic events is also evident as also depicted in Figure 6.19, where a drastic shift from low (DS0/DS1) to high (DS4/DS5) damage states is clearly observed.

Figure 6.18. Evolution of damage after (a) the first seismic event and (b) the sequence of events.

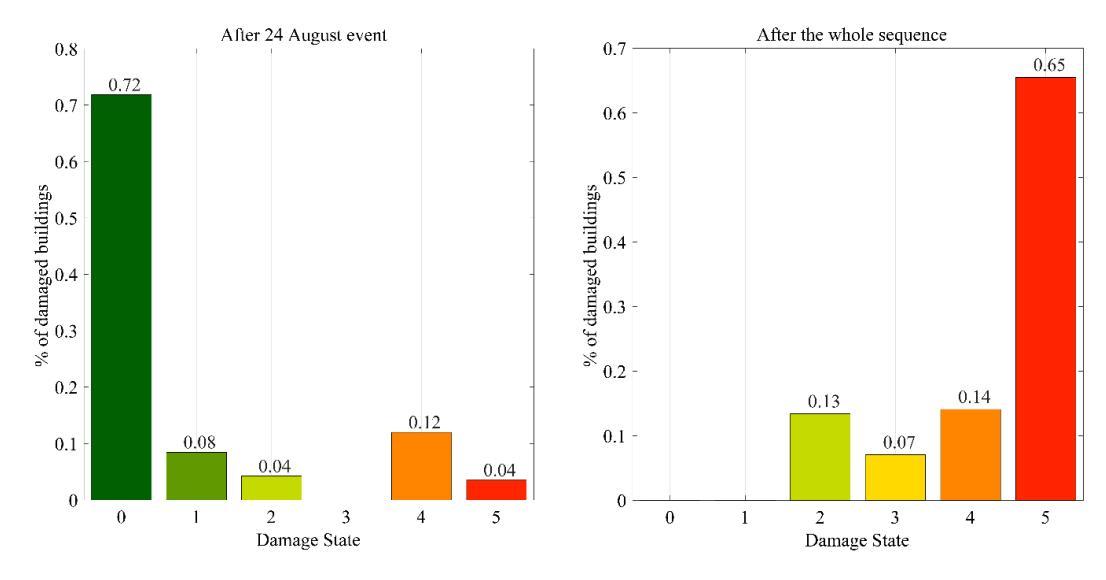
**Figure 6.19.** Percentage of damaged structures (a) after the first event and (b) after the whole sequence.

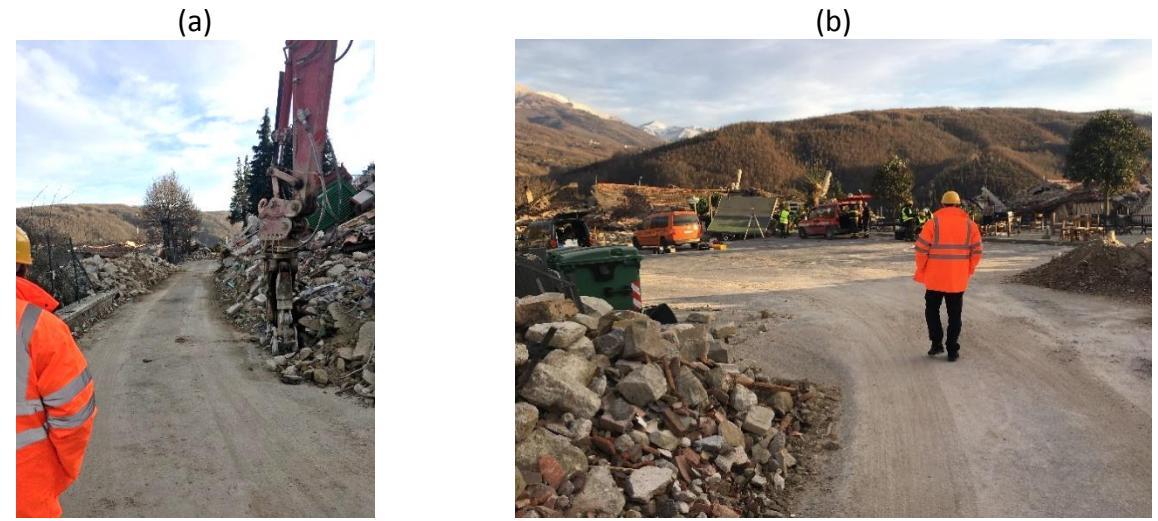
At the time of the visual inspection by the GEER team, the only accessible walking route was the one connecting the village entrance to the main square, because of the major building damage and collapse in the surrounding areas (Figure 6.20). As a result, a detailed inspection was feasible only within the eastern part of the village, the western part being inspected by means of UAVs. Figure 6.21, Figure 6.22, and Figure 6.23 illustrate the upper part of the village with a colored scale distinguishing three main zones of distinct level of damage.

**Figure 6.20.** (a) Access route to the lowest (easternmost) portion village (V1). (b) Piazza San Francesco (V2).

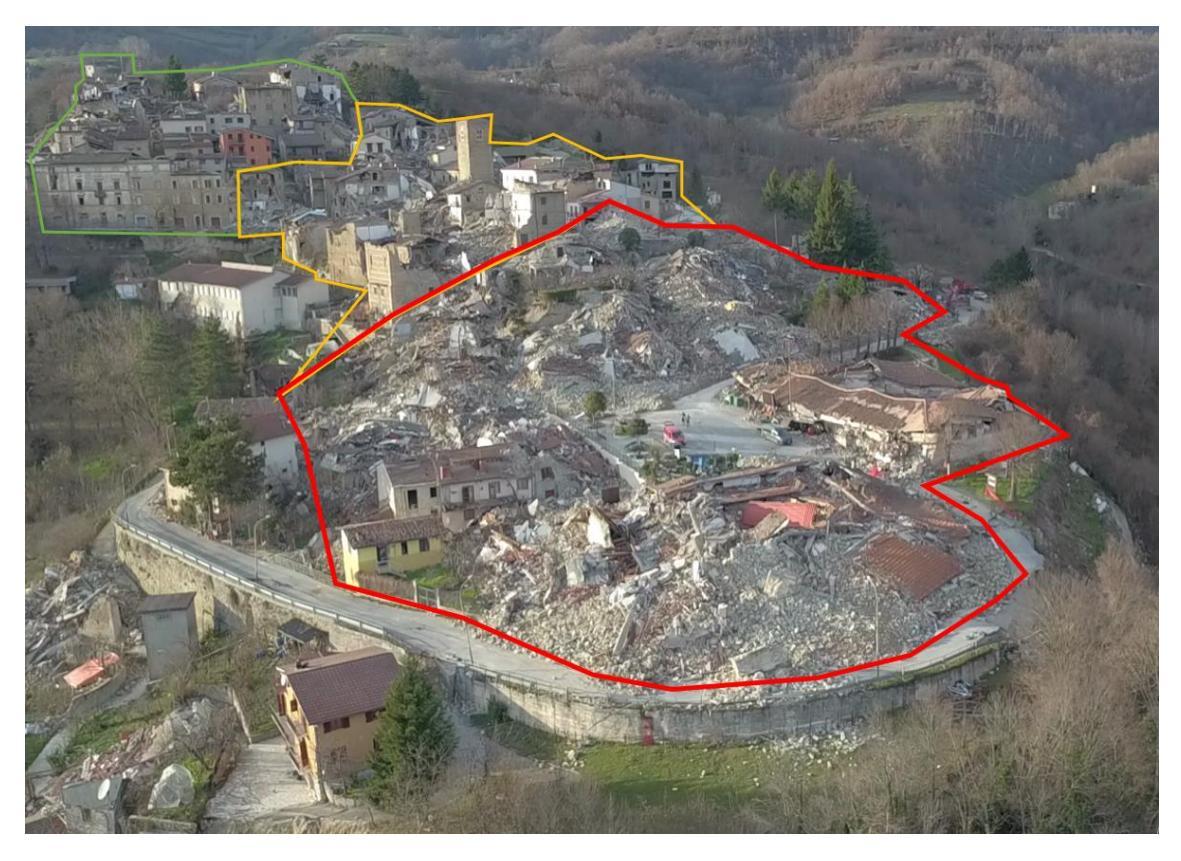
Figure 6.21. Aerial view, east-west direction (V3).

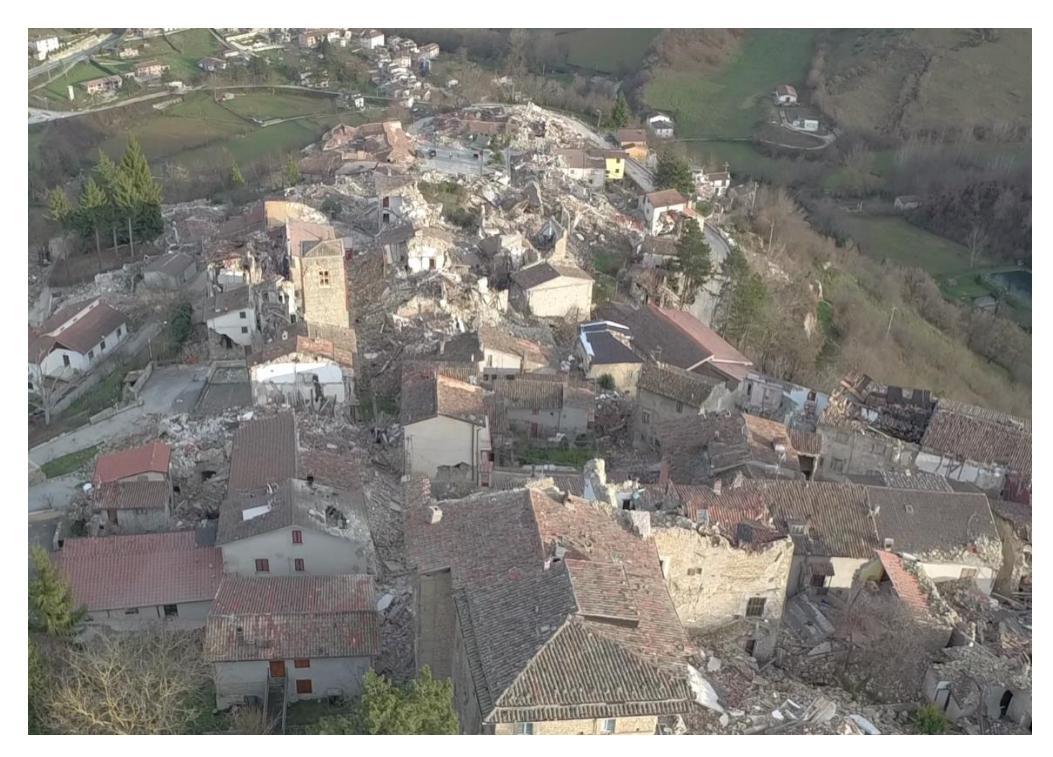
Figure 6.22. Aerial view, west-east direction (V4).

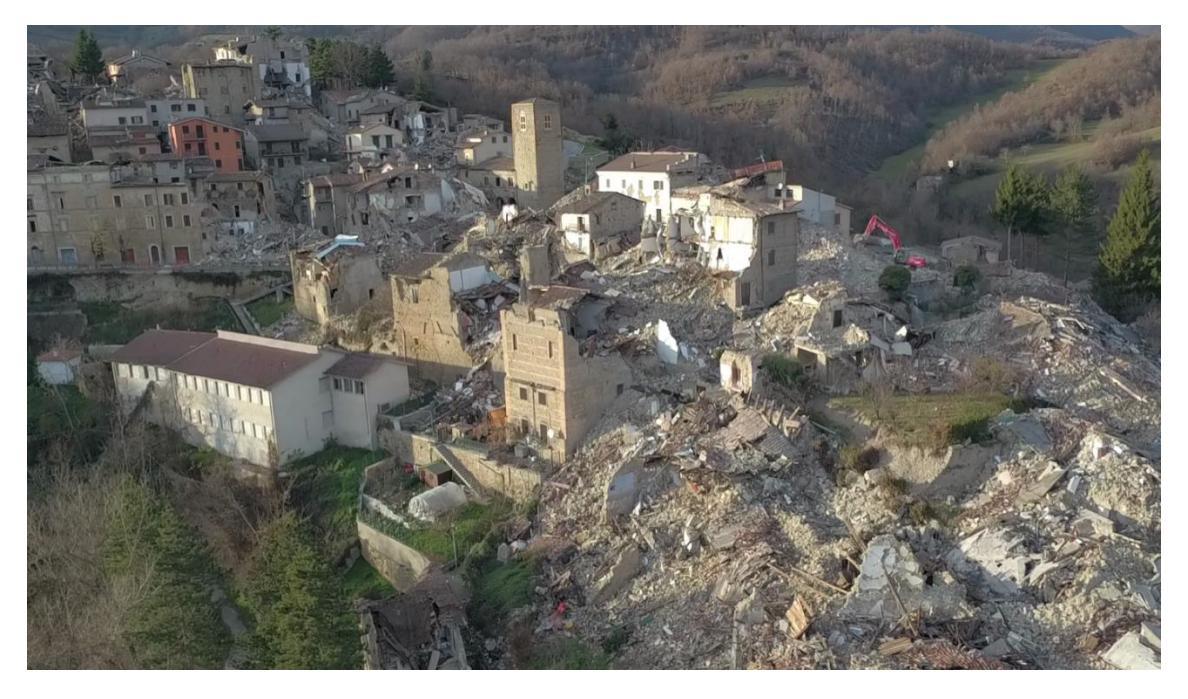
Figure 6.23. Aerial view, south-north direction (V5).

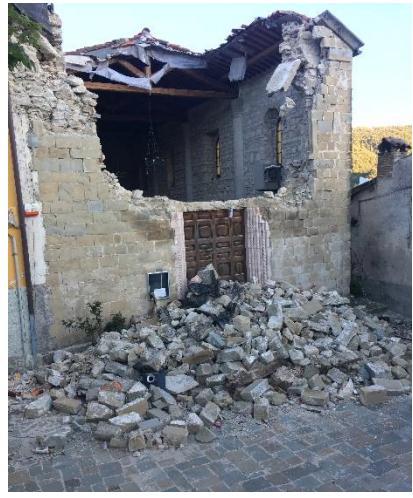
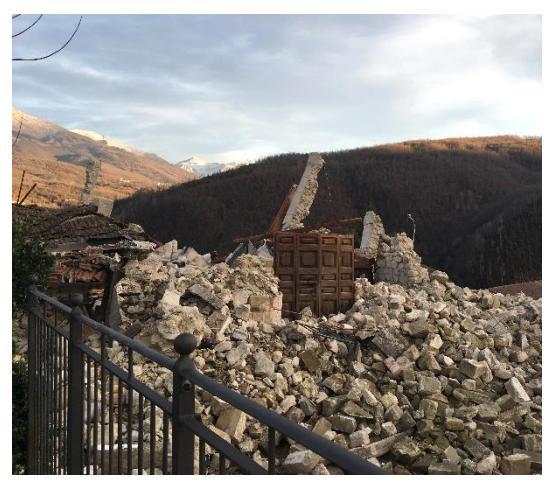
P01 (Church)

#### Figure 6.25. Representative pictures taken in Accumoli during the GEER survey (see Table 6.2).

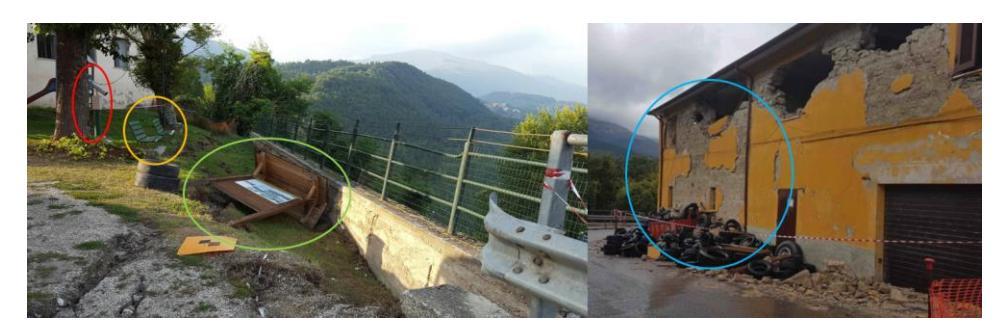
The accumulation of damage across seismic events is also evident by comparing the panoramic view of the village after the September and December field missions (Figure 6.26 and Figure 6.27). More precisely, it is seen that the retaining wall completely overturned, causing disruption of the adjacent road. It is noted that it was not possible to take the pictures from the same position, hence, colored circles are used to indicate the corresponding spots.

Figure 6.26. Representative pictures of landslide in eastern part of village (September 2016).

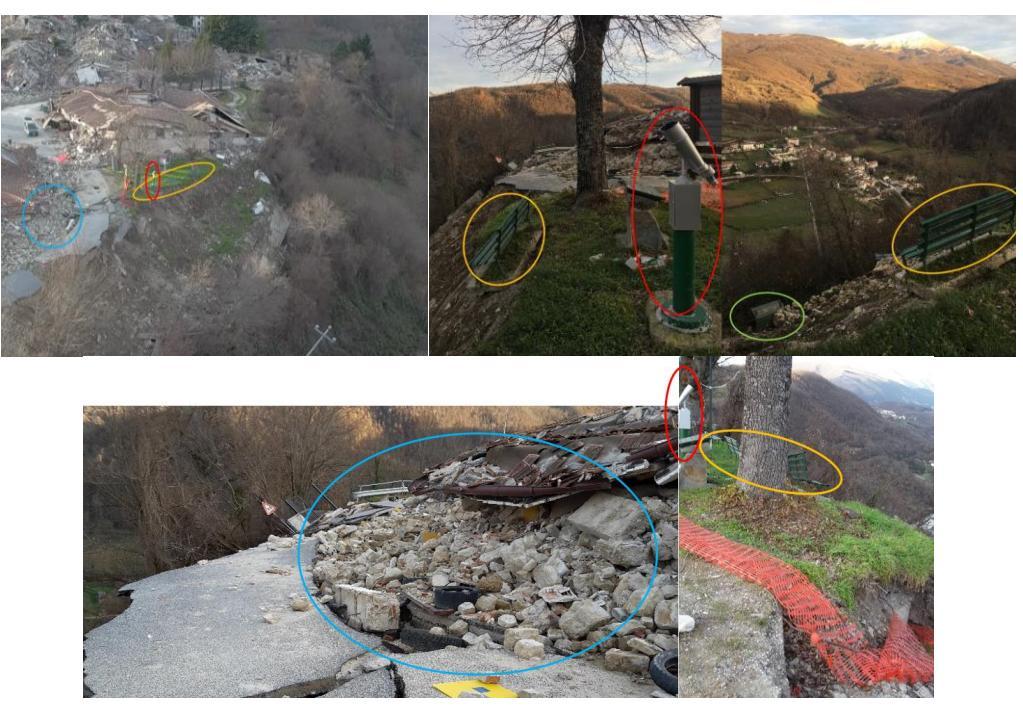
Figure 6.27. Representative pictures of landslide in the eastern part of village (December 2016).

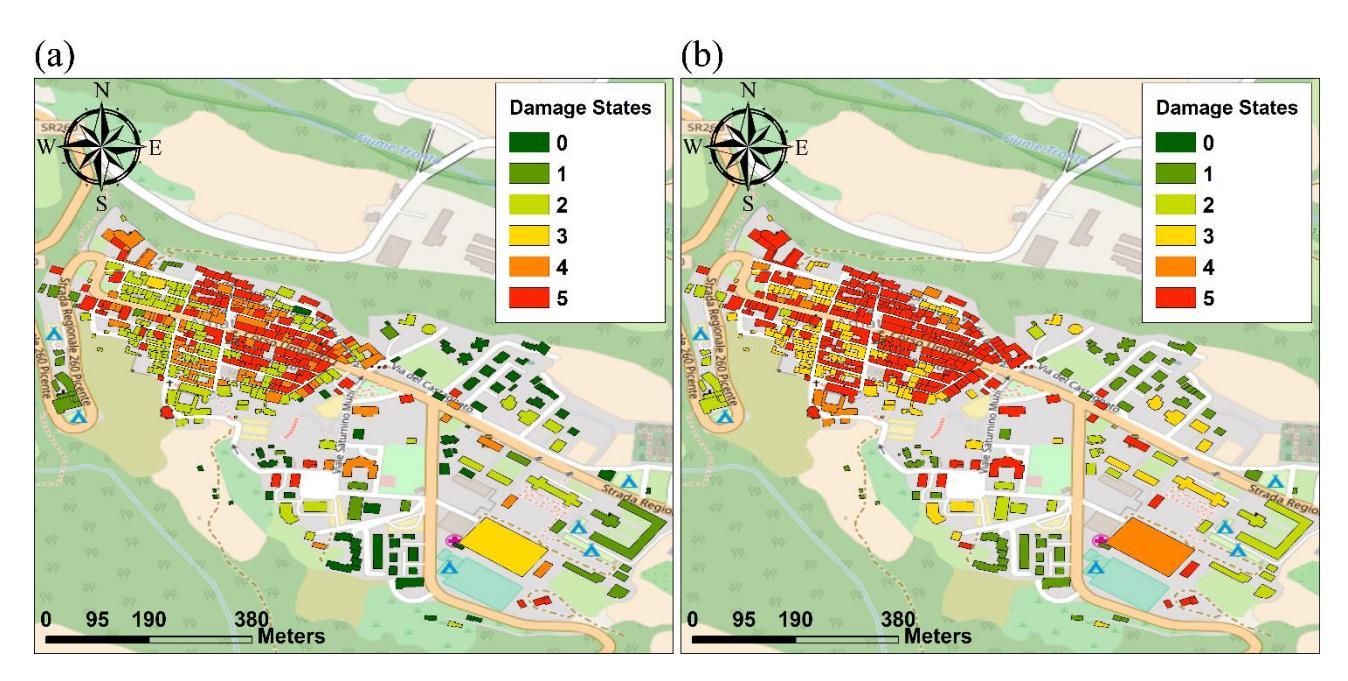
Amatrice's buildings were severely affected by August event sequence (Section 5.3.2 of GEER 2016). Many buildings that remained standing after the August events had only a small residual capacity, and then collapsed during September and October events. Figure 6.28 shows the multi-epoch damage evolution. This is also reflected in the histograms of red zone damage statistics in Figure 6.29, which show that the percentage of D5 structures increased from 23% to 42%. We distinguish performance of different structural systems qualitatively for a number of characteristic buildings, the locations of which are shown in Figure 6.30.

Figure 6.28. Evolution of damage after (a) the first seismic event and (b) the sequence of events.

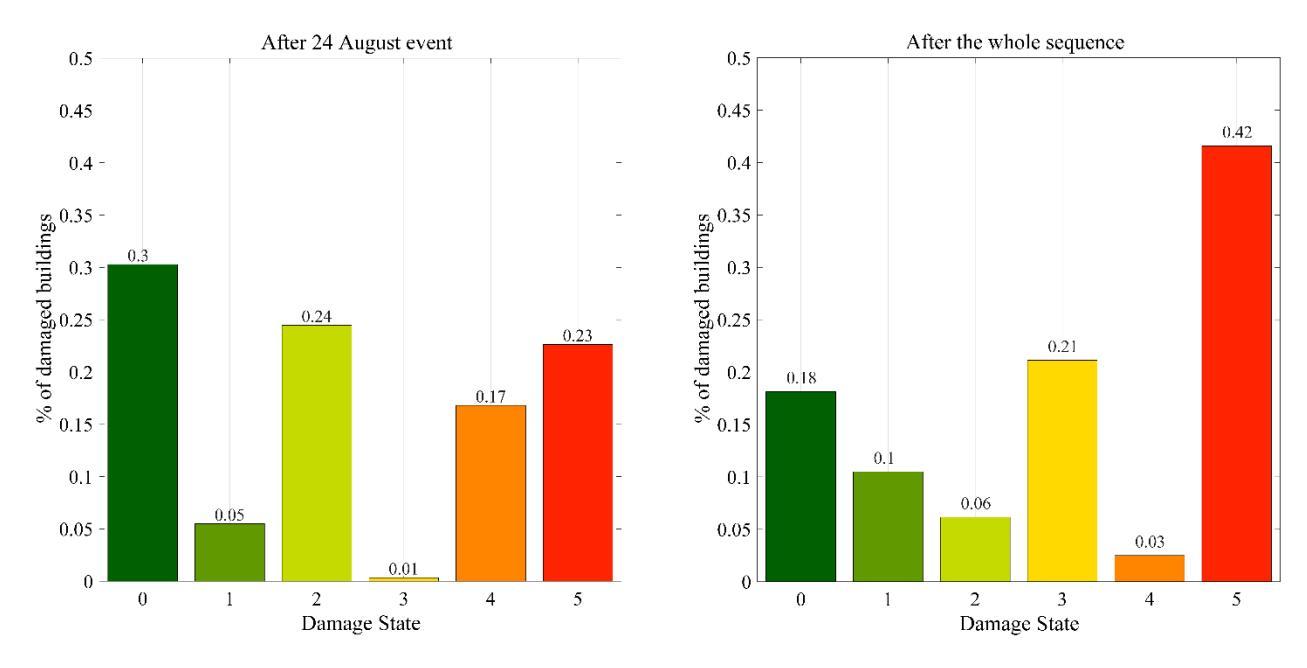
**Figure 6.29.** Percentage of damaged structures (a) in the aftermath of first event and (b) after the whole sequence.

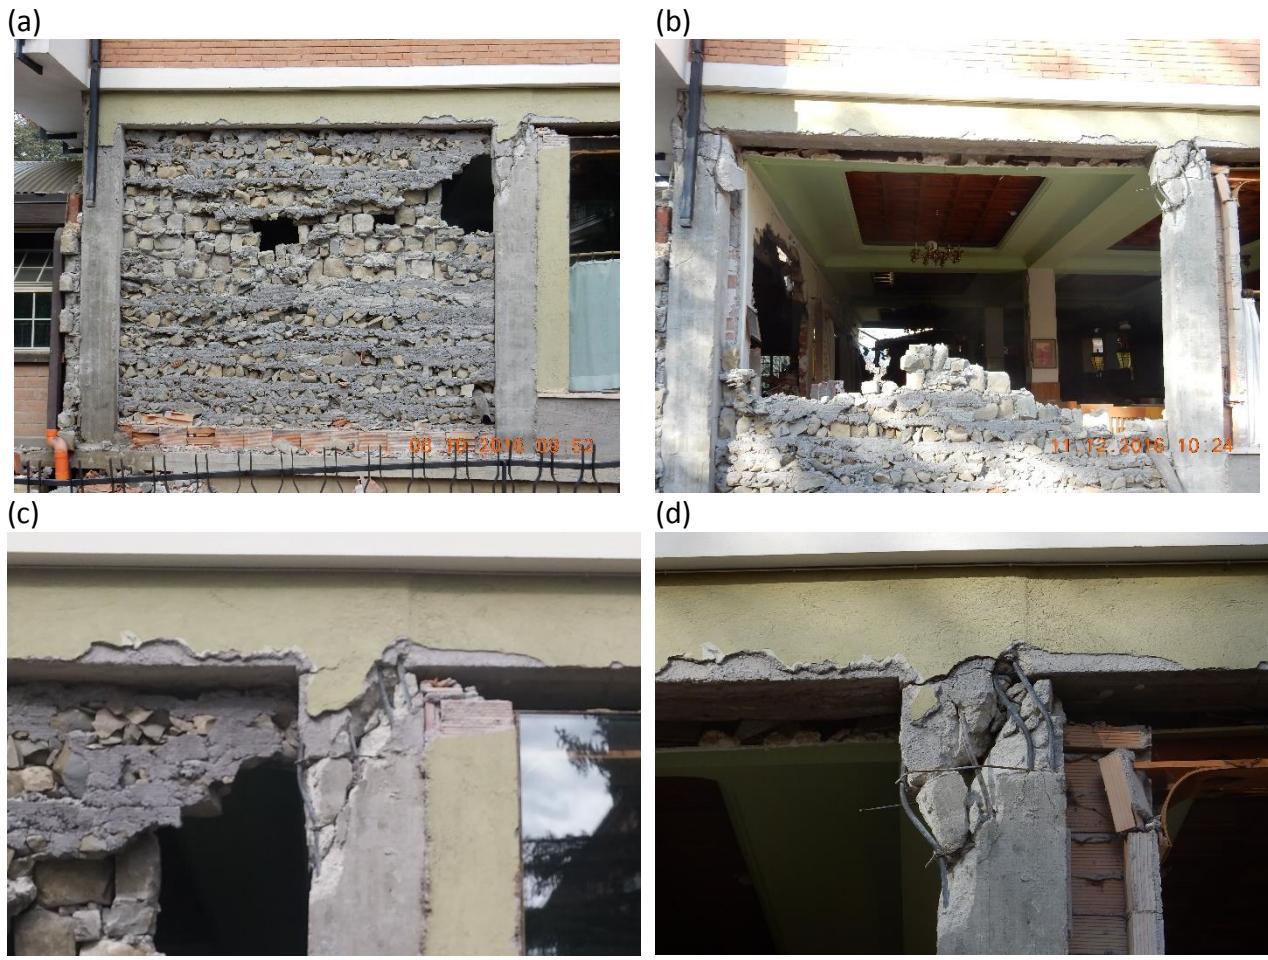
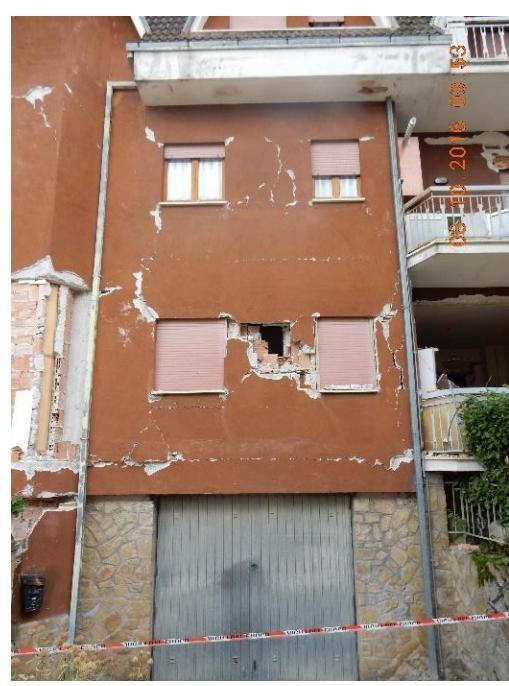
Figure 6.37. Building RC1.

Figure 6.37 illustrates building RC1 in the aftermath of the first event (a,c) and after the October sequence (b,d). It evident that the infill panel has failed out-of-plane after the seismic sequence (but not after the first main shock), whereas the shear failure at the top of the right column has been clearly pronounced. Figure 6.38 depicts building RC2, a dual shear wall – moment resisting frame built with the older Italian seismic code (The Italian National Annex DM 1996, Norme Tecniche per le Costruzioni, 1996; NTC96). Similar out of plane failure of the,

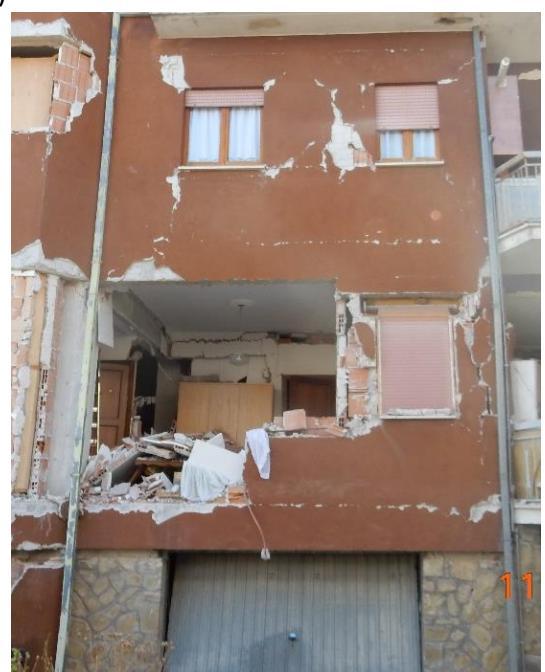
Figure 6.38. Building RC2.

initially diagonally cracked, infill panel is again observed as a result of shaking from multiple events. A detail of beam-column joint damage is illustrated in Figure 6.39 for building RC3. We observe cyclic degradation of column top, spalling of concrete, and minor longitudinal rebar buckling in the absence of adequate transverse reinforcement. Finally, building RC4 in Figure 6.40 experienced only minor damage after the August event but suffered out-of-plane failure of the majority of its infill panels subsequently, thus exposing the structure to a potential soft story mechanism. Performance of this type was characteristic of the area.

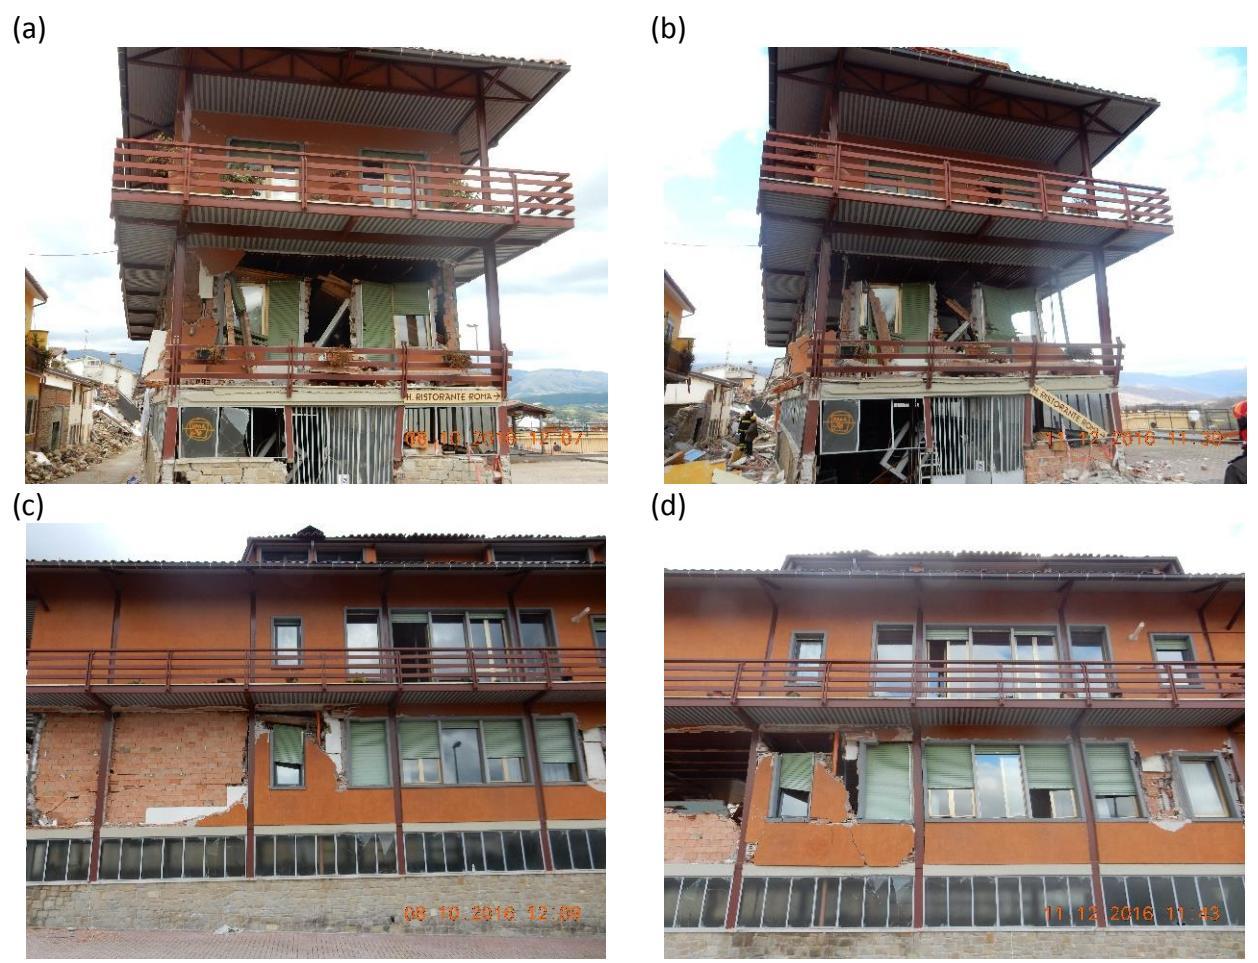
Figure 6.41. Building S1.

There is only one high-rise steel structure within the Amatrice red zone (Figure 6.41) built in the early 90's with the Italian seismic code of the time (The Italian National Annex DM 1996, Norme Tecniche per le Costruzioni, 1996; NTC96). It consists of a basement, a ground floor and two upper stories, alongside a shorter story on top that serves as a penthouse. Given the intensity of ground motion, its overall performance is deemed relatively satisfactory. Contrarily, Hotel Roma, one of Amatrice's most iconic structures, located a few meters from the steel building, collapsed completely. After the first event, damage was only concentrated to non-structural elements, with small local flange instability at the top of two front columns of the ground floor. At the end of the October event sequence, the building presented permanent deformation along the longer direction, as shown in Figure 6.41. Such permanent deformation is localized at the second level of the building with a visible inter-story drift. Preliminary finite element analyses of the building suggest that the fundamental mode period of the structure is approximately 0.75sec. The mode shape indicates an almost uncoupled translation along the long side, mainly due to the orientation of the steel columns whose strong axis is aligned with the short side of the building.

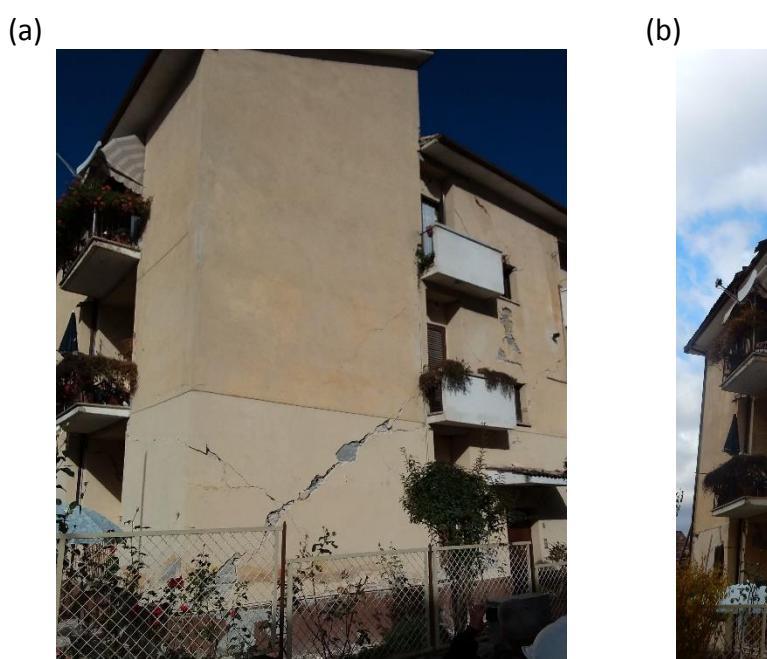
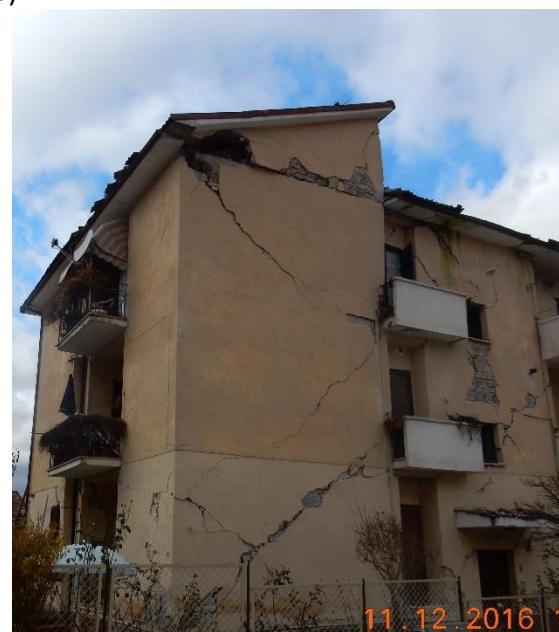
Figure 6.42. Building M1.

Figure 6.42 shows multi-epoch damage to a masonry building. Damage at the base of the structure is essentially unchanged, but new damage features are observed in the top story. Figure 6.43 shows the local police ("Carabinieri") station. It is evident that diagonal cracks were extended in both sides of the building after multiple seismic events. Notably, the local retrofit by means of steel ties at the corners of the upper story mitigated further damage and possible collapse.

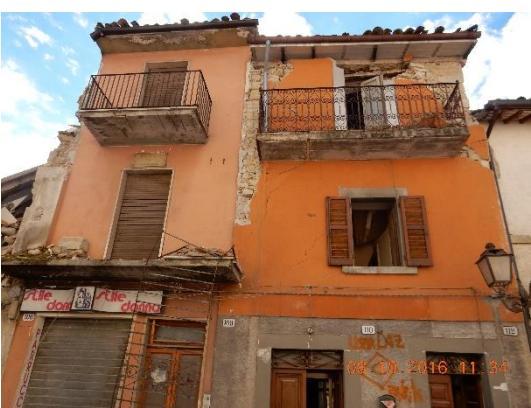
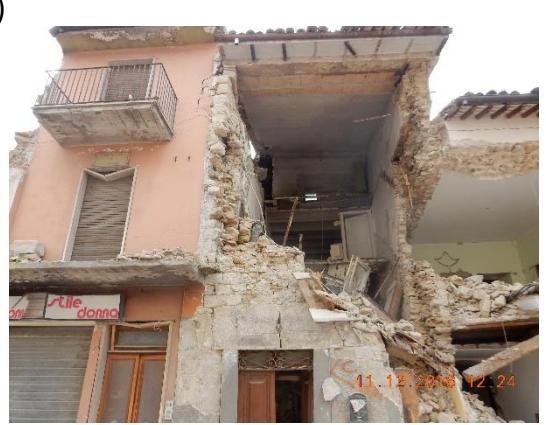
Figure 6.44. Building M3.

Figure 6.44 and Figure 6.45 present two buildings within the Amatrice red-zone, where initial damage of the outer masonry due to the first event evolved to partial collapse after the event sequence. This is also an interesting case in that such partial collapse is not always visible by satellite, thus highlighting the importance of careful on-site ground inspection. The soft-story of another masonry building is illustrated in Figure 6.45. Such a mechanism is presumably due to the higher stiffness of the upper part with respect to the ground floor, and due to the previous shear failures observed at the ground level in the aftermath of the first event. It is also a characteristic case where the evolution of damage in masonry structures under multiple seismic events, as well as the increase of the corresponding damage indeed, is strongly nonlinear. Figure 6.46 shows the complete collapse of a building that was heavily damaged from the first event.

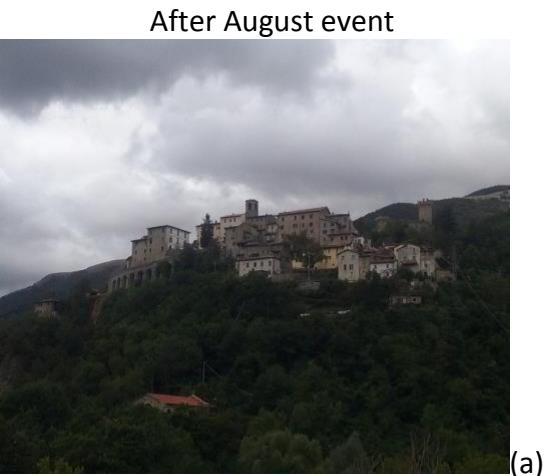
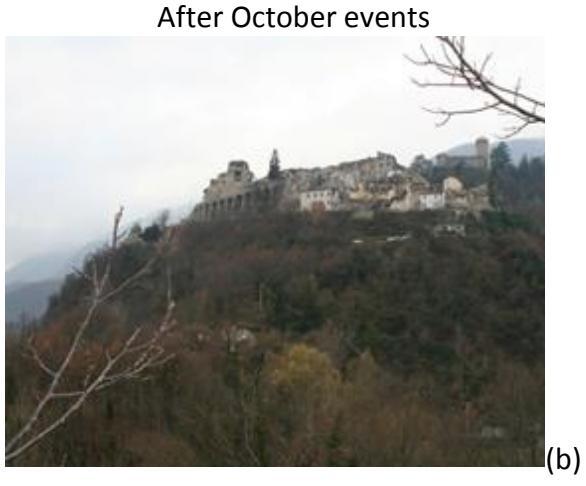
Figure 6.48. Overview of Arquata del Tronto (a) after the 24 August earthquake, and (b) after the October events.

The photographs in Figure 6.48 show Arquata del Tronto after the August and October events, from which a substantial damage increase is evident following the 26 and 30 October earthquakes. Conversely, Borgo did not suffer appreciable cumulated damage, as shown in Figure 6.49 and Figure 6.50. Figure 6.51 shows the collapse of a structure onto the access road for Arquata village. At the time of our November reconnaissance, the village was not accessible and much of the village center was destroyed. The damage level assigned to Arquata del Tronto

Picture	September Damage Level	December Damage Level
P01	Panoramic view of the village. Overall degree of damage D3-D4	Overall degree of damage: D5
P02	D1	
P03	D1	D1-D2
P04	D2	
P05	D2	
P06	D3	D3-D4
P07	D3	
P08	DO	
P10	D4	D5
P11	D4	D5
P12	D5	D5
P13	D5	D5
P14	D4	D5
P15	D2-D3

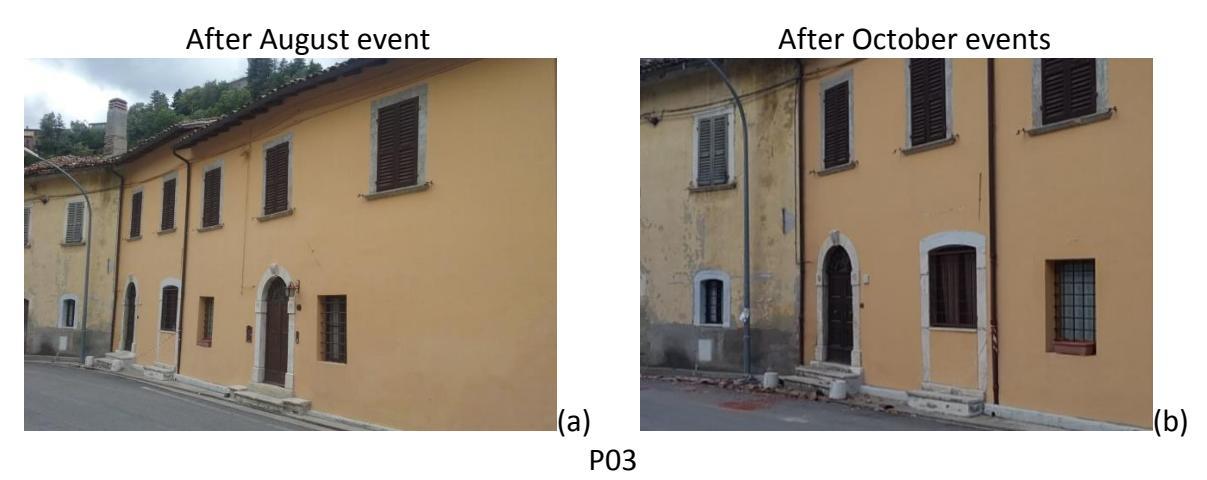
**Figure 6.49.** A reinforced masonry building in Borgo (a) after the 24 August earthquake, and (b) after the October events.

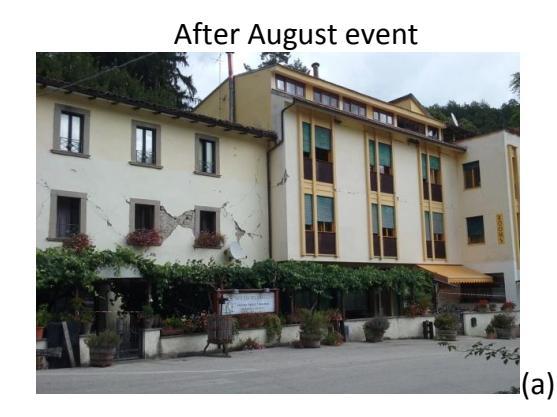
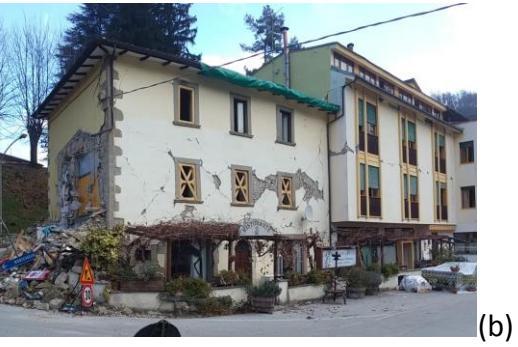
**Figure 6.50.** A building in Borgo (a) after the 24 August earthquake, and (b) after the October events.

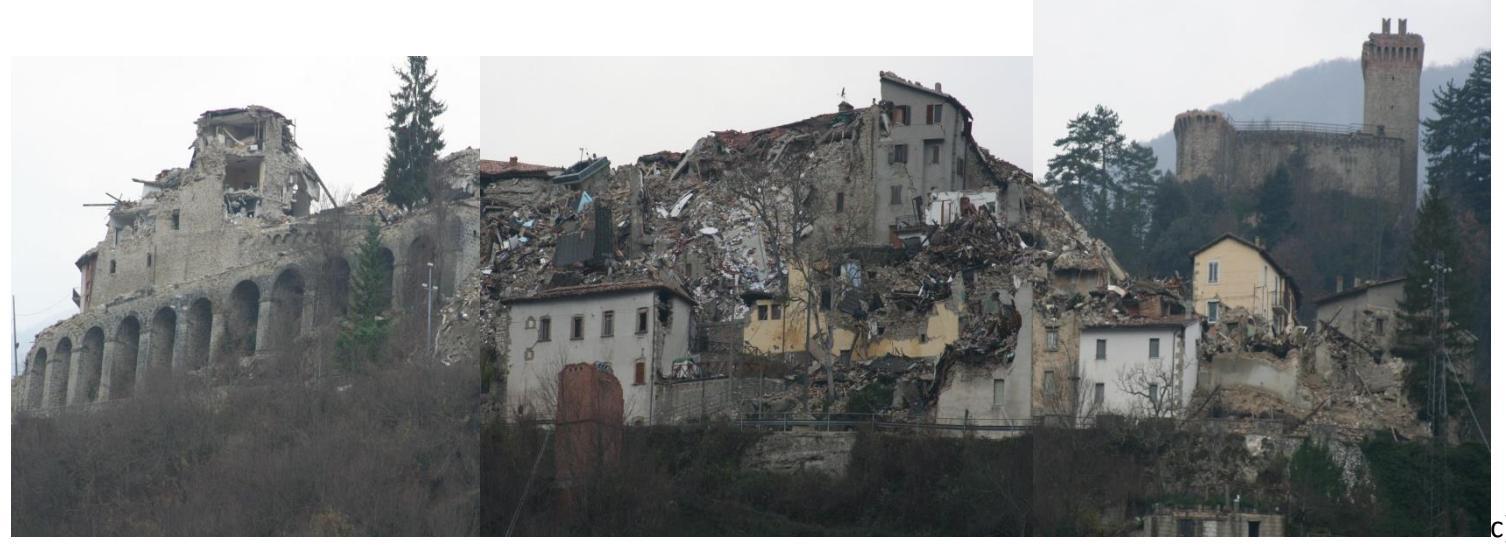
(D5) is documented in Figure 6.52. Table 6.3 shows the locations and damage levels for all selected representative structures.

Figure 6.52. Overview of the damage level in Arquata del Tronto after October events.

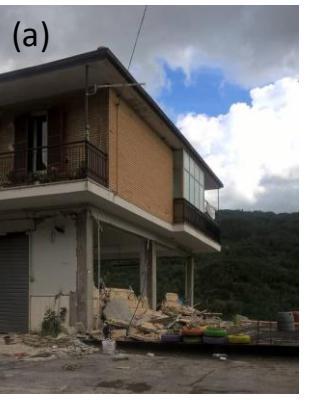
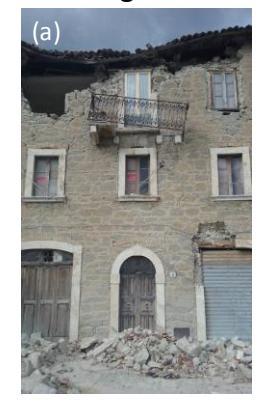
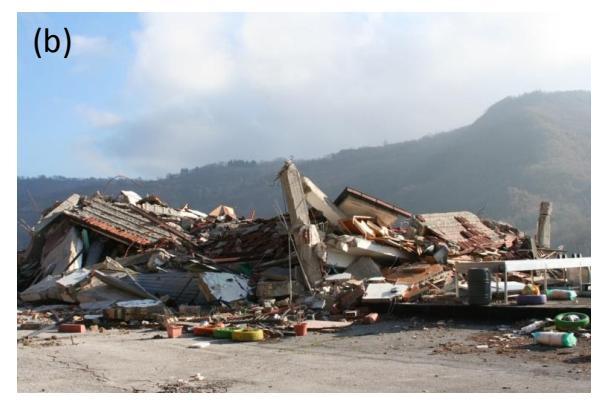
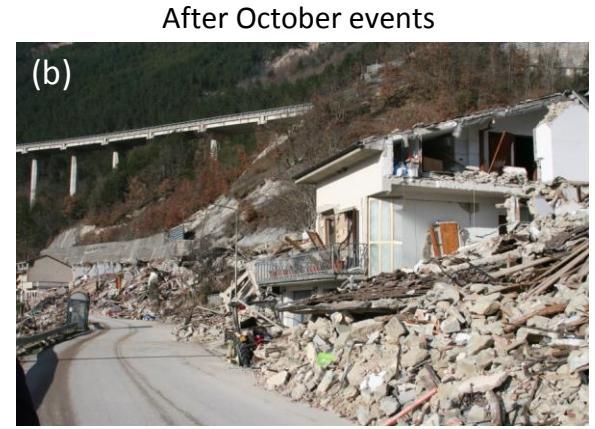
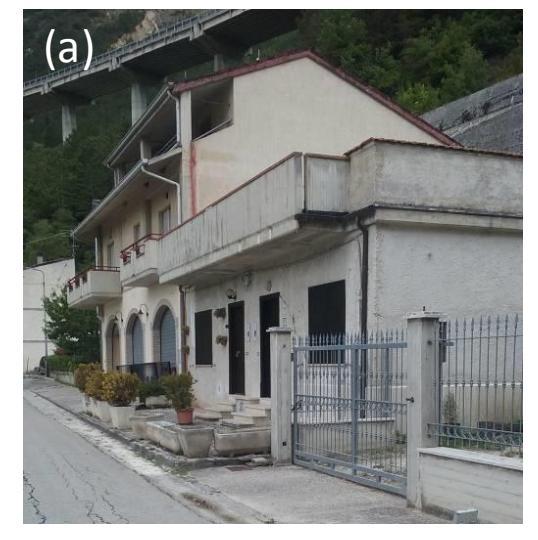
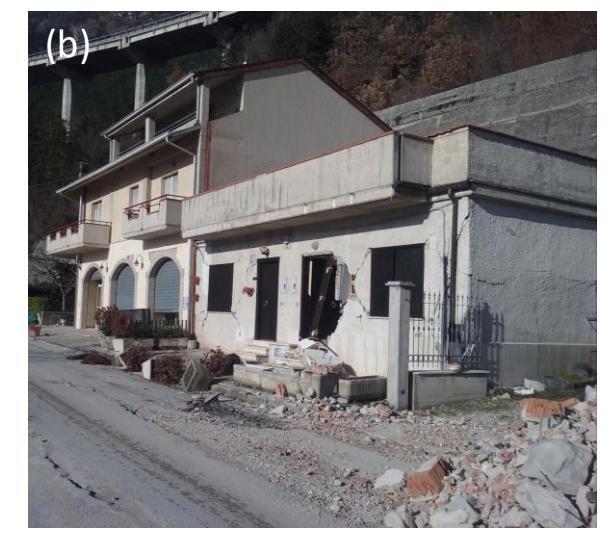
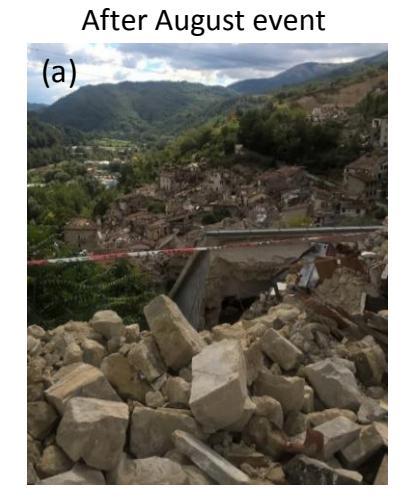
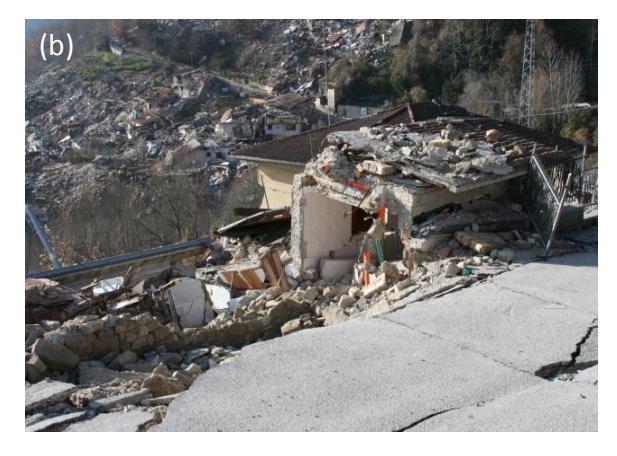
**Figure 6.56.** Comparative pictures of selected structures in Pescara del Tronto after the 24 August event, and after the October events.

Figure 6.55 shows locations of selected buildings for which we show photos taken after the August and October events. The cumulative damage is also evident from Figure 6.56. Figure 6.57 shows a photographic overview of the hamlet taken from a common perspective after the August and October events. Figure 6.58 shows screenshots captured from 3D models created from images taken by UAVs. Table 6.4 summarizes locations and damage levels for all selected representative structures.

Picture	September Damage Level	December Damage Level	
P01	D3	D5	
P02	D3		
P03	D2	D2-D3	
P04	D2-D3		
P05	D4		
P06	D5	D5	
P08	D5	D5	
P09	D4-D5	D5	
P10	D4-D5		
P11	D3	D5	
P12	D4-D5		
P13	D4-D5	D5

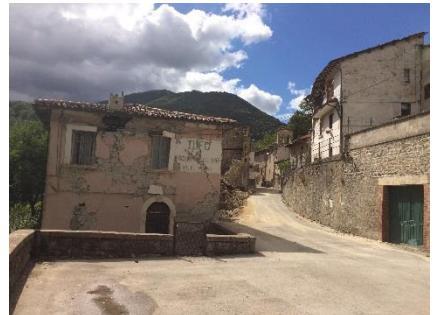
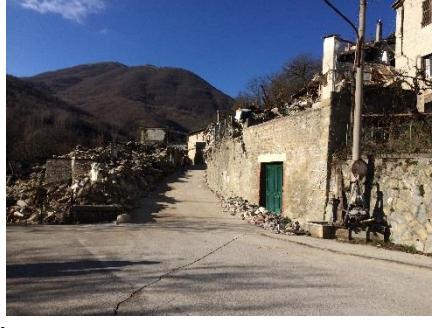
**Figure 6.62.** Comparative pictures of selected structures in Tufo after the 24 August event, and after the October events.

Figure 6.61 shows locations of selected buildings for which we show photos taken after the August and October events. Figure 6.62 shows these pictures, which were taken from a common perspective. Table 6.5 summarizes locations and damage levels for each of the representative structures. Structures M2, M3, and M4 (P1 and P2 in Figure 6.62) are unreinforced masonry buildings. They had damage levels ranging from D1-D3 after the August events and D5 (complete collapse) following the October events. We documented the performance of one reinforced concrete structure (RC1). It had no apparent damage from the August events and damage level D2 after the October events (P3 in Figure 6.62).

An important monument in Tufo is the *Santissima Maria Annunziata Church*. It is a church built in the XVII century that appears to have been recently retrofitted. The church had no apparent damage (D0) from the August events (P4, P5, and P6 in Figure 6.62) and damage level D3 (partial collapse of façade around the rose window; P4 in Figure 6.62) following the October events. Figure 6.62 also shows multiple layers of untied bricks and significant new cracks at corners (P5 and P6), possibly from lack of lateral reinforcement at the corner.

Location		September	December
Picture	DATUM	Description	Lat.	Long.	Damage	Damage
					Level	Level
P1	WGS-84	Entrance of the historical center (M2-M3)	42.7353°	13.2532°	D3	D5
P2	WGS-84	Masonry buildings (M4)	42.7354°	13.2528°	D1	D5
P3	WGS-84	Reinforced concrete	17 72510	12 25100	DO	2
		building (RC1)		13.2319	DU	02
D4	WGS-84	Santissima Maria	12 7351°	12 25220	DO	50
F 4		Annunziata Church (M1)	M1) 42.7551 15.2522		00	63
P5	WGS-84	Santissima Maria	17 7251°	13.2522°	DO	50
		Annunziata Church (M1)	42.7551		DU	03
P6	WGS-84	Santissima Maria	17 72510	13.2522°	DO	50
		Annunziata Church (M1)	42.7551		00	50
