# Engineering Reconnaissance Following the October 2016 Central Italy Earthquakes Version 2

GEER Team Leaders: Jonathan P. Stewart and Giuseppe Lanzo

Geotechnical Extreme Events Reconnaissance Association Report No. GEER-050D 8 May 2017

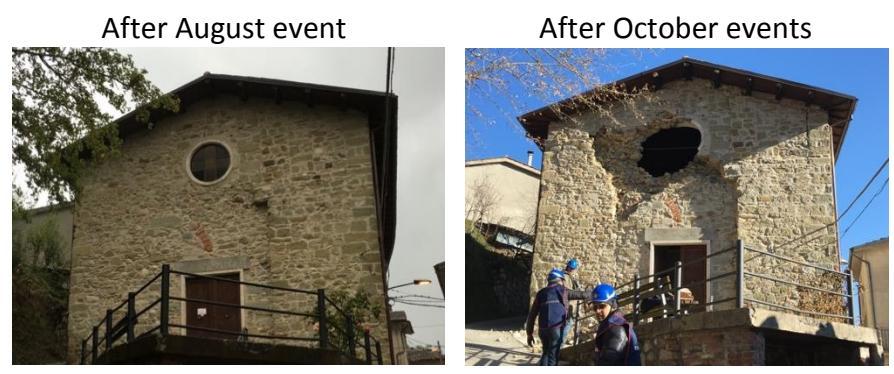
Ρ3

Figure 6.61 shows locations of selected buildings for which we show photos taken after the August and October events. Figure 6.62 shows these pictures, which were taken from a common perspective. Table 6.5 summarizes locations and damage levels for each of the representative structures. Structures M2, M3, and M4 (P1 and P2 in Figure 6.62) are unreinforced masonry buildings. They had damage levels ranging from D1-D3 after the August events and D5 (complete collapse) following the October events. We documented the performance of one reinforced concrete structure (RC1). It had no apparent damage from the August events and damage level D2 after the October events (P3 in Figure 6.62).

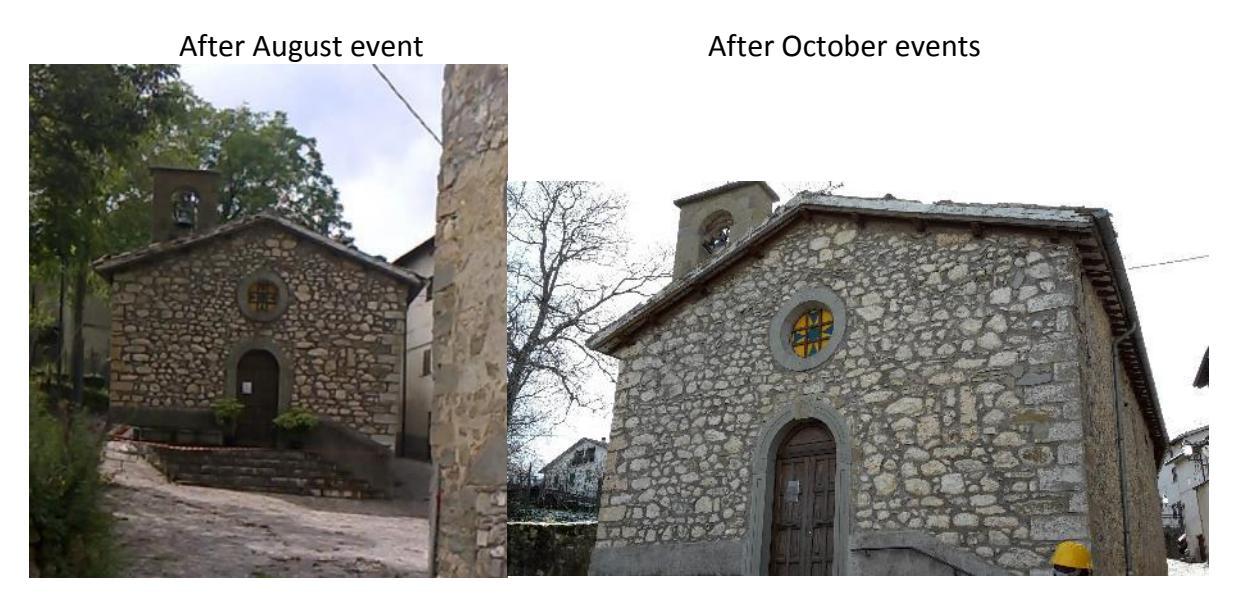
P01 (Astorara)

Hamlet	Structures	Damage description	
Astorara	P01*-P02-P03	At the entrance, there are recent buildings with evidence of recent structural retrofitting (D0 level). Many older structures at the back of the village show a D4/5 damage level. At the highest portion of the village a full collapse occurred.	
Balzo	P04	General D2/D3 damage level. The village is completely abandoned, while in September after the August main shock it was still populated and with shops and restaurants still in operation.	
Castro	P05-P06	Church with a full collapsed apse and the rest of the hamlet with diffused D4/5 damage level. A recent house on the main road with no damage (D0) and still inhabited.	
Colle	P07-P08-P09	Similar to Astorara with various levels of structures vulnerability. Recently restored buildings with D0; old masonry buildings with partial or full collapses (D4/D5).	
Collefratte	P10-P11*-P12	Very damaged hamlets D3/D3 and a full collapse D5.

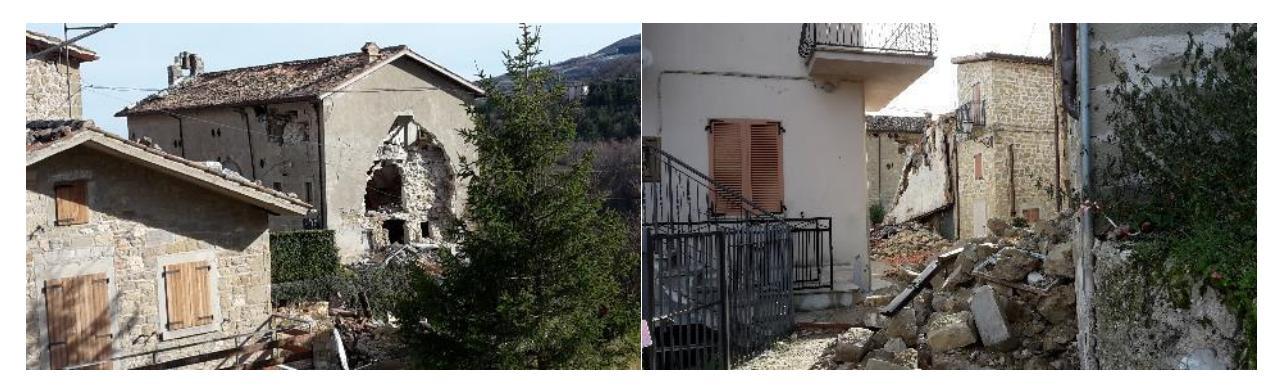
P06 (Castro)

Table 6.6 summarizes observed damage patterns for each hamlet. Most of these hamlets were visited (Astorara, Collefratte, Colleluce, Colle, Piano and Pistrino), although Balzo and Castro were assessed from afar due to limited access. In particular, the main access road to Castro was blocked by debris (see Picture P06 below).

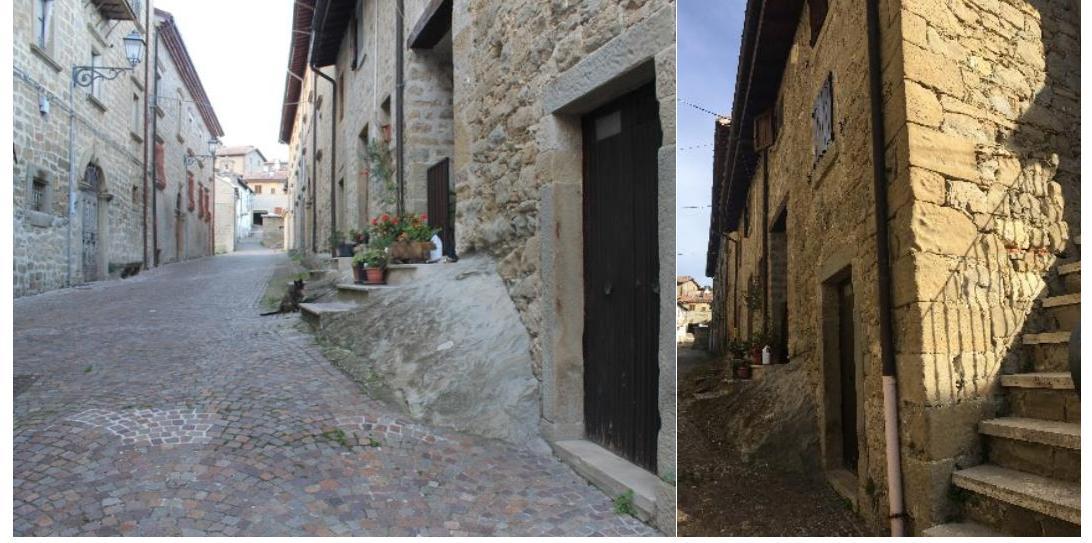
P14 (Piano)

Damage levels were variable across Montegallo, which is likely a result of variable ground motion levels (mostly as a result of different site effects) and variable construction types and quality. In general, we encountered significant increased damage levels (approximately one class, e.g., D2 to D3) following the October events. A notable exception is Piano, which showed no evidence of damage following either event sequence, despite some examples of apparently poor construction (P14 in Figure 6.63).

Colleluce	P13	Totally D4/5.	
Piano	P14*	Generally D0/D1.	
Pistrino	P15*-P16*-P17*	The initial part of the village (Pistrino di Sopra) was seriously damaged (D3/D4), whereas the other part (Pitrino di sotto, 1 km from Piano) showed minor problems (D0/D2) except for a collapsed small stones wall.

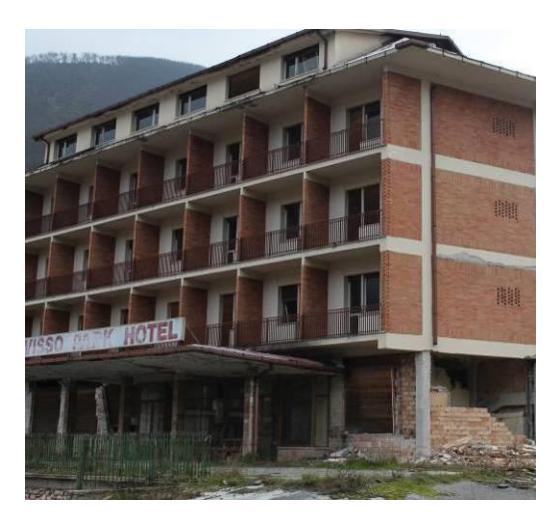
P01

The pictures are presented in Figure 6.66. The historical center consists mainly of unreinforced masonry structures (some of which have been recently retrofitted), 2-3 stories in height. Outside of the historical center, modern reinforced concrete structures were encountered (see P01-P02).

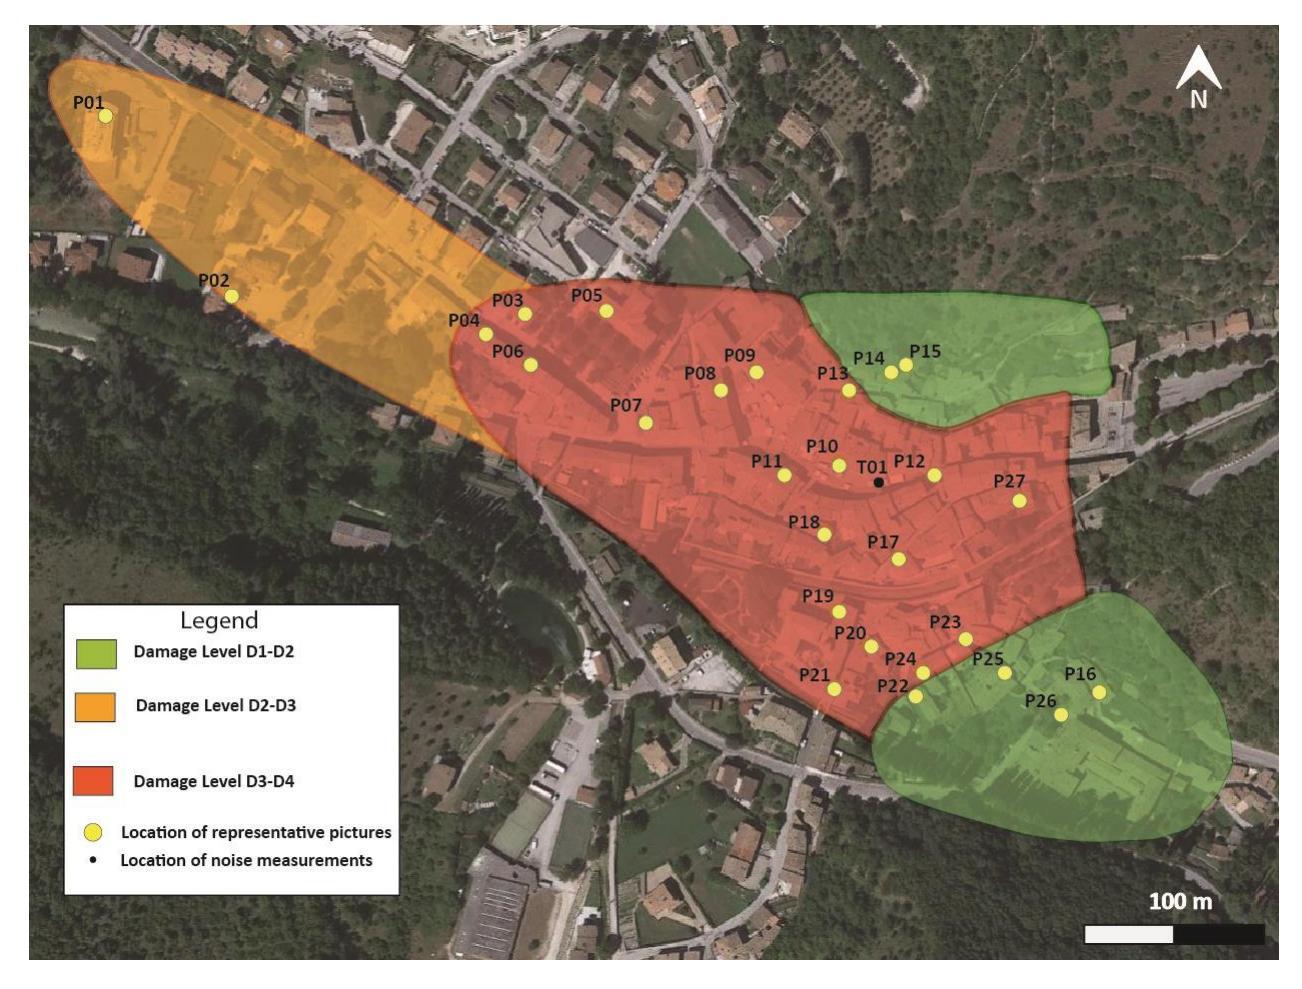
Figure 6.67. Damage zonation within the villages of Visso village.

The village was significantly damaged by the October events. However, the degree of damage to buildings is spatially variable. A tentative damage zonation map is reported in Figure 6.67. Damage levels as high as D3-D4 are concentrated in the historical center, especially the portion founded on the quaternary continental deposits (alluvial deposits, eluvio-colluvial deposits, and widespread slope deposits). Minor damage (D1-D2) was encountered in the portion founded on the SCC rock (Scaglia Cinerea Formation). In the NW portion (outside the historical center), we encountered D2-D3 on average. This part of the village is located on quaternary deposits. However, the relatively minor vulnerability of buildings was probably responsible for the minor damage observed in this part of the historical center.

The damage in Visso was likely related both to the presence of some vulnerable buildings in the historical center and to stratigraphic amplification effects related to the presence of quaternary soils resting on Scaglia rock formation (see also preliminary conclusions by Gaudiosi et al., 2016).

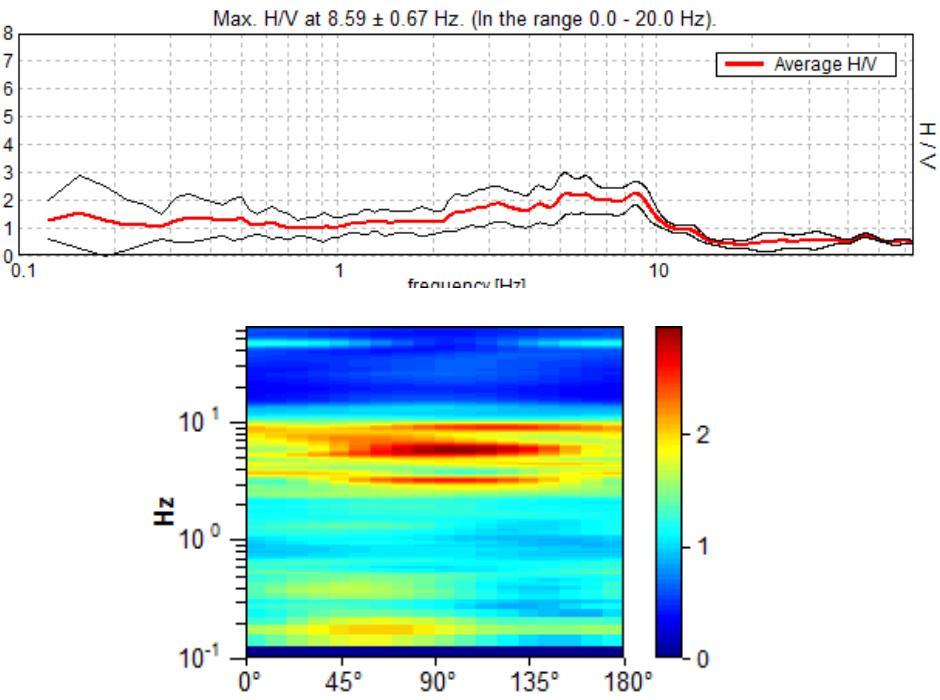
**Figure 6.68.** Noise measurement T01 results in terms of H/V spectral ratio (up) and H/V polar plots (bottom).

Microtremor noise measurements (location T01 in Figure 6.67) were carried out during the survey in the most damage zone of the historical center. A portable Tromino tomograph was employed and the total duration of each measurement was approximately 15 minutes. Horizontal-to-vertical (H/V) spectral ratios were computed by using the geometrical mean of horizontal components. Moreover, in order to investigate preferential directions of the amplification (i.e., polarization of ground motion), H/V ratios were computed by rotating the horizontal component between 0° and 180° (directional or polar HVSR). Both H/V and polar H/V

are reported in Figure 6.68. We observe no large H/V peaks at T1, suggesting the lack of a site condition producing a strong resonant site response.

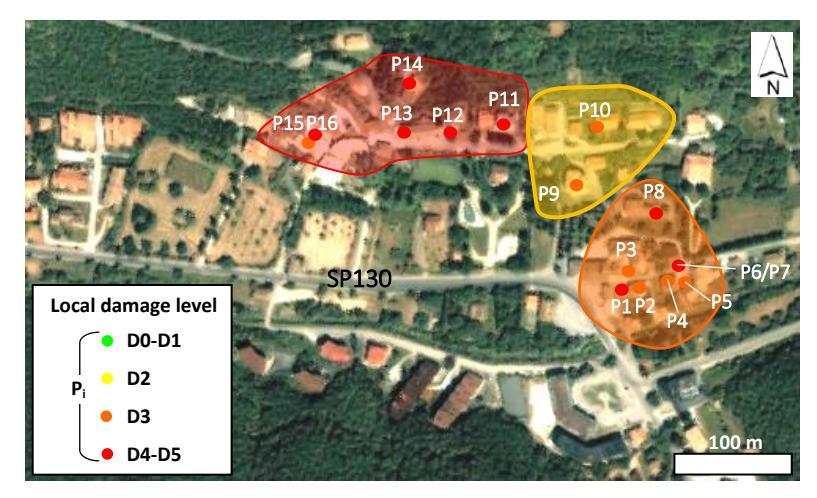
Figure 6.69. Locations of representative structures inspected in Ussita, and damage zonation within the village.

Figure 6.69 shows locations of representative structures inspected in Ussita and maps damage zones within the village. Damage levels were generally between D3 and D4. Figure 6.70 shows pictures of selected structures in the area of Ussita that experienced the higher level of damage.

D3: Overall, major damage to non-structural elements and limited to significant damage to load bearing elements can be identified.

D3-D4 - Heterogeneous area, which seems to be always characterized by high damages to non structural elements, often by damages to load bearing elements and in some cases also by local collapse.

D4-D5 - Strip characterized by structures interested by huge damage to load bearing elements and local collapse.

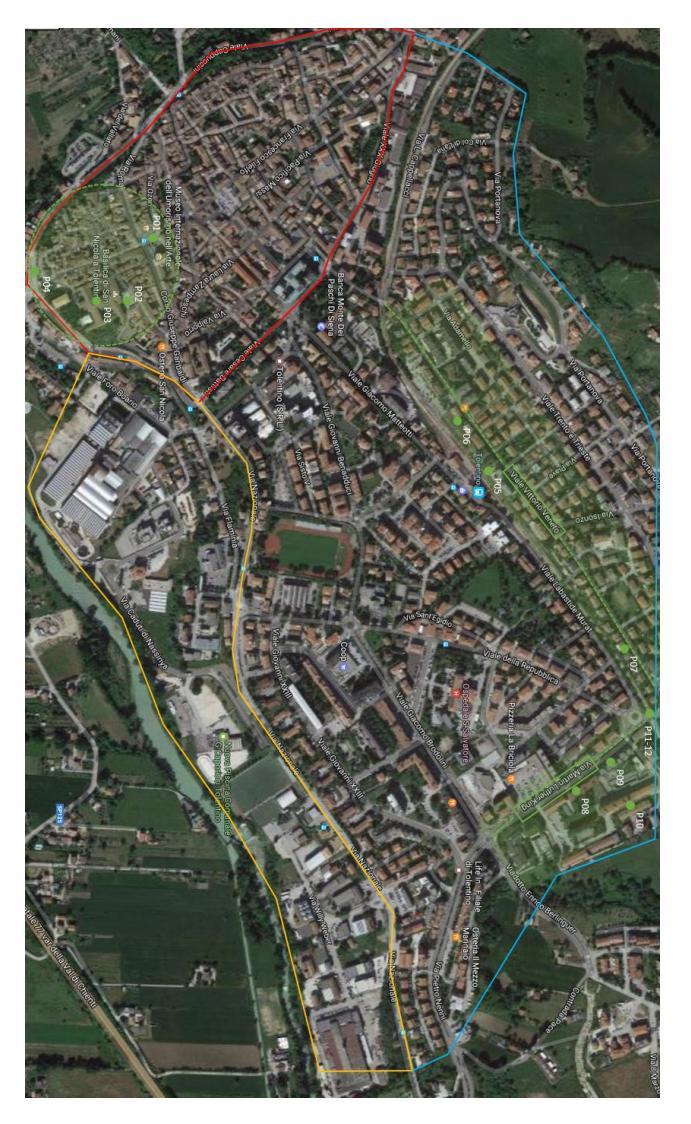
Figure 6.73. Tolentino reconnaissance map: in green the most damaged zones.

Tolentino was deeply damaged during the freedom battles conducted by the Italian resistance movement against the Nazi army after the World War II. For this reason, the town was almost totally reconstructed except for the center that was likely protected by the citizens (especially the San Nicola church). Figure 6.73 outlines three zones with different building types: (1) ancient town center (red), (2) industrial (yellow), and (3) contemporary-residential (blue). In the town center, masonry one or multi-stories structures are very common and retrofitting was adopted for many of them. The industrial part is located on the downhill and it is the most recent part of the town. The residential area is the typical postwar housing with a widespread use of the first reinforced concrete technologies of the 1960s and 1970s. Here also many 5-6 stories apartment buildings are diffused. Figure 6.73 also shows in green the locations

Very interesting is the Viale Vittorio Veneto-Viale Martin Luther King-Via Kennedy area. In this neighborhood, an evident site effect was observed, since diffused building damages are observed much more prominently than in the other parts of the town. In particular, the buildings along the eastern side of Martin Luther King road are recent reinforced concrete frames 5-to-8 floors above ground from the 1980s. Most of these buildings where seriously damaged and abandoned at the time of the reconnaissance. On the other side of the road, smaller buildings (most of them 3 floors above ground) suffered much less damage and were apparently in use at the time of the reconnaissance.

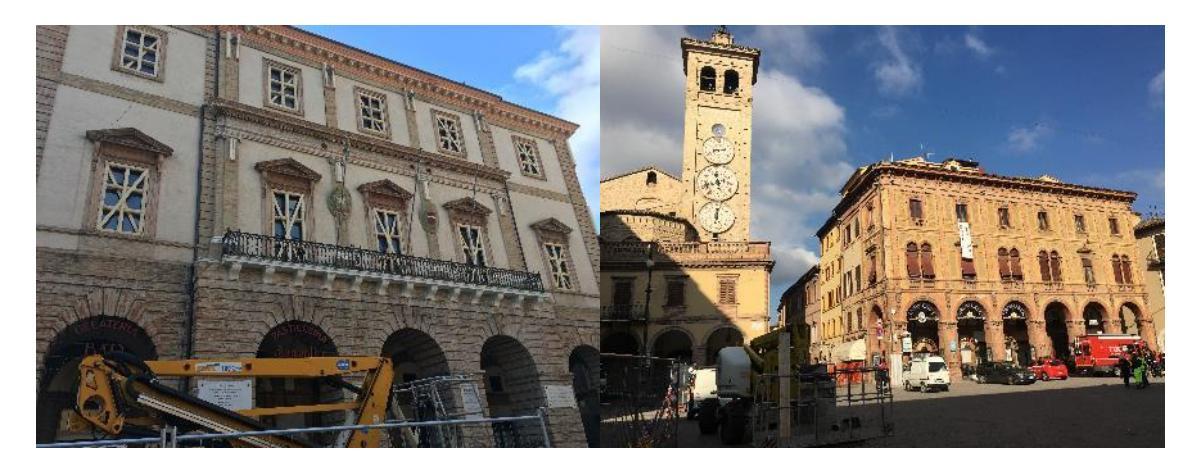
P01 (Piazza della Libertà)

Table 6.9 lists the locations of representative structures photographed and documented in the GEER reconnaissance. Figure 6.74 shows these structures. The town-center was partially damaged, especially Piazza della Libertà (main square of the town), where most of the buildings were strengthened with structural supports.

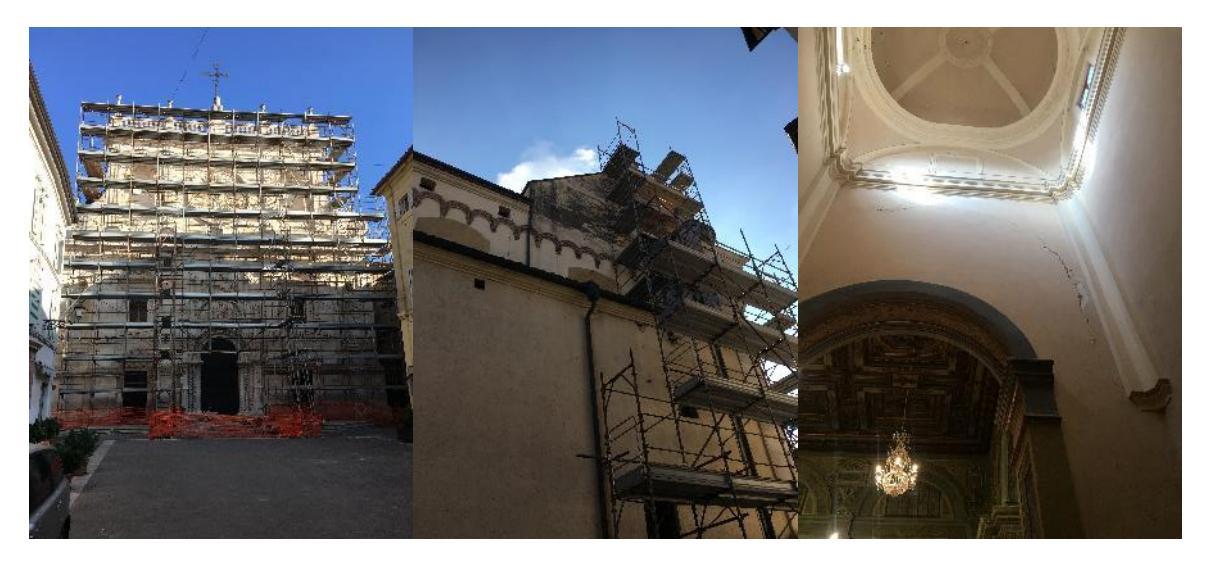
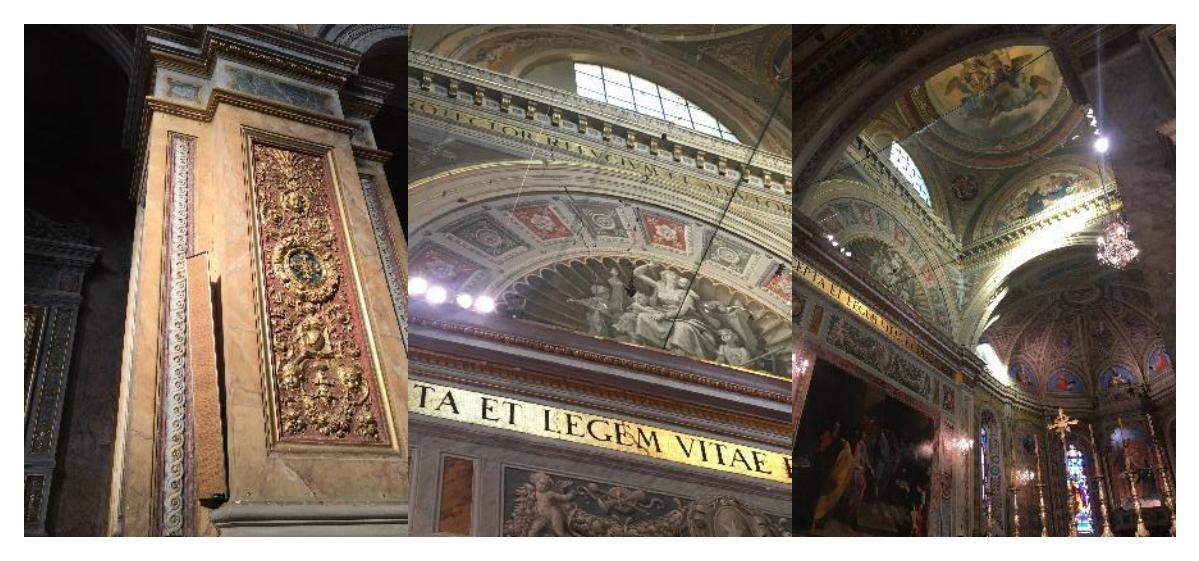
P02a-b-c Basilica di San Nicola (Saint Nicholas Church)

The San Nicola church is out of service and not accessible to the public as a result of diffused damage to the façade and the unstable wood decorated roof. The adjacent convent is a complex and heterogeneous building made by different and subsequent enlargements. For this reason, there are different states of damage inside the huge complex, depending on the structural type (masonry or reinforced concrete).

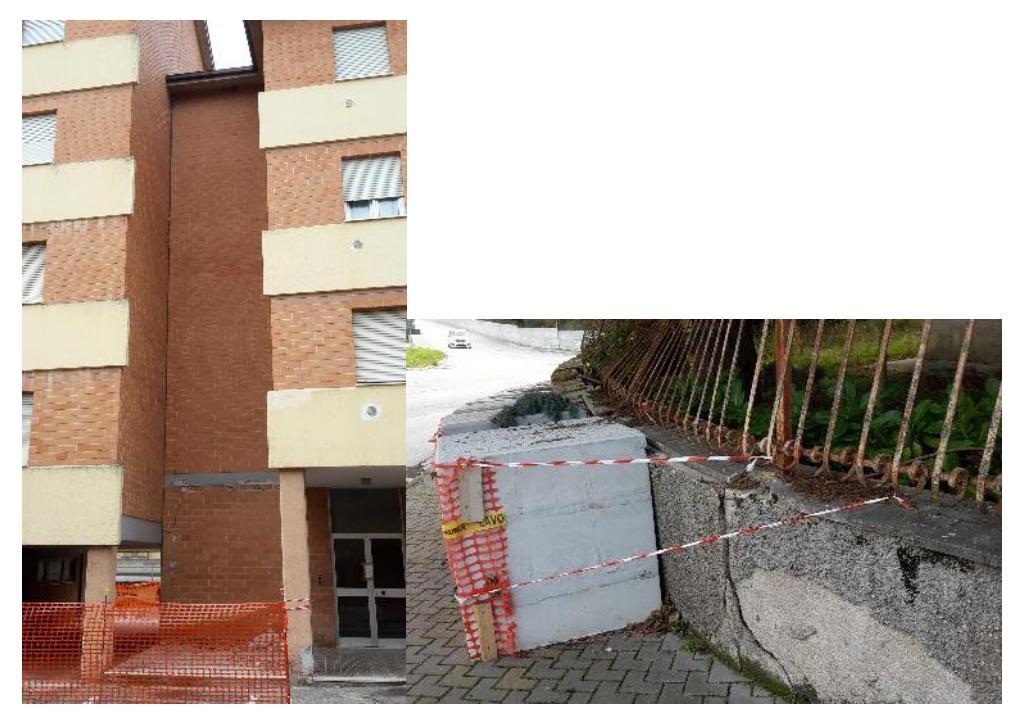
P11 (Retaining wall)

At the roundabout connecting Viale Vittorio Veneto e Viale Martin Luther King a retaining wall next to a rail bridge was seriously damaged. In particular, the wall was secured by huge concrete blocks in order to maintain the stability of the back private garden.

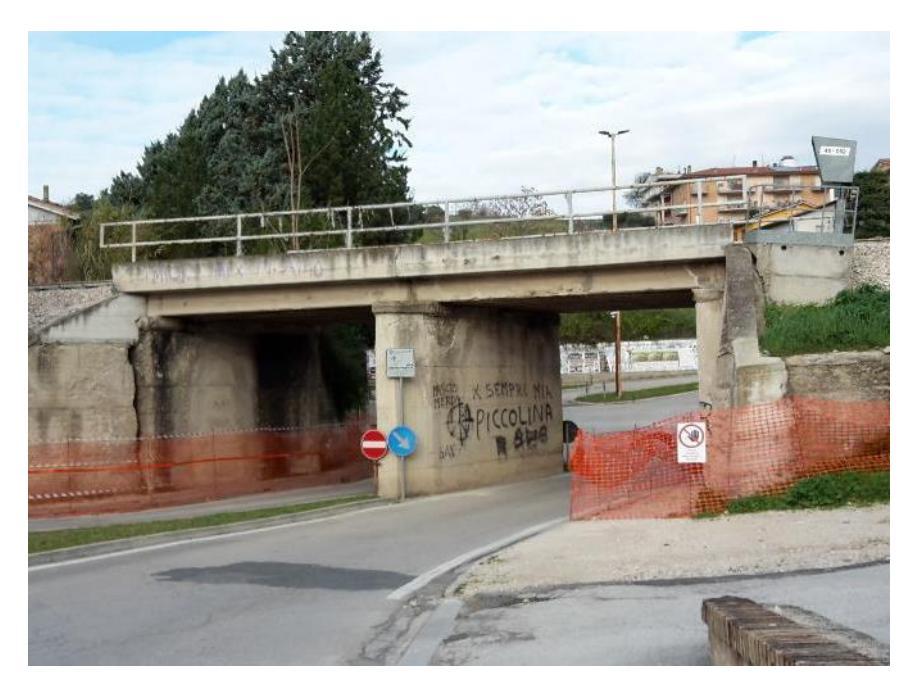
P12 (Damaged rail bridge)

Picture	DATUM	Description	Location		October
			Lat.	Long.	Damage Level
P06	WGS-84	Viale Vittorio Veneto	43.21399°	13.28918°	D2
P07	WGS-84	Viale Vittorio Veneto	43.21694°	13.29416°	D2
P08	WGS-84	Via Martin Luther King	43.21505°	13.29764°	D3
P09	WGS-84	Via Martin Luther King	43.21555°	13.2975°	D3
P10	WGS-84	Via Kennedy	43.21722°	13.29777°	D3
P11	WGS-84	Retaining wall	43.21874°	13.29686°	D3
P12	WGS-84	Damaged rail bridge	43.21874°	13.29686°	D2

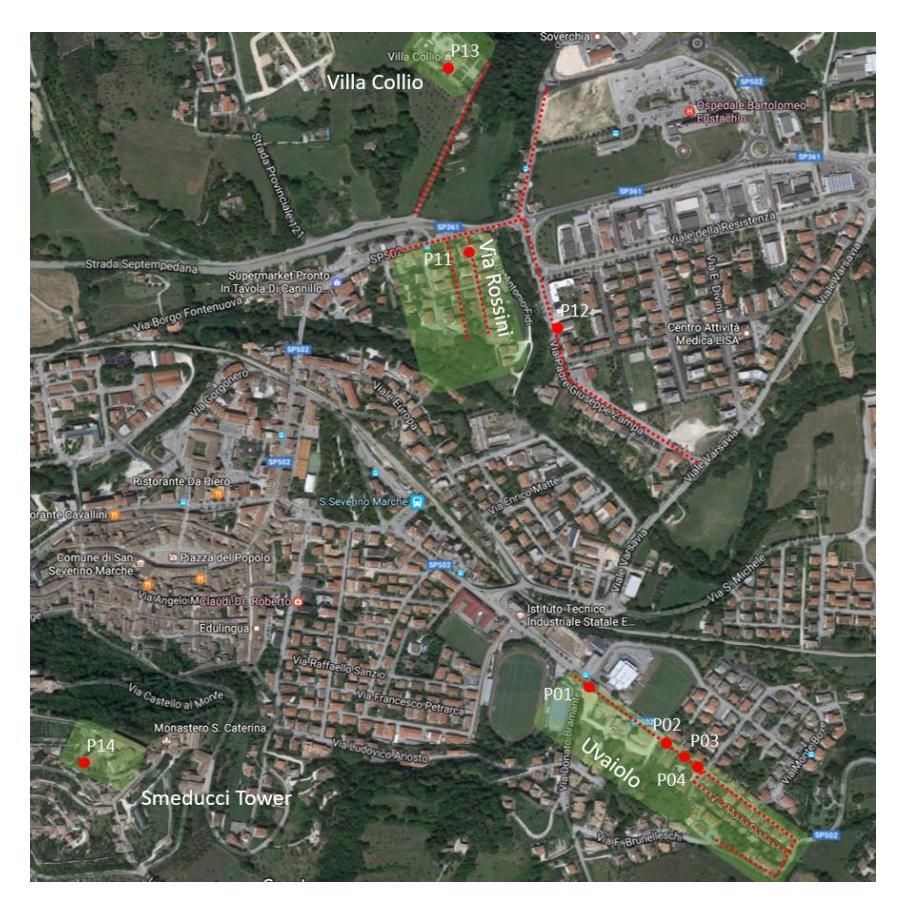
Figure 6.78. Summary reconnaissance map for San Severino Marche.

Major attention during the reconnaissance was paid to Via Mazzini and Via Rossini neighborhoods, since evident site effects were detected. The first is located on a rise and is parallel to another very damaged road (Via Monti Sibillini). The latter is very close to the Potenza River and the structures were likely built up on the ancient riverbed. Close to Via Rossini there is Villa Collio, a restaurant-villa that was severely damaged. Furthermore, a quick inspection of two towers located on the village hill was carried out (Torre Smeducci and the old Cathedral Tower), as there are plans for the installations of a permanent monitoring system by Politecnico di Torino and Nagoya City University.

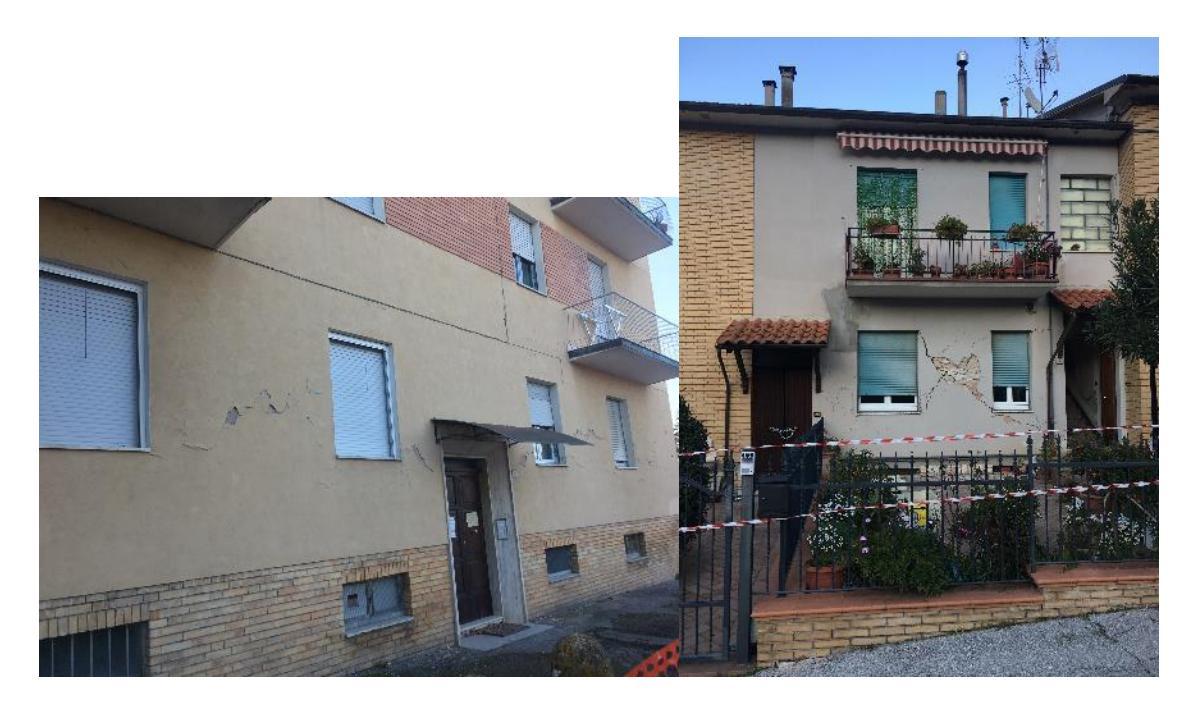
DATUM	Description	Position		October
Picture			Lat.	Long.	Damage Level
P01	WGS-84	Via Mazzini 76	43.22710°	13.18678°	D1-D2
P02	WGS-84	Via Mazzini 84	43.22605°	13.18883°	D2-D3
P03	WGS-84	Via Mazzini 86	43.2259°	13.1890°	D2
P04	WGS-84	Via Mazzini 91	43.2257°	13.1893°	D2
P05a	WGS-84	Via Mazzini 94	43.2255°	13.1897°	D4
P05b	WGS-84	Via Mazzini 94	43.2255°	13.1897°	D4
P06a	WGS-84	Via Mazzini 115	43.2249°	13.1907°	D4-D5
P06b	WGS-84	Via Mazzini 115	43.2249°	13.1907°	D4-D5
P06c	WGS-84	Via Mazzini 115	43.2249°	13.1907°	D4-D5
P07	WGS-84	Intersection Mazzini-Monti Sibillini	43.2255°	13.1897°	D2
P08	WGS-84	Via Monti Sibillini 6	43.2250°	13.1899°	D2
P09	WGS-84	Via Monti Sibillini 15	43.2248°	13.1902°	D2-D3
P10	WGS-84	Via Monte San Vicino	43.2246°	13.1898°	D0
P11	WGS-84	Via Rossini 1	43.2336°	13.1845°	D4
P12	WGS-84	Via Padre Giuseppe Zampa 30	43.2326°	13.1863°	D2
P13	WGS-84	Villa Collio	43.2369°	13.1841°	D2
P14	WGS-84	Smeducci Tower	43.2258°	13.1760°	D0

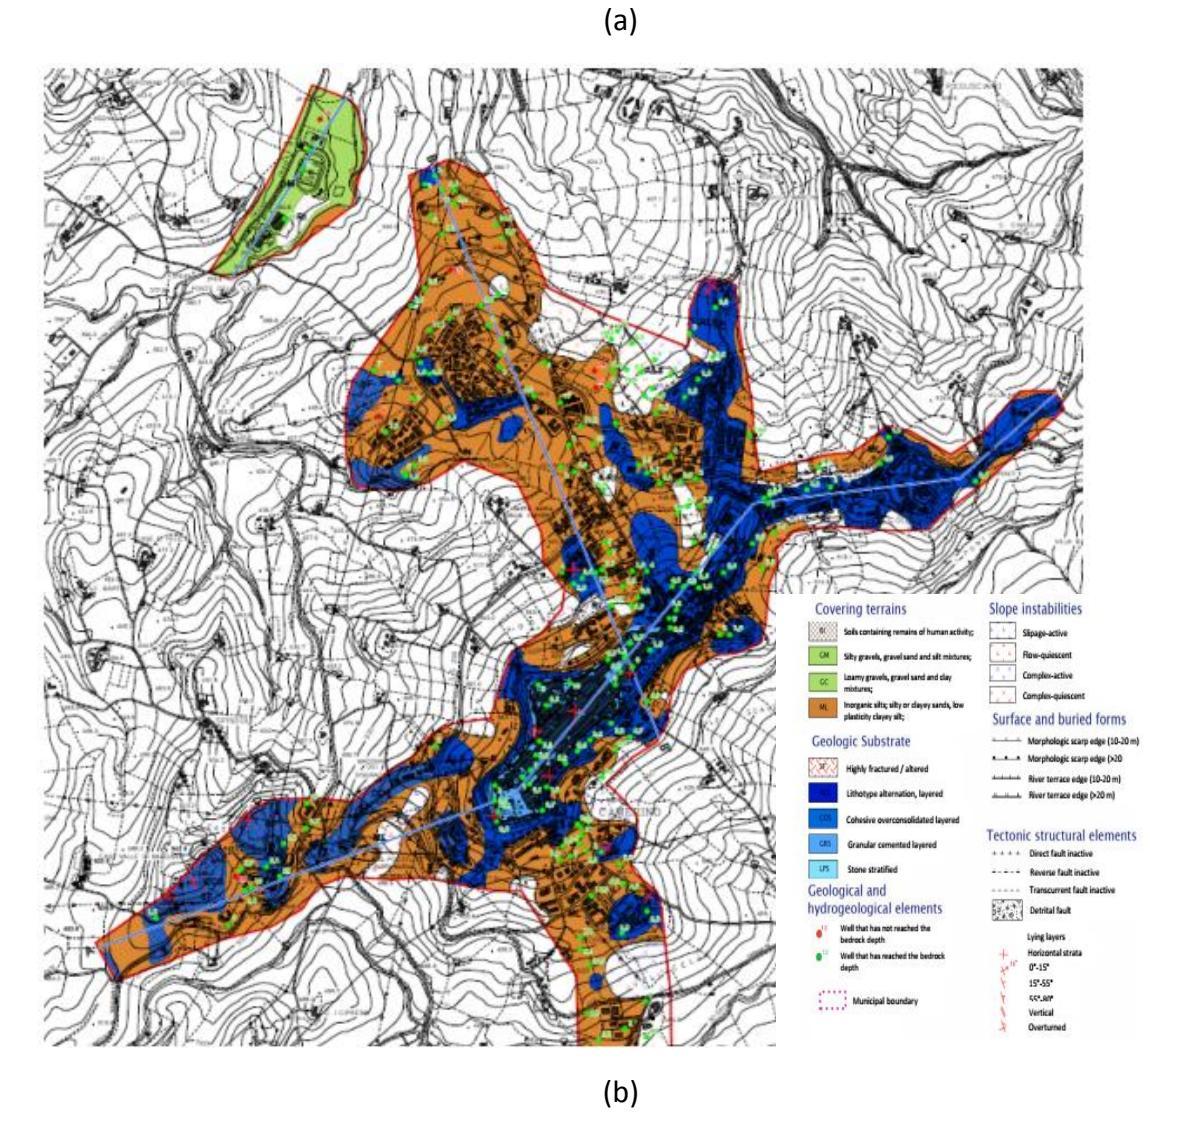
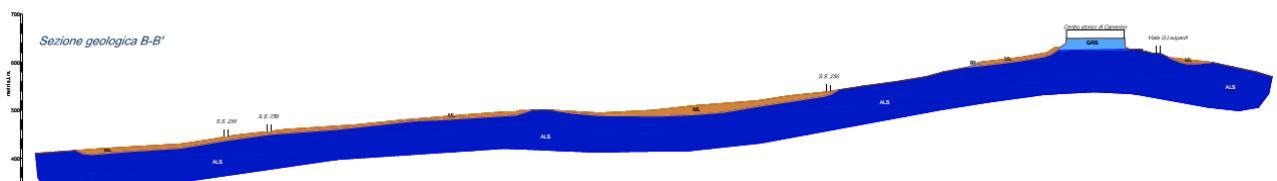
Figure 6.81. Geological map of Camerino (a) and cross section BB' (b) (Regione Marche, 2012).

on the arenaceous formation referred to as "Formazione delle Arenarie di Camerino" (Figure 6.81).

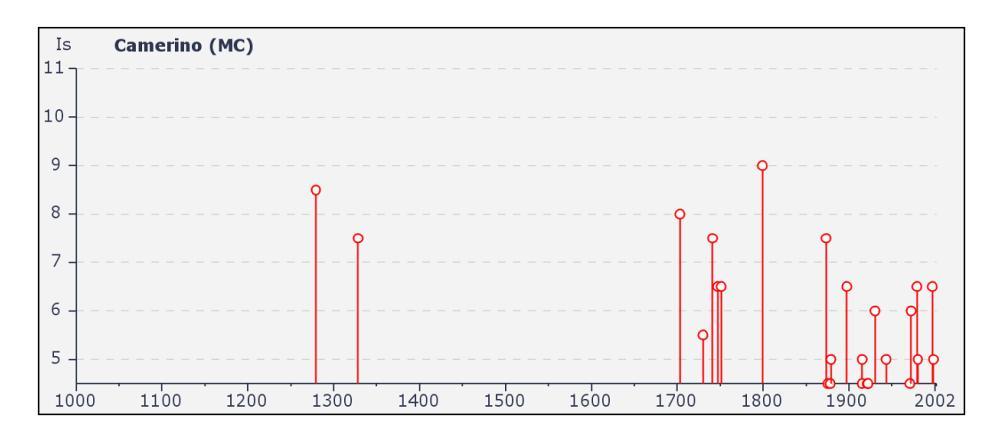
Figure 6.82. Historical earthquakes occurred in Camerino (CPTI- INGV).

The village was reported to have been damaged during the seismic sequence of 1279 and 1328 and the Reatin earthquake of 1703, which destroyed Norcia. The strongest earthquake in Camerino was in 1799. An excerpt of the historical seismicity as reported in the CPTI database by INGV is reported in Figure 6.82.

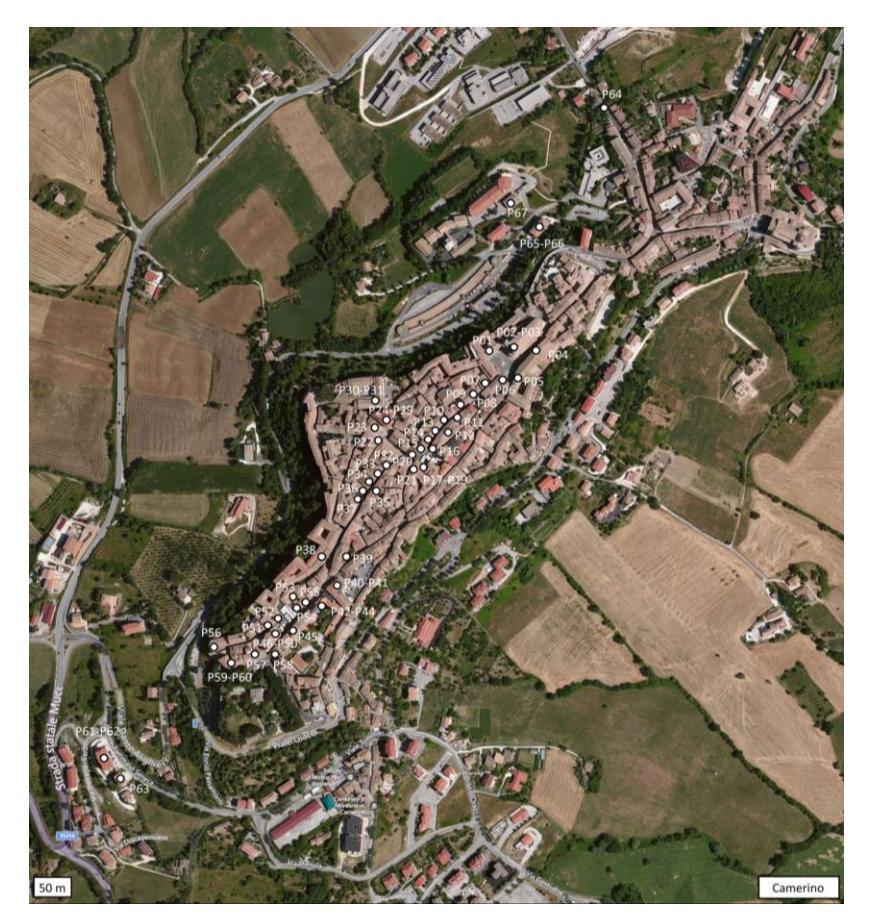
**Figure 6.83.** Locations of the representative structures inspected in Camerino (including red zone) (see Table 6.11 for details).

Figure 6.83 and Table 6.11 show locations of representative buildings inspected in the historic center of Camerino, including the red zone. Figure 6.84 shows photographs of these representative structures, which include both masonry and reinforced concrete dwellings two to four stories in height. The average damage level in the inspected zone was D2.
