# Engineering Reconnaissance Following the October 2016 Central Italy Earthquakes Version 2

GEER Team Leaders: Jonathan P. Stewart and Giuseppe Lanzo

Geotechnical Extreme Events Reconnaissance Association Report No. GEER-050D 8 May 2017

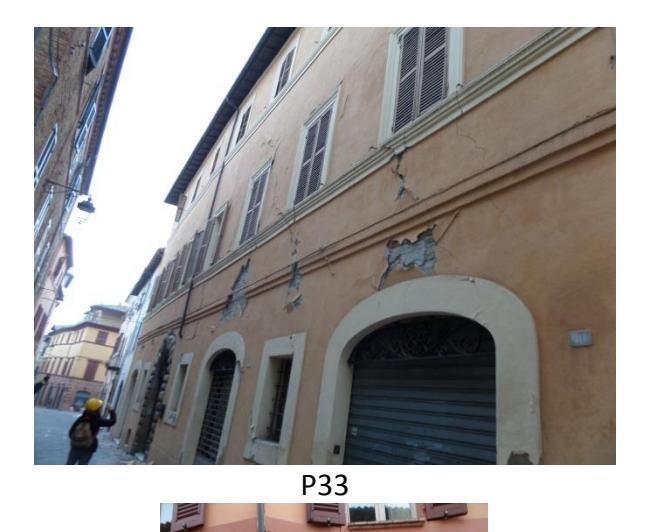
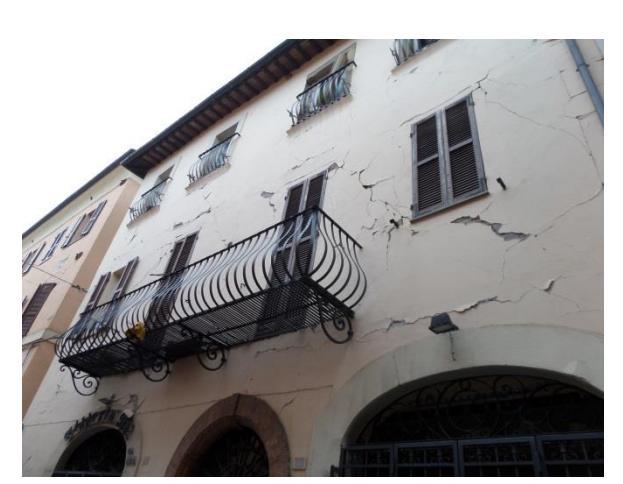
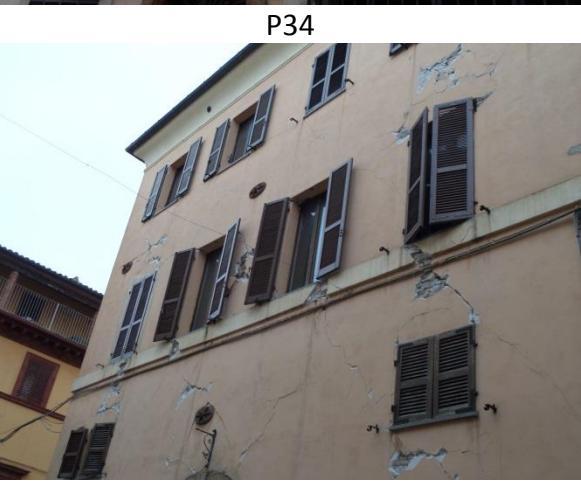
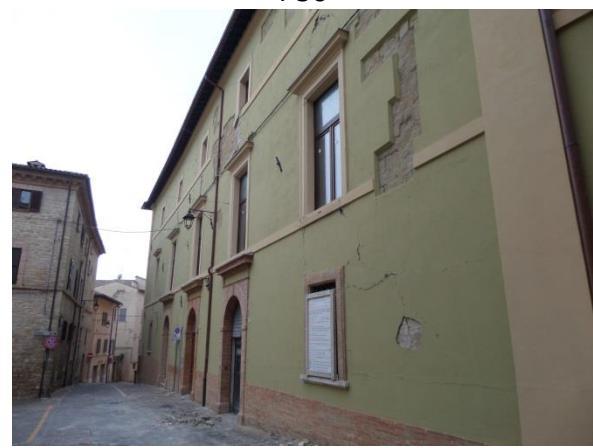
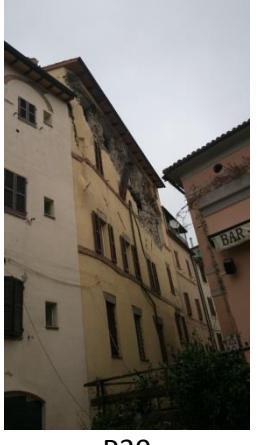
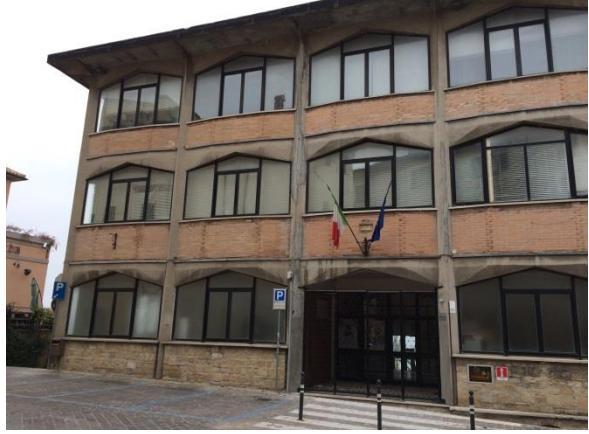
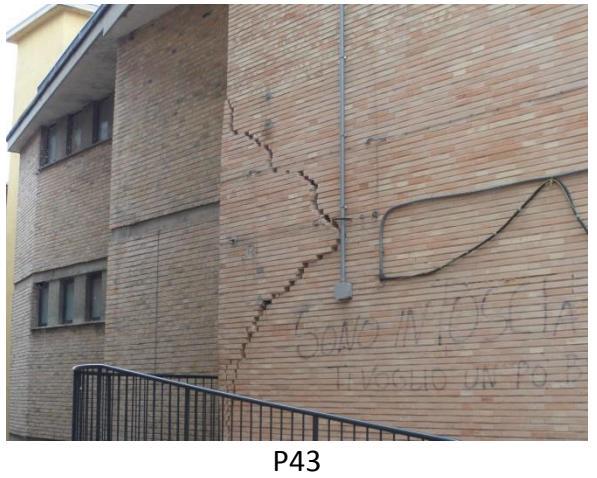
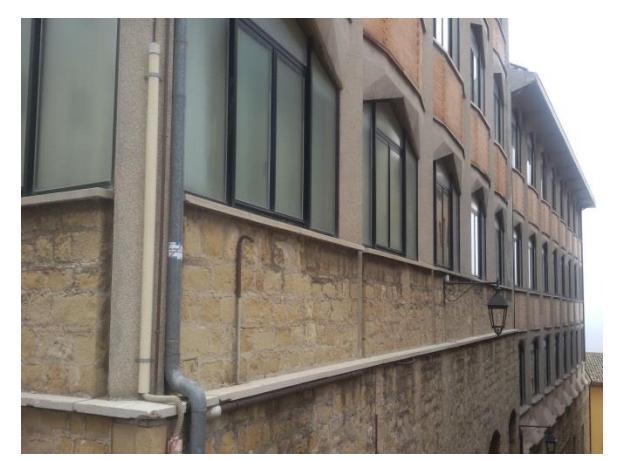
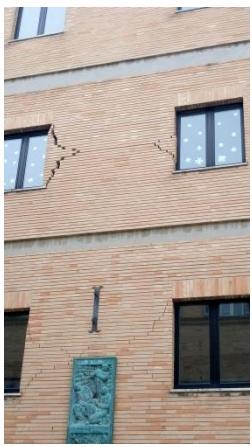
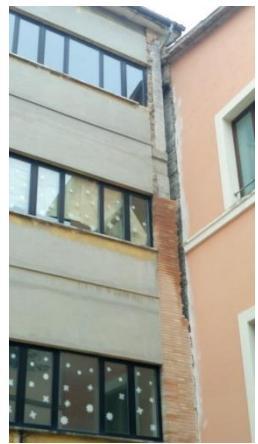
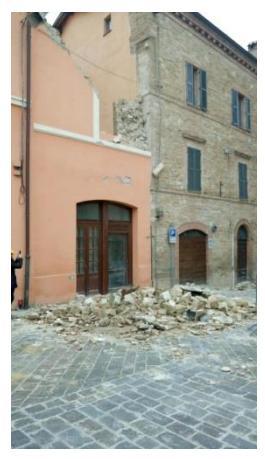
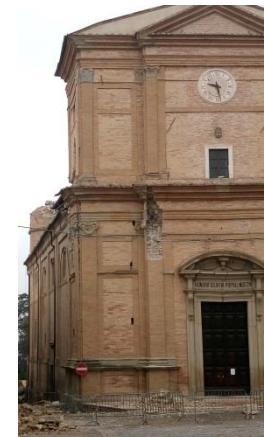
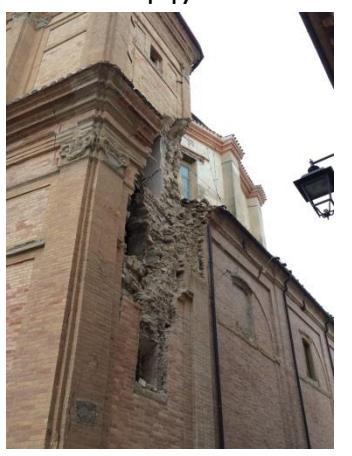
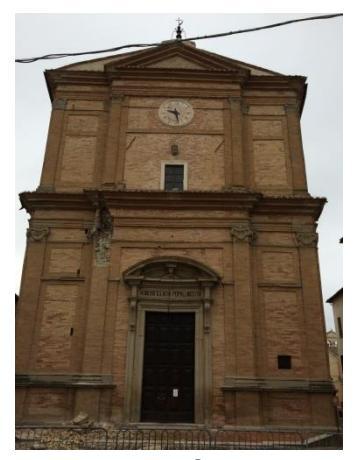
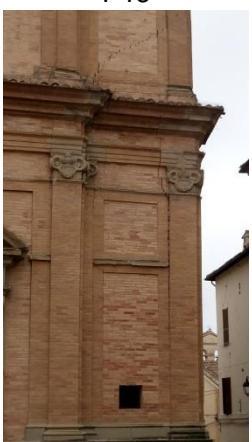
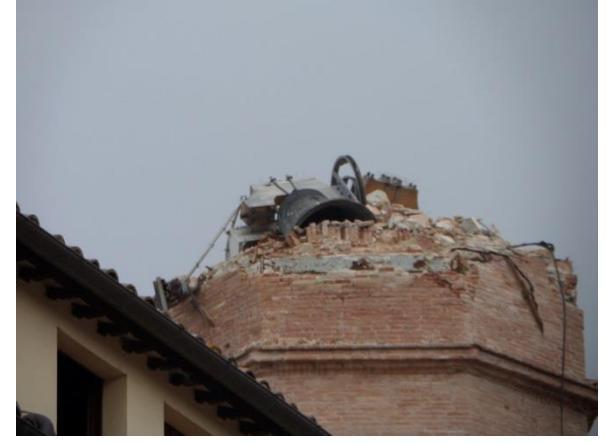
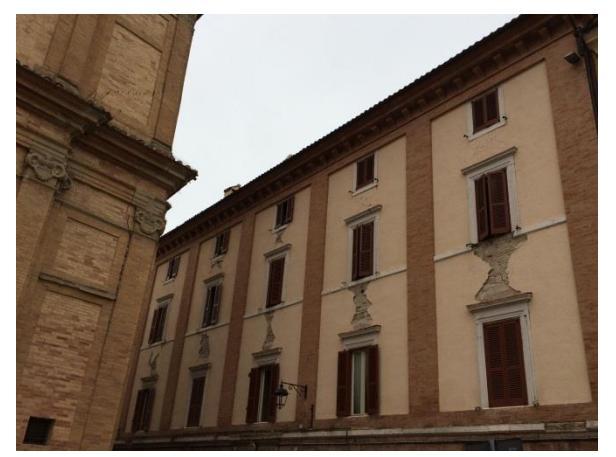
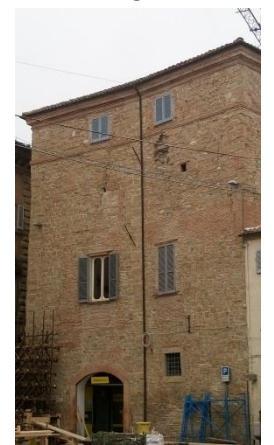
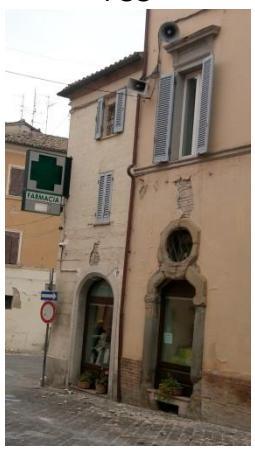
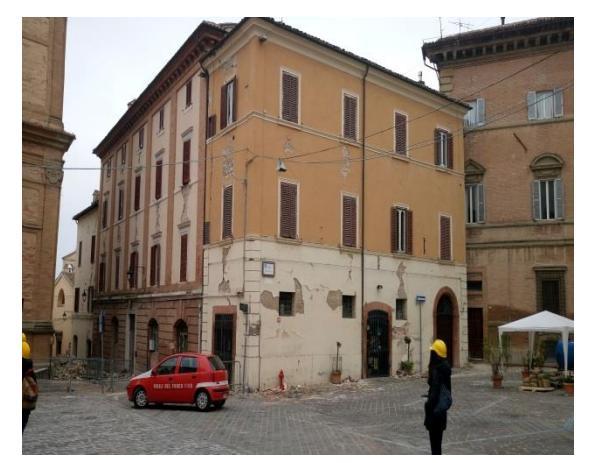
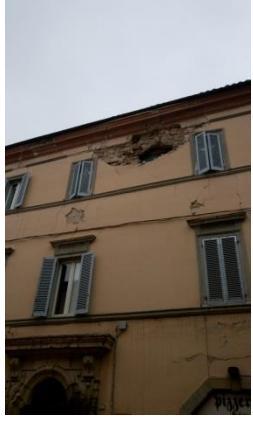
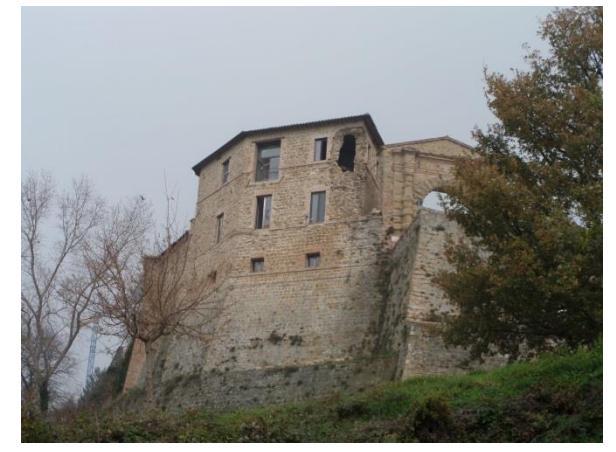
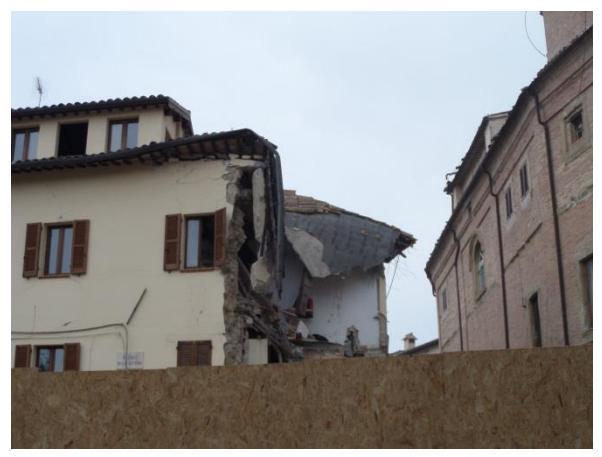
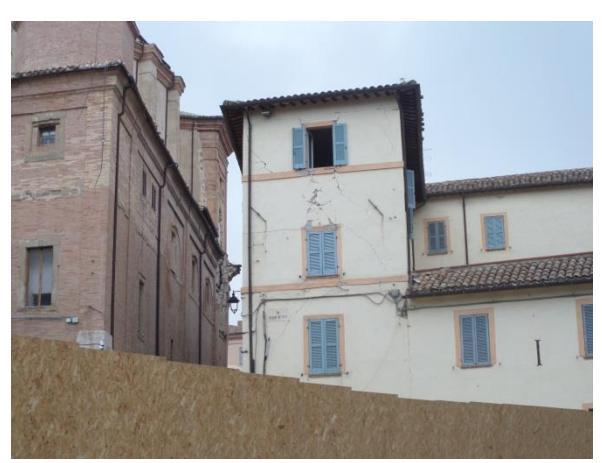
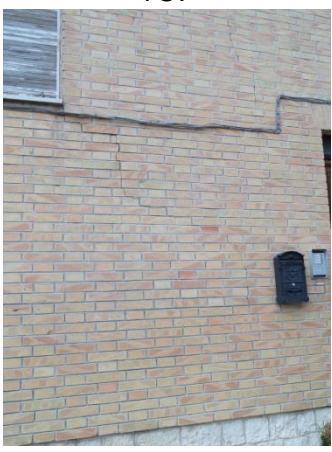
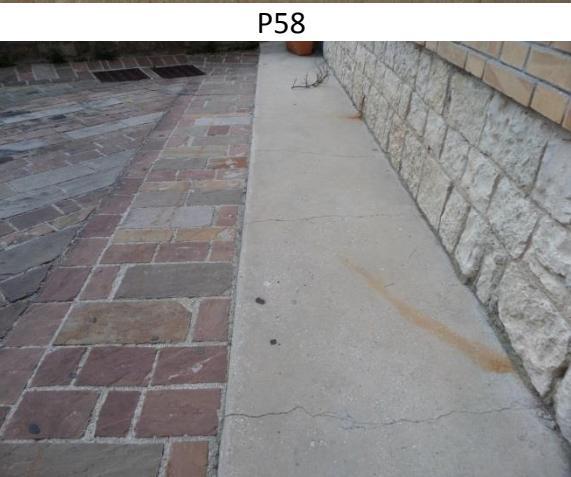
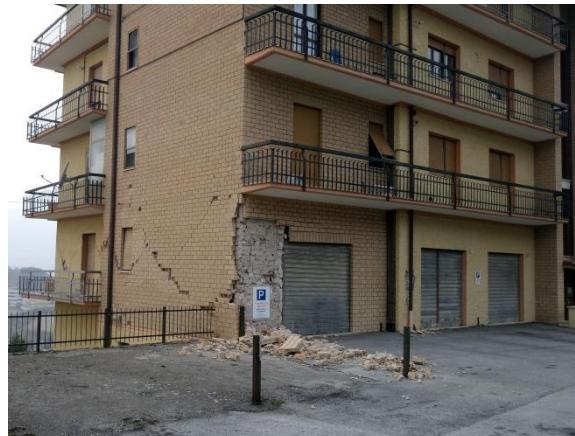
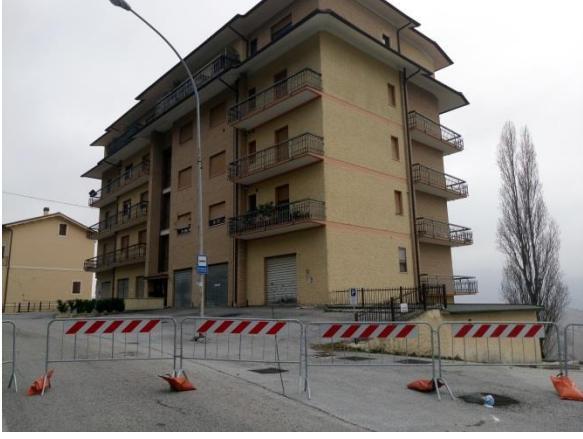
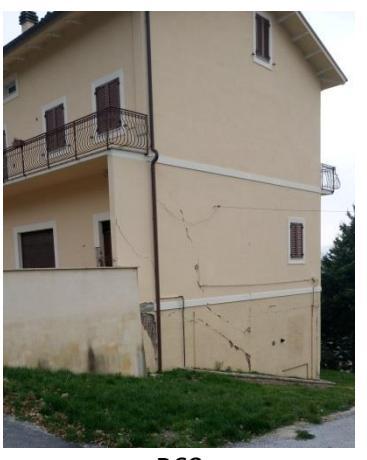
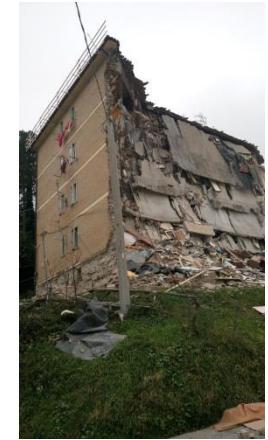
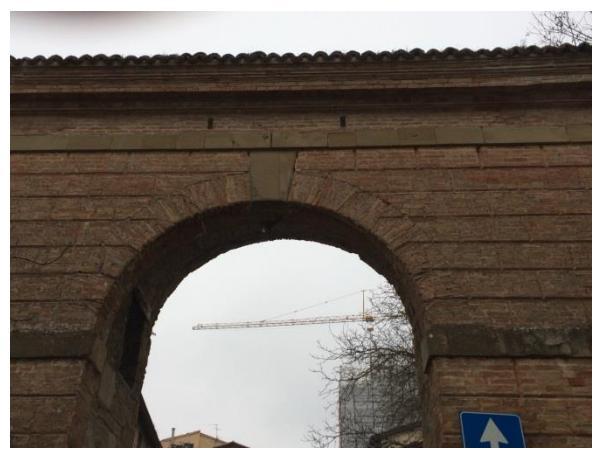
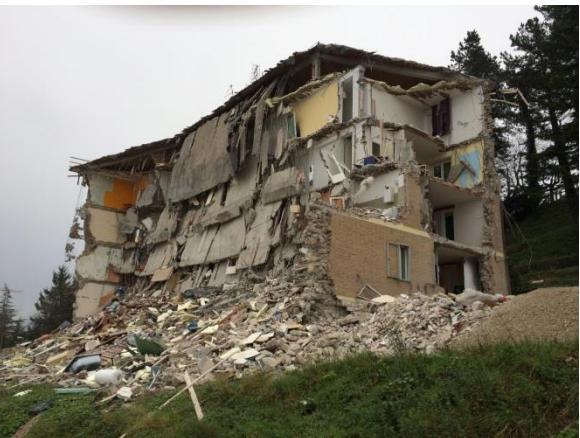
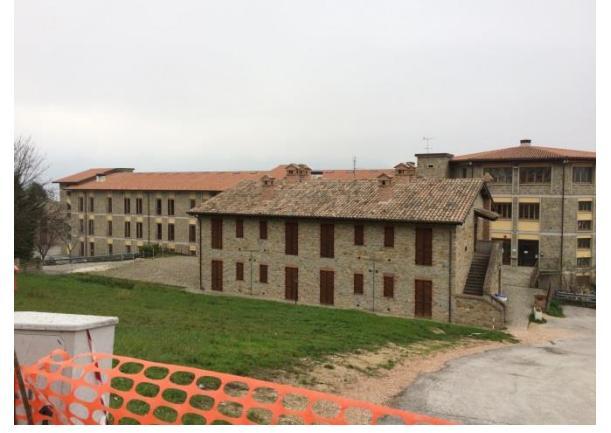
Figure 6.84. Representative pictures taken in Camerino (see Table 6.11 for details).

Figure 6.83 and Table 6.11 show locations of representative buildings inspected in the historic center of Camerino, including the red zone. Figure 6.84 shows photographs of these representative structures, which include both masonry and reinforced concrete dwellings two to four stories in height. The average damage level in the inspected zone was D2.

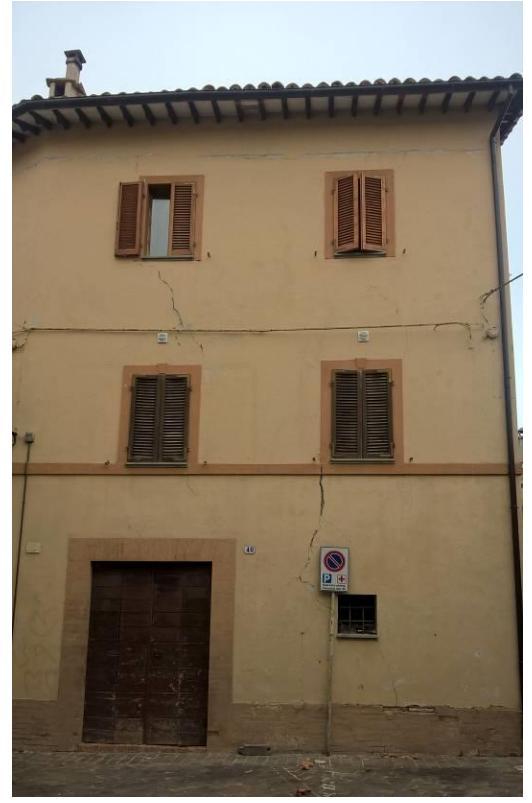
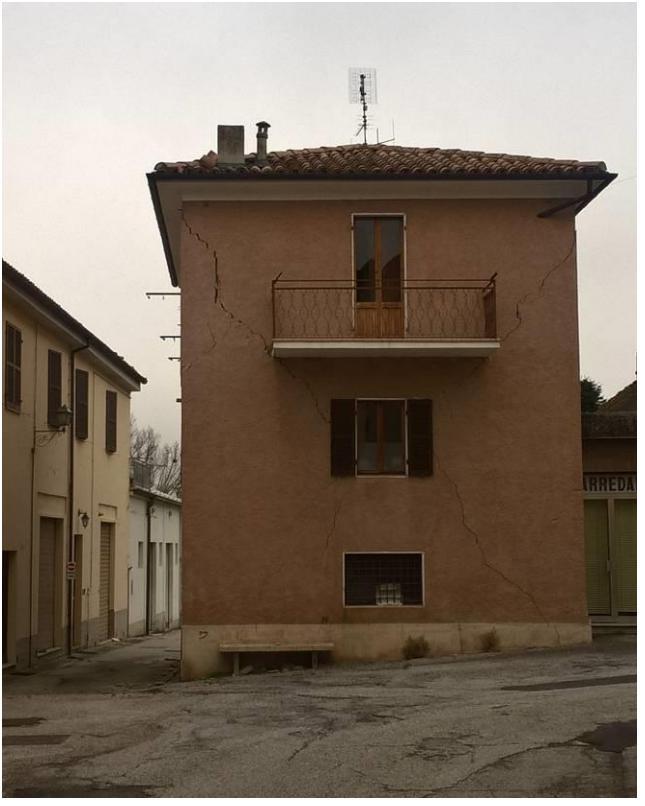
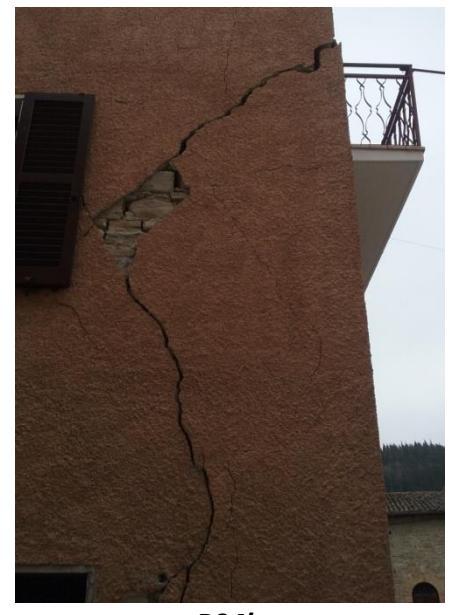
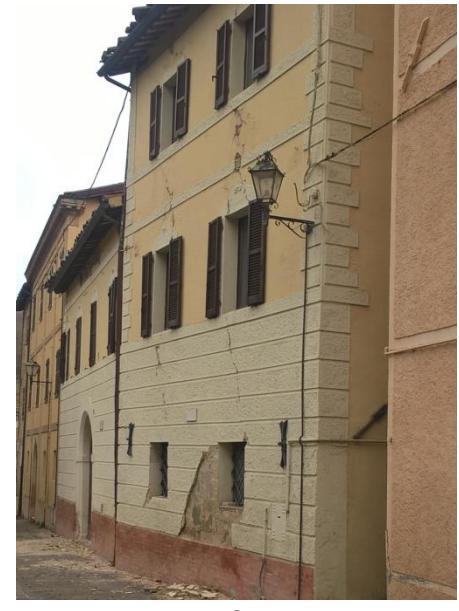
Figure 6.87. Representative pictures in Pievebovigliana during the survey (see Table 6.12).

Locations of representative photos taken in Pievebovigliana by the GEER team are reported in Figure 6.86. The pictures are presented in Figure 6.87. The historical center consists mainly of un-reinforced old masonry structures, 2-3 stories in height. Some of these structures have retrofitted. Outside of the historical center, isolated modern masonry and reinforced concrete structures were found (see P17-P18). Table 6.12 shows details and damage levels for the inspected structures.

Pievebovigliana was significantly damaged by the October events. However, the degree of damage to buildings is quite variable across the village. A preliminary damage zonation is reported in Figure 6.88. Damage levels as high as D3-D4 are concentrated in the southern portion (area of <u>Castello</u> or S. Maria Assunta church) built on a slight ridge oriented NNW-SSE that is comprised of Scaglia-Cinerea bedrock. Topographic site effects may have impacted structural performance in this area. The northern and central portions of the village generally have damage levels D2 to D2-D3. These areas are mainly located on alluvial terraced deposits. Minor damage was observed along the western portion of the village; the northern part of this area, located on alluvium, has relatively modern buildings (see P17) while the southern area is on bedrock at the toe of the Scaglia-Cinerea ridge.

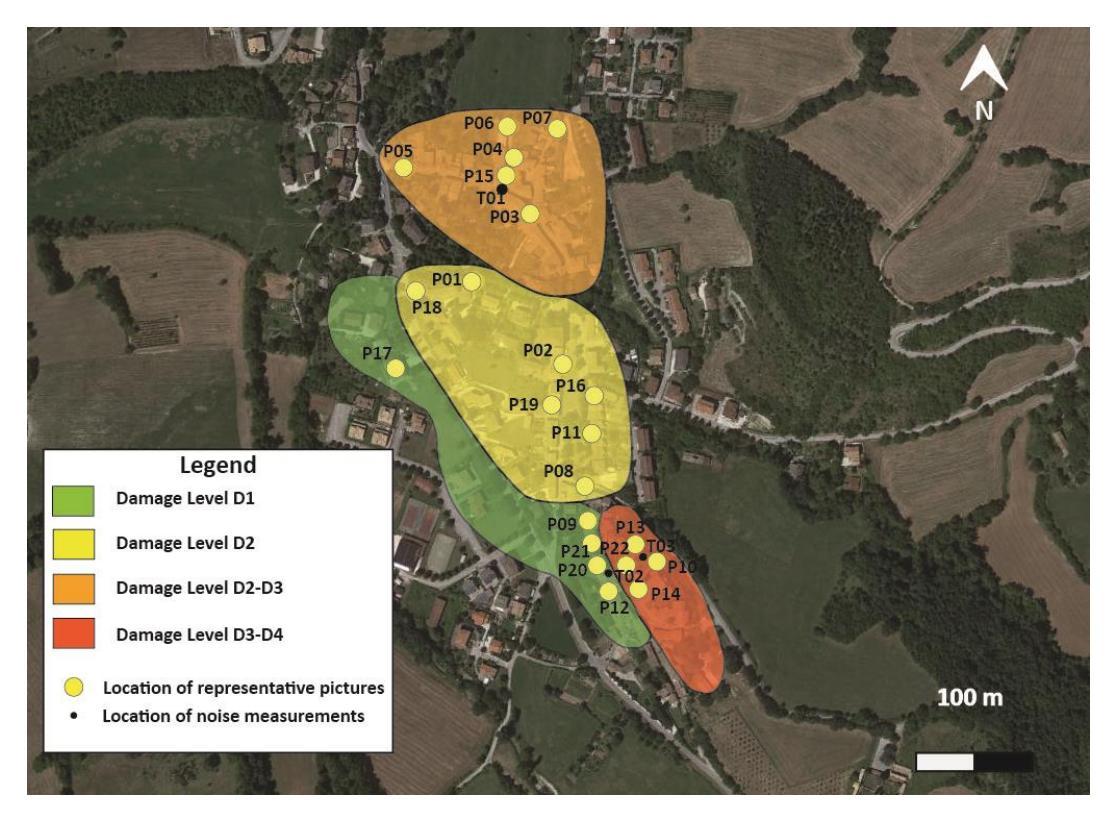
Figure 6.88. Damage zonation within the villages of Pievebovigliana village.

Three microtremor noise measurements (T01-T02-T03 in Figure 6.88) were carried out during the survey in the most damaged zone of the historical center. The same instrument and data acquisition procedures described for Visso were employed here. Average horizontal-to-vertical (H/V) spectral ratios and polar H/V are reported in Figure 6.89. The data indicate relevant H/V peaks in the 3-5 Hz range. The highest peak in T01 can be related to the resonance of alluvial soils on bedrock while peaks in T02 and T03, slightly lower in amplitude and strongly polarized, are probably influenced by the topographic feature present in southern portion of village.

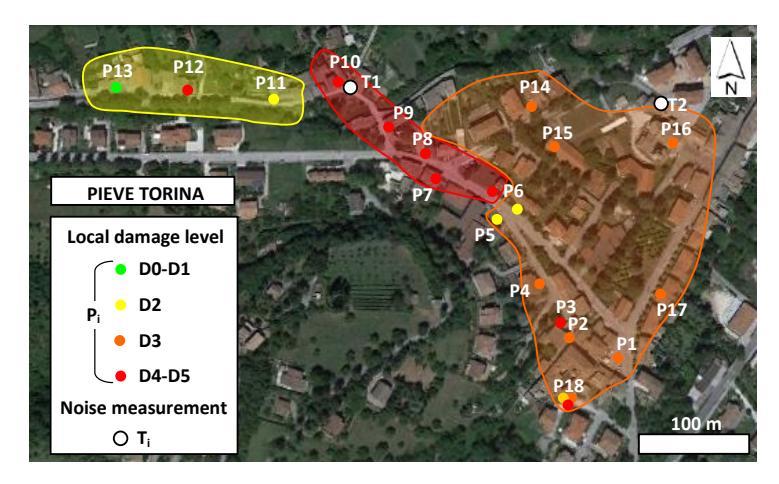
**Figure 6.90.** Locations of representative structures inspected in Pieve Torina, and damage zonation within the village.

Pieve Torina is crossed by the Sant'Angelo creek. Most of the buildings are masonry structures. Figure 6.90 shows the locations of representative structures inspected and a preliminary damage zonation. Figure 6.91 shows details of a building complex, and a damaged structure located in the center of the village. Two microtremor noise measurements (T01-T02 in Figure 6.90) were carried out during the survey in the most damaged zone of the town. Figure 6.92 shows noise measurements results in terms of H/V spectral ratio and H/V polar plots. Both measurements show a peak at about 10 Hz. This value is compatible with the high level of damage observed for one-two stories buildings (usually characterized by similar values of fundamental frequency), indicating possible double resonance phenomena.

D1-D2 - With the exception of complete collapse of pre-existing ruins, the area seems to be characterized by limited damages to non structural elements.

D3 - Heterogeneous area, in terms of structural typology and damage extent; overall, major damage to non structural elements and limited to significant damage to load bearing elements (with local collapse in some points) can be identified.

D4-D5 - Strip characterized by structures interested by huge damage to load bearing elements and local collapse.

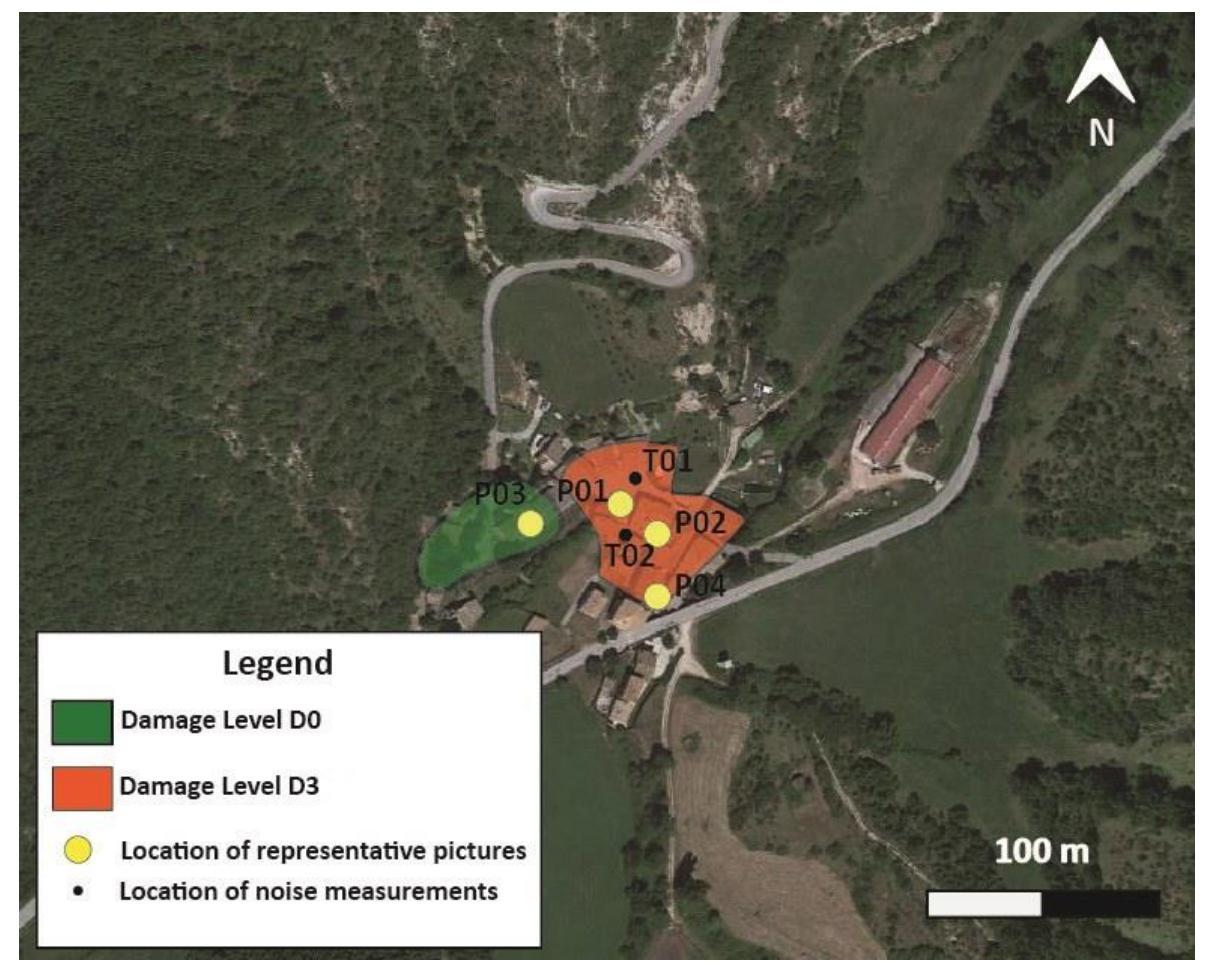
**Figure 6.94.** Locations of representative structures inspected in Fiume (Pieve Torina) and damage zonation (see Table 6.13 for details).

Fiume was significantly damaged by the October events. However, the degree of damage to buildings is strongly variable across the village (Figure 6.94). In particular, the eastern portion, founded on colluvial and alluvial deposits resting on bedrock, experienced high levels of damage (D3, see pictures P01-P02) whereas the western portion located on travertine rock had negligible damage (see P03).

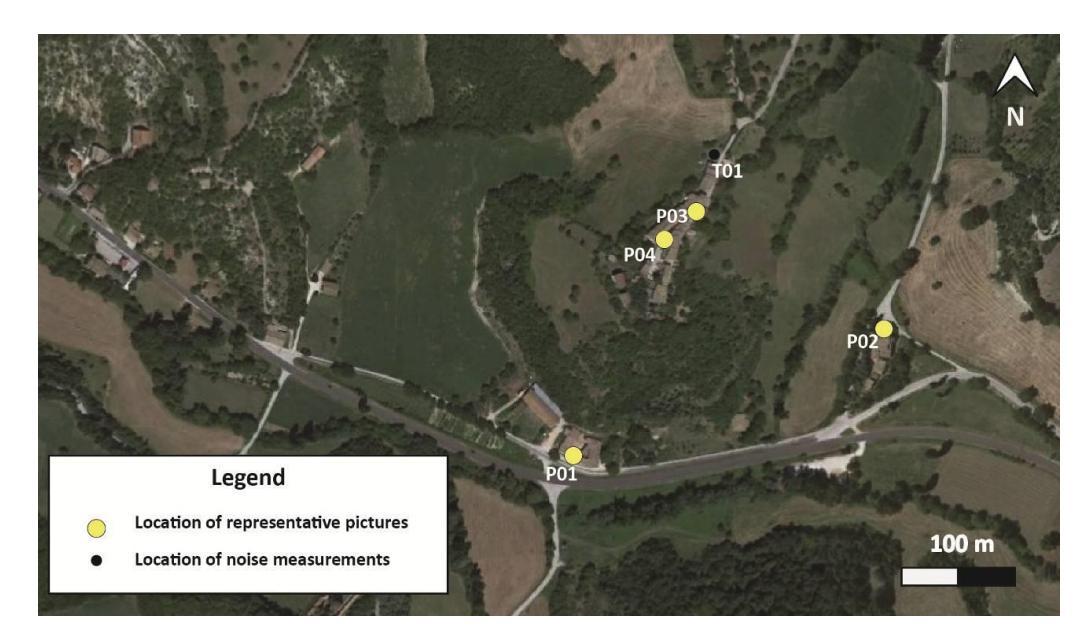
**Figure 6.98.** Locations of representative structures inspected in Casavecchia (see Table 6.14 for details).

The village consists essentially of un-reinforced old masonry structures, 2-3 stories in height. It was significantly damaged by the October events, being the damage level slightly higher in the upper part (Casavecchia Alta) where several partial and full collapses took place (see P03-P04) with respect to Piè Casavecchia (P01-P02).

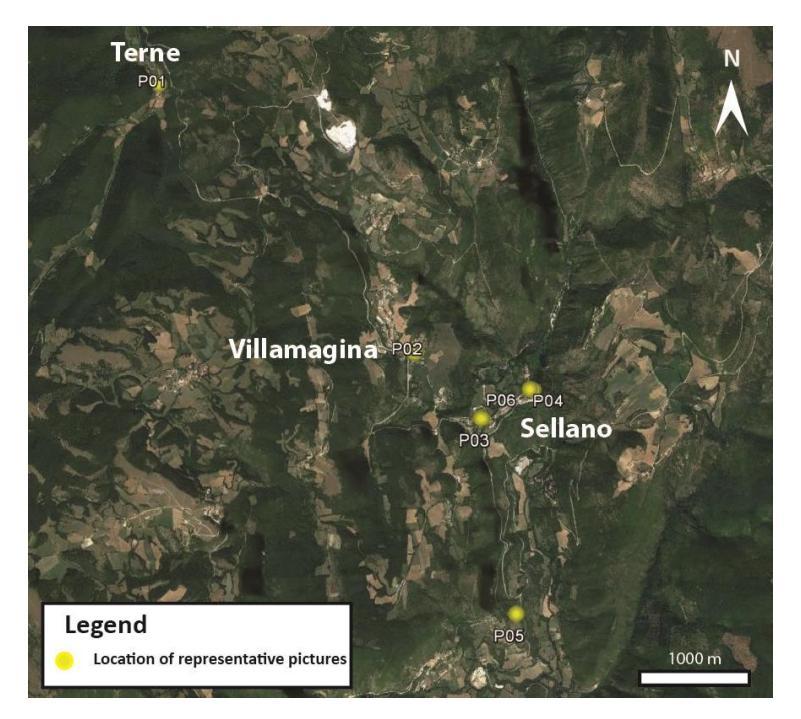
No or negligible damage was observed in the hamlets of Terne and Villamagina (on average D0-D1). Slightly higher damage (D1-D2) was reported in the upper part of Sellano (area of Santa Maria Assunta and Municipio, see P04 and P06).

**Figure 6.101.** Locations of representative structures inspected in Sellano and surrounding hamlets (see Table 6.15 for details).

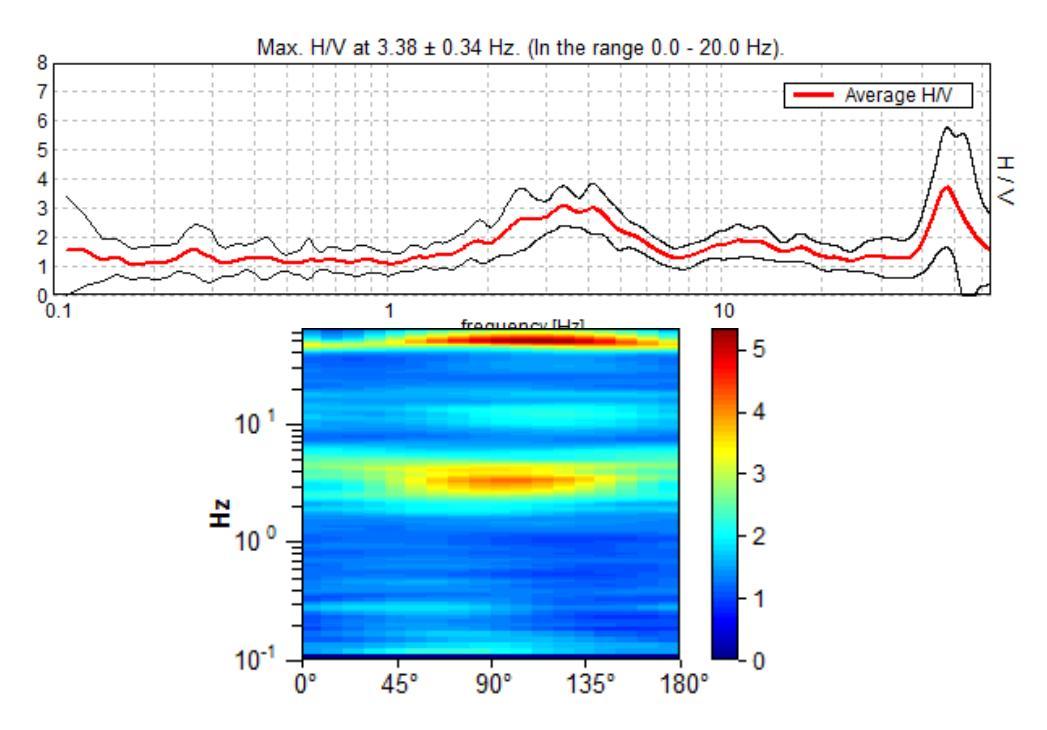
A noise measurement was carried out during the survey in the upper part of Sellano (close to P06 in the Municipio square), about 30 m from a slope. The same instrument and data acquisition procedures described for Visso survey were employed. Average horizontal-to-vertical (H/V) spectral ratios and polar H/V plots are reported in Figure 6.103. A broad band peak can be identified at about 3-5 Hz that is clearly polarized in the direction of about 90°, which is roughly orthogonal to the strike of the adjacent slope.

**Figure 6.103.** Noise measurement results in terms of H/V spectral ratio (top) and H/V polar plots (bottom) (Sellano, Municipio square, 42.888828°- 12.926805°).

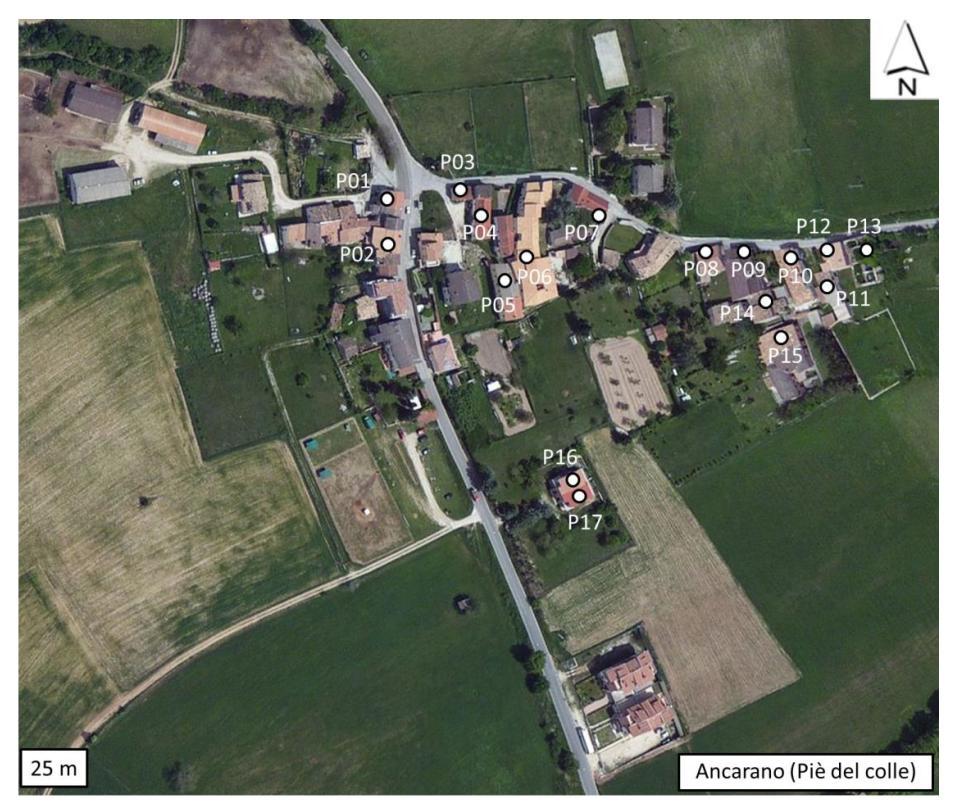
Figure 6.104 and Table 6.16 show locations and details of representative buildings inspected in Pié del Colle. Figure 6.105 shows representative structures, which include unreinforced masonry and reinforced concrete buildings. Damage was observed to both types of structures, although among reinforced concrete structures the principal damage was collapse of interior tiles from frames. Typical damage levels were between D2 and D3.

Figure 6.104. Locations of the representative structures inspected in Ancarano pié del c	colle (see
Table 6.16 for details).

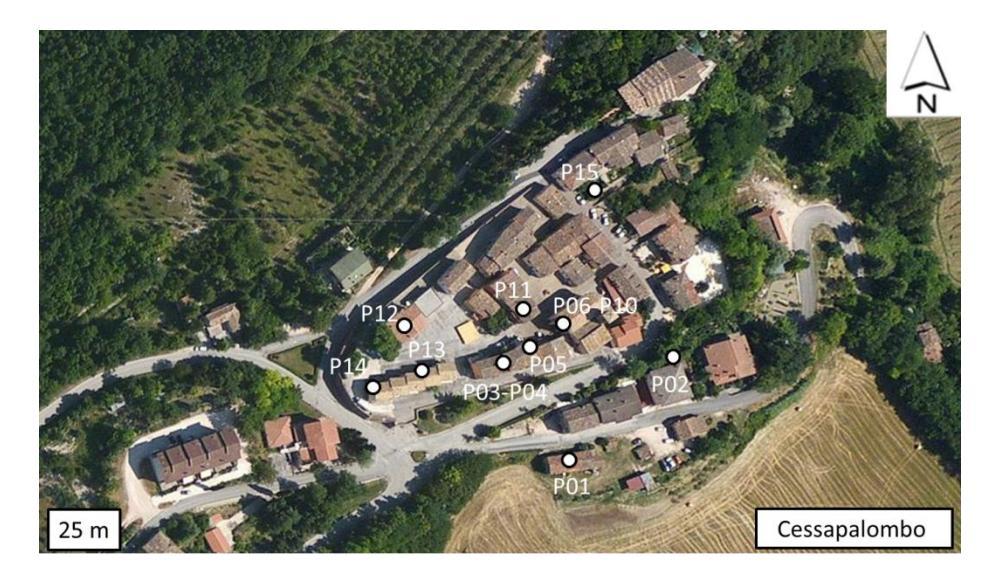
Table 6.17 summarizes locations and details of the representative inspected buildings, while Figure 6.108 shows locations of these buildings. Figure 6.109 shows pictures of representative structures in the village. The average damage level in the main village is approximately D1 to D2.

**Figure 6.108.** Locations of the representative structures inspected in Cessapalombo (see Table 6.17 for details).

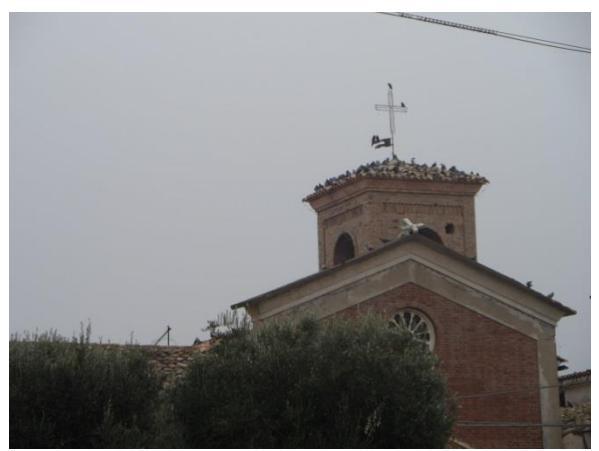
P08

Figure 6.109. Representative pictures taken at Cessapalombo (see Table 6.17 for details).

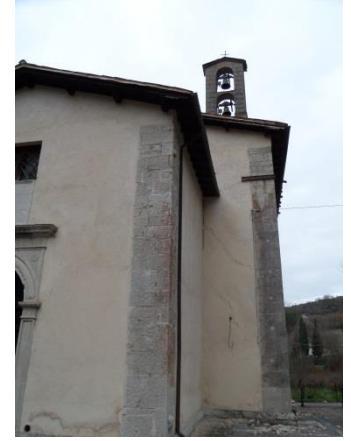
P01

Preci (42.880697, 13.039657) has about 750 inhabitants and is located in the province of Perugia. Apart from the main village, it has several hamlets: Abeto, Acquaro, Belforte, casali Belforte, Case sparse, Castelvecchio, Collazzoni, Collescille, Corone, Fiano, Montaglioni, Montebufo, Poggio di croce, Piedivalle, Roccanolfi, Sacco Vescio, San Lazzaro, Todiano, Villa del
Guado. Ground motion levels are reported in Table 6.1. The main village was lightly damaged. Figure 6.110 shows the location of representative pictures taken in Preci, while Figure 6.111 shows a church with damage level D1.

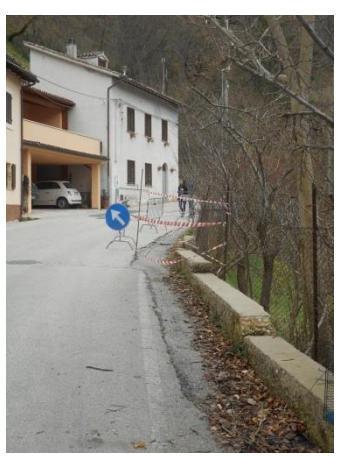
P02

The hamlet of Piedivalle (42.866786, 13.060767) belongs to the municipality of Preci and is about 2.5 km from the Preci center. Its elevation is 611 m a.s.l. and it has 35 inhabitants. Estimated ground motions are given in Table 6.1. We inspected three structures at the location shown in Figure 6.112. The building photographs are shown in Figure 6.113. The masonry structures have damage level D1.

#### Figure 6.113. Representative pictures taken at Piedivalle.

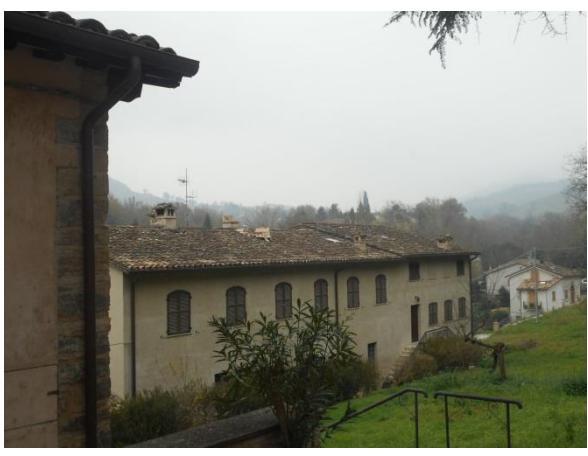
P01

Figure 6.115. Representative pictures taken at Caldarola (see Table 6.18 for details).

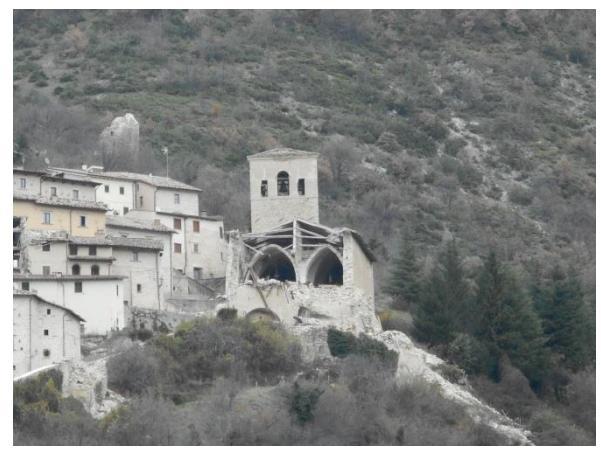
Picture	DATUM	Location		Damage Level	Notes
		Lat.	Long.		
P01	WGS-84	42.853422	13.101411	D4	
P02	WGS-84	42.853480	13.100616	D2-D5	
P03	WGS-84	42.853819	13.100276	D2-D5

Figure 6.117. Representative pictures taken at Castello di Campi (see Table 6.19 for details).

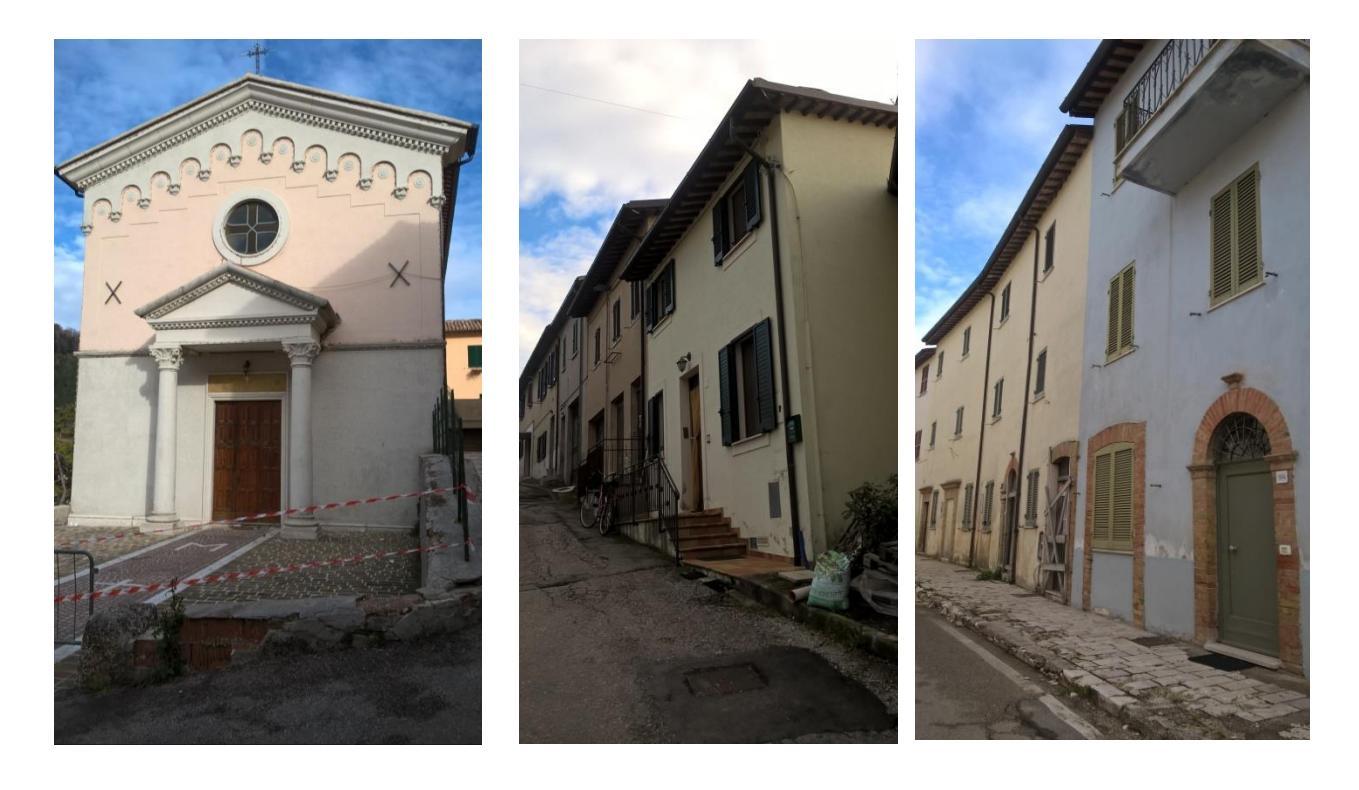
Colfiorito village consists essentially of masonry structures, 2-3 stories in height. Some structures were retrofitted following the 1997 earthquake. No or negligible damage was observed (on average D0-D1). Table 6.1 lists ground motion levels.

P01P02P03Figure 6.118. Representative pictures taken in Colfiorito during the survey (see Table 6.20)

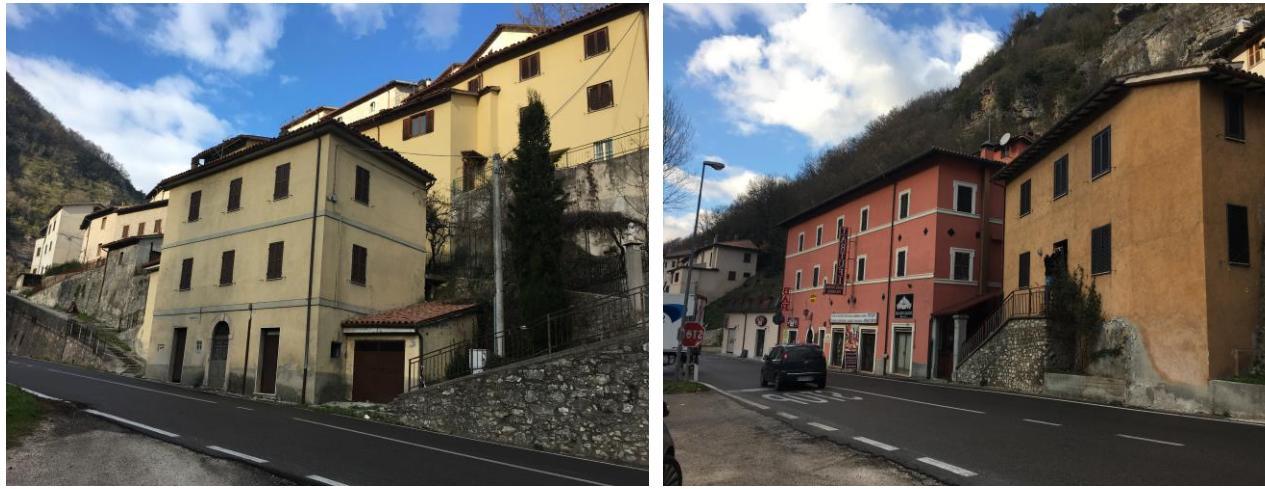
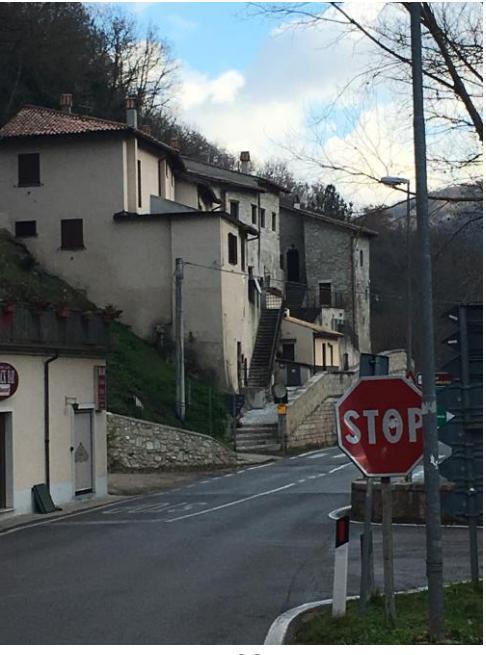
Serravalle is a hamlet part of the municipality of Norcia, in the province of Perugia, Umbria region. Serravalle is located about 6 kilometers from Norcia and it has a population of 25 people. Ground motion levels are reported in Table 6.1 The hamlet was not damaged by the earthquake and the generalized damage level was D0 (Figure 6.123, Table 6.22).

**Figure 6.123.** Representative pictures taken in Serravalle during the GEER reconnaissance (see Table 6.22).

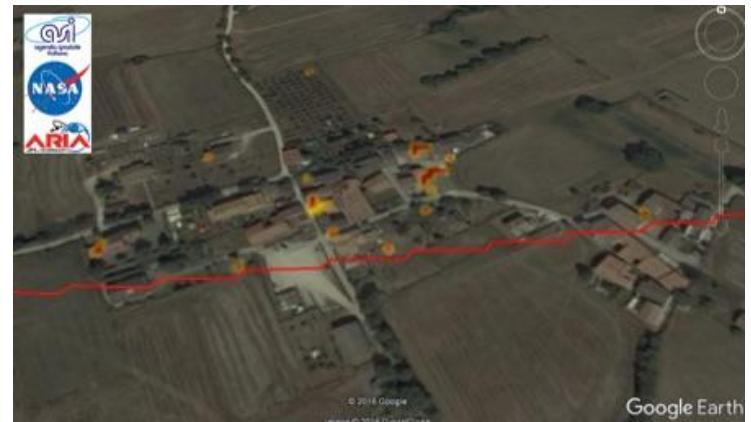
Figure 6.124. Damage proxy map of Popoli (http://aria-share.jpl.nasa.gov/events/20161030-Italy\_EQ/DPM/, last accessed 21 April, 2017).

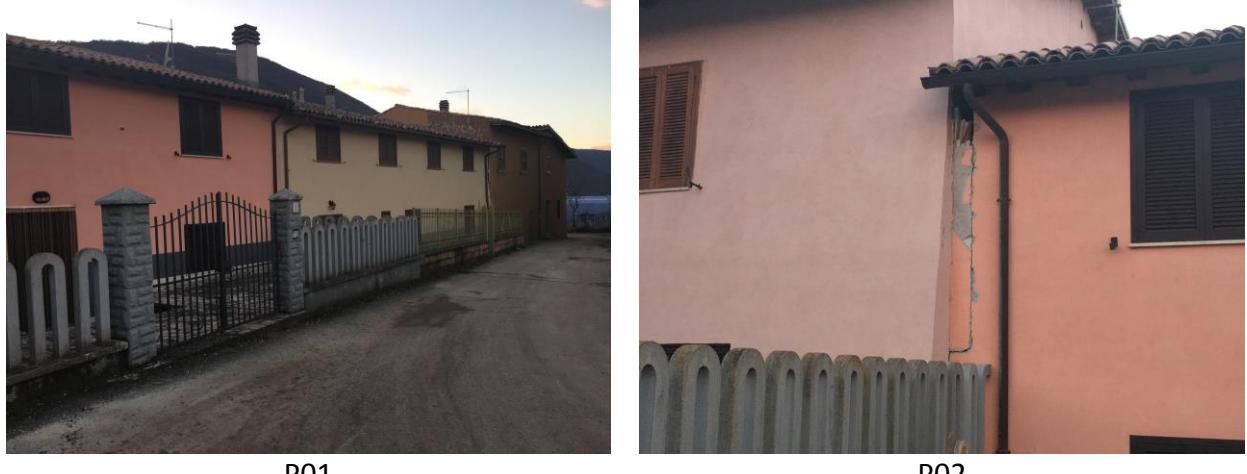
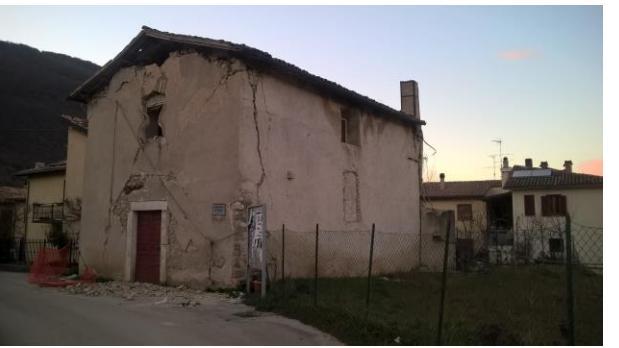
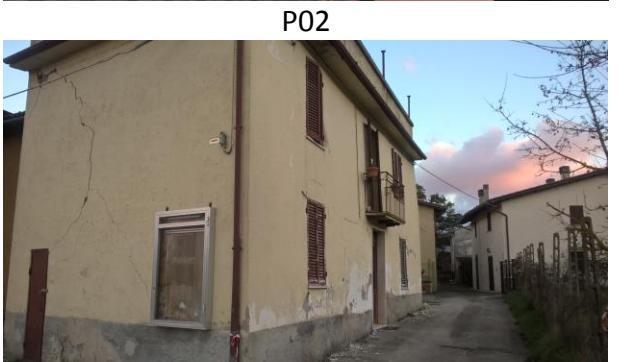
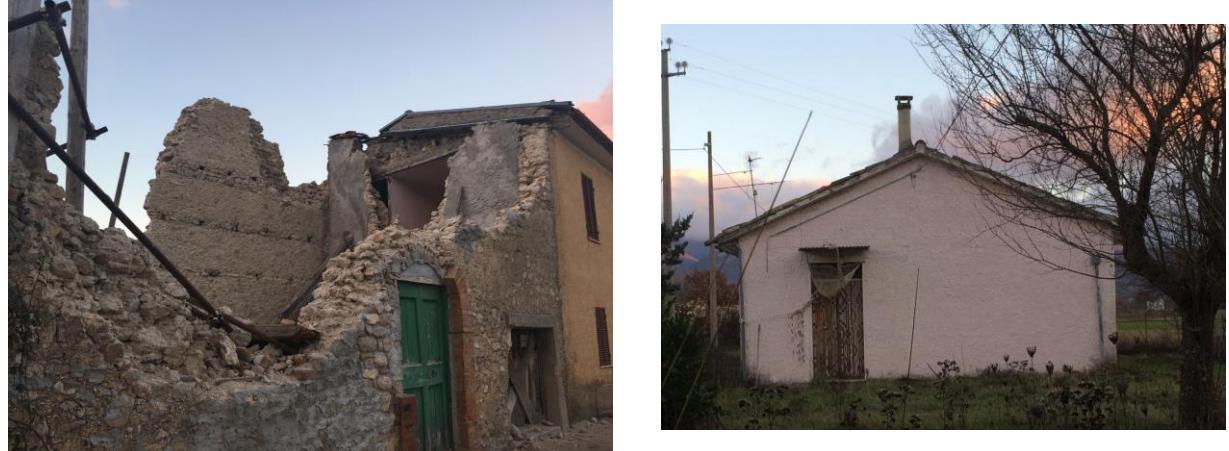
The small village of Popoli is located 4.67 km far from Norcia. Before the 24 August 2016 earthquake, 47 people lived there. There were 51 buildings, 43 of which for residential use. The majority of the structures are one or two-story masonry buildings, constructed before 1919. In the last 30 years, only seven buildings were built. Others structural types are also present (wooden and steel structures). Before the 24 August event, 32 buildings were assessed in excellent conditions, 7 in good conditions and 4 in poor conditions due to aging effects and lack of maintenance (<u>http://italia.indettaglio.it/ita/umbria/perugia norcia popoli.html</u>, last accessed 21 April, 2017). The village is located in a valley floor consisted of alluvial deposits, susceptible to seismic amplification phenomena. Ground motion levels are reported in Table 6.23 Figure 6.124 shows the damage proxy map after the 30 October earthquake. Red zones mark zones seriously damaged (damage level D5). Figure 6.125 shows buildings with different

level damage ranging from D0 to D5. Only poorly constructed masonry buildings experienced major damage.
