# Engineering Reconnaissance Following the October 2016 Central Italy Earthquakes Version 2

GEER Team Leaders: Jonathan P. Stewart and Giuseppe Lanzo

Geotechnical Extreme Events Reconnaissance Association Report No. GEER-050D 8 May 2017

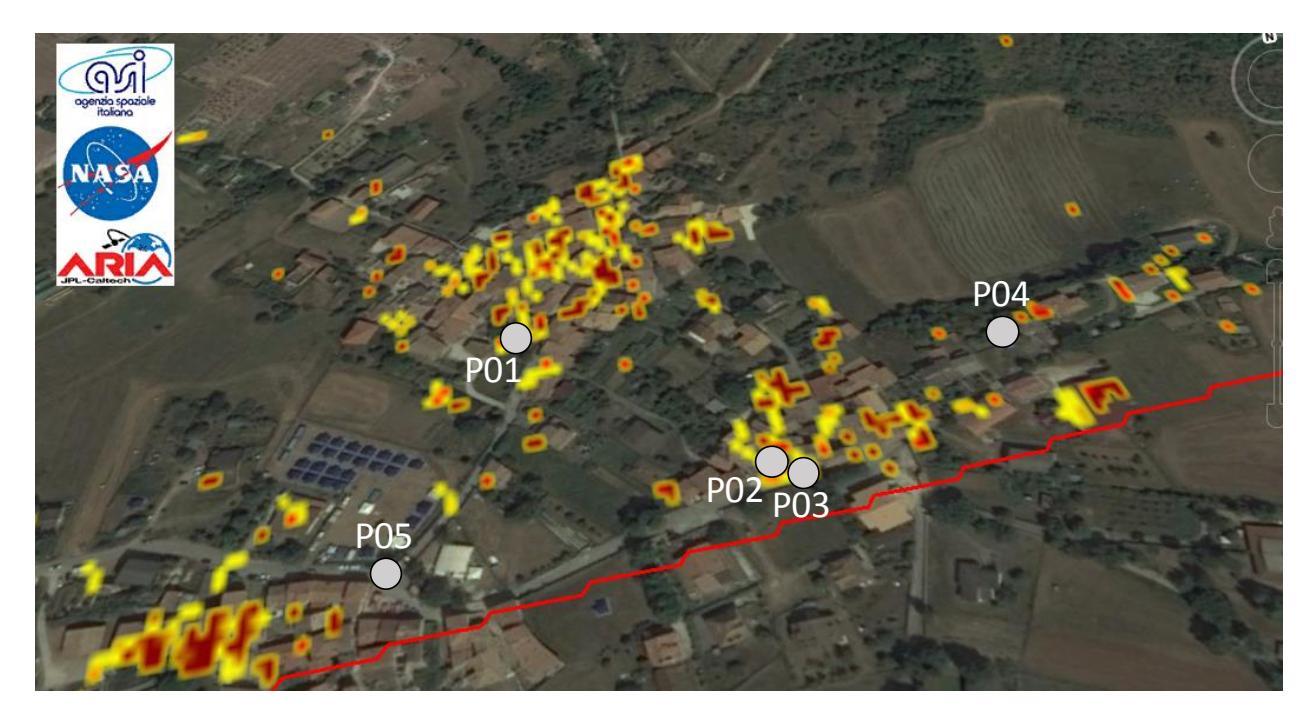
**Figure 6.126.** Damage proxy map of San Pellegrino (<u>http://aria-share.jpl.nasa.gov/events/20161030-Italy EQ/DPM/</u>) along with the identification numbers of the structures with assigned damage level D5.

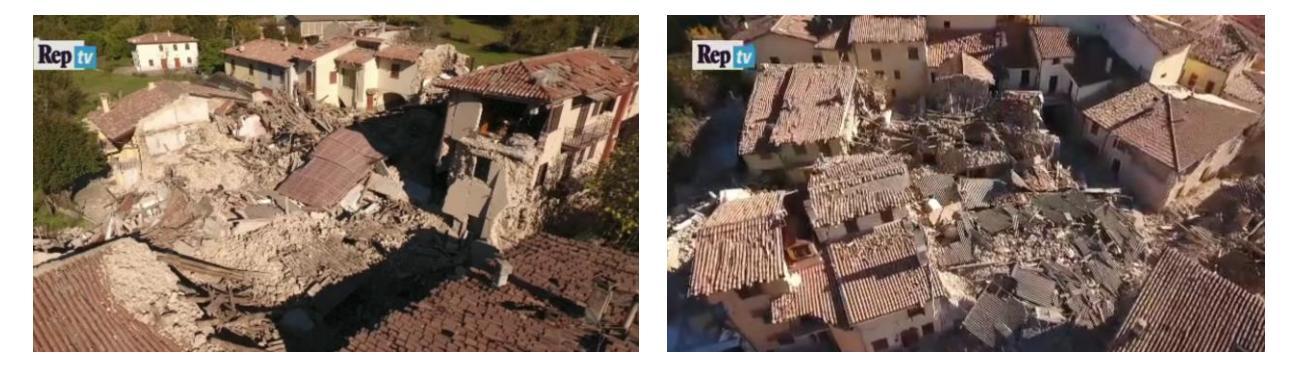
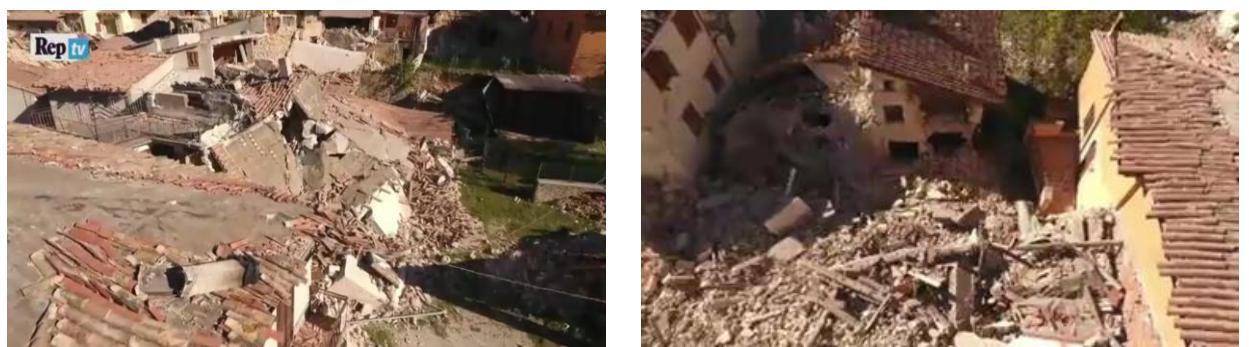
During our reconnaissance following the 30 October event, we observed extensive damages in almost all the masonry structures (classified as D3-D5) located mainly in the historical center of the town, which was in part not accessible. Some pictures of the damaged buildings in the historical center are shown in Figure 6.127 (source Repubblica.it, last accessed 21 April, 2017). In the new part of the town damages were concentrated on non-structural components of some of the reinforced concrete buildings recently constructed (classified as D2). Figure 6.128 shows multi-epoch pictures (before August and after 30 October, 2017) of selected locations. Table 6.24 summarizes the overall damage level observed in these locations.

**Figure 6.127.** Damaged constructions in the oldest part of San Pellegrino (http://video.repubblica.it/dossier/terremoto-30-ottobre/terremoto-centro-italia-la-distruzione-a-san-pellegrino-di-norcia-dal-drone/257495/257761).

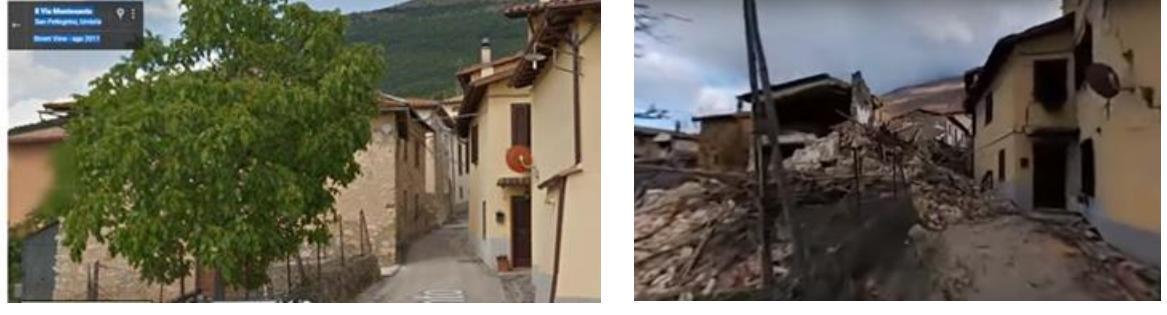
P01. Montesanto street

**Figure 6.128.** Pictures of the structures with assigned damage level D5 in San Pellegrino, before and after the October earthquake, along with their identification numbers.

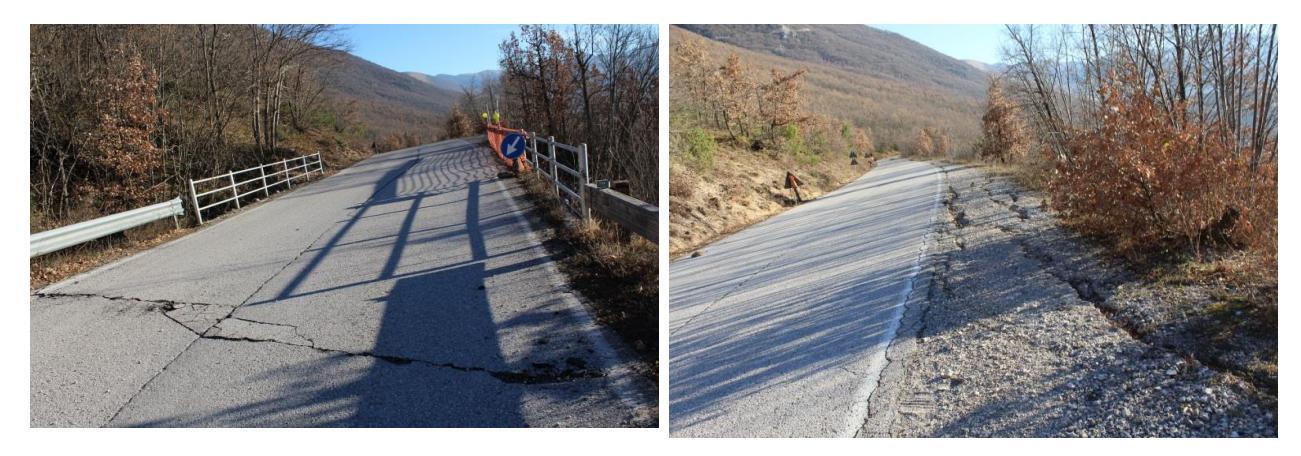
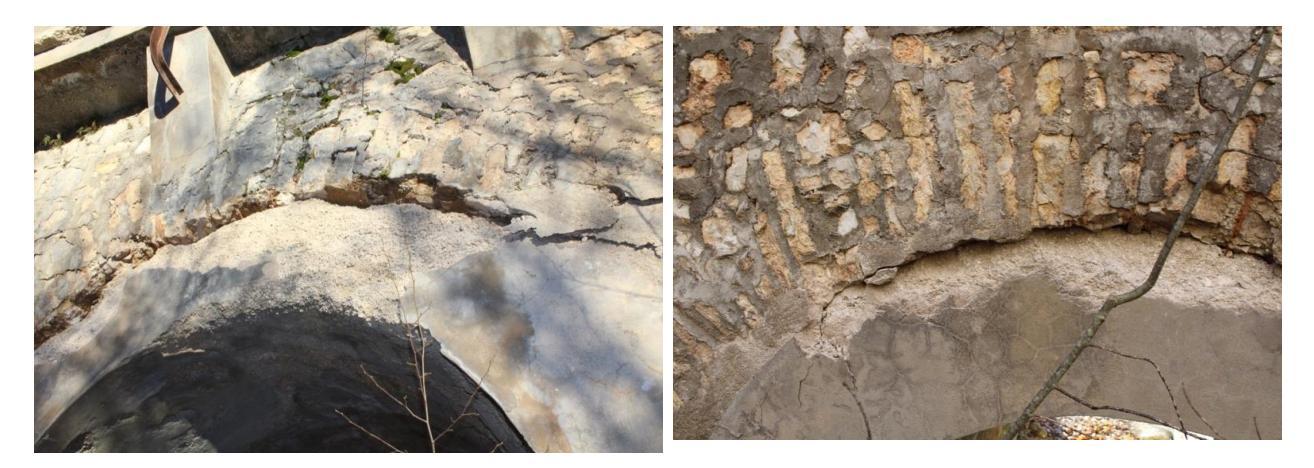
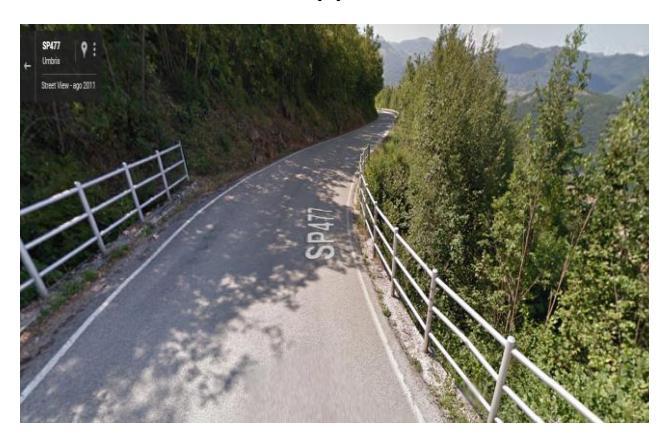
Figure 7.2 shows damage observed on the single arch masonry bridge along road SP477. The bridge did not appear seriously damaged, but several cracks were observed, especially in the road carriage. Transversal and longitudinal cracks along the road surface were documented (Figure 7.2a), with a measured maximum opening in the longitudinal direction of about 6 cm. From the visual inspection, the transversal cracks close to the road-bridge connection appear more recent when compared to those in the longitudinal direction. Longitudinal cracks also formed in road fill adjacent to the bridge (Figure 7.2b). Minor additional cracking was observed within the bridge arch (Figures 7.2c and 7.2d). Figure 7.2e (from Google earth) shows a photo of the bridge in December 2011, when no roadway cracks are evident. Because this bridge was not inspected in the reconnaissance performed following the August 2016 sequence, we cannot identify which events produced the observed effects.

**Figure 7.2.** Bridge along SP477 (42.782073 deg, 13.142383 deg): road surface cracks (a); longitudinal cracks along the road side (b); cracks between the bridge arch and the main structure (c-d); view of the bridge on December 2011 (e).

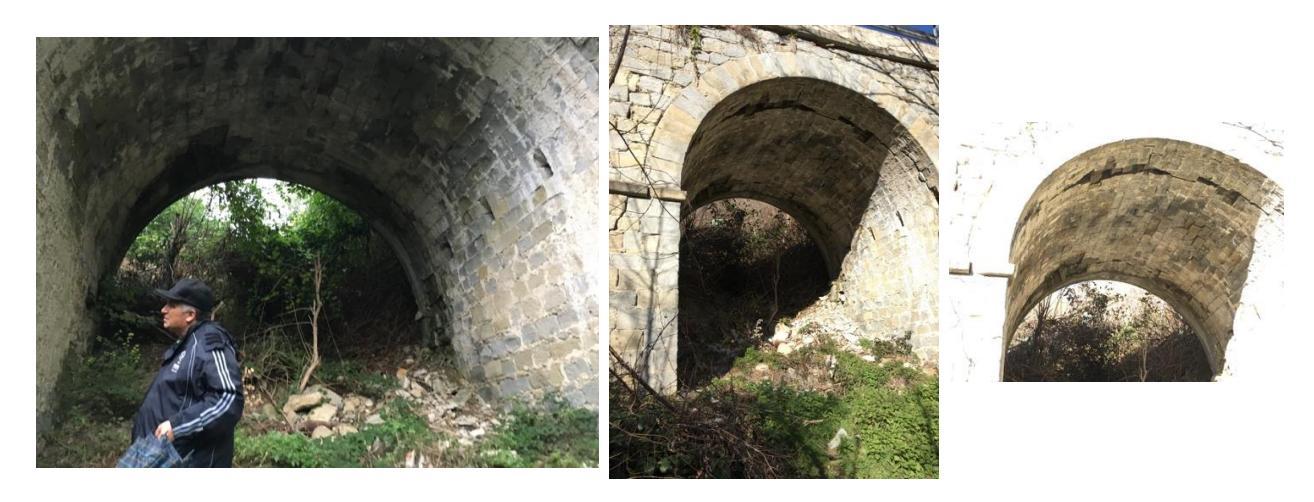
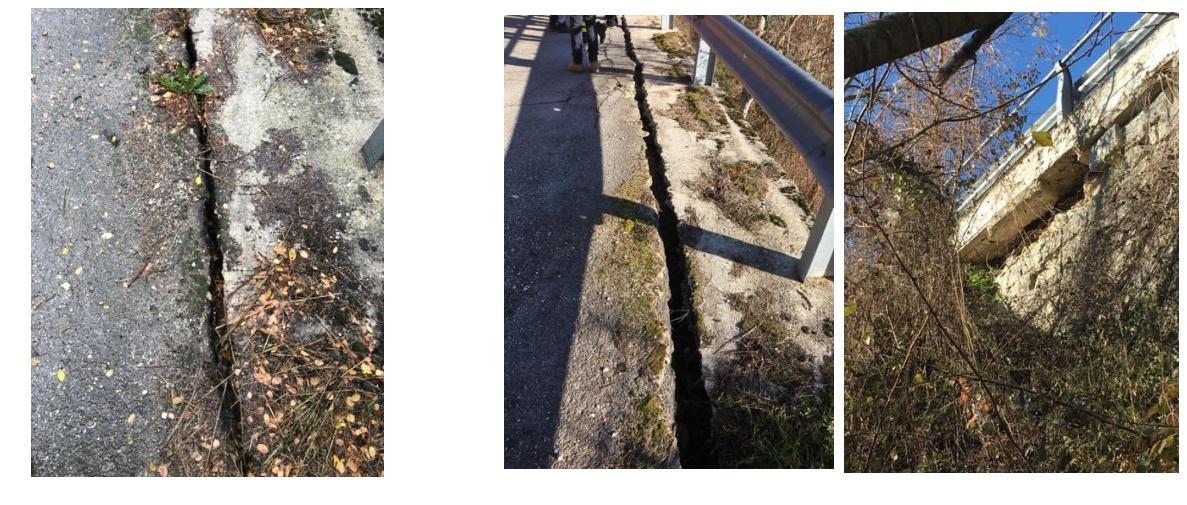
Figure 7.3 shows comparative pictures (taken after the 24 August and the October events) of the 1-span masonry bridge along the Trisungo route (along road SP129). The bridge presents additional cracks following the October events in the interior part of the arch (Figure 7.3b). The

width of the crack in the longitudinal direction (Figure 7.3d) has increased with respect to that observed in the first reconnaissance (Figure 7.3c). However, there was no additional spalling of masonry elements as had been observed following the first event.

**Figure 7.3.** Roman-era bridge along the Trisungo route (1 span bridge - Tufo area – Arquata del Tronto - N42.735981, E13.254862): view of the arch (a, b) and the road cracks (c, d) after the 24 August event (photo on September 7 2016 (a, c)) and after the 30 October event (photo on December 13 2016 (b, d)).

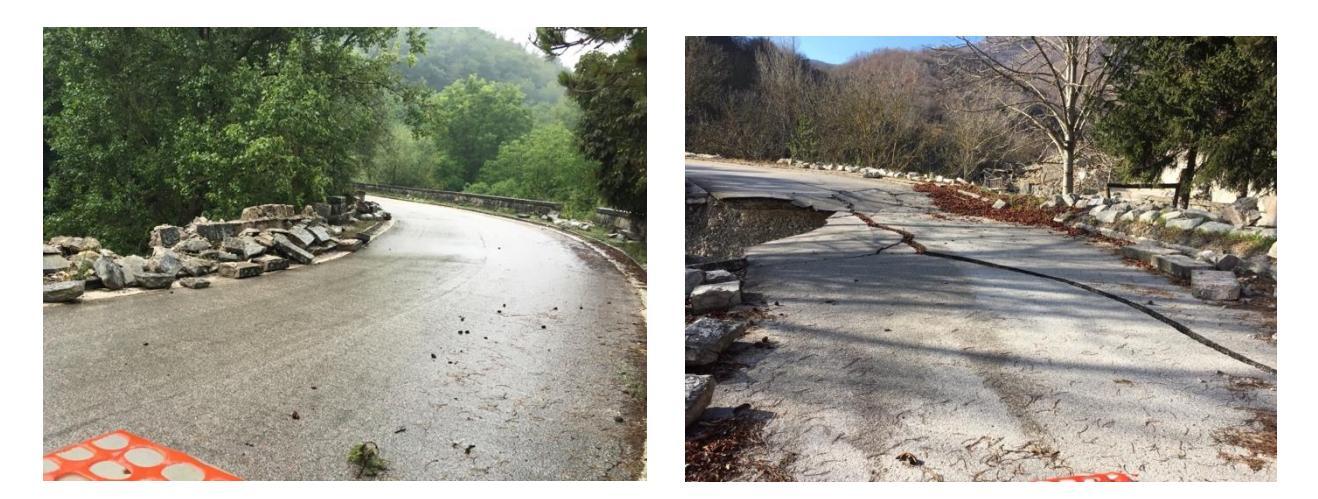
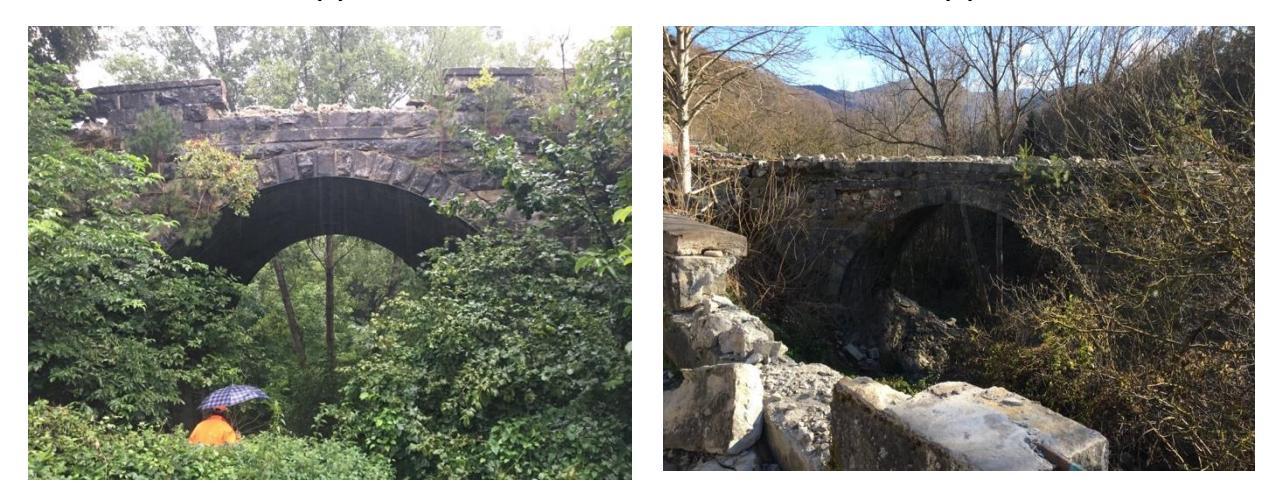
Figure 7.4 shows the response of the second arch along the Trisungo route (3 spans bridge) after the different events (24 August and October 2016). The incremental damage was significant: part of central arch, already damaged after the first event (Figures 7.4a and 7.4c), collapsed as a result of the October earthquakes (Figures 7.4b and 7.4d).

**Figure 7.4.** Roman-era bridge along the Trisungo route (3 spans bridge - Tufo area – Arquata del Tronto - N42.73538, E13.25365): (c) after the 24 August event (photo on September 7 2016) and (d) after the 30 October event (photo on December 13 2016).

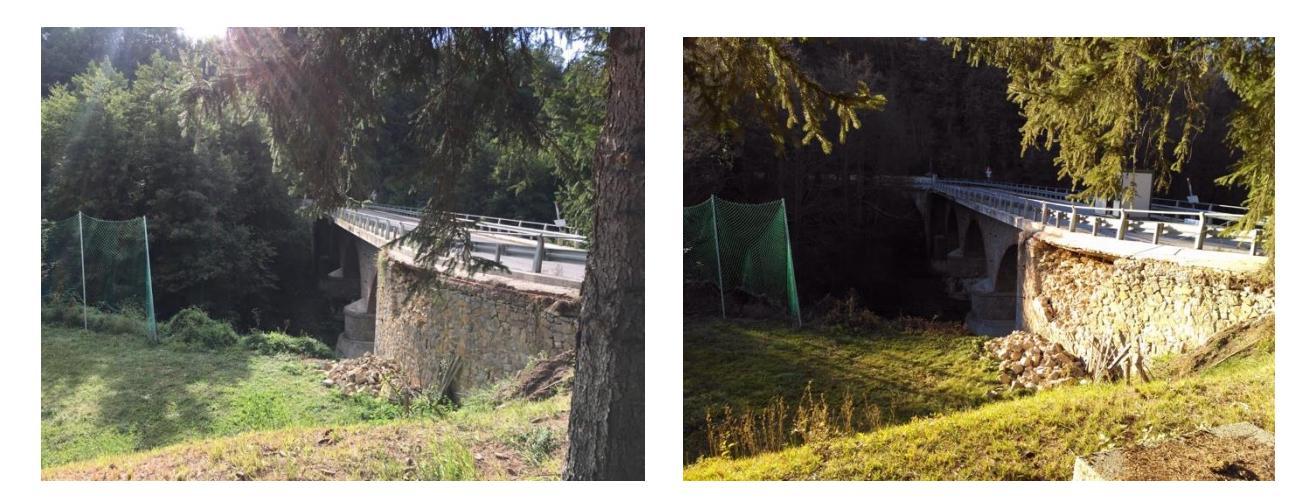
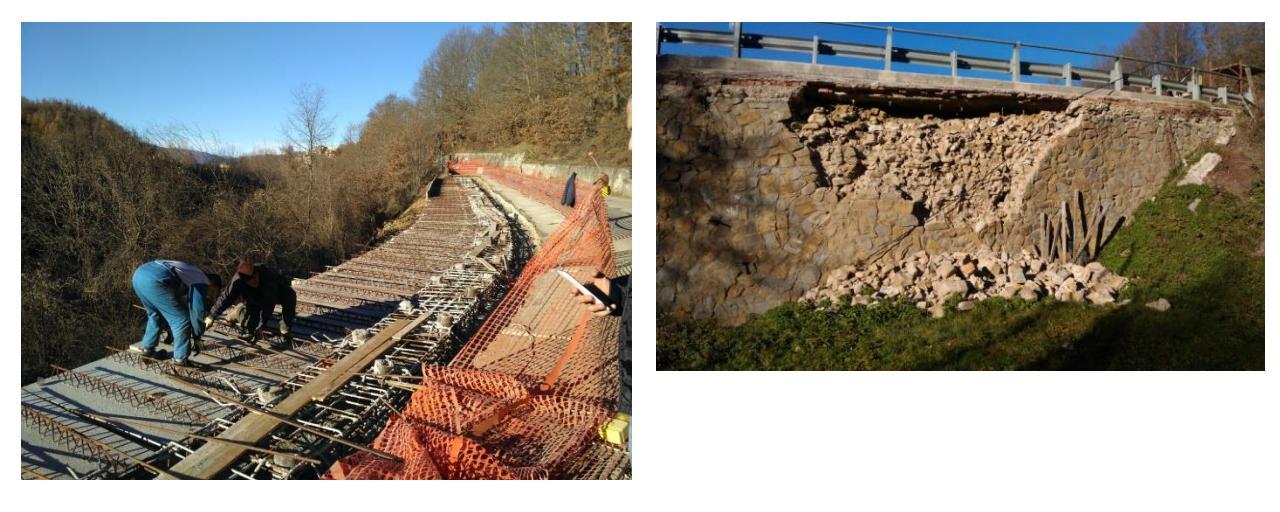
The Ponte a Tre Occhi (Three eyes) near Amatrice (Figure 7.5) also experienced additional damage, consisting mainly of spalling of outer-layer masonry elements located along abutment areas (not involving the three arches) (Figure 7.5b). At the time of the reconnaissance (December 2, 2016) repairs had been carried out on one of the two abutments (Figure 7.5c), while the bridge masonry and structure appeared to have not yet been repaired (Figure 7.5d).

**Figure 7.5.** Ponte a Tre Occhi (42.620668 deg, 13.290176deg): (a) after the 24 August event (photo on September 7 2016) and (b,c,d) after the 30 October event (photo on December 13 2016), repairing works (c) and bridge masonry collapse (d).

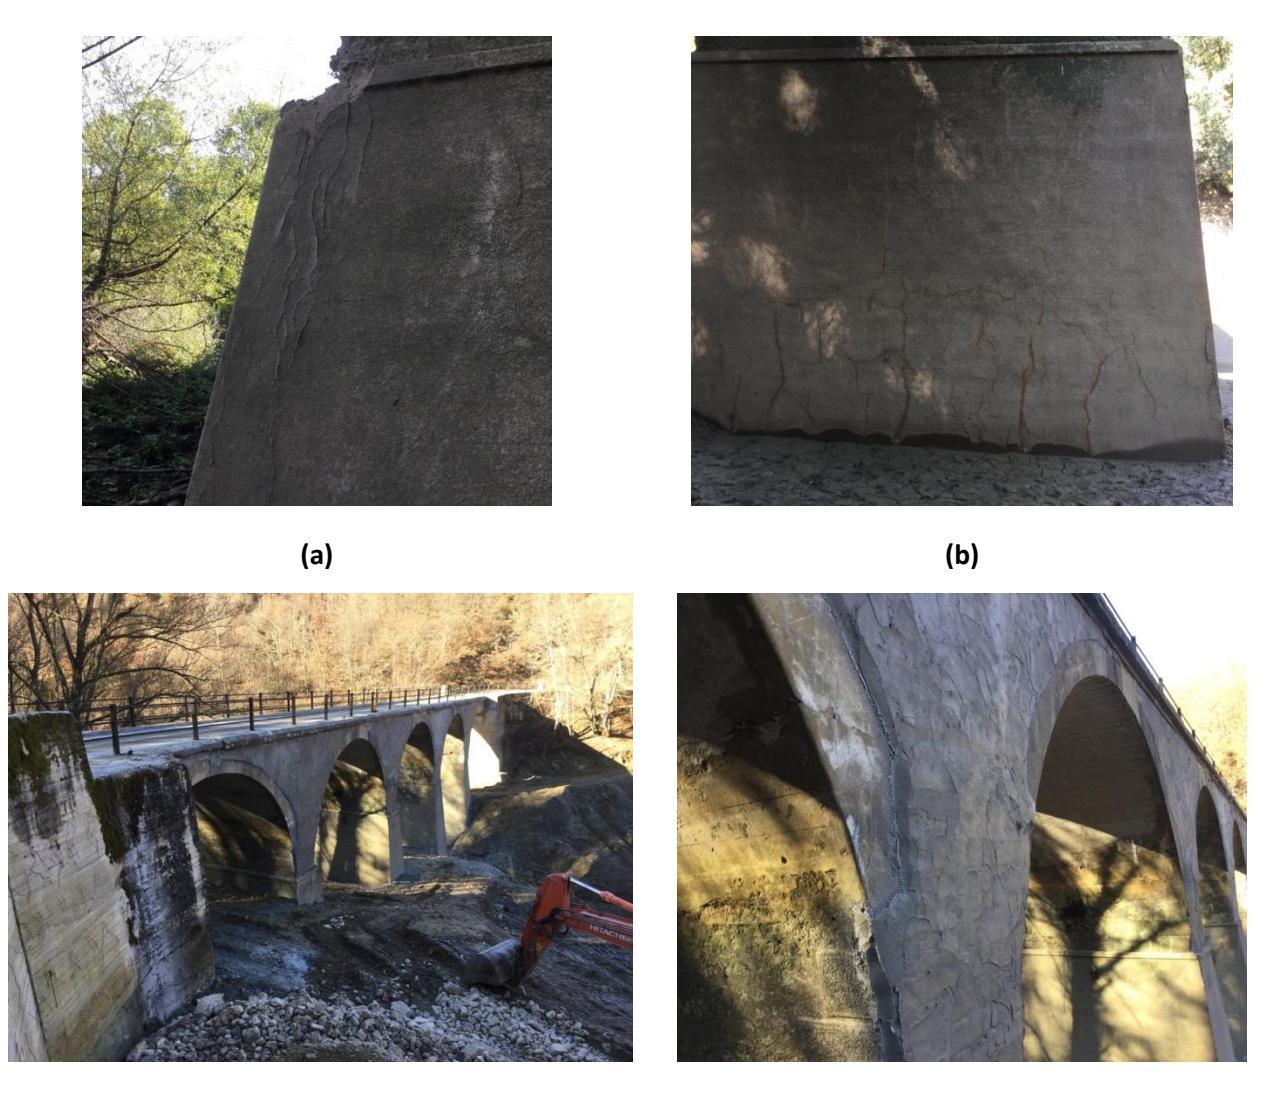
The Ponte a Cinque Occhi (Five eyes) along the internal road connecting SS4 (from the Casale Nibbi exit) to SR260 along Scandarello lake suffered additional damage during the October strong motions. The damage was concentrated in the arches and the piers as shown in Figures 7.6a and 7.6b. The bridge was retrofitted, as a rapid intervention, in early December 2016 with fiber-reinforced mortar and steel mesh (see Figures 7.6c and 7.6d). The latter intervention was aimed at restoring the structural capacity to the piers and the abutments. Construction was also carried out on the carriage way (bridge deck) and drainage ducts were installed.

**Figure 7.6.** Ponte a Cinque Occhi (42.623178 deg, 13.250428deg): increased sub-vertical cracks to the piers after the 30 October event at the top (a) and bottom (b) of the piers (photo on November 20 2016) and structural retrofitting of the bridge (c and d) (photo on December 15 2016).
