Engineering Reconnaissance of the 24 August 2016 Central Italy Earthquake. Version 2 GEER Team Leaders: Giuseppe Lanzo and Jonathan P. Stewart

Geotechnical Extreme Events Reconnaissance Association

Report No. GEER-050B

22 November 2016

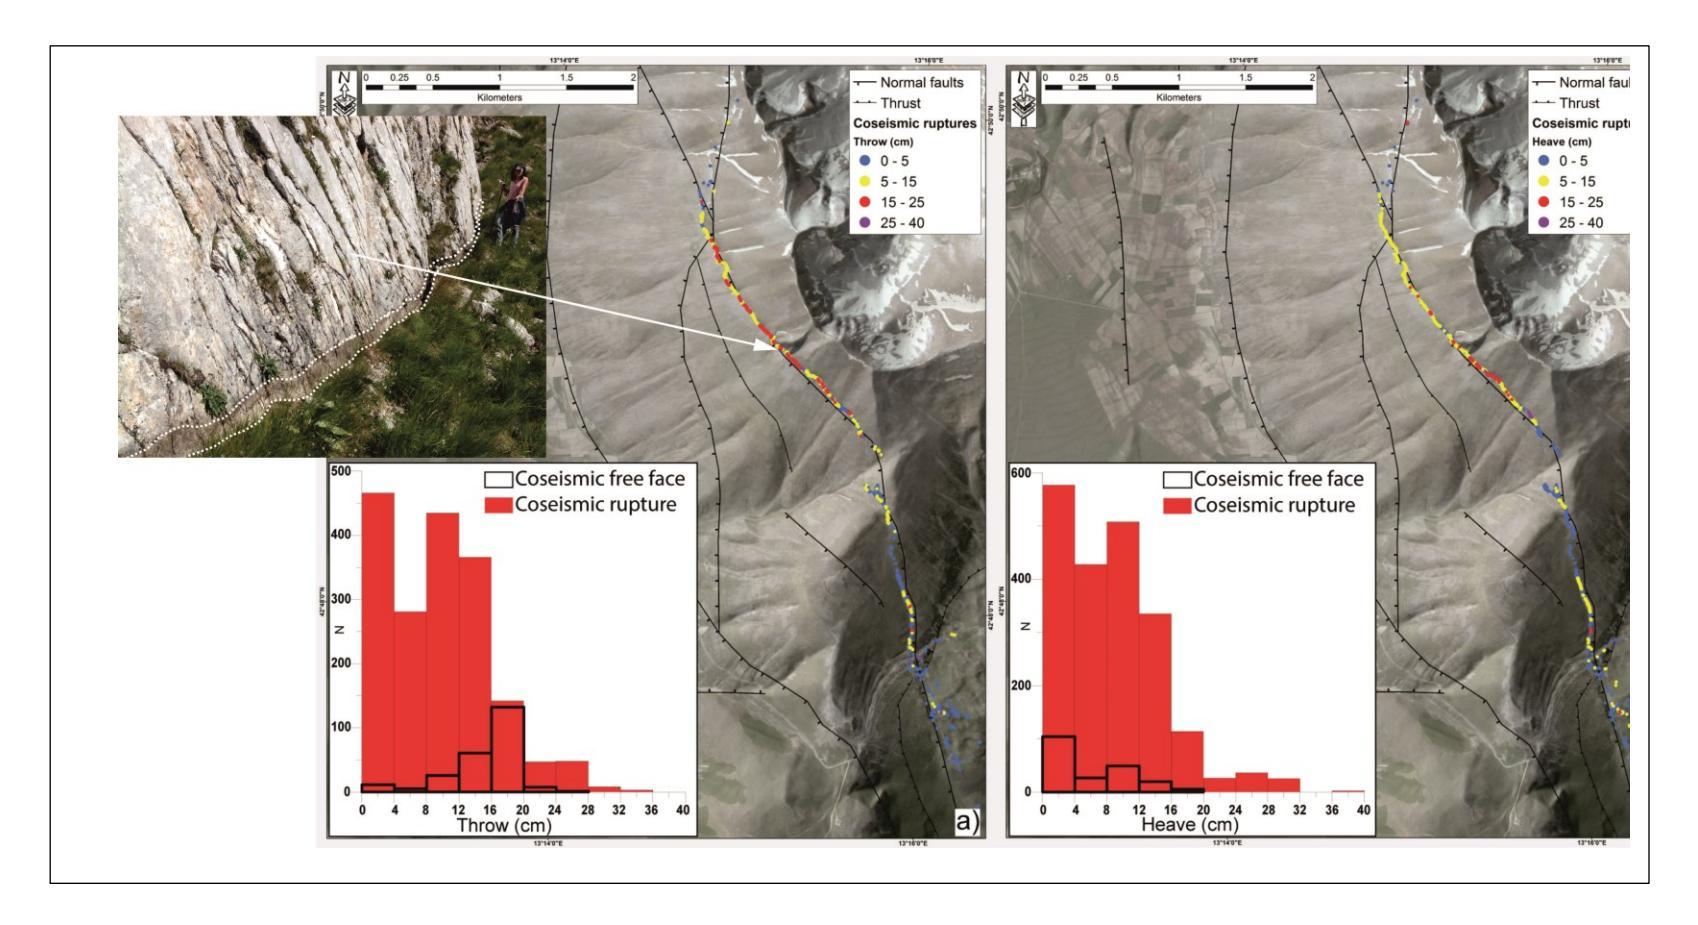
Figure 2.18 shows the locations of the three faults as described above, along with locations (and amounts) of measured displacements (EMERGEO, 2016). The displacement amounts ranged from null to approximately 35 cm in both the down-dip direction and in horizontal opening of cracks. These displacements were measured by INGV staff.

Figure 2.18. Relief map showing amounts of displacement down-dip and horizontally (from crack opening), and histograms of measured displacements (EMERGEO, 2016) along the Mt. Vettore fault splays. Free-face at the base of the fault plane, white dotted lines in inset.

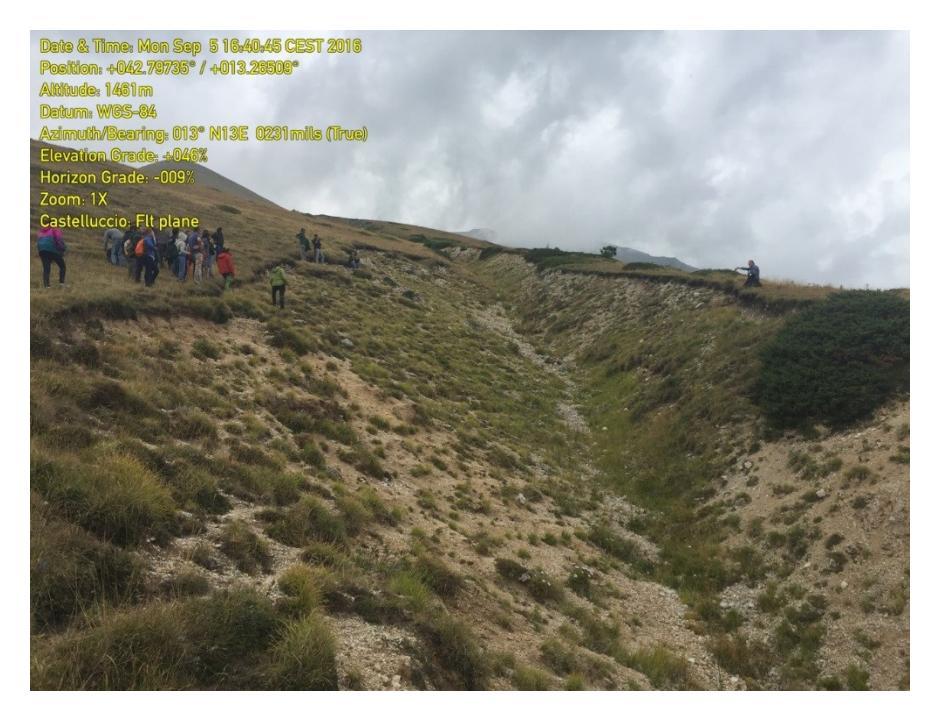
Figure 2.19a. The Mt. Vettore Fault as seen from the south near SP477 during our initial visit to the site on September 5 guided by Dr. Fabrizio Galadini.

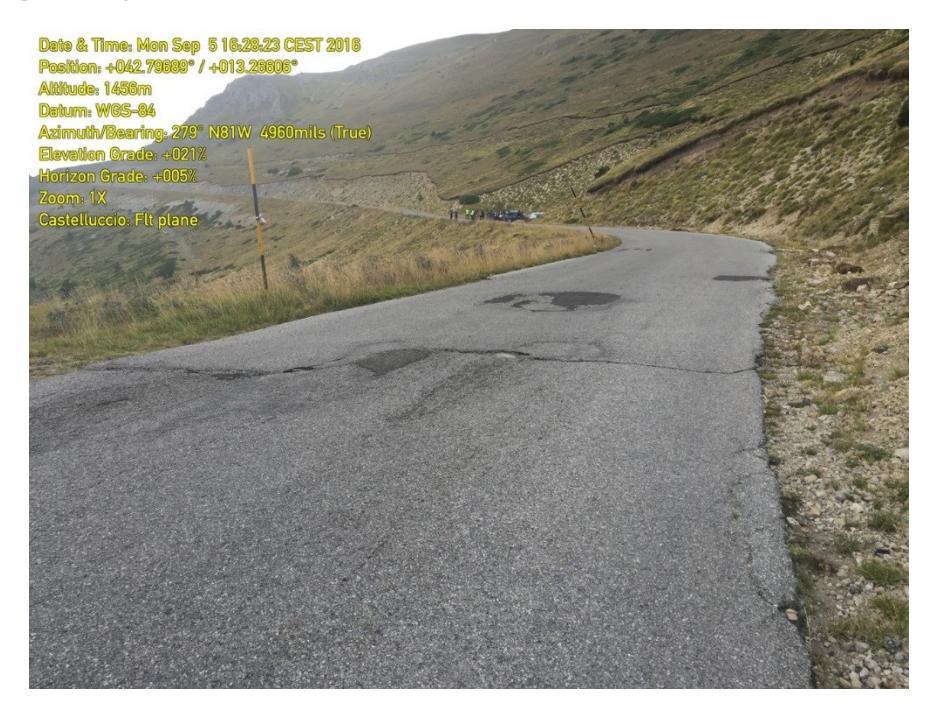
Figure 2.19b. Mt. Vettore fault: Damaged asphalt on SP477 at the fault crossing with less than 10cm of normal displacement down toward the west. Displacement are masked by bridging of the asphalt surface (Latitude and Longitude are annotated on the image).

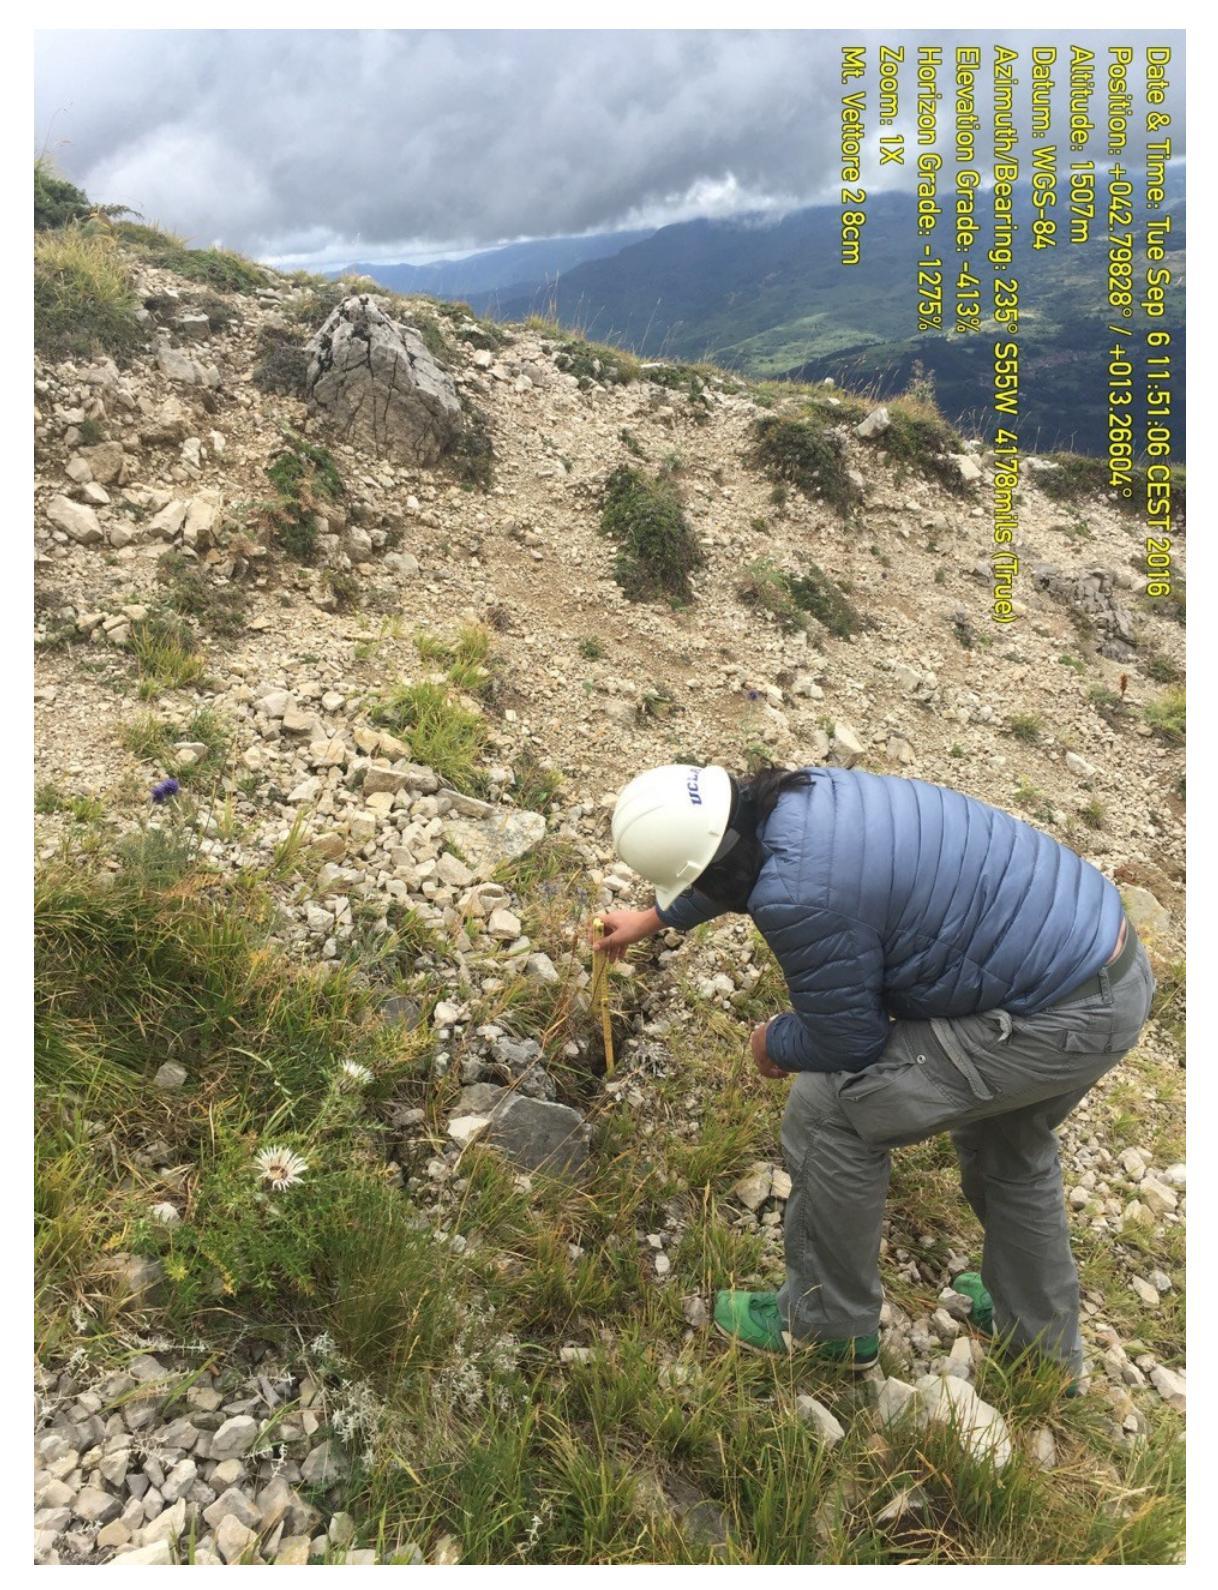
Figure 2.19d. t. Vettore fault Site 2 at a WGS84 ellipsoid elevation of 1507m. The normal fault displacement at this site was 8 cm down toward the west (Latitude and Longitude are annotated on the image).

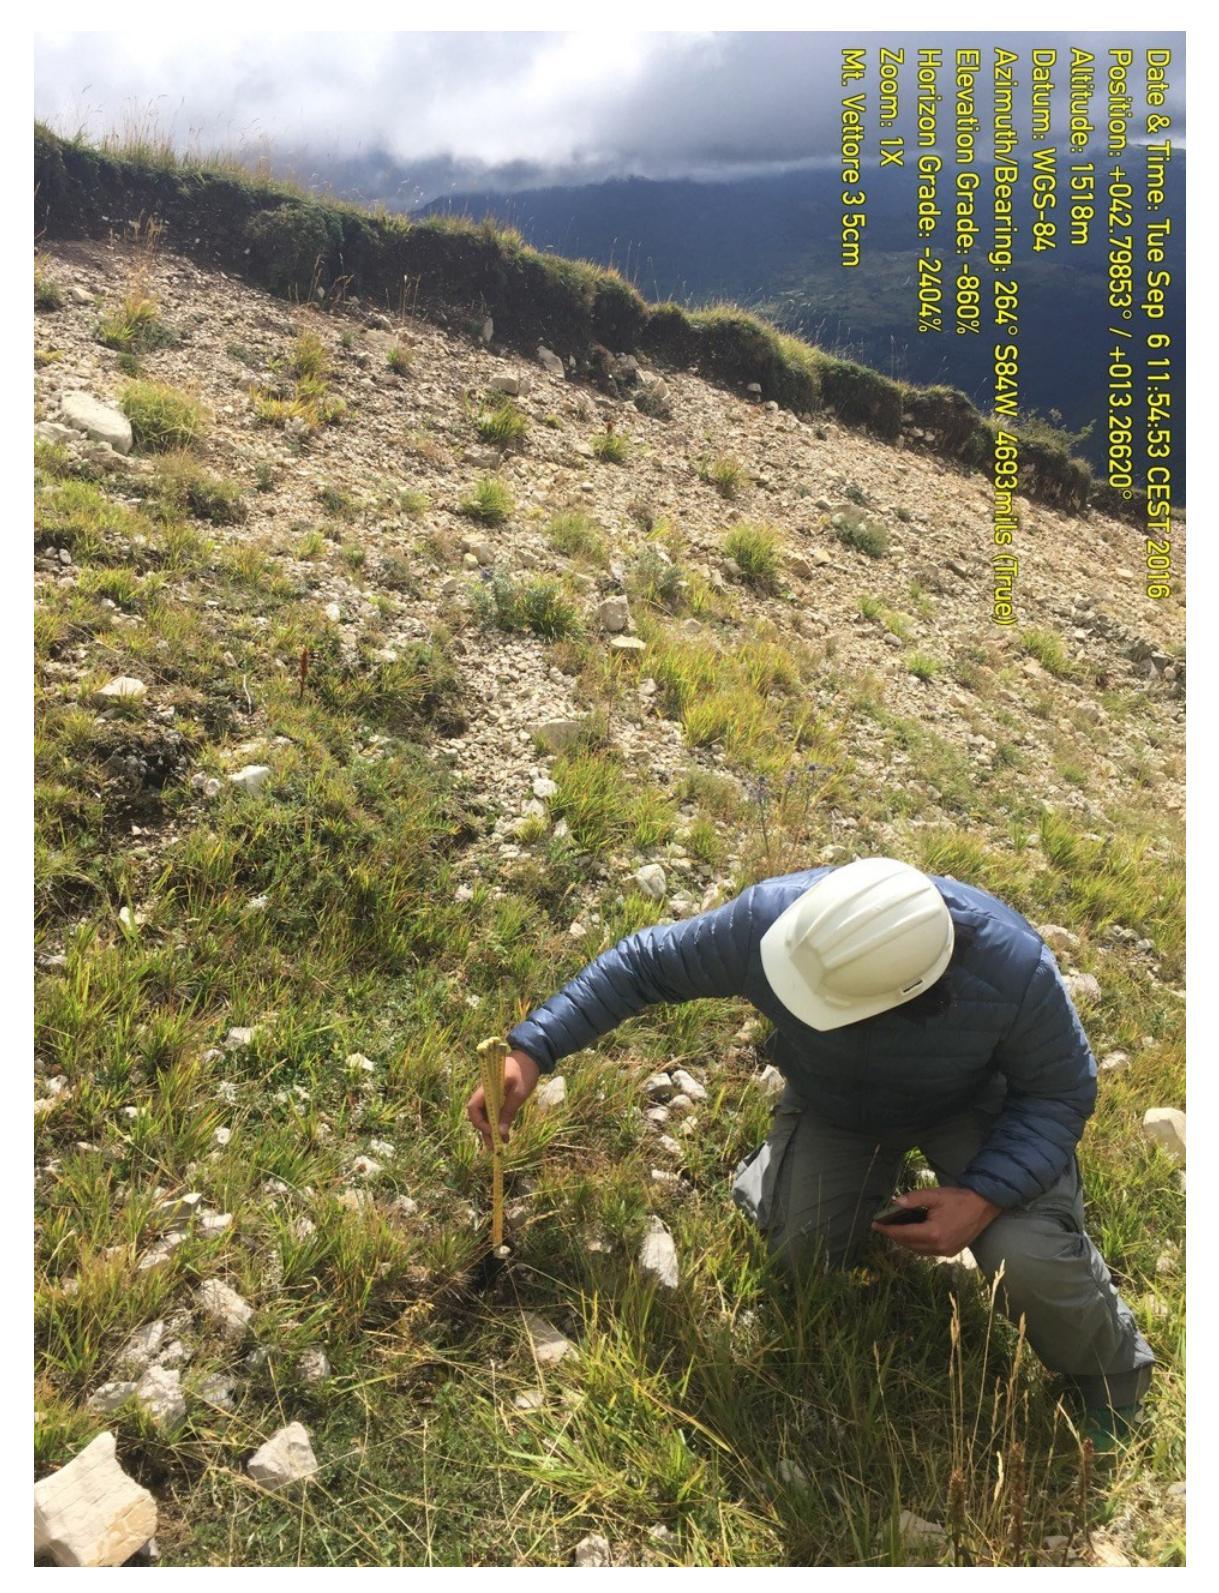
Figure 2.19e. Mt. Vettore fault Site 3 at a WGS84 ellipsoid elevation of 1518 m. The normal fault displacement at this site was 5 cm down toward the west (Latitude and Longitude are annotated on the image).

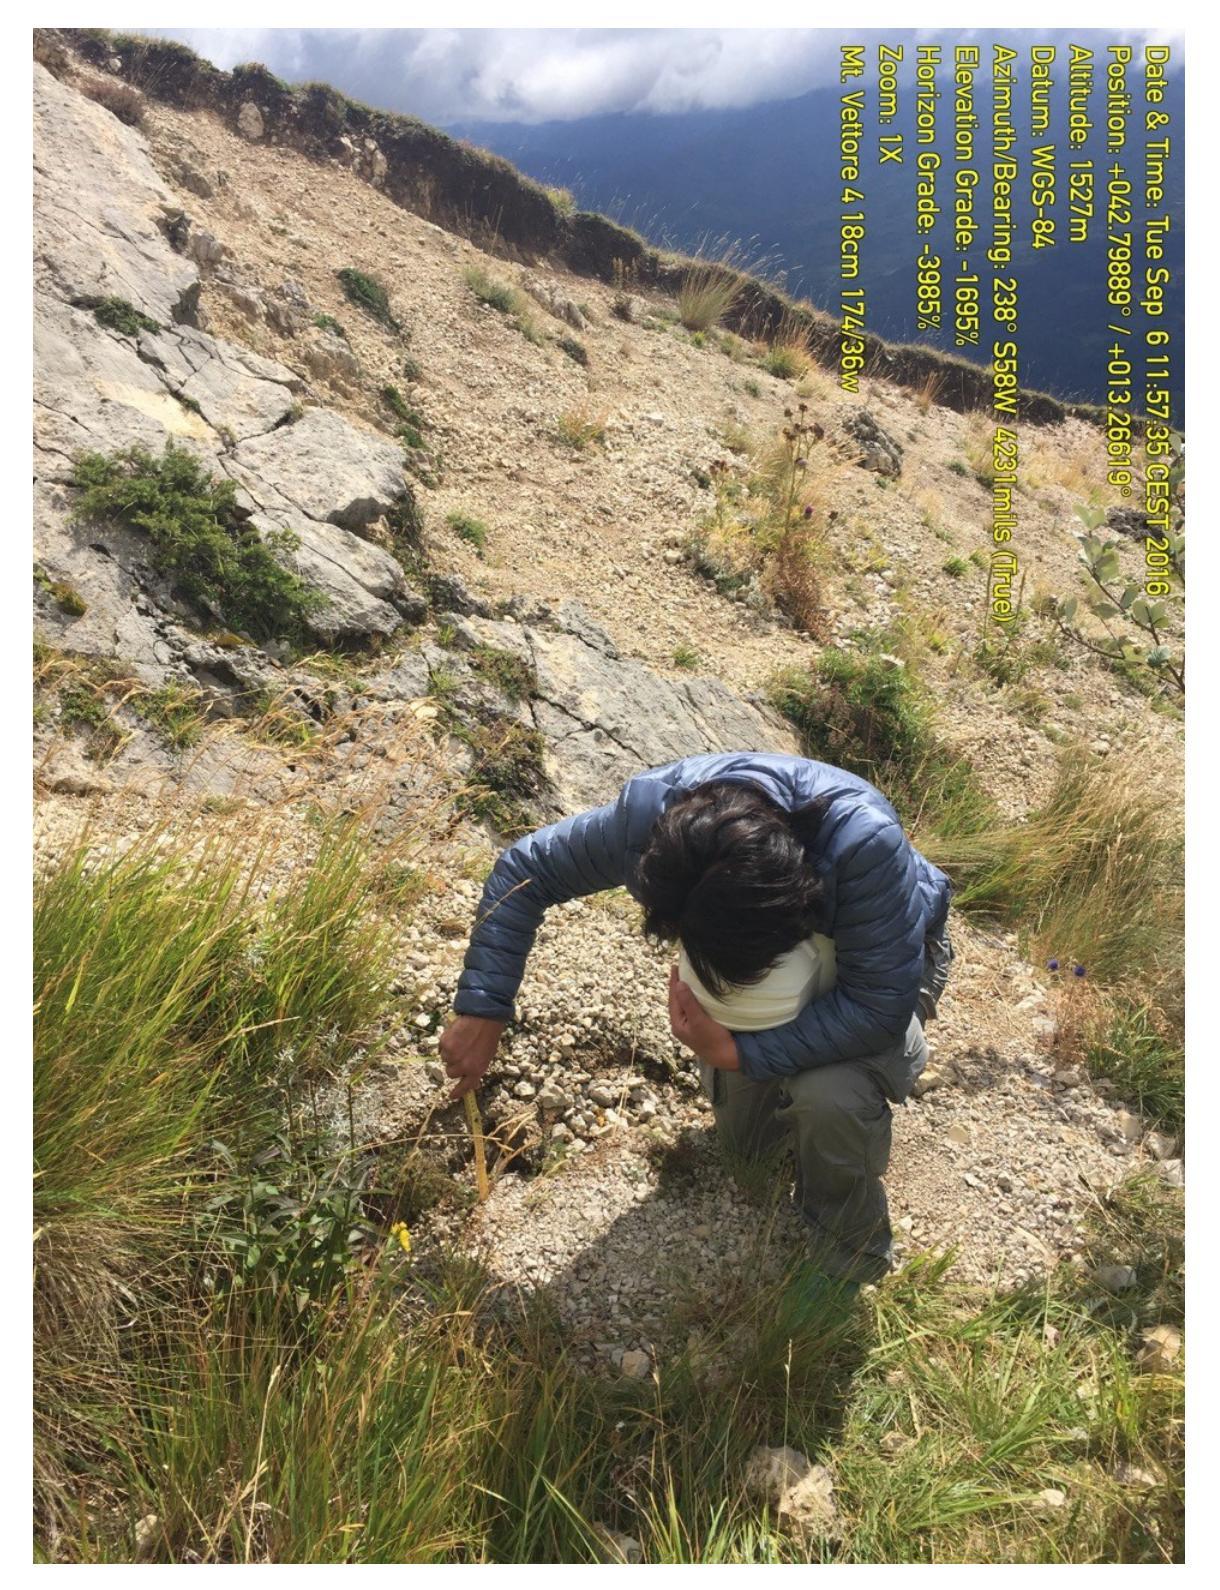
Figure 2.19f. Mt. Vettore fault Site 4 at a WGS84 ellipsoid elevation of 1527 m. The normal fault displacement at this site was 18 cm down toward the west, with a strike was 174° and dip of 36° west (Latitude and Longitude are annotated on the image).

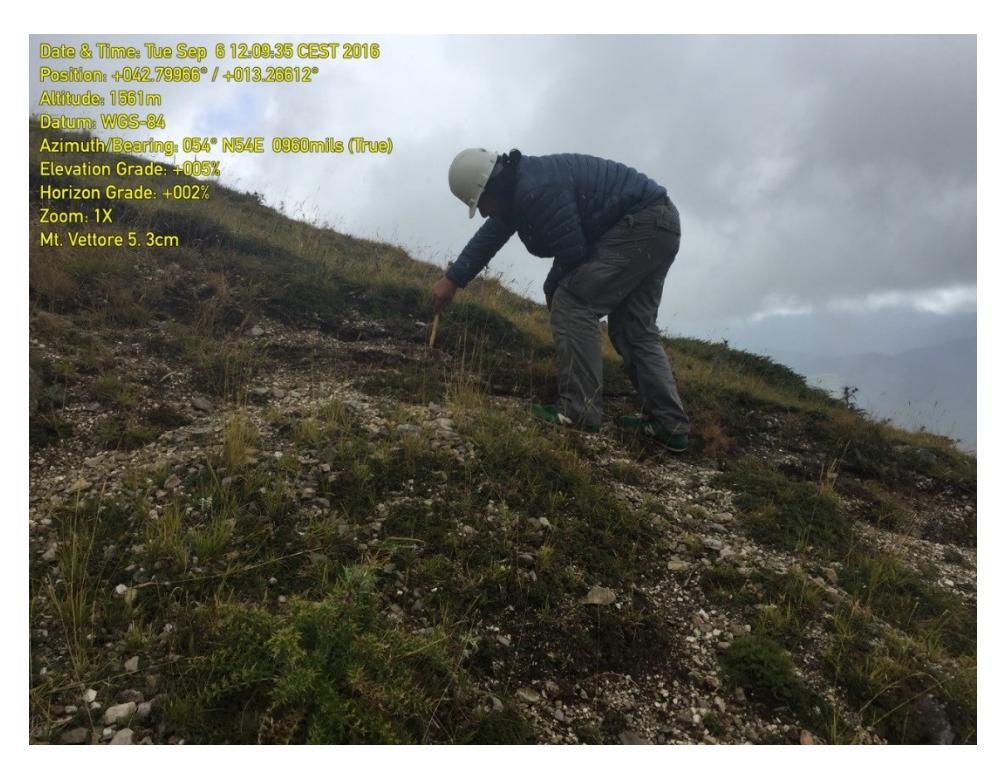
Figure 2.19g. Mt. Vettore fault Site 5 at a WGS84 ellipsoid elevation of 1561 m. The normal fault displacement at this site was 3 cm down toward the west (Latitude and Longitude are annotated on the image).

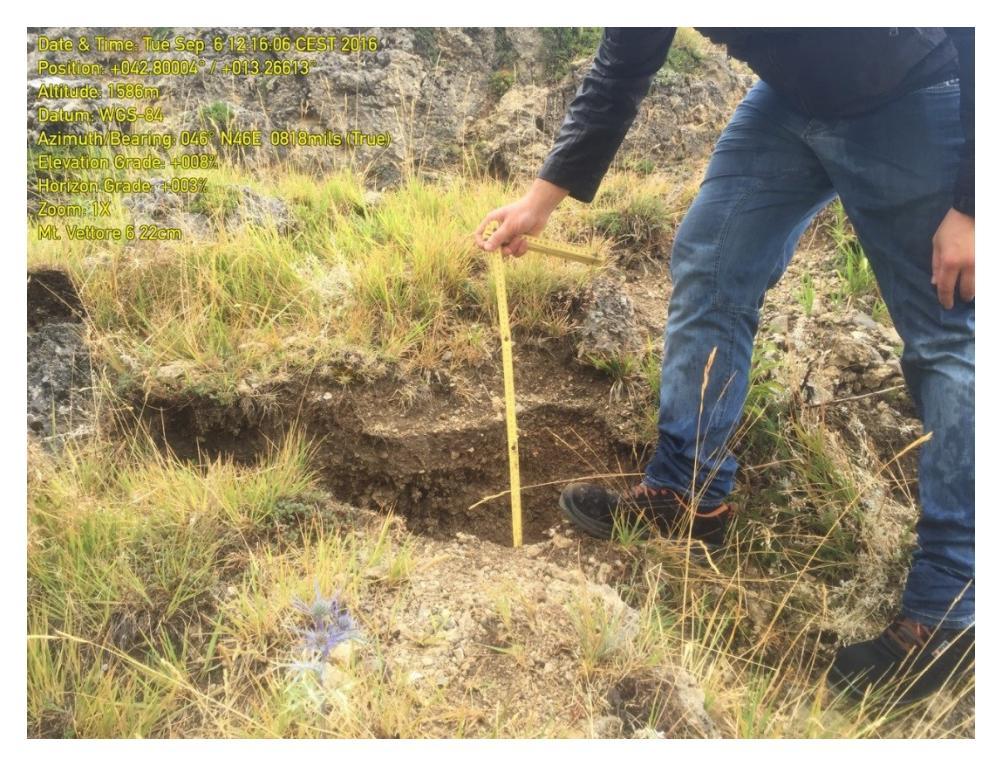
Figure 2.19h. Mt. Vettore fault Site 6 at a WGS84 ellipsoid elevation of 1527 m. The normal fault displacement at this site was 22 cm down toward the west (Latitude and Longitude are annotated on the image).

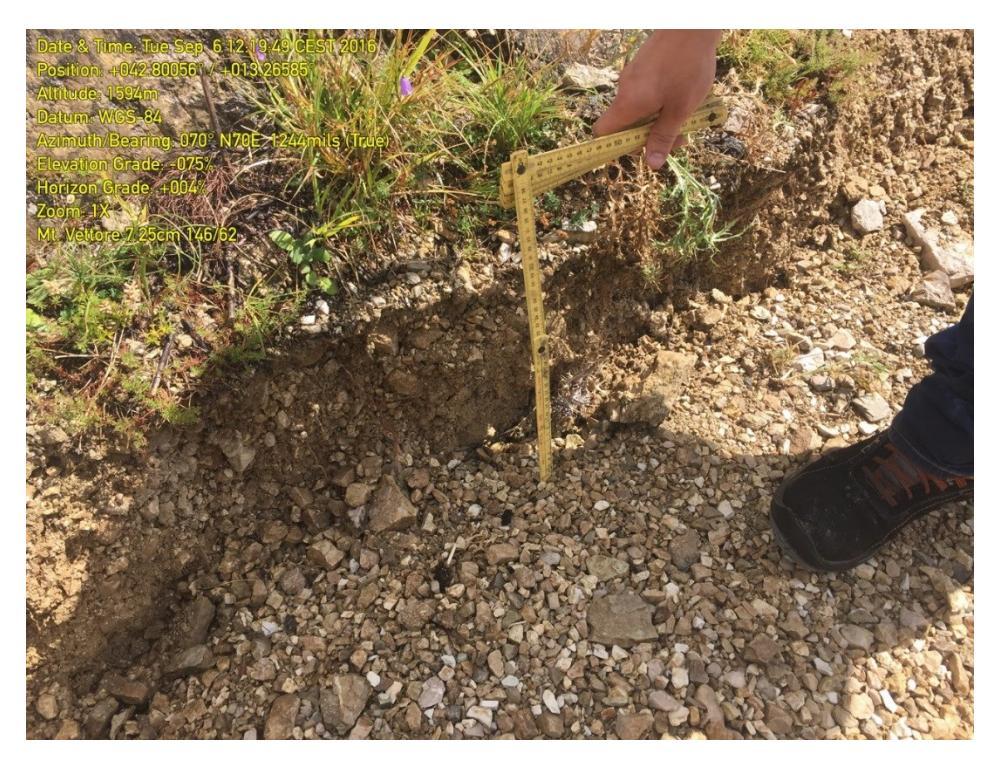
Figure 2.19i. Mt. Vettore fault Site 7 at a WGS84 ellipsoid elevation of 1594 m. The normal fault displacement at this site was 25 cm down toward the west. (Latitude and Longitude are annotated on the image).

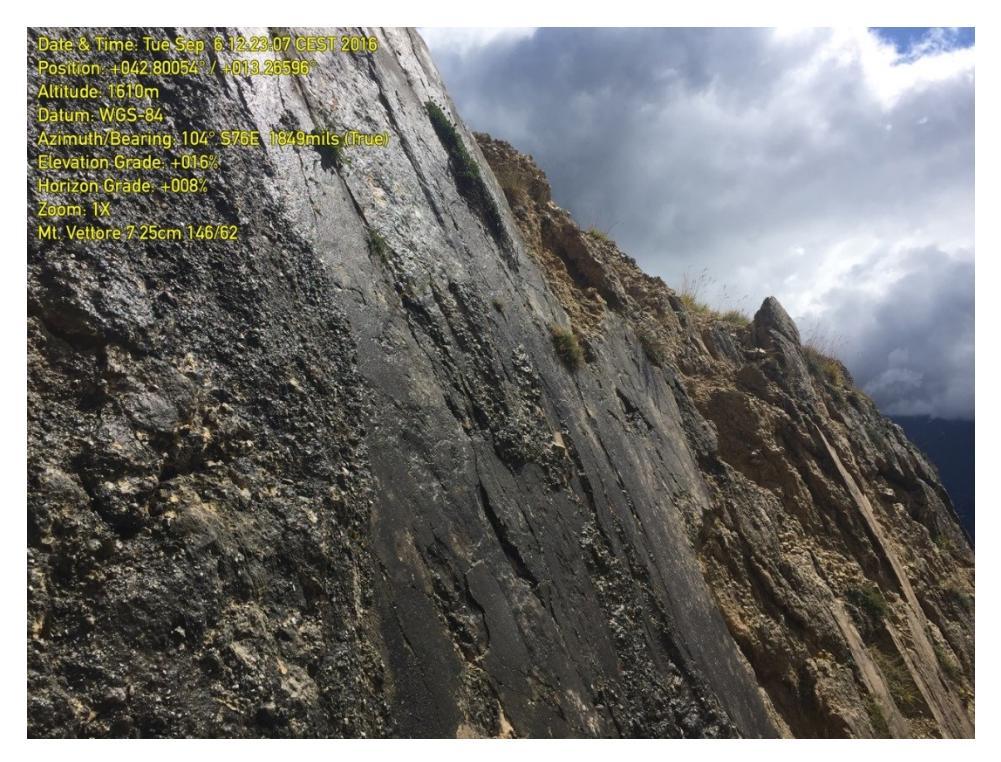
Figure 2.19j. Mt. Vettore fault Site 7 at a WGS84 ellipsoid elevation of 1527 m. The normal fault displacement at this site was 25 cm down toward the west. The strike of the bedrock fault was 146°, dipping 62° (Latitude and Longitude are annotated on the image).

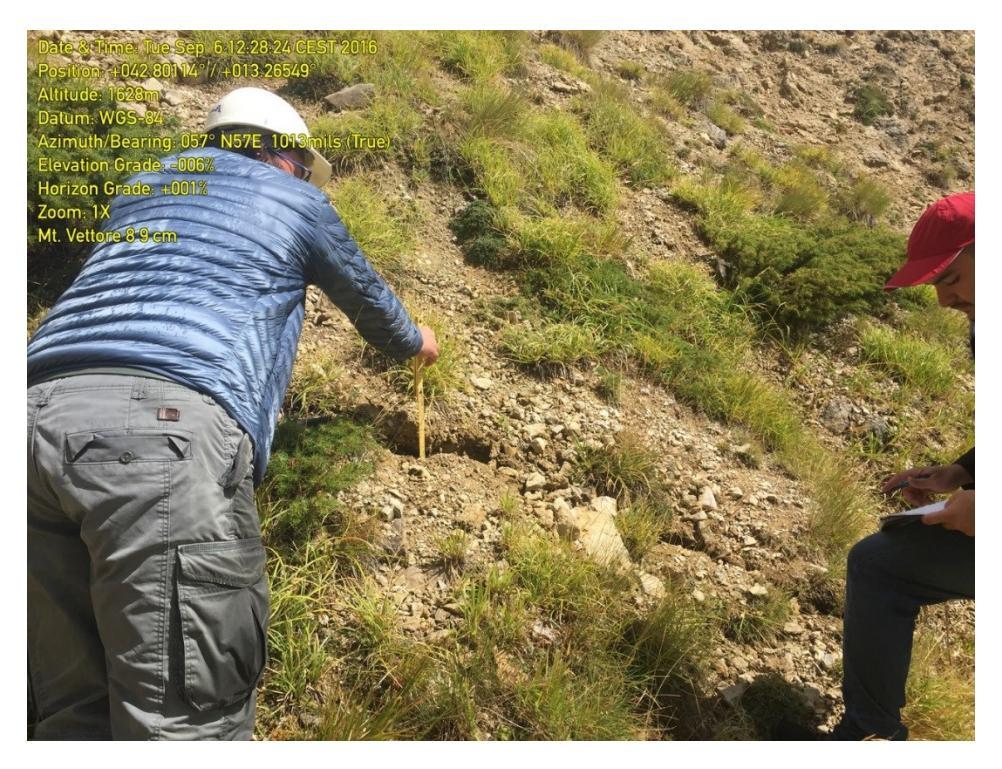
Figure 2.19k. Mt. Vettore fault Site 8 at a WGS84 ellipsoid elevation of 1628 m. The normal fault displacement at this site was 9 cm down toward the west (Latitude and Longitude are annotated on the image).

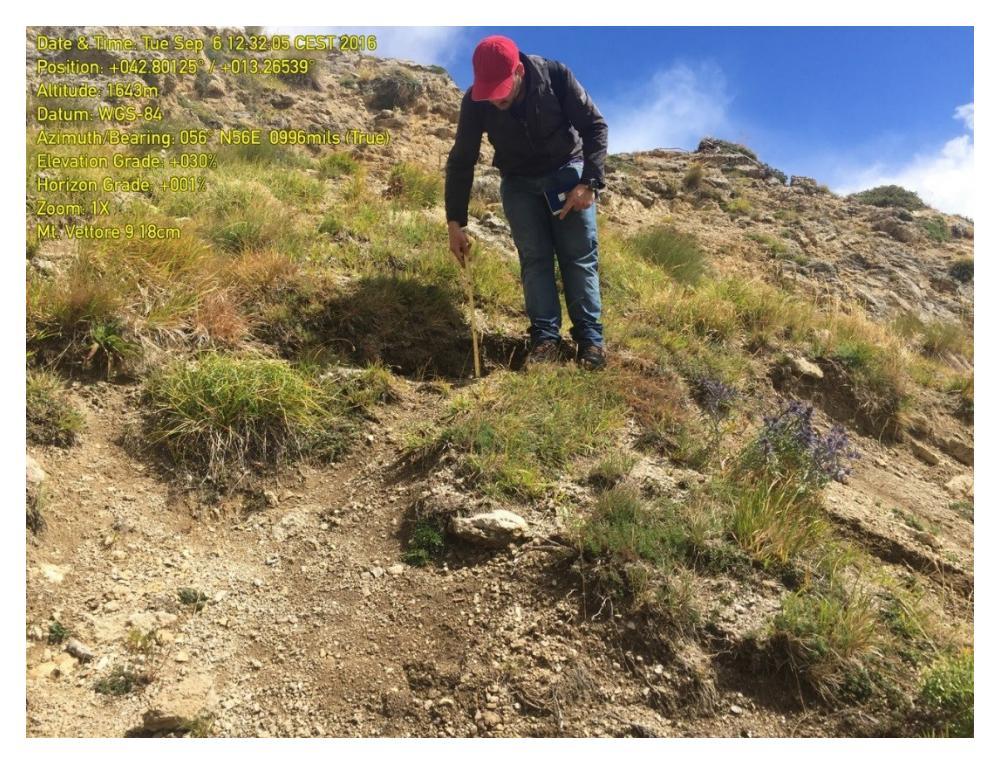
Figure 2.19I. Mt. Vettore fault Site 9 at a WGS84 ellipsoid elevation of 1643 m. The normal fault displacement at this site was 18 cm down toward the west (Latitude and Longitude are annotated on the image).

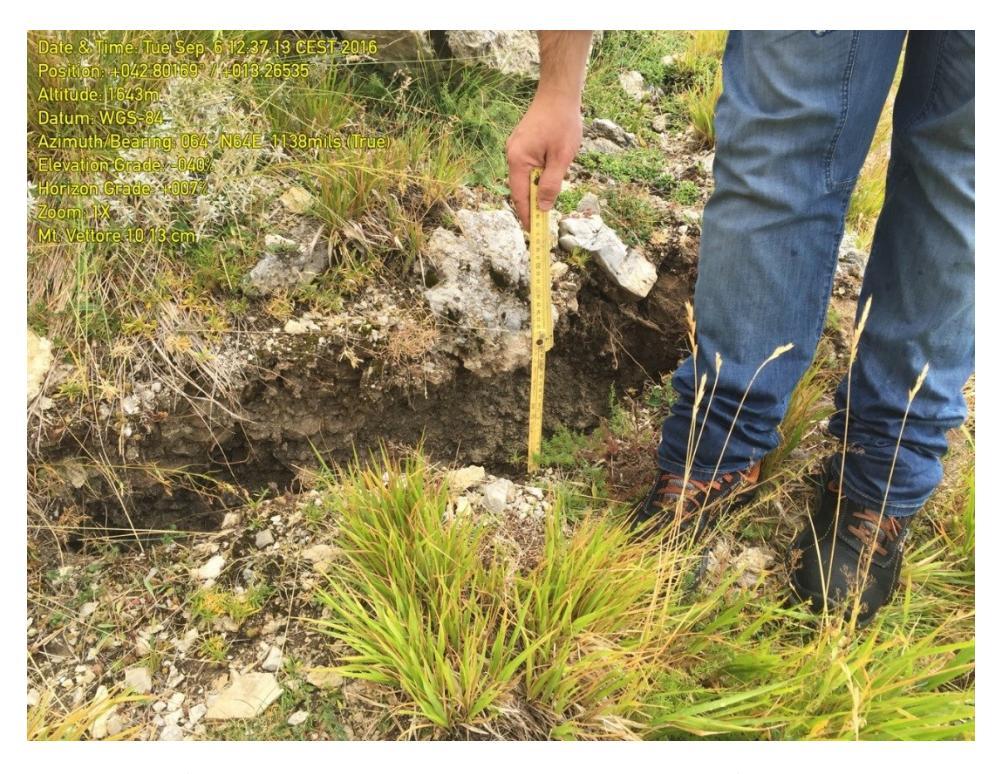
Figure 2.19m. Mt. Vettore fault Site 10 at a WGS84 ellipsoid elevation of 1643m.ch2. The normal fault displacement at this site was 13 cm down toward the west (Latitude and Longitude are annotated on the image).

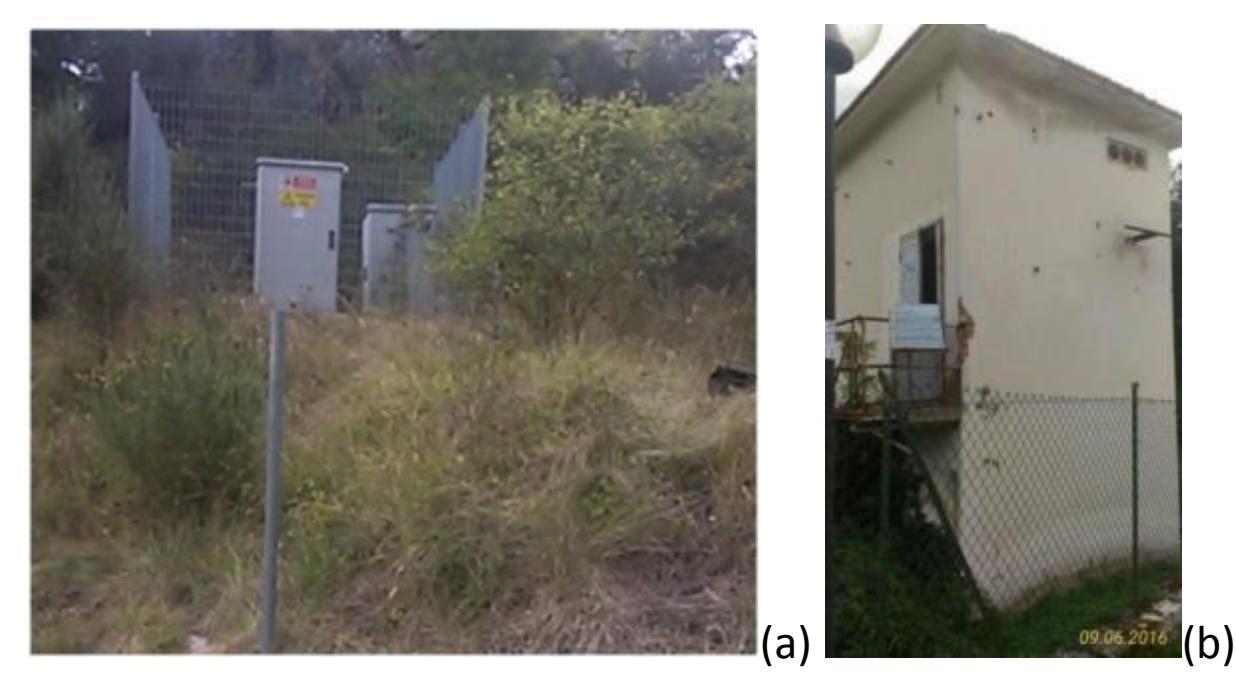
The GEER team inspected two recording station sites: (1) AMT in the town of Amatrice (Figure 3.2a; Lat: 42.632460 – Long: 13.286176), and (2) NRC in the town of Norcia (Figure 3.2b; Lat: 42.792543 – Long: 13.096475). Both stations are part of the RAN network, owned and operated by the Italian department of civil protection. AMT is a free-field station with a digital sensor protected by a fiberglass box, while the accelerometers at NRT are installed inside an ENEL electric transformer cabin. The AMT and NRC stations recorded the highest acceleration values during the M6.1 mainshock (0.43g and 0.36g, respectively) but the level of damage in Amatrice and Norcia was quite different as discussed in Chapter 5. As shown in Figure 3.2, we did not find ground failure features or earthquake-induced damage traces at these locations.

Figure 3.2. (a) AMT station; (b) NRC station.

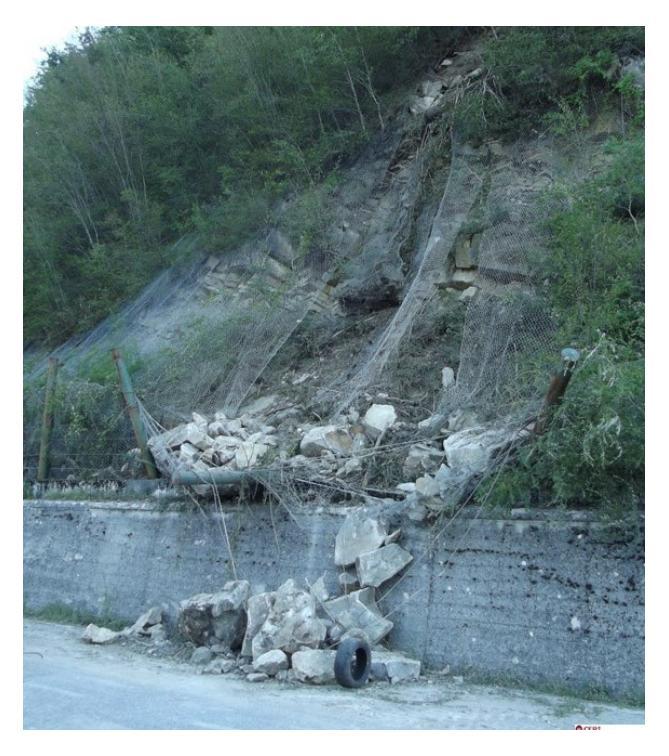
Rock failures observed after the Central Italy earthquake involve Miocene flysch units and the Carbonatic units of the Umbria-Marche Succession. Flysch units (*Laga formation*) consist of alternating sandstone and marls layers, where sandstone is always the prevailing component. The flysch, similar to many other turbidite formations, presents variations in sandstone/marl ratio and layer thickness due to the distance from the source area in the depositional basin. Discontinuity spacing further varies depending on the distance from fault zones. Weathering of marl layers, though limited to extremely shallow depth, occurs soon after marls are exposed from highway cuts and excavations. This weathering is sufficient to undercut overlying sandstone slabs, which can break free when exposed to strong ground motions (Figure 4.5).

Figure 4.5. Rockfall involving sandstone slabs overlying marl layers (after CERI 2016).

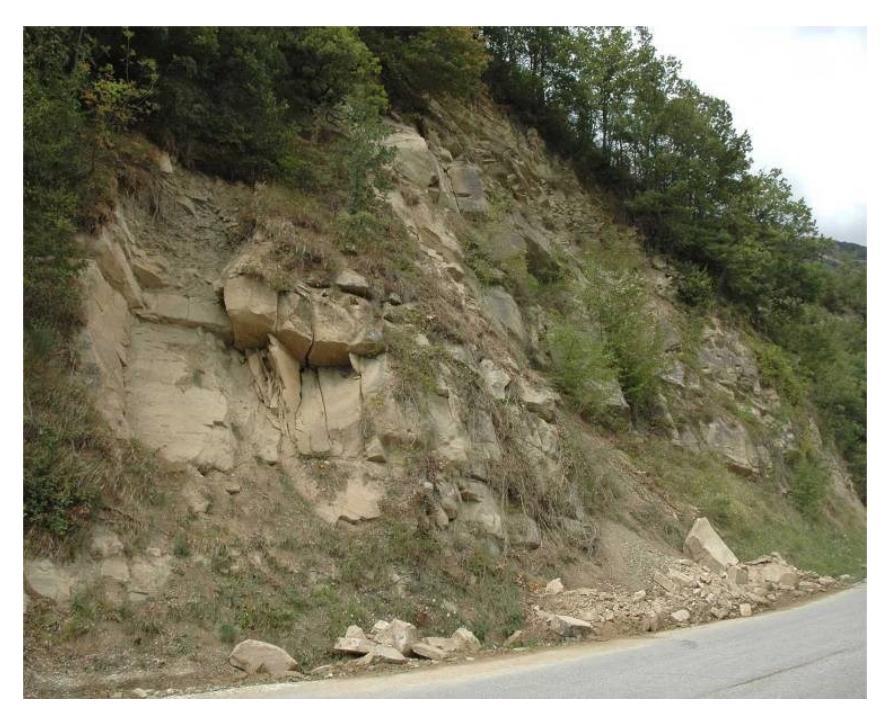
In the Central Italy event, strong ground motions triggered larger rock failures only where the flysch was regularly fractured and/or block interlocking was insufficient to keep the rocks in place due to relatively low confining stresses. Observed failures in the flysch most commonly occurred along highway cut slopes. Different mechanisms of rock failure were detected both by GEER and CERI investigators: detachment of sandstone slabs overlying marl layers (Figure 4.5), wedge sliding (Figure 4.6), or planar sliding along bedding joints and toppling.

Figure 4.6. Free-face wedge sliding that is governed by bedding joint attitude.

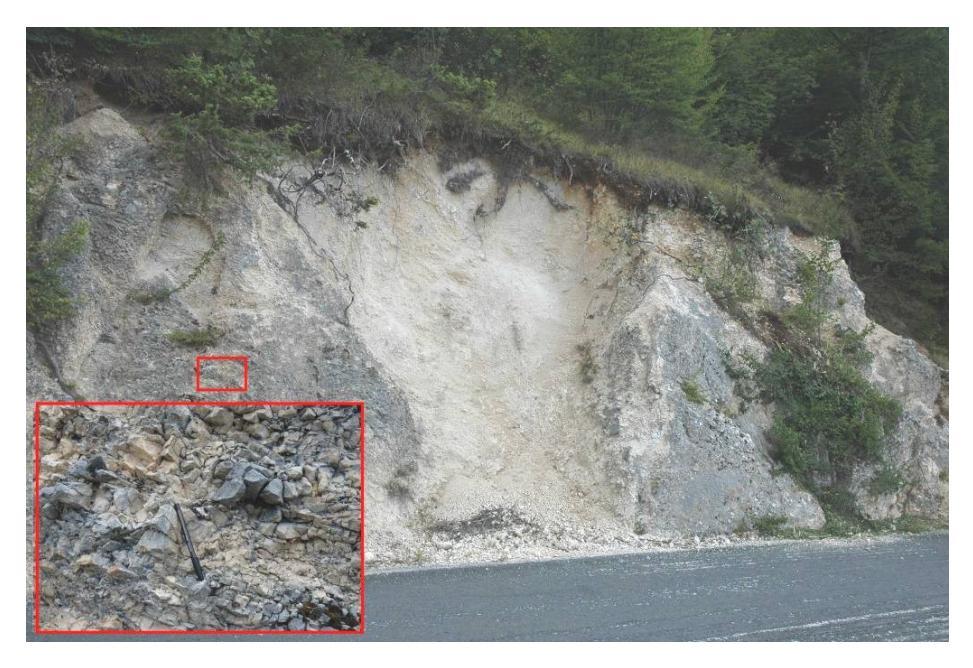
Observed carbonate units were generally comprised of limestone (*Calcare Massiccio formation*) and bedded limestone (*Maiolica formation*). Rock falls involving the *Calcare Massiccio* formation generally had large blocks (up to 4 cubic meters) and long runout distances. Rock falls involving the *Maiolica formation* generally had much smaller rock fragments and limited runout distances. Failures involved both natural cliffs and cut slopes, with intensely fractured limestone (Figure 4.7) in most cases.

Figure 4.7. Failure in intensely fractured (i.e., sugar-cube) limestones (cataclasite).

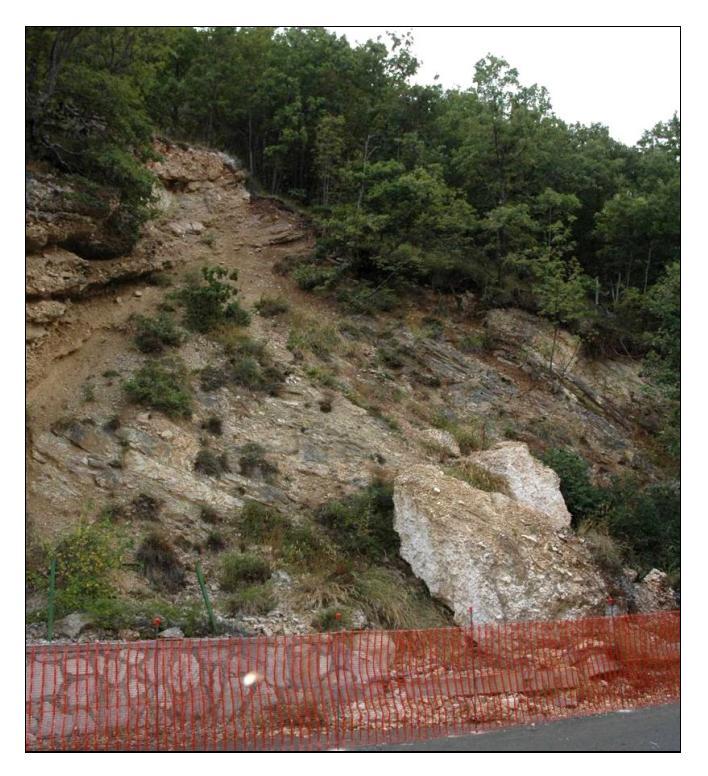
Figure 4.16. Failure in calcareous breccia along the SP11 road between Cittareale and Norcia.

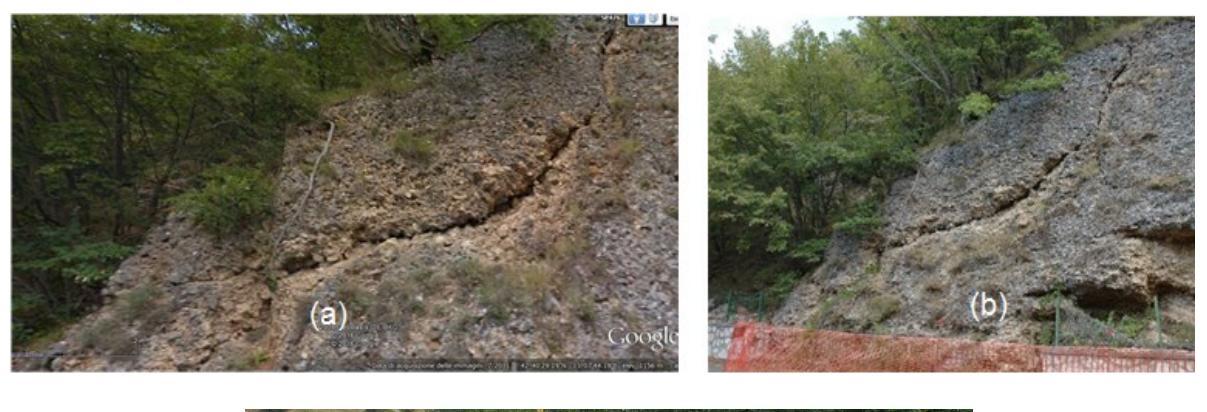
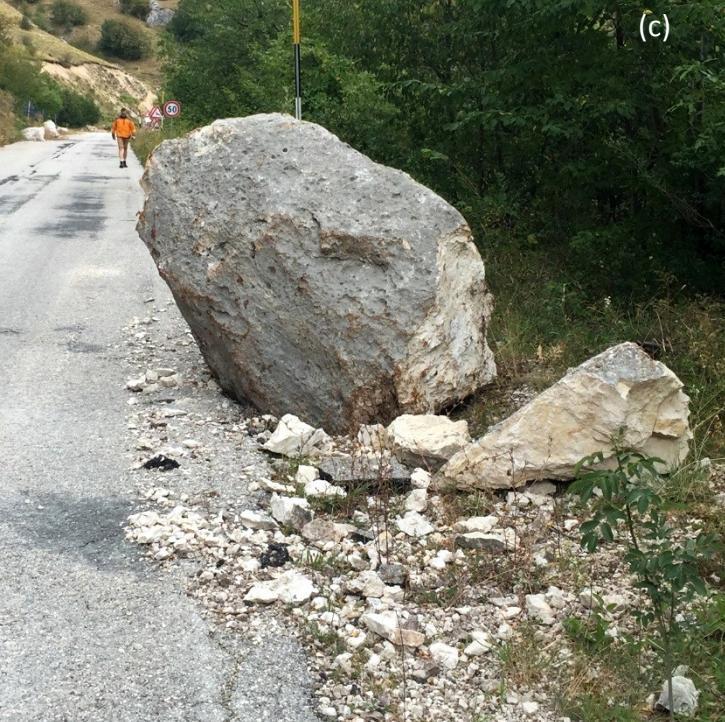
Figure 4.17. Large block of breccia (a) before the earthquake (image courtesy of Google 2016), (b) after the earthquake, and (c) example of rock fall below the Plano Grande on SP477. A large 2-m block of limestone crossed the road came to rest on the downslope side of the roadbed below a prominent outcrop of limestone (42.76729 N 13.16983 E).

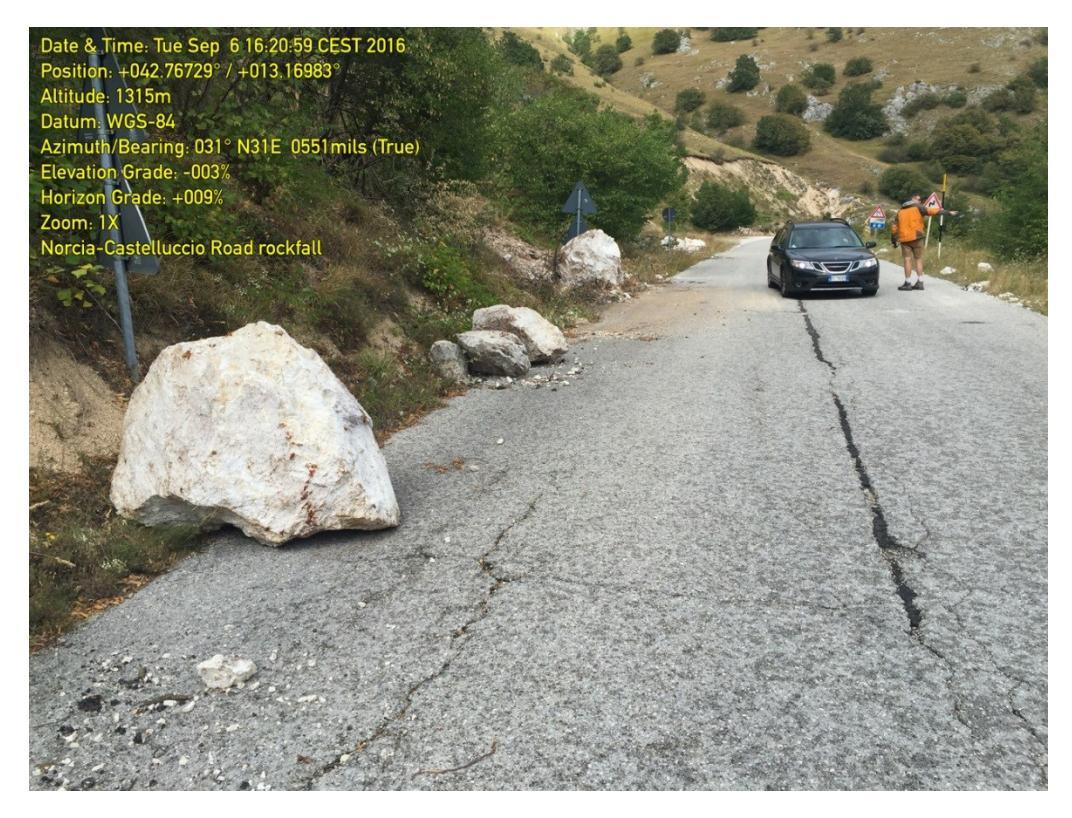
An area of intense rockfall was observed along state provincial route SP64 (Tufo– Castelliccio) and SP477 (Castelluccio-Norcia), along with a 12 km zone of steep terrain and switchback roads. Almost all of the rockfall occurred when isolated blocks of limestone detached from outcropping bedrock above the highway. Many of these blocks came to rest on the shoulder or pavement of the road, whereas other blocks maintained enough velocity to cross the road and continue descent downslope. An example of isolated blocks on Highway SP477 can be seen in Figure 4.17 and Figure 4.18. An online UAV-based 3D surface model of the rockfall area along Highway SP477 can be accessed from the GEER event webpage. An image of the 3D model developed for the SP477 rockfall is presented in Figure 4.19.

Figure 4.18. Example of rock fall below the Plano Grande on SP477. Blocks a large as 3 to 4 m across came to rest on the flat roadbed below a prominent outcrop of limestone (42.76729 N 13.16983 E).

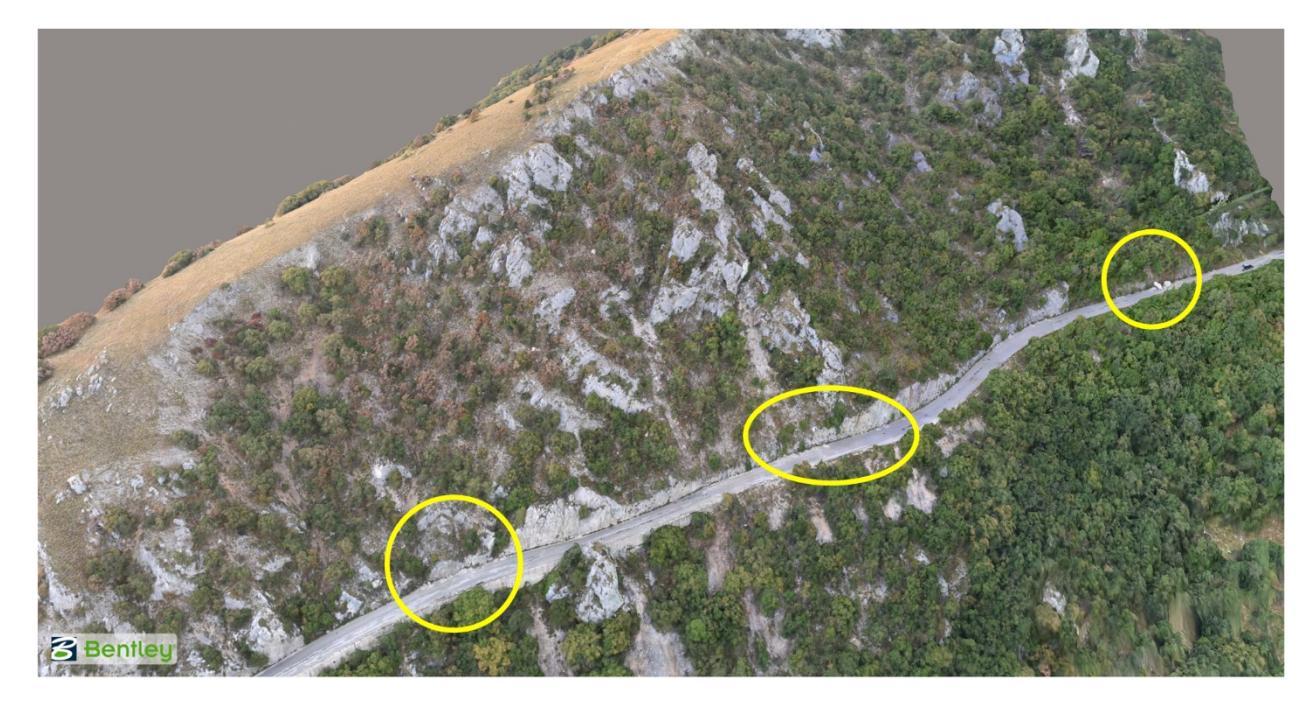
Figure 4.19. 3D model image of the SP 477 rockfall. Visible rocks and debris on the road are circled in yellow (42.7661 N 13.1669 E).
