Engineering Reconnaissance of the 24 August 2016 Central Italy Earthquake. Version 2 GEER Team Leaders: Giuseppe Lanzo and Jonathan P. Stewart

Geotechnical Extreme Events Reconnaissance Association

Report No. GEER-050B

22 November 2016

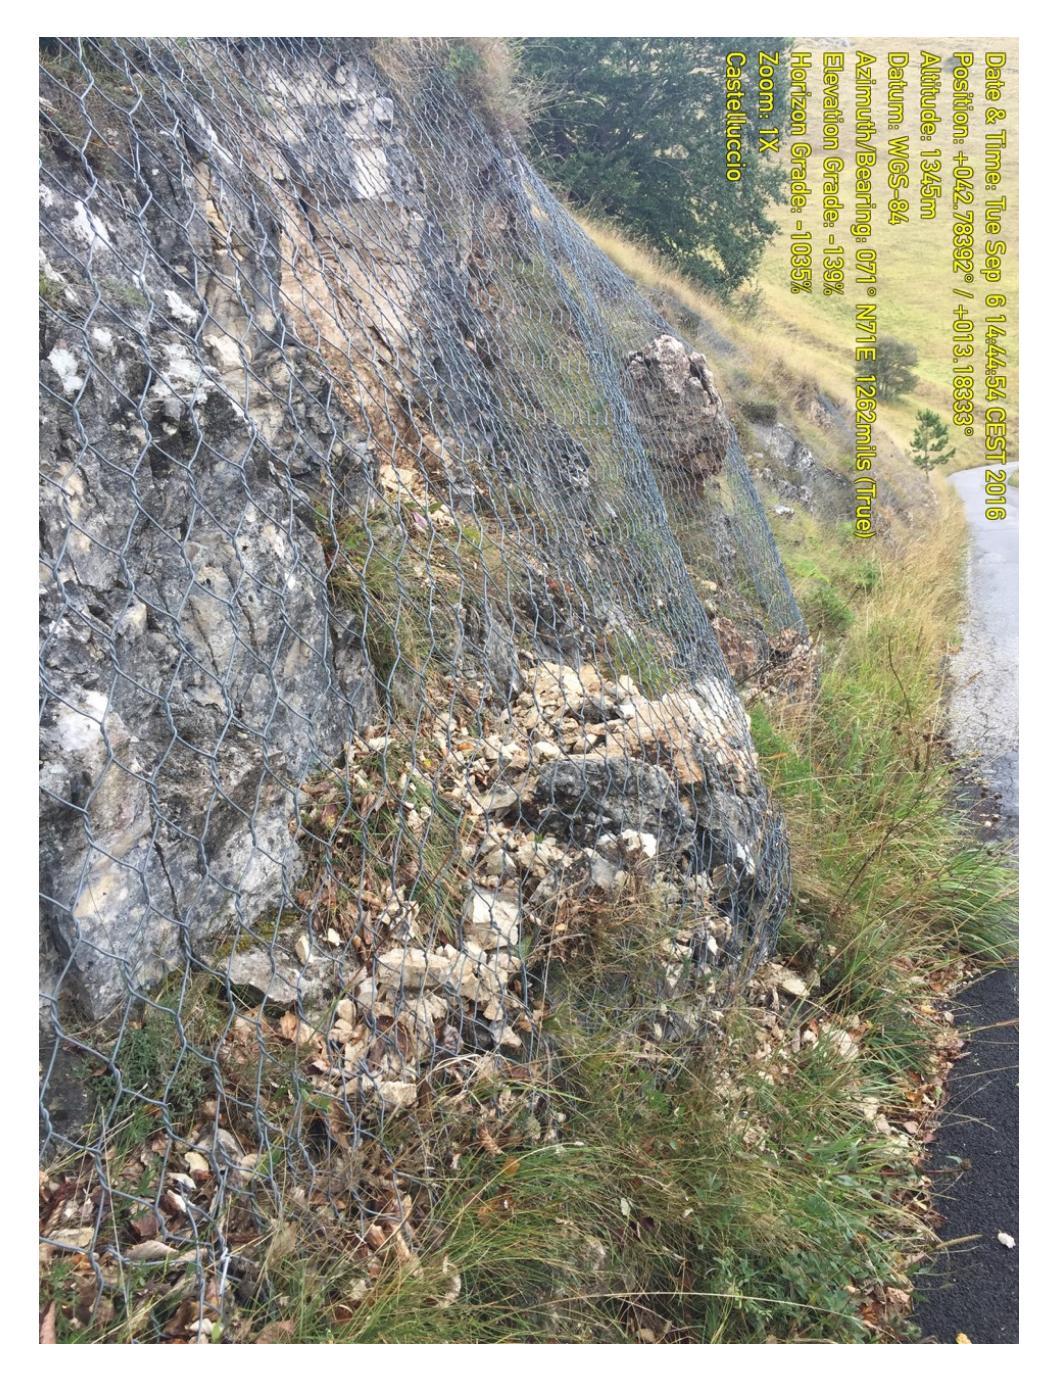
Slope protection in the form of rock bolts, tiebacks, retaining walls, and rockfall nets and fences were deployed in the epicentral region, and seemed to be effective at protecting roads and structures below. Figure 4.20 shows an example of falling debris caught behind rock-nets on the road to Plano Grande and Casteluccio. These successful applications of rock-net protection allowed roads to remain functional after the earthquake and provided critical access to the severely damaged town of Castelluccio immediately after the earthquake.

Figure 4.20. Rock-net protection with captured debris from the earthquake, including minor small debris in the foreground and a large ~0.5-m block in the background (42.78392 N 13.18333 E).

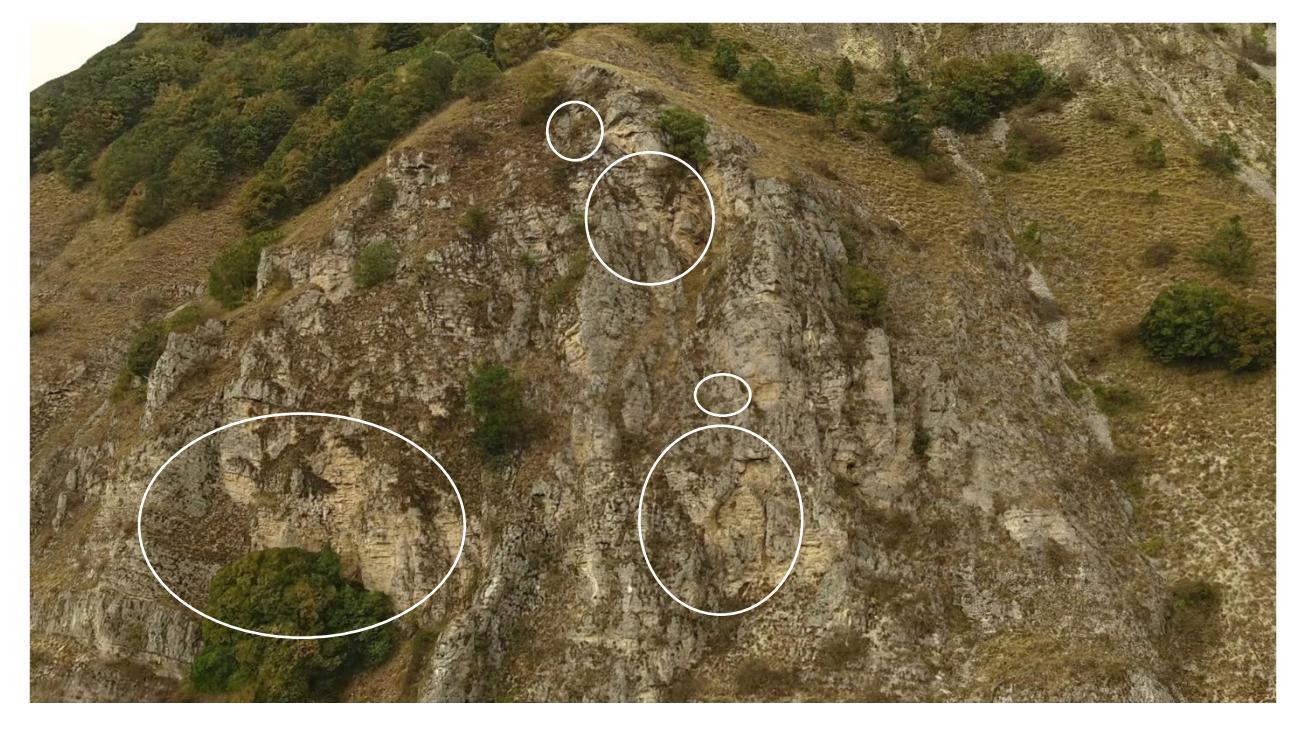
The Phantom 4 UAV was used to investigate mountain slopes high above Via del Passero, just north of the town of Pescia (42.69082 N 13.15368 E). None of the mountain slopes could be seen from the road due to the dense and tall vegetation immediately adjacent to the road. However, the Phantom 4 UAV allowed the GEER team to observe the mountain slopes above the vegetation. The general lack of vegetation and significant amount of eroded debris along the mountainside suggested that this was a pre-existing and active landslide/rockfall area. Lighter discoloration in the limestone rock along the mountainside suggests that some large boulders likely fell due to the earthquake, but could not be located due to the heavy vegetation below. A single flight was performed with the Phantom 4, and the subsequent video still images were processed with SfM computer vision using *ContextCapture* software by Bentley. A screen capture of the resulting 3D model of the rockfall is presented in Figure 4.21. The white circles in Figure 4.21 highlight the areas of lighter discoloration. Bentley *Acute3d Viewer* software was used to capture this image as well as the remainder of the 3D model images presented in this chapter.

Figure 4.21. 3D surface model of the rockfall north of Pescia (42.6908 N 13.1537 E)

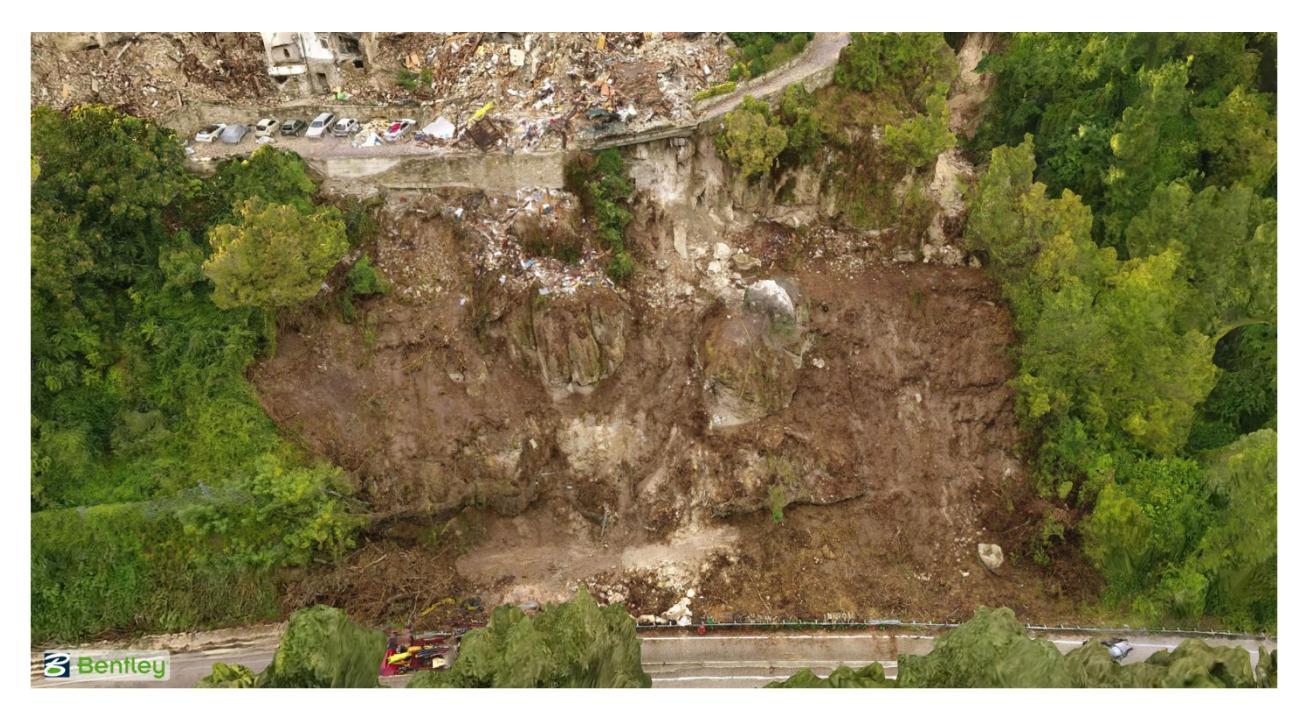
Investigation of the 3D model of Pescara del Tronto revealed numerous shallow earthquake-induced landslides and retaining wall failures. These landslide locations are summarized on a site vicinity map presented in Figure 4.24. The largest landslide occurred on the east slope below the city (42.75057 N 13.27223 E), directly above Highway SS4 (marked as #1 in Figure 4.24). A modeled image of this landslide is presented in Figure 4.25. At the time of the GEER reconnaissance, this landslide was approximately 75 meters wide by 30 meters high. The landslide itself was quite shallow, with only the upper meter or less of soil sliding downslope. The slope bedrock is formed by the flysch bedrock overlain by a layer of fluviolacustrine sediments and a slightly-to-moderately cemented travertine deposit. The landslide damaged and/or undercut retaining wall structures surrounding the city, leaving portions of the overlying city dangerously susceptible to collapse (Figure 4.26). Two large tilted travertine blocks remained exposed along the side slope (Figure 4.27), and it was not immediately clear whether those blocks were stable. Although there was no debris visible along Highway SS4 at the time of the GEER team visit, the road surface was discolored below the landslide, suggesting that the landslide most likely ran out onto the road and obstructed it until cleanup crews could remove the debris. An orthophoto of the landslide developed in Pix4D is presented in Figure 4.28.

Figure 4.25. 3D model image of the large landslide below Pescara del Tronto (42.75057 N 13.27223 E).

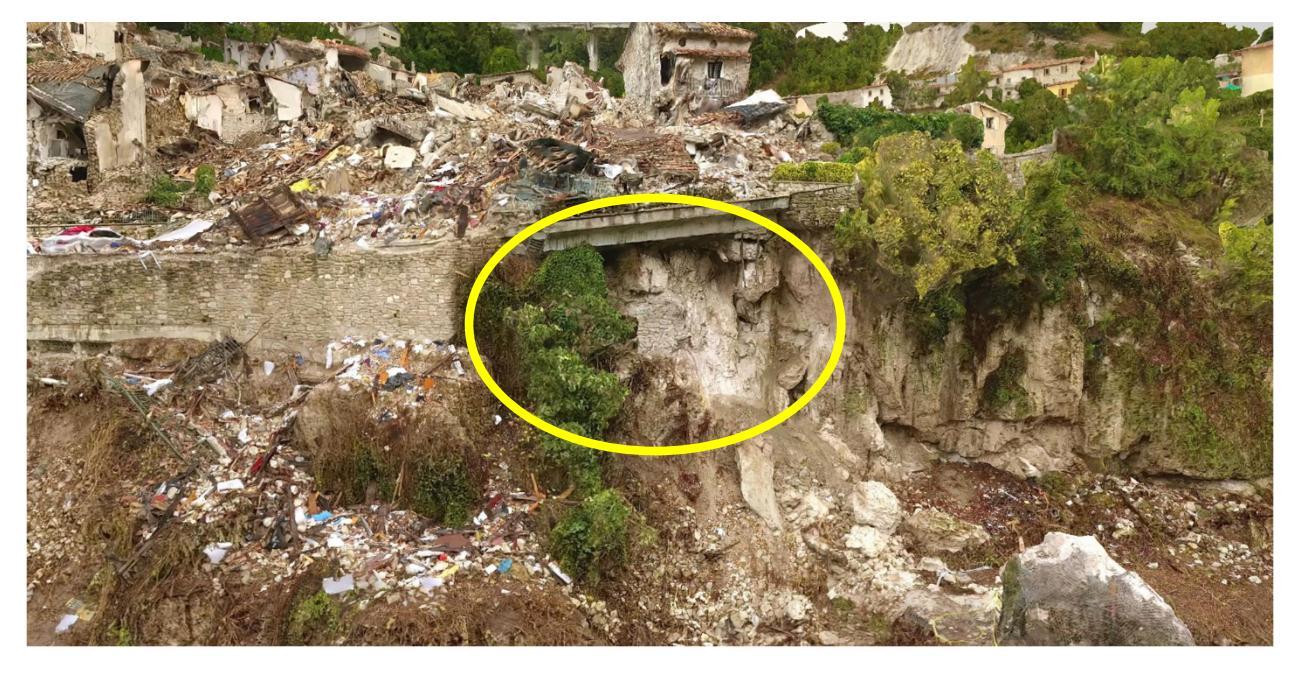
Figure 4.26. 3D model image of retaining wall damage from landslide below Pescara del Tronto (42.75057 N 13.27223 E).

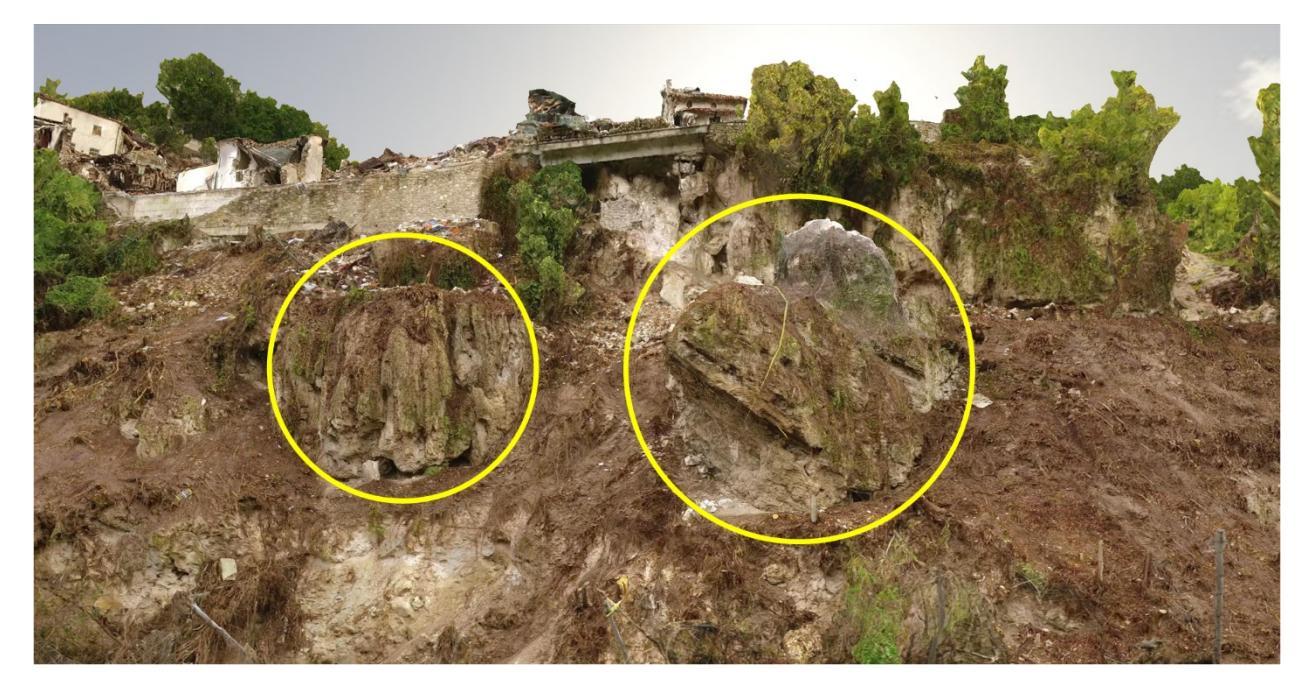
Figure 4.27. 3D model of two large protruding rock outcrops on the landslide below Pescara del Tronto (42.75057 N 13.27223 E).

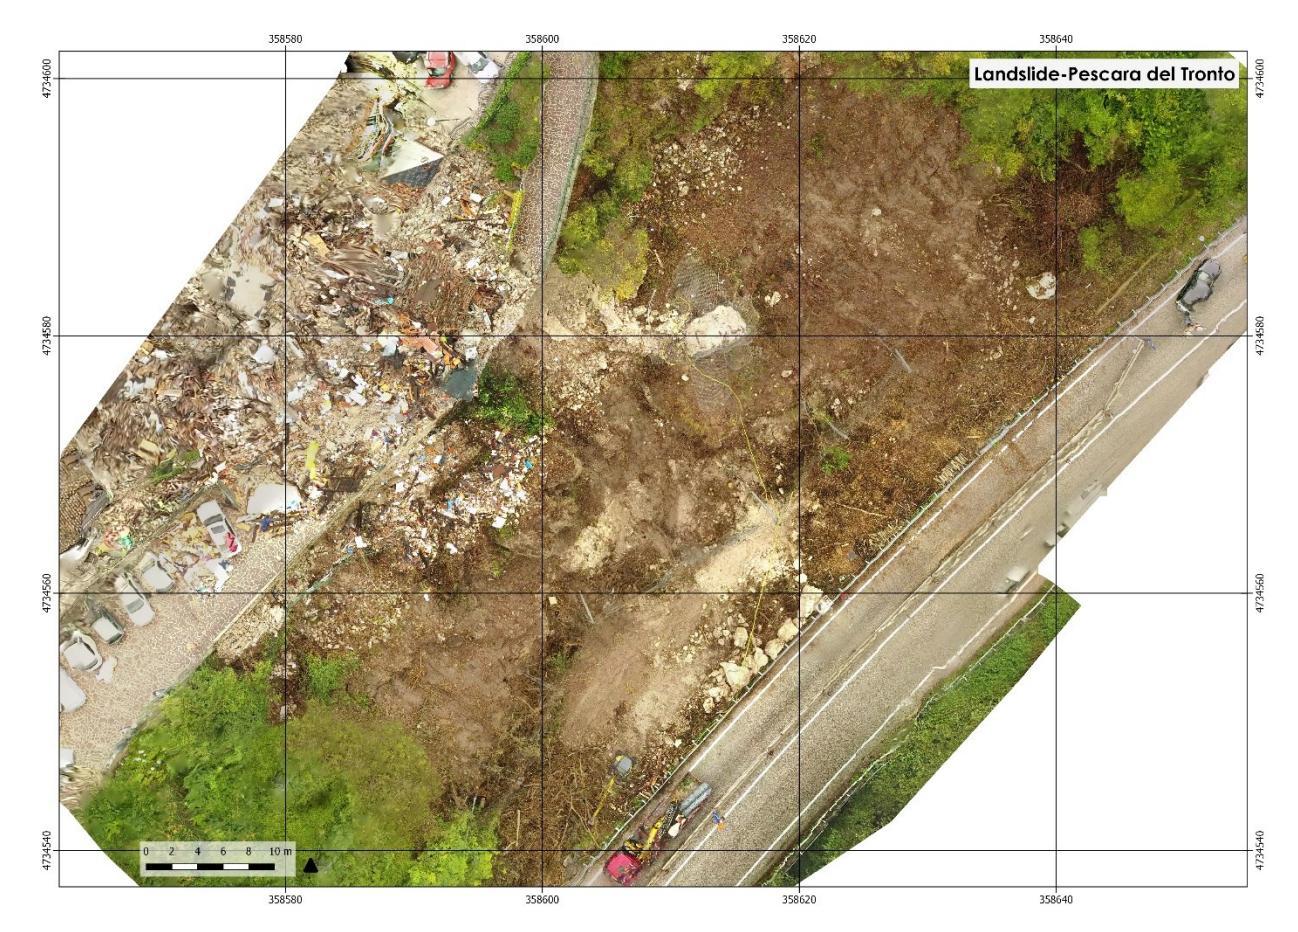
Figure 4.28. Orthophoto of the large landslide below Pescara del Tronto (42.75057 N 13.27223 E)

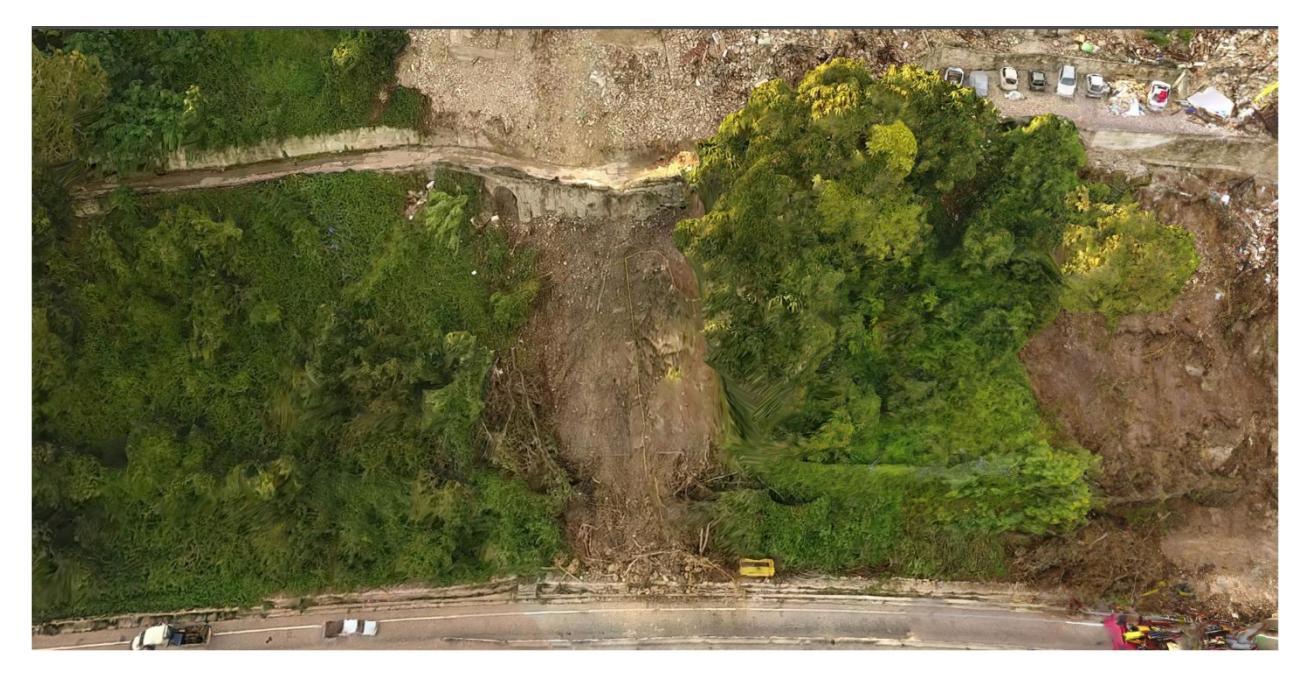
A second, smaller shallow landslide was located above Highway SS4 (marked as #2 in Figure 4.24), just south of the larger landslide discussed above (42.7501 N 13.2719 E). This landslide was approximately 16 meters wide and occurred on a slope 26 meters high. A model image of this landslide is presented in Figure 4.29.

Figure 4.29. 3D model of smaller landslide adjacent to Highway SS4 (42.7501 N 13.2719 E).

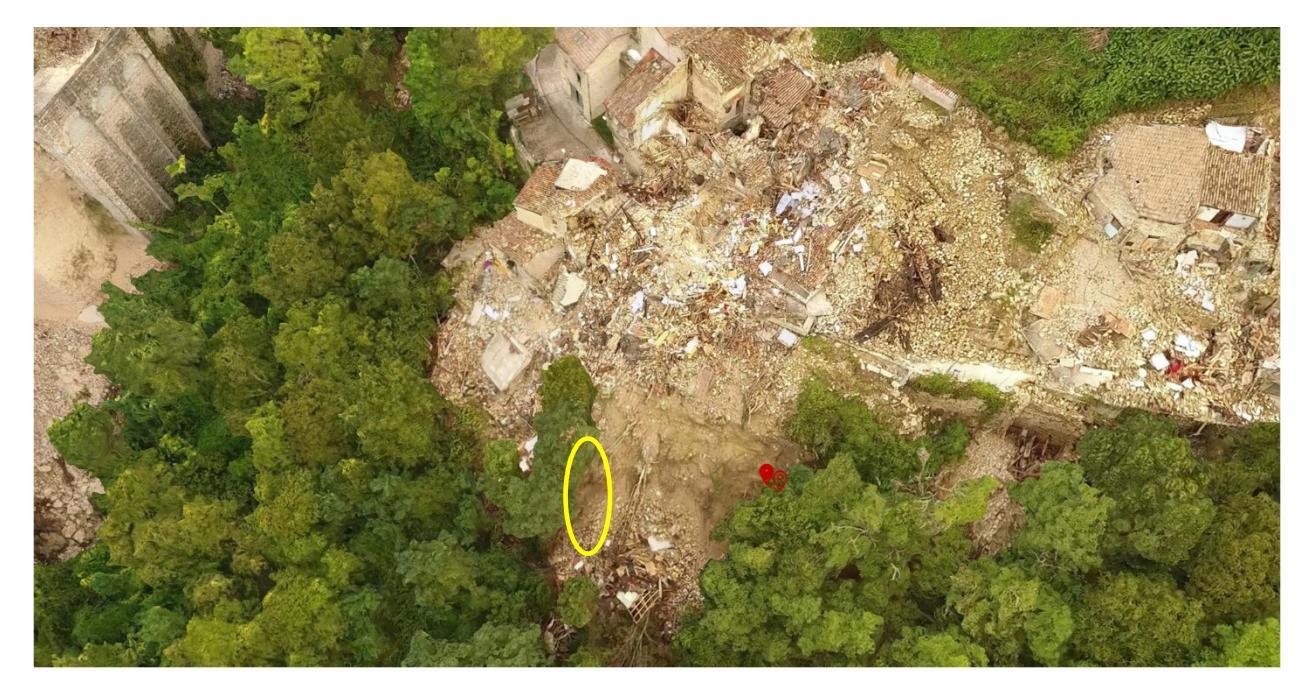
Another shallow landslide occurred on the northern side of Pescara del Tronto (marked as #6 in Figure 4.24; 42.75171 N 13.27261 E). Low-resolution pre-earthquake satellite imagery from Google Earth suggests that this area was already partially barren of vegetation, perhaps due to an existing localized landslide. However, the aerial imagery from the UAV and resulting

3D model, presented in Figure 4.34, show exposed tree roots (circled in yellow) and scarps that appear to be less than one meter-deep into the hillside. The landslide is approximately 17 meters wide by 20 meters high. Significant amount of structural rubble from collapsed residences is also visible in the landslide debris.

Figure 4.34. Model of shallow landslide below a northern portion of Pescara del Tronto (42.75171 N 13.27261 E).

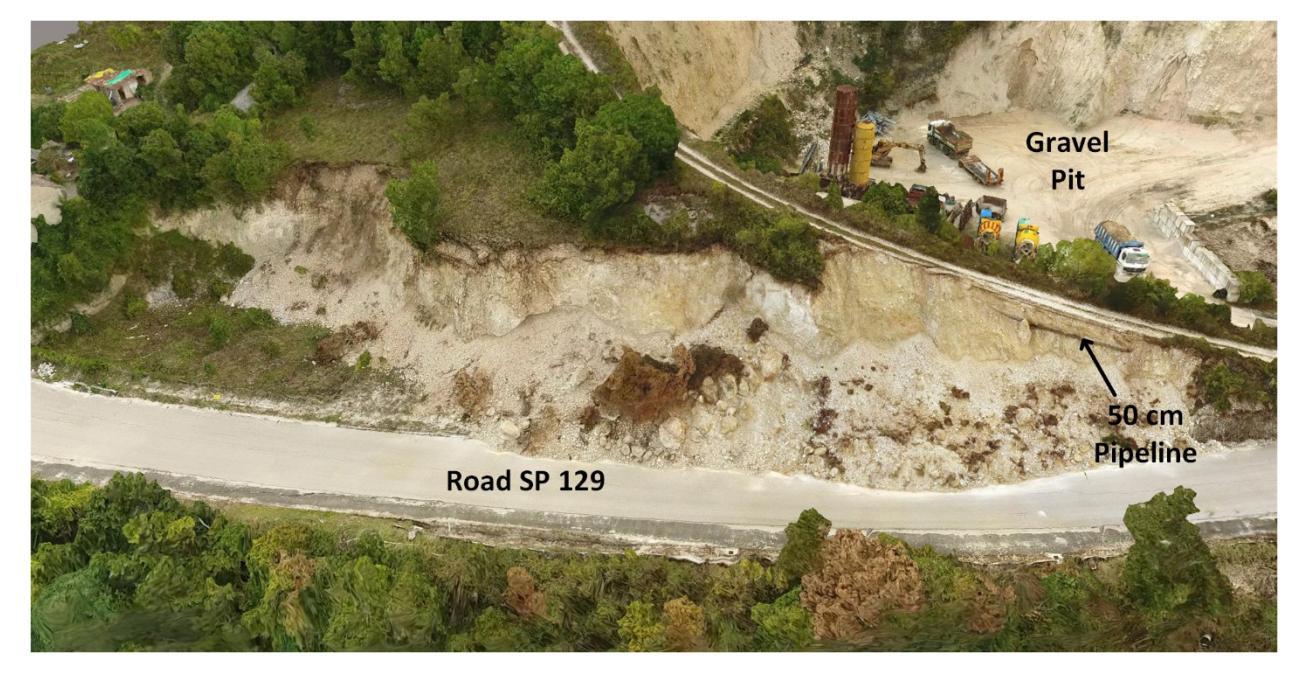
Figure 4.36. Model image of landslide near gravel pit and Road SP 129 that exposed a 50 cm-diameter pipeline (42.74950 N 13.26958 E).

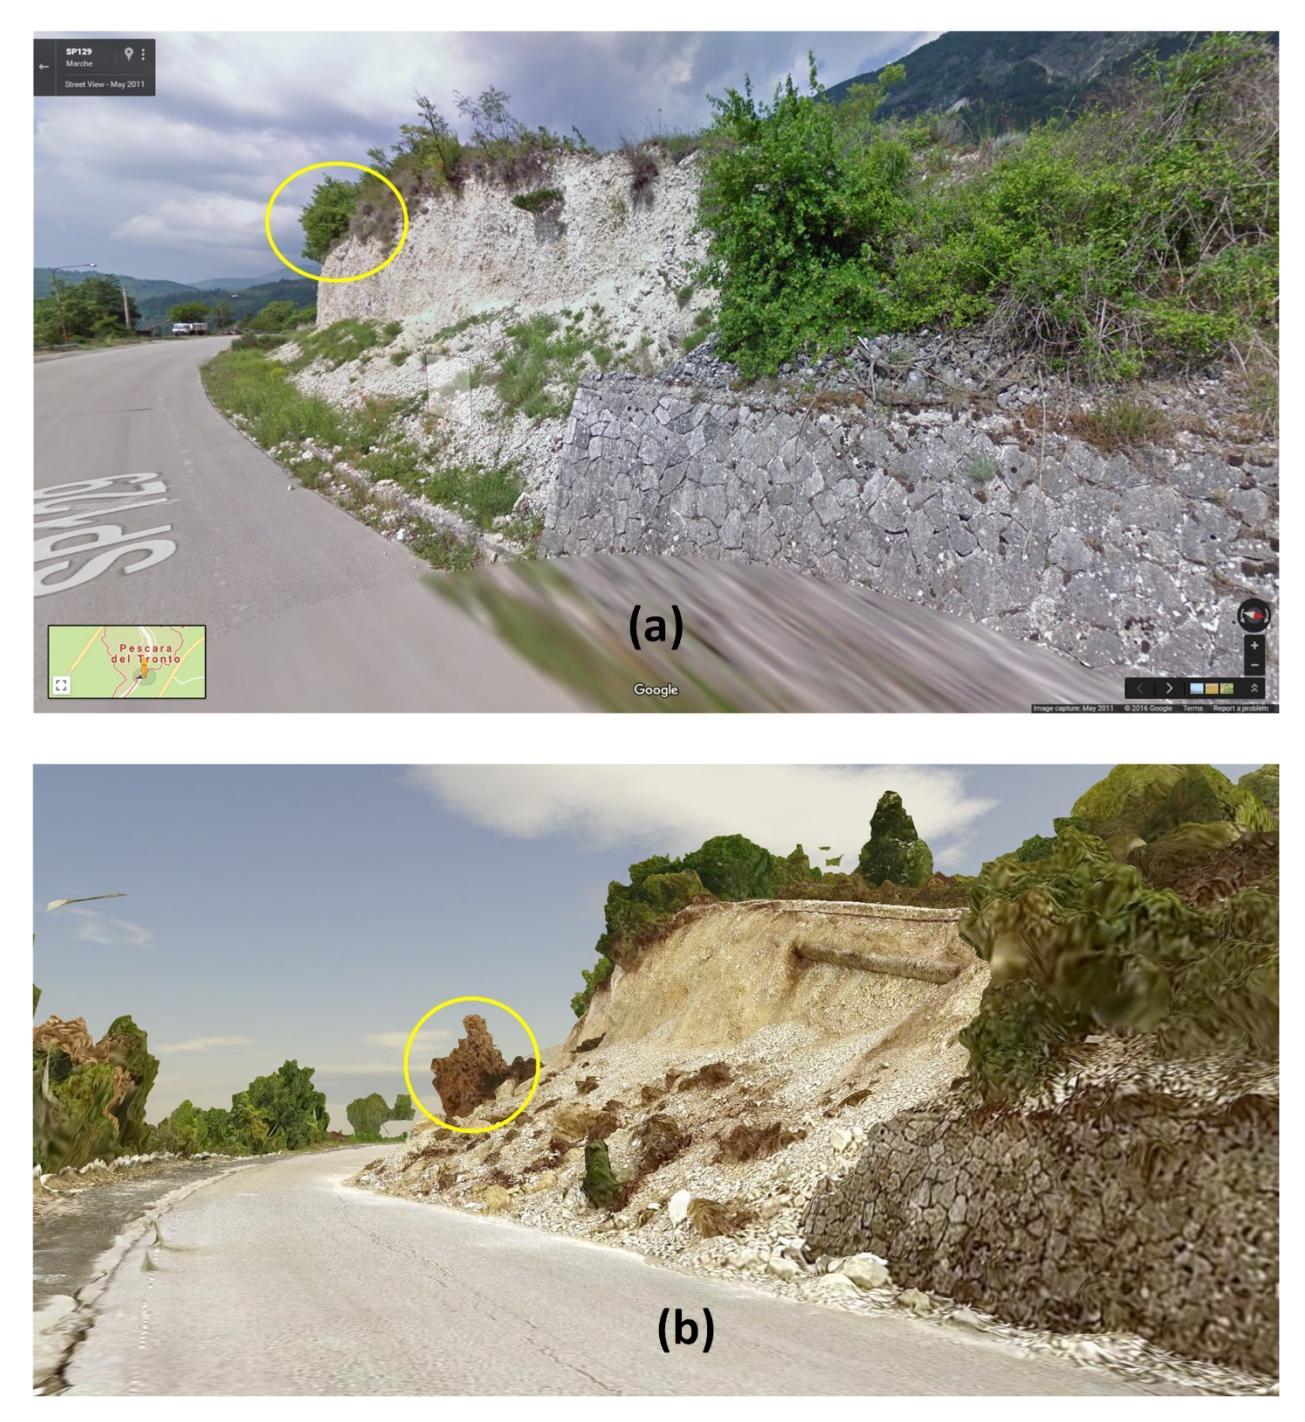
Figure 4.37. Both pre-earthquake (a) and post-earthquake (b) images of the slope near the gravel pit where a landslide exposed a pipeline. Pre-earthquake imagery courtesy of Google.

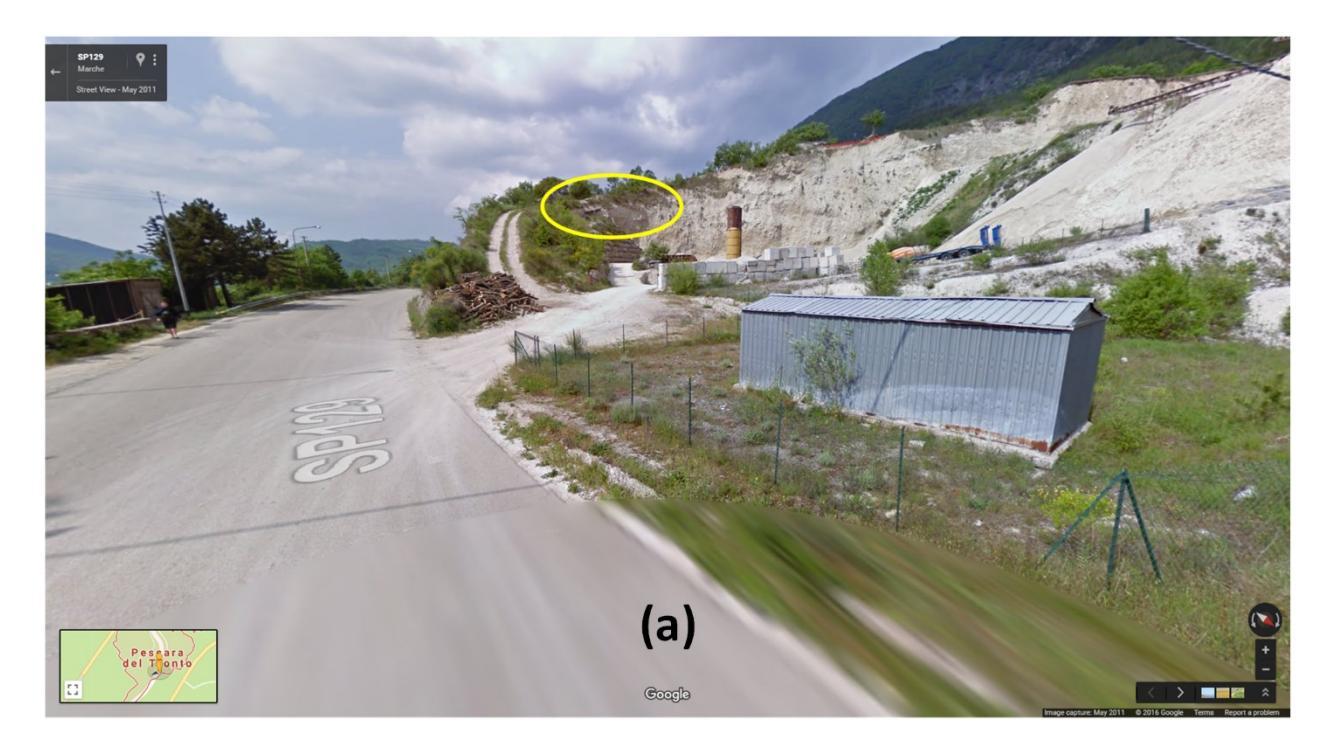
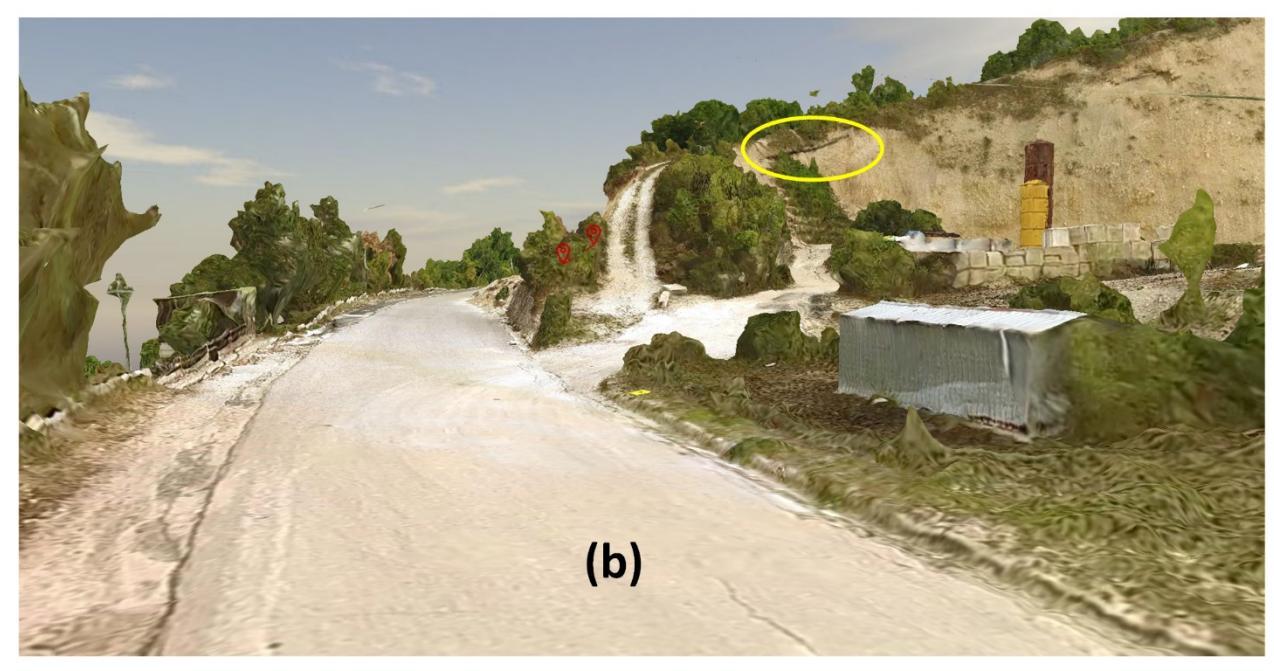
Figure 4.38. Pre-earthquake (a) and post-earthquake (b) images of the haul road slope inside the gravel pit, with exposed pipeline. Pre-earthquake imagery courtesy of Google. From these images, it appears that the earthquake and subsequent landslide into the gravel exposed 10 meters more of the pipeline.

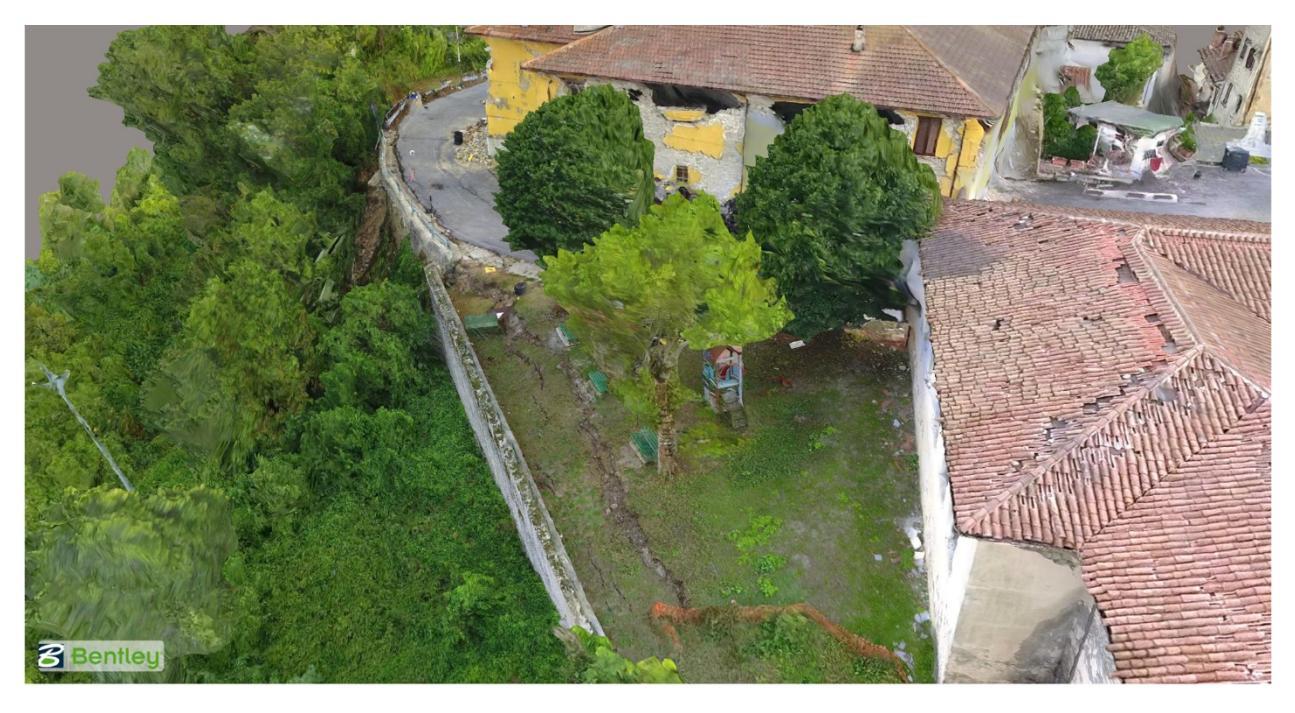
Figure 4.42. Model image of a rotated retaining wall (3.5-degrees) and the subsequent soil graben behind the wall (42.69446 N 13.24980 E).

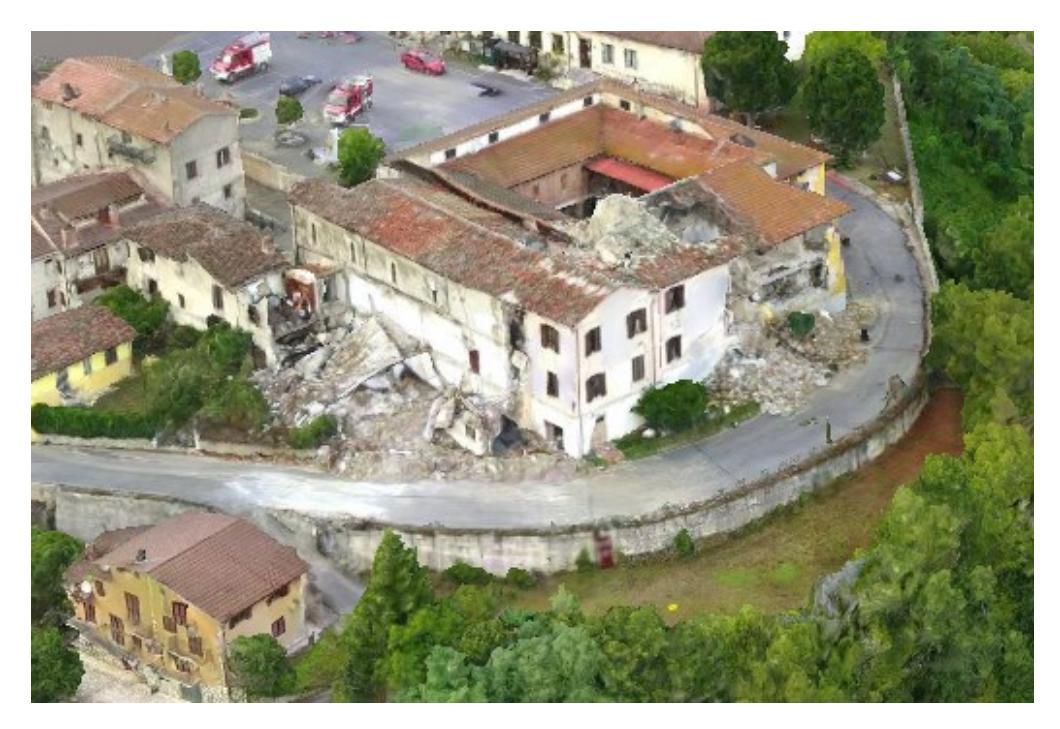
The most severe damage was observed at the easternmost margins of the village, likely associated with the specific ground conditions. The presence of man-made fills is likely in the area, considering the local topography. The damage observed on the earth retaining walls at the eastern edge of the village may indicate possible relative movements associated with instabilities, as discussed further in Section 4.4.6. Damage in other portions of the village is more homogeneous, and local variations are likely associated with different building vulnerabilities.

Figure 5.3. Excerpt of the 3D model with the most damaged portion of Accumoli (easternmost part of the village).

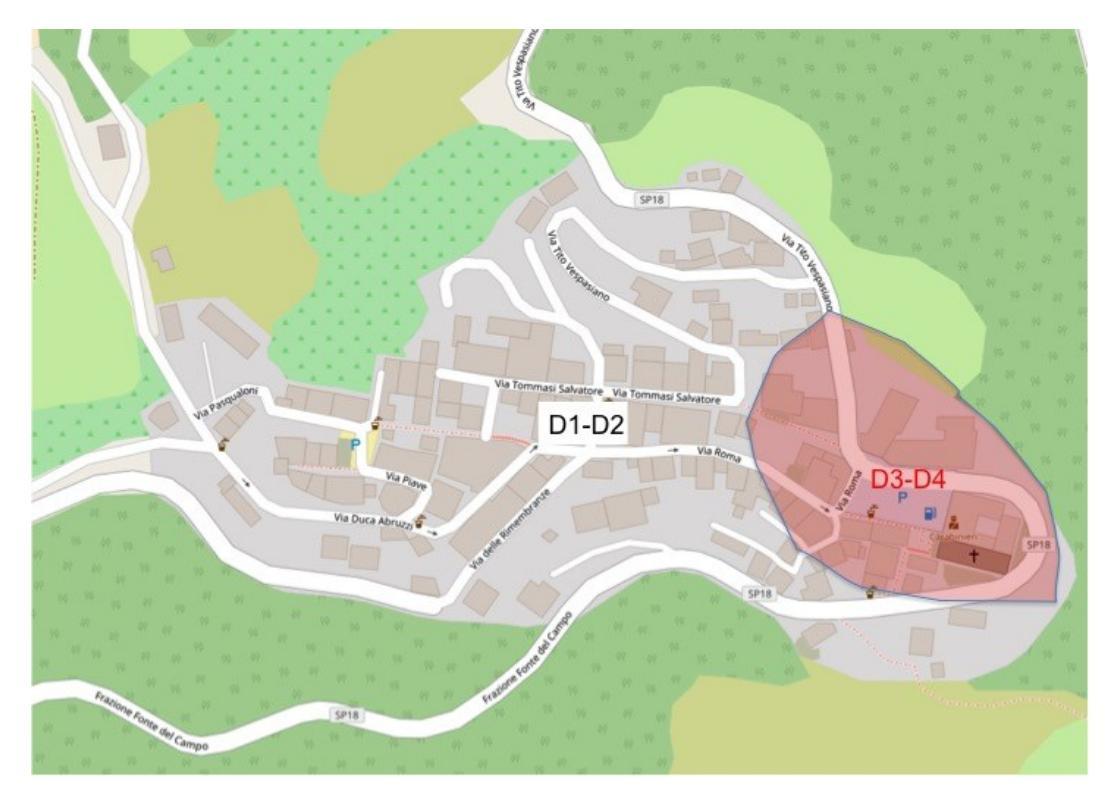
The level of damage increased from D1-D2 to D3-D4 moving downhill facing east. A tentative damage zonation is reported in Figure 5.5. A few cases of full collapse of vulnerable masonry buildings (Damage level D5) were observed along the eastern margin. These are also associated with relevant movements of backfill walls as observed in the 3D model. Damage patterns from the aerial image analysis from the Copernicus project were not well defined, as for other villages.

Figure 5.5. Damage zonation within the village of Accumoli.

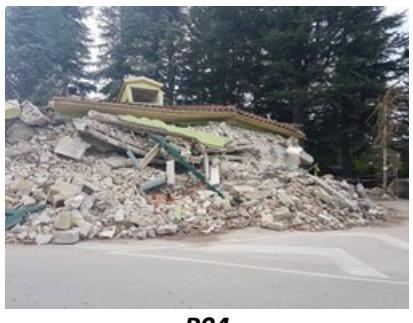
P02

The building surveys conducted in the Amatrice suburb and elsewhere enable (1) detecting variable levels of building performance, including minor damages; and (2) checking of the damage levels assigned by others based on Copernicus satellite surveys (Figure 5.10). As expected, we found that structures with minor damage (D1-D2) were not mapped as such from satellite images. Moreover, the Copernicus satellite survey does not correctly classify the collapse-level damage states observed in some structure, two examples of which are P04 and P05 in Figure 5.9. Picture P04 shows a masonry structure collapsed under a heavy RC roof, which remained intact. In this case, the satellite survey did not recognize the totally collapsed building under the roof and classified the building as moderately damaged. Picture P05 shows a structure with partial collapse (D4), which had been identified as collapsed (D5) by Copernicus.

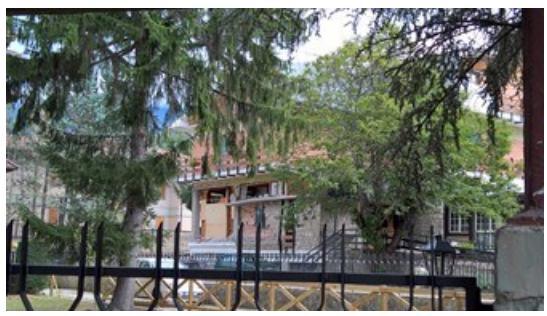
P11

Major damage was observed in critical buildings, such as police stations (the one of the *Carabinieri* corps, which is a three-story masonry structure strengthened with steel ties, P15 and P16 in Figure 5.9, and the one of the Highway Patrols, P11) and a school that, despite previous interventions, collapsed partially (P17). Also evident are structural members that were individually strengthened (P18). Multi-story reinforced concrete buildings behaved relatively well, mainly exhibiting in-plane shear failure of infill panels (P19) and minor to moderate damage at their beam-column joints (P20).

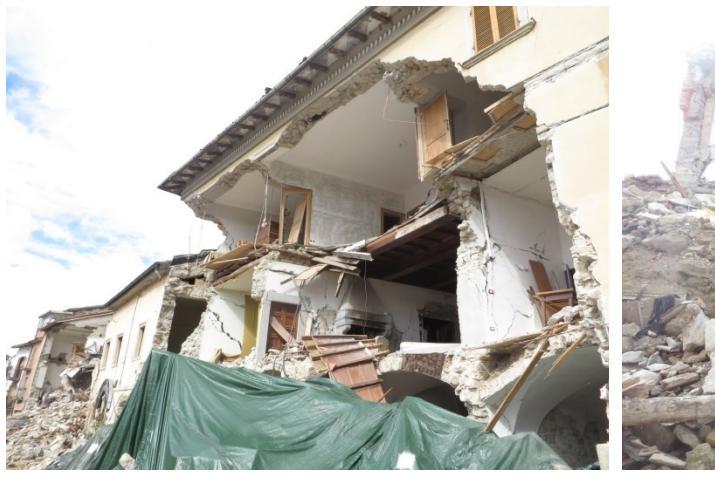
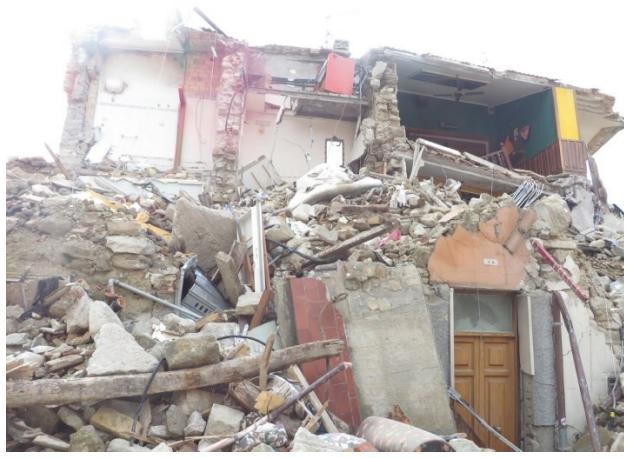
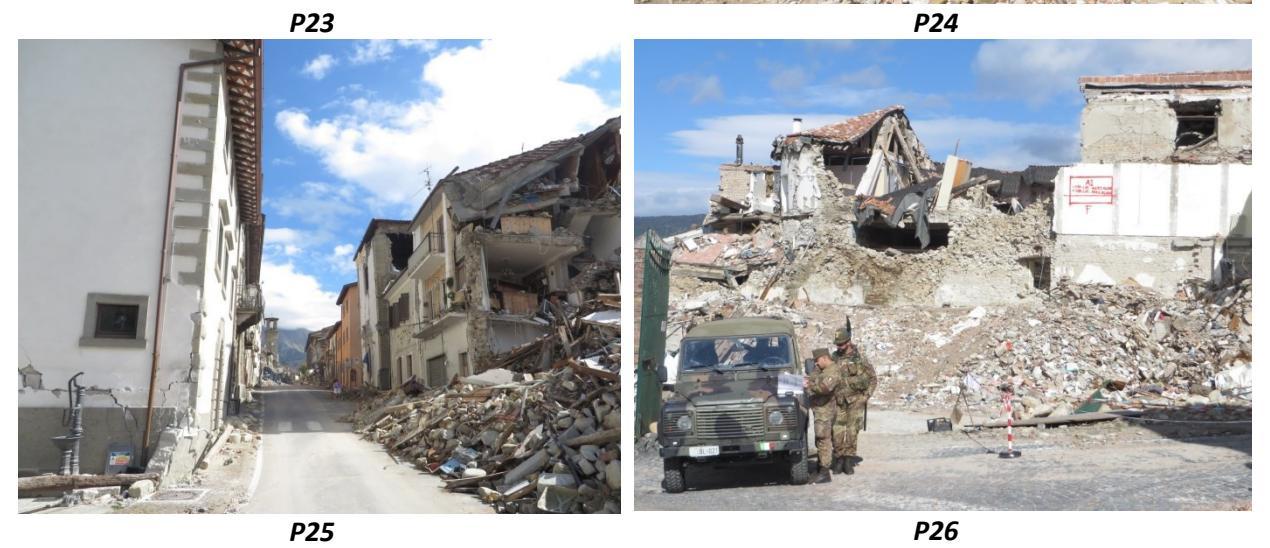
Figure 5.12 (top photograph) illustrates the extent of structural damage while the distribution of global damage is portrayed in lower figures (it is noted that the building sample is still being processed). Characteristic images of building collapses are shown in Figure 5.13 and Figure 5.14 (P21-P28) while corresponding coordinates are reported in Table 5.5. Of particular interest was the five story R/C building of P29-P30 in Figure 5.14 along the main market street, which exhibited major damage but did not collapse during the M6.1 main shock nor subsequent aftershocks. Unfortunately, it subsequently collapsed during the 26 October 2016 M6.1 event. A few buildings, recently restored, remained undamaged or suffered only minor damage, two of which are depicted in P31-P32. The same applies to the three-story steel building of P33-P34 (Figure 5.15) that experienced minor damage (i.e., shear failure of the infill panels and only minor buckling to one of its columns). The latter building was located very close to the R/C building of Hotel Roma, the town's main hotel, which collapsed (P35-P36 in Figure 5.15).

Figure 5.13. Photos of extensive building collapse within Amatrice Red Zone after the 24 August event.

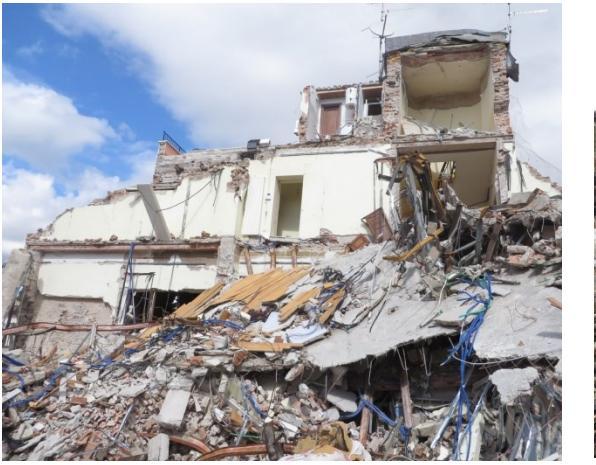
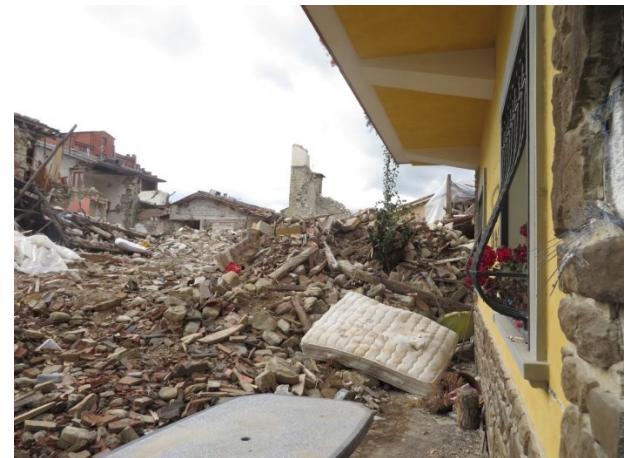
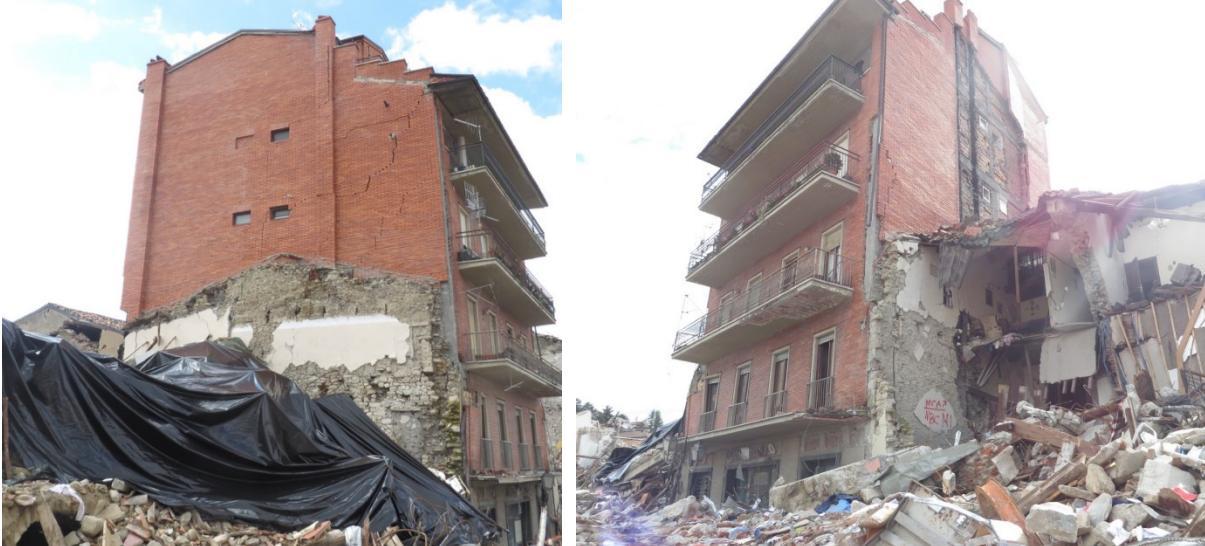
Figure 5.14. Photos of building collapse (P27, P28) but also mahor (P29 and P30) and minor (P31 and P32) damage along the main market street of Amatrice.

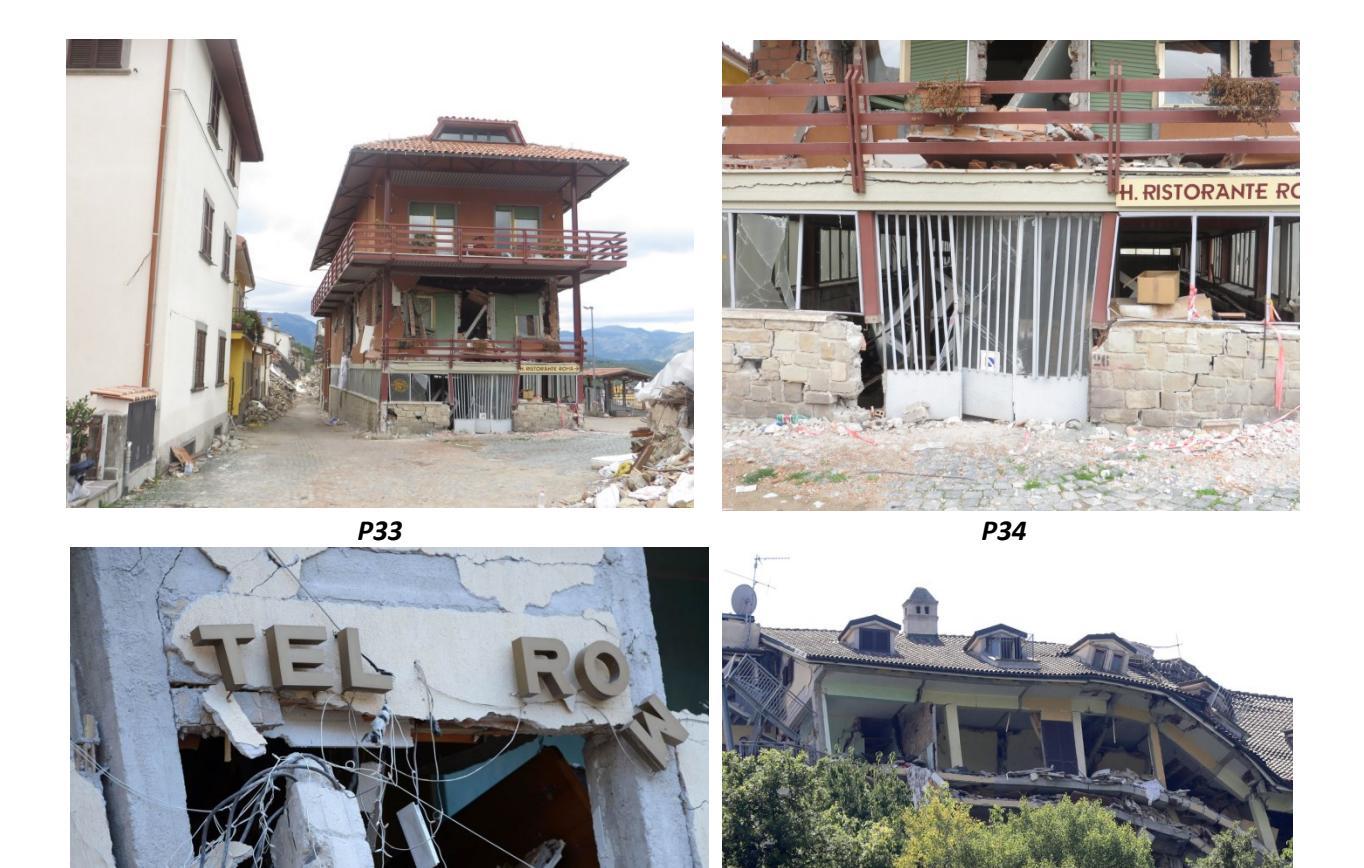
P35

Figure 5.15. Photos of a characteristic steel building with minor-to-moderate damage (DS2, P33-P34) next to Hotel Roma, a collapsed R/C building (P35, P36).
