Engineering Reconnaissance of the 24 August 2016 Central Italy Earthquake. Version 2 GEER Team Leaders: Giuseppe Lanzo and Jonathan P. Stewart

Geotechnical Extreme Events Reconnaissance Association

Report No. GEER-050B

22 November 2016

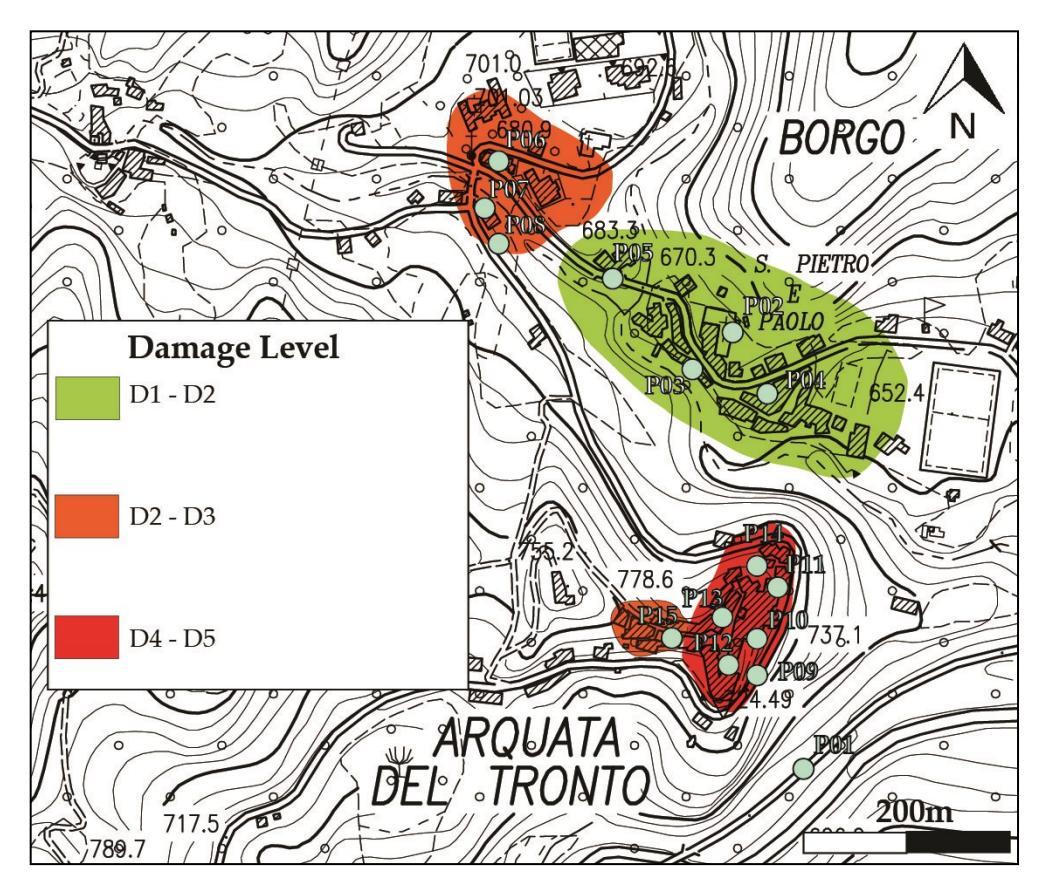
Figure 5.19. Damage zonation within the villages of Arquata and Borgo.

The village was significantly damaged by the mainshock. However, the degree of damage to buildings is quite variable in space. A tentative damage zonation is reported in Figure 5.19. The hamlet of Borgo suffered minor damage (mainly cracking of non-structural elements) and no collapses were observed. The level of damage slightly increased form D1-D2 to D2-D3 moving in the NW direction. Arquata, founded on top of the ridge, was highly damaged. Several unreinforced masonry structures were partially or fully collapsed (P10-P14). A few cases of retaining wall failures along the road leading to the village were observed, which consisted of permanent deformation of the wall as a whole and collapse of the upper part of the wall. Some buildings survived the event but appeared to have approached the point of collapse or severe damage (see P11 for instance). The level of damage decreased away from the edge of the cliff (P15), although this area was not fully accessible on the date of our survey.

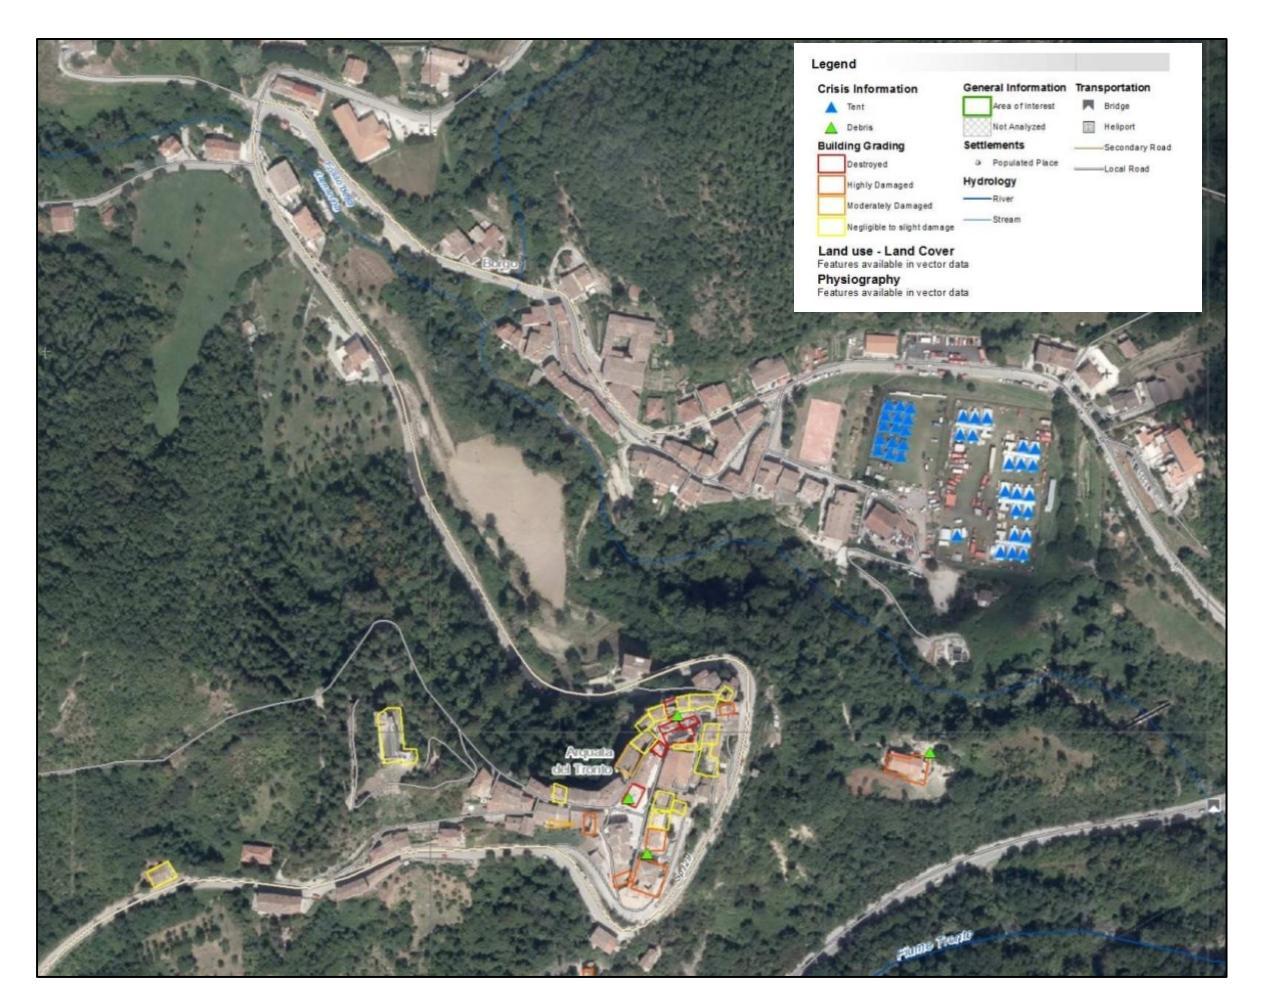
Figure 5.20. Damage pattern from Copernicus post event images (http://emergency.copernicus.eu/mapping/list-ofcomponents/EMSR177/ALL/EMSR177_19ARQUATADELTRONTOAERIAL)

Damage patterns evaluated from aerial image analysis of Arquata are presented in Figure 5.20. No information is provided for Borgo. The higher degree of damage in Arquata, located near the top of the ridge, relative to Borgo was captured on average. Again, a decreasing degree of damage was observed away from the edge. The cases of full collapse were generally captured by the aerial image analysis (P13 and P14 were reproduced, while P12 was reported as highly damaged). The degree of damage to highly damaged and partially collapsed buildings was sometimes underestimated and identified as "negligible to slight damage" (e.g., P11).

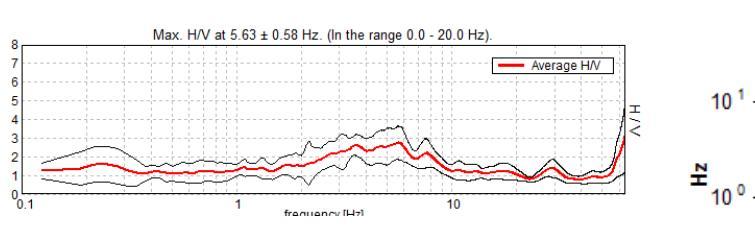
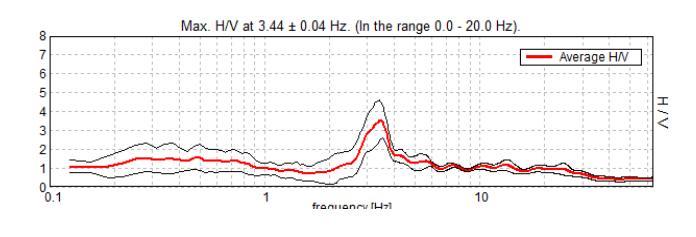
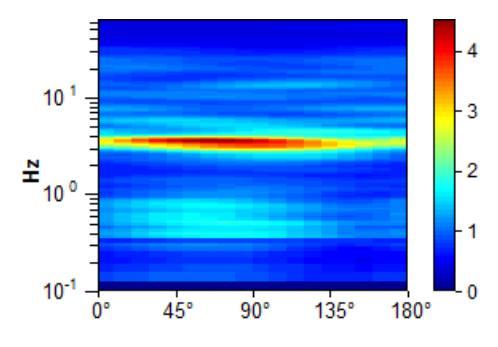
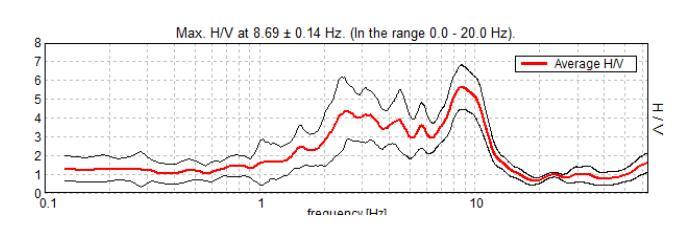
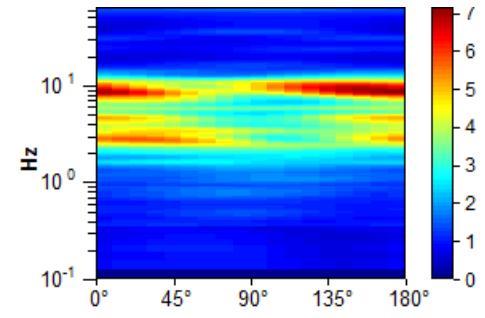
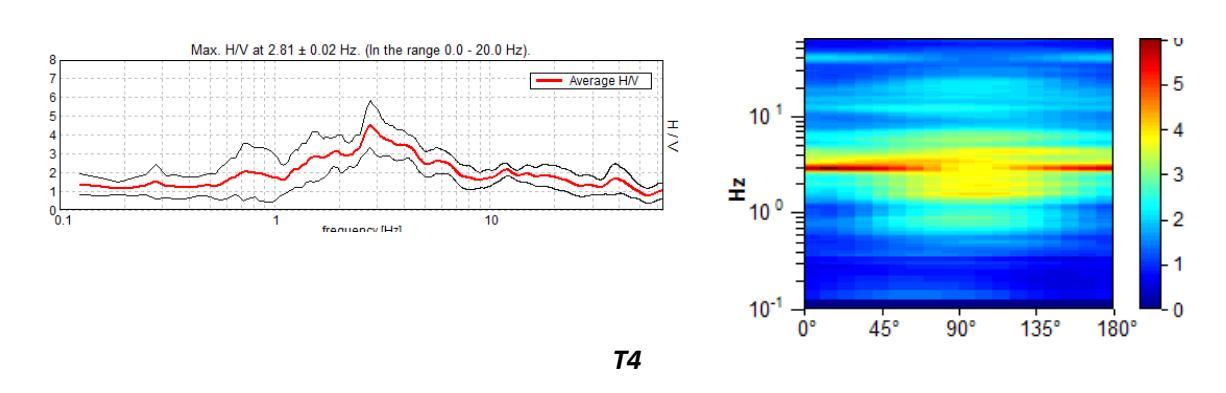
Figure 5.22. Noise measurements results in terms of H/V spectral ratio (on the left column) and H/V polar plots (on the right).

No significant H/V peaks can be observed in T1 measurements. A pronounced H/V peak was identified at about 3-4 Hz in T2, indicating possible site effects that may have contributed towards the damage observed in the NW portion of the Borgo hamlet. In this area, an MASW test was carried out in the level 1 seismic microzonation study, which highlighted an impedance contrast between gravelly covers (thickness in the range 12-18 m and Vs=200-300 m/s) and the underlying Flysch bedrock (Vs≈800 m/s). The fundamental frequency of the gravel cover reasonably matches that measured from H/V.

In Arquata, two noise measurements were carried out (T3 and T4) both of which indicate H/V peaks around 3 Hz, with horizontal motion polarized in the NS direction, i.e., roughly perpendicular to the axis of the major ridge. Close to the edge, a second peak at about 10 Hz was observed, again with NS polarization. These results are preliminary and the HVSR technique for complex topographies is far from ideal for the applicability of the method. Similar results for other regions have been obtained previously (Pagliaroli et al. 2015).

It appears that the major damage in Arquata may be partially related to topographic amplification effects. However, in this area, the buildings were also slightly more vulnerable compared to Borgo: no reinforced masonry structures were identified in the severely damaged area. Iron bar-reinforced buildings were observed only in Borgo, whereas isolated concrete structures and more recently constructed masonry buildings were found in Arquata. The combination of topographic amplification and greater structural vulnerability may explain the significant differences in damage level observed in the two hamlets. Moreover, the non-uniform damage patterns observed in Borgo can be tentatively explained by some stratigraphic amplification effects in the NW portion of the hamlet, roughly supported by geophysical data.

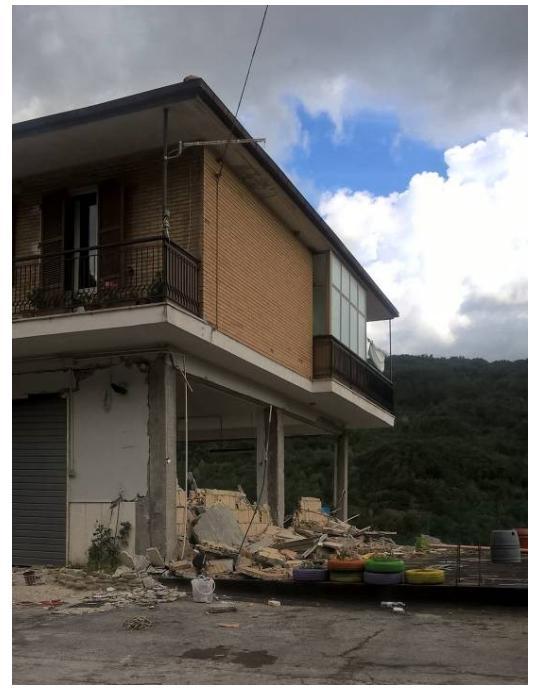
P01

Buildings in the village mainly consisted of un-reinforced masonry structures 2-3 stories in height. Very few of the structures were retrofitted (see for instance P11). Isolated, relatively modern reinforced concrete structures can be found along the road to access to the village and were subjected to relevant damage (P01).

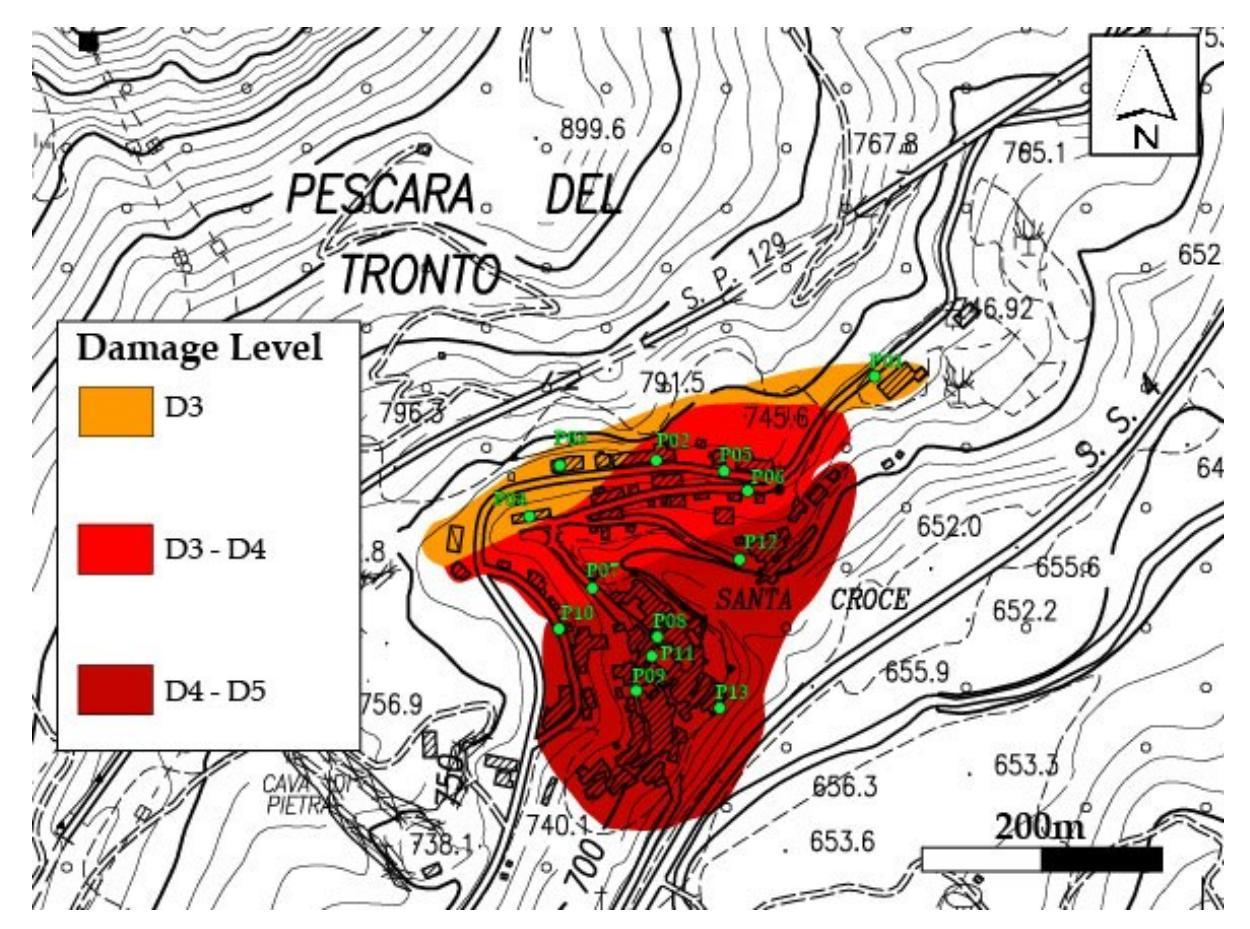
Figure 5.27. Tentative damage zonation within the village of Pescara del Tronto.

The village was extensively damaged by the mainshock, with the degree of damage greater than or equal to D3 in most places. A tentative damage zonation in this area is reported in Figure 5.27. On the road leading to the southern part of the hamlet (P01-P06) the level of damage seemed slightly lower; partial or full collapse (P02, P05 and P06) was observed together with smaller degrees of damage (P03, P04). It should be noted that the only concrete building in the village was subject to significant damage to beam-column nodes (D3 damage, see P1). The southern part of the hamlet was almost completely destroyed, ranging from partial to full collapse (P09-P13). These areas were not accessible to the GEER team, but the patterns can be

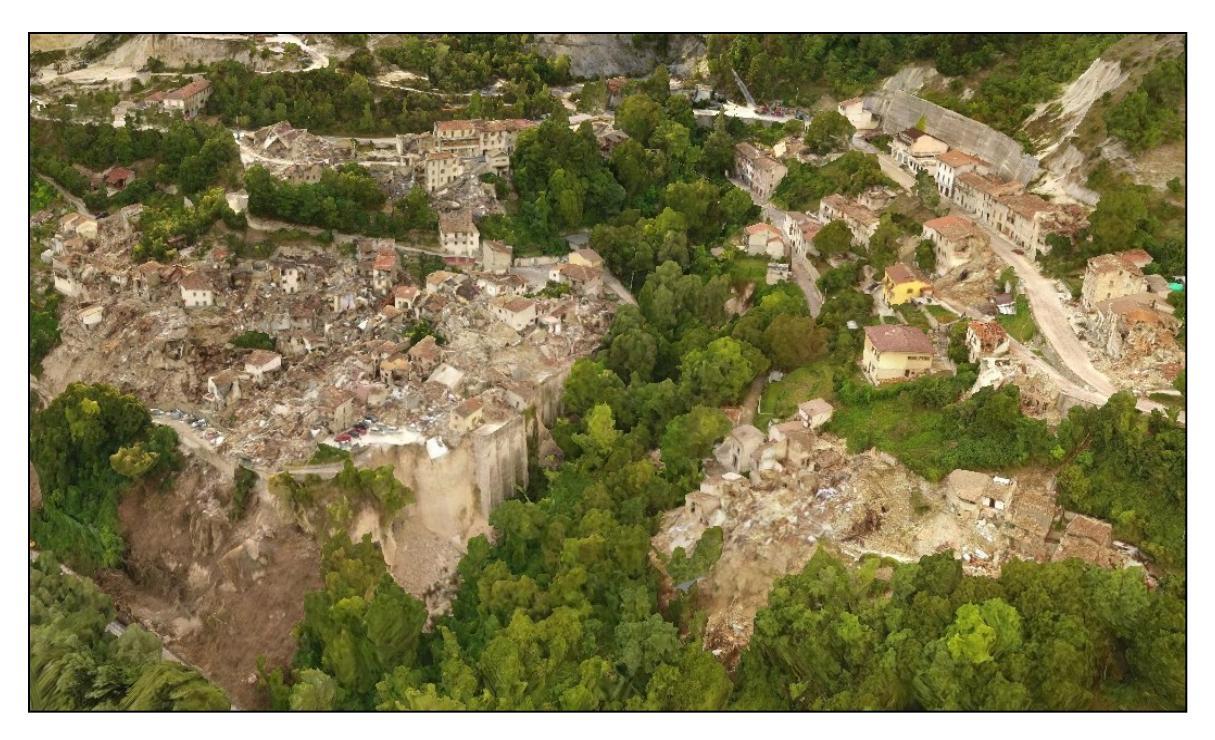
Figure 5.28. 3D model from drone flights on the village of Pescara del Tronto.

identified from the 3D model of the village built from drone flights and reported in Figure 5.28 (further details in Chapter 4).

The 3D model clearly showed complex landslides affecting the southern part of the village (see also Section 4.4.5). A photograph taken form Salaria road close to the Tronto river at the southern toe is presented in Figure 5.30. Moreover, tension cracks were observed to be widespread in the hamlet. The subsoil in the area affected by mass movement is quite complex and has not been studied. In addition to the flyschoid bedrock and slope debris deposits, a preliminary geologic survey highlighted in the area the presence of a travertine bank and highly heterogeneous anthropic covers.

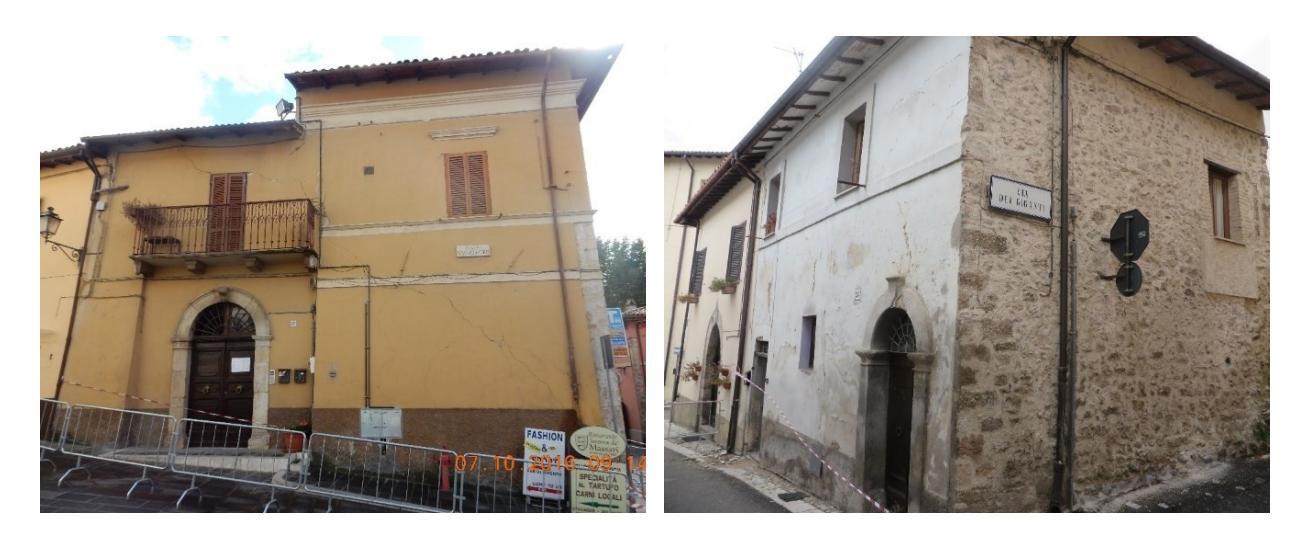
Following the 24 August 2016 earthquake sequence, some cracks were visible, especially inside houses. Few collapses occurred, which were old and non-maintained buildings. Some structures having typically small levels of damage in the center of Norcia are shown in Figure 5.33-5.34. The implementation of appropriate seismic design practices, careful repair of a number of structures, and the successful retrofitting of the buildings in Norcia contributed to the good performance of buildings under the 24 October 2016 event and its aftershocks.

Figure 5.33. Limited damage was observed in the buildings of Norcia.

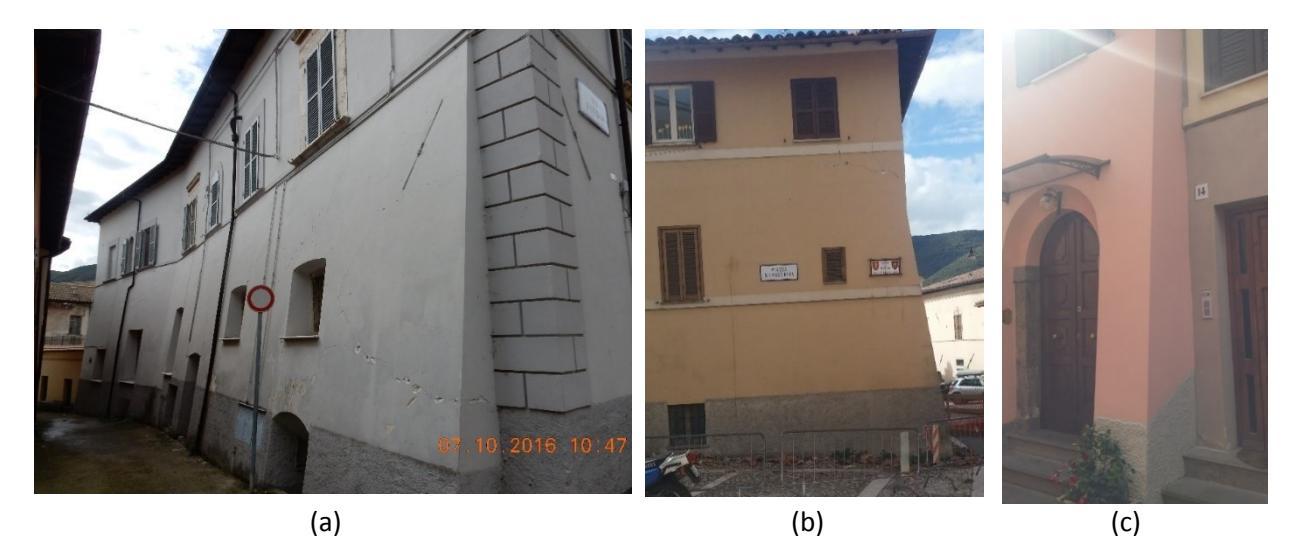
A devastating earthquake that occurred in 1859 led to the development of a new building code at the time. The reconstruction that followed was based on that new code, which established a minimum wall thickness, the use of buttresses, the reduction of the building height, the use of vaults only at the ground floor, and the mandatory presence of good wall-to-wall connections. The increased wall thickness is visible in many structures, while in several buildings, the thickness of the wall varies linearly along the height of the first story and remains constant along the rest of the building's height (Figure 5.34). These measures helped reduce the fatalities and extent of damage during the following earthquakes.

Figure 5.34. Earthquake resistant construction practices in the center of Norcia – linearly varying thickness of the first story.

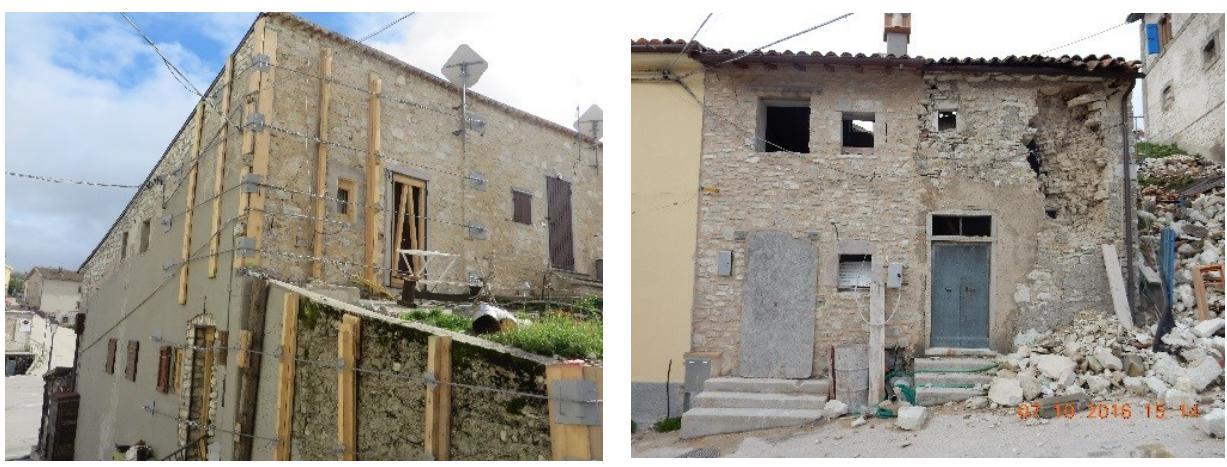
ruble bib. Locations of representative structures with damage descriptions.						
Picture	DATUM	Location		Damage Level	Notes	
		Lat.	Log.			
P01	WGS-84	42.829358	13.205331	D4		
P02	WGS-84	42.82886	13.206422	D4		
P03	WGS-84	42.828836	13.206584	D5		
P04	WGS-84	42.82846	13.207108	D4		
P05	WGS-84	42.828289	13.207392	D1

Figure 5.41. Representative pictures taken in Castelluccio during the survey.

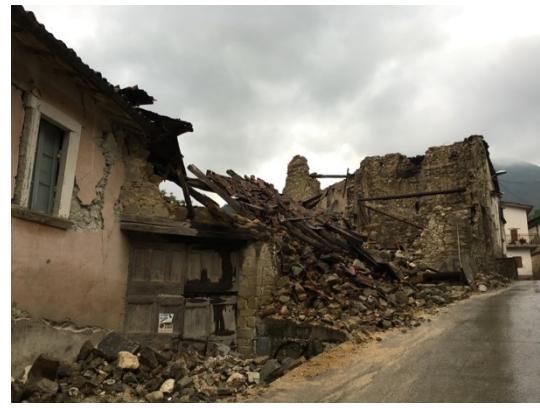
TAG	TAGDATUMLocationLat.Long.		Location		Notos
TAG			level	Notes	
P1	WGS-84	42.7353°	13.2532°	D3	Diffused cracks
P2	WGS-84	42.7353°	13.2530°	D5	Collapse of the entire structure
20	D2 M/CS 94 42 7254° 12 2529°	20	Crack starting from the window		
P3	WG3-84	42.7554	13.2328 D	DZ	corner
P4	WGS-84	42.7351°	<i>13.2519</i> °	DO	No damage
P5	WGS-84	42.7351°	<i>13.2522</i> °	DO	No damage
P6	WGS-84	42.735°	13.2522°	D4	Partial collapse of the structure

Figure 5.44. Representative pictures taken in Tufo during the survey.

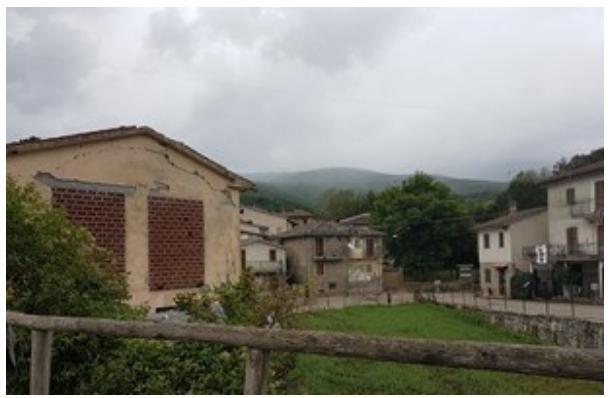
P03

Picture	DATUM	longitude	latitude	Damage	Note
				level	
P01.jpg	WGS- 84	13.255	42.69528	D3	
P02.jpg	WGS- 84	13.255	42.69417	D4	View of several buildings
P03.jpg	WGS- 84	13.255	42.69528	D3	View of several buildings
P04.jpg	WGS- 84	13.255	42.69528	D3	
P05.jpg				D3	Downloaded from
					http://www.fontedelcampo.it/foto/foto-terremoto/
P06.jpg				D5	Downloaded from
					http://www.fontedelcampo.it/foto/foto-terremoto/
P07.jpg				D3	Downloaded from
					http://www.fontedelcampo.it/foto/foto-terremoto/

Figure 5.49. Representative pictures taken in Fonte del Campo during the survey.

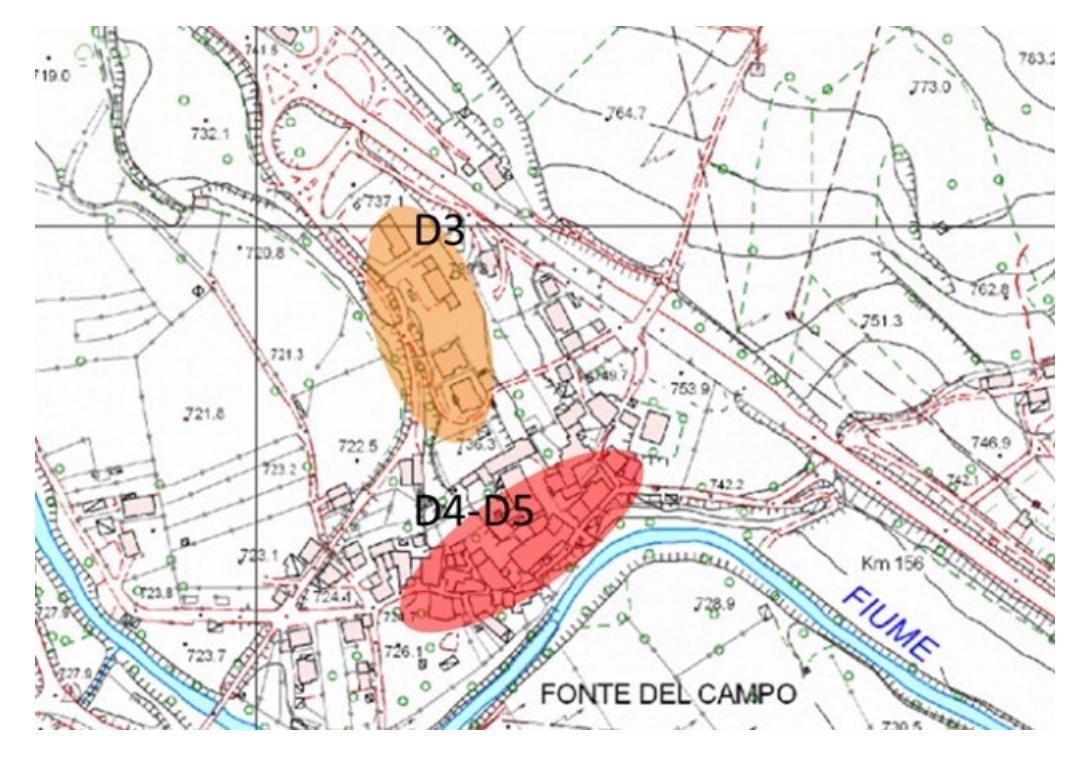
As reported in Figure 5.48 to Figure 5.51 and Table 5.11, masonry buildings were the most highly damaged structures in the area. Two zones have been drawn based on the distribution of the damage: the most ancient part of the village characterized by damage levels D4-D5, and the more recently built surrounding zones characterized by a damage levels not exceeding D3. The same damage pattern was reported on the Copernicus map (Figure 5.51).

Figure 5.50. Damage zonation within the village.

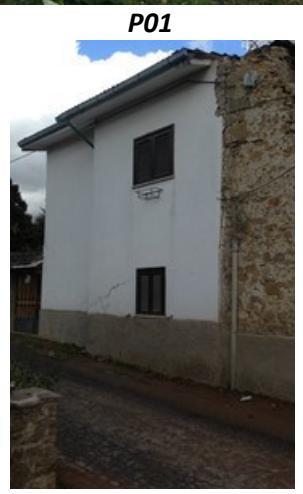
P03

Picture	DATUM	longitude	latitude	Damage level	Note
P01.jpg	WGS- 84	13.3084861	42.6349806	D4	Roof and inner walls collapsed
P02.jpg	WGS- 84	13.3101861	42.6350861	D4	Collapsed roof
P03.jpg	WGS- 84	13.3101972	42.6350861	D1	Only few cracks
P04.jpg	WGS- 84	13.3101972	42.635075	D0	Almost undamaged
P05.jpg	WGS- 84	13.3098639	42.6349722	D4	Collapsed roof showing poor masonry brickwork (adjacent to P04)
P06.jpg	WGS- 84	13.3099917	42.6349333	D3	Center - breached wall
P07.jpg	WGS- 84	13.3098361	42.6349333	D1	Effective tie rods
P08.jpg	WGS- 84	13.3098194	42.6349361	D4-D1	Collapsed unreinforced part (left) - Effective tie rods (right)
P09.jpg	WGS- 84	13.3098028	42.6349528	D3-D2	Diagonal cracks (left) – Almost effective tie rods (right)
P10.jpg	WGS- 84	13.3094667	42.6349056	D3	Diagonal cracks at the ground floor
P11.jpg	WGS- 84	13.3102028	42.6351083	D0	Undamaged recent (r.c.?) building
P12.jpg	WGS- 84	13.3098	42.6349	D1	Effective tie rods (installed also at the intermediate floor)

Figure 5.56. Representative pictures taken at Cascello (see Table 5.13 for details)

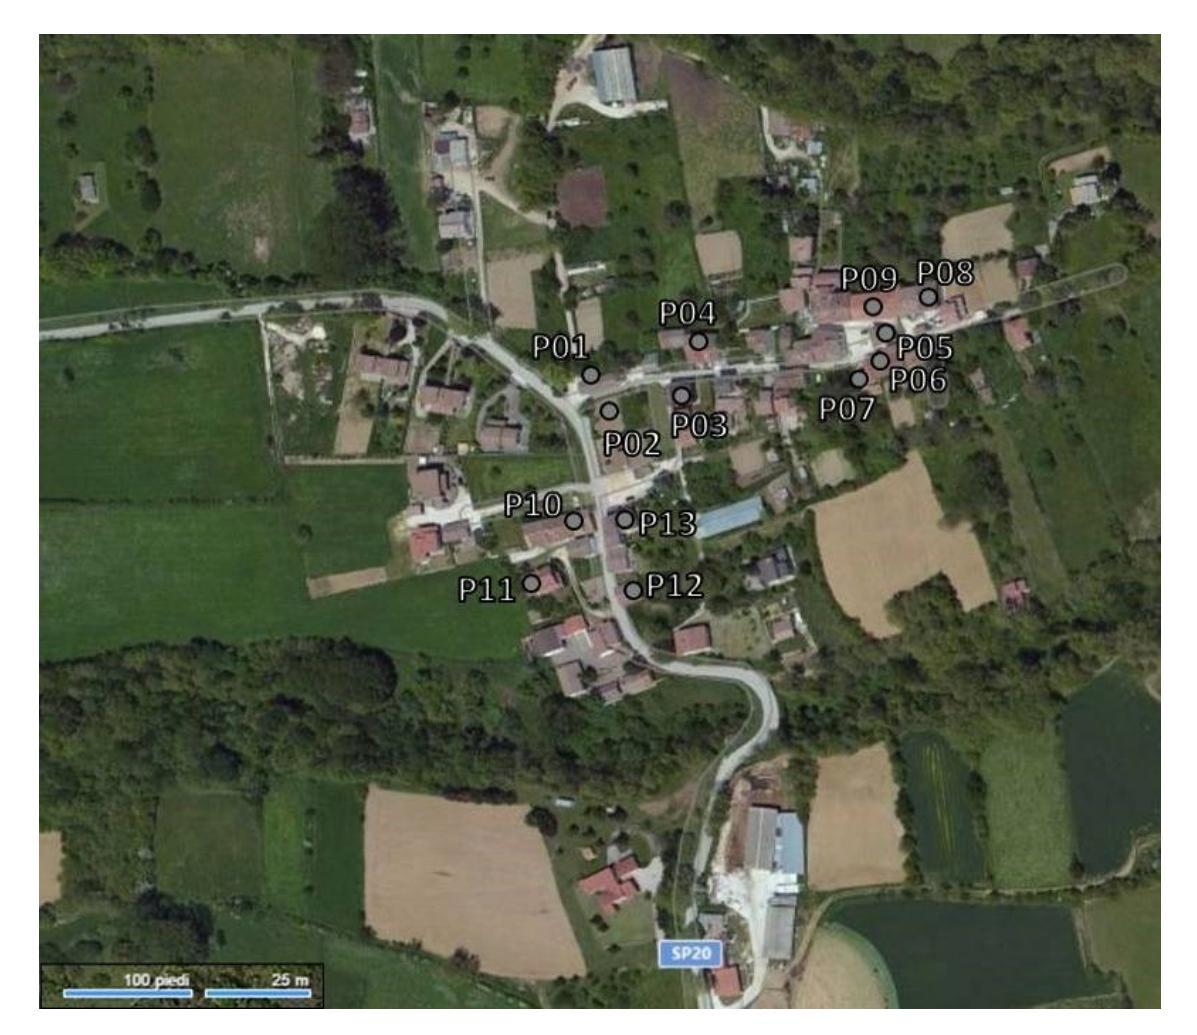
Voceto is a hamlet with 42 inhabitants, located on the east side of Amatrice at 1067 m ASL, close to a road bend (Figure 5.57), and at the toe of a Pleistocene fan (see Figure 5.53). In Voceto, the damage distribution was mainly related to the vulnerability of the structures (Figure 5.58). Table 5.14 shows locations of the most significant damage cases in the area. Old masonry structures closer to the main road (P10, P12, P13), including a small chapel (P01) and structures around the inner small square (P05, P06) were severely damaged with partially collapsed walls. Retrofitted structures (P07, P08) or more recent buildings (P09), including some reinforced concrete structures, in the village expansion uphill did not suffer significant damage. Overall, the average damage level was approximately D3 for IMCS=7 (Galli et al. 2016)

Figure 5.57. Locations of representative structures inspected in Voceto (see Table 5.14 for details).

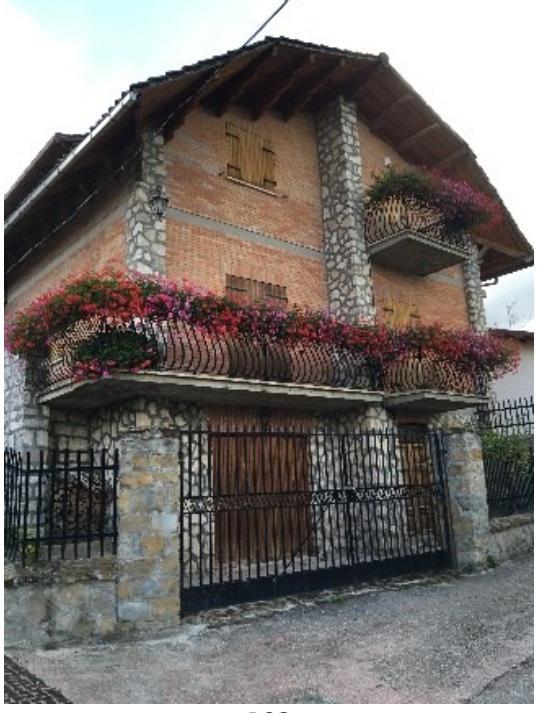
P02

Picture	DATUM	longitude	latitude	Damage level	Note
P01	WGS- 84	13.324171	42.634639	D3	Old chapel, façade and absidal walls very deformed and y grasked
					Almost undamaged new
PO2	WGS- 84	13 32/385	12 631513	00	huilding in front of the
102	W05 04	13.324303	42.034343	20	chapel
					Intensely cracked building
P03	WGS- 84	13.324870	42.634559	D3	with a singular breach at
					the toe
004		42 225442	42 62 4704		Small houses unevenly
P04	WGS- 84	13.325142	42.634781	D2 - D3	damaged
					Court house with
P05	WGS- 84	13.325969	42.634808	D3	dominating inter-
					openings cracks
P06	WGS- 84	13 325967	42 634803	D3-D4	Poor brickwork cracked
100	W05 04	15.525507	42.054005		(left) and breached (right)
P07	WGS- 84	13,325984	42,634731	00	Undamaged restored

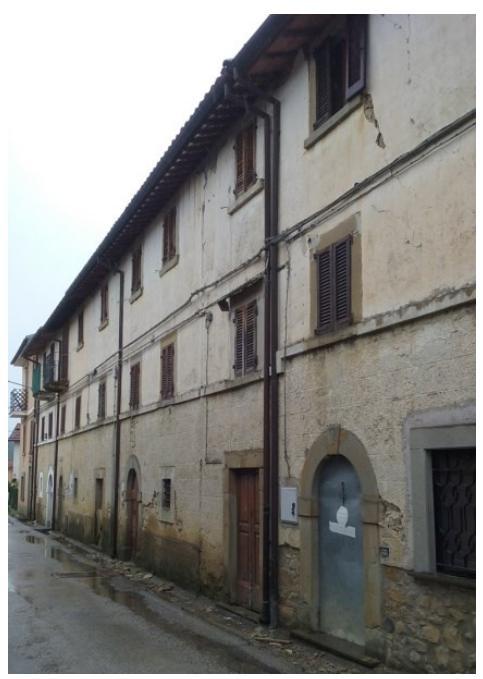
Dicture		Loca	ition	Damage	Notos
Picture	DATOM	Lat.	Long.	Level	NOLES
P01	WGS-84	42.622807°	13.279402°	D0-D1	
P02	WGS-84	42.623130°	13.279552°	D1-D2	
P03	WGS-84	42.623654°	13.279299°	D2-D3	
P04	P04 WGS-84		12 2702120	D4	Partial collapse of the
		42.023777	13.279313	04	roof

Noise measurements were obtained during the survey close to buildings shown in picture P01 (Figure 5.60). A portable Tromino tomograph was employed. The methodology used for these measurements is the same as that described in Section 5.3.3. Both H/V and polar H/V are reported in Figure 5.61. No significant H/V peaks can be observed in the measurements, roughly supporting that the village is located on seismic bedrock (Flysch) and often no significant amplification effects are expected. This apparent lack of site effect may have contributed to the low to moderate levels of damage.

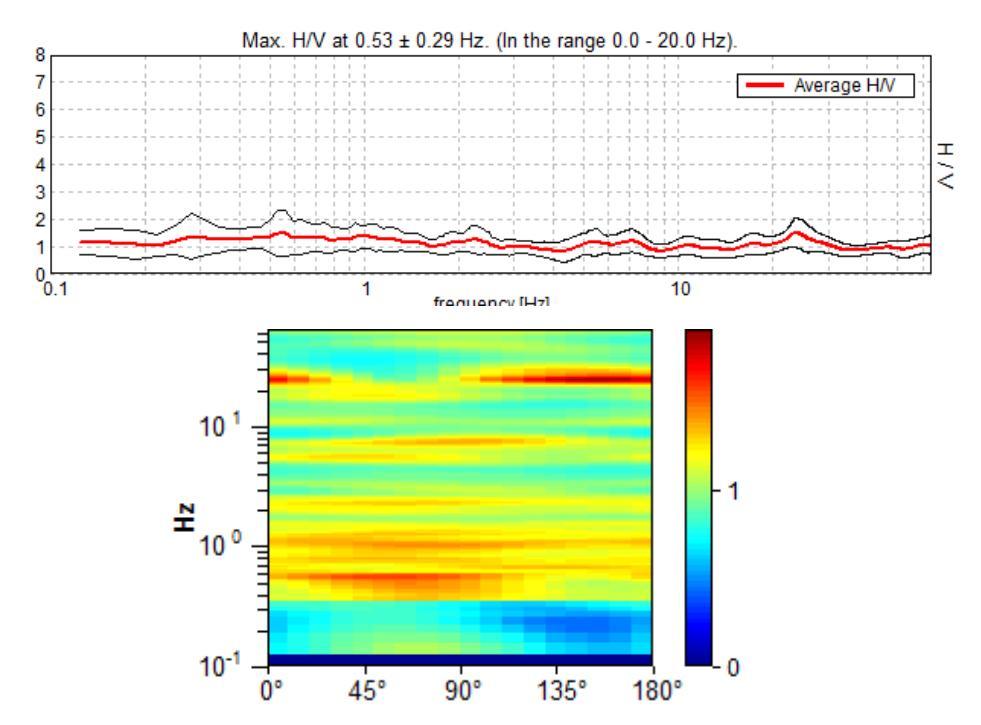
Figure 5.61. Noise measurements results in terms of H/V spectral ratio (on top) and H/V polar plots (on the bottom).

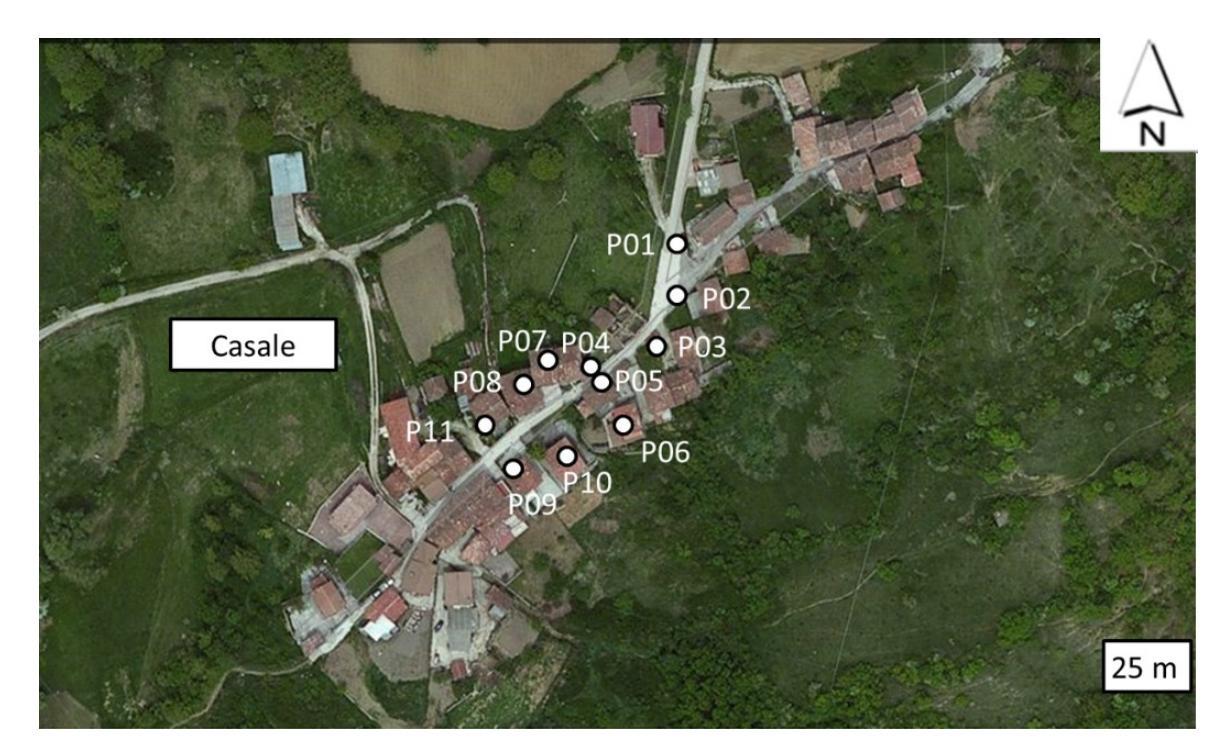
Figure 5.63 and Table 5.16 show locations and details of representative buildings inspected in Casale. Figure 5.64 shows representative structures. There were a significant number of partial (e.g. P03, P05, P07) or total (P01, P02, P08, P11) collapses of masonry buildings in Casale with an average damage level between D4 and D5, which is consistent with local I_{MCS} = 10 (Galli et al. 2016).

Figure 5.63. Locations of the representative structures inspected in Casale (see Table 5.16 for details).

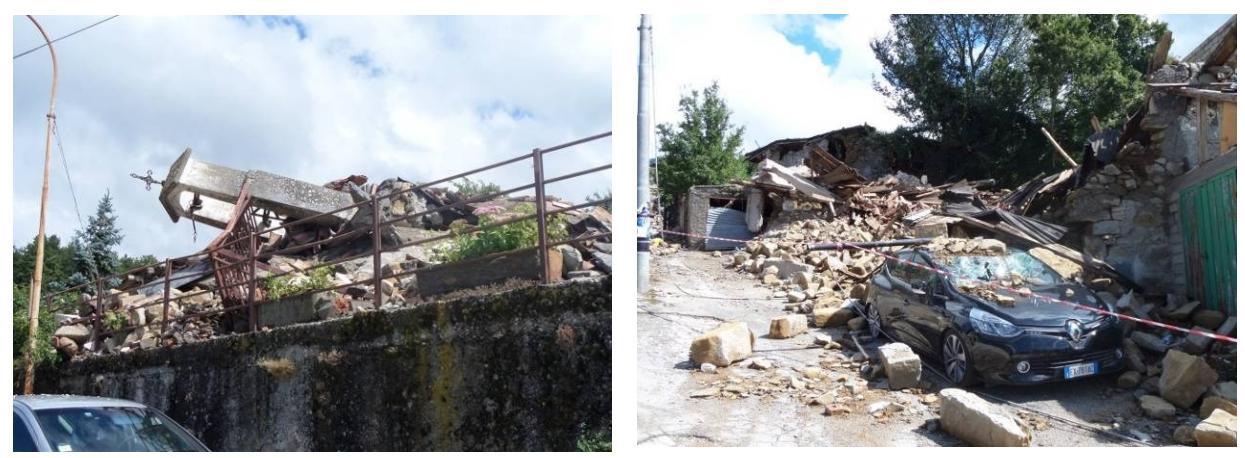
Picture	DATUM	Loca	ntion	Damage Level	Notes
		Lat.	Long.		
P01	WBG-84	42.670069	13.286015	D5	
P02	WBG-84	42.669812	13.285955	D5	
P03	WBG-84	42.669689	13.285857	D4	
P04	WBG-84	42.669553	13.285667	D3	
P05	WBG-84	42.669553	13.285667	D4	
P06	WBG-84	42.669596	13.285710	D0	
P07	WBG-84	42.669514	13.285550	D4	
P08	WBG-84	42.669473	13.285491	D5	
P09	WBG-84	42.669293	13.285254	D3	
P10	WBG-84	42.669330	13.285297	D3	
P11	WBG-84	42.669293	13.285254	D5

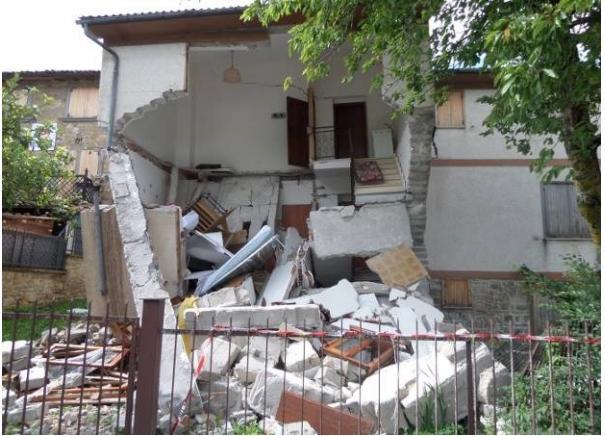
The buildings surveyed along the main road (Figure 5.66 and Table 5.17) showed a significant number of partial (e.g. P02, P06, P15 to P17) or total (P01, P03 to P05, P13, P18) collapse of the masonry buildings (Figure 5.67). The hamlet of Saletta had an average damage level between D4 and D5 for a local IMCS = 10 (Galli et al. 2016).

Picture	DATUM	Loca	ation	Damage Level	Notes
		Lat.	Long.		
P01	WBG-84	42.670660	13.273112	D5	
P02	WBG-84	42.670803	13.272817	D4	
P03	WBG-84	42.670873	13.272713	D5	
P04	WBG-84	42.670823	13.272245	D5	
P05	WBG-84	42.670770	13.272265	D5	
P06	WBG-84	42.670791	13.272260	D4	
P07	WBG-84	42.670791	13.272260	D3	
P08	WBG-84	42.670740	13.272282	D3	
P09	WBG-84	42.670740	13.272282	D3	
P10	WBG-84	42.670647	13.272412	D3	
P11	WBG-84	42.670332	13.272980	D3	
P12	WBG-84	42.670332	13.272980	D3	
P13	WBG-84	42.670427	13.272803	D5	
P14	WBG-84	42.670056	13.273478	D3	
P15	WBG-84	42.670137	13.273330	D4	
P16	WBG-84	42.672120	13.272418	D4	
P17	WBG-84	42.672120	13.272418	D4	
P18	WBG-84	42.672005	13.272686	D5

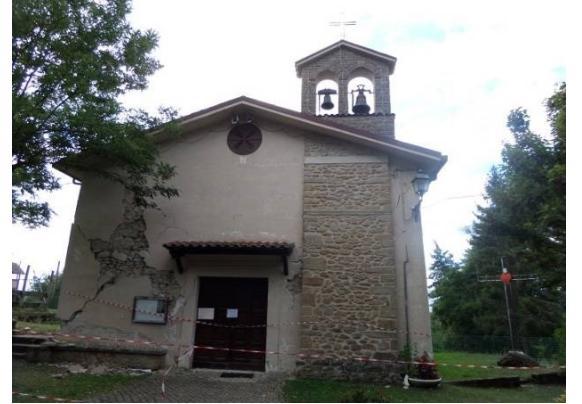
Only a small part of the village was accessible in the days of the reconnaissance, which was surveyed as shown in Figure 5.69 and Table 5.18. The few buildings inspected (Figure 5.70) in some cases were partially or totally collapsed (P02, P03, P07), but most frequently had diffuse cracking (P04, P05, P06). Sommati had an average damage level in the order of D3-D4 with a local IMCS = 9 (Galli et al. 2016).

Picture	DATUM	Location		Damage Level	Notes
		Lat.	Long.		
P01	WBG-84	42.642058	13.304934	D2	
P02	WBG-84	42.641640	13.305167	D4	
P03	WBG-84	42.641709	13.305461	D5	
P04	WBG-84	42.641251	13.306553	D1-D2	
P05	WBG-84	42.641172	13.306394	D3	
P06	WBG-84	42.641388	13.306857	D3	
P07	WBG-84	42.641438	13.307067	D3-D4

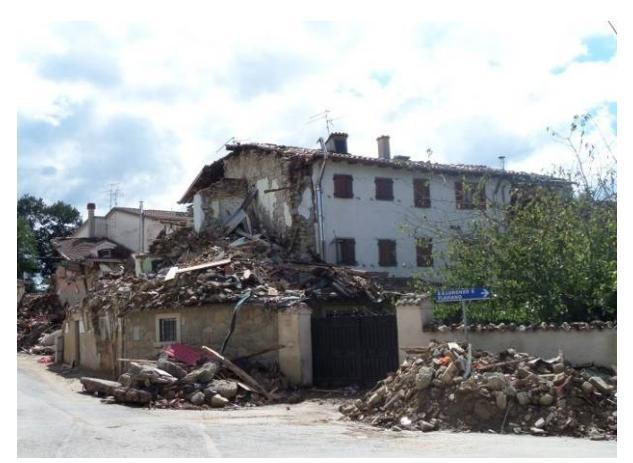
Notes
Picture	DATUM	Loca	ition	Damage Level	
		Lat.	Long.		
P01	WBG-84	42.665401	13.288931	D5	
P02	WBG-84	42.664418	13.289463	D4	
P03	WBG-84	42.664803	13.287449	D5	
P04	WBG-84	42.664831	13.287356	D3	
P05	WBG-84	42.664912	13.286910	D5	
P06	WBG-84	42.664897	13.286813	D4	
P07	WBG-84	42.664794	13.286675	D4	
P08	WBG-84	42.664897	13.286813	D3	
P09	WBG-84	42.664738	13.286589	D4	
P10	WBG-84	42.664724	13.286543	D4	
P11	WBG-84	42.664555	13.286144	D3	
P12	WBG-84	42.664167	13.285836	DO	
P13	WBG-84	42.664167	13.285836	D3	
P14	WBG-84	42.664066	13.285641	D5	
P15	WBG-84	42.664259	13.285575	D4	
P16	WBG-84	42.663913	13.289765	D4	
P17	WBG-84	42.664034	13.289765	D4	
P18	WBG-84	42.663913	13.289765	D5

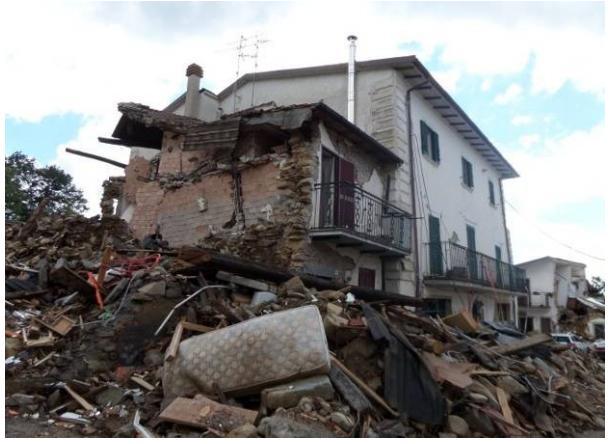
P15

Castro is located at an elevation of 827 m ASL, 2 km north of the county town of Balzo. This hamlet is built on a ridge constituted by the Laga Flysch Formation in arenaceous-pelitic facies. According to Galli et al. (2016), a local $I_{MCS} = 7.0$ was attributed to this village, which is the maximum macroseismic intensity in the Montegallo districts. The more vulnerable 1-2 story masonry buildings showed moderate to severe damage (P17-P18) to partial collapse (e.g. P15-

P16). The village had an average damage level between D3 and D4. More recently constructed buildings did not suffer noticeable damage.

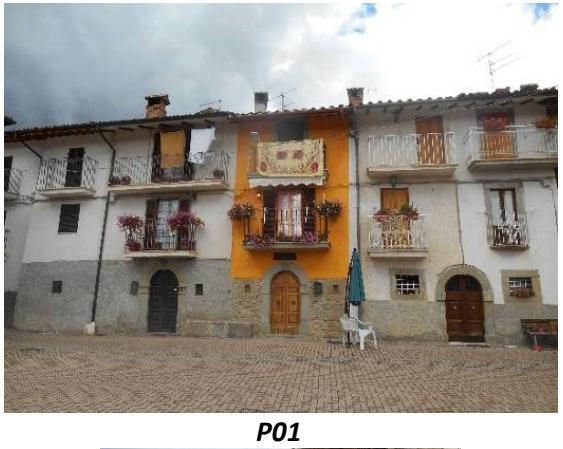
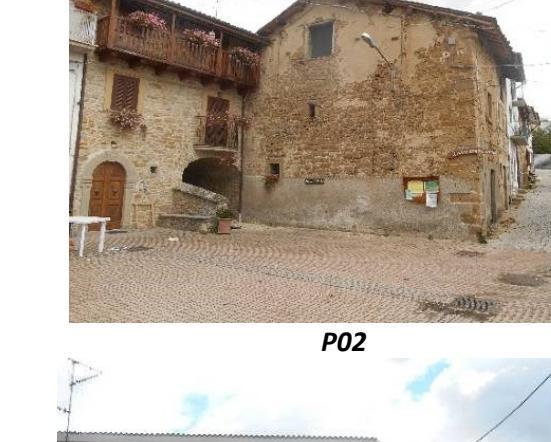
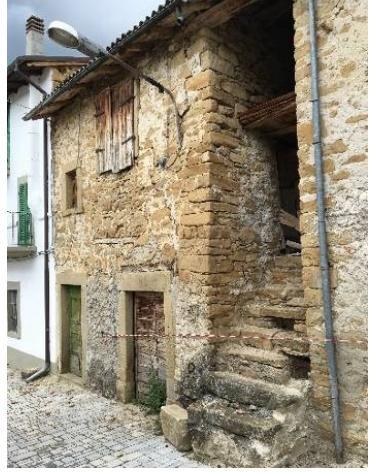
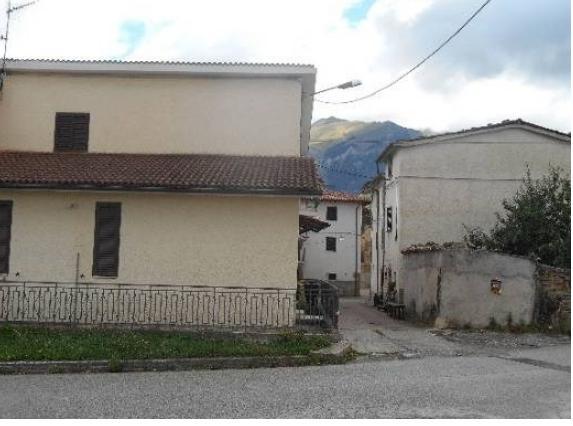
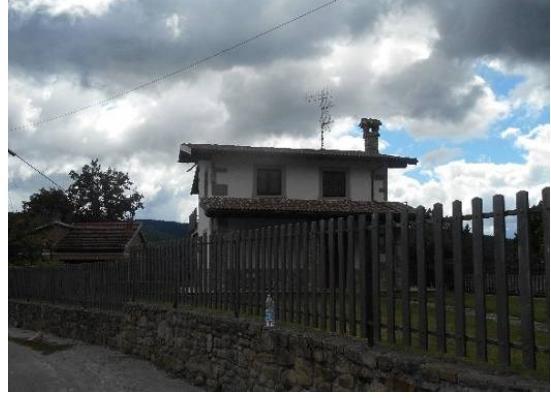
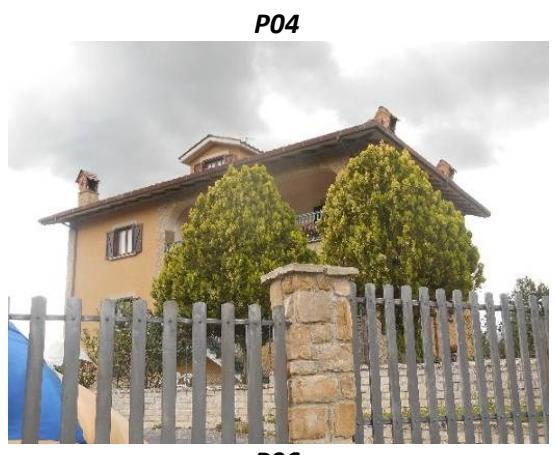
Picture	DATUM	longitude	latitude	Damage level	Note
P01	WGS- 84	13.324494	42.630019	D0	Traditional buildings facing the small square, all undamaged
P02	WGS- 84	13.324644	42.629939	D1	Only slight cracking visible
P03	WGS- 84	13.324978	42.629897	D1	Maybe the most 'damaged' building
P04	WGS- 84	13.323975	42.630127	D0	
P05	WGS- 84	13.323884	42.629816	D0	new nouses close to the main
P06	WGS- 84	13.323549	42.630106	D0	Toad, totally undarhaged

Figure 5.75. Representative pictures taken at Collecreta (see Table 5.20 for details).

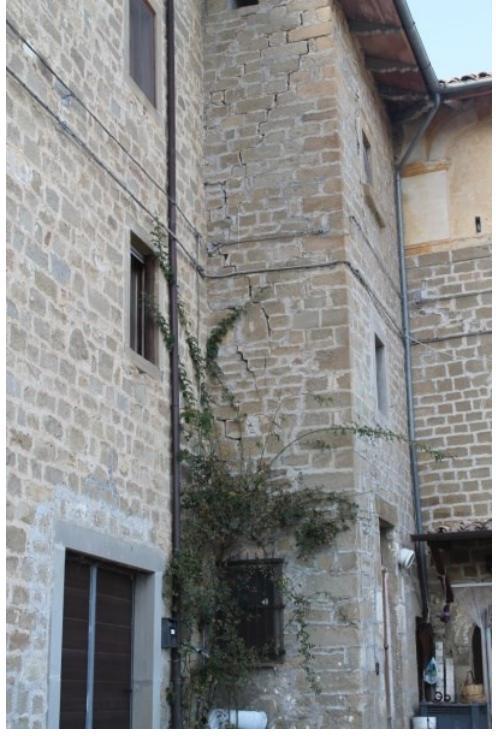
P04 (Pistrino lower part)

Pistrino is a very small hamlet located at an elevation of 813 m ASL, 4 km from Balzo. The hamelt was developed on a mild slope and built on eluvial-colluvial deposits consisting of silty sand-mixtures (from Seismic Microzonation Level 1) resting on the Laga Formation. The lower part of the hamlet had some damage to 1-2 story masonry structures (P04-P06). On the other hand, no observable damage was observed in the upper part only 0.5 km away (P07-P09). An example of a heritage masonry buildings is the *Santa Lucia* Church, which dates to approximately the XV century (construction date is unknown), which apparently had no observable damage (P07). Further, a more recent reinforced concrete building with a first soft-story ("pilotis") (Picture P08) suffered no damage. The upper part of the village had a damage level of D0-D1, while the lower part experienced a higher damage level of D2-D3. The different damage levels observed in the two adjacent areas points to the possibility of local site effects in the lower part of Pistrino.

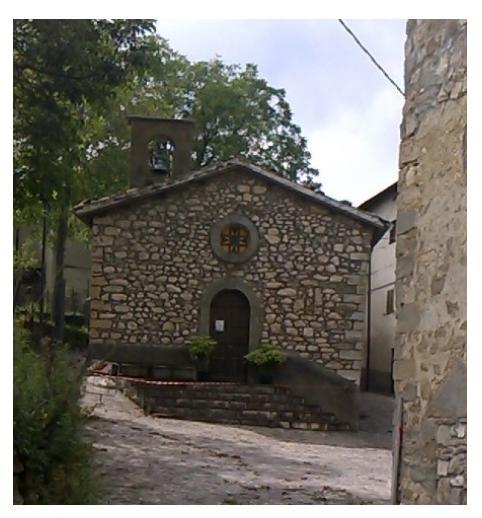
P13 (Astorara)

Astorara is a small hamlet located at elevation of 1008 m ASL, 3 km from Balzo. It is built on the Laga Flysch Formation, locally covered by eluvial colluvial deposits that in this area never exceed 2-10 m in thickness (from Seismic Microzonation Level 1-Regione Marche, Montegallo municipality, Regione Marche, 2015). The 1-2 story masonry buildings (P14) as well as the masonry monumental buildings behaved adequately, apparently suffering no damage. One such example, as evidenced in picture P13, is the *Santa Liberata* Chuch, dated presumably to the XVI-XVII century. The hamlet had an average damage level of D0-D1.

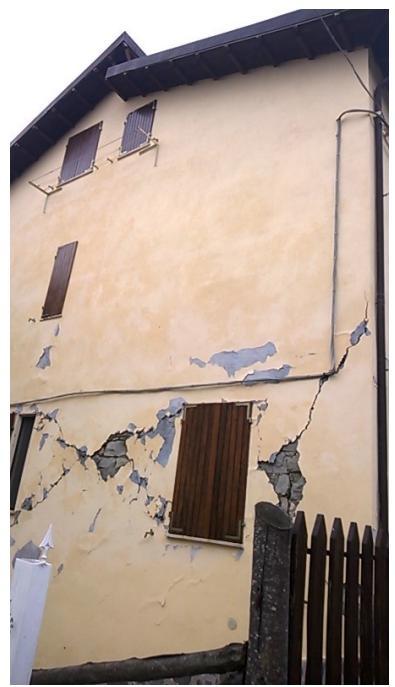
P19 (Collefratte)

Collefratte is located at an elevation of 899 m ASL, 2 km northwest of Balzo. From the geomorphological point of view it is similar to Castro, i.e., it is located on a ridge made of calcareous eluvial-colluvial deposits resting on the pelitic-arenaceous formation. About 30% of the 1-2 story masonry buildings showed significant cracking (P19-P20); in one case falling of a chimney was observed. The average damage level attributed to this village is D2-D3.
