Engineering Reconnaissance of the 24 August 2016 Central Italy Earthquake. Version 2 GEER Team Leaders: Giuseppe Lanzo and Jonathan P. Stewart

Geotechnical Extreme Events Reconnaissance Association

Report No. GEER-050B

22 November 2016

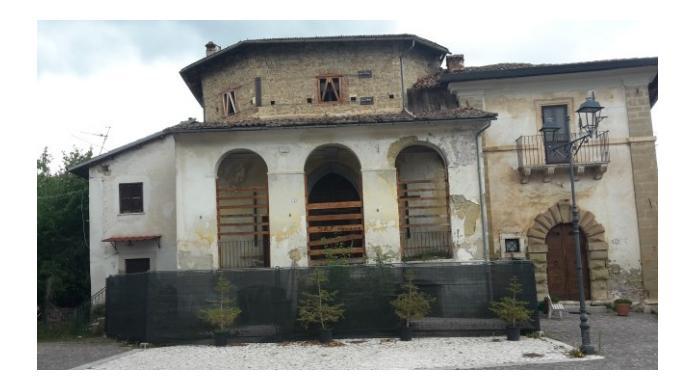
P01 42° 31' 22" N; 13° 14' 45" E

Some representative structures are shown in Figure 5.84 together with the corresponding coordinates. In particular, P01 shows damage from the 2009 Earthquake, whereas P02 shows an example of limited external damage as observed after the 2016 event. A temporary accelerometer network was placed by INGV in Montereale and Capitignano soon after the 24 August 2016 Earthquake to monitor aftershocks (Table 3.1, Figure 3.4).

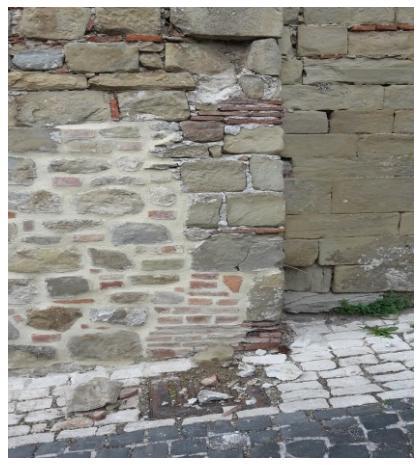
P02 42° 31' 24" N; 13° 14' 47" E

Figure 5.84. Representative structures in Montereale.

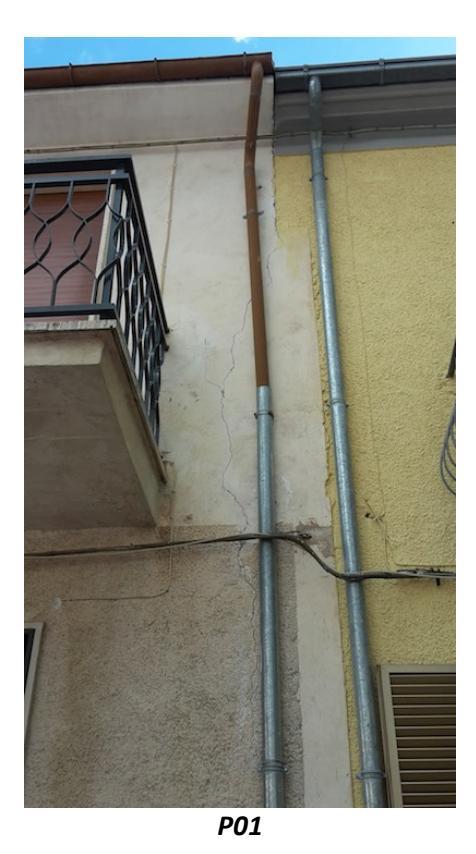
Figure 5.85. Representative pictures of damage in Capitignano.

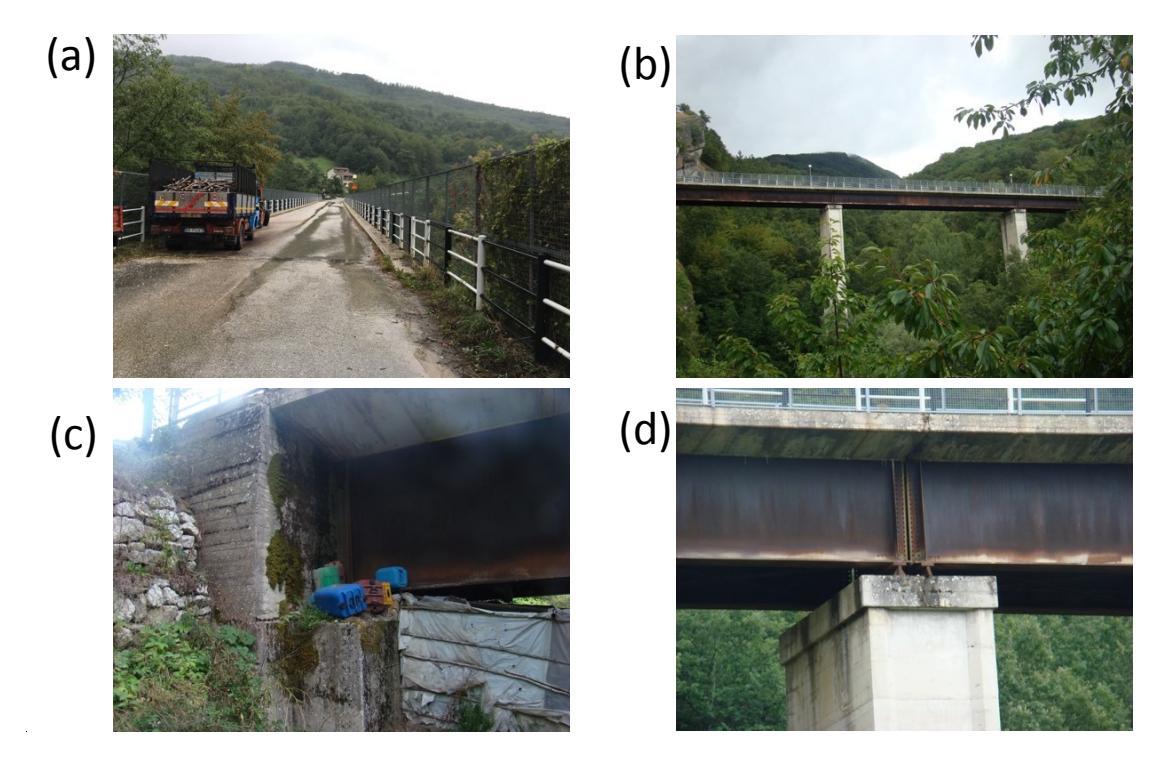
Most of the inspected contemporary bridges do not show evidence of seismic induced damage (Figures from 6.2 to 6.4) that, if present, would have required a limitation in bridge utilization.

Figure 6.2. Ponte Ramazzotti - Composite steel and concrete bridge along the SP20 in Colle (42.7276 deg, 13.311 deg): overview of the bridge (a,b), abutment (c) and bridge support (d) details.

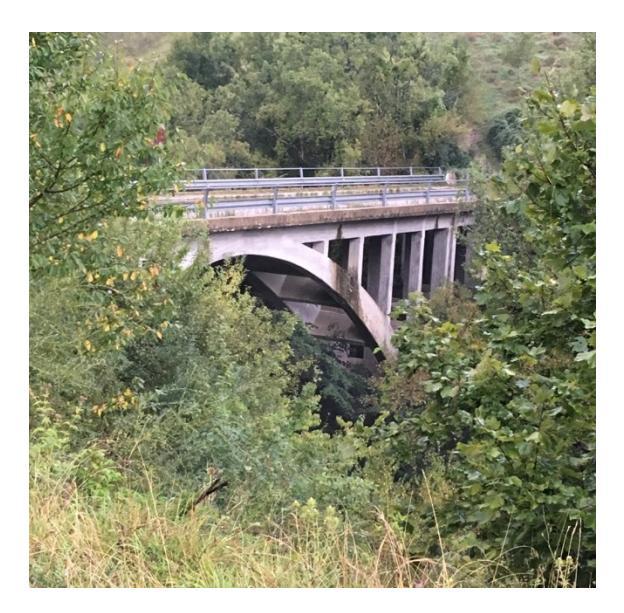
Figure 6.3. RC bridge along the SP7 in Boscomartese (42.7241 deg, 13.4405 deg).

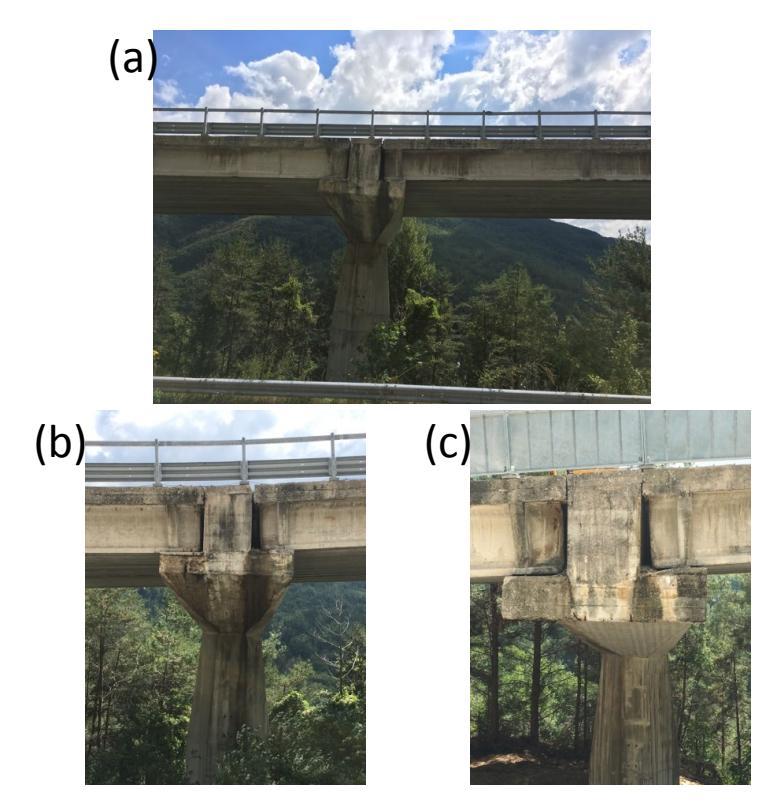
Figure 6.5 shows the RC bridge along the SS685 Tre Valli Umbre: from the visual inspection it seems that hammering occurs during the earthquake (Figures 6.5b and 6.5c), but it did not affect the functionality of the bridge, which continued to be operational after the event.

Figure 6.5. RC bridge along the SS685 Tre Valli Umbre (42.75625 deg, 13.277 deg): overview of the bridge (a), details of the hammering evidences (b and c).

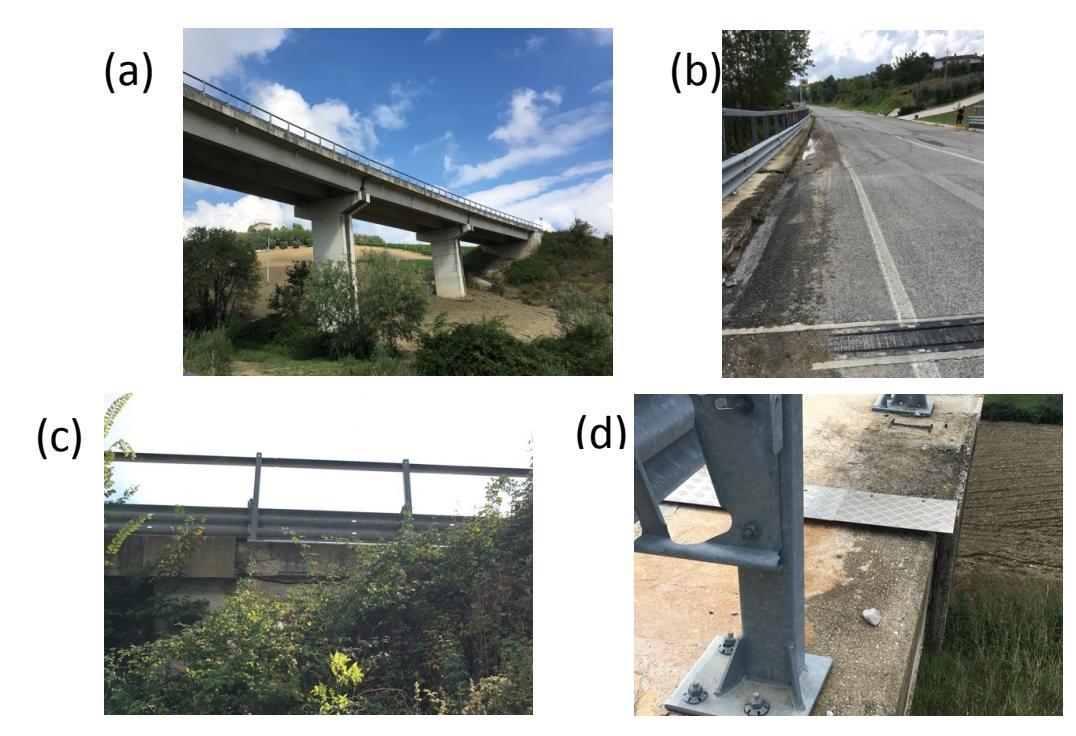
Figure 6.6 shows the RC bridge along the SP173 in Offida. This bridge presents significant settlements on the road close to the abutments (Figure 6.6b), that caused damage at the structural elements, as shown in Figure 6.6c. These settlements, which existed before the earthquake, have been amplified by seismic compression of backfill as a result of strong ground motion from the 24 August 2016 mainshock. Thus, it was suggested to limit the maximum load to be carried by the bridge, until specific geotechnical improvements to stabilize the area can be performed.

Figure 6.6. RC bridge along the SP173 in Offida (42.941687 deg, 13.702294 deg): overview of the bridge (a), settlement of the road (b) crack (c) and relative displacement of the abutment (d).

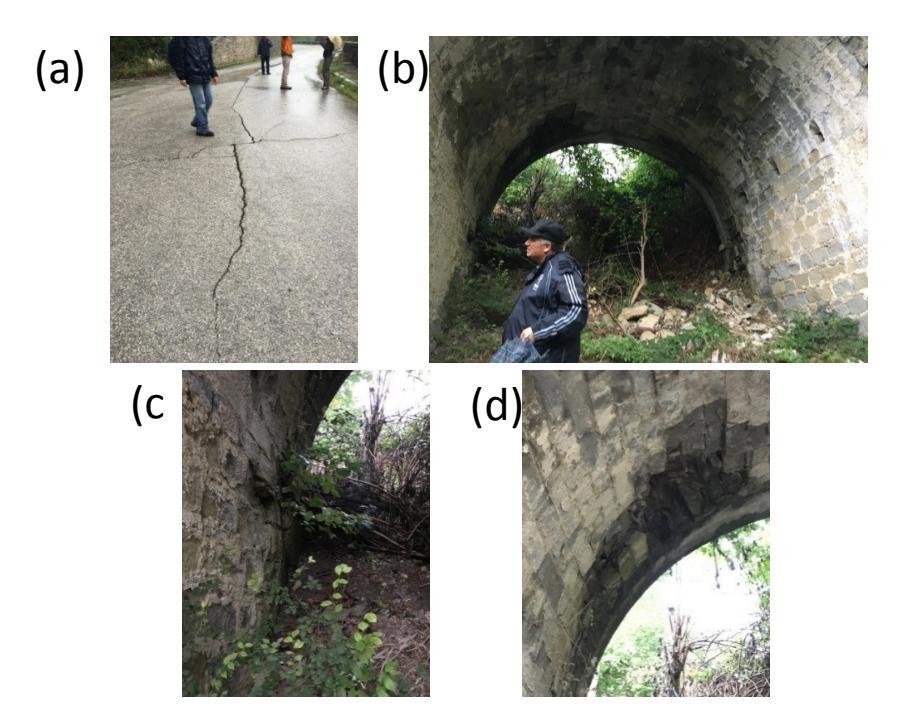
Two of the inspected masonry bridges showed evidence of seismically induced damage that affected the road surface (Figure 6.7a), typically as a result of differential settlement (Figure 6.9b). These effects caused local officials to limit the use of the SP129 bridge and to close the SR260 bridge, at the time of our site visits.

Figure 6.7 shows one of the two arch bridges inspected along the Trisungo route. It is a single arch bridge. Cracking within load-bearing masonry elements and spalling of surface masonry elements of the interior part of the arch (Figure 6.7d) were observed. Similar effects were observed for the second arch bridge along the Trisungo route (Figure 6.8), formed by three arches. In this case, partial collapse was observed of short walls above the roadway surface (Figures 6.8a and 6.8b), spalling of several elements in the central arch (Figure 6.8c) and significant cracks of some masonry elements on the east support of the central arch (Figure 6.8d). Due to the extensive damage, local officials decided to limit traffic loads over these bridges. It should also be noted that the damage and the partial collapse of masonry elements within the bridge was located in relatively recently added sections of the bridge. The bridge is comprised of an older (Roman era) part and a relatively recent extension; the latter behaved poorly during the earthquake and experienced the severe damage mentioned above.

Figure 6.7. Masonry bridge along the Trisugo route (42.735981 deg, 13.254862 deg): damages on the road (a), overview of the bridge (b), abutment (c) and partial collapse of the interior part of the arch (d).

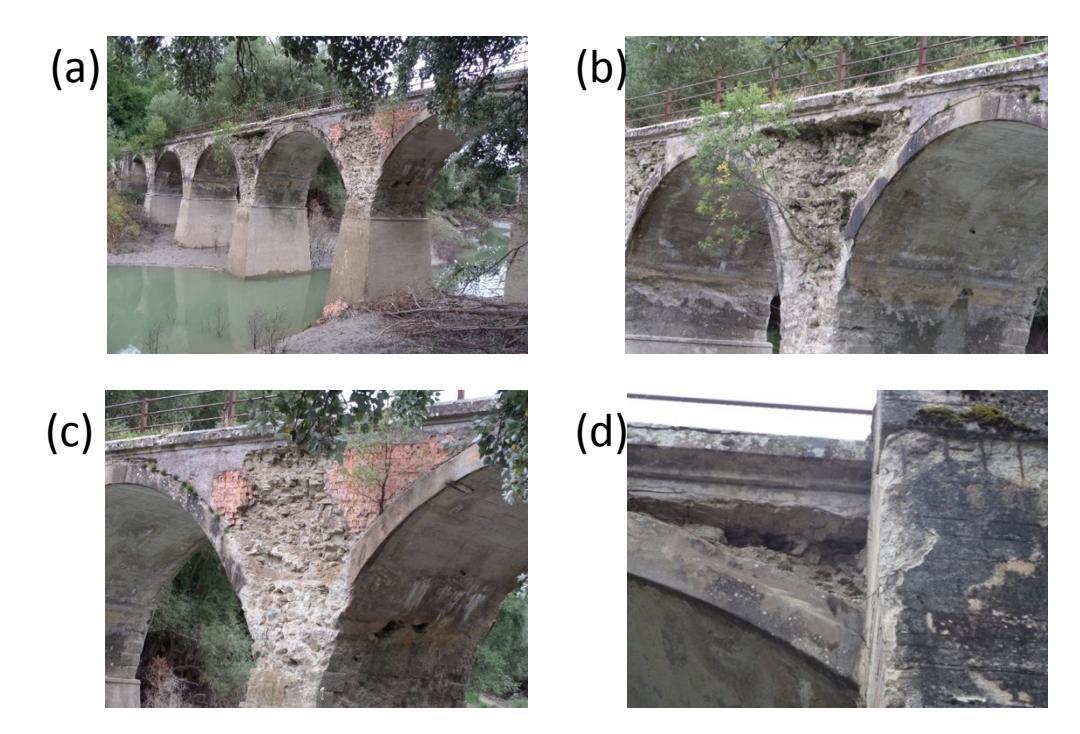
Figure 6.10 shows the masonry bridge called "Ponte a Cinque Occhi" along the internal road connecting SS4 (from the Casale Nibbio exit) and SR260 along Scandarello lake. The bridge was constructed using the *muratura a sacco* method (similar to "Ponte a Tre Occhi") and includes five arches. The earthquake caused the collapse of the external masonry panel (Figures 6.10a and 6.10c). Figures 6.10b and 6.10c show structural improvements (retrofits) that cover original masonry elements. Some damage was also observed at the southern abutment (Figure 6.10d). As shown in Figures 6.10b and 6.10c, bridge maintenance was poor.

The Ponte a Cinque Occhi bridge is a critical lifeline for access to Amatrice from the west. The bridge deck surface was not cracked along the road surface nor at abutments. Structural stability was judged to have not been affected by the earthquake and no traffic restrictions were applied.

Figure 6.10. Ponte a Cinque Occhi - Masonry bridge (42.623178 deg, 13.250428 deg): (a) view of the 5 bridge arches, (b, c) partial collapse of the bridge masonry with evidence of previous structural interventions, (d) detail of the bridge-abutment connection.

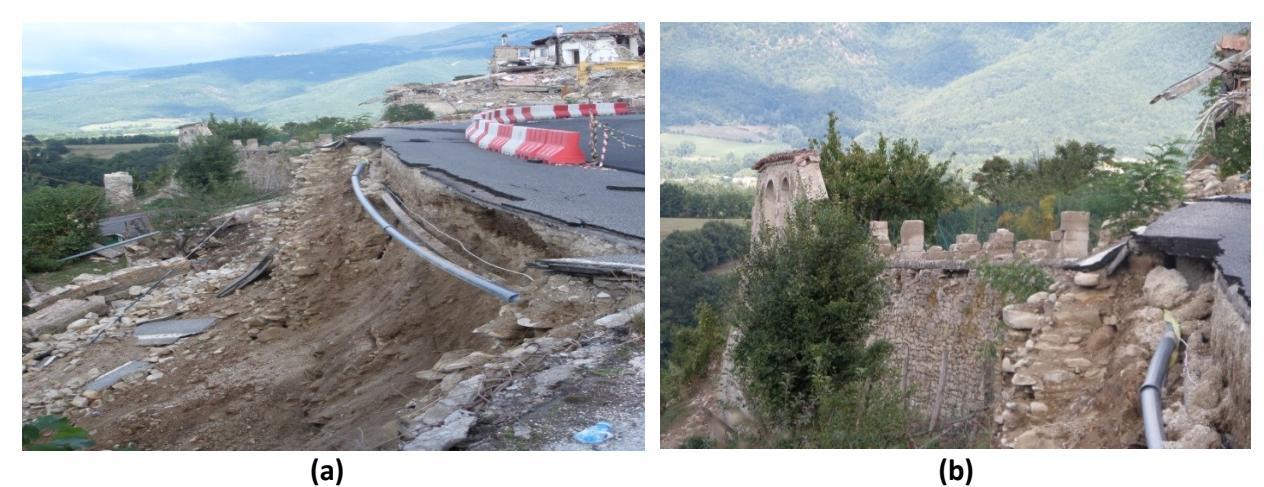
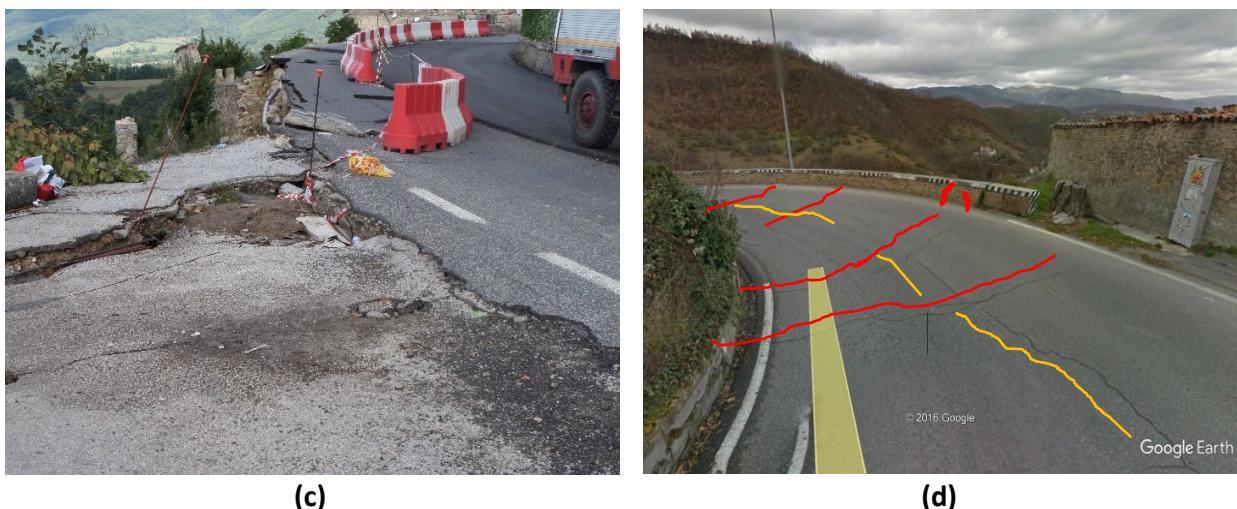
Figure 7.2a shows a gravity retaining wall collapsed along and beneath the SS260 road, near the intersection with the village street "Viale Francesco Grifoni". The wall is constructed of poorly-cemented stone masonry, which is typical of the area (Figure 7.2b). The backfill soil is likely drawn from a pebbly alluvial formation found in in the historical center of Amatrice.

In addition to wall collapse, diffuse cracks along the road surface were observed, which required some asphalt repair. During our reconnaissance (September, 2016), some of these cracks were still evident in the unpaved part of the road (Figure 7.2c). The cracks observed along and across the SS260 road may be linked to displacements of the wall and, probably, also of the slope interacting with it. As shown in Figure 7.2d, pre-event roadway cracks suggest that some deformation may have preceded the mainshock; the photograph shows diffuse cracking along the road surface (along and normal to the direction of travel) and cracking in the brick wall parapet.

Figure 7.2. Retaining wall along the SS260 road close to Amatrice urban area (42.629533N, 13.286448E): (a) collapse of the wall, (b) detail of the stone masonry texture, (c) cracks along the unpaved portion of the road, (d) Google Earth (July 2011) view of the SS260 road before the earthquake, with evidences of diffuse cracks along the asphalt.

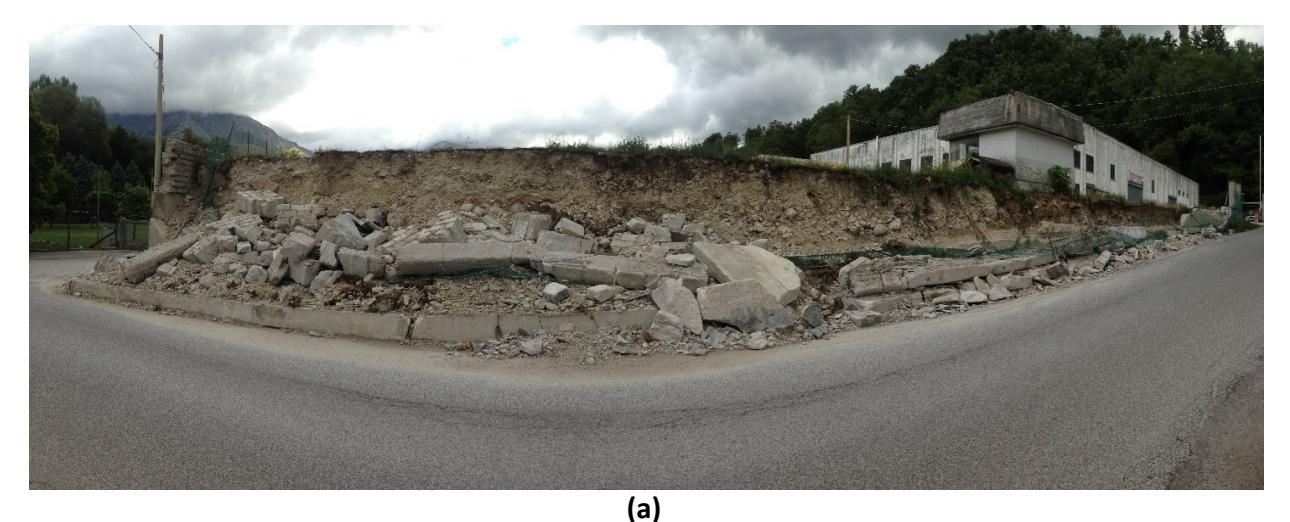
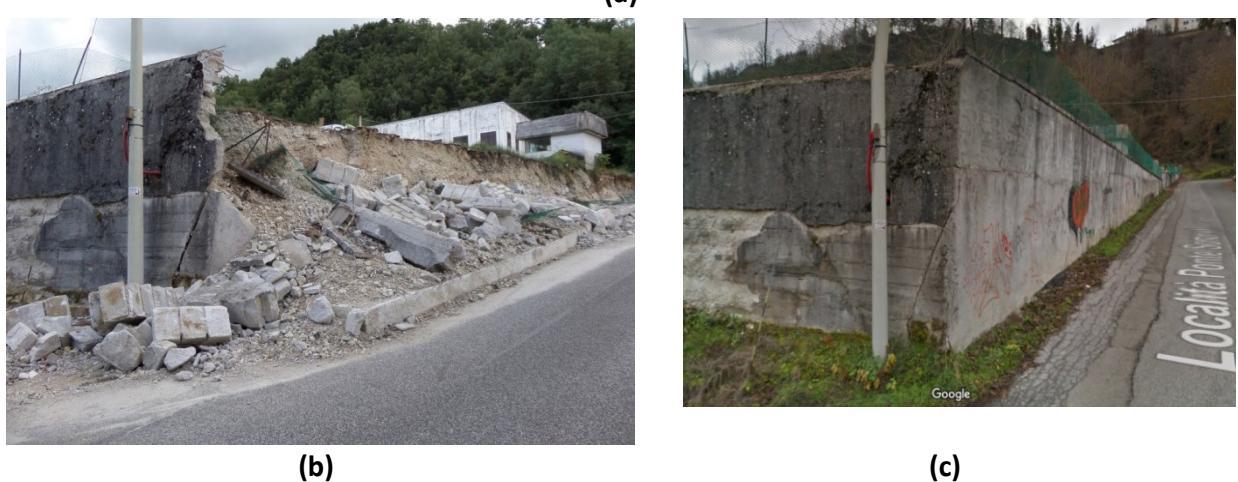
Figure 7.3a shows a collapsed retaining wall supporting a parking lot in the hamlet called "Ponte Sommati", near Amatrice. The lower part of the wall was made of poorly reinforced concrete and the upper part was built with concrete blocks. The images in Figure 7.3b-c indicate the poor quality of the wall, including poor connections between the upper and lower parts.

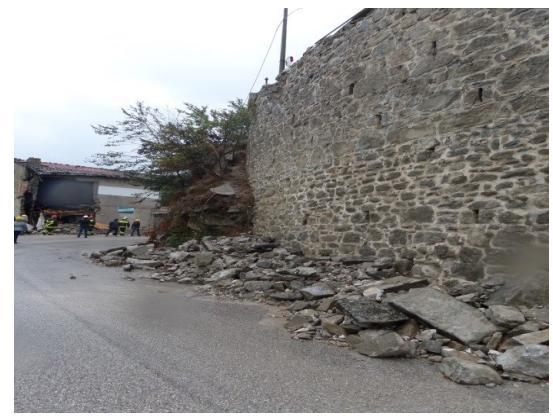
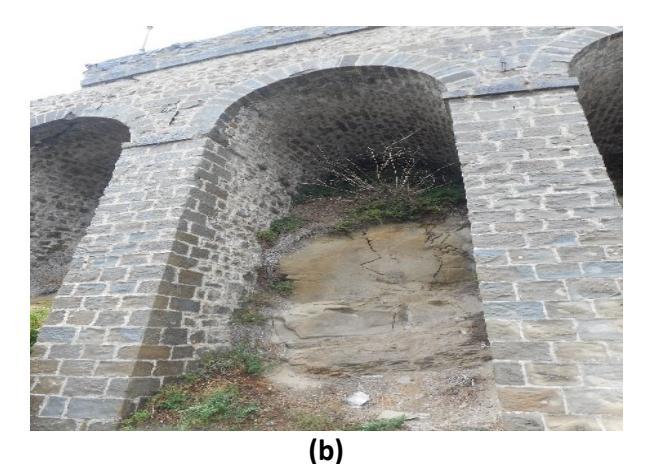
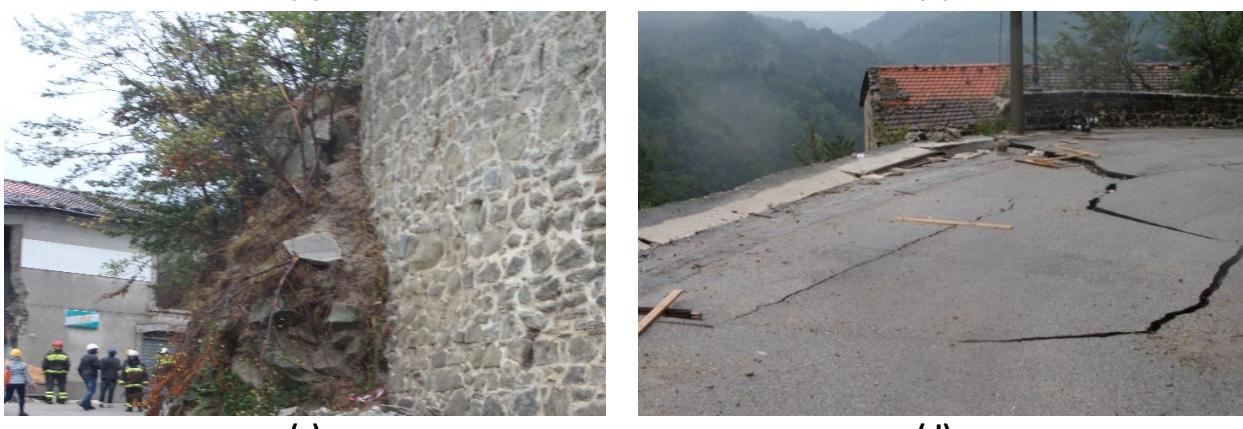
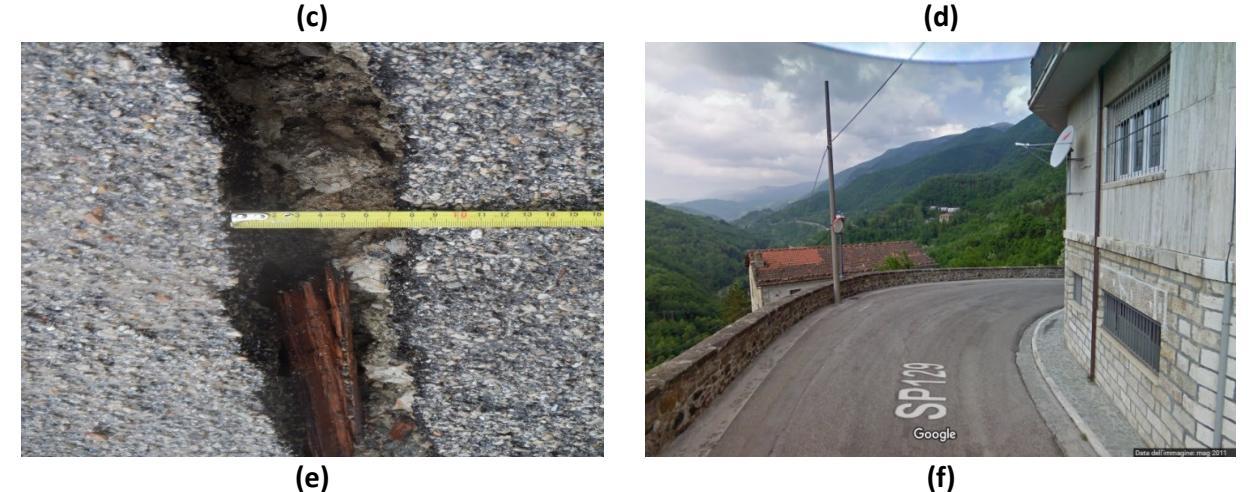
Figure 7.4a shows the collapse of the uppermost portion of a masonry wall located along SP129 road near the entry to Arquata del Tronto. The wall has a masonry arch structure, which appears to have been recently restored in the outer face (Figure 7.4b). The soil behind the wall consists of highly fractured marl or marl blocks of maximum size on the order of 1 m (Figure 7.4b-c). Co-seismic relaxation of these marl blocks towards the collapsed wall face contributed to roadway extension and settlement (Figure 7.4d). The cracks along the road surface have maximum openings on the order of 8.0 cm horizontally (Figure 7.4e) and maximum relative vertical displacements of 4 cm. At this site, there was no evidence of any pre-event instability (Figure 7.4f).

Figure 7.4. Masonry retaining wall in Arquata del Tronto (42.771898N, 13.296715E): (a) partial collapse of the wall parapet, (b) arch masonry structure, (c) marl blocks along the SP129 road, (d) road instability at the top of the wall, (e) opening of the cracks developing along the direction parallel to the road axis, (f) Google Earth view of the site (dated May 2011).

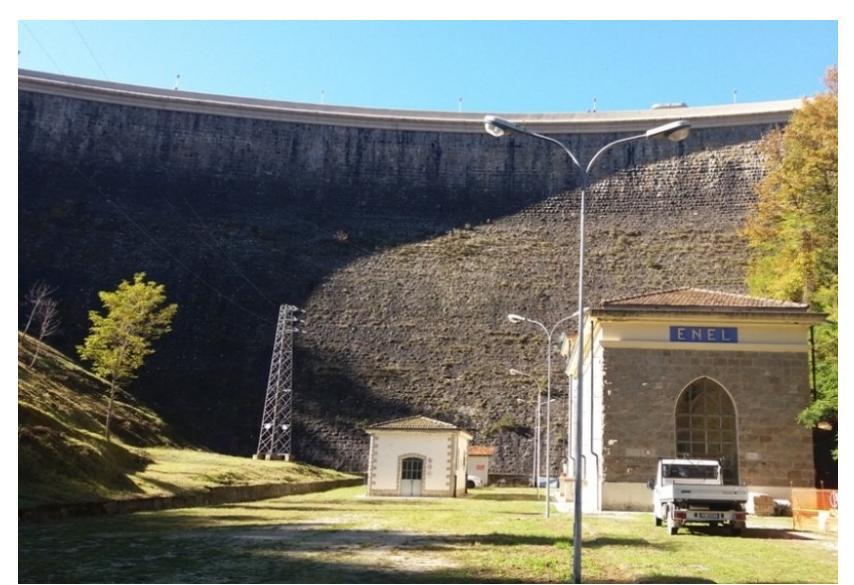
Inspections carried out by ENEL staff after the earthquake revealed no damage to Scandarello dam, which we confirmed on October 19, 2016 (Figure 7.12). Furthermore, ENEL staff stated that

Figure 7.12. Downstream face of Scandarello dam, with the homonymous station for hydroelectric power generation located at the foot of the dam (October 19, 2016).

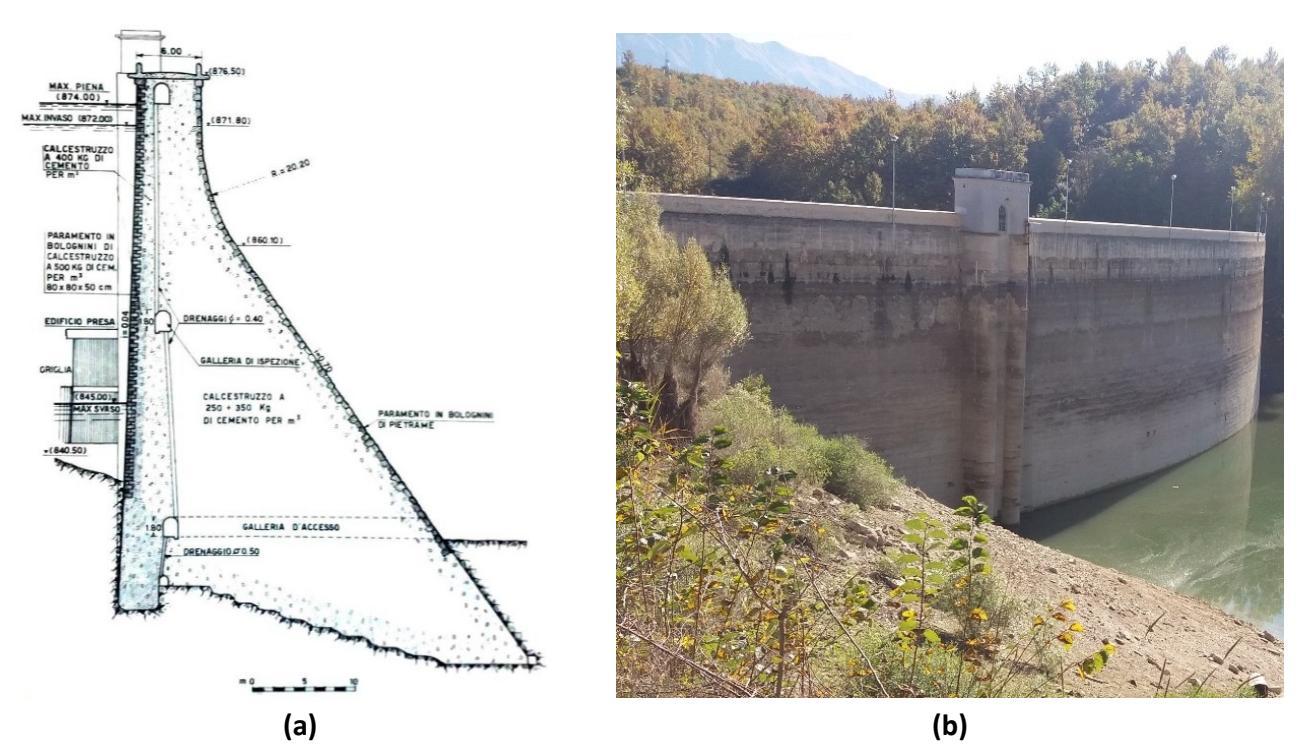
Figure 7.13. Scandarello dam: (a) cross-section (ANIDEL, 1951); (b) photo of the upstream face taken on October 19, 2016 (42.641560°N, 13.269000°E).

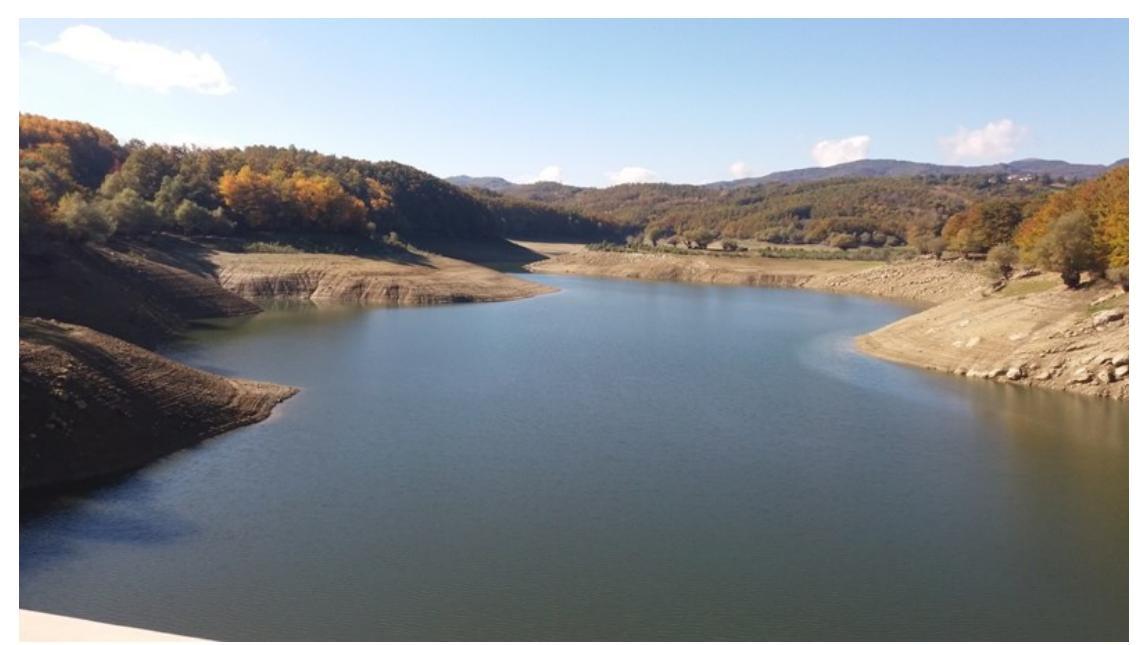
no slope instability could be observed along the banks of the reservoir (Figure 7.14). At the time of earthquake, the water was about 5 m below the maximum level, as during the survey on October 19, 2016. When the August, 24 mainshock occurred, the turbine within the station at the foot of the dam stopped operating, which was because of power loss, not damage caused by ground shaking. This turbine is not equipped with a vibration monitoring system.

Figure 7.14. View of the reservoir from Scandarello dam viewpoint (October 19, 2016): no phenomena of bank instability were observed after the earthquake.

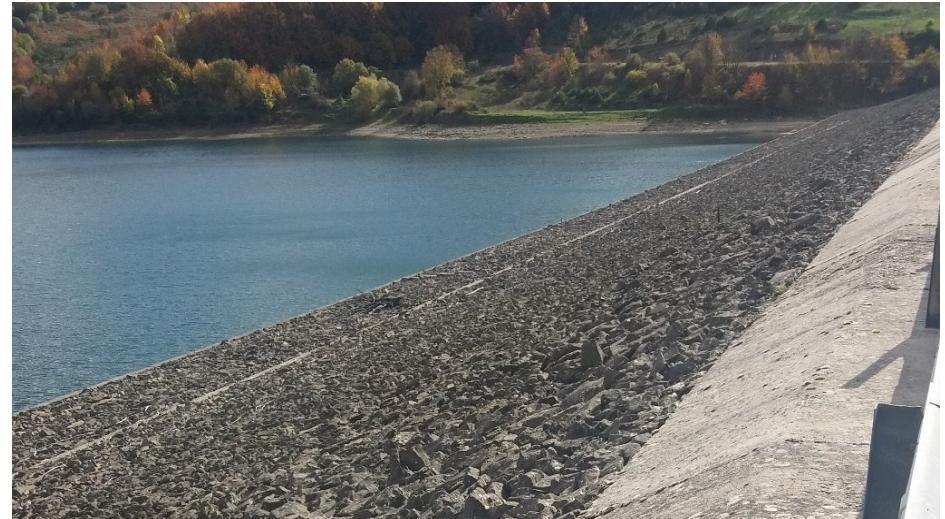
Settlements and interior pore pressures of the Poggio Cancelli dam are monitored by a complex system which includes several control points, located at the crest, within the core, vertically beneath the toe of the dam, and downstream of the toe of the dam. By combining the measurements provided by settlement gauges and from differential leveling surveys, the system allows to obtain separately the settlements of the core and in the underlying foundation. In the immediate aftermath of the August 24 mainshock, only a few millimeters of settlements of the crest were measured. More detailed information was not available at the time of the survey. The Poggio Cancelli dam hosts the PCB station (Figure 7.15), which, during the August 24 earthquake, recorded a horizontal peak ground acceleration as high as 0.31 g (Figure 7.10). The installation date is September 28, 1994 according to ITACA (ITalian ACcelerometric Archive, V2.1; http://itaca.mi.ingv.it). Despite the severity of ground motion, the seismic response of Poggio Cancelli dam was satisfactory.

Figure 7.15. Poggio Cancelli embankment dam on the Campotosto reservoir (L'Aquila): photo of the upstream face taken on October 19, 2016 (42.557106°N, 13.338342°E).

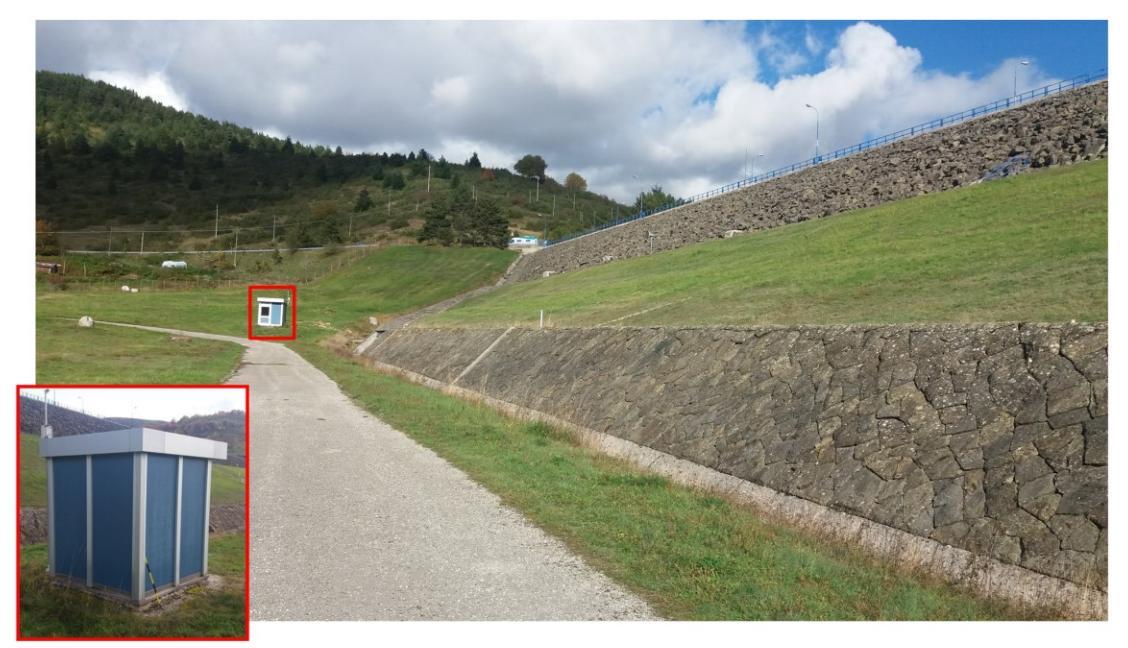
Figure 7.17. Downstream face of the Poggio Cancelli dam (October 19, 2016) with a close-up view of the light blue box hosting the PCB station (42.558022°N, 13.337990°E), which, during the August 24 earthquake, recorded a peak ground acceleration of about 0.31 g.

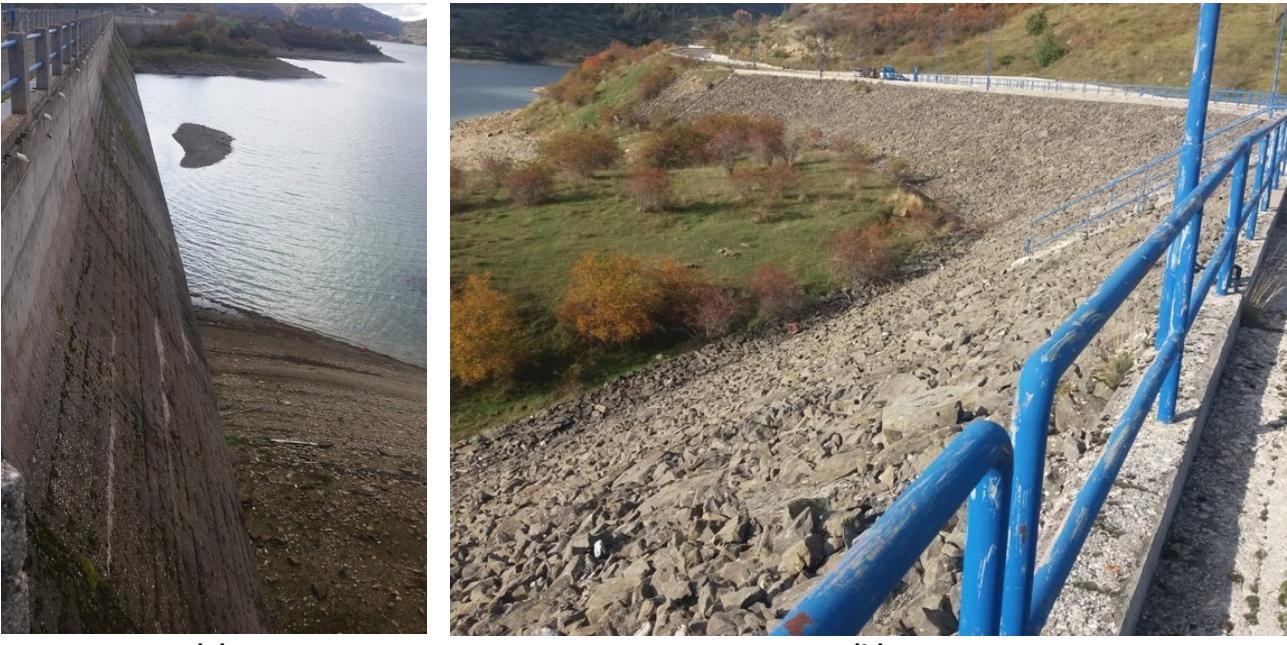
It is important to highlight that the SPD seismic station was located within the surveillance station of the dam since April 15, 2009 (after L'Aquila earthquake). During the August 24 earthquake, the SPD station recorded a peak ground acceleration of about 0.11 g. After the mainshock, no damage was observed to Sella Pedicate dam, which is located 23.7 km from the epicenter.

Figure 7.18. Photos taken on October 19, 2016 of the upstream face of Sella Pedicate concrete dam (a) and of one of its extremities (b), which is an embankment dam (42.514468°N, 13.370155°E).

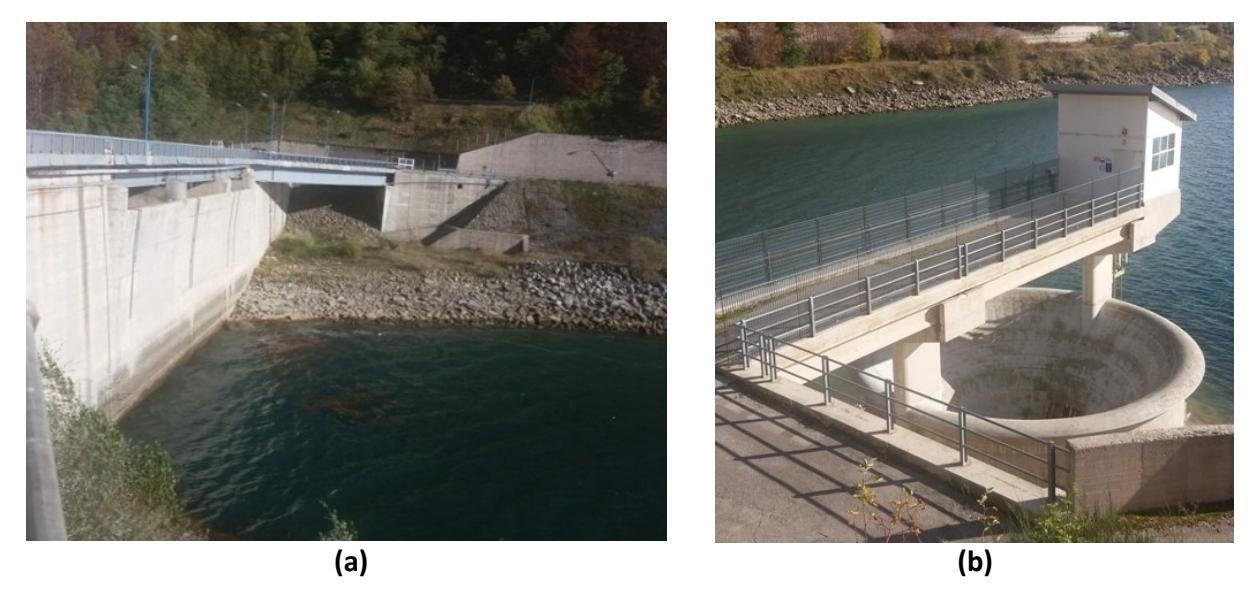
The inspections carried out by ENEL staff after the August 24, 2016 earthquake revealed that no damage to Rio Fucino dam was observed.

Figure 7.20. Photo of upstream face (a) and of the bell-mouth spillway (b) of the Rio Fucino dam (October 19, 2016).
