#### **4. LIQUEFACTION AND LATERAL SPREADING**

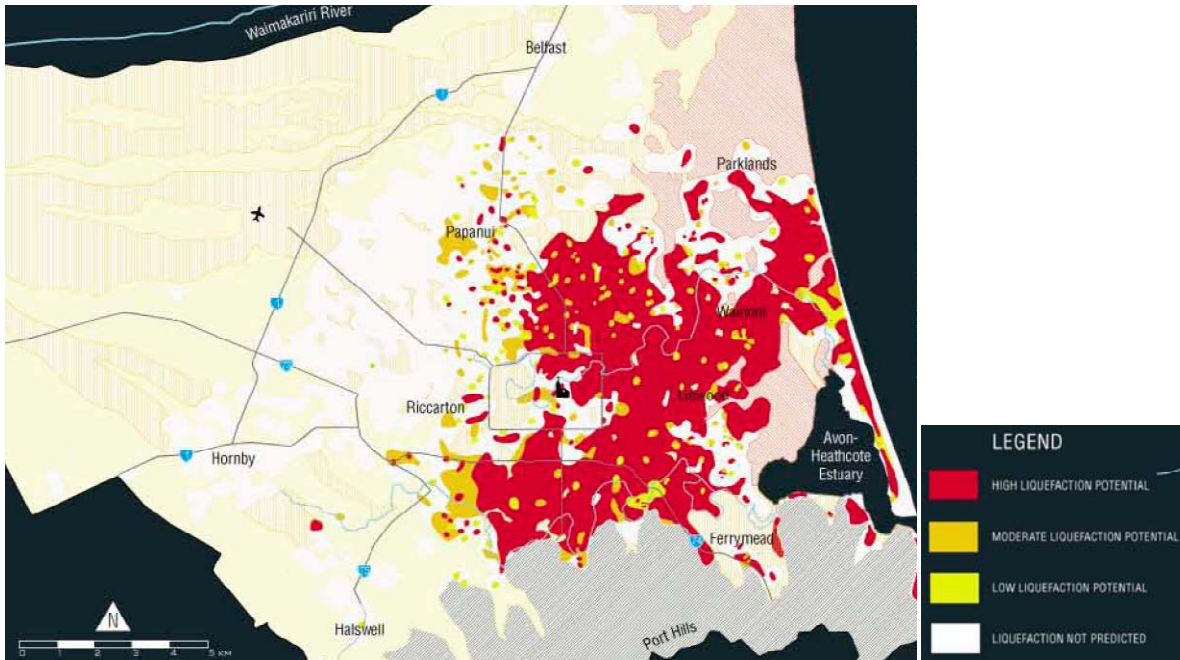
The high liquefaction hazard in Christchurch was known prior to the earthquake, as illustrated by the liquefaction hazard map (Figure 4.2) and information provided by the Environment Canterbury (ECan: <http://ecan.govt.nz/publications/General/solid-facts-christchurch-liquefaction.pdf>) to residents, based on a study from 2004.

Figure 4.2 High ground-water table liquefaction potential hazard map for Christchurch. (<http://ecan.govt.nz/publications/General/solid-facts-christchurch-liquefaction.pdf>; pre-event information provided to residents and public by ECan)

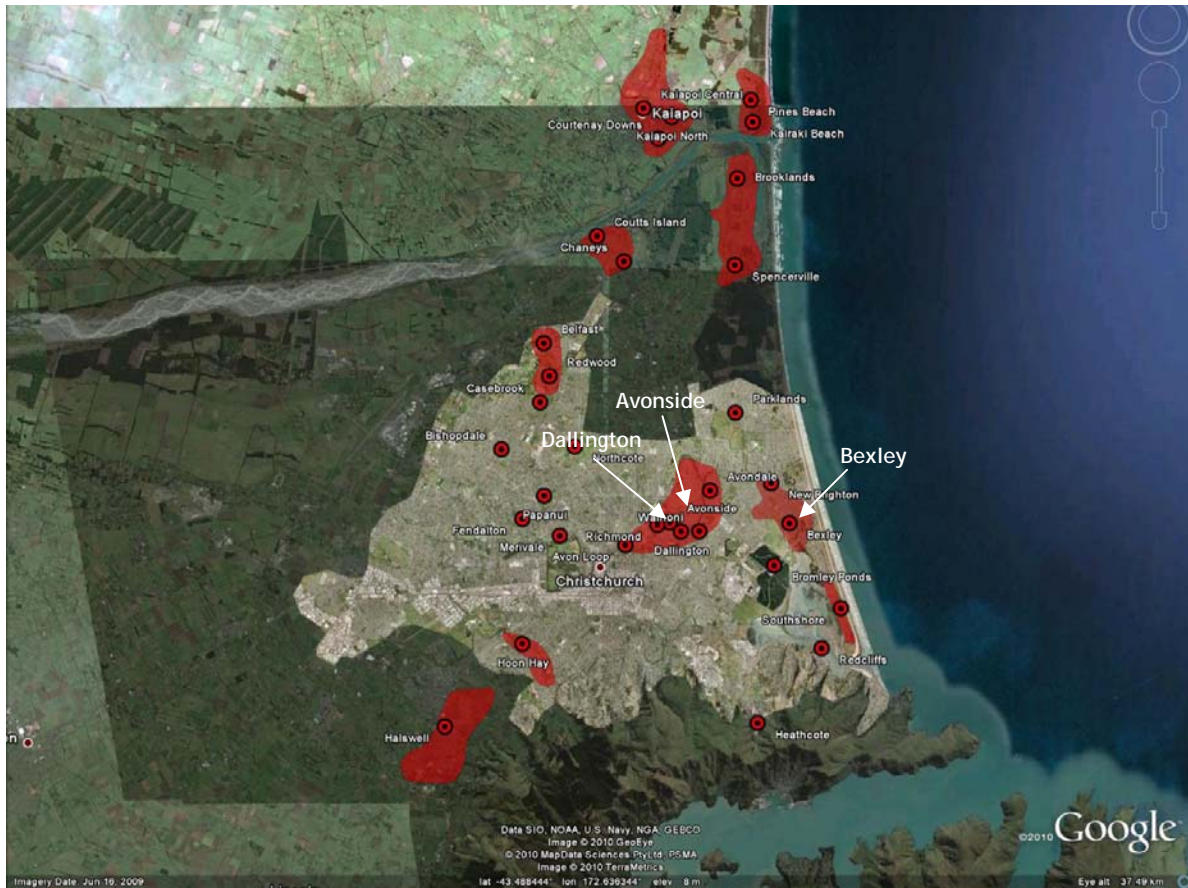
The Darfield earthquake caused widespread liquefaction in the eastern suburbs of Christchurch along the Avon River, particularly in Avonside, Dallington, Burwood and Bexley. Other suburbs, particularly to the east and northeast of CBD, were also affected by liquefaction, but to a lesser extent. Widespread liquefaction also occurred in Halswell, at the southwest end of the city. Pockets of limited or partial liquefaction were observed in various parts of Christchurch, though these were much fewer to the west of CBD. Figure 4.3 shows areas of observed liquefaction in the urban area of Christchurch based on surface manifestation of liquefaction visible in aerial photographs and initial observations from ground surveys. The areas most severely affected by liquefaction were close to waterways (rivers, streams, swamps). The effects of liquefaction were often localized and changed substantially over a relatively short distance (50-100 m) from very severe to little or no manifestation of liquefaction.

Figure 4.3 Areas of observed liquefaction (red shaded regions and red points) in Christchurch due to the 2010 Darfield earthquake (the liquefaction map is based on surface manifestation of liquefaction visible in aerial photographs and compiled evidence from ground surveys).

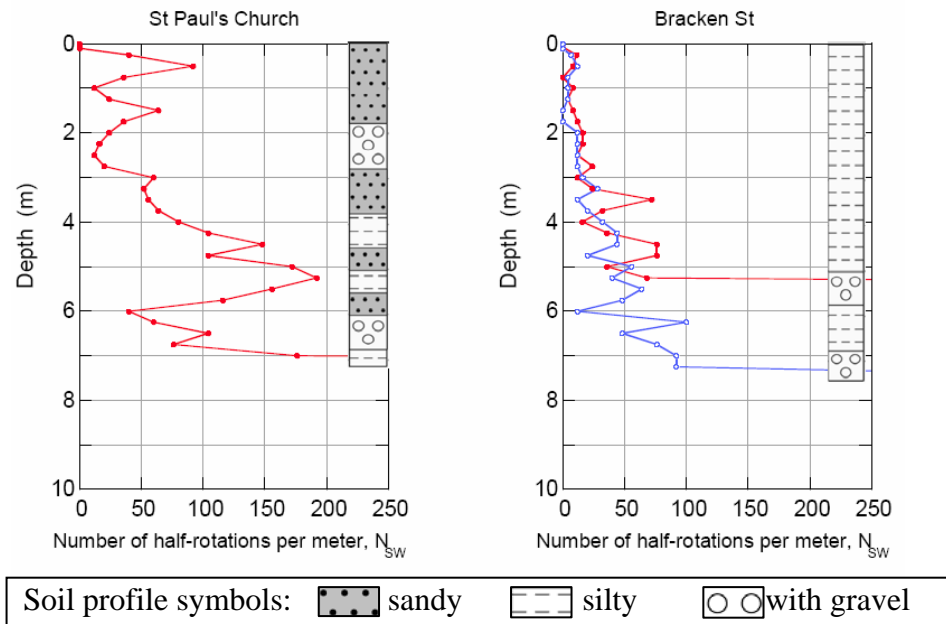
Ten days after the event, the team performed Swedish Weight Sounding (SWS) tests at Bracken St and in the backyard of St Paul’s Church. SWS is a simple manually operated penetration test under a dead-load of 100 kg in which the number of half-rotations required for a 25-cm penetration of a rod (screw point) is recorded (JIS, 1995). One of the advantages of the SWS test, which was heavily utilized in this investigation, is the ability to perform the test within a confined space in backyards of residential properties. Figure 4.6 shows the penetration resistance measured in the SWS tests conducted at Bracken St and St Paul’s Church, expressed in terms of the number of half-rotations per meter,  $N_{SW}$ . Correlations exist relating this penetration resistance to an equivalent SPT N-value (JIS, 1995). However, the N-value correlations are not presented herein.

Figure 4.6 Post-event penetration resistance in Dallington (St Paul’s Church/School) and Avonside (Bracken St) measured in SWS tests.

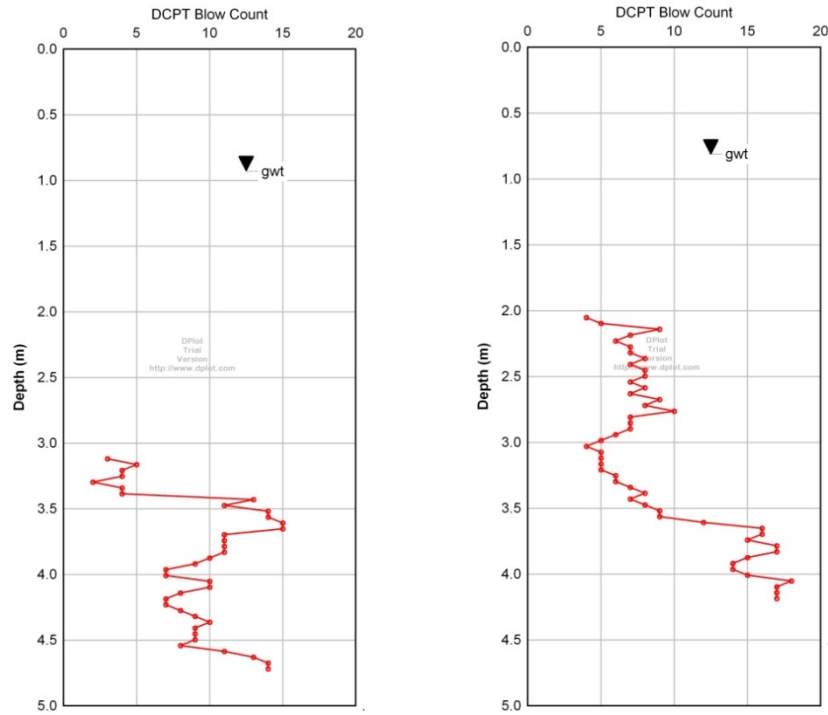
Additionally, two Dynamic Cone Penetration Tests (DCPT) were performed at the residence shown in Figure 4.4, one in the backyard and one in the front yard. The results of the DCPTs are shown in Figure 4.7. At each of the test locations, a hand auger was used to bore a hole down to the layer that liquefied. This layer was identified by comparing ejecta material with soil extracted by the hand auger. Once at the liquefied layer, the DCPTs were performed until the blow count significantly increased or the team ran out of DCPT rods (i.e., ~4.6 m below the ground surface).

The ground water table at both sounding locations at the Bracken Dr residence was at ~0.8m, and the top of the liquefiable layer was at a depth of ~2.1 to 2.4 m. The strata overlying the liquefiable layer were clayey. For one of the tests, the DCPT rods sank under their own weight 20+ cm, indicating very loose sand. Because no samples are recovered with the DCPT, the thickness of the liquefied sand layer cannot be determined for certain. However, from looking at the results shown in Figure 4.7, the penetration resistance sharply increases at a depth of ~3.5 m. Additionally, there is a very wet, very soft, thin (~10 to 15 cm) clay/plastic silt layer that overlies the liquefied layer. It is unknown whether this is a very sensitive material that softened as a result of earthquake shaking and/or sampling or whether it is a result of a water film that formed between the liquefied layer and the overlying clay layer.

Figure 4.7. Results of DCPT performed at a residence on Bracken St, Avonside.

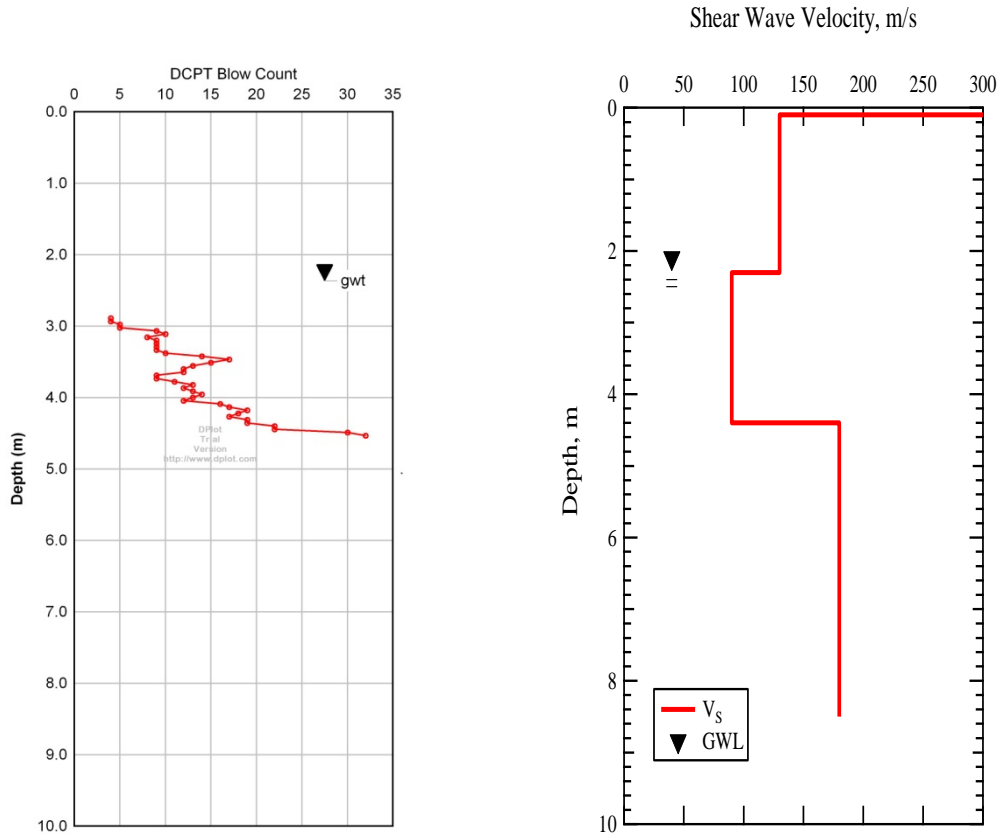
A DCPT and SASW test were also performed at St Paul's Church. The results of these tests are shown in Figure 4.8. Based on the bore hole augered for the DCPT test, the water table was at a depth of about 2.3 m and the top of the liquefied layer was at a depth of about 2.8 m. The SASW test was performed approximately 20 m away from the DCPT location.

Figure 4.8. Results of DCPT and SASW tests performed at St Paul's Church in Dallington.

The  $V_s$  profiles must be corrected for overburden pressure ( $V_{s1}$ ) prior to evaluating soil liquefaction triggering. Generally speaking, even without this correction any soil layers with  $V_s$  less than 150 m/s are quite soft and may be potentially liquefiable. However, it will be noted that  $V_s$  measurements alone cannot definitively determine liquefaction susceptibility, as the type of soil (i.e. clay or sand), not just its stiffness/velocity, is a key factor. The  $V_s$  profile shown in Figure 4.8 indicates soft soils down to 8 m depth, with the softest soils between approximately 2-4 m.

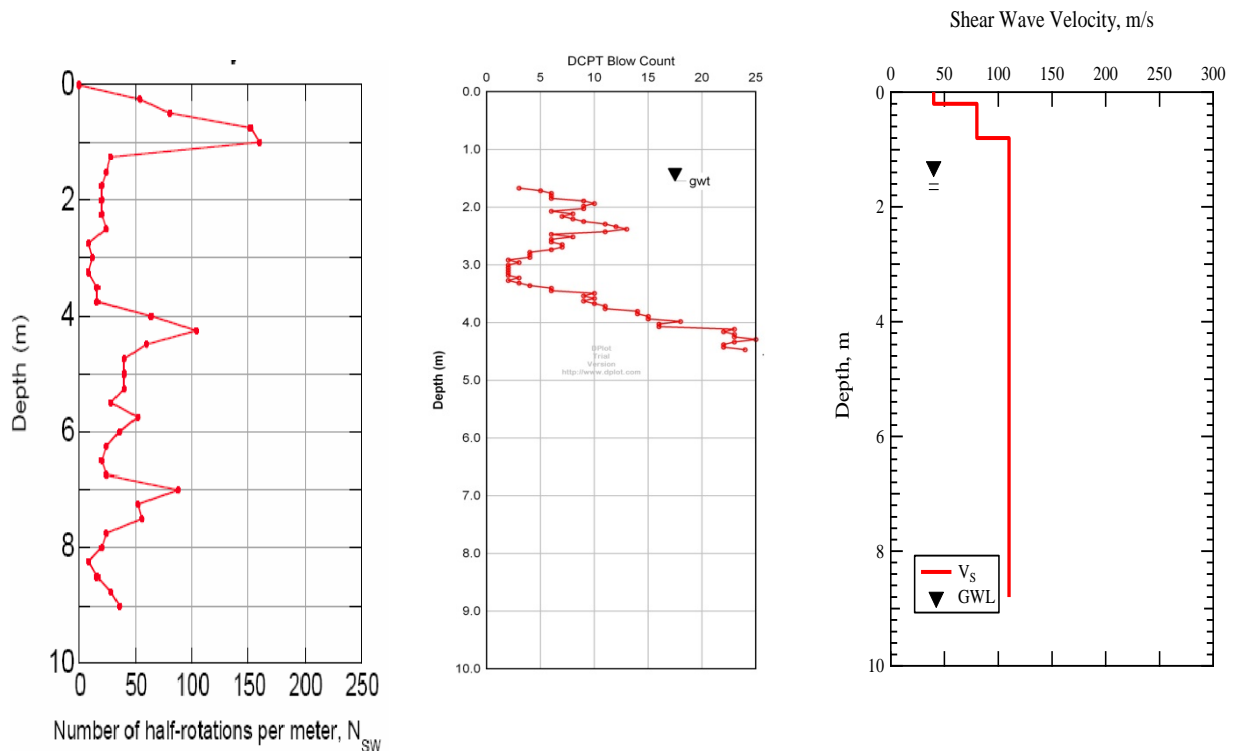
An SWS test, DCPT, and SASW test were performed in the backyard of a house in Bexley; the results are shown in Figure 4.11. Based on the bore hole augered for the DCPT test, the ground water table was at a depth of ~1.5 m and the top of the liquefied layer was at a depth of ~1.6 m. The SASW test was performed ~10 m away from the DCPT sounding.

Figure 4.11 Results of SWS test, DCPT, and SASW test performed in the backyard of a house in Bexley.

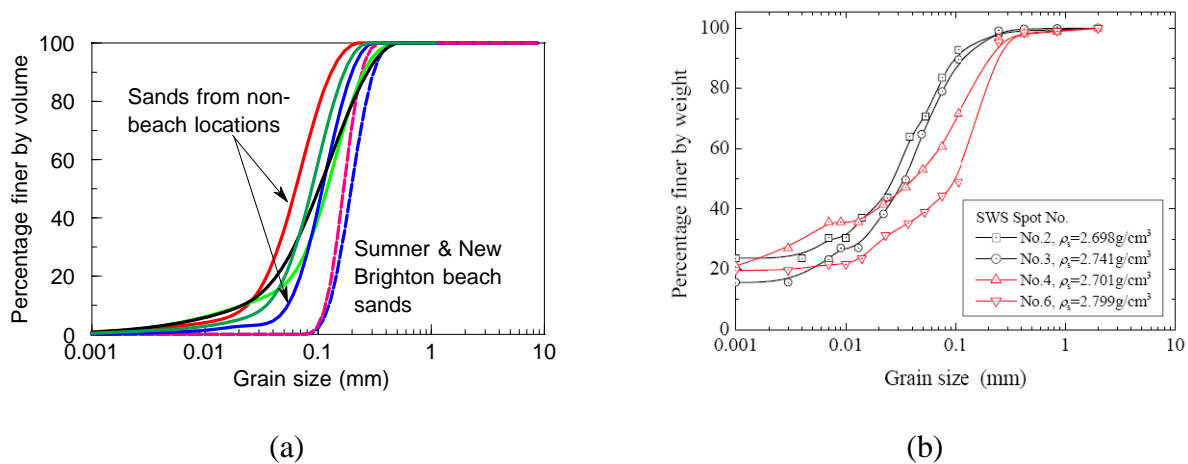
Grain-size distribution curves of ejecta samples taken from Dallington (Gayhurst Rd), Porritt Park and South Kaiapoi (Courtenay Dr) are shown in Figure 4.13a. Figure 4.13b shows grain size distribution of soil samples taken from the SWS screw point (representative of the deepest layer penetrated in a SWS test), which shows significantly higher fines content.

Figure 4.13 Grain-size distribution curves of Christchurch and Kaiapoi soils: (a) Grain size distribution curves of sand boil samples obtained by laser diffraction analysis; and (b) Grain size distribution curves of soil samples taken from the SWS screw point (deepest tested layer) obtained by sieve and hydrometer analyses: Dallington (No. 2 and 3) and Bexley (No. 4 and 6).

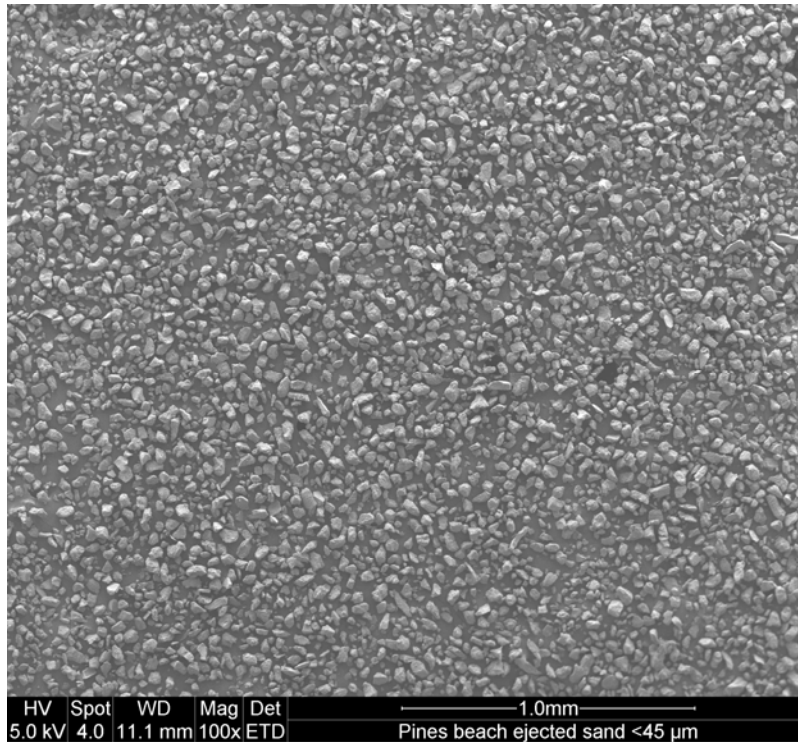
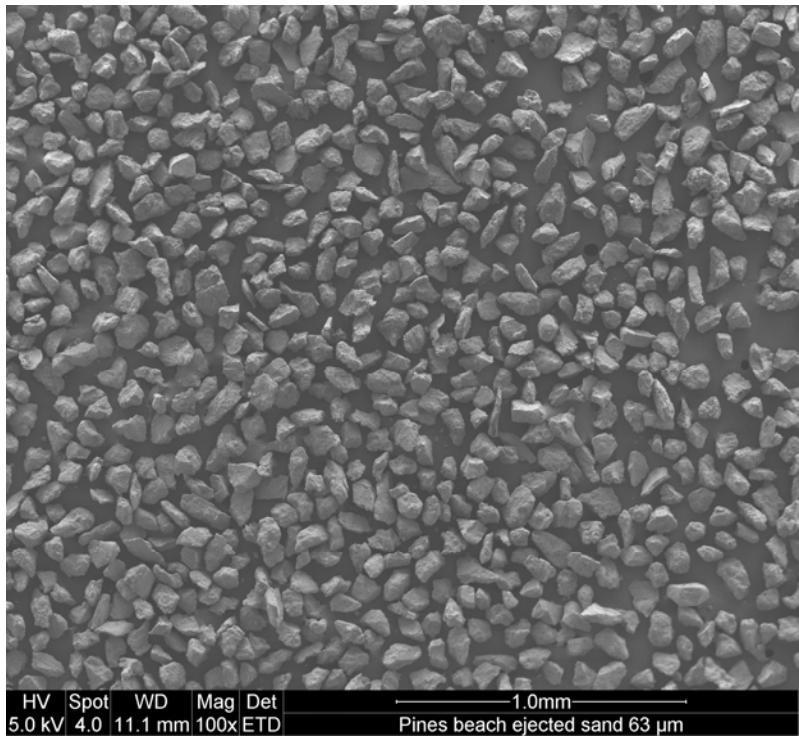
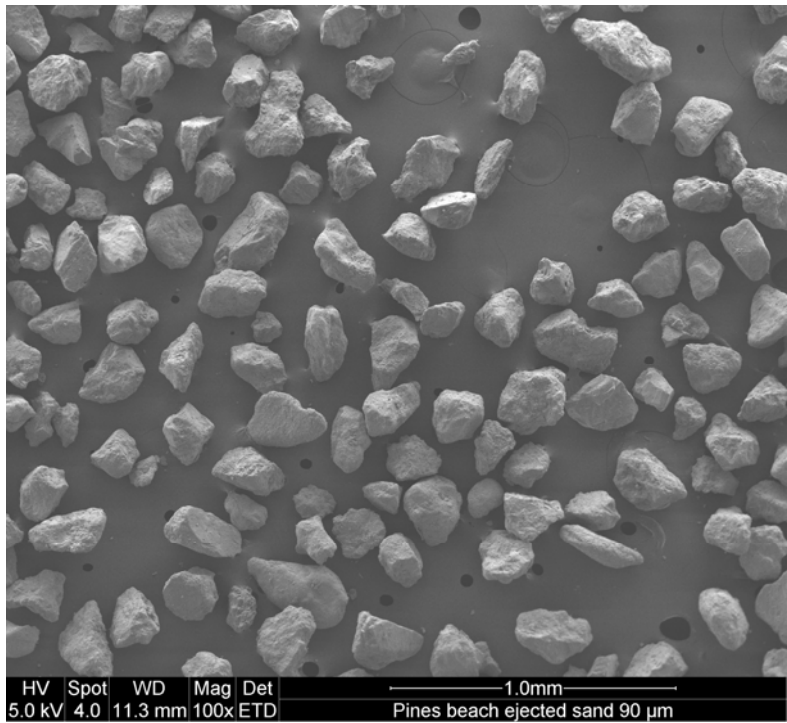
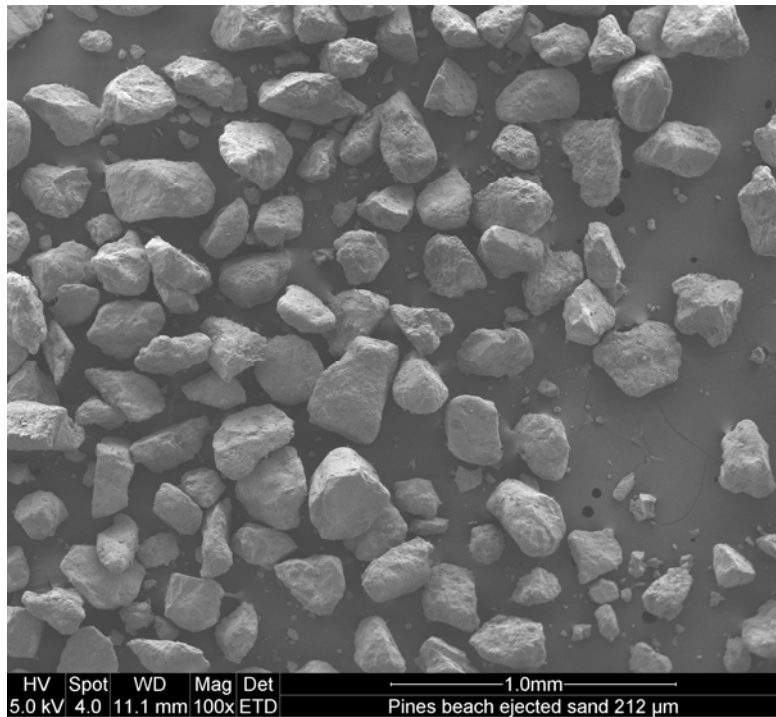
Figure 4.14 shows the large sandboil at Featherstone Reserve at Pines Beach, from which a bulk sample of the sand was recovered. Figures 4.15-4.18 give electron micrographs of various fractions of the sand in relation to sieve size. The micrographs are all at the same magnification, 100 times, and show that the particles tend to be angular to subrounded in shape. As the particle size decreases the angularity of the particles increases.

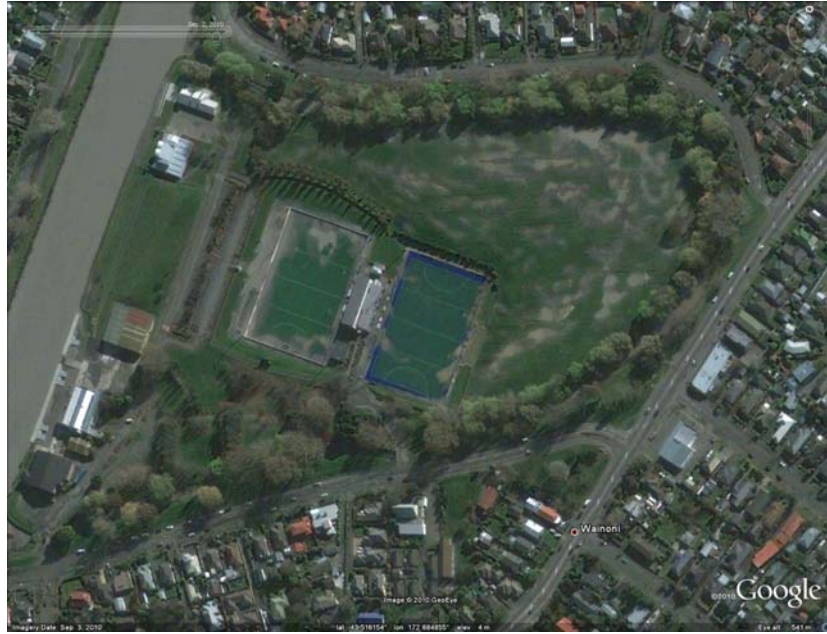
A few hours after the earthquake, a GeoEye image of part of the area affected by the earthquake was captured. Since Saturday 4 September 2010 was a clear day, this image provided good evidence of liquefaction in some parts of the city. Figure 4.21 shows part of the GeoEye image covering Porritt Park. Figure 4.9a shows a picture of Porritt Park taken from a helicopter on the afternoon of Friday, 10 September 2010.

Figure 4.21 Image of Porritt Park extracted from the GeoEye image taken a few hours after the earthquake. From the left to the right edge of the image is ~0.62 km (Google Inc., 2010). (-43.516154°, 172.684855°)

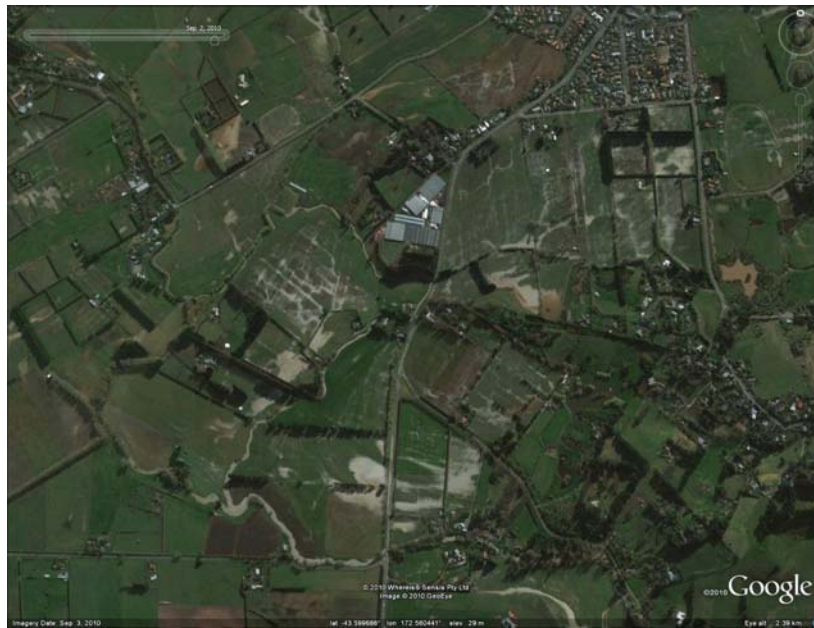
Local residents commented that on the morning after the earthquake the Avon and Heathcote rivers had a milky appearance. This is because the ejected sand contained enough fine material (typically 10 % finer than about 0.050 mm (No. 270 sieve)) to stay in suspension for some time when mixed with water. A GeoEye image of part of the Halswell area is shown in Figure 4.22. This figure suggests that there are some areas of Halswell where extensive liquefaction occurred. However, discussions with local residents revealed that a considerable volume of water came to the ground surface along with ejected sand, and this water had a milky color. So, the ejected sand could not be distinguished from the water in the satellite image. Some days after the earthquake this water had subsided.

Figure 4.22 Part of Halswell as imaged by GeoEye after the earthquake. The ejected sand is accompanied by considerable volumes of water forming mini-lakes having a similar color to the ejected sand. From the left to the right edge of the image is ~2.74 km (Google Inc., 2010). (-43.598349°, 172.566383°)

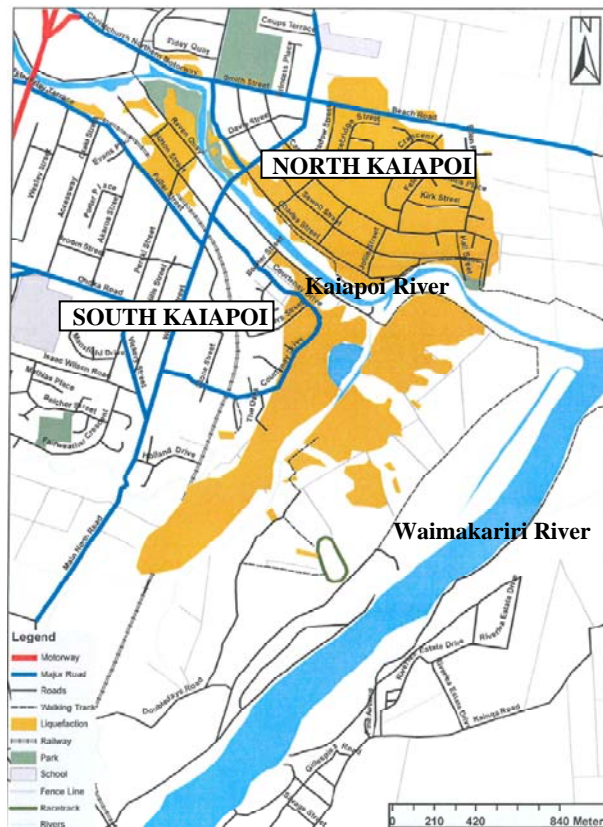
In the 2010 Darfield Earthquake, widespread liquefaction occurred north of the Kaiapoi River (Charles St, Sewell St, Cassia St) affecting a large number of residential houses. The houses in this area are typically single- or two-story brick/stone block masonry or timber structures on spread footings. Figure 4.24 shows areas of severe and moderate-to-low liquefaction in the town of Kaiapoi. A strong motion station located in north Kaiapoi recorded a PGA of approximately 0.32g (geometric mean of the horizontal components) during the earthquake.

Figure 4.24 Areas of observed liquefaction in the town of Kaiapoi due to the 2010 Darfield earthquake (the liquefaction map is based on surface manifestation of liquefaction visible on aerial photographs and compiled evidence from ground surveys).

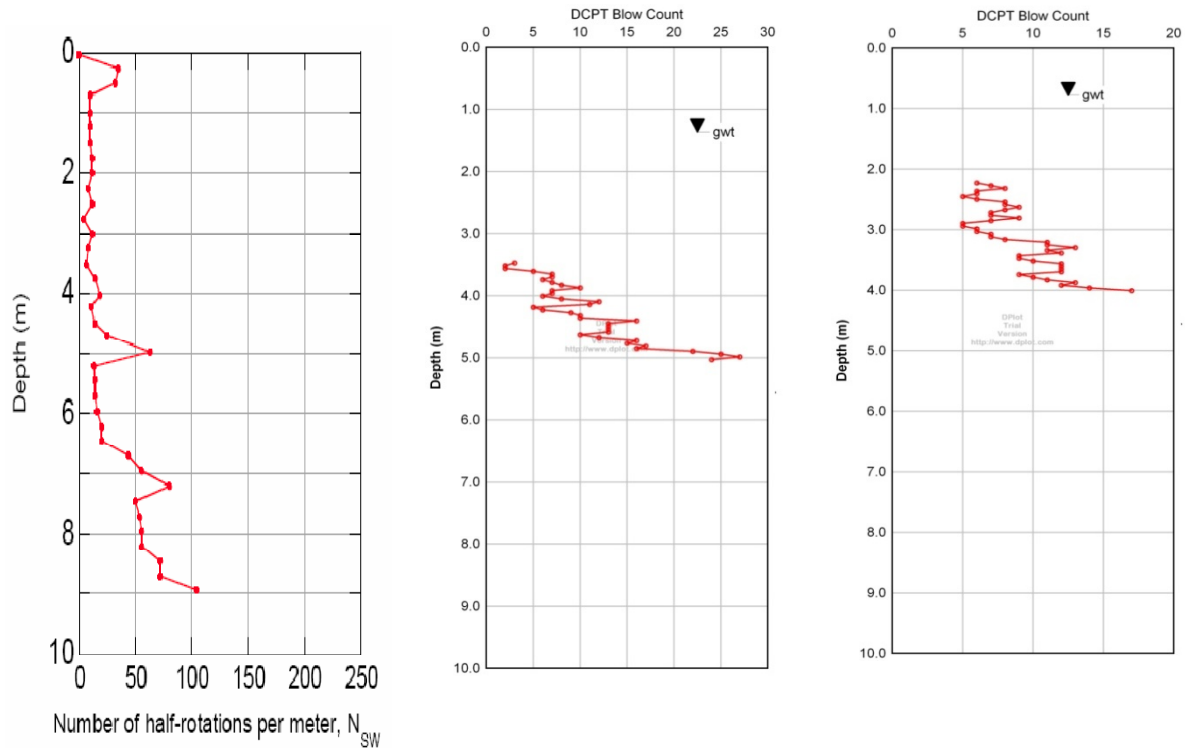
The liquefaction was particularly intense, producing massive sand boils of grey, silty sand, at Cassia Place and at the east end of Charles and Sewell Streets. In the worst hit area, the silty sand ejecta was about 400-mm thick, as shown in Figure 4.25. Some residents reported geysers appearing in the backyard following the earthquake, often forming a small pond near the house that remained for several days after the event. An SWS test and DPTs were performed by the GEER-NZ Team in this area, with the SWS test indicating loose/soft soils up to depths of 8-9 m (Figure 4.26).

Figure 4.26 Results of SWS test and DCPTs performed in the backyard of a house at Cassia Pl.

As determined from the bore holes augered for the DCPTs, the depth to the ground water table and to the top of the liquefied layer differed between the two test locations at Cassia Pl although the test locations were only ~25 m apart. However, the surface elevation of the two test locations differed by about 0.5 m. As a result, the elevations of the ground water table are similar for the two test locations, with the depth to the top of the liquefied layer differing slightly. As with the site on Bracken St (Figure 4.4), a 10- to 15-cm thick, very wet, very soft clay/plastic silt layer overlies the liquefied layer.

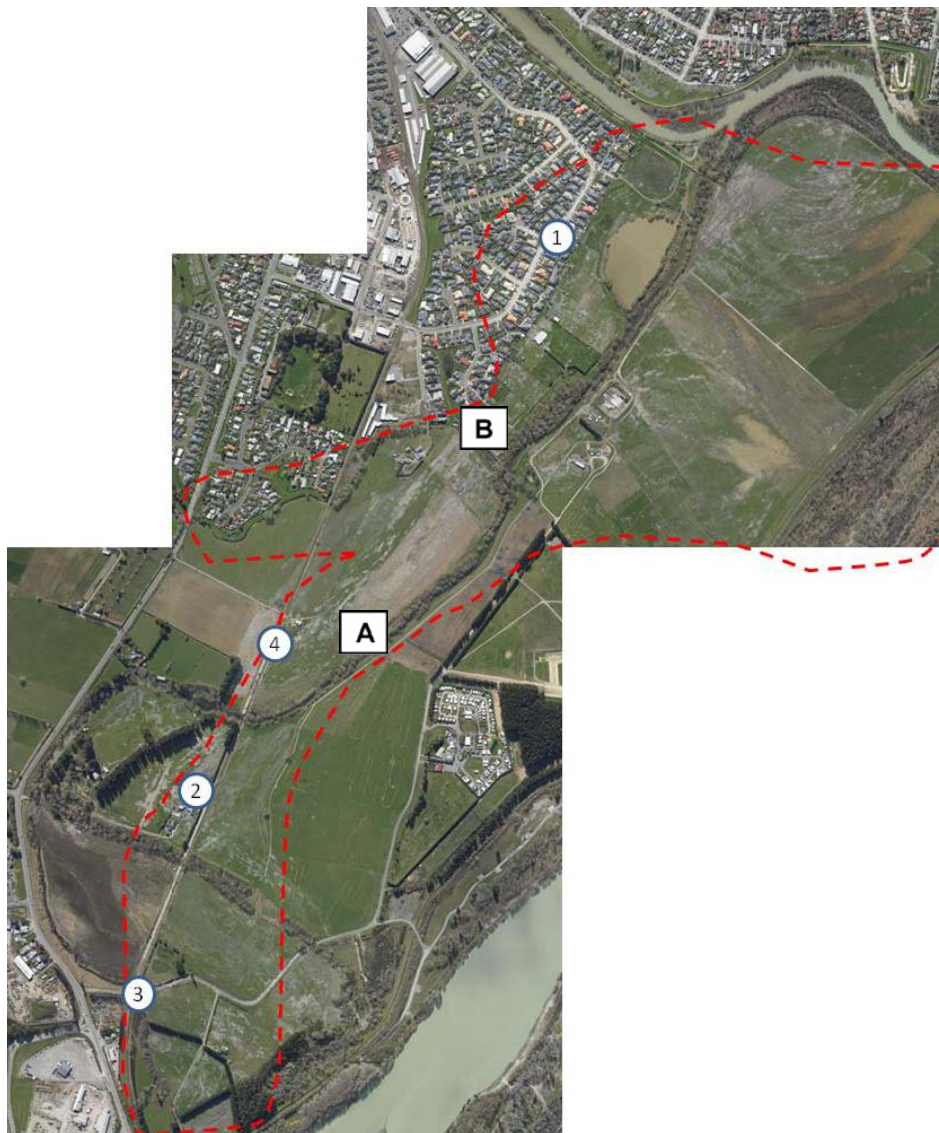
The eastern edge of Kaiapoi is shown in aerial photographs taken after the Darfield earthquake (Figure 4.30). The outline of the 1865 Waimakariri river channel (Figure 2.9) is shown by the dashed red line. On the eastern side of Kaiapoi, the old channel passes underneath the present day Courtenay Dr area shown as position 1, where severe damage to residential properties occurred due to lateral spreading (Figure 4.34). Further south at positions A and B (Figure 4.29), large cracks due to lateral spreading towards Courtenay Stream are evident. Along this stretch from position A to the north-east corner of Courtenay Dr (slightly north of position 1), detailed ground surveys were conducted along ten transects including measurement and mapping of width of cracks, vertical offsets, and geo-tagging of major cracks and other lateral spreading features. Figure 4.31 indicates geo-tagged major cracks and four transects of detailed measurements at position A.

Figure 4.30 Aerial view of the lateral spreading area at South Kaiapoi.

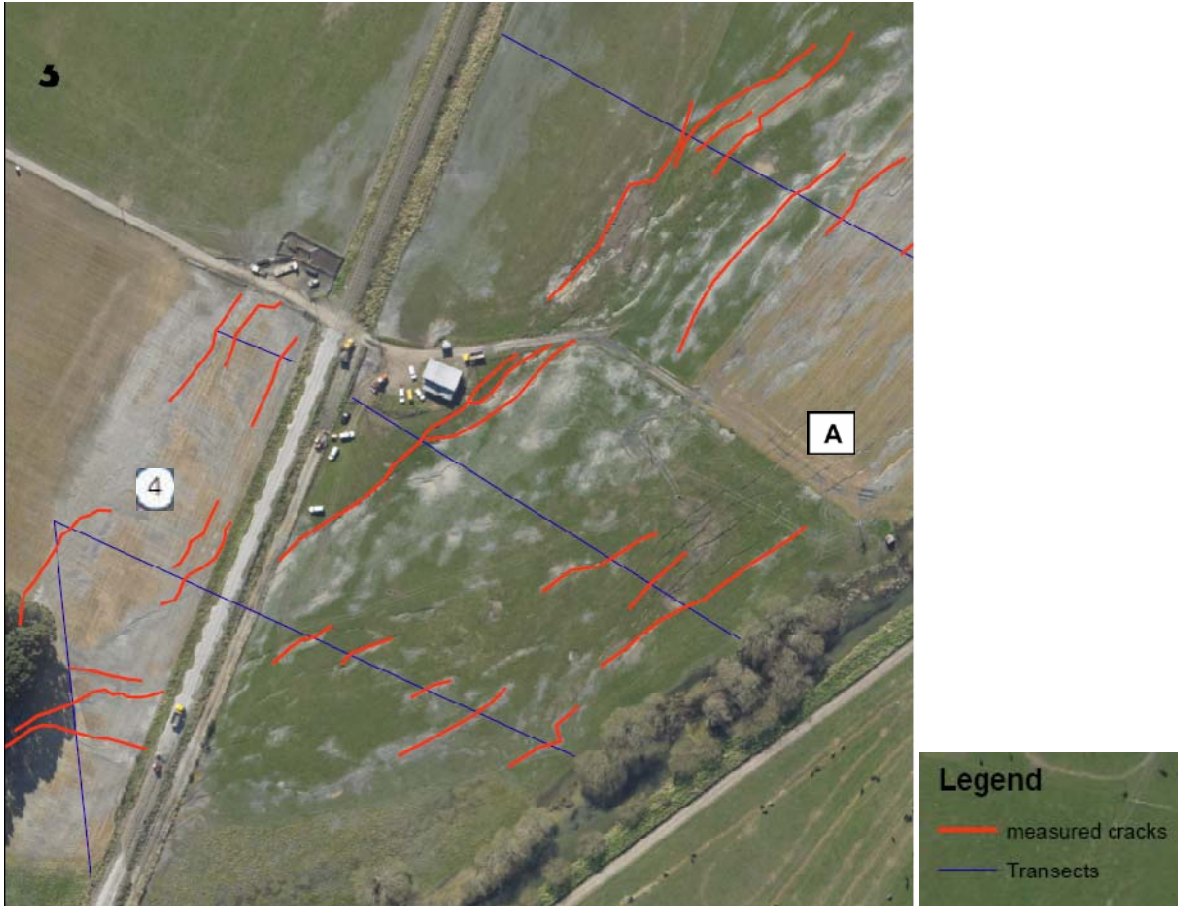
Figure 4.31 Aerial view of the lateral spreading area at position A at South Kaiapoi showing four transects of detailed ground surveys.

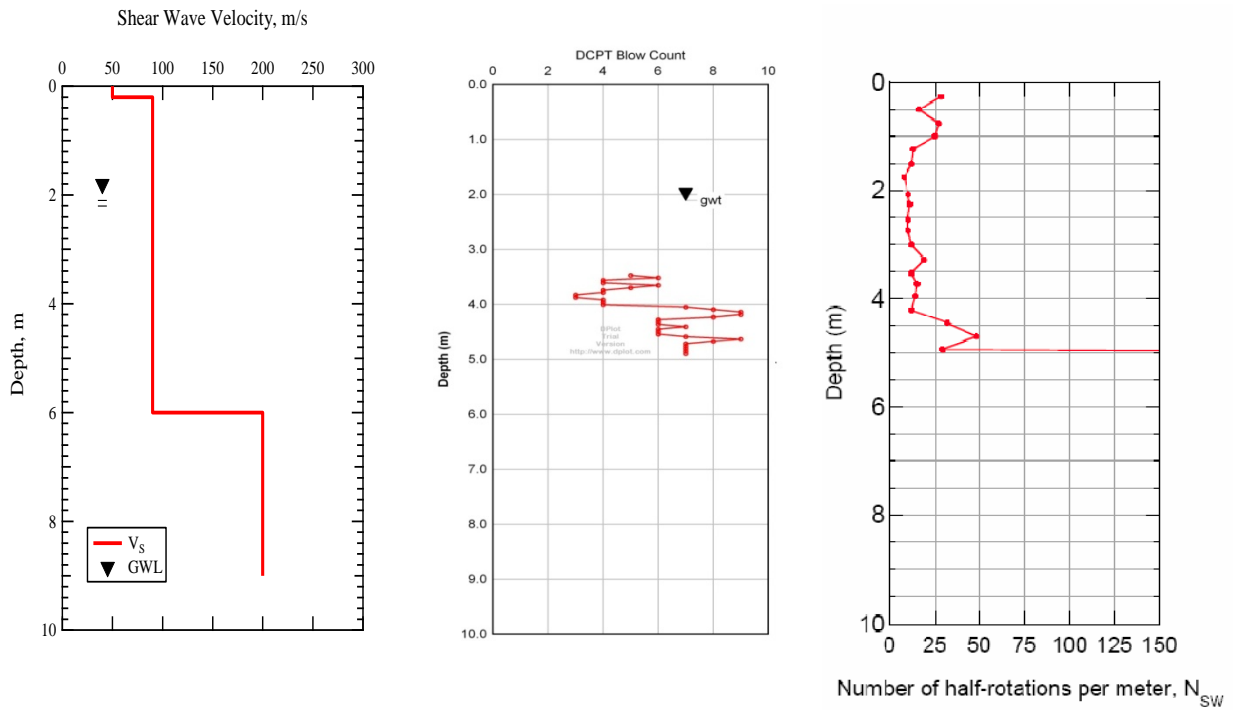
An SASW test, DCPT and SWS test were performed at a home along Courtenay Dr. The results are presented in Figure 4.35.

Figure 4.35 Results of SAWS test, DCPT and SWS test performed at a residential property along Courtenay Dr.

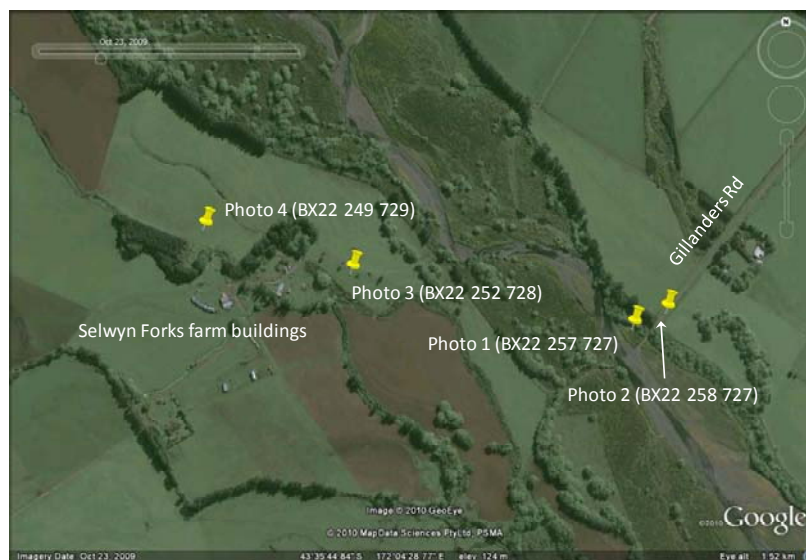
At the evening meeting of Sunday, 12 September 2010, Pilar Villamor of GNS reported to the Team that she had seen liquefaction in a farm paddock at the Greendale end of the fault trace. The paddock was on the Selwyn Forks property which is accessed from the Hororata - Dunsandel Rd on the southern side of the Hororata and Selwyn rivers. The locations of the liquefaction are shown in Figure 4.36.

Figure 4.36 Location of the liquefaction along the Selwyn River in the Greendale region. (Date of Google image 23 October 2009)

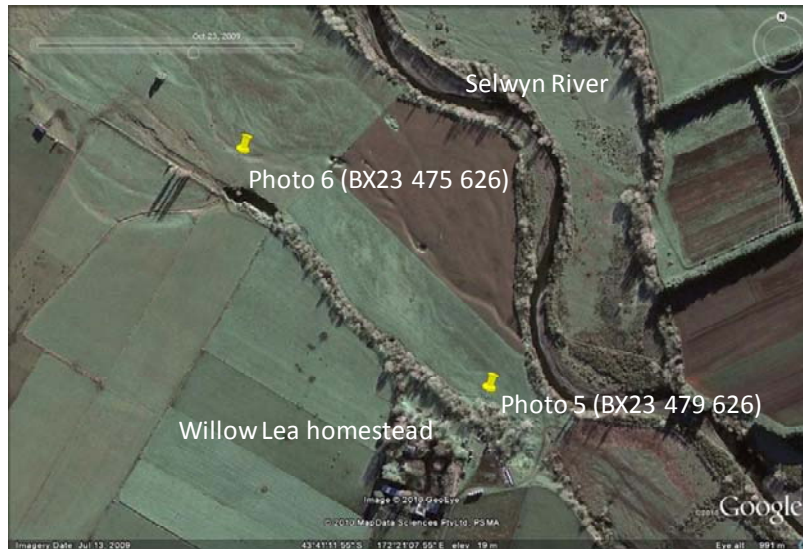
Further liquefaction adjacent to the Selwyn River, not far from the town of Leeston, was evident of the Willow Lea property near Irwell (Figure 4.41).

Figure 4.41 Location of the liquefaction along the Selwyn River in the Irwell region. (Date of Google image 13 July 2009)

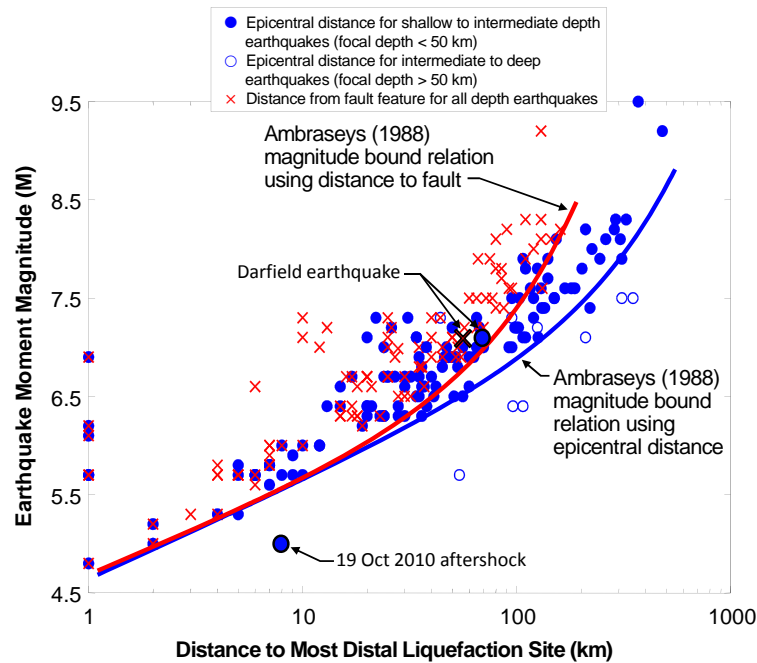
The most distal sites from the epicenter and fault rupture where liquefaction was induced during the main shock are in Waikuku Beach, north of Kaiapoi along the coast, and in Akaroa, southeast of Christchurch on Banks Peninsula. The site-to-source distance to Akaroa is slightly more than to Waikuku Beach. The epicentral distance and closest distance to the fault rupture for the Akaroa site are ~54 and 44 km, respectively. These distances are plotted in Figure 4.44, along with data compiled by Ambraseys (1988) from global earthquakes. As may be observed from this figure, the epicentral distance falls well within the boundary for maximum distance of observed liquefaction formed by data from global earthquakes, but the closest distance to the fault rupture is close to the global earthquake data boundary.

In addition to the liquefaction induced by the main shock of the Darfield earthquake, the M5.0 aftershock that occurred on 19 October 2010 re-liquefied soils at a few locations. The epicenter for this aftershock was south of Christchurch ( $-43.63^{\circ}$ ,  $172.56^{\circ}$ ) and the known most distal location where liquefaction was re-induced was in Hoon Hay, ~8 km north of the epicenter. This point plots ~5.5 km to the right of the boundary formed by data from global shallow to intermediate depth earthquakes (i.e., focal depths < 50 km) and is the only point that plots this far to the right of the boundary.

Figure 4.44. Comparison of the most distal liquefaction feature from the Darfield Earthquake with worldwide earthquake data collected by Ambraseys (1988) (Adapted from Rathje et al., 2010).
