5. IMPACT ON BUILDING STRUCTURES

General

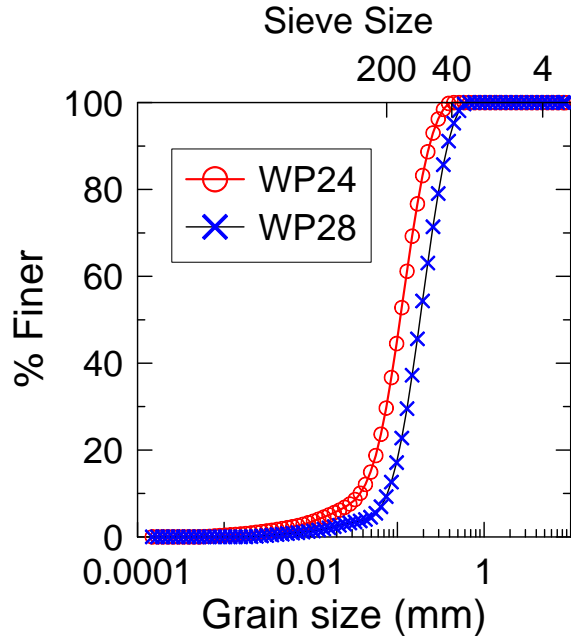
Figure 5.10 Grain-size distribution of samples taken from ejecta observed in Kaiapoi area (sample taken 11 September 2010 testing via laser diffraction). Sample WP24 taken at -43.381856° , 172.659149° (adjacent to law offices) and sample WP28 taken at -43.384723° , 172.661314° (adjacent to Kaiapoi wharf).

Soil samples taken from the largest visible ground ejecta features within the park adjacent to the Kaiapoi River are similar to the material observed within the small business district of Kaiapoi (Figure 5.10). These grain size distribution curves indicate the material directly adjacent to the wharf, and likely extending into the neighboring park, is a uniformly graded sandy soil with 10% to 30% fines (Table 5.1). In contrast material further from the rivers' edge (e.g. WP28 taken within the small business district of Kaiapoi) although similarly sandy and uniformly, graded contains a more appreciable amount of fines (30%). The largest content of fines of these samples approached 70% (WP169 taken at the Lyttelton Oil Terminal).

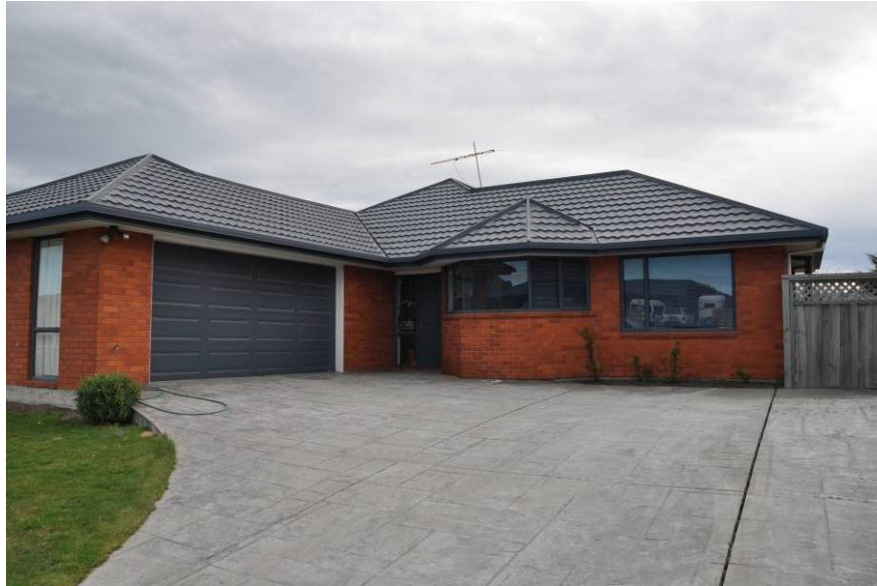
Kaiapoi South – In general damage to building structures in the Kaiapoi South community was limited to Courtenay Dr between Kaikanui St and ending at Parish Ln. This is a residential neighborhood with relatively new homes, all constructed within the last ten years. Most houses are one-story light wood framing or brick supported on unreinforced slabs with perimeter stemwall foundations and light metal roofing. An example of the typical construction style in this area is shown in Figure 5.19. Liquefaction was reported to inundate the neighborhood north of Courtenay Dr towards Charters St, however much of this had been cleaned up by the time of the GEER-NZ Team's visit and appeared to have minimal impact on the houses. The impact to houses along Courtenay Dr however, and particularly those on the east side of the drive, with direct facing to a paddocks' field as well as a branch of the Courtenay Stream, was extensive. Ground failure in this region manifested in large lateral spread zones coupled with liquefaction (Figure 5.20). A manual survey by the GEER-NZ Team indicated that of the 44 houses along this drive 48% suffered severe structural damage induced by ground failure, while 15 (36%) suffered moderate and minor damage, respectively. Laterally spreading ground was observed to extend through the backyards of these houses, with the lack of reinforcement within slab foundations and general light construction styles resulting in severe separation of the home directly in-line with the ground failure. The residences shown in Figures 5.21-5.24 demonstrate the observed damage due to excessive ground movement. The structure shown in Figures 5.21-5.22 suffered excessive tilting and a separation of 1.5 m from its approach driveway to the front of the home (Figure 5.22a), while the rear of the house collapsed inward due to surrounding ground fissures (Figure 5.22b). Similarly, the residence in Figures 5.23-5.24 articulated little to no damage at the backside of the house (Figure 5.23), however the front entry of the house at the interface between

Figure 5.19 Typical construction style of houses along Courtenay Dr in the South Kaiapoi residential community. (-43.389847°, 172.662049°; 1430 hrs on 11 September 2010)

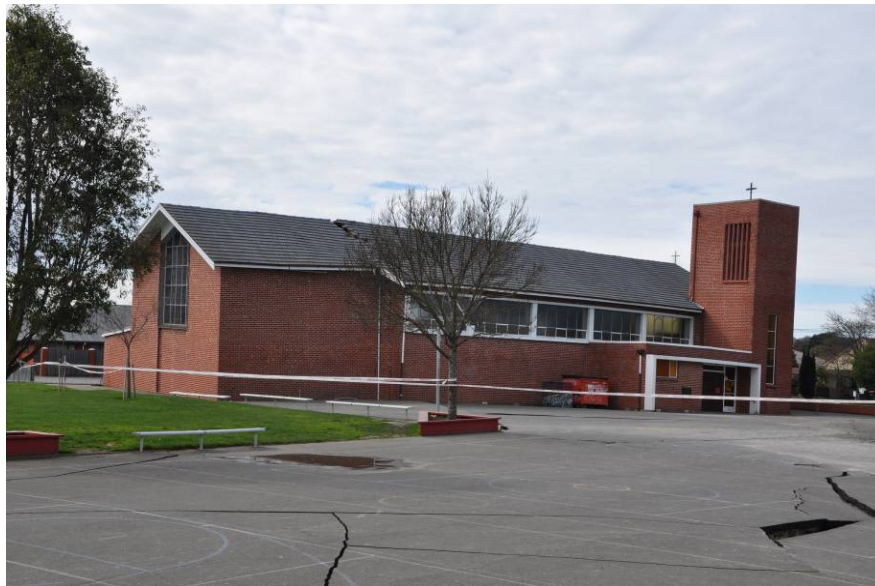
A historically significant feature in the neighbourhood of Dallington is the St. Paul's church and surrounding school (Figure 5.28). St. Paul's church was severely damaged due to surrounding ground movement, which was precipitated by extensive liquefaction within the general area shown in Figure 5.28. Most significantly the structure suffered through building separation due to ground extension and vertical offset subtending north-south approximately one-third of the length along the west end (orange separation location denoted in Figure 5.29). This resulted in separation of the building into two distinct pieces. The West end of the building rotated 2 degrees south and 4 degrees west (Figures 5.30-5.33), resulting in 46 cm of settlement of the south-west corner (estimated with reference to prior ground elevation). No significant lateral translation of the building was measured at its perimeter, rather structural movement was confined to rotation and settlement as described in Figure 5.29. This relatively heavy single story structure was constructed of running bond brick perimeter walls, with a timber (truss) roof. Wall heights were approximately 10 m at the perimeter of the sloping roof and 7m at flat portions. An ~12-m tall tower is articulated at the southeast corner of the structure (Figure 5.33b). The

Figure 5.30 St Paul's church in Dallington area - overall view of building looking north-east (-43.5196°, 172.6725°; 1345 hrs on 12 September 2010)

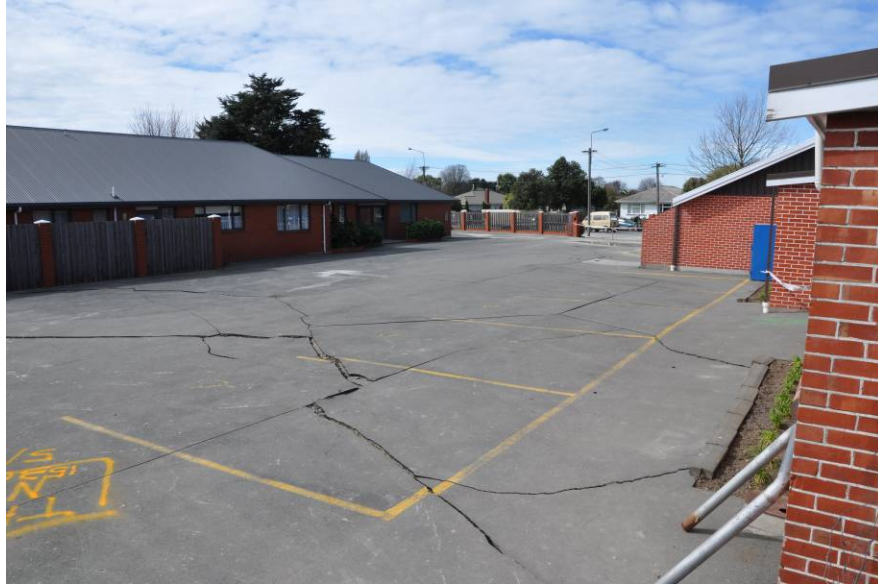
Surrounding St. Paul’s church is an Integrated State School affiliated with the church (buildings denoted B1-B8 in Figure 5.28). Building B1 (Figure 5.34) and B6 (Figure 5.36) are constructed of running bond brick perimeter walls with light metal roofs, whereas buildings B4, B5, and B7 incorporate light wood framing along their longitudinal axes and brick along their transverse axes. Building B2 is constructed of concrete masonry block units (Figure 5.35). All structures within the school appeared to be supported on elevated stem wall footings with interior wood joists, with the exception of B2, which appeared to be at grade with a slab on ground. Buildings B1-B8 are all single story with wall heights ranging from 7-8 m. Stiff brick and CMU buildings within this school complex suffered shear cracking and in some cases significant separation of brick-mortar joints (e.g. Figures 5.35b and 5.36b). Likewise mixed construction structures, such as building B7 suffered damage due to relative movement between contrasting materials (Figure 5.37b). Flexible wood buildings suffered little observable structural damage with the exception of hairline cracks in stucco aligned with ground movement features.

Figure 5.34 St Paul's church and surrounding school - Building B1 (on left) and St Paul's church (on right). (-43.519262°, 172.672636°; 1345 hrs on 12 September 2010)

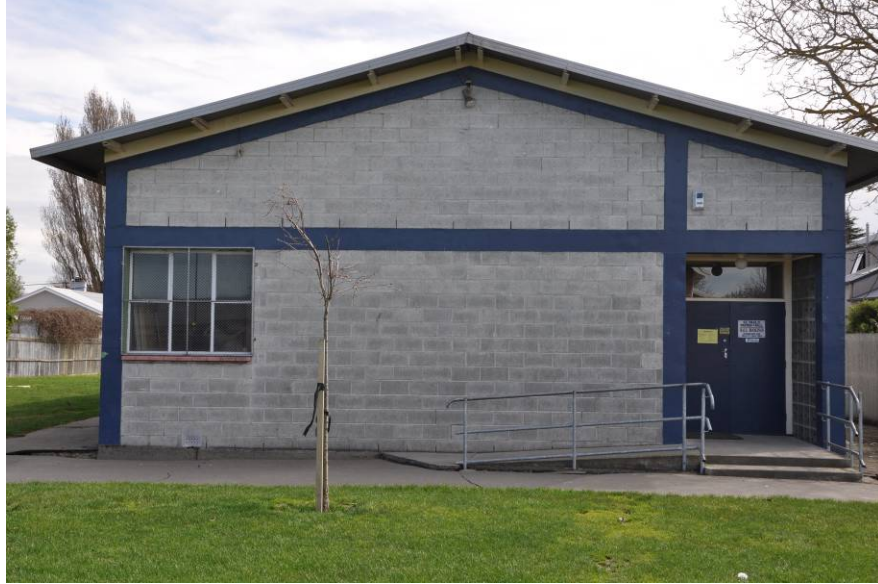
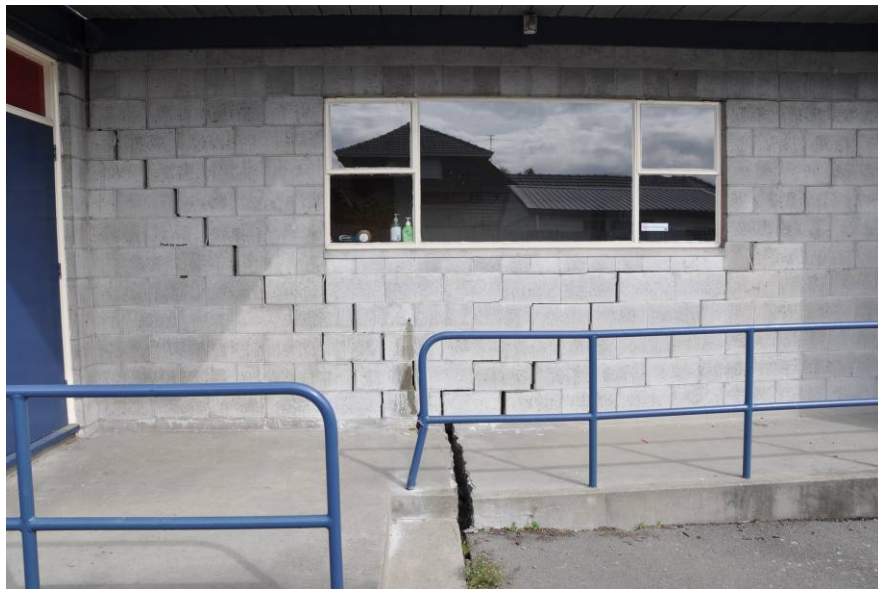
Figure 5.35 St Paul's church and surrounding school - Building B2: (a) view looking west and (b) view from north side of building, looking south. (-43.5193°, 172.6717°; 1300 hrs on 12 September 2010)

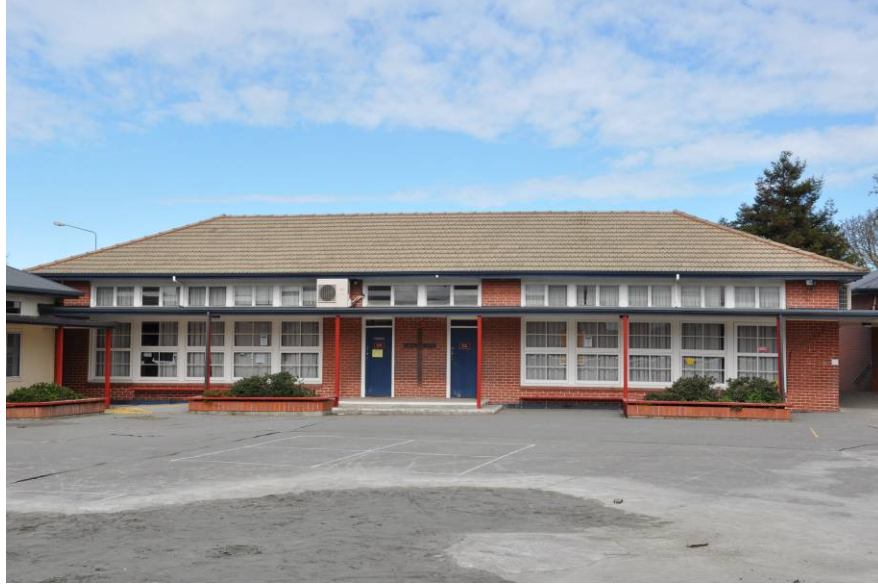
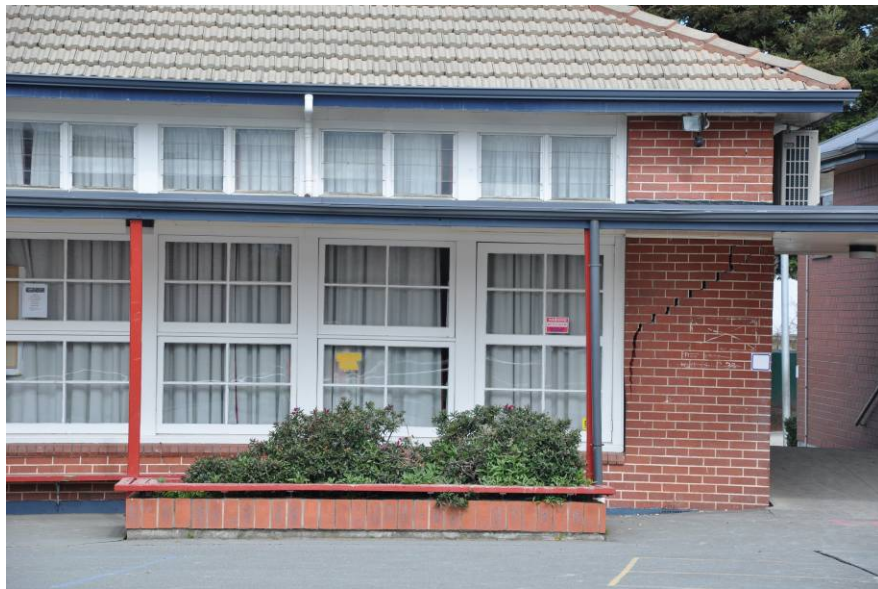
Figure 5.36 St Paul's church and surrounding school - Building B6 view looking south: (a) overall view of building and (b) West end of building. (-43.5200°, 172.6724°; 1300 hrs on 12 September 2010)
