6. PERFORMANCE OF LEVEES (OR STOPBANKS) AND OXIDATION POND EMBANKMENTS

Seismic Performance of Levees

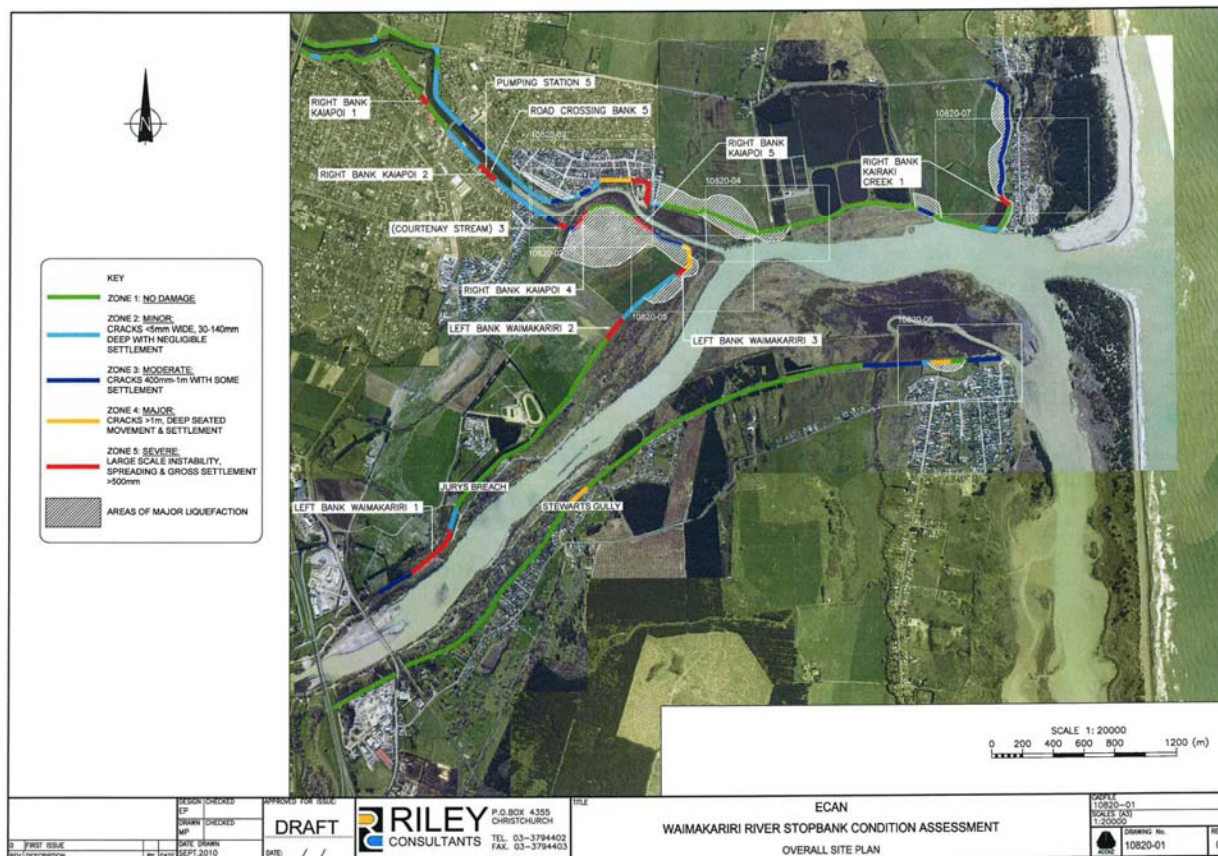
Overall, the levees along the Waimakariri River performed well during the earthquake, with only ~4 km out of ~17 km of levees requiring repair (Boyle, 2010). The majority of the damage along the Waimakariri River was downstream of SH1 (Figure 6.5). On the day of the Darfield event, ECan estimated that flood protection had been reduced from the 500 year event (5000 m³/sec) to the 15 year event (1500 m³/sec) in the lower reaches of the river, east of SH1. The river rose to 1000 m³/sec within days after the earthquake, raising concerns.

Figure 6.5 Post-earthquake damage survey of levees performed by Riley Consultants for Environment Canterbury along the Waimakariri River, downstream of SH1, and Kaipoi River. (Riley Consultants, 2010; courtesy of Ian Heslop and Tony Boyle, ECan)

Repairs to the high priority sites were expected to be completed within a few weeks after the earthquake, with medium priority sites expected to be completed in a couple of months. The cost of the repairs to the high and medium priority sites is estimated to be ~\$NZ 3million with total cost for all repair to be ~\$NZ 4million (Boyle, 2010, Heslop, 2010). ECan annual budget for maintenance and construction is \$NZ 4million.

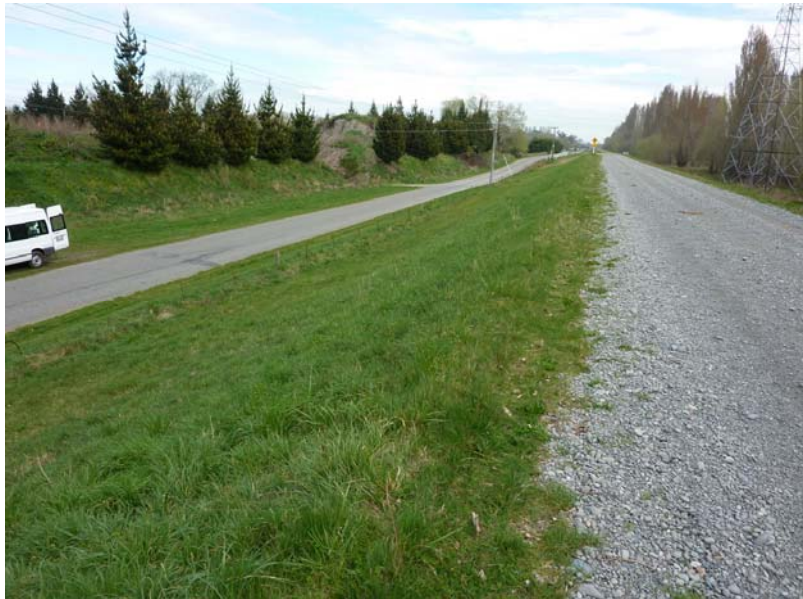
Figures 6.6-6.11 are photographs of the levees for the Waimakariri River along Coutts Island Rd. Numerous sand boils were found along the base of the levee for an ~0.5 km stretch (Figures 6.6-6.8), on both the river and land sides. By the time of the team's damage survey on 11 September 2010, the top of levee along this stretch had already been regraded (Figure 6.9), likely to fill in longitudinal cracks that formed along the crest of the levee. Figure 6.10 is of a ~2-cm wide longitudinal crack in the crest of the levee, located just outside of the ~0.5 km stretch where the crest road had been regraded. It is assumed that the longitudinal cracks in the stretch of levee where the crest road had been regraded were more significant than that crack shown in Figure 6.10, thus warranting the regrading. The liquefaction along the base of the levee and longitudinal cracks in the crest abruptly stopped outside of the ~0.5 km stretch; this may be seen in Figure 6.11, where no damage to the levee could be found.

Figure 6.11 Photo 6: Stretch of levee without evidence of liquefaction. In the distance, a small rise can be seen in the road. This rise is the start of the ~0.5 km stretch where liquefaction was observed along the base of the levee. The location of this photograph is denoted in Figure 6.4. (-43.4225°, 172.6350°)

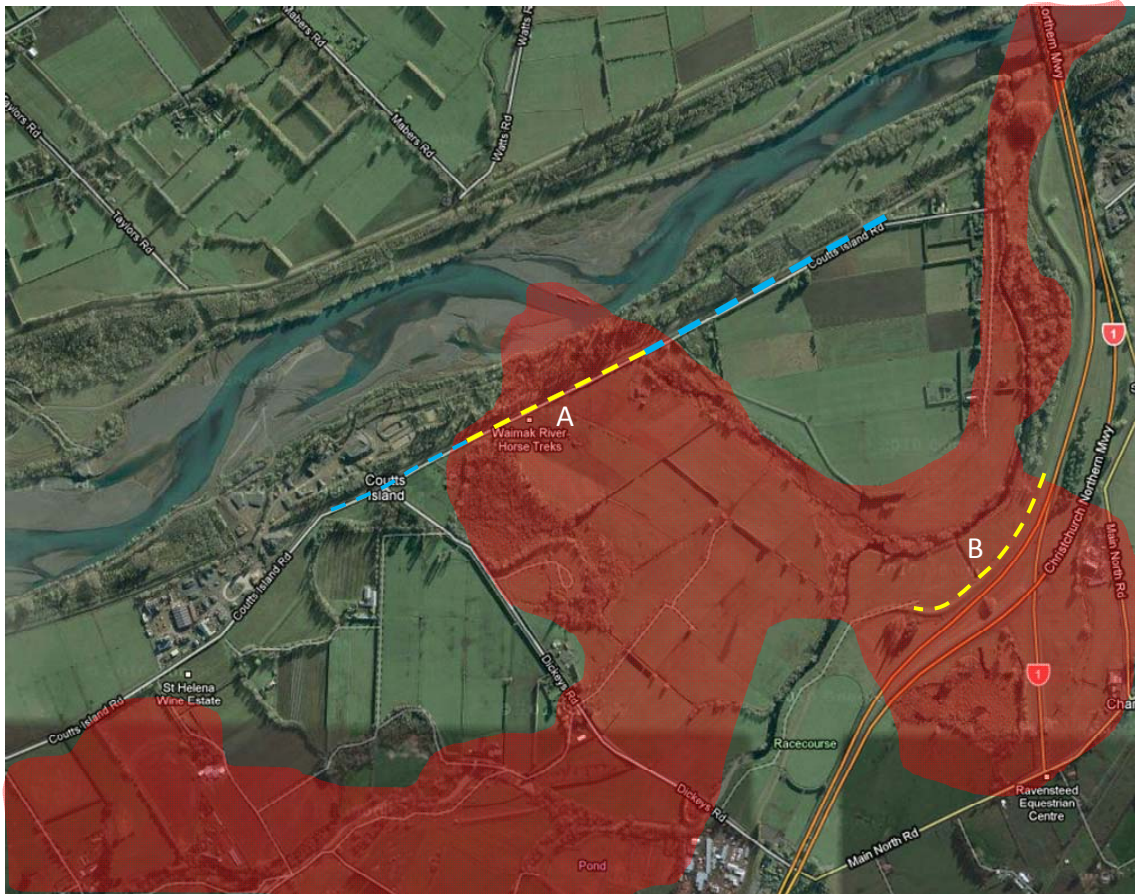
From interviews with local land owners, this section of the land that experienced widespread liquefaction was part of an old river channel. This was confirmed by review of old maps of the area. Figure 6.12 is an aerial image of the Coutts Island Rd area with the 1865 south branch of the Waimaikariri River channel highlighted in red. The ~0.5 km stretch of the levee where liquefaction was observed is denoted by the dashed yellow line (A) in this figure. As may be seen in this figure, the area that liquefied coincides with the location of the old river channel, while the stretches of levee with no observed liquefaction (dashed blue line) lie outside of the old river channel.

Figure 6.12 Overlay of 1865 stream channel on present day Coutts Island Rd. This image is ~3.5 km across (center -43.4266°, 172.6302°) (Google Inc. 2010)

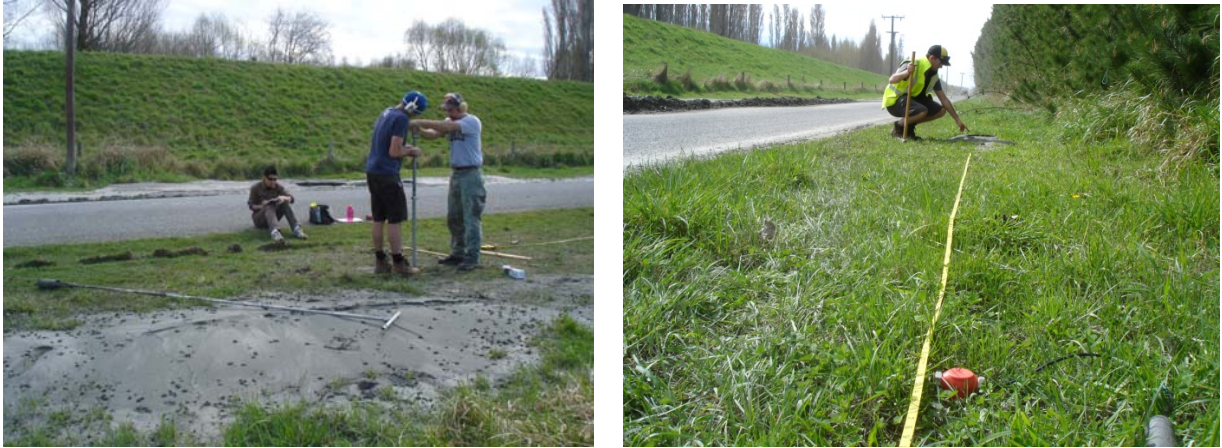
Three Dynamic Cone Penetration Tests (DCPT) and four Spectral Analysis of Surface Waves (SASW) tests were performed along the base of the levees along Coutts Island Rd, both in the areas that did and did not liquefy (Figure 6.13). The results of these tests are presented in Figures 6.14-6.16. The DCPT were performed in holes hand augered down to the top of the respective liquefied layers, with the layers identified by comparing sand boil ejecta with soil extracted with the auger at various depths. The test were performed until there was a noticeable increase in the DCPT N-value or we ran out of rods (~4.6 m from the top of the ground surface). (See the Liquefaction and Lateral Spreading chapter for a more detailed description of the DCPT test).

Figure 6.13 Photos 7 and 8: DCPT (left: -43.425137° , 172.628619°) and SASW test (right: -43.424342° , 172.630473°) performed in areas that did and did not liquefy along the levee on Coutts Island Rd. The locations of these photographs are denoted in Figure 6.4.

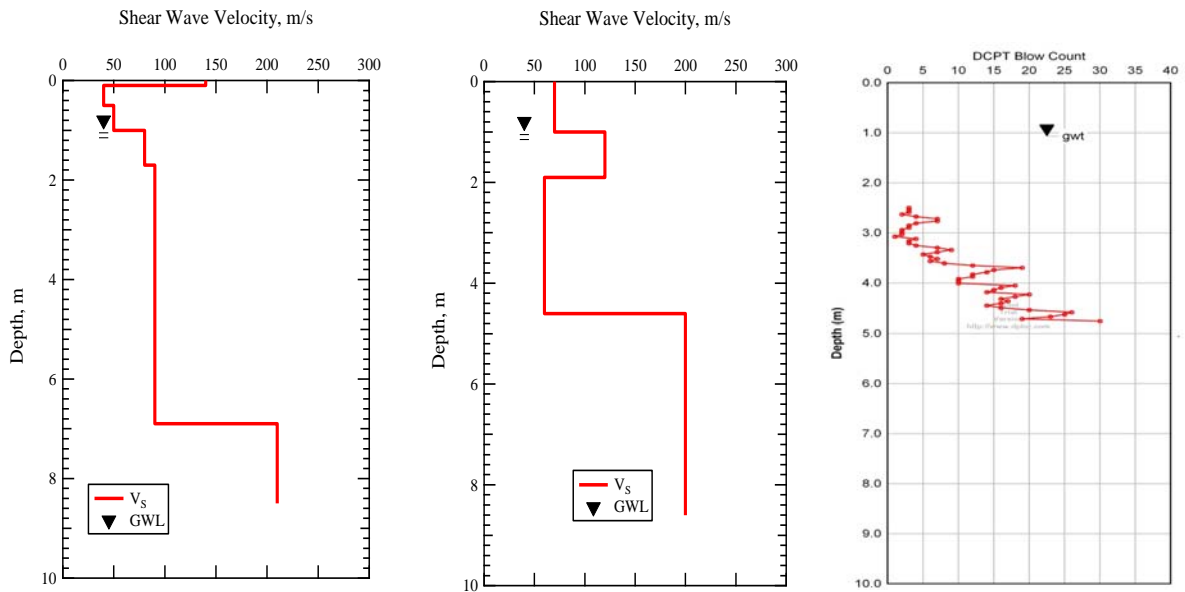
Figure 6.14 Results from SASW tests (left: SASW1 -43.425029° , 172.628676° ; middle: SASW3 -43.424351° , 172.630475°) and DCPT (right: DCPT1 -43.425139° , 172.628618°) performed along the base of the levee on Coutts Island Rd in an area that liquefied.

Other than SASW3 and DCPT1, performed about 175 m from each other in an area that liquefied, the agreement between the SASW and DCPT results is not very good in terms of depth to a stiff, presumably nonliquefiable layer. Further analyses are required to fully understand why. However, the sites that did not liquefy were along the banks of the old river channel. A liquefiable layer could not be found in these areas using the hand auger, and the soil profiles (DCPT2 and DCPT3) consisted of clayey sand and peat. Given the depositional environment of these profiles, it is likely that the strata varied significantly laterally, which could be the explanation for the poor agreement between the DCPT and SASW test results.

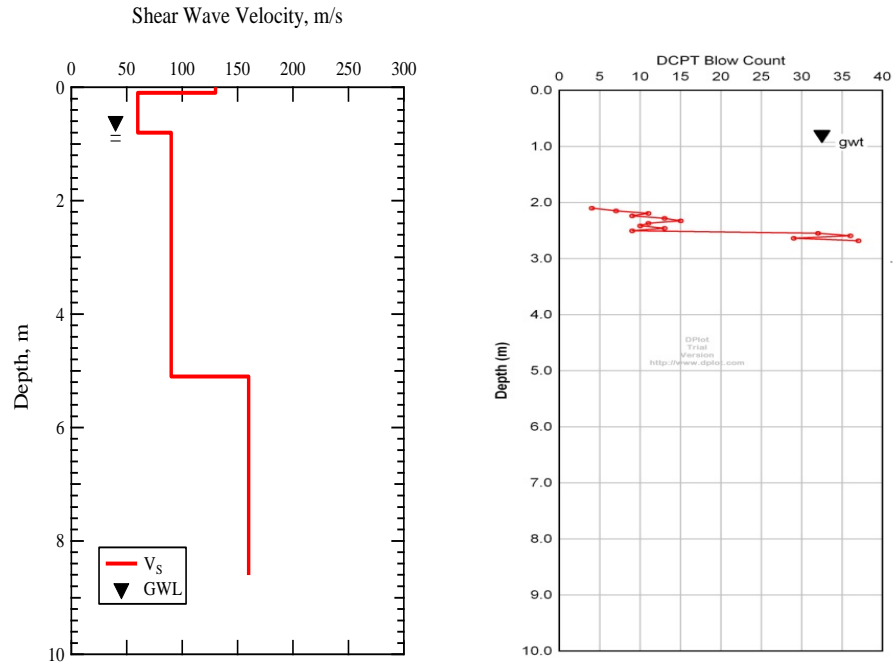
Figure 6.15 Results from SASW test (left: SASW2 -43.426294° , 172.625439°) and DCPT (right: DCPT1 -43.426186° , 172.625673°) performed along the base of the levee on Coutts Island Rd in an area that did not liquefy.

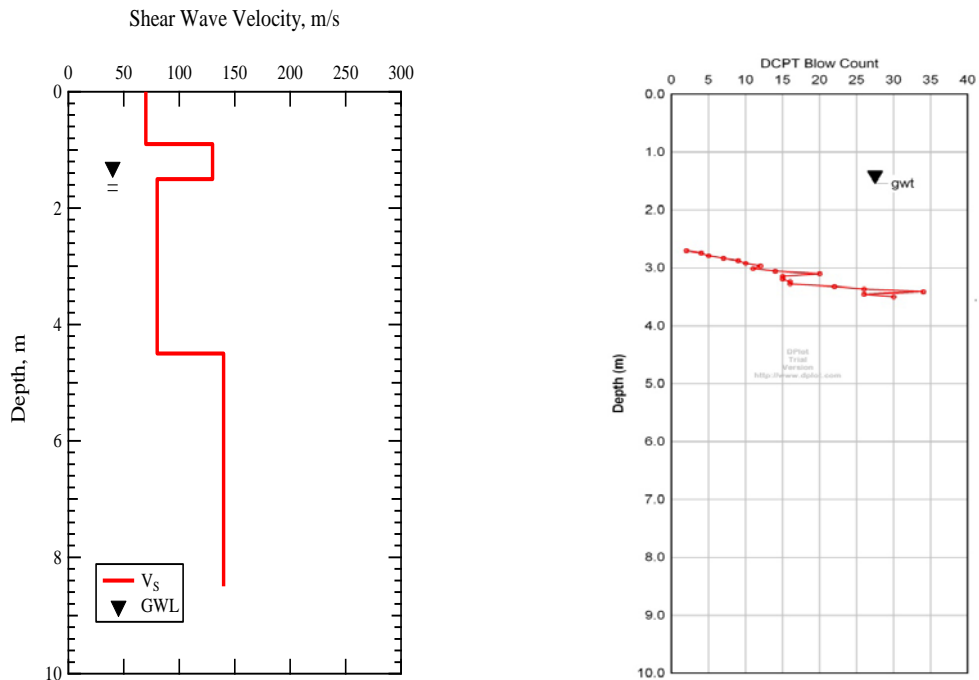
Figure 6.16 Results from SASW test (left: SASW4 -43.422635° , 172.635038°) and DCPT (right: DCPT3 -43.422685° , 172.635081°) performed along the base of the levee on Coutts Island Rd in an area that did not liquefy.

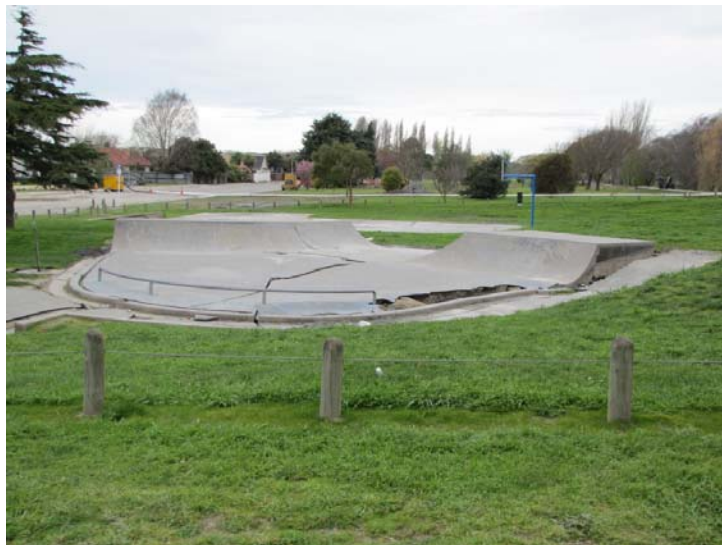
Figure 6.22 Photo 21: Skate park on the levee on the north side of the Kaiapoi River. The location of this photograph is denoted in Figure 6.4. (-43.384094° , 172.660370°)

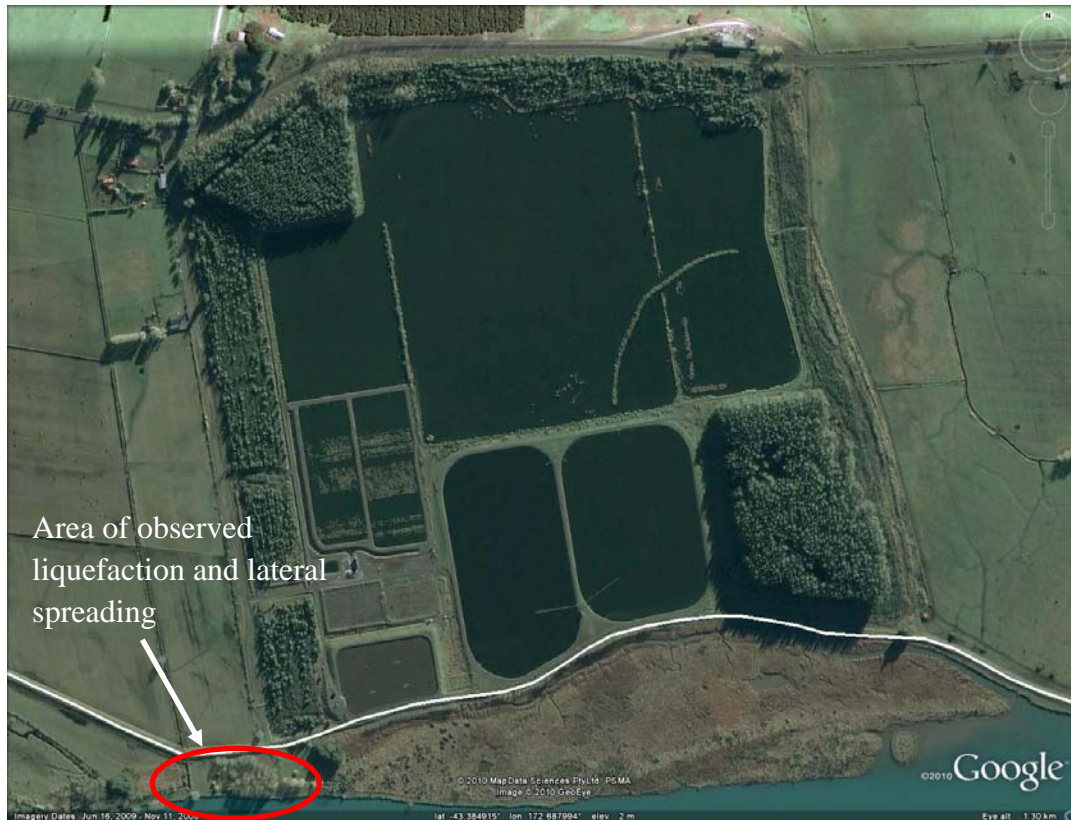
Figure 6.29 Aerial image of the Kaiapoi Sewage Treatment Plant. The southern perimeter (~0.6 km) of the oxidation ponds (bottom of image) forms the levees of the northside of the Waimakariri River. The distance from the left to the right edge of this image is ~1.5 km. (-43.384583°, 172.688240°)

The geotechnical reconnaissance team performed a damage survey on foot of the levees along the southern perimeter of the plant, denoted by the white line in Figure 6.29. No damage was observed along this stretch of the levees, although the team observed large lateral spread cracks (~30-cm wide) in the levees and shoreline about 100 m west of the southwest corner of the plant
