7. EFFECTS ON LIFELINES

This chapter includes the GEER-NZ Team observations for the transportation system (bridges, highways, rail, airports, and ports), water and wastewater systems, electric power, waste management and landfill, as well as other lifelines.

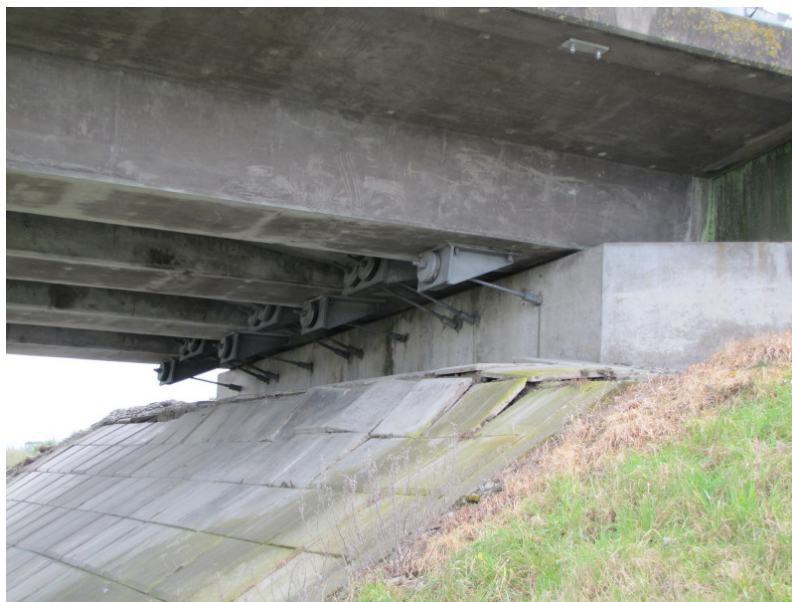
Figure 7.22 Cable Restrainers at north abutment, Chaney's Overpass. (-43.4300°, 172.6464°)

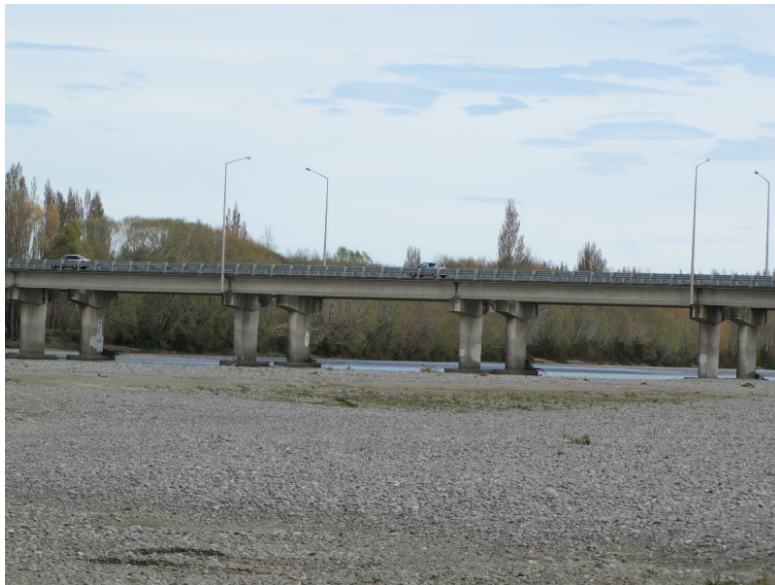
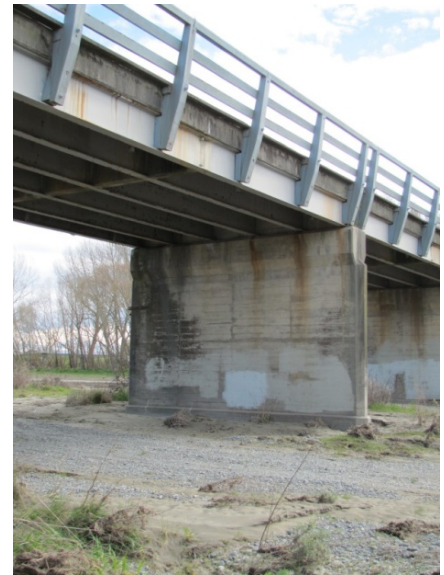
The GEER-NZ Team also inspected the two main spans for the Highway 1 crossing of the Waimakariri River (-43.4153°, 172.6467°) (Figure 7.28) and the adjacent railroad bridge (-43.4128°, 172.6508°). While there was some evidence of liquefaction adjacent to several of the piers for the east span of the Highway 1 crossing (Figure 7.29), there was no indication of displacement of the foundation piers or structural damage to the bridge.

Figure 7.28 Highway bridge across the Waimakariri River. (-43.4153°, 172.6467°)

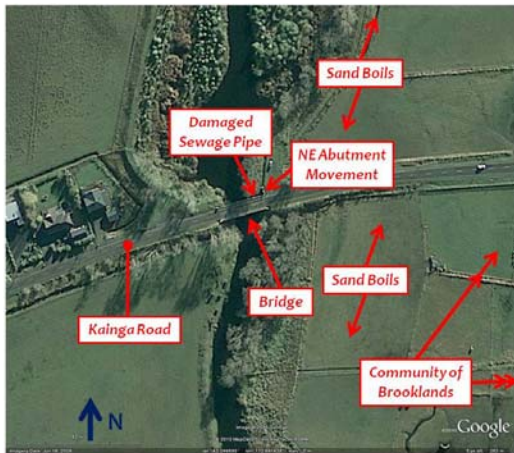
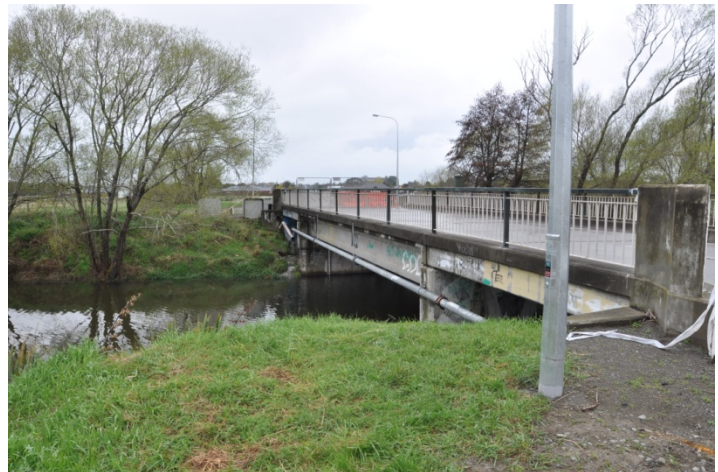
The Kainga Road Bridge is a short span bridge leading to the Brooklands residential community (Figure 7.30), and according to the New Zealand Natural Hazard Platform Bridge Research Group, the bridge remained closed at the time of the Team's visit on 13 September 2010 at the request of local authorities to limit access to an adjacent area extensively damaged by liquefaction. Structurally, the 1963 mixed girder-slab reinforced concrete bridge was in good condition. However, movement of the northeast abutment wing wall resulted in damage to an 18-cm diameter sewage pipe that was rigidly connected along the bridge span (Figure 7.31). Raw sewage continued to flow into the river from the damaged pipe at the time of the site visit (Figure 7.32a). Posted signs and discussions with locals confirmed that the flow was contaminated liquid (Figure 7.32b). Directly below the bridge, a pipe of similar diameter suffered no damage, and the Team noted that its support to the abutment wall was filled with flexible foam (Figure 7.33). At the East abutment, the northern wing wall moved towards the river and developed a gap with its backfill soils of about 2 cm, whereas the southern wing wall appeared to remain fixed. Soil spread away from the east abutment south wing wall leaving a gap of about 4 – 6 cm at its toe. Surrounding low lying marshlands and old paddock fields (as indicated by a postal worker interviewed during our visit) showed evidence of liquefaction (Figure 7.34).

Figure 7.30 Kainga Road Bridge to the Brooklands residential community (a) GoogleEarth image (-43.3998°, 172.6910°) and (b) overview of bridge looking west (-43.3997°, 172.6916°).

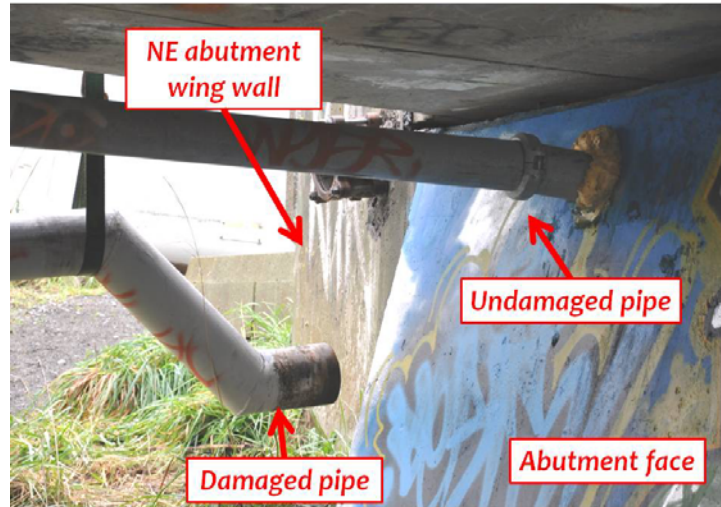
Figure 7.33 Below the East end of the Kainga road bridge (looking northeast). (-43.3998°, 172.6914°).

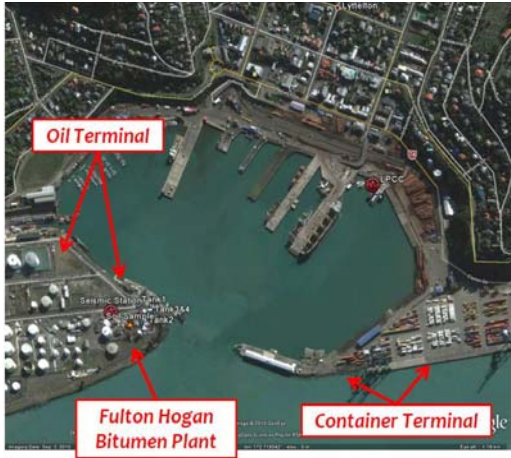
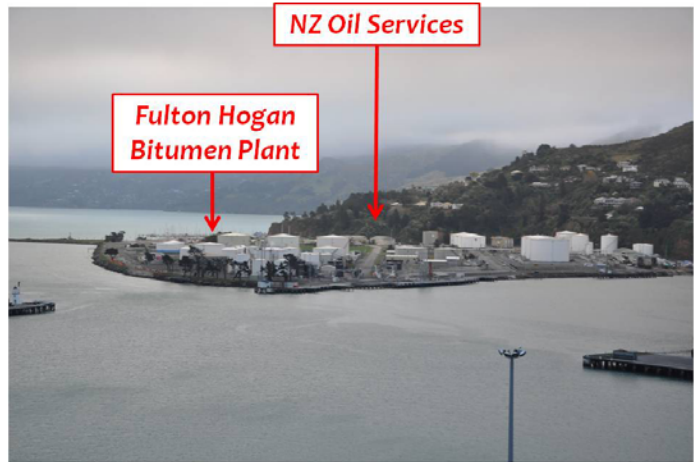
The Team visited the Oil Terminal side of the Lyttelton Port of Christchurch (Figure 7.40) on 13 September 2010, and the most significant damage was the area leased to the Fulton Hogan Bitumen plant (fultonhogan.com). The Team visited this plant and discussed observations with the plant manager, Steve Platt. He was advised by port officials that approximately 10 cm of lateral spreading of the wharf supporting the plants facilities had occurred on the eastern water face of the terminal.

Figure 7.40 Port of Lyttelton locating the oil terminal area (GoogleEarth image; -43.6088° , 172.7140°) and (b) Aerial view of the Fulton Hogan Bitumen Plant (image taken from -43.6068° , 172.7272°).

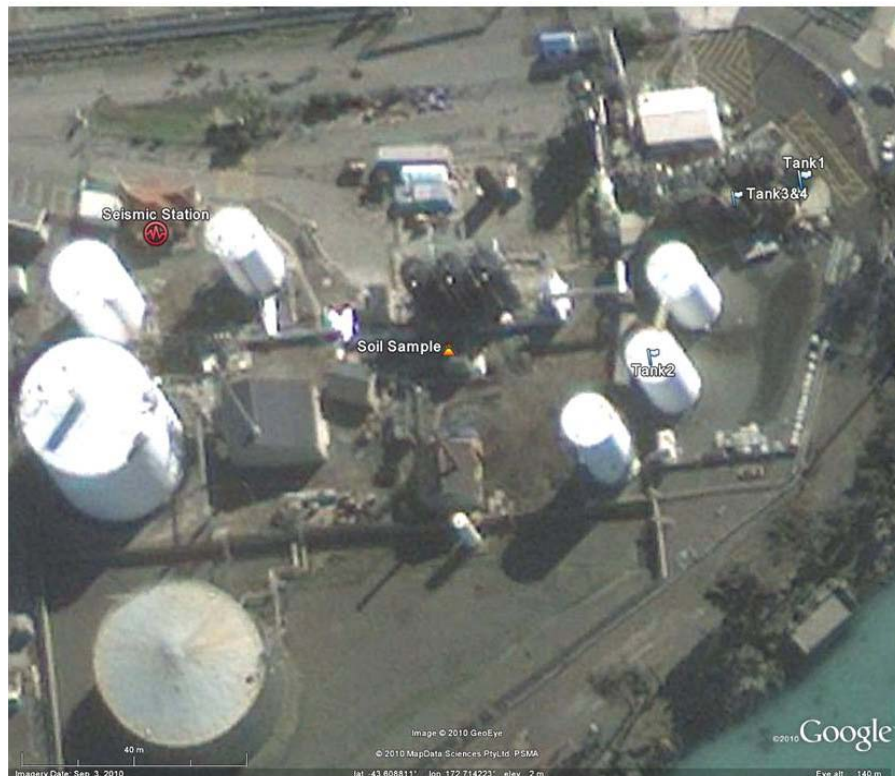
As a result of the lateral spreading, as well as liquefaction within the bitumen plant, four tanks and some supporting piping suffered movement and damage. These are noted in Figure 7.41 as Tanks 1-4. The most severe lateral movement was that of Tank 1 (located at -43.6085° , 172.7149°), which moved laterally 50 mm towards the water. Tank 2 (-43.608768° , 172.714651°) settled uniformly about 30 mm causing separation of the connecting bridge between it and a neighboring tank of like geometry (Figure 7.42). This tank, with dimensions of 12.8-m high by 13-m diameter, housed used oil and was nearly filled to capacity at the time of the main shock, weighing an estimated 550 tons. Tanks 3 and 4 (-43.6085° , 172.7149°) were side-by-side and each experienced movement that resulted in pullout of nearly all perimeter anchor bolts at their base. These tanks were 12.5-m tall by 6-m diameter with an estimated 150-ton weight at the time of the main shock. Crews were repairing the support anchorage for Tanks 3 and 4 with the retrofit shown in Figure 7.43. No structural damage to the tanks was observed and flexible connections survived the strong shaking with only minor leakage. Asphalt repair using cement injection to fill the lateral spread cracks was on-going during the Team's visit (Figure 7.44). Sand boils were also observed at several locations within the plants boundaries. Soil samples of the ejecta indicated the material was clean sand with little to no fines (Figure 7.45).

Figure 7.41 Zoomed into the region of the Fulton Hogan Bitumen Plant (GoogleEarth image; -43.6088° , 172.7140°).

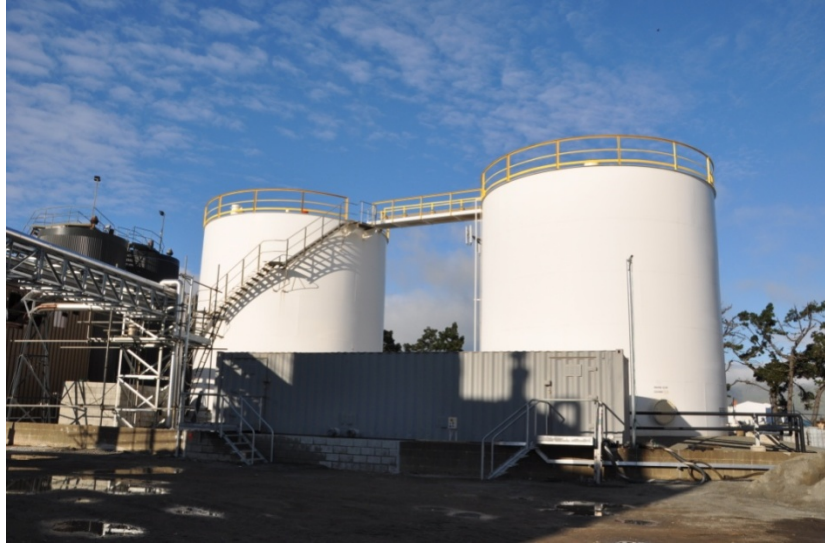
Figure 7.42 Tank 2 (right most large white tank) with Tanks 3 and 4 shown to the left (smaller grey tanks) at the Fulton Hogan Bitumen Plant (-43.6088°, 172.7147°).

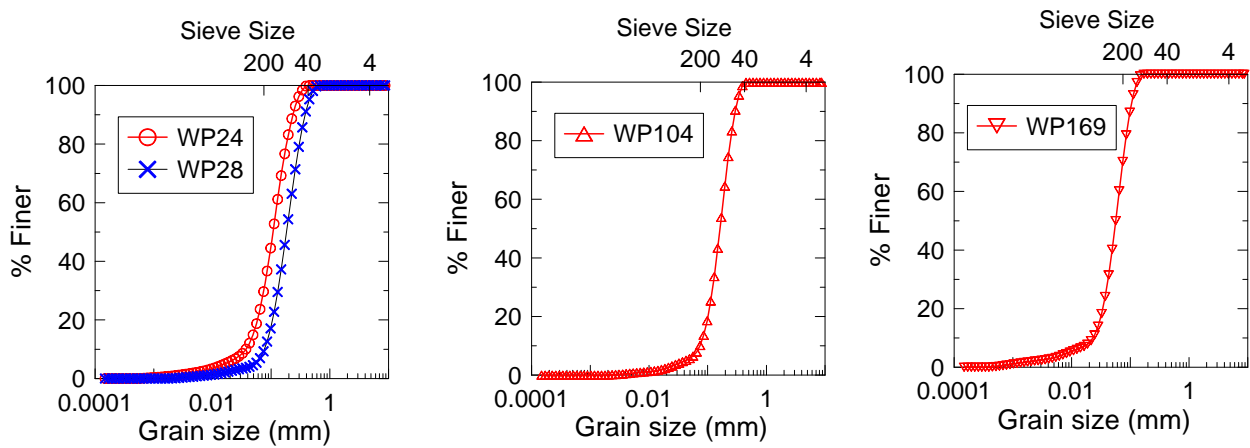
Figure 7.45 Laser diffraction tests of samples taken from ejecta observed at the Fulton Hogan Bitumen Plant. Sample WP169 taken at -43.6087°, 172.7142°.
